## **Occupational Health & Safety Report** 27 Bay Sample St Port Melbourne VIC 3207

## 27 Bay Sample St Port Melbourne VIC 3207

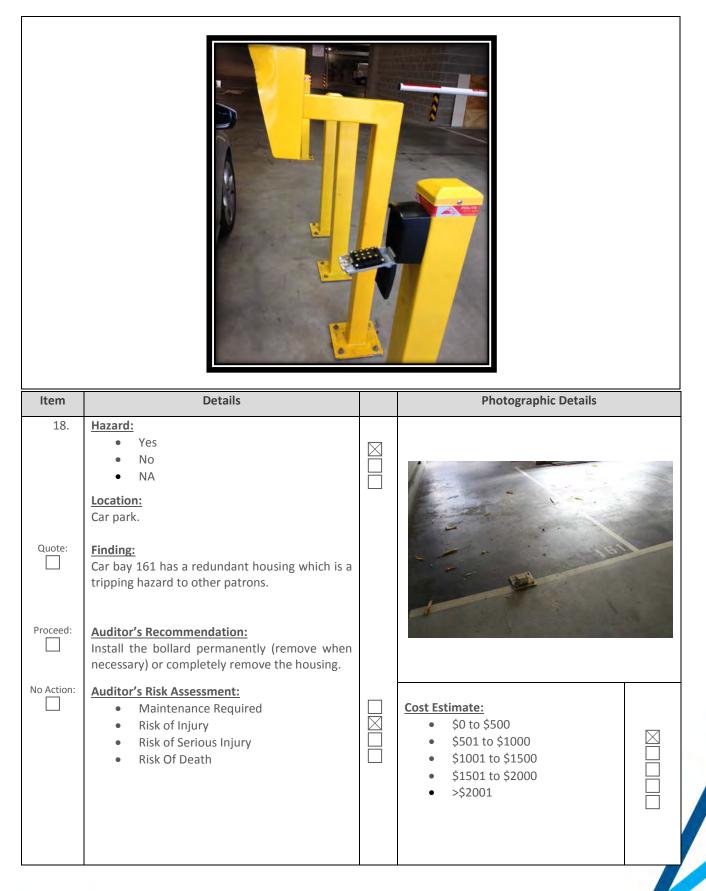
#### Example of a similar system

Item	Details	Photographic Details
Quote:	Hazard:       • Yes         • No       • NA         Location:       Car park entrance.         Car park entrance.       Finding:         Emergency exit door not labelled.       Mulitor's Recommendation:         Install appropriate label for emergency exit door.	
No Action:	Auditor's Risk Assessment: Maintenance Required Risk of Injury Risk of Serious Injury Risk Of Death	Cost Estimate:          • \$0 to \$500       □         • \$501 to \$1000       □         • \$1001 to \$1500       □         • \$1501 to \$2000       □         • \$2001       □
Quote:	<ul> <li>Hazard: <ul> <li>Yes</li> <li>No</li> <li>NA</li> </ul> </li> <li>Location: <ul> <li>Car park entrance.</li> </ul> </li> <li>Finding: <ul> <li>Currently residents are required their badge their access control fobs to open the front car park roller door on the opposite side of the drive way which could result in a head on collision.</li> </ul> </li> <li>Auditor's Recommendation:</li> </ul>

No Action:	Auditor's Recommendation: Relocate the access control on a pole and subsequently install line markings on the driveway. Please see the photo below of similar system installed in a car park. Auditor's Risk Assessment: Maintenance Required Risk of Injury Risk of Serious Injury Risk Of Death	Cost Estimate: <ul> <li>\$0 to \$500</li> <li>\$501 to \$1000</li> <li>\$1001 to \$1500</li> <li>\$1501 to \$2000</li> <li>\$2001</li> </ul>

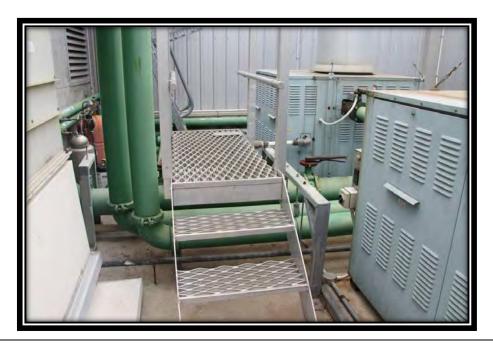
Condenser water pipes cat way example.

Item	Details	Photographic Details
Quote:	Hazard:       • Yes         • No       • NA         Location:       Roof.         Finding:       Catwalk ramp not installed over water pipes resulting in trade's men crushing the pipe due to walking over them.         Auditor's Recommendation:       To install a similar catwalk ramp as currently installed over the condenser water pipes.	
No Action:	Auditor's Risk Assessment: Maintenance Required Risk of Injury Risk of Serious Injury Risk Of Death	Cost Estimate:
