24/7 Emergency Property Maintenance Assistance Incident Report 16 May 2014 - 38 Bay Sample Street Port Melbourne VIC 3207

24/7 Incident Attendance Report

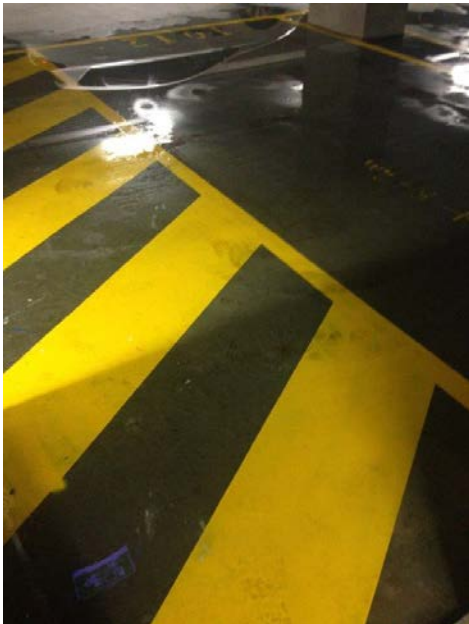
<p>Upon arriving onsite, three levels of the car park were full of black water (sewage/grease).</p>

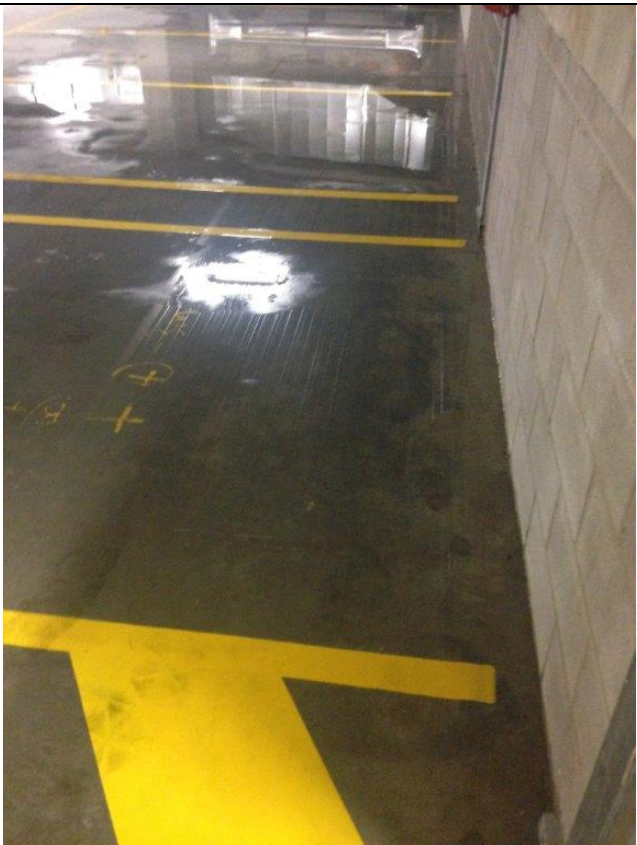
5

<p>Upon arriving onsite, three levels of the car park were full of black water (sewage/grease).</p>
6	 	<p>Upon arriving onsite, three levels of the car park were full of black water (sewage/grease).</p>

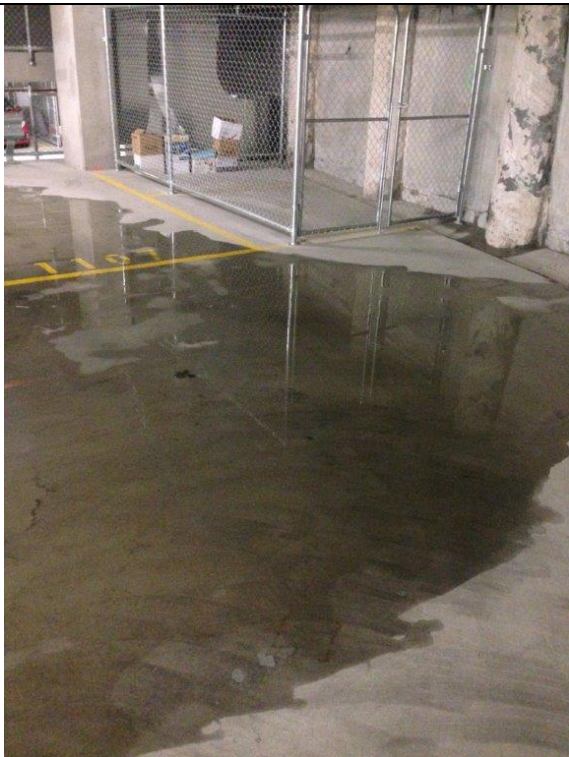
9

<p>Upon arriving onsite, three levels of the car park were full of black water (sewage/grease).</p>
10

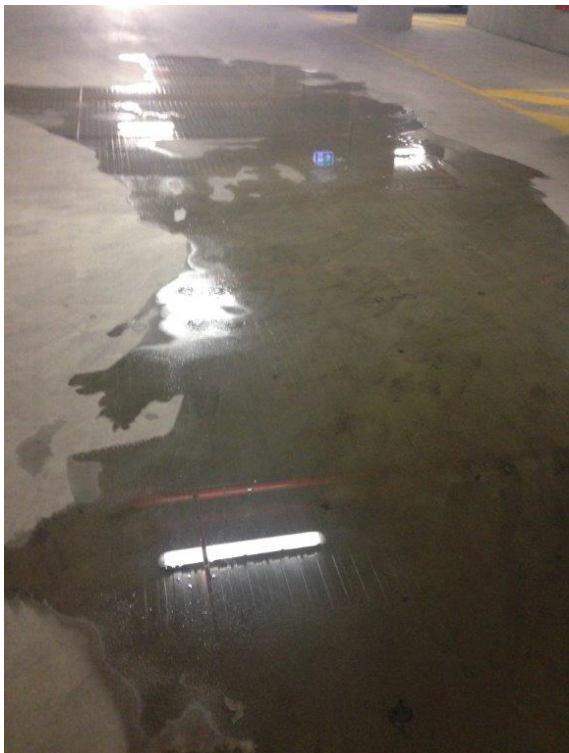
<p>Upon arriving onsite, three levels of the car park were full of black water (sewage/grease).</p>

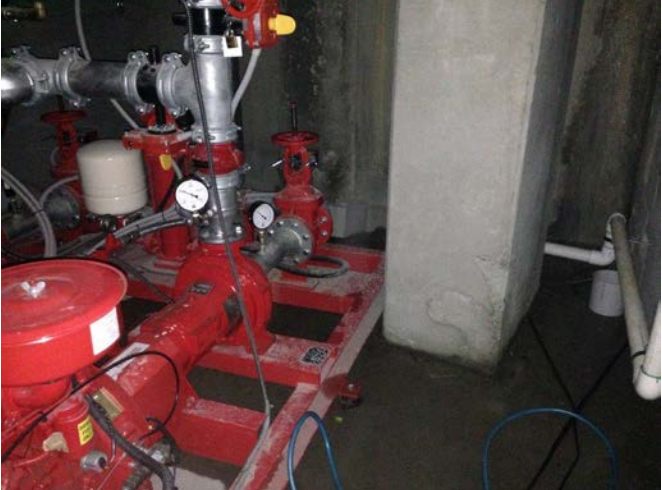
12

<p>Upon arriving onsite, the fire diesel pump room was full of black water (sewage/grease).</p>
13

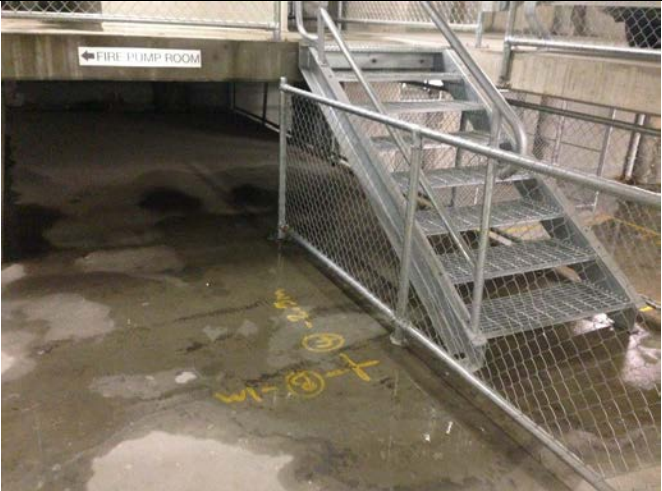
<p>Upon arriving onsite, three levels of the car park were full of black water (sewage/grease).</p>
14

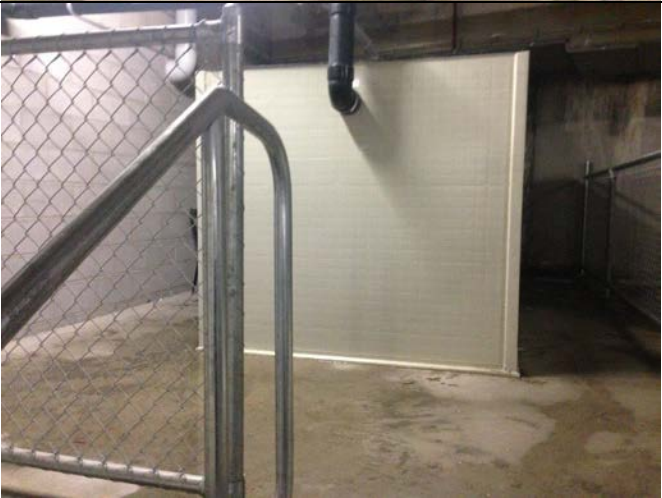
<p>Upon arriving onsite, three levels of the car park were full of black water (sewage/grease). This grease trap was full of sewage back flow.</p>

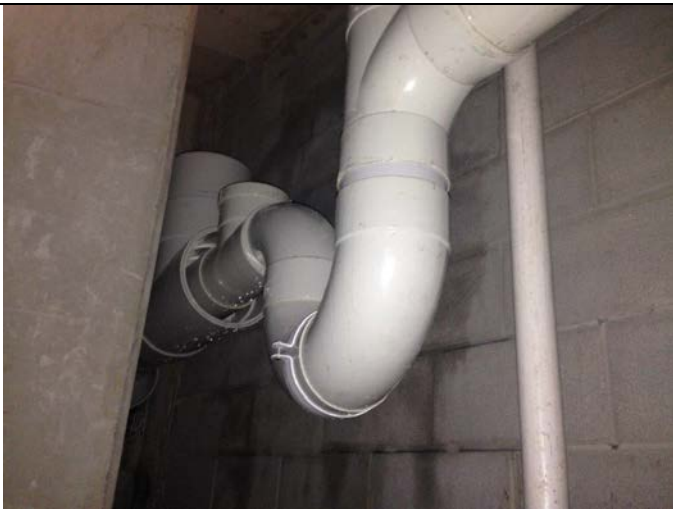
15

- Daniel indicated the affected blocked pipe had been cleared by a plumber (organised by the building manager Albert). This pipe which was blocked caused the sewage to back flow into the grease trap and subsequently overflow the grease trap.

<p>This is the pipe which was blocked and caused the sewage to back flow into the grease trap and subsequently overflow the grease trap.</p>
16
