Incident Report 3 June 2014 - 39 Bay Sample Street Port Melbourne VIC 3207

24/7 Incident Attendance Report

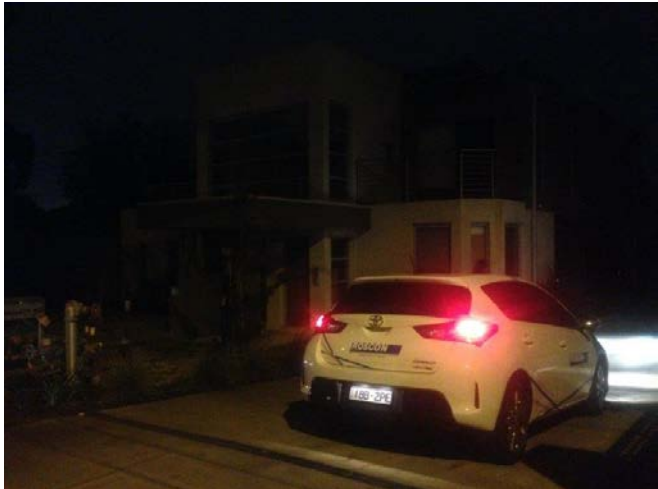
1

Roscon arrived onsite at 6:15pm.
2

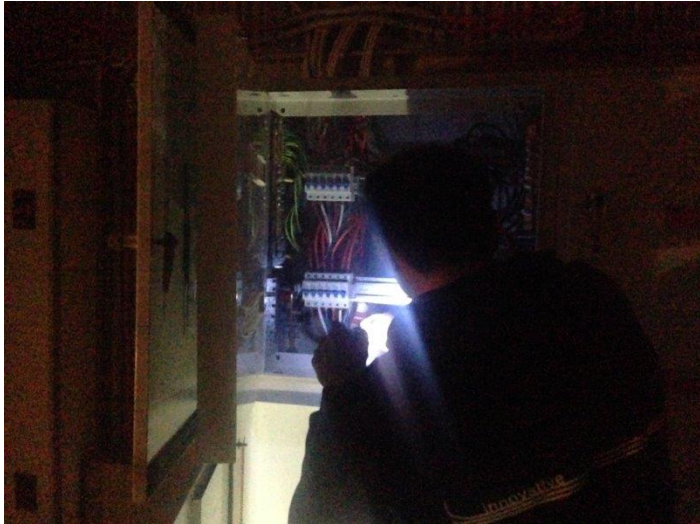
Roscon personnel conducting the required testing on the main switchboard.

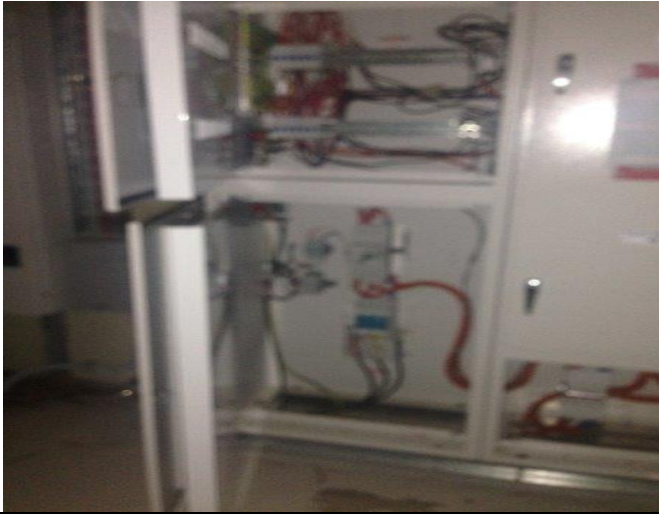
3

<p>Roscon personnel conducting the required testing on the main switchboard.</p>
4

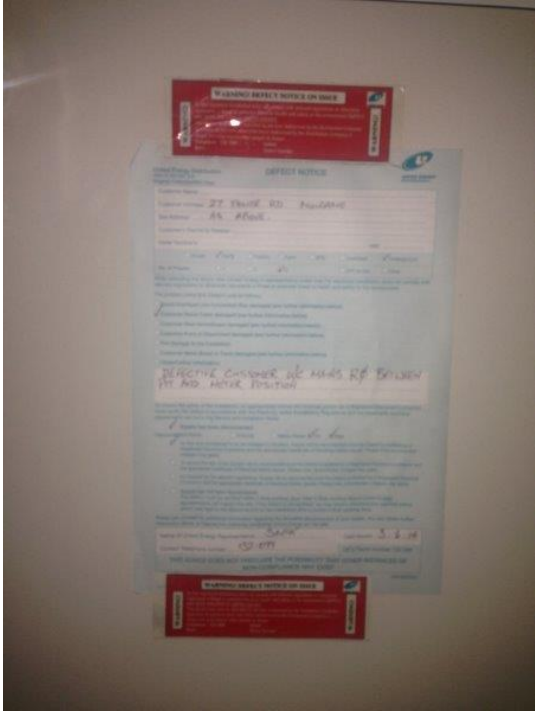
- Roscon found a defect notice left by United Energy, indicating **"Defective customer underground cable mains red phase between pit and meter position"**. When Roscon called United Energy they mentioned the occupant of unit 4 phoned United Energy today around 3pm regarding not having power. When the United Energy technician (SMcK) arrived onsite he tested the electrical pit on the footpath and the street pole/fuse on the nature strip which were both indicating power was available, however when he tested the main switchboard the red phase didn't have power. Subsequently the United Energy technician (SMcK) terminated the power to the entire complex at the pit and issued a defect notice (around 4:30pm), as he was under the impression the cable was damaged between the pit and main switchboard. United Energy mentioned this cable would need to be replaced and certificate of electrical safety issued prior to them attending site again.

<p>Defect notice issued by United Energy and left on the meter board.</p> <p>Defect Description – “Defective customer underground cable mains Red phase between pit and meter position”.</p>

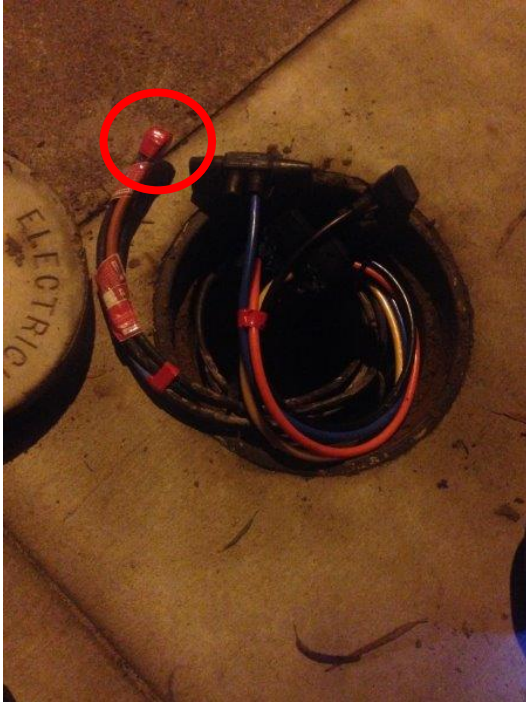
5

Location of the pit (footpath) where United Energy had terminated power to the development.

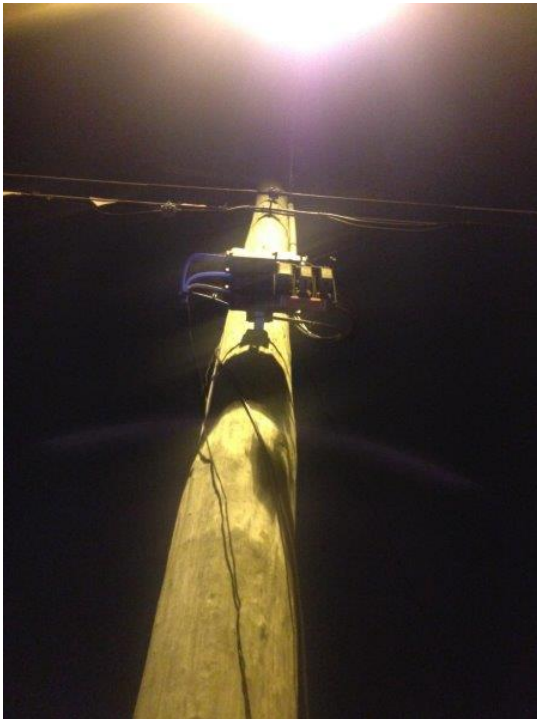
Location of power pole (nature strip) where United Energy had removed the fuses to power the development.

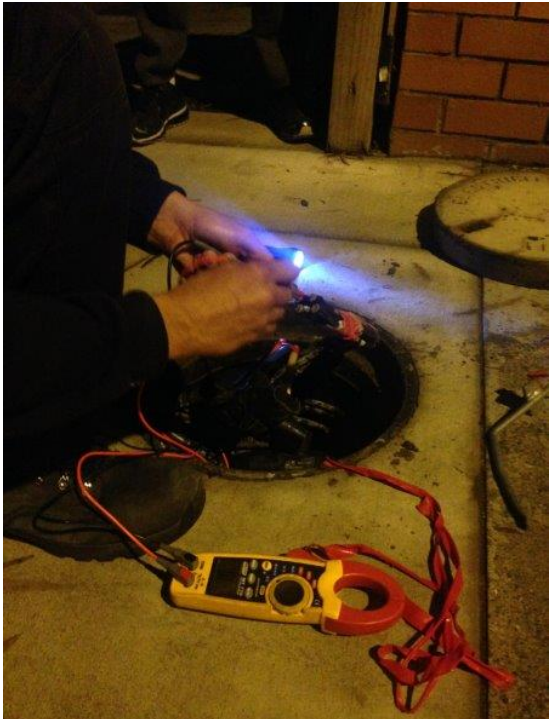
6

<p>Roscon personnel conducting the required testing on the terminated cabling.</p>
---	---	--

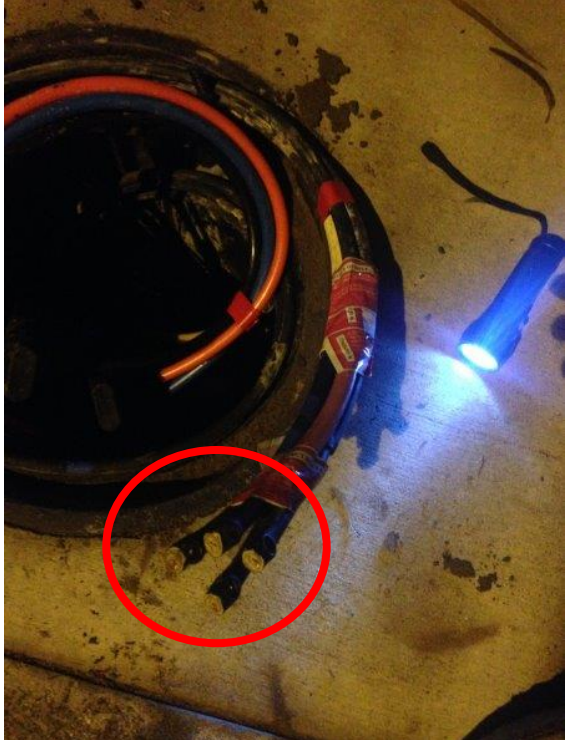
7

<p>Terminated cabling at footpath, all three phases had been disconnected by United Energy resulting in no power to the development.</p>
---	--	--

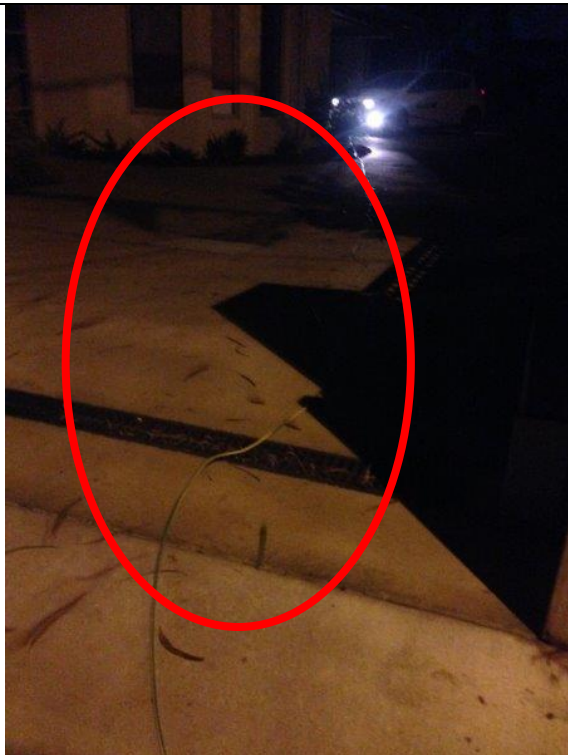
8

<p>Roscon personnel conducting the required testing by making a circuit to the switchboard with new cabling. Roscon had cordoned off the area to the public for OH&S, and using vehicles for temporary lighting.</p>
9

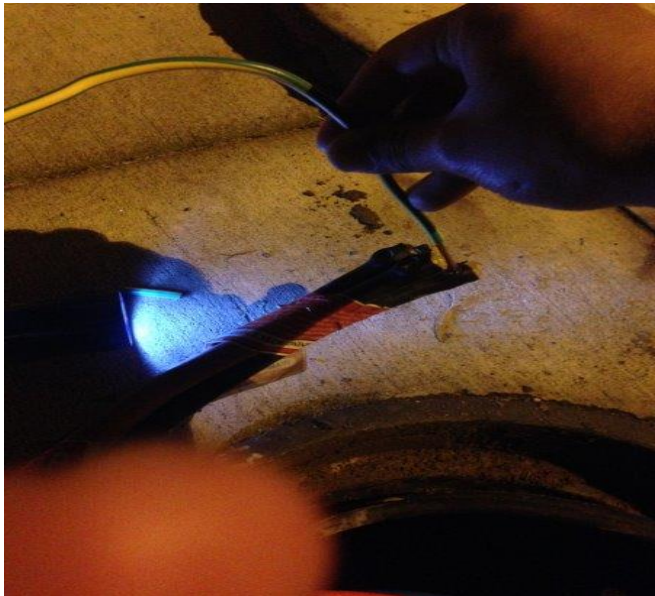
<p>Roscon personnel conducting the required testing by making a circuit to the switchboard with new cabling. Roscon had cordoned off the area to the public for OH&S, and using vehicles for temporary lighting.</p>

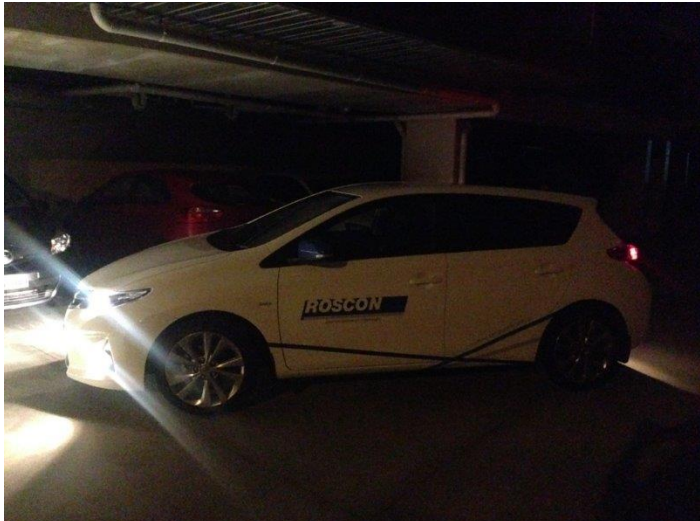
11

<p>Roscon had cordoned off the area to the public for OH&S, and using vehicles for temporary lighting.</p>
12

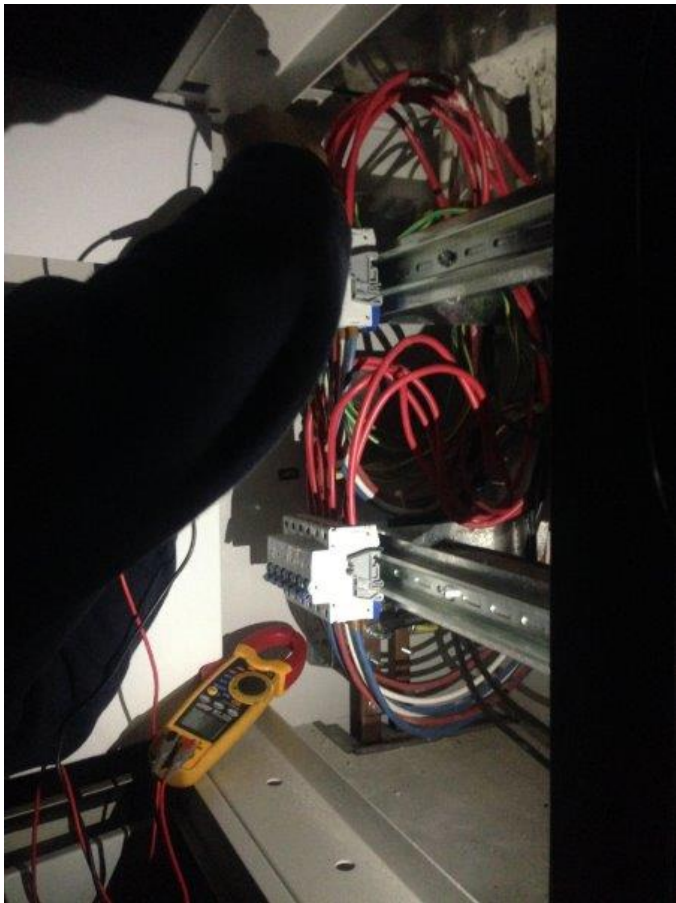
<p>Roscon personnel conducting the required testing by making a circuit to the switchboard with new cabling.</p>

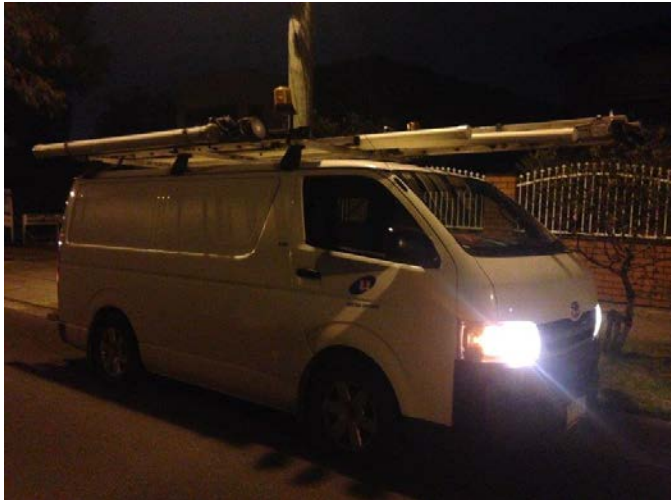
13

<p>United Energy arrived onsite at 8:30pm after Roscon completed the required testing and logged a job with the United Energy national help desk (132 099) and provided a certificate of electrical safety (certificate number 619167736).</p>
14

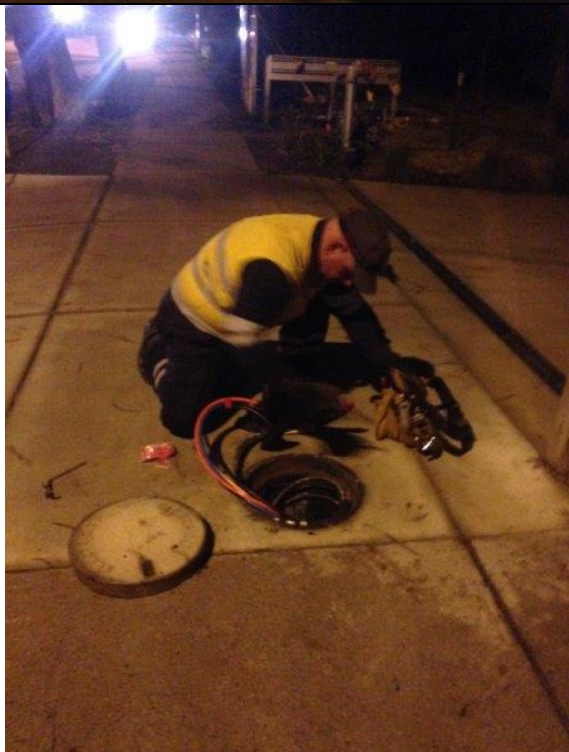
<p>United Energy arrived onsite at 8:30pm after Roscon completed the required testing and logged a job with the United Energy national help desk (132 099) and provided a certificate of electrical safety (certificate number 619167736).</p> <p>This photo illustrates the United Energy staff connecting all three phases again into the mains.</p>

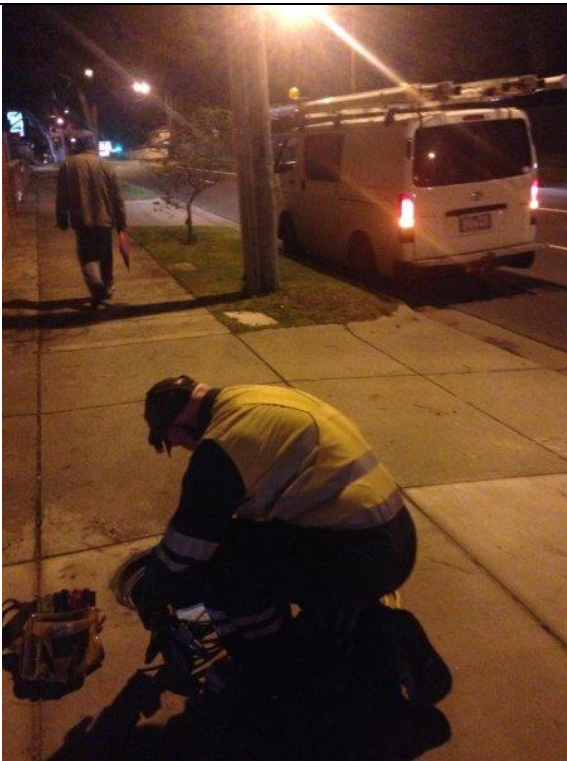
15

<p>United Energy arrived onsite at 8:30pm after Roscon completed the required testing and logged a job with the United Energy national help desk (132 099) and provided a certificate of electrical safety (certificate number 619167736).</p> <p>This photo illustrates the United Energy staff connecting all three phases again into the mains.</p>
16

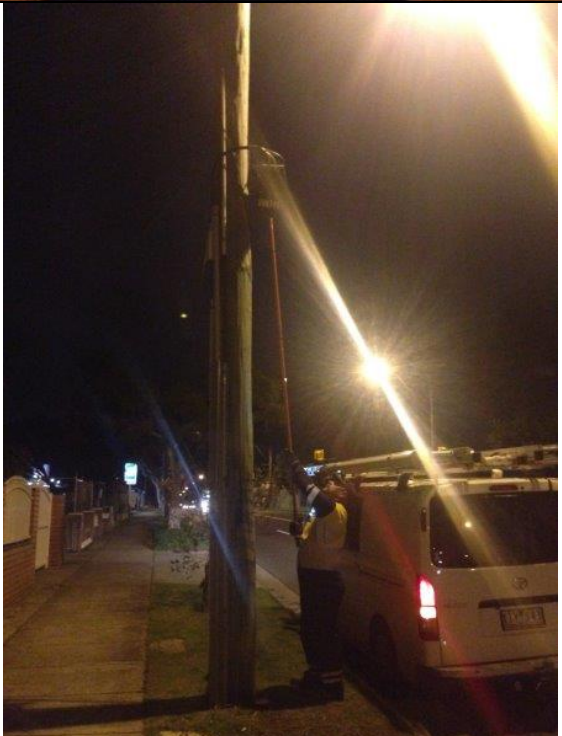
<p>This photo illustrates the United Energy staff connecting the fuse back into the power pole.</p>

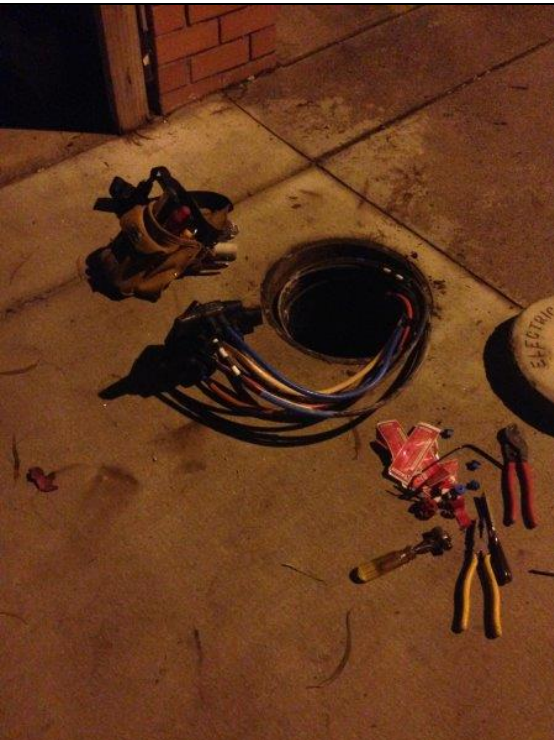
17

<p>This photo illustrates the United Energy staff connecting all three phases again into the mains.</p>
18

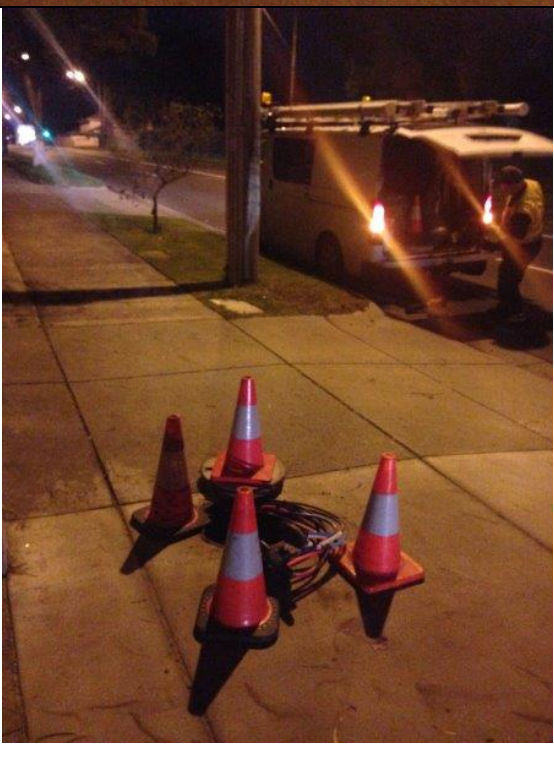
<p>This photo illustrates the United Energy staff connecting all three phases again into the mains.</p>

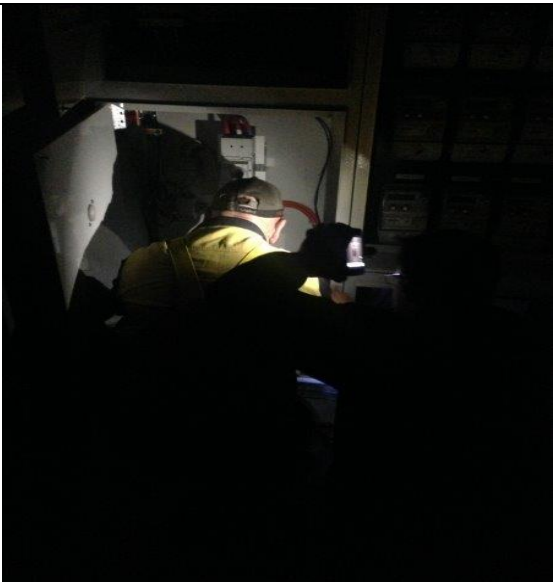
19

<p>This photo illustrates the United Energy staff allowing the connection to be returned after they were satisfied with the Roscon testing conducted.</p>
20

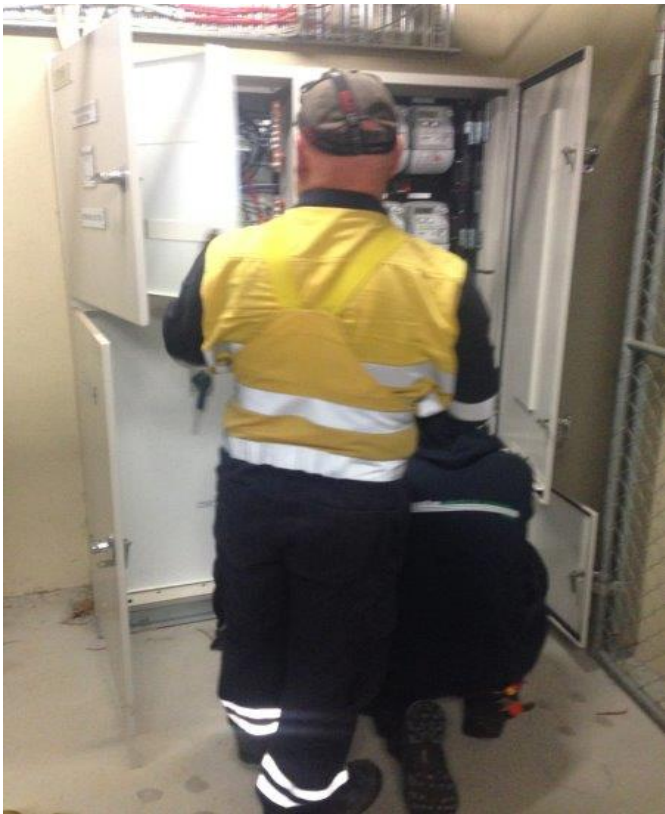
<p>Power was restored back to the development by Roscon at 8:57pm.</p>

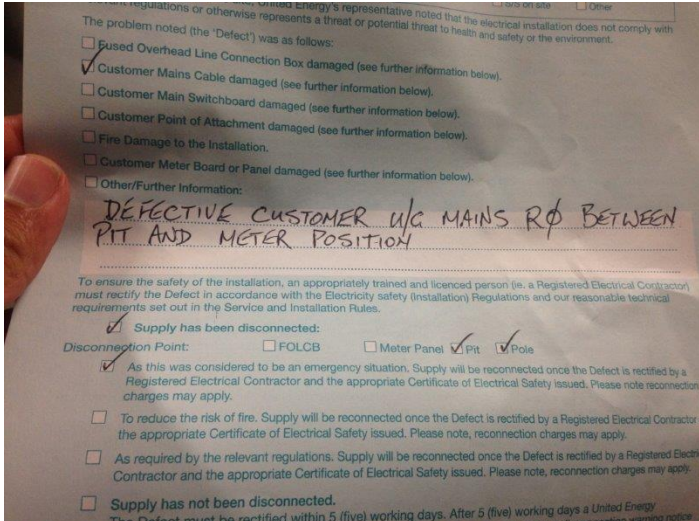
<p>21</p>

<p>Defect notice issued by United Energy and left on the meter board.</p> <p>Defect Description – “Defective customer underground cable mains Red phase between pit and meter position”.</p>
<p>22</p>

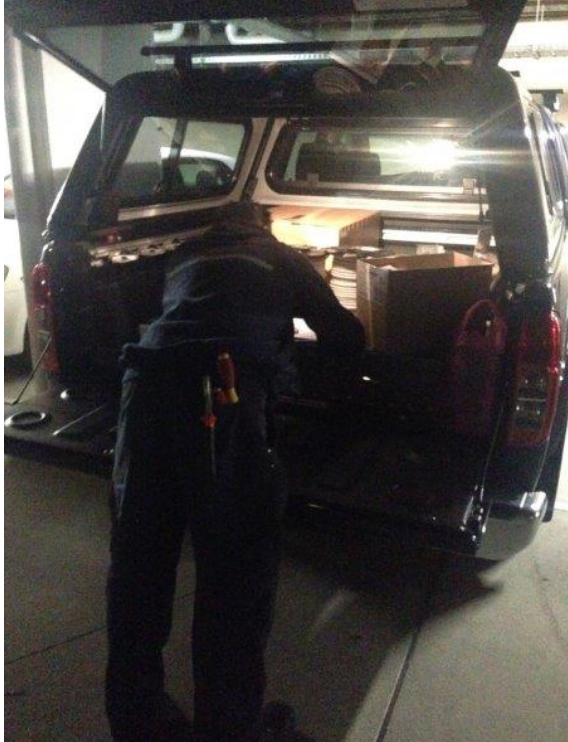
<p>Power was restored back to the development by Roscon at 8:57pm.</p>

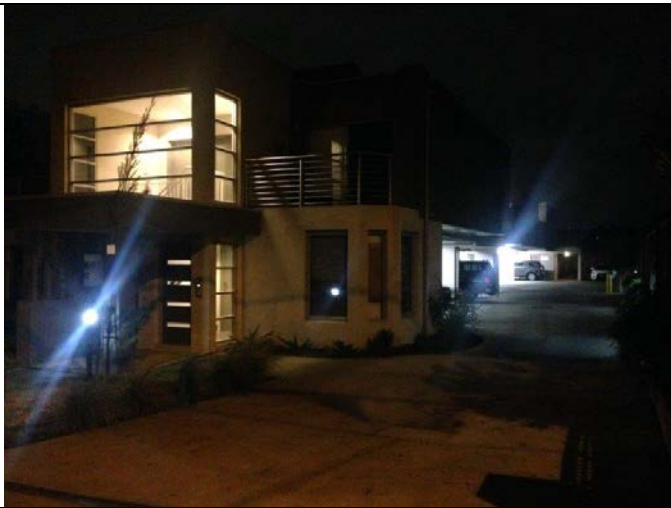
25

<p>Power was restored back to the development by Roscon at 8:57pm.</p>
26

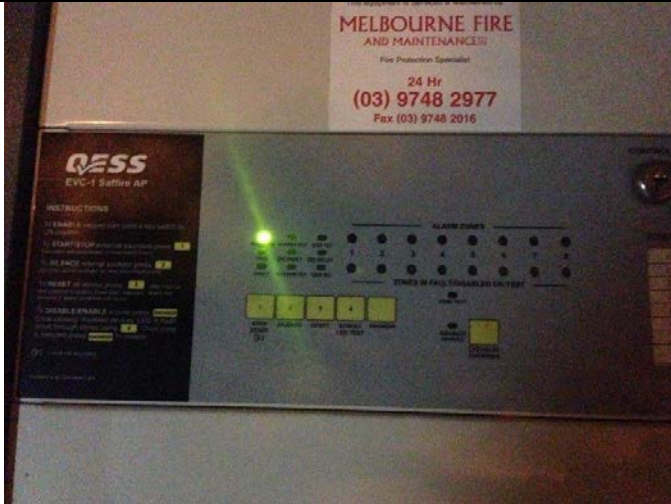
<p>Roscon also isolated the fire indicator panel (FIP) prior to restoring power to ensure no false alarms were sent to the MFB resulting in a call out.</p> <p>After the power was restored to the development, Roscon de- isolated the fire panel and the faults were cleared from the FIP.</p>

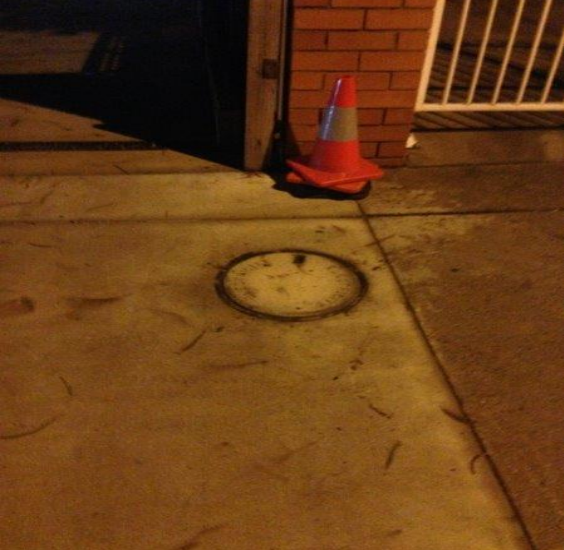
27

<p>Site was made safe by eliminating all trip hazards ASAP.</p>
28

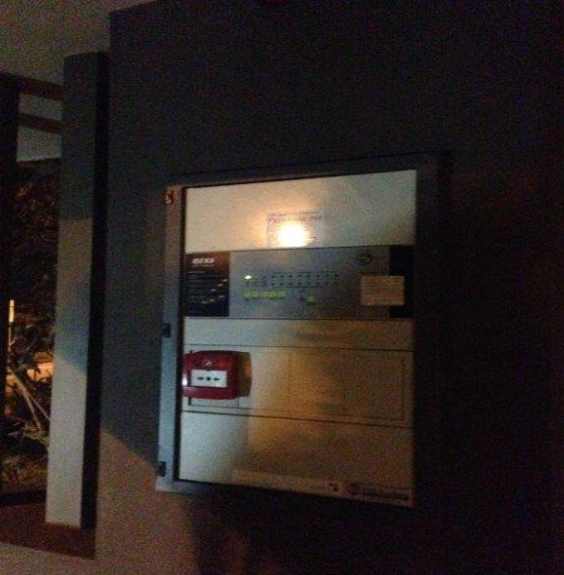
Tick where applicable (tick appropriate box's)	<input checked="" type="checkbox"/>	Other information
1 <input checked="" type="checkbox"/> Service call/s		Noted that the door of the FIP is missing, as the FIP is located outside, if water was to enter the panel it could lead to false alarms and an MFB callout. Roscon recommends replacing the door ASAP.
2 <input checked="" type="checkbox"/> Multi trades		
3 <input checked="" type="checkbox"/> Other

<p>Noted that the door of the FIP is missing, as the FIP is located outside, if water was to enter the panel it could lead to false alarms and an MFB callout. Roscon recommends replacing the door ASAP.</p>
