Detailed Costings Report

1 Sample Street, Melbourne VIC 3022

9 May 2017

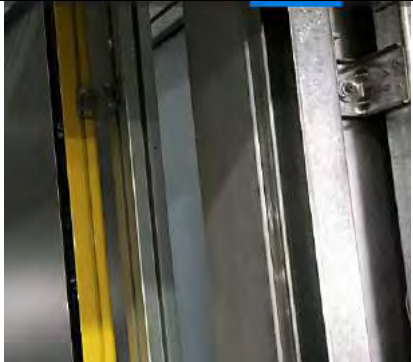
<p>NC1 MACHINE EXCLUSION ZONE: The machine is located in the basement carpark amongst aligning carpark spaces. The rear doors swing open into an undefined area that needs clearly defined exclusion from cars parking in the area and functionality to stop the doors opening or closing while a car is present in the area.</p>	 
<p>NC2 CONTROL STATIONS: Incorrectly identified control buttons and stop button functionality noncompliant. No operating instructions available within hoist operating area.</p>	 
<p>NC3 EMERGENCY EGRESS: Unidentified or monitored emergency egress allowing motion of platform outside of safe operating area.</p>	 
<p>NC4 MACHINE DOORS: Inadequate door locking control and mechanism.</p>

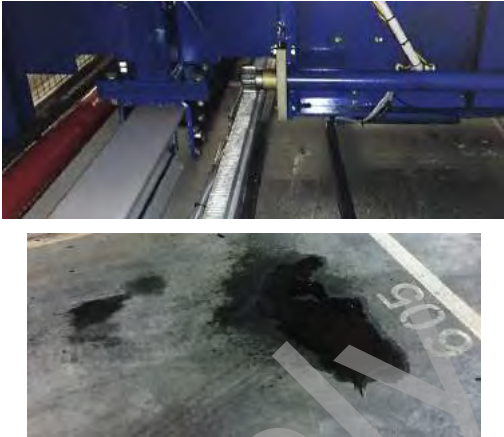
<p>D1 MACHINE ACCESS: The machine is located in the basement carpark amongst aligning carpark spaces. The access is inadequate to open control cabinet and in adequate lighting is provided.</p>	 
<p>D2 MACHINE ENCLOSURE: Machine enclosure has many open penetrations that need permanent fixings to cover up these areas.</p>	 
<p>D3 MACHINE STRUCTURE: Machine structure has some alignment and welding required. The anchoring bolts need to be pull tested for mechanical strength and fixing.</p>	 
<p>D4 PLATFORM CLEARANCE: Platform clearances are too small or too large and should be no less than 25mm and no more than 50mm. These clearances should be corrected.</p>

<p>D5 MACHINE LOCATION: The machine is located in the basement carpark above other carpark spaces.</p> <p>The machine does not have any fall restraint equipment in the event of structural failure of the lifting equipment.</p>

Car park lift platform	D5	The car park lift has no fall restraint system to protect cars below in the event of a failure.	Supply & install emergency brakes	Lift Contractor	2	24	48	\$90.00	\$4,320.00	\$8,800.00	\$13,120.00		\$3,936.00	\$17,056.00	\$1,705.60	\$18,761.60	\$26,312.00
			Supply & install fall restraints	Lift Contractor	2	16	32	\$90.00	\$2,880.00	\$2,400.00	\$5,280.00		\$1,584.00	\$6,864.00	\$686.40	\$7,550.40	
Car park lift platform enclosure	D6	Platform lift cage does not have rigidity for safe egress	Suply & install steel walkway	Access Consultant	1	32	32	\$90.00	\$2,880.00	\$6,200.00	\$9,080.00		\$2,724.00	\$11,804.00	\$1,180.40	\$12,984.40	\$12,984.40
Car park lift machine access	D7	Floor of machine enclosure leaks oil	Service machine	Lift Contractor	1	16	16	\$90.00	\$1,440.00	\$3,400.00	\$4,840.00		\$1,452.00	\$6,292.00	\$629.20	\$6,921.20	\$8,522.80
			Coat floor of machine room with industrial coating	Labourer	1	8	8	\$45.00	\$360.00	\$760.00	\$1,120.00		\$336.00	\$1,456.00	\$145.60	\$1,601.60

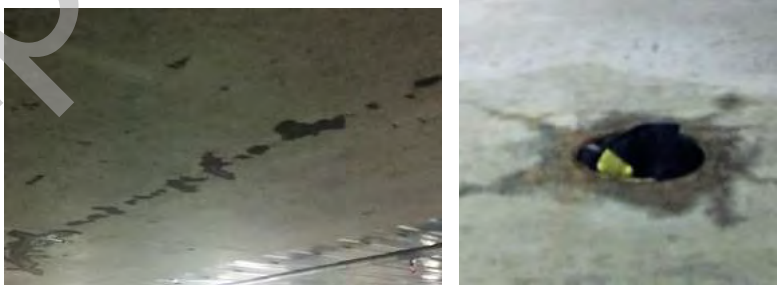
<p>D6 PLATFORM ENCLOSURE: Platform enclosure does not have rigidity to allow for safe egress. The enclosure has penetrations that need covering.</p>	 
<p>D7 MACHINE ENCLOSURE: Machine enclosure floor leaks oil and there are penetrations that need filling.</p>

Supply & install light	Electrician	1	8	8	\$85.00	\$680.00	\$150.00	\$830.00		\$249.00	\$1,079.00	\$107.90	\$1,186.90	
Car park lift machine enclosure	D2	Open penetrations around the face of the landing doors need to be covered.	Supply & Install 2mm thick aluminium sheet at voids	Lift Contractor	2	8	16	\$90.00	\$1,440.00	\$2,820.00	\$4,260.00		\$1,278.00	\$5,538.00	\$553.80	\$6,091.80	\$6,091.80
Car park lift machine structure	D3	The main supporting mast is misaligned at joints. Chemset bolts have been installed improperly	Remove existing steel guide uprights	Lift Contractor	2	32	64	\$90.00	\$5,760.00		\$5,760.00		\$1,728.00	\$7,488.00	\$748.80	\$8,236.80	\$51,708.80
			Supply and install new steel guide uprights	Lift Contractor	2	40	80	\$90.00	\$7,200.00	\$22,000.00	\$29,200.00	\$1,200.00	\$9,120.00	\$39,520.00	\$3,952.00	\$43,472.00	
Car park lift platform	D4	The platform is not aligned to give correct clearances between 25-50mm	Align Platforms	Lift Contractor	1	32	32	\$90.00	\$2,880.00		\$2,880.00		\$864.00	\$3,744.00	\$374.40	\$4,118.40	\$4,118.40
