Dilapidation Survey Report

76 Sample St Suburb VIC 3107

13 June 2014

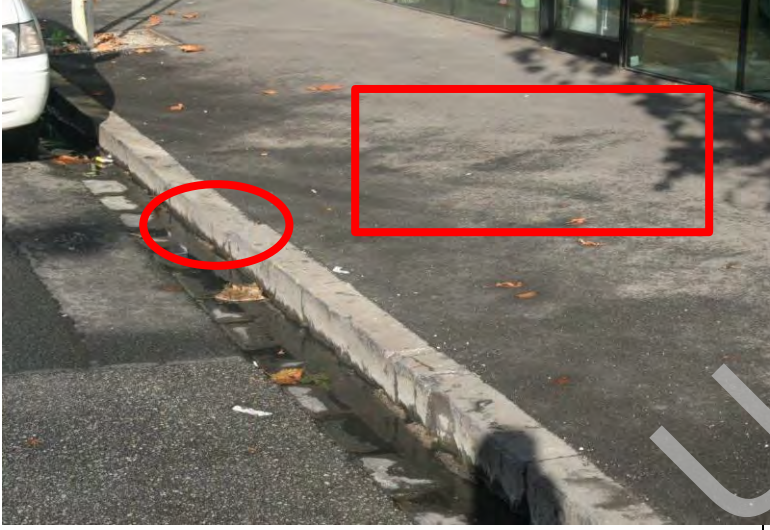
Item	Photographic Evidence	Assessments	
1.

Assessment Type: Good <input type="checkbox"/> Fair <input checked="" type="checkbox"/> Poor <input type="checkbox"/>	
		Impact Category: 1 <input type="checkbox"/> 2 <input checked="" type="checkbox"/> 3 <input type="checkbox"/> 4 <input type="checkbox"/> 5 <input type="checkbox"/>	
Location:	Auditors Comments: <ul style="list-style-type: none"> • Brick lined kerb and channel has lowered or sunk. • Road is also dirty and contains stains with fine cracks. • Scuffed asphalt footpath from environmental wear and lifespan.

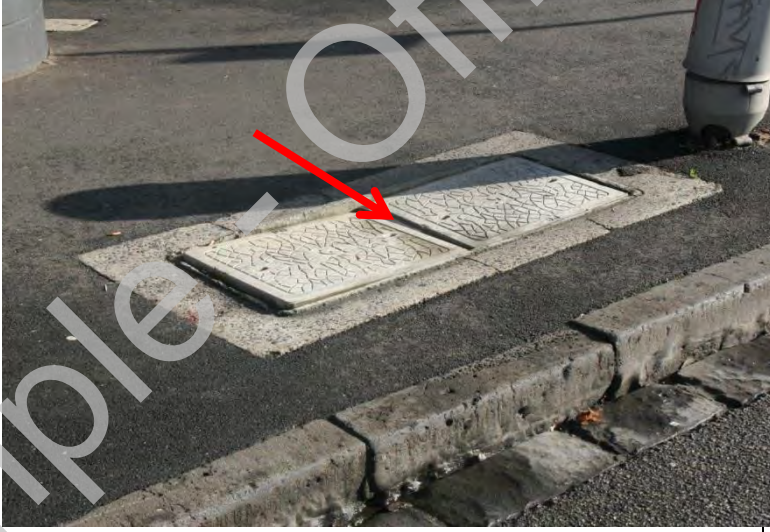
2.

Assessment Type: Good <input type="checkbox"/> Fair <input checked="" type="checkbox"/> Poor <input type="checkbox"/>	
		Impact Category: 1 <input type="checkbox"/> 2 <input checked="" type="checkbox"/> 3 <input type="checkbox"/> 4 <input type="checkbox"/> 5 <input type="checkbox"/>	
Location:	Auditors Comments: <ul style="list-style-type: none"> • Telstra Pit has depressed at its centre and is not finishing "at level" with the current surrounding concrete and asphalt. • Concrete around Telstra Pit has fine cracks that extend to the surrounding asphalt from the Telstra Pit. • Rainwater may pool around this Telstra Pit due to uneven levels. • Concrete kerb is uneven and discoloured. This is the typical condition of the concrete kerbs in the whole street. • Asphalt is discoloured in certain areas but is in serviceable condition.

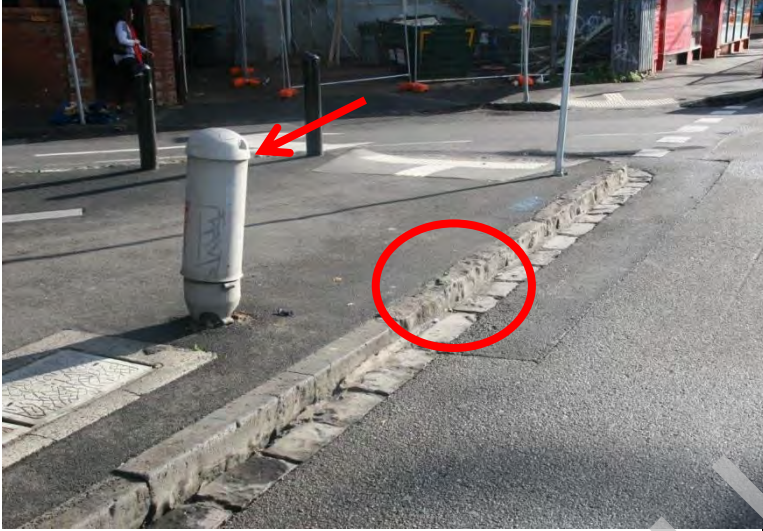
Item	Photographic Evidence	Assessments	
3.

Assessment Type: Good <input type="checkbox"/> Fair <input checked="" type="checkbox"/> Poor <input type="checkbox"/>	<input type="checkbox"/> <input checked="" type="checkbox"/> <input type="checkbox"/>
Location: Auditors Comments: <ul style="list-style-type: none"> • Saw cut section of asphalt does not finish at appropriate level with existing asphalt. • The concrete kerb is typically dirty, cracked and uneven. • Concrete kerb shows signs of wear and tear with chips taken off the top section of kerb. • Concrete services post is bent and leaning towards Belford Street. 		Impact Category: 1 <input type="checkbox"/> 2 <input checked="" type="checkbox"/> 3 <input type="checkbox"/> 4 <input type="checkbox"/> 5 <input type="checkbox"/>	<input type="checkbox"/> <input checked="" type="checkbox"/> <input type="checkbox"/> <input type="checkbox"/> <input type="checkbox"/>

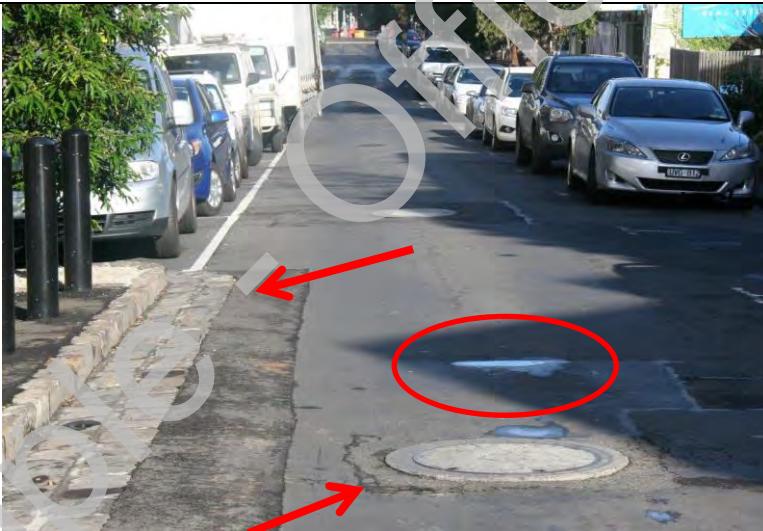
4.

Assessment Type: Good <input type="checkbox"/> Fair <input checked="" type="checkbox"/> Poor <input type="checkbox"/>	<input type="checkbox"/> <input checked="" type="checkbox"/> <input type="checkbox"/>
Location: Auditors Comments: <ul style="list-style-type: none"> • There is a raised asphalt section that leads to the kerb and channel. This asphalt does not finish at the level of the existing asphalt. • Water is ponding in the centre of the road pavement • Poor and uneven finish of asphalt around concrete services pit lid in centre of road pavement. • Concrete kerb shows signs of wear and tear with chips taken off the top section of kerb. 		Impact Category: 1 <input type="checkbox"/> 2 <input checked="" type="checkbox"/> 3 <input type="checkbox"/> 4 <input type="checkbox"/> 5 <input type="checkbox"/>	<input type="checkbox"/> <input checked="" type="checkbox"/> <input type="checkbox"/> <input type="checkbox"/> <input type="checkbox"/>

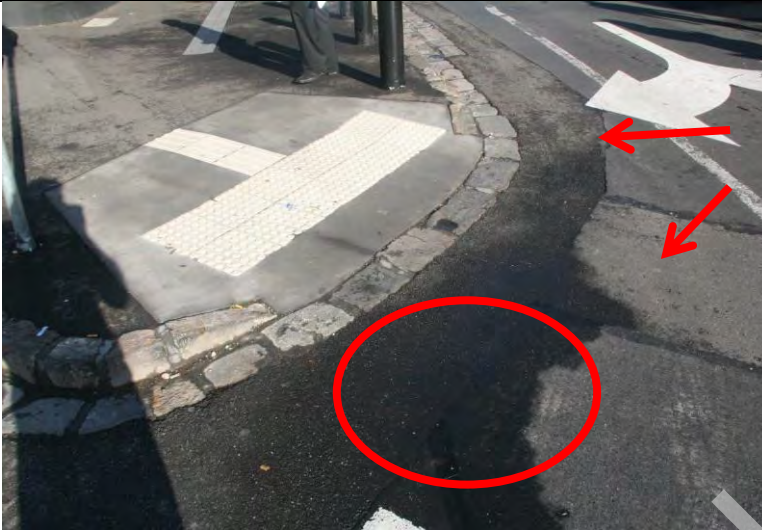
Item	Photographic Evidence	Assessments	
5.

Assessment Type: Good <input type="checkbox"/> Fair <input checked="" type="checkbox"/> Poor <input type="checkbox"/>	<input type="checkbox"/> <input checked="" type="checkbox"/> <input type="checkbox"/>
		Impact Category: 1 <input type="checkbox"/> 2 <input checked="" type="checkbox"/> 3 <input type="checkbox"/> 4 <input type="checkbox"/> 5 <input type="checkbox"/>	<input type="checkbox"/> <input checked="" type="checkbox"/> <input type="checkbox"/> <input type="checkbox"/> <input type="checkbox"/>
Location:	Auditors Comments: <ul style="list-style-type: none"> • Saw cutting has been utilised to safely install pram crossing. This has clearly led to a poor finish with existing asphalt and water is ponding on the asphalt at the exit /entrance of the pram crossing. • Concrete kerb shows signs of wear and tear with chips taken off the top section of kerb. • The concrete kerb is typically dirty, cracked and uneven.

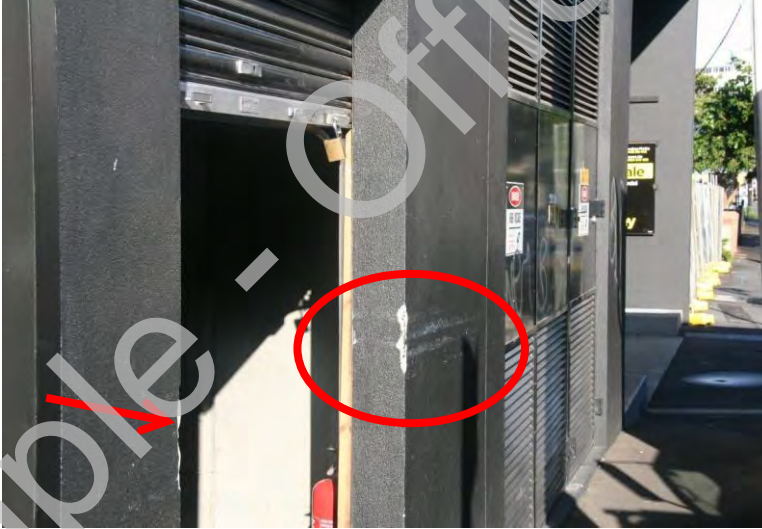
6.

Assessment Type: Good <input type="checkbox"/> Fair <input checked="" type="checkbox"/> Poor <input type="checkbox"/>	<input type="checkbox"/> <input checked="" type="checkbox"/> <input type="checkbox"/>
		Impact Category: 1 <input type="checkbox"/> 2 <input type="checkbox"/> 3 <input checked="" type="checkbox"/> 4 <input type="checkbox"/> 5 <input type="checkbox"/>	<input type="checkbox"/> <input type="checkbox"/> <input checked="" type="checkbox"/> <input type="checkbox"/> <input type="checkbox"/>
Location:	Auditors Comments: <ul style="list-style-type: none"> • The concrete wall has been significantly damaged and has been chipped on both sides of this small roller door. • Scraping marks are also evident along the length of the concrete side wall.

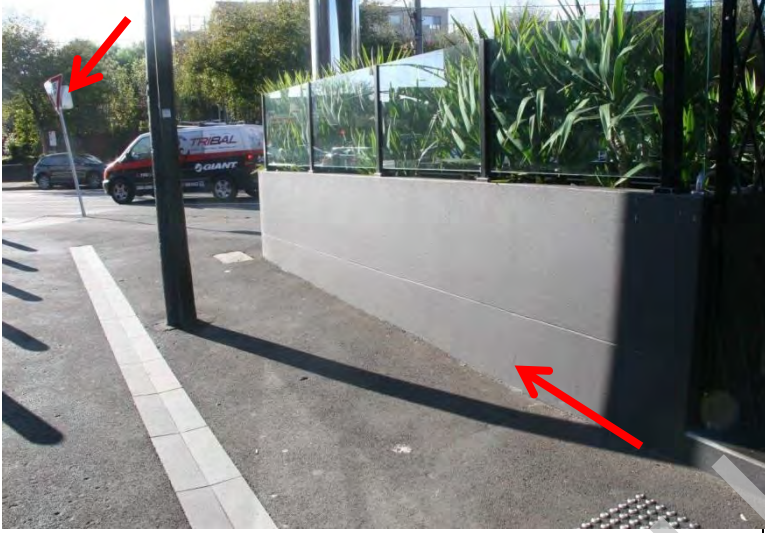
Item	Photographic Evidence	Assessments	
7.

Assessment Type: Good <input type="checkbox"/> Fair <input checked="" type="checkbox"/> Poor <input type="checkbox"/>	<input type="checkbox"/> <input checked="" type="checkbox"/> <input type="checkbox"/>
		Impact Category: 1 <input checked="" type="checkbox"/> 2 <input type="checkbox"/> 3 <input type="checkbox"/> 4 <input type="checkbox"/> 5 <input type="checkbox"/>	<input checked="" type="checkbox"/> <input type="checkbox"/> <input type="checkbox"/> <input type="checkbox"/> <input type="checkbox"/>
Location:	Auditors Comments: <ul style="list-style-type: none"> • The give way sign is significantly bent and is leaning towards Belford Street. • There are some hairline cracks in the concrete rendering. • Brick lined kerb and channel has lowered or sunk. • Road is also dirty and contains stains with fine cracks. • Scuffed asphalt footpath from environmental wear and lifespan.

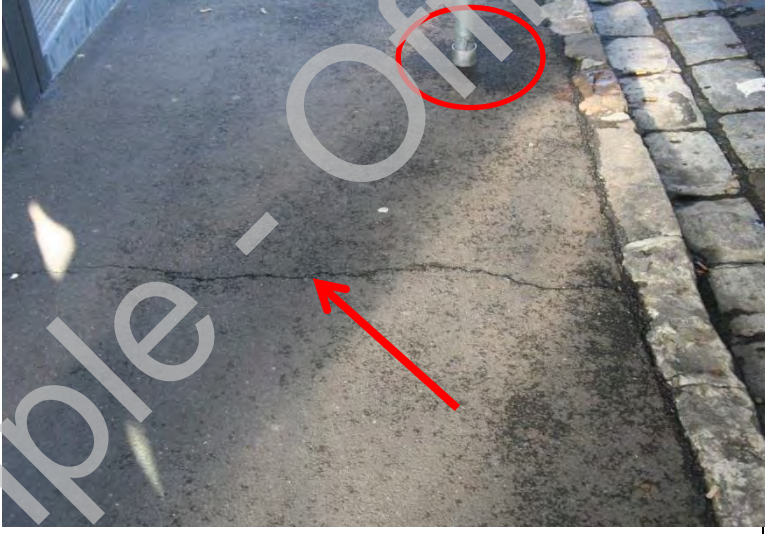
8.

Assessment Type: Good <input type="checkbox"/> Fair <input checked="" type="checkbox"/> Poor <input type="checkbox"/>	<input type="checkbox"/> <input checked="" type="checkbox"/> <input type="checkbox"/>
		Impact Category: 1 <input type="checkbox"/> 2 <input checked="" type="checkbox"/> 3 <input type="checkbox"/> 4 <input type="checkbox"/> 5 <input type="checkbox"/>	<input type="checkbox"/> <input checked="" type="checkbox"/> <input type="checkbox"/> <input type="checkbox"/> <input type="checkbox"/>
Location:	Auditors Comments: <ul style="list-style-type: none"> • Water is pooling around the base of the sign post. • There is a sizeable crack that extends from the kerb and channel to the side wall of the Luna building #173. • The crack is approximately 3 - 3.5mm wide. • The concrete kerb is typically dirty, cracked and uneven. • Concrete kerb shows signs of wear and tear with chips taken off the top section of kerb.

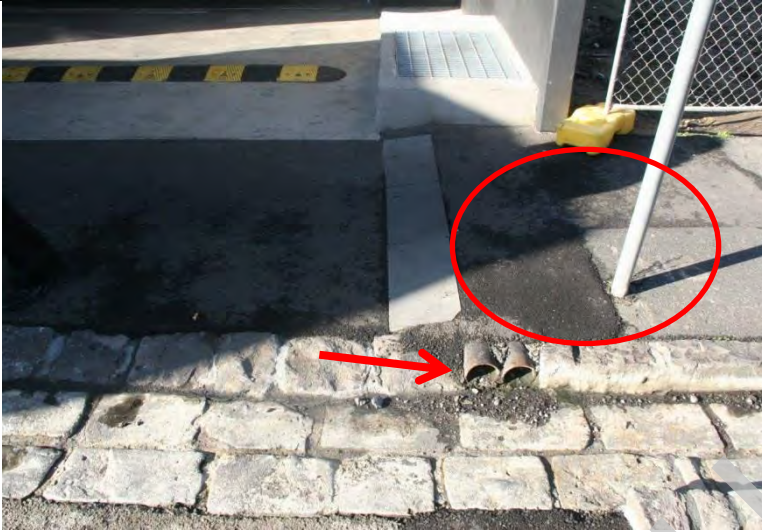
Item	Photographic Evidence	Assessments	
9.

Assessment Type: Good <input type="checkbox"/> Fair <input checked="" type="checkbox"/> Poor <input type="checkbox"/>	<input type="checkbox"/> <input checked="" type="checkbox"/> <input type="checkbox"/>
Location: Auditors Comments: <ul style="list-style-type: none"> Cracks are visible on the surface of the road and concrete kerb and gutter. The concrete kerb and gutter is typically dirty, cracked and uneven. The two drainage outlets are obstructed with small sized gravel and soil. The drainage channel is uneven, cracked, chipped and is filled with soil and gravel also. There is in-filled asphalt that attempts to fill in a depression of the walkway pavement. It also provides some extra cover to the two drainage outlets. This is poorly filled in and does not finish at an appropriate level with the existing walkway. 		Impact Category: 1 <input type="checkbox"/> 2 <input type="checkbox"/> 3 <input checked="" type="checkbox"/> 4 <input type="checkbox"/> 5 <input type="checkbox"/>	<input type="checkbox"/> <input type="checkbox"/> <input checked="" type="checkbox"/> <input type="checkbox"/> <input type="checkbox"/>

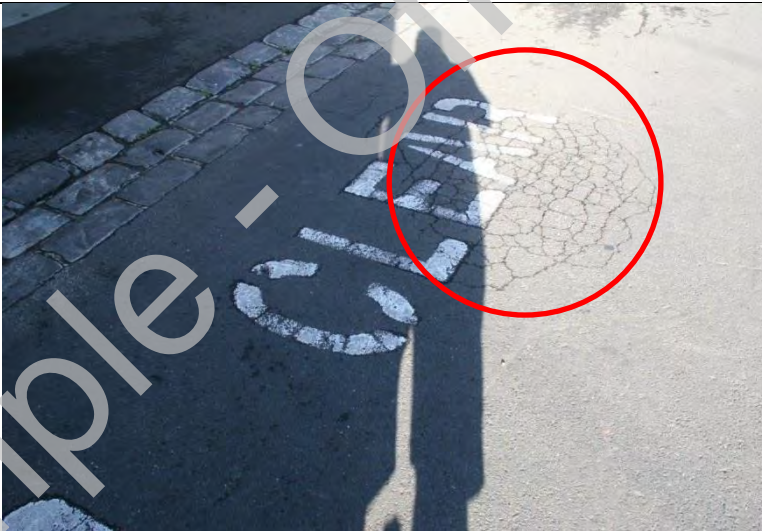
10.

Assessment Type: Good <input type="checkbox"/> Fair <input type="checkbox"/> Poor <input checked="" type="checkbox"/>	<input type="checkbox"/> <input type="checkbox"/> <input checked="" type="checkbox"/>
Location: Auditors Comments: <ul style="list-style-type: none"> Road pavement is significantly cracked in this section of the road pavement. This indicates that water is pooling at this point and may lead to a significant pothole. Other sections of the Belford Street are uneven and scuffed up but this is a significant issue; especially if potentially construction machinery will use this road as access to the # 7 construction site. 		Impact Category: 1 <input type="checkbox"/> 2 <input type="checkbox"/> 3 <input type="checkbox"/> 4 <input checked="" type="checkbox"/> 5 <input type="checkbox"/>	<input type="checkbox"/> <input type="checkbox"/> <input type="checkbox"/> <input checked="" type="checkbox"/> <input type="checkbox"/>

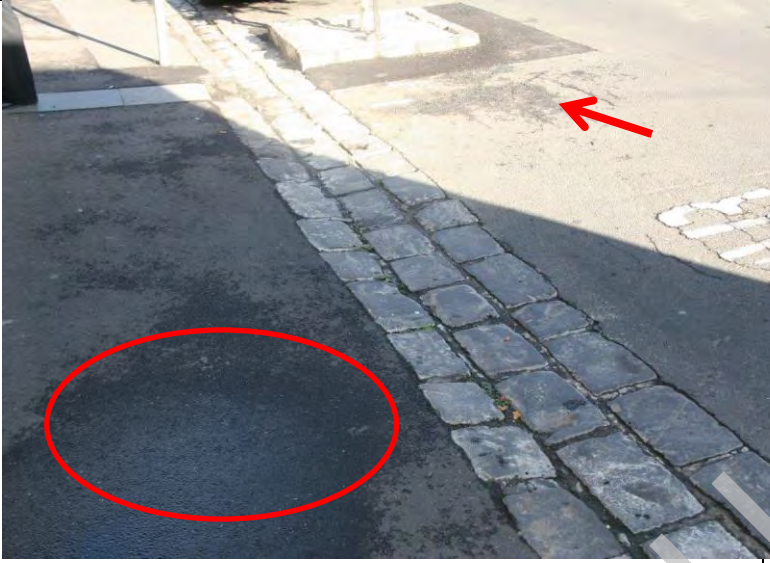
Assessment Type: Good <input type="checkbox"/> Fair <input checked="" type="checkbox"/> Poor <input type="checkbox"/>	<input type="checkbox"/> <input checked="" type="checkbox"/> <input type="checkbox"/>
Location: Auditors Comments: <ul style="list-style-type: none"> Water is pooling before the channel, may lead to potholes in this section if not rectified; especially because it is located within a driveway. Road is dirty and contains stains and fine cracks. Road pavement is scuffed up due to wear and tear over time. 		Impact Category: 1 <input type="checkbox"/> 2 <input checked="" type="checkbox"/> 3 <input type="checkbox"/> 4 <input type="checkbox"/> 5 <input type="checkbox"/>	<input type="checkbox"/> <input checked="" type="checkbox"/> <input type="checkbox"/> <input type="checkbox"/> <input type="checkbox"/>

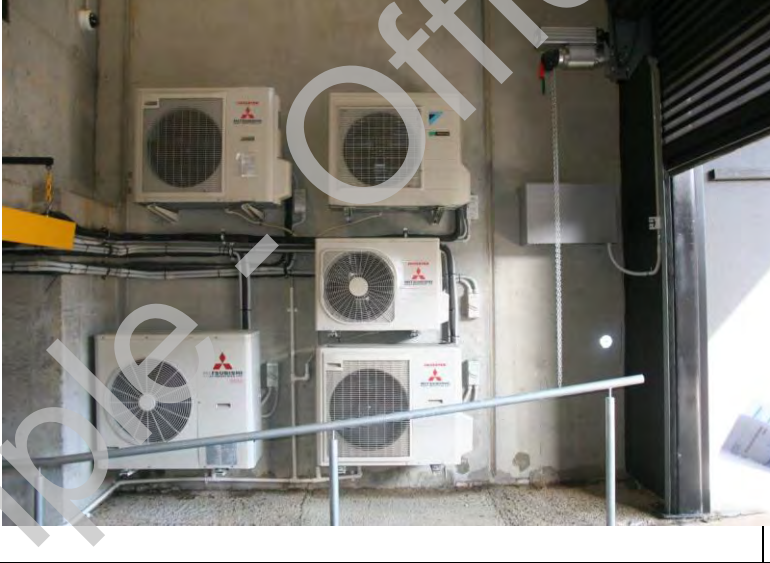
Assessment Type: Good <input checked="" type="checkbox"/> Fair <input type="checkbox"/> Poor <input type="checkbox"/>	<input checked="" type="checkbox"/> <input type="checkbox"/> <input type="checkbox"/>
Location: Auditors Comments: <ul style="list-style-type: none"> Air conditioner units are installed along the critical wall. The construction site at #7 Belford Street is located directly behind this wall. The wall is in good condition and no cracks are currently visible. 		Impact Category: 1 <input checked="" type="checkbox"/> 2 <input type="checkbox"/> 3 <input type="checkbox"/> 4 <input type="checkbox"/> 5 <input type="checkbox"/>	<input checked="" type="checkbox"/> <input type="checkbox"/> <input type="checkbox"/> <input type="checkbox"/> <input type="checkbox"/>

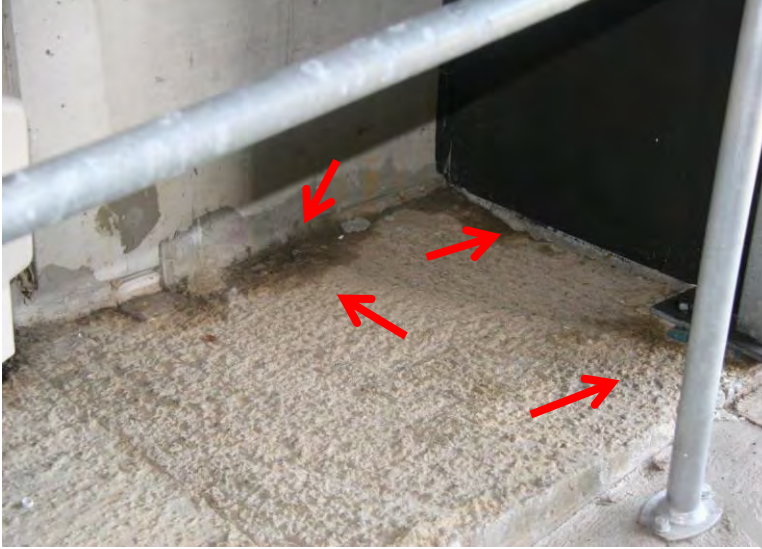
Assessment Type: Good <input type="checkbox"/> Fair <input checked="" type="checkbox"/> Poor <input type="checkbox"/>	<input type="checkbox"/> <input checked="" type="checkbox"/> <input type="checkbox"/>
Location: Basement		Impact Category: 1 <input type="checkbox"/> 2 <input checked="" type="checkbox"/> 3 <input type="checkbox"/> 4 <input type="checkbox"/> 5 <input type="checkbox"/>	
Auditors Comments: <ul style="list-style-type: none"> The air conditioning units are leaking water, which is pooling along the concrete wall. There is a raised concrete section that is not level with the existing concrete along this section. Concrete has been scuffed up and slightly damaged along the very base of the wall. The damage is only to the face and this is not excessive cracking. It is wear and tear of the basement concrete that has been exposed to moisture. 		Assessment Type: Good <input type="checkbox"/> Fair <input checked="" type="checkbox"/> Poor <input type="checkbox"/>

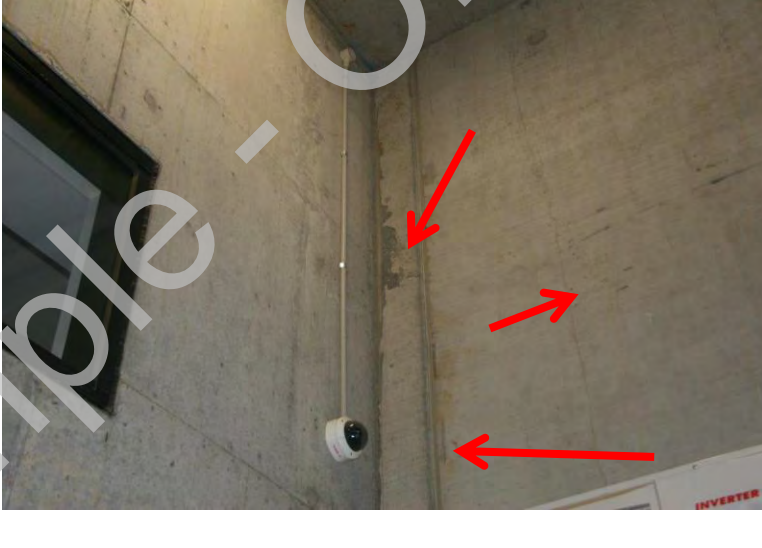
Impact Category: 1 <input type="checkbox"/> 2 <input checked="" type="checkbox"/> 3 <input type="checkbox"/> 4 <input type="checkbox"/> 5 <input type="checkbox"/>	<input type="checkbox"/> <input checked="" type="checkbox"/> <input type="checkbox"/> <input type="checkbox"/> <input type="checkbox"/>
Location:		Auditors Comments: <ul style="list-style-type: none"> Hairline cracks are noticeable along this wall of the basement entrance. They are only small at this stage and are not significant. They are mainly due to basement wear and tear. The corner is chipped in sections and quite scuffed up. The integrity of the wall is okay.

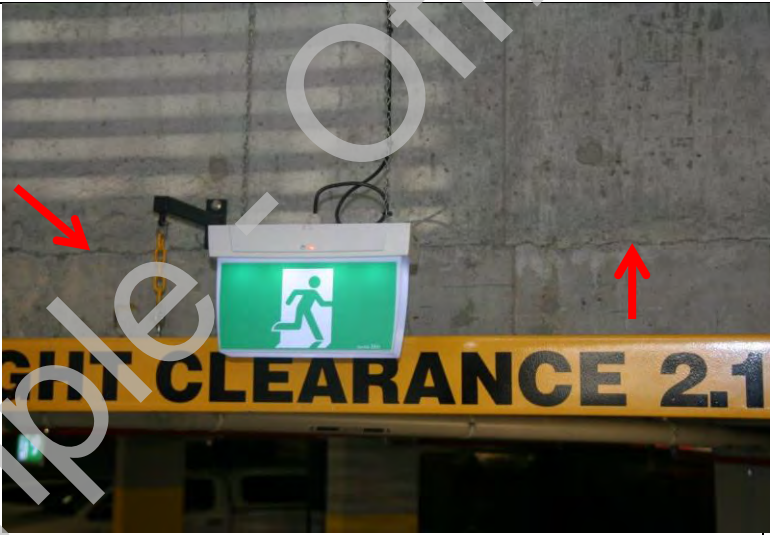
Assessment Type: Good <input type="checkbox"/> Fair <input checked="" type="checkbox"/> Poor <input type="checkbox"/>	<input type="checkbox"/> <input checked="" type="checkbox"/> <input type="checkbox"/>
Location: Basement Wall – Entrance to building		Impact Category: 1 <input type="checkbox"/> 2 <input checked="" type="checkbox"/> 3 <input type="checkbox"/> 4 <input type="checkbox"/> 5 <input type="checkbox"/>	<input type="checkbox"/> <input checked="" type="checkbox"/> <input type="checkbox"/> <input type="checkbox"/> <input type="checkbox"/>
Auditors Comments: <ul style="list-style-type: none"> Concrete has been poured in stages. This has led to a poor finish to this wall. Cracking should be monitored but this is mainly due to the consistent wear and tear of the basement wall and because the concrete has been poured in stages.

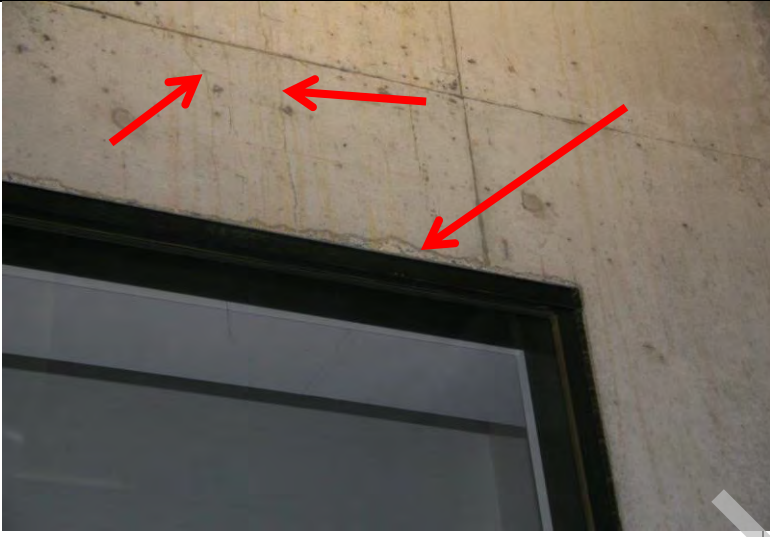
Assessment Type: Good <input type="checkbox"/> Fair <input checked="" type="checkbox"/> Poor <input type="checkbox"/>	<input type="checkbox"/> <input checked="" type="checkbox"/> <input type="checkbox"/>
Location: Basement Wall – Entrance to building		Auditors Comments: <ul style="list-style-type: none"> Hairline cracks are noticeable along this wall of the basement entrance way. They are only small at this stage and are not significant. They are mainly due to basement wear and tear. The concrete wall around the window is chipped in sections and quite scuffed up. The integrity of the wall is okay.

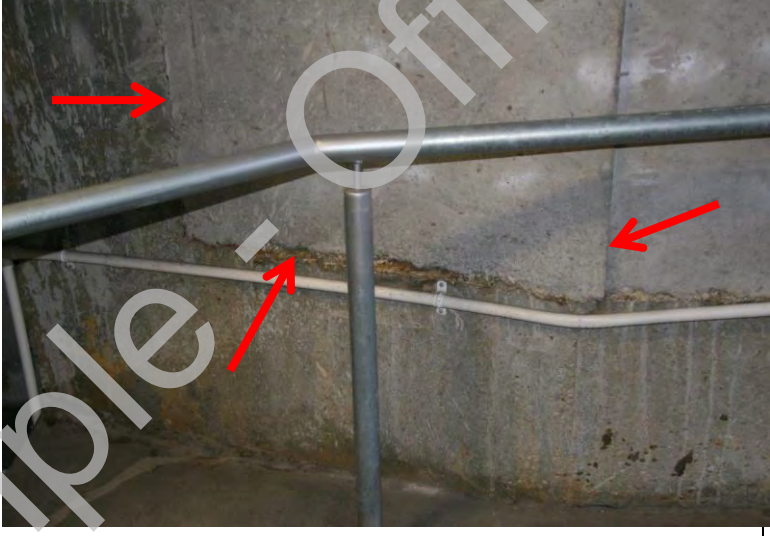
Assessment Type: Good <input type="checkbox"/> Fair <input checked="" type="checkbox"/> Poor <input type="checkbox"/>	<input type="checkbox"/> <input checked="" type="checkbox"/> <input type="checkbox"/>
Location: Basement entrance / exit ramp entrance to		Auditors Comments: <ul style="list-style-type: none"> Large separations are noticeable along this concrete wall of the basement. Concrete was poured separately and has settled separately, resulting in a clear separation. Separation gap can be in-filled also. 	
		Impact Category: 1 <input type="checkbox"/> 2 <input type="checkbox"/> 3 <input checked="" type="checkbox"/> 4 <input type="checkbox"/> 5 <input type="checkbox"/>	<input type="checkbox"/> <input type="checkbox"/> <input checked="" type="checkbox"/> <input type="checkbox"/> <input type="checkbox"/>

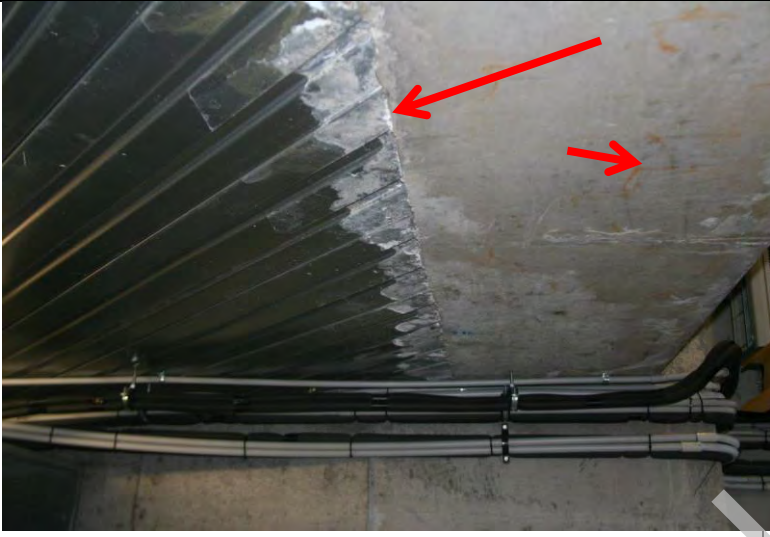
Assessment Type: Good <input type="checkbox"/> Fair <input checked="" type="checkbox"/> Poor <input type="checkbox"/>	<input type="checkbox"/> <input checked="" type="checkbox"/> <input type="checkbox"/>
Location: Basement		Auditors Comments: <ul style="list-style-type: none"> • Composite floor construction is evident. • Bondek is scuffed up but is structurally fine. • The suspended composite floor slab is evidently marked but this is mainly due to the wear and tear that a basement car park experiences.

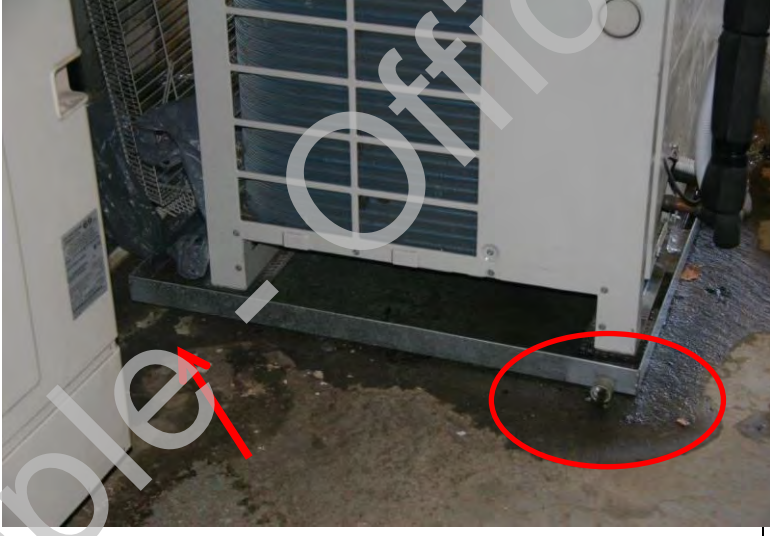
Assessment Type: Good <input type="checkbox"/> Fair <input type="checkbox"/> Poor <input checked="" type="checkbox"/>	<input type="checkbox"/> <input type="checkbox"/> <input checked="" type="checkbox"/>
Location: Basement		Auditors Comments: <ul style="list-style-type: none"> • Leaking water is pooling around the air conditioning units. • Staining is evident along the concrete slab. • Leaking water is not properly draining to the channel created around the perimeter wall of the basement car park. • This may lead to rust of the base of the air conditioning unit.

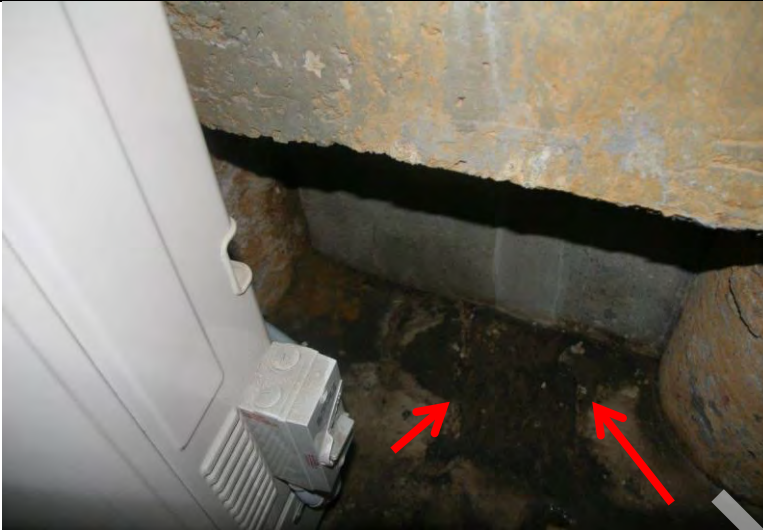
Assessment Type: Good <input type="checkbox"/> Fair <input type="checkbox"/> Poor <input checked="" type="checkbox"/>	<input type="checkbox"/> <input type="checkbox"/> <input checked="" type="checkbox"/>
Location: Basement		Impact Category: 1 <input type="checkbox"/> 2 <input type="checkbox"/> 3 <input checked="" type="checkbox"/> 4 <input type="checkbox"/> 5 <input type="checkbox"/>	
Auditors Comments:			
<ul style="list-style-type: none"> Leaking water is pooling around the air conditioning units and bored concrete piles. Staining is evident along the concrete slab and piles. Leaking water is not properly draining to the channel created around the perimeter wall of the basement car park. This may lead to rust of the base of the air conditioning unit. This will increase the scuff marking to concrete surfaces; especially with the wear and tear of the basement car park.

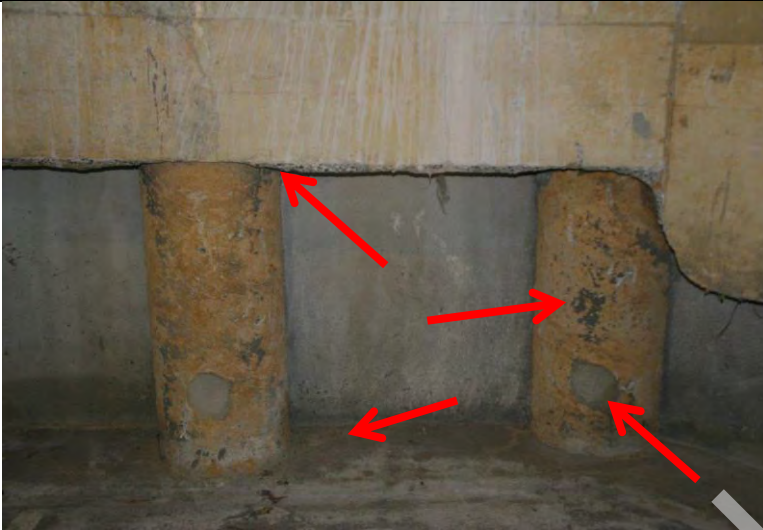
Assessment Type: Good <input type="checkbox"/> Fair <input checked="" type="checkbox"/> Poor <input type="checkbox"/>	<input type="checkbox"/> <input checked="" type="checkbox"/> <input type="checkbox"/>
		Impact Category: 1 <input type="checkbox"/> 2 <input checked="" type="checkbox"/> 3 <input type="checkbox"/> 4 <input type="checkbox"/> 5 <input type="checkbox"/>	<input type="checkbox"/> <input checked="" type="checkbox"/> <input type="checkbox"/> <input type="checkbox"/> <input type="checkbox"/>
Location: Basement	Auditors Comments: <ul style="list-style-type: none"> • Cast for bored concrete pile is significantly wearing. • The actual concrete pile is inside this cast and is not able to be inspected. • The wearing and tearing of the pile cast has no structural implications.

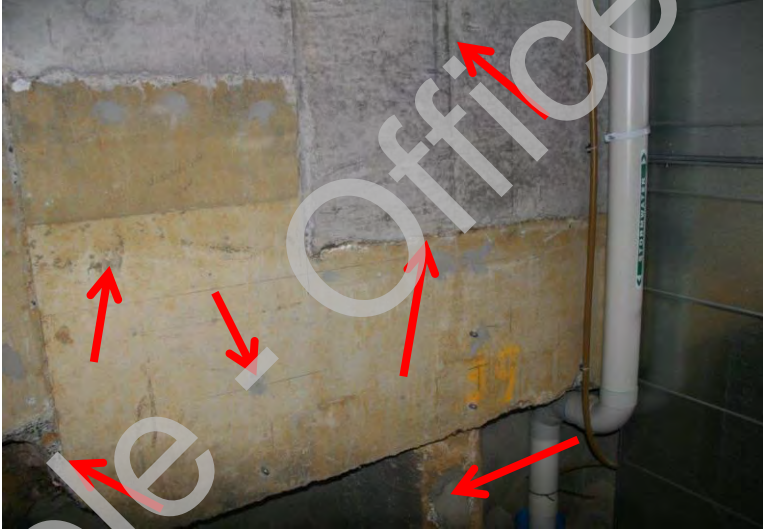
Assessment Type: Good <input type="checkbox"/> Fair <input checked="" type="checkbox"/> Poor <input type="checkbox"/>	<input type="checkbox"/> <input checked="" type="checkbox"/> <input type="checkbox"/>
		Impact Category: 1 <input type="checkbox"/> 2 <input checked="" type="checkbox"/> 3 <input type="checkbox"/> 4 <input type="checkbox"/> 5 <input type="checkbox"/>	<input type="checkbox"/> <input checked="" type="checkbox"/> <input type="checkbox"/> <input type="checkbox"/> <input type="checkbox"/>
Location: Basement	Auditors Comments: <ul style="list-style-type: none"> • Concrete has been poured in stages. • This has led to a poor finish to this wall. • Cracking or separations should be monitored. • Small cracks, dents and separation gaps are mainly due to the wear and tear experienced by the wall over time and because the concrete was poured in stages.

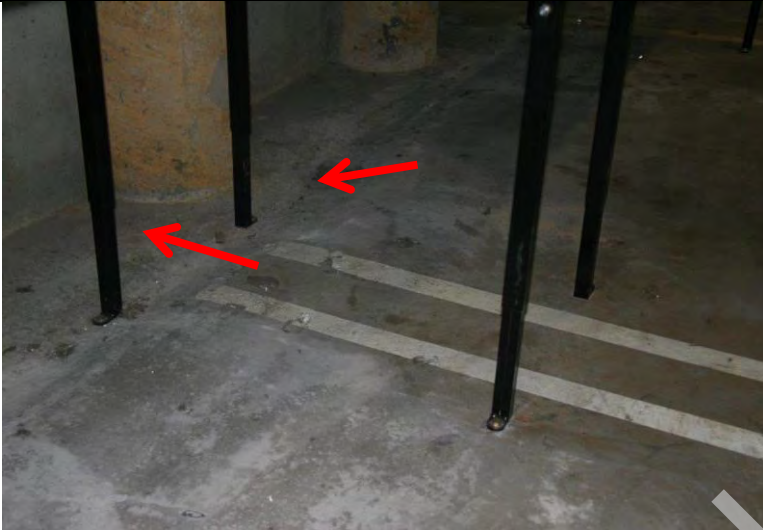
Assessment Type: Good <input type="checkbox"/> Fair <input type="checkbox"/> Poor <input checked="" type="checkbox"/>	<input type="checkbox"/> <input type="checkbox"/> <input checked="" type="checkbox"/>
Location: Basement lowest level		Auditors Comments: <ul style="list-style-type: none"> • Drainage channel for any excess runoff collected by the car park is obstructed in many sections around the perimeter. • Channel is filled with silt, gravel etc. Also it is obstructed by the bored concrete piles.

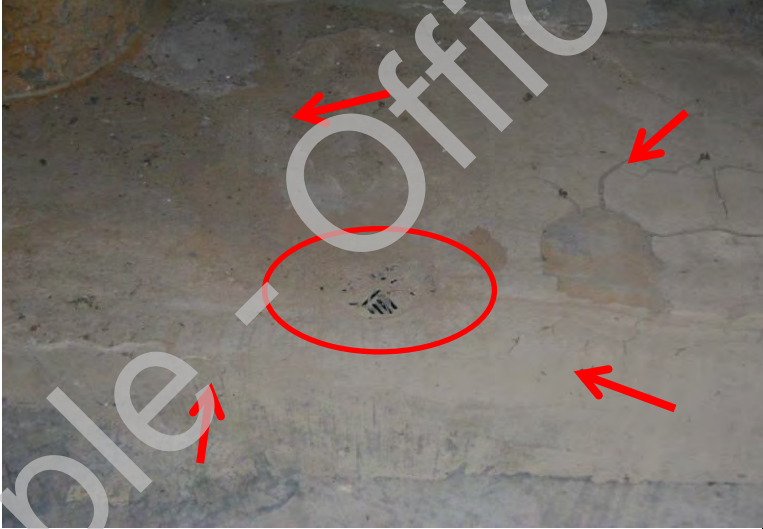
Assessment Type: Good <input type="checkbox"/> Fair <input checked="" type="checkbox"/> Poor <input type="checkbox"/>	<input type="checkbox"/> <input checked="" type="checkbox"/> <input type="checkbox"/>
Location: Basement lowest level		Auditors Comments: <ul style="list-style-type: none"> • Drain is obstructed and silt / additional run off has pooled around the drain.

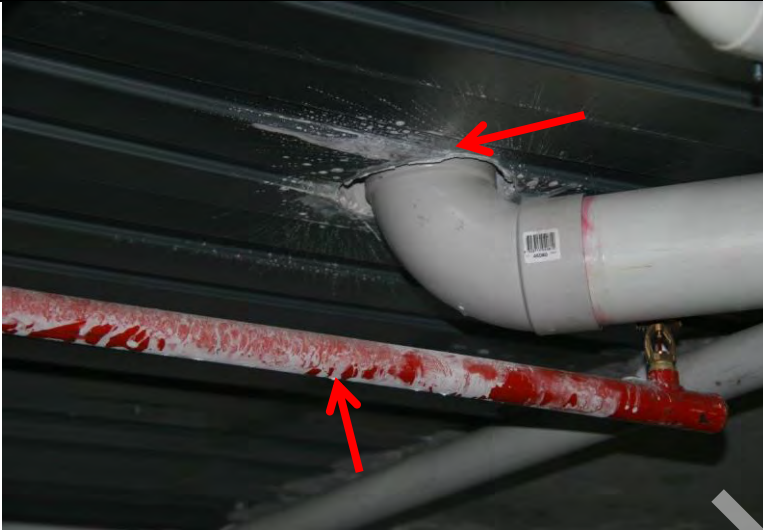
Assessment Type: Good <input type="checkbox"/> Fair <input type="checkbox"/> Poor <input checked="" type="checkbox"/>	<input type="checkbox"/> <input type="checkbox"/> <input checked="" type="checkbox"/>
Location: Basement lowest level		Auditors Comments: <ul style="list-style-type: none"> • Unsealed penetration. • Due to the unsealed penetration, there is water leaking down the pipe due to obvious staining's on the fire sprinkler pipe and stains on the bondek sheeting.

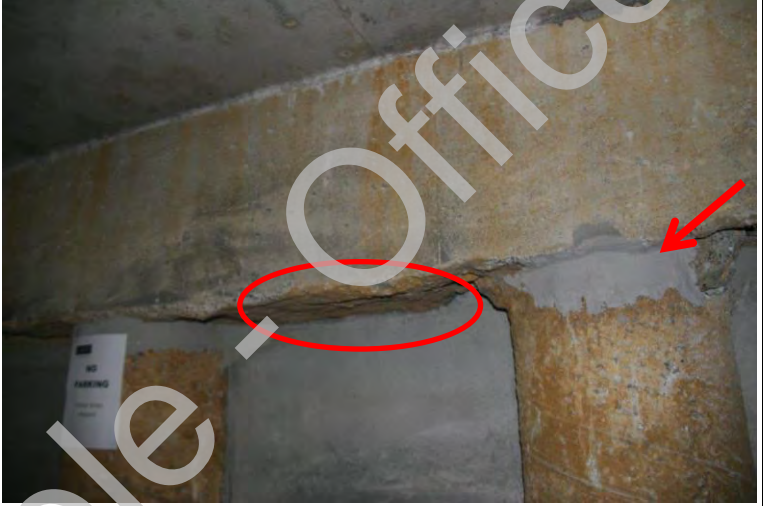
Assessment Type: Good <input type="checkbox"/> Fair <input checked="" type="checkbox"/> Poor <input type="checkbox"/>	<input type="checkbox"/> <input checked="" type="checkbox"/> <input type="checkbox"/>
Location: Basement wall		Auditors Comments: <ul style="list-style-type: none"> • Concrete filler (cement) may have been used to fill in voids between the bored piles and the concrete slab. • Slab loading is transferred into the bored piles or else there would be a depression in the slab. • Filler has been used however. • Restricted in methods of testing and the ability to alter /remove this filler to see why it was used.

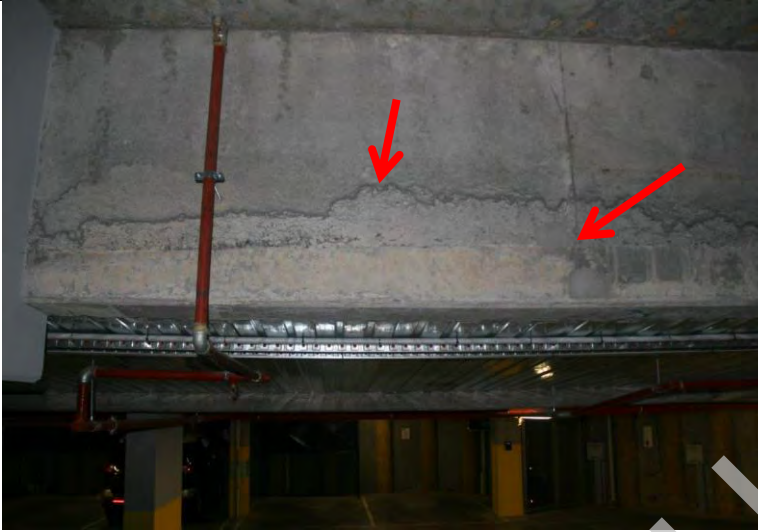
Assessment Type: Good <input type="checkbox"/> Fair <input checked="" type="checkbox"/> Poor <input type="checkbox"/>	<input type="checkbox"/> <input checked="" type="checkbox"/> <input type="checkbox"/>
Location: Basement wall		Auditors Comments: <ul style="list-style-type: none"> Concrete has been poured in stages. This has led to a poor finish to this wall. Cracking or separations should be monitored. Cracking, dents and separation gaps are mainly due to the wear and tear experienced by the wall over time and because the concrete was poured in stages.

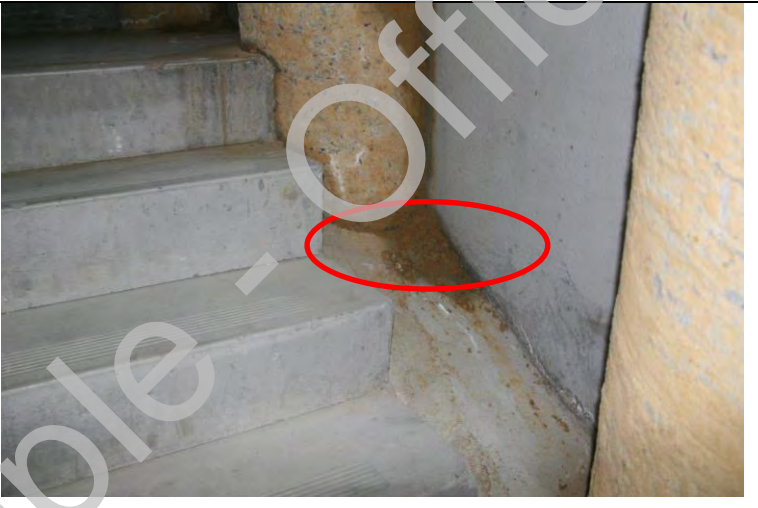
Assessment Type: Good <input type="checkbox"/> Fair <input checked="" type="checkbox"/> Poor <input type="checkbox"/>	<input type="checkbox"/> <input checked="" type="checkbox"/> <input type="checkbox"/>
Location: Stairs – Fire exit – along the rear wall of #173		Auditors Comments: <ul style="list-style-type: none"> Moisture has infiltrated through the casing of the bored pile. Soil is loaded up against this basement wall because the basement wall is lower than the construction site #7 Belford Street. Soil contains moisture and a water table may also be present at this depth of the construction site. This may have resulted in seepage through the eroded casing of the bored pile. A future concern may be the excess runoff that could be generated because of this construction site. More seepage could be experienced along this basement wall in the future. The basement concrete walls are in good condition nonetheless.

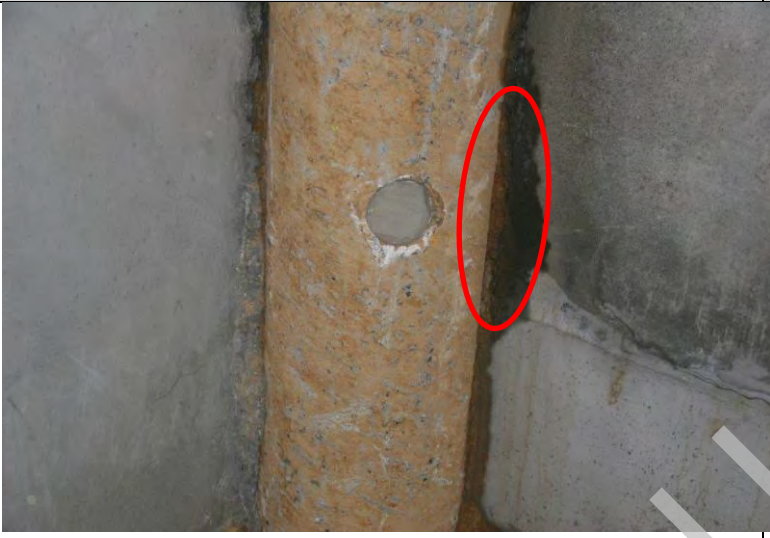
Assessment Type: Good <input type="checkbox"/> Fair <input checked="" type="checkbox"/> Poor <input type="checkbox"/>	<input type="checkbox"/> <input checked="" type="checkbox"/> <input type="checkbox"/>
Location: Stairs –Fire exit – along the rear		Auditors Comments: <ul style="list-style-type: none"> Moisture has infiltrated through the casing of the bored pile. Soil is loaded up against this basement wall because it is lower than the construction site #7 Belford Street. Soil contains moisture and a water table may also be present at this depth of the construction site. This may have resulted in seepage through the eroded casing of the bored pile. A future concern may be the excess runoff that could be generated because of this construction site. More seepage could be experienced along this basement wall in the future. The basement concrete walls are in good condition nonetheless. The piles are obviously restricted to access and assessment.

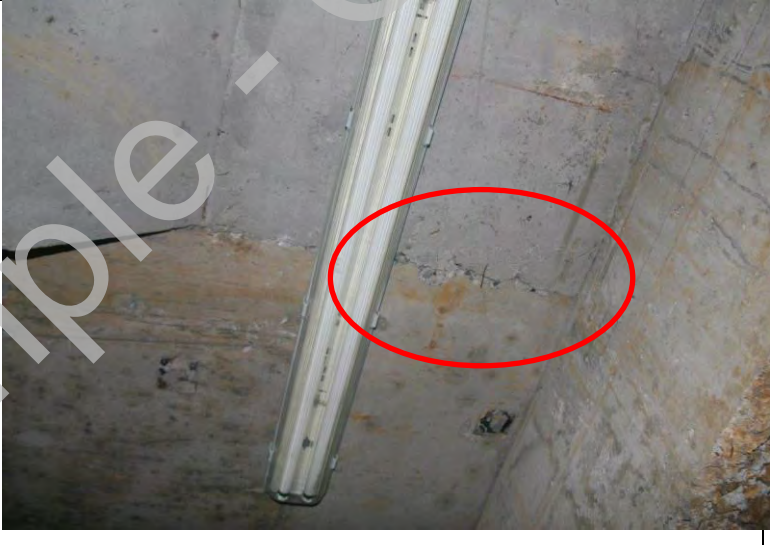
Assessment Type: Good <input type="checkbox"/> Fair <input checked="" type="checkbox"/> Poor <input type="checkbox"/>	<input type="checkbox"/> <input checked="" type="checkbox"/> <input type="checkbox"/>
Location: Roof –Fire exit – At the		Auditors Comments: <ul style="list-style-type: none"> Cracking has occurred along the roof line of this section of the fire exit. The cracking was extensive and large. Cracking needs to be monitored but is currently structurally okay.

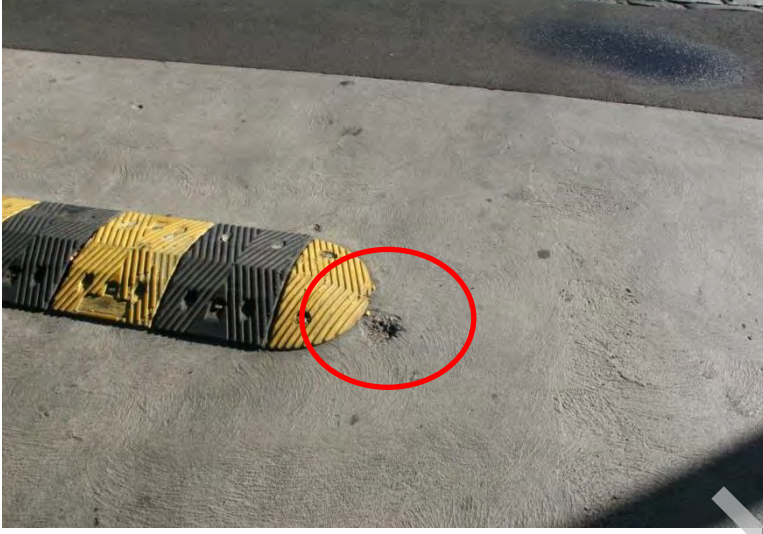
Assessment Type: Good <input type="checkbox"/> Fair <input checked="" type="checkbox"/> Poor <input type="checkbox"/>	<input type="checkbox"/> <input checked="" type="checkbox"/> <input type="checkbox"/>
Location: Driveway to #173		Impact Category: 1 <input type="checkbox"/> 2 <input type="checkbox"/> 3 <input checked="" type="checkbox"/> 4 <input type="checkbox"/> 5 <input type="checkbox"/>	
Auditors Comments: <ul style="list-style-type: none"> Exposed hole in concrete driveway that is not in-filled.

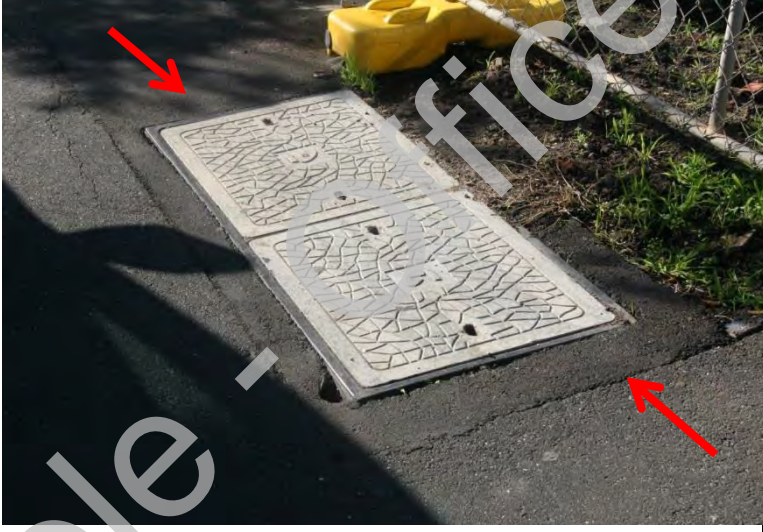
Assessment Type: Good <input type="checkbox"/> Fair <input checked="" type="checkbox"/> Poor <input type="checkbox"/>	<input type="checkbox"/> <input checked="" type="checkbox"/> <input type="checkbox"/>
Location: Belford Street along construction site boundary #7		Impact Category: 1 <input type="checkbox"/> 2 <input checked="" type="checkbox"/> 3 <input type="checkbox"/> 4 <input type="checkbox"/> 5 <input type="checkbox"/>	
Auditors Comments: <ul style="list-style-type: none"> Telstra pit is not "at level" with existing walkway pavement. Water will retain around this pit. Cracking is also evident around the pit within the walkway pavement.

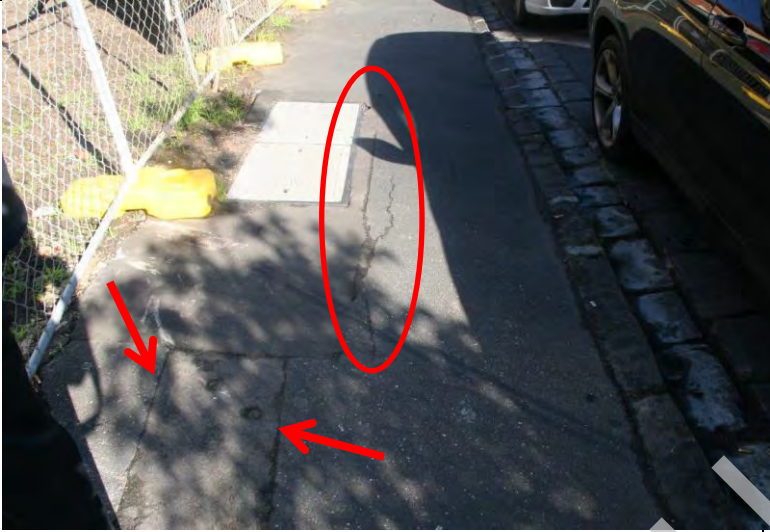
Assessment Type: Good <input type="checkbox"/> Fair <input checked="" type="checkbox"/> Poor <input type="checkbox"/>	<input type="checkbox"/> <input checked="" type="checkbox"/> <input type="checkbox"/>
		Impact Category: 1 <input type="checkbox"/> 2 <input checked="" type="checkbox"/> 3 <input type="checkbox"/> 4 <input type="checkbox"/> 5 <input type="checkbox"/>	<input type="checkbox"/> <input checked="" type="checkbox"/> <input type="checkbox"/> <input type="checkbox"/> <input type="checkbox"/>
Location: Belford Street along construction site boundary	Auditors Comments: <ul style="list-style-type: none"> • Filler has been used to seal cracking in walkway pavement. • There is a depressed saw cut section within the concrete pit. Potentially run off may pool at this point. • Concrete kerb shows signs of wear and tear with chips taken off the top section of kerb. • Walkway pavement is scuffed up and contains small cracks.

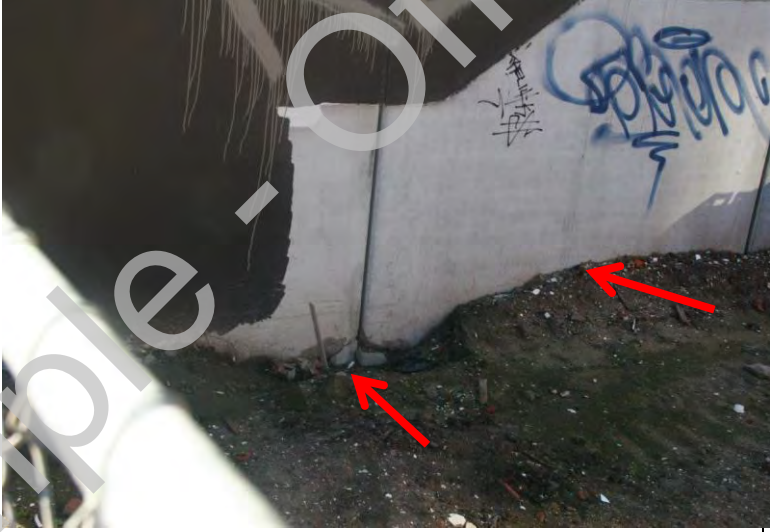
Assessment Type: Good <input type="checkbox"/> Fair <input type="checkbox"/> Poor <input checked="" type="checkbox"/>	<input type="checkbox"/> <input type="checkbox"/> <input checked="" type="checkbox"/>
		Impact Category: 1 <input type="checkbox"/> 2 <input type="checkbox"/> 3 <input checked="" type="checkbox"/> 4 <input type="checkbox"/> 5 <input type="checkbox"/>	<input type="checkbox"/> <input type="checkbox"/> <input checked="" type="checkbox"/> <input type="checkbox"/> <input type="checkbox"/>
Location: Located at the rear external wall of building	Auditors Comments: <ul style="list-style-type: none"> • Construction site soil is pushed up against the external concrete wall panels of building #173. This can lead to structural issues and may impact the integrity of the concrete wall panels.

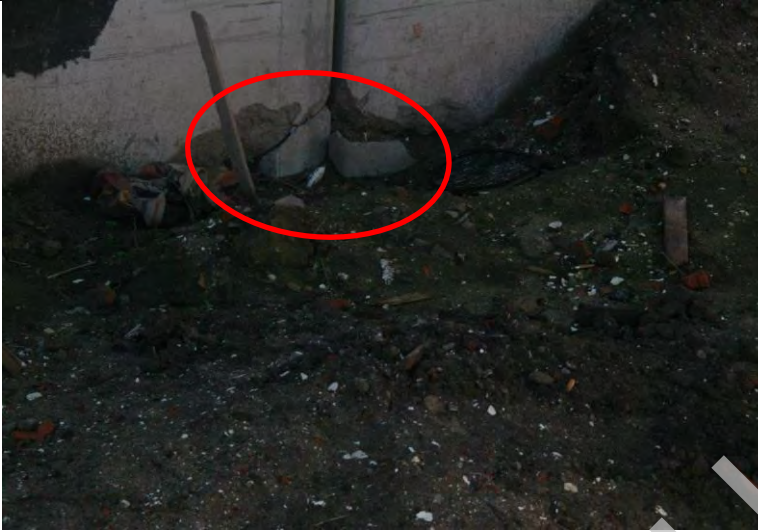
Assessment Type: Good <input type="checkbox"/> Fair <input checked="" type="checkbox"/> Poor <input type="checkbox"/>	<input type="checkbox"/> <input checked="" type="checkbox"/> <input type="checkbox"/>
		Impact Category: 1 <input type="checkbox"/> 2 <input type="checkbox"/> 3 <input checked="" type="checkbox"/> 4 <input type="checkbox"/> 5 <input type="checkbox"/>	<input type="checkbox"/> <input type="checkbox"/> <input checked="" type="checkbox"/> <input type="checkbox"/> <input type="checkbox"/>
Location: Located at the rear external wall of building	Auditors Comments: <ul style="list-style-type: none"> Construction site soil is pushed up against the external concrete wall panels of building #173. This can lead to structural issues and may impact the integrity of the concrete wall panels. Rubbish has built up at this depression in the soil. Cracking and damage has occurred to the concrete wall panel at this depression. Concrete panel wall is scuffed up and contains smaller cracks also.

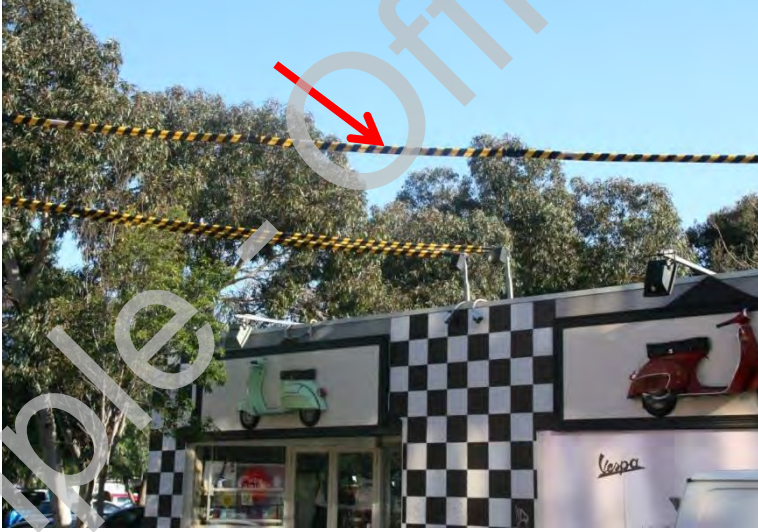
Assessment Type: Good <input checked="" type="checkbox"/> Fair <input type="checkbox"/> Poor <input type="checkbox"/>	<input checked="" type="checkbox"/> <input type="checkbox"/> <input type="checkbox"/>
		Impact Category: 1 <input checked="" type="checkbox"/> 2 <input type="checkbox"/> 3 <input type="checkbox"/> 4 <input type="checkbox"/> 5 <input type="checkbox"/>	<input checked="" type="checkbox"/> <input type="checkbox"/> <input type="checkbox"/> <input type="checkbox"/> <input type="checkbox"/>
Location:	Auditors Comments: <ul style="list-style-type: none"> The current power lines have been marked for safety reasons.
