Dilapidation Survey Report

76 Sample St Suburb VIC 3107

13 June 2014

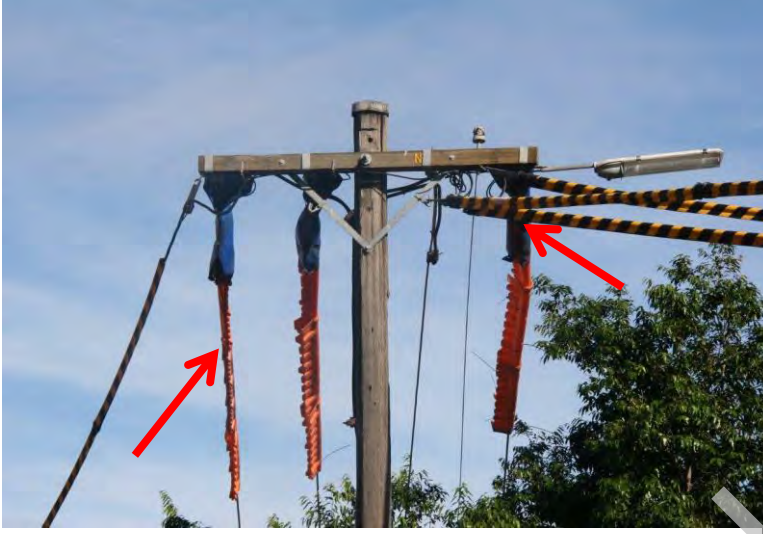
Assessment Type: Good <input checked="" type="checkbox"/> Fair <input type="checkbox"/> Poor <input type="checkbox"/>	<input checked="" type="checkbox"/> <input type="checkbox"/> <input type="checkbox"/>
		Impact Category: 1 <input checked="" type="checkbox"/> 2 <input type="checkbox"/> 3 <input type="checkbox"/> 4 <input type="checkbox"/> 5 <input type="checkbox"/>	<input checked="" type="checkbox"/> <input type="checkbox"/> <input type="checkbox"/> <input type="checkbox"/> <input type="checkbox"/>
Location:	Auditors Comments: <ul style="list-style-type: none"> The current power lines have been marked for safety reasons.

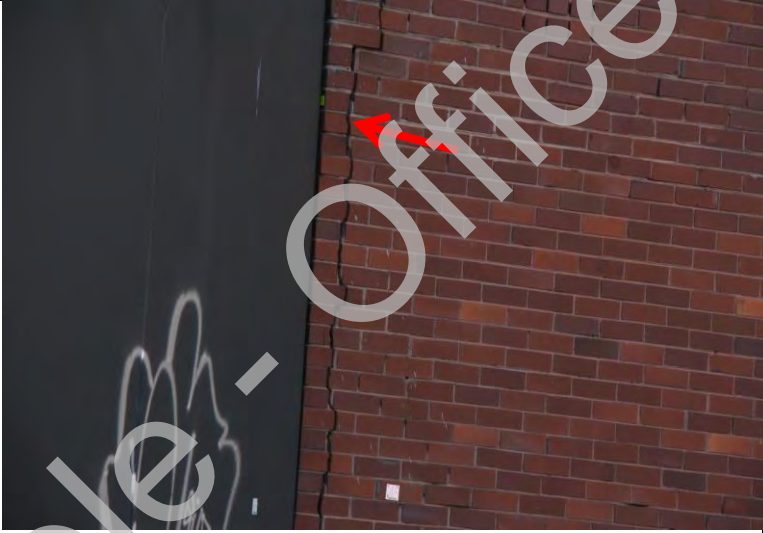
Assessment Type: Good <input type="checkbox"/> Fair <input type="checkbox"/> Poor <input checked="" type="checkbox"/>	<input type="checkbox"/> <input type="checkbox"/> <input checked="" type="checkbox"/>
		Impact Category: 1 <input type="checkbox"/> 2 <input type="checkbox"/> 3 <input type="checkbox"/> 4 <input type="checkbox"/> 5 <input checked="" type="checkbox"/>	<input type="checkbox"/> <input type="checkbox"/> <input type="checkbox"/> <input type="checkbox"/> <input checked="" type="checkbox"/>
Location:	Auditors Comments: <ul style="list-style-type: none"> This rigid brick wall is not a part of building #173. It is the external wall face of the building that is located next to #173 in question. This cracking is major and extends from almost the ground level to the top of the wall. The structural integrity of this wall should be assessed before construction continues; as collapse could be a major disaster for the workers of the construction site and also building #173.

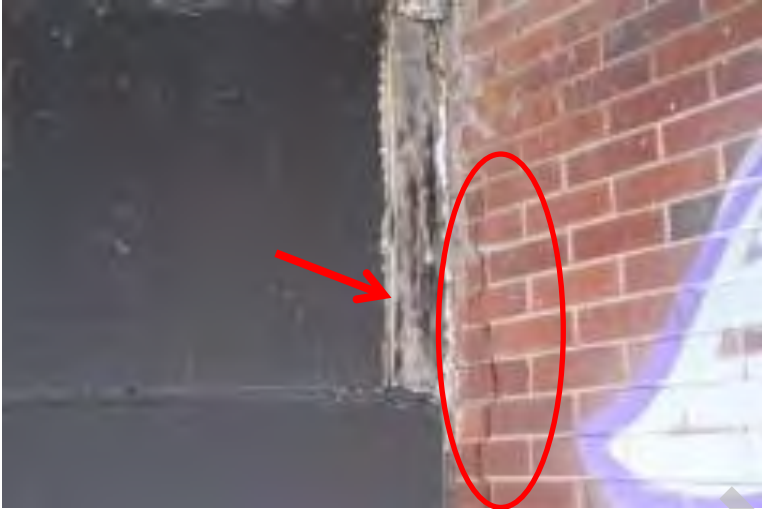
Assessment Type: Good <input type="checkbox"/> Fair <input type="checkbox"/> Poor <input checked="" type="checkbox"/>	<input type="checkbox"/> <input type="checkbox"/> <input checked="" type="checkbox"/>
		Impact Category: 1 <input type="checkbox"/> 2 <input type="checkbox"/> 3 <input type="checkbox"/> 4 <input type="checkbox"/> 5 <input checked="" type="checkbox"/>	<input type="checkbox"/> <input type="checkbox"/> <input type="checkbox"/> <input type="checkbox"/> <input checked="" type="checkbox"/>
Location: Rear external wall of building	Auditors Comments: <ul style="list-style-type: none"> • Timber formwork has fallen out of place. • Concrete wall panel is exposed. It is cracking at the bottom and top of the concrete wall panel. • The separate brick wall has also experienced excessive cracking. • This is an exposed concrete wall panel that sticks out from the continuous external concrete wall. A structural or foundation specialist engineer should assess the cracking in the brick wall before major construction begins. The concrete wall panel should also be assessed and repaired if necessary.

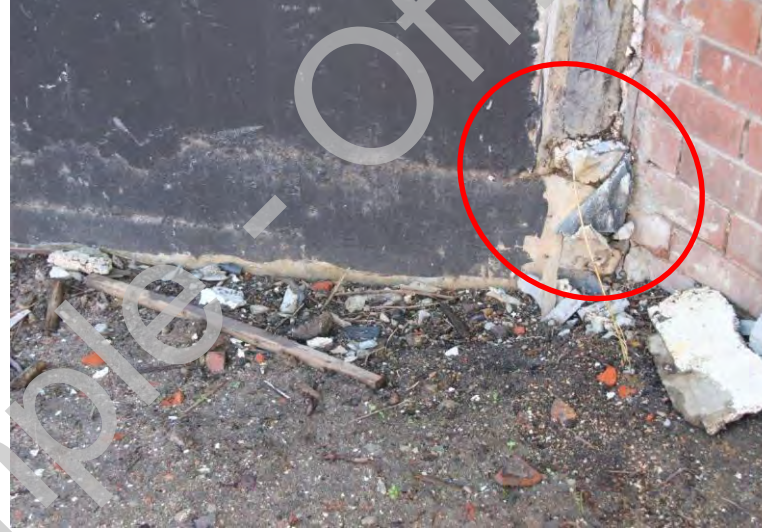
Assessment Type: Good <input type="checkbox"/> Fair <input type="checkbox"/> Poor <input checked="" type="checkbox"/>	<input type="checkbox"/> <input type="checkbox"/> <input checked="" type="checkbox"/>
		Impact Category: 1 <input type="checkbox"/> 2 <input type="checkbox"/> 3 <input type="checkbox"/> 4 <input type="checkbox"/> 5 <input checked="" type="checkbox"/>	<input type="checkbox"/> <input type="checkbox"/> <input type="checkbox"/> <input type="checkbox"/> <input checked="" type="checkbox"/>
Location: South boundary of	Auditors Comments: <ul style="list-style-type: none"> • Formwork is poorly finished and has collapsed. • Concrete panel has cracked at the base. Should be assessed and then repaired.

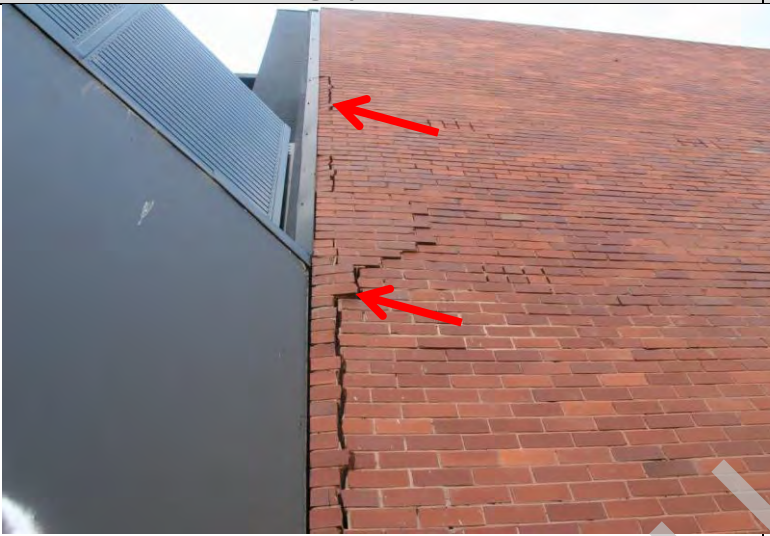
Assessment Type: Good <input type="checkbox"/> Fair <input type="checkbox"/> Poor <input checked="" type="checkbox"/>	<input type="checkbox"/> <input type="checkbox"/> <input checked="" type="checkbox"/>
		Impact Category: 1 <input type="checkbox"/> 2 <input type="checkbox"/> 3 <input type="checkbox"/> 4 <input type="checkbox"/> 5 <input checked="" type="checkbox"/>	<input type="checkbox"/> <input type="checkbox"/> <input type="checkbox"/> <input type="checkbox"/> <input checked="" type="checkbox"/>
Location: Rear external wall of building	Auditors Comments: <ul style="list-style-type: none"> • This rigid brick wall is not a part of building #173. It is the external wall face of the building that is adjoined to #173. • This cracking is major and extends from almost the ground level to the top of the wall. • The structural integrity of this wall should be assessed before construction continues; as collapse could be a major disaster for the workers of the construction site and also building #173.

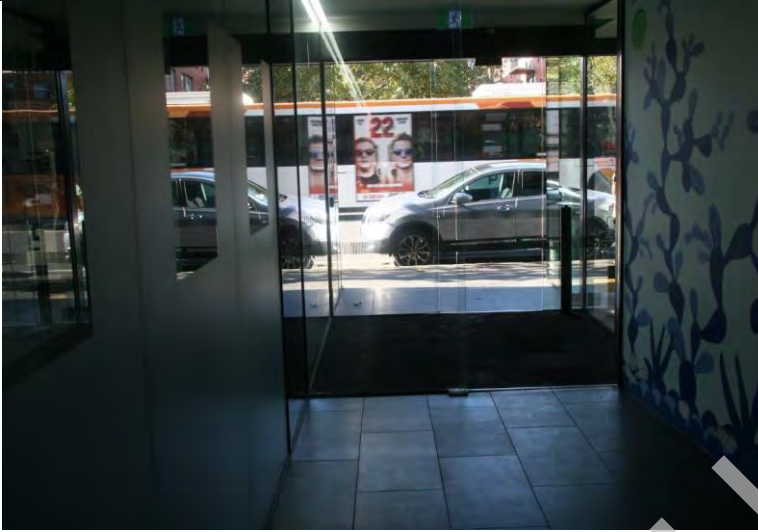
Assessment Type: Good <input checked="" type="checkbox"/> Fair <input type="checkbox"/> Poor <input type="checkbox"/>	<input checked="" type="checkbox"/> <input type="checkbox"/> <input type="checkbox"/>
Location: Exit from Foyer to		Auditors Comments: <ul style="list-style-type: none"> Flooring is in good condition. Walls also show no visible signs of cracking.

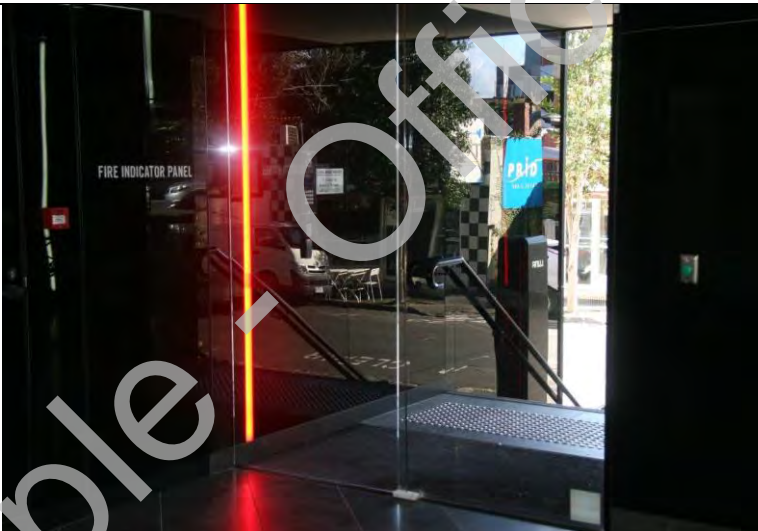
Assessment Type: Good <input checked="" type="checkbox"/> Fair <input type="checkbox"/> Poor <input type="checkbox"/>	<input checked="" type="checkbox"/> <input type="checkbox"/> <input type="checkbox"/>
Location: Foyer section of building		Auditors Comments: <ul style="list-style-type: none"> Foyer is in excellent condition. The glass backed panels that cover the concrete walls restricted access to assess any cracking of the concrete walls. Glass backed walls are in extremely good condition. 	
		Impact Category: 1 <input checked="" type="checkbox"/> 2 <input type="checkbox"/> 3 <input type="checkbox"/> 4 <input type="checkbox"/> 5 <input type="checkbox"/>	<input checked="" type="checkbox"/> <input type="checkbox"/> <input type="checkbox"/> <input type="checkbox"/> <input type="checkbox"/>
