## Detailed Windows Inspection

49 Sample Road Melbourne VIC 3122

## Part 1: Inspection Notes

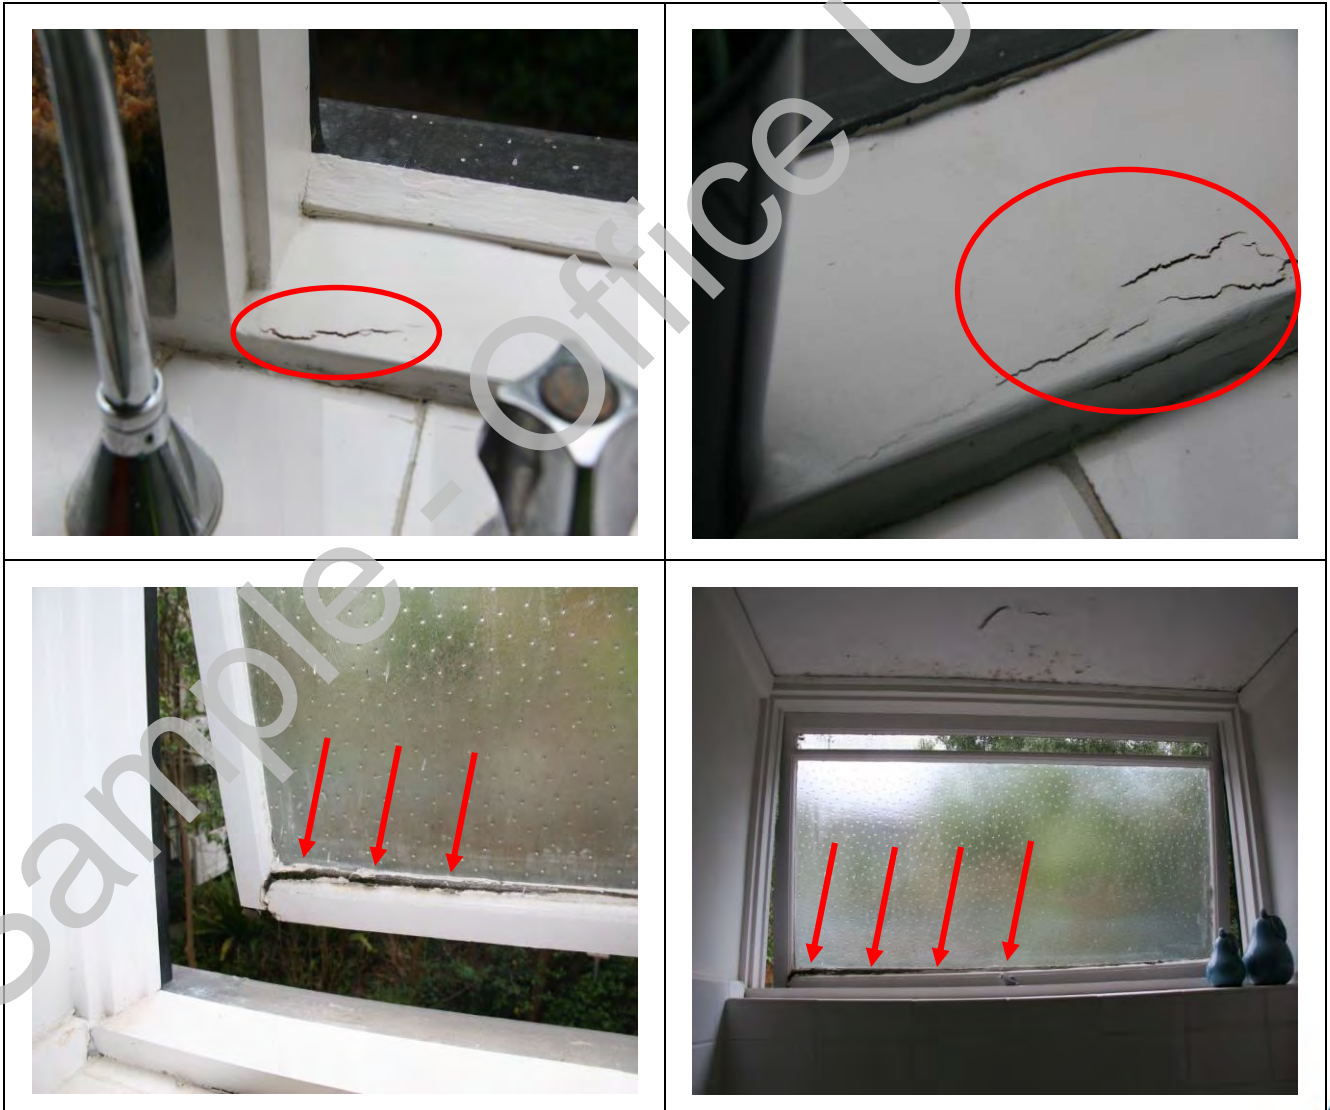
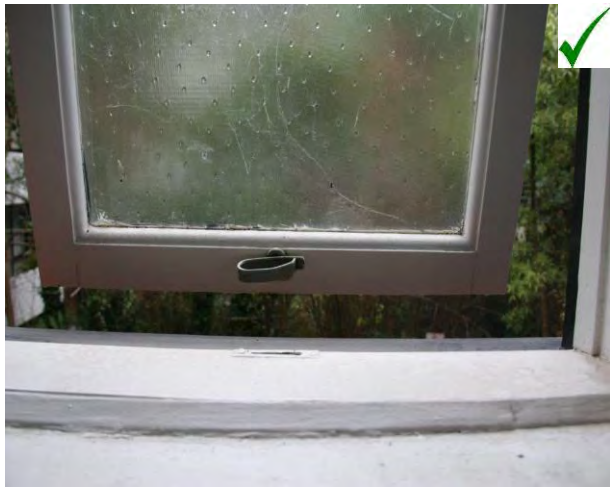
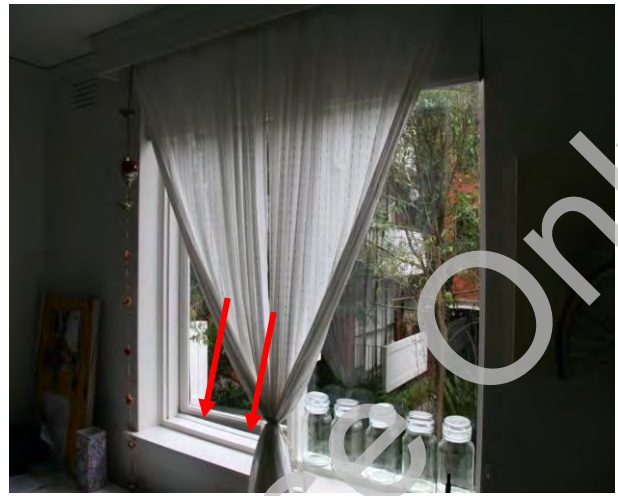
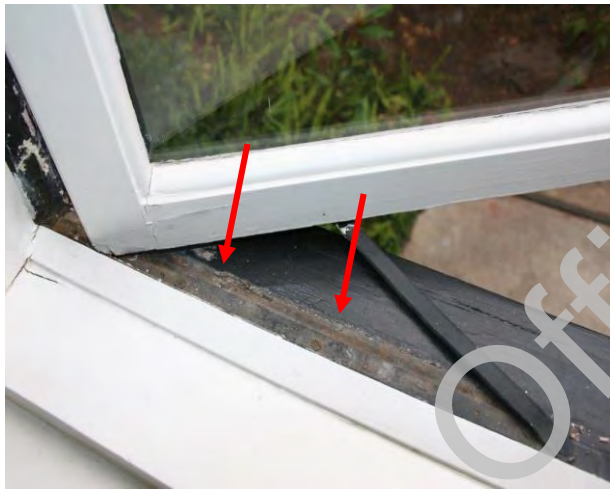
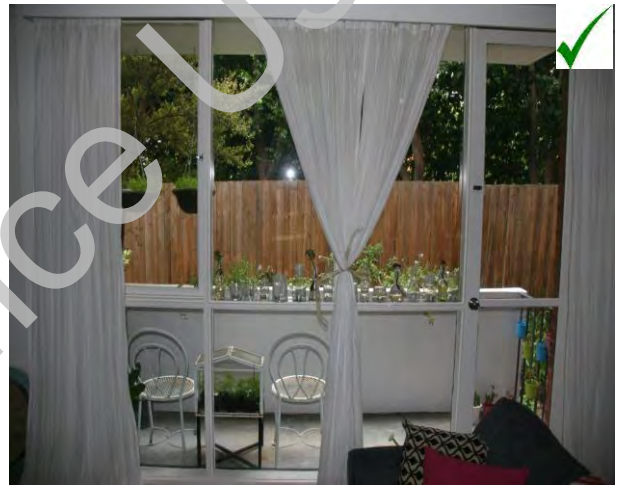
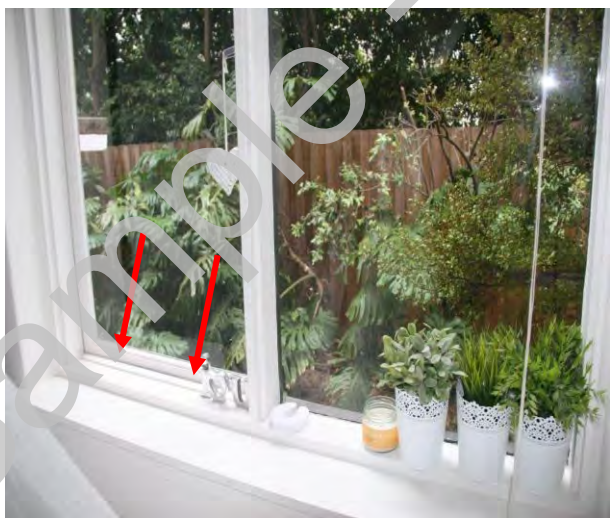
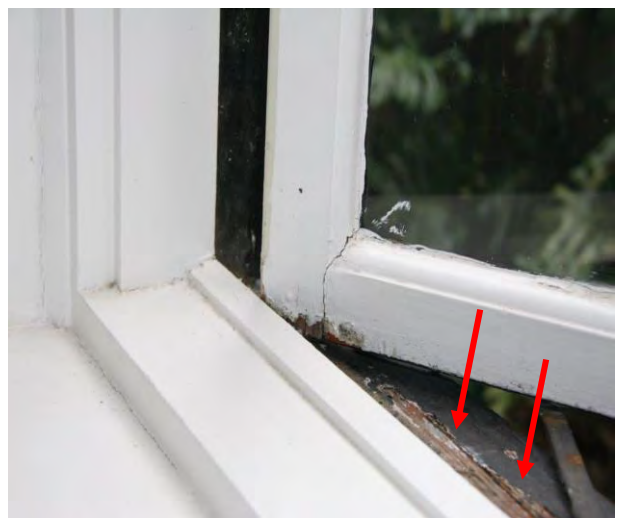
### Unit 8

Location	Inspection Notes
Kitchen	Replace window frame as it has deteriorated and cracked.
Bathroom	Replace window sash & glazing to include an exhaust fan. The tenants may sometimes forget to open the window and the ceiling has sustained damage due to the moisture from condensation.
Toilet	Good condition. No action required.
Bedroom 1	Prepare and paint external window sill.
Living	Good condition as it is undercover. No action required.
Bedroom 2	Prepare and paint window sash. Replace external window sill.

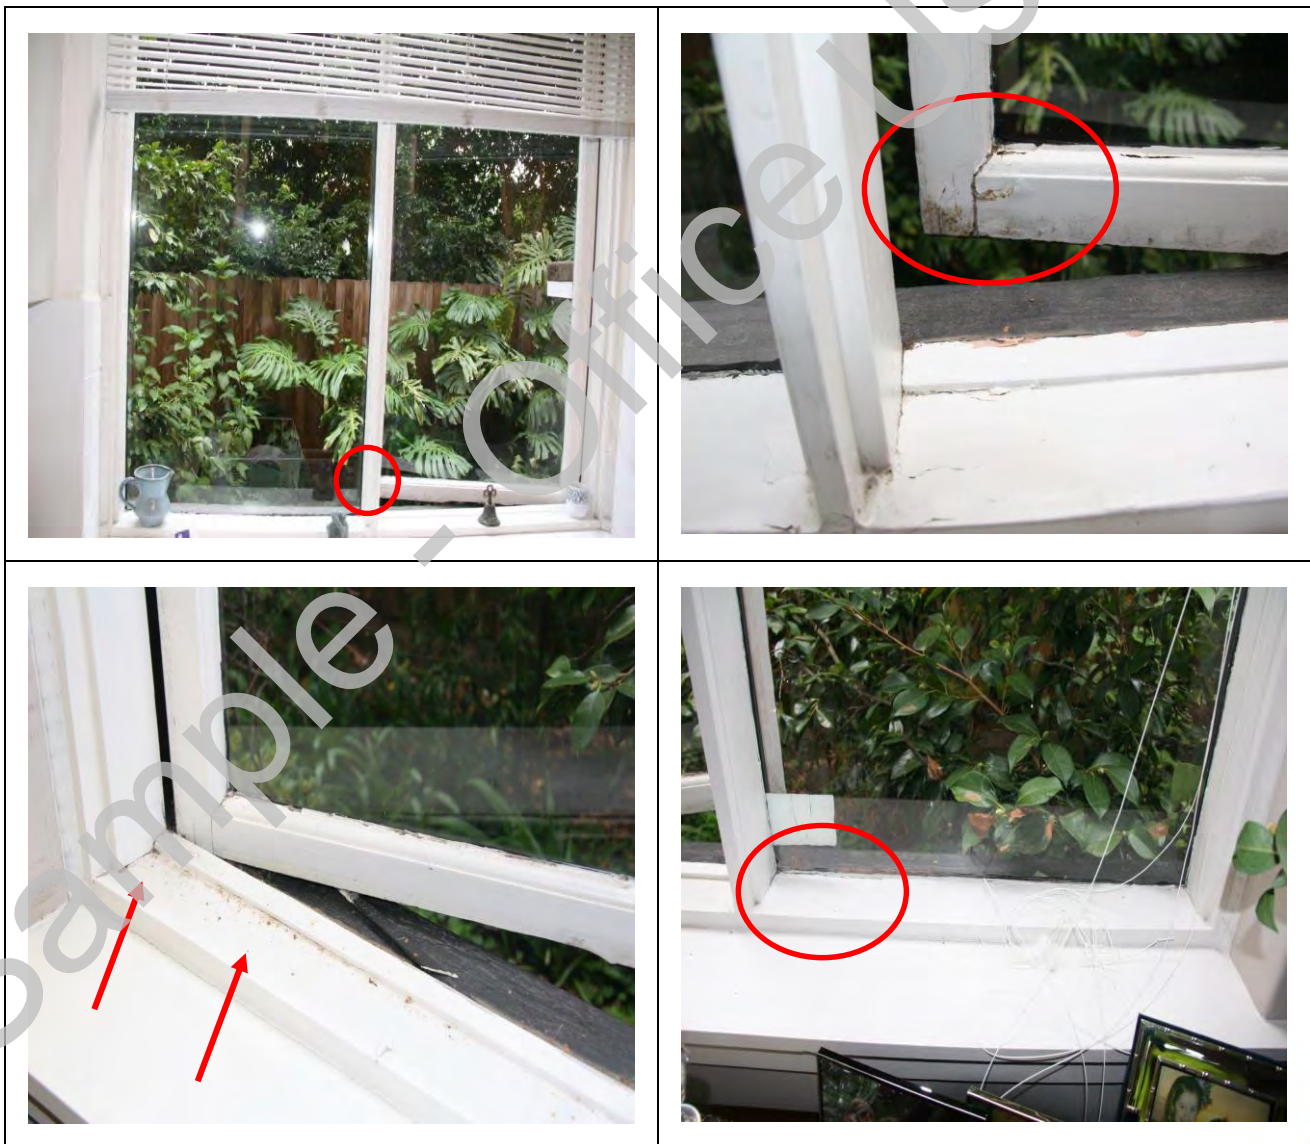
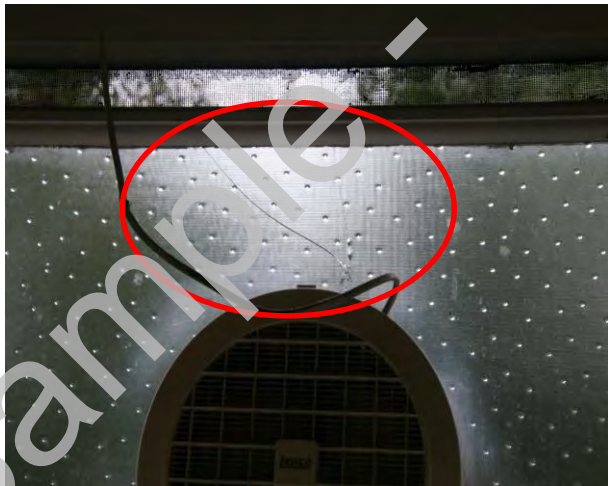
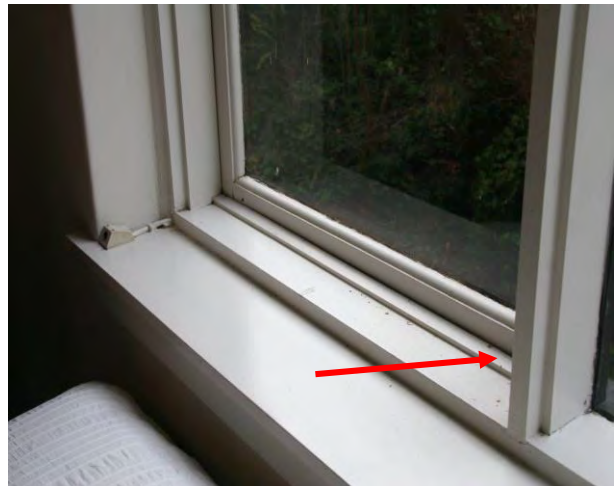
## Unit 7

Location	Inspection Notes
Kitchen	Replace window sash. Patch and paint window frame.
Dining	Prepare and paint entire window frame, sash and sill.
Living	Good condition. No action required.
Bedroom 1	Replace entire sash as it is falling apart, 'L' brackets have been used to hold the sash in place. Prepare and paint window frame.
Toilet	Good condition. No action required.
Bathroom	Replace glazing as it has cracked above the exhaust fan.
Bedroom 2	Replace window stays as it is not opening/closing properly.

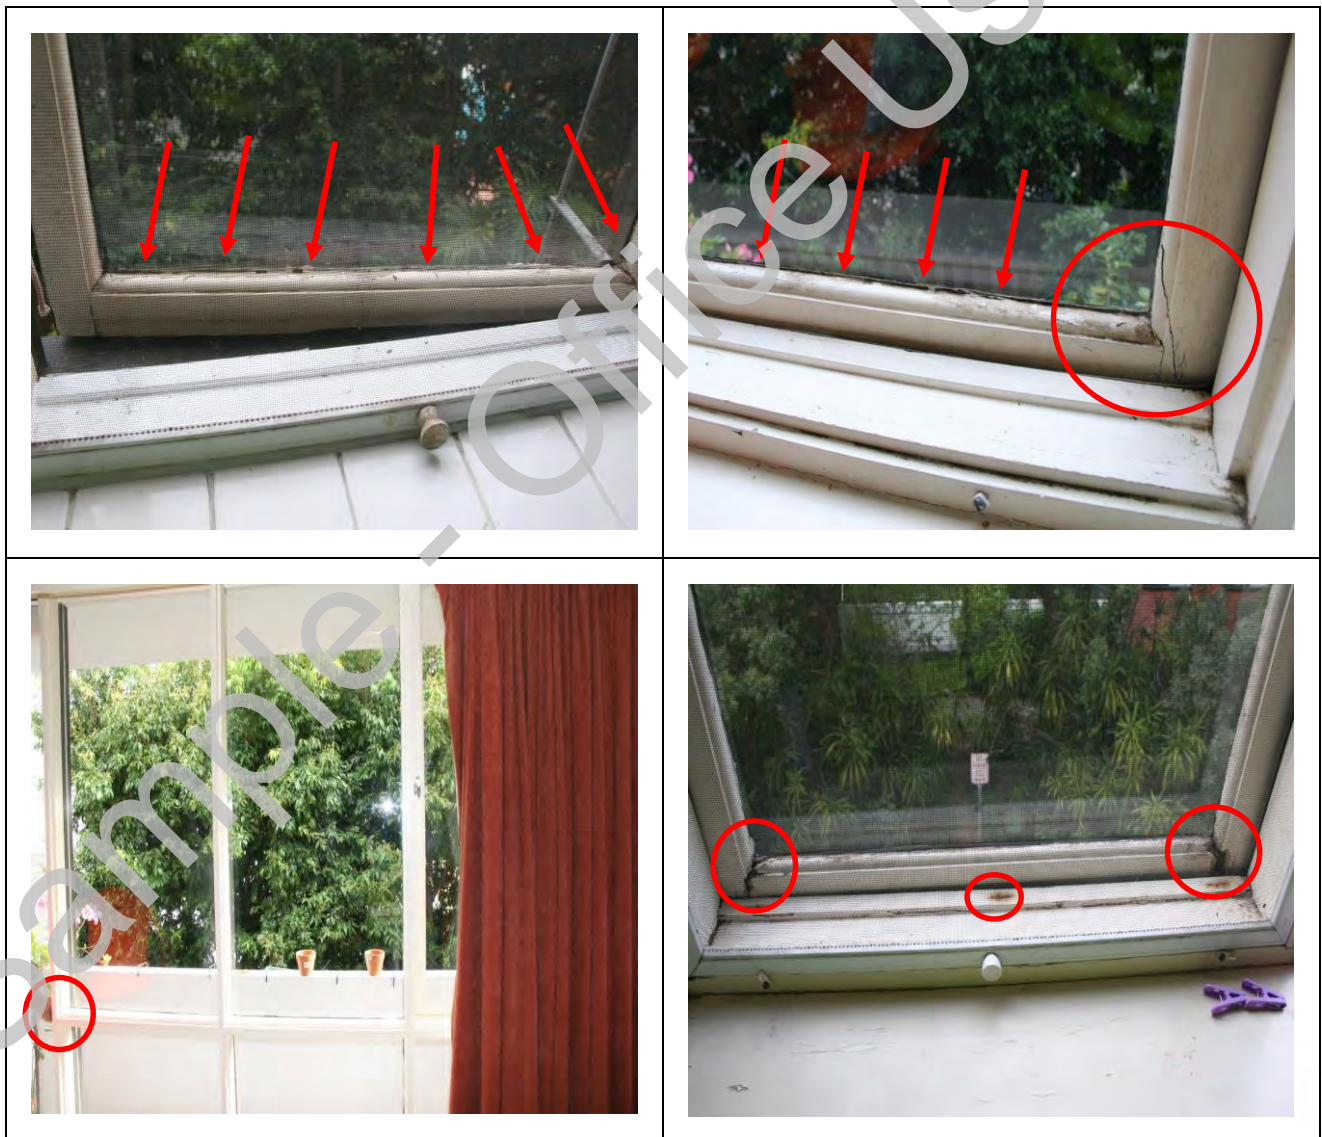
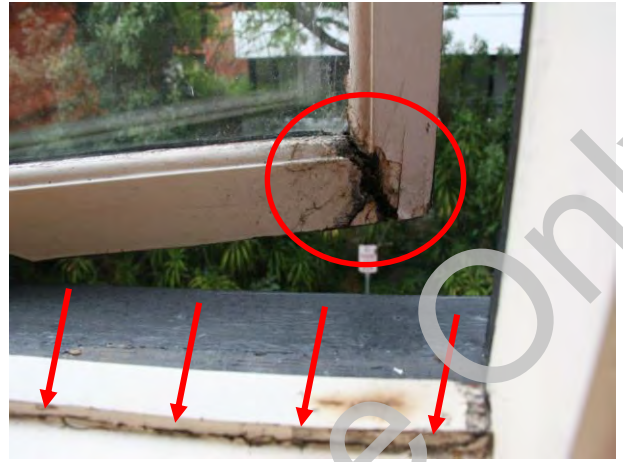
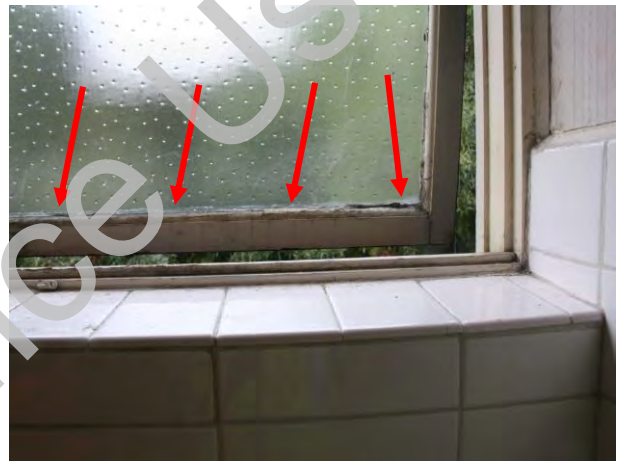
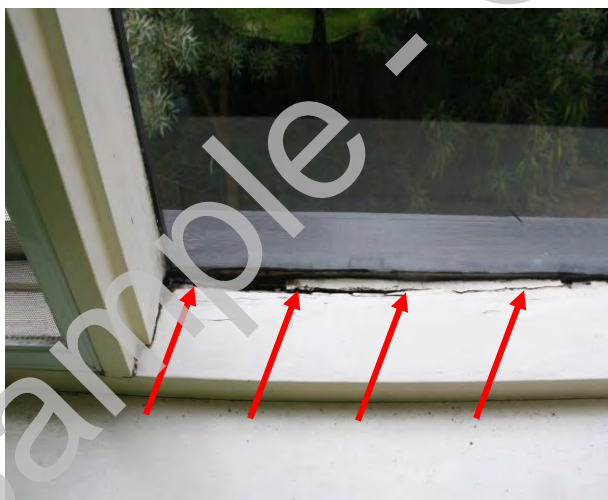
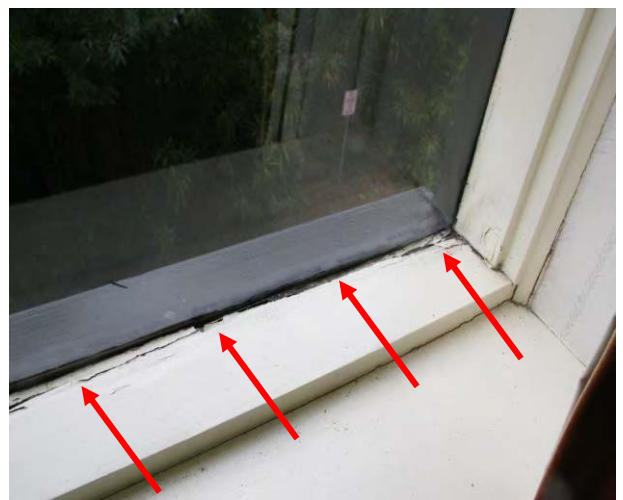
## Unit 9

Location	Inspection Notes
Kitchen	Replace window sash as the seal around the glazing has deteriorated and the sash is cracked. Prepare and paint window frame.
Dining	Replace entire window sash, frame & glazing as they have deteriorated beyond repair.
Living	Replace door hardware.
Bedroom 1	Replace entire window sash, frame & glazing as they have deteriorated beyond repair.
Toilet	Replace window sash. Prepare and paint frame.
Bathroom	Replace window sash. Prepare and paint frame.
Bedroom 2	Replace entire window sash, frame & glazing as they have deteriorated beyond repair.

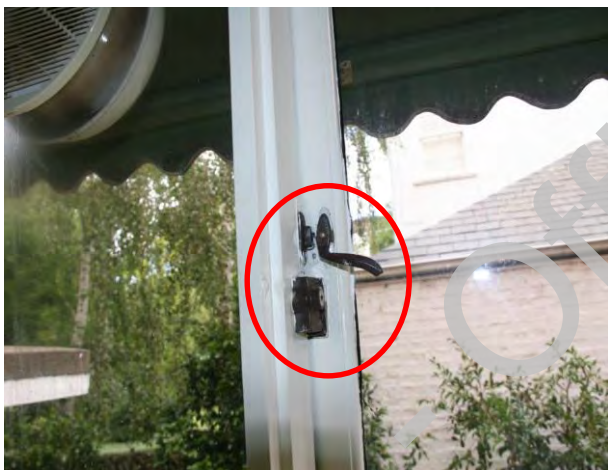
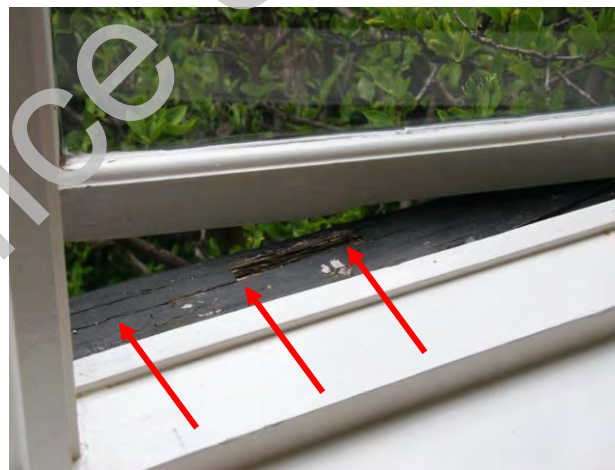
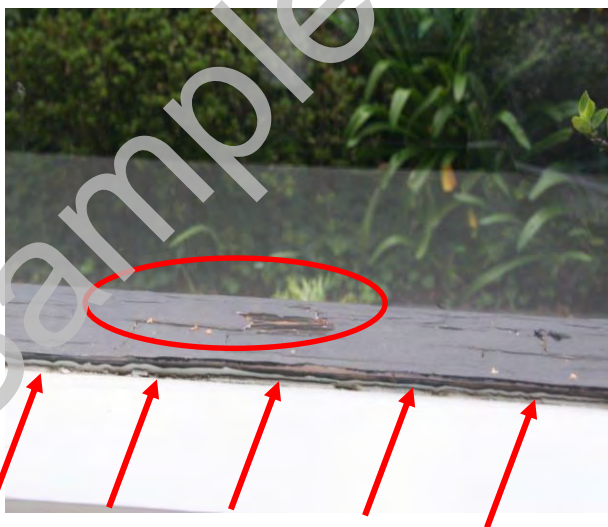
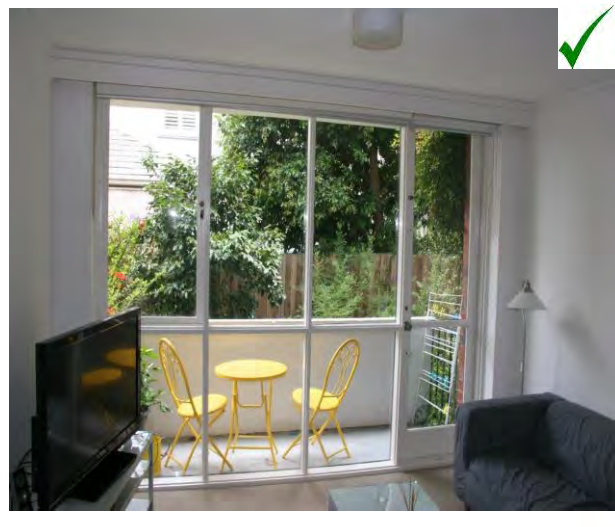
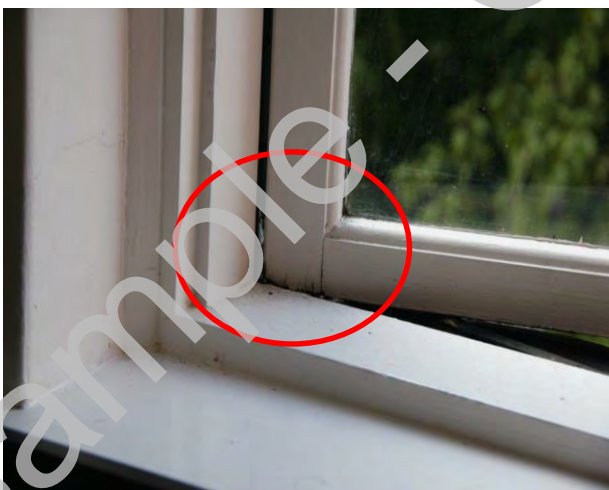
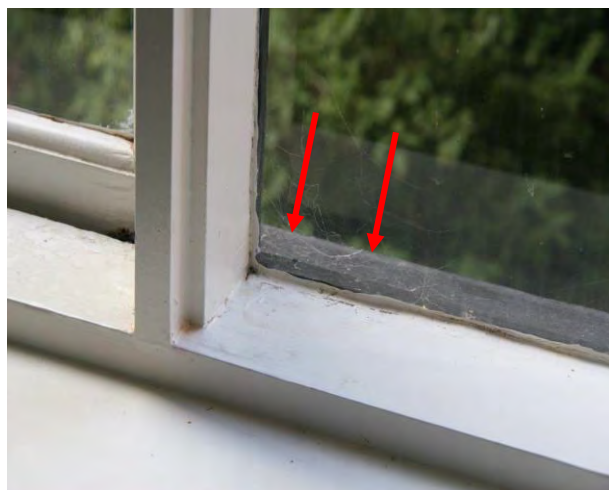
## Unit 2

Location	Inspection Notes
<b>Kitchen</b>	Replace window stays as the window does not open and has been screwed shut. A make safe was undertaken to screw the window shut as it was not secured properly. Patch and paint affected areas after replacement.
<b>Bedroom 1</b>	Replace external window sill.
<b>Living</b>	Good condition. No action required.
<b>Bedroom 2</b>	Replace window stays as the window does not open and has been screwed shut. A make safe was undertaken to screw the window shut as it was not secured properly. Patch and paint affected areas after replacement.
<b>Toilet</b>	Good condition. No action required.
<b>Bathroom</b>	Requires the window sash to be planed down as the window doesn't close properly. Patch and paint affected areas after replacement.
<b>Bedroom 3</b>	Replace window sash. Prepare and paint window frame and external sill.

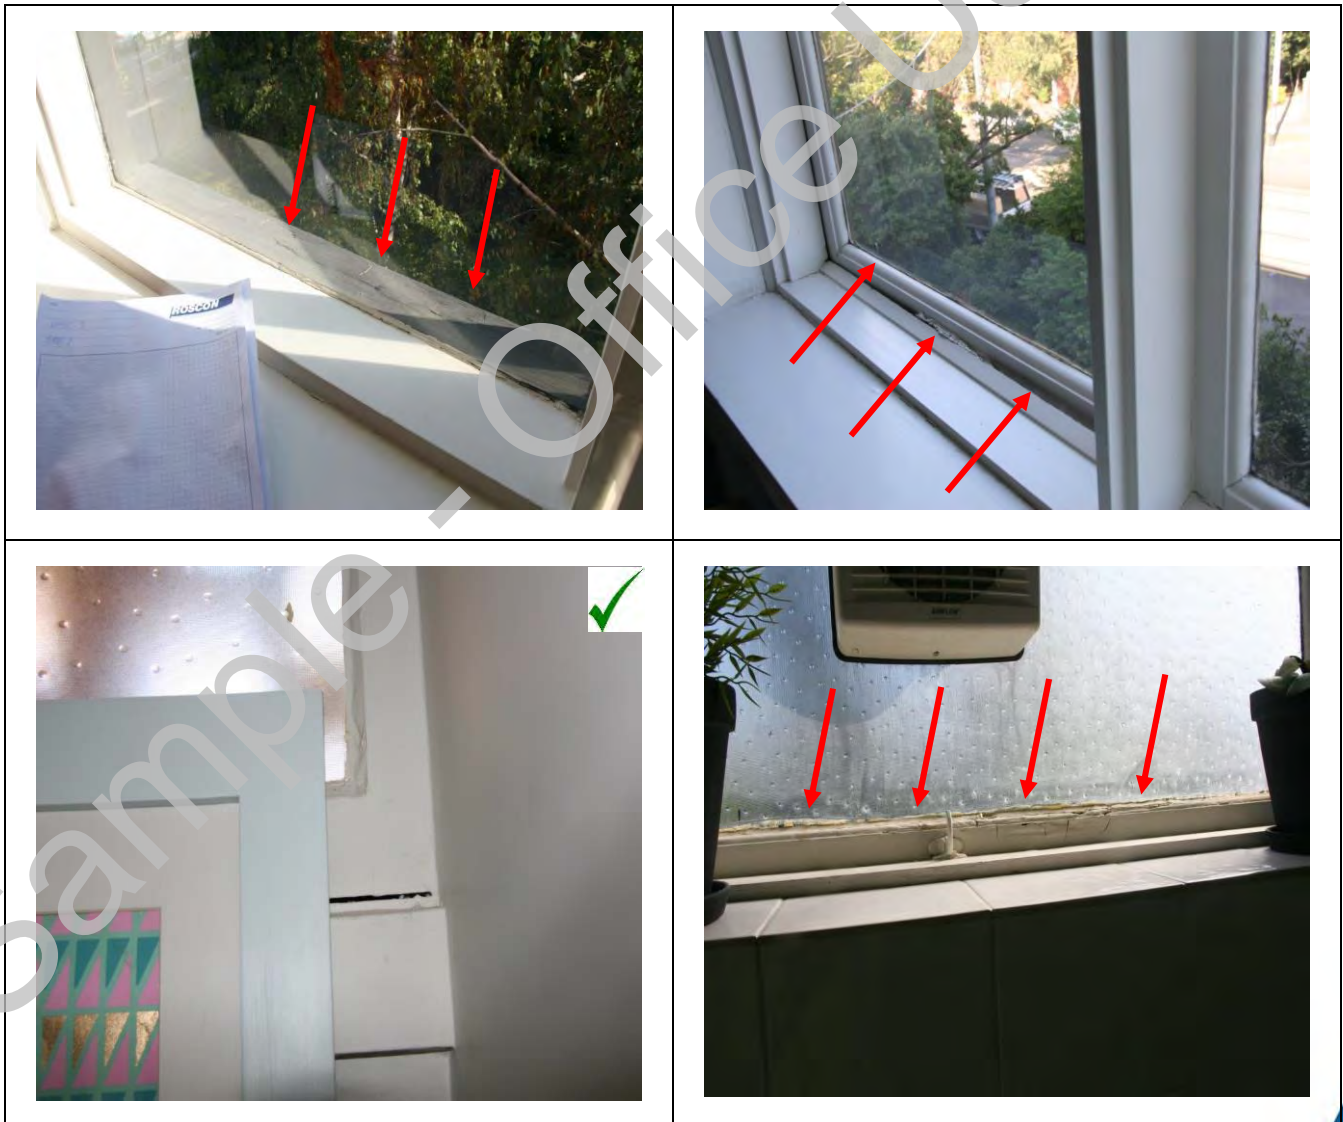
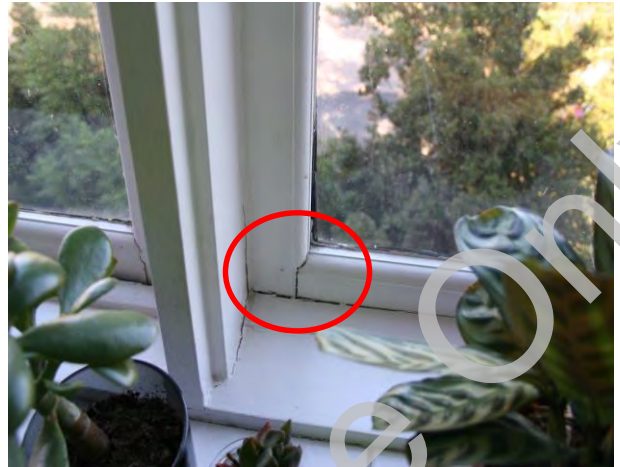
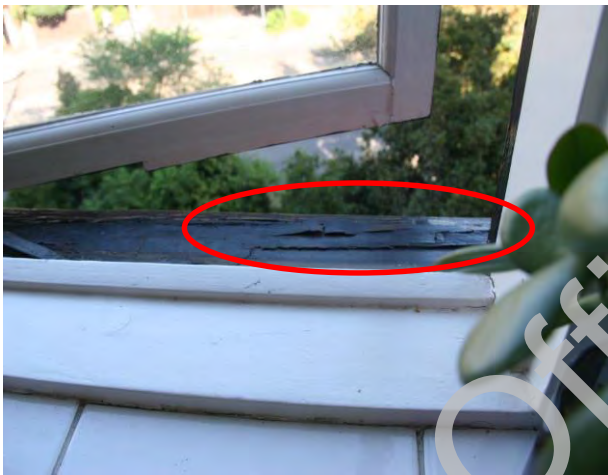
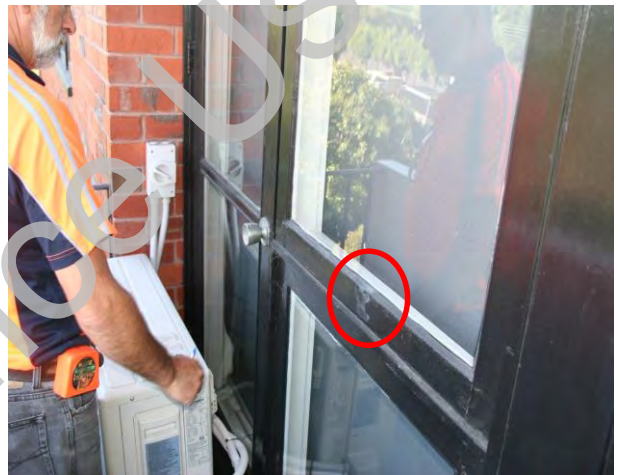
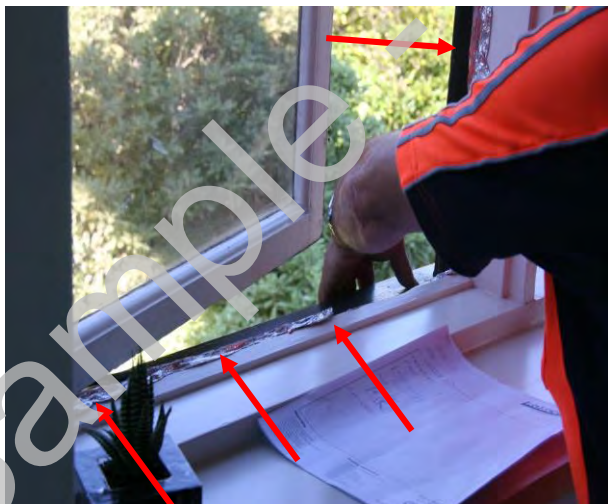
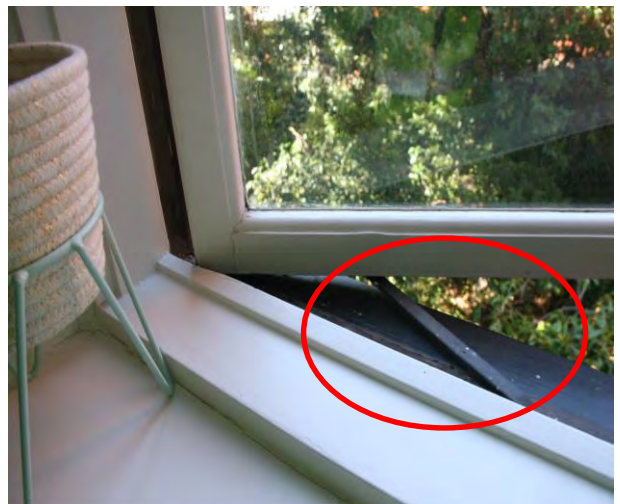
## Unit 3

Location	Inspection Notes
Bedroom 1	Replace the window sash and glazing for both windows as the seals have deteriorated.
Toilet	Good condition. No action required.
Bathroom	Replace the entire window sash, frame and glazing as they have deteriorated beyond repair.
Kitchen	Replace the window sash and external sill.
Living	Prepare and paint external frame.
Dining	Replace window sash as it has deteriorated and is allowing internal airflow. The tenants have placed aluminium foil to reduce the airflow however this is a temporary fix and a more permanent solution should be arranged.
Bedroom 2	Replace window hardware as it is not operational

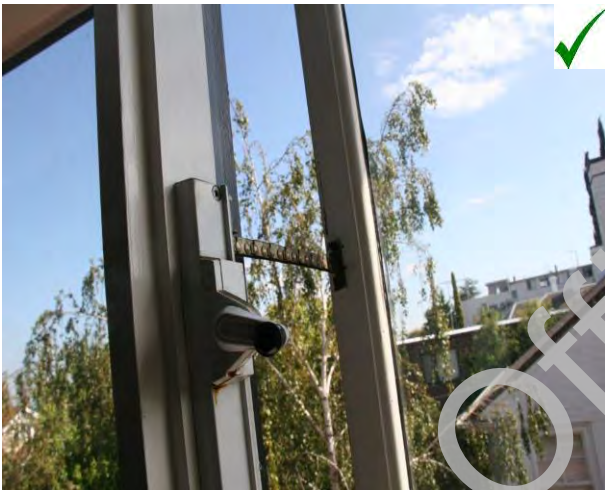
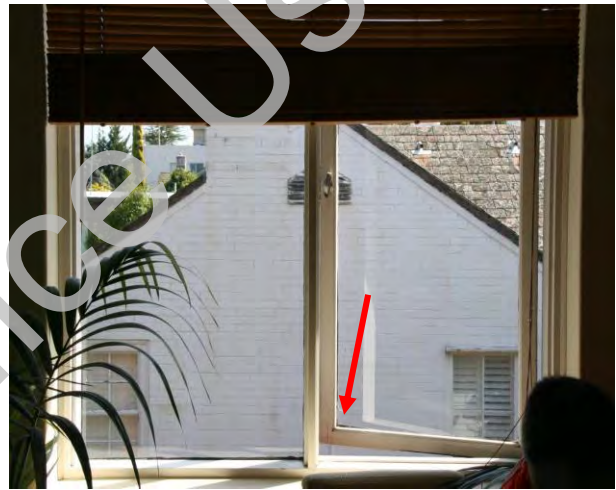
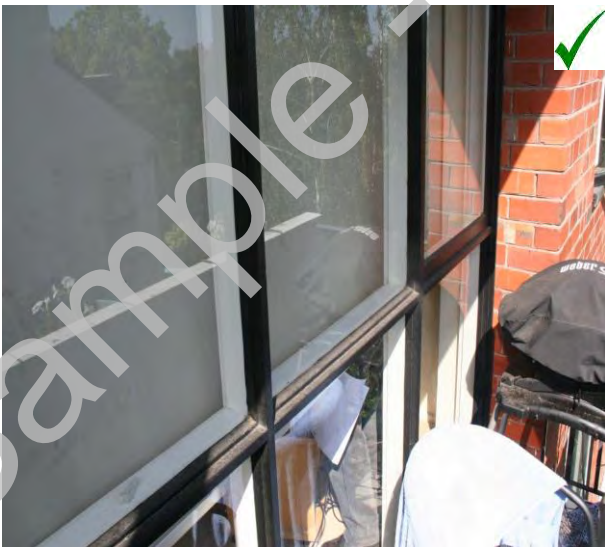
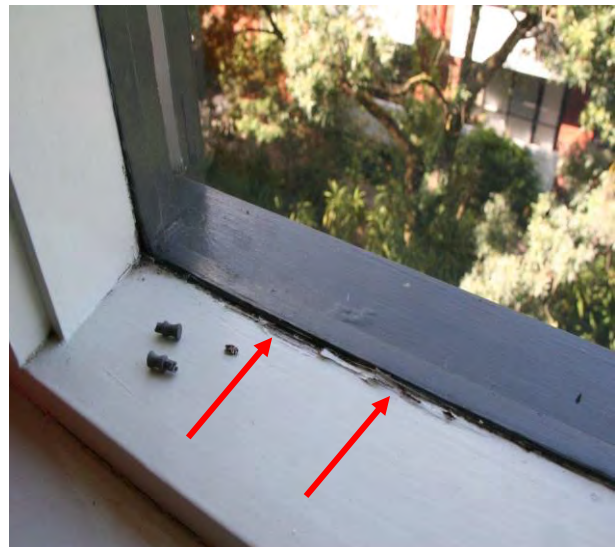
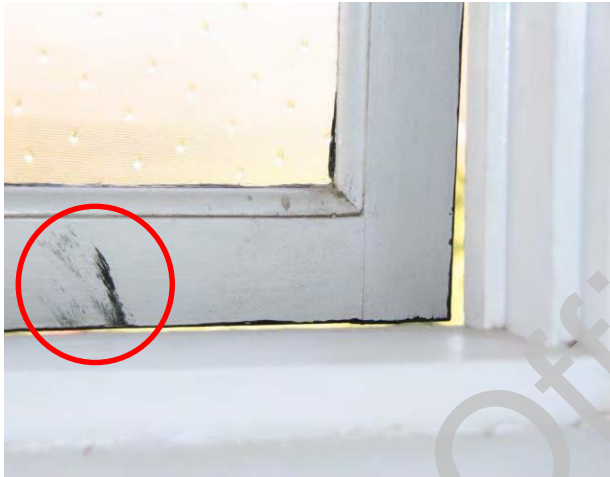
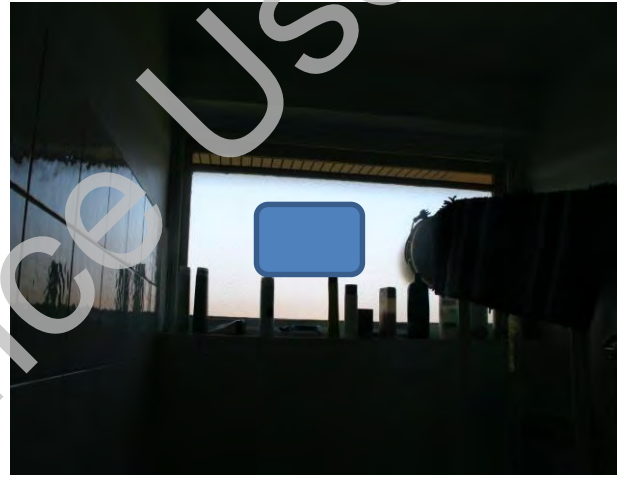
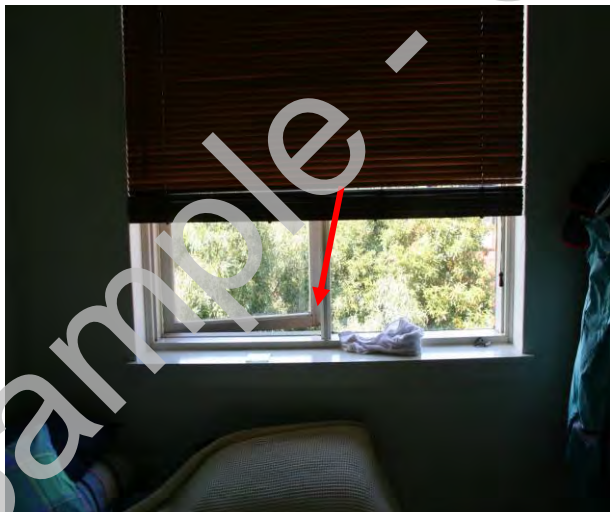
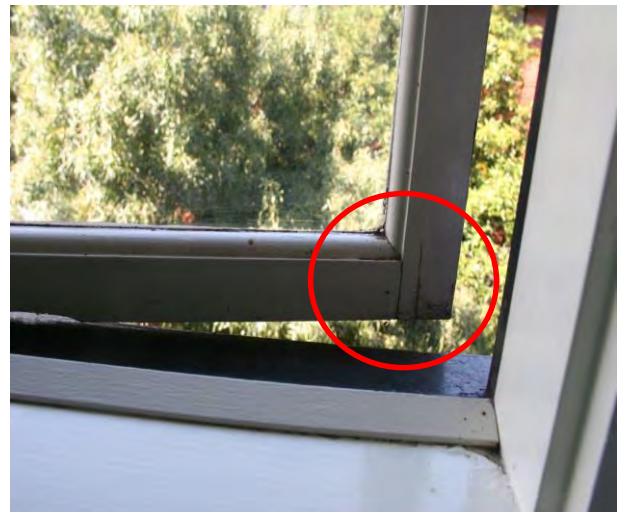
## Unit 6

Location	Inspection Notes
Kitchen	Good condition. No action required.
Dining	Prepare and paint window sash.
Living	Good condition. No action required.
Bedroom 1	Prepare and paint window frame.
Toilet	Prepare and paint window sash.
Bathroom	Replace window glazing to include an exhaust fan.
Bedroom 2	Prepare and paint window sash.

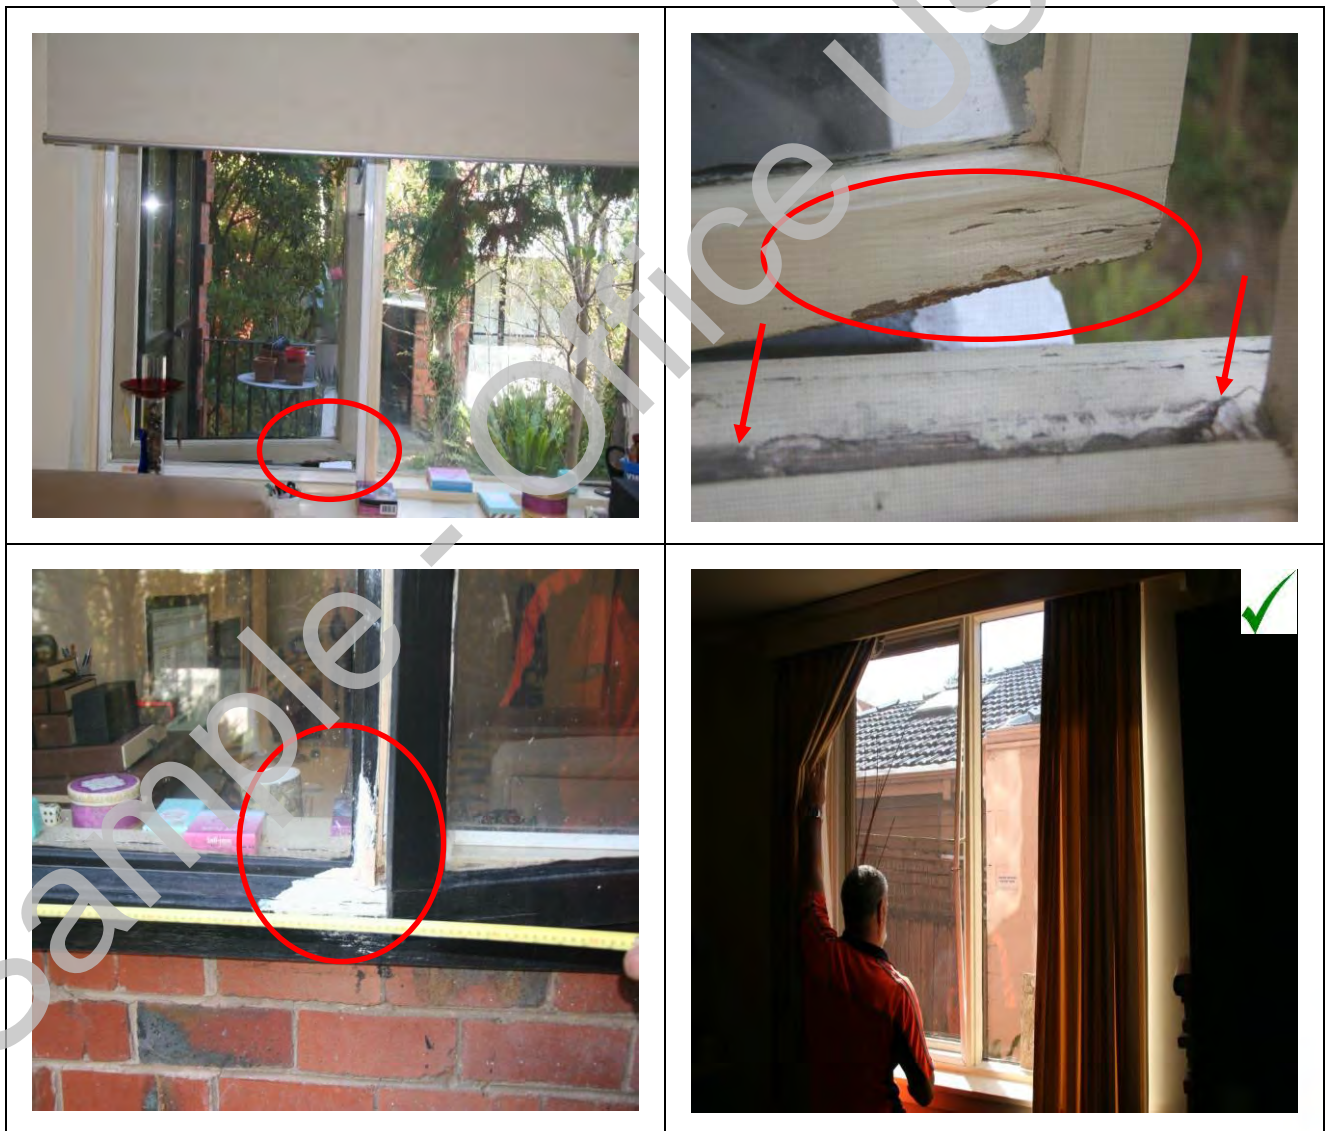
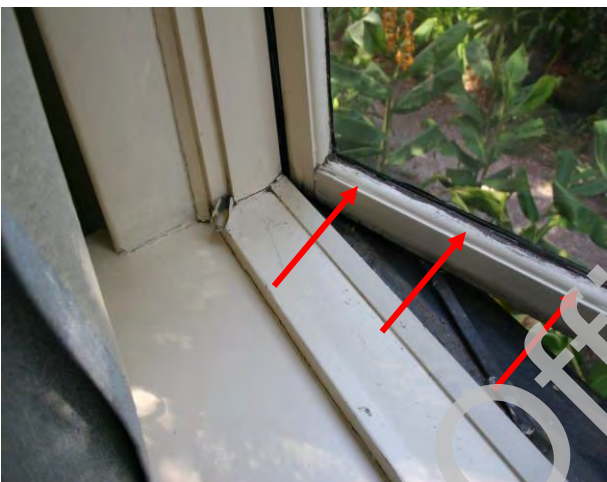
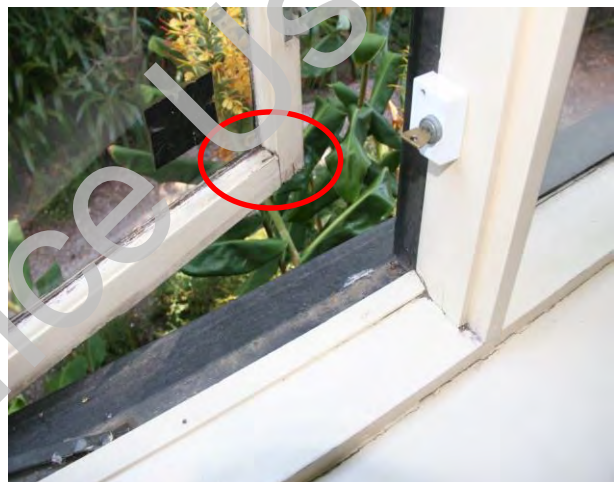
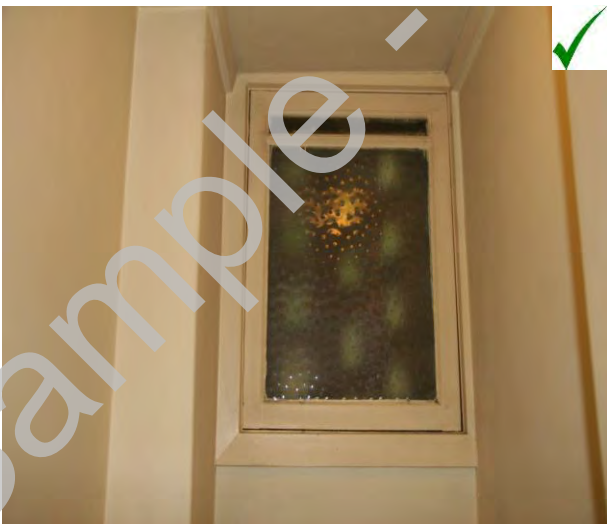
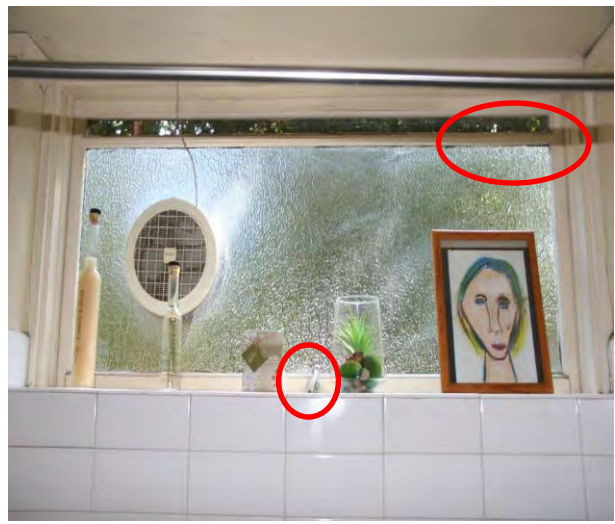
## Unit 13

Location	Inspection Notes
Bedroom 1	Replace window sash as it has completely deteriorated. Prepare and paint window frame.
Living	Good condition. No action required.
Dining	Prepare and paint window frame.
Kitchen	Replace window seal. Prepare and paint window sash.
Bedroom 2	Replace window sash. Prepare and paint external sill.
Toilet	Good condition. No action required.
Bathroom	Replace window chain. When the window is closed it does not open again. Prepare and paint window sash and frame.

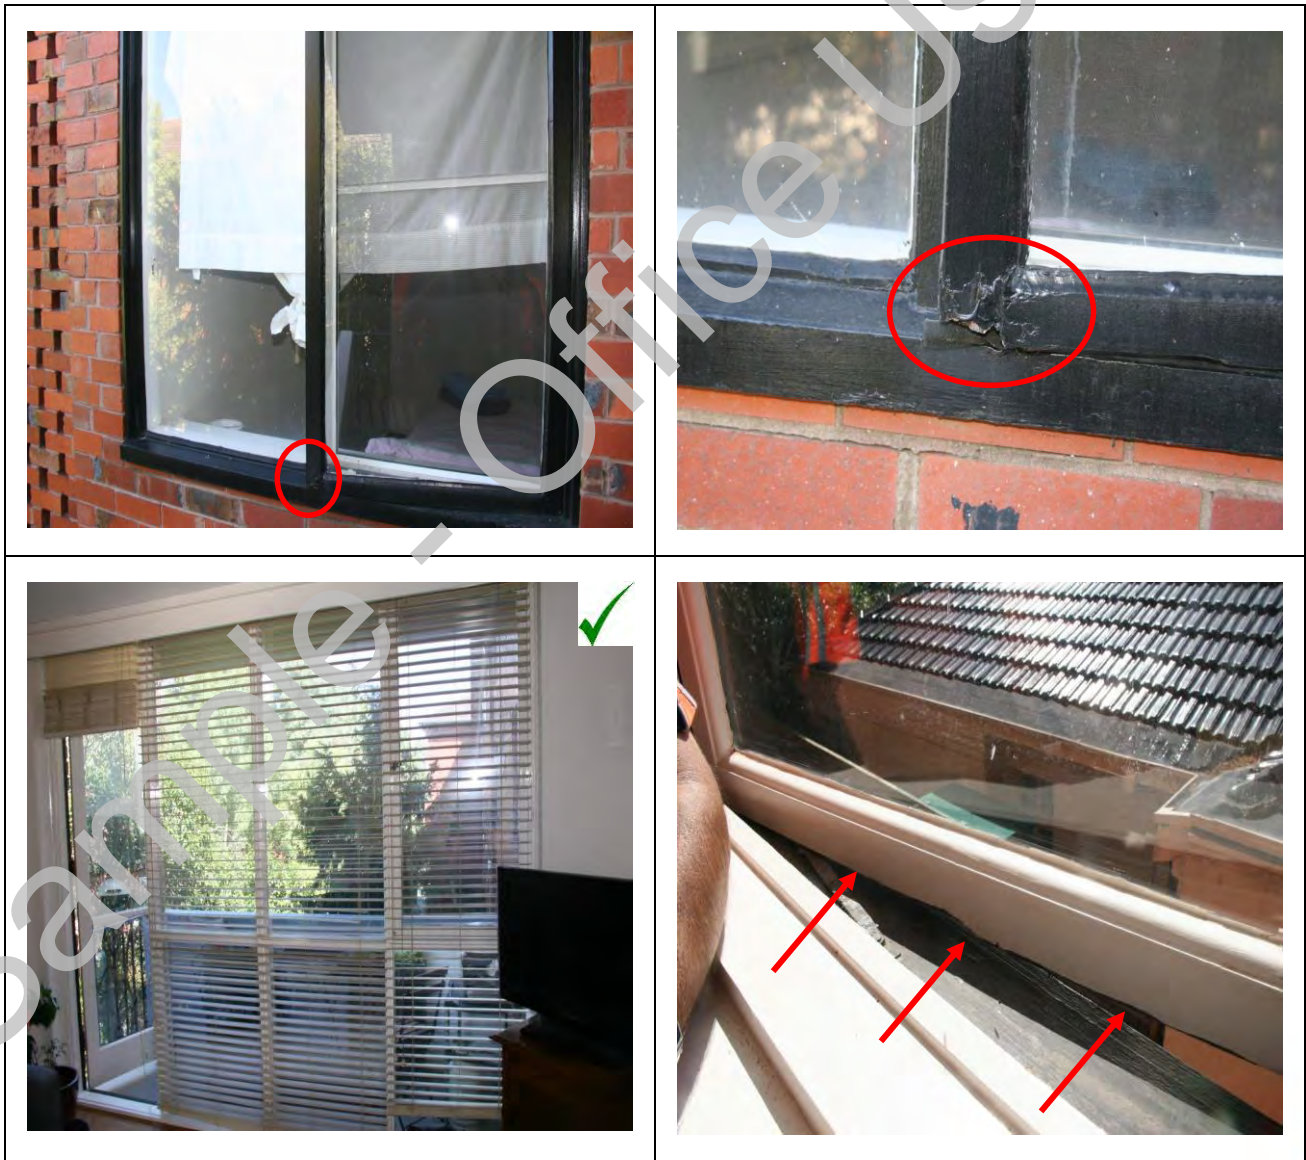
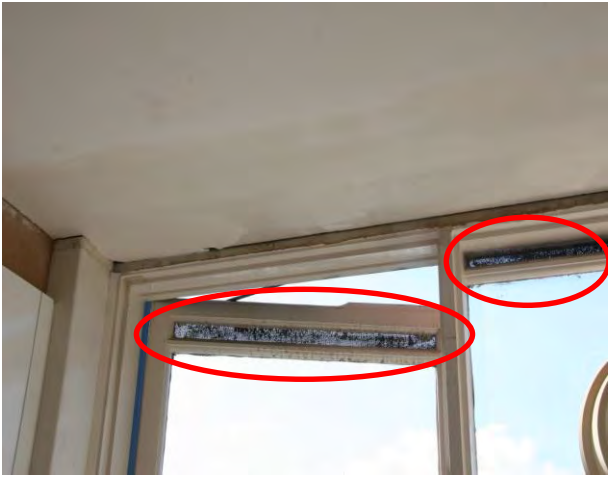
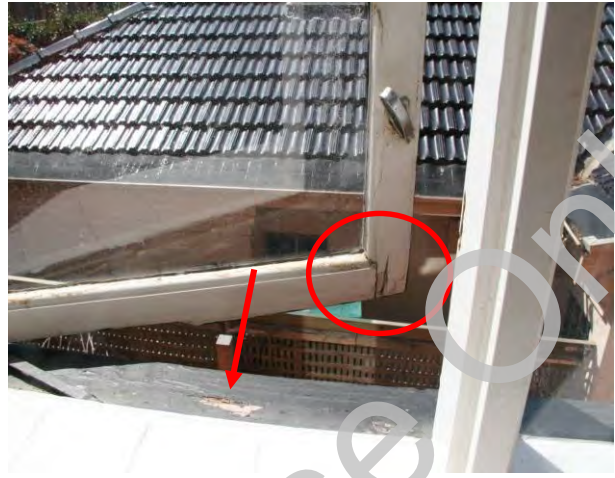
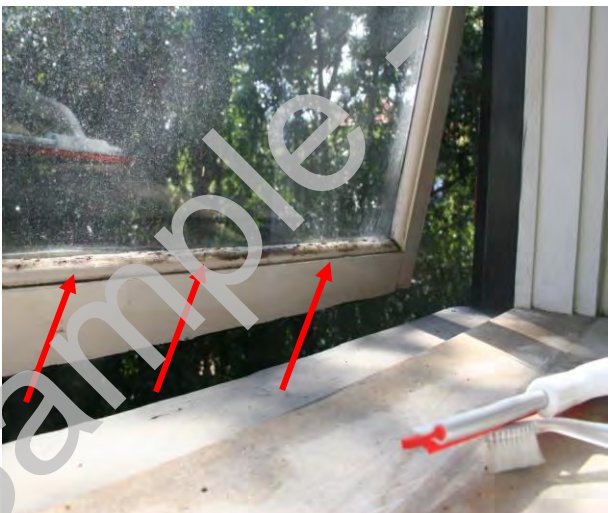
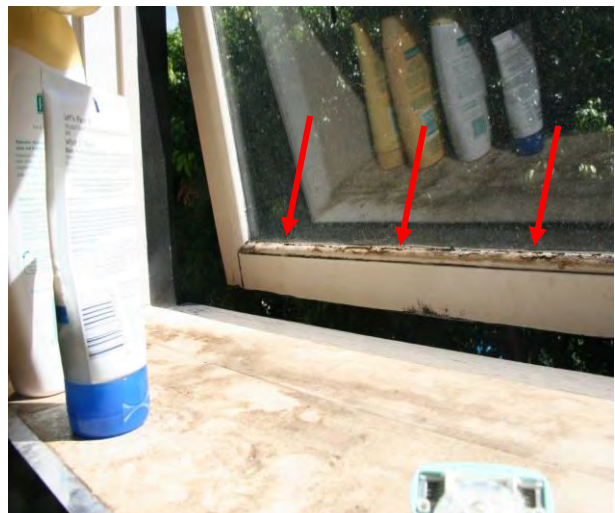
## Unit 14

Location	Inspection Notes
Bedroom 1	Replace window sash as is has completely deteriorated.
Living	Good condition. No action required.
Dining	Prepare and paint window sash.
Kitchen	Replace window sash and ventilation mesh at the top of the window. Prepare and paint external sill.
Bedroom 2	Good condition. No action required.
Toilet	Good condition. No action required.
Bathroom	Replace window sash as it has completely deteriorated. Prepare and paint window frame.
