## Detailed Windows Inspection

49 Sample Road Melbourne VIC 3122

## Part 1: Inspection Notes

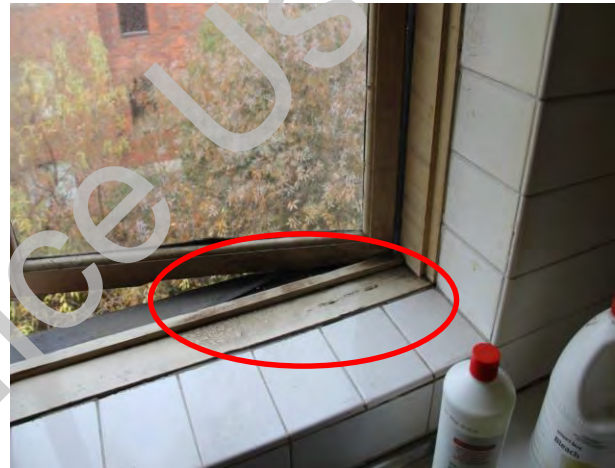
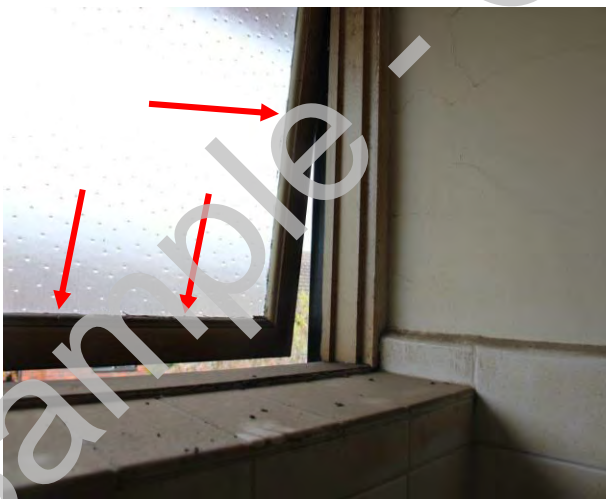
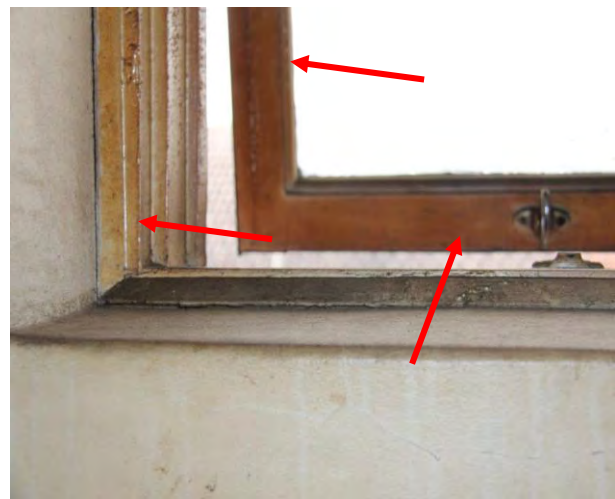
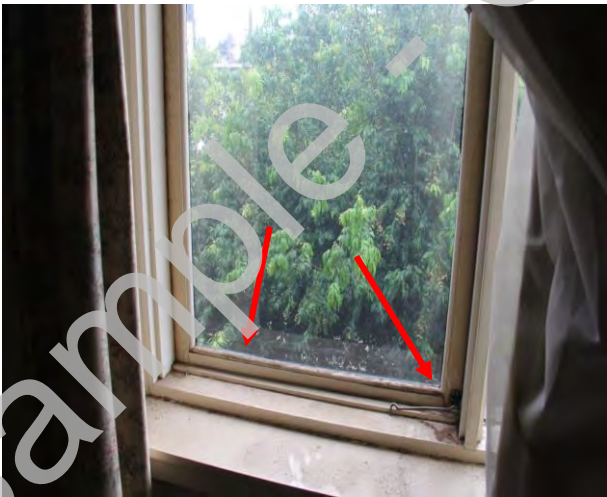
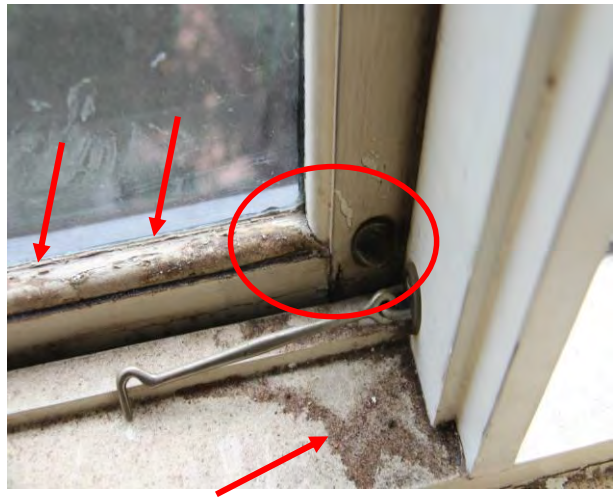
## Unit 12

Location	Inspection Notes
Kitchen	Replace entire window frame, sash and glazing as they have completely deteriorated.
Bathroom	Replace window sash. Prepare and paint window frame.
Toilet	Prepare & paint window frame and sash.
Bedroom 1	Replace entire window frame, sash and glazing as they have completely deteriorated.
Living	Replace window sash. Prepare and paint entire window frame. Replace seals around glazing as they have deteriorated.
Bedroom 2	Replace window sash. Prepare and paint window frame.

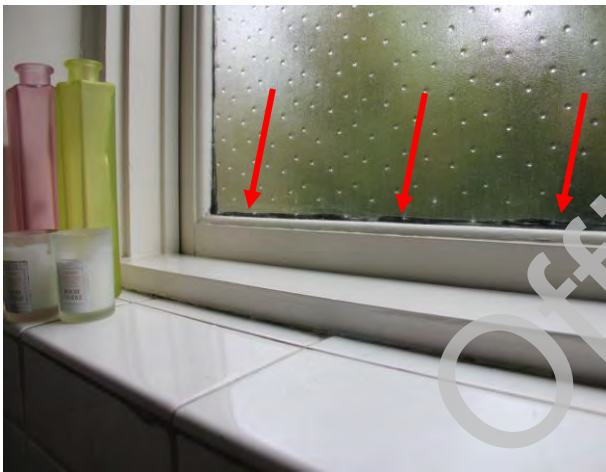
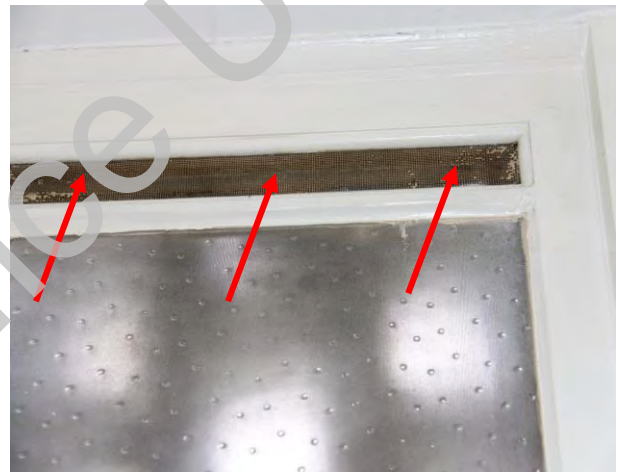
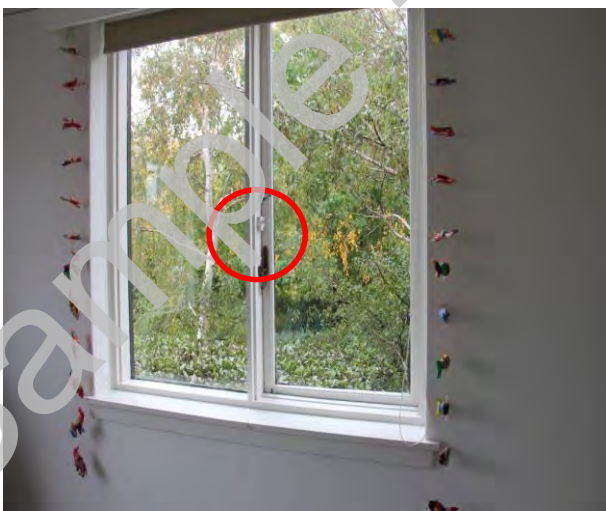
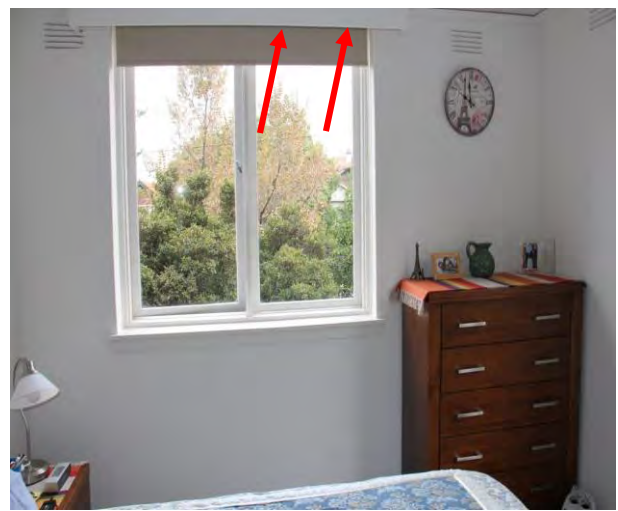
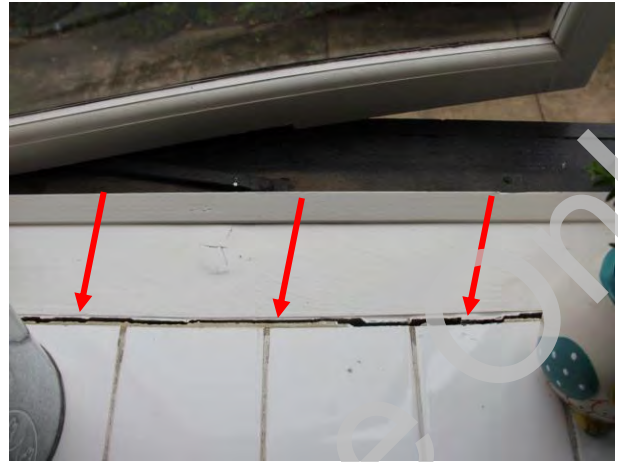
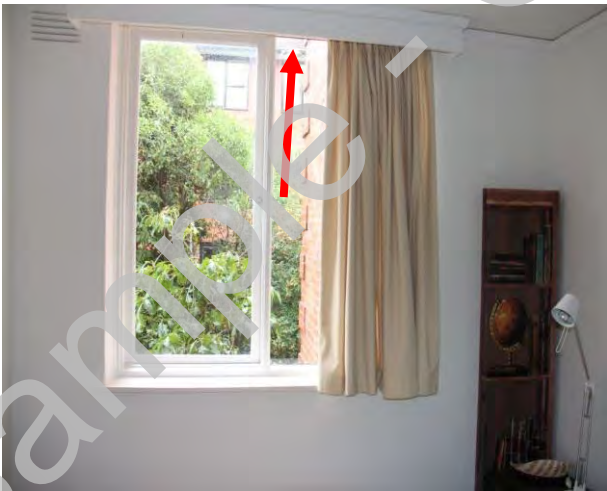
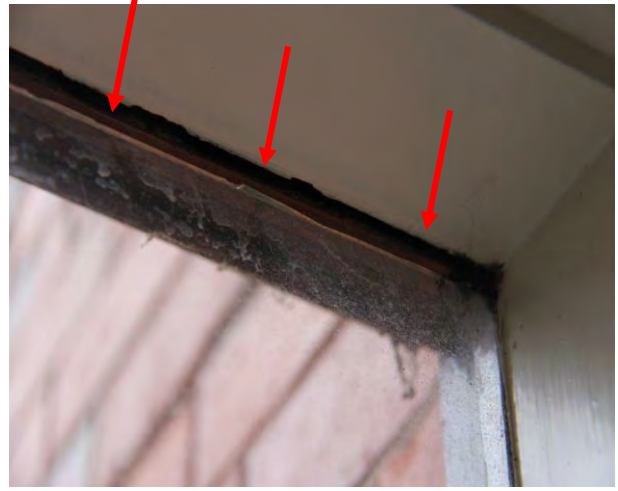
## Unit 1

Location	Inspection Notes
Bathroom	Replace seal around glazing.
Toilet	Replace ventilation mesh above the glazing.
Bedroom 1	Two windows: Replace window sash and hardware on north-facing window. Prepare and paint all other window frames and sash.
Kitchen	Re-seal crack between window frame and kitchen tiles. Prepare and paint after repairs are completed.
Living	Two windows: Replace door hardware and door sash on right hand side of west facing windows. Replace window sash on south face.
Bedroom 2	Replace and re-seal glazing as the glazing has dropped approx. 25mm out of the sash.

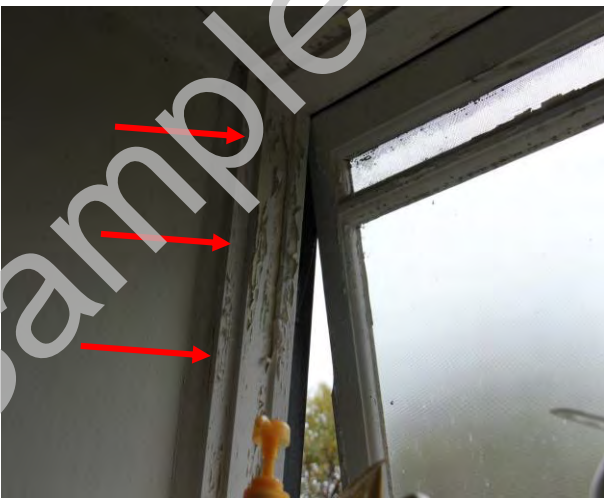
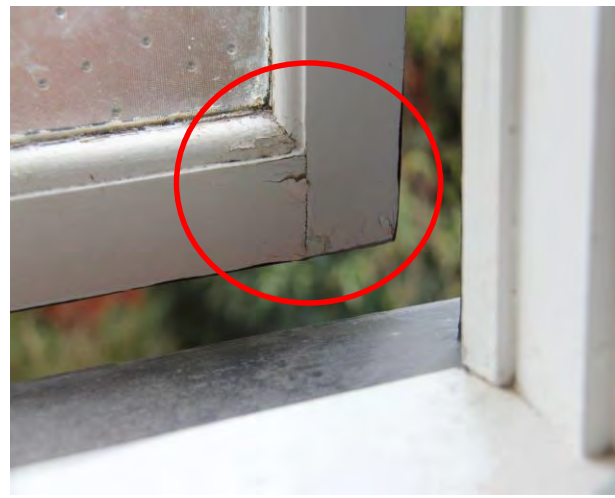
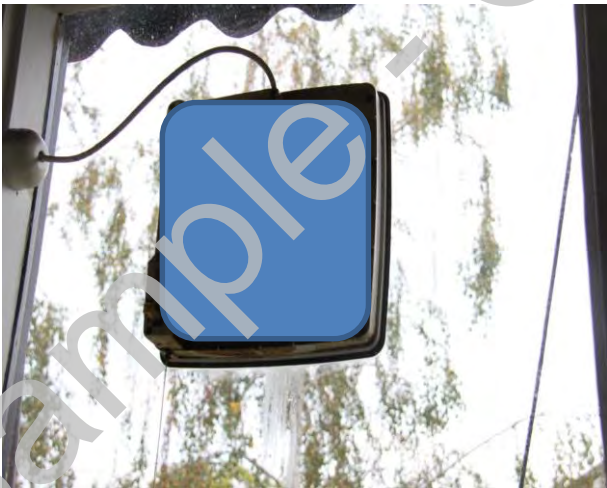
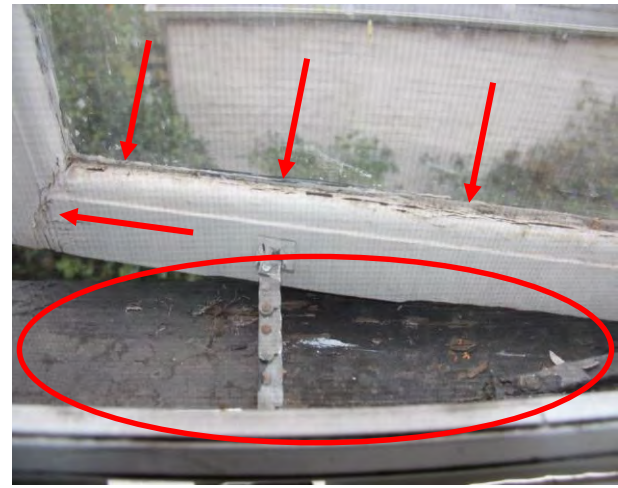
## Unit 4

Location	Inspection Notes
Bedroom 1	Prepare and paint window frame and sash.
Bathroom	Replace window frame and sash. Replace glazing to include an exhaust fan as the ceiling has been damaged by condensation.
Toilet	Replace window sash. Prepare and paint window frame.
Bedroom 2	Replace window sash. Prepare and paint window frame.
Living/Bedroom 3	Good condition. No action required.
Lounge	Replace window sash, external sill and window chain.
Kitchen	Replace window sash and external sill. Replace exhaust fan as it is not working and will eventually cause damage to the ceiling (similar to the bathroom)

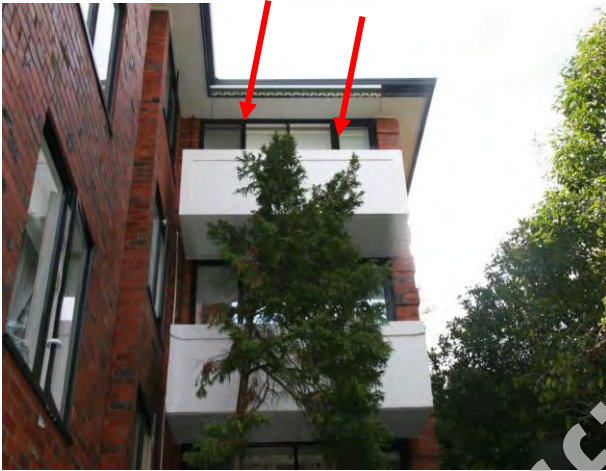
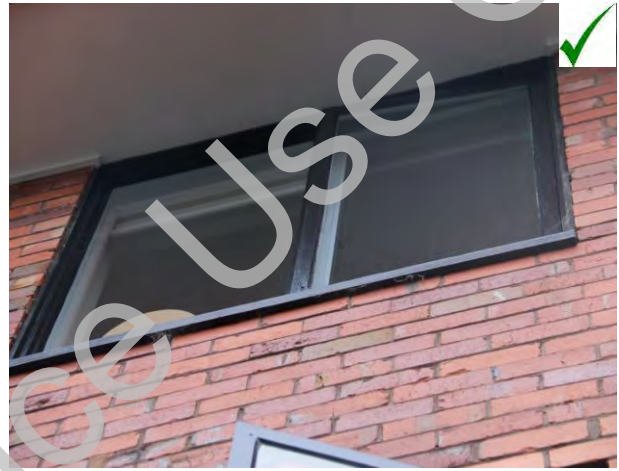
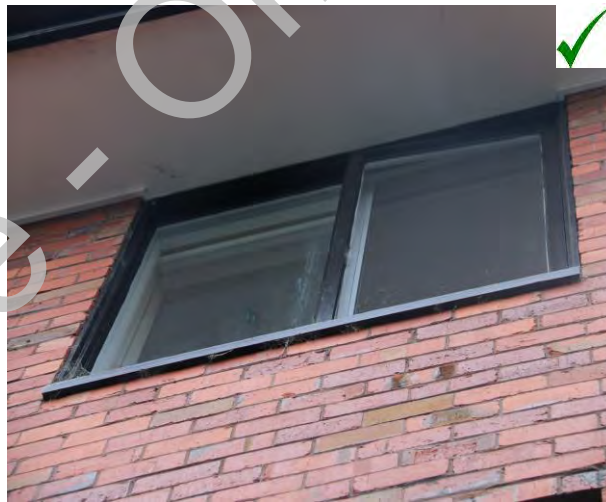
## Unit 15

Location	Inspection Notes
Living	Replace the window frame with a new PVC window frame as the existing frame has deteriorated due to water damage.
Bedroom 1	Good condition. No action required.
Kitchen	Good condition. No action required.

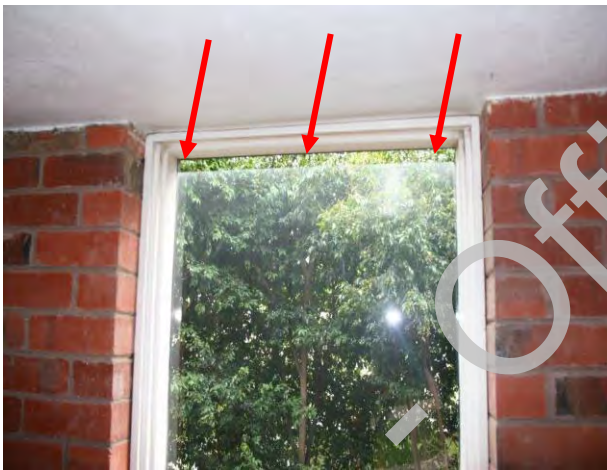
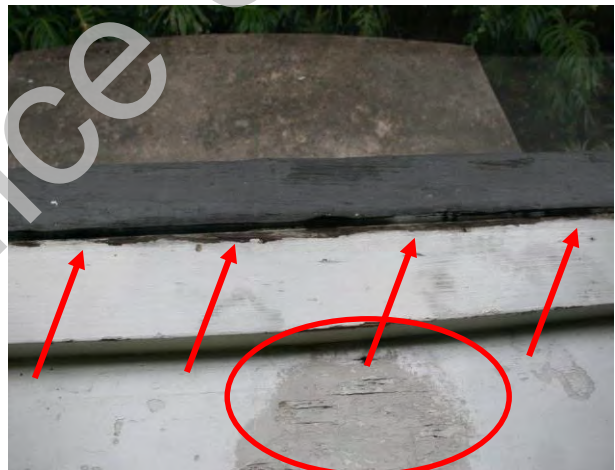
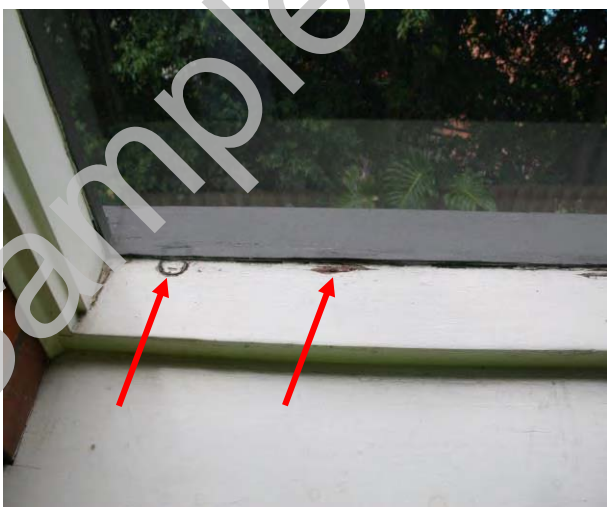
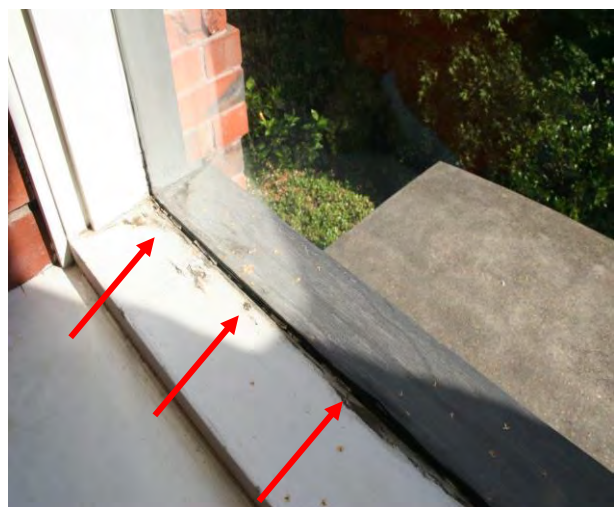
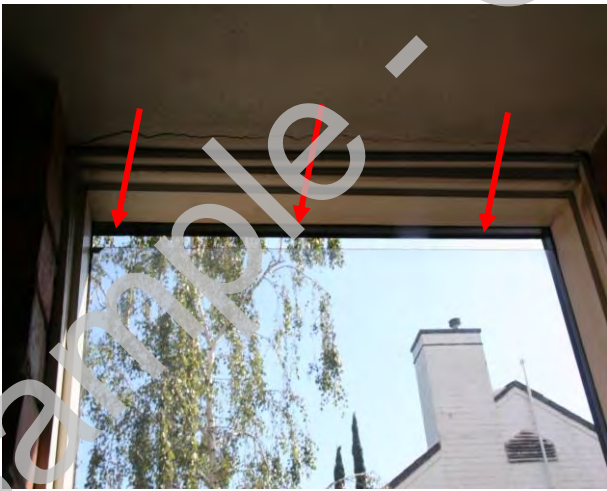
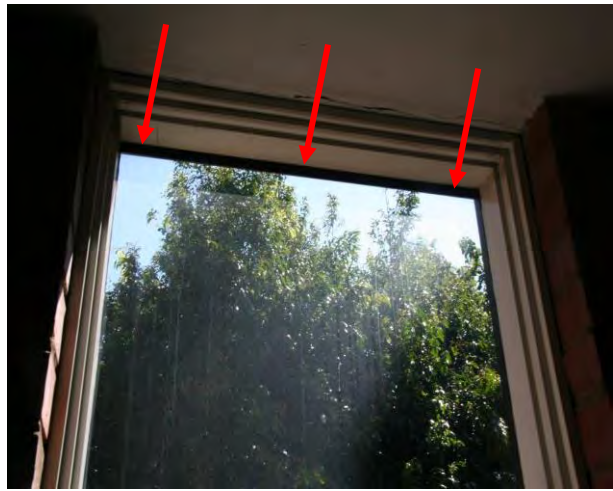
## Common Areas

Location	Inspection Notes:
<p><b>NB: These are general findings about the common areas in the building and are not specific to any location.</b></p>	
<b>Window Frame</b>	The majority of the window frames in the common areas require replacement as they have deteriorated. A minority have paint damage and require preparing and painting.
<b>Window Glazing</b>	A majority of the windows glazing have dropped by up to 50mm, this can be attributed to a poor window seal and need to be replaced as water ingress will cause further damage to the window frames.
<b>Glazing Seal</b>	As mentioned above, the glazing seal has deteriorated on all windows and will require replacement to mitigate further damages.
<b>Common Doors</b>	All common doors require preparation and painting to maintain the aesthetics of the building. Roscon recommends to plane the latch edge of the doors prior to painting as it was found that the doors fit too tightly in the frame and has been scratched on the latch edge.
