Forensic Building Defects Report

1 Sample St Suburb VIC 3000 (PS 123456X)

Roscon Property Services were engaged by OC manager to conduct a Forensic Building Defects Report for the property at 1 Sample St Suburb VIC 3000. The investigation was undertaken on Thursday 15 August 2018 at approximately 9:00am.

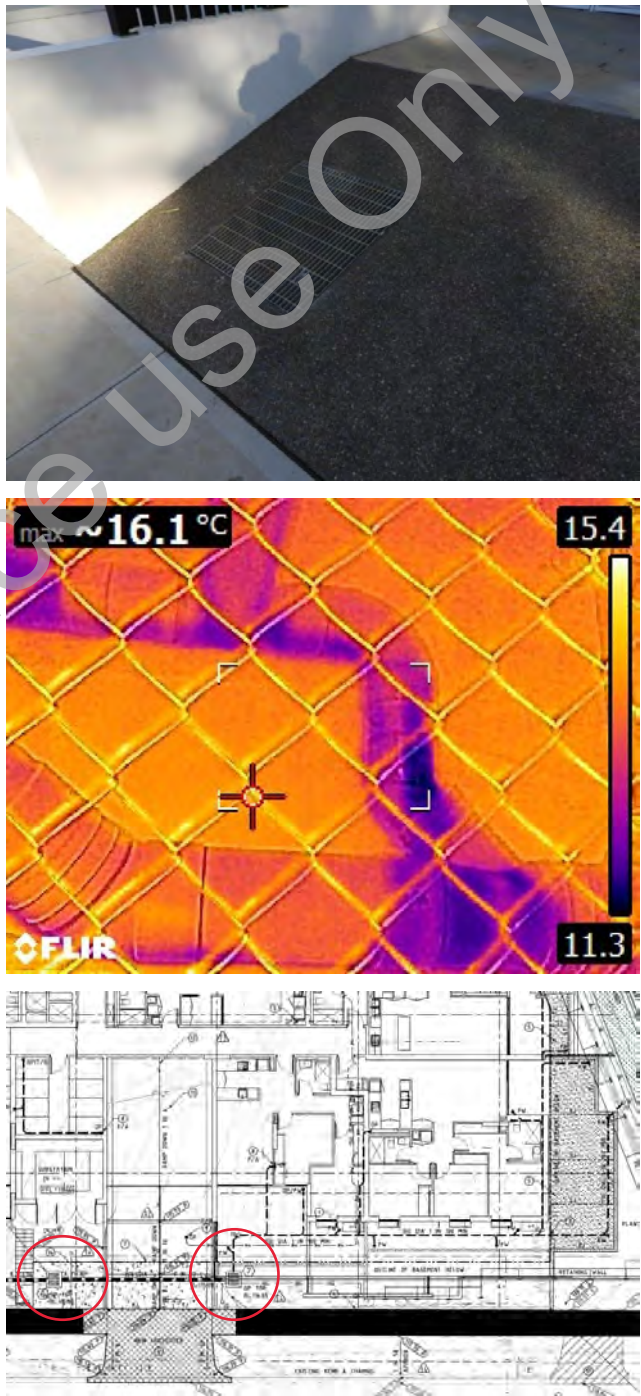
Item	Details	Photographic Details
1.	<p>Location:</p> <p>South-east of the property boundary</p> <p>Finding:</p> <p>At the time of inspection, the two south-east drainage pits were observed to have a continuous flow of water. The two drainage pits are connected to the planterboxes on the first floor and second floor areas. It is suspected that there is a water leak in the irrigation system of the building causing water to leak in the planterboxes which then get discharged into the stormwater system of the building.</p> <p>From the civil drawing C07 as shown in image 3, the drainage pits are also connected to several floor wastes and down pipes of apartments. It is possible that a water main has been compromised and is contributing to the constant flow of water into the drainage system.</p> <p>Video 1 in the video box shows the flow of water in both pits from the street level.</p> <p>Video 2 in the video box shows blue areas using a thermal imaging camera on the stormwater pipes. These blue areas indicate that there is water being discharged through them.</p> <p>Recommendations:</p> <p>It is recommended to firstly rectify the planterboxes and ensure that the waterproofing membrane is intact and functional.</p> <p>If the leak in the drainage pits persist, engage a forensic plumber to undertake a water investigation of the drainage system to determine the source of the leak and undertake the appropriate rectification actions to resolve the leak.</p>

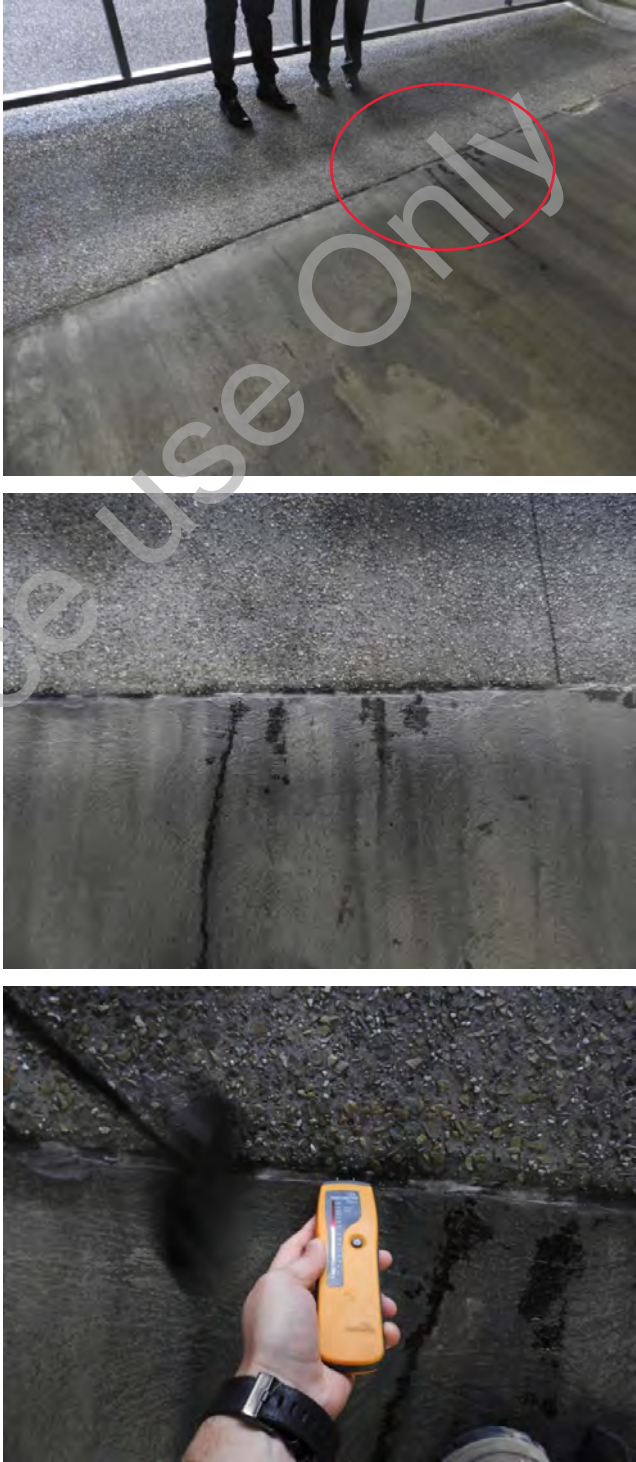
Item	Details	Photographic Details
4.	<p>Location:</p> <p>Carpark Driveway - Articulation Joint.</p> <p>Finding:</p> <p>The articulation joint at the edge of the driveway ramp and the carpark slab has water bleeding out of the joint.</p> <p>The building manager stated that the builder has agreed to replace the articulation joint during summer when the weather is dry.</p> <p>Recommendations:</p> <p>It is recommended that the articulation joint is raked out and left to vent for a couple of days to remove of all retaining water within the joint and concrete slab.</p> <p>Once the joint is dry then new expansion foam and approved sealant can be applied to the joint.</p>

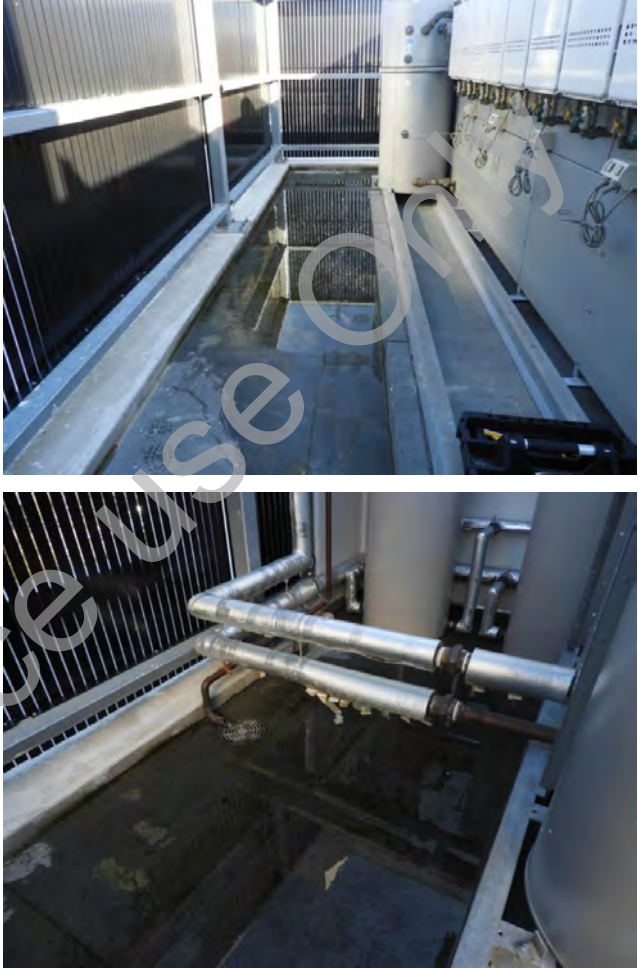
Item	Details	Photographic Details
5.	<p>Location:</p> <p>Level 14 - External hot water plant area</p> <p>Finding:</p> <p>It has been noted that at the time of inspection that water was ponding on the floor due to the lack of appropriate fall towards the floor waste causing water to chronically pond on the rooftop.</p> <p>AS 4654.2-2012 Clause 2.5.2 states:</p> <p><i>Falls in finishes shall ensure water drains to the drainage outlet. Water shall not be retained on the finished surface with the exception of residual water remaining due to surface tension. The fall shall be in the structural substrate, or formed by a screed over the structural substrate.</i></p> <p>NOTE: Falls for surface drainage should be no flatter than 1 in 100.</p> <p>A defect has been noted.</p> <p>Recommendations:</p> <p>The existing waterproofing membrane is to be stripped off the plant area with the concrete substrate being completely exposed.</p> <p>A layer of screed is to be applied to the substrate and is to be graded so that falls at a minimum grade of at least 1 in 100 towards the floor waste can be achieved.</p> <p>A new layer of waterproofing is to be applied to the plant area in accordance with AS4654.2-2012.</p>

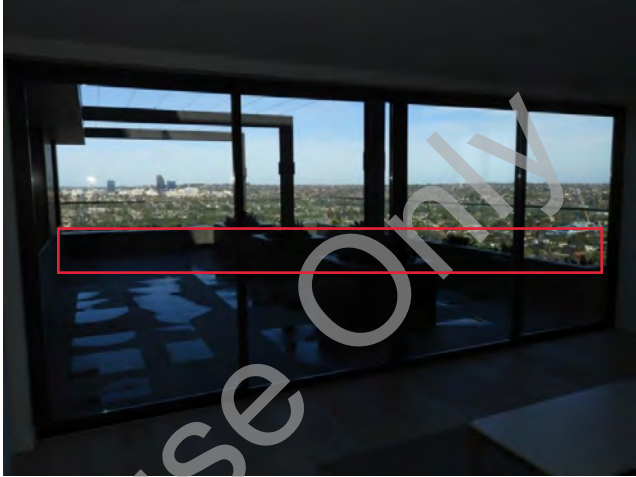
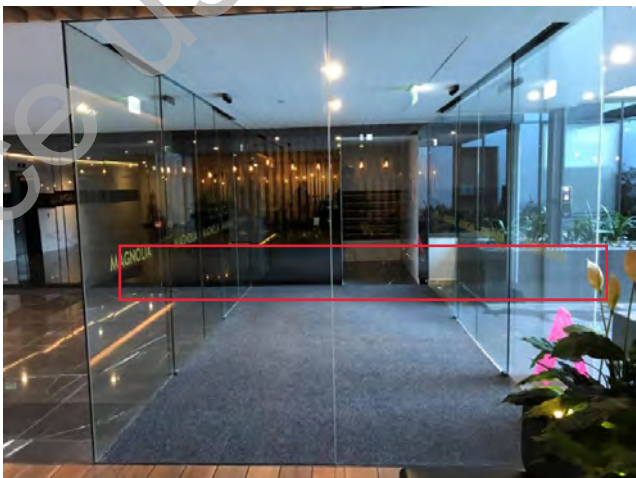
Item	Details	Photographic Details
7.	<p>Location:</p> <p>Glass Doors in Common Area Hallways.</p> <p>Finding:</p> <p>The glass doors throughout the building do not have any decals. These are prominent in areas found throughout car parks to lift access, the lobby, and entrances to courtyards. This is a safety hazard as the glass panes are transparent and pedestrians may collide into the glass, which can lead to serious injury.</p> <p>AS 1428.1-2009, clause 6.6 states:</p> <p><i>"Where there is no chair rail, handrail or transom, all frameless or fully glazed doors, sidelights, including any glazing capable of being mistaken for a doorway or opening, shall be clearly marked for their full width with a solid and non-transparent contrasting line. The contrasting line shall be not less than 75 mm wide and shall extend across the full width of the glazing panel. The lower edge of the contrasting line shall be located between 900 mm and 1000 mm above the plane of the finished floor level. Any contrasting line on the glazing shall provide a minimum of 30% luminance contrast when viewed against the floor surface or surfaces within 2 m of the glazing on the opposite side."</i></p> <p>A defect has been noted.</p> <p>Recommendations:</p> <p>Engage the builder to apply required marking in accordance with Clause 5.19.3 Marking of AS 1288-2006, which states:</p> <p><i>"Marking, where required, shall be in the form of an opaque band not less than 20 mm in height and located so that the vertical distance from the floor level is-</i></p> <p><i>(a) not less than 700 mm from the upper edge of the band; and</i></p> <p><i>(b) not more than 1200 mm to the lower edge of the band.</i></p> <p><i>The band shall be readily apparent. This may be achieved either by ensuring that the band contrasts with the background or by increasing the height of the band."</i></p>

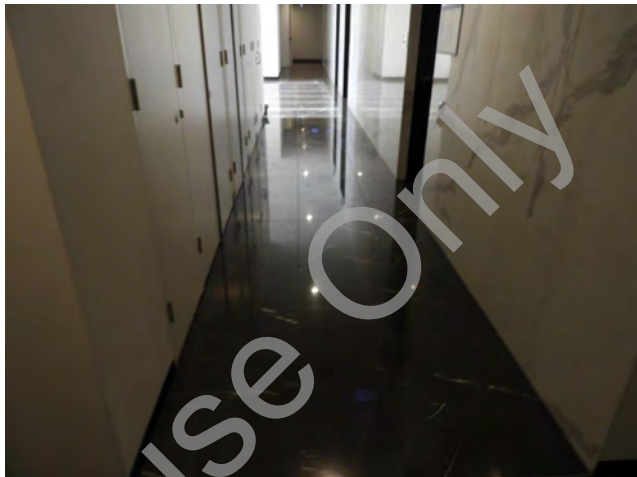
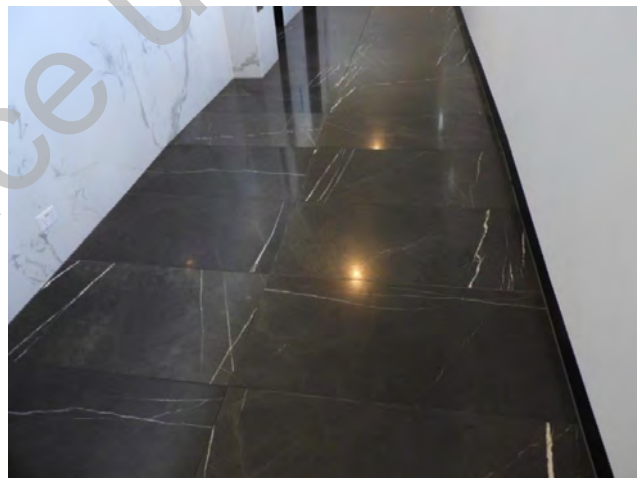
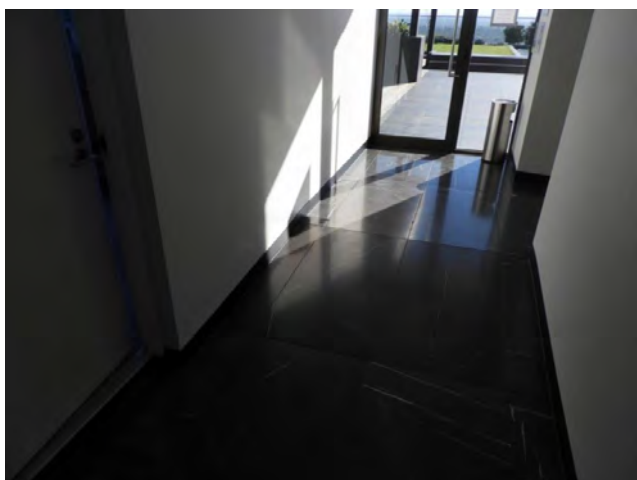
Item	Details	Photographic Details
8.	<p>Location:</p> <p>Throughout levels 1-14</p> <p>Finding:</p> <p>The internal floor tiles throughout the building have do not have intermediate joints installed at 4.5 m intervals or at locations where stress is likely to occur. The length of the internal tiled sections are greater than 9 m in length.</p> <p>For example on Level 14 there are multiple sections where the tiles change plan, these do not have an intermediate joints throughout the full thickness of the grout joint where the tile changes alignment.</p> <p>The majority of lift lobbies lack intermediate joints throughout the entire tiled surface.</p> <p>AS 3958.1-2007 clause 5.4.5.2 floors states:</p> <p><i>"(b) Intermediate movement joints Intermediate joints type (c), (d) or (e), as shown in Figure 5.1, should be inserted at intermediate positions to accommodate deflections of the base and movements in the flooring.</i></p> <p><i>They should be provided in evenly spaced positions at approximately 4.5 m centres, or at locations where stress might reasonably be expected in—</i></p> <p><i>(i) internal floors, where any dimension exceeds 9 m or 6 m if subjected to sunlight; and</i></p> <p><i>(ii) external floors where any dimension exceeds 4.5 m."</i></p> <p>A defect has been noted.</p> <p>Recommendations:</p> <p>The builder is to install intermediate joints at even 4.5 m spacings or at locations where stress is likely to occur.</p>

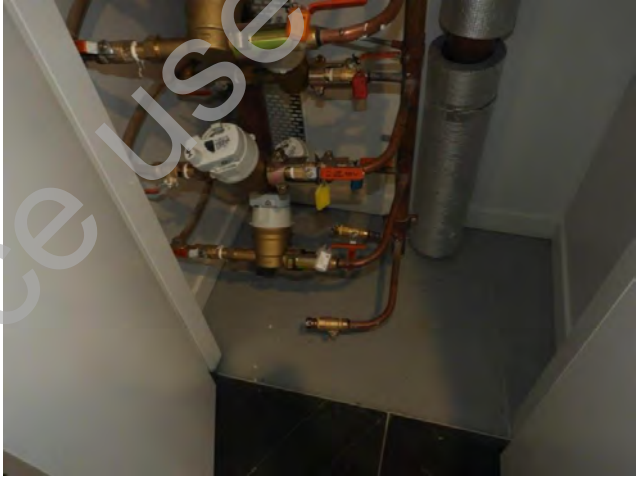
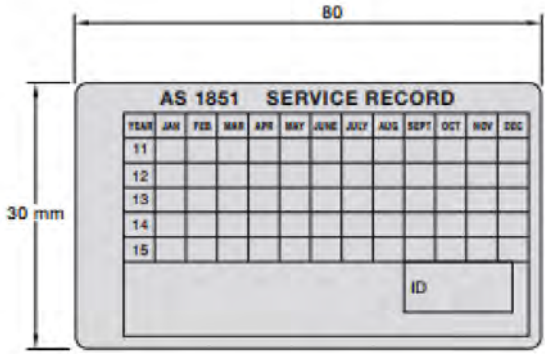
Item	Details	Photographic Details																		
9.	<p>Location:</p> <p>Fire Penetrations throughout Service risers within the building.</p> <p>Finding:</p> <p>Fire penetrations building do not have labels showing when they were last serviced.</p> <p>The Occupancy Permit Essential Safety Measures, as shown in image 1, requires an annual inspection for the elements required to be non-combustible, provide fire protection compartmentalisation or separation.</p> <p>The AS1851 Service records are to be installed to each fire penetration to show when they were last checked as a part of the annual inspection.</p> <p>AS 1851-2012 clause 12.2.6 states:</p> <p><i>"Passive fire and smoke system components, including penetrations, shall be labelled.</i></p> <p><i>NOTE: If the responsible entity and service provider agree, multiple services may be identified on a single label.</i></p> <p><i>Labels shall include—</i></p> <p><i>(a) a title 'AS 1851 Service Record';</i></p> <p><i>(b) the service performed* (e.g. three-monthly, six-monthly or yearly);</i></p> <p><i>(c) date (month/year); and</i></p> <p><i>(d) equipment ID (link to summary record);</i></p> <p><i>Labels shall include—</i></p> <p><i>(a) a title 'AS 1851 Service Record';</i></p> <p><i>(b) the service performed* (e.g. three-monthly, six-monthly or yearly);</i></p> <p><i>(c) date (month/year); and</i></p> <p><i>(d) equipment ID (link to summary record);"</i></p> <p>A defect has been noted.</p> <p>Recommendations:</p> <p>Builder is to install appropriate service tags to the fire penetrations throughout the building.</p> <p>Image 3 shows a sample of the service label that is to be installed.</p>

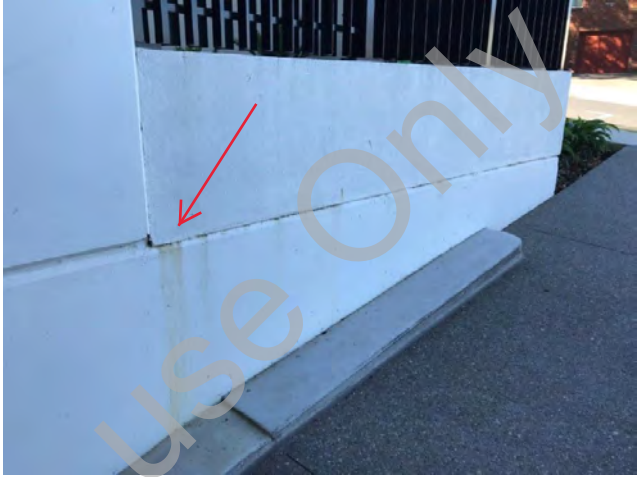
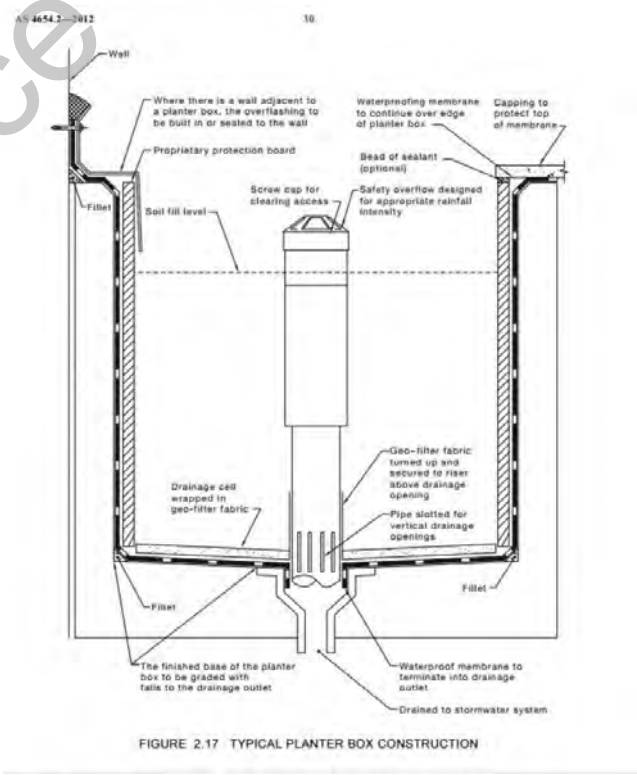
Item	Details	Photographic Details
10.	<p>Location:</p> <p>Northern wall - Adjacent to car park entrance</p> <p>Finding:</p> <p>The articulation joint has started to bleed. There is a planter box built behind this wall. Roscon staff did not have access to the planter box at the time of inspection, therefore confirmation of a water proofing membrane in the planter box could not be determined. Although, water leakage through the articulation joint suggests that the water proofing membrane in the planter box has failed, and water is seeping through the concrete and through the gaps in the articulation joint. This can lead to cracking or failure of structure in the future.</p> <p>Image 2 depicts the correct way to lay a membrane in a planterbox in accordance to AS 4654.2-2012.</p> <p>A defect has been noted.</p> <p>Recommendations:</p> <p>The builder is to rectify this issue in the summer when there are dry conditions.</p> <p>Remove all soil from the planter boxes and store onsite.</p> <p>Strip off the existing membrane, if any, and clean the substrate of the planter box so that it is ready for a new membrane application.</p> <p>Supply and install a membrane in accordance with AS4654.2-2012 ensure that the membrane extends 100 mm above the soil level, is flashed, and has a drainage overflow with protection boards.</p>

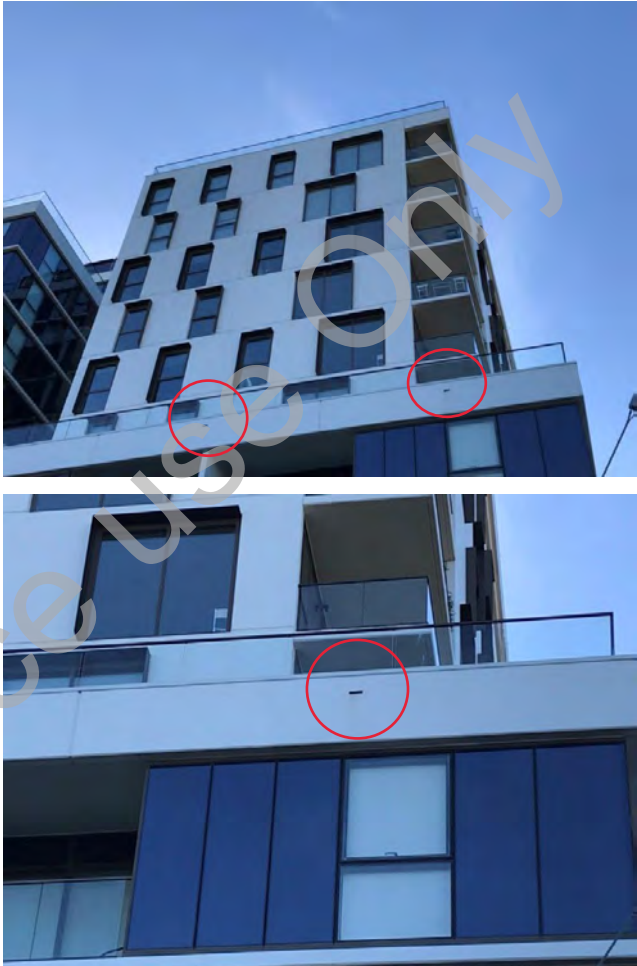
Item	Details	Photographic Details
12.	<p>Location:</p> <p>External facade</p> <p>Finding:</p> <p>Overflows are flush with the external facade.</p> <p>Over time, the flow of water along the wall can cause visible staining to appear on the facade from rainfall. If left alone, the staining can become more prominent and damage the paint of the building.</p> <p>A building defect has been noted.</p> <p>Recommendations:</p> <p>Supply and Install overflow pops</p> <p>It is recommended to extend the overflow provisions so that water is discharged away from the wall to prevent the flow of water on the facade of the building.</p>

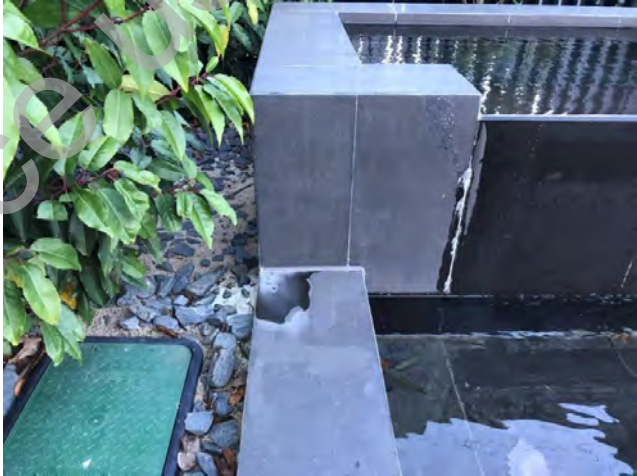
Item	Details	Photographic Details
13.	<p>Location:</p> <p>Front walkway to entrance</p> <p>Finding:</p> <p>Large amounts of calcification has formed along the eastern garden fountain along the entrance walkway. As the fountain is constantly used, this is an indication that waterproofing membrane within the water feature has failed.</p> <p>Given the building is just over 2 years old the waterproofing membrane of the fountain is still within the installers warranty period making the failure a building defect.</p> <p>A building defect has been noted.</p> <p>Recommendations:</p> <p>The waterproofing membrane of the tiled fountain is to be replaced by the builder.</p>

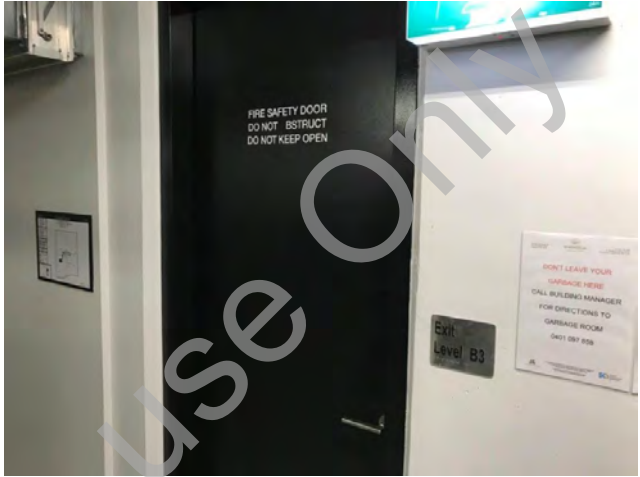
Item	Details	Photographic Details
14.	<p>Location:</p> <p>B3 car park - Western stairwell</p> <p>Finding:</p> <p>The western fire door is missing the letter 'O' on the door leaf facing the carpark and the letter 'N' on the door leaf facing the stairwell.</p> <p>The correct signage that needs to be placed on a fire door is stated on the NCC 2015 volume one clause D2.23 signs on doors:</p> <p><i>"(b)(ii) for a self-closing door— "FIRE SAFETY DOOR DO NOT OBSTRUCT DO NOT KEEP OPEN";"</i></p> <p>Given that the majority of proper signage is in place, the letters are assumed to have fallen off.</p> <p>This is a maintenance issue.</p> <p>Recommendations:</p> <p>The OC is to place appropriate letters to complete the sign.</p>

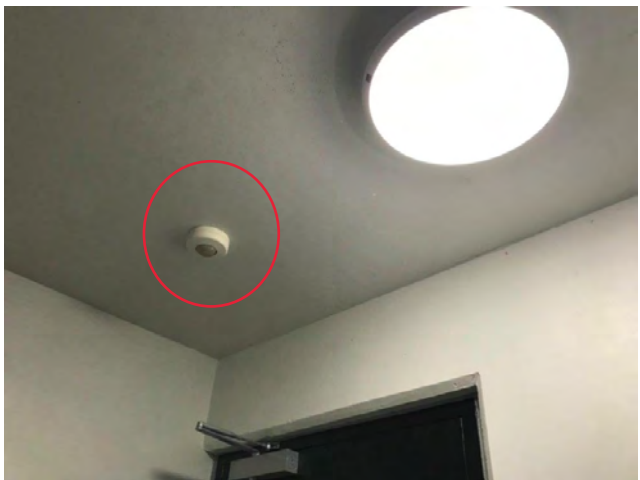
15.	<p>Location:</p> <p>B3 car park - Western stairwell</p> <p>Finding:</p> <p>The light's motion detector in the stairwell failed to activate upon entering within 1 m of the entrance to the fire stairwell.</p> <p>This is a safety hazard as insufficient lighting is a tripping hazard as vision is impaired, potentially leading to serious injury. The motion detector was only able to be activated by movement on the upper level.</p> <p>The NCC 2015 volume one, specification J6 section, 4. motion detectors states:</p> <p><i>"(a) In a Class 2, 3 or 9c aged care building other than within a sole-occupancy unit, a motion detector must— (i) be capable of sensing movement such as by infra-red, ultrasonic or microwave detection or by a combination of these means; and (ii) be capable of detecting a person before they are 1 m into the space; "</i></p> <p>A defect has been noted.</p> <p>Recommendations:</p> <p>The builder is to repair or replace the motion sensor to ensure that the lights illuminate after entering a maximum of 1 m into the stairwell.</p>

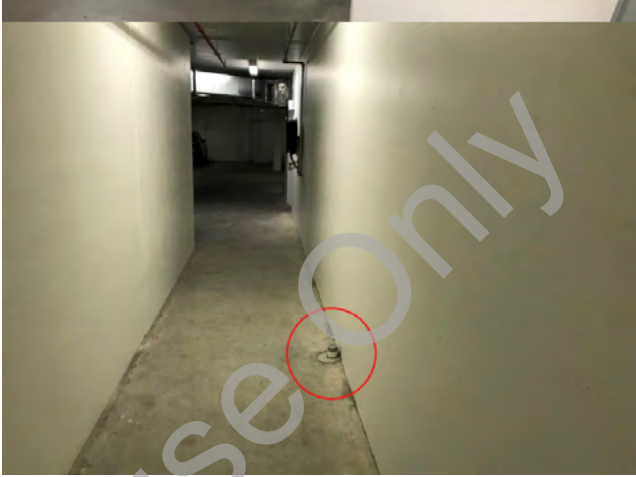
Item	Details	Photographic Details
17.	<p>Location:</p> <p>B3 car park - Corridor</p> <p>Finding:</p> <p>A redundant service pipe has been left behind and protruding out of the floor. This is tripping hazard for pedestrians using this corridor. The builder should have removed this pipe prior to handover of the building.</p> <p>The Guide to Standards and Tolerances 2015, clause 18.08 cleaning states:</p> <p><i>"Building sites are defective if they are not clear of building debris."</i></p> <p>This has not been removed after construction of the building site. Therefore, a defect has been noted.</p> <p>Recommendations:</p> <p>The redundant pipe be cut down, sealed appropriately and flush with the concrete slab to ensure the safety of occupants using this area.</p>

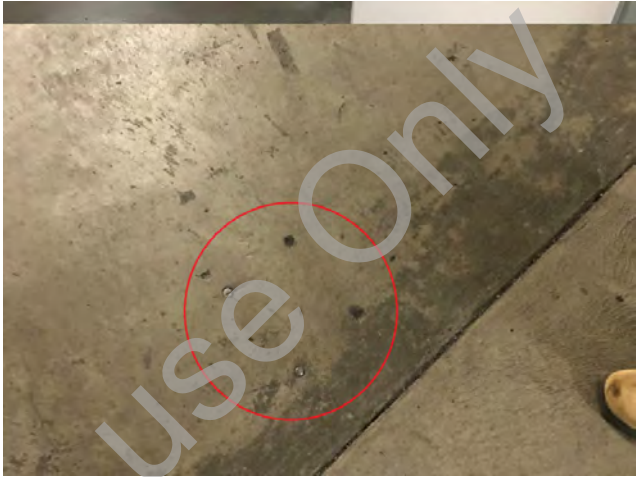
Item	Details	Photographic Details
18.	<p>Location:</p> <p>Ground floor car park - Adjacent to car ramp</p> <p>Finding:</p> <p>Rusted joints were found embedded into the concrete floor. These are exposed to oxygen from the external air and is likely to rust over time if left as is. As rust forms, it creates a layer that pushes out into the concrete slab and can cause cracks and damage in the concrete slab.</p> <p>Recommendations:</p> <p>It is recommended that the builder appropriately treat the rusted joints first. Then they are to seal the exposed bars with a suitable concrete repair epoxy compound to ensure that the bars are not exposed.</p>

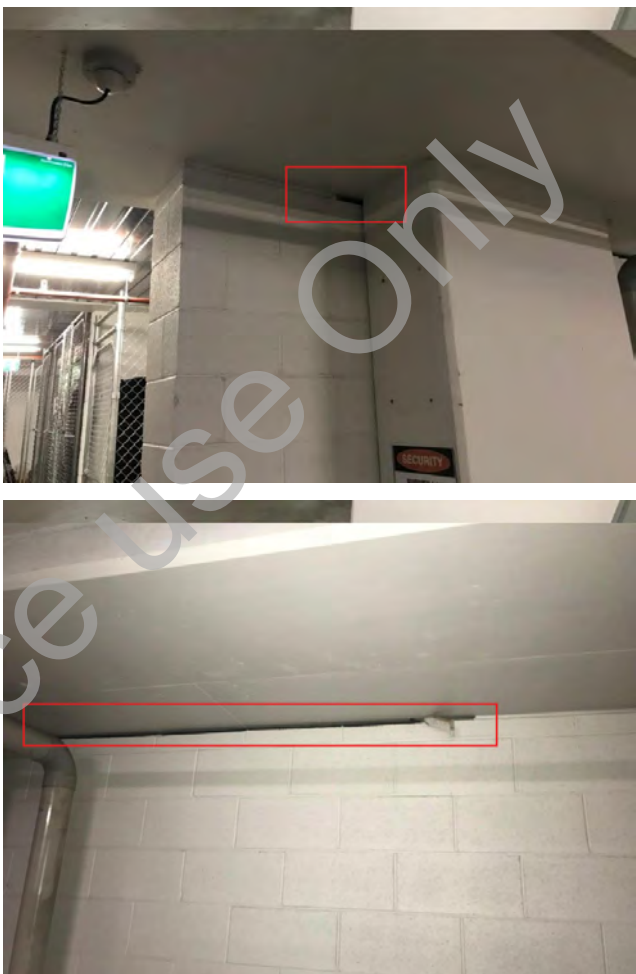
Item	Details	Photographic Details
19.	<p>Location:</p> <p>Ground floor car park - Adjacent to storage cages</p> <p>Finding:</p> <p>The sealant along the joint adjoining the masonry wall and the ceiling has come off. It appears as though it has been manually pulled out and not re-sealed.</p> <p>The Guide to Standards and Tolerances 2015 clause 3.03 states:</p> <p><i>"Where required, control joints are defective if not installed as required by the Building Code of Australia or in accordance with the contract documents.</i></p> <p><i>Control joints are defective if they do not extend through the full thickness of masonry skin.</i></p> <p><i>Where required, control joints are defective if they are not sealed in accordance with AS 3700."</i></p> <p>And, AS 3700-2011 Clause 12.4.3 Movement Control Joints states:</p> <p><i>"Expansion joints (closing control joints) and articulation joints shall be clean and free from any hard or incompressible material for the full width and depth of the joint before joint-filling material (if any) is inserted.</i></p> <p>Expansion joints shall be completely filled with joint filler— <i>(a) where specified in the documents; or</i> <i>(b) where they are located below ground level or where they can be accidentally filled with debris."</i></p> <p>A defect has been noted.</p> <p>Recommendations:</p> <p>It is recommended that the builder strip the remaining sealant.</p> <p>Ensure that the joint is clean and free of mortar. Place expansion foam into the gap then supply and appropriately apply a new layer of mastic sealant that extends to the full length and width of the joint. The colour of the mastic sealant should match the colour of the surrounding structure. In this case, it should be white and have required FRL.</p>

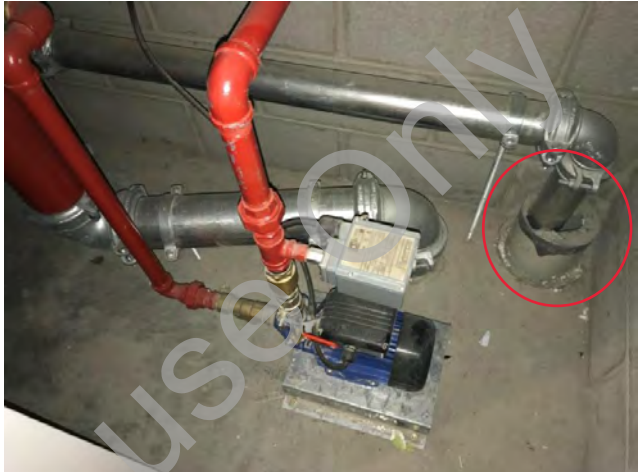
Item	Details	Photographic Details
20.	<p>Location:</p> <p>Ground floor - Sprinkler control valve assembly cabinet</p> <p>Finding:</p> <p>The sprinkler pipe has not been properly fire sealed. A PVC pipe was set into the concrete slab during construction and is now being used to allow for annular space of the fire sprinkler pipe. Duct tape has been used to seal the opening which has torn and left a hole. In the event of a fire emergency event, fire will be able to penetrate through this PVC pipe and cause damage to the immediate and surrounding floors.</p> <p>NCC 2015 volume one, performance requirement CP8 states:</p> <p><i>"Any building element provided to resist the spread of fire must be protected, to the degree necessary, so that an adequate level of performance is maintained—</i></p> <p><i>(a) where openings, construction joints and the like occur; and</i></p> <p><i>(b) where penetrations occur for building services."</i></p> <p>A defect has been noted.</p> <p>Recommendations:</p> <p>The penetration needs to be properly sealed to ensure it upholds the fire integrity of the building.</p> <p>The fire services pipe has moved from the center of the PVC pipe. Because of this, a fire collar is no longer viable. The PVC pipe is to be completely removed out of the slab. The void is recommended to be packed with fire pillows and sealed with an appropriate fire rated sealant. This will reinstate the fire integrity of the building, as well as allow movement of the sprinkler pipe.</p>

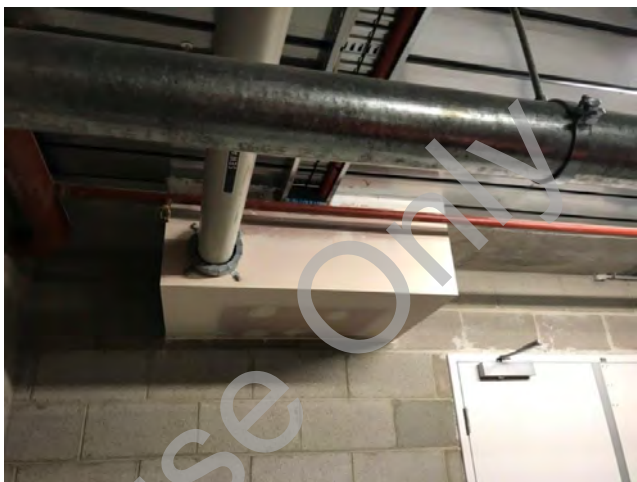
Item	Details	Photographic Details
21.	<p>Location:</p> <p>Ground floor - Inside the Fire Pump room</p> <p>Finding:</p> <p>The fire rated plasterboard containing services on the ceiling has not been adequately painted. There are clear signs of bare paint which have been left. This should have been painted prior to handover of the building.</p> <p>The Guide to Standards and Tolerances 2015 clause 12.02 states:</p> <p><i>"Paintwork is defective if the application has blemishes such as paint runs, paint sags, wrinkling, dust, bare or starved painted areas, colour variations, surface cracks, irregular and coarse brush marks, sanding marks, blistering, non-uniformity of gloss level and other irregularities in the surface that are visible from a normal viewing position.</i></p> <p>A defect has been noted.</p> <p>Recommendations:</p> <p>The builder is to supply and finish off the paintwork required. The builder is to ensure it is uniform with the existing paint works.</p>

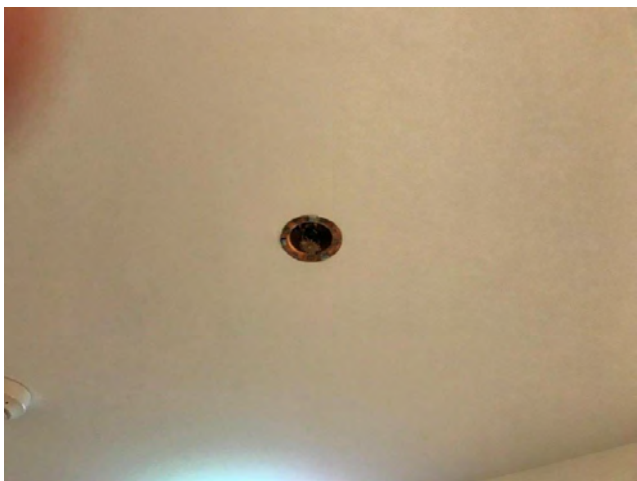
22.	<p>Location:</p> <p>Ground floor - adjacent to room G03</p> <p>Finding:</p> <p>The white cap is missing on the ceiling fire sprinkler. It is unclear whether this cap was ever installed or if it has been misplaced/ tampered with.</p> <p>The Occupancy Permit was signed on 04/11/2016. Given the amount of time that has passed since handover, it is likely that this not due the builder's workmanship and is now a maintenance issue.</p> <p>Recommendations:</p> <p>The OC is to replace the cap that is matching the other white caps that are placed throughout the ceiling fire sprinklers in the building.</p>

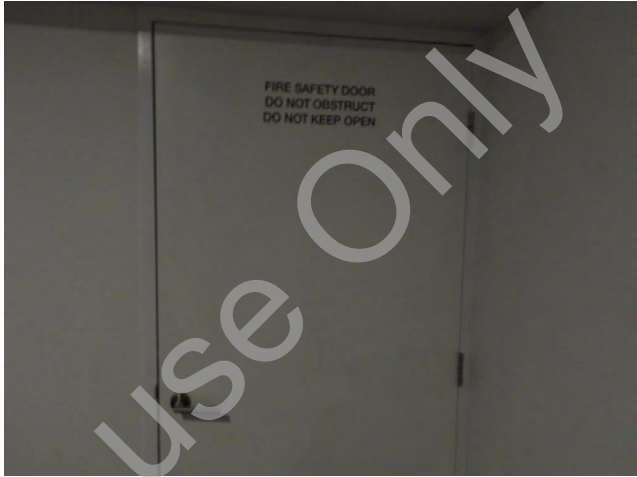
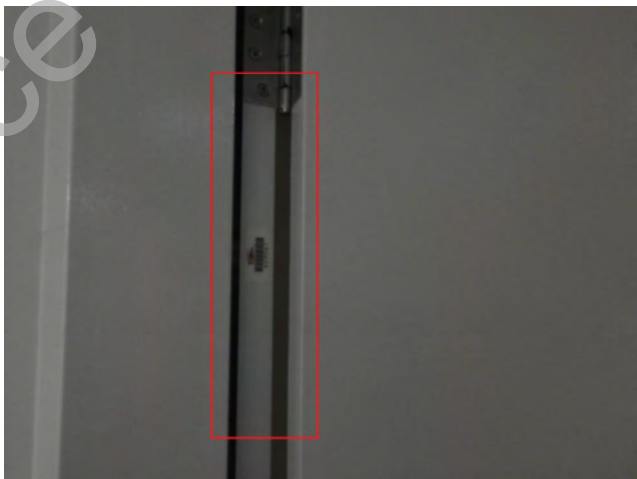
Item	Details	Photographic Details
24.	<p>Location:</p> <p>Level 1 - Western door to car park</p> <p>Finding:</p> <p>The western door to the carpark is a fire safety door that does not contain the metal fire rating labels on the door frames and leafs. Proper signage indicating that the door is a fire safety door has been displayed.</p> <p>AS 1905.1-2005 clause 6.1.2 states:</p> <p>"(a) When the installation is complete, the manufacturer or the certifier shall inspect each installed fire-resistant doorset and shall affix the prescribed metal tag to the edge of the door leaf and to the doorframe, only if it can be confirmed that-</p> <ul style="list-style-type: none"> (i) hardware has been installed in accordance with the specified instructions of the relevant manufacturer; (ii) hinges are correctly aligned; (iii) the doorset latches satisfactorily from the fully open position and from any intermediate position; (iv) the closer, if any, demonstrates satisfactory action as specified in Clause 2.2.5; (v) on the basis of evidence of test or the opinion of a registered testing authority, or both, and evidence of manufacture to the specifications of the tested specimen, the doorset complies with all other requirements of this Standard; <p>and</p> <p>(vi) the clearances specified in Clause 5.5.2 have been met."</p> <p>A defect has been noted.</p> <p>Recommendations:</p> <p>The builder is to install appropriate metal tags on door frame and leaf in accordance to the manufacturer's specifications.</p>

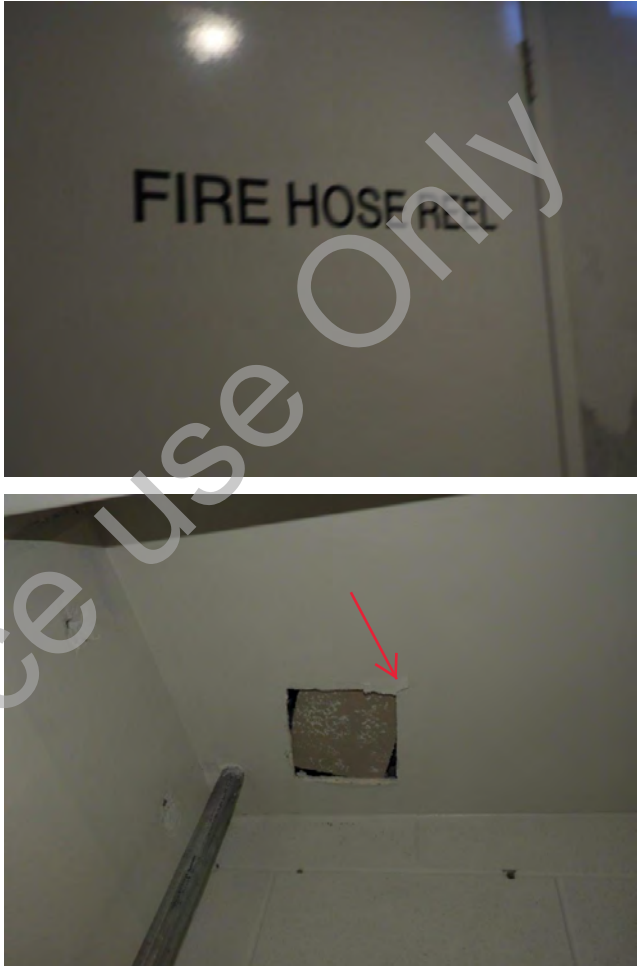
Item	Details	Photographic Details
25.	<p>Location:</p> <p>Level 1 - Inside the Fire Hose Reel cabinet</p> <p>Finding:</p> <p>A redundant hole has been cut out in the ceiling of the cabinet. A section of plasterboard adjacent to the hole has been ripped. It is assumed that this was used for access during construction. It has not been sealed or patched up after the builder has finished works.</p> <p>The Guide to Standards and Tolerances 2015, clause 18.08 cleaning states:</p> <p><i>"Building sites are defective if they are not clear of building debris."</i></p> <p>This has not been patched up after construction. Therefore, a defect has been noted.</p> <p>Recommendations:</p> <p>The builder is to cut away the section that has been ripped. A piece of plasterboard is to be measured and fit snugly into the hole. An appropriate filler that is closely matching to the paintwork is to be used along the gaps and smoothed over once dried.</p>

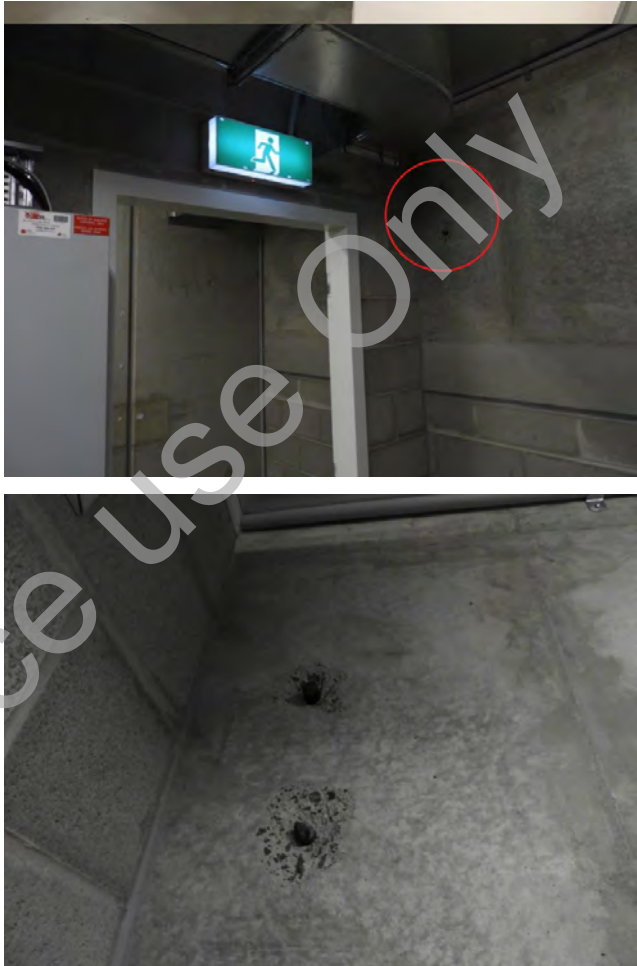
Item	Details	Photographic Details
26.	<p>Location:</p> <p>Level 1 car park - Inside the Main Switchboard room</p> <p>Finding:</p> <p>There are two steel bars protruding out of the concrete wall. These bars are susceptible to reacting with the oxygen in air and oxidising. This will cause the steel to rust over time, and cause potential damage to the building's integrity. When rust around steel forms, it creates a layer that expands out, which is detrimental to the concrete's structure.</p> <p>Recommendations:</p> <p>It is recommended that the builder appropriately seal the exposed bars with a suitable concrete repair epoxy compound to ensure that the bars are not exposed.</p>

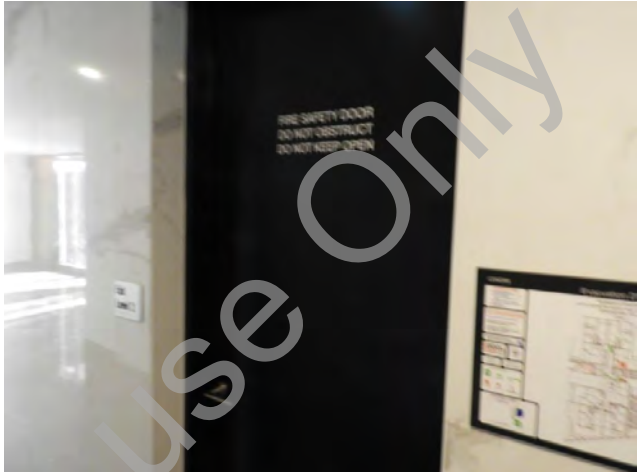
Item	Details	Photographic Details
27.	<p>Location:</p> <p>Level 2 - Western fire door to stairwell</p> <p>Finding:</p> <p>At the time of inspection, it was noted that the western self-closing fire door to the stairwell does not latch shut. Self-closing fire doors need to be able to fully close and latch on its own. This is a safety hazard during a fire emergency event as it can allow fire and smoke to slip through the gap.</p> <p>The NCC 2015 volume one, performance requirement C3.4 states:</p> <p><i>"(a) Where protection is required, doorways, windows and other openings must be protected as follows:</i></p> <p><i>(i) Doorways—</i></p> <p><i>(A) internal or external wall-wetting sprinklers as appropriate used with doors that are self-closing or automatic closing; or</i></p> <p><i>(B) –/60/30 fire doors that are self-closing or automatic closing."</i></p> <p>Given the time since handover, this is a maintenance issue.</p> <p>Recommendations:</p> <p>The OC is to rectify this issue by adjusting the self-closing mechanism of the fire safety door to the appropriate closing speed. Ensure that the door is able to latch shut upon closing.</p>

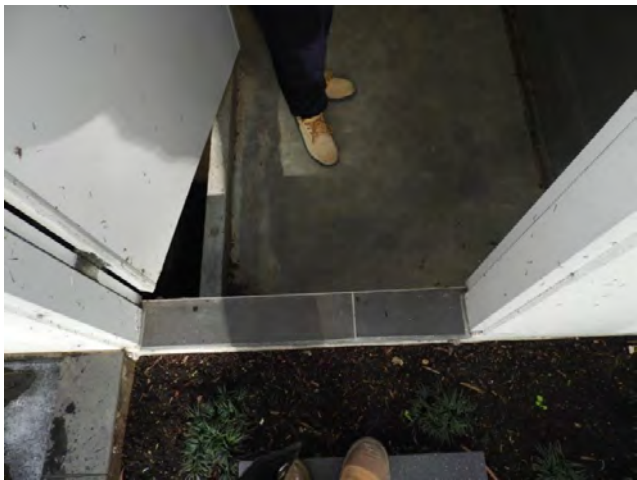
28.	<p>Location:</p> <p>Level 2 Courtyard - Utility room</p> <p>Finding:</p> <p>There is a notable step down from the courtyard to the floor of the utility room. No hand rail or additional step has been provided to allow smooth transition in and out of the space. This is a safety concern as trips and falls of this height can lead to serious injury, especially when vision is impaired.</p> <p>This is an OH&S issue.</p> <p>Recommendations:</p> <p>It is recommended that the OC engage a licensed contractor to install an additional step with a non-slip nosing and a high-vis strip to allow easy and safe access to and from the utility room.</p> <p>A 'MIND YOUR STEP' sign should be placed on the both sides of the wall at an appropriate height adjacent to the utility room door. This acts as a visual warning upon accessing and egressing the space.</p>

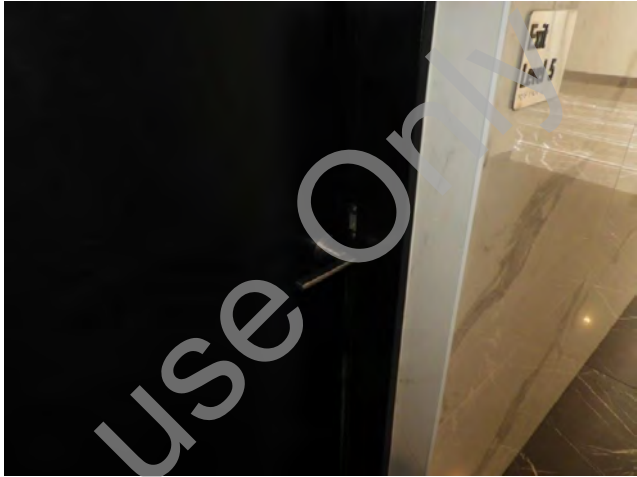
Item	Details	Photographic Details
29.	<p>Location:</p> <p>Level 5 - Eastern fire door to the stairwell</p> <p>Finding:</p> <p>At the time of inspection, it was noted that the eastern self-closing fire door to the stairwell does not latch shut. Self-closing fire doors need to be able to fully close and latch on its own. This is a safety hazard during a fire emergency event as it can allow fire and smoke to slip through the gap.</p> <p>The NCC 2015 Volume One Performance Requirement C3.4 states:</p> <p><i>"(a) Where protection is required, doorways, windows and other openings must be protected as follows:</i></p> <p><i>(i) Doorways—</i></p> <p><i>(A) internal or external wall-wetting sprinklers as appropriate used with doors that are self-closing or automatic closing; or</i></p> <p><i>(B) –/60/30 fire doors that are self-closing or automatic closing."</i></p> <p>Given the time since handover, this is a maintenance issue.</p> <p>Recommendations:</p> <p>The OC is to fix the fire safety door by adjusting the self-closing mechanism to the appropriate closing speed. Ensure that the door is able to latch shut by itself.</p>

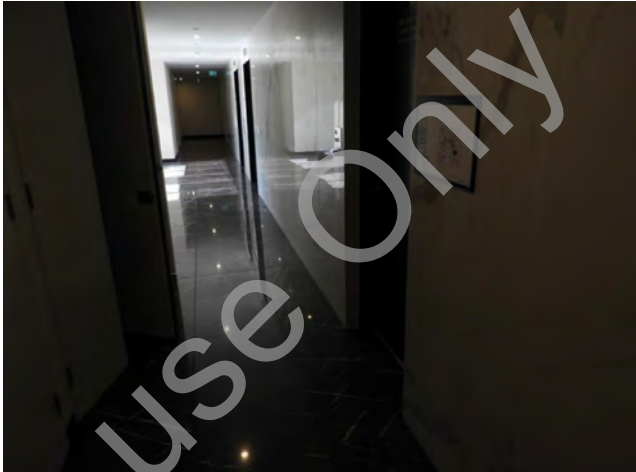
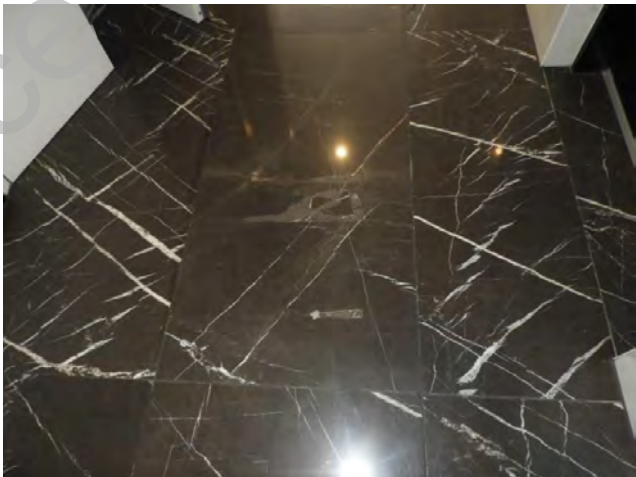
Item	Details	Photographic Details
30.	<p>Location:</p> <p>Level 6 - Adjacent to Western fire door</p> <p>Finding:</p> <p>At the time of inspection, a noticeable amount of scraping and chipping was found on the floor tiles in front of the western fire door stairwell.</p> <p>The Guide to Standards and Tolerances 2015 clause 11.05 states:</p> <p><i>"Tiles are defective if they are cracked, pitted, chipped, scratched or loose at handover. After handover, tiles are defective where the builder's workmanship causes the tiles to become cracked, pitted, chipped or loose within 24 months."</i></p> <p>The Occupancy Permit was signed on the 04/11/2016, this still falls within the 24 month period.</p> <p>A defect has been noted.</p> <p>Recommendations:</p> <p>The builder is to remove defective tiles and reinstall new tiles. The tiles that are to be placed must match the existing pattern and colour of the surrounding floor tiles.</p>

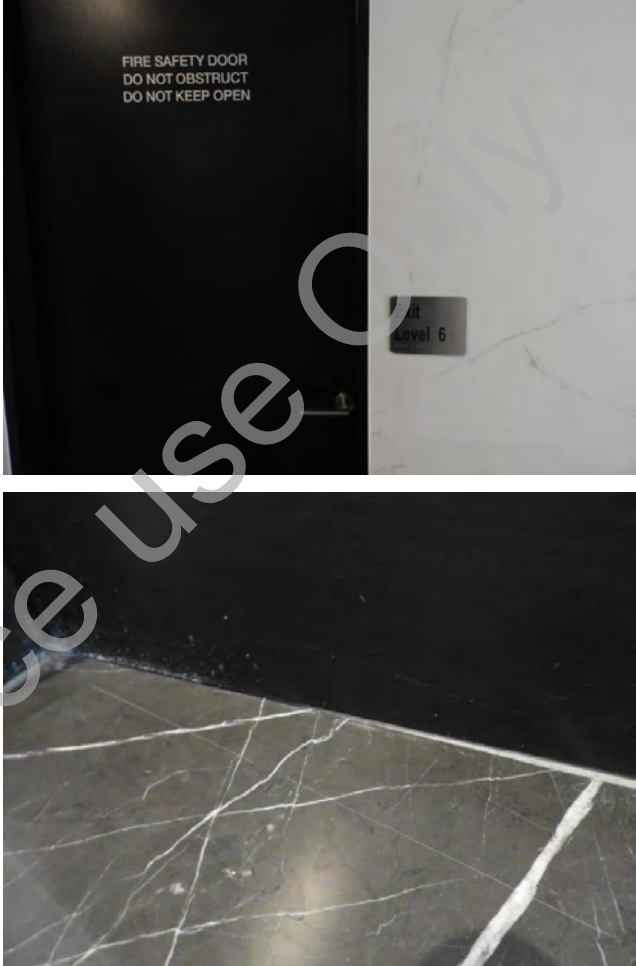
Item	Details	Photographic Details
31.	<p>Location:</p> <p>Level 6 - Western fire door to stairwell</p> <p>Finding:</p> <p>At the time of inspection, the fire door does not self-close.</p> <p>The NCC 2015 volume one, performance requirement C3.4 states:</p> <p><i>"(a) Where protection is required, doorways, windows and other openings must be protected as follows:</i></p> <p><i>(i) Doorways—</i></p> <p><i>(A) internal or external wall-wetting sprinklers as appropriate used with doors that are self-closing or automatic closing; or</i></p> <p><i>(B) –/60/30 fire doors that are self-closing or automatic closing."</i></p> <p>However, upon further inspection, it was observed that there are scrapes along the floor tiles where the door fully closes. This indicates that the door has been hung too low and is scraping along the tiles when it's being forced shut.</p> <p>This is a safety hazard during a fire emergency event as it can allow fire and smoke to slip through the gap of the open door.</p> <p>A defect has been noted.</p> <p>Recommendations:</p> <p>The fire safety door leaf is to be replaced by a correctly measured and fitted fire door leaf. Ensure that the fire door's function and clearances are compliant with AS1905.1-2015.</p>

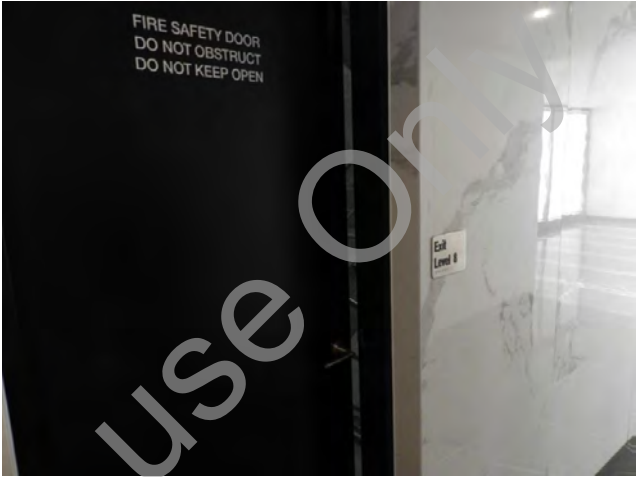
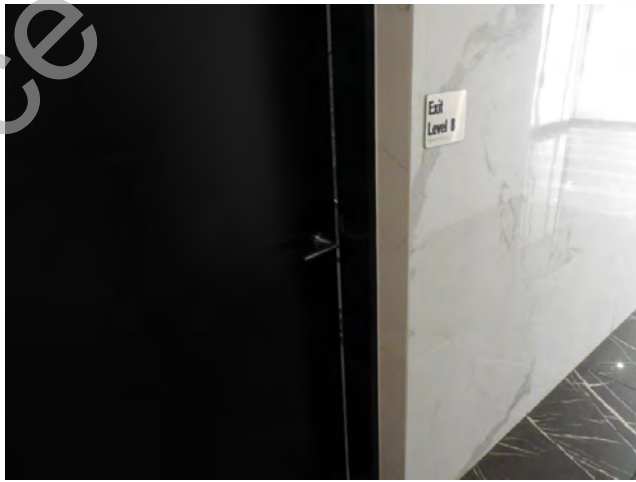
Item	Details	Photographic Details
32.	<p>Location:</p> <p>Level 8 - Western fire door to stairwell</p> <p>Finding:</p> <p>On the day of inspection, the fire safety door did not self-close. This is a safety hazard during a fire emergency event as it can allow fire and smoke to slip through the gap.</p> <p>The NCC 2015 volume one, performance requirement C3.4 states:</p> <p><i>"(a) Where protection is required, doorways, windows and other openings must be protected as follows:</i></p> <p><i>(i) Doorways—</i></p> <p><i>(A) internal or external wall-wetting sprinklers as appropriate used with doors that are self-closing or automatic closing; or</i></p> <p><i>(B) –/60/30 fire doors that are self-closing or automatic closing."</i></p> <p>Given the time since handover, this is a maintenance issue.</p> <p>Recommendations:</p> <p>The OC is to adjust the fire door's self-closing mechanism so that it is able to self-close and self-latch.</p>

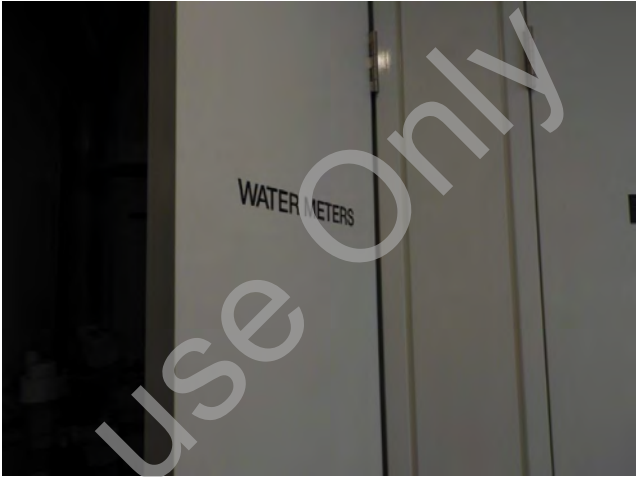
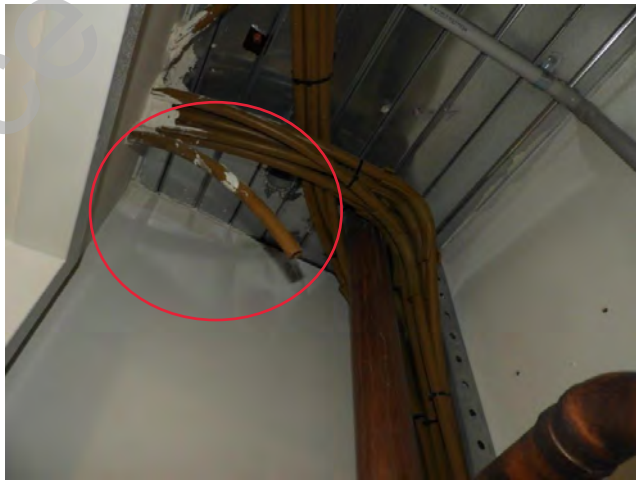
Item	Details	Photographic Details
33.	<p>Location:</p> <p>Level 9 - Eastern Water Meters cabinet</p> <p>Finding:</p> <p>A redundant water pipe has been left behind and was not cleared after construction. This should have been removed prior to handover of the building.</p> <p>The Guide to Standards and Tolerances 2015 clause 18.08 cleaning states:</p> <p><i>"Building sites are defective if they are not clear of building debris."</i></p> <p>A defect has been noted.</p> <p>Recommendations:</p> <p>The builder is to be cut down the redundant water pipe so that it is flush with the wall. The leftover opening is to be sealed appropriately afterwards and the redundant pipe is to be disposed of.</p>
