Forensic Building Defects Report

1 Sample St Suburb VIC 3000 (PS 123456X)

Roscon Property Services were engaged by OC manager to conduct a Forensic Building Defects Report for the property at 1 Sample St Suburb VIC 3000. The investigation was undertaken on Thursday 15 August 2018 at approximately 9:00am.

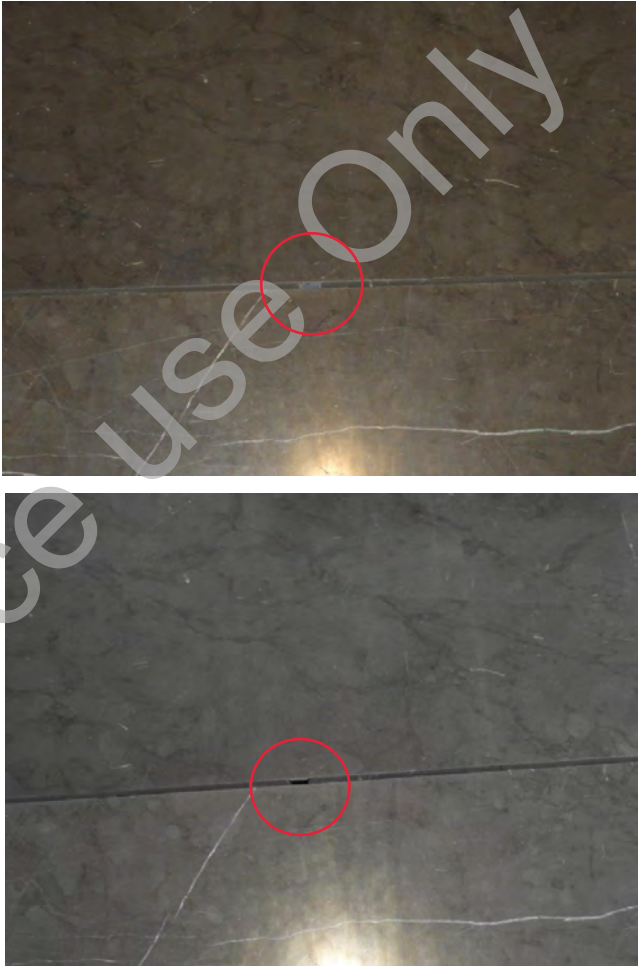
Item	Details	Photographic Details
34.	<p>Location:</p> <p>Level 10 - In front of the western lift</p> <p>Finding:</p> <p>The grout in the floor tiles has come loose and is able to be lifted off which leaves a void behind.</p> <p>The Guide to Standards and Tolerances 2015 clause 11.06 grouting and joints states:</p> <p><i>"Grout is defective if it becomes loose within 24 months of handover."</i></p> <p>The Occupancy Permit was signed on the 04/11/2016. Therefore, this still falls within the first 24 months after handover.</p> <p>A building defect has been noted.</p> <p>Recommendations:</p> <p>The existing grout is to be raked out and a new grout is to be applied to ensure there are no voids in between floor tiles.</p>

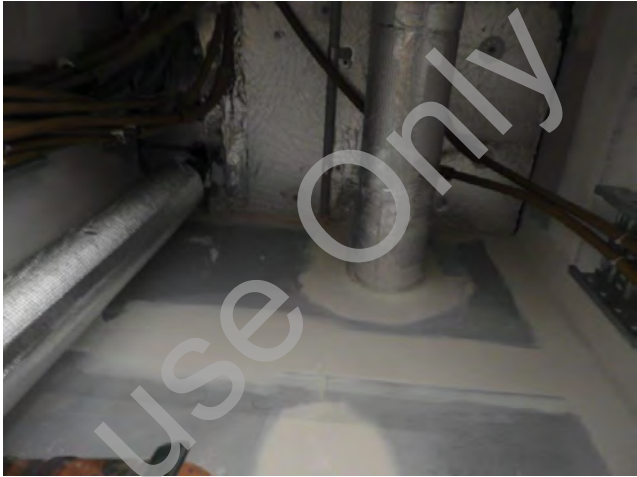
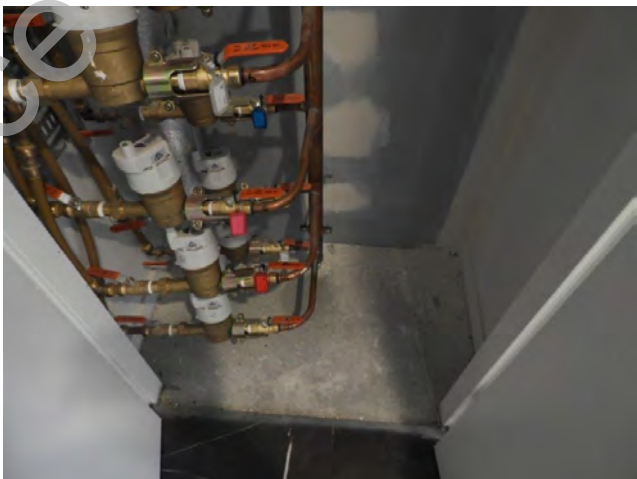
Item	Details	Photographic Details
35.	<p>Location:</p> <p>Level 11 - Western Water Meters cabinet</p> <p>Finding:</p> <p>The walls of the service cabinet is starved of paint. This was left incomplete after construction. Paint should have been applied to the entirety of the wall prior to handover of the building.</p> <p>The Guide to Standards and Tolerances 2015 clause 12.02 surface finish of paintwork states:</p> <p><i>"Paintwork is defective if the application has blemishes such as paint runs, paint sags, wrinkling, dust, bare or starved painted areas, colour variations, surface cracks, irregular and coarse brush marks, sanding marks, blistering, non-uniformity of gloss level and other irregularities in the surface that are visible from a normal viewing position."</i></p> <p>A defect is noted.</p> <p>Recommendations:</p> <p>The matching paint is to be supplied and applied onto the entirety of the wall in the service rise.</p>

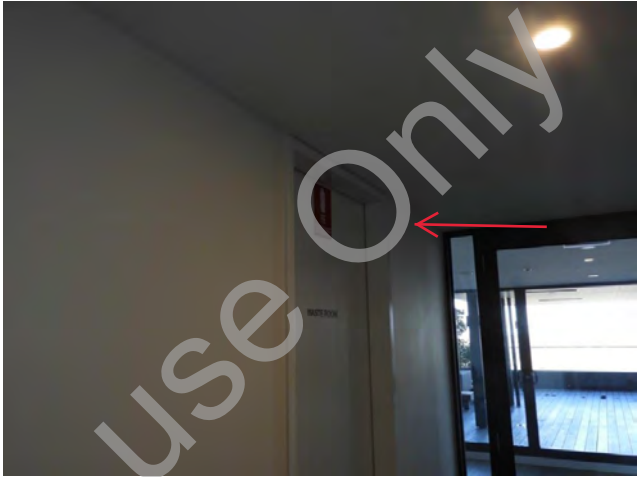
Item	Details	Photographic Details
36.	<p>Location:</p> <p>Level 12 - Waste room</p> <p>Finding:</p> <p>There is a fire extinguisher located inside the waste room. A fire extinguisher sign has been placed on the door leaf of the waste room. However, this is not visible from all points of direction towards the waste room. In an event of a fire emergency, this becomes a safety hazard as occupants in a state of panic may be unable to locate the nearest fire extinguisher.</p> <p>AS 2444-2001 clause 3.4 visibility states:</p> <p><i>"The extinguisher, or extinguisher location sign, shall be clearly visible from a distance up to 20 m in all directions of approach."</i></p> <p>A defect is noted.</p> <p>Recommendations:</p> <p>The builder is to place a perpendicular fire extinguisher sign that can be seen up to 20 m in all points of direction.</p>

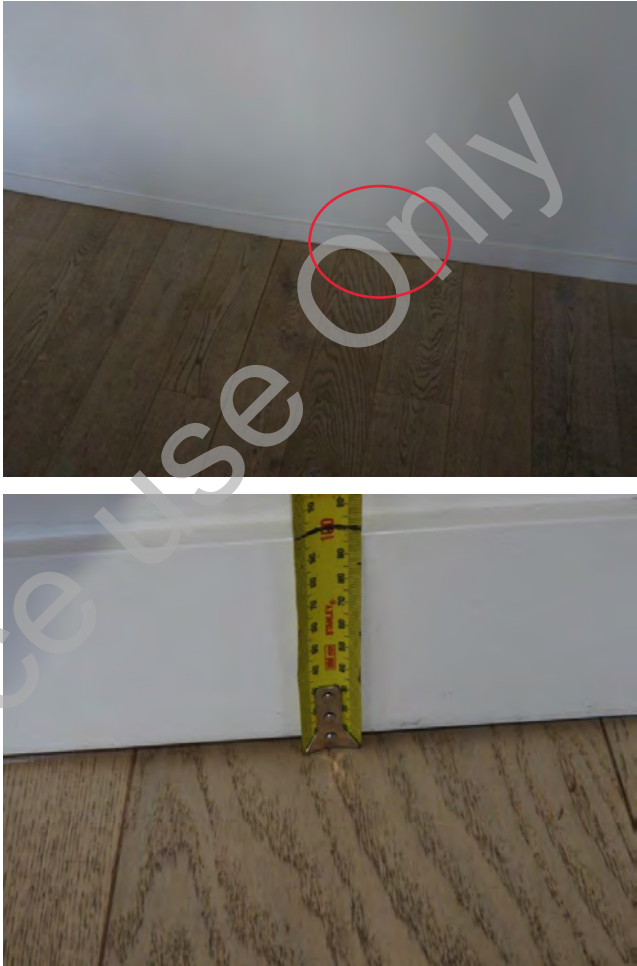
Item	Details	Photographic Details
37.	<p>Location:</p> <p>Level 12 - Common room area on the North-Western wall</p> <p>Finding:</p> <p>A gap between the skirting board and the floorboard has been seen from a normal viewing position. Upon further inspection, the gap was measured to be 6 mm.</p> <p>The Guide to Standards and Tolerances 2015 clause 10.01 gaps associated with internal fixing states:</p> <p><i>"Gaps between skirting and flooring are defective if they exceed 2 mm within the first 24 months after handover and are visible from a normal viewing position."</i></p> <p>Given the occupancy permit was signed on 04/11/2016, this still falls within the 24 month period after handover.</p> <p>A defect has been noted.</p> <p>Recommendations:</p> <p>The builder is to carefully apply an appropriate sealant to fill in the gap. The sealant used is to be white in colour to match the colour of the skirting board and ensure that excess sealant on the floor boards be cleaned off.</p>

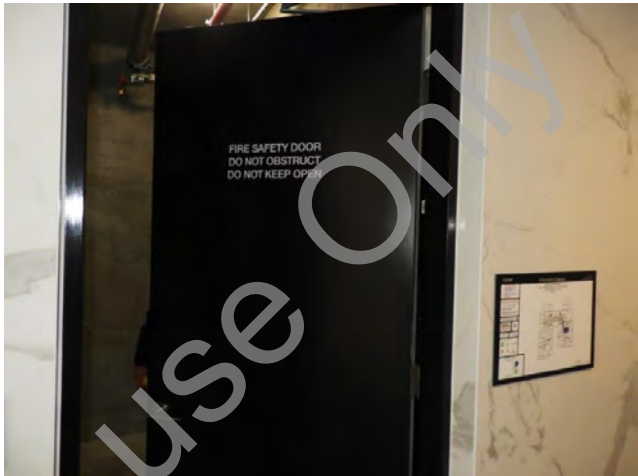
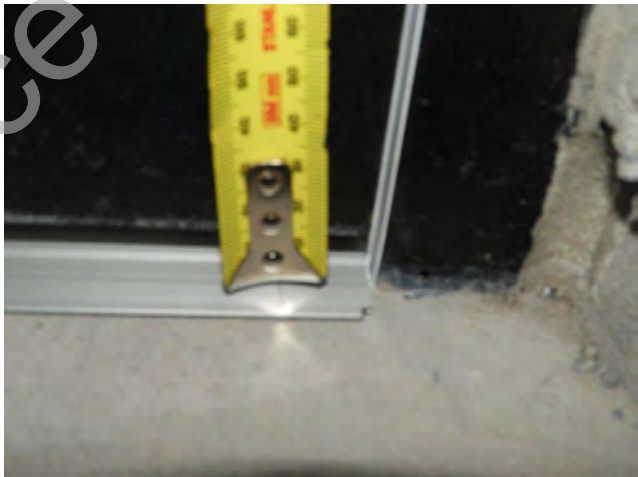
Item	Details	Photographic Details
38.	<p>Location:</p> <p>Level 13 - Western fire door</p> <p>Finding:</p> <p>The fire door was measured to have a 13 mm clearance from the door leaf to the floor covering. A metal trim has previously been installed to reduce the clearance that was stated in a previous inspection. This is a safety hazard as fire and smoke are able to slip through this gap during a fire emergency event.</p> <p>AS 1905.1-2015 clause 5.5.1 threshold and floor finish states:</p> <p><i>"Clearances between the bottom of all door leaves and the floor shall be as follows:</i></p> <p><i>NOTE: See Figures 1.4(A) and 5.5.1.</i></p> <p><i>(a) Between the leaf and the top surface of the floor including any floor covering—not less than 3 mm and not more than 10 mm."</i></p> <p>A defect has been noted.</p> <p>Recommendations:</p> <p>It is recommended that the fire safety door be replaced with a correctly measured and fitted fire safety door to ensure that clearances are compliant with AS 1905.1-2015.</p>

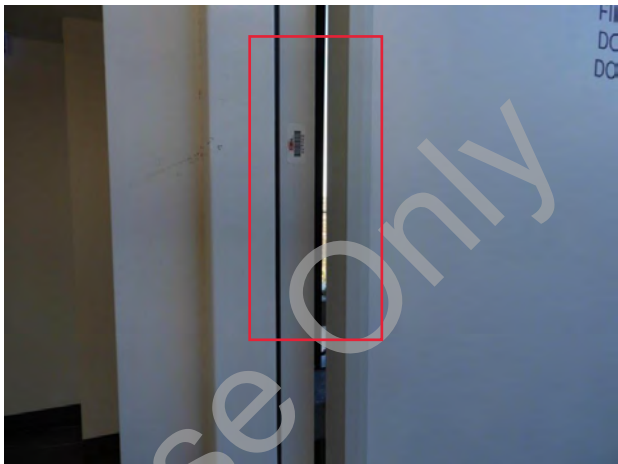
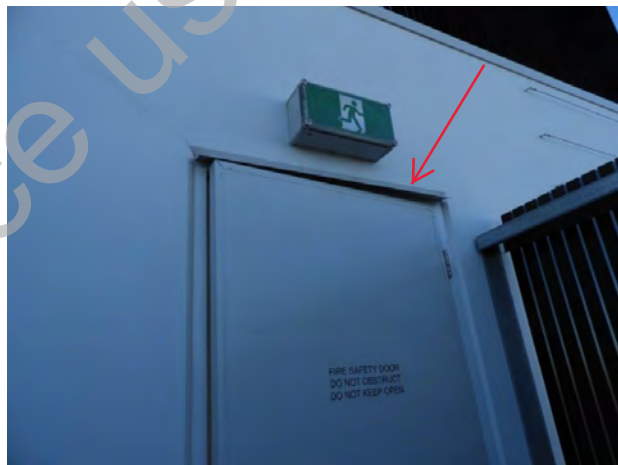
Item	Details	Photographic Details
40.	<p>Location:</p> <p>Level 14 - External hot water plant area</p> <p>Finding:</p> <p>The fire safety door does not contain the proper metal tags that are required to be attached onto the door leaf and door frame. Also, the door does not have a self-closing mechanism which allows the door to be open at all times.</p> <p>AS 1905.1-2005 clause 6.1.2 states:</p> <p>"(a) When the installation is complete, the manufacturer or the certifier shall inspect each installed fire-resistant doorset and shall affix the prescribed metal tag to the edge of the door leaf and to the doorframe, only if it can be confirmed that-</p> <p>(i) hardware has been installed in accordance with the specified instructions of the relevant manufacturer;</p> <p>(ii) hinges are correctly aligned;</p> <p>(iii) the doorset latches satisfactorily from the fully open position and from any intermediate position;</p> <p>(iv) the closer, if any, demonstrates satisfactory action as specified in Clause 2.2.5;</p> <p>(v) on the basis of evidence of test or the opinion of a registered testing authority, or both, and evidence of manufacture to the specifications of the tested specimen, the doorset complies with all other requirements of this Standard; and</p> <p>(vi) the clearances specified in Clause 5.5.2 have been met."</p> <p>And, Clause 2.1.4.3 Self-closing states:</p> <p>"Fire doorsets shall be self-closing. The self-closing device shall close the door from any angle of swing. Automatic doorsets incorporating permissible variation hold-open devices shall revert to self-closing on operation of a sensing device installed in accordance with the requirements of Clause 5.6.3 or, in the event of power failure to the hold-open device, the leaf or leaves fail-safe to the closed position."</p> <p>A defect has been noted.</p> <p>Recommendations:</p> <p>The prescribed metal fire-rating tags are to be installed on the door leaf and door frame by the builder. A self-closing mechanism is to be installed on the external of the door to ensure that the fire safety door is able to self-close from any angle of swing.</p>

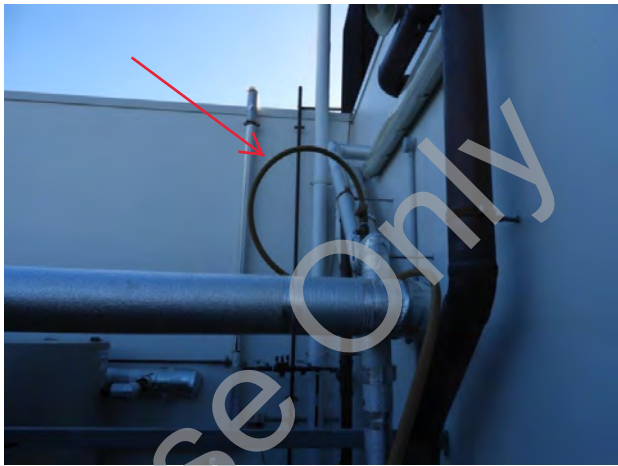
Item	Details	Photographic Details
42.	<p>Location:</p> <p>Level 14 - External hot water plant area</p> <p>Finding:</p> <p>PEX piping has been used in an external area for the plant system. This is unsuitable to be used in area that is continuously exposed to UV radiation.</p> <p>Image 2 is taken directly from the Sharkbite website which a supplier of PEX piping. In their FAQ section, it clearly states that PEX piping is unsuitable for outdoor use.</p> <p>A defect has been noted.</p> <p>Recommendations:</p> <p>The PEX piping is to be removed and replaced with a suitable pipe for outdoor use.</p>

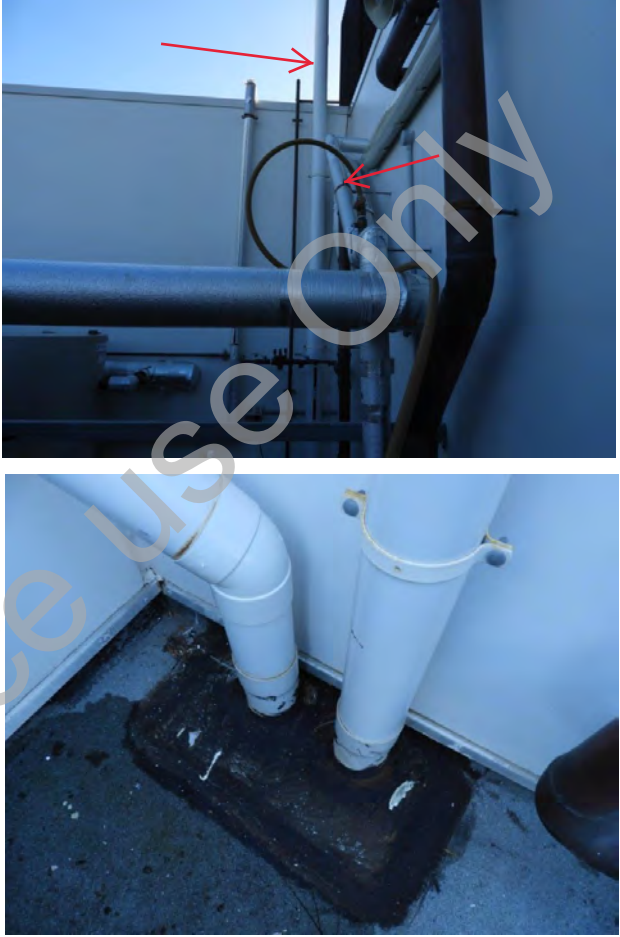
Item	Details	Photographic Details
43.	<p>Location:</p> <p>Level 14 - Hot water plant area</p> <p>Finding:</p> <p>PVC piping has been installed in an external environment without being protected from UV radiation.</p> <p>AS 2032-2006 clause 3.4.5 protection from UV radiation states:</p> <p><i>"PVC pressure pipes installed to operate in direct sunlight shall be painted with light coloured water-based paints, or be otherwise protected."</i></p> <p>A defect has been noted.</p> <p>Recommendations:</p> <p>A UV-resistant paint is to be applied to the entirety of the PVC pipes exposed to the external environment.</p>

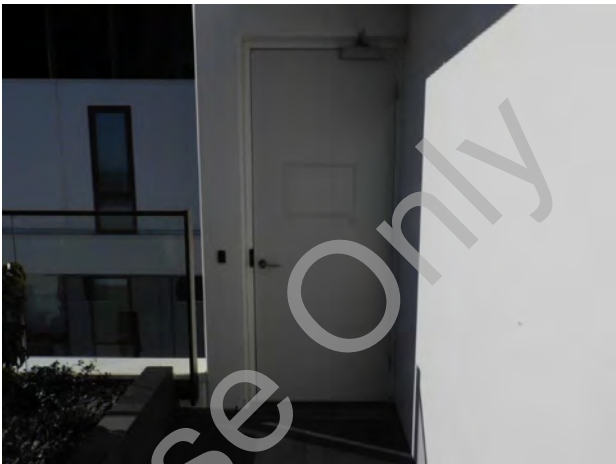
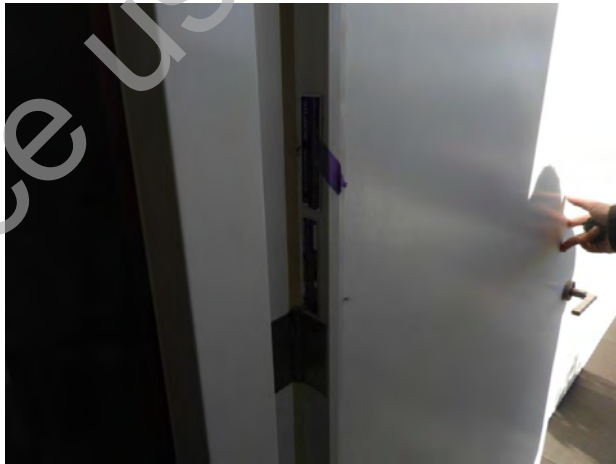
Item	Details	Photographic Details
44.	<p>Location:</p> <p>Level 14 Courtyard</p> <p>Finding:</p> <p>A fire safety door does not contain the proper signage. Metal fire tags are attached to the door leaf and a self-closing mechanism is installed.</p> <p>The NCC 2015 volume one clause D2.23 signs on doors states:</p> <p><i>"(b) A sign referred to in (a) must be in capital letters not less than 20 mm high in a colour contrasting with the background and state—</i> <i>(ii) for a self-closing door—</i> "FIRE SAFETY DOOR DO NOT OBSTRUCT DO NOT KEEP OPEN";</p> <p>A defect has been noted.</p> <p>Recommendations:</p> <p>The proper signage is to be placed onto the door to indicate that it is a fire safety door. The metal tag that has fallen off and taped onto the door leaf is to be installed correctly onto the door frame.</p>

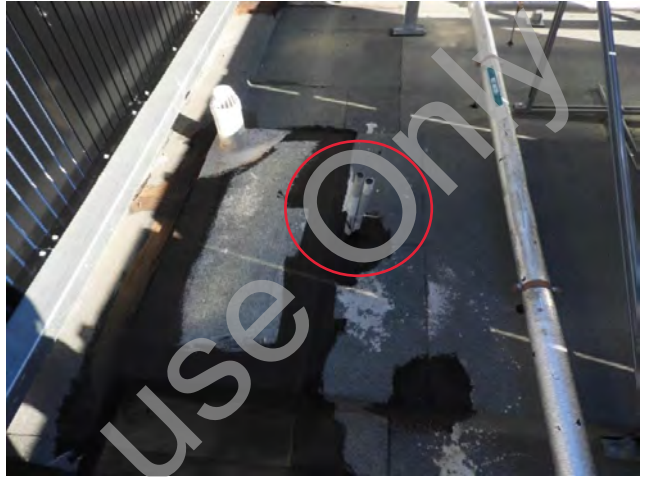
Item	Details	Photographic Details
45.	<p>Location:</p> <p>Rooftop plant area - Adjacent to solar panels</p> <p>Finding:</p> <p>There are redundant pipes protruding out of the floor. These have not been removed after construction. This is a safety hazard as trips and falls are likely to occur from this. This should have been removed prior to handover.</p> <p>The Guide to Standards and Tolerances 2015 clause 18.08 cleaning states:</p> <p><i>"Building sites are defective if they are not clear of building debris."</i></p> <p>A defect has been noted.</p> <p>Recommendations:</p> <p>The redundant pipes are to be cut and flushed into the floor. It should be properly sealed and a waterproofing membrane applied over the top to prevent water ingress.</p>

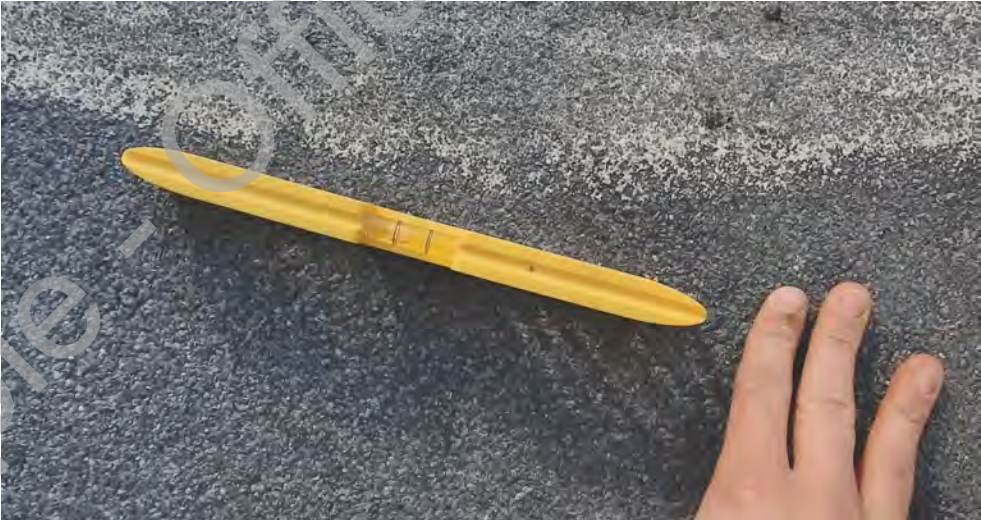
<p>Video 4 Rooftop Waterproofing Membrane</p>

- The rooftop plant waterproofing membrane has failed as water was present at the time of inspection under the floor waste. The stored water is able to be shifted around underneath the sheet membrane. Multiple areas of the sheet membrane have been chalked, indicating that EFVM has pointed out failure points. This is consistent with areas of the sheet membrane being flashed with bitumen.
