Detailed Window Inspection Report

1 Sample Street, Melbourne VIC 3022

Unit 1

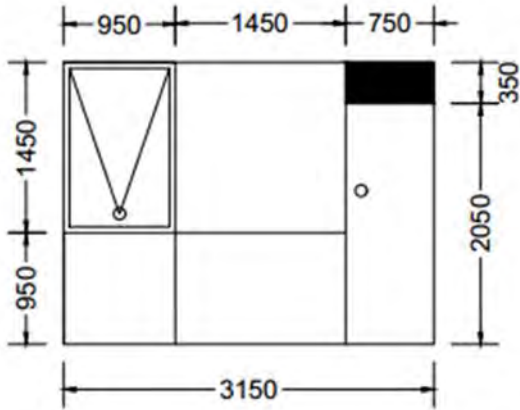
Location	Inspection Notes
(1) Lounge Room	Minor repairs and paint works required.
(2) Kitchen	Good condition, no works required.
(3) Right Bedroom	Full windows replacement due to signs of deterioration, rotting and damage to the centre mullion. Ensure that sash is reposition higher to eliminate gap in the window.
(4) Left Bedroom	Full windows replacement due to signs of deterioration, rotting and damage to the centre mullion. Ensure that sash is reposition higher to eliminate gap in the window.

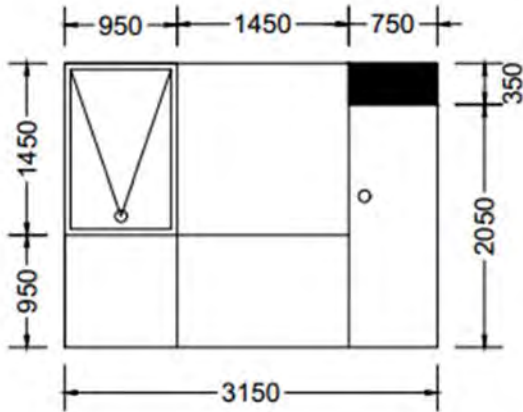
Location	Inspection Notes
(1) Lounge Room	Repair bottom of door, minor repairs and paint works required.
(2) Kitchen	Patch and paint works required.
(3) Left Bedroom	Full replacement of window as window seal has weathered, mullion has started to rot and sash require minor repairs and be adjusted upwards to eliminate gap in the window.
(4) Bathroom and Toilet	Full replacement of windows since both are heavily damaged and have to continue to deteriorate.
(5) Right Bedroom	Full replacement of window as centre mullion has heavy rotting damage, window sill has withered and sash needs to adjusted upwards to eliminate gap in window.

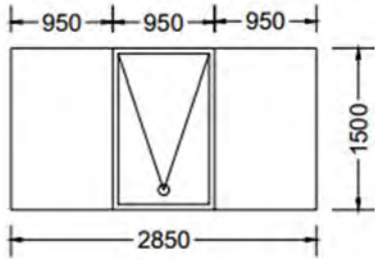
Location	Inspection Notes
(1) Left Bedroom	Sash replacement, minor repairs and paint works required.
(2) Toilet	Sash replacement, minor repairs and paint works required.
(3) Bathroom	Sash replacement, minor repairs and paint works required.
(4) Middle Bedroom	Sash replacement, minor repairs and paint works required.
(5) Lounge Room	Minor repairs and paint works required.
(6) Door	Minor repairs on window bead and paint works required.
(7) Kitchen	Replace left window as signs of rotting has appeared in the frame, minor repairs and paint required for sash window.

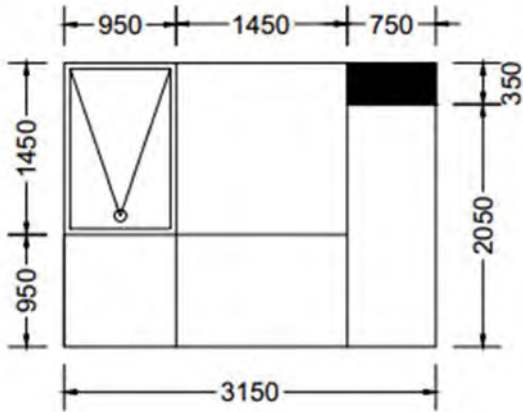
Location	Inspection Notes
(1) Lounge Room	Patch and paint required.
(2) Kitchen	Patch and paint works required.
(3) Right Bedroom	Minor repairs and paint works required.
(4) Left Bedroom	Minor repairs and paint works required.

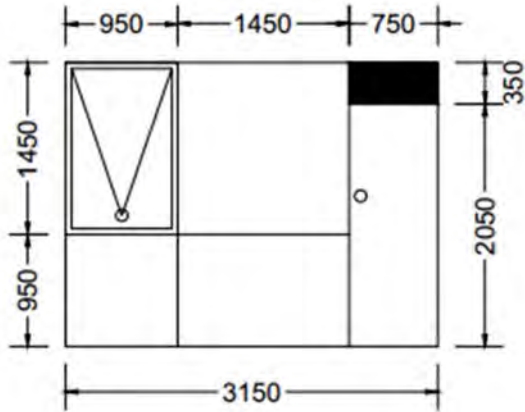
Location	Inspection Notes
(1) Lounge Room	Minor repairs and paint works required.
(2) Kitchen	Replace winder, minor repairs and paint works required.
(3) Left Bedroom	New winder, replace glass bead to fix panel, minor repairs and paint works required.
(4) Bathroom and Toilet	Patch and paint required.
(5) Right Bedroom	Replace glass bead to fix panel, minor repairs and paint works required.

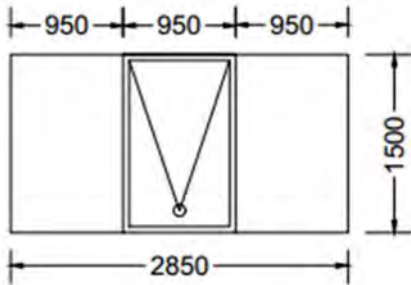
Location	Inspection Notes
(1) Left Bedroom	Replace sash, minor repairs and paint works required.
(2) Toilet	Replace sash, minor repairs and paint works required.
(3) Bathroom	Minor repairs and paint works required. May need to replace frame due to a sizable size of the timber frame is missing however no signs of rot can be seen.
(4) Middle Bedroom	Patch and paint required.
(5) Lounge Room	Minor repairs and paint works required.
(6) Door	Minor repairs and paint works required.
(7) Kitchen	Remove existing layer of paint by sanding and reapply paint. Sash beading needs replacement.
