## Detailed Costings Report

1 Sample Street, Melbourne VIC 3022 (PS12345U)

10 October 2016

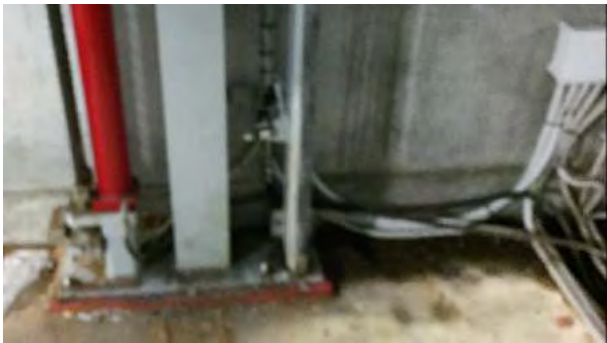
<p><b>D1 MACHINE ACCESS:</b> The machine is located in the basement carpark amongst aligning carpark spaces. The access is inadequate to open control cabinet and in adequate lighting is provided.</p>	 
<p><b>D2 MACHINE ENCLOSURE:</b> Machine enclosure has many open penetrations that need permanent fixings to cover up these areas.</p>	 
<p><b>D3 MACHINE STRUCTURE:</b> Machine structure has some alignment and welding required. The anchoring bolts need to be pull tested for mechanical strength and fixing.</p>	 
<p><b>D4 PLATFORM CLEARANCE:</b> Platform clearances are too small or too large and should be no less than 25mm and no more than 50mm. These clearances should be corrected.</p>

<p><b>D5 MACHINE LOCATION:</b> The machine is located in the basement carpark above other carpark spaces.</p> <p>The machine does not have any fall restraint equipment in the event of structural failure of the lifting equipment.</p>	 
<p><b>D6 PLATFORM ENCLOSURE:</b> Platform enclosure does not have rigidity to allow for safe egress. The enclosure has penetrations that need covering.</p>	 
<p><b>D7 MACHINE ENCLOSURE:</b> Machine enclosure floor leaks oil and there are penetrations that need filling.</p>	 
<p><b>D8 HYDRAULIC PIPEWORK:</b> Machine pipe work is unprotected and exposed to mechanical damage.</p>

<b>D1 MACHINE ACCESS</b>	<b>D2 MACHINE ENCLOSURE</b>
The main supporting mast is misaligned at its joins. Align steel guide uprights, fillet weld and grind flush. The main support mast have used chemset bolts that have been installed incorrectly pull test each fixing.	The platform is not aligned to give correct clearances not to be less than 25mm or over 50mm. Align or modify platform to provide clearances within the limits.
<b>D3 MACHINE STRUCTURE</b>	<b>D4 PLATFORM CLEARANCE</b>
Install rupture valve, emergency brake or rail gripper to each platform lifting device and exclude the car spaces below with a fixed barrier.	Upgrade Platform cage to provide walkway and strength to allow safe egress.
<b>D5 MACHINE LOCATION</b>	<b>D6 PLATFORM ENCLOSURE</b>
Seal machine floor with industrial coating, and fill penetrations with a fire stop.	Provide pipe supports and steel cover plates to protect hoses from mechanical damage.
