## Dilapidation Survey Report

1 Sample Street, Melbourne VIC 3022

1. This report is intended to record the current condition of 1 Sample Street, Melbourne VIC 3022 prior to construction works commencing opposite at 2 Sample Street, Melbourne VIC 3022.
2. The site inspection was carried out on 26<sup>th</sup> Feb 2017. The weather during the course of inspection was fine with sunny skies for the most part of the day.
3. This report of condition contains the following definitions and their descriptions are as follows:
  - **Good** – No signs of wear of tear and able to perform the function for which it was installed.
  - **Fair** – Showing signs of wear/soiling but still serviceable and functioning adequately.
  - **Poor** – Subject to hard and long term wear with repair and/or renovation generally necessary.
4. The below tables identify the classification of cracks and their sizes in relation to building elements.

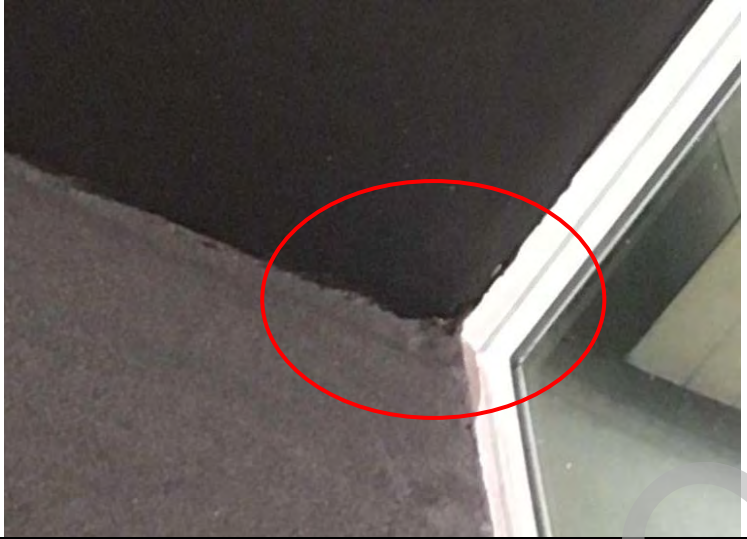
Item	Photographic Evidence	Assessments	
3.

<p><b>Assessment Type:</b></p> <p>Good <input type="checkbox"/></p> <p>Fair <input checked="" type="checkbox"/></p> <p>Poor <input type="checkbox"/></p>	<p><input type="checkbox"/></p> <p><input checked="" type="checkbox"/></p> <p><input type="checkbox"/></p>
<p><b>Location:</b> Entrance – Northern Side</p>		<p><b>Auditors Comments:</b></p> <ul style="list-style-type: none"> <li>Minor crack and chipping of wall was visible at the northern corner of the wall at the entrance.</li> </ul>

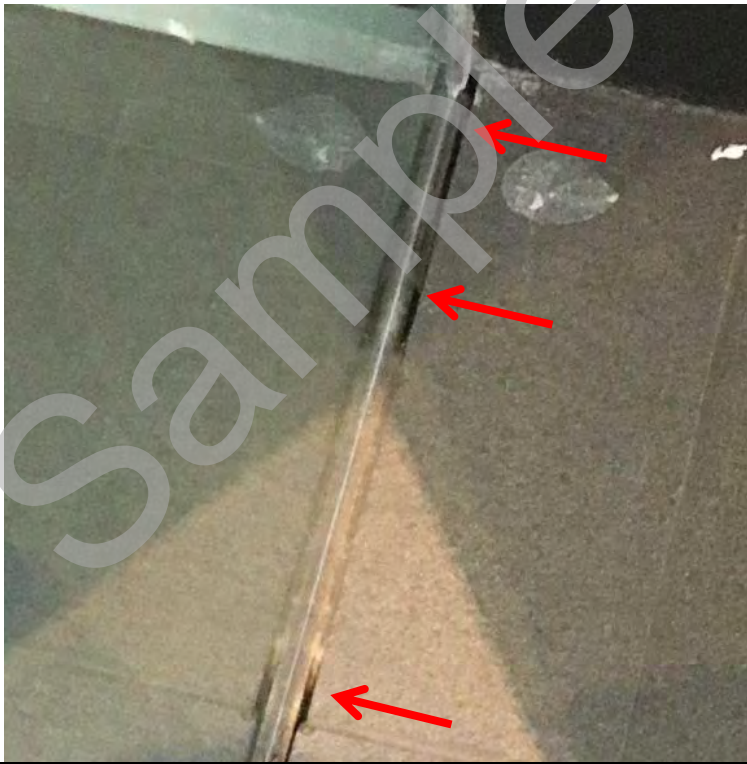
4.

<p><b>Assessment Type:</b></p> <p>Good <input type="checkbox"/></p> <p>Fair <input checked="" type="checkbox"/></p> <p>Poor <input type="checkbox"/></p>	<p><input type="checkbox"/></p> <p><input checked="" type="checkbox"/></p> <p><input type="checkbox"/></p>
<p><b>Location:</b> Entrance – Southeast Side</p>		<p><b>Auditors Comments:</b></p> <ul style="list-style-type: none"> <li>Existing deteriorated grout was visible situated between the tiled floor and glazed window.</li> </ul>

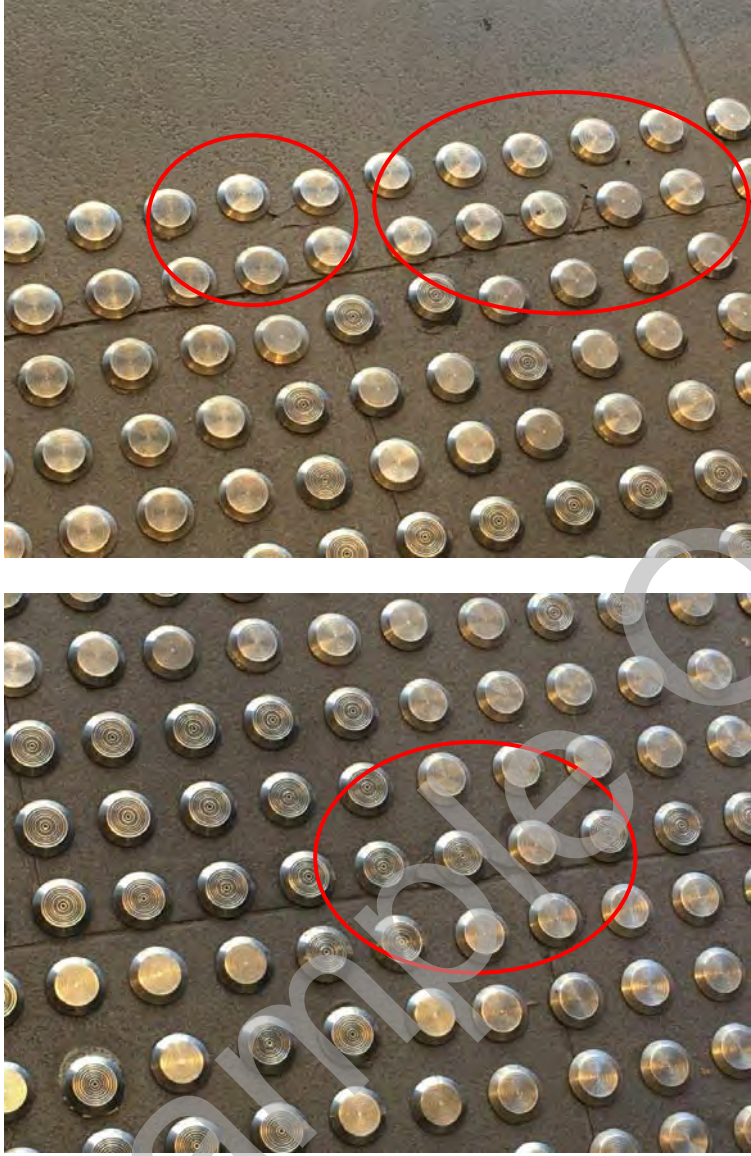
Item	Photographic Evidence	Assessments	
5.

<p><b>Assessment Type:</b></p> <p>Good <input type="checkbox"/></p> <p>Fair <input checked="" type="checkbox"/></p> <p>Poor <input type="checkbox"/></p>	<p><input type="checkbox"/></p> <p><input checked="" type="checkbox"/></p> <p><input type="checkbox"/></p>
<p><b>Location:</b> Entrance</p> <p><b>Auditors Comments:</b></p> <ul style="list-style-type: none"> <li>Minor cracking and normal wear and tear of the tiled floor at the entrance on tactile surface.</li> </ul>		<p><b>Impact Category:</b></p> <p>1 <input checked="" type="checkbox"/></p> <p>2 <input type="checkbox"/></p> <p>3 <input type="checkbox"/></p> <p>4 <input type="checkbox"/></p> <p>5 <input type="checkbox"/></p>	<p><input checked="" type="checkbox"/></p> <p><input type="checkbox"/></p> <p><input type="checkbox"/></p> <p><input type="checkbox"/></p> <p><input type="checkbox"/></p>

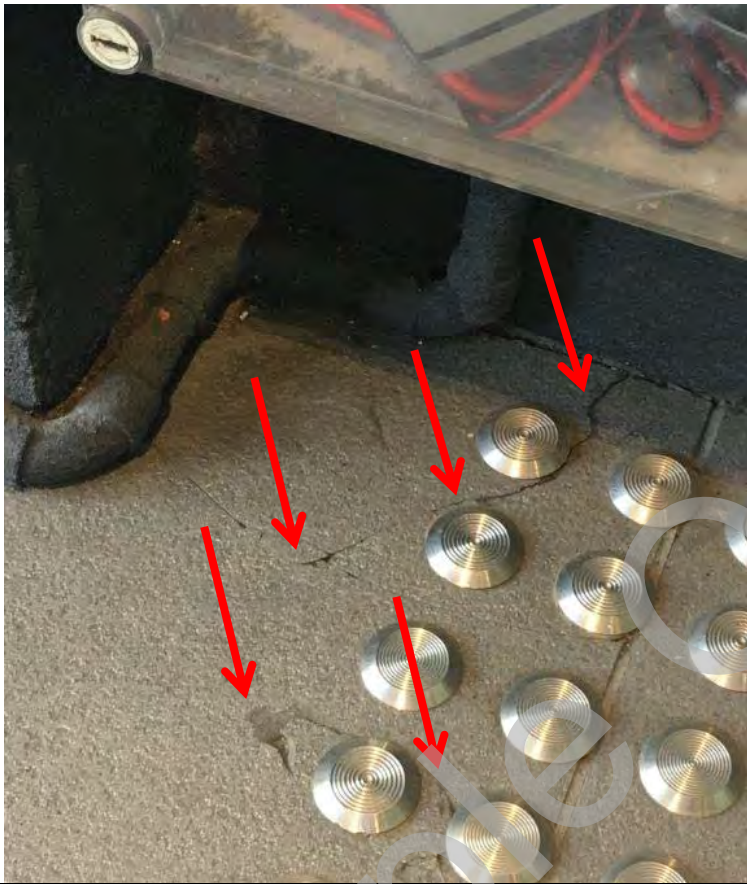
<p><b>Assessment Type:</b></p> <p>Good <input type="checkbox"/></p> <p>Fair <input checked="" type="checkbox"/></p> <p>Poor <input type="checkbox"/></p>	
<p><b>Location:</b> Entrance</p> <p><b>Auditors Comments:</b></p> <ul style="list-style-type: none"> <li>Hairline cracks were visible on the floor tile of the entrance.</li> </ul>		<p><b>Impact Category:</b></p> <p>1 <input checked="" type="checkbox"/></p> <p>2 <input type="checkbox"/></p> <p>3 <input type="checkbox"/></p> <p>4 <input type="checkbox"/></p> <p>5 <input type="checkbox"/></p>

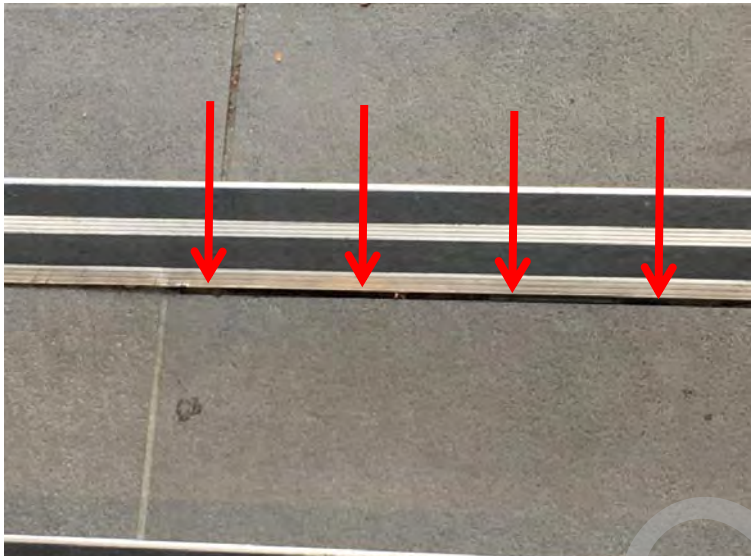
<p><b>Assessment Type:</b></p> <p>Good <input type="checkbox"/></p> <p>Fair <input checked="" type="checkbox"/></p> <p>Poor <input type="checkbox"/></p>	<p><input type="checkbox"/></p> <p><input checked="" type="checkbox"/></p> <p><input type="checkbox"/></p>
<p><b>Location:</b> Entrance - Staircase</p>	<p><b>Auditors Comments:</b></p> <ul style="list-style-type: none"> <li>Gap was present between the nosing and the step</li> </ul>

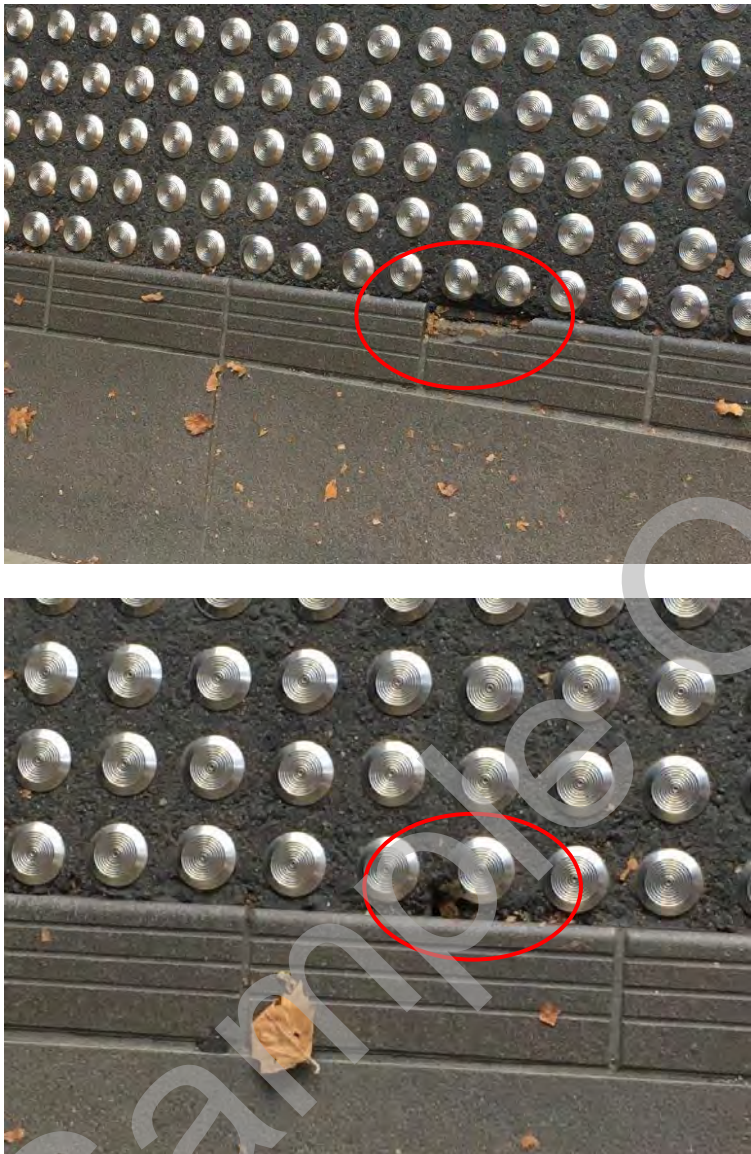
<p><b>Assessment Type:</b></p> <p>Good <input type="checkbox"/></p> <p>Fair <input type="checkbox"/></p> <p>Poor <input checked="" type="checkbox"/></p>	<p><input type="checkbox"/></p> <p><input type="checkbox"/></p> <p><input checked="" type="checkbox"/></p>
		<p><b>Impact Category:</b></p> <p>1 <input type="checkbox"/></p> <p>2 <input checked="" type="checkbox"/></p> <p>3 <input type="checkbox"/></p> <p>4 <input type="checkbox"/></p> <p>5 <input type="checkbox"/></p>	<p><input type="checkbox"/></p> <p><input checked="" type="checkbox"/></p> <p><input type="checkbox"/></p> <p><input type="checkbox"/></p> <p><input type="checkbox"/></p>
<p><b>Location:</b> Entrance – Staircase landing</p>	<p><b>Auditors Comments:</b></p> <ul style="list-style-type: none"> <li>• Cracking at the edge of the floor tile was visible</li> <li>• A crack/indentation of the asphalt was evident.</li> </ul>

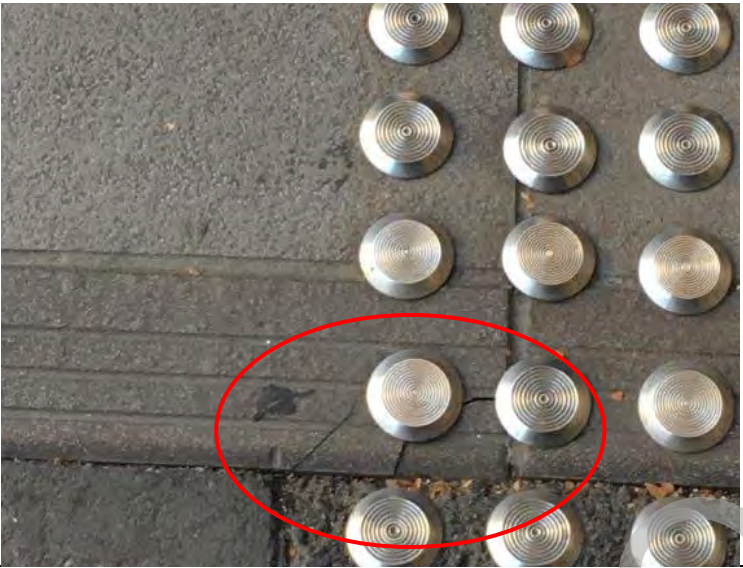
<p><b>Assessment Type:</b></p> <p>Good <input type="checkbox"/></p> <p>Fair <input checked="" type="checkbox"/></p> <p>Poor <input type="checkbox"/></p>	<p><input checked="" type="checkbox"/></p> <p><input type="checkbox"/></p> <p><input type="checkbox"/></p>
<p><b>Location:</b> Entrance – Staircase landing</p>	<p><b>Auditors Comments:</b></p> <ul style="list-style-type: none"> <li>Concrete footpath has minor cracks and is discoloured near the entrance gate of Unit 2.</li> <li>Concrete slab in front of entrance gate generally shows signs of wear and tear.</li> </ul>

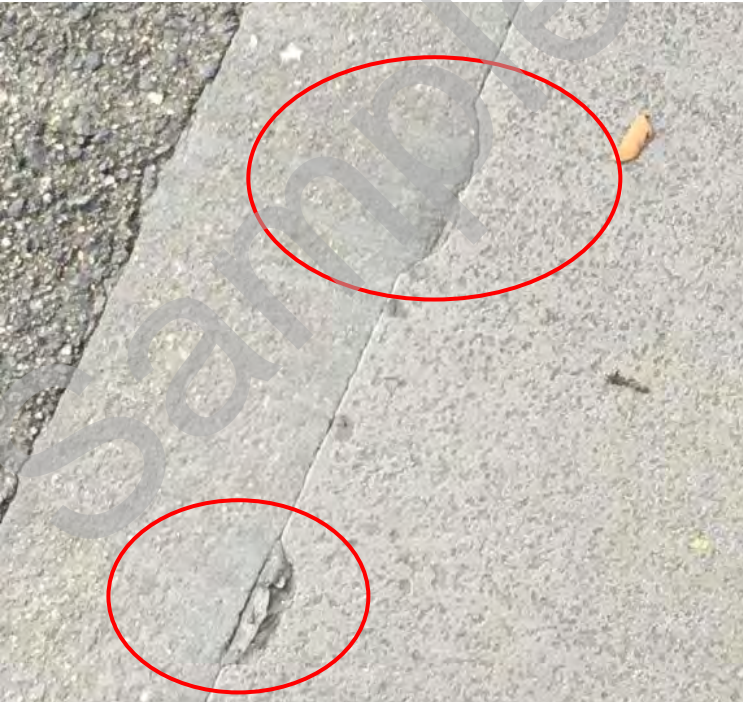
10.

<p><b>Assessment Type:</b></p> <p>Good <input type="checkbox"/></p> <p>Fair <input checked="" type="checkbox"/></p> <p>Poor <input type="checkbox"/></p>	<p><input type="checkbox"/></p> <p><input checked="" type="checkbox"/></p> <p><input type="checkbox"/></p>
<p><b>Location:</b> Entrance – Near council footpath</p>	<p><b>Auditors Comments:</b></p> <ul style="list-style-type: none"> <li>Concrete surface has minor cracks and indentation.</li> </ul>

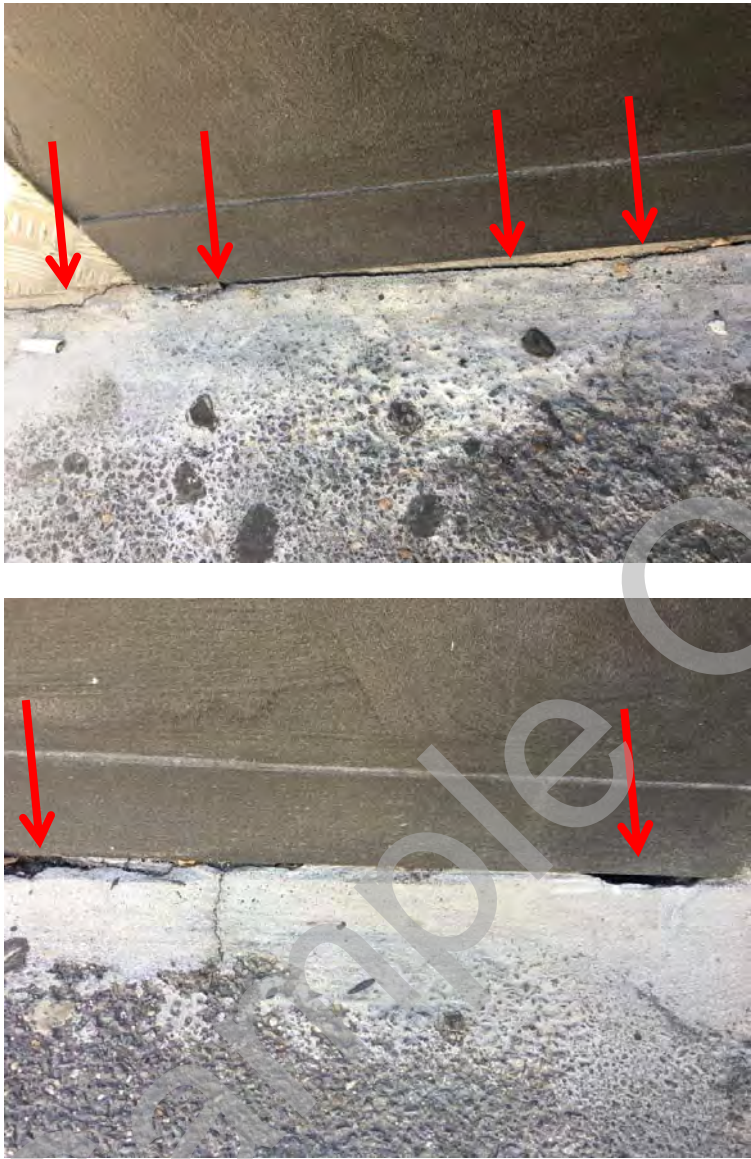
<p><b>Assessment Type:</b></p> <p>Good <input type="checkbox"/></p> <p>Fair <input type="checkbox"/></p> <p>Poor <input checked="" type="checkbox"/></p>	<p><input type="checkbox"/></p> <p><input type="checkbox"/></p> <p><input checked="" type="checkbox"/></p>
		<p><b>Impact Category:</b></p> <p>1 <input type="checkbox"/></p> <p>2 <input type="checkbox"/></p> <p>3 <input checked="" type="checkbox"/></p> <p>4 <input type="checkbox"/></p> <p>5 <input type="checkbox"/></p>	<p><input type="checkbox"/></p> <p><input type="checkbox"/></p> <p><input checked="" type="checkbox"/></p> <p><input type="checkbox"/></p> <p><input type="checkbox"/></p>
<p><b>Location:</b> Sample Street - Pavement</p>	<p><b>Auditors Comments:</b></p> <ul style="list-style-type: none"> <li>• Gap was visible between the asphalt pavement and wall.</li> <li>• Rendering of wall is generally good, asphalt floor is heavily stained.</li> </ul>

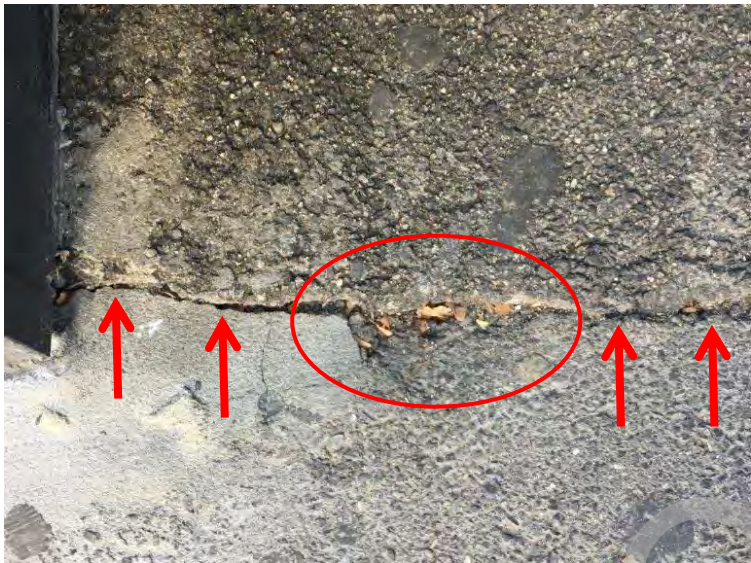
<p><b>Assessment Type:</b></p> <p>Good <input type="checkbox"/></p> <p>Fair <input type="checkbox"/></p> <p>Poor <input checked="" type="checkbox"/></p>	<p><input type="checkbox"/></p> <p><input type="checkbox"/></p> <p><input checked="" type="checkbox"/></p>
<p><b>Location:</b> Sample Street – Pavement</p>	<p><b>Auditors Comments:</b></p> <ul style="list-style-type: none"> <li>Cracking of the asphalt was evident outside the entrance of the property.</li> </ul>

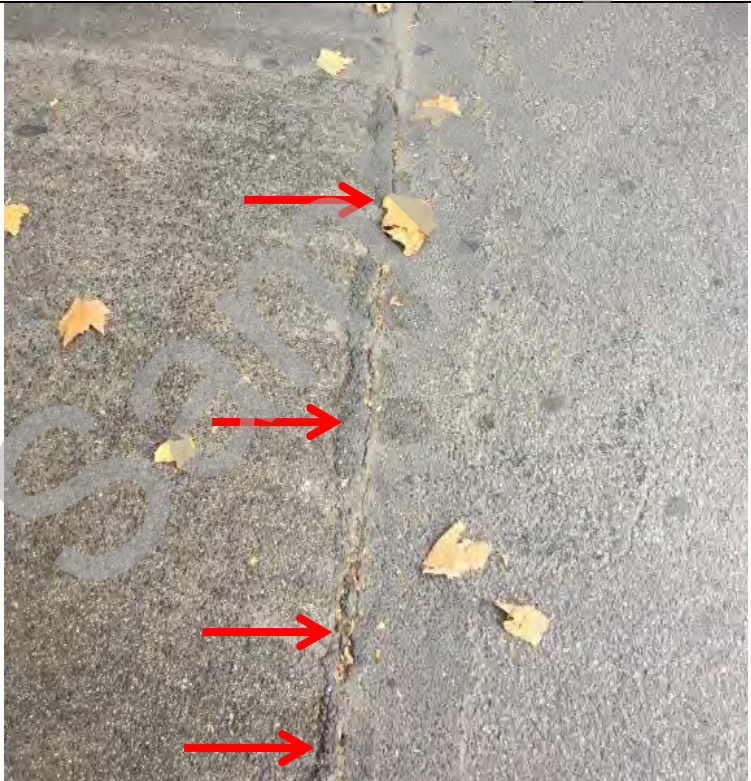
13.

<p><b>Assessment Type:</b></p> <p>Good <input type="checkbox"/></p> <p>Fair <input type="checkbox"/></p> <p>Poor <input checked="" type="checkbox"/></p>	<p><input type="checkbox"/></p> <p><input type="checkbox"/></p> <p><input checked="" type="checkbox"/></p>
<p><b>Location:</b> Sample Street - Pavement</p>	<p><b>Auditors Comments:</b></p> <ul style="list-style-type: none"> <li>Parts of asphalt pavement in front of the property was poorly finished.</li> <li>Cracks were evident at the boundary between property footpath and council footpath.</li> </ul>

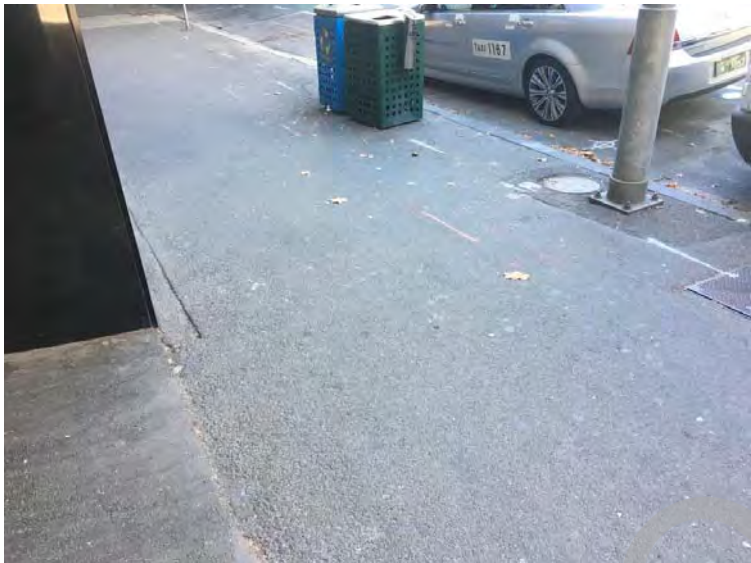
<p><b>Assessment Type:</b></p> <p>Good <input type="checkbox"/></p> <p>Fair <input checked="" type="checkbox"/></p> <p>Poor <input type="checkbox"/></p>	<p><input type="checkbox"/></p> <p><input checked="" type="checkbox"/></p> <p><input type="checkbox"/></p>
<p><b>Location:</b> Sample Street – Pavement</p> <p><b>Auditors Comments:</b></p> <ul style="list-style-type: none"> <li>General view of the council footpath.</li> </ul>		<p><b>Impact Category:</b></p> <p>1 <input type="checkbox"/></p> <p>2 <input checked="" type="checkbox"/></p> <p>3 <input type="checkbox"/></p> <p>4 <input type="checkbox"/></p> <p>5 <input type="checkbox"/></p>

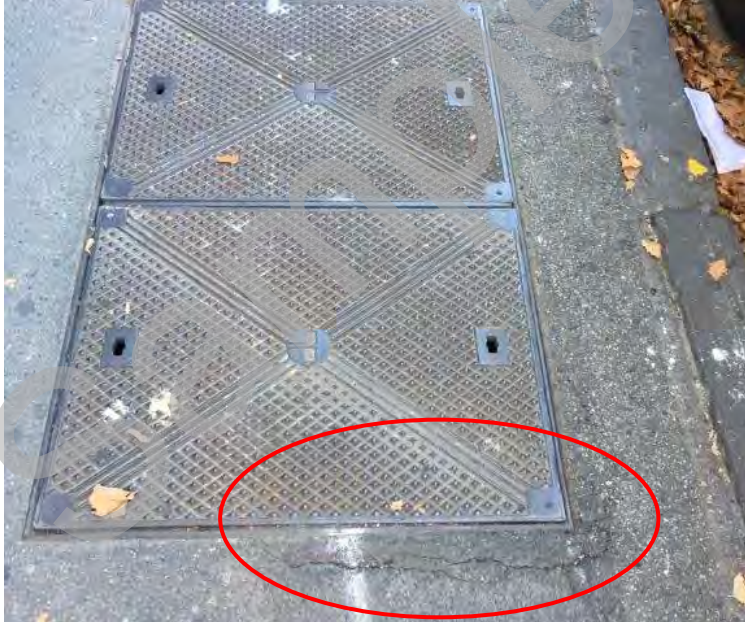
15.

<p><b>Assessment Type:</b></p> <p>Good <input type="checkbox"/></p> <p>Fair <input checked="" type="checkbox"/></p> <p>Poor <input type="checkbox"/></p>	<p><input type="checkbox"/></p> <p><input checked="" type="checkbox"/></p> <p><input type="checkbox"/></p>
<p><b>Location:</b> Sample Street – Pavement</p> <p><b>Auditors Comments:</b></p> <ul style="list-style-type: none"> <li>Minimal cracking (approx. 1-2mm) is noted at the corner of the service pit on the council footpath.</li> </ul>		<p><b>Impact Category:</b></p> <p>1 <input type="checkbox"/></p> <p>2 <input checked="" type="checkbox"/></p> <p>3 <input type="checkbox"/></p> <p>4 <input type="checkbox"/></p> <p>5 <input type="checkbox"/></p>

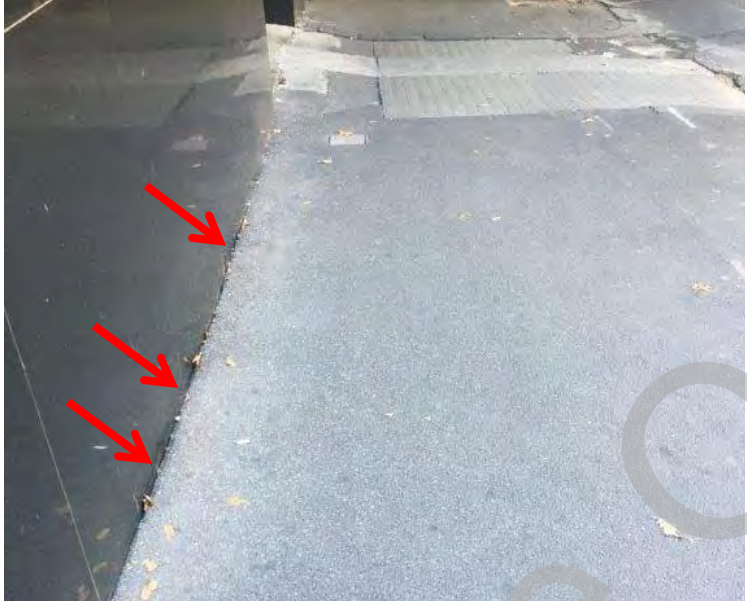
<p><b>Assessment Type:</b></p> <p>Good <input type="checkbox"/></p> <p>Fair <input checked="" type="checkbox"/></p> <p>Poor <input type="checkbox"/></p> <hr/> <p><b>Impact Category:</b></p> <p>1 <input type="checkbox"/></p> <p>2 <input checked="" type="checkbox"/></p> <p>3 <input type="checkbox"/></p> <p>4 <input type="checkbox"/></p> <p>5 <input type="checkbox"/></p>
<p><b>Location:</b> Sample Street – Pavement</p>	<p><b>Auditors Comments:</b></p> <ul style="list-style-type: none"> <li>Existing raised edge was visible between wall and asphalt pavement.</li> </ul>

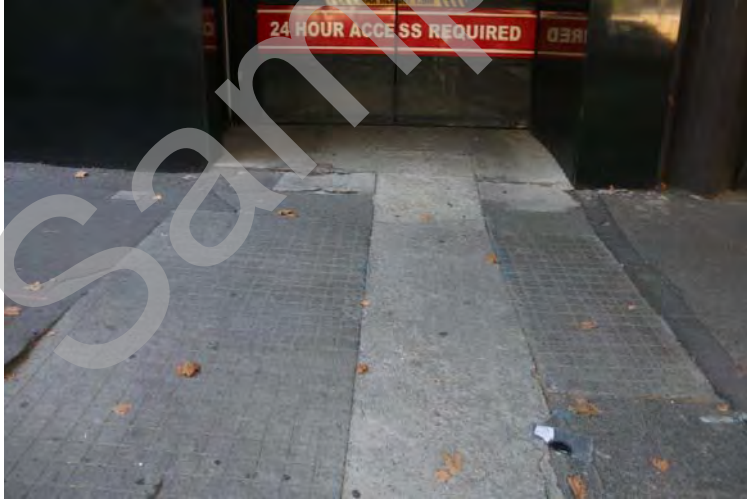
<p><b>Assessment Type:</b></p> <p>Good <input type="checkbox"/></p> <p>Fair <input type="checkbox"/></p> <p>Poor <input checked="" type="checkbox"/></p> <hr/> <p><b>Impact Category:</b></p> <p>1 <input type="checkbox"/></p> <p>2 <input type="checkbox"/></p> <p>3 <input checked="" type="checkbox"/></p> <p>4 <input type="checkbox"/></p> <p>5 <input type="checkbox"/></p>
<p><b>Location:</b> Carpark Entrance</p>	<p><b>Auditors Comments:</b></p> <ul style="list-style-type: none"> <li>General view of the entrance of the carpark.</li> <li>The condition of this area was poor with raised sections, signs of wear and tear with existing chips and cracks.</li> </ul>

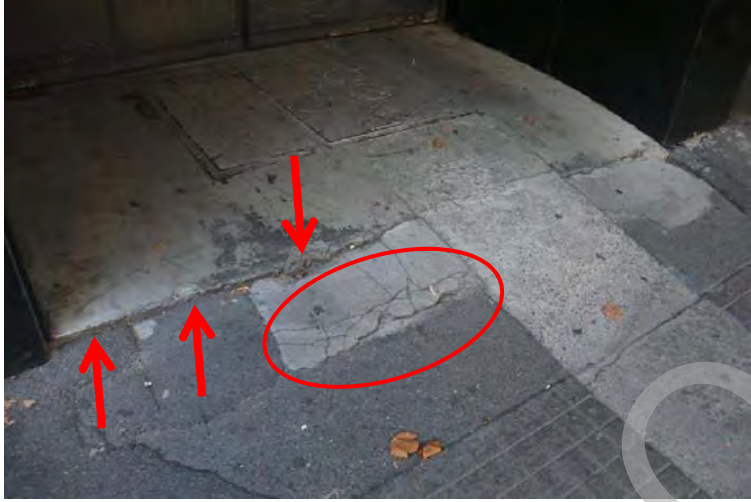
<p><b>Assessment Type:</b></p> <p>Good <input type="checkbox"/></p> <p>Fair <input type="checkbox"/></p> <p>Poor <input checked="" type="checkbox"/></p> <hr/> <p><b>Impact Category:</b></p> <p>1 <input type="checkbox"/></p> <p>2 <input type="checkbox"/></p> <p>3 <input checked="" type="checkbox"/></p> <p>4 <input type="checkbox"/></p> <p>5 <input type="checkbox"/></p>
<p><b>Location:</b> Carpark Entrance</p>	<p><b>Auditors Comments:</b></p> <ul style="list-style-type: none"> <li>• Cracking and indentation of a concrete section.</li> <li>• Asphalt and concrete surface are not at the same level.</li> <li>• Patchwork is evident on the asphalt driveway.</li> </ul>

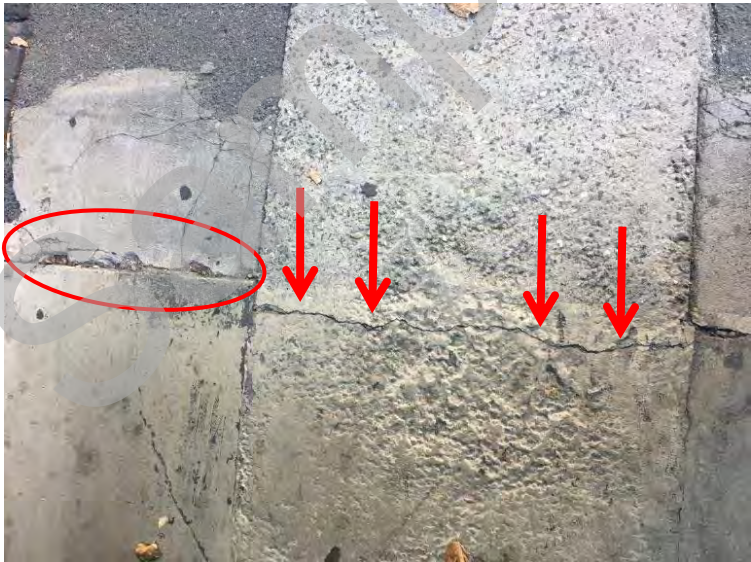
<p><b>Assessment Type:</b></p> <p>Good <input checked="" type="checkbox"/></p> <p>Fair <input type="checkbox"/></p> <p>Poor <input type="checkbox"/></p> <hr/> <p><b>Impact Category:</b></p> <p>1 <input checked="" type="checkbox"/></p> <p>2 <input type="checkbox"/></p> <p>3 <input type="checkbox"/></p> <p>4 <input type="checkbox"/></p> <p>5 <input type="checkbox"/></p>
<p><b>Location:</b> Carpark Entrance</p>	<p><b>Auditors Comments:</b></p> <ul style="list-style-type: none"> <li>• Hairline cracks (approx. 1-2mm) and chipping of concrete were found on the surface.</li> </ul>

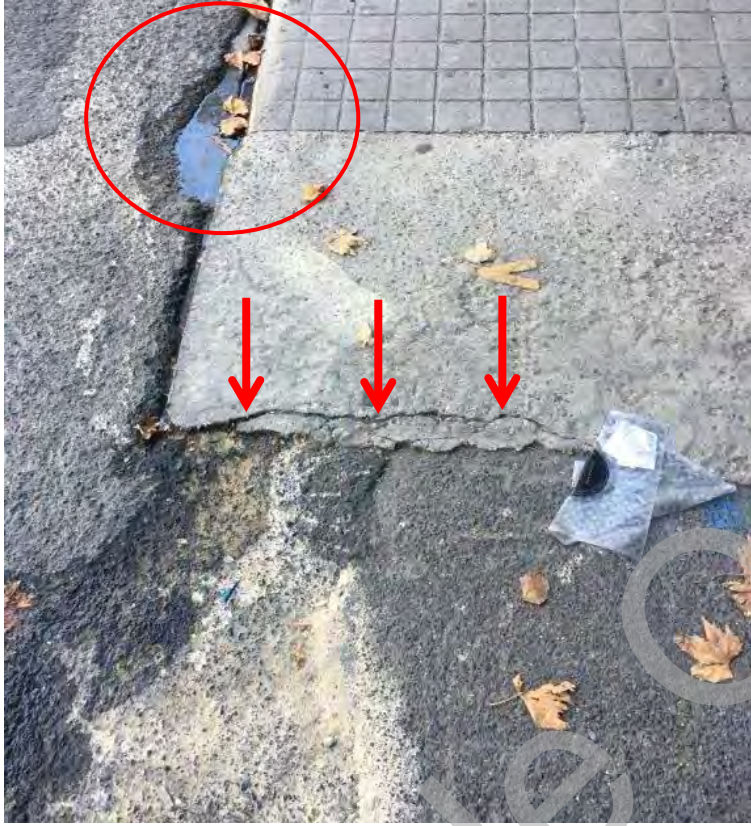
<b>Assessment Type:</b>  Good <input type="checkbox"/> Fair <input type="checkbox"/> Poor <input type="checkbox"/>	<input checked="" type="checkbox"/> <input type="checkbox"/> <input type="checkbox"/>
		<b>Impact Category:</b>  1 <input type="checkbox"/> 2 <input type="checkbox"/> 3 <input type="checkbox"/> 4 <input type="checkbox"/> 5 <input type="checkbox"/>	<input type="checkbox"/> <input type="checkbox"/> <input type="checkbox"/> <input type="checkbox"/> <input type="checkbox"/>
<b>Location:</b> Front Entrance	<b>Auditors Comments:</b> <ul style="list-style-type: none"> <li>Cracks and chipping of concrete were found on the surface.</li> <li>Surface was generally in poor condition.</li> </ul>

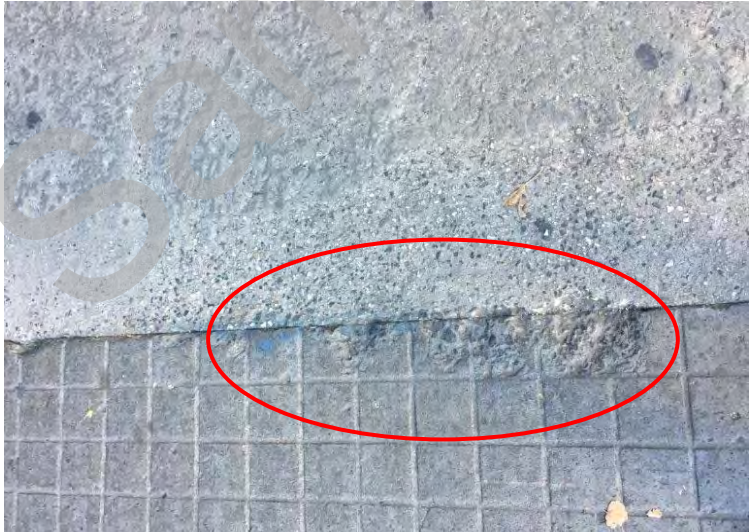
<b>Assessment Type:</b>  Good <input type="checkbox"/> Fair <input checked="" type="checkbox"/> Poor <input type="checkbox"/>	<input type="checkbox"/> <input checked="" type="checkbox"/> <input type="checkbox"/>
		<b>Impact Category:</b>  1 <input type="checkbox"/> 2 <input checked="" type="checkbox"/> 3 <input type="checkbox"/> 4 <input type="checkbox"/> 5 <input type="checkbox"/>	<input type="checkbox"/> <input checked="" type="checkbox"/> <input type="checkbox"/> <input type="checkbox"/> <input type="checkbox"/>
<b>Location:</b> Front Entrance	<b>Auditors Comments:</b> <ul style="list-style-type: none"> <li>Chipping and minor indentation of concrete was evident.</li> </ul>

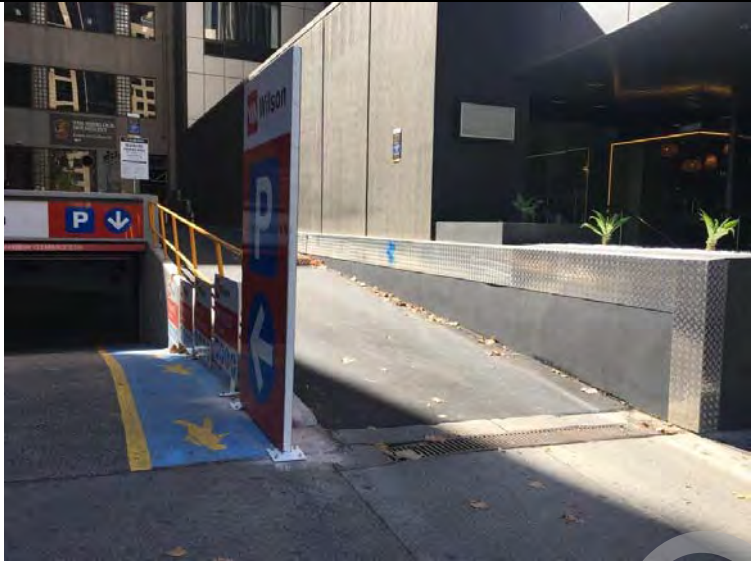
<b>Assessment Type:</b>  Good <input type="checkbox"/> Fair <input checked="" type="checkbox"/> Poor <input type="checkbox"/>	<input type="checkbox"/> <input checked="" type="checkbox"/> <input type="checkbox"/>
<b>Location:</b> Northwest Boundary		<b>Auditors Comments:</b> <ul style="list-style-type: none"> <li>General view of the entrance to the northwest boundary of the property.</li> <li>Overall condition of this area was fairly good.</li> </ul>

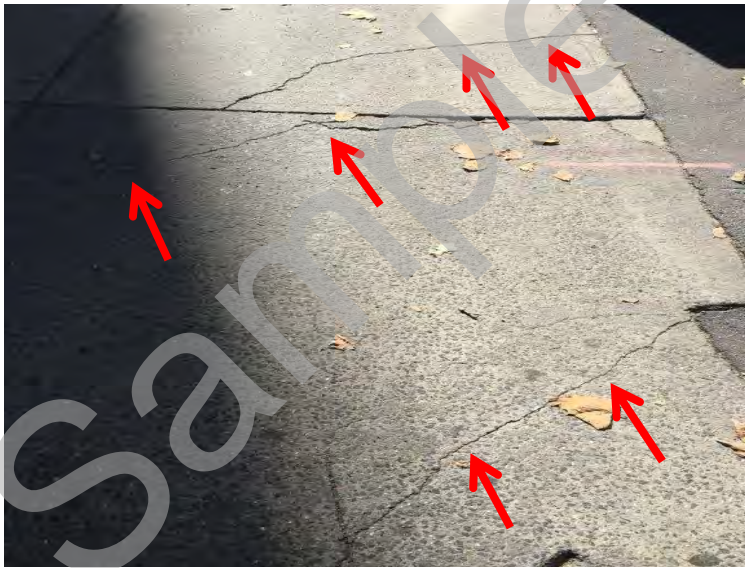
<b>Assessment Type:</b>  Good <input type="checkbox"/> Fair <input type="checkbox"/> Poor <input checked="" type="checkbox"/>	<input type="checkbox"/> <input type="checkbox"/> <input checked="" type="checkbox"/>
<b>Location:</b> Northwest Boundary		<b>Auditors Comments:</b> <ul style="list-style-type: none"> <li>Cracking of the concrete surface were noted throughout the entrance of the area located at the northwest boundary.</li> </ul>

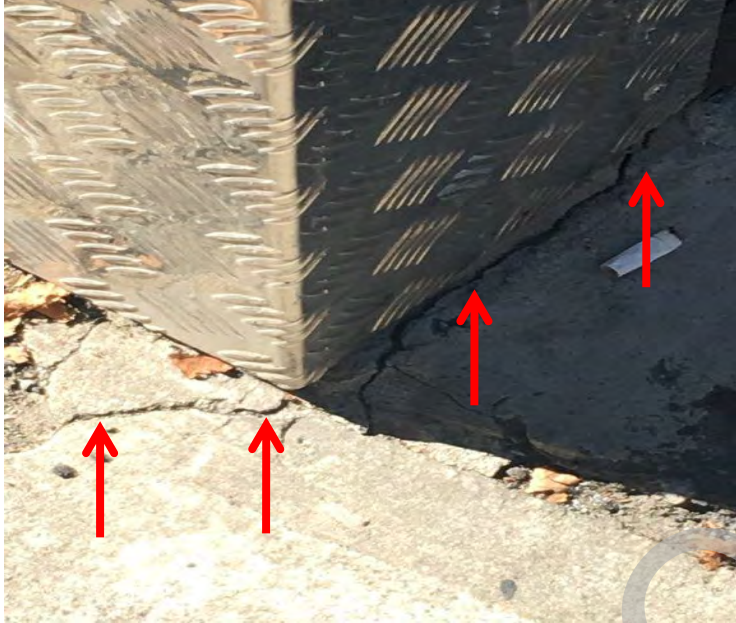
<p><b>Assessment Type:</b></p> <p>Good <input type="checkbox"/></p> <p>Fair <input checked="" type="checkbox"/></p> <p>Poor <input type="checkbox"/></p>	<input type="checkbox"/> <input checked="" type="checkbox"/> <input type="checkbox"/>
		<p><b>Impact Category:</b></p> <p>1 <input type="checkbox"/></p> <p>2 <input checked="" type="checkbox"/></p> <p>3 <input type="checkbox"/></p> <p>4 <input type="checkbox"/></p> <p>5 <input type="checkbox"/></p>	<input type="checkbox"/> <input checked="" type="checkbox"/> <input type="checkbox"/> <input type="checkbox"/> <input type="checkbox"/>
<p><b>Location:</b> Northwest Boundary</p>	<p><b>Auditors Comments:</b></p> <ul style="list-style-type: none"> <li>Cracking had occurred at the bottom corner wall of the building.</li> </ul>

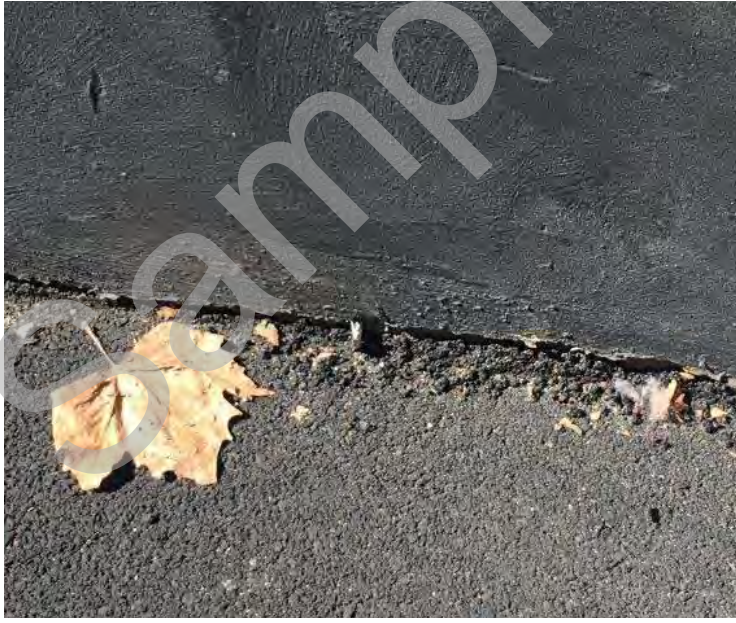
<p><b>Assessment Type:</b></p> <p>Good <input type="checkbox"/></p> <p>Fair <input checked="" type="checkbox"/></p> <p>Poor <input type="checkbox"/></p>	<input type="checkbox"/> <input checked="" type="checkbox"/> <input type="checkbox"/>
		<p><b>Impact Category:</b></p> <p>1 <input type="checkbox"/></p> <p>2 <input type="checkbox"/></p> <p>3 <input checked="" type="checkbox"/></p> <p>4 <input type="checkbox"/></p> <p>5 <input type="checkbox"/></p>	<input type="checkbox"/> <input type="checkbox"/> <input checked="" type="checkbox"/> <input type="checkbox"/> <input type="checkbox"/>
<p><b>Location:</b> Northwest Boundary</p>	<p><b>Auditors Comments:</b></p> <ul style="list-style-type: none"> <li>Gap was visible between the asphalt pavement and rendered wall.</li> <li>Signs of minor cracking was also evident.</li> </ul>

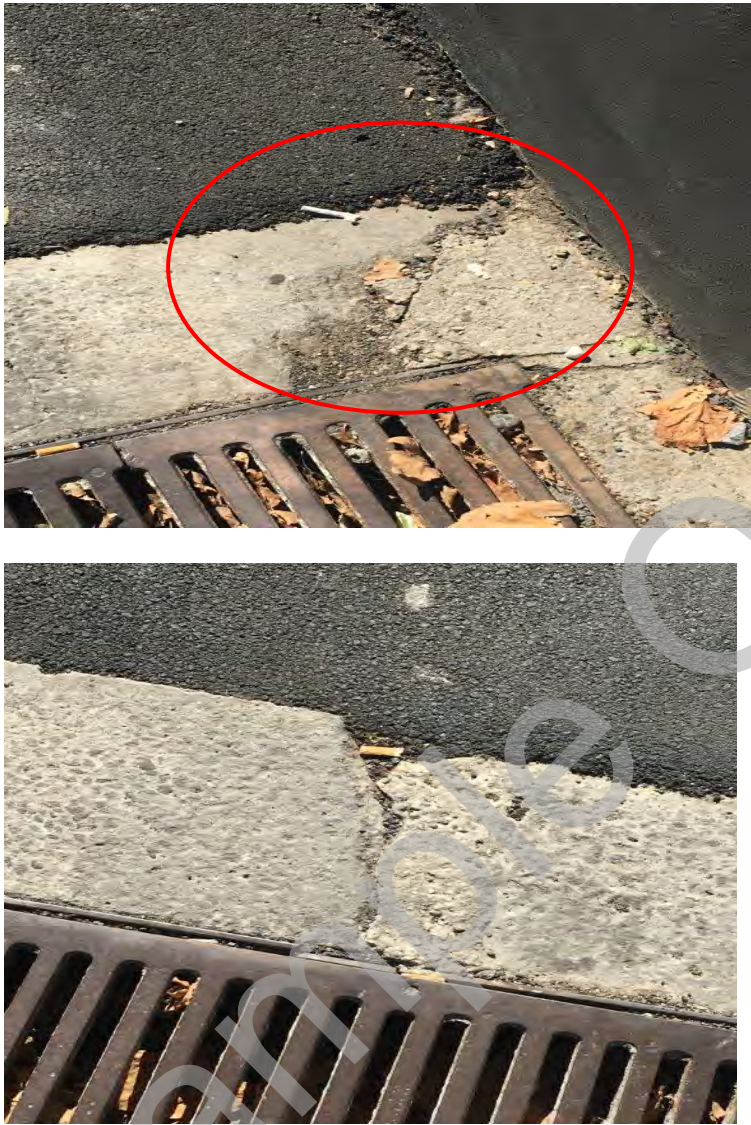
<p><b>Assessment Type:</b></p> <p>Good <input type="checkbox"/></p> <p>Fair <input type="checkbox"/></p> <p>Poor <input checked="" type="checkbox"/></p>	<p><input type="checkbox"/></p> <p><input type="checkbox"/></p> <p><input checked="" type="checkbox"/></p>
		<p><b>Impact Category:</b></p> <p>1 <input type="checkbox"/></p> <p>2 <input checked="" type="checkbox"/></p> <p>3 <input type="checkbox"/></p> <p>4 <input type="checkbox"/></p> <p>5 <input type="checkbox"/></p>	<p><input type="checkbox"/></p> <p><input checked="" type="checkbox"/></p> <p><input type="checkbox"/></p> <p><input type="checkbox"/></p> <p><input type="checkbox"/></p>
<p><b>Location:</b> Northwest Boundary</p>	<p><b>Auditors Comments:</b></p> <ul style="list-style-type: none"> <li>Chipping of the concrete at the corners of the strip drain were evident, shows signs of cracking.</li> </ul>

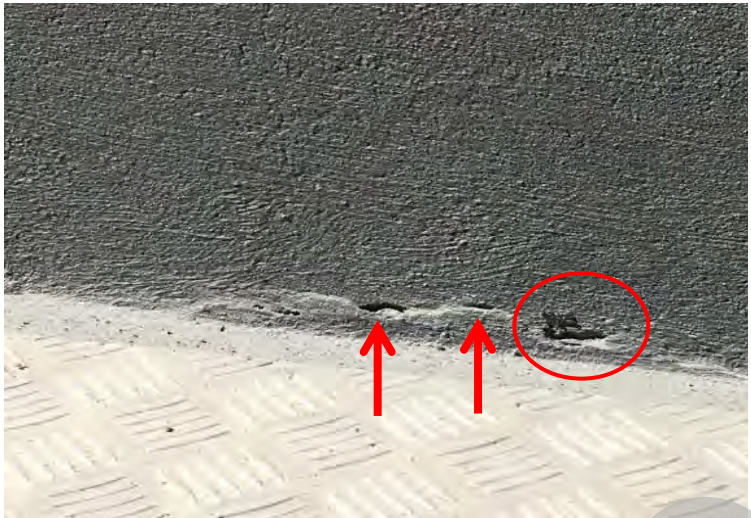
<p><b>Assessment Type:</b></p> <p>Good <input type="checkbox"/></p> <p>Fair <input checked="" type="checkbox"/></p> <p>Poor <input type="checkbox"/></p>	<p><input type="checkbox"/></p> <p><input checked="" type="checkbox"/></p> <p><input type="checkbox"/></p>
<p><b>Location:</b> Northwest Boundary</p> <p><b>Auditors Comments:</b></p> <ul style="list-style-type: none"> <li>Chipping and cracking of the rendered wall was evident at the side of the driveway.</li> </ul>		<p><b>Impact Category:</b></p> <p>1 <input checked="" type="checkbox"/></p> <p>2 <input type="checkbox"/></p> <p>3 <input type="checkbox"/></p> <p>4 <input type="checkbox"/></p> <p>5 <input type="checkbox"/></p>

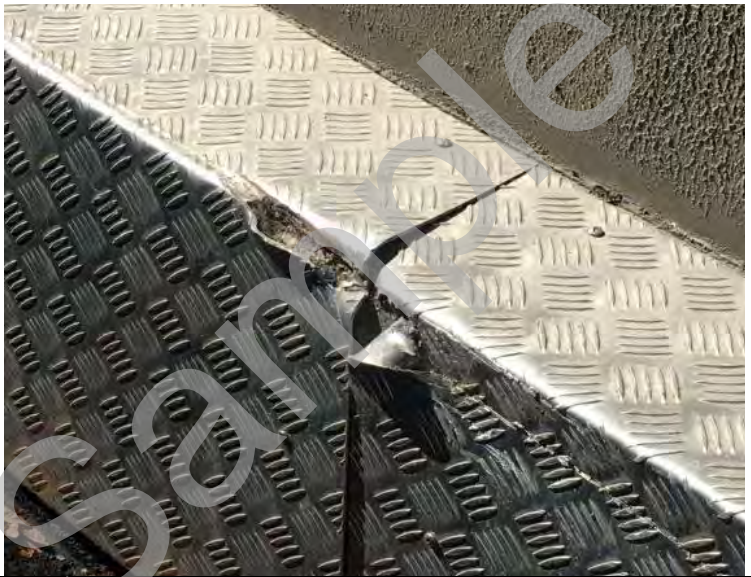
<p><b>Assessment Type:</b></p> <p>Good <input type="checkbox"/></p> <p>Fair <input type="checkbox"/></p> <p>Poor <input checked="" type="checkbox"/></p>	<p><input type="checkbox"/></p> <p><input type="checkbox"/></p> <p><input checked="" type="checkbox"/></p>
<p><b>Location:</b> Northwest Boundary</p> <p><b>Auditors Comments:</b></p> <ul style="list-style-type: none"> <li>Impact damage on metal protection sheet to the rendered wall along the driveway.</li> </ul>		<p><b>Impact Category:</b></p> <p>1 <input checked="" type="checkbox"/></p> <p>2 <input type="checkbox"/></p> <p>3 <input type="checkbox"/></p> <p>4 <input type="checkbox"/></p> <p>5 <input type="checkbox"/></p>

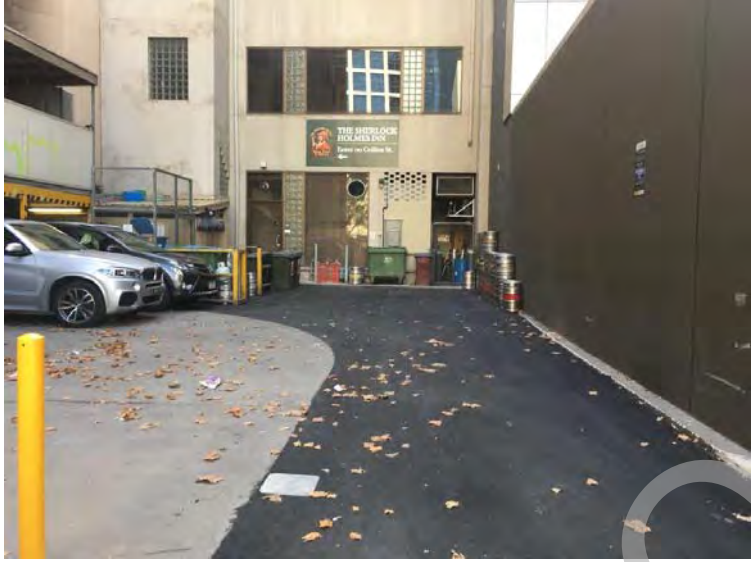
<p><b>Assessment Type:</b></p> <p>Good <input checked="" type="checkbox"/></p> <p>Fair <input type="checkbox"/></p> <p>Poor <input type="checkbox"/></p>	<input checked="" type="checkbox"/> <input type="checkbox"/> <input type="checkbox"/>
		<p><b>Impact Category:</b></p> <p>1 <input checked="" type="checkbox"/></p> <p>2 <input type="checkbox"/></p> <p>3 <input type="checkbox"/></p> <p>4 <input type="checkbox"/></p> <p>5 <input type="checkbox"/></p>	<input checked="" type="checkbox"/> <input type="checkbox"/> <input type="checkbox"/> <input type="checkbox"/> <input type="checkbox"/>
<p><b>Location:</b> Northwest Boundary</p>	<p><b>Auditors Comments:</b></p> <ul style="list-style-type: none"> <li>General view of northwest boundary.</li> </ul>

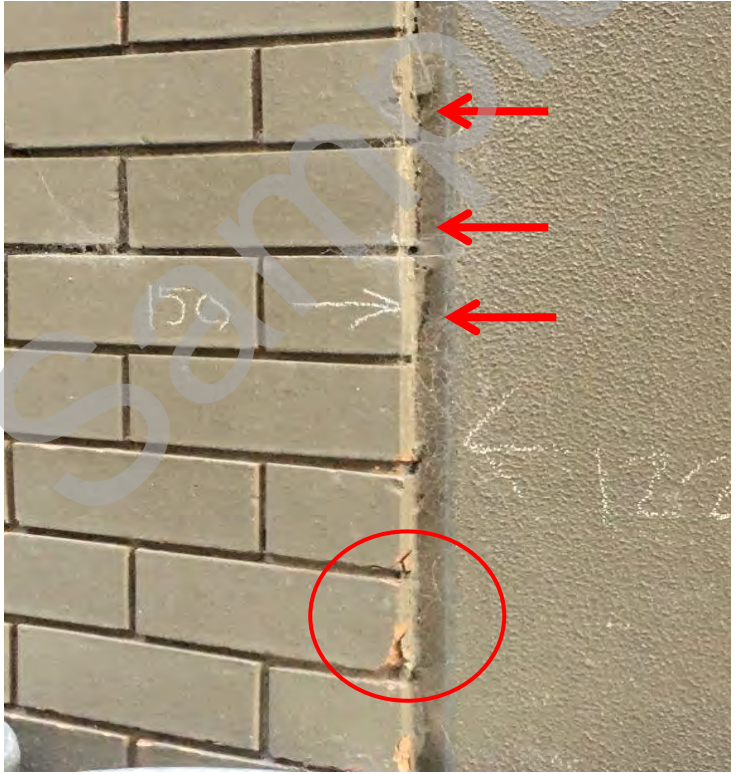
<p><b>Assessment Type:</b></p> <p>Good <input type="checkbox"/></p> <p>Fair <input checked="" type="checkbox"/></p> <p>Poor <input type="checkbox"/></p>	<input type="checkbox"/> <input checked="" type="checkbox"/> <input type="checkbox"/>
		<p><b>Impact Category:</b></p> <p>1 <input checked="" type="checkbox"/></p> <p>2 <input type="checkbox"/></p> <p>3 <input type="checkbox"/></p> <p>4 <input type="checkbox"/></p> <p>5 <input type="checkbox"/></p>	<input checked="" type="checkbox"/> <input type="checkbox"/> <input type="checkbox"/> <input type="checkbox"/> <input type="checkbox"/>
<p><b>Location:</b> Northwest Boundary</p>	<p><b>Auditors Comments:</b></p> <ul style="list-style-type: none"> <li>Minor cracks and chipping were evident along the northwest façade of the building.</li> </ul>

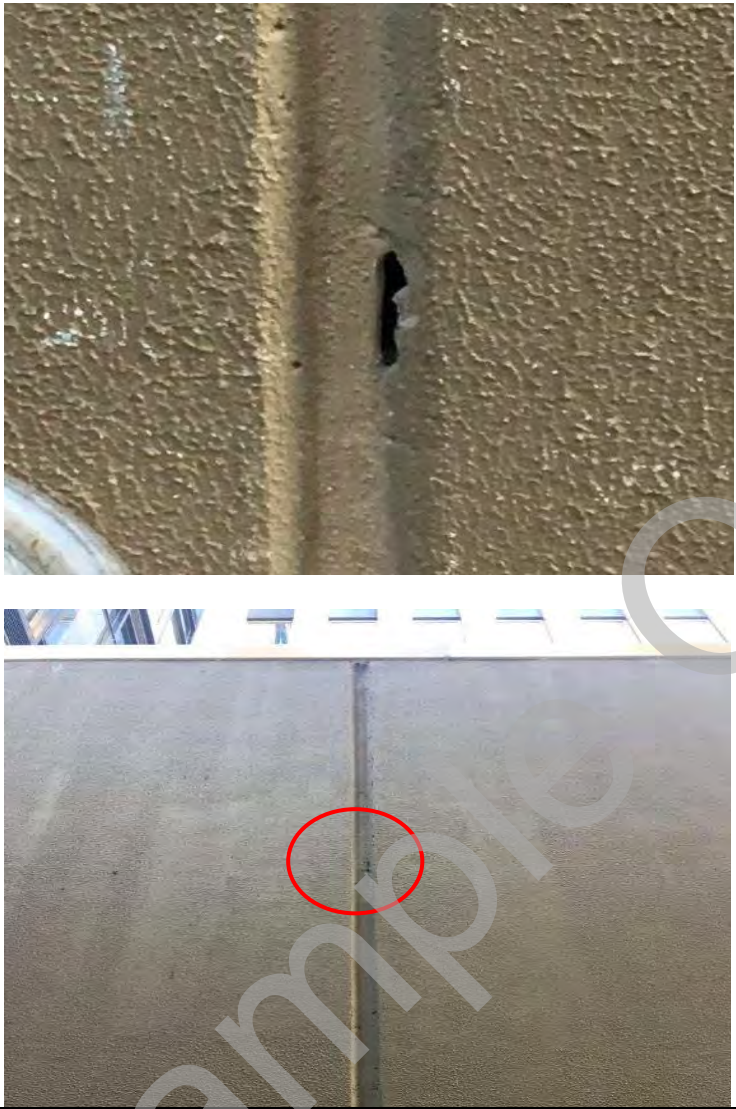
<p><b>Assessment Type:</b></p> <p>Good <input type="checkbox"/></p> <p>Fair <input checked="" type="checkbox"/></p> <p>Poor <input type="checkbox"/></p>	<p><input type="checkbox"/></p> <p><input checked="" type="checkbox"/></p> <p><input type="checkbox"/></p>
		<p><b>Impact Category:</b></p> <p>1 <input type="checkbox"/></p> <p>2 <input checked="" type="checkbox"/></p> <p>3 <input type="checkbox"/></p> <p>4 <input type="checkbox"/></p> <p>5 <input type="checkbox"/></p>	<p><input type="checkbox"/></p> <p><input checked="" type="checkbox"/></p> <p><input type="checkbox"/></p> <p><input type="checkbox"/></p> <p><input type="checkbox"/></p>
<p><b>Location:</b> Northwest Boundary Wall</p>	<p><b>Auditors Comments:</b></p> <ul style="list-style-type: none"> <li>Minor cracking on the flexible caulking on the control joint on bottom and top of rendered wall at the northwest boundary wall.</li> </ul>

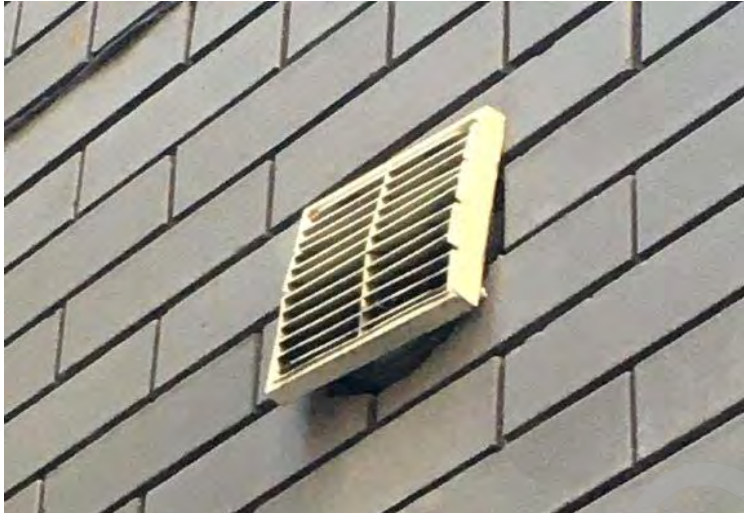
<p><b>Assessment Type:</b></p> <p>Good <input type="checkbox"/></p> <p>Fair <input checked="" type="checkbox"/></p> <p>Poor <input type="checkbox"/></p>	<input type="checkbox"/> <input checked="" type="checkbox"/> <input type="checkbox"/>
<p><b>Location:</b> Northwest Boundary Wall</p>		<p><b>Auditors Comments:</b></p> <ul style="list-style-type: none"> <li>Exhaust fan vent cover was found to be slightly detached from the face of the wall.</li> </ul>

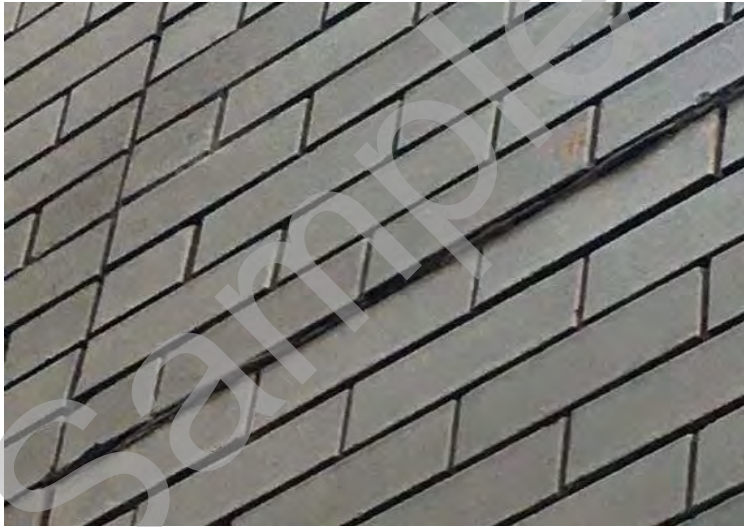
<p><b>Assessment Type:</b></p> <p>Good <input type="checkbox"/></p> <p>Fair <input checked="" type="checkbox"/></p> <p>Poor <input type="checkbox"/></p>	<input type="checkbox"/> <input checked="" type="checkbox"/> <input type="checkbox"/>
<p><b>Location:</b> Northwest Boundary Wall</p>		<p><b>Auditors Comments:</b></p> <ul style="list-style-type: none"> <li>Expansion joints in between of brick panels had visible distress.</li> </ul>

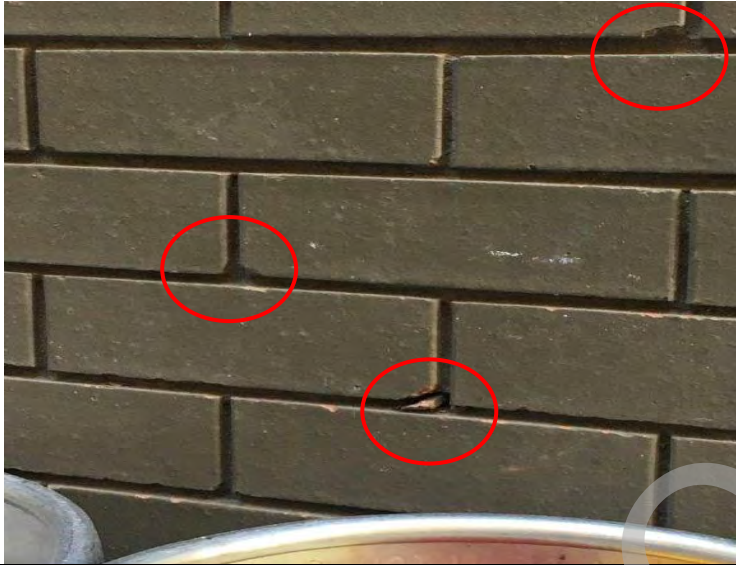
<b>Assessment Type:</b>  Good <input type="checkbox"/> Fair <input checked="" type="checkbox"/> Poor <input type="checkbox"/>	<input type="checkbox"/> <input checked="" type="checkbox"/> <input type="checkbox"/>
<b>Location:</b> Northwest Boundary Wall		<b>Auditors Comments:</b> <ul style="list-style-type: none"> <li>Minor chippings were found on the face of the wall.</li> </ul>	
37.
