## Dilapidation Survey Report

1 Sample Street, Melbourne VIC 3022

1. This report is intended to record the current condition of 1 Sample Street, Melbourne VIC 3022 prior to construction works commencing opposite at 2 Sample Street, Melbourne VIC 3022.
2. The site inspection was carried out on 26<sup>th</sup> Feb 2017. The weather during the course of inspection was fine with sunny skies for the most part of the day.
3. This report of condition contains the following definitions and their descriptions are as follows:
  - **Good** – No signs of wear of tear and able to perform the function for which it was installed.
  - **Fair** – Showing signs of wear/soiling but still serviceable and functioning adequately.
  - **Poor** – Subject to hard and long term wear with repair and/or renovation generally necessary.
4. The below tables identify the classification of cracks and their sizes in relation to building elements.

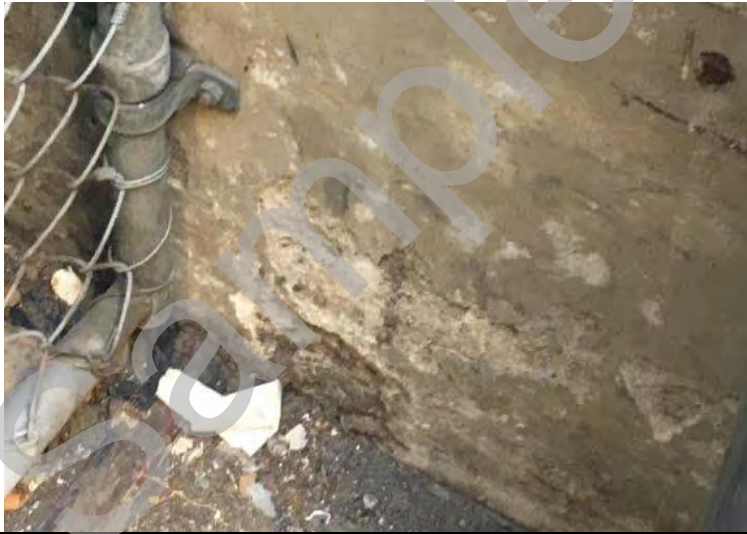
<b>Assessment Type:</b>  Good <input type="checkbox"/> Fair <input type="checkbox"/> Poor <input checked="" type="checkbox"/>	<input type="checkbox"/> <input type="checkbox"/> <input checked="" type="checkbox"/>
<b>Location:</b> Northwest Boundary Wall		<b>Auditors Comments:</b> <ul style="list-style-type: none"> <li>Chipping of concrete at the bottom face of the wall, shows signs of cracking.</li> </ul>

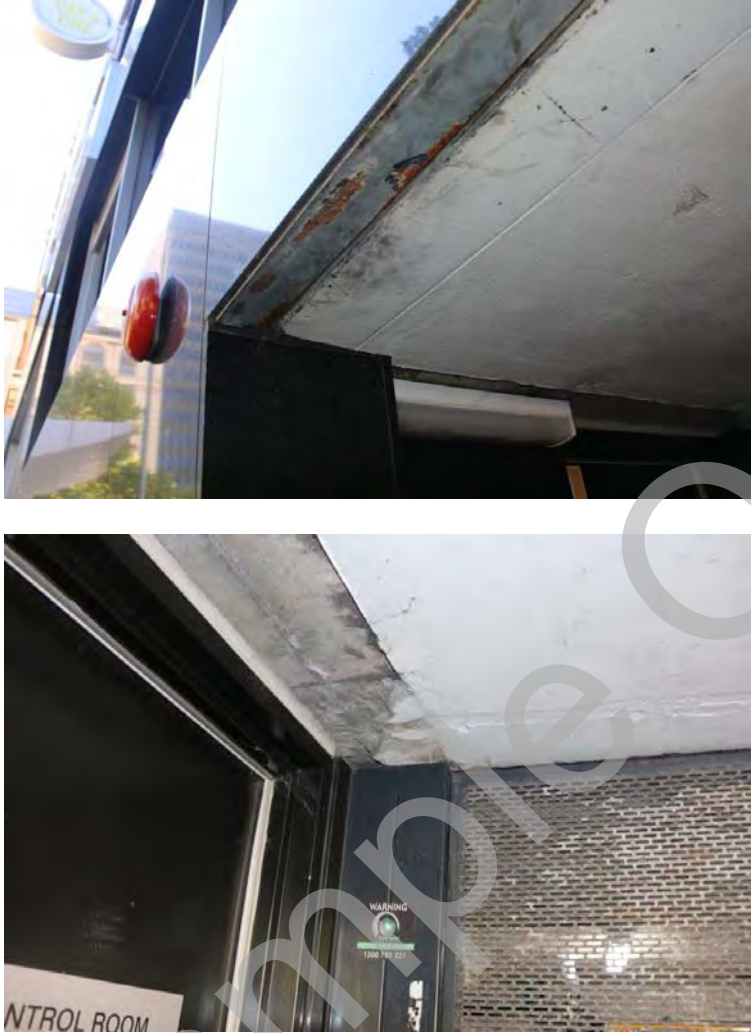
<p><b>Assessment Type:</b></p> <p>Good <input type="checkbox"/></p> <p>Fair <input type="checkbox"/></p> <p>Poor <input checked="" type="checkbox"/></p>	<p><input type="checkbox"/></p> <p><input type="checkbox"/></p> <p><input checked="" type="checkbox"/></p>
		<p><b>Impact Category:</b></p> <p>1 <input checked="" type="checkbox"/></p> <p>2 <input type="checkbox"/></p> <p>3 <input type="checkbox"/></p> <p>4 <input type="checkbox"/></p> <p>5 <input type="checkbox"/></p>	<p><input checked="" type="checkbox"/></p> <p><input type="checkbox"/></p> <p><input type="checkbox"/></p> <p><input type="checkbox"/></p> <p><input type="checkbox"/></p>
<p><b>Location:</b> Carpark Entrance</p>	<p><b>Auditors Comments:</b></p> <ul style="list-style-type: none"> <li>• Rusting of metal lintel on the soffit and gate at the entrance of the carpark was evident.</li> <li>• Poor rendering of side of the soffit.</li> <li>• General condition of the soffit was poor.</li> </ul>

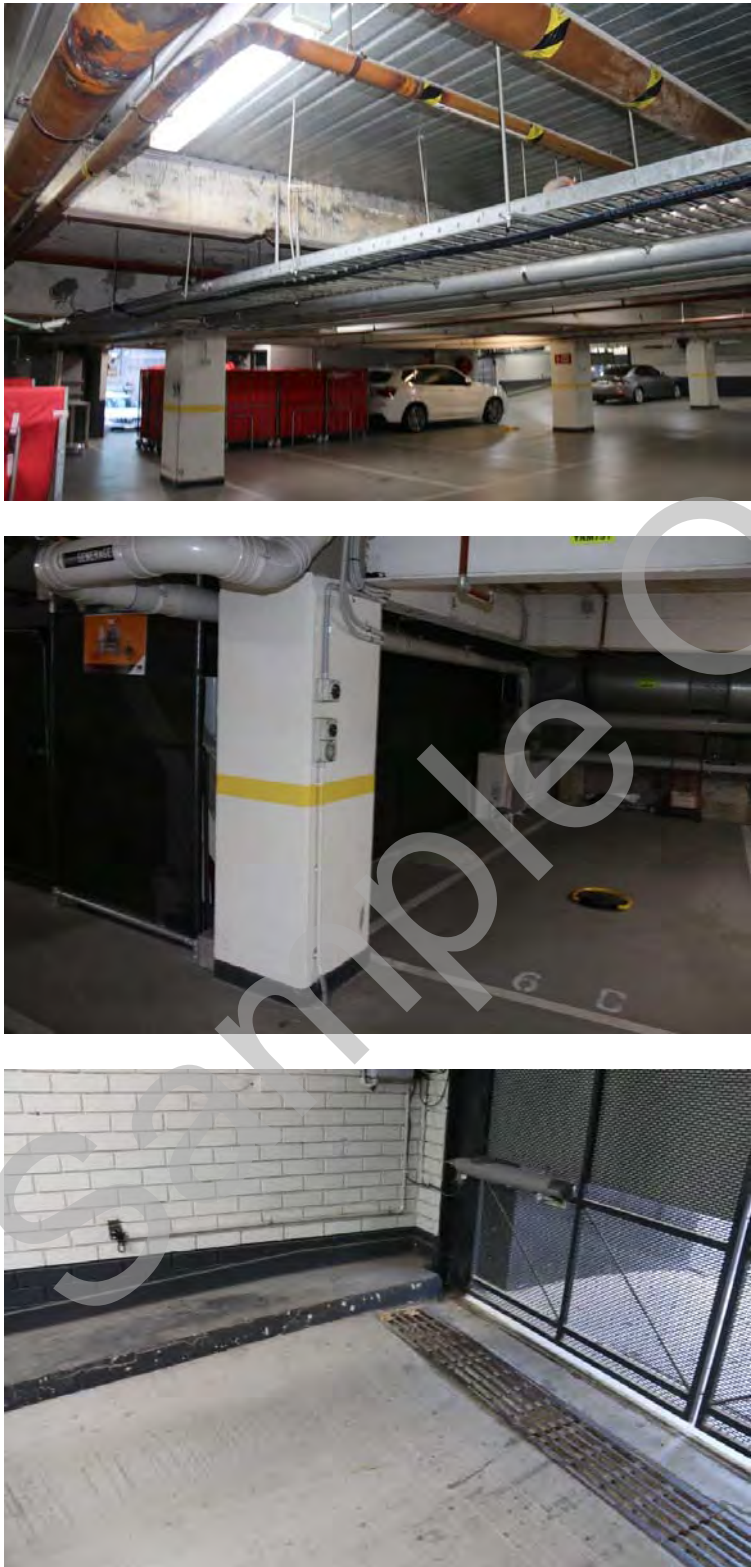
<p><b>Assessment Type:</b></p> <p>Good <input type="checkbox"/></p> <p>Fair <input checked="" type="checkbox"/></p> <p>Poor <input type="checkbox"/></p>	<p><input type="checkbox"/></p> <p><input checked="" type="checkbox"/></p> <p><input type="checkbox"/></p>
<p><b>Location:</b> Basement Carpark</p>		<p><b>Impact Category:</b></p> <p>1 <input checked="" type="checkbox"/></p> <p>2 <input type="checkbox"/></p> <p>3 <input type="checkbox"/></p> <p>4 <input type="checkbox"/></p> <p>5 <input type="checkbox"/></p>	
<p><b>Auditors Comments:</b></p> <ul style="list-style-type: none"> <li>General views of the basement carpark.</li> </ul>

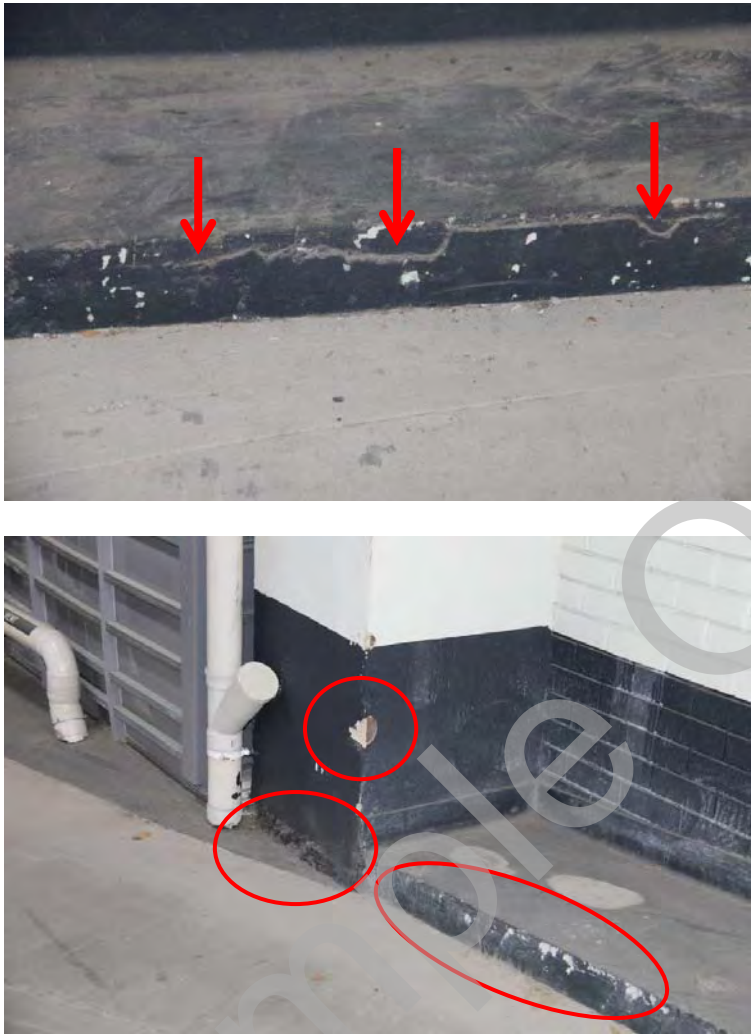
<p><b>Assessment Type:</b></p> <p>Good <input type="checkbox"/></p> <p>Fair <input checked="" type="checkbox"/></p> <p>Poor <input type="checkbox"/></p>	
		<p><b>Impact Category:</b></p> <p>1 <input checked="" type="checkbox"/></p> <p>2 <input type="checkbox"/></p> <p>3 <input type="checkbox"/></p> <p>4 <input type="checkbox"/></p> <p>5 <input type="checkbox"/></p>	
<p><b>Location:</b> Basement Carpark</p>	<p><b>Auditors Comments:</b></p> <ul style="list-style-type: none"> <li>• Kerb and wall shows signs of cracking and chipping on the right side, upon entering the carpark.</li> <li>• Walls are stained.</li> </ul>

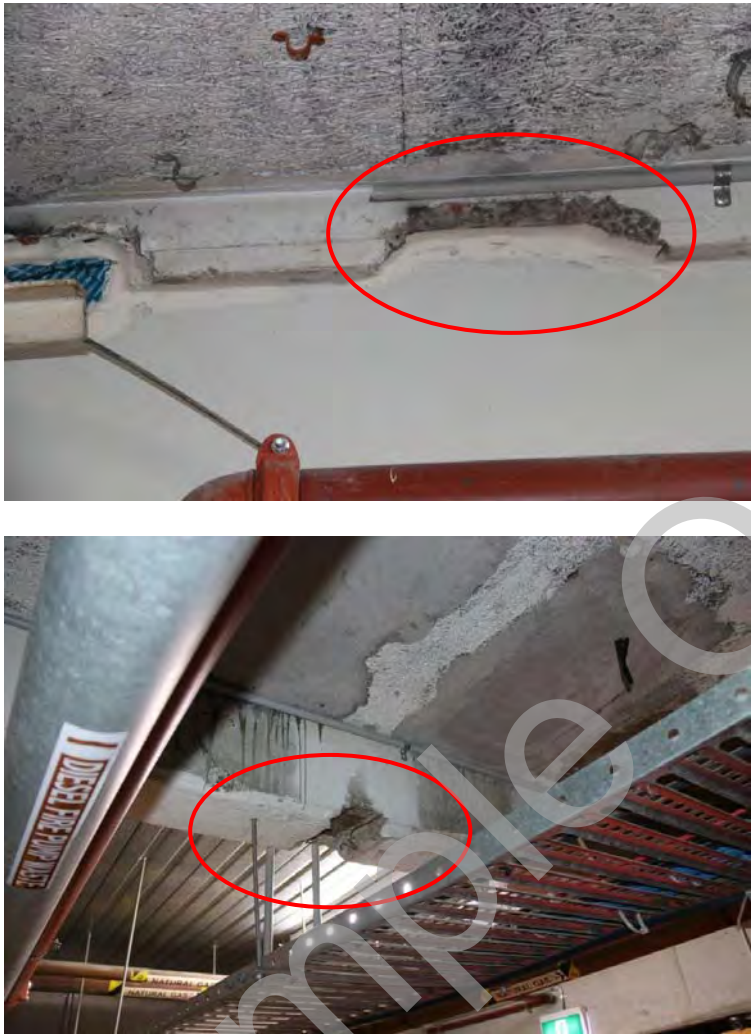
<p><b>Assessment Type:</b></p> <p>Good <input type="checkbox"/></p> <p>Fair <input checked="" type="checkbox"/></p> <p>Poor <input type="checkbox"/></p>	<p><input type="checkbox"/></p> <p><input checked="" type="checkbox"/></p> <p><input type="checkbox"/></p>
		<p><b>Impact Category:</b></p> <p>1 <input checked="" type="checkbox"/></p> <p>2 <input type="checkbox"/></p> <p>3 <input type="checkbox"/></p> <p>4 <input type="checkbox"/></p> <p>5 <input type="checkbox"/></p>	<p><input checked="" type="checkbox"/></p> <p><input type="checkbox"/></p> <p><input type="checkbox"/></p> <p><input type="checkbox"/></p> <p><input type="checkbox"/></p>
<p><b>Location:</b> Basement Carpark</p>	<p><b>Auditors Comments:</b></p> <ul style="list-style-type: none"> <li>Concrete beam and soffit had existing damages involving chippings and broken structures.</li> <li>One of the damages was exposing the reinforcement.</li> </ul>

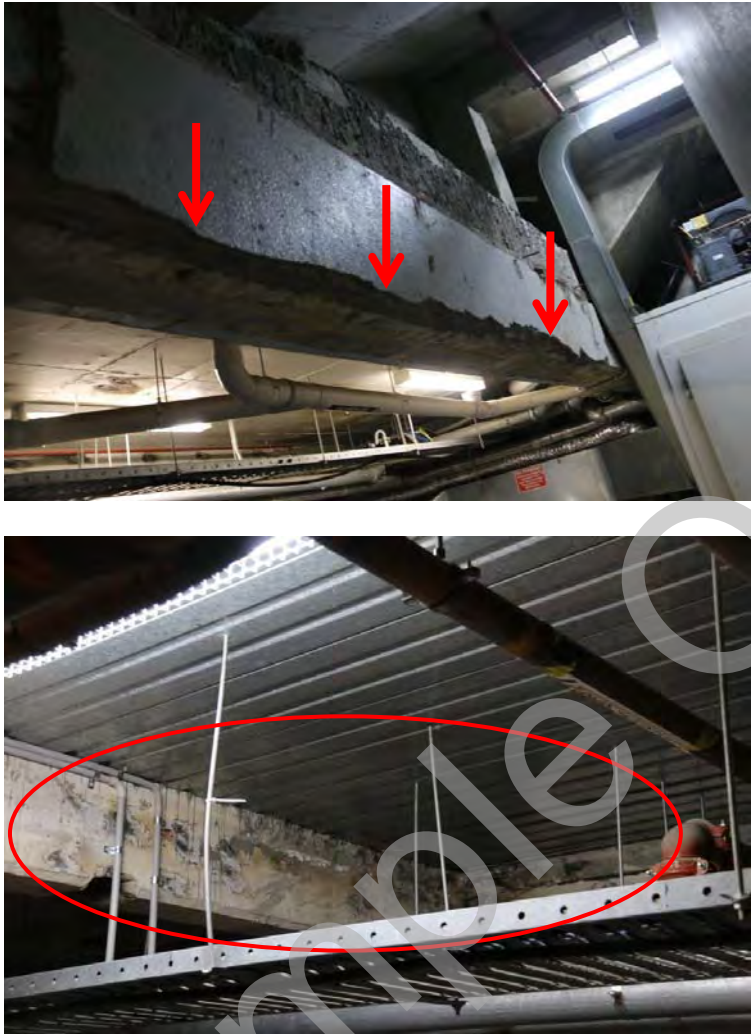
<p><b>Assessment Type:</b></p> <p>Good <input type="checkbox"/></p> <p>Fair <input type="checkbox"/></p> <p>Poor <input checked="" type="checkbox"/></p>	<input type="checkbox"/> <input type="checkbox"/> <input checked="" type="checkbox"/>
		<p><b>Impact Category:</b></p> <p>1 <input type="checkbox"/></p> <p>2 <input type="checkbox"/></p> <p>3 <input type="checkbox"/></p> <p>4 <input checked="" type="checkbox"/></p> <p>5 <input type="checkbox"/></p>	<input type="checkbox"/> <input type="checkbox"/> <input type="checkbox"/> <input checked="" type="checkbox"/> <input type="checkbox"/>
<p><b>Location:</b> Bathroom</p>	<p><b>Auditors Comments:</b></p> <ul style="list-style-type: none"> <li>• Chipping and damages of concrete structure on the wall near parking spot 11C was noted.</li> <li>• Overall, the ceiling throughout the carpark was in a poor condition.</li> </ul>

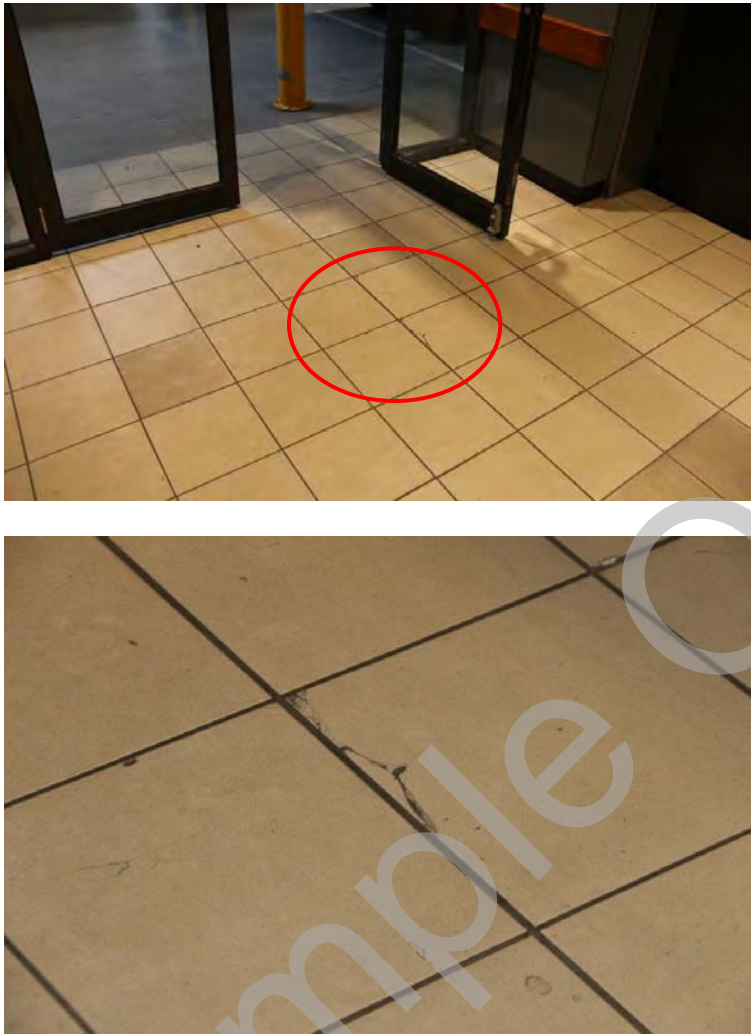
<p><b>Assessment Type:</b></p> <p>Good <input type="checkbox"/></p> <p>Fair <input checked="" type="checkbox"/></p> <p>Poor <input type="checkbox"/></p>	<p><input type="checkbox"/></p> <p><input checked="" type="checkbox"/></p> <p><input type="checkbox"/></p>
<p><b>Location:</b> Basement</p>		<p><b>Auditors Comments:</b></p> <ul style="list-style-type: none"> <li>Minor stains and hairline crack on one of the tiles was noted.</li> </ul>

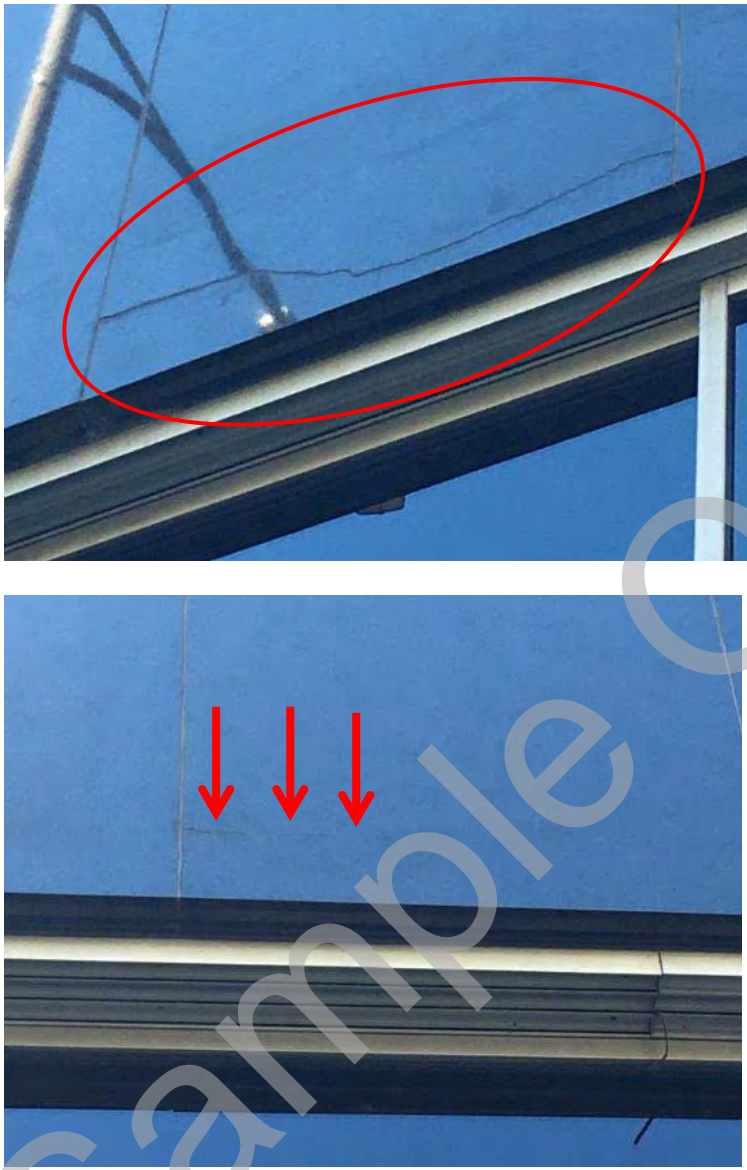
<p><b>Assessment Type:</b></p> <p>Good <input type="checkbox"/></p> <p>Fair <input checked="" type="checkbox"/></p> <p>Poor <input type="checkbox"/></p>	<p><input type="checkbox"/></p> <p><input checked="" type="checkbox"/></p> <p><input type="checkbox"/></p>
		<p><b>Impact Category:</b></p> <p>1 <input type="checkbox"/></p> <p>2 <input type="checkbox"/></p> <p>3 <input checked="" type="checkbox"/></p> <p>4 <input type="checkbox"/></p> <p>5 <input type="checkbox"/></p>	<p><input type="checkbox"/></p> <p><input type="checkbox"/></p> <p><input checked="" type="checkbox"/></p> <p><input type="checkbox"/></p> <p><input type="checkbox"/></p>
<p><b>Location:</b> Front Facade</p>	<p><b>Auditors Comments:</b></p> <ul style="list-style-type: none"> <li>Cracking has occurred at two sections of the tiled wall cladding that ranges from minor to distinct cracks.</li> <li>Condition of the front façade was overall fair.</li> </ul>

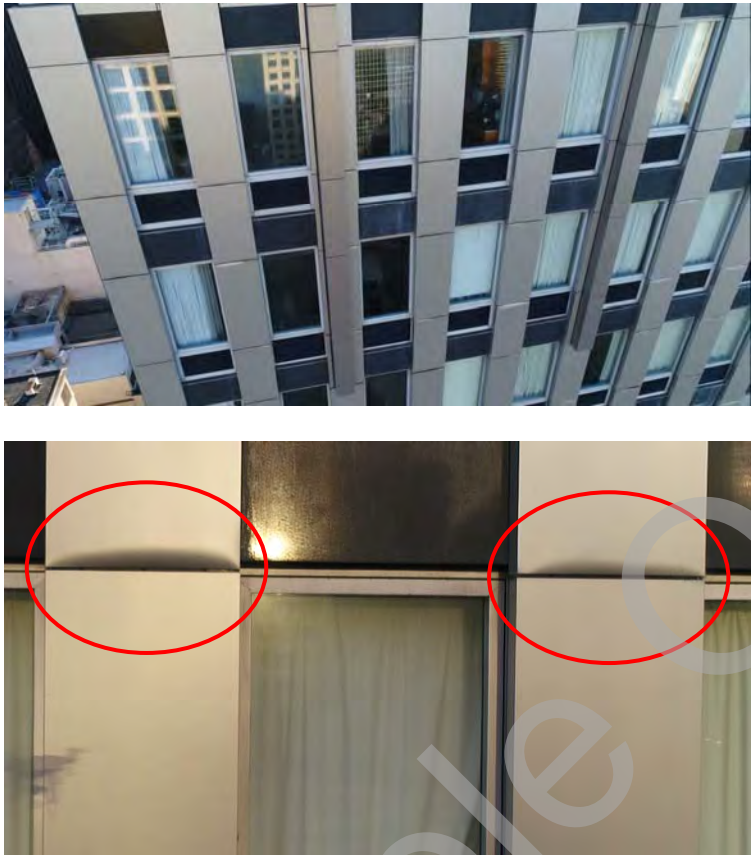
<p><b>Assessment Type:</b></p> <p>Good <input type="checkbox"/></p> <p>Fair <input checked="" type="checkbox"/></p> <p>Poor <input type="checkbox"/></p>	
		<p><b>Impact Category:</b></p> <p>1 <input checked="" type="checkbox"/></p> <p>2 <input type="checkbox"/></p> <p>3 <input type="checkbox"/></p> <p>4 <input type="checkbox"/></p> <p>5 <input type="checkbox"/></p>	
<p><b>Location:</b> Front Facade</p>	<p><b>Auditors Comments:</b></p> <ul style="list-style-type: none"> <li>Aluminium panels were noted to be bent/dented from the drone footage</li> <li>Affected levels: Levels 2-8, Levels 19-22</li> </ul>

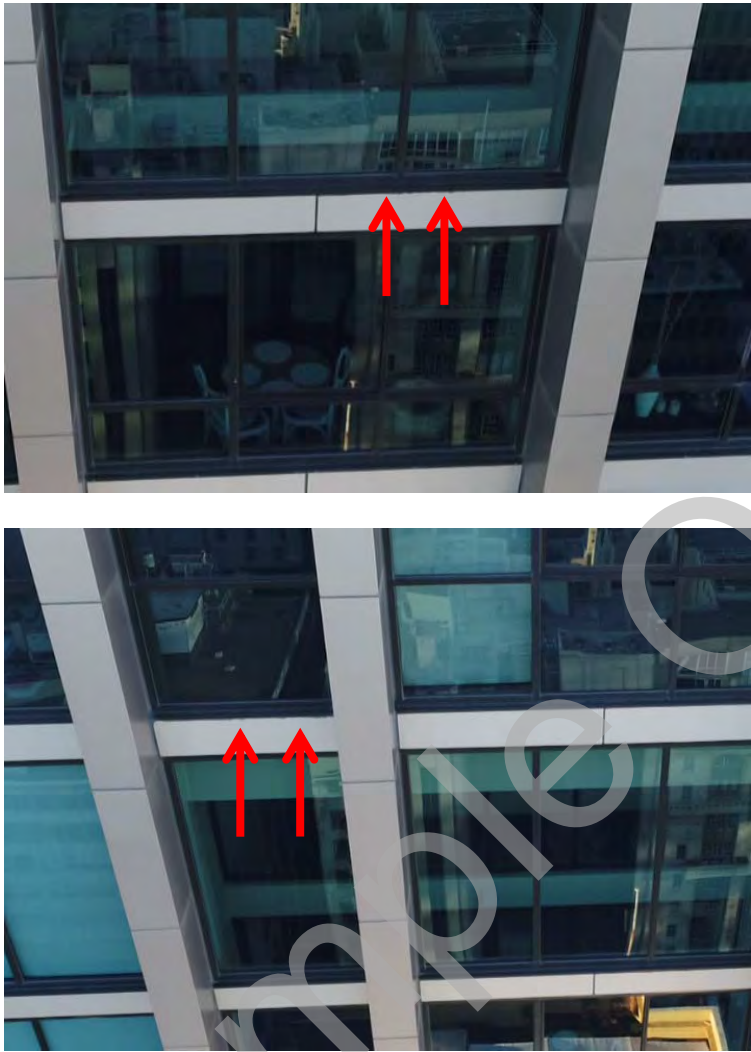
<p><b>Assessment Type:</b></p> <p>Good <input type="checkbox"/></p> <p>Fair <input checked="" type="checkbox"/></p> <p>Poor <input type="checkbox"/></p>	
		<p><b>Impact Category:</b></p> <p>1 <input checked="" type="checkbox"/></p> <p>2 <input type="checkbox"/></p> <p>3 <input type="checkbox"/></p> <p>4 <input type="checkbox"/></p> <p>5 <input type="checkbox"/></p>	
<p><b>Location:</b> Northwest Façade</p>	<p><b>Auditors Comments:</b></p> <ul style="list-style-type: none"> <li>Dirt and minor staining was noted at the top of the aluminium panels in levels 24 and 25 respectively.</li> </ul>

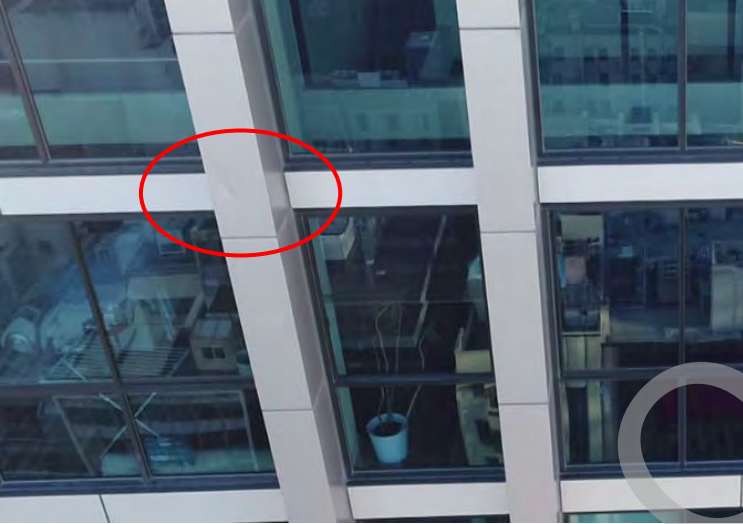
<p><b>Assessment Type:</b></p> <p>Good <input type="checkbox"/></p> <p>Fair <input checked="" type="checkbox"/></p> <p>Poor <input type="checkbox"/></p> <hr/> <p><b>Impact Category:</b></p> <p>1 <input checked="" type="checkbox"/></p> <p>2 <input type="checkbox"/></p> <p>3 <input type="checkbox"/></p> <p>4 <input type="checkbox"/></p> <p>5 <input type="checkbox"/></p>
<p><b>Location:</b> Northwest Facade – Level 27</p>	<p><b>Auditors Comments:</b></p> <ul style="list-style-type: none"> <li>Dent was found on the bottom of the aluminium cladding panel located in level 27.</li> </ul>

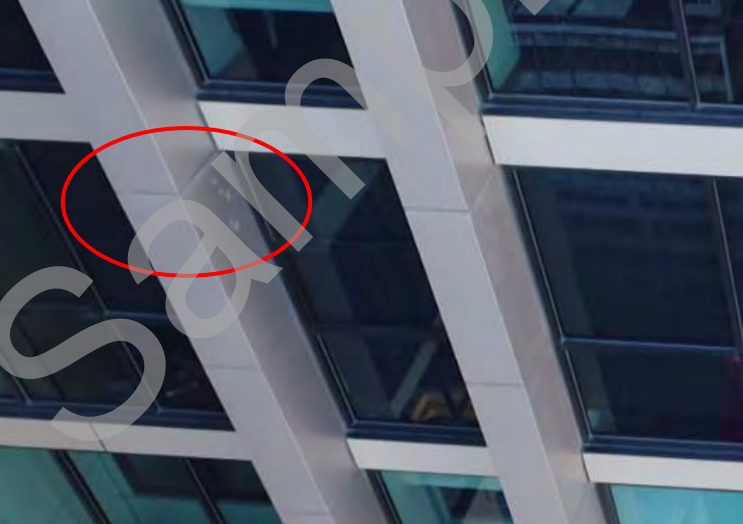
<p><b>Assessment Type:</b></p> <p>Good <input type="checkbox"/></p> <p>Fair <input checked="" type="checkbox"/></p> <p>Poor <input type="checkbox"/></p> <hr/> <p><b>Impact Category:</b></p> <p>1 <input checked="" type="checkbox"/></p> <p>2 <input type="checkbox"/></p> <p>3 <input type="checkbox"/></p> <p>4 <input type="checkbox"/></p> <p>5 <input type="checkbox"/></p>
<p><b>Location:</b> Northwest Façade – Level 25</p>	<p><b>Auditors Comments:</b></p> <ul style="list-style-type: none"> <li>Marks were evident on the side of the aluminium cladding from the drone footage.</li> <li>Slight dent was noted on the top of aluminium panel.</li> </ul>

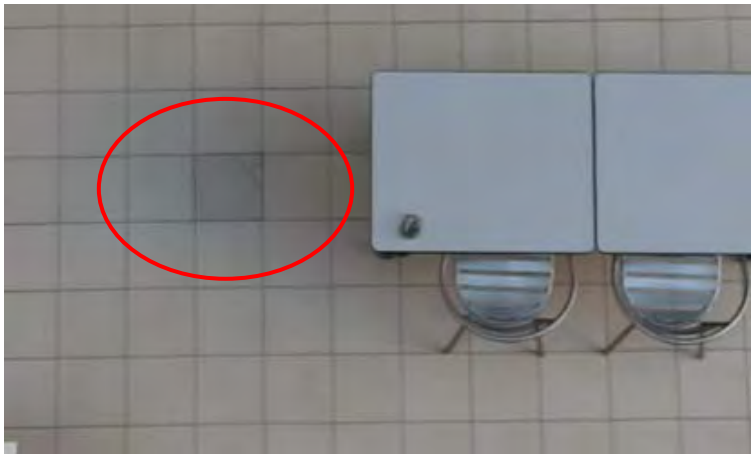
<p><b>Assessment Type:</b></p> <p>Good <input type="checkbox"/></p> <p>Fair <input checked="" type="checkbox"/></p> <p>Poor <input type="checkbox"/></p>	<p><input type="checkbox"/></p> <p><input checked="" type="checkbox"/></p> <p><input type="checkbox"/></p>
		<p><b>Impact Category:</b></p> <p>1 <input type="checkbox"/></p> <p>2 <input checked="" type="checkbox"/></p> <p>3 <input type="checkbox"/></p> <p>4 <input type="checkbox"/></p> <p>5 <input type="checkbox"/></p>	<p><input type="checkbox"/></p> <p><input checked="" type="checkbox"/></p> <p><input type="checkbox"/></p> <p><input type="checkbox"/></p> <p><input type="checkbox"/></p>
<p><b>Location:</b> Level 1 Balcony</p>	<p><b>Auditors Comments:</b></p> <ul style="list-style-type: none"> <li>• One of the tiles had a deeper contrast compared to the rest of the tiles.</li> <li>• Cracking of the tile was also noted.</li> </ul>

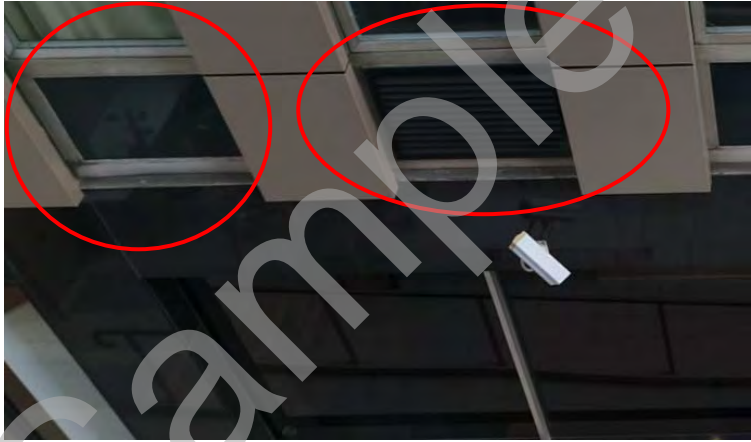
<p><b>Assessment Type:</b></p> <p>Good <input type="checkbox"/></p> <p>Fair <input checked="" type="checkbox"/></p> <p>Poor <input type="checkbox"/></p>	<p><input checked="" type="checkbox"/></p> <p><input type="checkbox"/></p> <p><input checked="" type="checkbox"/></p>
		<p><b>Impact Category:</b></p> <p>1 <input checked="" type="checkbox"/></p> <p>2 <input type="checkbox"/></p> <p>3 <input type="checkbox"/></p> <p>4 <input type="checkbox"/></p> <p>5 <input type="checkbox"/></p>	<p><input checked="" type="checkbox"/></p> <p><input type="checkbox"/></p> <p><input type="checkbox"/></p> <p><input type="checkbox"/></p> <p><input type="checkbox"/></p>
<p><b>Location:</b> Northwest Façade – Level 2</p>	<p><b>Auditors Comments:</b></p> <ul style="list-style-type: none"> <li>• The condition of the windows was exceptionally dirty compared to the rest of the windows on this façade.</li> </ul>

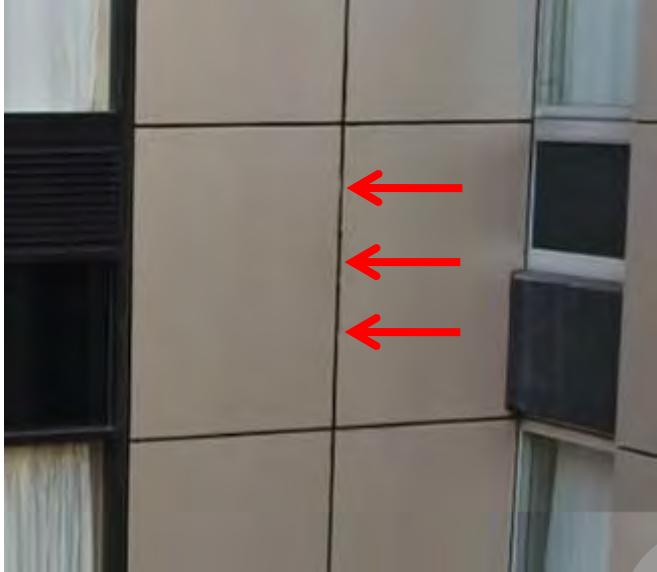
<p><b>Assessment Type:</b></p> <p>Good <input type="checkbox"/></p> <p>Fair <input checked="" type="checkbox"/></p> <p>Poor <input type="checkbox"/></p>	<p><input type="checkbox"/></p> <p><input checked="" type="checkbox"/></p> <p><input type="checkbox"/></p>
<p><b>Location:</b> West Façade – Level 7</p>		<p><b>Auditors Comments:</b></p> <ul style="list-style-type: none"> <li>Dents and damages on the aluminium panel in level 7 were evident.</li> </ul>

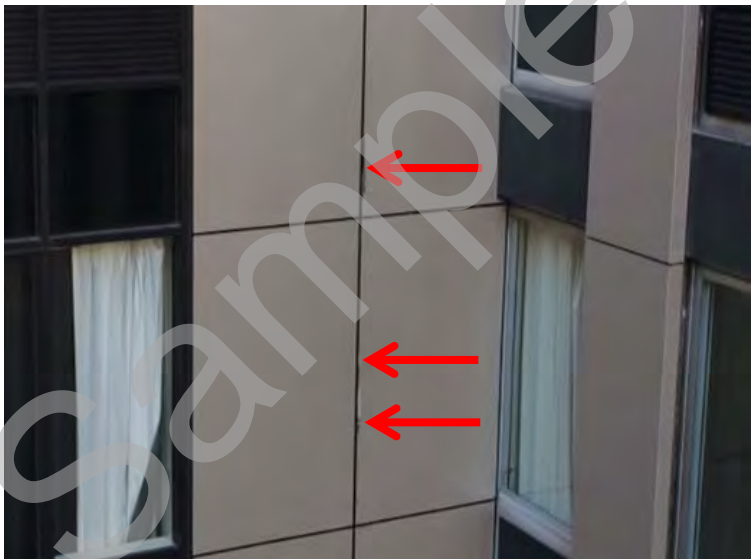
<p><b>Assessment Type:</b></p> <p>Good <input type="checkbox"/></p> <p>Fair <input checked="" type="checkbox"/></p> <p>Poor <input type="checkbox"/></p>	<p><input type="checkbox"/></p> <p><input checked="" type="checkbox"/></p> <p><input type="checkbox"/></p>
<p><b>Location:</b> West Façade – Levels 5 &amp; 6</p>		<p><b>Auditors Comments:</b></p> <ul style="list-style-type: none"> <li>Aluminium panels that are situated at the corner of both level 5 and 6 had dents and was slightly damaged.</li> </ul>	
<p><b>Impact Category:</b></p> <p>1 <input checked="" type="checkbox"/></p> <p>2 <input type="checkbox"/></p> <p>3 <input type="checkbox"/></p> <p>4 <input type="checkbox"/></p> <p>5 <input type="checkbox"/></p>		<p><b>Impact Category:</b></p> <p>1 <input checked="" type="checkbox"/></p> <p>2 <input type="checkbox"/></p> <p>3 <input type="checkbox"/></p> <p>4 <input type="checkbox"/></p> <p>5 <input type="checkbox"/></p>

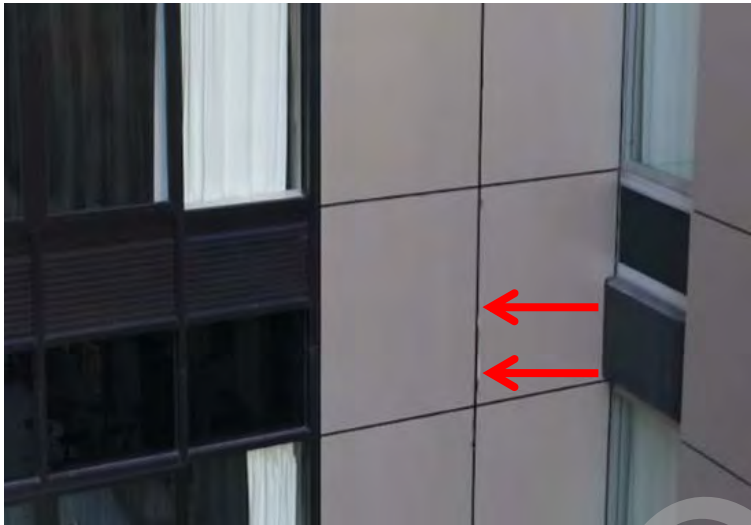
<p><b>Assessment Type:</b></p> <p>Good <input type="checkbox"/></p> <p>Fair <input checked="" type="checkbox"/></p> <p>Poor <input type="checkbox"/></p>	<input type="checkbox"/> <input checked="" type="checkbox"/> <input type="checkbox"/>
<p><b>Location:</b> West Façade – Level 3</p>		<p><b>Impact Category:</b></p> <p>1 <input checked="" type="checkbox"/></p> <p>2 <input type="checkbox"/></p> <p>3 <input type="checkbox"/></p> <p>4 <input type="checkbox"/></p> <p>5 <input type="checkbox"/></p> <p><b>Auditors Comments:</b></p> <ul style="list-style-type: none"> <li>Dents and damages on the aluminium panel in level 3 were evident.</li> </ul>
