Dilapidation Survey Report

28 Sample Street Suburb VIC 3008

Plan of Subdivision: PS 123456

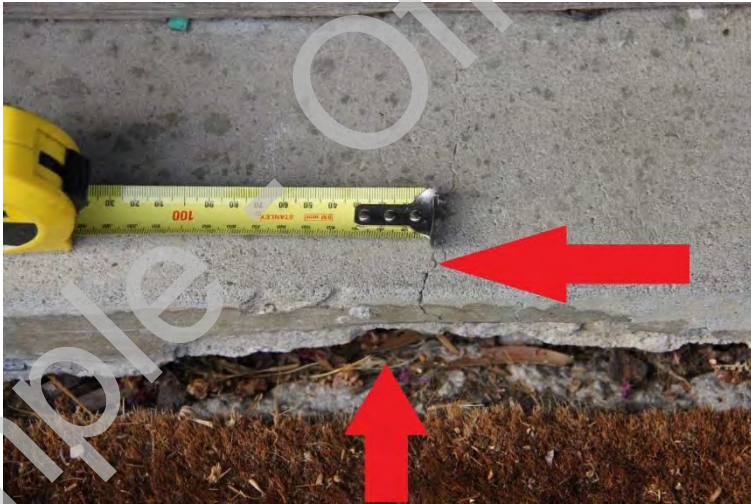
2.

Assessment Type: Good <input type="checkbox"/> Fair <input checked="" type="checkbox"/> Poor <input type="checkbox"/>	Impact Category: 1 <input checked="" type="checkbox"/> 2 <input type="checkbox"/> 3 <input type="checkbox"/> 4 <input type="checkbox"/> 5 <input type="checkbox"/>
Location: Unit 1 - front door, slab	Auditors Comments: <ul style="list-style-type: none"> Fine crack (Approx. 1mm) in slab and large gap (approx. 20-30mm) between slab and concrete walkway.

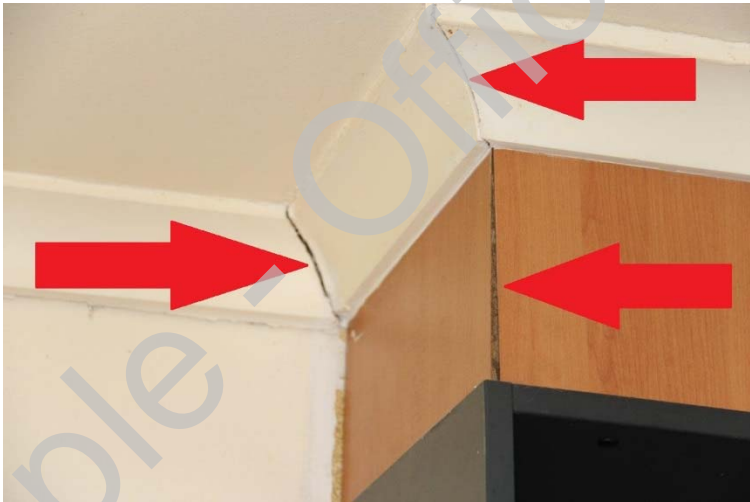
4.

Assessment Type: Good Fair Poor	<input type="checkbox"/> <input checked="" type="checkbox"/> <input type="checkbox"/>
		Impact Category: 1 2 3 4 5	<input type="checkbox"/> <input checked="" type="checkbox"/> <input type="checkbox"/> <input type="checkbox"/> <input type="checkbox"/>
Location: Unit 1 – Eastern wall of kitchen	Auditors Comments: <ul style="list-style-type: none"> Gaps in skirting are present (ranging from approx. 1-5mm)

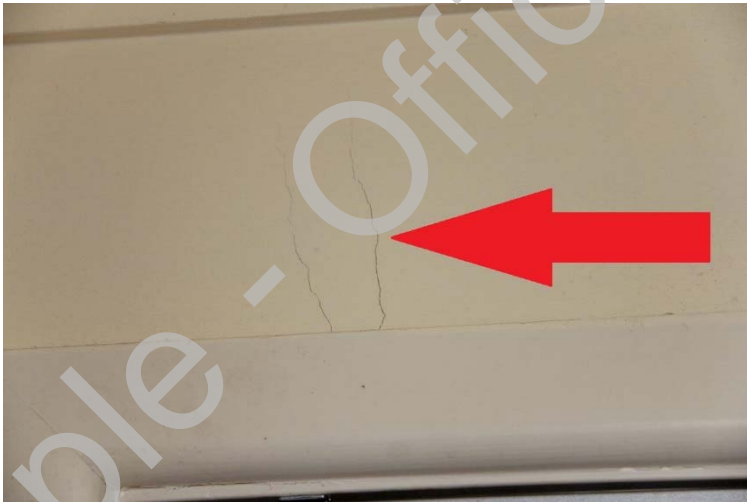
6.

Assessment Type: Good Fair Poor	<input type="checkbox"/> <input checked="" type="checkbox"/> <input type="checkbox"/>
		Impact Category: 1 2 3 4 5	<input checked="" type="checkbox"/> <input type="checkbox"/> <input type="checkbox"/> <input type="checkbox"/> <input type="checkbox"/>
Location: Unit 1 – Northern internal wall	Auditors Comments: <ul style="list-style-type: none"> Fine cracks above window frame near front door. Approx. 1mm.

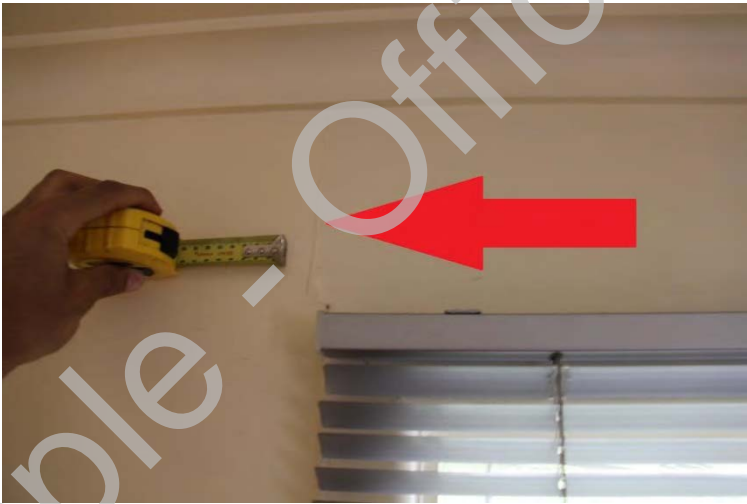
8.

Assessment Type: Good Fair Poor	<input type="checkbox"/> <input checked="" type="checkbox"/> <input type="checkbox"/>
		Impact Category: 1 2 3 4 5	<input checked="" type="checkbox"/> <input type="checkbox"/> <input type="checkbox"/> <input type="checkbox"/> <input type="checkbox"/>
Location: Unit 1 – Western wall of lounge	Auditors Comments: <ul style="list-style-type: none"> Paint blistering occurring which is likely to be cover a crack of the same size beneath.

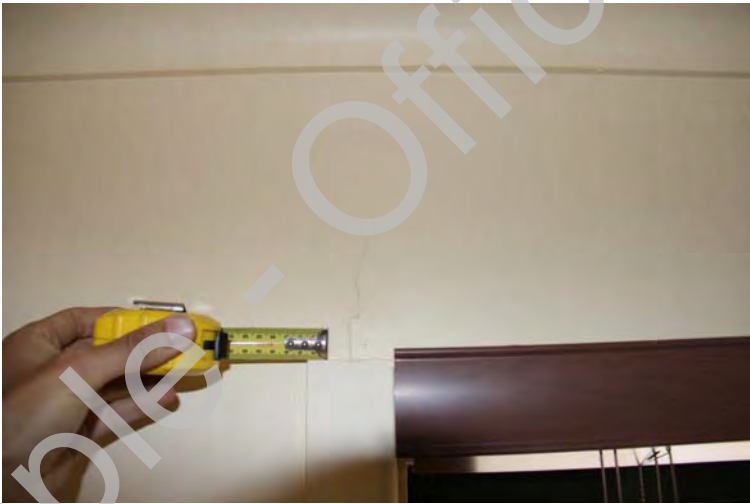
10.

Assessment Type: Good Fair Poor	<input type="checkbox"/> <input checked="" type="checkbox"/> <input type="checkbox"/>
		Impact Category: 1 2 3 4 5	<input checked="" type="checkbox"/> <input type="checkbox"/> <input type="checkbox"/> <input type="checkbox"/> <input type="checkbox"/>
Location: Unit 1 – bedroom	Auditors Comments: <ul style="list-style-type: none"> Fine cracks above door/window frame in bedroom. Approx. 1mm.

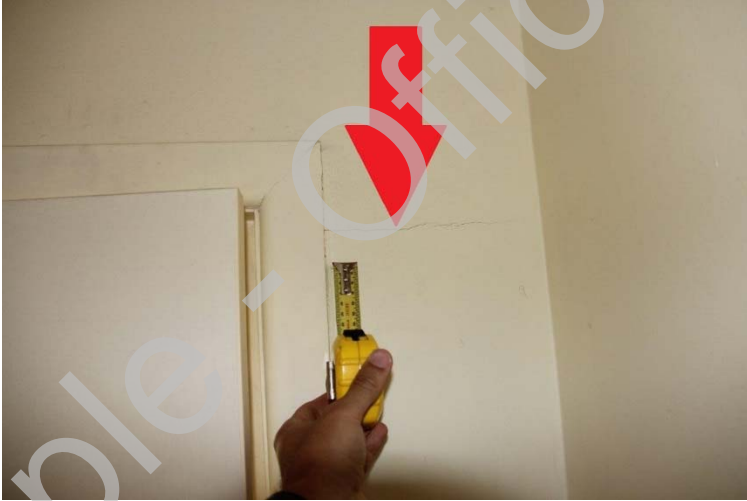
12.

Assessment Type: Good Fair Poor	<input type="checkbox"/> <input checked="" type="checkbox"/> <input type="checkbox"/>
		Impact Category: 1 2 3 4 5	<input checked="" type="checkbox"/> <input type="checkbox"/> <input type="checkbox"/> <input type="checkbox"/> <input type="checkbox"/>
Location: Unit 1 – bedroom	Auditors Comments: <ul style="list-style-type: none"> Fine crack to right of bathroom door frame. Approx. 1mm.

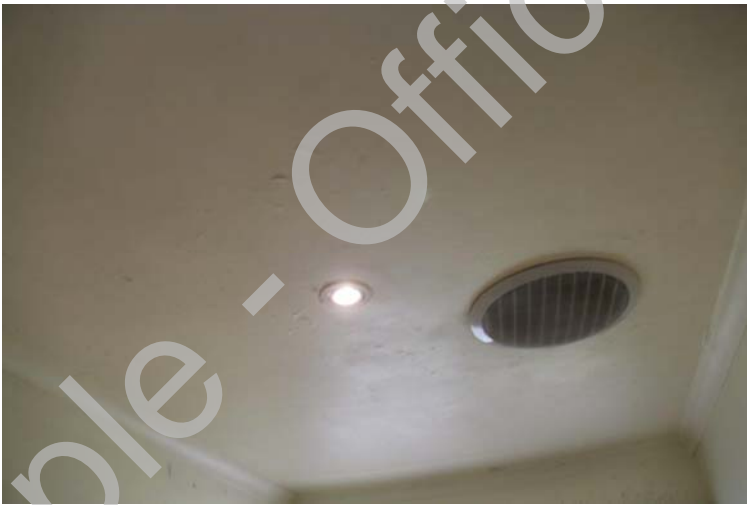
14.

Assessment Type: Good Fair Poor	<input type="checkbox"/> <input checked="" type="checkbox"/> <input type="checkbox"/>
		Impact Category: 1 2 3 4 5	<input type="checkbox"/> <input type="checkbox"/> <input type="checkbox"/> <input type="checkbox"/> <input type="checkbox"/>
Location: Unit 1 – bedroom	Auditors Comments: <ul style="list-style-type: none"> General condition of paint in bathroom is blistered in multiple areas (likely due to excess moisture exposure).

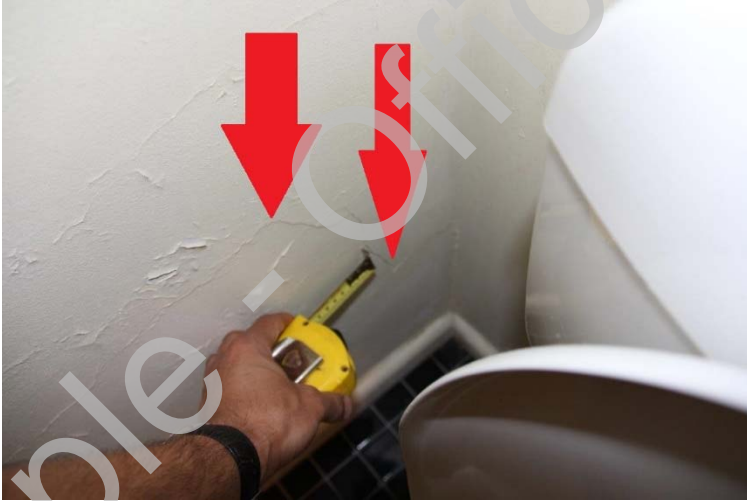
16.

Assessment Type: Good Fair Poor	<input type="checkbox"/> <input checked="" type="checkbox"/> <input type="checkbox"/>
		Impact Category: 1 2 3 4 5	<input checked="" type="checkbox"/> <input type="checkbox"/> <input type="checkbox"/> <input type="checkbox"/> <input type="checkbox"/>
Location: Unit 1 – bedroom	Auditors Comments: <ul style="list-style-type: none"> Multiple fine cracks throughout wall near toilet (eastern wall). Approx. 1mm.

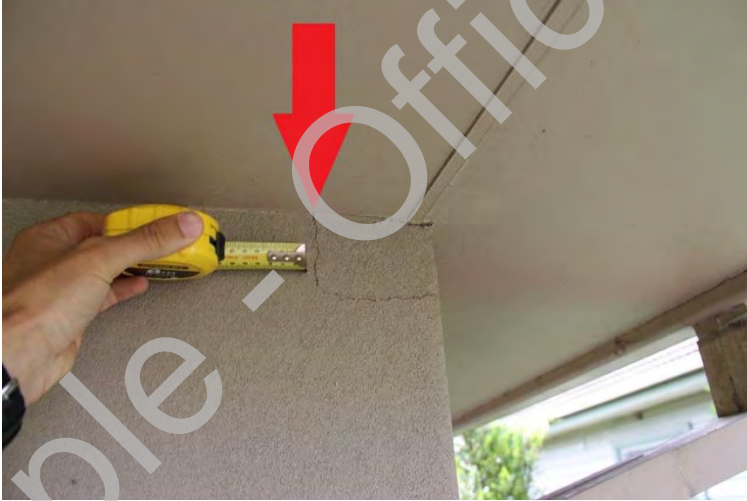
18.

Assessment Type: Good Fair Poor	<input type="checkbox"/> <input checked="" type="checkbox"/> <input type="checkbox"/>
		Impact Category: 1 2 3 4 5	<input checked="" type="checkbox"/> <input type="checkbox"/> <input type="checkbox"/> <input type="checkbox"/> <input type="checkbox"/>
Location: Unit 1 – Exterior	Auditors Comments: <ul style="list-style-type: none"> Crack at south-western corner of building near eaves. Approx. 1mm.

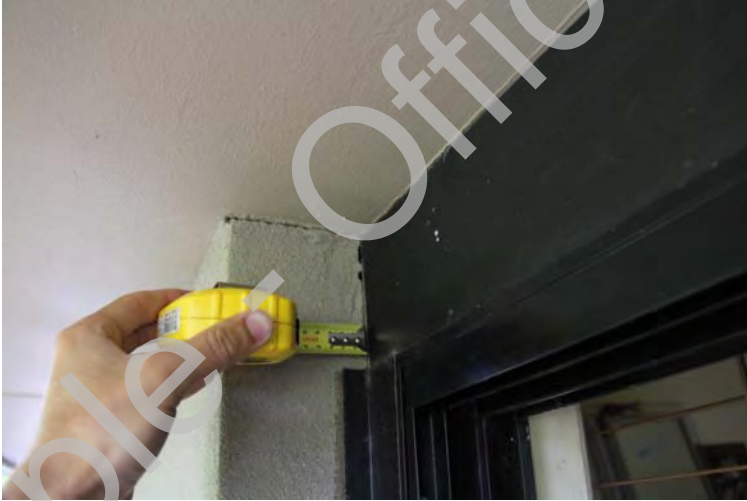
20.

Assessment Type: Good Fair Poor	<input type="checkbox"/> <input checked="" type="checkbox"/> <input type="checkbox"/>
		Impact Category: 1 2 3 4 5	<input type="checkbox"/> <input checked="" type="checkbox"/> <input type="checkbox"/> <input type="checkbox"/> <input type="checkbox"/>
Location: Unit 1 – Exterior	Auditors Comments: <ul style="list-style-type: none"> Crack between western façade and eaves (near door frame). Approx. 1-2mm.

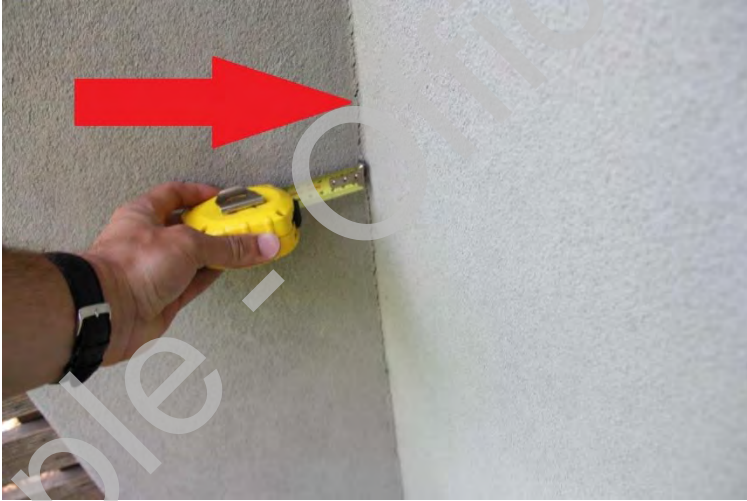
22.

Assessment Type: Good Fair Poor	<input type="checkbox"/> <input checked="" type="checkbox"/> <input type="checkbox"/>
		Impact Category: 1 2 3 4 5	<input checked="" type="checkbox"/> <input type="checkbox"/> <input type="checkbox"/> <input type="checkbox"/> <input type="checkbox"/>
Location: Unit 1 – Exterior	Auditors Comments: <ul style="list-style-type: none"> Fine crack running between concrete fence pillar and western building façade (northern fence). Approx. 1mm.

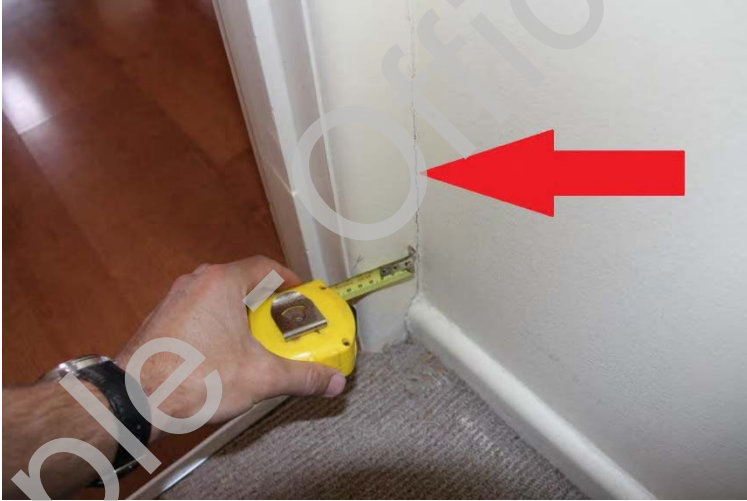
24.

Assessment Type: Good Fair Poor	<input type="checkbox"/> <input checked="" type="checkbox"/> <input type="checkbox"/>
		Impact Category: 1 2 3 4 5	<input type="checkbox"/> <input checked="" type="checkbox"/> <input type="checkbox"/> <input type="checkbox"/> <input type="checkbox"/>
Location: Unit 1 – Bedroom	Auditors Comments: <ul style="list-style-type: none"> Fine crack running up corner of internal wall. Approx. 1-2mm.

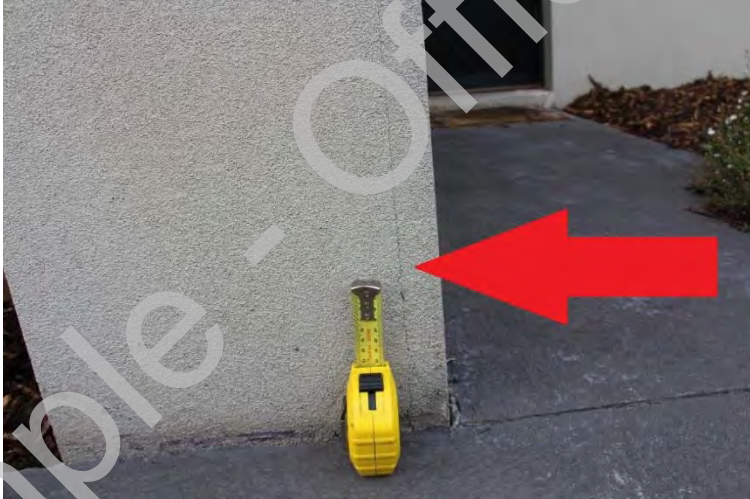
26.

Assessment Type: Good <input type="checkbox"/> Fair <input checked="" type="checkbox"/> Poor <input type="checkbox"/>	<input checked="" type="checkbox"/> <input type="checkbox"/> <input type="checkbox"/> <input type="checkbox"/> <input type="checkbox"/>
Location: Unit 2 – Exterior	Auditors Comments: <ul style="list-style-type: none"> Fine crack running up corner of fence pillar (same pillar as noted in Item 25). Approx. 1mm.

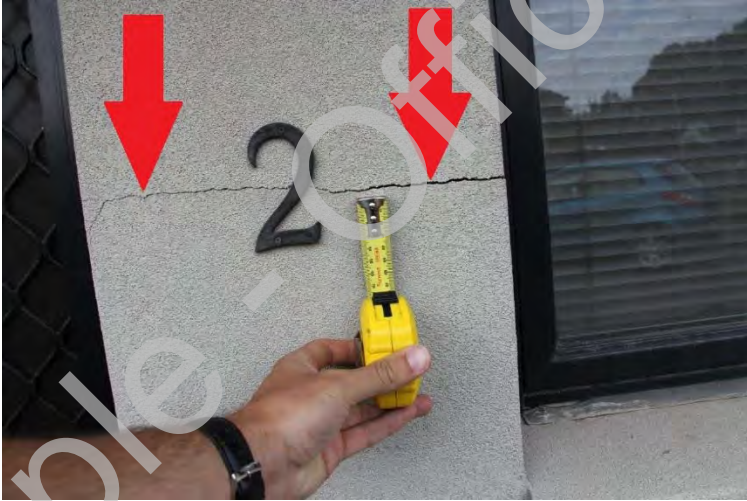
28.

Assessment Type: Good Fair Poor	<input type="checkbox"/> <input checked="" type="checkbox"/> <input type="checkbox"/>
		Impact Category: 1 2 3 4 5	<input type="checkbox"/> <input checked="" type="checkbox"/> <input type="checkbox"/> <input type="checkbox"/> <input type="checkbox"/>
Location: Unit 2 – Exterior	Auditors Comments: <ul style="list-style-type: none"> Crack running across external facade of Unit 2 near right side of door entrance. Approx. 3mm.

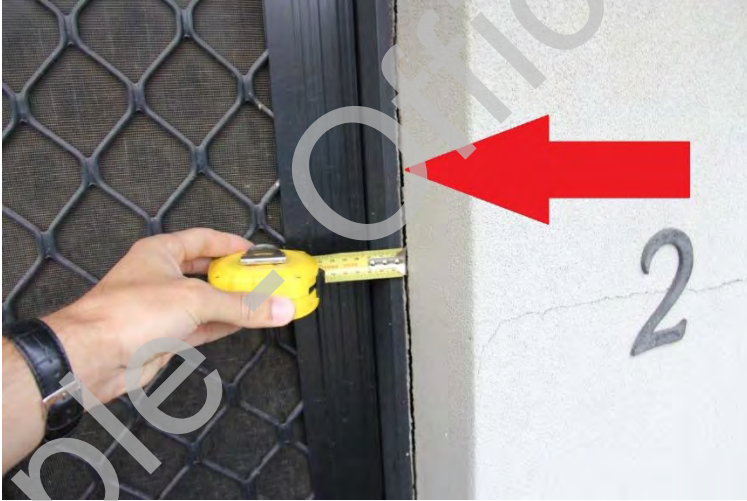
30.

Assessment Type: Good Fair Poor	<input type="checkbox"/> <input checked="" type="checkbox"/> <input type="checkbox"/>
		Impact Category: 1 2 3 4 5	<input type="checkbox"/> <input checked="" type="checkbox"/> <input type="checkbox"/> <input type="checkbox"/> <input type="checkbox"/>
Location: Unit 2 – Exterior	Auditors Comments: <ul style="list-style-type: none"> Crack running vertically between front door frame and rendered façade. Approx. 2-3mm.

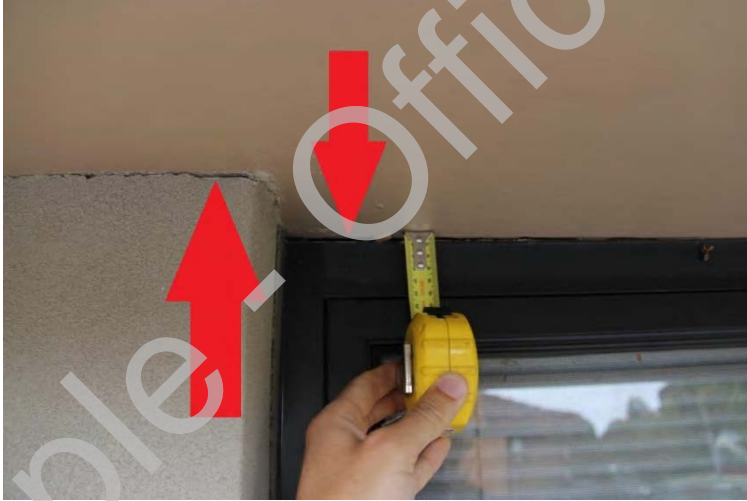
32.

Assessment Type: Good Fair Poor	<input type="checkbox"/> <input checked="" type="checkbox"/> <input type="checkbox"/>
		Impact Category: 1 2 3 4 5	<input type="checkbox"/> <input checked="" type="checkbox"/> <input type="checkbox"/> <input type="checkbox"/> <input type="checkbox"/>
Location: Unit 2 – Exterior	Auditors Comments: <ul style="list-style-type: none"> Crack running between eaves & façade and eaves & window frame (northern exterior). Approx. 1-3mm.

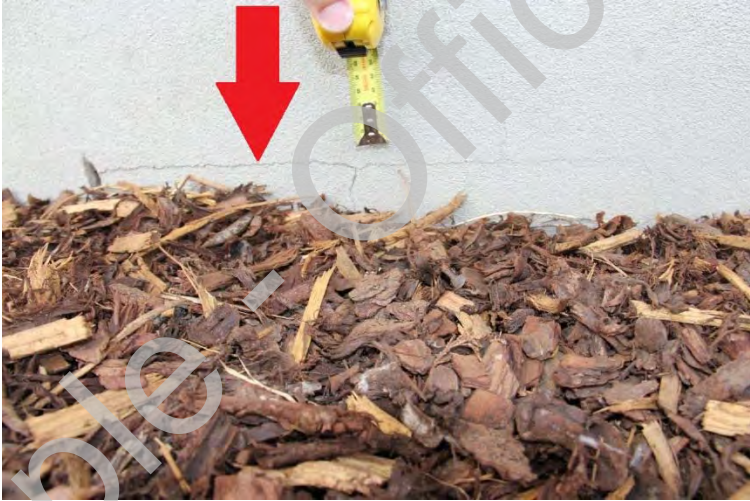
34.

Assessment Type: Good Fair Poor	<input type="checkbox"/> <input checked="" type="checkbox"/> <input type="checkbox"/>
		Impact Category: 1 2 3 4 5	<input checked="" type="checkbox"/> <input type="checkbox"/> <input type="checkbox"/> <input type="checkbox"/> <input type="checkbox"/>
Location: Unit 2 – Exterior	Auditors Comments: <ul style="list-style-type: none"> Crack running along northern façade between Units 1 & 2. Approx. 1mm.

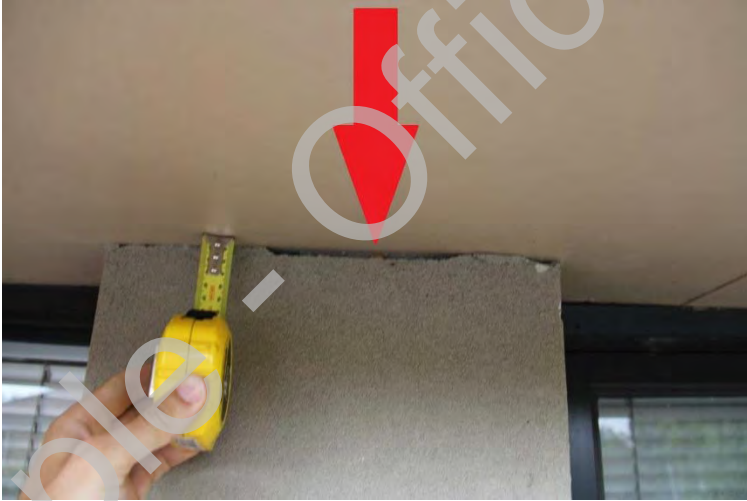
36.

Assessment Type: Good Fair Poor	<input type="checkbox"/> <input checked="" type="checkbox"/> <input type="checkbox"/>
		Impact Category: 1 2 3 4 5	<input type="checkbox"/> <input checked="" type="checkbox"/> <input type="checkbox"/> <input type="checkbox"/> <input type="checkbox"/>
Location: Unit 2 – Exterior	Auditors Comments: <ul style="list-style-type: none"> Façade rendering has broken away between eaves and northern façade. Approx. 5mm.

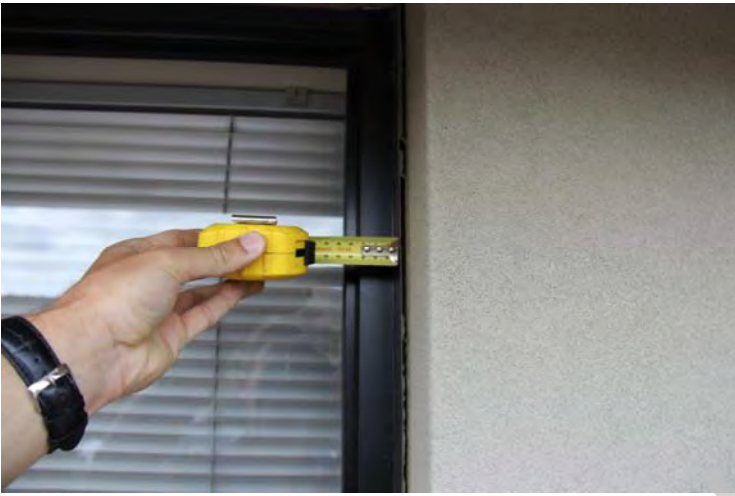
Item	Photographic Evidence	Assessments	
37.

Assessment Type: Good Fair Poor	<input type="checkbox"/> <input checked="" type="checkbox"/> <input type="checkbox"/>
		Impact Category: 1 2 3 4 5	<input type="checkbox"/> <input checked="" type="checkbox"/> <input type="checkbox"/> <input type="checkbox"/> <input type="checkbox"/>
Location: Unit 2 – Exterior	Auditors Comments: <ul style="list-style-type: none"> Gap between window frame and northern façade. Approx. 3-5mm.

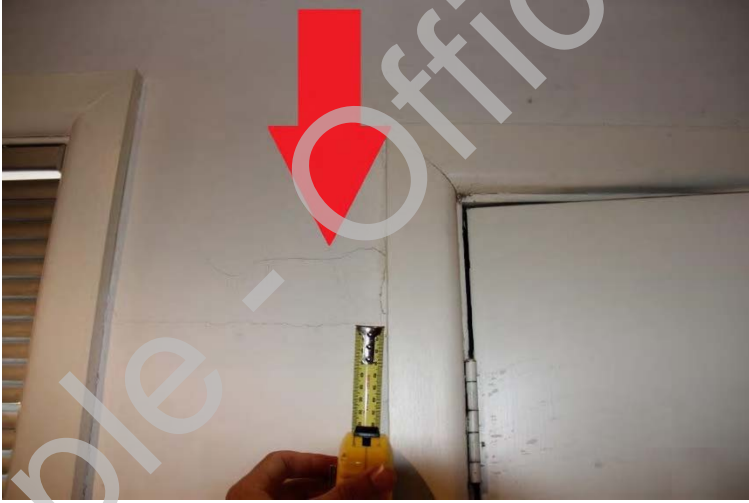
Assessment Type: Good Fair Poor	<input type="checkbox"/> <input checked="" type="checkbox"/> <input type="checkbox"/>
		Impact Category: 1 2 3 4 5	<input checked="" type="checkbox"/> <input type="checkbox"/> <input type="checkbox"/> <input type="checkbox"/> <input type="checkbox"/>
Location: Unit 2 – Interior, Lounge	Auditors Comments: <ul style="list-style-type: none"> Fine cracking present to left of entrance door.

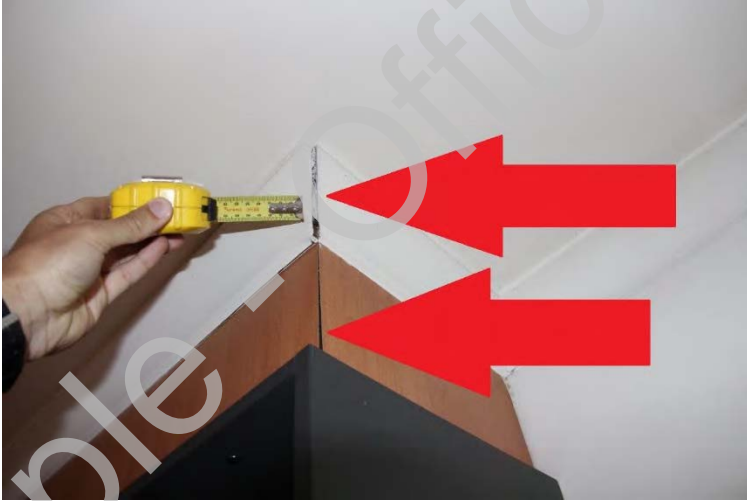
Assessment Type: Good Fair Poor	<input type="checkbox"/> <input checked="" type="checkbox"/> <input type="checkbox"/>
		Impact Category: 1 2 3 4 5	<input type="checkbox"/> <input checked="" type="checkbox"/> <input type="checkbox"/> <input type="checkbox"/> <input type="checkbox"/>
Location: Unit 2 – Interior, kitchen	Auditors Comments: <ul style="list-style-type: none"> Gap between skirting board sections. Approx. 3-5mm.

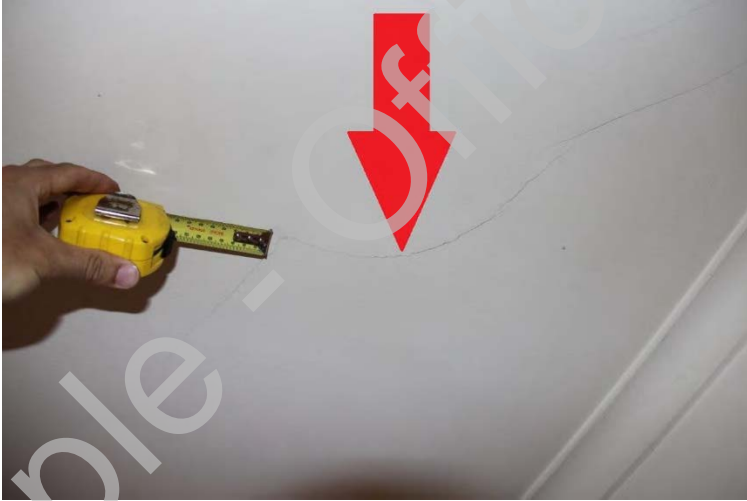
Assessment Type: Good Fair Poor	<input type="checkbox"/> <input checked="" type="checkbox"/> <input type="checkbox"/>
		Impact Category: 1 2 3 4 5	<input checked="" type="checkbox"/> <input type="checkbox"/> <input type="checkbox"/> <input type="checkbox"/> <input type="checkbox"/>
Location: Unit 2 – Interior	Auditors Comments: <ul style="list-style-type: none"> Cracking in plaster board ceiling. Approx. 1mm.

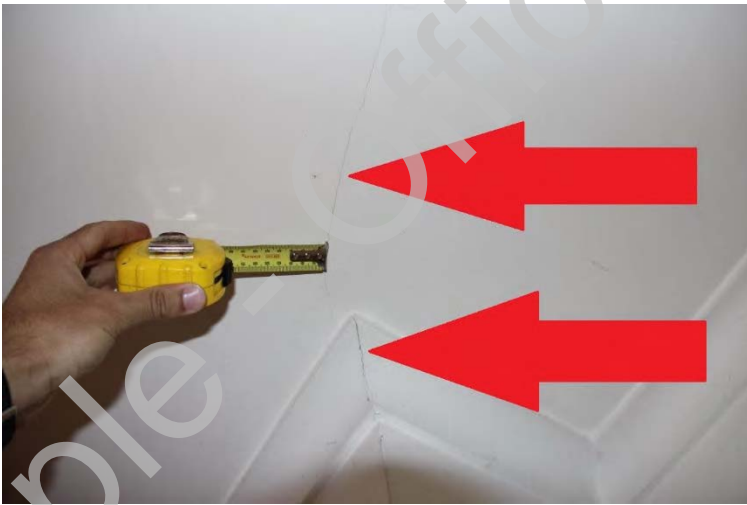
Assessment Type: Good Fair Poor	<input type="checkbox"/> <input checked="" type="checkbox"/> <input type="checkbox"/>
		Impact Category: 1 2 3 4 5	<input checked="" type="checkbox"/> <input type="checkbox"/> <input type="checkbox"/> <input type="checkbox"/> <input type="checkbox"/>
Location: Unit 2 – Interior	Auditors Comments: <ul style="list-style-type: none"> Cracking in plaster board ceiling and between skirting section join. Approx. 1mm.

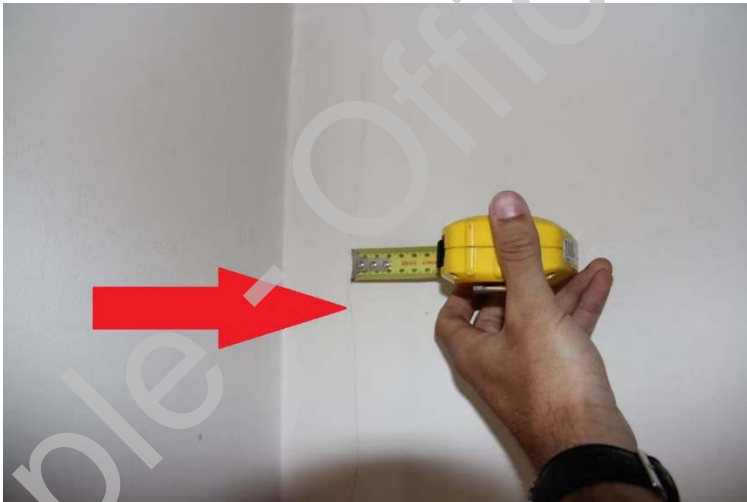
Assessment Type: Good Fair Poor	<input type="checkbox"/> <input checked="" type="checkbox"/> <input type="checkbox"/>
		Impact Category: 1 2 3 4 5	<input checked="" type="checkbox"/> <input type="checkbox"/> <input type="checkbox"/> <input type="checkbox"/> <input type="checkbox"/>
Location: Unit 2 – Interior, lounge & kitchen	Auditors Comments: <ul style="list-style-type: none"> Cracking in plaster board. Approx. 1mm.

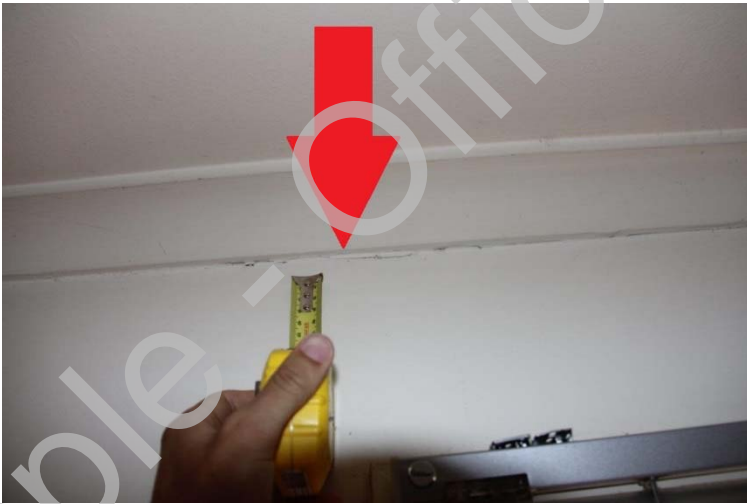
Assessment Type: Good Fair Poor	<input type="checkbox"/> <input checked="" type="checkbox"/> <input type="checkbox"/>
		Impact Category: 1 2 3 4 5	<input checked="" type="checkbox"/> <input type="checkbox"/> <input type="checkbox"/> <input type="checkbox"/> <input type="checkbox"/>
Location: Unit 2 – Interior, lounge & kitchen	Auditors Comments: <ul style="list-style-type: none"> Crack between skirting and plaster wall. Approx. 1mm.

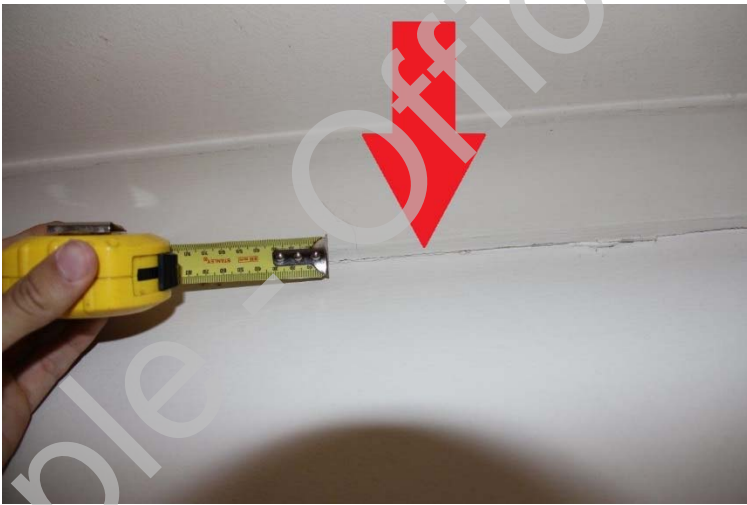
Assessment Type: Good Fair Poor	<input type="checkbox"/> <input checked="" type="checkbox"/> <input type="checkbox"/>
		Impact Category: 1 2 3 4 5	<input type="checkbox"/> <input checked="" type="checkbox"/> <input type="checkbox"/> <input type="checkbox"/> <input type="checkbox"/>
Location: Unit 2 – Bedroom	Auditors Comments: <ul style="list-style-type: none"> Gap between skirting and wall and fine crack in skirting board. Both approx. 1mm.

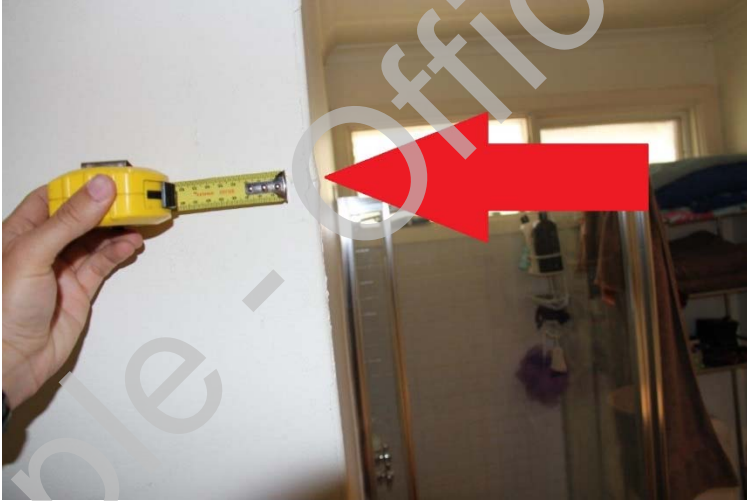
Assessment Type: Good Fair Poor	<input type="checkbox"/> <input checked="" type="checkbox"/> <input type="checkbox"/>
		Impact Category: 1 2 3 4 5	<input type="checkbox"/> <input checked="" type="checkbox"/> <input type="checkbox"/> <input type="checkbox"/> <input type="checkbox"/>
Location: Unit 2 – Bathroom	Auditors Comments: <ul style="list-style-type: none"> Movement has caused a small area of rendering and paint to push out away from the wall by approx. 3mm.

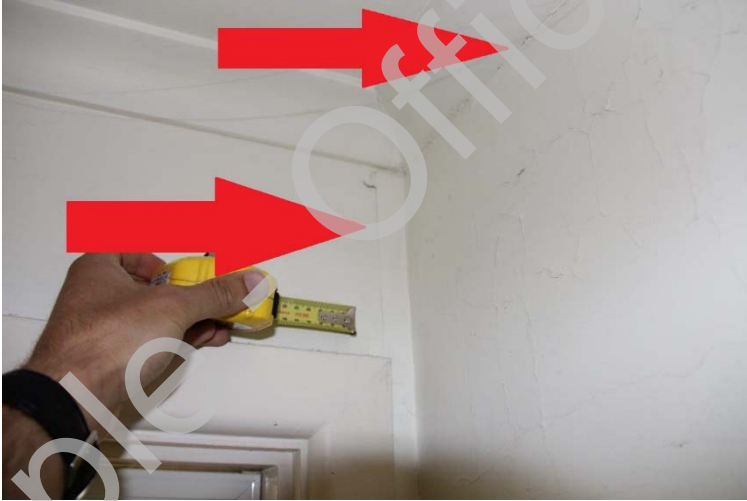
Assessment Type: Good Fair Poor	<input type="checkbox"/> <input checked="" type="checkbox"/> <input type="checkbox"/>
		Impact Category: 1 2 3 4 5	<input checked="" type="checkbox"/> <input type="checkbox"/> <input type="checkbox"/> <input type="checkbox"/> <input type="checkbox"/>
Location: Unit 2 – Bathroom	Auditors Comments: <ul style="list-style-type: none"> Cracks above bathroom door frame. Approx. 1mm.

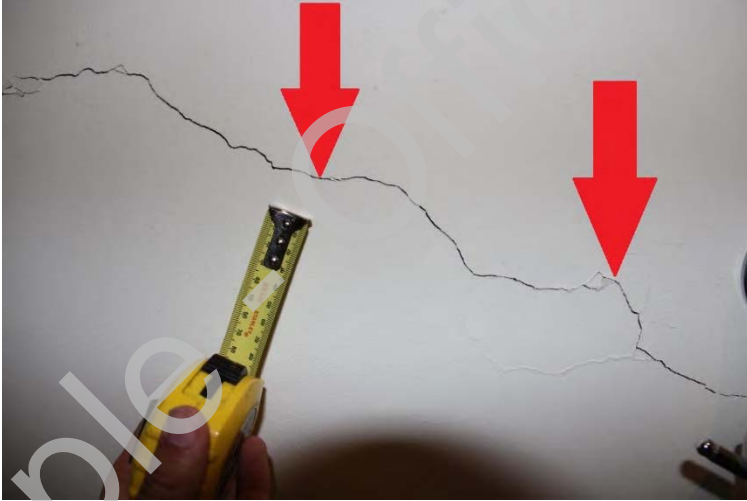
Assessment Type: Good Fair Poor	<input type="checkbox"/> <input type="checkbox"/> <input checked="" type="checkbox"/>
		Impact Category: 1 2 3 4 5	<input type="checkbox"/> <input checked="" type="checkbox"/> <input type="checkbox"/> <input type="checkbox"/> <input type="checkbox"/>
Location: Unit 2 – Bathroom	Auditors Comments: <ul style="list-style-type: none"> Long and significant cracking present near toilet roll dispenser hardware. This crack runs from the corner of the wall to approximately the basin cabinet and has a width of approx. 2mm for most of its length. Please refer to the attached “High Resolution Photos” document for further evidence.

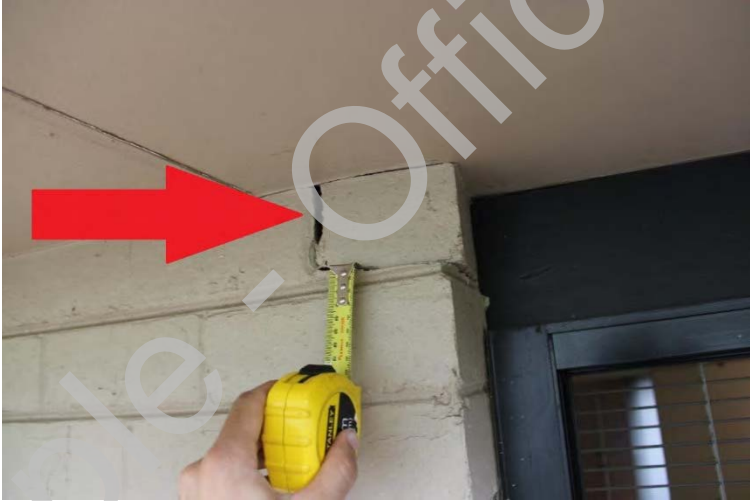
Assessment Type: Good Fair Poor	<input type="checkbox"/> <input type="checkbox"/> <input checked="" type="checkbox"/>
		Impact Category: 1 2 3 4 5	<input type="checkbox"/> <input type="checkbox"/> <input checked="" type="checkbox"/> <input type="checkbox"/> <input type="checkbox"/>
Location: Unit 2 – Courtyard	Auditors Comments: <ul style="list-style-type: none"> Brick has been dislodged by approx. 5-7mm.

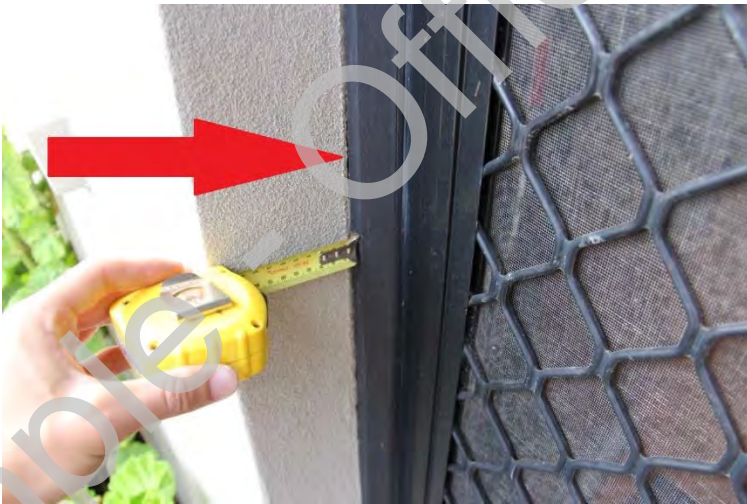
Assessment Type: Good Fair Poor	<input type="checkbox"/> <input checked="" type="checkbox"/> <input type="checkbox"/>
		Impact Category: 1 2 3 4 5	<input checked="" type="checkbox"/> <input type="checkbox"/> <input type="checkbox"/> <input type="checkbox"/> <input type="checkbox"/>
Location: Unit 3 – Doorway entrance	Auditors Comments: <ul style="list-style-type: none"> Small gap between door frame and façade. Approx. 1mm.

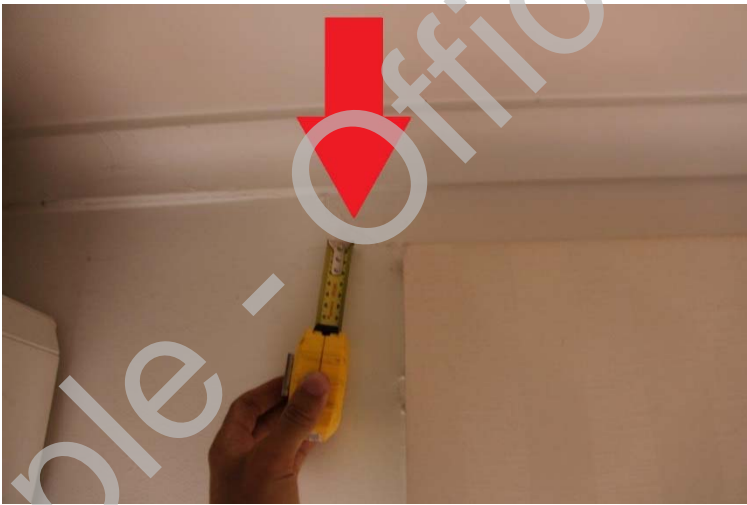
Assessment Type: Good Fair Poor	<input type="checkbox"/> <input checked="" type="checkbox"/> <input type="checkbox"/>
		Impact Category: 1 2 3 4 5	<input checked="" type="checkbox"/> <input type="checkbox"/> <input type="checkbox"/> <input type="checkbox"/> <input type="checkbox"/>
Location: Unit 3 – Doorway entrance	Auditors Comments: <ul style="list-style-type: none"> Fine cracking near air conditioner. Approx. 1mm.

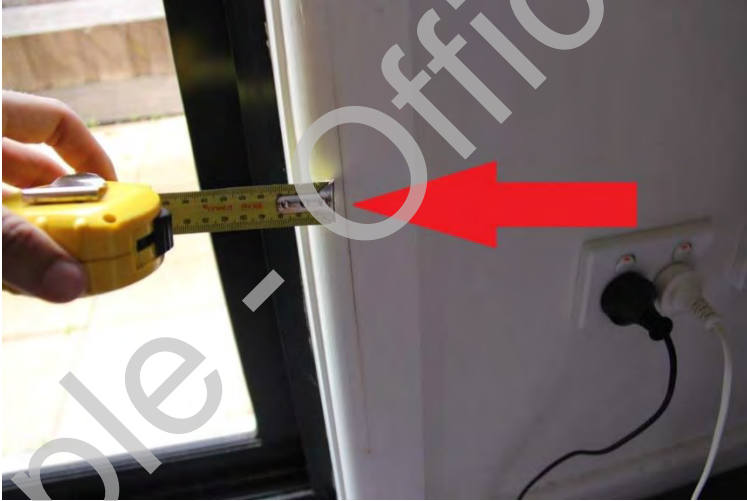
Assessment Type: Good Fair Poor	<input type="checkbox"/> <input checked="" type="checkbox"/> <input type="checkbox"/>
		Impact Category: 1 2 3 4 5	<input type="checkbox"/> <input checked="" type="checkbox"/> <input type="checkbox"/> <input type="checkbox"/> <input type="checkbox"/>
Location: Unit 3 – Bedroom	Auditors Comments: <ul style="list-style-type: none"> Crack in skirting to right of doorway to courtyard. Approx. 1-2mm.

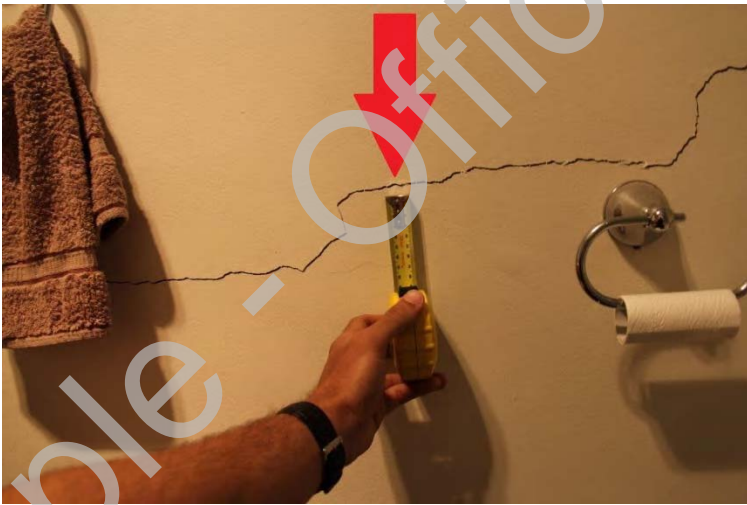
Assessment Type: Good <input type="checkbox"/> Fair <input type="checkbox"/> Poor <input checked="" type="checkbox"/>	<input type="checkbox"/> <input type="checkbox"/> <input checked="" type="checkbox"/>
		Impact Category: 1 <input type="checkbox"/> 2 <input checked="" type="checkbox"/> 3 <input type="checkbox"/> 4 <input type="checkbox"/> 5 <input type="checkbox"/>	<input type="checkbox"/> <input checked="" type="checkbox"/> <input type="checkbox"/> <input type="checkbox"/> <input type="checkbox"/>
Location: Unit 3 – Bathroom	Auditors Comments: <ul style="list-style-type: none"> Long and significant cracking present near toilet roll dispenser hardware. This crack runs from the corner of the wall to approximately the basin cabinet and has a width of approx. 2mm for most of its length. Please refer to the attached "High Resolution Photos" document for further evidence.

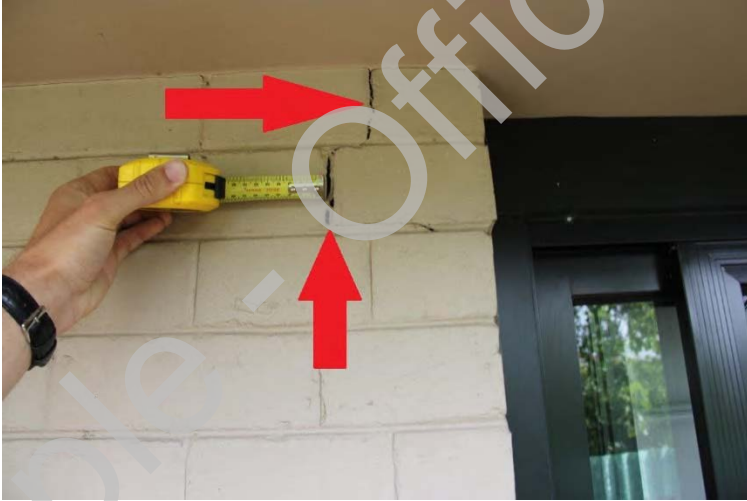
Assessment Type: Good Fair Poor	<input type="checkbox"/> <input checked="" type="checkbox"/> <input type="checkbox"/>
		Impact Category: 1 2 3 4 5	<input type="checkbox"/> <input type="checkbox"/> <input checked="" type="checkbox"/> <input type="checkbox"/> <input type="checkbox"/>
Location: Unit 3 – Courtyard	Auditors Comments: <ul style="list-style-type: none"> Bricks dislodged near doorframe. Approx. 5-7mm.

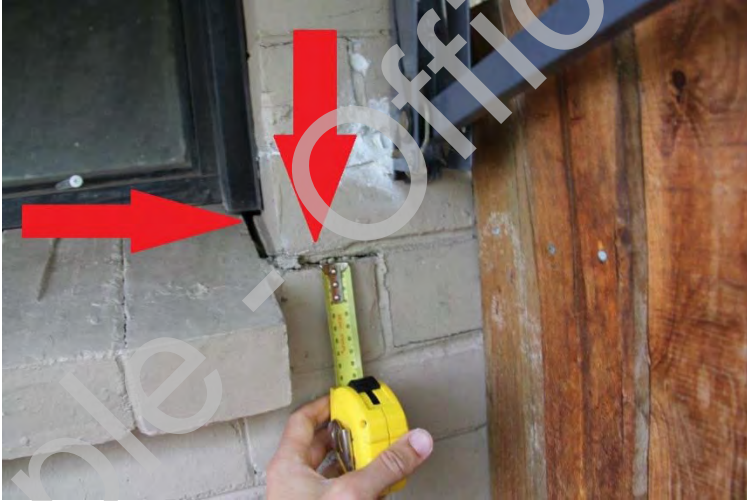
Assessment Type: Good Fair Poor	<input type="checkbox"/> <input checked="" type="checkbox"/> <input type="checkbox"/>
		Impact Category: 1 2 3 4 5	<input type="checkbox"/> <input checked="" type="checkbox"/> <input type="checkbox"/> <input type="checkbox"/> <input type="checkbox"/>
Location: Unit 3 – Courtyard	Auditors Comments: <ul style="list-style-type: none"> Gaps present to lower right-hand side of window frame. Approx. 3-5mm.

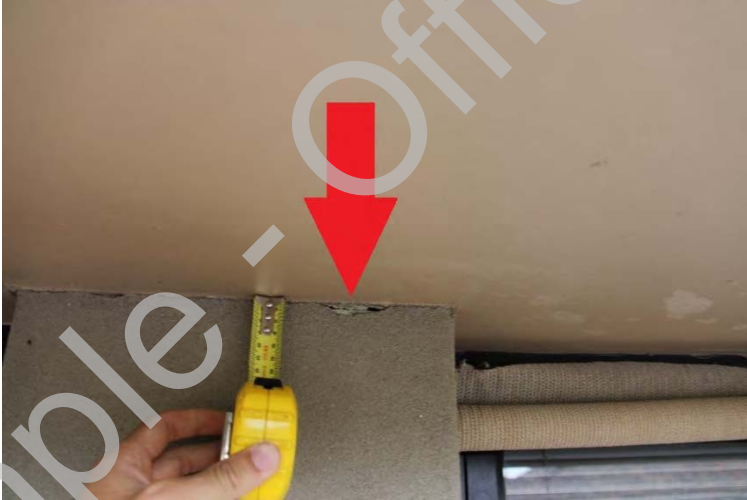
Assessment Type: Good Fair Poor	<input type="checkbox"/> <input checked="" type="checkbox"/> <input type="checkbox"/>
		Impact Category: 1 2 3 4 5	<input type="checkbox"/> <input checked="" type="checkbox"/> <input type="checkbox"/> <input type="checkbox"/> <input type="checkbox"/>
Location: Unit 4 – Northern exterior	Auditors Comments: <ul style="list-style-type: none"> Missing render near window frame has created a gap. Approx. 3-5mm.

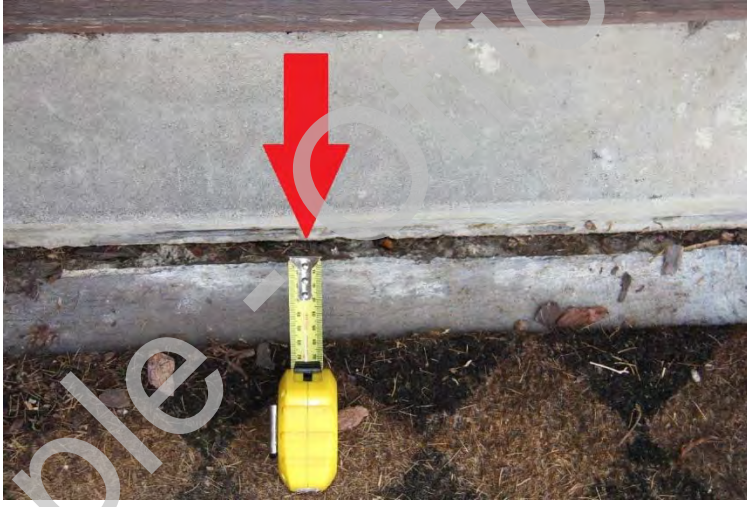
Assessment Type: Good Fair Poor	<input type="checkbox"/> <input checked="" type="checkbox"/> <input type="checkbox"/>
		Impact Category: 1 2 3 4 5	<input type="checkbox"/> <input type="checkbox"/> <input checked="" type="checkbox"/> <input type="checkbox"/> <input type="checkbox"/>
Location: Unit 4 – Northern exterior	Auditors Comments: <ul style="list-style-type: none"> Gap between floor slab and walkway slab present. Approx. 20mm.

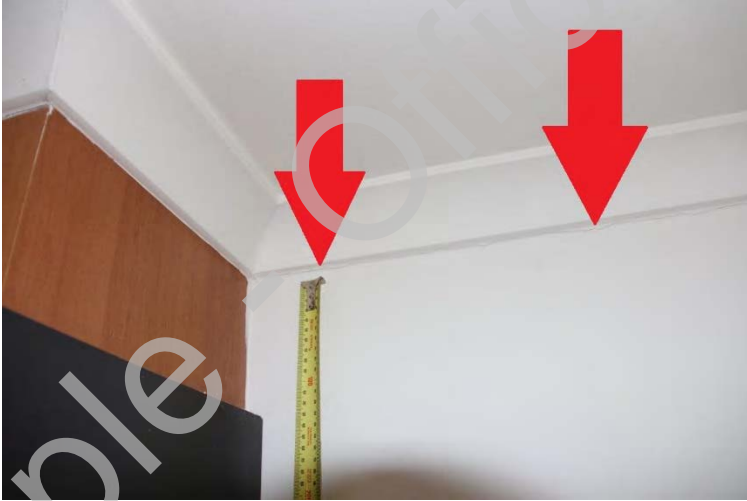
Assessment Type: Good Fair Poor	<input type="checkbox"/> <input checked="" type="checkbox"/> <input type="checkbox"/>
		Impact Category: 1 2 3 4 5	<input checked="" type="checkbox"/> <input type="checkbox"/> <input type="checkbox"/> <input type="checkbox"/> <input type="checkbox"/>
Location: Unit 4 – Kitchen	Auditors Comments: <ul style="list-style-type: none"> Fine cracking underneath skirting. Approx. 0.5mm.

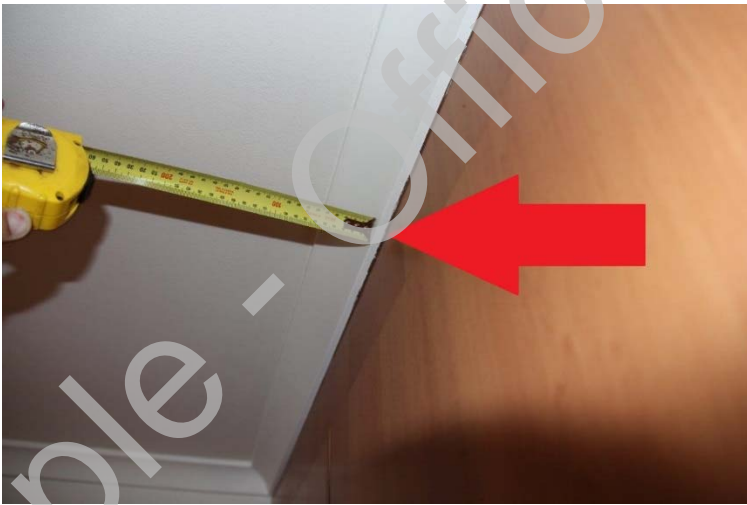
Assessment Type: Good Fair Poor	<input type="checkbox"/> <input checked="" type="checkbox"/> <input type="checkbox"/>
		Impact Category: 1 2 3 4 5	<input type="checkbox"/> <input checked="" type="checkbox"/> <input type="checkbox"/> <input type="checkbox"/> <input type="checkbox"/>
Location: Unit 4 – Kitchen	Auditors Comments: <ul style="list-style-type: none"> Gap between skirting and wall. Approx. 2-3mm.

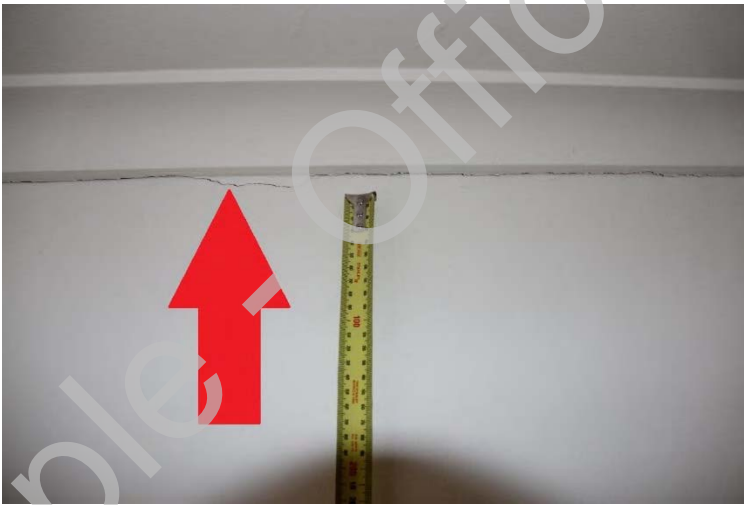
Assessment Type: Good Fair Poor	<input type="checkbox"/> <input checked="" type="checkbox"/> <input type="checkbox"/>
		Impact Category: 1 2 3 4 5	<input checked="" type="checkbox"/> <input type="checkbox"/> <input type="checkbox"/> <input type="checkbox"/> <input type="checkbox"/>
Location: Unit 4 – Kitchen & lounge	Auditors Comments: <ul style="list-style-type: none"> Cracking near skirting board. Approx. 1mm.

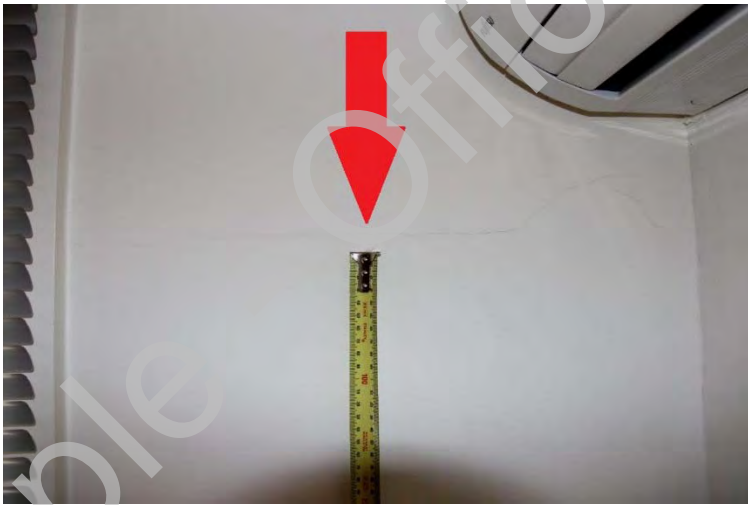
Assessment Type: Good Fair Poor	<input type="checkbox"/> <input checked="" type="checkbox"/> <input type="checkbox"/>
		Impact Category: 1 2 3 4 5	<input checked="" type="checkbox"/> <input type="checkbox"/> <input type="checkbox"/> <input type="checkbox"/> <input type="checkbox"/>
Location: Unit 4 – Kitchen & lounge	Auditors Comments: <ul style="list-style-type: none"> Fine crack running from window frame to corner of perpendicular wall. Approx. 0.5mm.

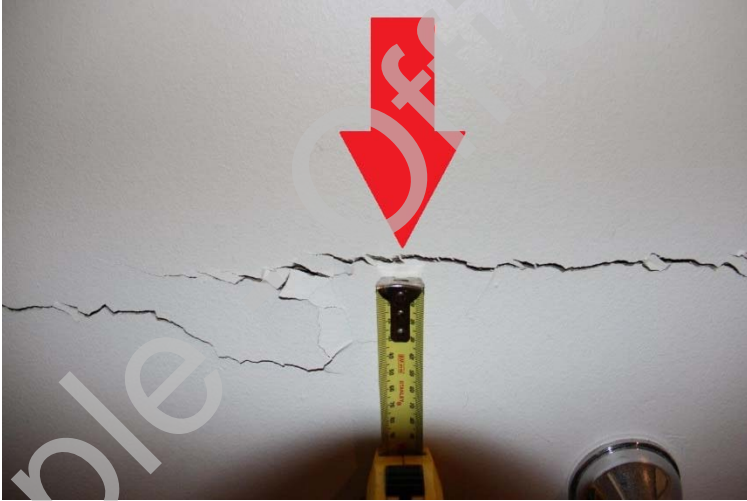
Assessment Type: Good Fair Poor	<input type="checkbox"/> <input type="checkbox"/> <input checked="" type="checkbox"/>
		Impact Category: 1 2 3 4 5	<input type="checkbox"/> <input checked="" type="checkbox"/> <input type="checkbox"/> <input type="checkbox"/> <input type="checkbox"/>
Location: Unit 4 – Bathroom	Auditors Comments: <ul style="list-style-type: none"> Long and significant cracking present near toilet roll dispenser hardware. This crack runs from the corner of the wall to approximately the basin cabinet and has a width of approx. 2-3mm for most of its length. Please refer to the attached “High Resolution Photos” document for further evidence.

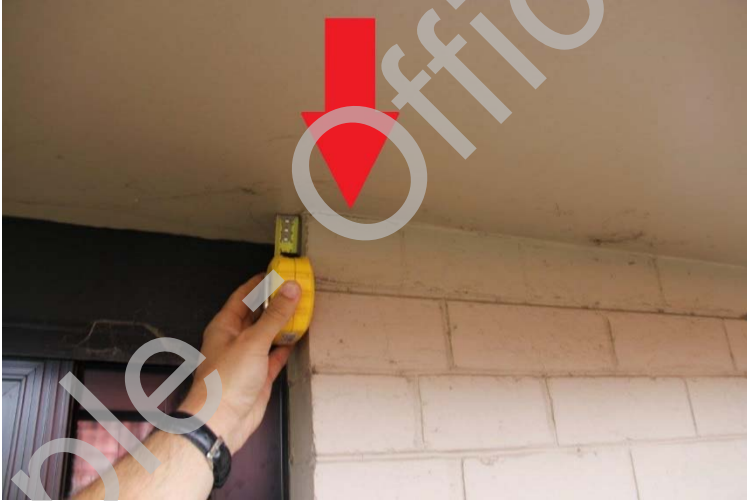
Assessment Type: Good Fair Poor	<input type="checkbox"/> <input checked="" type="checkbox"/> <input type="checkbox"/>
		Impact Category: 1 2 3 4 5	<input checked="" type="checkbox"/> <input type="checkbox"/> <input type="checkbox"/> <input type="checkbox"/> <input type="checkbox"/>
Location: Unit 4 – Bathroom	Auditors Comments: <ul style="list-style-type: none"> Crack to the right of doorframe between wall and eave. Approx. 1mm.

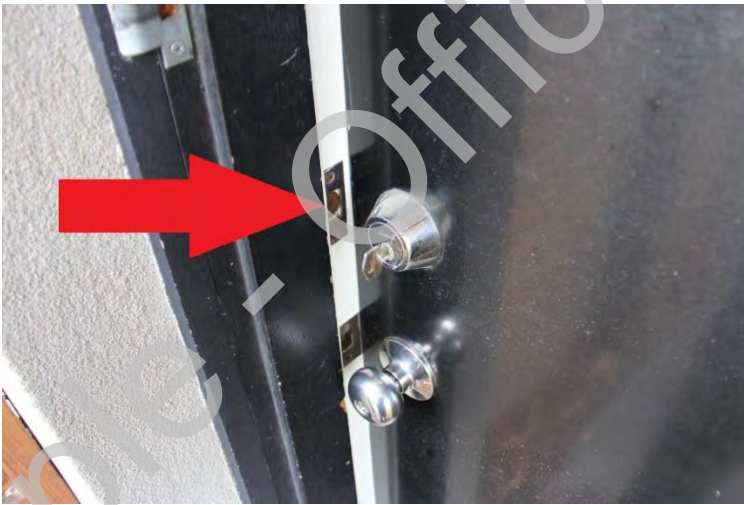
Assessment Type: Good Fair Poor	<input type="checkbox"/> <input checked="" type="checkbox"/> <input type="checkbox"/>
		Impact Category: 1 2 3 4 5	<input type="checkbox"/> <input type="checkbox"/> <input type="checkbox"/> <input type="checkbox"/> <input type="checkbox"/>
Location: Unit 4 – Front entrance	Auditors Comments: <ul style="list-style-type: none"> Secondary lock of Unit 4 door does not close due to misalignment.
