Dilapidation Survey Report

28 Sample Street Suburb VIC 3008

Plan of Subdivision: PS 123456

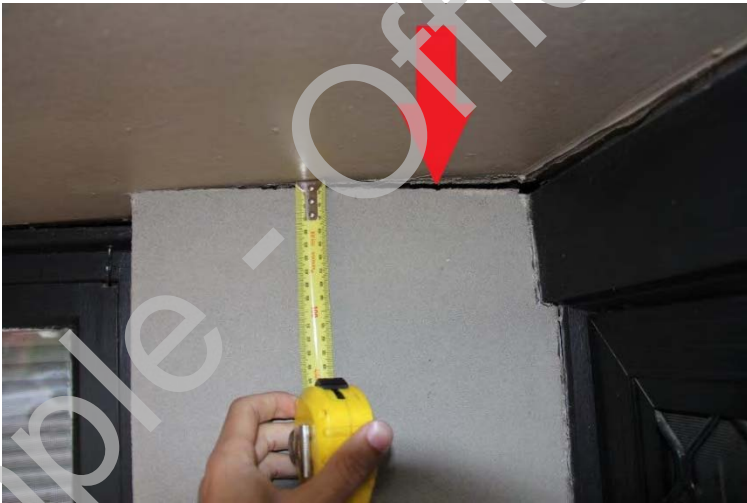
<u>Assessment Type:</u> Good Fair Poor	<input type="checkbox"/> <input checked="" type="checkbox"/> <input type="checkbox"/>
		<u>Impact Category:</u> 1 2 3 4 5	<input type="checkbox"/> <input checked="" type="checkbox"/> <input type="checkbox"/> <input type="checkbox"/> <input type="checkbox"/>
<u>Location:</u> Unit 5 – Exterior	<u>Auditors Comments:</u> <ul style="list-style-type: none"> Gap between eave and rendered wall. Approx. 4mm.

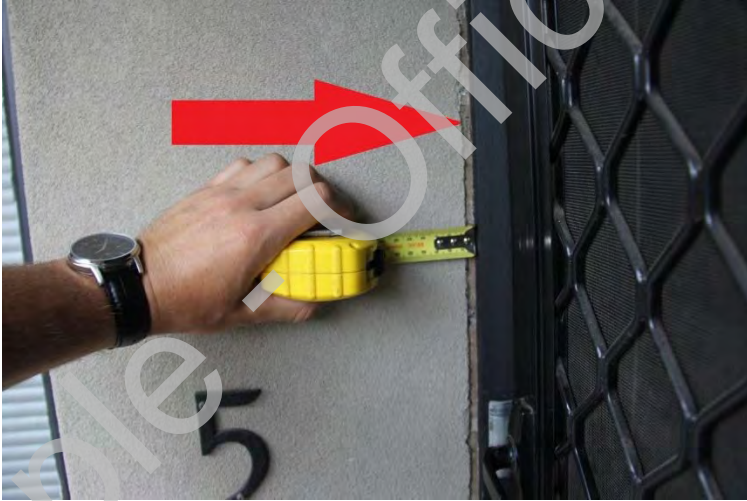
Assessment Type: Good Fair Poor	<input type="checkbox"/> <input checked="" type="checkbox"/> <input type="checkbox"/>
		Impact Category: 1 2 3 4 5	<input type="checkbox"/> <input checked="" type="checkbox"/> <input type="checkbox"/> <input type="checkbox"/> <input type="checkbox"/>
Location: Unit 5 – Exterior	Auditors Comments: <ul style="list-style-type: none"> Missing render near door frame for Unit 5. Approx. 5mm.
