Dilapidation Survey Report

76 Sample St Suburb VIC 3107

13 June 2014

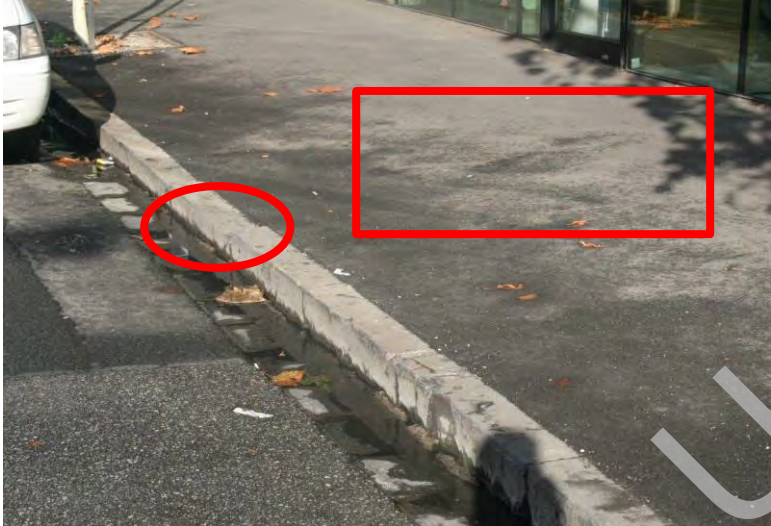
Assessment Type: Good <input type="checkbox"/> Fair <input checked="" type="checkbox"/> Poor <input type="checkbox"/>	Impact Category: 1 <input type="checkbox"/> 2 <input checked="" type="checkbox"/> 3 <input type="checkbox"/> 4 <input type="checkbox"/> 5 <input type="checkbox"/>
Location:	Auditors Comments: <ul style="list-style-type: none"> Brick lined kerb and channel has lowered or sunk. Road is also dirty and contains stains with fine cracks. Scuffed asphalt footpath from environmental wear and lifespan.

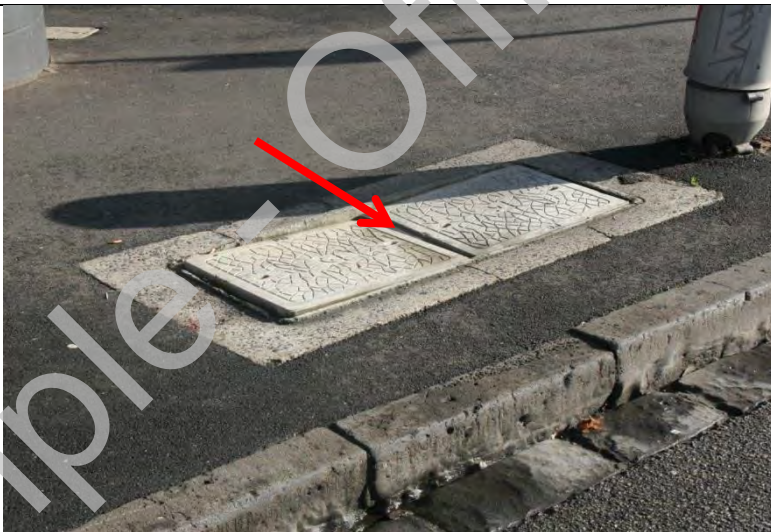
2.

Assessment Type: Good <input type="checkbox"/> Fair <input checked="" type="checkbox"/> Poor <input type="checkbox"/>	Impact Category: 1 <input type="checkbox"/> 2 <input checked="" type="checkbox"/> 3 <input type="checkbox"/> 4 <input type="checkbox"/> 5 <input type="checkbox"/>
Location:	Auditors Comments: <ul style="list-style-type: none"> Telstra Pit has depressed at its centre and is not finishing "at level" with the current surrounding concrete and asphalt. Concrete around Telstra Pit has fine cracks that extend to the surrounding asphalt from the Telstra Pit. Rainwater may pool around this Telstra Pit due to uneven levels. Concrete kerb is uneven and discoloured. This is the typical condition of the concrete kerbs in the whole street. Asphalt is discoloured in certain areas but is in serviceable condition.

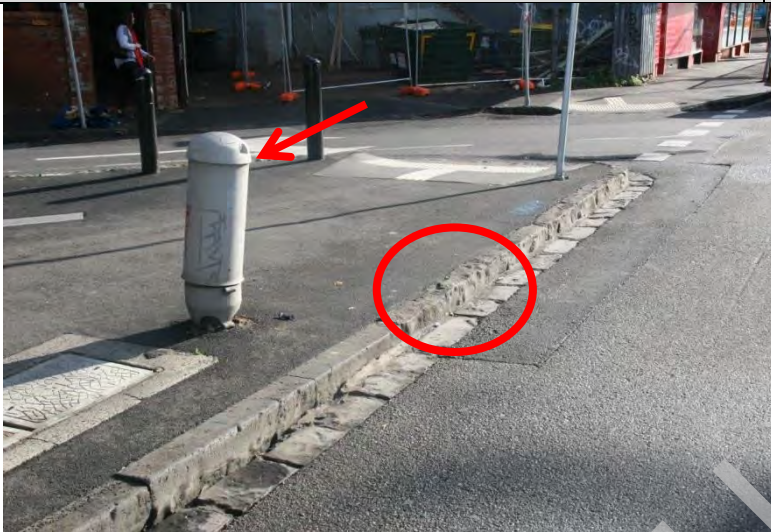
<p>Assessment Type:</p> <p>Good <input type="checkbox"/></p> <p>Fair <input checked="" type="checkbox"/></p> <p>Poor <input type="checkbox"/></p> <p>Impact Category:</p> <p>1 <input type="checkbox"/></p> <p>2 <input checked="" type="checkbox"/></p> <p>3 <input type="checkbox"/></p> <p>4 <input type="checkbox"/></p> <p>5 <input type="checkbox"/></p>
Location:	<p>Auditors Comments:</p> <ul style="list-style-type: none"> • Saw cut section of asphalt does not finish at appropriate level with existing asphalt. • The concrete kerb is typically dirty, cracked and uneven. • Concrete kerb shows signs of wear and tear with chips taken off the top section of kerb. • Concrete services post is bent and leaning towards Belford Street.

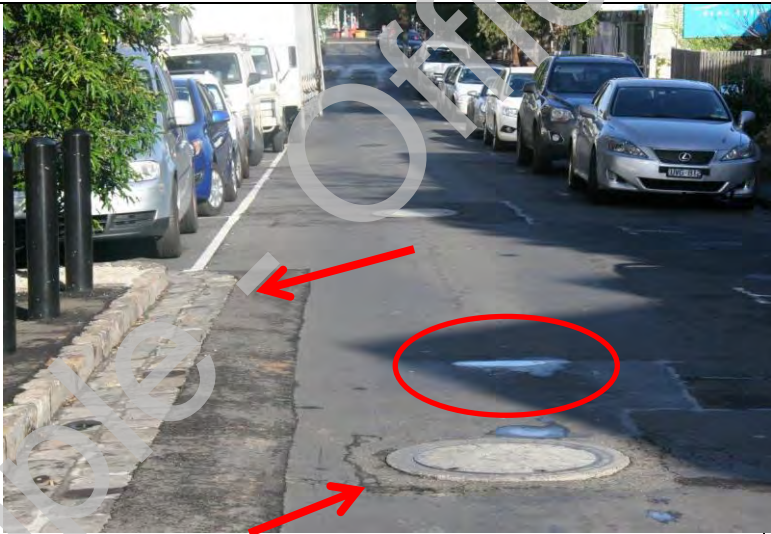
4.

<p>Assessment Type:</p> <p>Good <input type="checkbox"/></p> <p>Fair <input checked="" type="checkbox"/></p> <p>Poor <input type="checkbox"/></p> <p>Impact Category:</p> <p>1 <input type="checkbox"/></p> <p>2 <input checked="" type="checkbox"/></p> <p>3 <input type="checkbox"/></p> <p>4 <input type="checkbox"/></p> <p>5 <input type="checkbox"/></p>
Location:	<p>Auditors Comments:</p> <ul style="list-style-type: none"> • There is a raised asphalt section that leads to the kerb and channel. This asphalt does not finish at the level of the existing asphalt. • Water is ponding in the centre of the road pavement • Poor and uneven finish of asphalt around concrete services pit lid in centre of road pavement. • Concrete kerb shows signs of wear and tear with chips taken off the top section of kerb.

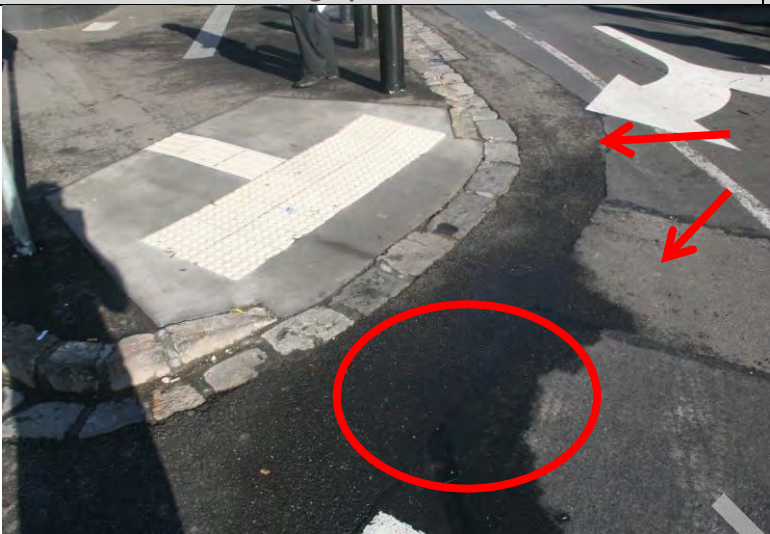
Assessment Type: Good <input type="checkbox"/> Fair <input checked="" type="checkbox"/> Poor <input type="checkbox"/>	<input type="checkbox"/> <input checked="" type="checkbox"/> <input type="checkbox"/>
		Impact Category: 1 <input type="checkbox"/> 2 <input checked="" type="checkbox"/> 3 <input type="checkbox"/> 4 <input type="checkbox"/> 5 <input type="checkbox"/>	<input type="checkbox"/> <input checked="" type="checkbox"/> <input type="checkbox"/> <input type="checkbox"/> <input type="checkbox"/>
Location:	Auditors Comments: <ul style="list-style-type: none"> Saw cutting has been utilised to safely install pram crossing. This has clearly led to a poor finish with existing asphalt and water is ponding on the asphalt at the exit /entrance of the pram crossing. Concrete kerb shows signs of wear and tear with chips taken off the top section of kerb. The concrete kerb is typically dirty, cracked and uneven.

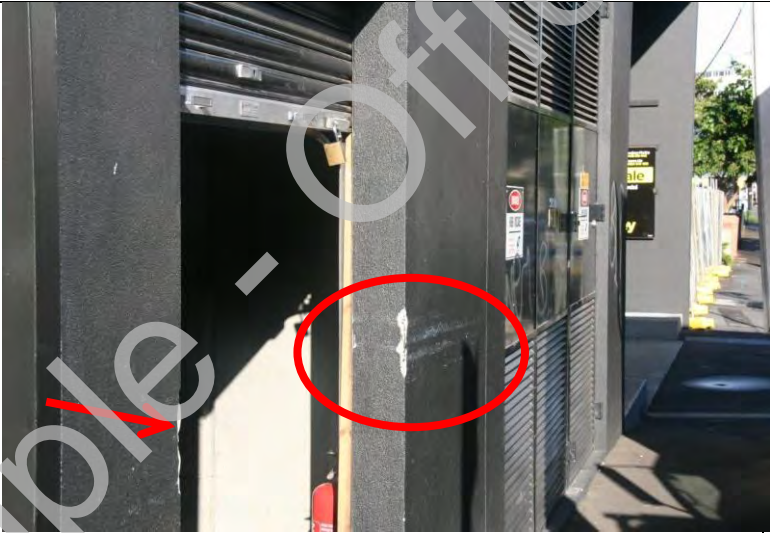
6.

Assessment Type: Good <input type="checkbox"/> Fair <input checked="" type="checkbox"/> Poor <input type="checkbox"/>	<input type="checkbox"/> <input checked="" type="checkbox"/> <input type="checkbox"/>
		Impact Category: 1 <input type="checkbox"/> 2 <input type="checkbox"/> 3 <input checked="" type="checkbox"/> 4 <input type="checkbox"/> 5 <input type="checkbox"/>	<input type="checkbox"/> <input type="checkbox"/> <input checked="" type="checkbox"/> <input type="checkbox"/> <input type="checkbox"/>
Location:	Auditors Comments: <ul style="list-style-type: none"> The concrete wall has been significantly damaged and has been chipped on both sides of this small roller door. Scraping marks are also evident along the length of the concrete side wall.

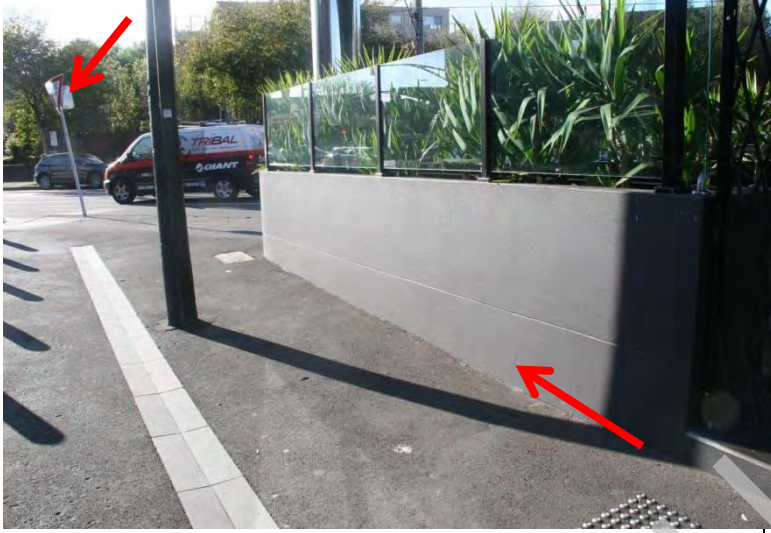
Assessment Type: Good <input type="checkbox"/> Fair <input checked="" type="checkbox"/> Poor <input type="checkbox"/>	<input type="checkbox"/> <input checked="" type="checkbox"/> <input type="checkbox"/>
		Impact Category: 1 <input checked="" type="checkbox"/> 2 <input type="checkbox"/> 3 <input type="checkbox"/> 4 <input type="checkbox"/> 5 <input type="checkbox"/>	<input checked="" type="checkbox"/> <input type="checkbox"/> <input type="checkbox"/> <input type="checkbox"/> <input type="checkbox"/>
Location:	Auditors Comments: <ul style="list-style-type: none"> The give way sign is significantly bent and is leaning towards Belford Street. There are some hairline cracks in the concrete rendering. Brick lined kerb and channel has lowered or sunk. Road is also dirty and contains stains with fine cracks. Scuffed asphalt footpath from environmental wear and lifespan.

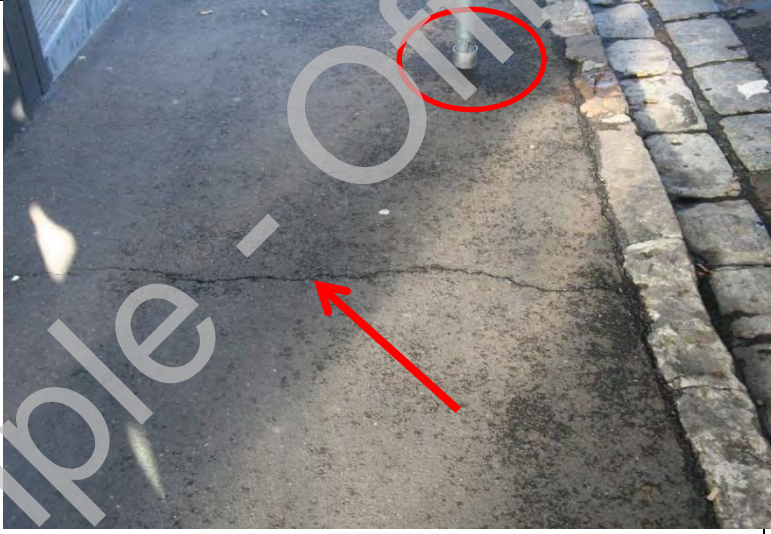
8.

Assessment Type: Good <input type="checkbox"/> Fair <input checked="" type="checkbox"/> Poor <input type="checkbox"/>	<input type="checkbox"/> <input checked="" type="checkbox"/> <input type="checkbox"/>
		Impact Category: 1 <input type="checkbox"/> 2 <input checked="" type="checkbox"/> 3 <input type="checkbox"/> 4 <input type="checkbox"/> 5 <input type="checkbox"/>	<input type="checkbox"/> <input checked="" type="checkbox"/> <input type="checkbox"/> <input type="checkbox"/> <input type="checkbox"/>
Location:	Auditors Comments: <ul style="list-style-type: none"> Water is pooling around the base of the sign post. There is a sizeable crack that extends from the kerb and channel to the side wall of the Luna building #173. The crack is approximately 3 - 3.5mm wide. The concrete kerb is typically dirty, cracked and uneven. Concrete kerb shows signs of wear and tear with chips taken off the top section of kerb.

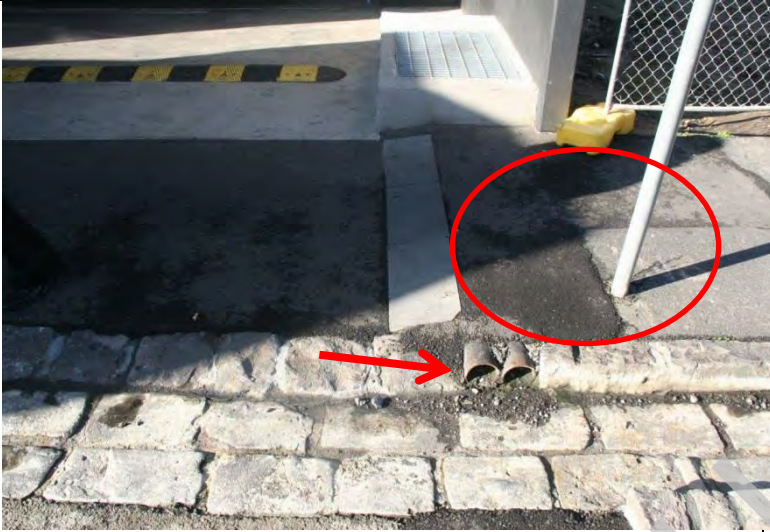
Assessment Type: Good <input type="checkbox"/> Fair <input checked="" type="checkbox"/> Poor <input type="checkbox"/>	<input type="checkbox"/> <input checked="" type="checkbox"/> <input type="checkbox"/>
		Impact Category: 1 <input type="checkbox"/> 2 <input type="checkbox"/> 3 <input checked="" type="checkbox"/> 4 <input type="checkbox"/> 5 <input type="checkbox"/>	<input type="checkbox"/> <input type="checkbox"/> <input checked="" type="checkbox"/> <input type="checkbox"/> <input type="checkbox"/>
Location:	Auditors Comments: <ul style="list-style-type: none"> Cracks are visible on the surface of the road and concrete kerb and gutter. The concrete kerb and gutter is typically dirty, cracked and uneven. The two drainage outlets are obstructed with small sized gravel and soil. The drainage channel is uneven, cracked, chipped and is filled with soil and gravel also. There is in-filled asphalt that attempts to fill in a depression of the walkway pavement. It also provides some extra cover to the two drainage outlets. This is poorly filled in and does not finish at an appropriate level with the existing walkway.

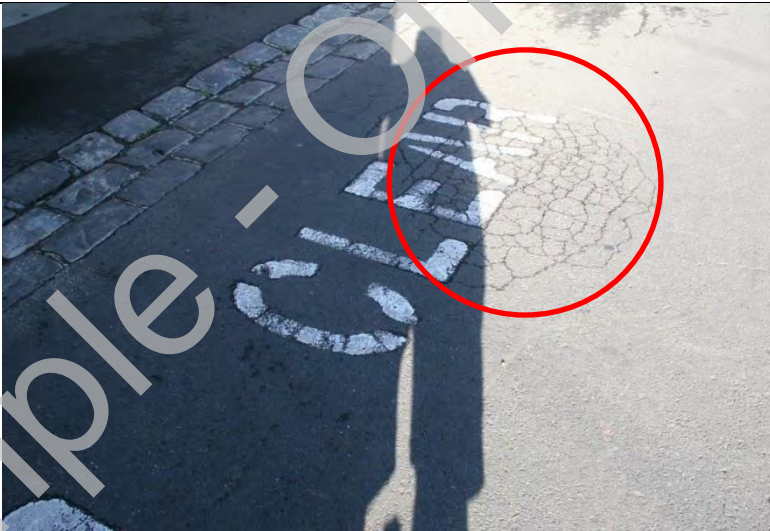
10.

Assessment Type: Good <input type="checkbox"/> Fair <input type="checkbox"/> Poor <input checked="" type="checkbox"/>	<input type="checkbox"/> <input type="checkbox"/> <input checked="" type="checkbox"/>
		Impact Category: 1 <input type="checkbox"/> 2 <input type="checkbox"/> 3 <input type="checkbox"/> 4 <input checked="" type="checkbox"/> 5 <input type="checkbox"/>	<input type="checkbox"/> <input type="checkbox"/> <input type="checkbox"/> <input checked="" type="checkbox"/> <input type="checkbox"/>
Location:	Auditors Comments: <ul style="list-style-type: none"> Road pavement is significantly cracked in this section of the road pavement. This indicates that water is pooling at this point and may lead to a significant pothole. Other sections of the Belford Street are uneven and scuffed up but this is a significant issue; especially if potentially construction machinery will use this road as access to the # 7 construction site.

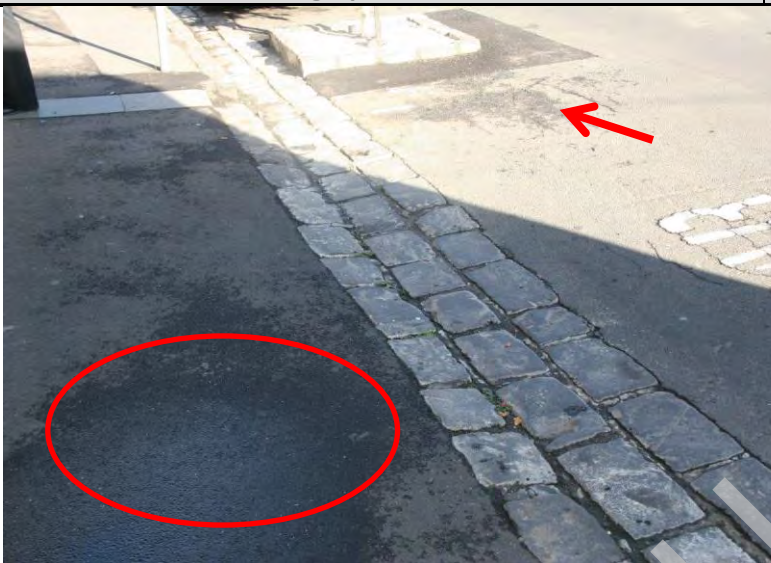
Assessment Type: Good <input type="checkbox"/> Fair <input checked="" type="checkbox"/> Poor <input type="checkbox"/>	<input type="checkbox"/> <input checked="" type="checkbox"/> <input type="checkbox"/>
		Impact Category: 1 <input type="checkbox"/> 2 <input checked="" type="checkbox"/> 3 <input type="checkbox"/> 4 <input type="checkbox"/> 5 <input type="checkbox"/>	<input type="checkbox"/> <input checked="" type="checkbox"/> <input type="checkbox"/> <input type="checkbox"/> <input type="checkbox"/>
Location:	Auditors Comments: <ul style="list-style-type: none"> Water is pooling before the channel, may lead to potholes in this section if not rectified; especially because it is located within a driveway. Road is dirty and contains stains and fine cracks. Road pavement is scuffed up due to wear and tear over time.

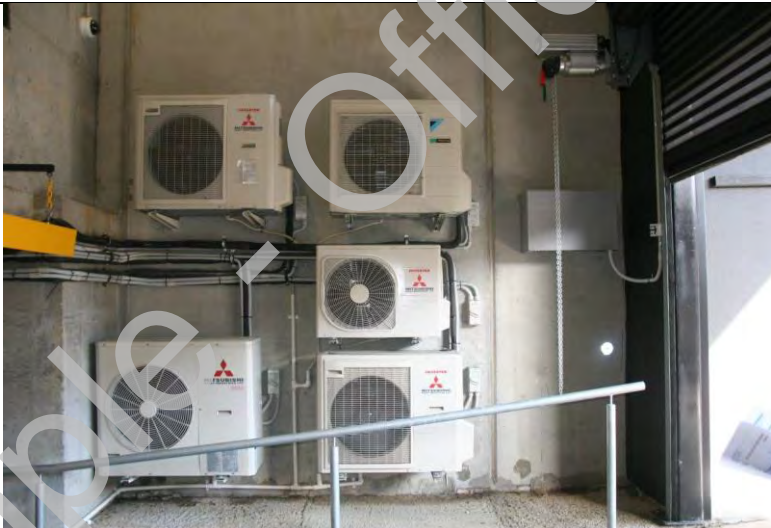
12.

Assessment Type: Good <input type="checkbox"/> Fair <input type="checkbox"/> Poor <input checked="" type="checkbox"/>	<input checked="" type="checkbox"/> <input type="checkbox"/> <input type="checkbox"/>
		Impact Category: 1 <input type="checkbox"/> 2 <input type="checkbox"/> 3 <input type="checkbox"/> 4 <input type="checkbox"/> 5 <input type="checkbox"/>	<input checked="" type="checkbox"/> <input type="checkbox"/> <input type="checkbox"/> <input type="checkbox"/> <input type="checkbox"/>
Location:	Auditors Comments: <ul style="list-style-type: none"> Air conditioner units are installed along the critical wall. The construction site at #7 Belford Street is located directly behind this wall. The wall is in good condition and no cracks are currently visible.

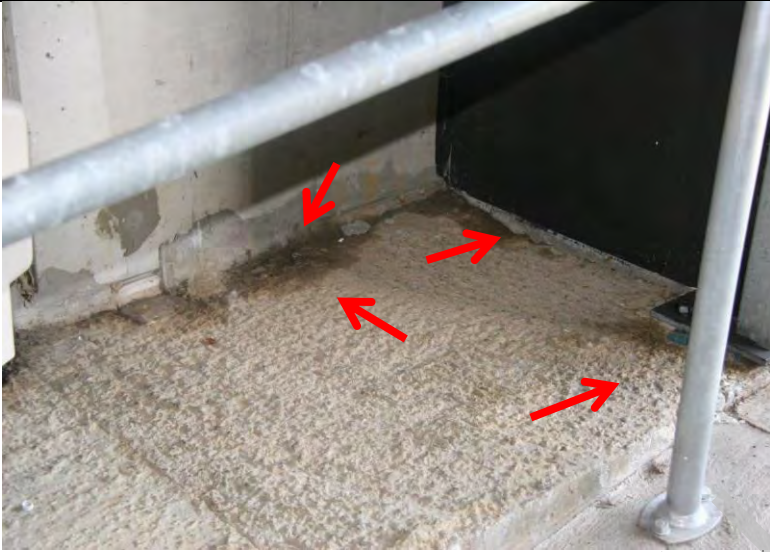
Assessment Type: Good <input type="checkbox"/> Fair <input checked="" type="checkbox"/> Poor <input type="checkbox"/>	<input type="checkbox"/> <input checked="" type="checkbox"/> <input type="checkbox"/>
		Impact Category: 1 <input type="checkbox"/> 2 <input checked="" type="checkbox"/> 3 <input type="checkbox"/> 4 <input type="checkbox"/> 5 <input type="checkbox"/>	<input type="checkbox"/> <input checked="" type="checkbox"/> <input type="checkbox"/> <input type="checkbox"/> <input type="checkbox"/>
Location: Basement	Auditors Comments: <ul style="list-style-type: none"> The air conditioning units are leaking water, which is pooling along the concrete wall. There is a raised concrete section that is not level with the existing concrete along this section. Concrete has been scuffed up and slightly damaged along the very base of the wall. The damage is only to the face and this is not excessive cracking. It is wear and tear of the basement concrete that has been exposed to moisture.

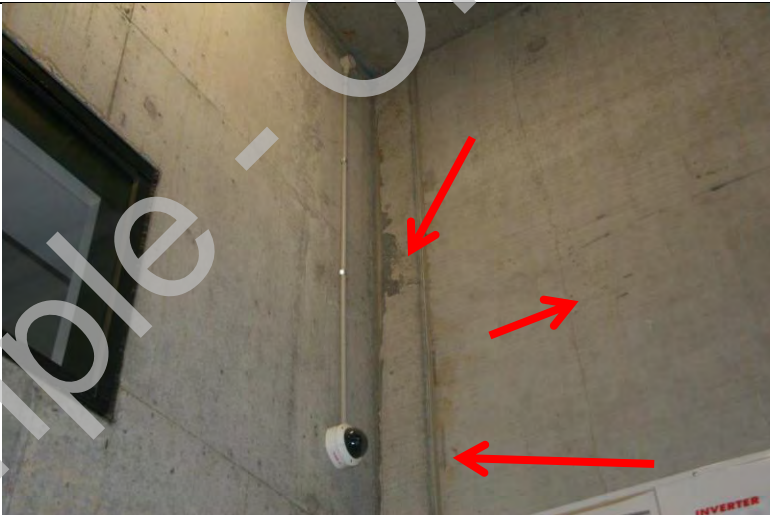
Assessment Type: Good <input type="checkbox"/> Fair <input checked="" type="checkbox"/> Poor <input type="checkbox"/>	<input type="checkbox"/> <input checked="" type="checkbox"/> <input type="checkbox"/>
		Impact Category: 1 <input type="checkbox"/> 2 <input checked="" type="checkbox"/> 3 <input type="checkbox"/> 4 <input type="checkbox"/> 5 <input type="checkbox"/>	<input type="checkbox"/> <input checked="" type="checkbox"/> <input type="checkbox"/> <input type="checkbox"/> <input type="checkbox"/>
Location:	Auditors Comments: <ul style="list-style-type: none"> Hairline cracks are noticeable along this wall of the basement entrance. They are only small at this stage and are not significant. They are mainly due to basement wear and tear. The corner is chipped in sections and quite scuffed up. The integrity of the wall is okay.

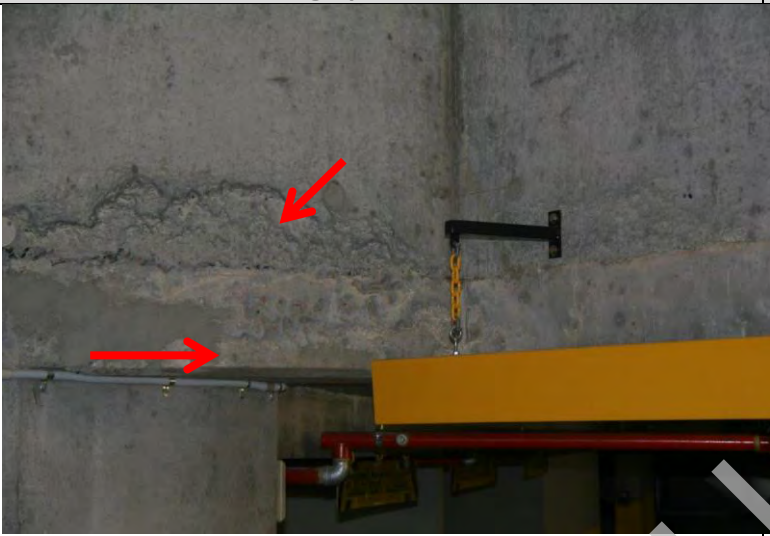
Assessment Type: Good <input type="checkbox"/> Fair <input checked="" type="checkbox"/> Poor <input type="checkbox"/>	Impact Category: 1 <input type="checkbox"/> 2 <input checked="" type="checkbox"/> 3 <input type="checkbox"/> 4 <input type="checkbox"/> 5 <input type="checkbox"/>
Location:	Auditors Comments: <ul style="list-style-type: none"> Concrete has been poured in stages. This has led to this poor finish to this wall. Cracking should be monitored but this is mainly due to the consistent wear and tear of the basement wall.

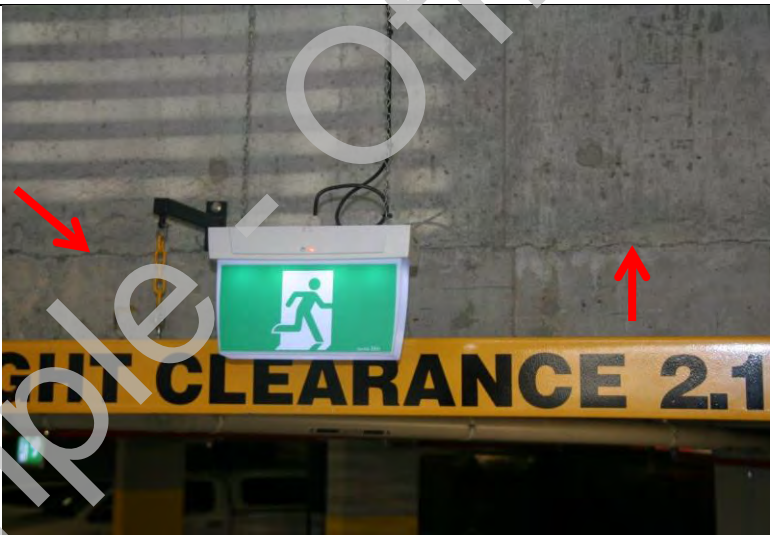
Assessment Type: Good <input type="checkbox"/> Fair <input checked="" type="checkbox"/> Poor <input type="checkbox"/>	Impact Category: 1 <input type="checkbox"/> 2 <input checked="" type="checkbox"/> 3 <input type="checkbox"/> 4 <input type="checkbox"/> 5 <input type="checkbox"/>
Location: Basement Wall – Entrance to building	Auditors Comments: <ul style="list-style-type: none"> Concrete has been poured in stages. This has led to a poor finish to this wall. Cracking should be monitored but this is mainly due to the consistent wear and tear of the basement wall and because the concrete has been poured in stages.

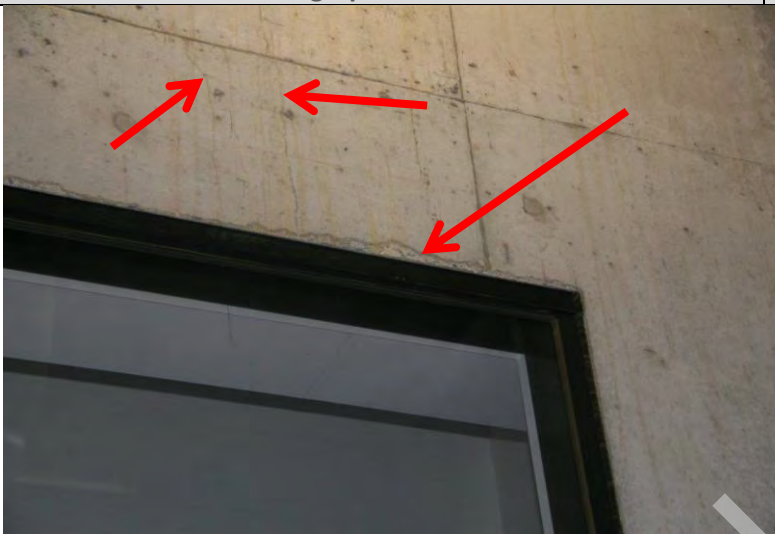
Assessment Type: Good <input type="checkbox"/> Fair <input checked="" type="checkbox"/> Poor <input type="checkbox"/>	<input type="checkbox"/> <input checked="" type="checkbox"/> <input type="checkbox"/>
		Impact Category: 1 <input type="checkbox"/> 2 <input checked="" type="checkbox"/> 3 <input type="checkbox"/> 4 <input type="checkbox"/> 5 <input type="checkbox"/>	<input type="checkbox"/> <input checked="" type="checkbox"/> <input type="checkbox"/> <input type="checkbox"/> <input type="checkbox"/>
Location: Basement Wall – Entrance to building	Auditors Comments: <ul style="list-style-type: none"> Hairline cracks are noticeable along this wall of the basement entrance way. They are only small at this stage and are not significant. They are mainly due to basement wear and tear. The concrete wall around the window is chipped in sections and quite scuffed up. The integrity of the wall is okay.

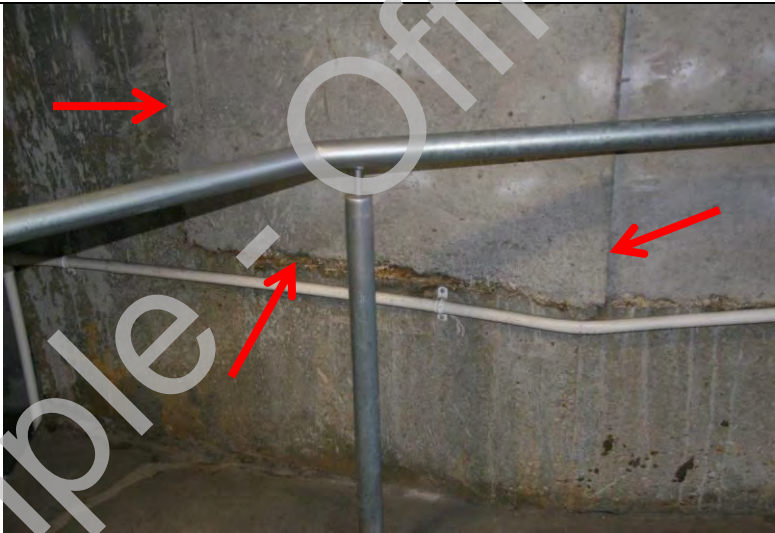
Assessment Type: Good <input type="checkbox"/> Fair <input checked="" type="checkbox"/> Poor <input type="checkbox"/>	<input type="checkbox"/> <input checked="" type="checkbox"/> <input type="checkbox"/>
		Impact Category: 1 <input type="checkbox"/> 2 <input type="checkbox"/> 3 <input checked="" type="checkbox"/> 4 <input type="checkbox"/> 5 <input type="checkbox"/>	<input type="checkbox"/> <input type="checkbox"/> <input checked="" type="checkbox"/> <input type="checkbox"/> <input type="checkbox"/>
Location: Basement entrance / exit ramp entrance to	Auditors Comments: <ul style="list-style-type: none"> Large separations are noticeable along this concrete wall of the basement. Concrete was poured separately and has settled separately, resulting in a clear separation. Separation gap can be in-filled also.

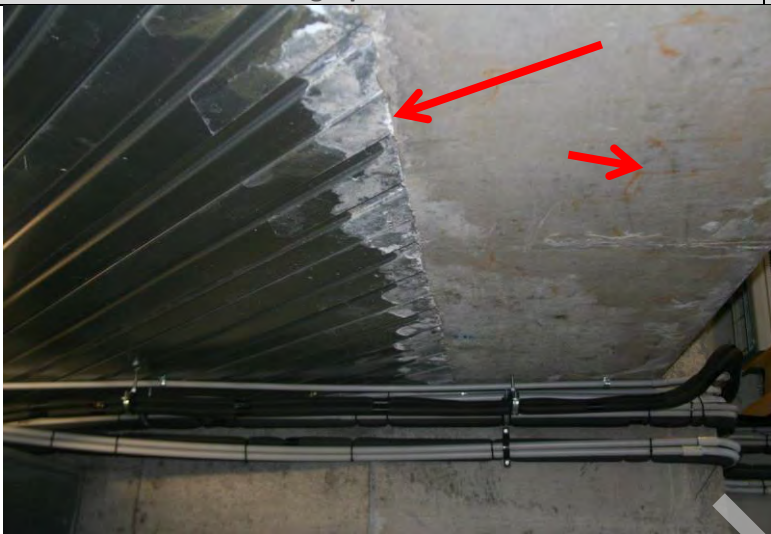
Assessment Type: Good <input type="checkbox"/> Fair <input checked="" type="checkbox"/> Poor <input type="checkbox"/>	<input checked="" type="checkbox"/> <input checked="" type="checkbox"/> <input type="checkbox"/>
		Impact Category: 1 <input checked="" type="checkbox"/> 2 <input type="checkbox"/> 3 <input type="checkbox"/> 4 <input type="checkbox"/> 5 <input type="checkbox"/>	<input checked="" type="checkbox"/> <input type="checkbox"/> <input type="checkbox"/> <input type="checkbox"/> <input type="checkbox"/>
Location: Basement	Auditors Comments: <ul style="list-style-type: none"> Composite floor construction is evident. Bondek is scuffed up but is structurally fine. The suspended composite floor slab is evidently marked but this is mainly due to the wear and tear that a basement car park experiences.

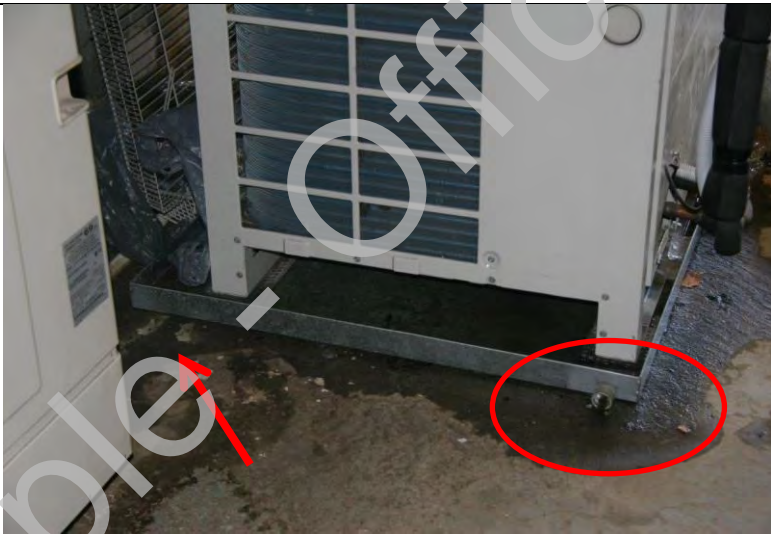
Assessment Type: Good <input type="checkbox"/> Fair <input type="checkbox"/> Poor <input checked="" type="checkbox"/>	<input type="checkbox"/> <input type="checkbox"/> <input checked="" type="checkbox"/>
		Impact Category: 1 <input type="checkbox"/> 2 <input type="checkbox"/> 3 <input checked="" type="checkbox"/> 4 <input type="checkbox"/> 5 <input type="checkbox"/>	<input type="checkbox"/> <input type="checkbox"/> <input checked="" type="checkbox"/> <input type="checkbox"/> <input type="checkbox"/>
Location: Basement	Auditors Comments: <ul style="list-style-type: none"> Leaking water is pooling around the air conditioning units. Staining is evident along the concrete slab. Leaking water is not properly draining to the channel created around the perimeter wall of the basement car park. This may lead to rust of the base of the air conditioning unit.

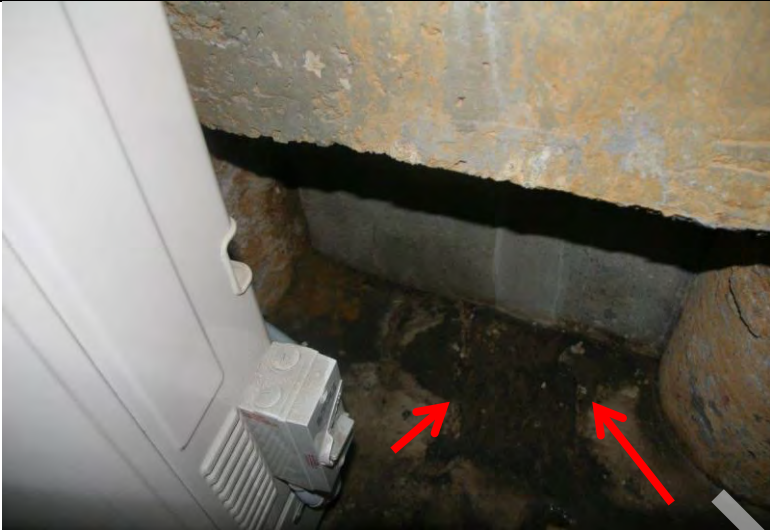
Assessment Type: Good <input type="checkbox"/> Fair <input type="checkbox"/> Poor <input checked="" type="checkbox"/>	<input type="checkbox"/> <input type="checkbox"/> <input checked="" type="checkbox"/>
		Impact Category: 1 <input type="checkbox"/> 2 <input type="checkbox"/> 3 <input checked="" type="checkbox"/> 4 <input type="checkbox"/> 5 <input type="checkbox"/>	<input type="checkbox"/> <input type="checkbox"/> <input checked="" type="checkbox"/> <input type="checkbox"/> <input type="checkbox"/>
Location: Basement	Auditors Comments: <ul style="list-style-type: none"> Leaking water is pooling around the air conditioning units and bored concrete piles. Staining is evident along the concrete slab and piles. Leaking water is not properly draining to the channel created around the perimeter wall of the basement car park. This may lead to rust of the base of the air conditioning unit. This will increase the scuff marking to concrete surfaces; especially with the wear and tear of the basement car park.

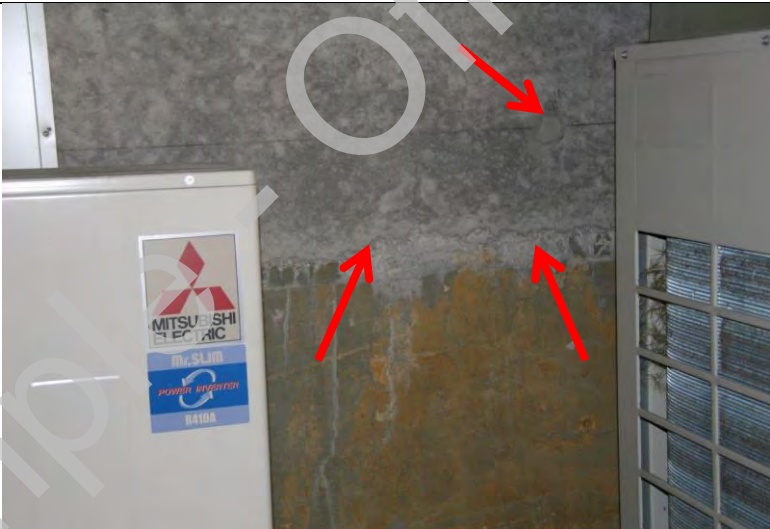
Assessment Type: Good <input type="checkbox"/> Fair <input checked="" type="checkbox"/> Poor <input type="checkbox"/>	<input type="checkbox"/> <input checked="" type="checkbox"/> <input type="checkbox"/>
		Impact Category: 1 <input type="checkbox"/> 2 <input checked="" type="checkbox"/> 3 <input type="checkbox"/> 4 <input type="checkbox"/> 5 <input type="checkbox"/>	<input type="checkbox"/> <input checked="" type="checkbox"/> <input type="checkbox"/> <input type="checkbox"/> <input type="checkbox"/>
Location: Basement	Auditors Comments: <ul style="list-style-type: none"> Hairline cracks are noticeable along this wall of the basement. They are only small at this stage and are not significant. They are mainly due to basement wear and tear. The concrete was poured in stages and has settled in segments. There is also patchy scuff marks and cracking along this basement wall. The integrity of the wall is okay.

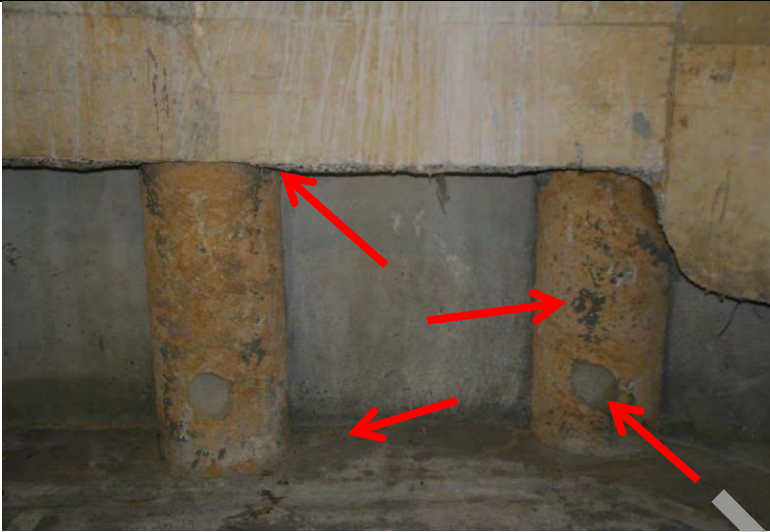
Assessment Type: Good <input type="checkbox"/> Fair <input checked="" type="checkbox"/> Poor <input type="checkbox"/>	<input type="checkbox"/> <input checked="" type="checkbox"/> <input type="checkbox"/>
		Impact Category: 1 <input type="checkbox"/> 2 <input checked="" type="checkbox"/> 3 <input type="checkbox"/> 4 <input type="checkbox"/> 5 <input type="checkbox"/>	<input type="checkbox"/> <input checked="" type="checkbox"/> <input type="checkbox"/> <input type="checkbox"/> <input type="checkbox"/>
Location: Basement	Auditors Comments: <ul style="list-style-type: none"> • Cast for bored concrete pile is significantly wearing. • The actual concrete pile is inside this cast and is not able to be inspected. • The wearing and tearing of the pile cast has no structural implications.

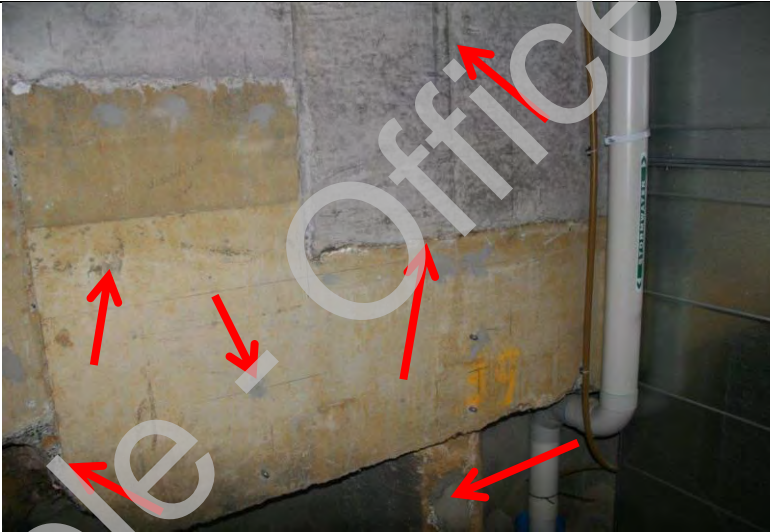
Assessment Type: Good <input type="checkbox"/> Fair <input checked="" type="checkbox"/> Poor <input type="checkbox"/>	<input type="checkbox"/> <input checked="" type="checkbox"/> <input type="checkbox"/>
		Impact Category: 1 <input type="checkbox"/> 2 <input checked="" type="checkbox"/> 3 <input type="checkbox"/> 4 <input type="checkbox"/> 5 <input type="checkbox"/>	<input type="checkbox"/> <input checked="" type="checkbox"/> <input type="checkbox"/> <input type="checkbox"/> <input type="checkbox"/>
Location: Basement	Auditors Comments: <ul style="list-style-type: none"> • Concrete has been poured in stages. • This has led to a poor finish to this wall. • Cracking or separations should be monitored. • Small cracks, dents and separation gaps are mainly due to the wear and tear experienced by the wall over time and because the concrete was poured in stages.

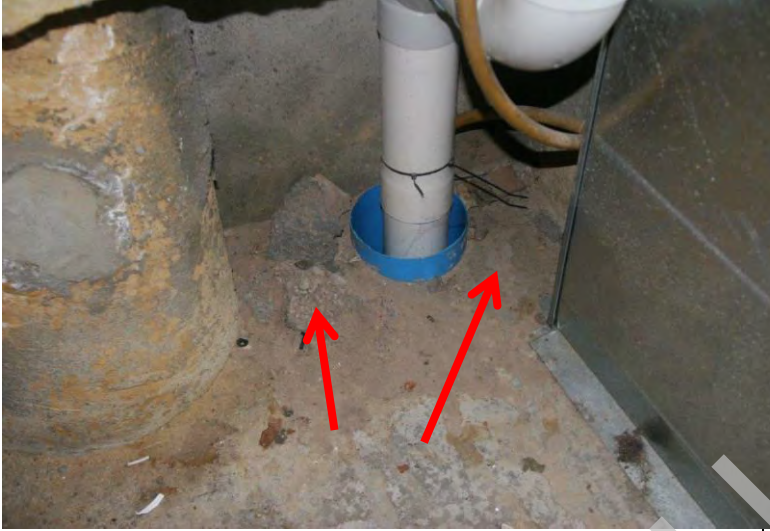
Assessment Type: Good Fair Poor	<input type="checkbox"/> <input checked="" type="checkbox"/> <input type="checkbox"/>
		Impact Category: 1 2 3 4 5	<input type="checkbox"/> <input checked="" type="checkbox"/> <input type="checkbox"/> <input type="checkbox"/> <input type="checkbox"/>
Location: Basement #173	Auditors Comments: <ul style="list-style-type: none"> Poor drainage around this downpipe. A cast has been placed around the downpipe to prevent inflow; especially of soils and gravels. This has led to a build-up of soils and gravel around the cast.

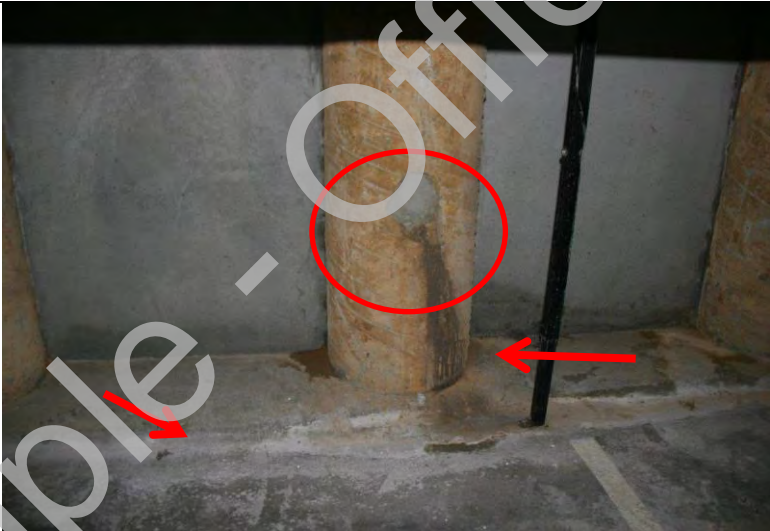
Assessment Type: Good Fair Poor	<input type="checkbox"/> <input checked="" type="checkbox"/> <input type="checkbox"/>
		Impact Category: 1 2 3 4 5	<input type="checkbox"/> <input checked="" type="checkbox"/> <input type="checkbox"/> <input type="checkbox"/> <input type="checkbox"/>
Location: Basement #173	Auditors Comments: <ul style="list-style-type: none"> Cast for bored concrete pile is significantly wearing. The actual concrete pile is inside this cast and is not able to be inspected. The wearing and tearing of the pile cast has no structural implications. Drainage around this pile is poor and this is the situation around the perimeter of the basement. Silt / gravel build up is evident around the perimeter of the site.

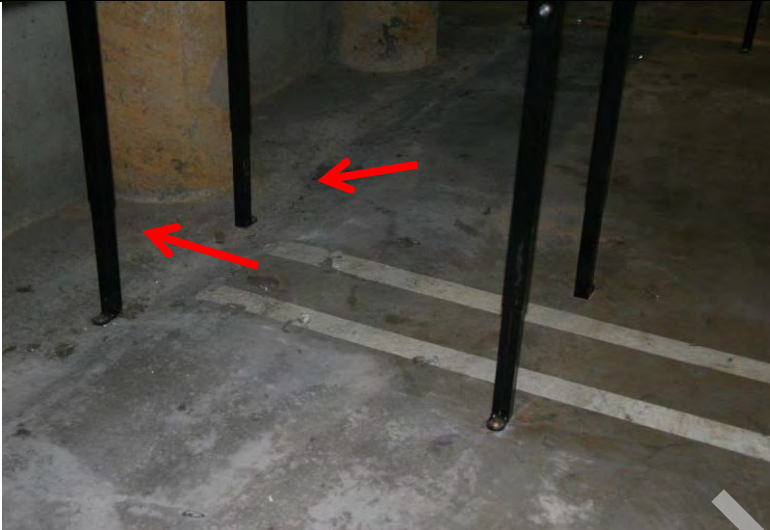
Assessment Type: Good <input type="checkbox"/> Fair <input type="checkbox"/> Poor <input checked="" type="checkbox"/>	<input checked="" type="checkbox"/> <input type="checkbox"/> <input type="checkbox"/>
		Impact Category: 1 <input checked="" type="checkbox"/> 2 <input type="checkbox"/> 3 <input type="checkbox"/> 4 <input type="checkbox"/> 5 <input type="checkbox"/>	<input checked="" type="checkbox"/> <input type="checkbox"/> <input type="checkbox"/> <input type="checkbox"/> <input type="checkbox"/>
Location: Basement lowest level	Auditors Comments: <ul style="list-style-type: none"> Drainage channel for any excess runoff collected by the car park is obstructed in many sections around the perimeter. Channel is filled with silt, gravel etc. Also it is obstructed by the bored concrete piles.

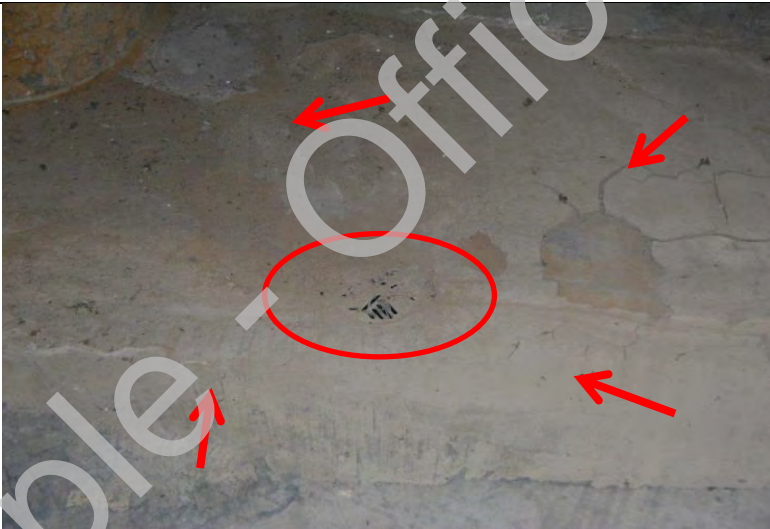
Assessment Type: Good <input type="checkbox"/> Fair <input checked="" type="checkbox"/> Poor <input type="checkbox"/>	<input type="checkbox"/> <input checked="" type="checkbox"/> <input type="checkbox"/>
		Impact Category: 1 <input type="checkbox"/> 2 <input checked="" type="checkbox"/> 3 <input type="checkbox"/> 4 <input type="checkbox"/> 5 <input type="checkbox"/>	<input type="checkbox"/> <input checked="" type="checkbox"/> <input type="checkbox"/> <input type="checkbox"/> <input type="checkbox"/>
Location: Basement lowest level	Auditors Comments: <ul style="list-style-type: none"> Drain is obstructed and silt / additional run off has pooled around the drain.

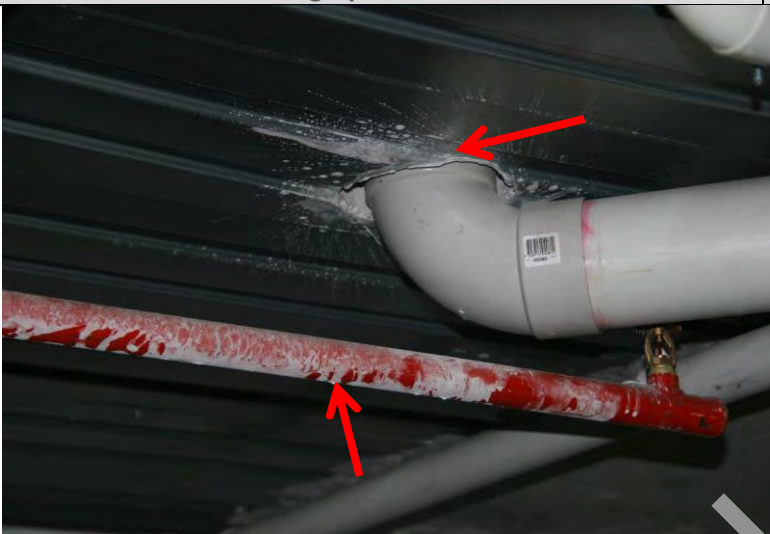
Assessment Type: Good <input type="checkbox"/> Fair <input type="checkbox"/> Poor <input checked="" type="checkbox"/>	<input type="checkbox"/> <input type="checkbox"/> <input checked="" type="checkbox"/>
		Impact Category: 1 <input type="checkbox"/> 2 <input checked="" type="checkbox"/> 3 <input type="checkbox"/> 4 <input type="checkbox"/> 5 <input type="checkbox"/>	<input type="checkbox"/> <input checked="" type="checkbox"/> <input type="checkbox"/> <input type="checkbox"/> <input type="checkbox"/>
Location: Basement lowest level	Auditors Comments: <ul style="list-style-type: none"> Unsealed penetration. Due to the unsealed penetration, there is water leaking down the pipe due to obvious staining's on the fire sprinkler pipe and stains on the bondek sheeting.

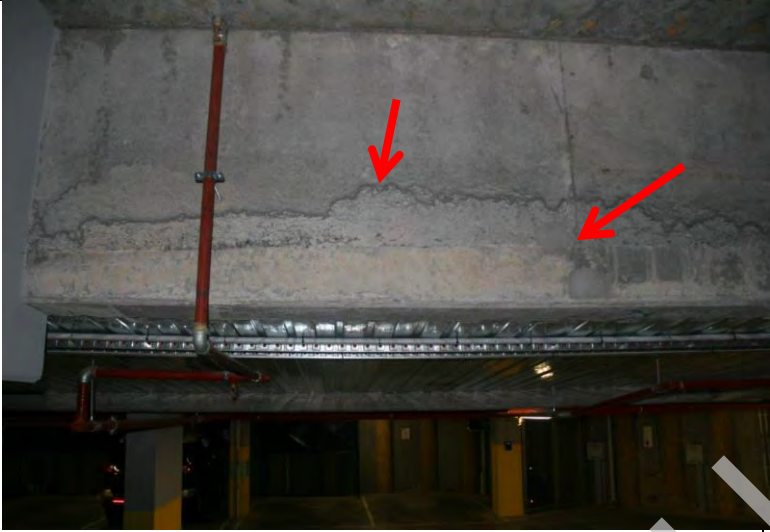
Assessment Type: Good <input type="checkbox"/> Fair <input checked="" type="checkbox"/> Poor <input type="checkbox"/>	<input type="checkbox"/> <input checked="" type="checkbox"/> <input type="checkbox"/>
		Impact Category: 1 <input type="checkbox"/> 2 <input checked="" type="checkbox"/> 3 <input type="checkbox"/> 4 <input type="checkbox"/> 5 <input type="checkbox"/>	<input type="checkbox"/> <input checked="" type="checkbox"/> <input type="checkbox"/> <input type="checkbox"/> <input type="checkbox"/>
Location: Basement wall	Auditors Comments: <ul style="list-style-type: none"> Concrete has been poured in stages. This has led to a poor finish to this wall. Cracking or separations should be monitored. Cracking, dents and separation gaps are mainly due to the wear and tear experienced by the wall over time and because the concrete was poured in stages.

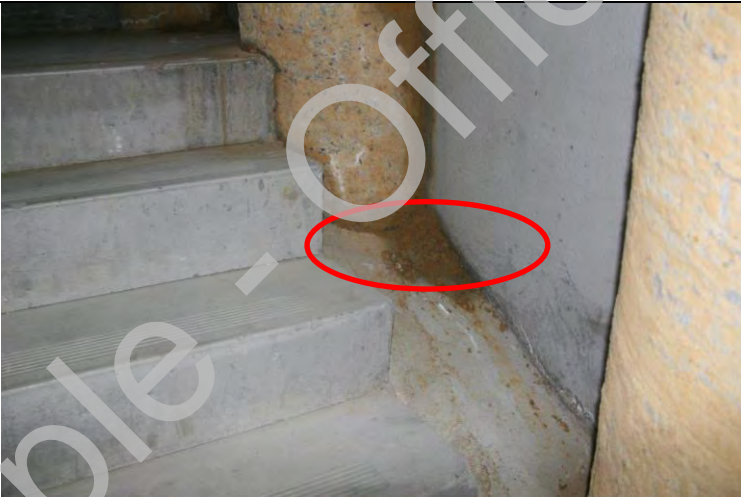
Assessment Type: Good <input type="checkbox"/> Fair <input checked="" type="checkbox"/> Poor <input type="checkbox"/>	<input type="checkbox"/> <input checked="" type="checkbox"/> <input type="checkbox"/>
		Impact Category: 1 <input type="checkbox"/> 2 <input checked="" type="checkbox"/> 3 <input type="checkbox"/> 4 <input type="checkbox"/> 5 <input type="checkbox"/>	<input type="checkbox"/> <input checked="" type="checkbox"/> <input type="checkbox"/> <input type="checkbox"/> <input type="checkbox"/>
Location: Stairs – Fire exit – along the rear wall of #173	Auditors Comments: <ul style="list-style-type: none"> Moisture has infiltrated through the casing of the bored pile. Soil is loaded up against this basement wall because the basement wall is lower than the construction site #7 Belford Street. Soil contains moisture and a water table may also be present at this depth of the construction site. This may have resulted in seepage through the eroded casing of the bored pile. A future concern may be the excess runoff that could be generated because of this construction site. More seepage could be experienced along this basement wall in the future. The basement concrete walls are in good condition nonetheless.

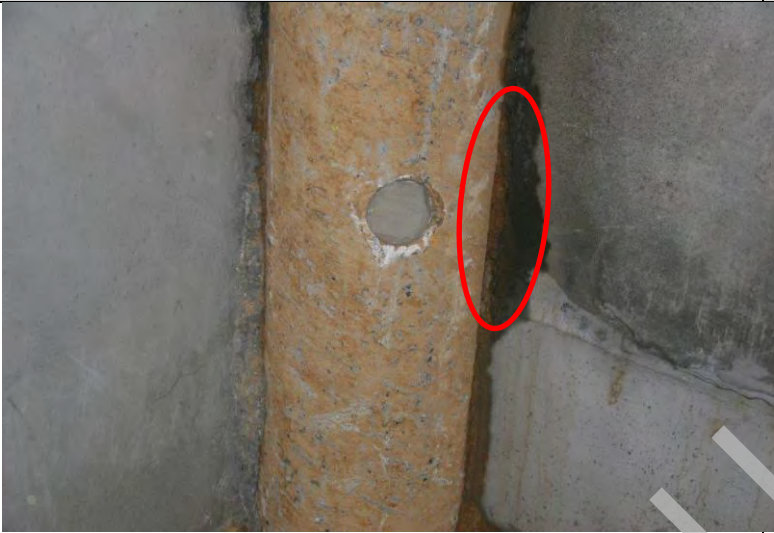
Assessment Type: Good Fair Poor	<input type="checkbox"/> <input checked="" type="checkbox"/> <input type="checkbox"/>
		Impact Category: 1 2 3 4 5	<input type="checkbox"/> <input checked="" type="checkbox"/> <input type="checkbox"/> <input type="checkbox"/> <input type="checkbox"/>
Location: Stairs –Fire exit – along the rear	Auditors Comments: <ul style="list-style-type: none"> Moisture has infiltrated through the casing of the bored pile. Soil is loaded up against this basement wall because it is lower than the construction site #7 Belford Street. Soil contains moisture and a water table may also be present at this depth of the construction site. This may have resulted in seepage through the eroded casing of the bored pile. A future concern may be the excess runoff that could be generated because of this construction site. More seepage could be experienced along this basement wall in the future. The basement concrete walls are in good condition nonetheless. The piles are obviously restricted to access and assessment.

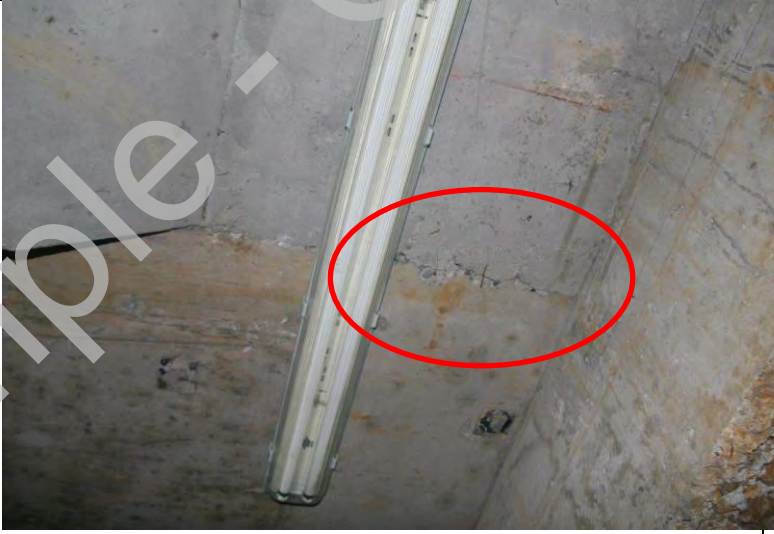
Assessment Type: Good Fair Poor	<input type="checkbox"/> <input checked="" type="checkbox"/> <input type="checkbox"/>
		Impact Category: 1 2 3 4 5	<input type="checkbox"/> <input type="checkbox"/> <input checked="" type="checkbox"/> <input type="checkbox"/> <input type="checkbox"/>
Location: Roof –Fire exit – At the	Auditors Comments: <ul style="list-style-type: none"> Cracking has occurred along the roof line of this section of the fire exit. The cracking was extensive and large. Cracking needs to be monitored but is currently structurally okay.

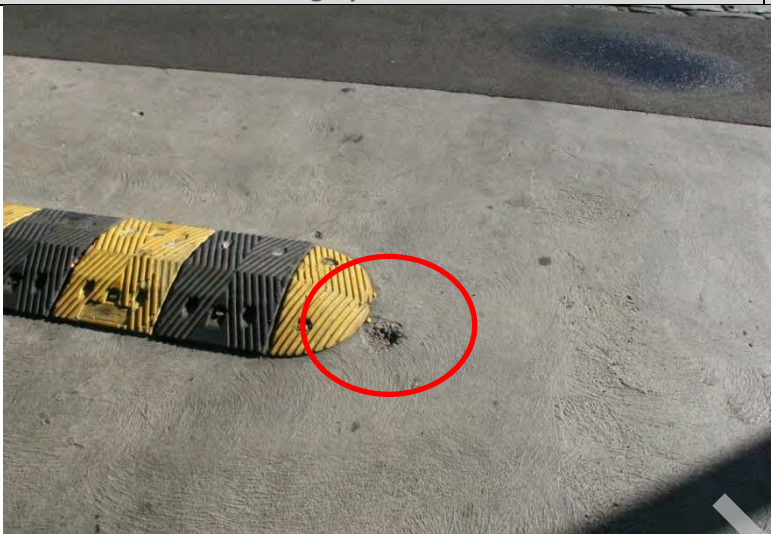
Assessment Type: Good <input type="checkbox"/> Fair <input checked="" type="checkbox"/> Poor <input type="checkbox"/>	Impact Category: 1 <input type="checkbox"/> 2 <input type="checkbox"/> 3 <input checked="" type="checkbox"/> 4 <input type="checkbox"/> 5 <input type="checkbox"/>
Location: Driveway to #173	Auditors Comments: <ul style="list-style-type: none"> Exposed hole in concrete driveway that is not in-filled.

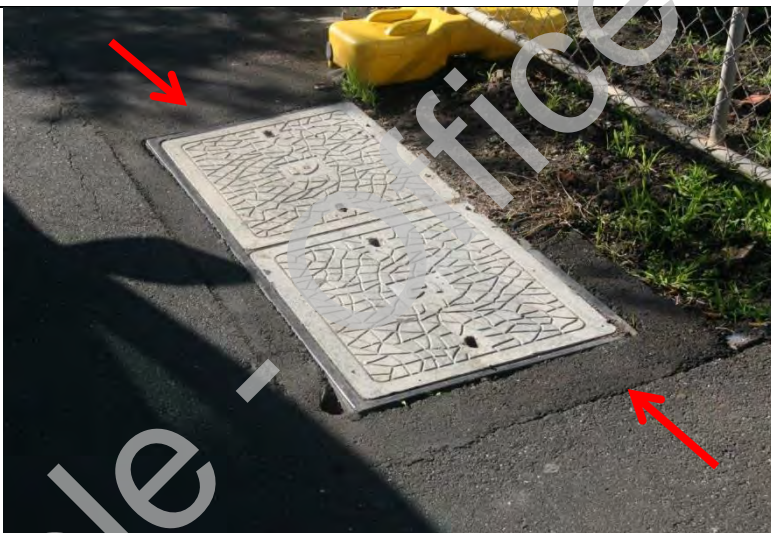
Assessment Type: Good <input type="checkbox"/> Fair <input checked="" type="checkbox"/> Poor <input type="checkbox"/>	Impact Category: 1 <input type="checkbox"/> 2 <input checked="" type="checkbox"/> 3 <input type="checkbox"/> 4 <input type="checkbox"/> 5 <input type="checkbox"/>
Location: Belford Street along construction site boundary #7	Auditors Comments: <ul style="list-style-type: none"> Telstra pit is not "at level" with existing walkway pavement. Water will retain around this pit. Cracking is also evident around the pit within the walkway pavement.
