Dilapidation Survey Report

76 Sample St Suburb VIC 3107

13 June 2014

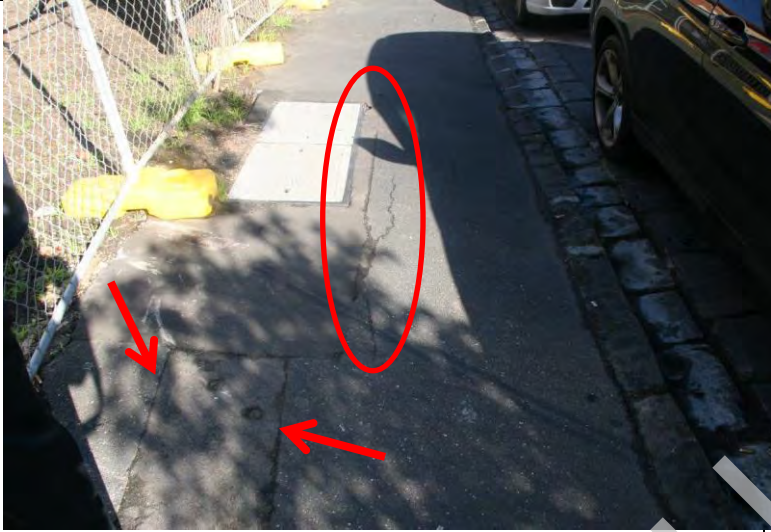
Assessment Type: Good <input type="checkbox"/> Fair <input checked="" type="checkbox"/> Poor <input type="checkbox"/>	Impact Category: 1 <input type="checkbox"/> 2 <input checked="" type="checkbox"/> 3 <input type="checkbox"/> 4 <input type="checkbox"/> 5 <input type="checkbox"/>
Location: Belford Street along construction site boundary	Auditors Comments: <ul style="list-style-type: none"> • Filler has been used to seal cracking in walkway pavement. • There is a depressed saw cut section within the concrete pit. Potentially run off may pool at this point. • Concrete kerb shows signs of wear and tear with chips taken off the top section of kerb. • Walkway pavement is scuffed up and contains small cracks.

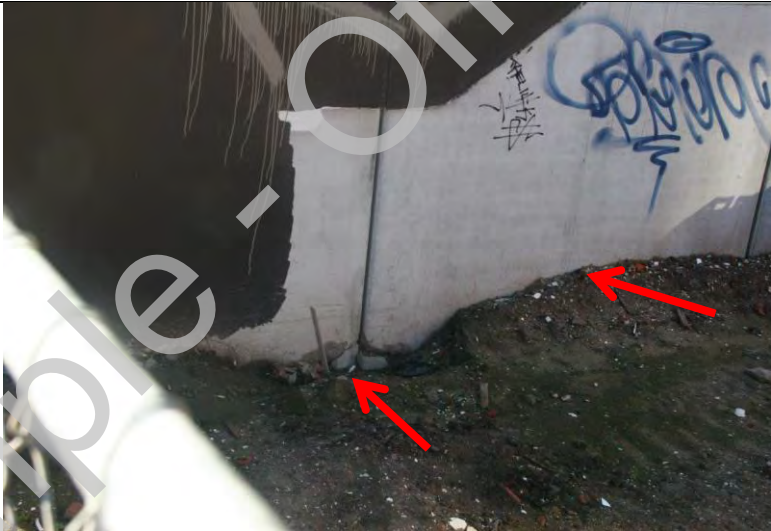
Assessment Type: Good <input type="checkbox"/> Fair <input type="checkbox"/> Poor <input checked="" type="checkbox"/>	Impact Category: 1 <input type="checkbox"/> 2 <input type="checkbox"/> 3 <input checked="" type="checkbox"/> 4 <input type="checkbox"/> 5 <input type="checkbox"/>
Location: Located at the rear external wall of building	Auditors Comments: <ul style="list-style-type: none"> • Construction site soil is pushed up against the external concrete wall panels of building #173. This can lead to structural issues and may impact the integrity of the concrete wall panels.

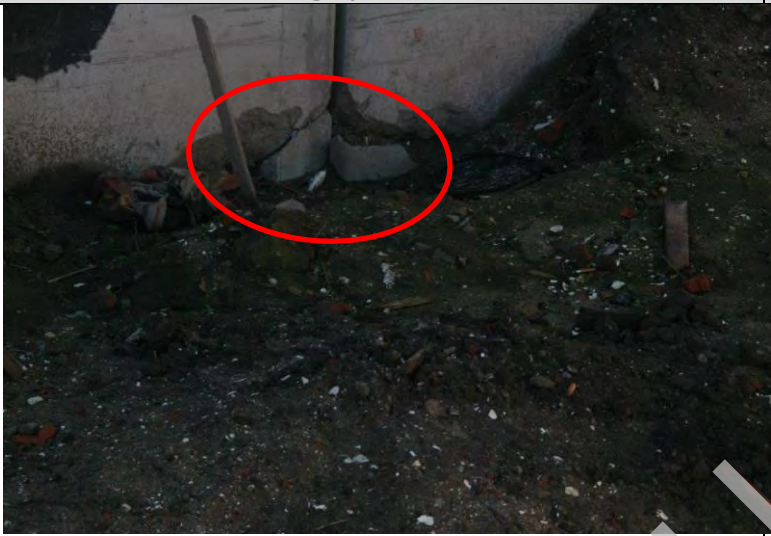
Assessment Type: Good <input type="checkbox"/> Fair <input checked="" type="checkbox"/> Poor <input type="checkbox"/>	<input type="checkbox"/> <input checked="" type="checkbox"/> <input type="checkbox"/>
		Impact Category: 1 <input type="checkbox"/> 2 <input type="checkbox"/> 3 <input checked="" type="checkbox"/> 4 <input type="checkbox"/> 5 <input type="checkbox"/>	<input type="checkbox"/> <input type="checkbox"/> <input checked="" type="checkbox"/> <input type="checkbox"/> <input type="checkbox"/>
Location: Located at the rear external wall of building	Auditors Comments: <ul style="list-style-type: none"> Construction site soil is pushed up against the external concrete wall panels of building #173. This can lead to structural issues and may impact the integrity of the concrete wall panels. Rubbish has built up at this depression in the soil. Cracking and damage has occurred to the concrete wall panel at this depression. Concrete panel wall is scuffed up and contains smaller cracks also.

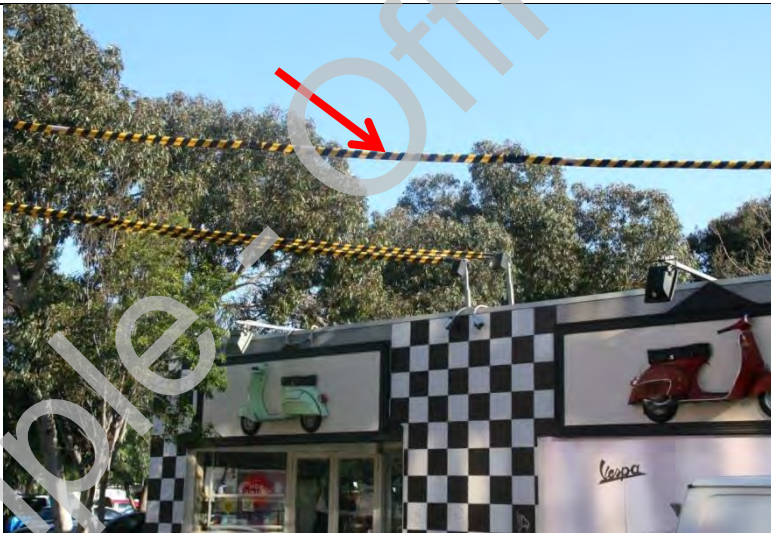
Assessment Type: Good <input checked="" type="checkbox"/> Fair <input type="checkbox"/> Poor <input type="checkbox"/>	<input checked="" type="checkbox"/> <input type="checkbox"/> <input type="checkbox"/>
		Impact Category: 1 <input checked="" type="checkbox"/> 2 <input type="checkbox"/> 3 <input type="checkbox"/> 4 <input type="checkbox"/> 5 <input type="checkbox"/>	<input checked="" type="checkbox"/> <input type="checkbox"/> <input type="checkbox"/> <input type="checkbox"/> <input type="checkbox"/>
Location:	Auditors Comments: <ul style="list-style-type: none"> The current power lines have been marked for safety reasons.

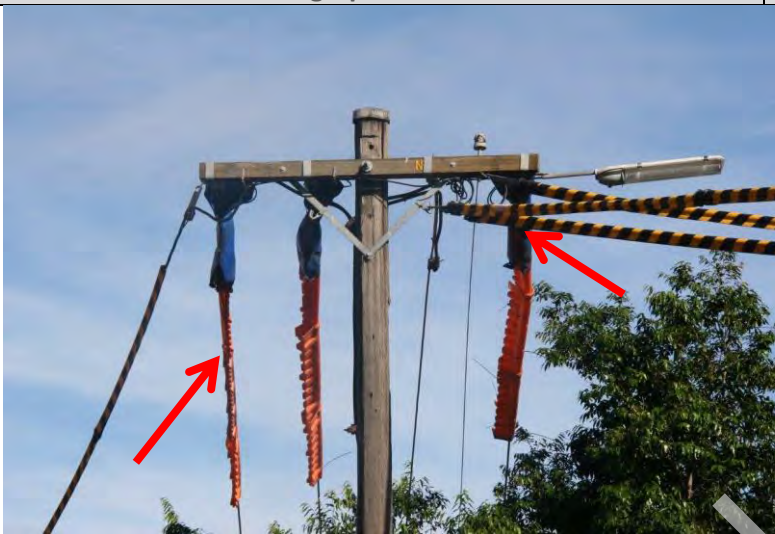
Assessment Type: Good <input type="checkbox"/> Fair <input type="checkbox"/> Poor <input type="checkbox"/>	<input checked="" type="checkbox"/> <input type="checkbox"/> <input type="checkbox"/>
		Impact Category: 1 <input checked="" type="checkbox"/> 2 <input type="checkbox"/> 3 <input type="checkbox"/> 4 <input type="checkbox"/> 5 <input type="checkbox"/>	<input checked="" type="checkbox"/> <input type="checkbox"/> <input type="checkbox"/> <input type="checkbox"/> <input type="checkbox"/>
Location:	Auditors Comments: <ul style="list-style-type: none"> The current power lines have been marked for safety reasons.

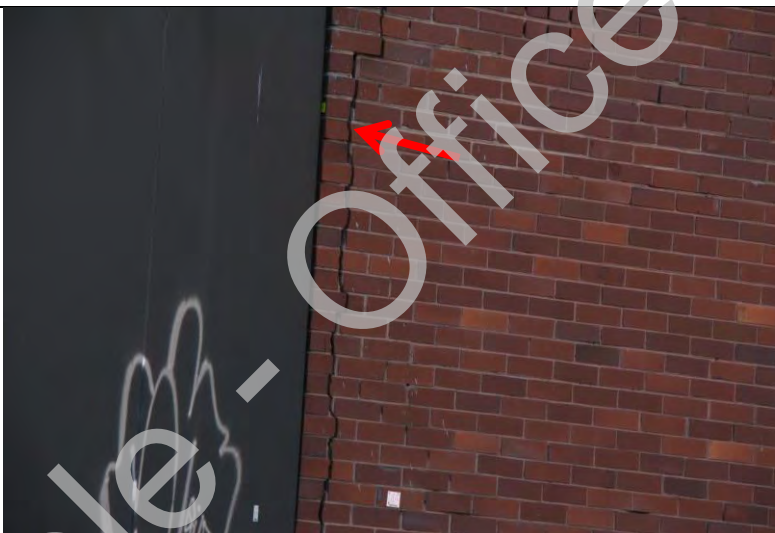
Assessment Type: Good <input type="checkbox"/> Fair <input type="checkbox"/> Poor <input checked="" type="checkbox"/>	<input type="checkbox"/> <input type="checkbox"/> <input checked="" type="checkbox"/>
		Impact Category: 1 <input type="checkbox"/> 2 <input type="checkbox"/> 3 <input type="checkbox"/> 4 <input type="checkbox"/> 5 <input checked="" type="checkbox"/>	<input type="checkbox"/> <input type="checkbox"/> <input type="checkbox"/> <input type="checkbox"/> <input checked="" type="checkbox"/>
Location:	Auditors Comments: <ul style="list-style-type: none"> This rigid brick wall is not a part of building #173. It is the external wall face of the building that is located next to #173 in question. This cracking is major and extends from almost the ground level to the top of the wall. The structural integrity of this wall should be assessed before construction continues; as collapse could be a major disaster for the workers of the construction site and also building #173.

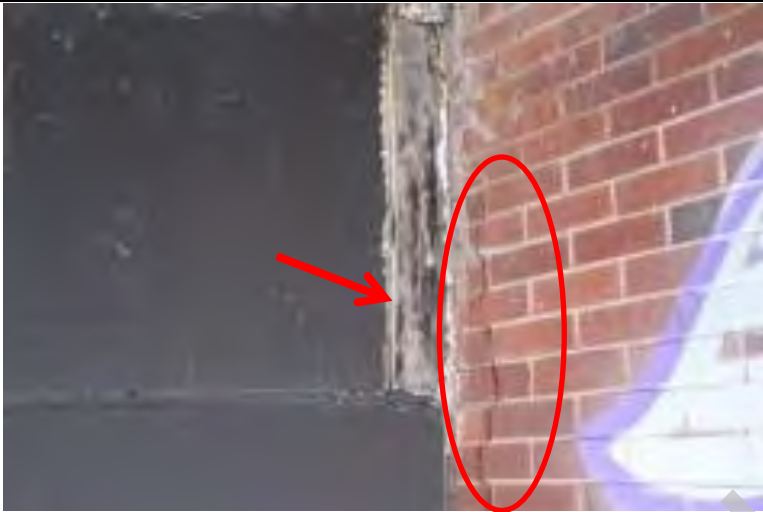
Assessment Type: Good <input type="checkbox"/> Fair <input type="checkbox"/> Poor <input checked="" type="checkbox"/>	<input type="checkbox"/> <input type="checkbox"/> <input checked="" type="checkbox"/>
		Impact Category: 1 <input type="checkbox"/> 2 <input type="checkbox"/> 3 <input type="checkbox"/> 4 <input type="checkbox"/> 5 <input checked="" type="checkbox"/>	<input type="checkbox"/> <input type="checkbox"/> <input type="checkbox"/> <input type="checkbox"/> <input checked="" type="checkbox"/>
Location: Rear external wall of building	Auditors Comments: <ul style="list-style-type: none"> • Timber formwork has fallen out of place. • Concrete wall panel is exposed. It is cracking at the bottom and top of the concrete wall panel. • The separate brick wall has also experienced excessive cracking. • This is an exposed concrete wall panel that sticks out from the continuous external concrete wall. A structural or foundation specialist engineer should assess the cracking in the brick wall before major construction begins. The concrete wall panel should also be assessed and repaired if necessary.

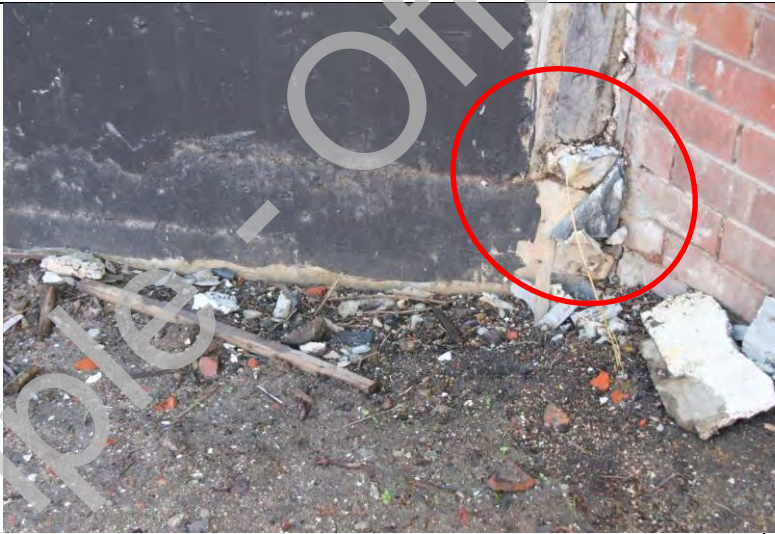
Assessment Type: Good <input type="checkbox"/> Fair <input type="checkbox"/> Poor <input checked="" type="checkbox"/>	<input type="checkbox"/> <input type="checkbox"/> <input checked="" type="checkbox"/>
		Impact Category: 1 <input type="checkbox"/> 2 <input type="checkbox"/> 3 <input type="checkbox"/> 4 <input type="checkbox"/> 5 <input checked="" type="checkbox"/>	<input type="checkbox"/> <input type="checkbox"/> <input type="checkbox"/> <input type="checkbox"/> <input checked="" type="checkbox"/>
Location: South boundary of	Auditors Comments: <ul style="list-style-type: none"> • Formwork is poorly finished and has collapsed. • Concrete panel has cracked at the base. Should be assessed and then repaired.

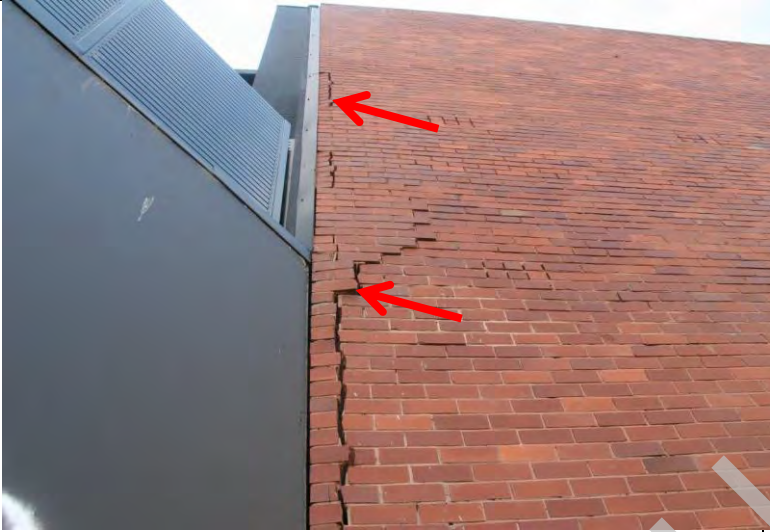
Assessment Type: Good <input type="checkbox"/> Fair <input type="checkbox"/> Poor <input checked="" type="checkbox"/>	<input type="checkbox"/> <input checked="" type="checkbox"/>
		Impact Category: 1 <input type="checkbox"/> 2 <input type="checkbox"/> 3 <input type="checkbox"/> 4 <input type="checkbox"/> 5 <input checked="" type="checkbox"/>	<input type="checkbox"/> <input type="checkbox"/> <input type="checkbox"/> <input type="checkbox"/> <input checked="" type="checkbox"/>
Location: Rear external wall of building	Auditors Comments: <ul style="list-style-type: none"> This rigid brick wall is not a part of building #173. It is the external wall face of the building that is adjoined to #173. This cracking is major and extends from almost the ground level to the top of the wall. The structural integrity of this wall should be assessed before construction continues; as collapse could be a major disaster for the workers of the construction site and also building #173.

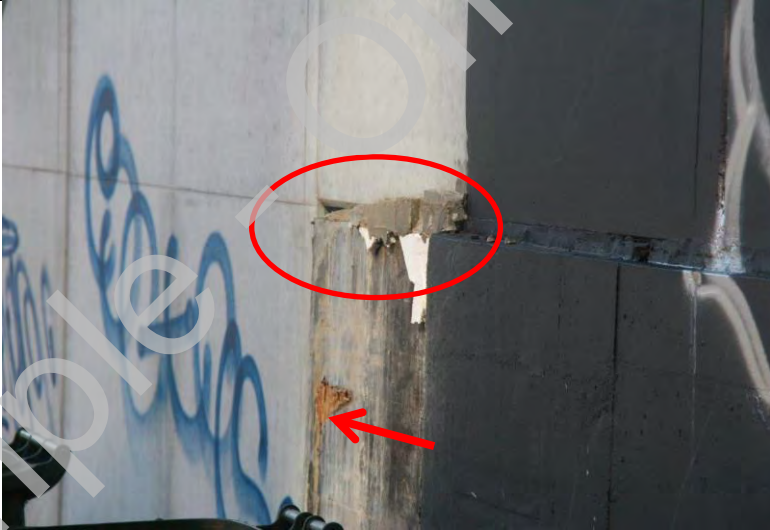
Assessment Type: Good <input type="checkbox"/> Fair <input type="checkbox"/> Poor <input checked="" type="checkbox"/>	<input type="checkbox"/> <input type="checkbox"/> <input checked="" type="checkbox"/>
		Impact Category: 1 <input type="checkbox"/> 2 <input type="checkbox"/> 3 <input type="checkbox"/> 4 <input checked="" type="checkbox"/> 5 <input type="checkbox"/>	<input type="checkbox"/> <input type="checkbox"/> <input type="checkbox"/> <input checked="" type="checkbox"/> <input type="checkbox"/>
Location: Rear external wall of building	Auditors Comments: <ul style="list-style-type: none"> Concrete wall panel is sticking out and does not finish evenly with the remaining wall structure. Formwork and fillers are clearly sticking out of the excessive expansion gaps. The concrete panel has also been chipped and is damaged throughout the panel. This panel should be properly assessed and fixed appropriately; as this panel is located along the corresponding critical wall that comprises the rear wall of the building #173 and the northern boundary of #7 construction site. This may result in cracking along other concrete panels of this wall if not assessed and properly fixed.

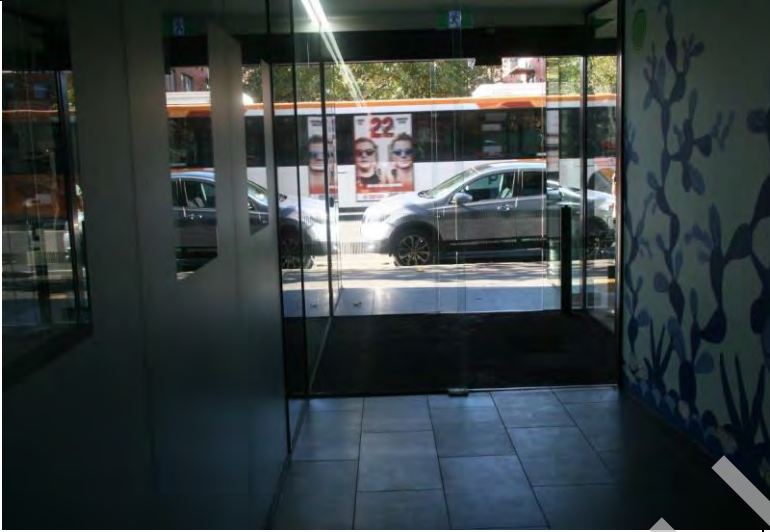
Assessment Type: Good <input checked="" type="checkbox"/> Fair <input type="checkbox"/> Poor <input type="checkbox"/>	<input checked="" type="checkbox"/> <input type="checkbox"/> <input type="checkbox"/>
		Impact Category: 1 <input checked="" type="checkbox"/> 2 <input type="checkbox"/> 3 <input type="checkbox"/> 4 <input type="checkbox"/> 5 <input type="checkbox"/>	<input checked="" type="checkbox"/> <input type="checkbox"/> <input type="checkbox"/> <input type="checkbox"/> <input type="checkbox"/>
Location: Exit from Foyer to	Auditors Comments: <ul style="list-style-type: none"> Flooring is in good condition. Walls also show no visible signs of cracking.

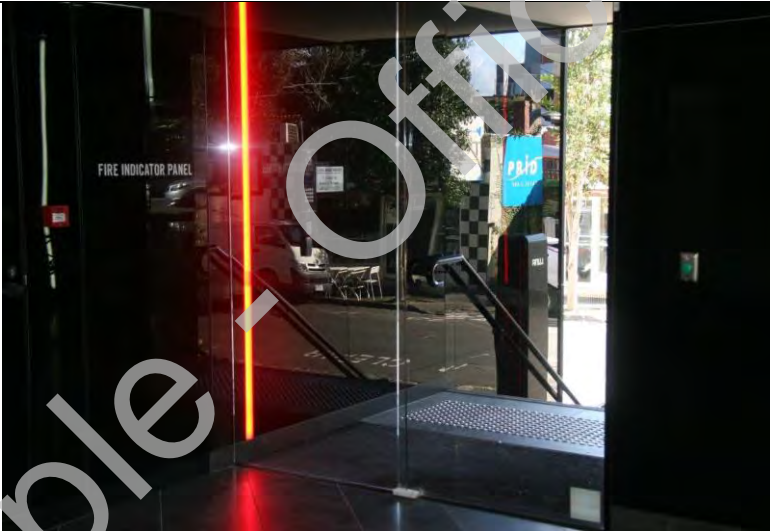
Assessment Type: Good <input checked="" type="checkbox"/> Fair <input type="checkbox"/> Poor <input type="checkbox"/>	<input checked="" type="checkbox"/> <input type="checkbox"/> <input type="checkbox"/>
		Impact Category: 1 <input checked="" type="checkbox"/> 2 <input type="checkbox"/> 3 <input type="checkbox"/> 4 <input type="checkbox"/> 5 <input type="checkbox"/>	<input checked="" type="checkbox"/> <input type="checkbox"/> <input type="checkbox"/> <input type="checkbox"/> <input type="checkbox"/>
Location: Foyer section of building	Auditors Comments: <ul style="list-style-type: none"> Foyer is in excellent condition. The glass backed panels that cover the concrete walls restricted access to assess any cracking of the concrete walls. Glass backed walls are in extremely good condition.

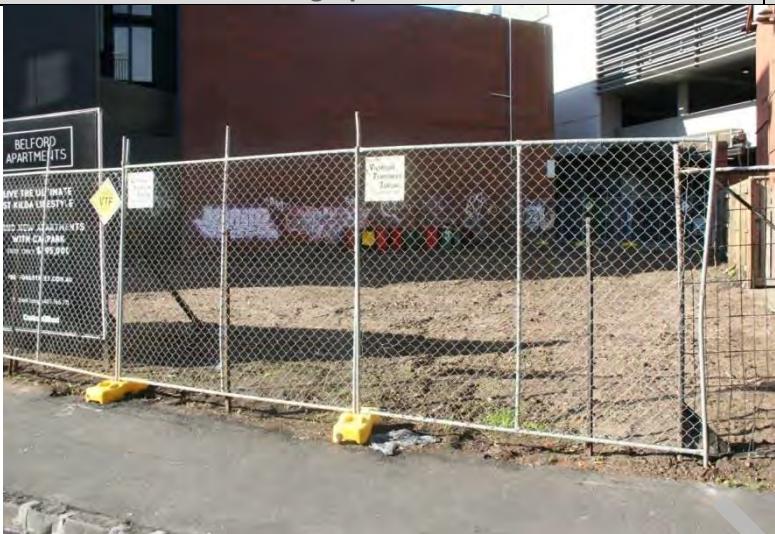
Assessment Type: Good <input type="checkbox"/> Fair <input type="checkbox"/> Poor <input type="checkbox"/>	<input type="checkbox"/> <input type="checkbox"/> <input type="checkbox"/>
		Impact Category: 1 <input type="checkbox"/> 2 <input type="checkbox"/> 3 <input type="checkbox"/> 4 <input type="checkbox"/> 5 <input type="checkbox"/>	<input type="checkbox"/> <input type="checkbox"/> <input type="checkbox"/> <input type="checkbox"/> <input type="checkbox"/>
Location:	Auditors Comments: <ul style="list-style-type: none"> General view of construction works at #7 Belford Street
