# Dilapidation Survey Report

1 Sample Street, Melbourne VIC 3022

9 March 2017

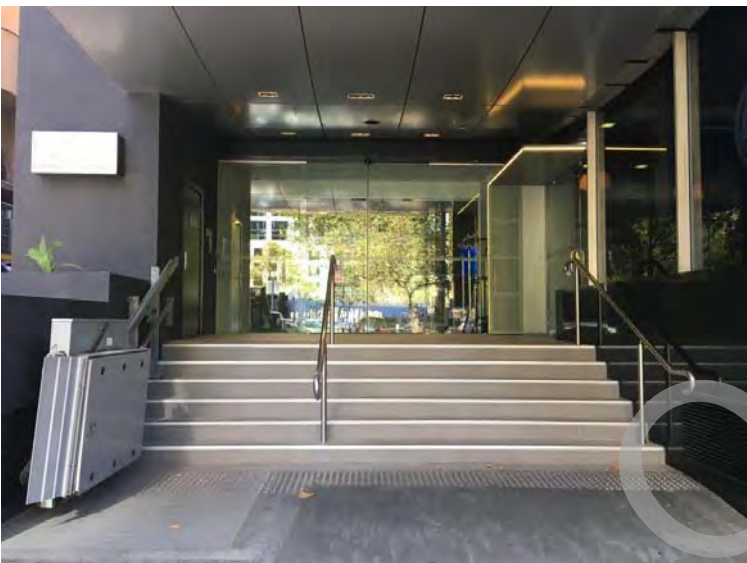
Item	Photographic Evidence	Assessments	
1.

<b>Assessment Type:</b>  Good <input type="checkbox"/> Fair <input type="checkbox"/> Poor <input type="checkbox"/>	<input checked="" type="checkbox"/> <input type="checkbox"/> <input type="checkbox"/>
		<b>Impact Category:</b>  1 <input checked="" type="checkbox"/> 2 <input type="checkbox"/> 3 <input type="checkbox"/> 4 <input type="checkbox"/> 5 <input type="checkbox"/>	<input checked="" type="checkbox"/> <input type="checkbox"/> <input type="checkbox"/> <input type="checkbox"/> <input type="checkbox"/>
<b>Location:</b> Entrance	<b>Auditors Comments:</b> <ul style="list-style-type: none"> <li>General view of the property's entrance.</li> <li>General condition of the property's entrance was good.</li> </ul>

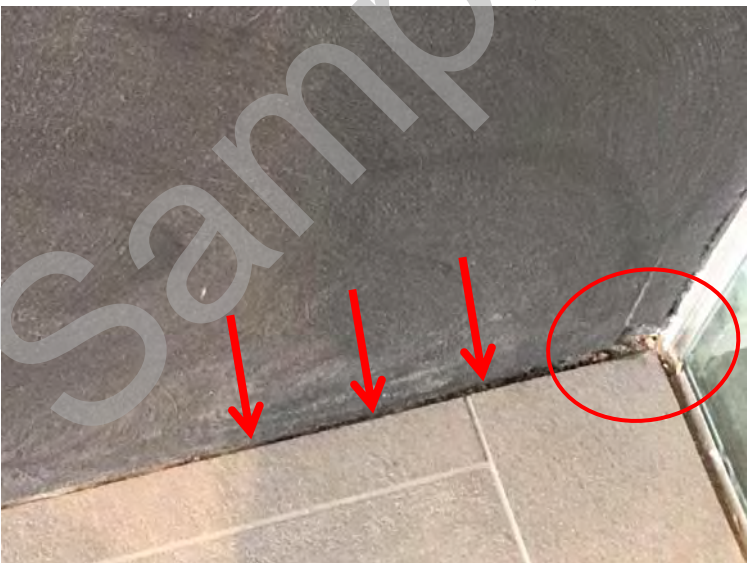
2.

<b>Assessment Type:</b>  Good <input type="checkbox"/> Fair <input checked="" type="checkbox"/> Poor <input type="checkbox"/>	<input type="checkbox"/> <input checked="" type="checkbox"/> <input type="checkbox"/>
		<b>Impact Category:</b>  1 <input type="checkbox"/> 2 <input checked="" type="checkbox"/> 3 <input type="checkbox"/> 4 <input type="checkbox"/> 5 <input type="checkbox"/>	<input type="checkbox"/> <input checked="" type="checkbox"/> <input type="checkbox"/> <input type="checkbox"/> <input type="checkbox"/>
<b>Location:</b> Entrance – Northern Side	<b>Auditors Comments:</b> <ul style="list-style-type: none"> <li>Existing gap was found between the tiled floor and wall.</li> <li>Minor crack and chipping of wall was also visible.</li> </ul>

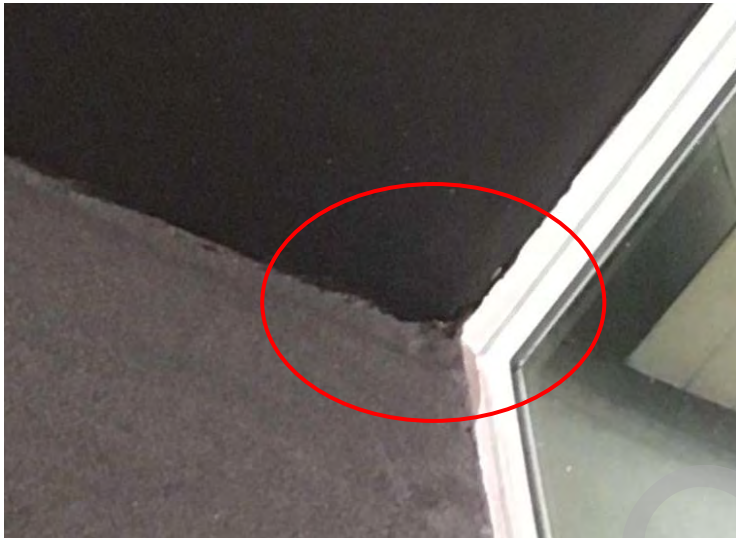
<b>Assessment Type:</b>  Good <input type="checkbox"/> Fair <input checked="" type="checkbox"/> Poor <input type="checkbox"/>	<input type="checkbox"/> <input checked="" type="checkbox"/> <input type="checkbox"/>
		<b>Impact Category:</b>  1 <input type="checkbox"/> 2 <input checked="" type="checkbox"/> 3 <input type="checkbox"/> 4 <input type="checkbox"/> 5 <input type="checkbox"/>	<input type="checkbox"/> <input checked="" type="checkbox"/> <input type="checkbox"/> <input type="checkbox"/> <input type="checkbox"/>
<b>Location:</b> Entrance – Northern Side	<b>Auditors Comments:</b> <ul style="list-style-type: none"> <li>Minor crack and chipping of wall was visible at the northern corner of the wall at the entrance.</li> </ul>

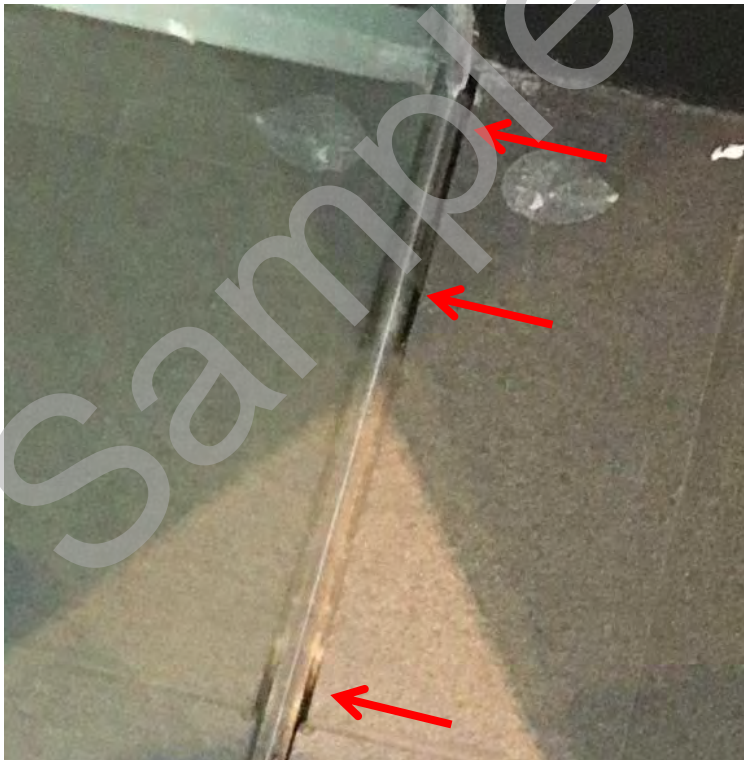
4.

<b>Assessment Type:</b>  Good <input type="checkbox"/> Fair <input checked="" type="checkbox"/> Poor <input type="checkbox"/>	<input type="checkbox"/> <input checked="" type="checkbox"/> <input type="checkbox"/>
		<b>Impact Category:</b>  1 <input type="checkbox"/> 2 <input checked="" type="checkbox"/> 3 <input type="checkbox"/> 4 <input type="checkbox"/> 5 <input type="checkbox"/>	<input type="checkbox"/> <input checked="" type="checkbox"/> <input type="checkbox"/> <input type="checkbox"/> <input type="checkbox"/>
<b>Location:</b> Entrance – Southeast Side	<b>Auditors Comments:</b> <ul style="list-style-type: none"> <li>Existing deteriorated grout was visible situated between the tiled floor and glazed window.</li> </ul>

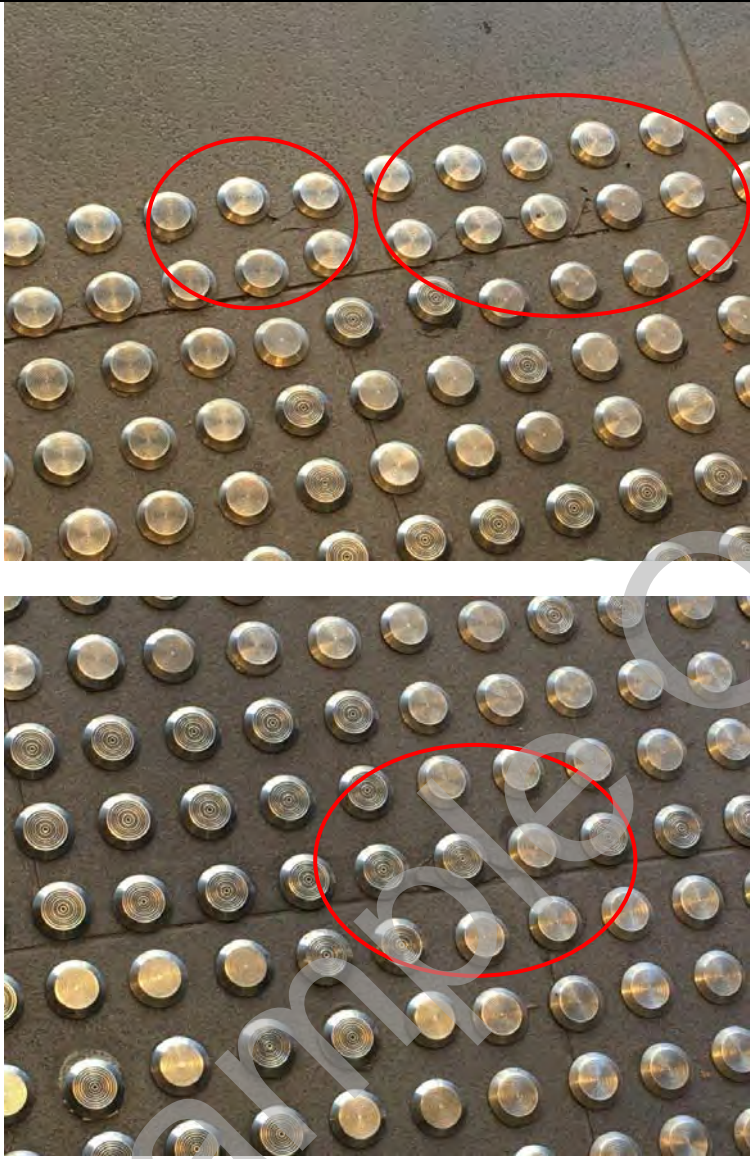
<b>Assessment Type:</b>  Good <input type="checkbox"/> Fair <input checked="" type="checkbox"/> Poor <input type="checkbox"/>	<input type="checkbox"/> <input checked="" type="checkbox"/> <input type="checkbox"/>
		<b>Impact Category:</b>  1 <input checked="" type="checkbox"/> 2 <input type="checkbox"/> 3 <input type="checkbox"/> 4 <input type="checkbox"/> 5 <input type="checkbox"/>	<input checked="" type="checkbox"/> <input type="checkbox"/> <input type="checkbox"/> <input type="checkbox"/> <input type="checkbox"/>
<b>Location:</b> Entrance	<b>Auditors Comments:</b> <ul style="list-style-type: none"> <li>Minor cracking and normal wear and tear of the tiled floor at the entrance on tactile surface.</li> </ul>

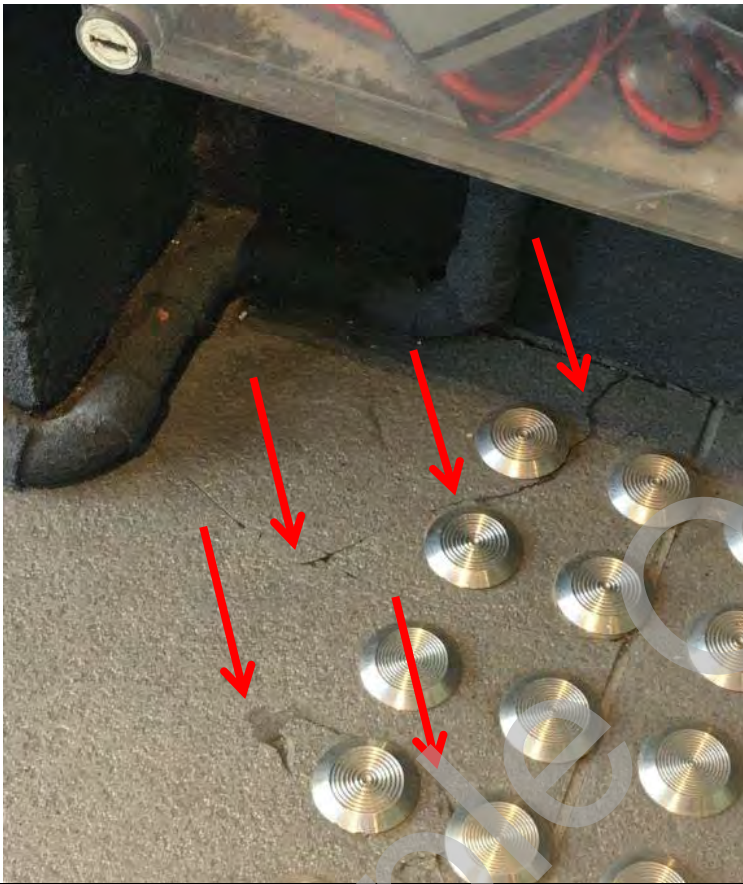
<u>Assessment Type:</u>  Good Fair Poor	<input type="checkbox"/> <input checked="" type="checkbox"/> <input type="checkbox"/>
		<u>Impact Category:</u>  1 2 3 4 5	<input checked="" type="checkbox"/> <input type="checkbox"/> <input type="checkbox"/> <input type="checkbox"/> <input type="checkbox"/>
<u>Location:</u> Entrance	<u>Auditors Comments:</u> <ul style="list-style-type: none"> <li>Hairline cracks were visible on the floor tile of the entrance.</li> </ul>

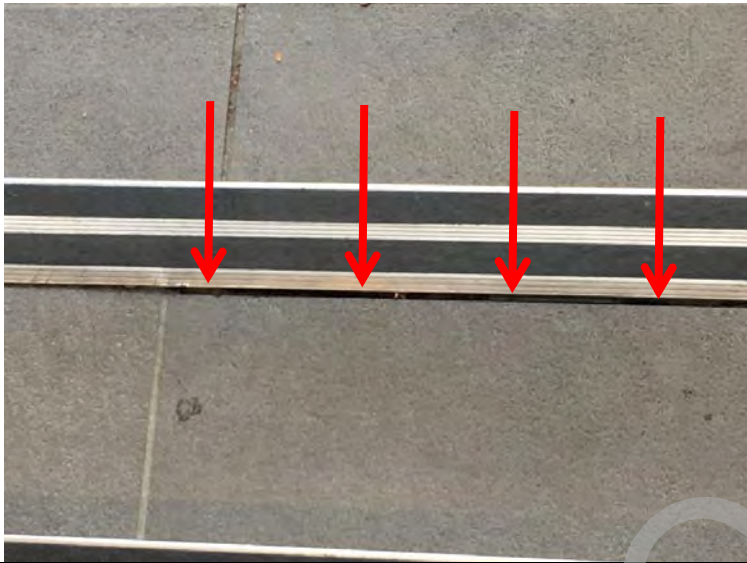
<b>Assessment Type:</b>  Good Fair Poor	<input type="checkbox"/> <input checked="" type="checkbox"/> <input type="checkbox"/>
		<b>Impact Category:</b>  1 2 3 4 5	<input checked="" type="checkbox"/> <input type="checkbox"/> <input type="checkbox"/> <input type="checkbox"/> <input type="checkbox"/>
<b>Location:</b> Entrance - Staircase	<b>Auditors Comments:</b> <ul style="list-style-type: none"> <li>Gap was present between the nosing and the step</li> </ul>

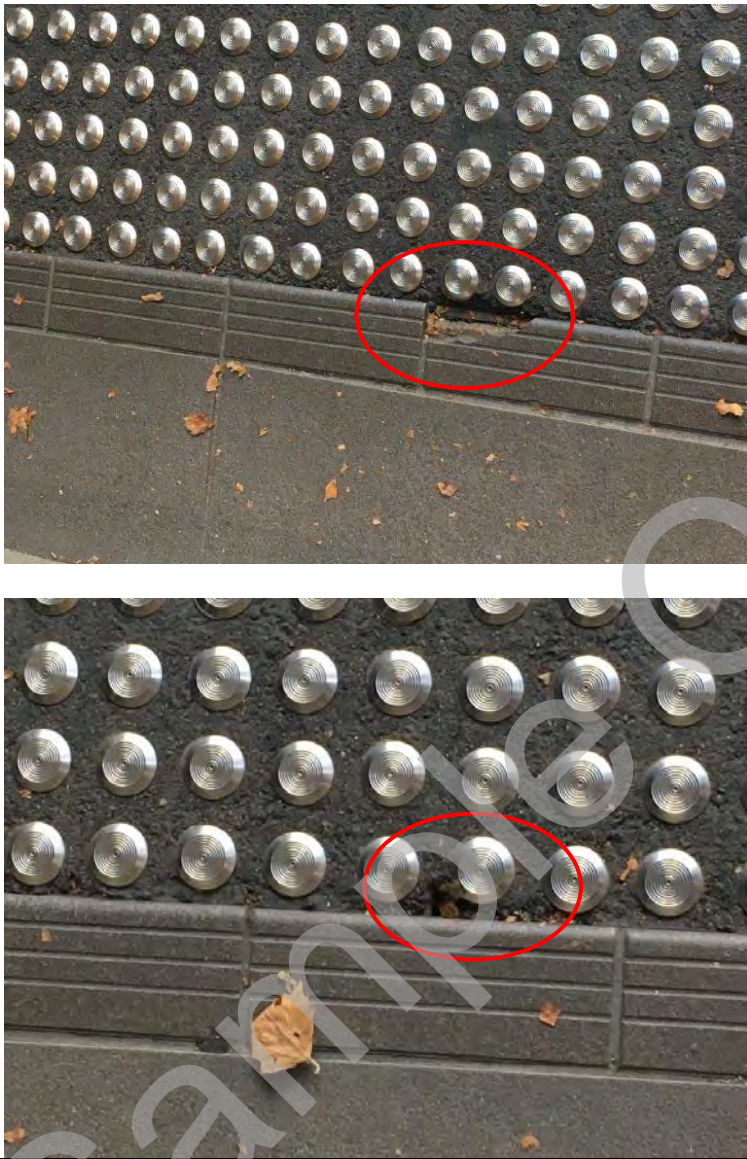
<b>Assessment Type:</b>  Good <input type="checkbox"/> Fair <input type="checkbox"/> Poor <input checked="" type="checkbox"/>	<input type="checkbox"/> <input type="checkbox"/> <input checked="" type="checkbox"/>
		<b>Impact Category:</b>  1 <input type="checkbox"/> 2 <input checked="" type="checkbox"/> 3 <input type="checkbox"/> 4 <input type="checkbox"/> 5 <input type="checkbox"/>	<input type="checkbox"/> <input checked="" type="checkbox"/> <input type="checkbox"/> <input type="checkbox"/> <input type="checkbox"/>
<b>Location:</b> Entrance – Staircase landing	<b>Auditors Comments:</b> <ul style="list-style-type: none"> <li>Cracking at the edge of the floor tile was visible</li> <li>A crack/indentation of the asphalt was evident.</li> </ul>

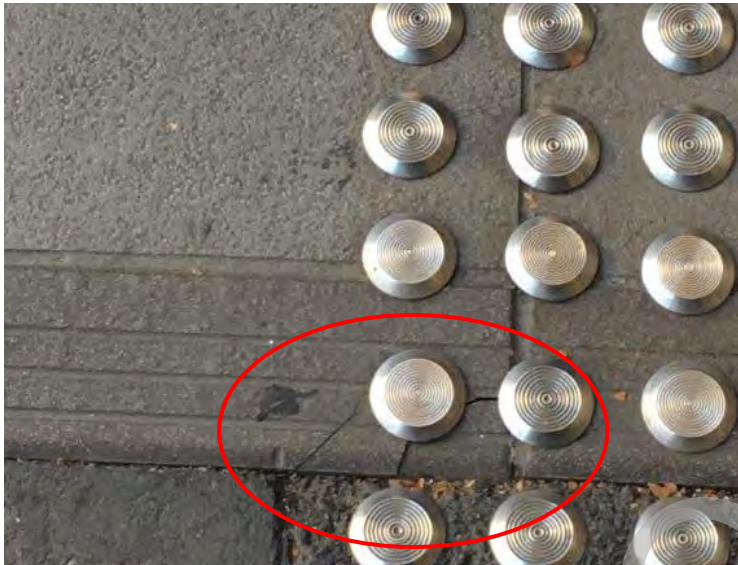
<b>Assessment Type:</b>  Good Fair Poor	<input checked="" type="checkbox"/> <input type="checkbox"/> <input type="checkbox"/>
		<b>Impact Category:</b>  1 2 3 4 5	<input checked="" type="checkbox"/> <input type="checkbox"/> <input type="checkbox"/> <input type="checkbox"/> <input type="checkbox"/>
<b>Location:</b> Entrance – Staircase landing	<b>Auditors Comments:</b> <ul style="list-style-type: none"> <li>Concrete footpath has minor cracks and is discoloured near the entrance gate of Unit 2.</li> <li>Concrete slab in front of entrance gate generally shows signs of wear and tear.</li> </ul>

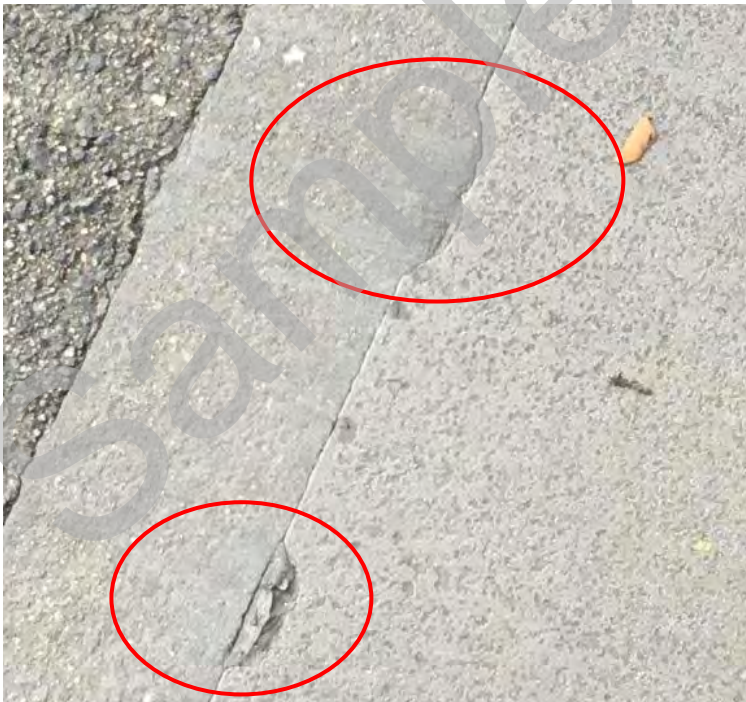
10.

<b>Assessment Type:</b>  Good Fair Poor	<input type="checkbox"/> <input checked="" type="checkbox"/> <input type="checkbox"/>
		<b>Impact Category:</b>  1 2 3 4 5	<input checked="" type="checkbox"/> <input type="checkbox"/> <input type="checkbox"/> <input type="checkbox"/> <input type="checkbox"/>
<b>Location:</b> Entrance – Near council footpath	<b>Auditors Comments:</b> <ul style="list-style-type: none"> <li>Concrete surface has minor cracks and indentation.</li> </ul>

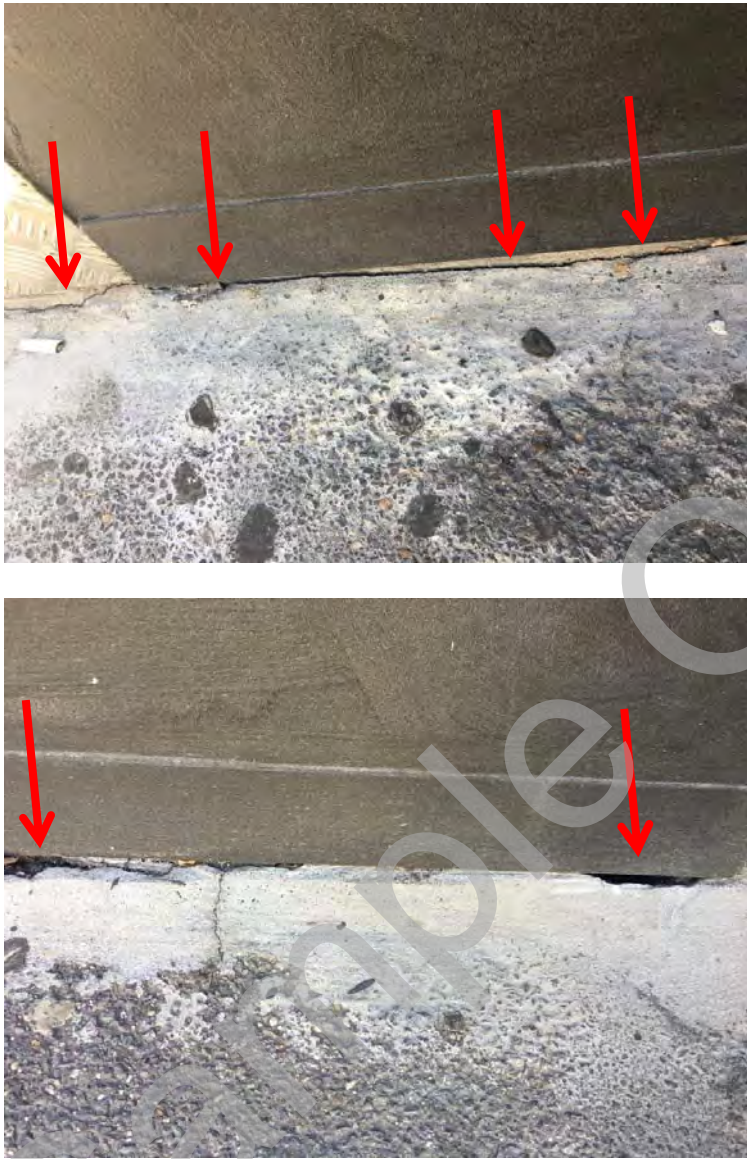
<b>Assessment Type:</b>  Good <input type="checkbox"/> Fair <input type="checkbox"/> Poor <input checked="" type="checkbox"/>	<input type="checkbox"/> <input type="checkbox"/> <input checked="" type="checkbox"/>
		<b>Impact Category:</b>  1 <input type="checkbox"/> 2 <input type="checkbox"/> 3 <input checked="" type="checkbox"/> 4 <input type="checkbox"/> 5 <input type="checkbox"/>	<input type="checkbox"/> <input type="checkbox"/> <input checked="" type="checkbox"/> <input type="checkbox"/> <input type="checkbox"/>
<b>Location:</b> Sample Street - Pavement	<b>Auditors Comments:</b> <ul style="list-style-type: none"> <li>Gap was visible between the asphalt pavement and wall.</li> <li>Rendering of wall is generally good, asphalt floor is heavily stained.</li> </ul>

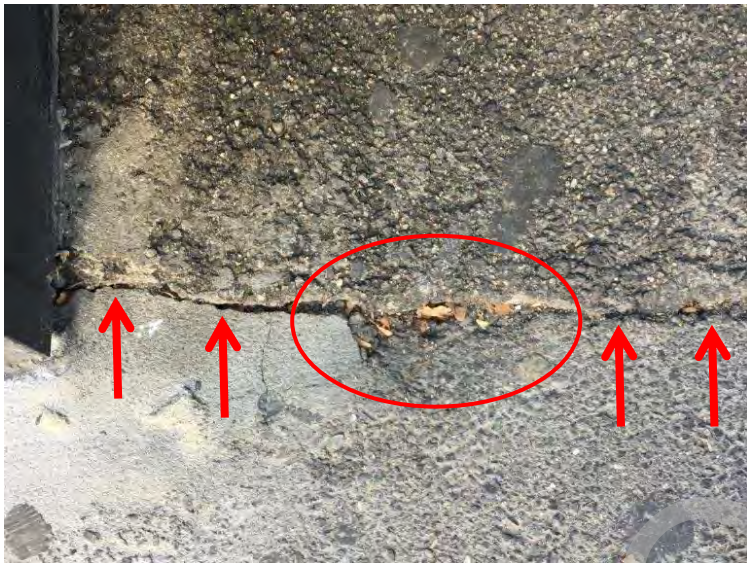
<b>Assessment Type:</b>  Good <input type="checkbox"/> Fair <input type="checkbox"/> Poor <input checked="" type="checkbox"/>	<input type="checkbox"/> <input type="checkbox"/> <input checked="" type="checkbox"/>
		<b>Impact Category:</b>  1 <input type="checkbox"/> 2 <input checked="" type="checkbox"/> 3 <input type="checkbox"/> 4 <input type="checkbox"/> 5 <input type="checkbox"/>	<input type="checkbox"/> <input checked="" type="checkbox"/> <input type="checkbox"/> <input type="checkbox"/> <input type="checkbox"/>
<b>Location:</b> Sample Street – Pavement	<b>Auditors Comments:</b> <ul style="list-style-type: none"> <li>Cracking of the asphalt was evident outside the entrance of the property.</li> </ul>

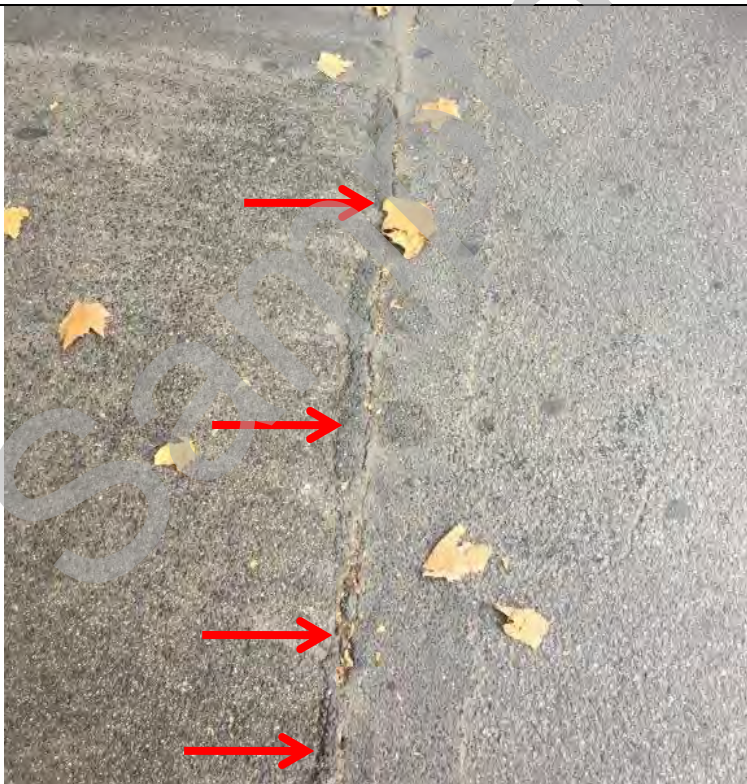
13.

<b>Assessment Type:</b>  Good <input type="checkbox"/> Fair <input type="checkbox"/> Poor <input checked="" type="checkbox"/>	<input type="checkbox"/> <input type="checkbox"/> <input checked="" type="checkbox"/>
		<b>Impact Category:</b>  1 <input type="checkbox"/> 2 <input checked="" type="checkbox"/> 3 <input type="checkbox"/> 4 <input type="checkbox"/> 5 <input type="checkbox"/>	<input type="checkbox"/> <input checked="" type="checkbox"/> <input type="checkbox"/> <input type="checkbox"/> <input type="checkbox"/>
<b>Location:</b> Sample Street - Pavement	<b>Auditors Comments:</b> <ul style="list-style-type: none"> <li>Parts of asphalt pavement in front of the property was poorly finished.</li> <li>Cracks were evident at the boundary between property footpath and council footpath.</li> </ul>

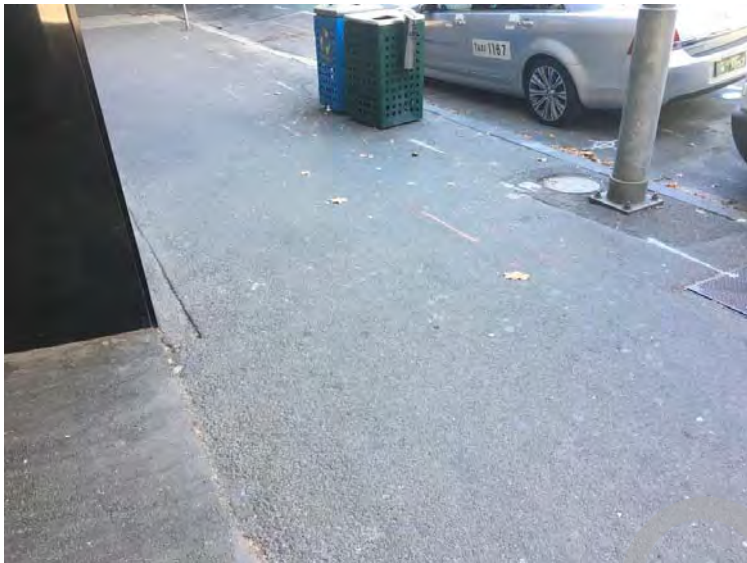
<b>Assessment Type:</b>  Good <input type="checkbox"/> Fair <input checked="" type="checkbox"/> Poor <input type="checkbox"/>	<input type="checkbox"/> <input checked="" type="checkbox"/> <input type="checkbox"/>
		<b>Impact Category:</b>  1 <input type="checkbox"/> 2 <input checked="" type="checkbox"/> 3 <input type="checkbox"/> 4 <input type="checkbox"/> 5 <input type="checkbox"/>	<input type="checkbox"/> <input checked="" type="checkbox"/> <input type="checkbox"/> <input type="checkbox"/> <input type="checkbox"/>
<b>Location:</b> Sample Street – Pavement	<b>Auditors Comments:</b> <ul style="list-style-type: none"> <li>General view of the council footpath.</li> </ul>

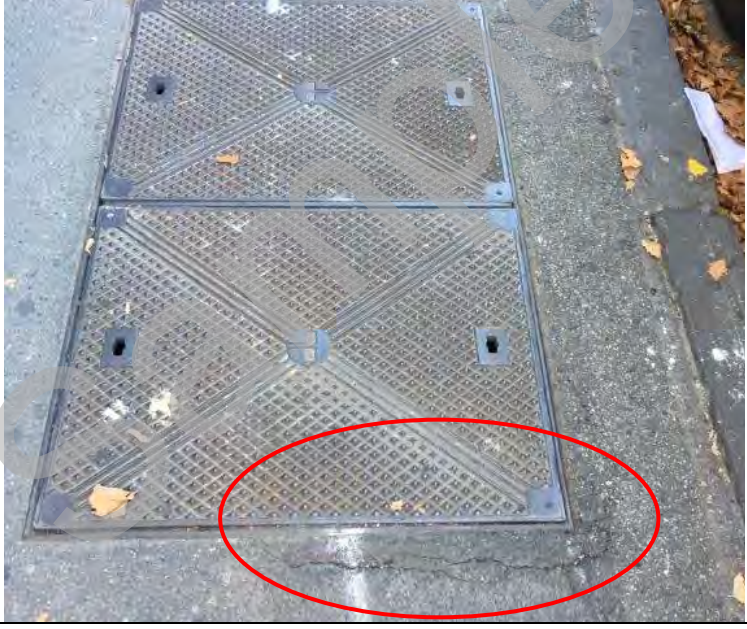
15.

<b>Assessment Type:</b>  Good <input type="checkbox"/> Fair <input checked="" type="checkbox"/> Poor <input type="checkbox"/>	<input type="checkbox"/> <input checked="" type="checkbox"/> <input type="checkbox"/>
		<b>Impact Category:</b>  1 <input type="checkbox"/> 2 <input checked="" type="checkbox"/> 3 <input type="checkbox"/> 4 <input type="checkbox"/> 5 <input type="checkbox"/>	<input type="checkbox"/> <input checked="" type="checkbox"/> <input type="checkbox"/> <input type="checkbox"/> <input type="checkbox"/>
<b>Location:</b> Sample Street – Pavement	<b>Auditors Comments:</b> <ul style="list-style-type: none"> <li>Minimal cracking (approx. 1-2mm) is noted at the corner of the service pit on the council footpath.</li> </ul>

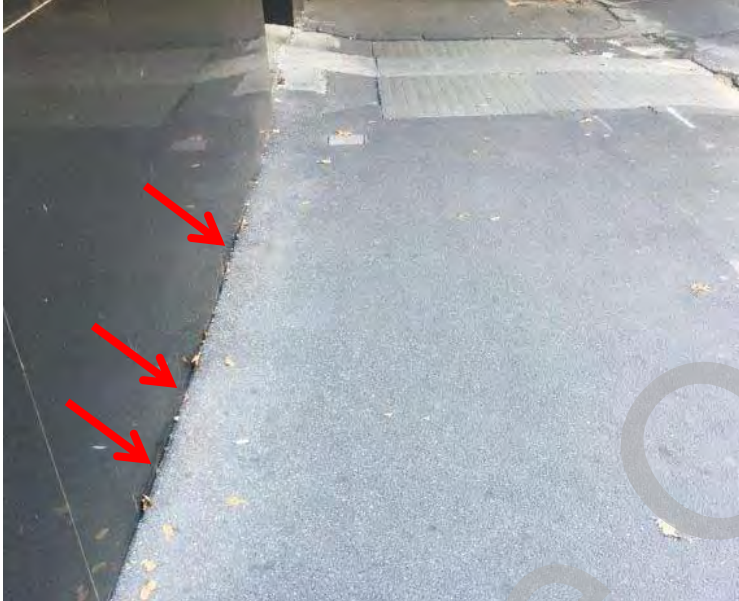
<b>Assessment Type:</b>  Good <input type="checkbox"/> Fair <input checked="" type="checkbox"/> Poor <input type="checkbox"/>	<input type="checkbox"/> <input checked="" type="checkbox"/> <input type="checkbox"/> <input type="checkbox"/>
		<b>Impact Category:</b>  1 <input type="checkbox"/> 2 <input checked="" type="checkbox"/> 3 <input type="checkbox"/> 4 <input type="checkbox"/> 5 <input type="checkbox"/>	<input type="checkbox"/> <input checked="" type="checkbox"/> <input type="checkbox"/> <input type="checkbox"/> <input type="checkbox"/>
<b>Location:</b> Sample Street – Pavement	<b>Auditors Comments:</b> <ul style="list-style-type: none"> <li>Existing raised edge was visible between wall and asphalt pavement.</li> </ul>

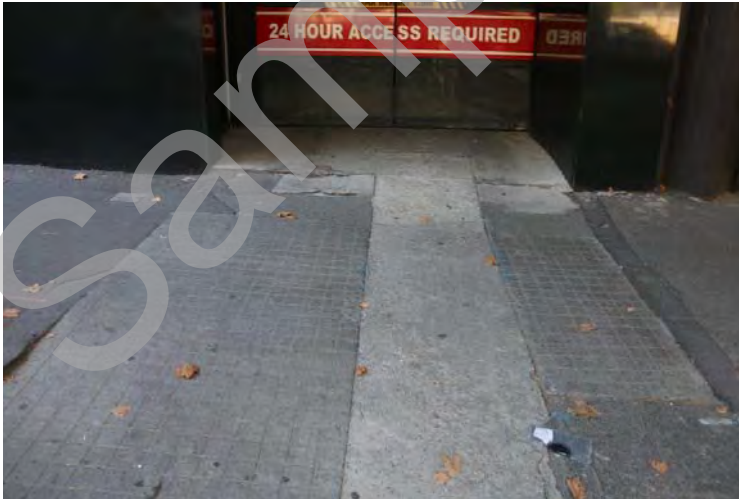
<b>Assessment Type:</b>  Good <input type="checkbox"/> Fair <input type="checkbox"/> Poor <input checked="" type="checkbox"/>	<input type="checkbox"/> <input type="checkbox"/> <input checked="" type="checkbox"/>
		<b>Impact Category:</b>  1 <input type="checkbox"/> 2 <input type="checkbox"/> 3 <input checked="" type="checkbox"/> 4 <input type="checkbox"/> 5 <input type="checkbox"/>	<input type="checkbox"/> <input type="checkbox"/> <input checked="" type="checkbox"/> <input type="checkbox"/> <input type="checkbox"/>
<b>Location:</b> Carpark Entrance	<b>Auditors Comments:</b> <ul style="list-style-type: none"> <li>General view of the entrance of the carpark.</li> <li>The condition of this area was poor with raised sections, signs of wear and tear with existing chips and cracks.</li> </ul>

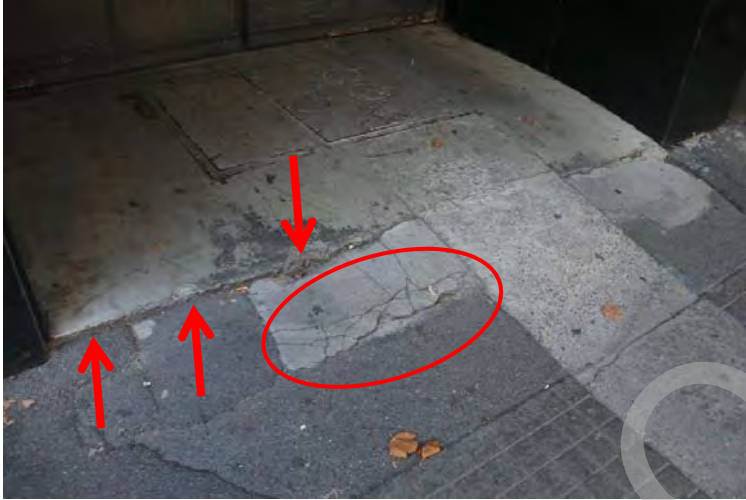
<b>Assessment Type:</b>  Good <input type="checkbox"/> Fair <input type="checkbox"/> Poor <input checked="" type="checkbox"/>	<input type="checkbox"/> <input type="checkbox"/> <input checked="" type="checkbox"/>
		<b>Impact Category:</b>  1 <input type="checkbox"/> 2 <input type="checkbox"/> 3 <input checked="" type="checkbox"/> 4 <input type="checkbox"/> 5 <input type="checkbox"/>	<input type="checkbox"/> <input type="checkbox"/> <input checked="" type="checkbox"/> <input type="checkbox"/> <input type="checkbox"/>
<b>Location:</b> Carpark Entrance	<b>Auditors Comments:</b> <ul style="list-style-type: none"> <li>Cracking and indentation of a concrete section.</li> <li>Asphalt and concrete surface are not at the same level.</li> <li>Patchwork is evident on the asphalt driveway.</li> </ul>

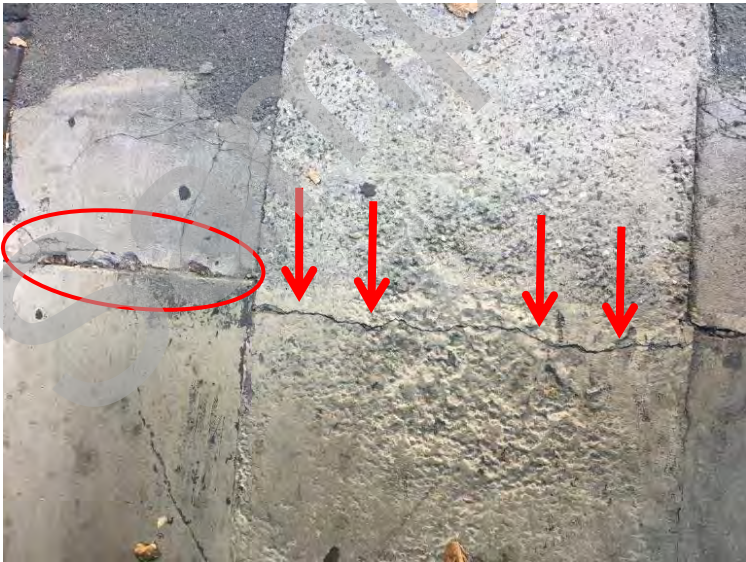
<b>Assessment Type:</b>  Good <input checked="" type="checkbox"/> Fair <input type="checkbox"/> Poor <input type="checkbox"/>	<input checked="" type="checkbox"/> <input type="checkbox"/> <input type="checkbox"/>
		<b>Impact Category:</b>  1 <input checked="" type="checkbox"/> 2 <input type="checkbox"/> 3 <input type="checkbox"/> 4 <input type="checkbox"/> 5 <input type="checkbox"/>	<input checked="" type="checkbox"/> <input type="checkbox"/> <input type="checkbox"/> <input type="checkbox"/> <input type="checkbox"/>
<b>Location:</b> Carpark Entrance	<b>Auditors Comments:</b> <ul style="list-style-type: none"> <li>Hairline cracks (approx. 1-2mm) and chipping of concrete were found on the surface.</li> </ul>

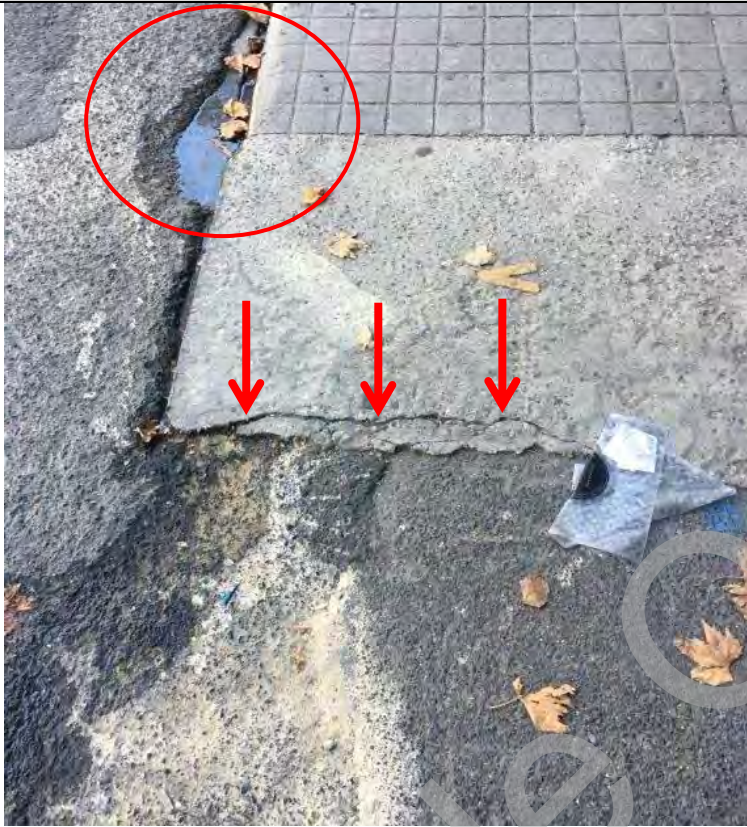
<b>Assessment Type:</b>  Good <input type="checkbox"/> Fair <input type="checkbox"/> Poor <input type="checkbox"/>	<input checked="" type="checkbox"/>
		<b>Impact Category:</b>  1 <input type="checkbox"/> 2 <input type="checkbox"/> 3 <input type="checkbox"/> 4 <input type="checkbox"/> 5 <input type="checkbox"/>	<input type="checkbox"/> <input type="checkbox"/> <input type="checkbox"/> <input type="checkbox"/> <input type="checkbox"/>
<b>Location:</b> Front Entrance	<b>Auditors Comments:</b> <ul style="list-style-type: none"> <li>Cracks and chipping of concrete were found on the surface.</li> <li>Surface was generally in poor condition.</li> </ul>

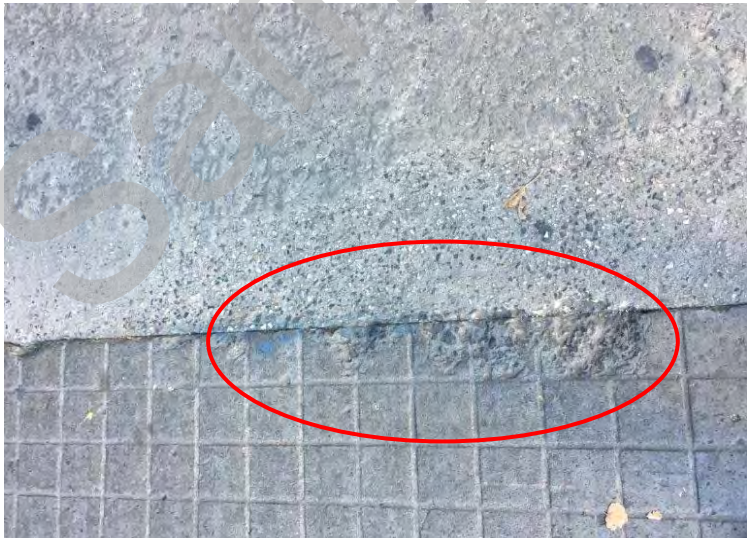
<b>Assessment Type:</b>  Good <input type="checkbox"/> Fair <input checked="" type="checkbox"/> Poor <input type="checkbox"/>	<input type="checkbox"/>
		<b>Impact Category:</b>  1 <input type="checkbox"/> 2 <input checked="" type="checkbox"/> 3 <input type="checkbox"/> 4 <input type="checkbox"/> 5 <input type="checkbox"/>	<input type="checkbox"/> <input checked="" type="checkbox"/> <input type="checkbox"/> <input type="checkbox"/> <input type="checkbox"/>
<b>Location:</b> Front Entrance	<b>Auditors Comments:</b> <ul style="list-style-type: none"> <li>Chipping and minor indentation of concrete was evident.</li> </ul>

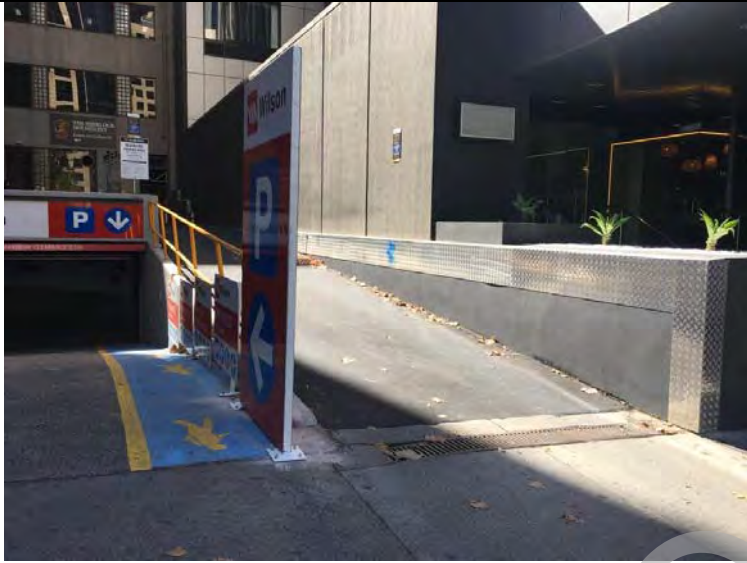
<b>Assessment Type:</b>  Good <input type="checkbox"/> Fair <input checked="" type="checkbox"/> Poor <input type="checkbox"/>	<input type="checkbox"/> <input checked="" type="checkbox"/> <input type="checkbox"/>
		<b>Impact Category:</b>  1 <input type="checkbox"/> 2 <input checked="" type="checkbox"/> 3 <input type="checkbox"/> 4 <input type="checkbox"/> 5 <input type="checkbox"/>	<input type="checkbox"/> <input checked="" type="checkbox"/> <input type="checkbox"/> <input type="checkbox"/> <input type="checkbox"/>
<b>Location:</b> Northwest Boundary	<b>Auditors Comments:</b> <ul style="list-style-type: none"> <li>General view of the entrance to the northwest boundary of the property.</li> <li>Overall condition of this area was fairly good.</li> </ul>

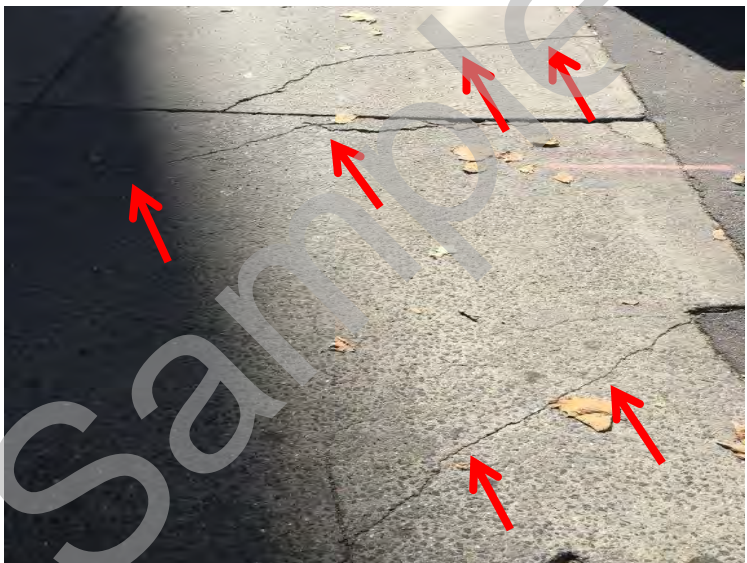
<b>Assessment Type:</b>  Good <input type="checkbox"/> Fair <input type="checkbox"/> Poor <input checked="" type="checkbox"/>	<input type="checkbox"/> <input type="checkbox"/> <input checked="" type="checkbox"/>
		<b>Impact Category:</b>  1 <input type="checkbox"/> 2 <input checked="" type="checkbox"/> 3 <input type="checkbox"/> 4 <input type="checkbox"/> 5 <input type="checkbox"/>	<input type="checkbox"/> <input checked="" type="checkbox"/> <input type="checkbox"/> <input type="checkbox"/> <input type="checkbox"/>
<b>Location:</b> Northwest Boundary	<b>Auditors Comments:</b> <ul style="list-style-type: none"> <li>Cracking of the concrete surface were noted throughout the entrance of the area located at the northwest boundary.</li> </ul>

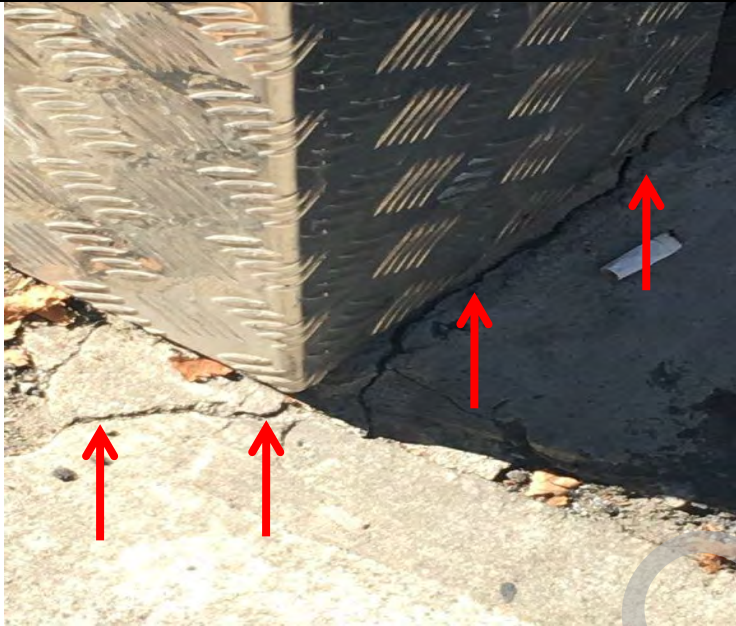
<b>Assessment Type:</b>  Good <input type="checkbox"/> Fair <input checked="" type="checkbox"/> Poor <input type="checkbox"/>	<input type="checkbox"/> <input checked="" type="checkbox"/> <input type="checkbox"/>
		<b>Impact Category:</b>  1 <input type="checkbox"/> 2 <input checked="" type="checkbox"/> 3 <input type="checkbox"/> 4 <input type="checkbox"/> 5 <input type="checkbox"/>	<input type="checkbox"/> <input checked="" type="checkbox"/> <input type="checkbox"/> <input type="checkbox"/> <input type="checkbox"/>
<b>Location:</b> Northwest Boundary	<b>Auditors Comments:</b> <ul style="list-style-type: none"> <li>Cracking had occurred at the bottom corner wall of the building.</li> </ul>

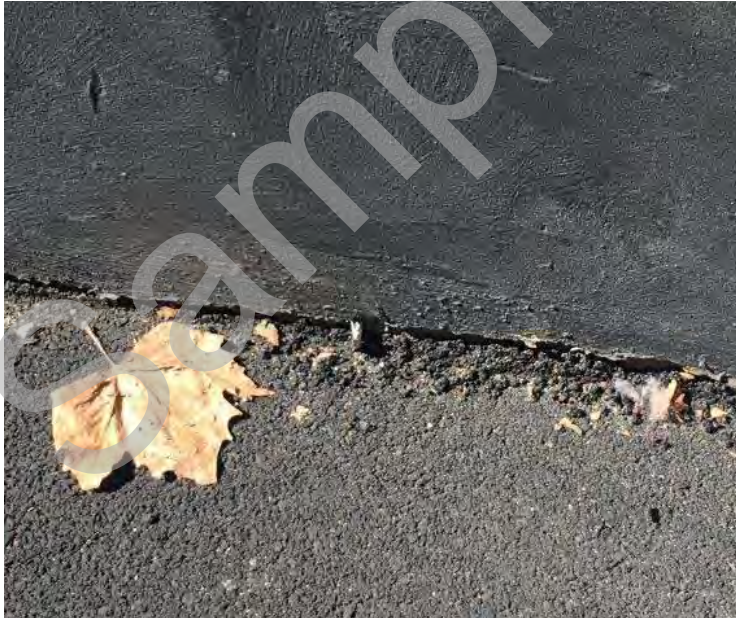
<b>Assessment Type:</b>  Good <input type="checkbox"/> Fair <input checked="" type="checkbox"/> Poor <input type="checkbox"/>	<input type="checkbox"/> <input checked="" type="checkbox"/> <input type="checkbox"/>
		<b>Impact Category:</b>  1 <input type="checkbox"/> 2 <input type="checkbox"/> 3 <input checked="" type="checkbox"/> 4 <input type="checkbox"/> 5 <input type="checkbox"/>	<input type="checkbox"/> <input type="checkbox"/> <input checked="" type="checkbox"/> <input type="checkbox"/> <input type="checkbox"/>
<b>Location:</b> Northwest Boundary	<b>Auditors Comments:</b> <ul style="list-style-type: none"> <li>Gap was visible between the asphalt pavement and rendered wall.</li> <li>Signs of minor cracking was also evident.</li> </ul>

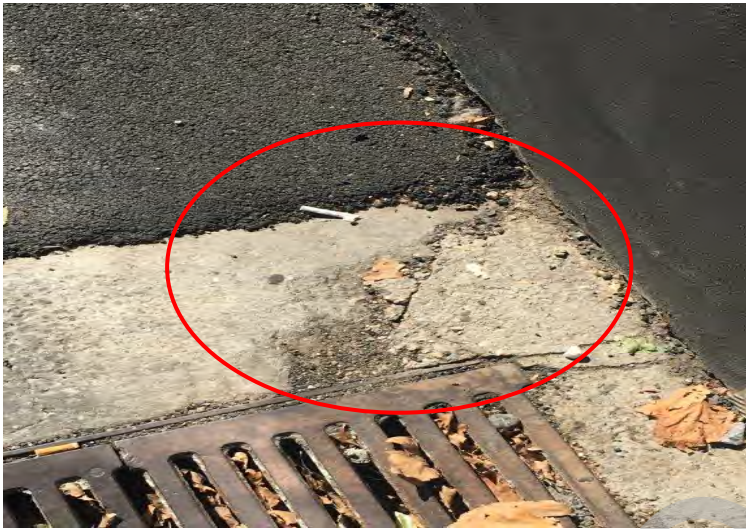
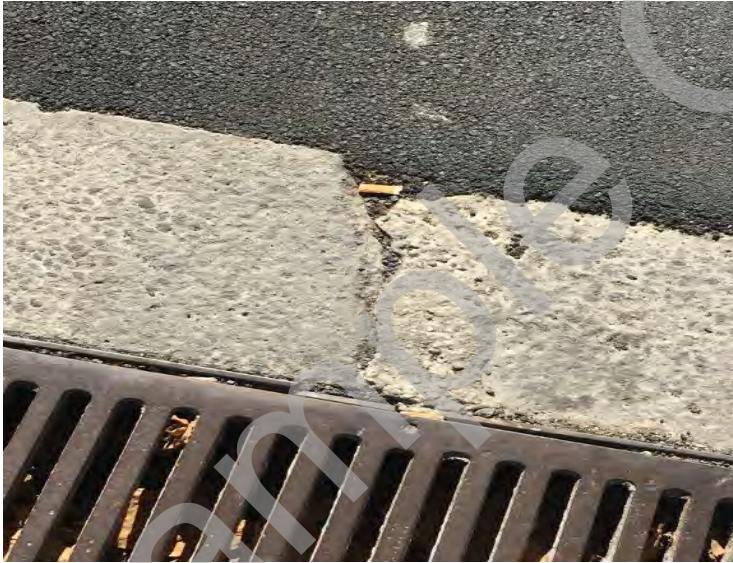
<b>Assessment Type:</b>  Good <input type="checkbox"/> Fair <input type="checkbox"/> Poor <input checked="" type="checkbox"/>	<input type="checkbox"/> <input type="checkbox"/> <input checked="" type="checkbox"/>
		<b>Impact Category:</b>  1 <input type="checkbox"/> 2 <input checked="" type="checkbox"/> 3 <input type="checkbox"/> 4 <input type="checkbox"/> 5 <input type="checkbox"/>	<input type="checkbox"/> <input checked="" type="checkbox"/> <input type="checkbox"/> <input type="checkbox"/> <input type="checkbox"/>
<b>Location:</b> Northwest Boundary	<b>Auditors Comments:</b> <ul style="list-style-type: none"> <li>Chipping of the concrete at the corners of the strip drain were evident, shows signs of cracking.</li> </ul>

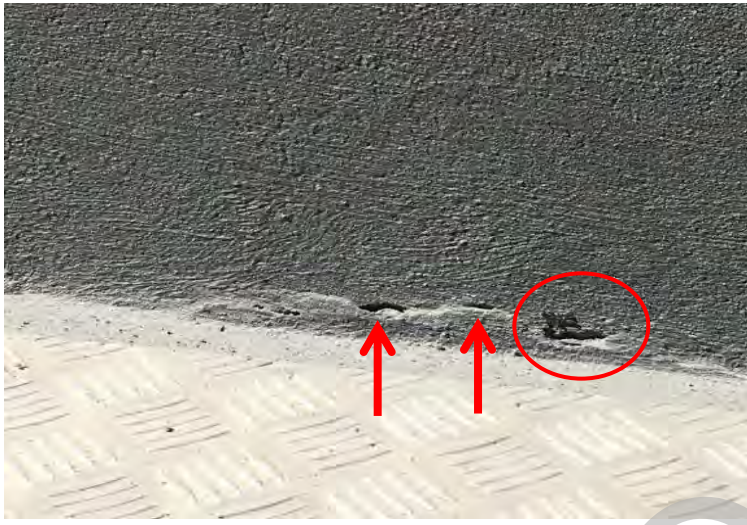
<b>Assessment Type:</b>  Good <input type="checkbox"/> Fair <input checked="" type="checkbox"/> Poor <input type="checkbox"/>	<input type="checkbox"/> <input checked="" type="checkbox"/> <input type="checkbox"/>
		<b>Impact Category:</b>  1 <input checked="" type="checkbox"/> 2 <input type="checkbox"/> 3 <input type="checkbox"/> 4 <input type="checkbox"/> 5 <input type="checkbox"/>	<input checked="" type="checkbox"/> <input type="checkbox"/> <input type="checkbox"/> <input type="checkbox"/> <input type="checkbox"/>
<b>Location:</b> Northwest Boundary	<b>Auditors Comments:</b> <ul style="list-style-type: none"> <li>Chipping and cracking of the rendered wall was evident at the side of the driveway.</li> </ul>

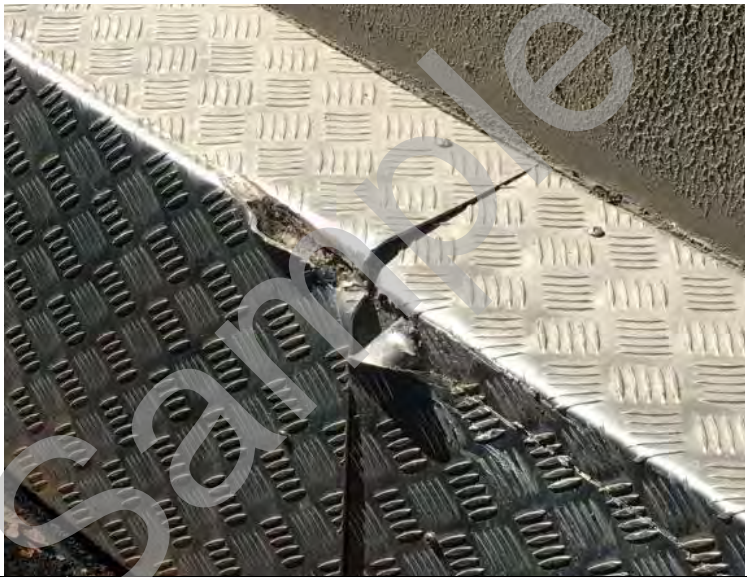
<b>Assessment Type:</b>  Good <input type="checkbox"/> Fair <input type="checkbox"/> Poor <input checked="" type="checkbox"/>	<input type="checkbox"/> <input type="checkbox"/> <input checked="" type="checkbox"/>
		<b>Impact Category:</b>  1 <input checked="" type="checkbox"/> 2 <input type="checkbox"/> 3 <input type="checkbox"/> 4 <input type="checkbox"/> 5 <input type="checkbox"/>	<input checked="" type="checkbox"/> <input type="checkbox"/> <input type="checkbox"/> <input type="checkbox"/> <input type="checkbox"/>
<b>Location:</b> Northwest Boundary	<b>Auditors Comments:</b> <ul style="list-style-type: none"> <li>Impact damage on metal protection sheet to the rendered wall along the driveway.</li> </ul>

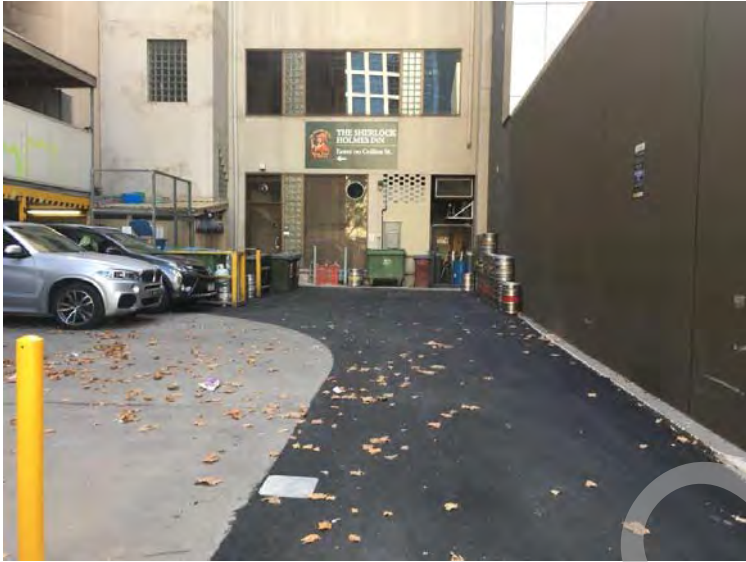
<b>Assessment Type:</b>  Good <input type="checkbox"/> Fair <input type="checkbox"/> Poor <input type="checkbox"/>	<input checked="" type="checkbox"/> <input type="checkbox"/> <input type="checkbox"/>
		<b>Impact Category:</b>  1 <input checked="" type="checkbox"/> 2 <input type="checkbox"/> 3 <input type="checkbox"/> 4 <input type="checkbox"/> 5 <input type="checkbox"/>	<input checked="" type="checkbox"/> <input type="checkbox"/> <input type="checkbox"/> <input type="checkbox"/> <input type="checkbox"/>
<b>Location:</b> Northwest Boundary	<b>Auditors Comments:</b> <ul style="list-style-type: none"> <li>General view of northwest boundary.</li> </ul>

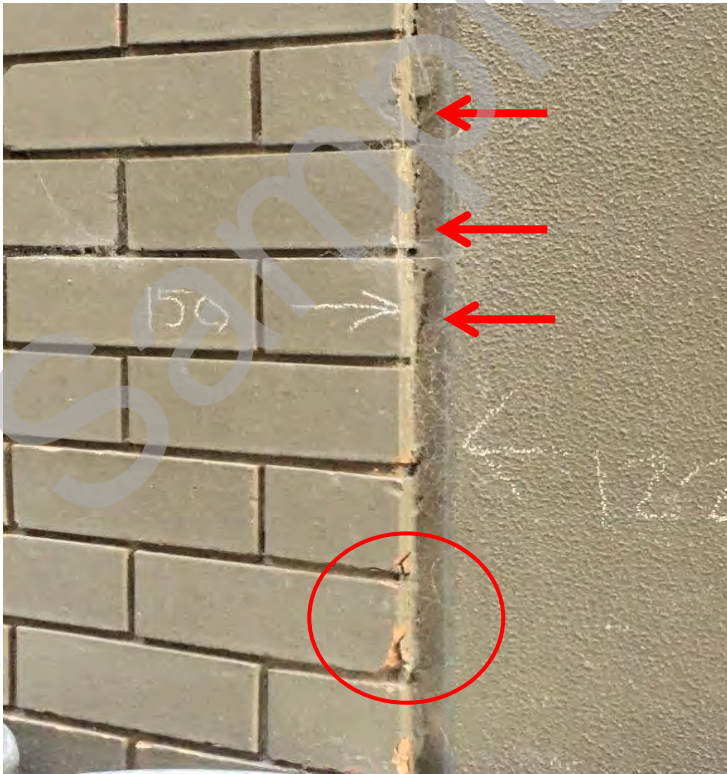
<b>Assessment Type:</b>  Good <input type="checkbox"/> Fair <input checked="" type="checkbox"/> Poor <input type="checkbox"/>	<input type="checkbox"/> <input checked="" type="checkbox"/> <input type="checkbox"/>
		<b>Impact Category:</b>  1 <input checked="" type="checkbox"/> 2 <input type="checkbox"/> 3 <input type="checkbox"/> 4 <input type="checkbox"/> 5 <input type="checkbox"/>	<input checked="" type="checkbox"/> <input type="checkbox"/> <input type="checkbox"/> <input type="checkbox"/> <input type="checkbox"/>
<b>Location:</b> Northwest Boundary	<b>Auditors Comments:</b> <ul style="list-style-type: none"> <li>Minor cracks and chipping were evident along the northwest façade of the building.</li> </ul>

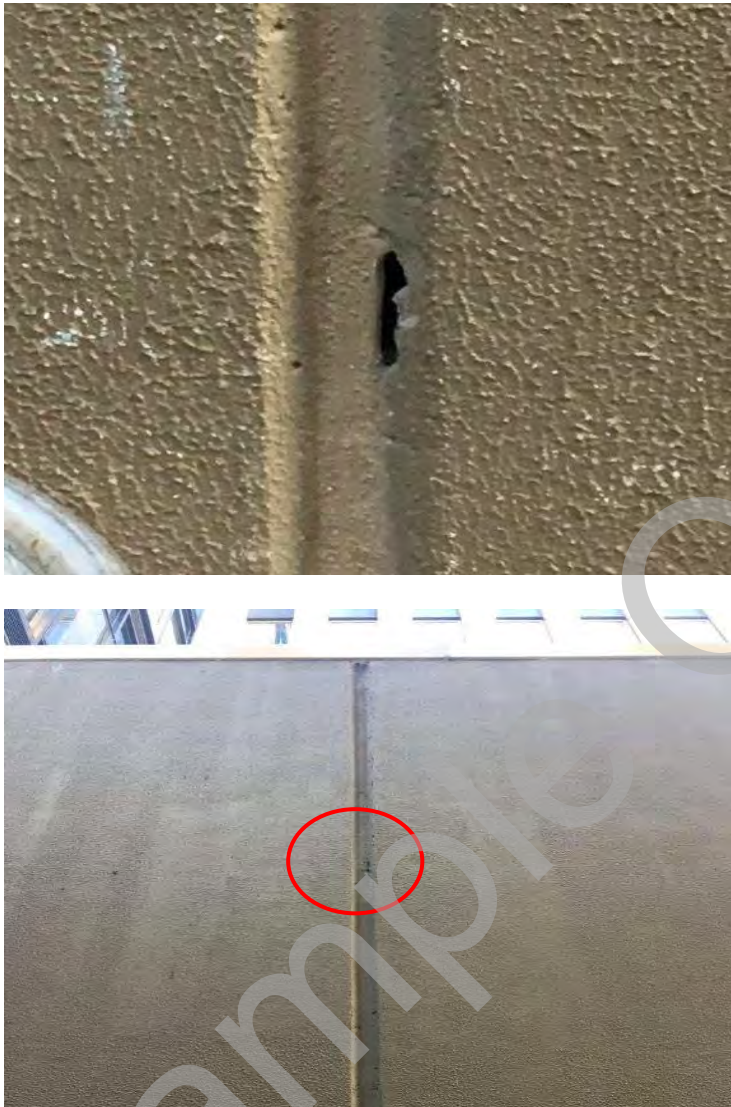
<u>Assessment Type:</u>  Good Fair Poor	<input type="checkbox"/> <input checked="" type="checkbox"/> <input type="checkbox"/>
		<u>Impact Category:</u>  1 2 3 4 5	<input type="checkbox"/> <input checked="" type="checkbox"/> <input type="checkbox"/> <input type="checkbox"/> <input type="checkbox"/>
<u>Location:</u> Northwest Boundary Wall	<u>Auditors Comments:</u> <ul style="list-style-type: none"> <li>Minor cracking on the flexible caulking on the control joint on bottom and top of rendered wall at the northwest boundary wall.</li> </ul>

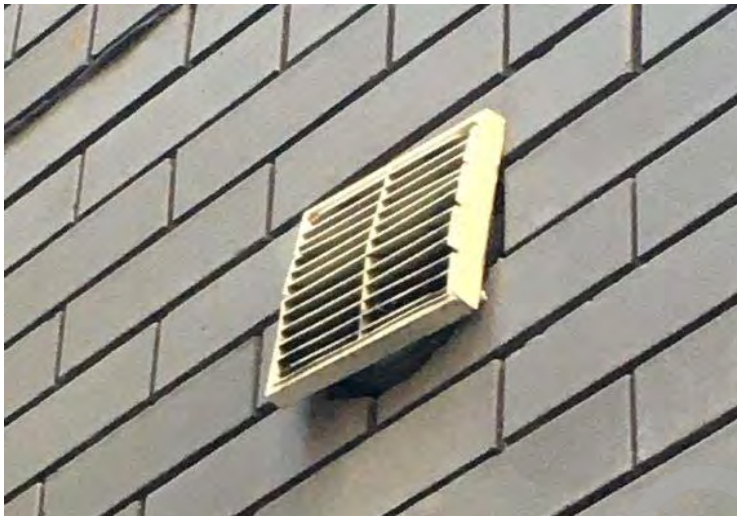
<b>Assessment Type:</b>  Good Fair Poor	<input type="checkbox"/> <input checked="" type="checkbox"/> <input type="checkbox"/>
		<b>Impact Category:</b>  1 2 3 4 5	<input checked="" type="checkbox"/> <input type="checkbox"/> <input type="checkbox"/> <input type="checkbox"/> <input type="checkbox"/>
<b>Location:</b> Northwest Boundary Wall	<b>Auditors Comments:</b> <ul style="list-style-type: none"> <li>Exhaust fan vent cover was found to be slightly detached from the face of the wall.</li> </ul>
