# Dilapidation Survey Report

1 Sample Street, Melbourne VIC 3022

9 March 2017

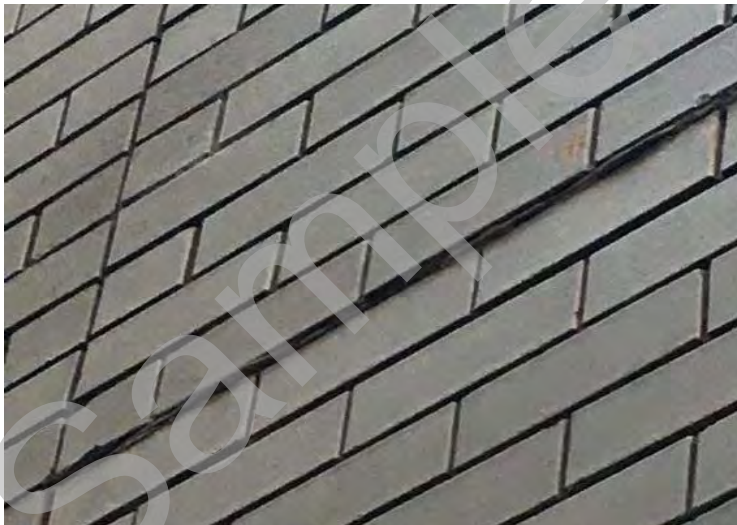
<b>Assessment Type:</b>  Good Fair Poor	<input type="checkbox"/> <input checked="" type="checkbox"/> <input type="checkbox"/>
		<b>Impact Category:</b>  1 2 3 4 5	<input checked="" type="checkbox"/> <input type="checkbox"/> <input type="checkbox"/> <input type="checkbox"/> <input type="checkbox"/>
<b>Location:</b> Northwest Boundary Wall	<b>Auditors Comments:</b> <ul style="list-style-type: none"> <li>Expansion joints in between of brick panels had visible distress.</li> </ul>

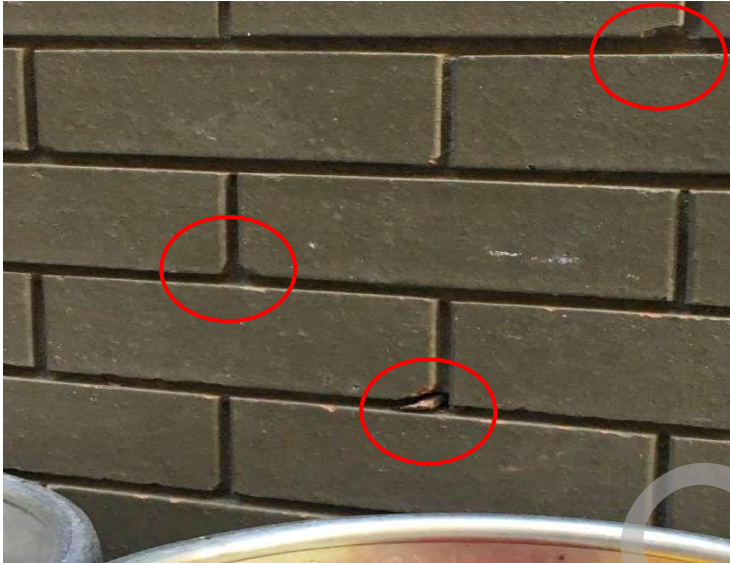
<b>Assessment Type:</b>  Good <input type="checkbox"/> Fair <input checked="" type="checkbox"/> Poor <input type="checkbox"/>	<input type="checkbox"/> <input checked="" type="checkbox"/> <input type="checkbox"/>
		<b>Impact Category:</b>  1 <input checked="" type="checkbox"/> 2 <input type="checkbox"/> 3 <input type="checkbox"/> 4 <input type="checkbox"/> 5 <input type="checkbox"/>	<input checked="" type="checkbox"/> <input type="checkbox"/> <input type="checkbox"/> <input type="checkbox"/> <input type="checkbox"/>
<b>Location:</b> Northwest Boundary Wall	<b>Auditors Comments:</b> <ul style="list-style-type: none"> <li>Minor chippings were found on the face of the wall.</li> </ul>

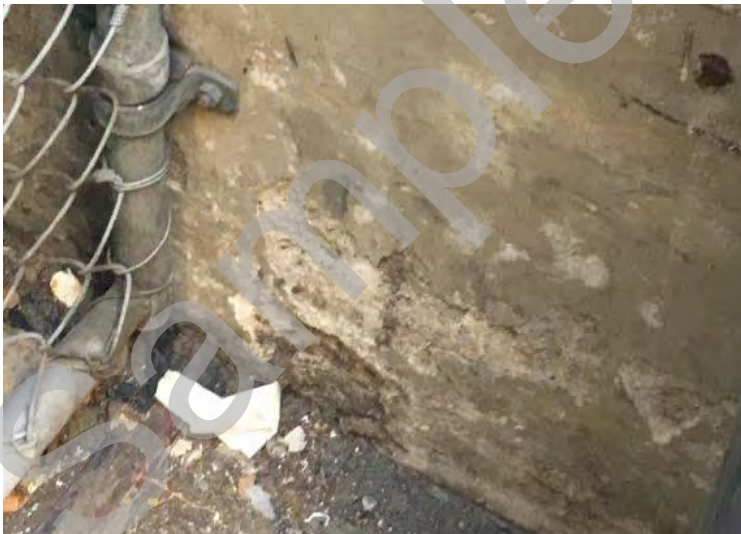
<b>Assessment Type:</b>  Good <input type="checkbox"/> Fair <input type="checkbox"/> Poor <input checked="" type="checkbox"/>	<input type="checkbox"/> <input type="checkbox"/> <input checked="" type="checkbox"/>
		<b>Impact Category:</b>  1 <input type="checkbox"/> 2 <input type="checkbox"/> 3 <input checked="" type="checkbox"/> 4 <input type="checkbox"/> 5 <input type="checkbox"/>	<input type="checkbox"/> <input type="checkbox"/> <input checked="" type="checkbox"/> <input type="checkbox"/> <input type="checkbox"/>
<b>Location:</b> Northwest Boundary Wall	<b>Auditors Comments:</b> <ul style="list-style-type: none"> <li>Chipping of concrete at the bottom face of the wall, shows signs of cracking.</li> </ul>

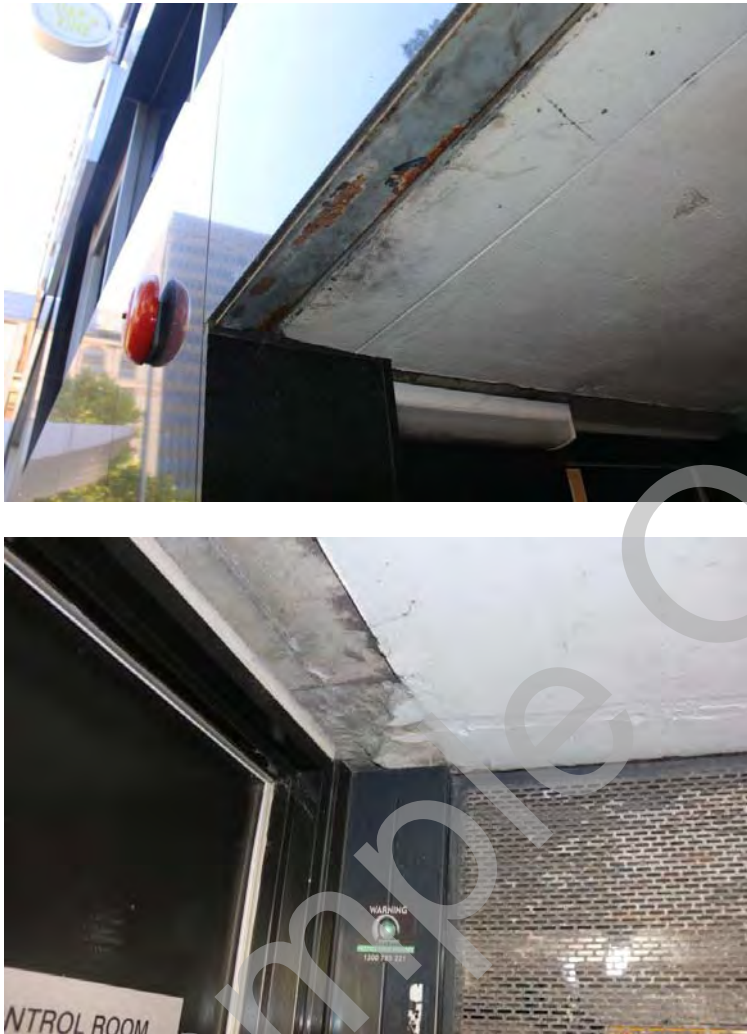
<b>Assessment Type:</b>  Good <input type="checkbox"/> Fair <input type="checkbox"/> Poor <input checked="" type="checkbox"/>	<input type="checkbox"/> <input type="checkbox"/> <input checked="" type="checkbox"/>
		<b>Impact Category:</b>  1 <input type="checkbox"/> 2 <input type="checkbox"/> 3 <input type="checkbox"/> 4 <input type="checkbox"/> 5 <input type="checkbox"/>	<input checked="" type="checkbox"/> <input type="checkbox"/> <input type="checkbox"/> <input type="checkbox"/> <input type="checkbox"/>
<b>Location:</b> Carpark Entrance	<b>Auditors Comments:</b> <ul style="list-style-type: none"> <li>• Rusting of metal lintel on the soffit and gate at the entrance of the carpark was evident.</li> <li>• Poor rendering of side of the soffit.</li> <li>• General condition of the soffit was poor.</li> </ul>

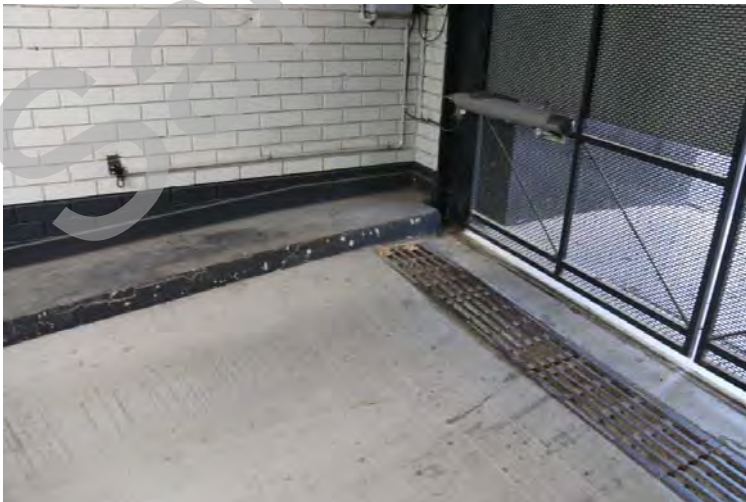
<p><b>Assessment Type:</b></p> <p>Good <input type="checkbox"/></p> <p>Fair <input checked="" type="checkbox"/></p> <p>Poor <input type="checkbox"/></p>	<p><b>Impact Category:</b></p> <p>1 <input checked="" type="checkbox"/></p> <p>2 <input type="checkbox"/></p> <p>3 <input type="checkbox"/></p> <p>4 <input type="checkbox"/></p> <p>5 <input type="checkbox"/></p>
<p><b>Location:</b> Basement Carpark</p>	<p><b>Auditors Comments:</b></p> <ul style="list-style-type: none"> <li>General views of the basement carpark.</li> </ul>

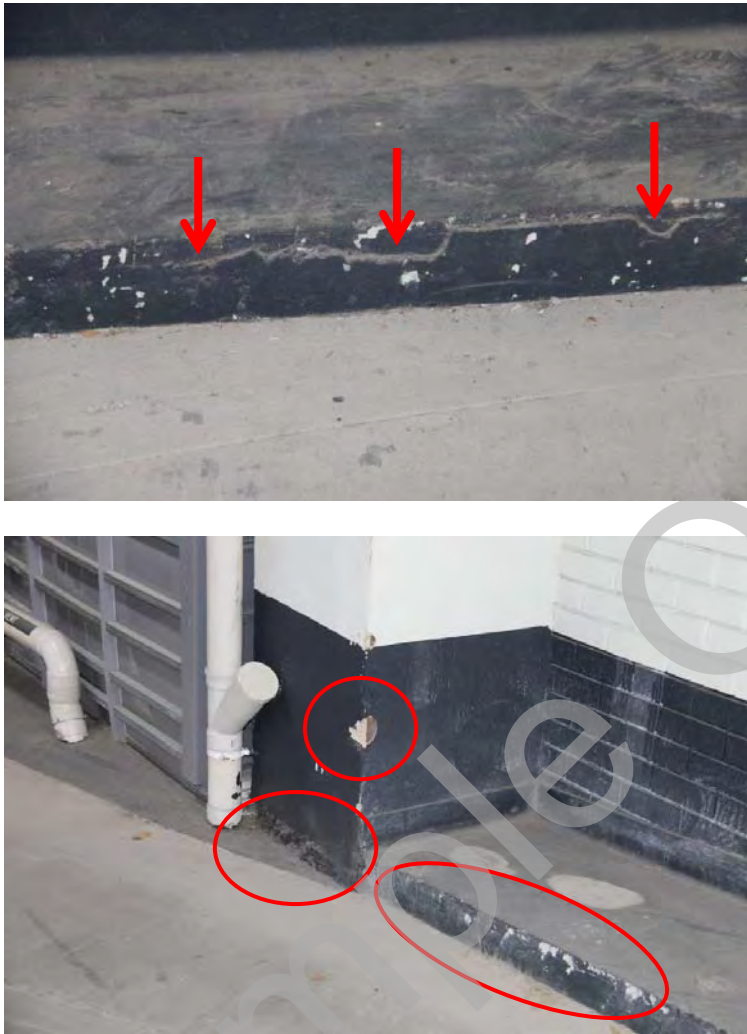
<b>Assessment Type:</b>  Good Fair Poor	<input type="checkbox"/> <input checked="" type="checkbox"/> <input type="checkbox"/>
		<b>Impact Category:</b>  1 2 3 4 5	<input checked="" type="checkbox"/> <input type="checkbox"/> <input type="checkbox"/> <input type="checkbox"/> <input type="checkbox"/>
<b>Location:</b> Basement Carpark	<b>Auditors Comments:</b> <ul style="list-style-type: none"> <li>Kerb and wall shows signs of cracking and chipping on the right side, upon entering the carpark.</li> <li>Walls are stained.</li> </ul>

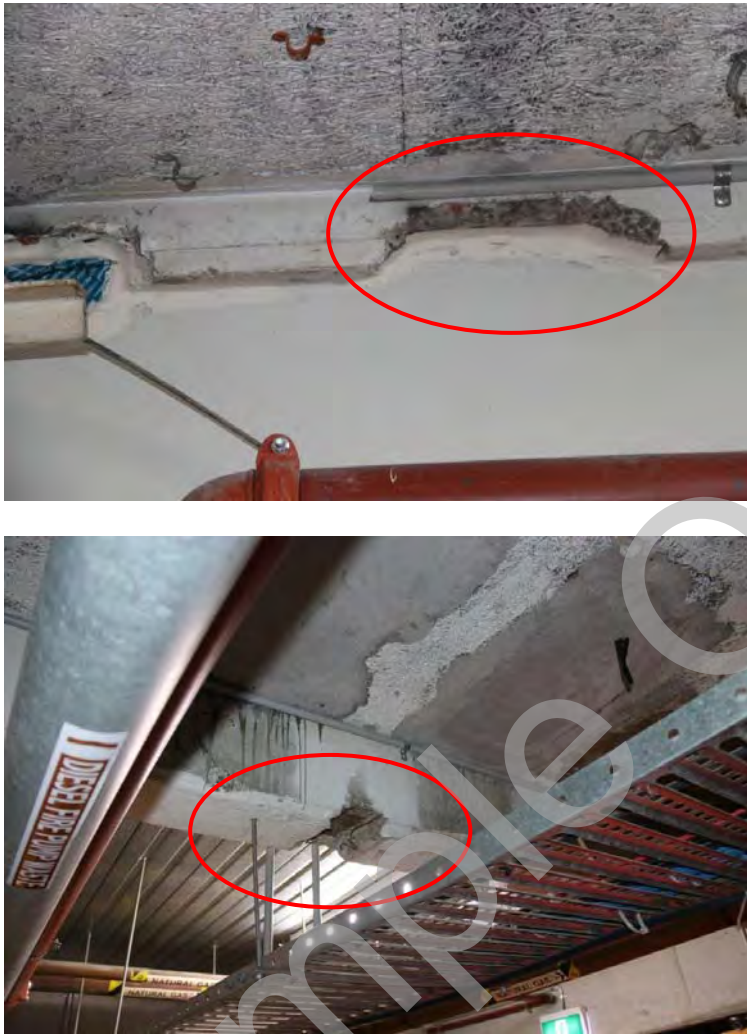
<b>Assessment Type:</b>  Good Fair Poor	<input type="checkbox"/> <input checked="" type="checkbox"/> <input type="checkbox"/>
		<b>Impact Category:</b>  1 2 3 4 5	<input checked="" type="checkbox"/> <input type="checkbox"/> <input type="checkbox"/> <input type="checkbox"/> <input type="checkbox"/>
<b>Location:</b> Basement Carpark	<b>Auditors Comments:</b> <ul style="list-style-type: none"> <li>Concrete beam and soffit had existing damages involving chippings and broken structures.</li> <li>One of the damages was exposing the reinforcement.</li> </ul>

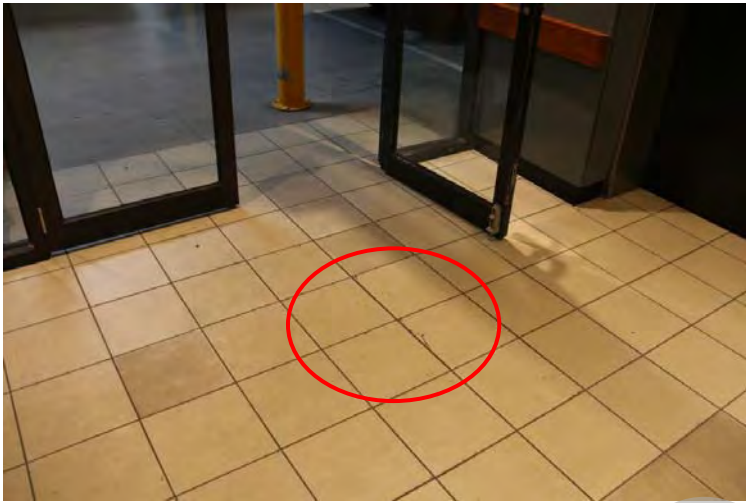
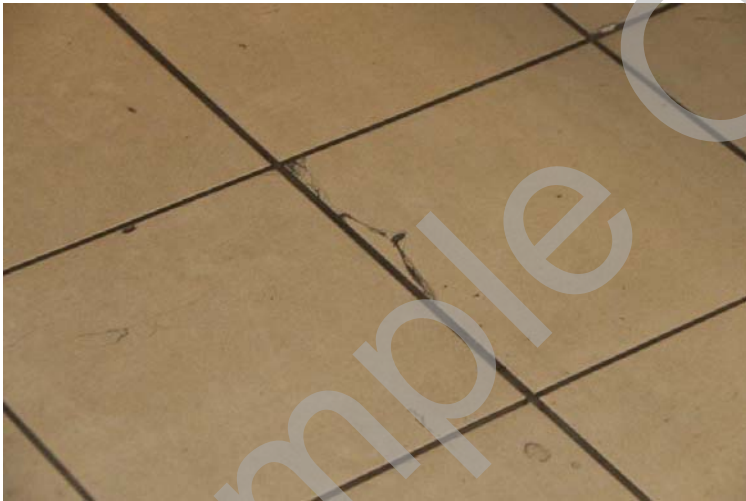
<b>Assessment Type:</b>  Good Fair Poor	<input type="checkbox"/> <input checked="" type="checkbox"/> <input type="checkbox"/>
		<b>Impact Category:</b>  1 2 3 4 5	<input checked="" type="checkbox"/> <input type="checkbox"/> <input type="checkbox"/> <input type="checkbox"/> <input type="checkbox"/>
<b>Location:</b> Basement	<b>Auditors Comments:</b> <ul style="list-style-type: none"> <li>Minor stains and hairline crack on one of the tiles was noted.</li> </ul>

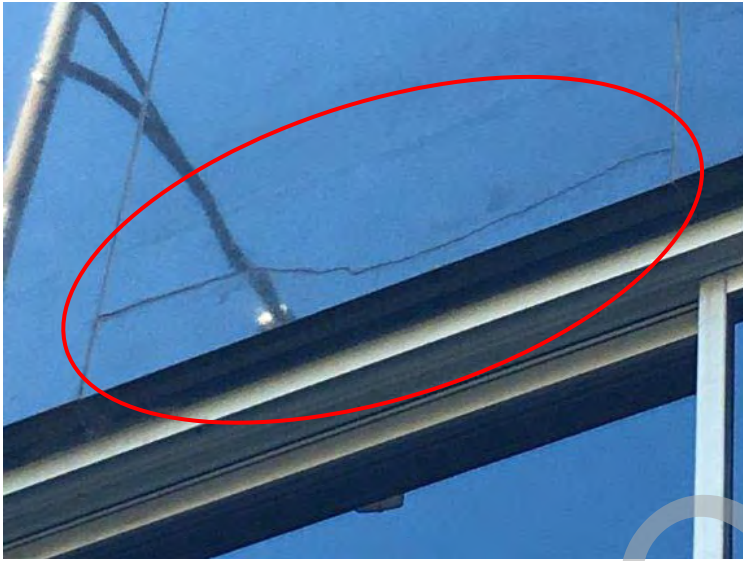
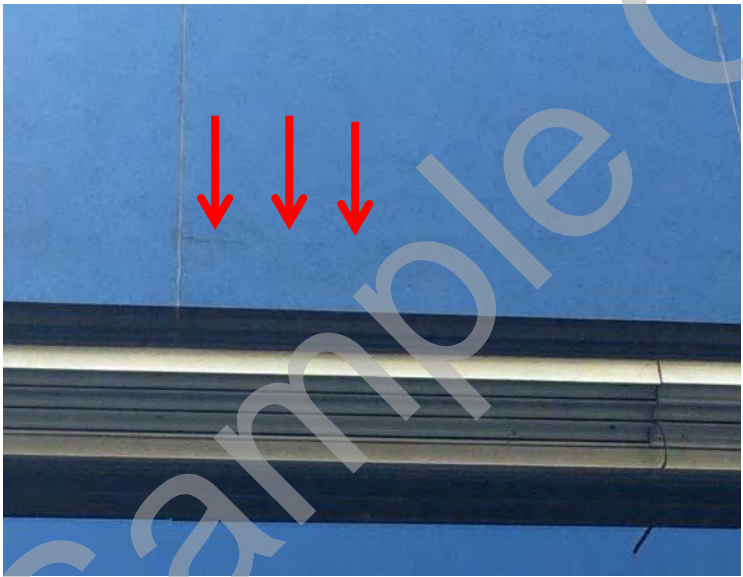
<b>Assessment Type:</b>  Good <input type="checkbox"/> Fair <input checked="" type="checkbox"/> Poor <input type="checkbox"/>	<input type="checkbox"/> <input checked="" type="checkbox"/> <input type="checkbox"/>
		<b>Impact Category:</b>  1 <input type="checkbox"/> 2 <input type="checkbox"/> 3 <input checked="" type="checkbox"/> 4 <input type="checkbox"/> 5 <input type="checkbox"/>	<input type="checkbox"/> <input type="checkbox"/> <input checked="" type="checkbox"/> <input type="checkbox"/> <input type="checkbox"/>
<b>Location:</b> Front Facade	<b>Auditors Comments:</b> <ul style="list-style-type: none"> <li>Cracking has occurred at two sections of the tiled wall cladding that ranges from minor to distinct cracks.</li> <li>Condition of the front façade was overall fair.</li> </ul>

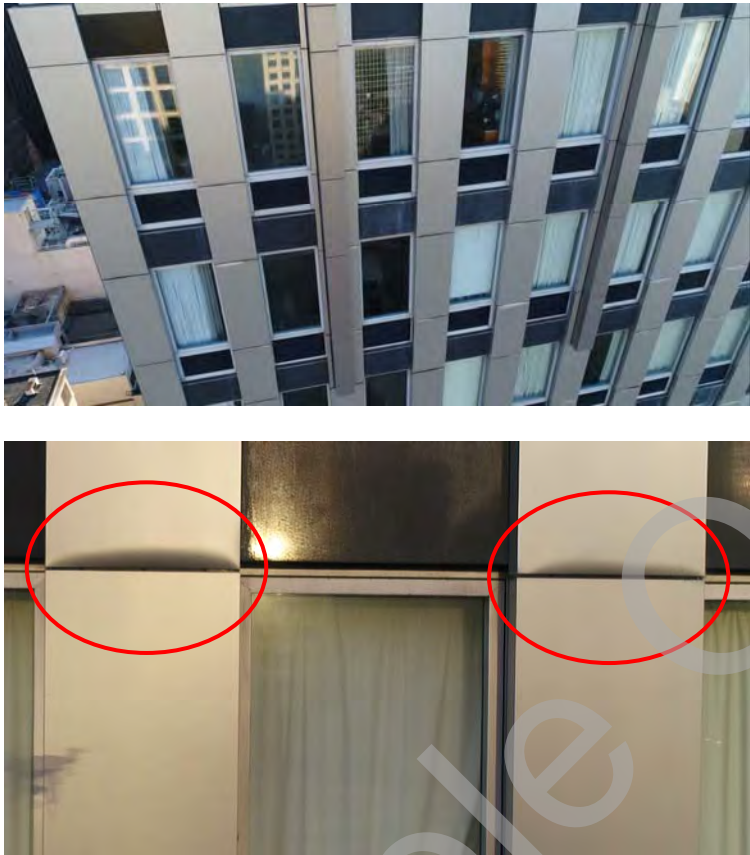
<b>Assessment Type:</b>  Good <input type="checkbox"/> Fair <input checked="" type="checkbox"/> Poor <input type="checkbox"/>	<input type="checkbox"/> <input checked="" type="checkbox"/> <input type="checkbox"/>
		<b>Impact Category:</b>  1 <input type="checkbox"/> 2 <input type="checkbox"/> 3 <input type="checkbox"/> 4 <input type="checkbox"/> 5 <input type="checkbox"/>	<input checked="" type="checkbox"/> <input type="checkbox"/> <input type="checkbox"/> <input type="checkbox"/> <input type="checkbox"/>
<b>Location:</b> Front Facade	<b>Auditors Comments:</b> <ul style="list-style-type: none"> <li>Aluminium panels were noted to be bent/dented from the drone footage</li> <li>Affected levels: Levels 2-8, Levels 19-22</li> </ul>

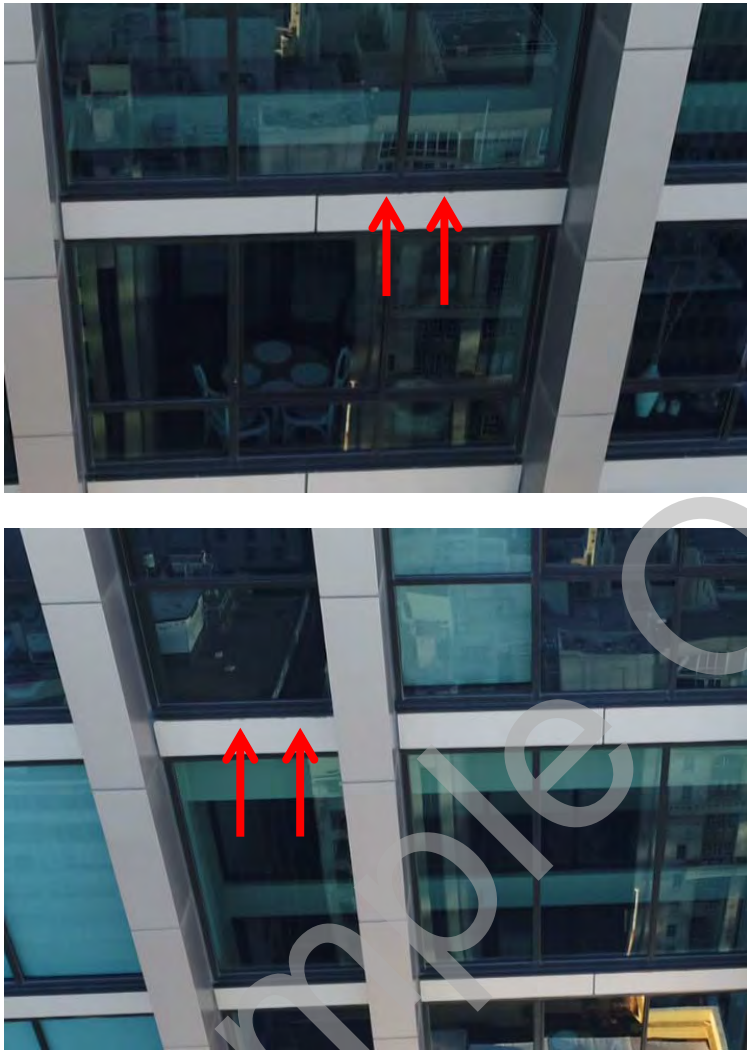
<b>Assessment Type:</b>  Good Fair Poor	<input type="checkbox"/> <input checked="" type="checkbox"/> <input type="checkbox"/>
		<b>Impact Category:</b>  1 2 3 4 5	<input checked="" type="checkbox"/> <input type="checkbox"/> <input type="checkbox"/> <input type="checkbox"/> <input type="checkbox"/>
<b>Location:</b> Northwest Façade	<b>Auditors Comments:</b> <ul style="list-style-type: none"> <li>Dirt and minor staining was noted at the top of the aluminium panels in levels 24 and 25 respectively.</li> </ul>

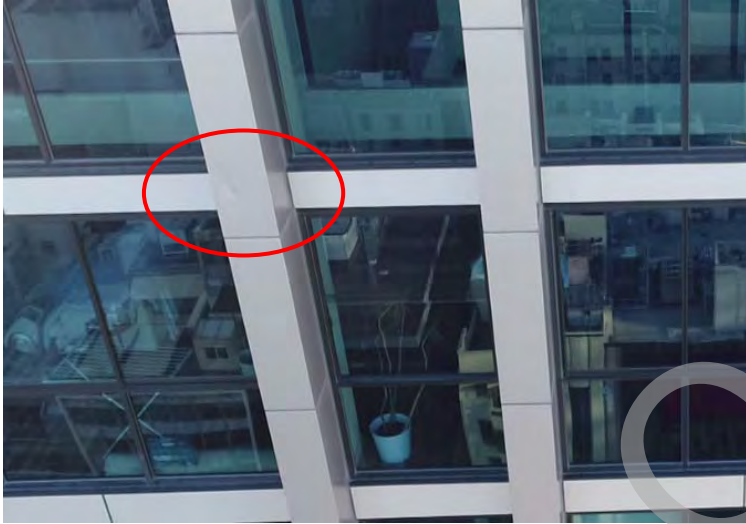
<b>Assessment Type:</b>  Good <input type="checkbox"/> Fair <input checked="" type="checkbox"/> Poor <input type="checkbox"/>	<b>Impact Category:</b>  1 <input checked="" type="checkbox"/> 2 <input type="checkbox"/> 3 <input type="checkbox"/> 4 <input type="checkbox"/> 5 <input type="checkbox"/>
<b>Location:</b> Northwest Facade – Level 27	<b>Auditors Comments:</b> <ul style="list-style-type: none"> <li>Dent was found on the bottom of the aluminium cladding panel located in level 27.</li> </ul>

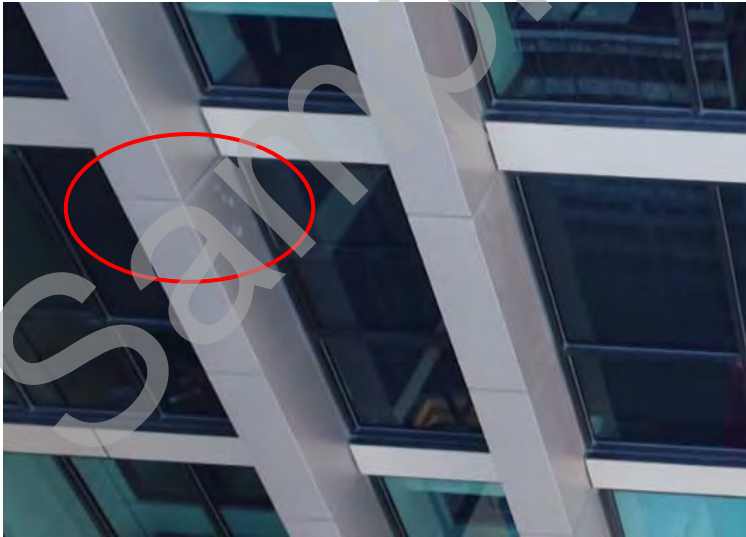
<b>Assessment Type:</b>  Good <input type="checkbox"/> Fair <input checked="" type="checkbox"/> Poor <input type="checkbox"/>	<b>Impact Category:</b>  1 <input checked="" type="checkbox"/> 2 <input type="checkbox"/> 3 <input type="checkbox"/> 4 <input type="checkbox"/> 5 <input type="checkbox"/>
<b>Location:</b> Northwest Façade – Level 25	<b>Auditors Comments:</b> <ul style="list-style-type: none"> <li>Marks were evident on the side of the aluminium cladding from the drone footage.</li> <li>Slight dent was noted on the top of aluminium panel.</li> </ul>

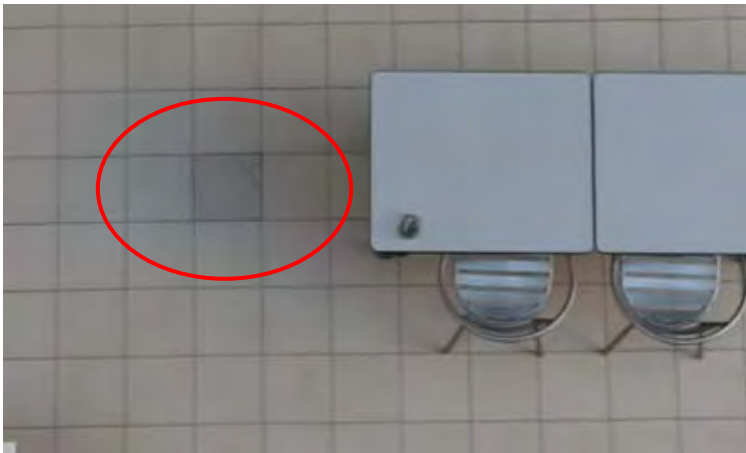
<u>Assessment Type:</u>  Good Fair Poor	<input type="checkbox"/> <input checked="" type="checkbox"/> <input type="checkbox"/>
		<u>Impact Category:</u>  1 2 3 4 5	<input type="checkbox"/> <input checked="" type="checkbox"/> <input type="checkbox"/> <input type="checkbox"/> <input type="checkbox"/>
<u>Location:</u> Level 1 Balcony	<u>Auditors Comments:</u> <ul style="list-style-type: none"> <li>One of the tiles had a deeper contrast compared to the rest of the tiles.</li> <li>Cracking of the tile was also noted.</li> </ul>

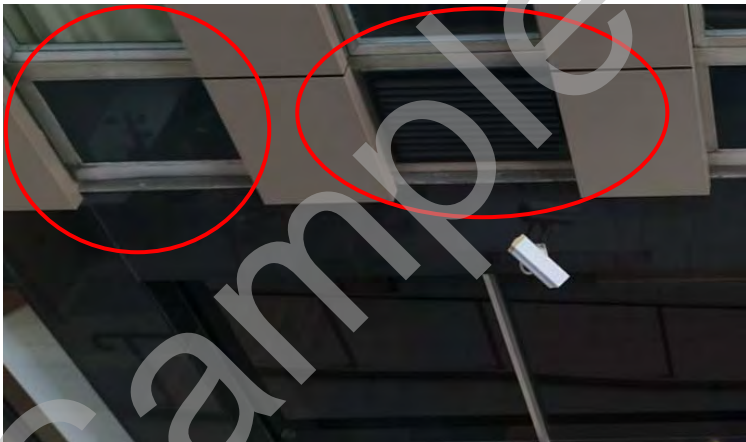
<u>Assessment Type:</u>  Good Fair Poor	<input checked="" type="checkbox"/> <input type="checkbox"/> <input checked="" type="checkbox"/>
		<u>Impact Category:</u>  1 2 3 4 5	<input checked="" type="checkbox"/> <input type="checkbox"/> <input type="checkbox"/> <input type="checkbox"/> <input type="checkbox"/>
<u>Location:</u> Northwest Façade – Level 2	<u>Auditors Comments:</u> <ul style="list-style-type: none"> <li>The condition of the windows was exceptionally dirty compared to the rest of the windows on this façade.</li> </ul>

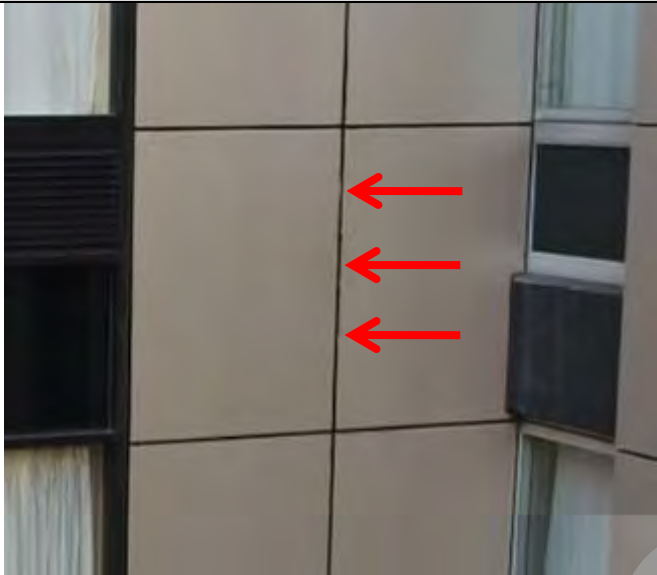
<div> <b>Assessment Type:</b>             Good <input type="checkbox"/>            Fair <input checked="" type="checkbox"/>            Poor <input type="checkbox"/> </div> <div> <b>Impact Category:</b>             1 <input checked="" type="checkbox"/>            2 <input type="checkbox"/>            3 <input type="checkbox"/>            4 <input type="checkbox"/>            5 <input type="checkbox"/> </div>
<b>Location:</b> West Façade – Level 7	<b>Auditors Comments:</b> <ul style="list-style-type: none"> <li>Dents and damages on the aluminium panel in level 7 were evident.</li> </ul>

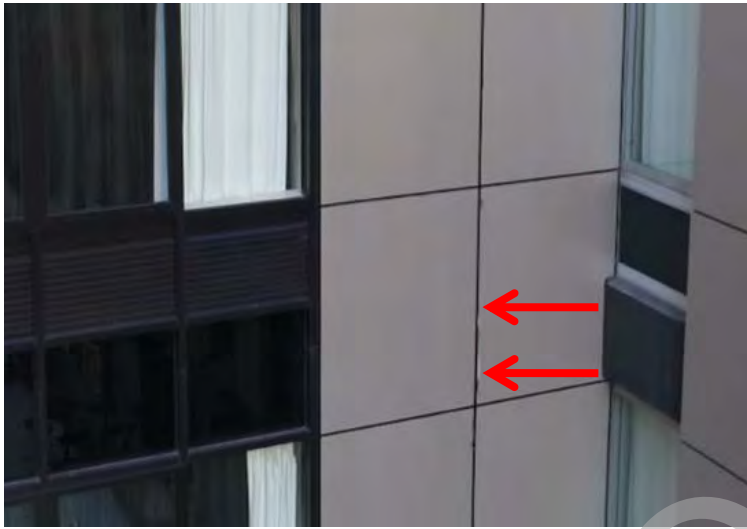
<u>Assessment Type:</u>  Good Fair Poor	<input type="checkbox"/> <input checked="" type="checkbox"/> <input type="checkbox"/>
		<u>Impact Category:</u>  1 2 3 4 5	<input checked="" type="checkbox"/> <input type="checkbox"/> <input type="checkbox"/> <input type="checkbox"/> <input type="checkbox"/>
<u>Location:</u> West Façade – Level 3	<u>Auditors Comments:</u> <ul style="list-style-type: none"> <li>Dents and damages on the aluminium panel in level 3 were evident.</li> </ul>
