## Detailed Windows Inspection

49 Sample Road Melbourne VIC 3122

## Part 2: Detailed Windows Inspection

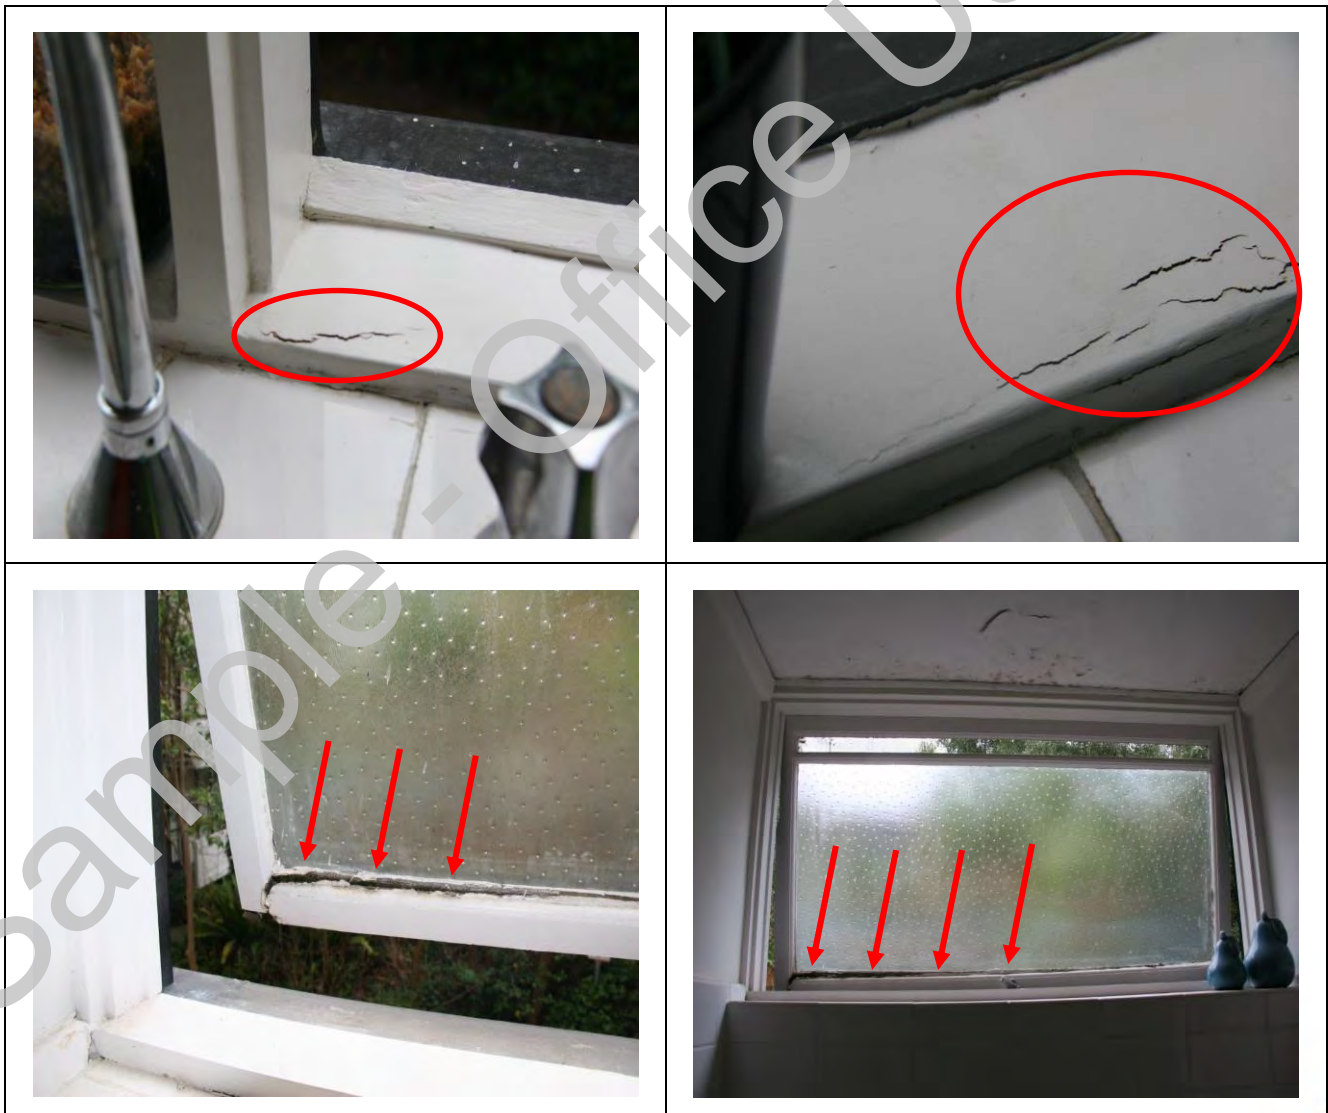
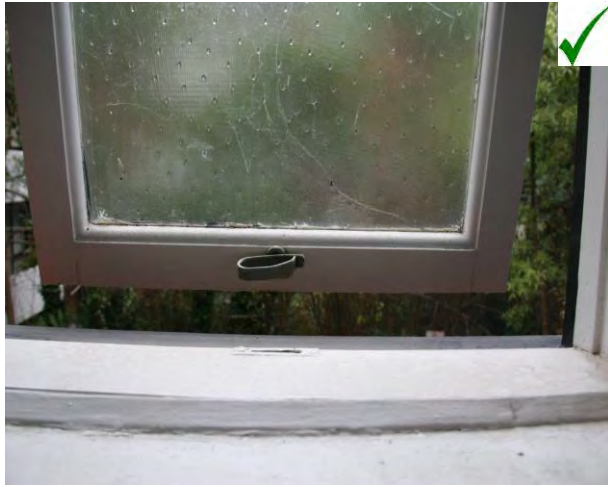
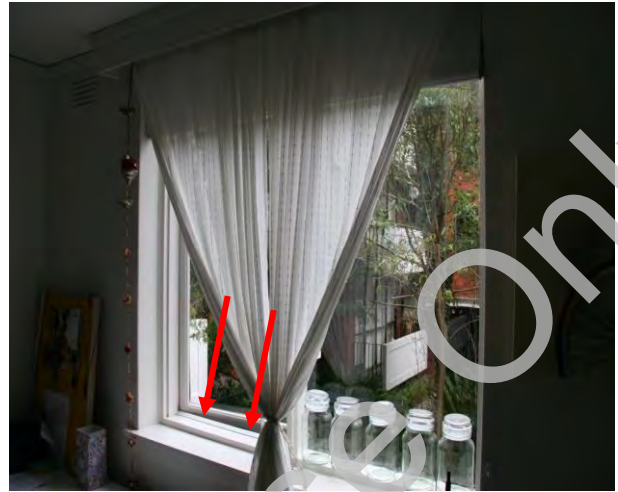
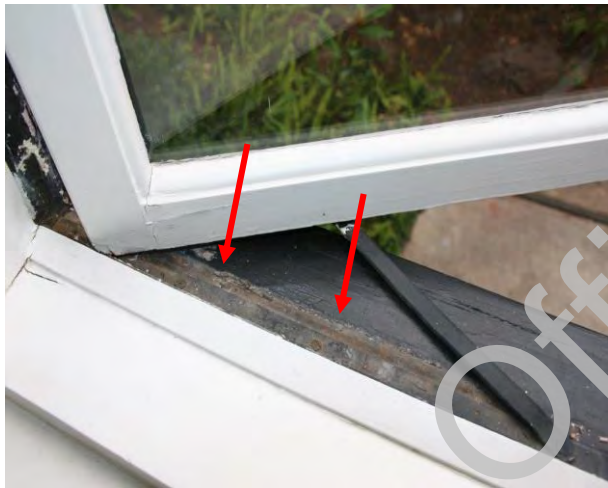
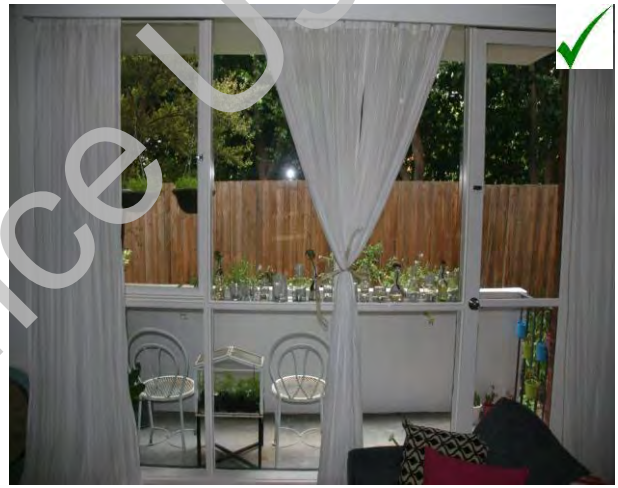
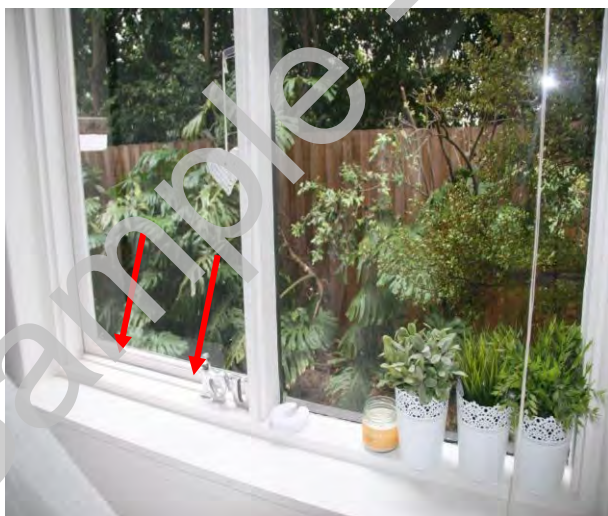
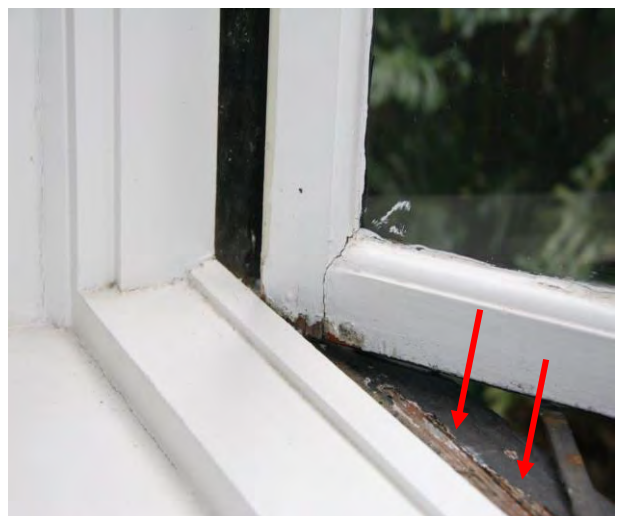
### Unit 8

Location	Inspection Notes
Kitchen	Replace window frame as it has deteriorated and cracked.
Bathroom	Replace window sash & glazing to include an exhaust fan. The tenants may sometimes forget to open the window and the ceiling has sustained damage due to the moisture from condensation.
Toilet	Good condition. No action required.
Bedroom 1	Prepare and paint external window sill.
Living	Good condition as it is undercover. No action required.
Bedroom 2	Prepare and paint window sash. Replace external window sill.

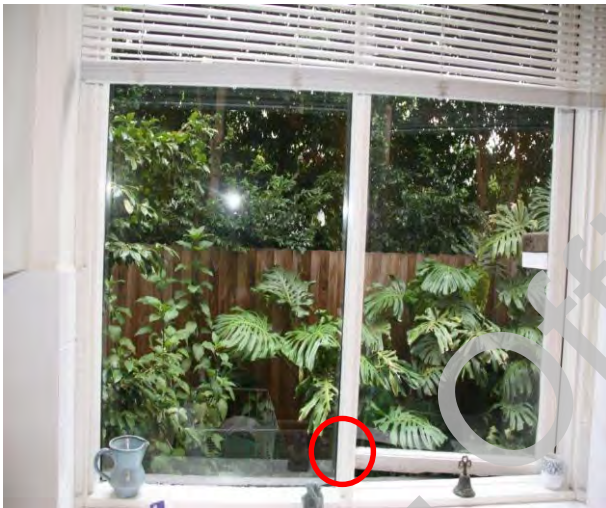
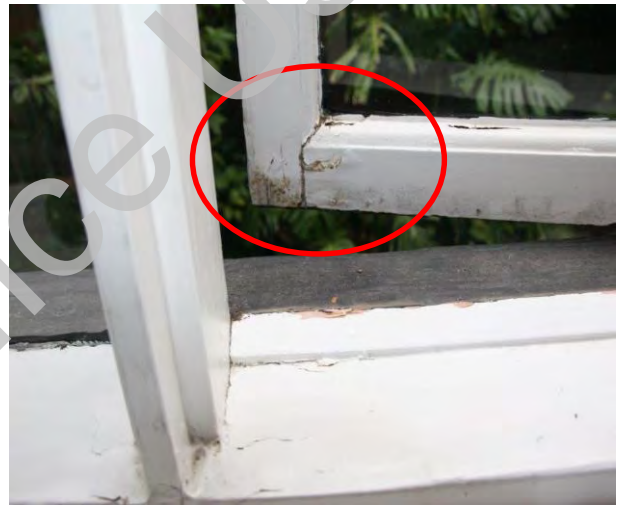
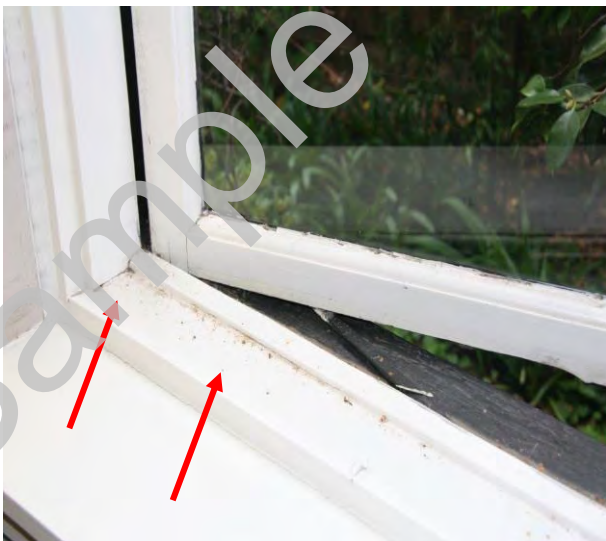
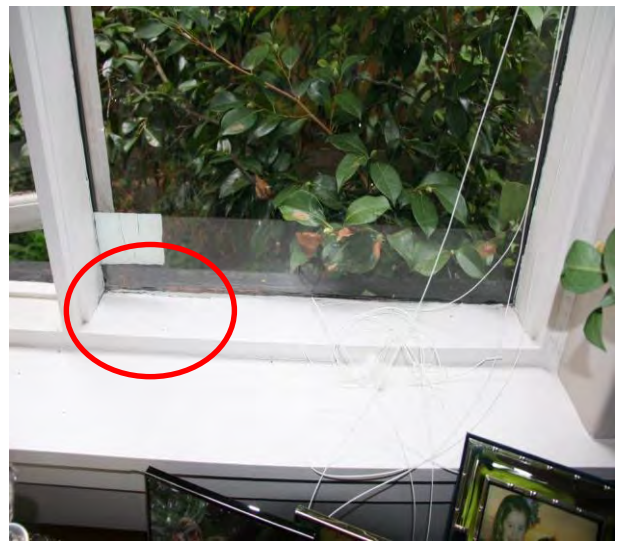
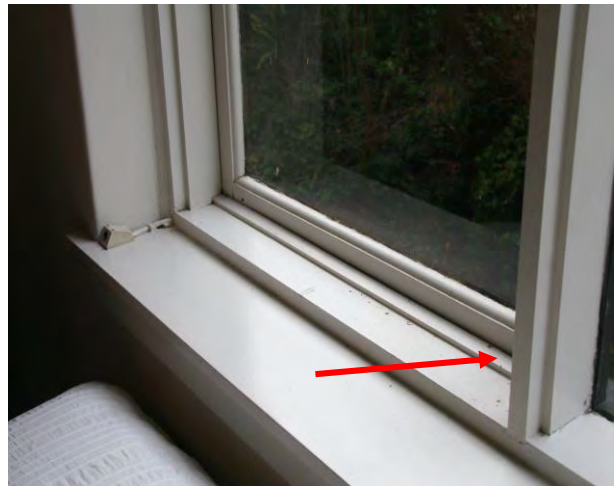
## Unit 7

Location	Inspection Notes
Kitchen	Replace window sash. Patch and paint window frame.
Dining	Prepare and paint entire window frame, sash and sill.
Living	Good condition. No action required.
Bedroom 1	Replace entire sash as it is falling apart, 'L' brackets have been used to hold the sash in place. Prepare and paint window frame.
Toilet	Good condition. No action required.
Bathroom	Replace glazing as it has cracked above the exhaust fan.
Bedroom 2	Replace window stays as it is not opening/closing properly.

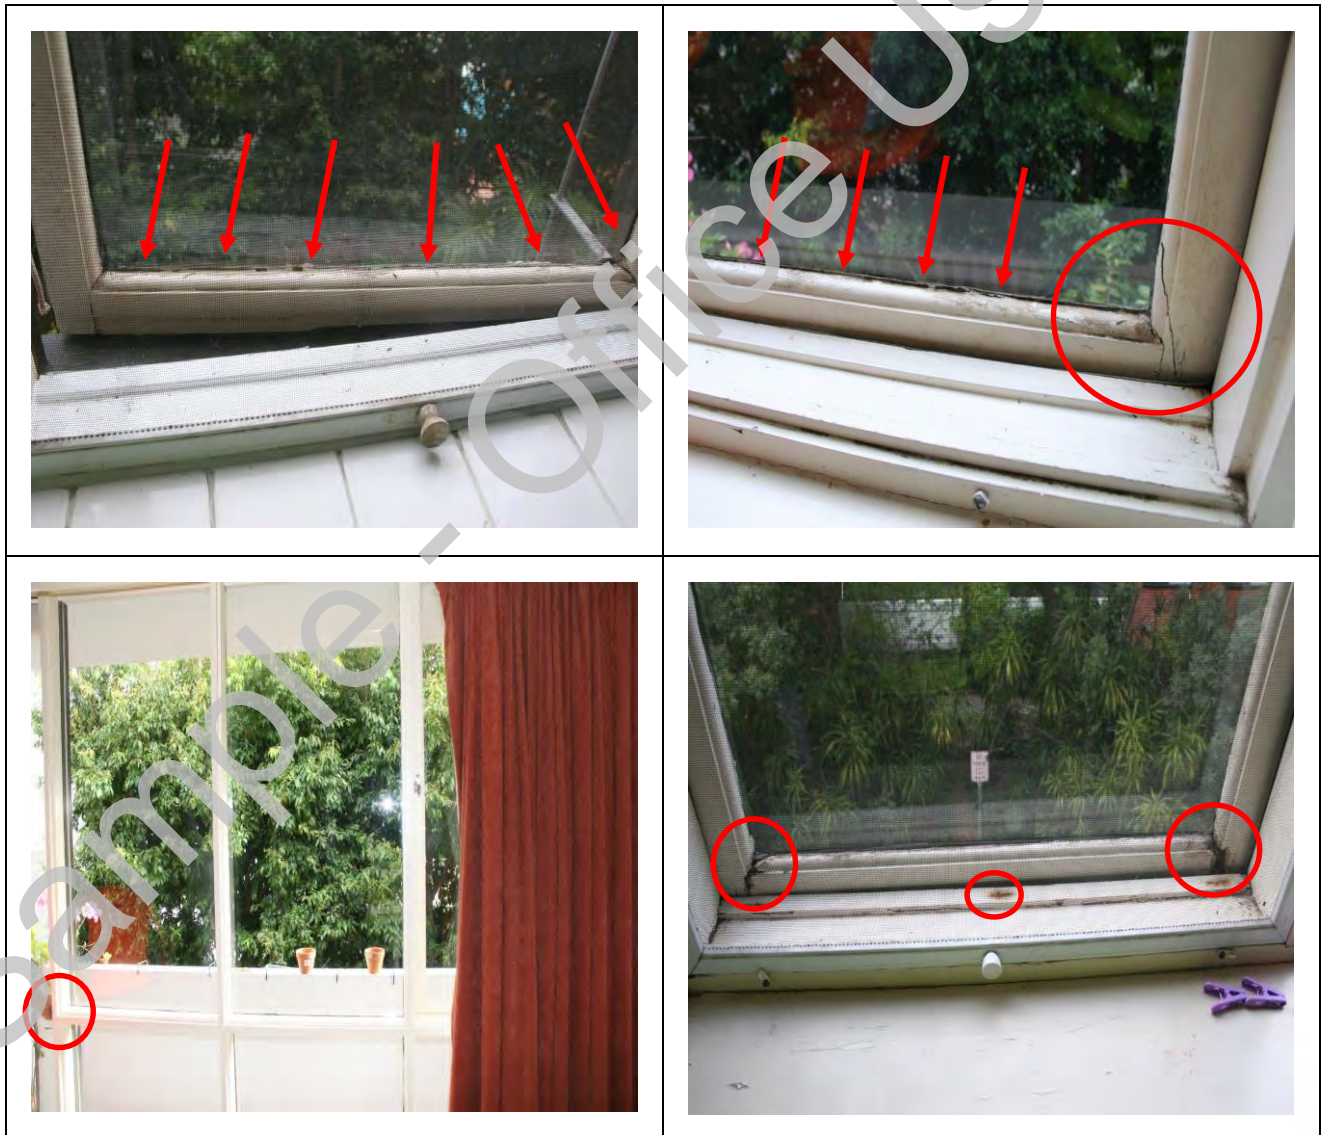
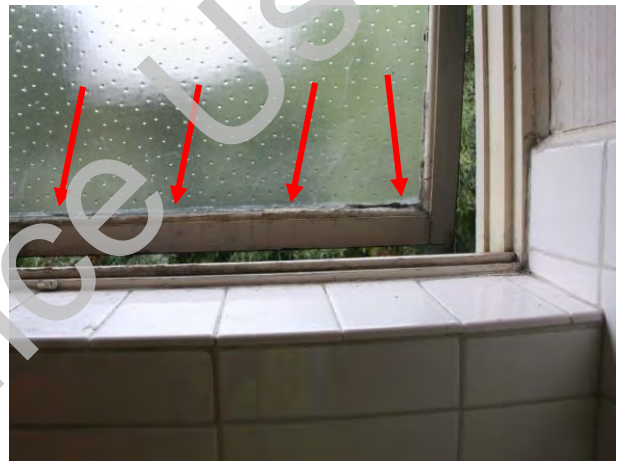
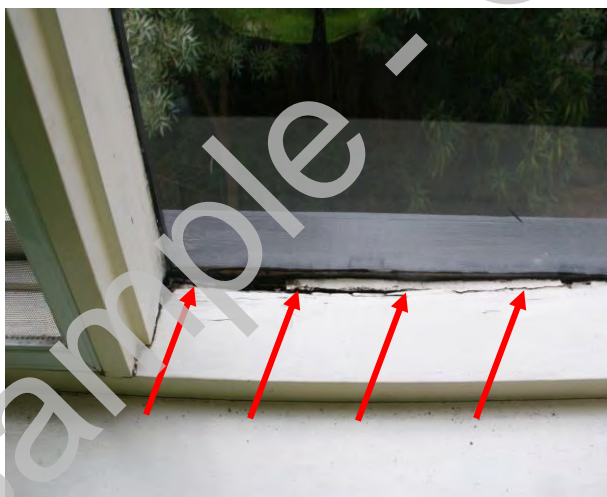
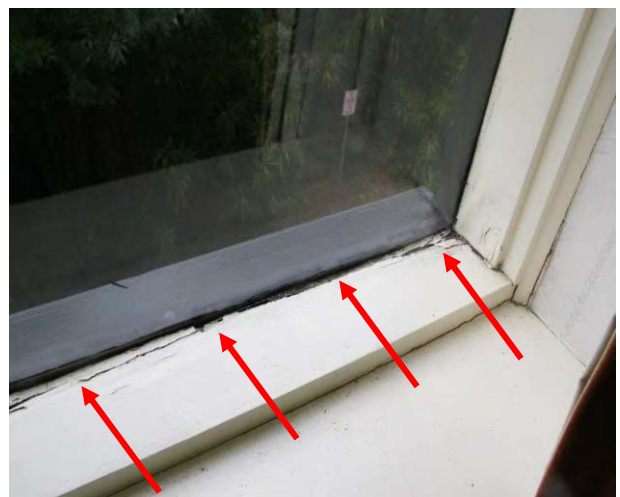
## Unit 9

Location	Inspection Notes
Kitchen	Replace window sash as the seal around the glazing has deteriorated and the sash is cracked. Prepare and paint window frame.
Dining	Replace entire window sash, frame & glazing as they have deteriorated beyond repair.
Living	Replace door hardware.
Bedroom 1	Replace entire window sash, frame & glazing as they have deteriorated beyond repair.
Toilet	Replace window sash. Prepare and paint frame.
Bathroom	Replace window sash. Prepare and paint frame.
Bedroom 2	Replace entire window sash, frame & glazing as they have deteriorated beyond repair.

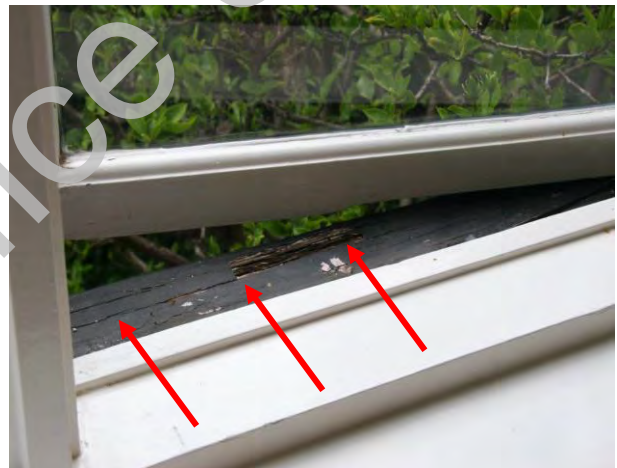
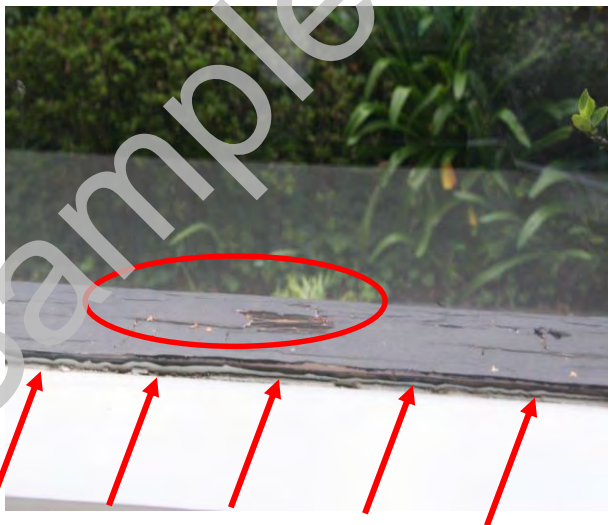
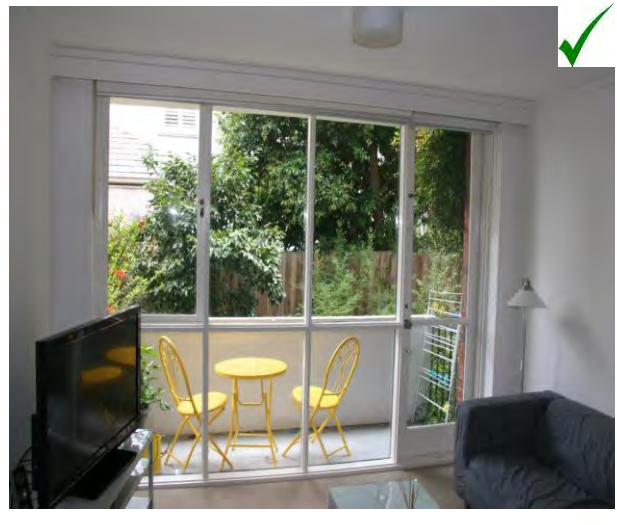
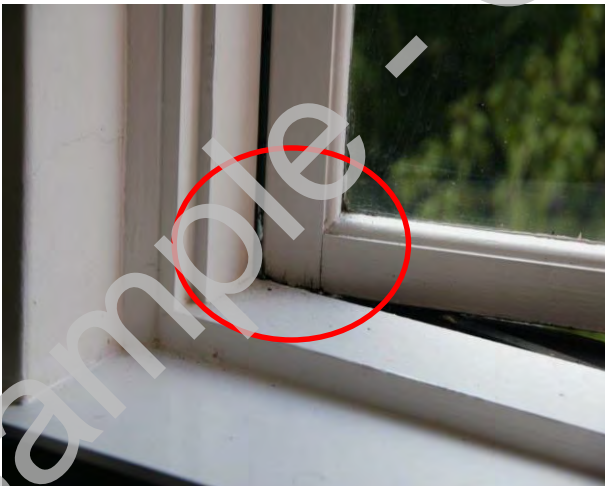
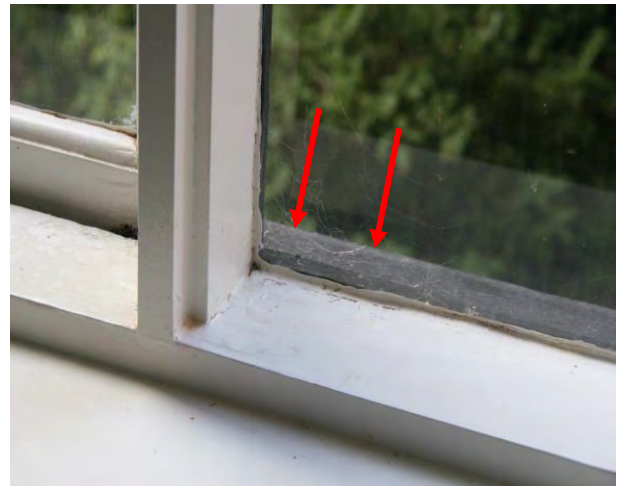
## Unit 2

Location	Inspection Notes
Kitchen	Replace window stays as the window does not open and has been screwed shut. A make safe was undertaken to screw the window shut as it was not secured properly. Patch and paint affected areas after replacement.
Bedroom 1	Replace external window sill.
Living	Good condition. No action required.
Bedroom 2	Replace window stays as the window does not open and has been screwed shut. A make safe was undertaken to screw the window shut as it was not secured properly. Patch and paint affected areas after replacement.
Toilet	Good condition. No action required.
Bathroom	Requires the window sash to be planed down as the window doesn't close properly. Patch and paint affected areas after replacement.
Bedroom 3	Replace window sash. Prepare and paint window frame and external sill.

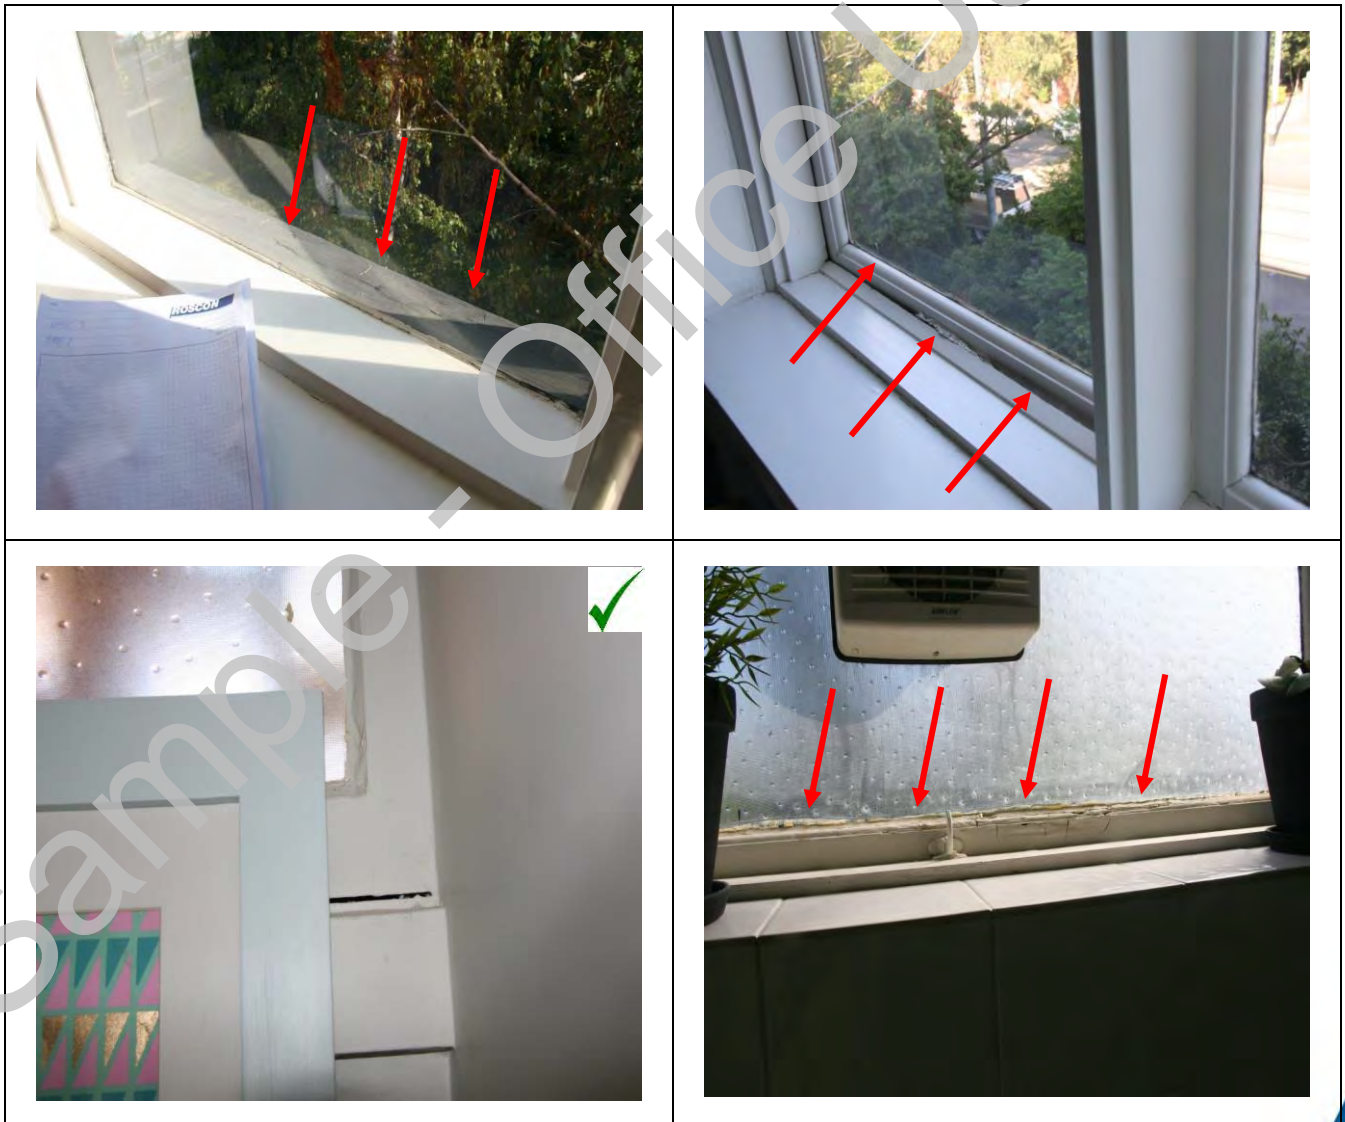
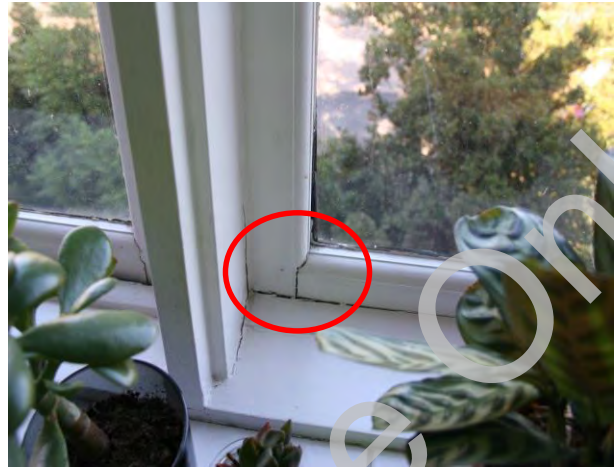
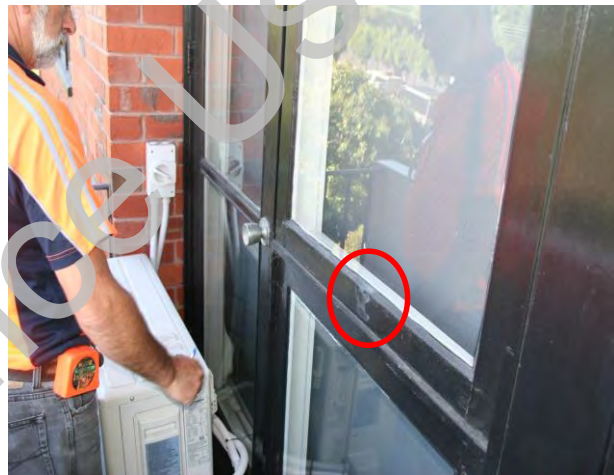
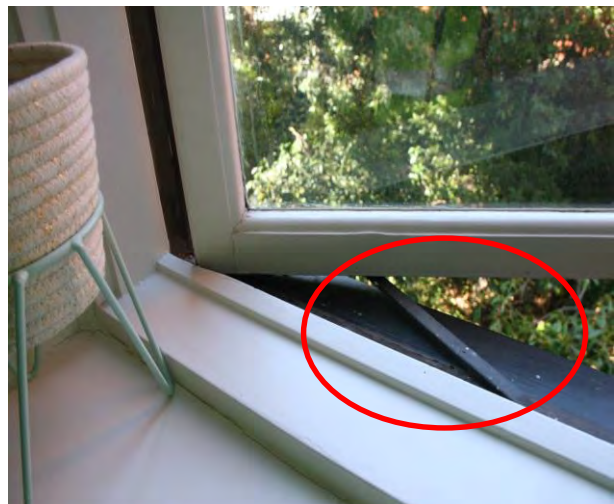
## Unit 3

Location	Inspection Notes
Bedroom 1	Replace the window sash and glazing for both windows as the seals have deteriorated.
Toilet	Good condition. No action required.
Bathroom	Replace the entire window sash, frame and glazing as they have deteriorated beyond repair.
Kitchen	Replace the window sash and external sill.
Living	Prepare and paint external frame.
Dining	Replace window sash as it has deteriorated and is allowing internal airflow. The tenants have placed aluminium foil to reduce the airflow however this is a temporary fix and a more permanent solution should be arranged.
Bedroom 2	Replace window hardware as it is not operational

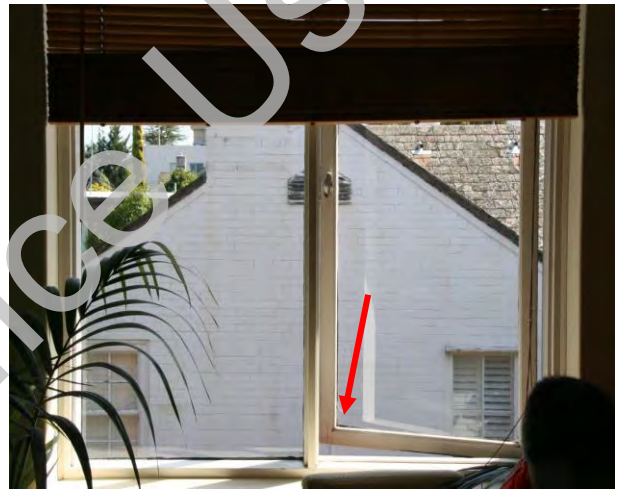
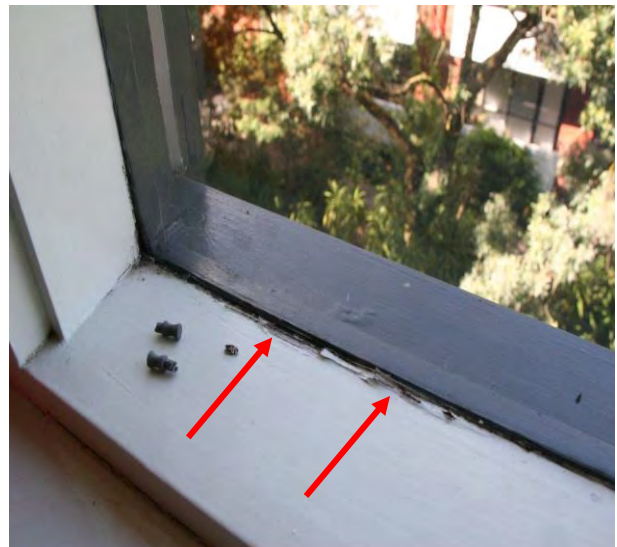
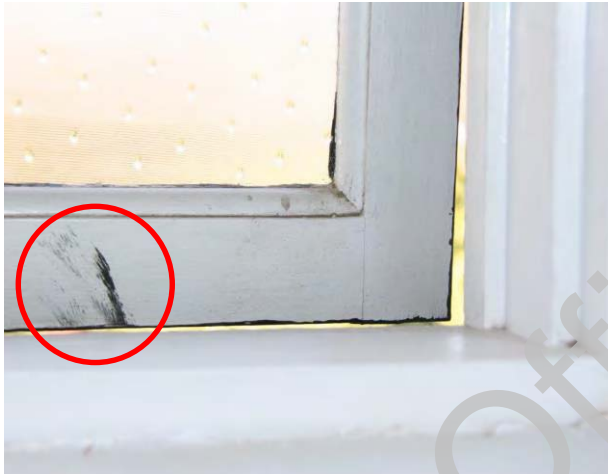
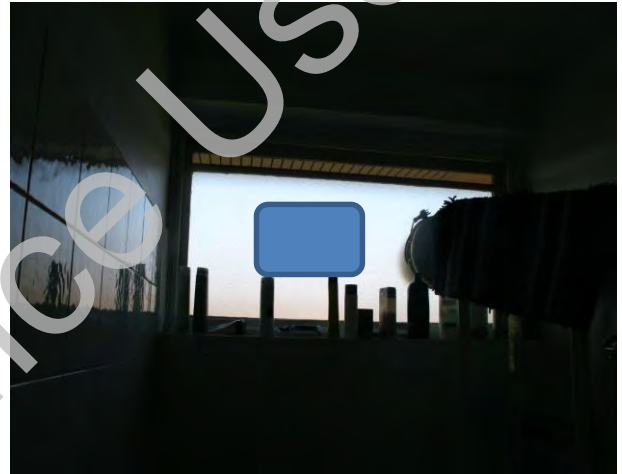
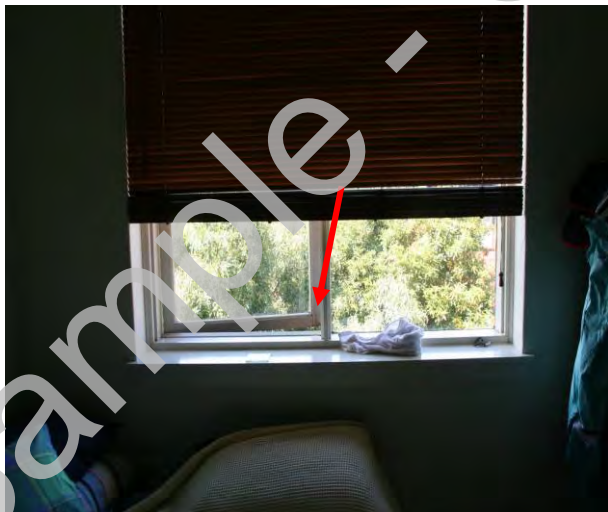
## Unit 6

Location	Inspection Notes
Kitchen	Good condition. No action required.
Dining	Prepare and paint window sash.
Living	Good condition. No action required.
Bedroom 1	Prepare and paint window frame.
Toilet	Prepare and paint window sash.
Bathroom	Replace window glazing to include an exhaust fan.
Bedroom 2	Prepare and paint window sash.

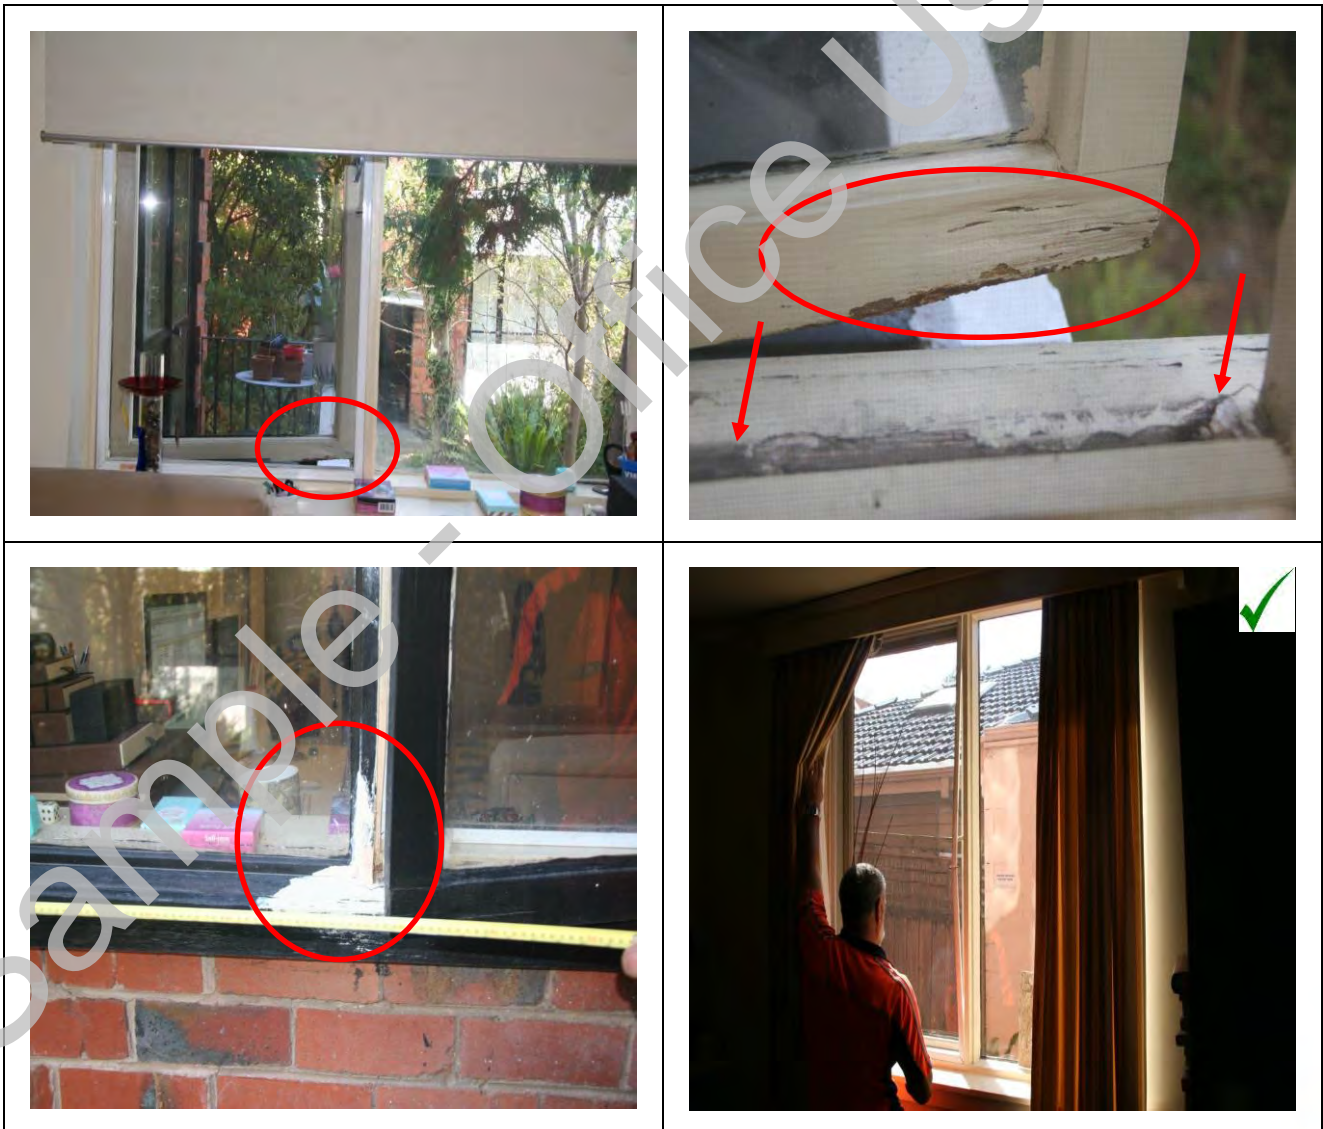
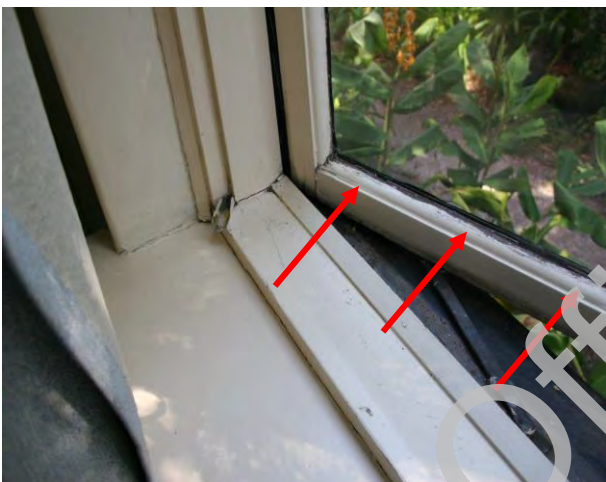
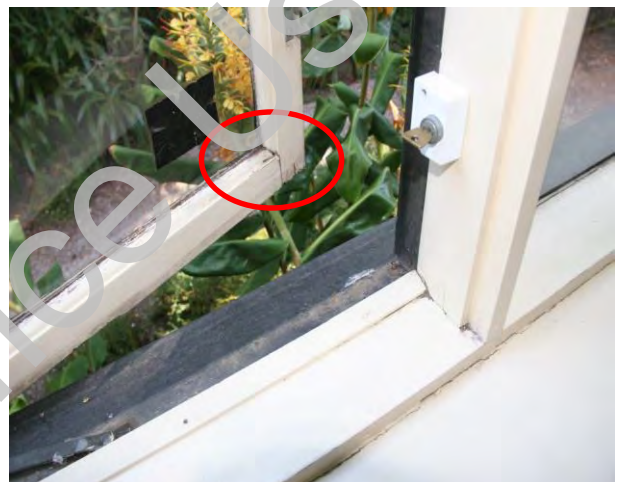
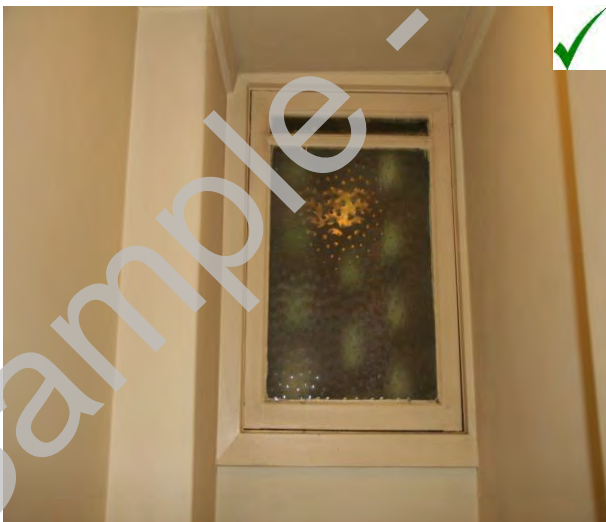
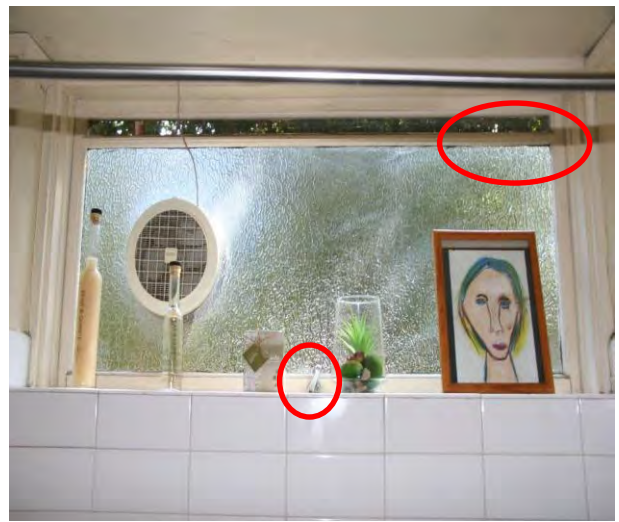
## Unit 13

Location	Inspection Notes
Bedroom 1	Replace window sash as it has completely deteriorated. Prepare and paint window frame.
Living	Good condition. No action required.
Dining	Prepare and paint window frame.
Kitchen	Replace window seal. Prepare and paint window sash.
Bedroom 2	Replace window sash. Prepare and paint external sill.
Toilet	Good condition. No action required.
Bathroom	Replace window chain. When the window is closed it does not open again. Prepare and paint window sash and frame.

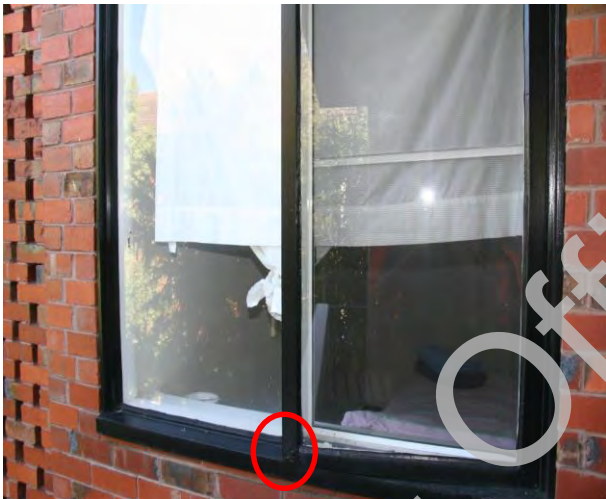
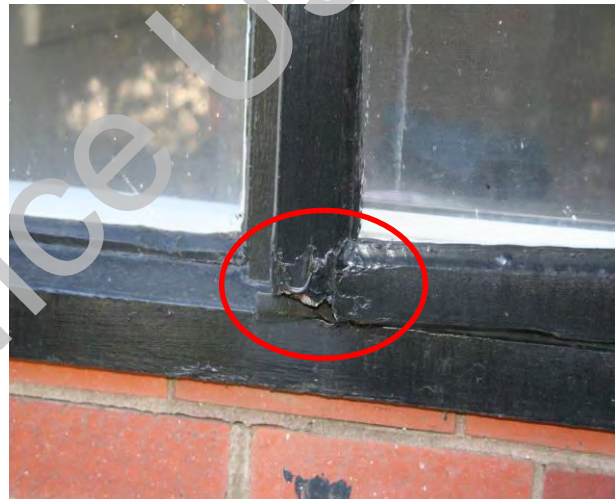
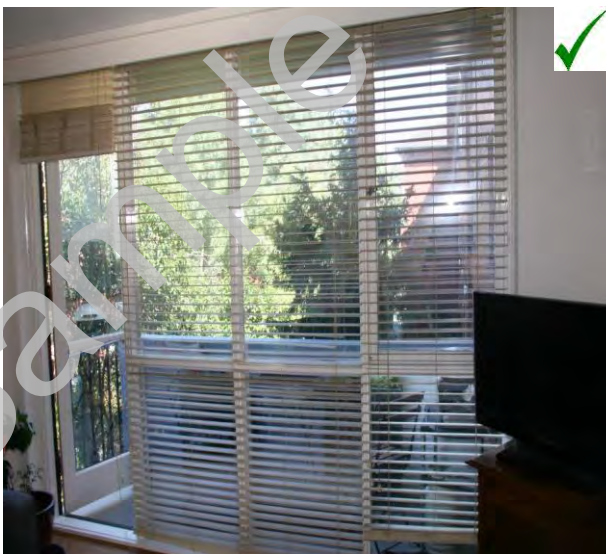
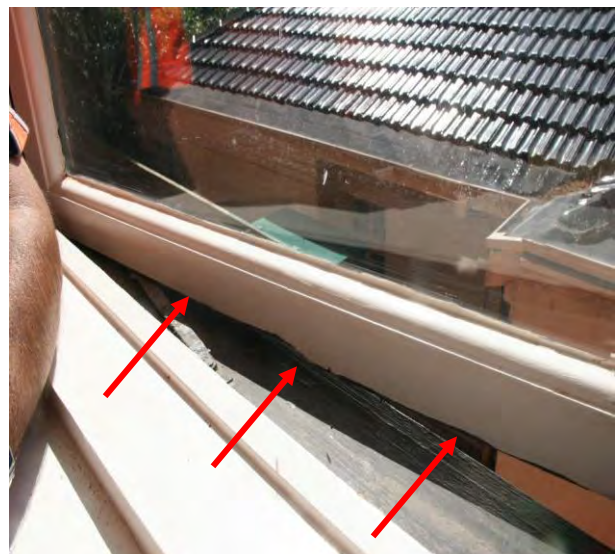
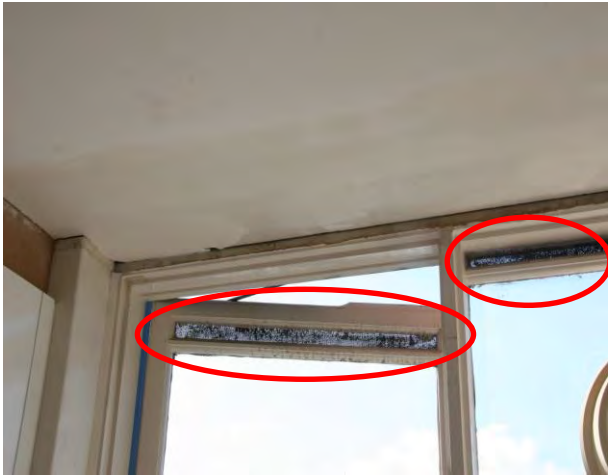
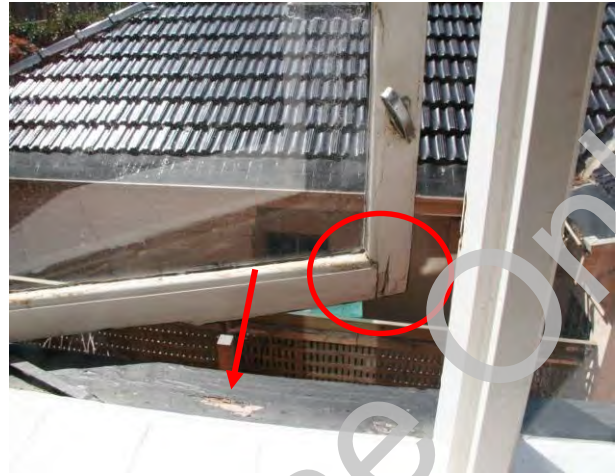
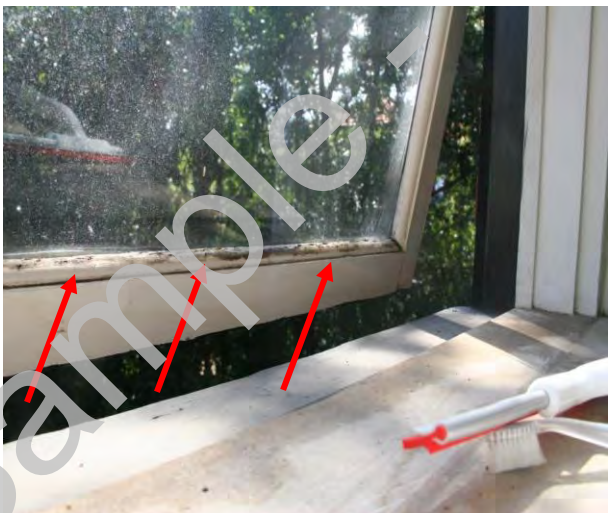
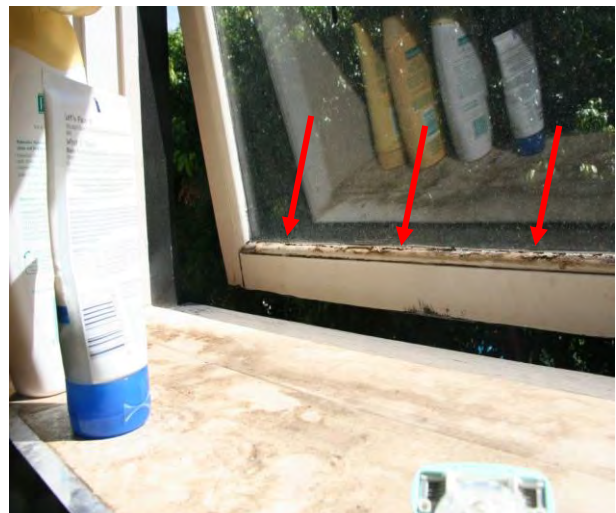
## Unit 14

Location	Inspection Notes
Bedroom 1	Replace window sash as is has completely deteriorated.
Living	Good condition. No action required.
Dining	Prepare and paint window sash.
Kitchen	Replace window sash and ventilation mesh at the top of the window. Prepare and paint external sill.
Bedroom 2	Good condition. No action required.
Toilet	Good condition. No action required.
Bathroom	Replace window sash as it has completely deteriorated. Prepare and paint window frame.

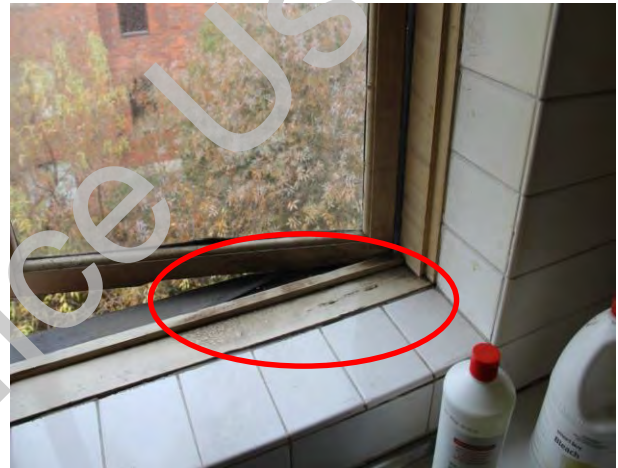
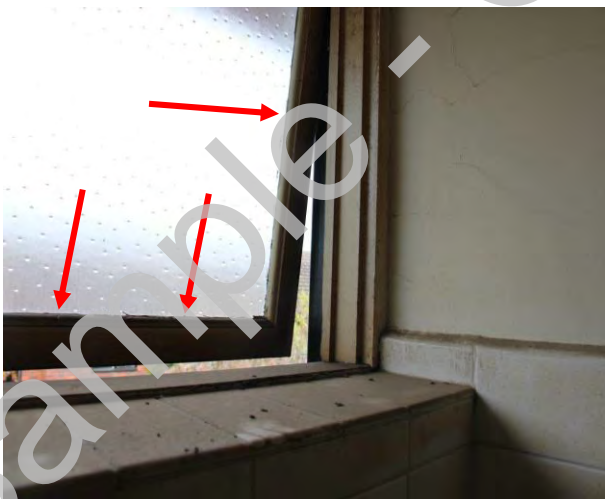
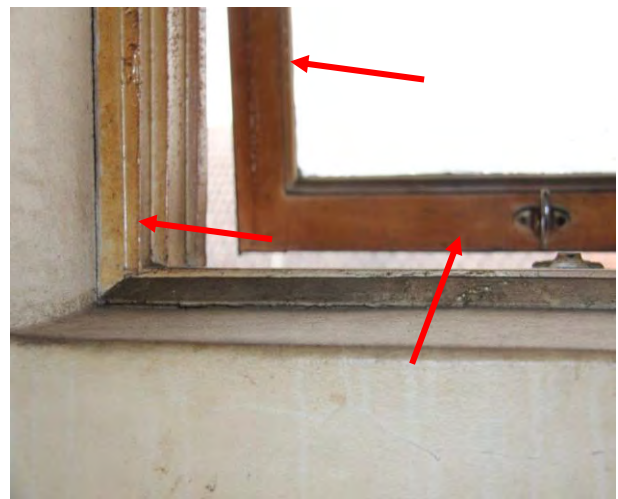
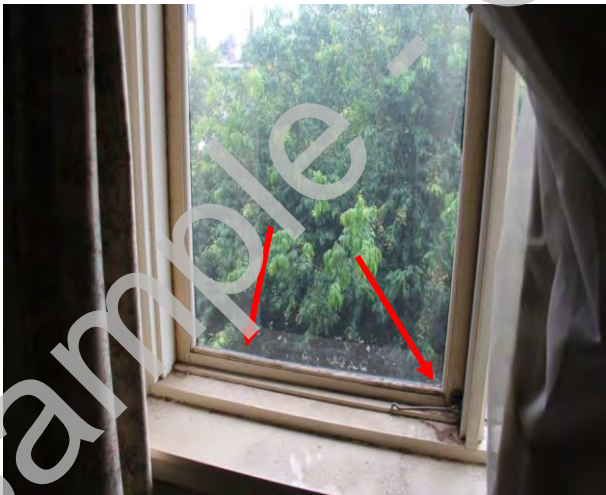
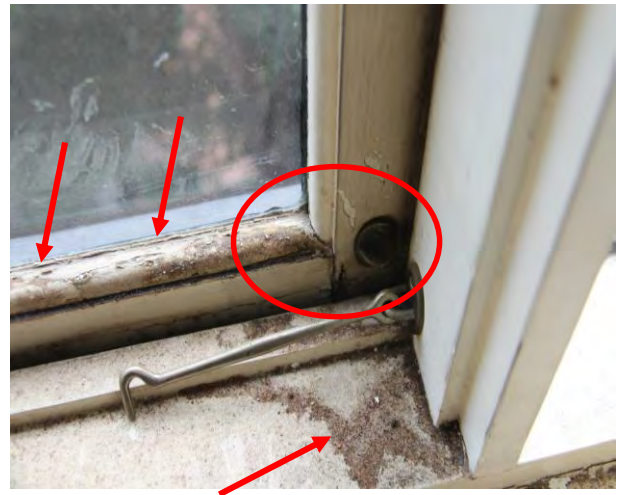
## Unit 12

Location	Inspection Notes
Kitchen	Replace entire window frame, sash and glazing as they have completely deteriorated.
Bathroom	Replace window sash. Prepare and paint window frame.
Toilet	Prepare & paint window frame and sash.
Bedroom 1	Replace entire window frame, sash and glazing as they have completely deteriorated.
Living	Replace window sash. Prepare and paint entire window frame. Replace seals around glazing as they have deteriorated.
Bedroom 2	Replace window sash. Prepare and paint window frame.

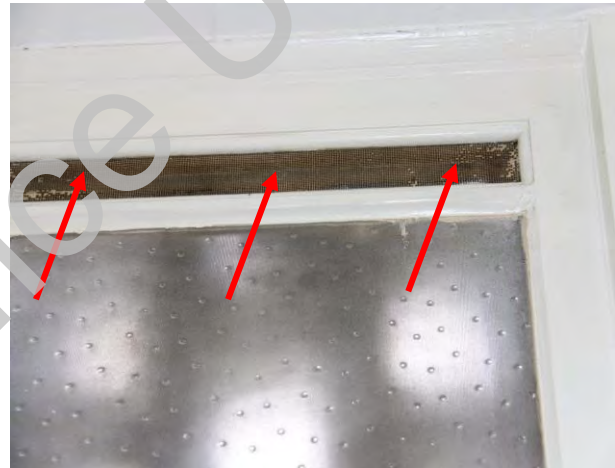
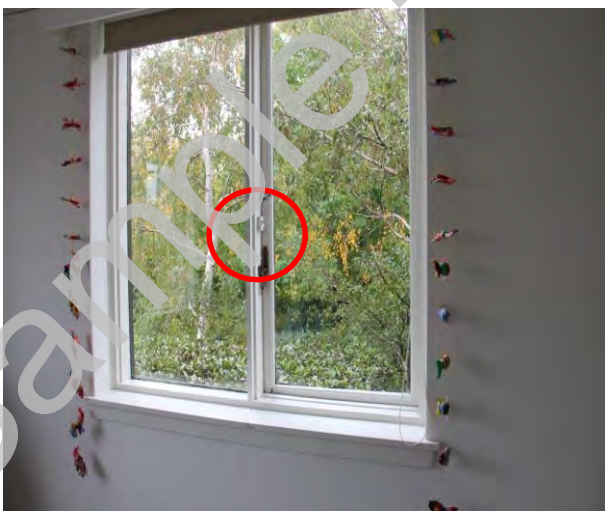
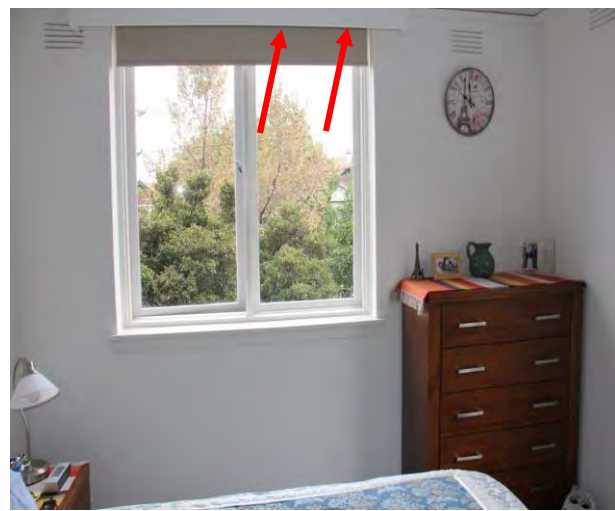
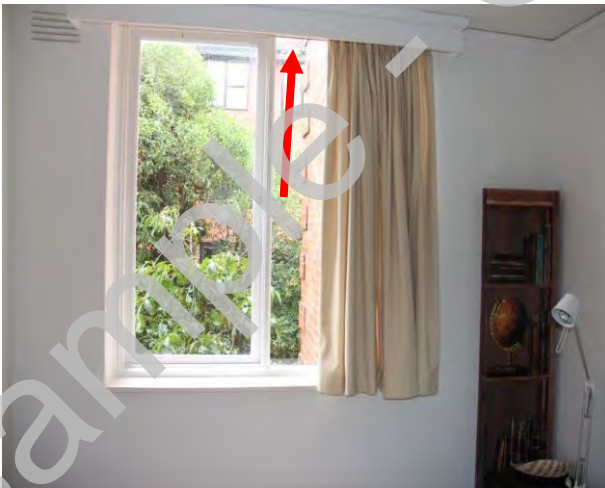
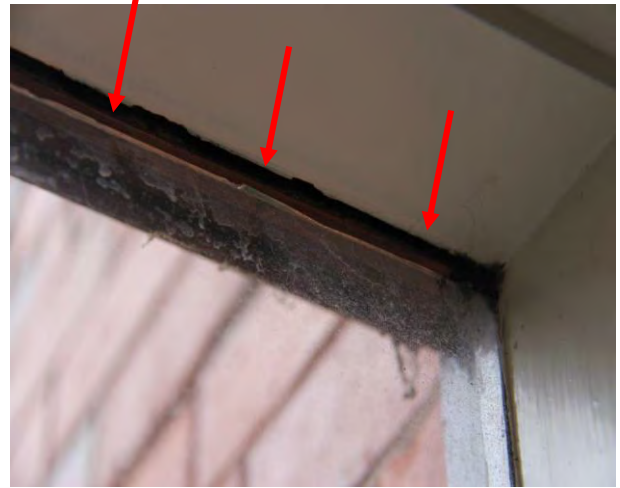
## Unit 1

Location	Inspection Notes
Bathroom	Replace seal around glazing.
Toilet	Replace ventilation mesh above the glazing.
Bedroom 1	Two windows: Replace window sash and hardware on north-facing window. Prepare and paint all other window frames and sash.
Kitchen	Re-seal crack between window frame and kitchen tiles. Prepare and paint after repairs are completed.
Living	Two windows: Replace door hardware and door sash on right hand side of west facing windows. Replace window sash on south face.
Bedroom 2	Replace and re-seal glazing as the glazing has dropped approx. 25mm out of the sash.
