## Detailed Windows Inspection

49 Sample Road Melbourne VIC 3122

## Part 2: Detailed Windows Inspection

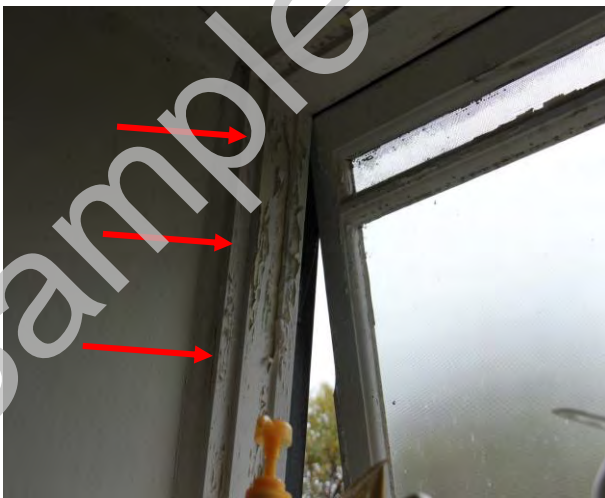
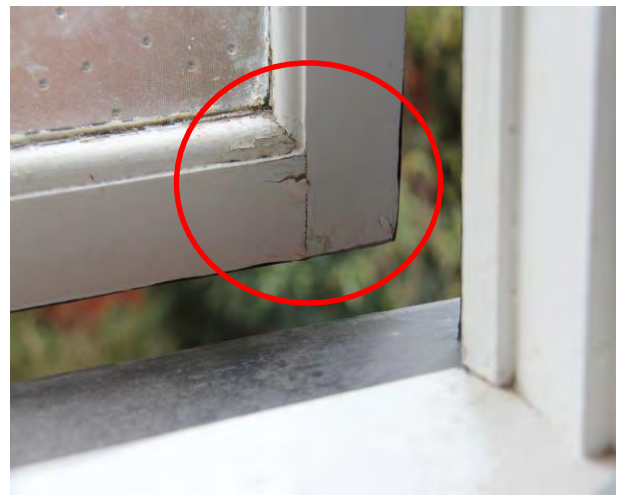
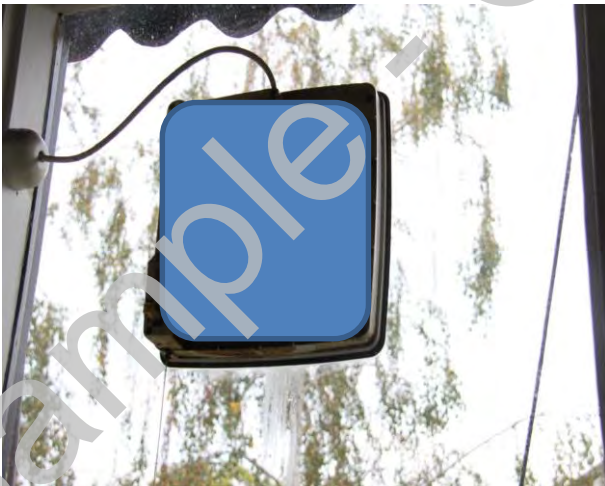
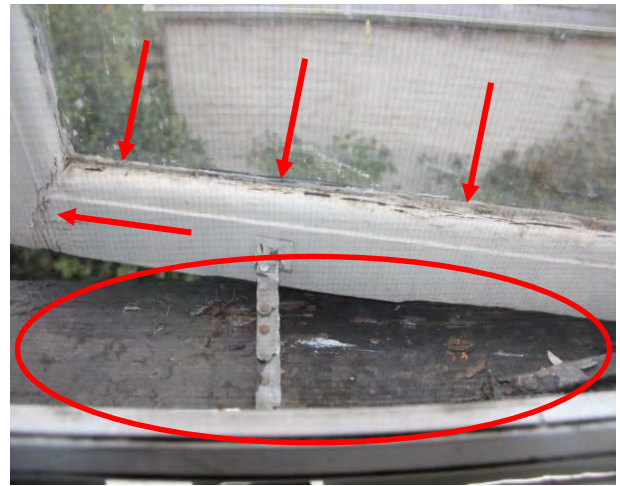
## Unit 4

Location	Inspection Notes
Bedroom 1	Prepare and paint window frame and sash.
Bathroom	Replace window frame and sash. Replace glazing to include an exhaust fan as the ceiling has been damaged by condensation.
Toilet	Replace window sash. Prepare and paint window frame.
Bedroom 2	Replace window sash. Prepare and paint window frame.
Living/Bedroom 3	Good condition. No action required.
Lounge	Replace window sash, external sill and window chain.
Kitchen	Replace window sash and external sill. Replace exhaust fan as it is not working and will eventually cause damage to the ceiling (similar to the bathroom)

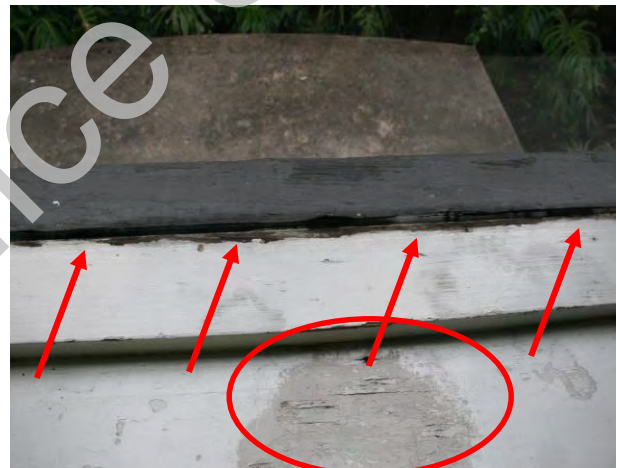
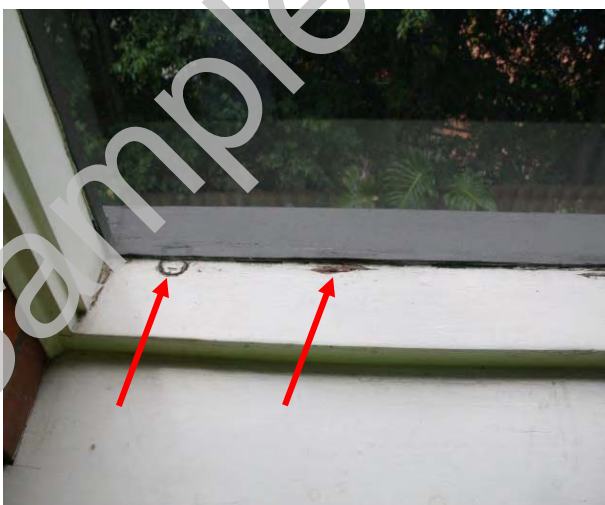
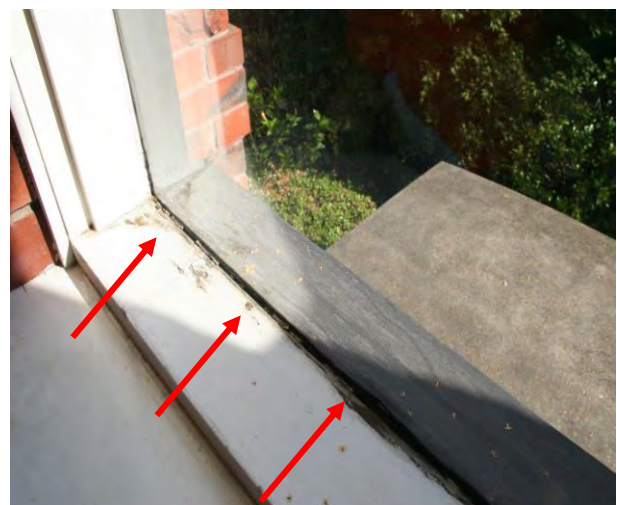
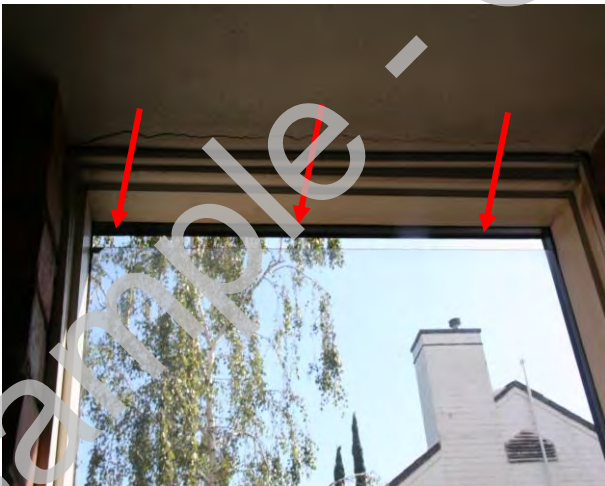
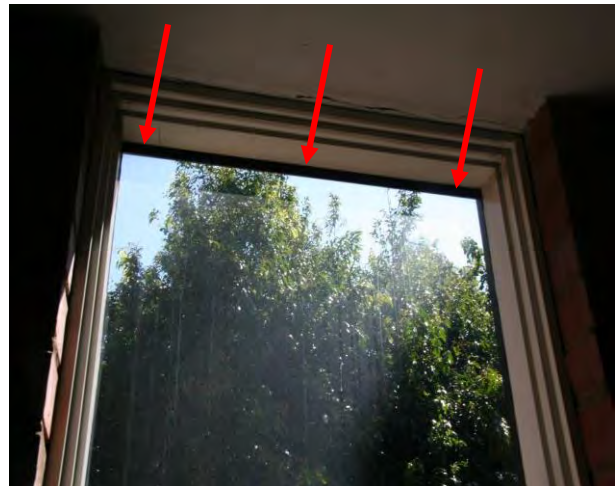
## Common Areas

Location	Inspection Notes:
	NB: These are general findings about the common areas in the building and are not specific to any location.
Window Frame	The majority of the window frames in the common areas require replacement as they have deteriorated. A minority have paint damage and require preparing and painting.
Window Glazing	A majority of the windows glazing have dropped by up to 50mm, this can be attributed to a poor window seal and need to be replaced as water ingress will cause further damage to the window frames.
Glazing Seal	As mentioned above, the glazing seal has deteriorated on all windows and will require replacement to mitigate further damages.
Common Doors	All common doors require preparation and painting to maintain the aesthetics of the building. Roscon recommends to plane the latch edge of the doors prior to painting as it was found that the doors fit too tightly in the frame and has been scratched on the latch edge.
