## Occupational Health & Safety Report

1 Sample Street, Melbourne VIC 3022 Sample Only (PS 123456 - OC1 only)

13 December 2016

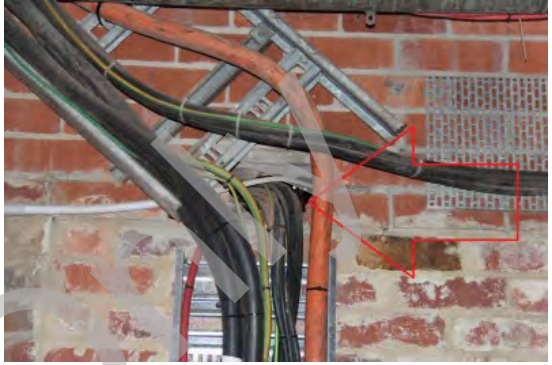
HIGH PRIORITY		
Item	Details	Photo
<p>#1</p> <p>Quote <input type="checkbox"/></p> <p>Proceed <input type="checkbox"/></p> <p>No Action <input type="checkbox"/></p>	<p><b>Risk Assessment:</b></p> <p><input type="checkbox"/> Maintenance Required  <input type="checkbox"/> Risk Of Injury  <input checked="" type="checkbox"/> Risk Of Serious Injury  <input type="checkbox"/> Risk Of Death</p> <p><b>Location:</b>            Central Walkway Southern Boundary adjacent Main switchboard assembly.</p> <p><b>Auditor's Finding:</b>            Penetrations of the electrical wiring are not sealed effectively and effects the fire integrity and is deemed as a fire hazard.</p> <p><b>Auditor's Recommendation:</b>            Engage a suitably qualified contractor to seal the electrical wiring penetration into the masonry wall by implementing fire pillows and fire rated caulking.</p>

<p><b>Rectification Estimate:</b></p> <p><input checked="" type="checkbox"/> \$0 to \$500  <input type="checkbox"/> \$501 to \$1000  <input type="checkbox"/> \$1001 to \$1500  <input type="checkbox"/> \$1501 to \$2000  <input type="checkbox"/> &gt; \$2001</p>

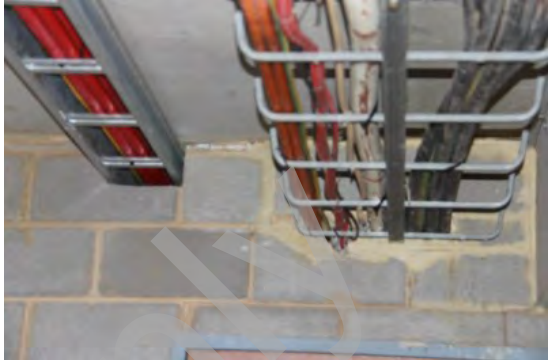
Item	Details	Photo
<p>#3</p> <p>Quote <input type="checkbox"/></p> <p>Proceed <input type="checkbox"/></p> <p>No Action <input type="checkbox"/></p>	<p><b>Risk Assessment:</b></p> <p><input type="checkbox"/> Maintenance Required  <input type="checkbox"/> Risk Of Injury  <input checked="" type="checkbox"/> Risk Of Serious Injury  <input type="checkbox"/> Risk Of Death</p> <p><b>Location:</b>            Central Walkway Southern Boundary adjacent Main switchboard assembly.</p> <p><b>Auditor's Finding:</b>            Penetrations of the electrical wiring are not sealed effectively and effects the fire integrity and is deemed as a fire hazard.</p> <p><b>Auditor's Recommendation:</b>            Engage a suitably qualified contractor to secure the connection of the electrical wiring penetration into the masonry wall is undertaken by implementing fire pillows and fire rated caulking.</p>

<p><b>Rectification Estimate:</b></p> <p><input type="checkbox"/> \$0 to \$500  <input checked="" type="checkbox"/> \$501 to \$1000  <input type="checkbox"/> \$1001 to \$1500  <input type="checkbox"/> \$1501 to \$2000  <input type="checkbox"/> &gt; \$2001</p>

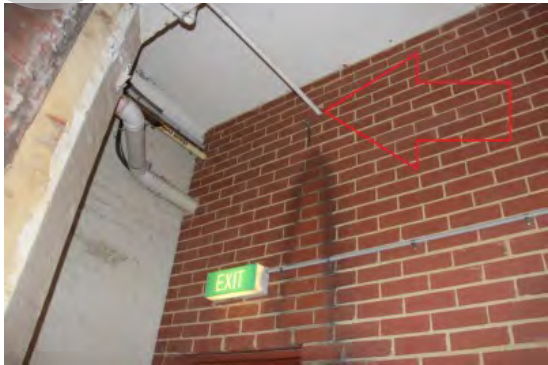
<p>#4</p> <p>Quote <input type="checkbox"/></p> <p>Proceed <input type="checkbox"/></p> <p>No Action <input type="checkbox"/></p>	<p><b>Risk Assessment:</b></p> <p><input type="checkbox"/> Maintenance Required  <input type="checkbox"/> Risk Of Injury  <input checked="" type="checkbox"/> Risk Of Serious Injury  <input type="checkbox"/> Risk Of Death</p> <p><b>Location:</b>            Central Walkway Fire Exit between Lot 18 and 16A.</p> <p><b>Auditor's Finding:</b>            Penetration of pipe gas lines and service pipes above the fire exit are not effectively seal in relation to fire integrity. In the case of a fire, this area would allow for smoke and toxic chemicals in/out of the area due to not being sealed appropriately.</p> <p><b>Auditor's Recommendation:</b>            Engage a suitably qualified contractor to seal the area effectively to ensure fire exits and associated areas are secure during times of emergency.</p>

<p><b>Rectification Estimate:</b></p> <p><input checked="" type="checkbox"/> \$0 to \$500  <input type="checkbox"/> \$501 to \$1000  <input type="checkbox"/> \$1001 to \$1500  <input type="checkbox"/> \$1501 to \$2000  <input type="checkbox"/> &gt; \$2001</p>

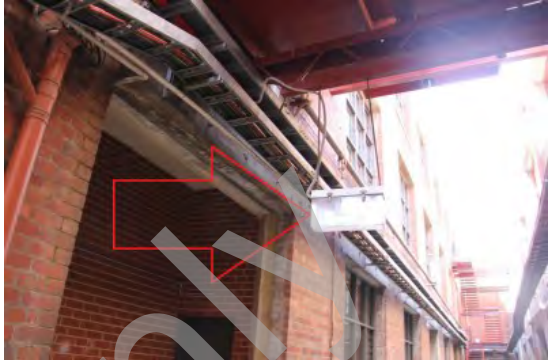
Item	Details	Photo
<p>#5</p> <p>Quote <input type="checkbox"/></p> <p>Proceed <input type="checkbox"/></p> <p>No Action <input type="checkbox"/></p>	<p><b>Risk Assessment:</b></p> <ul style="list-style-type: none"> <li><input type="checkbox"/> Maintenance Required</li> <li><input type="checkbox"/> Risk Of Injury</li> <li><input type="checkbox"/> Risk Of Serious Injury</li> <li><input checked="" type="checkbox"/> Risk Of Death</li> </ul> <p><b>Location:</b> Central Walkway Exit Sign</p> <p><b>Auditor's Finding:</b> The exit sign box does not house any form of existing exit light signage. In the case of emergency, those in the walkway will encounter trouble locating the fire exit and therefore may be prone to serious injury or death.</p> <p><b>Auditor's Recommendation:</b> Install the relevant exit sign signage into the exit sign box.</p>

<p><b>Rectification Estimate:</b></p> <ul style="list-style-type: none"> <li><input checked="" type="checkbox"/> \$0 to \$500</li> <li><input type="checkbox"/> \$501 to \$1000</li> <li><input type="checkbox"/> \$1001 to \$1500</li> <li><input type="checkbox"/> \$1501 to \$2000</li> <li><input type="checkbox"/> &gt; \$2001</li> </ul>

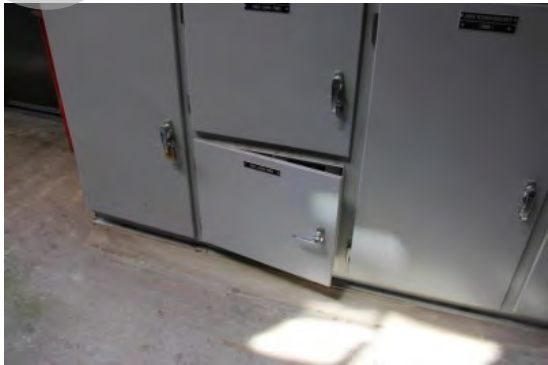
<p>#6</p> <p>Quote <input type="checkbox"/></p> <p>Proceed <input type="checkbox"/></p> <p>No Action <input type="checkbox"/></p>	<p><b>Risk Assessment:</b></p> <ul style="list-style-type: none"> <li><input checked="" type="checkbox"/> Maintenance Required</li> <li><input type="checkbox"/> Risk Of Injury</li> <li><input type="checkbox"/> Risk Of Serious Injury</li> <li><input type="checkbox"/> Risk Of Death</li> </ul> <p><b>Location:</b> Central Walkway Southern Boundary - Main switchboard</p> <p><b>Auditor's Finding:</b> The "Public Lighting &amp; Power" and "Electricity Meters Tenant 2" cabinets had been unlocked at the time of inspection.</p> <p><b>Auditor's Recommendation:</b> Install standard power industry pad locks locks on all unlocked cabinets to prevent unauthorised tampering with the services.</p>

<p><b>Rectification Estimate:</b></p> <ul style="list-style-type: none"> <li><input checked="" type="checkbox"/> \$0 to \$500</li> <li><input type="checkbox"/> \$501 to \$1000</li> <li><input type="checkbox"/> \$1001 to \$1500</li> <li><input type="checkbox"/> \$1501 to \$2000</li> <li><input type="checkbox"/> &gt; \$2001</li> </ul>

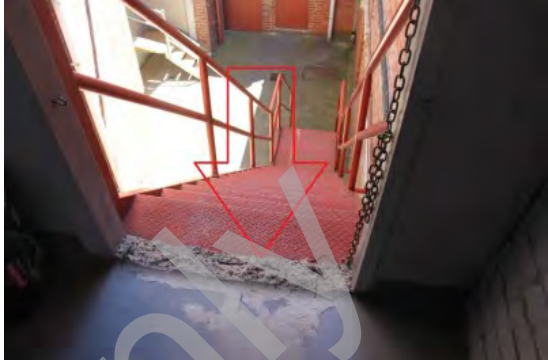
Item	Details	Photo
<p>#9</p> <p>Quote <input type="checkbox"/></p> <p>Proceed <input type="checkbox"/></p> <p>No Action <input type="checkbox"/></p>	<p><b>Risk Assessment:</b></p> <p><input type="checkbox"/> Maintenance Required  <input type="checkbox"/> Risk Of Injury  <input checked="" type="checkbox"/> Risk Of Serious Injury  <input type="checkbox"/> Risk Of Death</p> <p><b>Location:</b>            First Floor Common Area Walkway Stairwell adjacent Northern boundary</p> <p><b>Auditor's Finding:</b>            Entry opening on to staircase has a section of unfinished concrete which is deemed as a trip hazard.</p> <p><b>Auditor's Recommendation:</b>            Engage a suitably qualified contractor to screed the section to create an even flush surface eliminating the trip hazard.</p>

<p><b>Rectification Estimate:</b></p> <p><input checked="" type="checkbox"/> \$0 to \$500  <input type="checkbox"/> \$501 to \$1000  <input type="checkbox"/> \$1001 to \$1500  <input type="checkbox"/> \$1501 to \$2000  <input type="checkbox"/> &gt; \$2001</p>

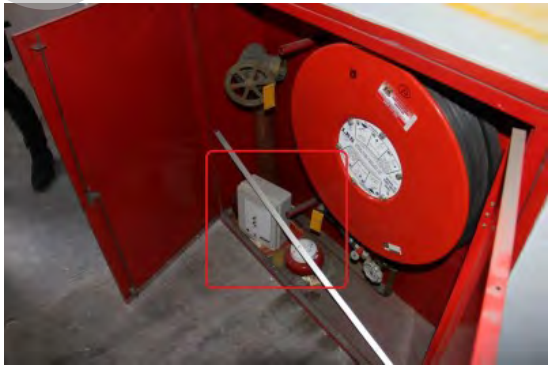
<p>#10</p> <p>Quote <input type="checkbox"/></p> <p>Proceed <input type="checkbox"/></p> <p>No Action <input type="checkbox"/></p>	<p><b>Risk Assessment:</b></p> <p><input type="checkbox"/> Maintenance Required  <input type="checkbox"/> Risk Of Injury  <input checked="" type="checkbox"/> Risk Of Serious Injury  <input type="checkbox"/> Risk Of Death</p> <p><b>Location:</b>            First Floor Common Area Walkway Stairwell adjacent Northern boundary</p> <p><b>Auditor's Finding:</b>            Redundant ESM items and personal belongings found in hose reel cupboard causing obstruction to fire services is deemed as a hazard.</p> <p><b>Auditor's Recommendation:</b>            Please ensure there is no obstruction to fire services in the cabinet by disposing of redundant items appropriately.</p>

<p><b>Rectification Estimate:</b></p> <p><input checked="" type="checkbox"/> \$0 to \$500  <input type="checkbox"/> \$501 to \$1000  <input type="checkbox"/> \$1001 to \$1500  <input type="checkbox"/> \$1501 to \$2000  <input type="checkbox"/> &gt; \$2001</p>

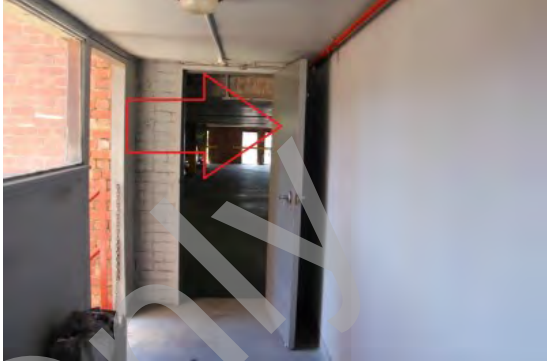
Item	Details	Photo
<p>#11</p> <p>Quote <input type="checkbox"/></p> <p>Proceed <input type="checkbox"/></p> <p>No Action <input type="checkbox"/></p>	<p><b>Risk Assessment:</b></p> <p><input type="checkbox"/> Maintenance Required  <input type="checkbox"/> Risk Of Injury  <input checked="" type="checkbox"/> Risk Of Serious Injury  <input type="checkbox"/> Risk Of Death</p> <p><b>Location:</b>            First Floor Common Area Walkway to first level Car Park adjacent northern boundary.</p> <p><b>Auditor's Finding:</b>            The existing fire door (identified by manufacturers tags) had been propped and unable to close. As the purpose of a fire door is to remain closed to prevent the spreading of fire, this is therefore in need to be rectified. The door also has non-compliant hardware (latches/dead bolts) fixed to it. No signage had been identified on the fire door. As this is a requirement, this is therefore non compliant and in need of installation Furthermore, a locking bolt mechanism had been found on the door. As the purpose of a fire door is to provide an escape for all of those accessing the area; if the bolt were employed during an emergency there may be no further path for those to escape.</p> <p><b>Auditor's Recommendation:</b>            Engage a suitably qualified contractor to remove any non-compliant hardware and repair the self closer so as to make the fire door compliant.</p>

<p><b>Rectification Estimate:</b></p> <p><input checked="" type="checkbox"/> \$0 to \$500  <input type="checkbox"/> \$501 to \$1000  <input type="checkbox"/> \$1001 to \$1500  <input type="checkbox"/> \$1501 to \$2000  <input type="checkbox"/> &gt; \$2001</p>

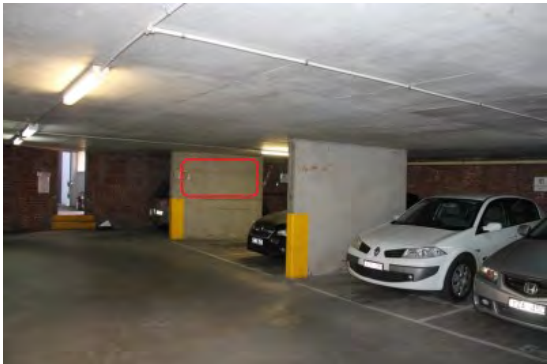
<p>#12</p> <p>Quote <input type="checkbox"/></p> <p>Proceed <input type="checkbox"/></p> <p>No Action <input type="checkbox"/></p>	<p><b>Risk Assessment:</b></p> <p><input type="checkbox"/> Maintenance Required  <input type="checkbox"/> Risk Of Injury  <input checked="" type="checkbox"/> Risk Of Serious Injury  <input type="checkbox"/> Risk Of Death</p> <p><b>Location:</b>            Level 1 Car Park</p> <p><b>Auditor's Finding:</b>            The location of the Fire Hose Reel is out of view from those accessing the area. In the case of emergency, the knowledge of this area is key and may create a serious risk if not in view. It was also noted that there were no Evacuation diagrams in place in the common areas.</p> <p><b>Auditor's Recommendation:</b>            Engage a suitably qualified contractor to install the required pop up signage on an open area to allow for further recognition of the location of the Fire Hose Reel. It is also essential to install Evacuation diagrams with Fire evacuation procedures in common areas to increase overall safety of occupants.</p>

<p><b>Rectification Estimate:</b></p> <p><input type="checkbox"/> \$0 to \$500  <input type="checkbox"/> \$501 to \$1000  <input type="checkbox"/> \$1001 to \$1500  <input checked="" type="checkbox"/> \$1501 to \$2000  <input type="checkbox"/> &gt; \$2001</p>

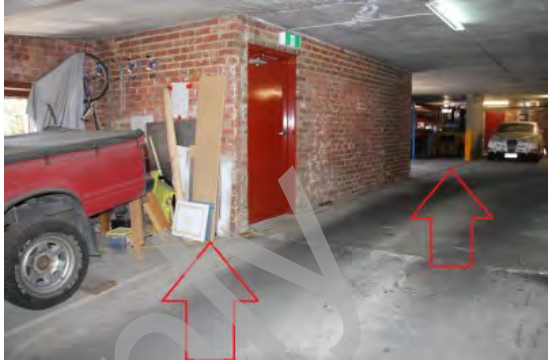
Item	Details	Photo
<p>#13</p> <p>Quote <input type="checkbox"/></p> <p>Proceed <input type="checkbox"/></p> <p>No Action <input type="checkbox"/></p>	<p><b>Risk Assessment:</b></p> <p><input type="checkbox"/> Maintenance Required  <input type="checkbox"/> Risk Of Injury  <input checked="" type="checkbox"/> Risk Of Serious Injury  <input type="checkbox"/> Risk Of Death</p> <p><b>Location:</b> 1st level carpark adjacent car space 72.</p> <p><b>Auditor's Finding:</b> A live electrical lead was found to be running through common area causing trip and electrocution hazard. The lead was connected to a pick up truck adjacent carspot 72 and runs all way across the carpark to a GPO.</p> <p><b>Auditor's Recommendation:</b> Ensure the lead is removed from common area to eliminate the hazard.</p>

<p><b>Rectification Estimate:</b></p> <p><input checked="" type="checkbox"/> \$0 to \$500  <input type="checkbox"/> \$501 to \$1000  <input type="checkbox"/> \$1001 to \$1500  <input type="checkbox"/> \$1501 to \$2000  <input type="checkbox"/> &gt; \$2001</p>

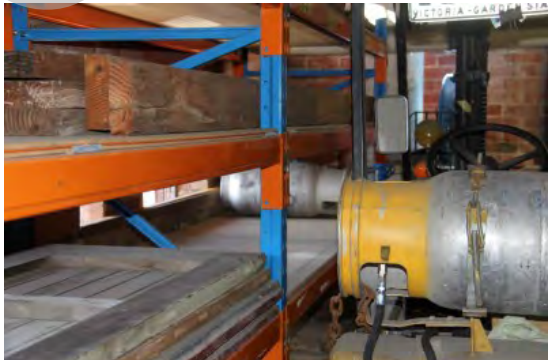
<p>#14</p> <p>Quote <input type="checkbox"/></p> <p>Proceed <input type="checkbox"/></p> <p>No Action <input type="checkbox"/></p>	<p><b>Risk Assessment:</b></p> <p><input type="checkbox"/> Maintenance Required  <input type="checkbox"/> Risk Of Injury  <input checked="" type="checkbox"/> Risk Of Serious Injury  <input type="checkbox"/> Risk Of Death</p> <p><b>Location:</b> Car space 82</p> <p><b>Auditor's Finding:</b> LPG containers for forklift stored in common area carpark is deemed as a fire hazard.</p> <p><b>Auditor's Recommendation:</b> OC to remind owner to remove the gas canisters from the carpark area to eliminate the hazard.</p>

<p><b>Rectification Estimate:</b></p> <p><input checked="" type="checkbox"/> \$0 to \$500  <input type="checkbox"/> \$501 to \$1000  <input type="checkbox"/> \$1001 to \$1500  <input type="checkbox"/> \$1501 to \$2000  <input type="checkbox"/> &gt; \$2001</p>

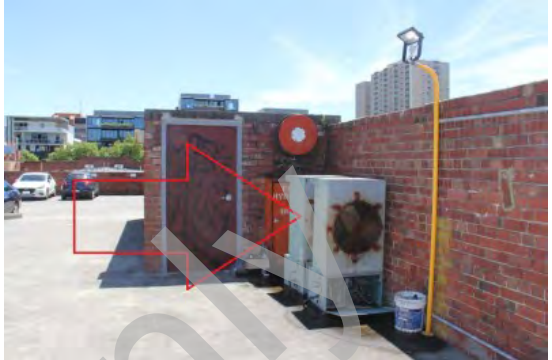
Item	Details	Photo
<p>#15</p> <p>Quote <input type="checkbox"/></p> <p>Proceed <input type="checkbox"/></p> <p>No Action <input type="checkbox"/></p>	<p><b>Risk Assessment:</b></p> <ul style="list-style-type: none"> <li><input type="checkbox"/> Maintenance Required</li> <li><input type="checkbox"/> Risk Of Injury</li> <li><input checked="" type="checkbox"/> Risk Of Serious Injury</li> <li><input type="checkbox"/> Risk Of Death</li> </ul> <p><b>Location:</b> Car Park - topmost level.</p> <p><b>Auditor's Finding:</b> Redundant HVAC equipment was found to be obstructing the fire services adjacent exit stairwell door. also the fire hose reel is causing leaks into the carpark level below.</p> <p><b>Auditor's Recommendation:</b> Engage contractor to remove the equipment so as to eliminate the obstruction and hazard.</p>

<p><b>Rectification Estimate:</b></p> <ul style="list-style-type: none"> <li><input checked="" type="checkbox"/> \$0 to \$500</li> <li><input type="checkbox"/> \$501 to \$1000</li> <li><input type="checkbox"/> \$1001 to \$1500</li> <li><input type="checkbox"/> \$1501 to \$2000</li> <li><input type="checkbox"/> &gt; \$2001</li> </ul>

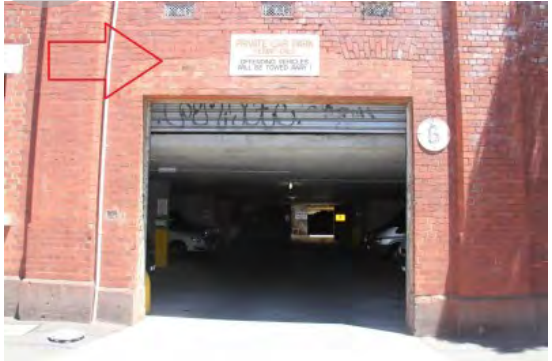
<p>#16</p> <p>Quote <input type="checkbox"/></p> <p>Proceed <input type="checkbox"/></p> <p>No Action <input type="checkbox"/></p>	<p><b>Risk Assessment:</b></p> <ul style="list-style-type: none"> <li><input type="checkbox"/> Maintenance Required</li> <li><input type="checkbox"/> Risk Of Injury</li> <li><input checked="" type="checkbox"/> Risk Of Serious Injury</li> <li><input type="checkbox"/> Risk Of Death</li> </ul> <p><b>Location:</b> Carpark Entrance</p> <p><b>Auditor's Finding:</b> 'Speed limit 5km/hr' signage and height limit signage missing at entry of driveway.</p> <p><b>Auditor's Recommendation:</b> Install both signage to all entry carpark areas appropriately to eliminate collision hazards.</p>

<p><b>Rectification Estimate:</b></p> <ul style="list-style-type: none"> <li><input type="checkbox"/> \$0 to \$500</li> <li><input checked="" type="checkbox"/> \$501 to \$1000</li> <li><input type="checkbox"/> \$1001 to \$1500</li> <li><input type="checkbox"/> \$1501 to \$2000</li> <li><input type="checkbox"/> &gt; \$2001</li> </ul>

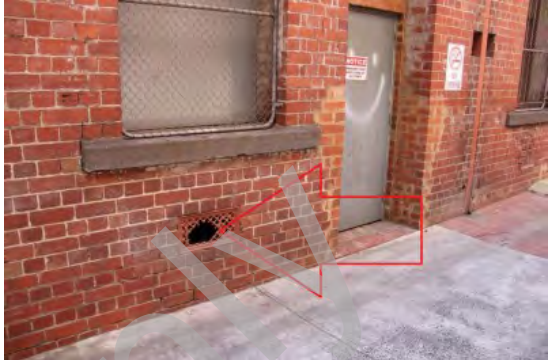
Item	Details	Photo
<p>#19</p> <p>Quote <input type="checkbox"/></p> <p>Proceed <input type="checkbox"/></p> <p>No Action <input type="checkbox"/></p>	<p><b>Risk Assessment:</b></p> <p><input checked="" type="checkbox"/> Maintenance Required</p> <p><input type="checkbox"/> Risk Of Injury</p> <p><input type="checkbox"/> Risk Of Serious Injury</p> <p><input type="checkbox"/> Risk Of Death</p> <p><b>Location:</b> Central Walkway</p> <p><b>Auditor's Finding:</b> Brick vent grills with excessive damage had been identified and may allow accessibility for pests into the adjacent private lot areas.</p> <p><b>Auditor's Recommendation:</b> Engage a suitably qualified contractor to install a similar brick vent grill to eliminate the possibility of pest infestation.</p>

<p><b>Rectification Estimate:</b></p> <p><input checked="" type="checkbox"/> \$0 to \$500</p> <p><input type="checkbox"/> \$501 to \$1000</p> <p><input type="checkbox"/> \$1001 to \$1500</p> <p><input type="checkbox"/> \$1501 to \$2000</p> <p><input type="checkbox"/> &gt; \$2001</p>

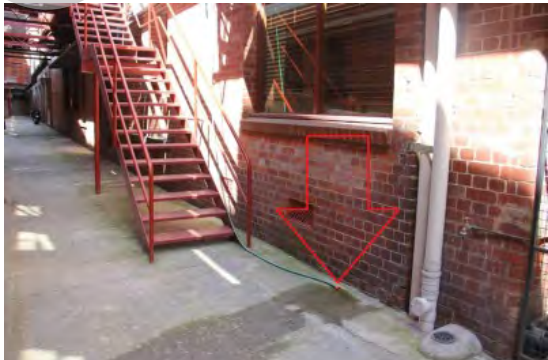
<p>#20</p> <p>Quote <input type="checkbox"/></p> <p>Proceed <input type="checkbox"/></p> <p>No Action <input type="checkbox"/></p>	<p><b>Risk Assessment:</b></p> <p><input type="checkbox"/> Maintenance Required</p> <p><input checked="" type="checkbox"/> Risk Of Injury</p> <p><input type="checkbox"/> Risk Of Serious Injury</p> <p><input type="checkbox"/> Risk Of Death</p> <p><b>Location:</b> Central Walkway</p> <p><b>Auditor's Finding:</b> A hose extending from the roof to the ground of the central walkway had been identified. This may pose as a tripping and slipping hazard to those within the walkway.</p> <p><b>Auditor's Recommendation:</b> Remove the hose from the common walkway and if found to be OC property, secure it onto a hose mount or store appropriately.</p>

<p><b>Rectification Estimate:</b></p> <p><input checked="" type="checkbox"/> \$0 to \$500</p> <p><input type="checkbox"/> \$501 to \$1000</p> <p><input type="checkbox"/> \$1001 to \$1500</p> <p><input type="checkbox"/> \$1501 to \$2000</p> <p><input type="checkbox"/> &gt; \$2001</p>

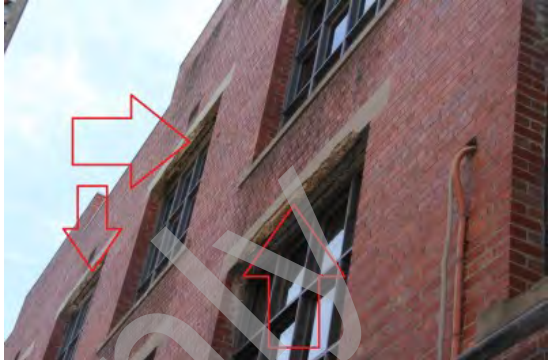
Item	Details	Photo
<p>#21</p> <p>Quote <input type="checkbox"/></p> <p>Proceed <input type="checkbox"/></p> <p>No Action <input type="checkbox"/></p>	<p><b>Risk Assessment:</b></p> <ul style="list-style-type: none"> <li><input type="checkbox"/> Maintenance Required</li> <li><input checked="" type="checkbox"/> Risk Of Injury</li> <li><input type="checkbox"/> Risk Of Serious Injury</li> <li><input type="checkbox"/> Risk Of Death</li> </ul> <p><b>Location:</b> Central Walkway - Building facade</p> <p><b>Auditor's Finding:</b> Lintels with excessive cracks and concrete cancer had been identified throughout. These areas are prone to spalling concrete breaking off and falling where they may impact with occupants accessing the central walkway area.</p> <p><b>Auditor's Recommendation:</b> Engage a suitably qualified structural engineer to further assess the concrete cancer affected area and take remedial action as recommended.</p>

<p><b>Rectification Estimate:</b></p> <ul style="list-style-type: none"> <li><input type="checkbox"/> \$0 to \$500</li> <li><input type="checkbox"/> \$501 to \$1000</li> <li><input type="checkbox"/> \$1001 to \$1500</li> <li><input type="checkbox"/> \$1501 to \$2000</li> <li><input checked="" type="checkbox"/> &gt; \$2001</li> </ul>

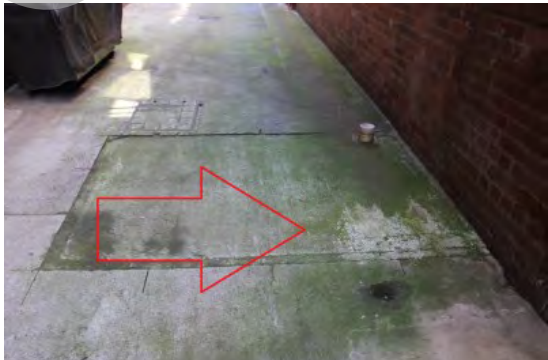
<p>#24</p> <p>Quote <input type="checkbox"/></p> <p>Proceed <input type="checkbox"/></p> <p>No Action <input type="checkbox"/></p>	<p><b>Risk Assessment:</b></p> <ul style="list-style-type: none"> <li><input type="checkbox"/> Maintenance Required</li> <li><input checked="" type="checkbox"/> Risk Of Injury</li> <li><input type="checkbox"/> Risk Of Serious Injury</li> <li><input type="checkbox"/> Risk Of Death</li> </ul> <p><b>Location:</b> Central Walkway - multiple areas</p> <p><b>Auditor's Finding:</b> Evidence of moss growing in sections of walkway, this is a potential slip hazard.</p> <p><b>Auditor's Recommendation:</b> Engage a suitably qualified contractor to pressure clean the area and treat it with moss repellent so that the slip hazard is effectively eradicated.</p>

<p><b>Rectification Estimate:</b></p> <ul style="list-style-type: none"> <li><input type="checkbox"/> \$0 to \$500</li> <li><input type="checkbox"/> \$501 to \$1000</li> <li><input checked="" type="checkbox"/> \$1001 to \$1500</li> <li><input type="checkbox"/> \$1501 to \$2000</li> <li><input type="checkbox"/> &gt; \$2001</li> </ul>

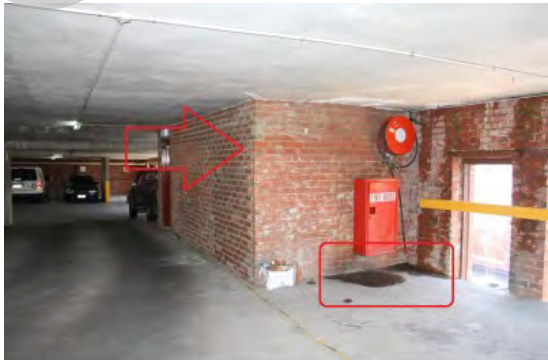
<p>#28</p> <p>Quote <input type="checkbox"/></p> <p>Proceed <input type="checkbox"/></p> <p>No Action <input type="checkbox"/></p>	<p><b>Risk Assessment:</b></p> <ul style="list-style-type: none"> <li><input type="checkbox"/> Maintenance Required</li> <li><input checked="" type="checkbox"/> Risk Of Injury</li> <li><input type="checkbox"/> Risk Of Serious Injury</li> <li><input type="checkbox"/> Risk Of Death</li> </ul> <p><b>Location:</b> 1st level carpark adjacent fire exit stairwell.</p> <p><b>Auditor's Finding:</b> Current water ingress through slab causing water pooling and slip hazards in the carpark levels not to mention concrete cancer issues in the future.</p> <p><b>Auditor's Recommendation:</b> Leak was identified to be coming from a leaking fire hose reel on topmost level.</p>

<p><b>Rectification Estimate:</b></p> <ul style="list-style-type: none"> <li><input type="checkbox"/> \$0 to \$500</li> <li><input checked="" type="checkbox"/> \$501 to \$1000</li> <li><input type="checkbox"/> \$1001 to \$1500</li> <li><input type="checkbox"/> \$1501 to \$2000</li> <li><input type="checkbox"/> &gt; \$2001</li> </ul>

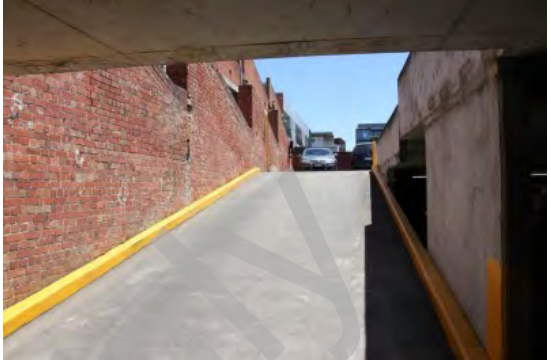
Item	Details	Photo
<p>#29</p> <p>Quote <input type="checkbox"/></p> <p>Proceed <input type="checkbox"/></p> <p>No Action <input type="checkbox"/></p>	<p><b>Risk Assessment:</b></p> <ul style="list-style-type: none"> <li><input type="checkbox"/> Maintenance Required</li> <li><input checked="" type="checkbox"/> Risk Of Injury</li> <li><input type="checkbox"/> Risk Of Serious Injury</li> <li><input type="checkbox"/> Risk Of Death</li> </ul> <p><b>Location:</b> All ramps in car park level</p> <p><b>Auditor's Finding:</b> No convex mirrors were found in the car park ramp areas. The visibility of oncoming traffic up or down the ramp can be a possible hazard.</p> <p><b>Auditor's Recommendation:</b> Install convex mirrors in locations that enable safe ingress and egress of vehicles from carpark area.</p>

<p><b>Rectification Estimate:</b></p> <ul style="list-style-type: none"> <li><input type="checkbox"/> \$0 to \$500</li> <li><input type="checkbox"/> \$501 to \$1000</li> <li><input checked="" type="checkbox"/> \$1001 to \$1500</li> <li><input type="checkbox"/> \$1501 to \$2000</li> <li><input type="checkbox"/> &gt; \$2001</li> </ul>

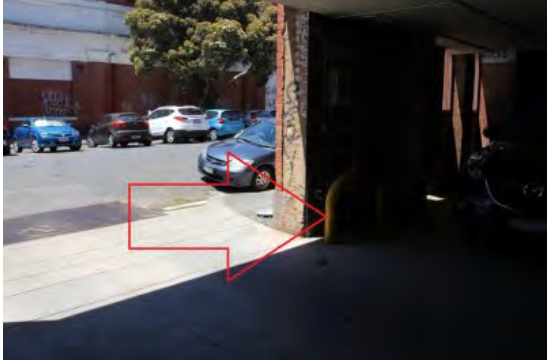
<p>#30</p> <p>Quote <input type="checkbox"/></p> <p>Proceed <input type="checkbox"/></p> <p>No Action <input type="checkbox"/></p>	<p><b>Risk Assessment:</b></p> <ul style="list-style-type: none"> <li><input checked="" type="checkbox"/> Maintenance Required</li> <li><input type="checkbox"/> Risk Of Injury</li> <li><input type="checkbox"/> Risk Of Serious Injury</li> <li><input type="checkbox"/> Risk Of Death</li> </ul> <p><b>Location:</b> car space 17 near entry roller door.</p> <p><b>Auditor's Finding:</b> Fire services pipe is in risk of collision with vehicles.</p> <p><b>Auditor's Recommendation:</b> Engage contractor to install bollards to protect the service pipe.</p>

<p><b>Rectification Estimate:</b></p> <ul style="list-style-type: none"> <li><input checked="" type="checkbox"/> \$0 to \$500</li> <li><input type="checkbox"/> \$501 to \$1000</li> <li><input type="checkbox"/> \$1001 to \$1500</li> <li><input type="checkbox"/> \$1501 to \$2000</li> <li><input type="checkbox"/> &gt; \$2001</li> </ul>

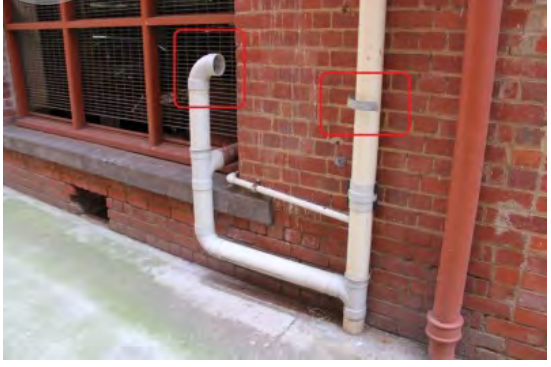
<p>#32</p> <p>Quote <input type="checkbox"/></p> <p>Proceed <input type="checkbox"/></p> <p>No Action <input type="checkbox"/></p>	<p><b>Risk Assessment:</b></p> <ul style="list-style-type: none"> <li><input checked="" type="checkbox"/> Maintenance Required</li> <li><input type="checkbox"/> Risk Of Injury</li> <li><input type="checkbox"/> Risk Of Serious Injury</li> <li><input type="checkbox"/> Risk Of Death</li> </ul> <p><b>Location:</b> Central Walkway plumbing service stack/riser</p> <p><b>Auditor's Finding:</b> Securing of the downpipe had been unhinged and loose. Additionally, no existing cap at the end of the air vent/stack had been identified.</p> <p><b>Auditor's Recommendation:</b> Engage a plumbing contractor to align and tighten the bracket mount and it is also advised to install vent capping at the end of the stack.</p>

<p><b>Rectification Estimate:</b></p> <ul style="list-style-type: none"> <li><input checked="" type="checkbox"/> \$0 to \$500</li> <li><input type="checkbox"/> \$501 to \$1000</li> <li><input type="checkbox"/> \$1001 to \$1500</li> <li><input type="checkbox"/> \$1501 to \$2000</li> <li><input type="checkbox"/> &gt; \$2001</li> </ul>

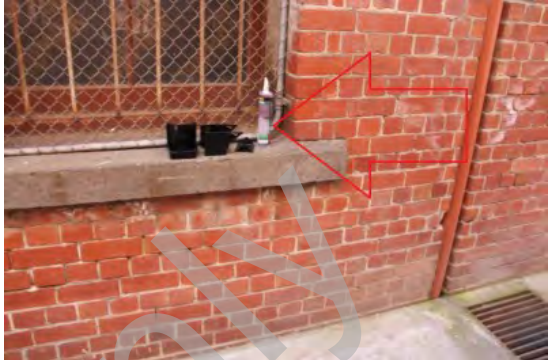
Item	Details	Photo
<p>#35</p> <p>Quote <input type="checkbox"/></p> <p>Proceed <input type="checkbox"/></p> <p>No Action <input type="checkbox"/></p>	<p><b>Risk Assessment:</b></p> <p><input type="checkbox"/> Maintenance Required</p> <p><input checked="" type="checkbox"/> Risk Of Injury</p> <p><input type="checkbox"/> Risk Of Serious Injury</p> <p><input type="checkbox"/> Risk Of Death</p> <p><b>Location:</b> Central Walkway</p> <p><b>Auditor's Finding:</b> Personal belongings/redundant building waste found in common area. These may be considered as a minor tripping hazard under circumstances.</p> <p><b>Auditor's Recommendation:</b> OC to remind residents/occupants of correct storage &amp; waste disposal procedures as outlined within agreement. If residents do not remove the belongings, we recommend that the OC engages a contractor to remove the items.</p>

<p><b>Rectification Estimate:</b></p> <p><input checked="" type="checkbox"/> \$0 to \$500</p> <p><input type="checkbox"/> \$501 to \$1000</p> <p><input type="checkbox"/> \$1001 to \$1500</p> <p><input type="checkbox"/> \$1501 to \$2000</p> <p><input type="checkbox"/> &gt; \$2001</p>

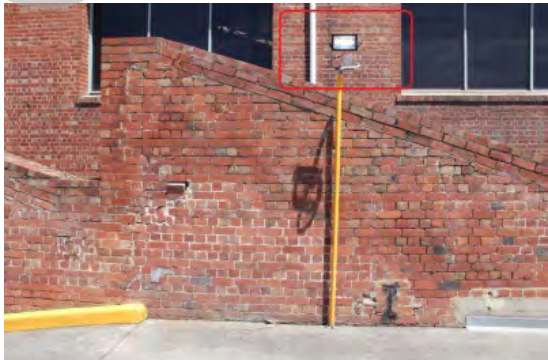
<p>#36</p> <p>Quote <input type="checkbox"/></p> <p>Proceed <input type="checkbox"/></p> <p>No Action <input type="checkbox"/></p>	<p><b>Risk Assessment:</b></p> <p><input checked="" type="checkbox"/> Maintenance Required</p> <p><input type="checkbox"/> Risk Of Injury</p> <p><input type="checkbox"/> Risk Of Serious Injury</p> <p><input type="checkbox"/> Risk Of Death</p> <p><b>Location:</b> Car Park - topmost level</p> <p><b>Auditor's Finding:</b> All common area lights were on during time of inspection.</p> <p><b>Auditor's Recommendation:</b> Ensure all lights are switched off during h day to minimise energy wastage.</p>

<p><b>Rectification Estimate:</b></p> <p><input checked="" type="checkbox"/> \$0 to \$500</p> <p><input type="checkbox"/> \$501 to \$1000</p> <p><input type="checkbox"/> \$1001 to \$1500</p> <p><input type="checkbox"/> \$1501 to \$2000</p> <p><input type="checkbox"/> &gt; \$2001</p>

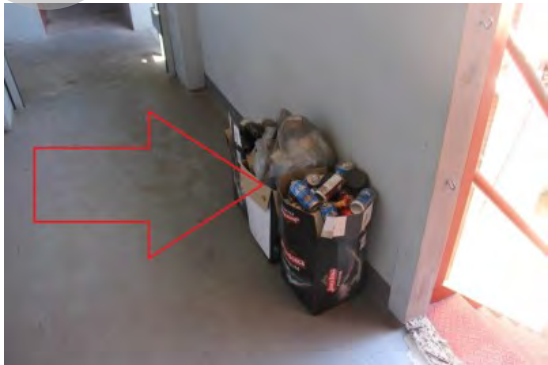
<p>#38</p> <p>Quote <input type="checkbox"/></p> <p>Proceed <input type="checkbox"/></p> <p>No Action <input type="checkbox"/></p>	<p><b>Risk Assessment:</b></p> <ul style="list-style-type: none"> <li><input type="checkbox"/> Maintenance Required</li> <li><input checked="" type="checkbox"/> Risk Of Injury</li> <li><input type="checkbox"/> Risk Of Serious Injury</li> <li><input type="checkbox"/> Risk Of Death</li> </ul> <p><b>Location:</b> First Floor Common Area Walkway to first level Car Park adjacent northern boundary.</p> <p><b>Auditor's Finding:</b> Personal belongings/rubbish found in common area walkway on 1st floor. These may be considered as a minor tripping hazard as paths of travel need to be clear of obstructions.</p> <p><b>Auditor's Recommendation:</b> OC to remind occupants of correct storage procedures as outlined within OC agreement. If occupants do not remove the belongings, we recommend that the OC engages a contractor to remove the items.</p>

<p><b>Rectification Estimate:</b></p> <ul style="list-style-type: none"> <li><input checked="" type="checkbox"/> \$0 to \$500</li> <li><input type="checkbox"/> \$501 to \$1000</li> <li><input type="checkbox"/> \$1001 to \$1500</li> <li><input type="checkbox"/> \$1501 to \$2000</li> <li><input type="checkbox"/> &gt; \$2001</li> </ul>

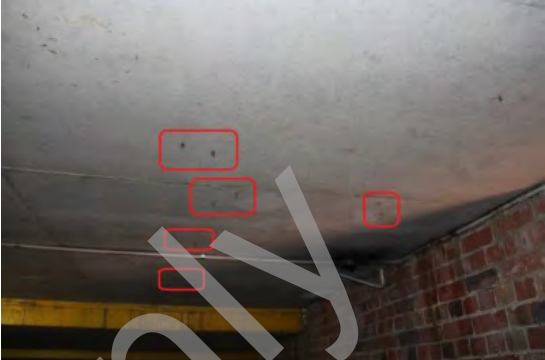
Item	Details	Photo
<p>#39</p> <p>Quote <input type="checkbox"/></p> <p>Proceed <input type="checkbox"/></p> <p>No Action <input type="checkbox"/></p>	<p><b>Risk Assessment:</b></p> <ul style="list-style-type: none"> <li><input type="checkbox"/> Maintenance Required</li> <li><input checked="" type="checkbox"/> Risk Of Injury</li> <li><input type="checkbox"/> Risk Of Serious Injury</li> <li><input type="checkbox"/> Risk Of Death</li> </ul> <p><b>Location:</b> Level 1 Car Park</p> <p><b>Auditor's Finding:</b> Redundant nails protruding from the concrete slab ceiling can cause injury to occupants accessing these areas.</p> <p><b>Auditor's Recommendation:</b> Remove or grind back the redundant nails to the face of the slab so as to eradicate the hazard.</p>

<p><b>Rectification Estimate:</b></p> <ul style="list-style-type: none"> <li><input type="checkbox"/> \$0 to \$500</li> <li><input checked="" type="checkbox"/> \$501 to \$1000</li> <li><input type="checkbox"/> \$1001 to \$1500</li> <li><input type="checkbox"/> \$1501 to \$2000</li> <li><input type="checkbox"/> &gt; \$2001</li> </ul>

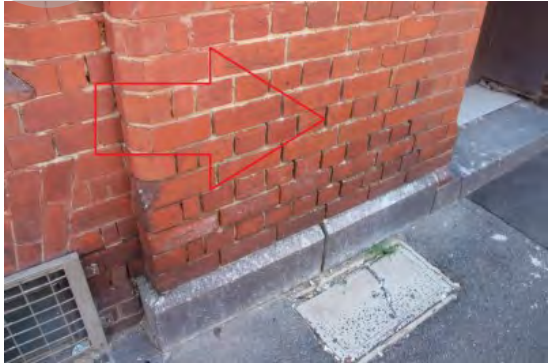
<p>#41</p> <p>Quote <input type="checkbox"/></p> <p>Proceed <input type="checkbox"/></p> <p>No Action <input type="checkbox"/></p>	<p><b>Risk Assessment:</b></p> <p><input checked="" type="checkbox"/> Maintenance Required  <input type="checkbox"/> Risk Of Injury  <input type="checkbox"/> Risk Of Serious Injury  <input type="checkbox"/> Risk Of Death</p> <p><b>Location:</b>            South-Western Boundary adjacent 22 Peel St Collingwood development.</p> <p><b>Auditor's Finding:</b>            Rising damp area between the masonry brickwork had been identified with an approximate 65% moisture reading on moisture meter confirming our finding. Such exposure to moisture ingress may compromise the integrity of the masonry wall itself.</p> <p><b>Auditor's Recommendation:</b>            Engage a structural engineer to further assess the rising damp area and re-point the brick work once moisture issue has been addressed.</p>

<p><b>Rectification Estimate:</b></p> <p><input type="checkbox"/> \$0 to \$500  <input type="checkbox"/> \$501 to \$1000  <input type="checkbox"/> \$1001 to \$1500  <input type="checkbox"/> \$1501 to \$2000  <input checked="" type="checkbox"/> &gt; \$2001</p>

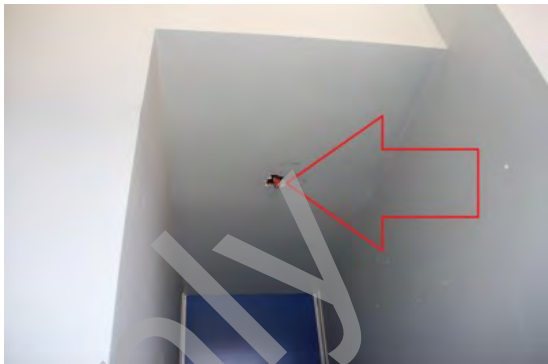
Item	Details	Photo
<p>#42</p> <p>Quote <input type="checkbox"/></p> <p>Proceed <input type="checkbox"/></p> <p>No Action <input type="checkbox"/></p>	<p><b>Risk Assessment:</b></p> <p><input type="checkbox"/> Maintenance Required  <input type="checkbox"/> Risk Of Injury  <input checked="" type="checkbox"/> Risk Of Serious Injury  <input type="checkbox"/> Risk Of Death</p> <p><b>Location:</b>            First Floor Common Area Walkway adjacent Northern boundary.</p> <p><b>Auditor's Finding:</b>            Sprinkler head servicing the area has been found to be made redundant.</p> <p><b>Auditor's Recommendation:</b>            Engage a suitably qualified fire sprinkler contractor to re-install the fire sprinkler servicing the area.</p>

<p><b>Rectification Estimate:</b></p> <p><input checked="" type="checkbox"/> \$0 to \$500  <input type="checkbox"/> \$501 to \$1000  <input type="checkbox"/> \$1001 to \$1500  <input type="checkbox"/> \$1501 to \$2000  <input type="checkbox"/> &gt; \$2001</p>

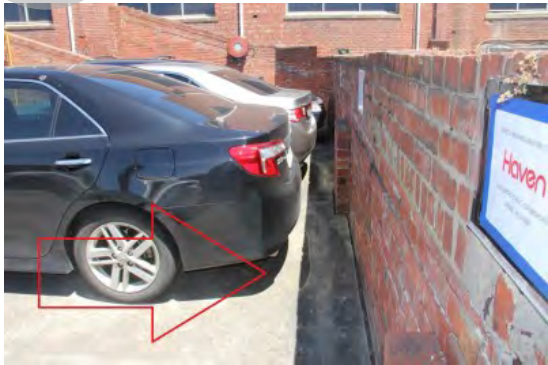
<p>#43</p> <p>Quote <input type="checkbox"/></p> <p>Proceed <input type="checkbox"/></p> <p>No Action <input type="checkbox"/></p>	<p><b>Risk Assessment:</b></p> <p><input type="checkbox"/> Maintenance Required  <input checked="" type="checkbox"/> Risk Of Injury  <input type="checkbox"/> Risk Of Serious Injury  <input type="checkbox"/> Risk Of Death</p> <p><b>Location:</b>            Car Park - topmost level</p> <p><b>Auditor's Finding:</b>            No wheel stops or bollards provided to prevent cars from impacting with masonry wall.</p> <p><b>Auditor's Recommendation:</b>            It is recommended that rubber wheel stops be installed to improve overall safety.</p>

<p><b>Rectification Estimate:</b></p> <p><input type="checkbox"/> \$0 to \$500  <input type="checkbox"/> \$501 to \$1000  <input type="checkbox"/> \$1001 to \$1500  <input type="checkbox"/> \$1501 to \$2000  <input checked="" type="checkbox"/> &gt; \$2001</p>

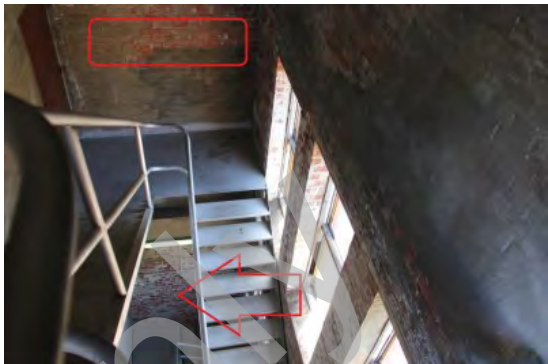
Item	Details	Photo
<p>#44</p> <p>Quote <input type="checkbox"/></p> <p>Proceed <input type="checkbox"/></p> <p>No Action <input type="checkbox"/></p>	<p><b>Risk Assessment:</b></p> <p><input type="checkbox"/> Maintenance Required  <input checked="" type="checkbox"/> Risk Of Injury  <input type="checkbox"/> Risk Of Serious Injury  <input type="checkbox"/> Risk Of Death</p> <p><b>Location:</b> Fire exit stairwell</p> <p><b>Auditor's Finding:</b> Once occupants enter the stairwell there are no more exit direction signage provided.</p> <p><b>Auditor's Recommendation:</b> It is recommended to install a few exit signage in the stairwell to facilitate ease of egress during emergencies.</p>

<p><b>Rectification Estimate:</b></p> <p><input type="checkbox"/> \$0 to \$500  <input checked="" type="checkbox"/> \$501 to \$1000  <input type="checkbox"/> \$1001 to \$1500  <input type="checkbox"/> \$1501 to \$2000  <input type="checkbox"/> &gt; \$2001</p>

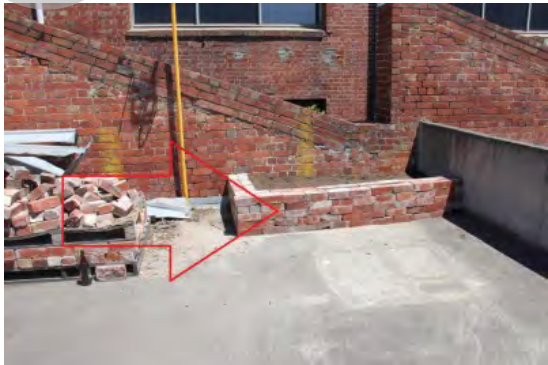
<p>#45</p> <p>Quote <input type="checkbox"/></p> <p>Proceed <input type="checkbox"/></p> <p>No Action <input type="checkbox"/></p>	<p><b>Risk Assessment:</b></p> <p><input checked="" type="checkbox"/> Maintenance Required  <input type="checkbox"/> Risk Of Injury  <input type="checkbox"/> Risk Of Serious Injury  <input type="checkbox"/> Risk Of Death</p> <p><b>Location:</b> Planter box area on top most carpark level.</p> <p><b>Auditor's Finding:</b> make shift planter box did not appear to be a solid structure and was not water proofed appropriately. This can cause water ingress issues and lead to deterioration of the slab.</p> <p><b>Auditor's Recommendation:</b> Engage a suitably qualified contractor to remove the planter box from the area.</p>

<p><b>Rectification Estimate:</b></p> <p><input checked="" type="checkbox"/> \$0 to \$500  <input type="checkbox"/> \$501 to \$1000  <input type="checkbox"/> \$1001 to \$1500  <input type="checkbox"/> \$1501 to \$2000  <input type="checkbox"/> &gt; \$2001</p>
