## Occupational Health & Safety Report

1 Sample Street, Melbourne VIC 3022 (PS123456)

18 April 2017

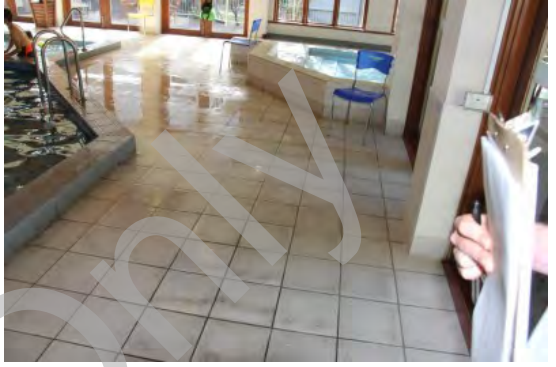
HIGH PRIORITY		
Item	Details	Photo
<p>#1</p> <p>Quote <input type="checkbox"/></p> <p>Proceed <input type="checkbox"/></p> <p>No Action <input type="checkbox"/></p>	<p><b>Risk Assessment:</b></p> <p><input type="checkbox"/> Maintenance Required  <input type="checkbox"/> Risk Of Injury  <input checked="" type="checkbox"/> Risk Of Serious Injury  <input type="checkbox"/> Risk Of Death</p> <p><b>Location:</b> Pool</p> <p><b>Auditor's Finding:</b> The pool has a raised concrete edge which sits next to a concrete surface which is often wet and slippery, a slip at this location could cause serious injury.</p> <p><b>Auditor's Recommendation:</b> It is recommended that non-slip PVC matting be installed around the edges of the pool to reduce the slipping hazard. It is also recommended to consider the option of putting new floor wastes in the areas to drain excess water away so as to eliminate any slip hazards.</p>

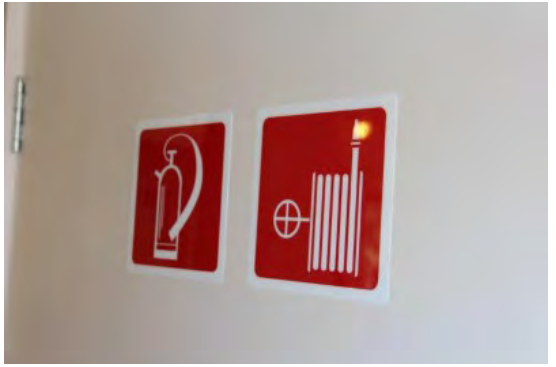
<p>#2</p> <p>Quote <input type="checkbox"/></p> <p>Proceed <input type="checkbox"/></p> <p>No Action <input type="checkbox"/></p>	<p><b>Risk Assessment:</b></p> <p><input type="checkbox"/> Maintenance Required  <input checked="" type="checkbox"/> Risk Of Injury  <input type="checkbox"/> Risk Of Serious Injury  <input type="checkbox"/> Risk Of Death</p> <p><b>Location:</b> Pool</p> <p><b>Auditor's Finding:</b> The fire hose reel and fire extinguisher both don't meet the relevant Australian Standard for ESM signage.</p> <p><b>Auditor's Recommendation:</b> Install new signs which satisfy AS 2441-2005 and AS 2444-2001 which require text designation on the signs of each ESM element.</p>

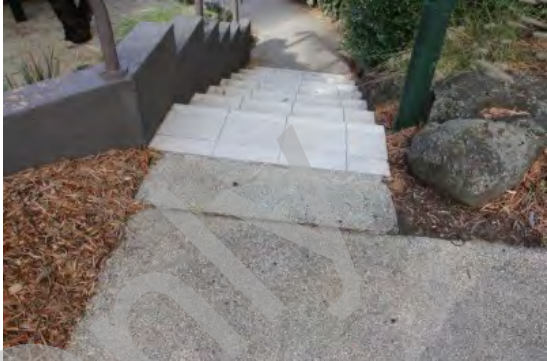
Item	Details	Photo
<p>#3</p> <p>Quote <input type="checkbox"/></p> <p>Proceed <input type="checkbox"/></p> <p>No Action <input type="checkbox"/></p>	<p><b>Risk Assessment:</b></p> <ul style="list-style-type: none"> <li><input type="checkbox"/> Maintenance Required</li> <li><input type="checkbox"/> Risk Of Injury</li> <li><input checked="" type="checkbox"/> Risk Of Serious Injury</li> <li><input type="checkbox"/> Risk Of Death</li> </ul> <p><b>Location:</b> Stairwells Throughout</p> <p><b>Auditor's Finding:</b> Staircases throughout the property are not appropriately marked. As they are external staircases they may become very slippery when wet. The most up to date building code requires a minimum 30% luminance contrast. The steps to at the entrance to reception, to the Casino building, and at the car park entry near the BBQ area were noted to have non-slip contrast nosing, at all other locations these were absent. Owing to the age of the building tactile ground surface indicators (TGSIs) were also absent from all stairwells. This represents a trip/slip hazard.</p> <p><b>Auditor's Recommendation:</b> Best practice would involve setting slip resistant strips with a luminance contrast greater than 30% to the very edge of the stairs. The width of the strips should be between 50-75mm on the landing and 25 to 35 mm on the rising. In addition TGSI should be installed at all staircases in accordance with AS 1428.1-2009 Design for access and mobility which stipulates they should be 600mm long and be set back 300 mm from the start or end of a stairway.</p>

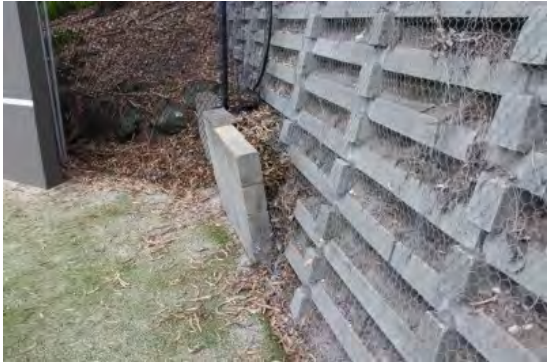
<p>#4</p> <p>Quote <input type="checkbox"/></p> <p>Proceed <input type="checkbox"/></p> <p>No Action <input type="checkbox"/></p>	<p><b>Risk Assessment:</b></p> <ul style="list-style-type: none"> <li><input type="checkbox"/> Maintenance Required</li> <li><input type="checkbox"/> Risk Of Injury</li> <li><input checked="" type="checkbox"/> Risk Of Serious Injury</li> <li><input type="checkbox"/> Risk Of Death</li> </ul> <p><b>Location:</b> Tennis Court 1</p> <p><b>Auditor's Finding:</b> Retaining wall at the southern end of tennis court 1 is bent outward indicating it has partially failed, and is at risk of collapse.</p> <p><b>Auditor's Recommendation:</b> Rebuild the retaining wall at this location to eliminate the danger of the fence collapsing near a guest, or the failure of this smaller element presenting issues for the larger retaining wall structure behind.</p>

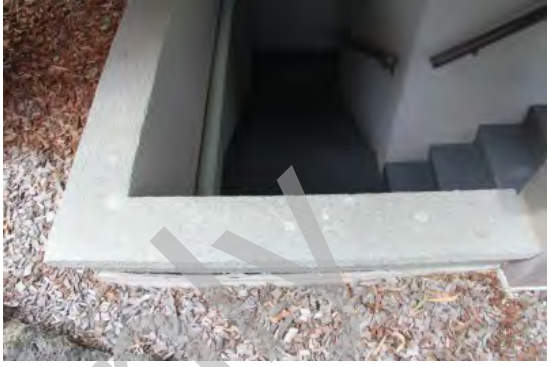
Item	Details	Photo
<p>#5</p> <p>Quote <input type="checkbox"/></p> <p>Proceed <input type="checkbox"/></p> <p>No Action <input type="checkbox"/></p>	<p><b>Risk Assessment:</b></p> <ul style="list-style-type: none"> <li><input type="checkbox"/> Maintenance Required</li> <li><input type="checkbox"/> Risk Of Injury</li> <li><input checked="" type="checkbox"/> Risk Of Serious Injury</li> <li><input type="checkbox"/> Risk Of Death</li> </ul> <p><b>Location:</b> Car Park Entrance - Tennis Courts</p> <p><b>Auditor's Finding:</b> There is a large void next to the pathway that falls away into the stairwell of the car park near the tennis courts. A child could fall through this gap.</p> <p><b>Auditor's Recommendation:</b> It is recommended that a guardrail or balustrade be erected at this location to eliminate the risk of someone falling through the void.</p>

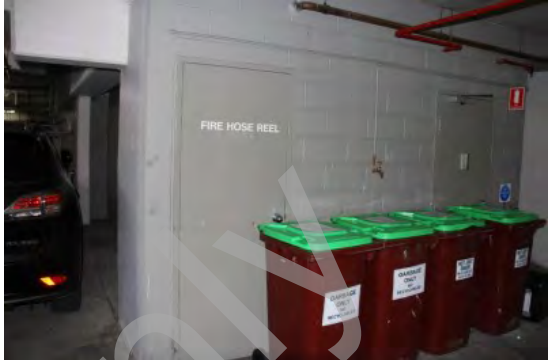
Item	Details	Photo
<p>#7</p> <p>Quote <input type="checkbox"/></p> <p>Proceed <input type="checkbox"/></p> <p>No Action <input type="checkbox"/></p>	<p><b>Risk Assessment:</b></p> <ul style="list-style-type: none"> <li><input type="checkbox"/> Maintenance Required</li> <li><input type="checkbox"/> Risk Of Injury</li> <li><input checked="" type="checkbox"/> Risk Of Serious Injury</li> <li><input type="checkbox"/> Risk Of Death</li> </ul> <p><b>Location:</b> Car Park</p> <p><b>Auditor's Finding:</b> Access to the fire hose reel cabinet is obstructed by garbage bins, access is required to be clear of obstructions in accordance with AS 2441-2005 Installation of fire hose reels.</p> <p><b>Auditor's Recommendation:</b> Permanently move the location of the bin which is obstructing access to the fire hose reel.</p>

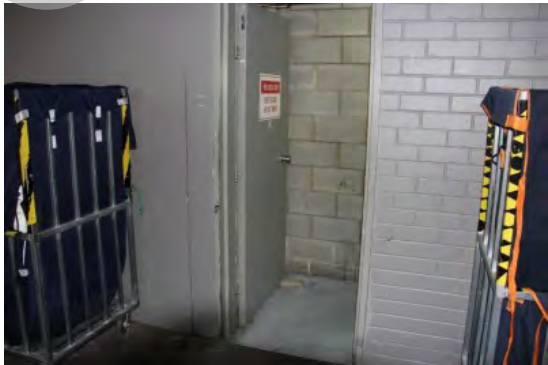
<p>#8</p> <p>Quote <input type="checkbox"/></p> <p>Proceed <input type="checkbox"/></p> <p>No Action <input type="checkbox"/></p>	<p><b>Risk Assessment:</b></p> <ul style="list-style-type: none"> <li><input type="checkbox"/> Maintenance Required</li> <li><input type="checkbox"/> Risk Of Injury</li> <li><input checked="" type="checkbox"/> Risk Of Serious Injury</li> <li><input type="checkbox"/> Risk Of Death</li> </ul> <p><b>Location:</b> Rear Car Park Entrance</p> <p><b>Auditor's Finding:</b> The pictured door is a designated fire door, as per instructions on the door which read "keep closed at all times" these are required to be closed at all times. The door has been propped open with a wedge.</p> <p><b>Auditor's Recommendation:</b> Remove the wedge from the door and ensure that the person who placed the wedge there is educated on the need for the door to remain closed. Fire doors are essential design elements which ensure proper separation of building areas in the event of a fire.</p>

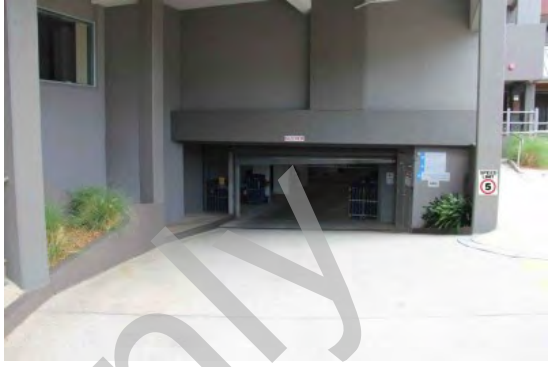
Item	Details	Photo
#11	<p><b>Risk Assessment:</b></p> <ul style="list-style-type: none"> <li><input type="checkbox"/> Maintenance Required</li> <li><input type="checkbox"/> Risk Of Injury</li> <li><input checked="" type="checkbox"/> Risk Of Serious Injury</li> <li><input type="checkbox"/> Risk Of Death</li> </ul> <p><b>Location:</b> Car Park Entrance</p> <p><b>Auditor's Finding:</b> The minimum height sign is not visible outside the car park and is only visible once a vehicle has entered. This represents a collision hazard for vehicles taller than the minimum height. Additionally a 5km/h speed limit sign should be installed at the car park entry.</p> <p><b>Auditor's Recommendation:</b> The minimum height sign should be relocated so that it is visible before a vehicle enters the car park and a 5km/h sign should be installed as indicated</p>

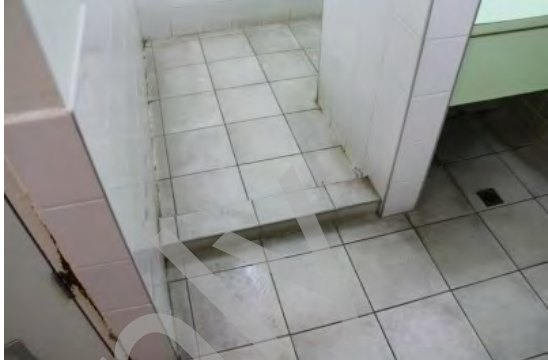
Item	Details	Photo
<p>#12</p> <p>Quote <input type="checkbox"/></p> <p>Proceed <input type="checkbox"/></p> <p>No Action <input type="checkbox"/></p>	<p><b>Risk Assessment:</b></p> <p><input type="checkbox"/> Maintenance Required</p> <p><input checked="" type="checkbox"/> Risk Of Injury</p> <p><input type="checkbox"/> Risk Of Serious Injury</p> <p><input type="checkbox"/> Risk Of Death</p> <p><b>Location:</b> Shower</p> <p><b>Auditor's Finding:</b> The shower hobb in the men's bathroom represents a tripping hazard as it isn't a distinctive colour from the surrounding tiles. The layout is assumed to be the same in the women's bathroom.</p> <p><b>Auditor's Recommendation:</b> A waterproof contrast strip should be applied to the edge of the shower hobb to highlight the hazard and to ensure people step over the hobb when entering the shower.</p>

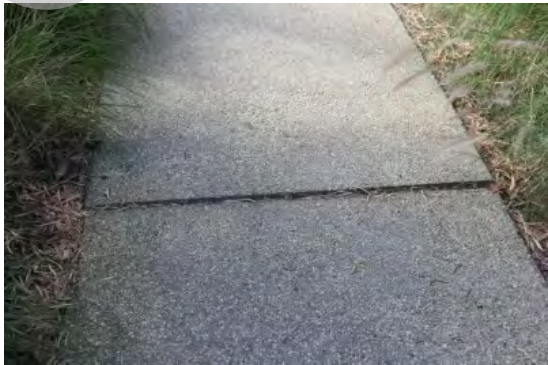
<p>#13</p> <p>Quote <input type="checkbox"/></p> <p>Proceed <input type="checkbox"/></p> <p>No Action <input type="checkbox"/></p>	<p><b>Risk Assessment:</b></p> <p><input type="checkbox"/> Maintenance Required</p> <p><input checked="" type="checkbox"/> Risk Of Injury</p> <p><input type="checkbox"/> Risk Of Serious Injury</p> <p><input type="checkbox"/> Risk Of Death</p> <p><b>Location:</b> Path Adjacent Pool</p> <p><b>Auditor's Finding:</b> Path adjacent pool entry is raised on one side presenting a tripping hazard.</p> <p><b>Auditor's Recommendation:</b> Engage a suitably qualified contractor to grind down the concrete at the raised point until both sections sit flush.</p>

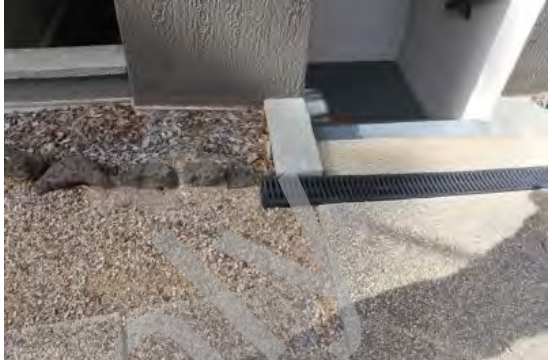
Item	Details	Photo
<p>#14</p> <p>Quote <input type="checkbox"/></p> <p>Proceed <input type="checkbox"/></p> <p>No Action <input type="checkbox"/></p>	<p><b>Risk Assessment:</b></p> <p><input checked="" type="checkbox"/> Maintenance Required</p> <p><input type="checkbox"/> Risk Of Injury</p> <p><input type="checkbox"/> Risk Of Serious Injury</p> <p><input type="checkbox"/> Risk Of Death</p> <p><b>Location:</b> Car Park Entrance - Tennis Courts</p> <p><b>Auditor's Finding:</b> The drainage grate at the top of the stairs at the car park entrance near the tennis courts does not fit flush with the ground, presenting a tripping hazard.</p> <p><b>Auditor's Recommendation:</b> Engage a suitably qualified contractor the refit the grate so that it sits flush with the surrounding surface.</p>

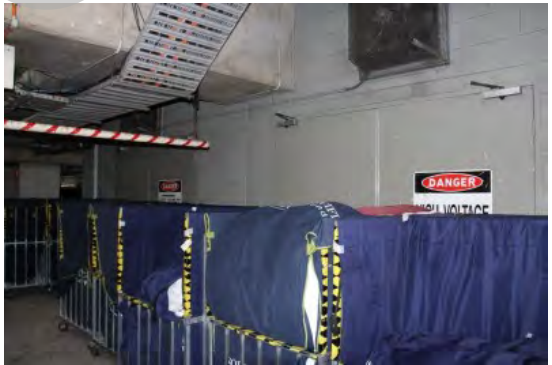
<p>#15</p> <p>Quote <input type="checkbox"/></p> <p>Proceed <input type="checkbox"/></p> <p>No Action <input type="checkbox"/></p>	<p><b>Risk Assessment:</b></p> <p><input type="checkbox"/> Maintenance Required</p> <p><input checked="" type="checkbox"/> Risk Of Injury</p> <p><input type="checkbox"/> Risk Of Serious Injury</p> <p><input type="checkbox"/> Risk Of Death</p> <p><b>Location:</b> Car Park Entrance</p> <p><b>Auditor's Finding:</b> Access to the substation is blocked, this area should be kept clear of obstructions.</p> <p><b>Auditor's Recommendation:</b> It is recommended the location of the linen storage is permanently moved to prevent access obstructions to the substation.</p>

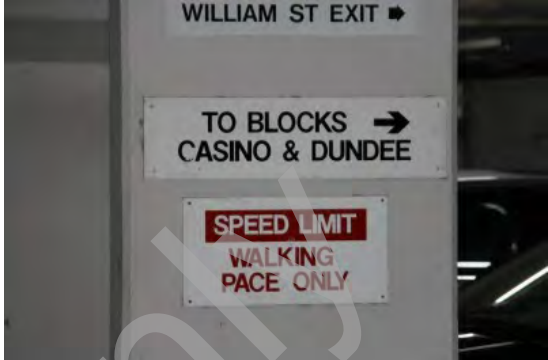
Item	Details	Photo
<p>#16</p> <p>Quote <input type="checkbox"/></p> <p>Proceed <input type="checkbox"/></p> <p>No Action <input type="checkbox"/></p>	<p><b>Risk Assessment:</b></p> <p><input checked="" type="checkbox"/> Maintenance Required</p> <p><input type="checkbox"/> Risk Of Injury</p> <p><input type="checkbox"/> Risk Of Serious Injury</p> <p><input type="checkbox"/> Risk Of Death</p> <p><b>Location:</b> Car Park</p> <p><b>Auditor's Finding:</b> The speed limit sign is not in the standard format and may not be immediately recognisable as a speed limit. Increasing the likelihood that people will not obey the speed limit and the chance of a collision.</p> <p><b>Auditor's Recommendation:</b> It is recommended this speed limit sign be replaced with a standard 5km/h speed limit sign.</p>

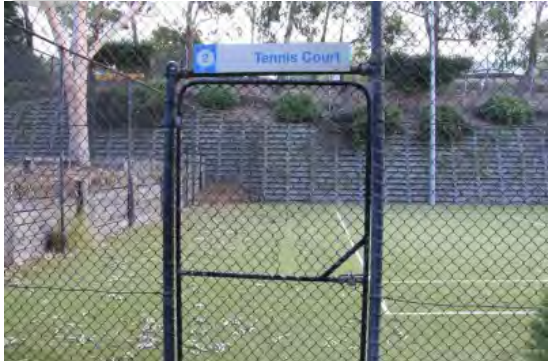
<p>#17</p> <p>Quote <input type="checkbox"/></p> <p>Proceed <input type="checkbox"/></p> <p>No Action <input type="checkbox"/></p>	<p><b>Risk Assessment:</b></p> <p><input type="checkbox"/> Maintenance Required</p> <p><input checked="" type="checkbox"/> Risk Of Injury</p> <p><input type="checkbox"/> Risk Of Serious Injury</p> <p><input type="checkbox"/> Risk Of Death</p> <p><b>Location:</b> Tennis Courts</p> <p><b>Auditor's Finding:</b> Signs indicating "surface slippery when wet" are absent.</p> <p><b>Auditor's Recommendation:</b> Install appropriate signage to ensure players are aware that the surface will be dangerous to play on after a rainfall event.</p>

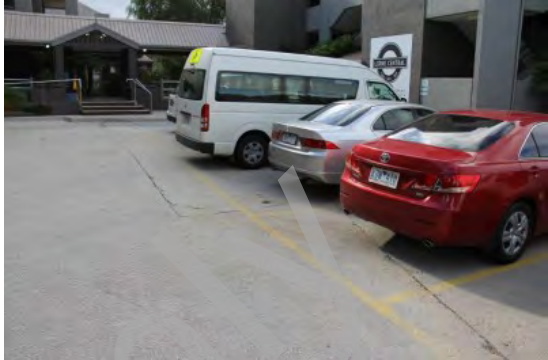
Item	Details	Photo
<p>#18</p> <p>Quote <input type="checkbox"/></p> <p>Proceed <input type="checkbox"/></p> <p>No Action <input type="checkbox"/></p>	<p><b>Risk Assessment:</b></p> <ul style="list-style-type: none"> <li><input type="checkbox"/> Maintenance Required</li> <li><input checked="" type="checkbox"/> Risk Of Injury</li> <li><input type="checkbox"/> Risk Of Serious Injury</li> <li><input type="checkbox"/> Risk Of Death</li> </ul> <p><b>Location:</b> Car Park Entrance</p> <p><b>Auditor's Finding:</b> The yellow boundary lines for the car parking spaces have faded and are difficult to see, representing a collision hazard when cars park improperly.</p> <p><b>Auditor's Recommendation:</b> Engage a suitably qualified contractor to re-paint the car park boundary lines.</p>

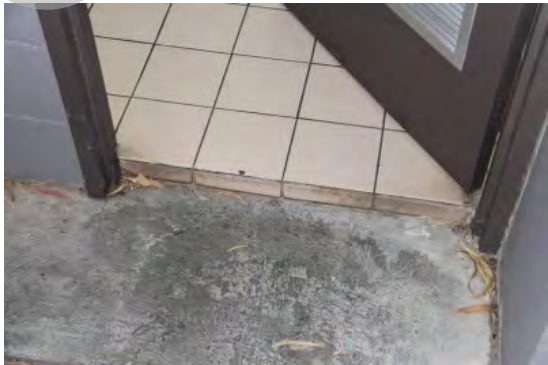
<p>#19</p> <p>Quote <input type="checkbox"/></p> <p>Proceed <input type="checkbox"/></p> <p>No Action <input type="checkbox"/></p>	<p><b>Risk Assessment:</b></p> <ul style="list-style-type: none"> <li><input type="checkbox"/> Maintenance Required</li> <li><input checked="" type="checkbox"/> Risk Of Injury</li> <li><input type="checkbox"/> Risk Of Serious Injury</li> <li><input type="checkbox"/> Risk Of Death</li> </ul> <p><b>Location:</b> Car Park Rear Entrance</p> <p><b>Auditor's Finding:</b> There is a raised step into the staff room that isn't immediately obvious when entering the area. This represents a tripping hazard.</p> <p><b>Auditor's Recommendation:</b> Install a contrasting strip to highlight the hazard and reduce the chance of a trip.</p>

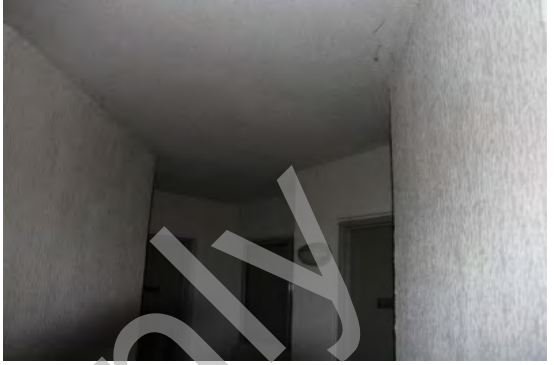
Item	Details	Photo
<p>#22</p> <p>Quote <input type="checkbox"/></p> <p>Proceed <input type="checkbox"/></p> <p>No Action <input type="checkbox"/></p>	<p><b>Risk Assessment:</b></p> <ul style="list-style-type: none"> <li><input checked="" type="checkbox"/> Maintenance Required</li> <li><input type="checkbox"/> Risk Of Injury</li> <li><input type="checkbox"/> Risk Of Serious Injury</li> <li><input type="checkbox"/> Risk Of Death</li> </ul> <p><b>Location:</b> External Hallways Throughout</p> <p><b>Auditor's Finding:</b> The corners of all external accommodation hallways are illuminated only by sunlight during the day, this makes them very dim on overcast days (defect not captured with camera flash).</p> <p><b>Auditor's Recommendation:</b> It is recommended that motion sensors are installed to activate the lights when guests approach. Otherwise certain lights should be left on at all times.</p>

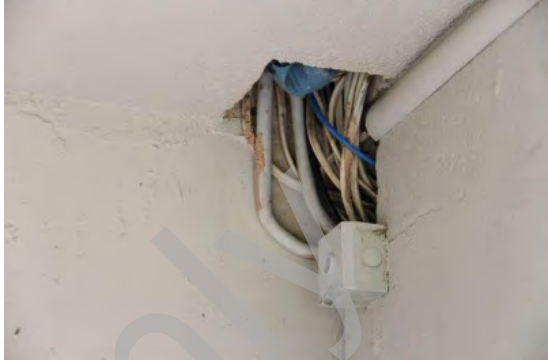
Item	Details	Photo
<p>#25</p> <p>Quote <input type="checkbox"/></p> <p>Proceed <input type="checkbox"/></p> <p>No Action <input type="checkbox"/></p>	<p><b>Risk Assessment:</b></p> <p><input type="checkbox"/> Maintenance Required  <input checked="" type="checkbox"/> Risk Of Injury  <input type="checkbox"/> Risk Of Serious Injury  <input type="checkbox"/> Risk Of Death</p> <p><b>Location:</b> Car Park Entrance Tennis Courts</p> <p><b>Auditor's Finding:</b> Exposed wiring noted in the corner of the stairwell near the tennis courts, although unlikely the tampering of these wires is possible.</p> <p><b>Auditor's Recommendation:</b> It is recommended that a cover be installed at this location.</p>

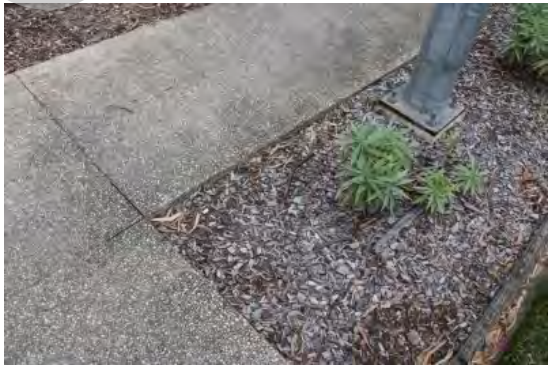
<p>#26</p> <p>Quote <input type="checkbox"/></p> <p>Proceed <input type="checkbox"/></p> <p>No Action <input type="checkbox"/></p>	<p><b>Risk Assessment:</b></p> <p><input type="checkbox"/> Maintenance Required  <input checked="" type="checkbox"/> Risk Of Injury  <input type="checkbox"/> Risk Of Serious Injury  <input type="checkbox"/> Risk Of Death</p> <p><b>Location:</b> Tennis Court 1</p> <p><b>Auditor's Finding:</b> The garden bed adjacent the entry to tennis court 1 does not finish level with the pavement height. This poses a trip hazard to people walking along this designated pathway.</p> <p><b>Auditor's Recommendation:</b> Fill the garden beds up with garden mulch or topsoil to ensure a level finish between the garden beds and the paved pathway.</p>

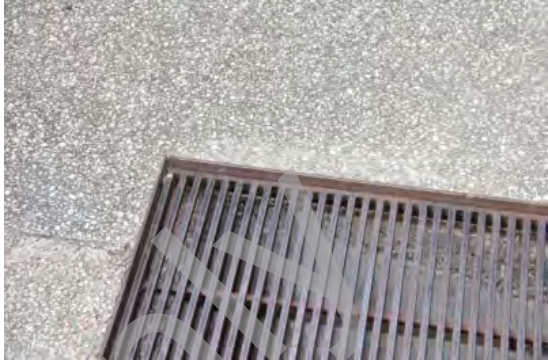
Item	Details	Photo
#29 Quote <input type="checkbox"/> Proceed <input type="checkbox"/> No Action <input type="checkbox"/>	<p><b>Risk Assessment:</b></p> <input checked="" type="checkbox"/> Maintenance Required <input type="checkbox"/> Risk Of Injury <input type="checkbox"/> Risk Of Serious Injury <input type="checkbox"/> Risk Of Death

<p><b>Location:</b> Retail Common Area</p> <p><b>Auditor's Finding:</b> The grate outside edge gallery does not sit flush with the surrounding surface.</p> <p><b>Auditor's Recommendation:</b> engage a suitably qualified contractor to reinstall the grate so that it sits flush with the surrounding concrete surface.</p>

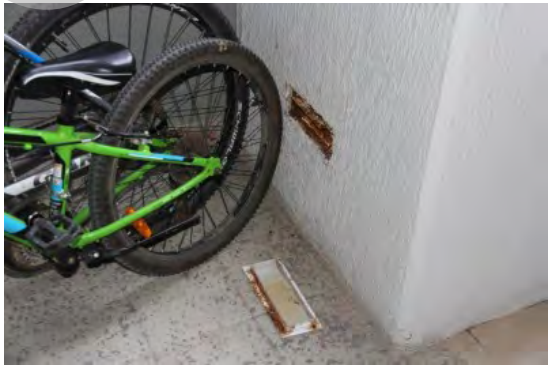
#30 Quote <input type="checkbox"/> Proceed <input type="checkbox"/> No Action <input type="checkbox"/>	<p><b>Risk Assessment:</b></p> <input checked="" type="checkbox"/> Maintenance Required <input type="checkbox"/> Risk Of Injury <input type="checkbox"/> Risk Of Serious Injury <input type="checkbox"/> Risk Of Death

<p><b>Location:</b> Beringara</p> <p><b>Auditor's Finding:</b> It was noted that the light fitting opposite 209 has been damaged.</p> <p><b>Auditor's Recommendation:</b> Repair the damaged fitting.</p>

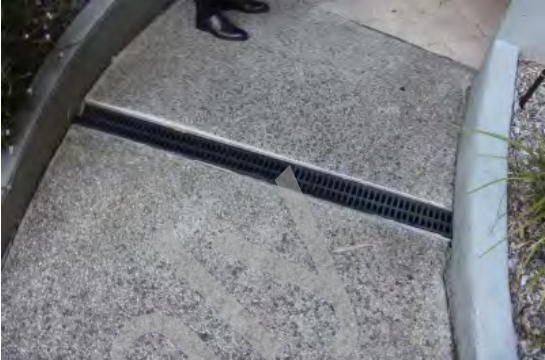
Item	Details	Photo
<p>#31</p> <p>Quote <input type="checkbox"/></p> <p>Proceed <input type="checkbox"/></p> <p>No Action <input type="checkbox"/></p>	<p><b>Risk Assessment:</b></p> <ul style="list-style-type: none"> <li><input type="checkbox"/> Maintenance Required</li> <li><input checked="" type="checkbox"/> Risk Of Injury</li> <li><input type="checkbox"/> Risk Of Serious Injury</li> <li><input type="checkbox"/> Risk Of Death</li> </ul> <p><b>Location:</b> Foam Building</p> <p><b>Auditor's Finding:</b> The drainage grate at the entrance to the foam building does not fit flush with the ground, presenting a tripping hazard.</p> <p><b>Auditor's Recommendation:</b> Engage a suitably qualified contractor the refit the grate so that it sits flush with the surrounding surface.</p>

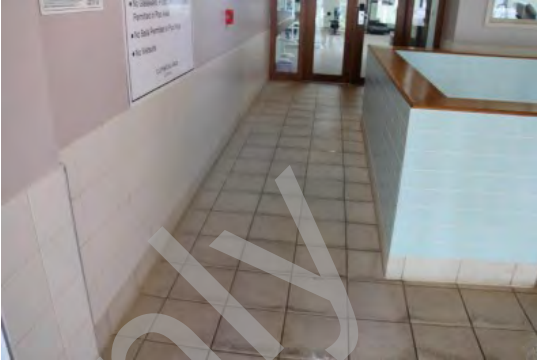
Item	Details	Photo
<p>#32</p> <p>Quote <input type="checkbox"/></p> <p>Proceed <input type="checkbox"/></p> <p>No Action <input type="checkbox"/></p>	<p><b>Risk Assessment:</b></p> <ul style="list-style-type: none"> <li><input checked="" type="checkbox"/> Maintenance Required</li> <li><input type="checkbox"/> Risk Of Injury</li> <li><input type="checkbox"/> Risk Of Serious Injury</li> <li><input type="checkbox"/> Risk Of Death</li> </ul> <p><b>Location:</b> Pool</p> <p><b>Auditor's Finding:</b> No tactile ground surface indicators (TGSIs) at base of ramp to the gymnasium</p> <p><b>Auditor's Recommendation:</b> It is recommended tactile ground surface indicators are installed at the base of both ramps towards the gymnasium in accordance with AS 1428.1-2009 Design for access and mobility, which stipulates they should be 600mm long and be set back 300 mm from the leading edge at a change of gradient of a ramp.</p>

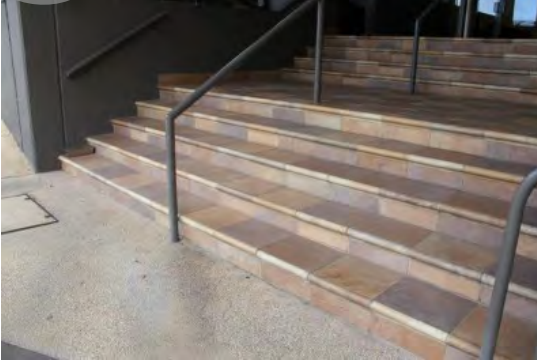
<p>#33</p> <p>Quote <input type="checkbox"/></p> <p>Proceed <input type="checkbox"/></p> <p>No Action <input type="checkbox"/></p>	<p><b>Risk Assessment:</b></p> <ul style="list-style-type: none"> <li><input checked="" type="checkbox"/> Maintenance Required</li> <li><input type="checkbox"/> Risk Of Injury</li> <li><input type="checkbox"/> Risk Of Serious Injury</li> <li><input type="checkbox"/> Risk Of Death</li> </ul> <p><b>Location:</b> External Staircases Throughout Property</p> <p><b>Auditor's Finding:</b> Given the age of the building handrails throughout have not been built to AS-1428 Access and mobility which states "the handrail must extend at least 300mm from the point at which the nosing line intersects with the bottom floor level"</p> <p><b>Auditor's Recommendation:</b> Best Practice would involve replacing external handrails throughout the property with units which satisfy AS 1428 requirements for handrails.</p>
