Occupational Health & Safety Report

1 Sample Street, Melbourne VIC 3022 (PS 123456 - OC1 only)

13 December 2016

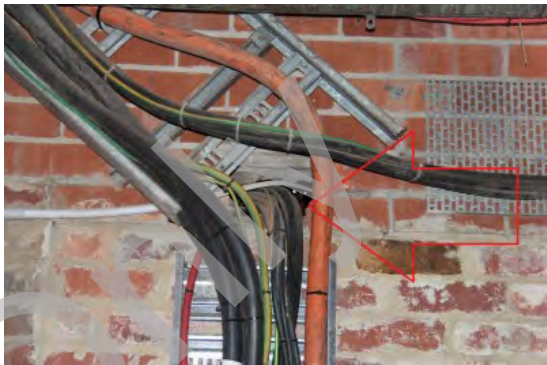
HIGH PRIORITY		
Item	Details	Photo
#1 Quote <input type="checkbox"/> Proceed <input type="checkbox"/> No Action <input type="checkbox"/>	<p>Risk Assessment:</p> <p><input type="checkbox"/> Maintenance Required</p> <p><input type="checkbox"/> Risk Of Injury</p> <p><input checked="" type="checkbox"/> Risk Of Serious Injury</p> <p><input type="checkbox"/> Risk Of Death</p> <p>Location: Central Walkway Southern Boundary adjacent Main switchboard assembly.</p> <p>Auditor's Finding: Penetrations of the electrical wiring are not sealed effectively and effects the fire integrity and is deemed as a fire hazard.</p> <p>Auditor's Recommendation: Engage a suitably qualified contractor to seal the electrical wiring penetration into the masonry wall by implementing fire pillows and fire rated caulking.</p>

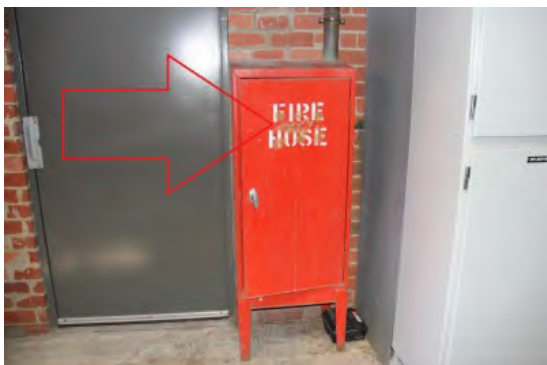
#2 Quote <input type="checkbox"/> Proceed <input type="checkbox"/> No Action <input type="checkbox"/>	<p>Risk Assessment:</p> <p><input type="checkbox"/> Maintenance Required</p> <p><input type="checkbox"/> Risk Of Injury</p> <p><input checked="" type="checkbox"/> Risk Of Serious Injury</p> <p><input type="checkbox"/> Risk Of Death</p> <p>Location: Central Walkway Southern Boundary adjacent Main switchboard assembly.</p> <p>Auditor's Finding: Fire Hose reel cabinet had been found containing one single fire hydrant service and no fire hose. Therefore, the existing signage is incorrect.</p> <p>Auditor's Recommendation: Install the correct signage on the fire cabinet as per relevant Australian Standards. It is also recommended that a CO2 (carbon di-oxide) fire extinguisher be installed in the area adjacent to the Main switchboard to tackle the fire more appropriately during an emergency.</p>

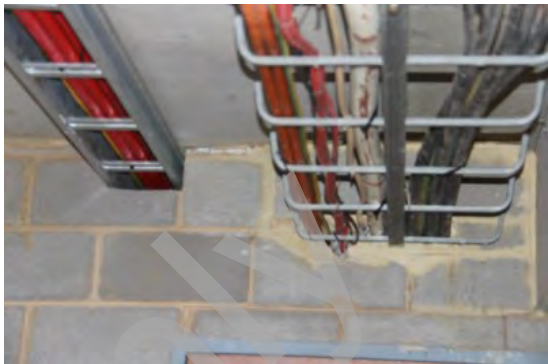
Item	Details	Photo
#3 Quote <input type="checkbox"/> Proceed <input type="checkbox"/> No Action <input type="checkbox"/>	<p>Risk Assessment:</p> <p><input type="checkbox"/> Maintenance Required</p> <p><input type="checkbox"/> Risk Of Injury</p> <p><input checked="" type="checkbox"/> Risk Of Serious Injury</p> <p><input type="checkbox"/> Risk Of Death</p> <p>Location:</p> <p>Central Walkway Southern Boundary adjacent Main switchboard assembly.</p> <p>Auditor's Finding:</p> <p>Penetrations of the electrical wiring are not sealed effectively and effects the fire integrity and is deemed as a fire hazard.</p> <p>Auditor's Recommendation:</p> <p>Engage a suitably qualified contractor to secure the connection of the electrical wiring penetration into the masonry wall is undertaken by implementing fire pillows and fire rated caulking.</p>

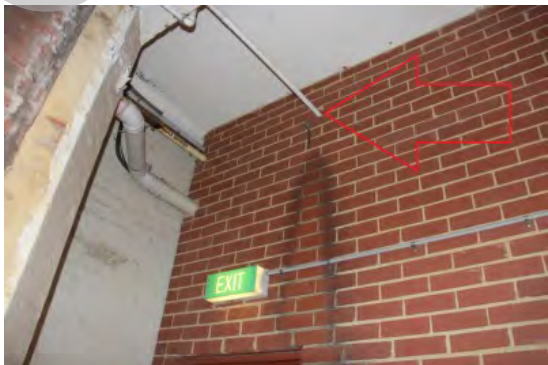
#4 Quote <input type="checkbox"/> Proceed <input type="checkbox"/> No Action <input type="checkbox"/>	<p>Risk Assessment:</p> <p><input type="checkbox"/> Maintenance Required</p> <p><input type="checkbox"/> Risk Of Injury</p> <p><input checked="" type="checkbox"/> Risk Of Serious Injury</p> <p><input type="checkbox"/> Risk Of Death</p> <p>Location:</p> <p>Central Walkway Fire Exit between Lot 18 and 16A.</p> <p>Auditor's Finding:</p> <p>Penetration of pipe gas lines and service pipes above the fire exit are not effectively seal in relation to fire integrity. In the case of a fire, this area would allow for smoke and toxic chemicals in/out of the area due to not being sealed appropriately.</p> <p>Auditor's Recommendation:</p> <p>Engage a suitably qualified contractor to seal the area effectively to ensure fire exits and associated areas are secure during times of emergency.</p>

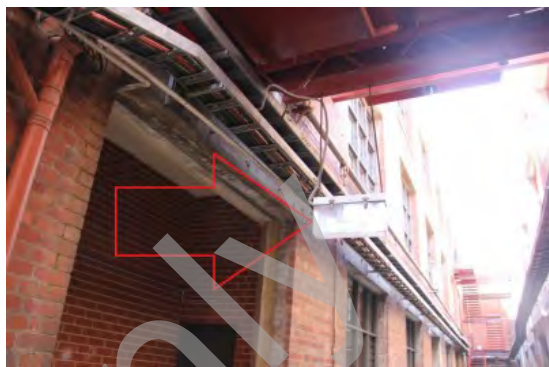
Item	Details	Photo
#5 Quote <input type="checkbox"/> Proceed <input type="checkbox"/> No Action <input type="checkbox"/>	<p>Risk Assessment:</p> <p><input type="checkbox"/> Maintenance Required</p> <p><input type="checkbox"/> Risk Of Injury</p> <p><input type="checkbox"/> Risk Of Serious Injury</p> <p><input checked="" type="checkbox"/> Risk Of Death</p> <p>Location: Central Walkway Exit Sign</p> <p>Auditor's Finding: The exit sign box does not house any form of existing exit light signage. In the case of emergency, those in the walkway will encounter trouble locating the fire exit and therefore may be prone to serious injury or death.</p> <p>Auditor's Recommendation: Install the relevant exit sign signage into the exit sign box.</p>

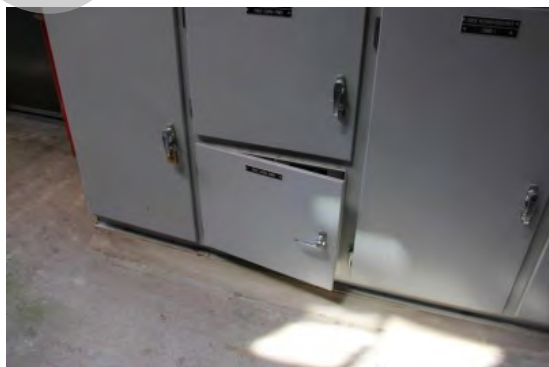
#6 Quote <input type="checkbox"/> Proceed <input type="checkbox"/> No Action <input type="checkbox"/>	<p>Risk Assessment:</p> <p><input checked="" type="checkbox"/> Maintenance Required</p> <p><input type="checkbox"/> Risk Of Injury</p> <p><input type="checkbox"/> Risk Of Serious Injury</p> <p><input type="checkbox"/> Risk Of Death</p> <p>Location: Central Walkway Southern Boundary - Main switchboard</p> <p>Auditor's Finding: The "Public Lighting & Power" and "Electricity Meters Tenant 2" cabinets had been unlocked at the time of inspection.</p> <p>Auditor's Recommendation: Install standard power industry pad locks on all unlocked cabinets to prevent unauthorised tampering with the services.</p>

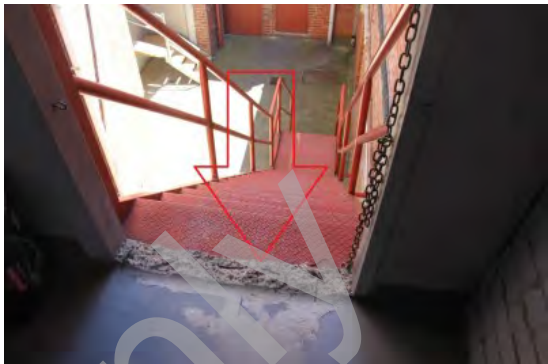
Item	Details	Photo
#9 Quote <input type="checkbox"/> Proceed <input type="checkbox"/> No Action <input type="checkbox"/>	<p>Risk Assessment:</p> <p><input type="checkbox"/> Maintenance Required</p> <p><input type="checkbox"/> Risk Of Injury</p> <p><input checked="" type="checkbox"/> Risk Of Serious Injury</p> <p><input type="checkbox"/> Risk Of Death</p> <p>Location: First Floor Common Area Walkway Stairwell adjacent Northern boundary</p> <p>Auditor's Finding: Entry opening on to staircase has a section of unfinished concrete which is deemed as a trip hazard.</p> <p>Auditor's Recommendation: Engage a suitably qualified contractor to screed the section to create an even flush surface eliminating the trip hazard.</p>

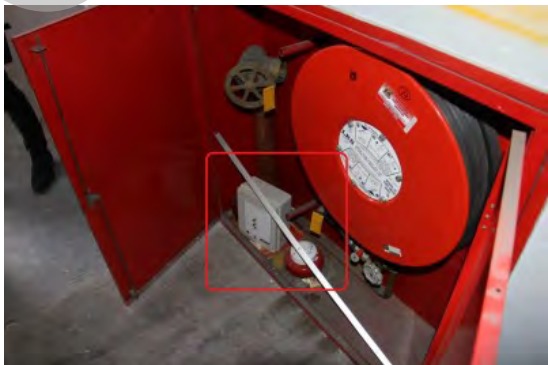
#10 Quote <input type="checkbox"/> Proceed <input type="checkbox"/> No Action <input type="checkbox"/>	<p>Risk Assessment:</p> <p><input type="checkbox"/> Maintenance Required</p> <p><input type="checkbox"/> Risk Of Injury</p> <p><input checked="" type="checkbox"/> Risk Of Serious Injury</p> <p><input type="checkbox"/> Risk Of Death</p> <p>Location: First Floor Common Area Walkway Stairwell adjacent Northern boundary</p> <p>Auditor's Finding: Redundant ESM items and personal belongings found in hose reel cupboard causing obstruction to fire services is deemed as a hazard.</p> <p>Auditor's Recommendation: Please ensure there is no obstruction to fire services in the cabinet by disposing of redundant items appropriately.</p>

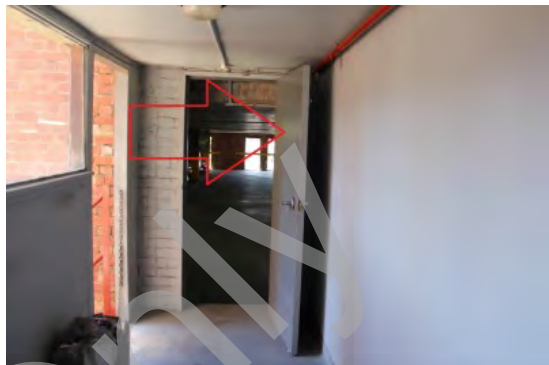
Item	Details	Photo
#11 Quote <input type="checkbox"/> Proceed <input type="checkbox"/> No Action <input type="checkbox"/>	<p>Risk Assessment:</p> <p><input type="checkbox"/> Maintenance Required</p> <p><input type="checkbox"/> Risk Of Injury</p> <p><input checked="" type="checkbox"/> Risk Of Serious Injury</p> <p><input type="checkbox"/> Risk Of Death</p> <p>Location: First Floor Common Area Walkway to first level Car Park adjacent northern boundary.</p> <p>Auditor's Finding: The existing fire door (identified by manufacturers tags) had been propped and unable to close. As the purpose of a fire door is to remain closed to prevent the spreading of fire, this is therefore in need to be rectified. The door also has non - compliant hardware (latches/dead bolts) fixed to it. No signage had been identified on the fire door. As this is a requirement, this is therefore non compliant and in need of installation Furthermore, a locking bolt mechanism had been found on the door. As the purpose of a fire door is to provide an escape for all of those accessing the area; if the bolt were employed during an emergency there may be no further path for those to escape.</p> <p>Auditor's Recommendation: Engage a suitably qualified contractor to remove any non-compliant hardware and repair the self closer so as to make the fire door compliant.</p>

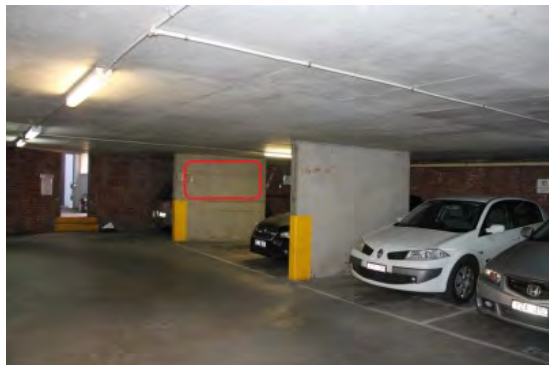
#12 Quote <input type="checkbox"/> Proceed <input type="checkbox"/> No Action <input type="checkbox"/>	<p>Risk Assessment:</p> <p><input type="checkbox"/> Maintenance Required</p> <p><input type="checkbox"/> Risk Of Injury</p> <p><input checked="" type="checkbox"/> Risk Of Serious Injury</p> <p><input type="checkbox"/> Risk Of Death</p> <p>Location: Level 1 Car Park</p> <p>Auditor's Finding: The location of the Fire Hose Reel is out of view from those accessing the area. In the case of emergency, the knowledge of this area is key and may create a serious risk if not in view. It was also noted that there were no Evacuation diagrams in place in the common areas.</p> <p>Auditor's Recommendation: Engage a suitably qualified contractor to install the required pop up signage on an open area to allow for further recognition of the location of the Fire Hose Reel. It is also essential to install Evacuation diagrams with Fire evacuation procedures in common areas to increase overall safety of occupants.</p>

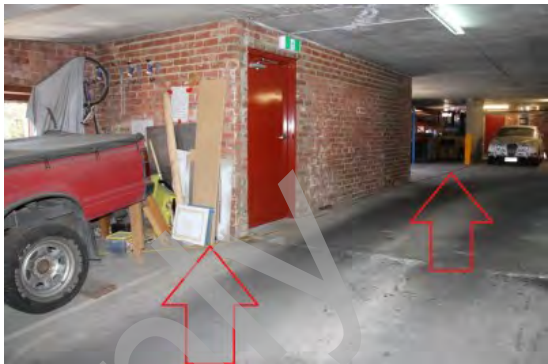
Item	Details	Photo
#13 Quote <input type="checkbox"/> Proceed <input type="checkbox"/> No Action <input type="checkbox"/>	<p>Risk Assessment:</p> <p><input type="checkbox"/> Maintenance Required</p> <p><input type="checkbox"/> Risk Of Injury</p> <p><input checked="" type="checkbox"/> Risk Of Serious Injury</p> <p><input type="checkbox"/> Risk Of Death</p> <p>Location: 1st level carpark adjacent car space 72.</p> <p>Auditor's Finding: A live electrical lead was found to be running through common area causing trip and electrocution hazard. The lead was connected to a pick up truck adjacent carspot 72 and runs all way across the carpark to a GPO.</p> <p>Auditor's Recommendation: Ensure the lead is removed from common area to eliminate the hazard.</p>

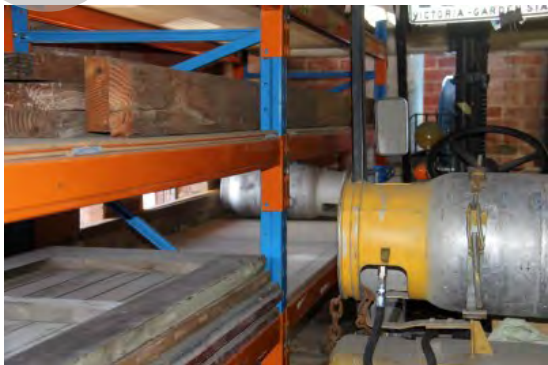
#14 Quote <input type="checkbox"/> Proceed <input type="checkbox"/> No Action <input type="checkbox"/>	<p>Risk Assessment:</p> <p><input type="checkbox"/> Maintenance Required</p> <p><input type="checkbox"/> Risk Of Injury</p> <p><input checked="" type="checkbox"/> Risk Of Serious Injury</p> <p><input type="checkbox"/> Risk Of Death</p> <p>Location: Car space 82</p> <p>Auditor's Finding: LPG containers for forklift stored in common area carpark is deemed as a fire hazard.</p> <p>Auditor's Recommendation: OC to remind owner to remove the gas canisters from the carpark area to eliminate the hazard.</p>

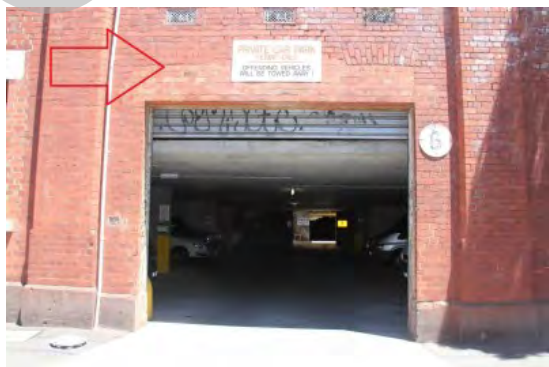
#16 Quote <input type="checkbox"/> Proceed <input type="checkbox"/> No Action <input type="checkbox"/>	<p>Risk Assessment:</p> <p><input type="checkbox"/> Maintenance Required</p> <p><input type="checkbox"/> Risk Of Injury</p> <p><input checked="" type="checkbox"/> Risk Of Serious Injury</p> <p><input type="checkbox"/> Risk Of Death</p> <p>Location: Carpark Entrance</p> <p>Auditor's Finding: 'Speed limit 5km/hr' signage and height limit signage missing at entry of driveway.</p> <p>Auditor's Recommendation: Install both signage to all entry carpark areas appropriately to eliminate collision hazards.</p>

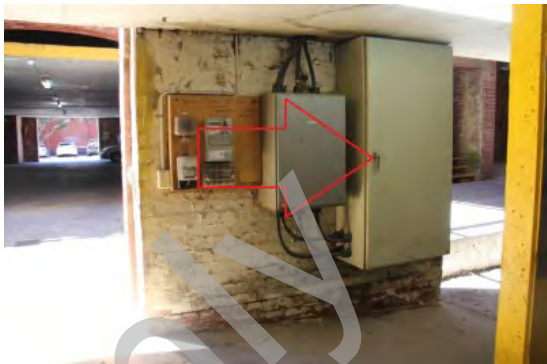
Item	Details	Photo
#17 Quote <input type="checkbox"/> Proceed <input type="checkbox"/> No Action <input type="checkbox"/>	<p>Risk Assessment:</p> <p><input type="checkbox"/> Maintenance Required</p> <p><input checked="" type="checkbox"/> Risk Of Injury</p> <p><input type="checkbox"/> Risk Of Serious Injury</p> <p><input type="checkbox"/> Risk Of Death</p> <p>Location: Main Switchboard - northern boundary.</p> <p>Auditor's Finding: 'MAIN SWITCHBOARD' is prone for tampering</p> <p>Auditor's Recommendation: It is recommended that a standard power industry lock be installed for the cabinet to prevent unauthorised access.</p>

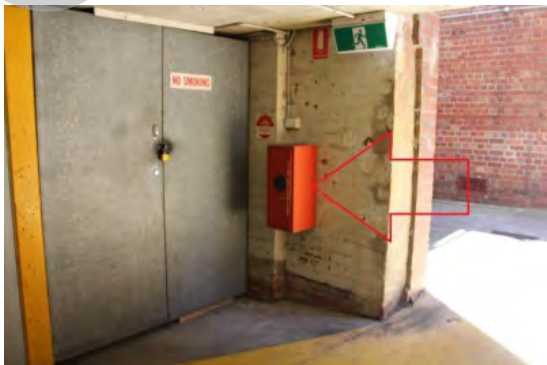
#18 Quote <input type="checkbox"/> Proceed <input type="checkbox"/> No Action <input type="checkbox"/>	<p>Risk Assessment:</p> <p><input type="checkbox"/> Maintenance Required</p> <p><input type="checkbox"/> Risk Of Injury</p> <p><input checked="" type="checkbox"/> Risk Of Serious Injury</p> <p><input type="checkbox"/> Risk Of Death</p> <p>Location: Main Switchboard - northern boundary.</p> <p>Auditor's Finding: No 003 keys provided for occupants to access the fire extinguisher in times of emergency.</p> <p>Auditor's Recommendation: It is recommended that a 003 key be kept on site in a safe break glass case to be used to access the fire extinguisher in times of emergency.</p>

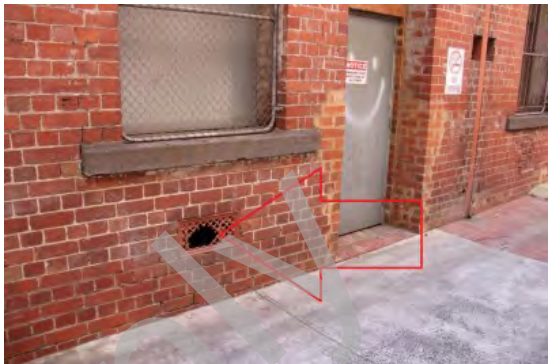
Item	Details	Photo
#19 Quote <input type="checkbox"/> Proceed <input type="checkbox"/> No Action <input type="checkbox"/>	<p>Risk Assessment: <input checked="" type="checkbox"/> Maintenance Required <input type="checkbox"/> Risk Of Injury <input type="checkbox"/> Risk Of Serious Injury <input type="checkbox"/> Risk Of Death</p> <p>Location: Central Walkway</p> <p>Auditor's Finding: Brick vent grills with excessive damage had been identified and may allow accessibility for pests into the adjacent private lot areas.</p> <p>Auditor's Recommendation: Engage a suitably qualified contractor to install a similar brick vent grill to eliminate the possibility of pest infestation.</p>

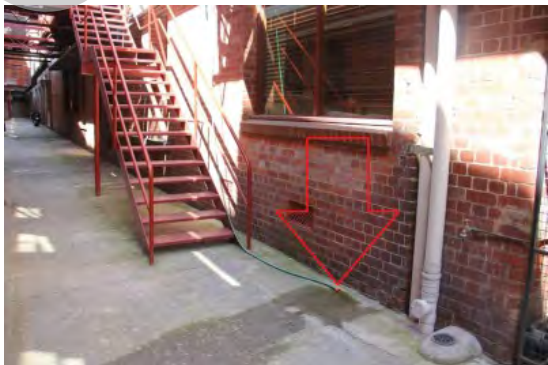
#20 Quote <input type="checkbox"/> Proceed <input type="checkbox"/> No Action <input type="checkbox"/>	<p>Risk Assessment: <input type="checkbox"/> Maintenance Required <input checked="" type="checkbox"/> Risk Of Injury <input type="checkbox"/> Risk Of Serious Injury <input type="checkbox"/> Risk Of Death</p> <p>Location: Central Walkway</p> <p>Auditor's Finding: A hose extending from the roof to the ground of the central walkway had been identified. This may pose as a tripping and slipping hazard to those within the walkway.</p> <p>Auditor's Recommendation: Remove the hose from the common walkway and if found to be OC property, secure it onto a hose mount or store appropriately.</p>

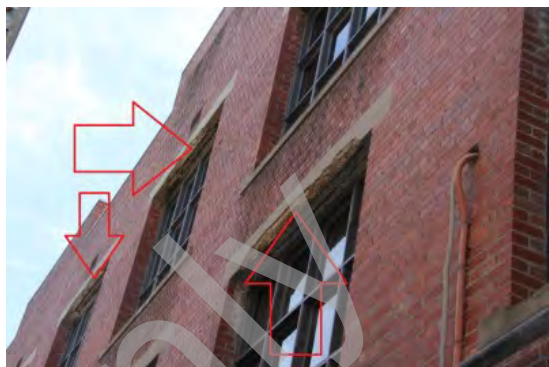
Item	Details	Photo
#21 Quote <input type="checkbox"/> Proceed <input type="checkbox"/> No Action <input type="checkbox"/>	<p>Risk Assessment:</p> <p><input type="checkbox"/> Maintenance Required</p> <p><input checked="" type="checkbox"/> Risk Of Injury</p> <p><input type="checkbox"/> Risk Of Serious Injury</p> <p><input type="checkbox"/> Risk Of Death</p> <p>Location: Central Walkway - Building facade</p> <p>Auditor's Finding: Lintels with excessive cracks and concrete cancer had been identified throughout. These areas are prone to spalling concrete breaking off and falling where they may impact with occupants accessing the central walkway area.</p> <p>Auditor's Recommendation: Engage a suitably qualified structural engineer to further assess the concrete cancer affected area and take remedial action as recommended.</p>

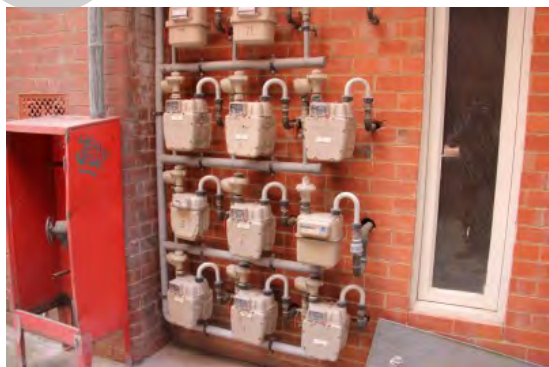
#22 Quote <input type="checkbox"/> Proceed <input type="checkbox"/> No Action <input type="checkbox"/>	<p>Risk Assessment:</p> <p><input checked="" type="checkbox"/> Maintenance Required</p> <p><input type="checkbox"/> Risk Of Injury</p> <p><input type="checkbox"/> Risk Of Serious Injury</p> <p><input type="checkbox"/> Risk Of Death</p> <p>Location: Central Walkway</p> <p>Auditor's Finding: Gas meters have no existing lock and are prone to tampering by unauthorised personnel.</p> <p>Auditor's Recommendation: Engage a suitably qualified contractor to secure the area by installing a cage and standard industry pad locks as a measure to prevent unauthorised tampering.</p>

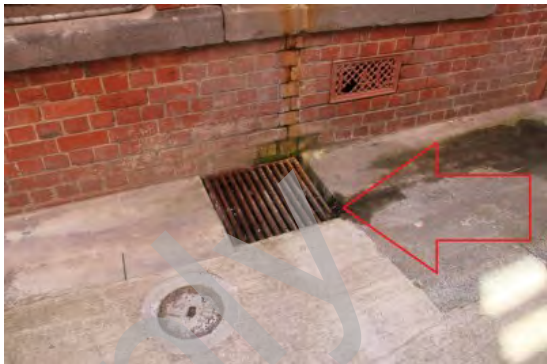
Item	Details	Photo
#23 Quote <input type="checkbox"/> Proceed <input type="checkbox"/> No Action <input type="checkbox"/>	<p>Risk Assessment:</p> <p><input type="checkbox"/> Maintenance Required</p> <p><input checked="" type="checkbox"/> Risk Of Injury</p> <p><input type="checkbox"/> Risk Of Serious Injury</p> <p><input type="checkbox"/> Risk Of Death</p> <p>Location:</p> <p>Central Walkway - storm water grate adjacent Lot PT16A.</p> <p>Auditor's Finding:</p> <p>Storm water grate is not flush with the finished floor level and is a trip hazard.</p> <p>Auditor's Recommendation:</p> <p>Engage a suitably qualified concreter to reinstall the grate to finish flush with floor level to minimise risk of injury.</p>

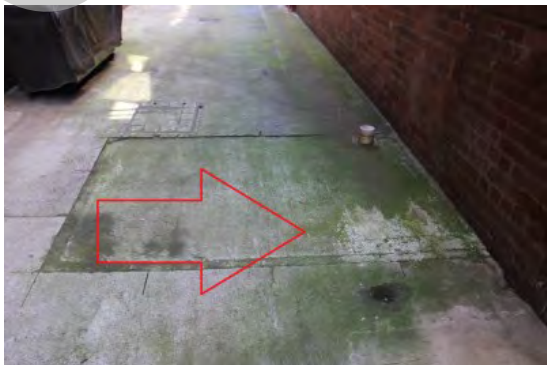
#24 Quote <input type="checkbox"/> Proceed <input type="checkbox"/> No Action <input type="checkbox"/>	<p>Risk Assessment:</p> <p><input type="checkbox"/> Maintenance Required</p> <p><input checked="" type="checkbox"/> Risk Of Injury</p> <p><input type="checkbox"/> Risk Of Serious Injury</p> <p><input type="checkbox"/> Risk Of Death</p> <p>Location:</p> <p>Central Walkway - multiple areas</p> <p>Auditor's Finding:</p> <p>Evidence of moss growing in sections of walkway, this is a potential slip hazard.</p> <p>Auditor's Recommendation:</p> <p>Engage a suitably qualified contractor to pressure clean the area and treat it with moss repellent so that the slip hazard is effectively eradicated.</p>

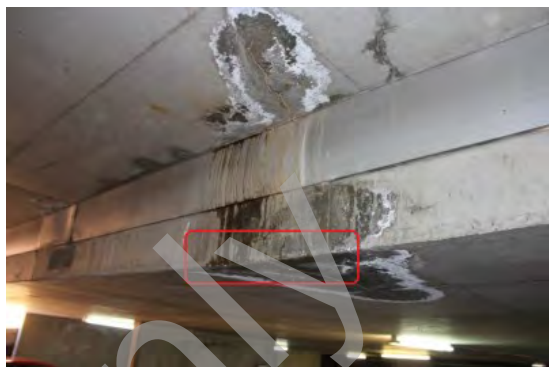
Item	Details	Photo
#27 Quote <input type="checkbox"/> Proceed <input type="checkbox"/> No Action <input type="checkbox"/>	<p>Risk Assessment:</p> <p><input type="checkbox"/> Maintenance Required</p> <p><input checked="" type="checkbox"/> Risk Of Injury</p> <p><input type="checkbox"/> Risk Of Serious Injury</p> <p><input type="checkbox"/> Risk Of Death</p> <p>Location: 1st level carpark adjacent car space 72.</p> <p>Auditor's Finding: Current water ingress through slab causing water pooling and slip hazards in the carpark levels not to mention concrete cancer issues in the future.</p> <p>Auditor's Recommendation: Address water ingress issues by a suitably qualified contractor.</p>

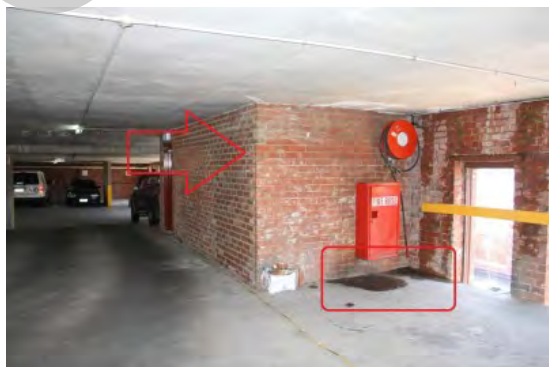
#28 Quote <input type="checkbox"/> Proceed <input type="checkbox"/> No Action <input type="checkbox"/>	<p>Risk Assessment:</p> <p><input type="checkbox"/> Maintenance Required</p> <p><input checked="" type="checkbox"/> Risk Of Injury</p> <p><input type="checkbox"/> Risk Of Serious Injury</p> <p><input type="checkbox"/> Risk Of Death</p> <p>Location: 1st level carpark adjacent fire exit stairwell.</p> <p>Auditor's Finding: Current water ingress through slab causing water pooling and slip hazards in the carpark levels not to mention concrete cancer issues in the future.</p> <p>Auditor's Recommendation: Leak was identified to be coming from a leaking fire hose reel on topmost level.</p>

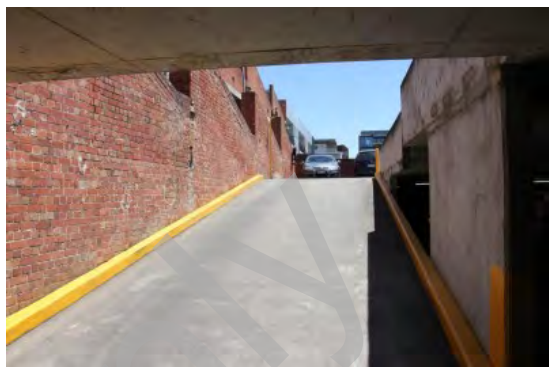
Item	Details	Photo
#29 Quote <input type="checkbox"/> Proceed <input type="checkbox"/> No Action <input type="checkbox"/>	<p>Risk Assessment:</p> <p><input type="checkbox"/> Maintenance Required</p> <p><input checked="" type="checkbox"/> Risk Of Injury</p> <p><input type="checkbox"/> Risk Of Serious Injury</p> <p><input type="checkbox"/> Risk Of Death</p> <p>Location:</p> <p>All ramps in car park level</p> <p>Auditor's Finding:</p> <p>No convex mirrors were found in the car park ramp areas. The visibility of oncoming traffic up or down the ramp can be a possible hazard.</p> <p>Auditor's Recommendation:</p> <p>Install convex mirrors in locations that enable safe ingress and egress of vehicles from carpark area.</p>

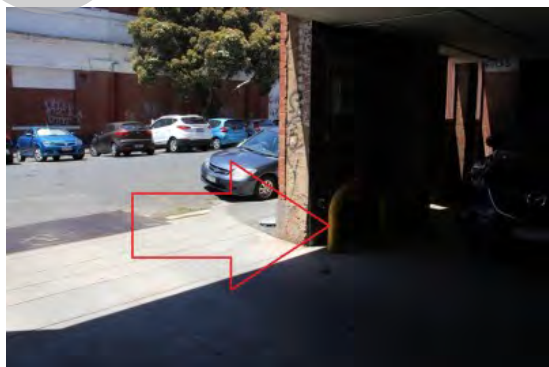
#30 Quote <input type="checkbox"/> Proceed <input type="checkbox"/> No Action <input type="checkbox"/>	<p>Risk Assessment:</p> <p><input checked="" type="checkbox"/> Maintenance Required</p> <p><input type="checkbox"/> Risk Of Injury</p> <p><input type="checkbox"/> Risk Of Serious Injury</p> <p><input type="checkbox"/> Risk Of Death</p> <p>Location:</p> <p>car space 17 near entry roller door.</p> <p>Auditor's Finding:</p> <p>Fire services pipe is in risk of collision with vehicles.</p> <p>Auditor's Recommendation:</p> <p>Engage contractor to install bollards to protect the service pipe.</p>

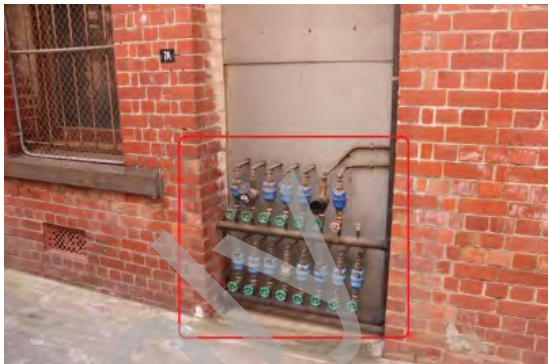
Item	Details	Photo
#31 Quote <input type="checkbox"/> Proceed <input type="checkbox"/> No Action <input type="checkbox"/>	<p>Risk Assessment:</p> <p><input checked="" type="checkbox"/> Maintenance Required</p> <p><input type="checkbox"/> Risk Of Injury</p> <p><input type="checkbox"/> Risk Of Serious Injury</p> <p><input type="checkbox"/> Risk Of Death</p> <p>Location: Central Walkway - Water Meters adjacent 7A.</p> <p>Auditor's Finding: Water meter valves are exposed within a common area and therefore unauthorised personnel are able to tamper with the unit.</p> <p>Auditor's Recommendation: We recommend that a suitably qualified contractor is engaged to install a metal cage around the unit, including a standard service industry padlock, so that only authorised access is enabled when it is required.</p>

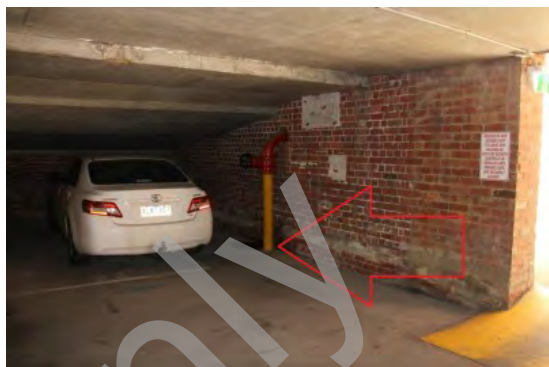
Item	Details	Photo
#37 Quote <input type="checkbox"/> Proceed <input type="checkbox"/> No Action <input type="checkbox"/>	<p>Risk Assessment:</p> <p><input type="checkbox"/> Maintenance Required</p> <p><input checked="" type="checkbox"/> Risk Of Injury</p> <p><input type="checkbox"/> Risk Of Serious Injury</p> <p><input type="checkbox"/> Risk Of Death</p> <p>Location: Car space 23 on ground level.</p> <p>Auditor's Finding: Fire services pipe is in risk of collision with vehicles.</p> <p>Auditor's Recommendation: Engage contractor to install bollards to protect the service pipe.</p>

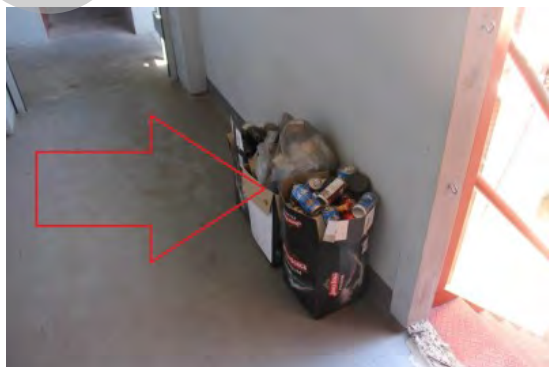
#38 Quote <input type="checkbox"/> Proceed <input type="checkbox"/> No Action <input type="checkbox"/>	<p>Risk Assessment:</p> <p><input type="checkbox"/> Maintenance Required</p> <p><input checked="" type="checkbox"/> Risk Of Injury</p> <p><input type="checkbox"/> Risk Of Serious Injury</p> <p><input type="checkbox"/> Risk Of Death</p> <p>Location: First Floor Common Area Walkway to first level Car Park adjacent northern boundary.</p> <p>Auditor's Finding: Personal belongings/rubbish found in common area walkway on 1st floor. These may be considered as a minor tripping hazard as paths of travel need to be clear of obstructions.</p> <p>Auditor's Recommendation: OC to remind occupants of correct storage procedures as outlined within OC agreement. If occupants do not remove the belongings, we recommend that the OC engages a contractor to remove the items.</p>

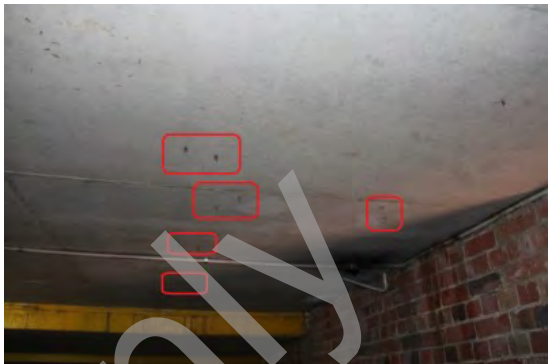
Item	Details	Photo
#39 Quote <input type="checkbox"/> Proceed <input type="checkbox"/> No Action <input type="checkbox"/>	<p>Risk Assessment:</p> <p><input type="checkbox"/> Maintenance Required</p> <p><input checked="" type="checkbox"/> Risk Of Injury</p> <p><input type="checkbox"/> Risk Of Serious Injury</p> <p><input type="checkbox"/> Risk Of Death</p> <p>Location: Level 1 Car Park</p> <p>Auditor's Finding: Redundant nails protruding from the concrete slab ceiling can cause injury to occupants accessing these areas.</p> <p>Auditor's Recommendation: Remove or grind back the redundant nails to the face of the slab so as to eradicate the hazard.</p>

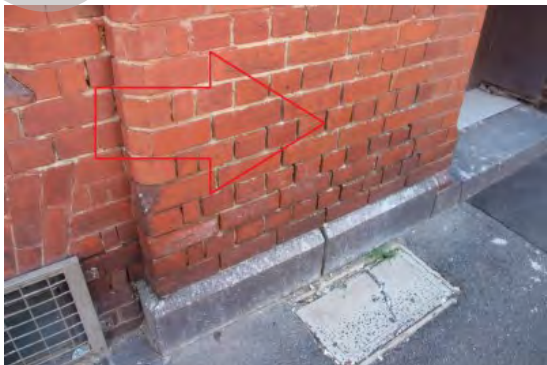
#41 Quote <input type="checkbox"/> Proceed <input type="checkbox"/> No Action <input type="checkbox"/>	<p>Risk Assessment:</p> <p><input checked="" type="checkbox"/> Maintenance Required</p> <p><input type="checkbox"/> Risk Of Injury</p> <p><input type="checkbox"/> Risk Of Serious Injury</p> <p><input type="checkbox"/> Risk Of Death</p> <p>Location: South-Western Boundary adjacent 22 Peel St Collingwood development.</p> <p>Auditor's Finding: Rising damp area between the masonry brickwork had been identified with an approximate 65% moisture reading on moisture meter confirming our finding. Such exposure to moisture ingress may compromise the integrity of the masonry wall itself.</p> <p>Auditor's Recommendation: Engage a structural engineer to further assess the rising damp area and re-point the brick work once moisture issue has been addressed.</p>
