Drone Facade Inspection Report

1 Sample Street, Melbourne VIC 3022 (PS 12345S)

12 May 2017

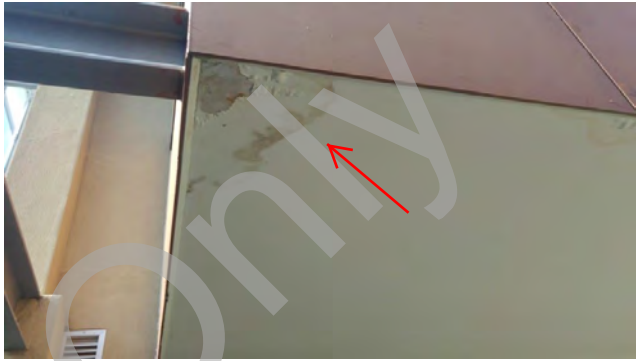
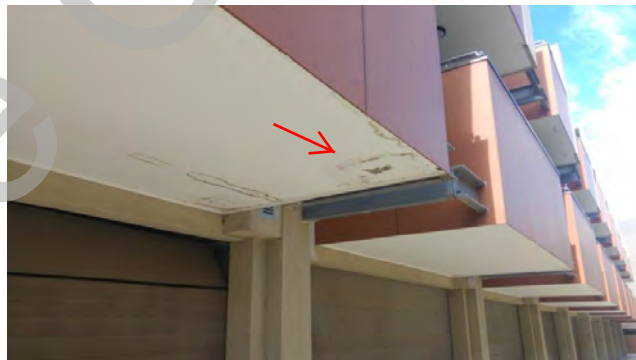
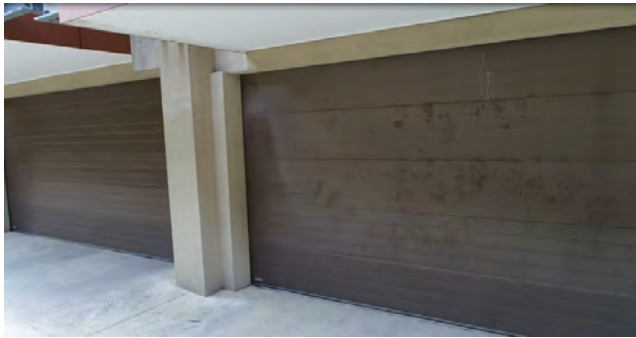
Item	Details	Photographic Details
1.	<p>Location:</p> <p>First Floor Balcony Soffits on the Western Facade.</p> <p>Finding:</p> <p>Throughout the western facade the first floor balcony soffits have water stains indicating that the water proof membrane throughout the first floor balconies have failed.</p> <p>Image 1 shows an exposed slab soffit in the north western corner of the balcony for Unit 10 where the paint has peeled off due to water ingress.</p> <p>Image 2 shows water staining on the bottom of the first floor slab soffit of Unit 9.</p> <p>Image 3 shows water staining on the north western corner of the first floor balcony of Unit 8.</p> <p>Recommendations:</p> <p>It is recommended that the water damaged balcony soffits are replaced with a new water proofing membrane.</p>

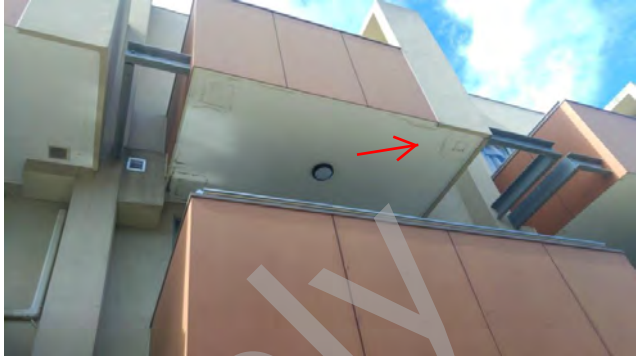
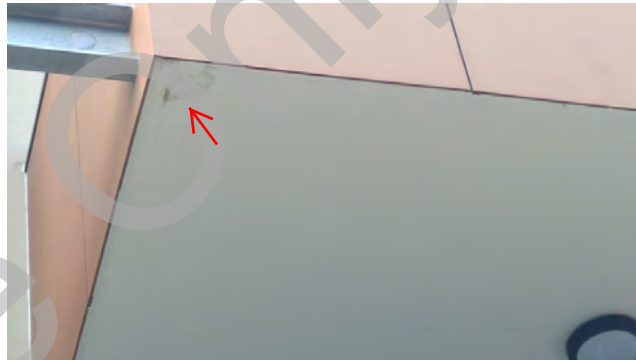
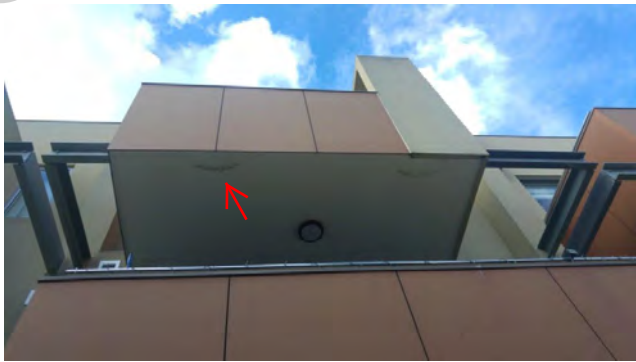
Item	Details	Photographic Details
2.	<p>Location:</p> <p>Sample Street Western Facade Second Floor Balcony Soffits.</p> <p>Finding:</p> <p>The second floor balcony soffits had water stains indicating that the water proofing membrane has failed throughout the second floor balconies.</p> <p>Image 1 is the second floor balcony soffit of Unit 9 where there is water staining in both the corners of the balcony soffits.</p> <p>Image 2 the second floor balcony soffit of Unit 8 has a water stain in the north western corner of the balcony soffit.</p> <p>Image 3 the second floor balcony soffit of Unit 7 has water staining across the western edge of the balcony soffit.</p> <p>Recommendations:</p> <p>It is recommended that the water damaged balcony soffits are replaced with a new water proofing membrane.</p>

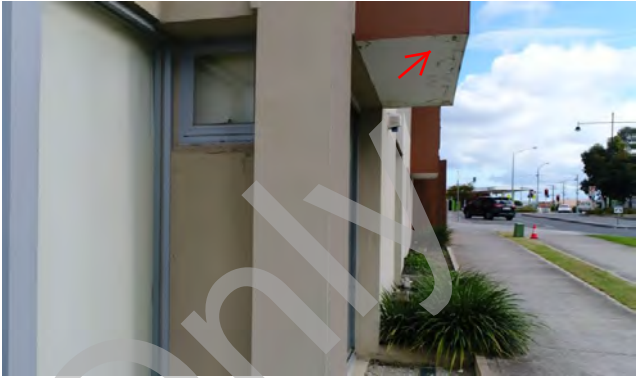
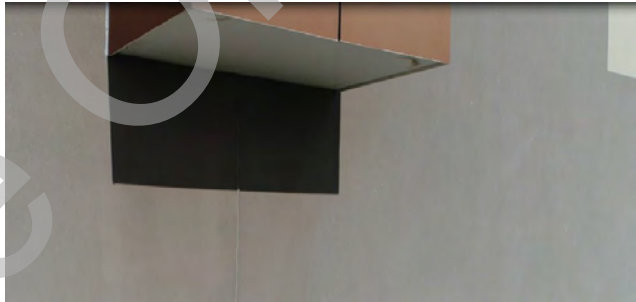
Item	Details	Photographic Details
3.	<p>Location:</p> <p>Northern Facade Soffits.</p> <p>Finding:</p> <p>Both the soffits on the northern facade have water stains indicating that water is seeping through the soffit. Based off this observation the soffit's water proofing membrane has failed allowing water ingress.</p> <p>Recommendations:</p> <p>It is recommended that the water proofing membrane on the soffits are replaced.</p>

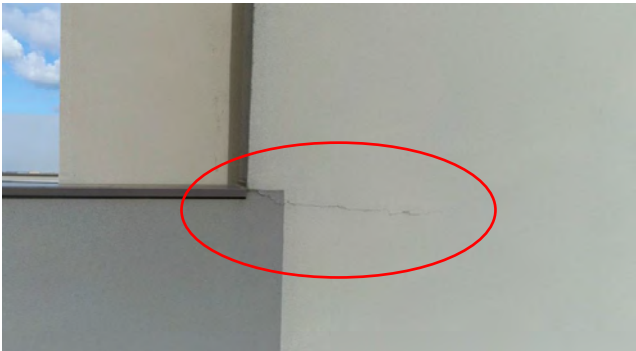
4.	<p>Location:</p> <p>Unit 10 Second Storey Balcony.</p> <p>Finding:</p> <p>There is a hairline crack at the edge of the parapet of the second storey balcony.</p> <p>Recommendations:</p> <p>It is recommended that the hairline crack is monitored to ensure that it does not worsen.</p>

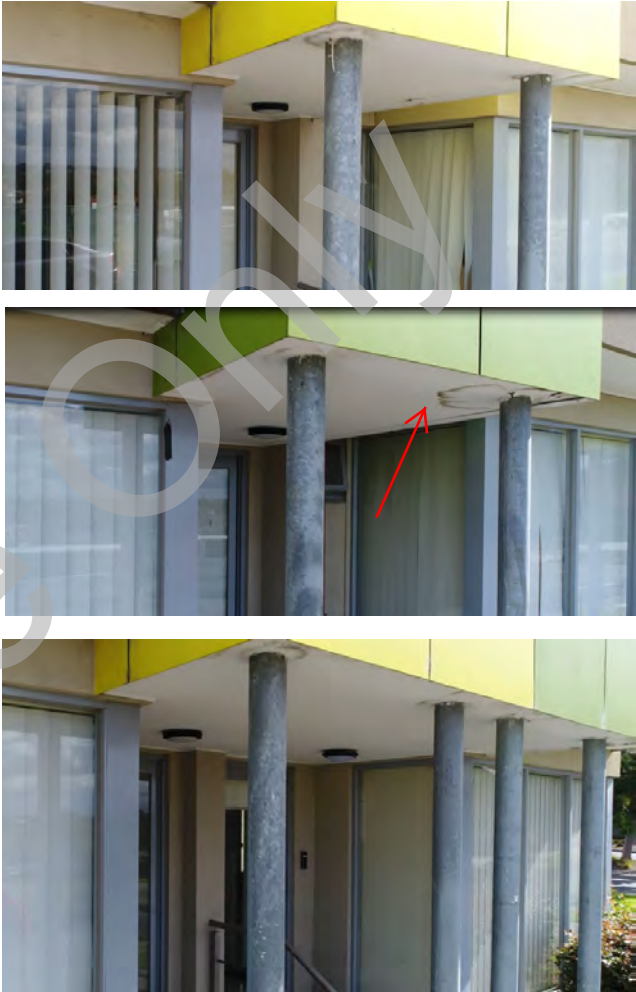
Item	Details	Photographic Details
7.	<p>Location:</p> <p>Ground Floor Balcony Soffits.</p> <p>Finding:</p> <p>The first floor balcony soffits have significant water damage around the steel columns. Based off these observations the soffits have not been adequately water proofed.</p> <p>Recommendations:</p> <p>It is recommended that the balcony soffits on the first floor are replaced.</p>

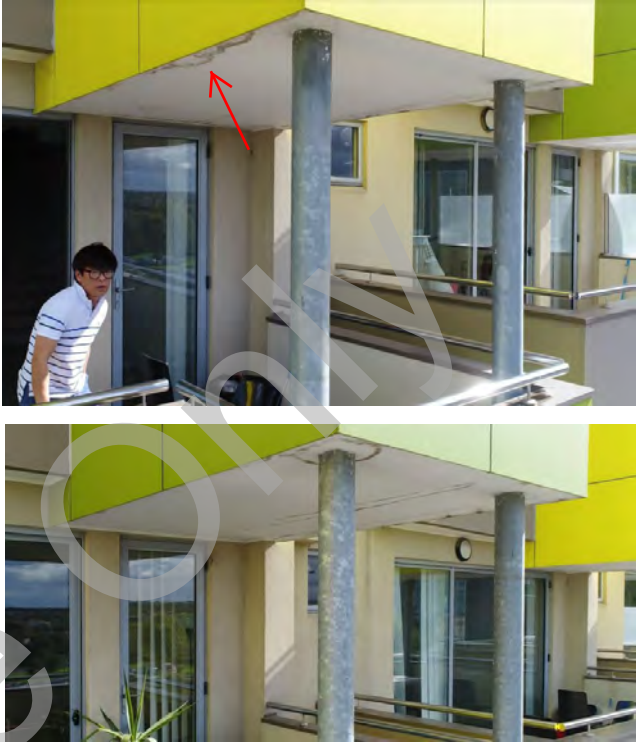
Item	Details	Photographic Details
8.	<p><u>Location:</u></p> <p>The Second Storey Balcony Soffits.</p> <p><u>Finding:</u></p> <p>The second storey balcony soffits have water staining indicating that the balconies water proofing membrane has failed allowing water to ingress onto the soffit below.</p> <p><u>Recommendations:</u></p> <p>It is recommended that the second storey balconies throughout the eastern facade are replaced.</p>

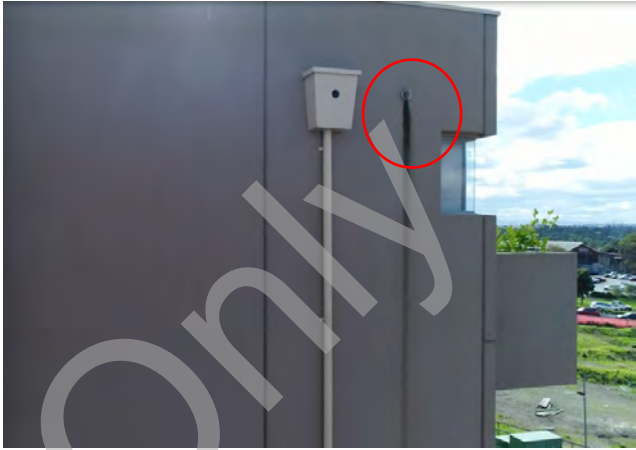
Item	Details	Photographic Details
10.	<p>Location:</p> <p>South Eastern Corner Second Storey Overflow Pipe.</p> <p>Finding:</p> <p>The overflow pipe on the second storey south eastern corner has not been connected a downpipe and is leaking water onto the facade.</p> <p>Recommendations:</p> <p>It is recommended that the overflow is connected a rain head, which is then connected to a downpipe.</p>

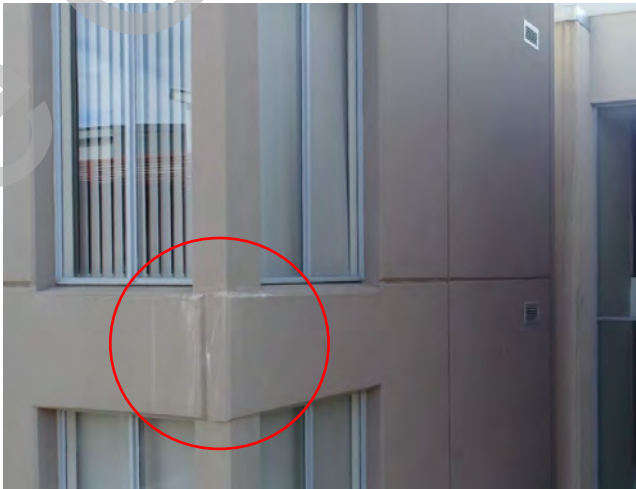
11.	<p>Location:</p> <p>Second Storey Window Frame.</p> <p>Finding:</p> <p>The window frame on the second storey has signs of efflorescence at the bottom of the column adjacent to the window sill. Based off these observations water from the window sill is seeping into the bottom of the column.</p> <p>Recommendations:</p> <p>It is recommended that the window frames are reinstalled with a damp proof course on the window sill to prevent water ingressing into the window sill.</p>

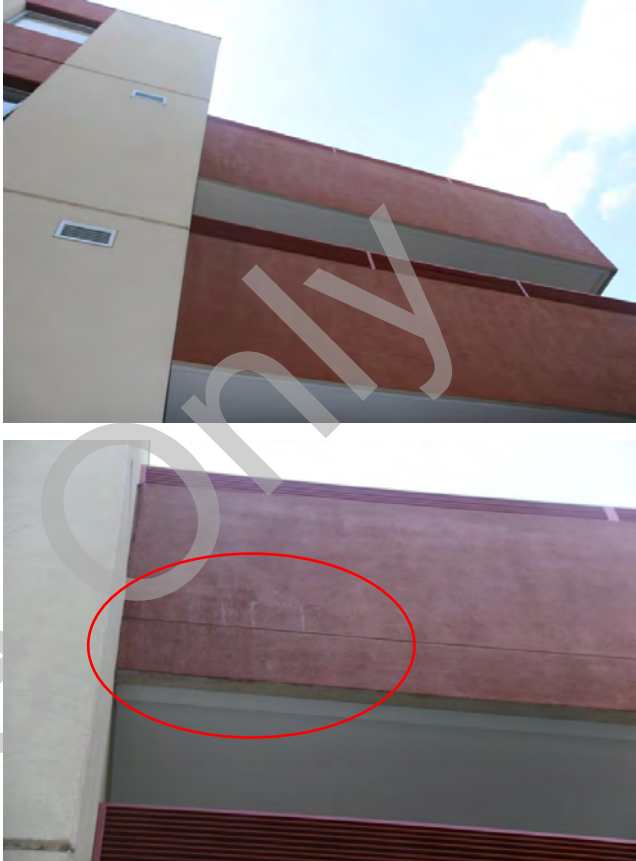
Item	Details	Photographic Details
12.	<p>Location:</p> <p>Third Storey Balcony Parapet on Western Side.</p> <p>Finding:</p> <p>The third storey balcony parapet has a hairline crack with efflorescence seeping out of it. Given the balcony parapet has not been capped with flashing water has seeped into the balcony parapet causing a hairline crack in the render of the parapet below.</p> <p>Recommendations:</p> <p>It is recommended that the balcony parapet is capped with an appropriate flashing to prevent water ingress into the render of the parapet.</p>

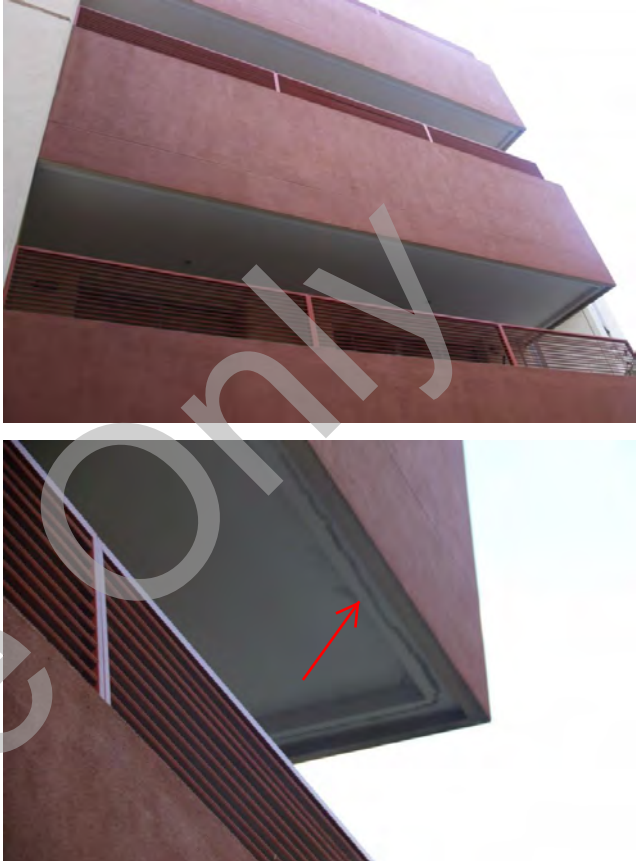
Item	Details	Photographic Details
13.	<p><u>Location:</u></p> <p>Second Storey Balcony on the West Side of the South Facade.</p> <p><u>Finding:</u></p> <p>The edge of the second storey balcony soffit has water stains indicating that the water proofing membrane has failed allowing water to seep into the balcony soffit.</p> <p><u>Recommendations:</u></p> <p>It is recommended that the balcony soffit water proofing membrane is replaced and the damaged sections of the soffit is repaired and repainted.</p>

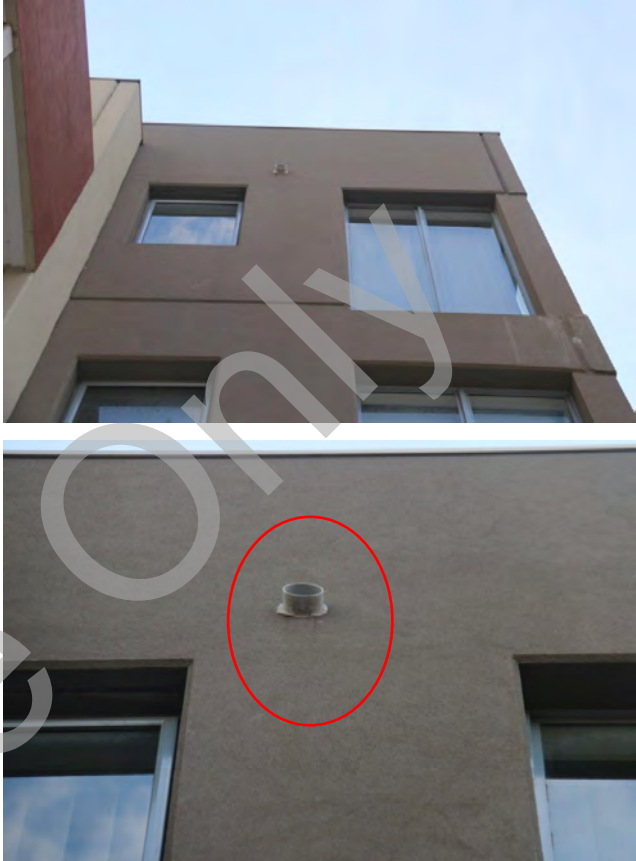
Item	Details	Photographic Details
16.	<p><u>Location:</u></p> <p>Third Storey Overflow.</p> <p><u>Finding:</u></p> <p>The overflow to the roof is not connected to a downpipe meaning that water will track down the facade accelerating the damage to the external facade.</p> <p><u>Recommendations:</u></p> <p>It is recommended that the overflow is connected to a rainhead and downpipe, so that the discharged water does not track along the facade of the building.</p>

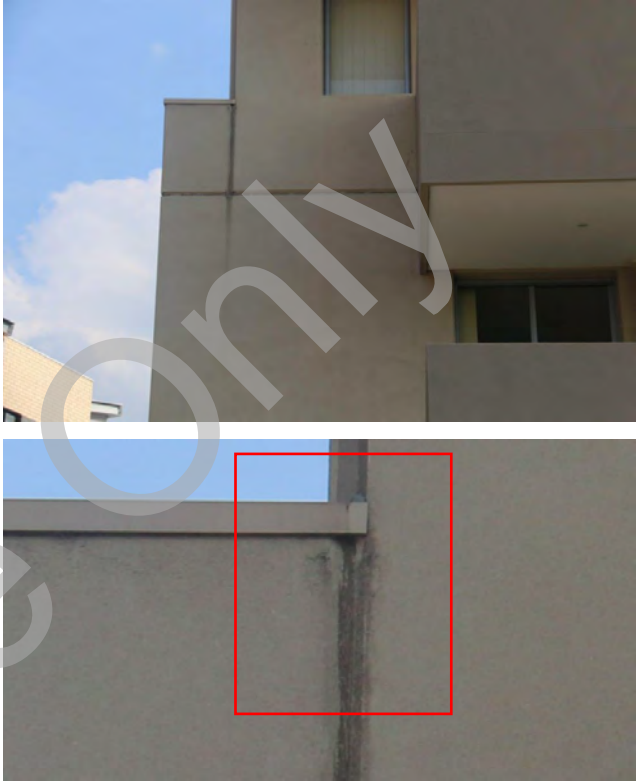
Item	Details	Photographic Details
17.	<p>Location:</p> <p>Second Floor Balcony Parapet on the South Eastern Corner.</p> <p>Finding:</p> <p>The capping on the balcony parapet has been installed over the vertical articulation joint on the balcony parapet. Water is seeping around the edge of the capping and is tracking down the channel of the articulation joint, this is shown by the dirt stains in Image 2.</p> <p>Recommendations:</p> <p>It is recommended the capping on the parapet of the balcony is replaced with a capping that has a drip edge further away from the building to prevent water from tracking down the articulation joint.</p>

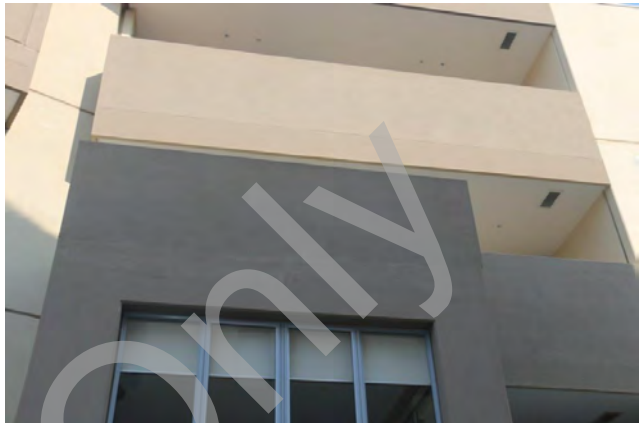
Item	Details	Photographic Details
20.	<p>Location:</p> <p>First Storey Balcony Parapet.</p> <p>Finding:</p> <p>There is a hairline crack on the first storey balcony with efflorescence stains. The parapet has not been capped with flashing, this allows water to send into the top edge of the balcony parapet. The water seeps into the render of the parapet causing cracking at the bottom of the balcony parapet.</p> <p>Recommendations:</p> <p>It is recommended that flashing is installed on the parapet of the balcony.</p>

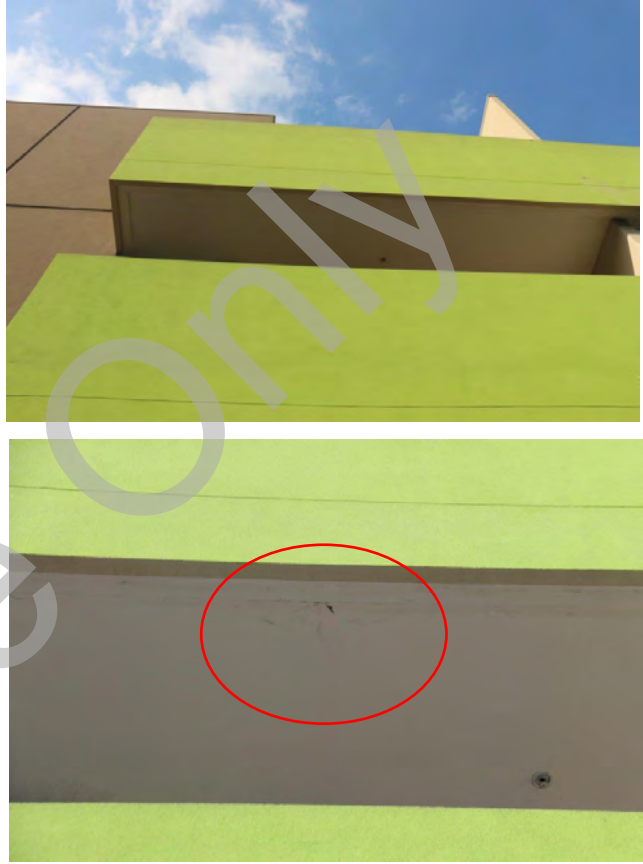
Item	Details	Photographic Details
21.	<p>Location:</p> <p>Third Storey Balcony Soffit on the North Western Corner.</p> <p>Finding:</p> <p>The western edge of the balcony soffit has water damage indicating that the water proofing membrane has failed.</p> <p>Recommendations:</p> <p>It is recommended that the water proofing membrane is replaced and the damaged section of the soffit is repaired and repainted.</p>

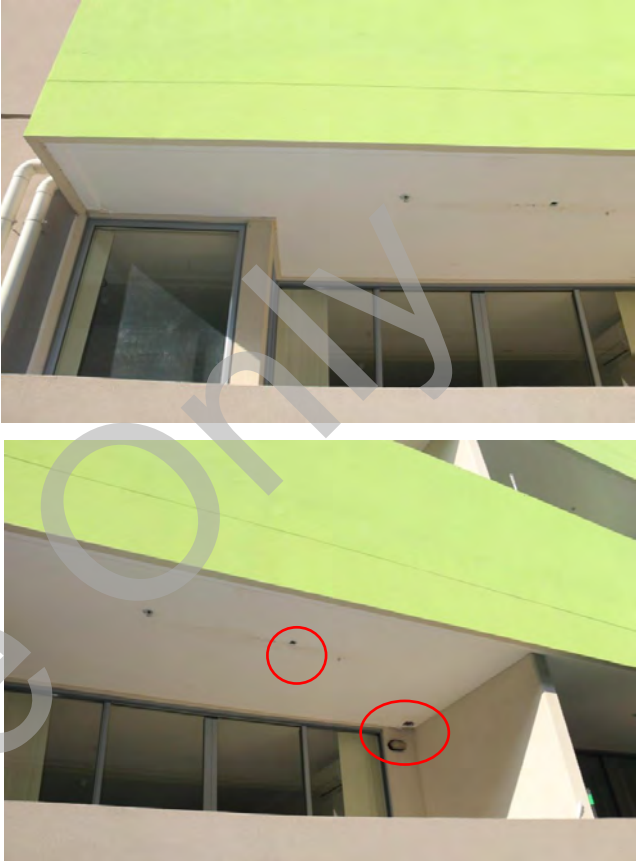
Item	Details	Photographic Details
22.	<p>Location:</p> <p>Second Storey Balcony Soffit.</p> <p>Finding:</p> <p>The balcony soffit has water damage to the soffit. Inspection holes have been cut into the soffit.</p> <p>Recommendations:</p> <p>It is recommended that the water proofing membrane is replaced and the balcony soffit is replaced.</p>

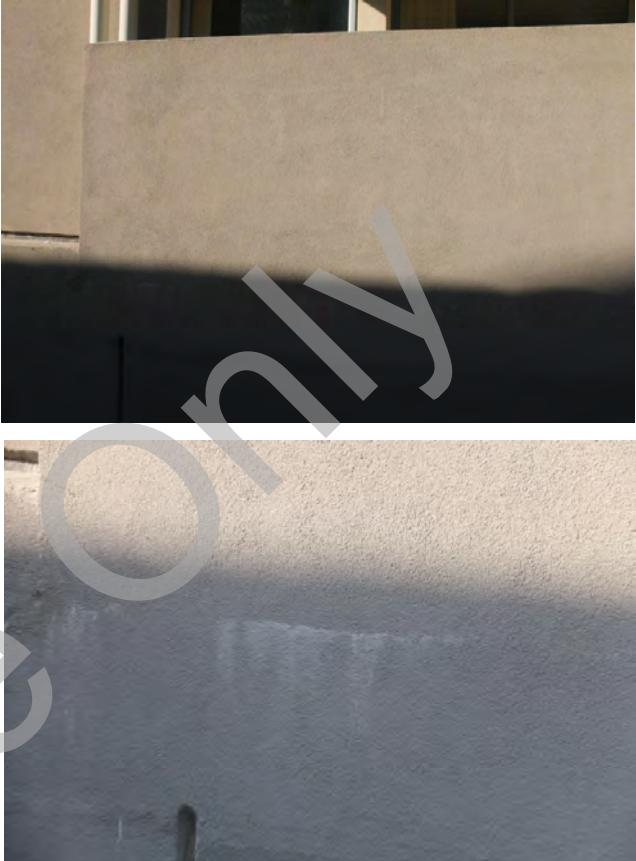
Item	Details	Photographic Details
23.	<p>Location:</p> <p>First Floor Balcony Parapet North Western Corner of the Western Facade.</p> <p>Finding:</p> <p>The balcony parapet has efflorescence stains from water seeping through the render of the parapet, due to the top edge not being capped with the appropriate flashing.</p> <p>Recommendations:</p> <p>It is recommended that the parapet is capped with flashing to prevent future water ingress and the damaged section of the rendered parapet is replaced.</p>

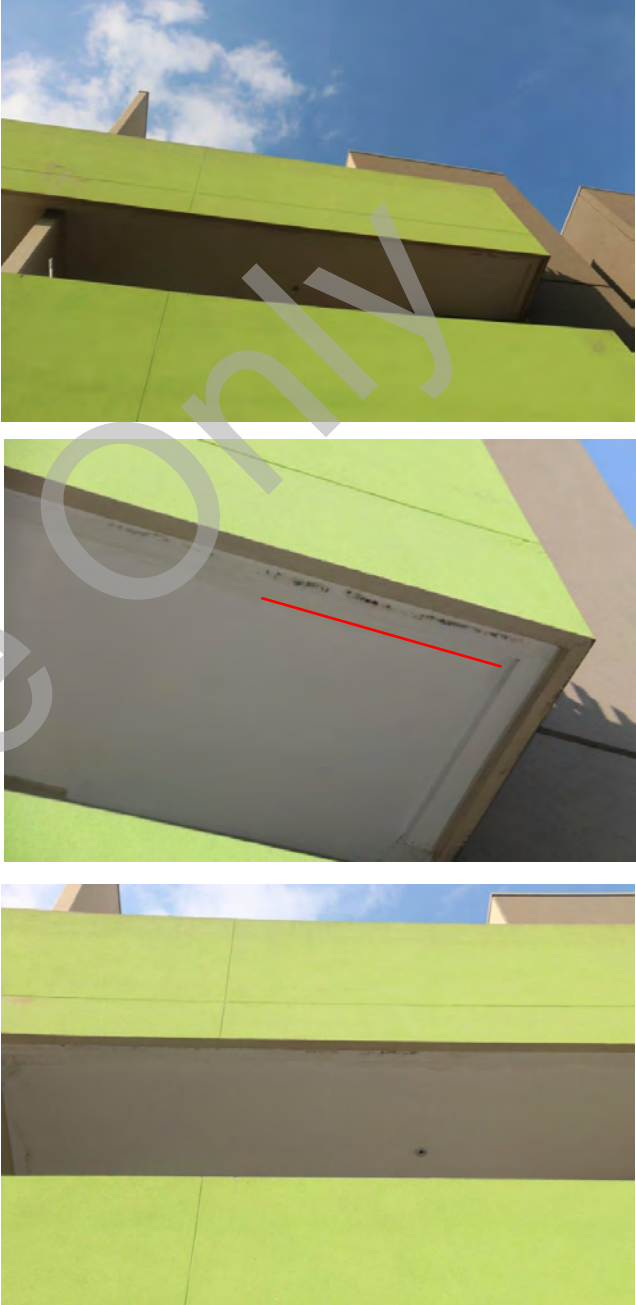
Item	Details	Photographic Details
24.	<p><u>Location:</u></p> <p>Third Storey Balcony Soffit North Western Corner.</p> <p><u>Finding:</u></p> <p>The balcony soffit has water stains on the western edge indicating that the water proofing membrane has failed causing water to seep into the balcony soffit.</p> <p><u>Recommendations:</u></p> <p>It is recommended that the water proofing membrane on the balcony is replaced and the damaged section of the soffit is replaced.</p>

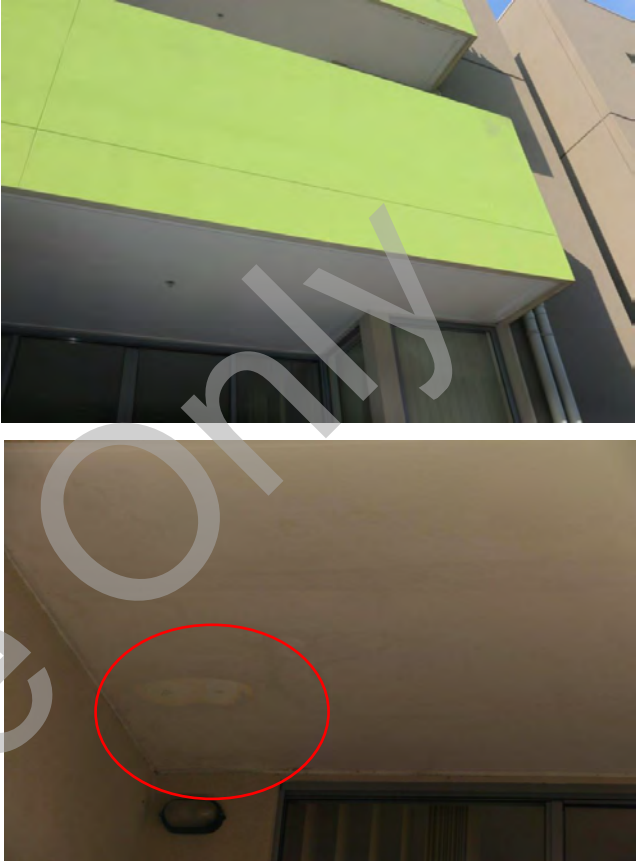
Item	Details	Photographic Details
25.	<p>Location:</p> <p>Second Storey Balcony Soffit on the Western Facade.</p> <p>Finding:</p> <p>The balcony soffit has been repaired with the paint on the patch not matching the finish of the balcony soffit.</p>

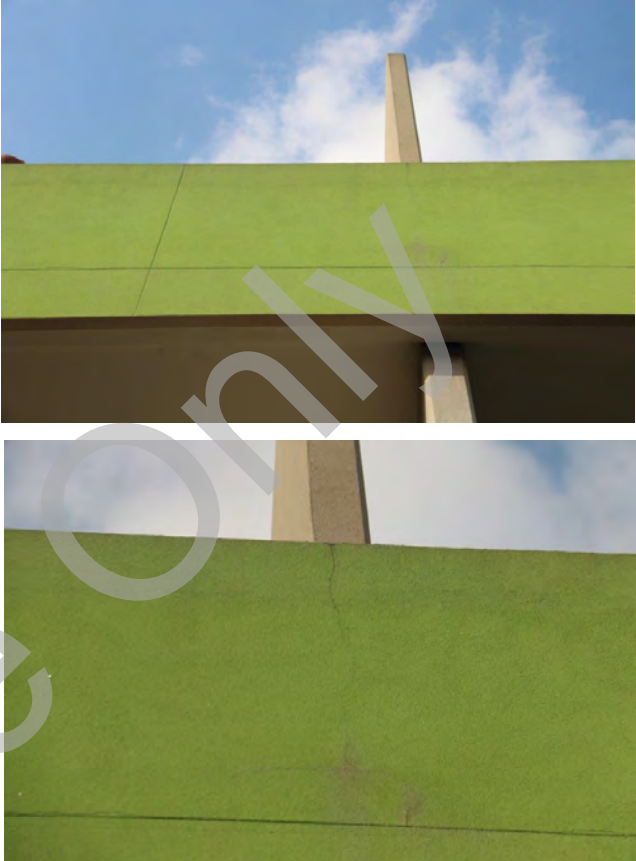
Item	Details	Photographic Details
26.	<p><u>Location:</u></p> <p>Third Storey Balcony Parapet.</p> <p><u>Finding:</u></p> <p>The parapet to the third storey balcony has hairline cracks due to water tracking down the parapet of the balcony. Articulation joints have also been rendered over.</p> <p><u>Recommendations:</u></p> <p>It is recommended that the parapet is capped with an appropriate flashing to prevent future water ingress.</p>

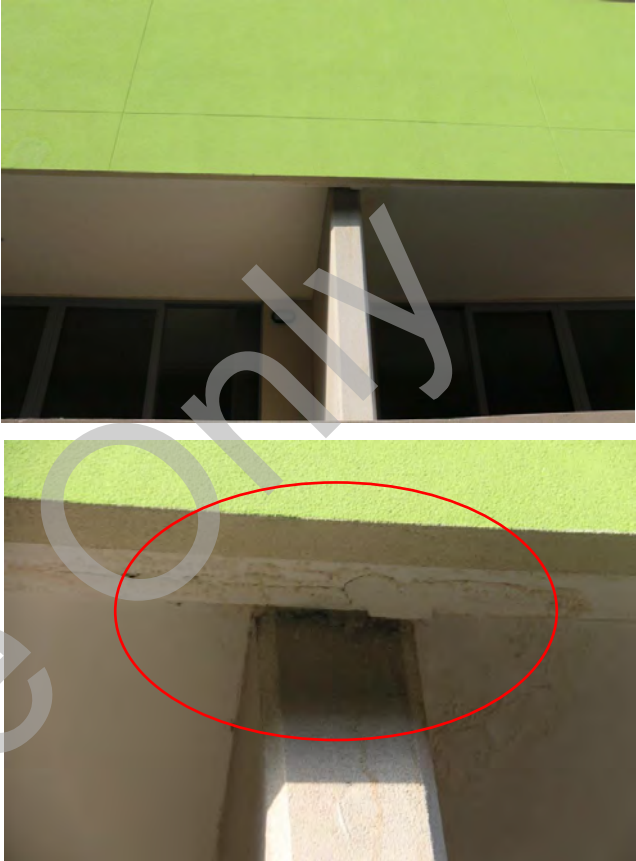
Item	Details	Photographic Details
27.	<p>Location:</p> <p>Second Storey Balcony Soffit on the South Western Corner.</p> <p>Finding:</p> <p>The edge of the balcony soffit has water damage due to water seeping through the balcony due to a failed water proofing membrane.</p> <p>Recommendations:</p> <p>It is recommended that the water proofing membrane of the balcony is replaced and the damaged sections of the balcony soffit is repaired.</p>

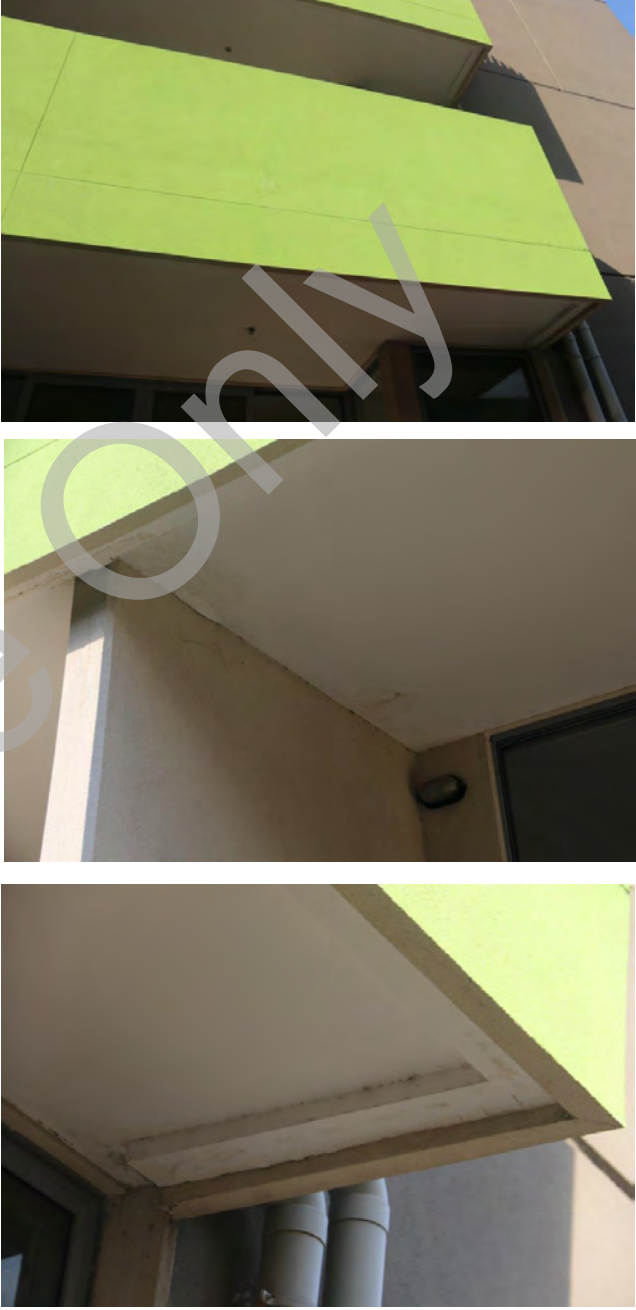
Item	Details	Photographic Details
28.	<p>Location:</p> <p>Second Storey Balcony Soffit towards the South of the Western Facade.</p> <p>Finding:</p> <p>The balcony soffit has been water damaged indicating that the water proofing membrane has failed.</p> <p>Recommendations:</p> <p>It is recommended that the damaged sections of the balcony soffit are replaced and the failed water proofing membrane is replaced.</p>
