Main Switchboard Thermal Imaging Inspection & Report

183 Sample Road Suburb VIC 3004

12 October 2015

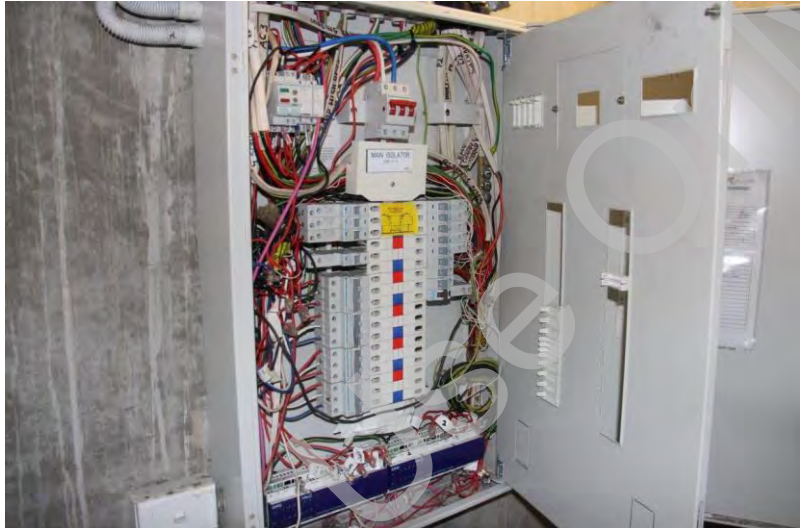
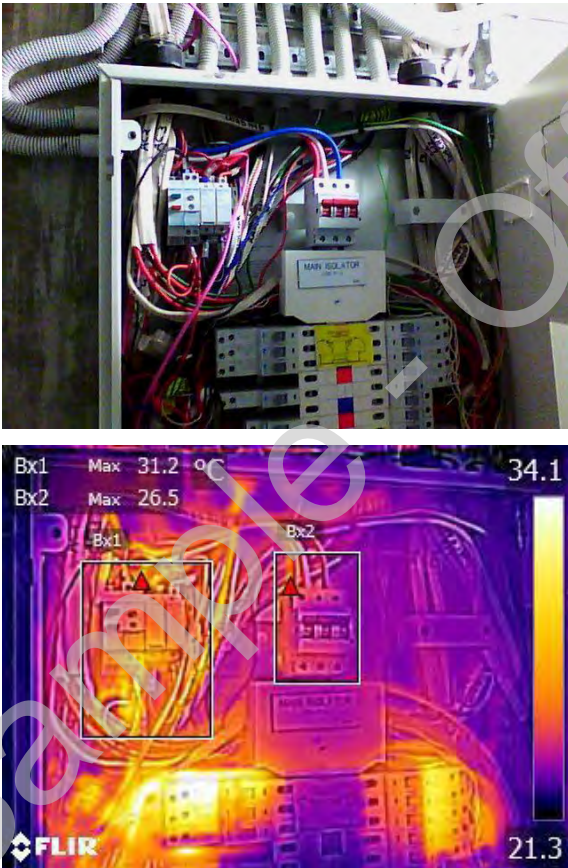
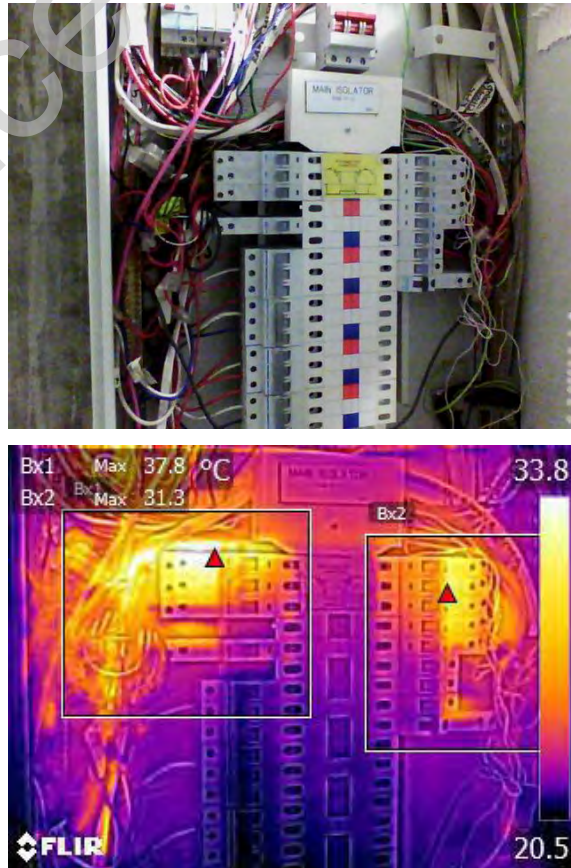
Details	Photographic Details
<p>Location: Distribution Board - Ground Level</p> <p>Finding: All circuit breakers, associated connections and wiring within the distribution board were operating within normal temperature conditions at the time of inspection.</p>

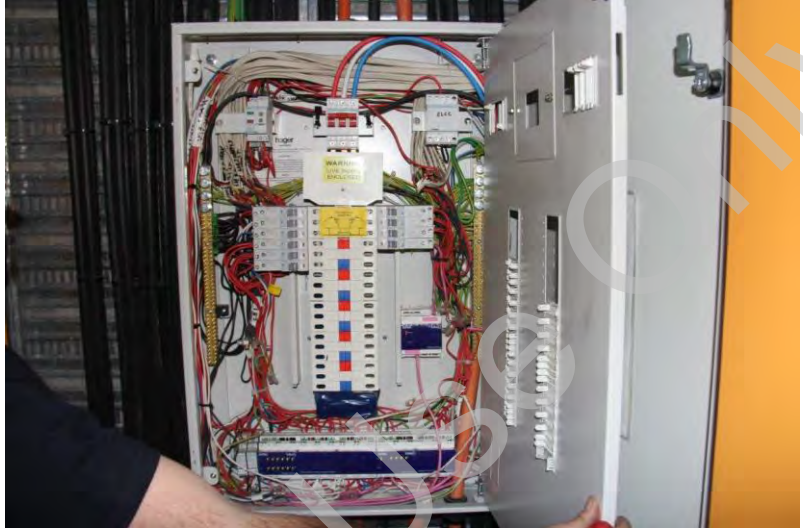
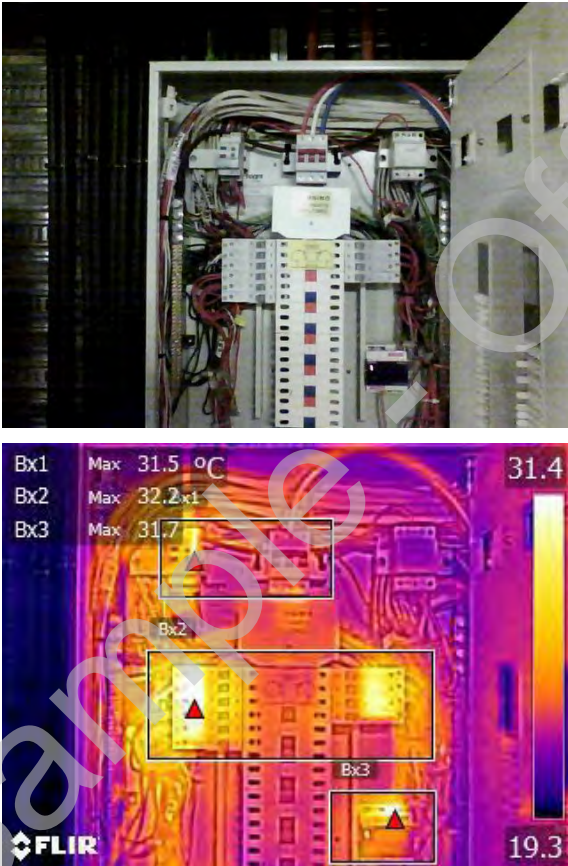
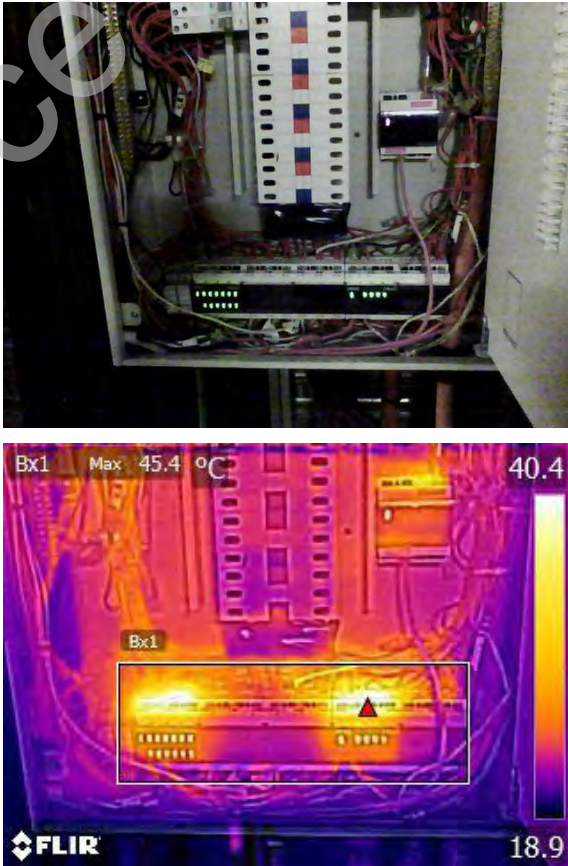
Details	Photographic Details
<p>Location: Distribution Board – Level 2</p> <p>Finding: Main isolator, all circuit breakers, associated connections and wiring within the distribution board were observed to be operating within normal temperature conditions at the time of inspection.</p> <p>C-Bus2 relay units were operational at the time of inspection and were operating within normal conditions.</p> <p>Note: Normal operating conditions are considered to be between ambient temperature and 70°C, as this is generally the point that thermal overload protection is enabled.</p>

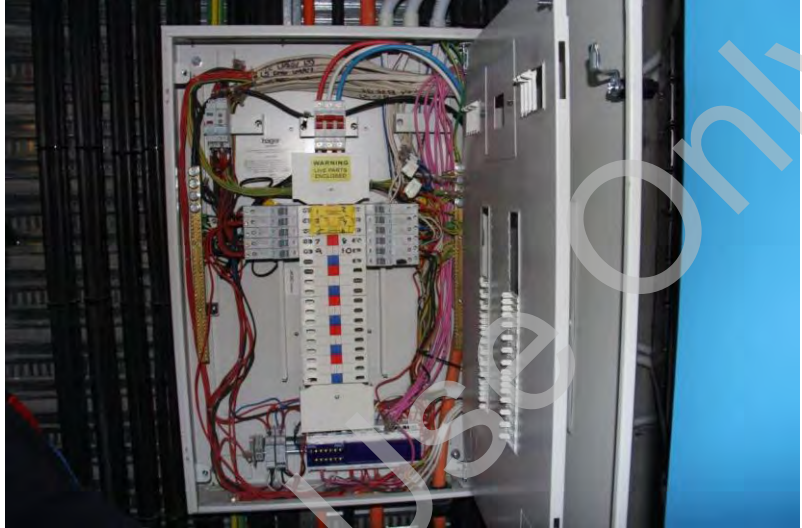
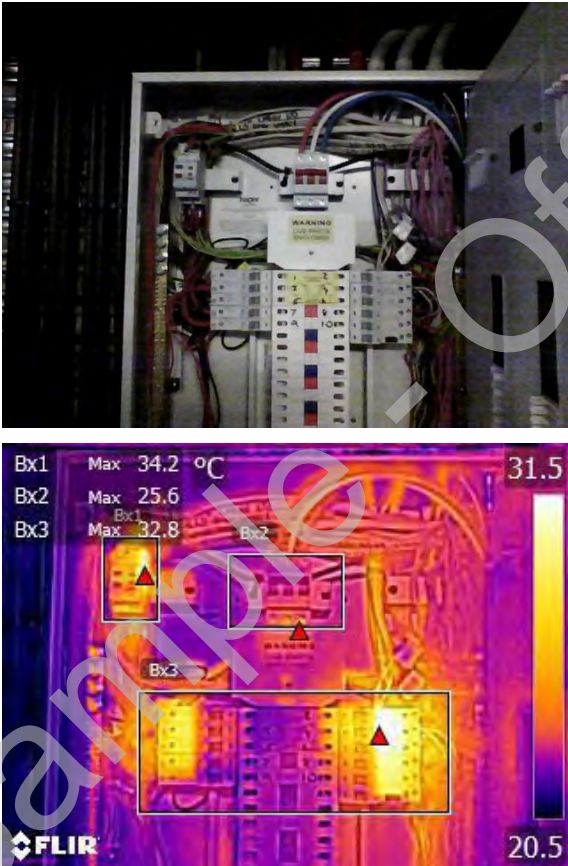
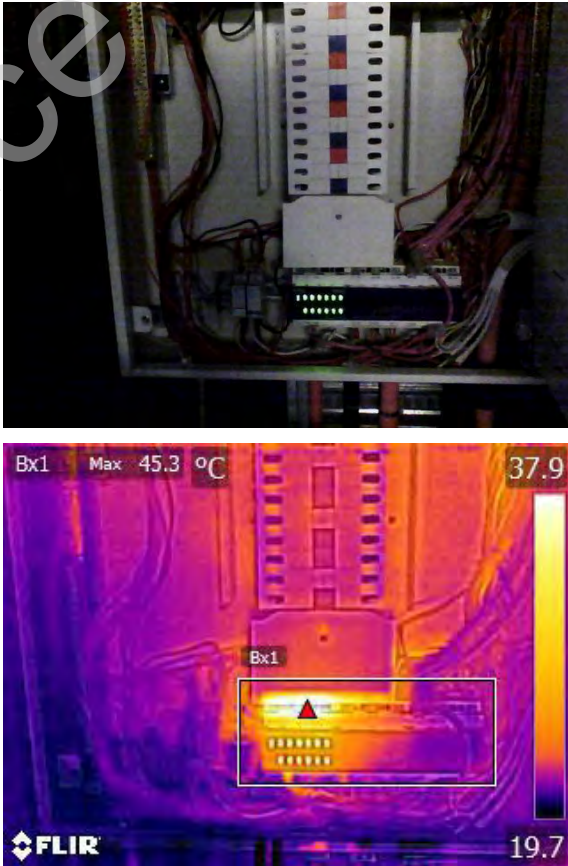
Details	Photographic Details
<p>Location: Distribution Board – Level 5</p> <p>Finding: Main isolator, all circuit breakers, associated connections and wiring within the distribution board were observed to be operating within normal temperature conditions at the time of inspection.</p> <p>C-Bus2 relay unit was operational at the time of inspection and was operating within normal conditions.</p> <p>Note: Normal operating conditions are considered to be between ambient temperature and 70°C.</p>

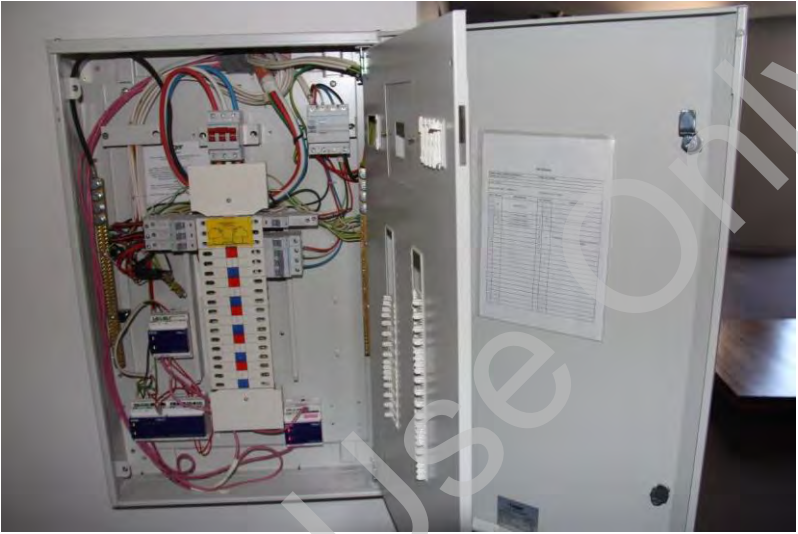
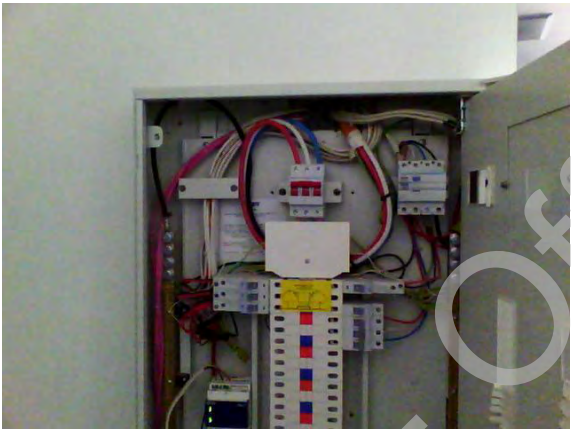
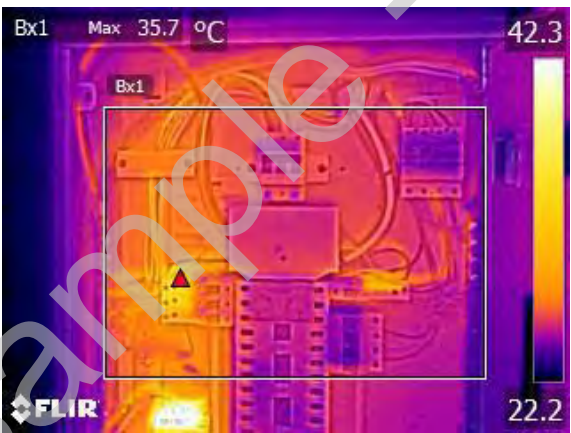
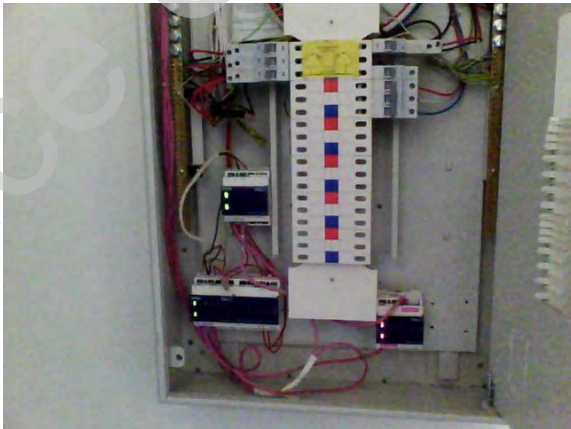
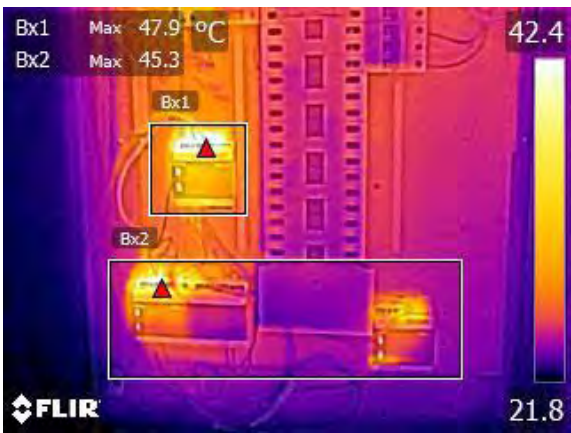
Details	Photographic Details
<p>Location: Distribution Board: Lounge – Level 8</p> <p>Finding: Main isolator, all circuit breakers, associated connections and wiring within the distribution board were observed to be operating within normal temperature conditions at the time of inspection.</p> <p>C-Bus2 units were operational at the time of inspection and were operating within normal conditions.</p> <p>Note: Normal operating conditions are considered to be between ambient temperature and 70°C.</p>

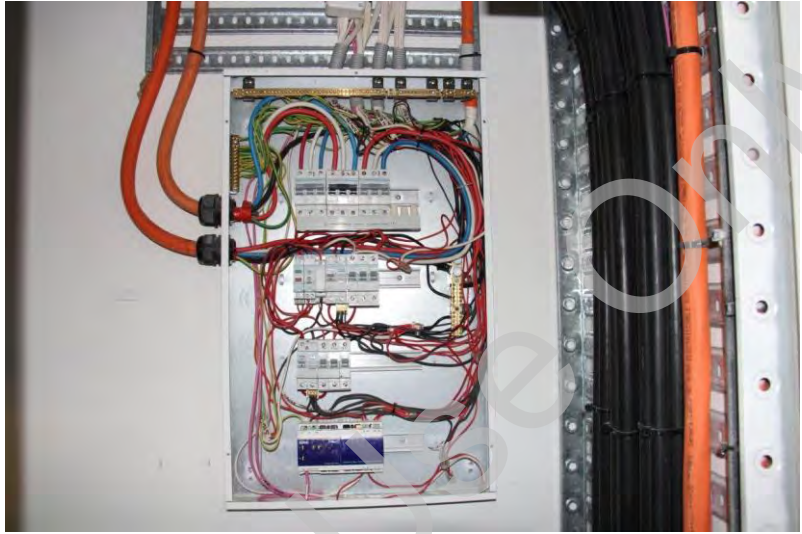
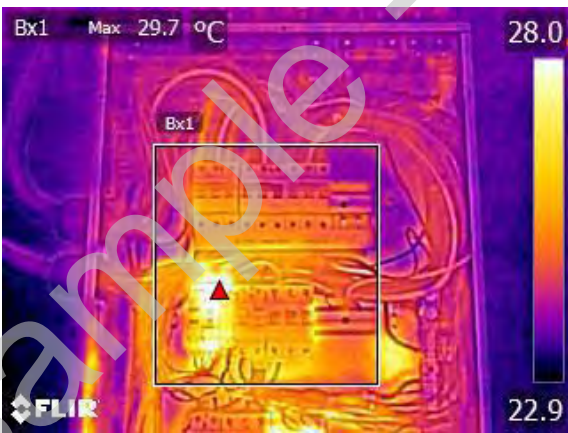
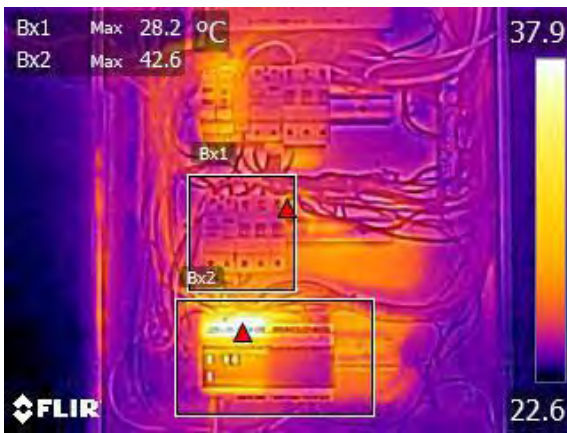
Details	Photographic Details
<p>Location: Distribution Board: Common Area – Level 8</p> <p>Finding: All isolators, circuit breakers, associated connections and wiring within the distribution board were observed to be operating within normal temperature conditions at the time of inspection.</p> <p>C-Bus2 relay unit was operational at the time of inspection and was operating within normal conditions.</p> <p>Note: Normal operating conditions are considered to be between ambient temperature and 70°C.</p>

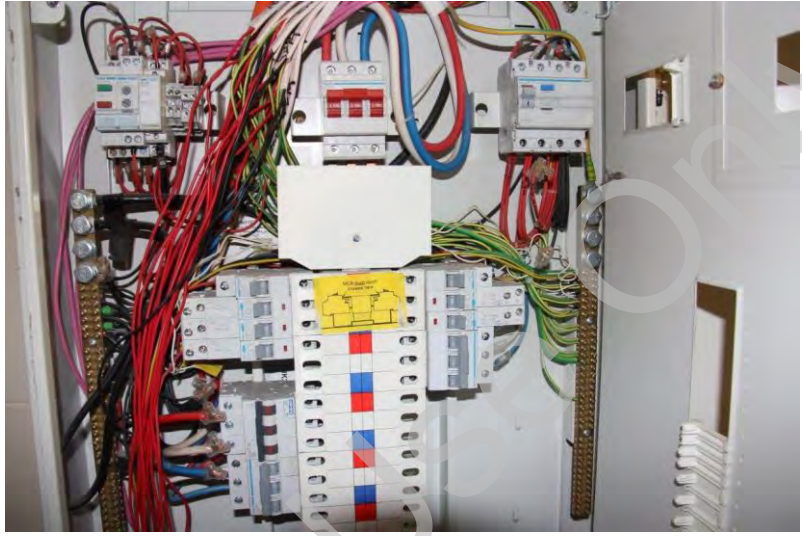
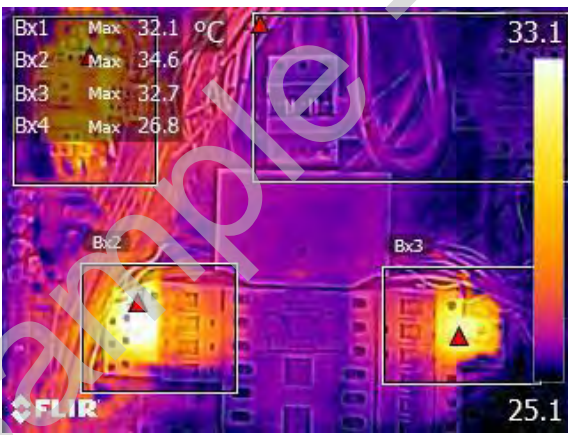
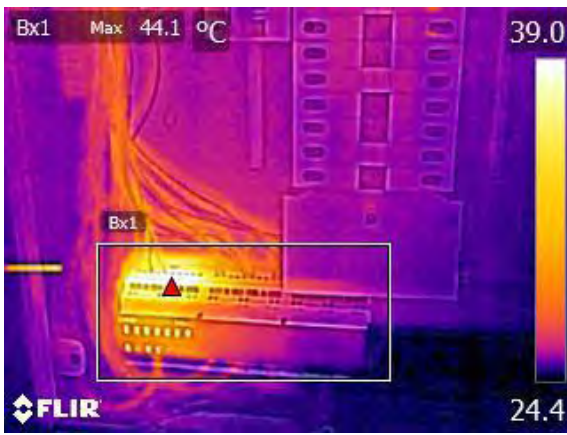
Details	Photographic Details
<p>Location: Distribution Board: Gym/Pool – Level 8</p> <p>Finding: All isolators, circuit breakers, associated connections and wiring within the distribution board were observed to be operating within normal temperature conditions at the time of inspection.</p> <p>C-Bus2 relay unit was operational at the time of inspection and was operating within normal conditions.</p> <p>Note: Normal operating conditions are considered to be between ambient temperature and 70°C.</p>

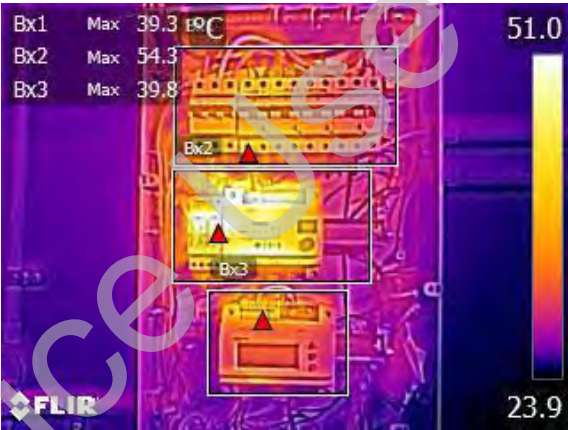
Details	Photographic Details
<p>Location: Distribution Board: Pool Plant Area– Level 8</p> <p>Finding: All isolating circuit breakers, associated connections and wiring within the distribution board were observed to be operating within normal temperature conditions at the time of inspection.</p> <p>Transformers are generally rated, as a minimum, to withstand a ~40°C temperature rise from ambient. This transformer was found to be operating at ~30°C above ambient temperature on the day of inspection, which is considered to be within a normal operating range.</p> <p>Controller, and associated wiring and connections, was found to be operating within a normal temperature range.</p>

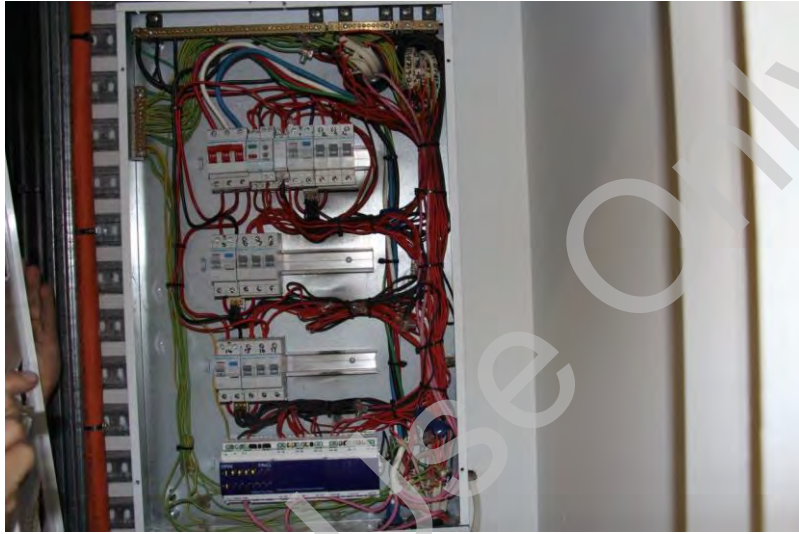
Details	Photographic Details
<p>Location: Distribution Board – Level 10</p> <p>Finding: All isolators, circuit breakers, associated connections and wiring within the distribution board were observed to be operating within normal temperature conditions at the time of inspection.</p> <p>C-Bus2 relay unit was operational at the time of inspection and was operating within normal conditions.</p> <p>Note: Normal operating conditions are considered to be between ambient temperature and 70°C.</p>

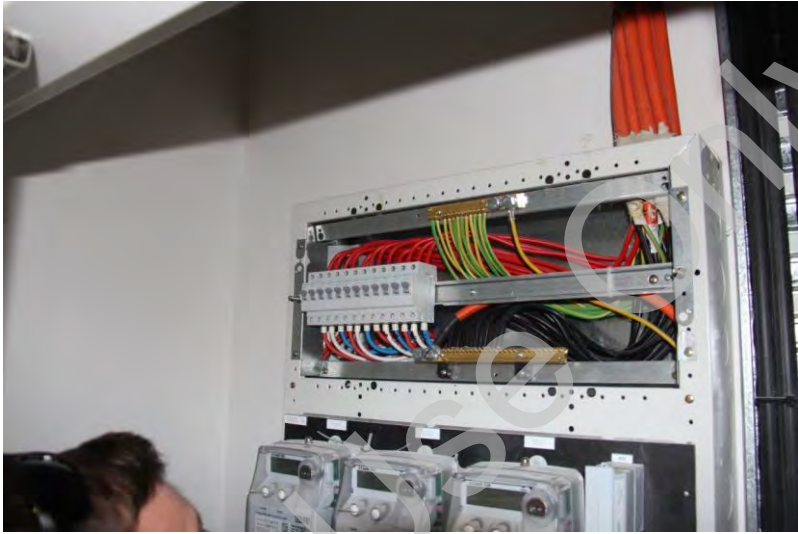
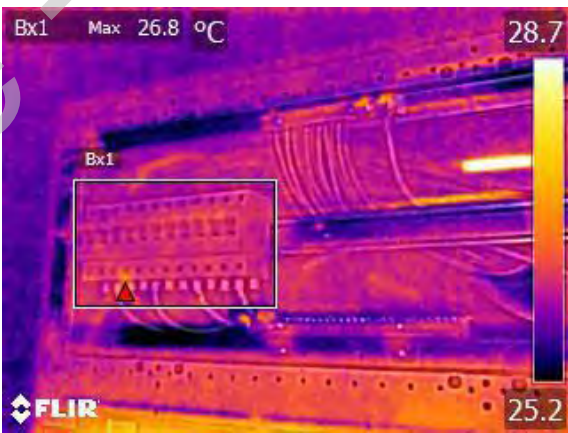
Details	Photographic Details
<p>Location: Tenancy Isolators – Level 10</p> <p>Finding: Isolating circuit breakers, and associated wiring and connections, were observed to be inoperative or operating within normal temperature conditions at the time of inspection.</p>

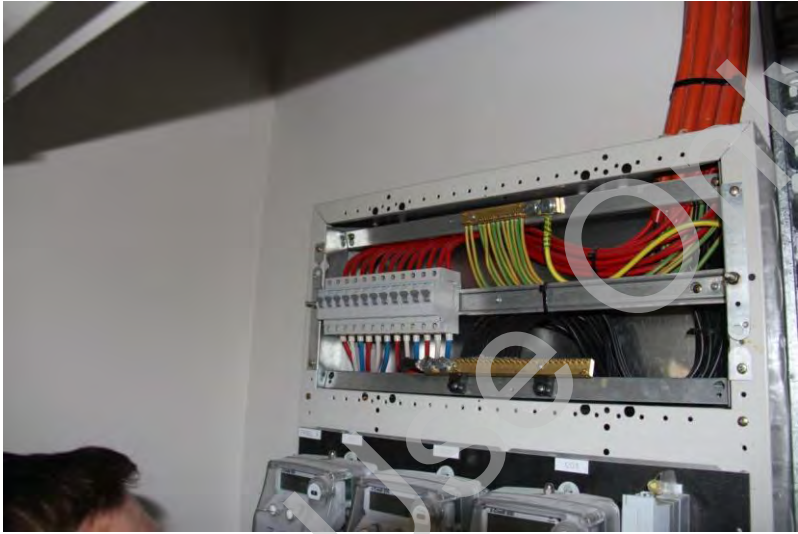
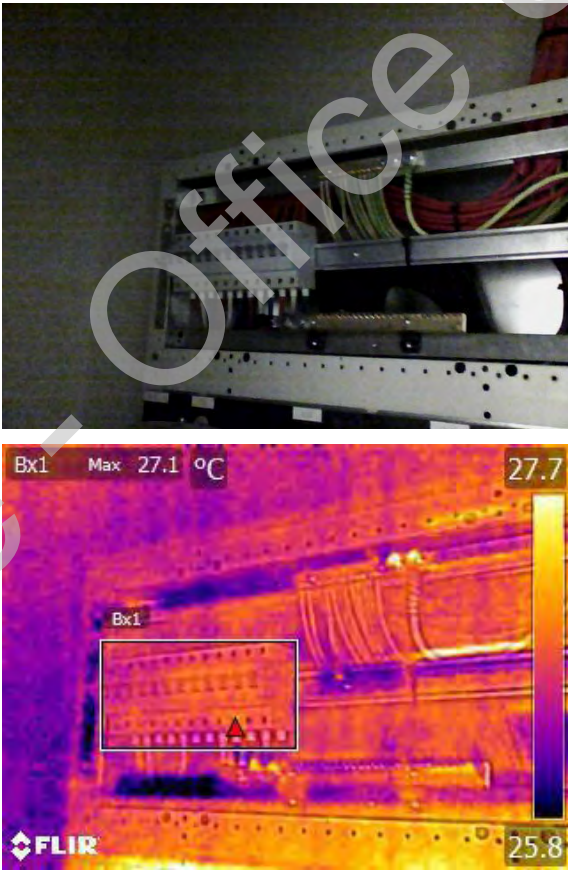
Details	Photographic Details
<p>Location: Tenancy Isolators – Level 12</p> <p>Finding: Isolating circuit breakers, and associated wiring and connections, were observed to be inoperative or operating within normal temperature conditions at the time of inspection.</p>

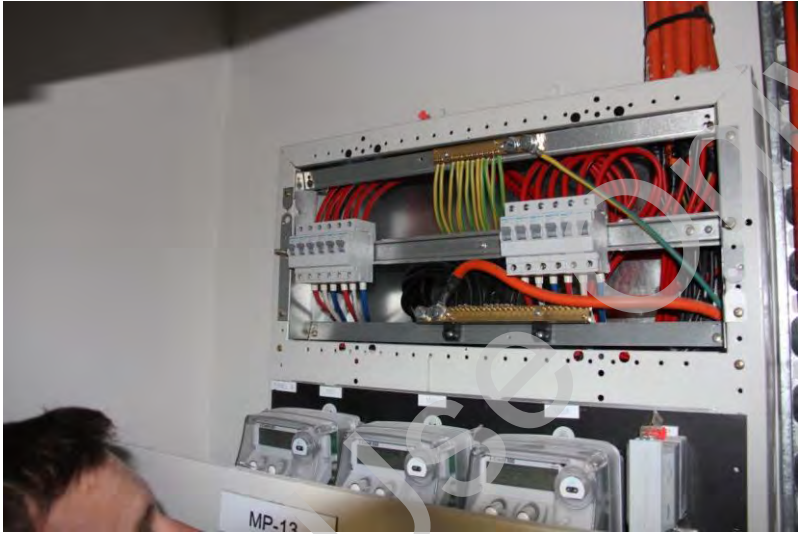
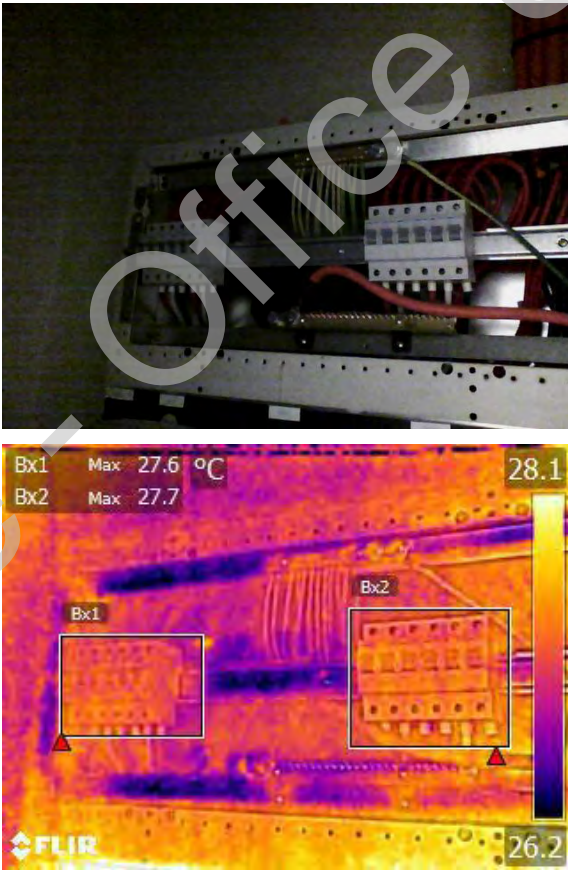
Details	Photographic Details
<p>Location: Tenancy Isolators – Level 13</p> <p>Finding: Isolating circuit breakers, and associated wiring and connections, were observed to be inoperative or operating within normal temperature conditions at the time of inspection.</p>

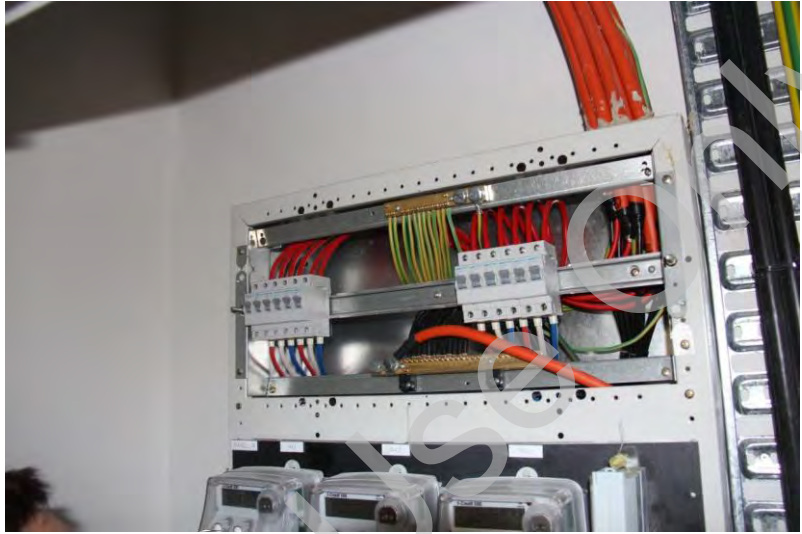
Details	Photographic Details
<p>Location: Tenancy Isolators – Level 14</p> <p>Finding: Isolating circuit breakers, and associated wiring and connections, were observed to be inoperative or operating within normal temperature conditions at the time of inspection.</p>

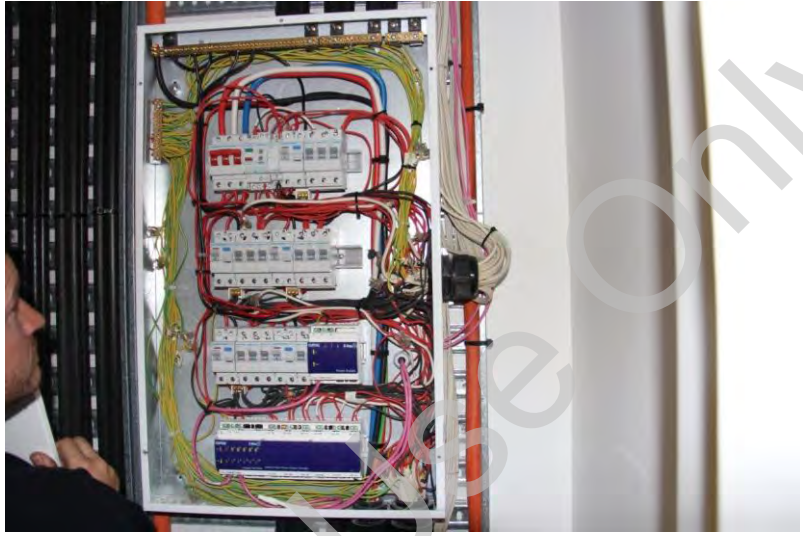
Details	Photographic Details
<p>Location: Distribution Board – Level 15</p> <p>Finding: All isolators, circuit breakers, associated connections and wiring within the distribution board were observed to be operating within normal temperature conditions at the time of inspection.</p> <p>C-Bus2 relay units were operational at the time of inspection and were operating within normal conditions.</p> <p>Note: Normal operating conditions are considered to be between ambient temperature and 70°C.</p>

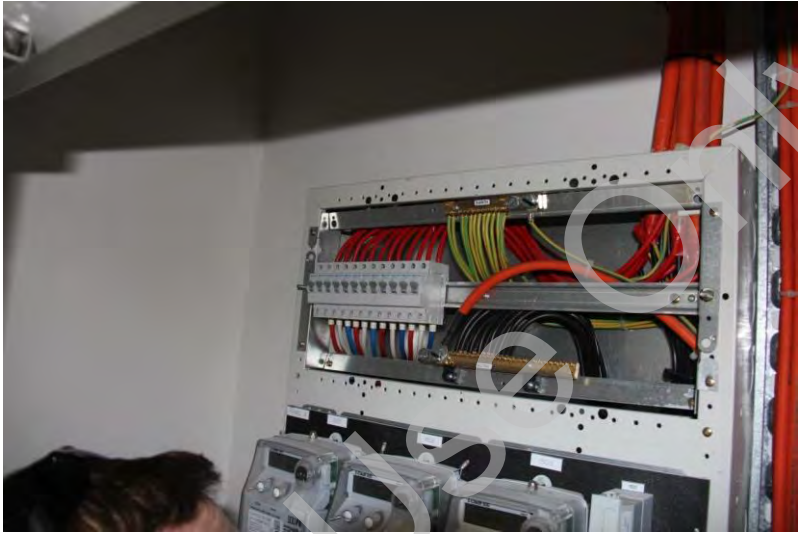
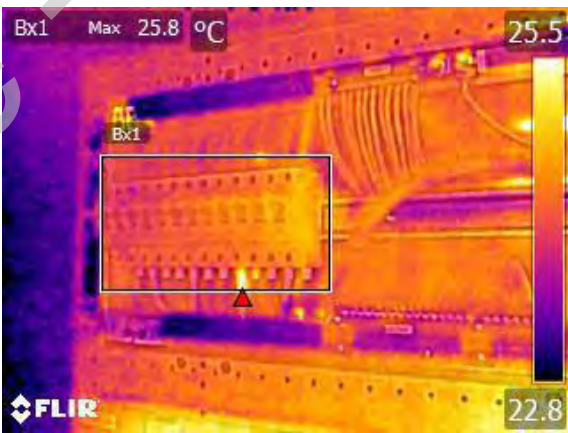
Details	Photographic Details
<p>Location: Tenancy Isolators – Level 15</p> <p>Finding: Isolating circuit breakers, and associated wiring and connections, were observed to be inoperative or operating within normal temperature conditions at the time of inspection.</p>

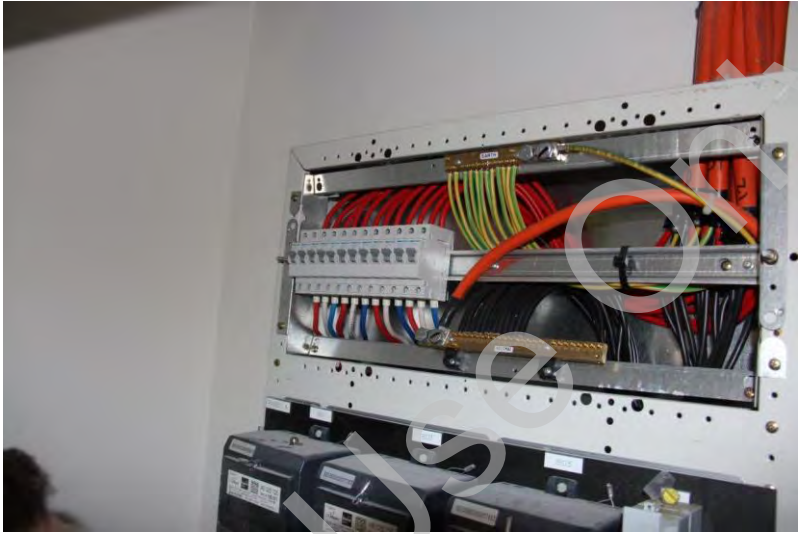
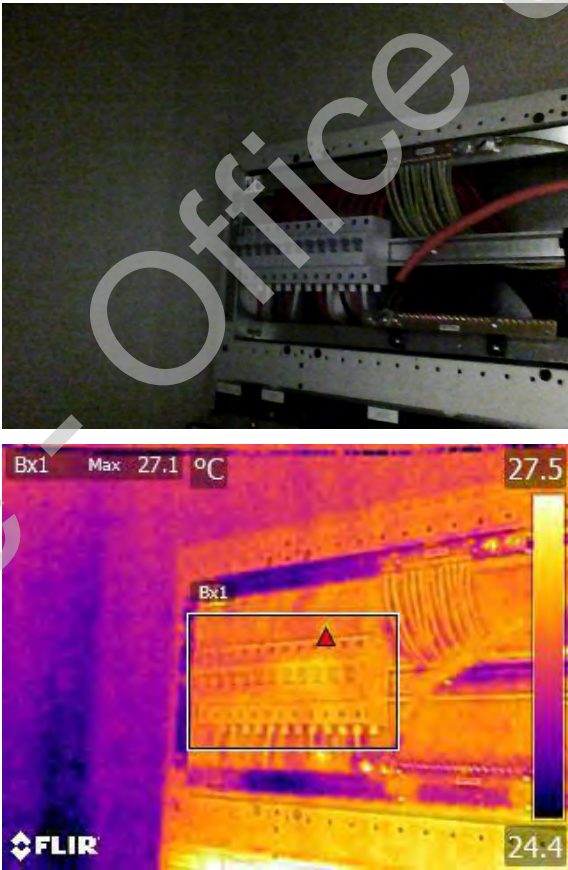
Details	Photographic Details
<p>Location: Tenancy Isolators – Level 18</p> <p>Finding: Isolating circuit breakers, and associated wiring and connections, were observed to be inoperative or operating within normal temperature conditions at the time of inspection.</p>

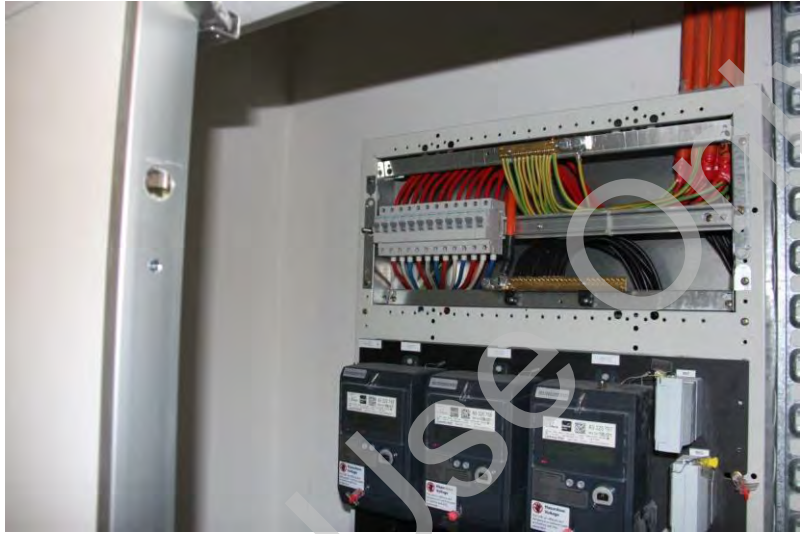
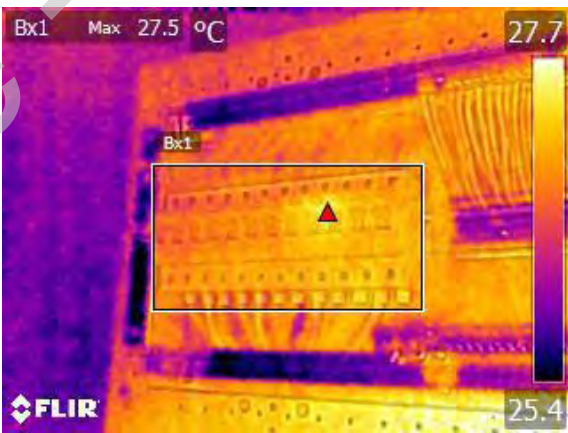
Details	Photographic Details
<p>Location: Tenancy Isolators – Level 19</p> <p>Finding: Isolating circuit breakers, and associated wiring and connections, were observed to be inoperative or operating within normal temperature conditions at the time of inspection.</p>

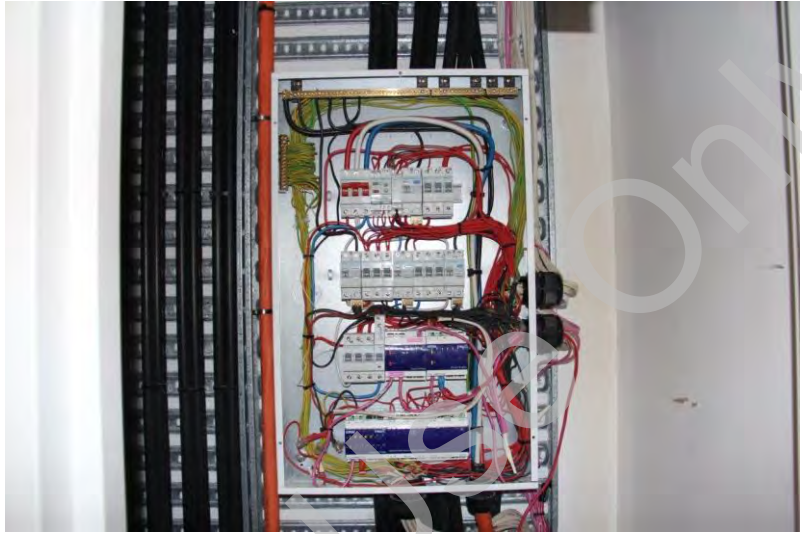
Details	Photographic Details
<p>Location: Distribution Board – Level 20</p> <p>Finding: All isolators, circuit breakers, associated connections and wiring within the distribution board were observed to be operating within normal temperature conditions at the time of inspection.</p> <p>C-Bus2 relay units were operational at the time of inspection and were operating within normal conditions.</p> <p>Note: Normal operating conditions are considered to be between ambient temperature and 70°C.</p>

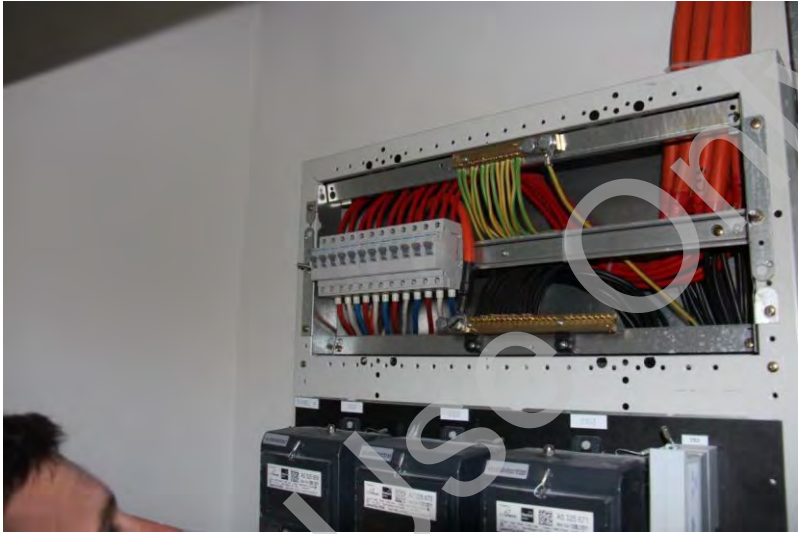
Details	Photographic Details
<p>Location: Tenancy Isolators – Level 21</p> <p>Finding: Isolating circuit breakers, and associated wiring and connections, were observed to be inoperative or operating within normal temperature conditions at the time of inspection.</p>

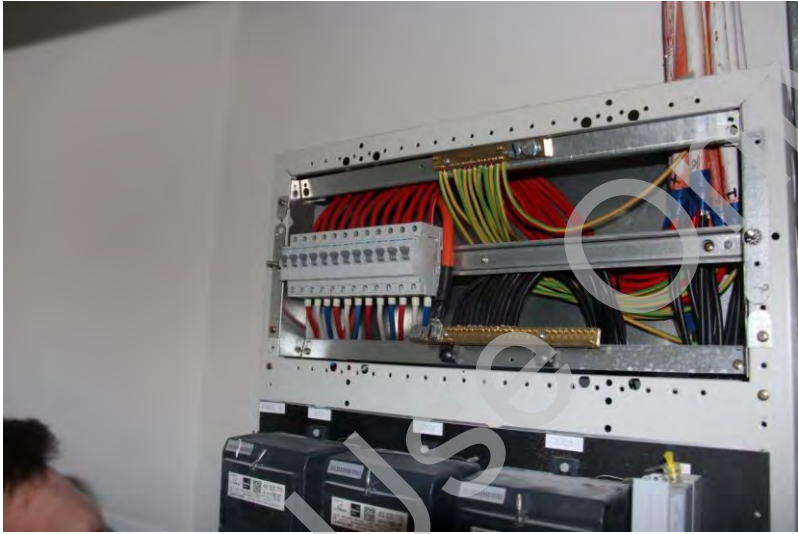
Details	Photographic Details
<p>Location: Tenancy Isolators – Level 22</p> <p>Finding: Isolating circuit breakers, and associated wiring and connections, were observed to be inoperative or operating within normal temperature conditions at the time of inspection.</p>

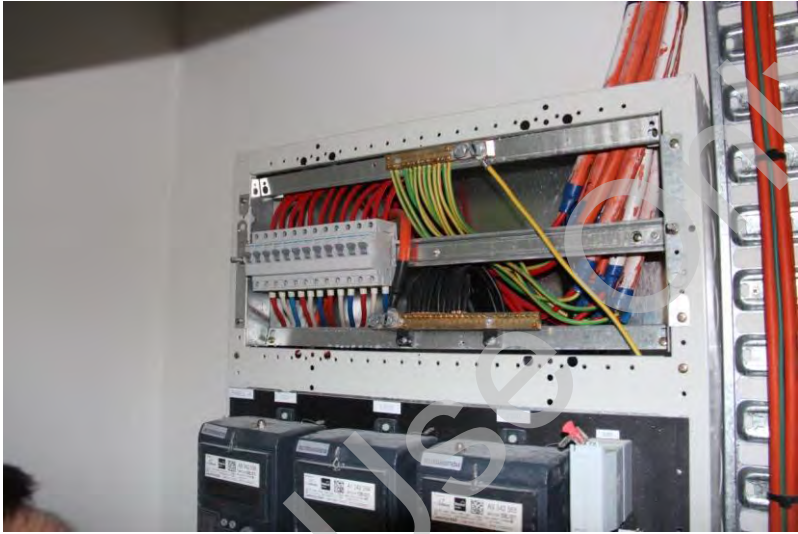
Details	Photographic Details
<p>Location: Tenancy Isolators – Level 23</p> <p>Finding: Isolating circuit breakers, and associated wiring and connections, were observed to be inoperative or operating within normal temperature conditions at the time of inspection.</p>

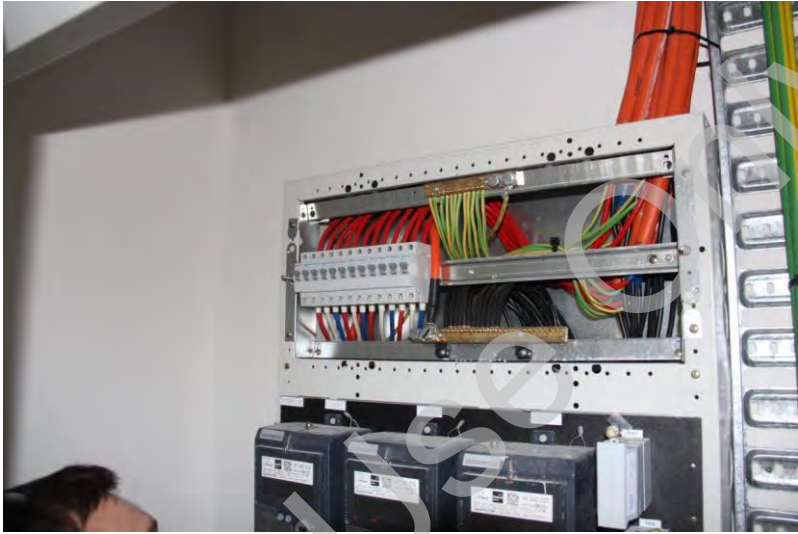
Details	Photographic Details
<p>Location: Tenancy Isolators – Level 24</p> <p>Finding: Isolating circuit breakers, and associated wiring and connections, were observed to be inoperative or operating within normal temperature conditions at the time of inspection.</p>

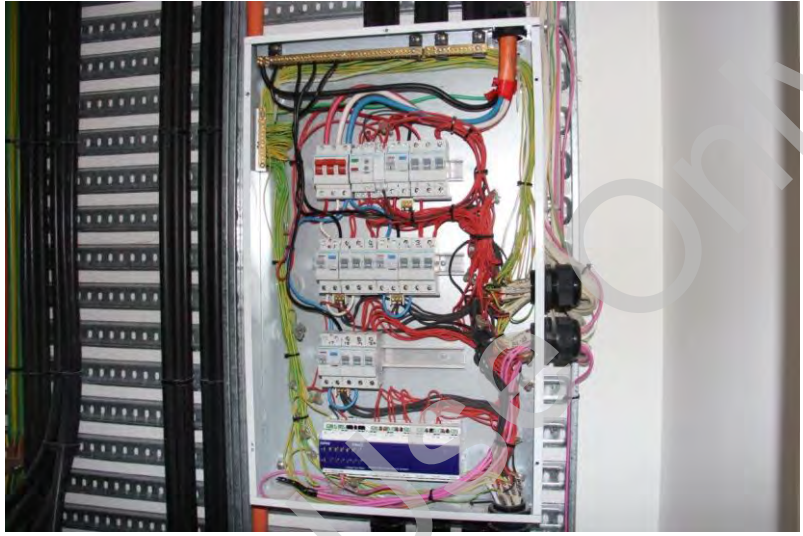
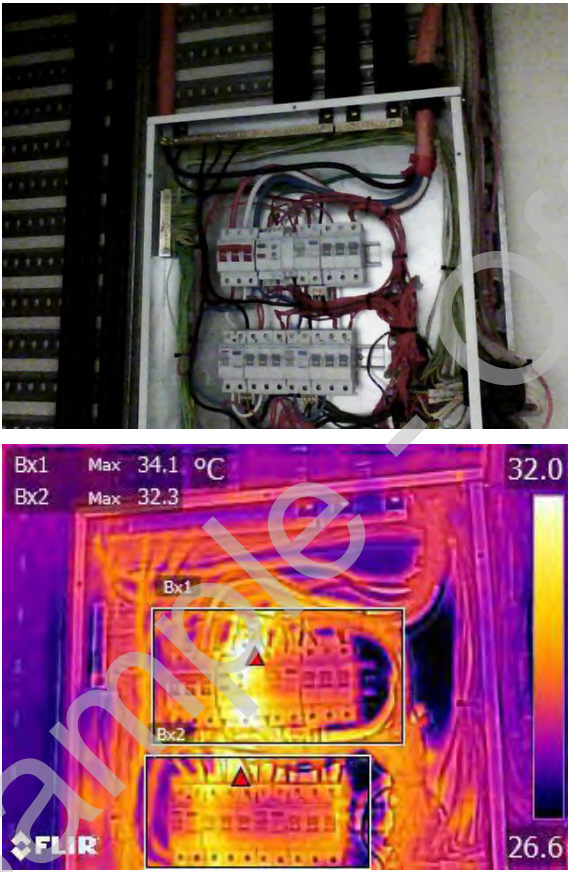
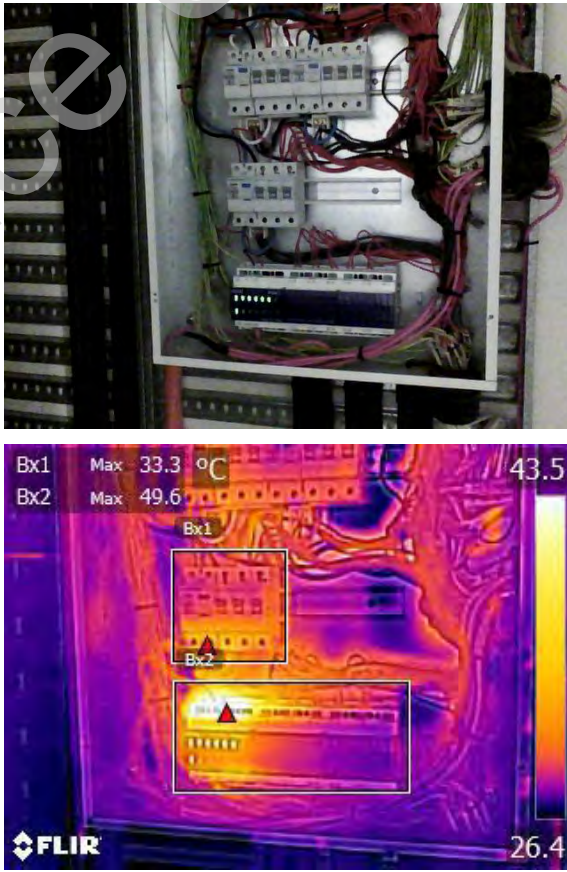
Details	Photographic Details
<p>Location: Distribution Board – Level 25</p> <p>Finding: All isolators, circuit breakers, associated connections and wiring within the distribution board were observed to be operating within normal temperature conditions at the time of inspection.</p> <p>C-Bus2 relay unit was operational at the time of inspection and was operating within normal conditions.</p> <p>Note: Normal operating conditions are considered to be between ambient temperature and 70°C.</p>

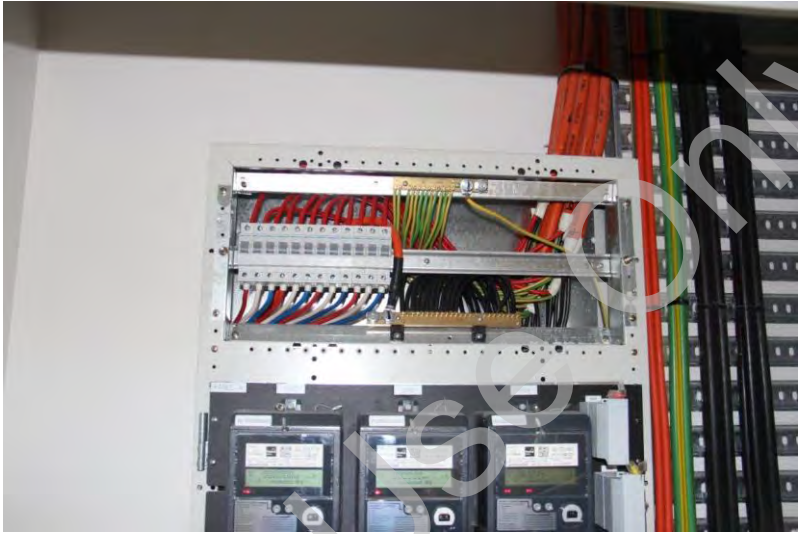
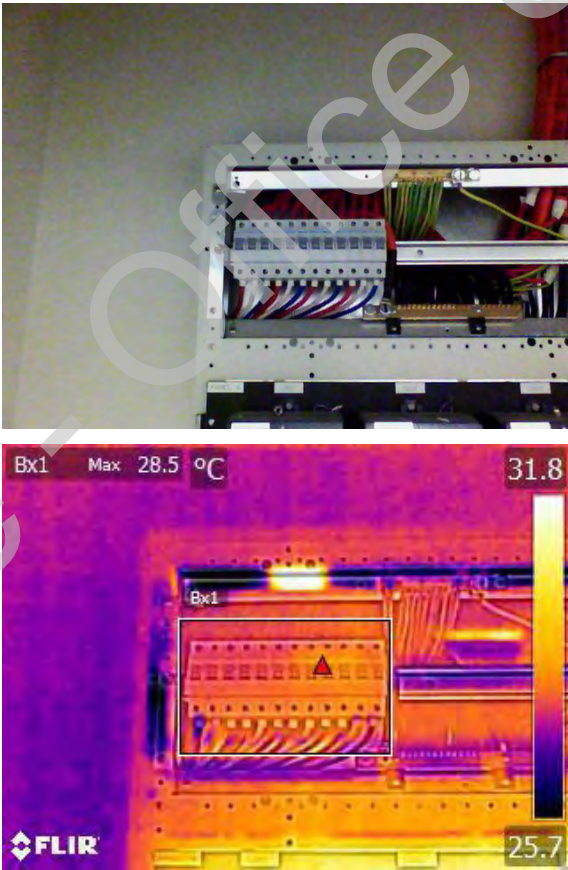
Details	Photographic Details
<p>Location: Tenancy Isolators – Level 25</p> <p>Finding: Isolating circuit breakers, and associated wiring and connections, were observed to be inoperative or operating within normal temperature conditions at the time of inspection.</p>

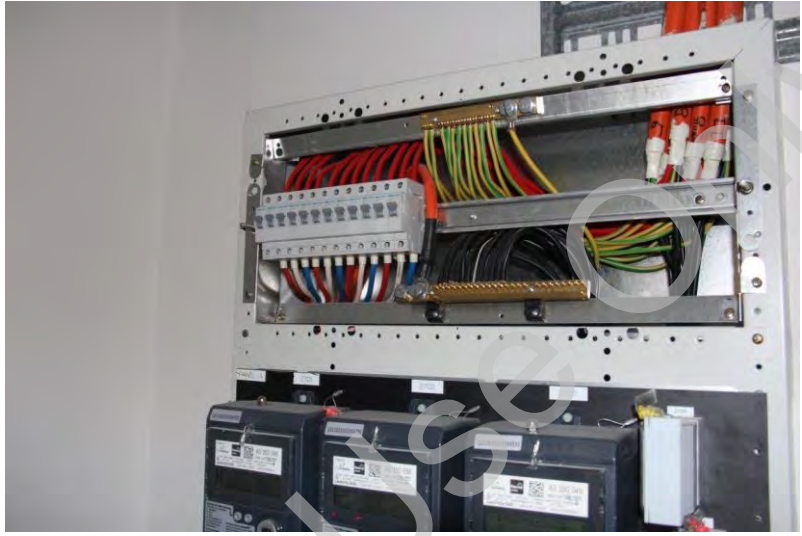
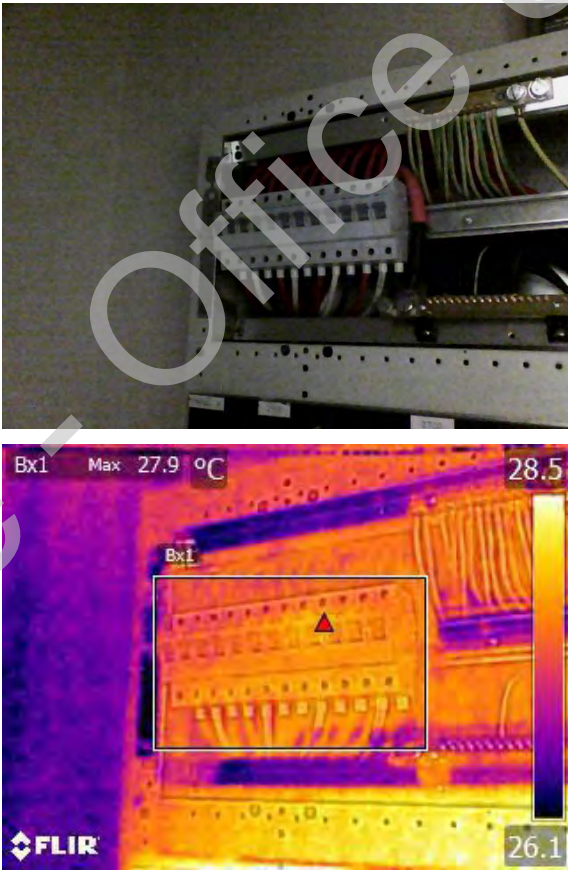
Details	Photographic Details
<p>Location: Tenancy Isolators – Level 27</p> <p>Finding: Isolating circuit breakers, and associated wiring and connections, were observed to be inoperative or operating within normal temperature conditions at the time of inspection.</p>

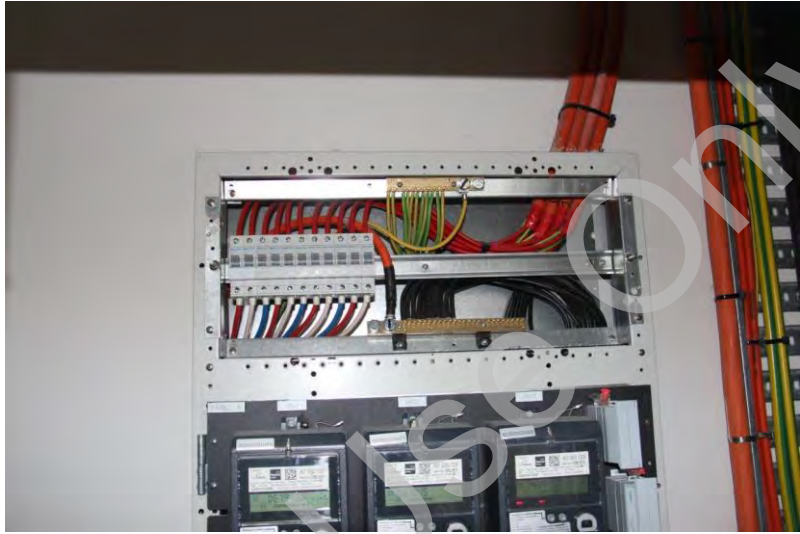
Details	Photographic Details
<p>Location: Tenancy Isolators – Level 28</p> <p>Finding: Isolating circuit breakers, and associated wiring and connections, were observed to be inoperative or operating within normal temperature conditions at the time of inspection.</p>

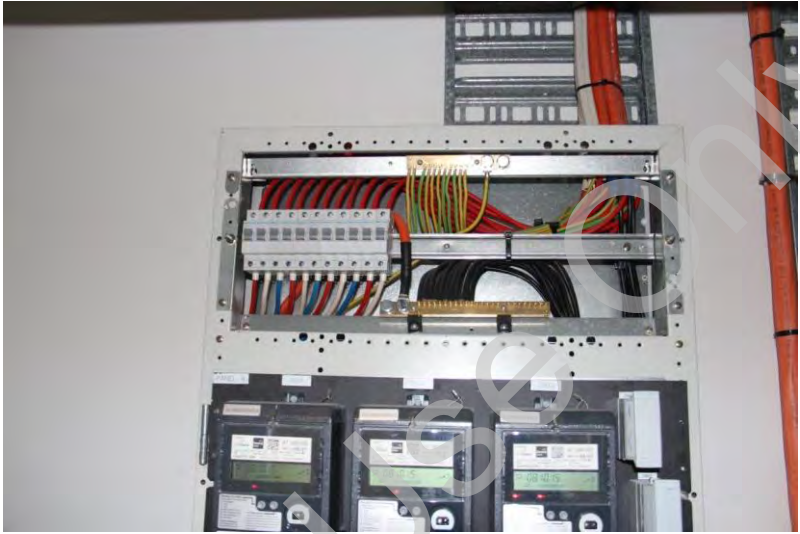
Details	Photographic Details
<p>Location: Tenancy Isolators – Level 29</p> <p>Finding: Isolating circuit breakers, and associated wiring and connections, were observed to be inoperative or operating within normal temperature conditions at the time of inspection.</p>
