Main Switchboard Thermal Imaging Inspection & Report

183 Sample Road Suburb VIC 3004

12 October 2015

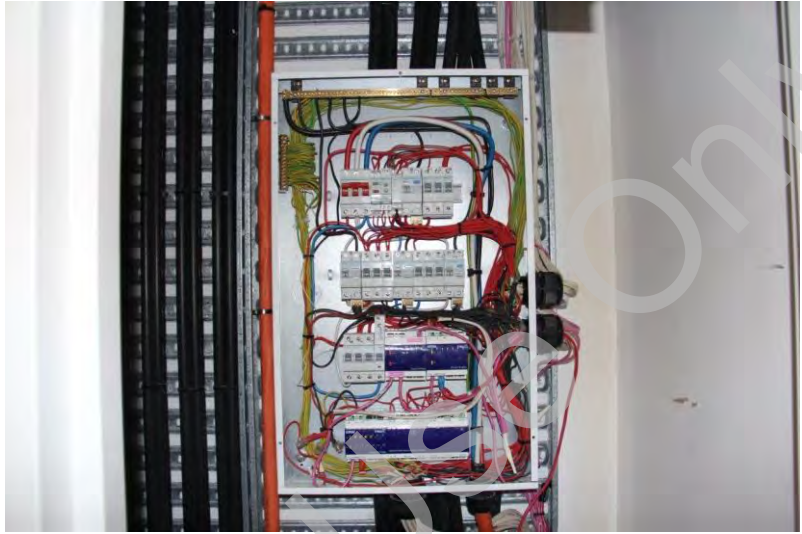
Details	Photographic Details
<p>Location: Distribution Board – Level 30</p> <p>Finding: All isolators, circuit breakers, associated connections and wiring within the distribution board were observed to be operating within normal temperature conditions at the time of inspection.</p> <p>C-Bus2 relay units were operational at the time of inspection and were operating within normal conditions.</p> <p>Note: Normal operating conditions are considered to be between ambient temperature and 70°C.</p>

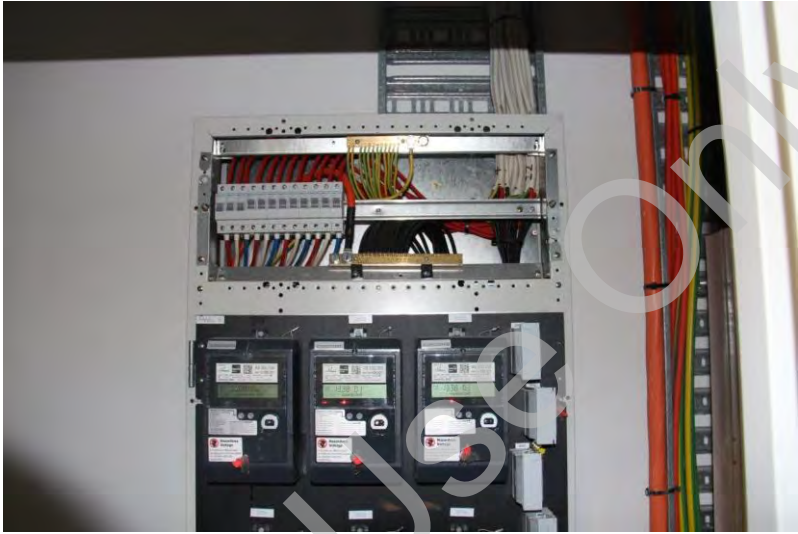
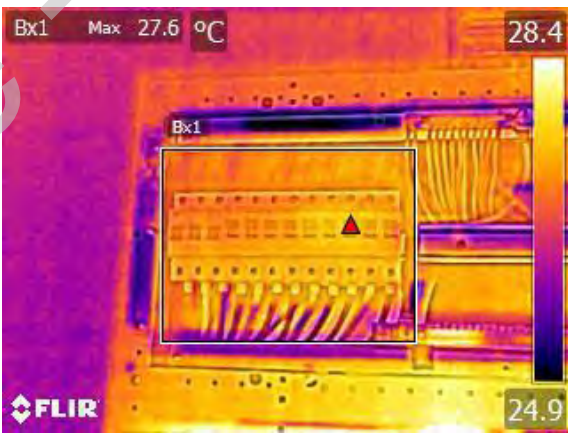
Details	Photographic Details
<p>Location: Tenancy Isolators – Level 30</p> <p>Finding: Isolating circuit breakers, and associated wiring and connections, were observed to be inoperative or operating within normal temperature conditions at the time of inspection.</p>

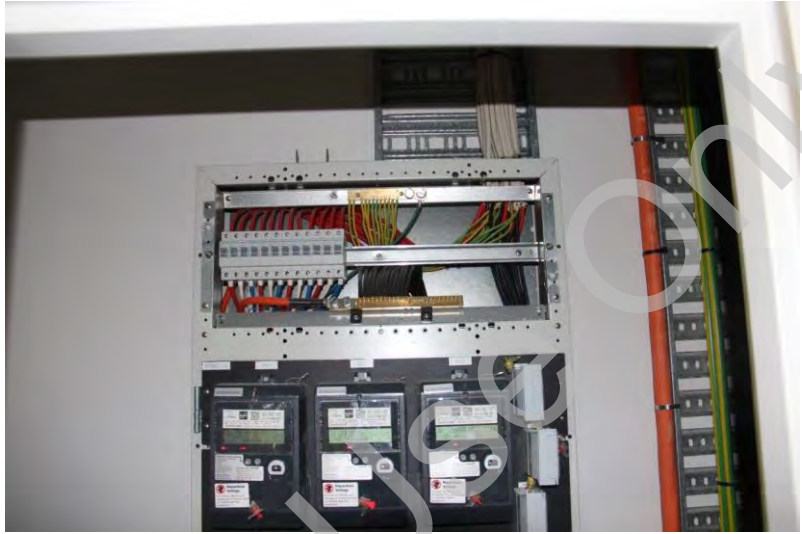
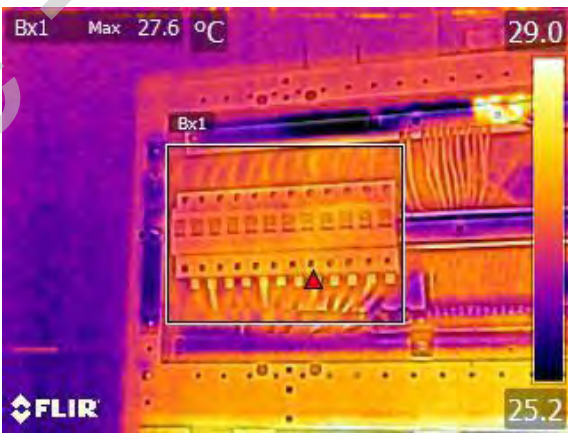
Details	Photographic Details
<p>Location: Tenancy Isolators – Level 31</p> <p>Finding: Isolating circuit breakers, and associated wiring and connections, were observed to be inoperative or operating within normal temperature conditions at the time of inspection.</p>

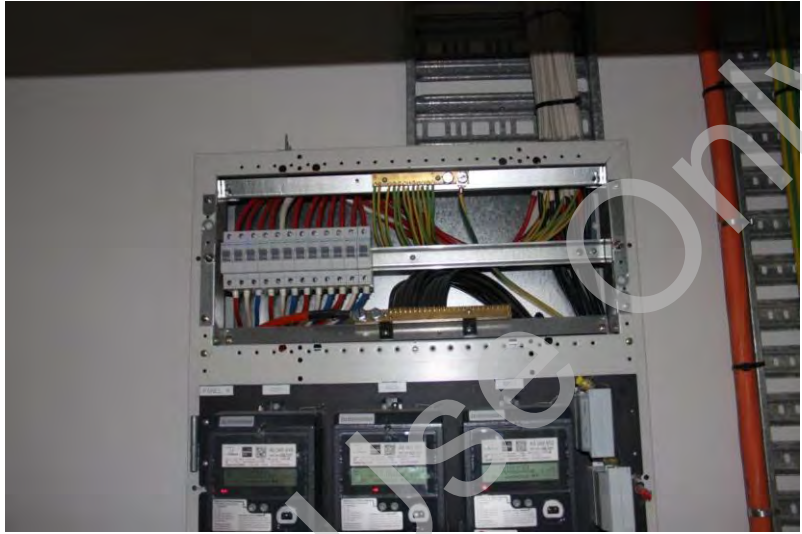
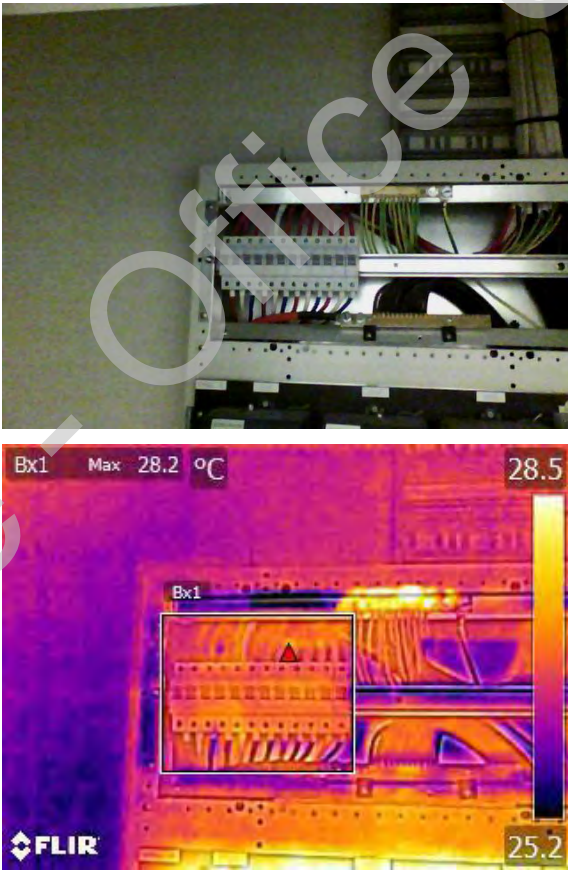
Details	Photographic Details
<p>Location: Tenancy Isolators – Level 32</p> <p>Finding: Isolating circuit breakers, and associated wiring and connections, were observed to be inoperative or operating within normal temperature conditions at the time of inspection.</p>

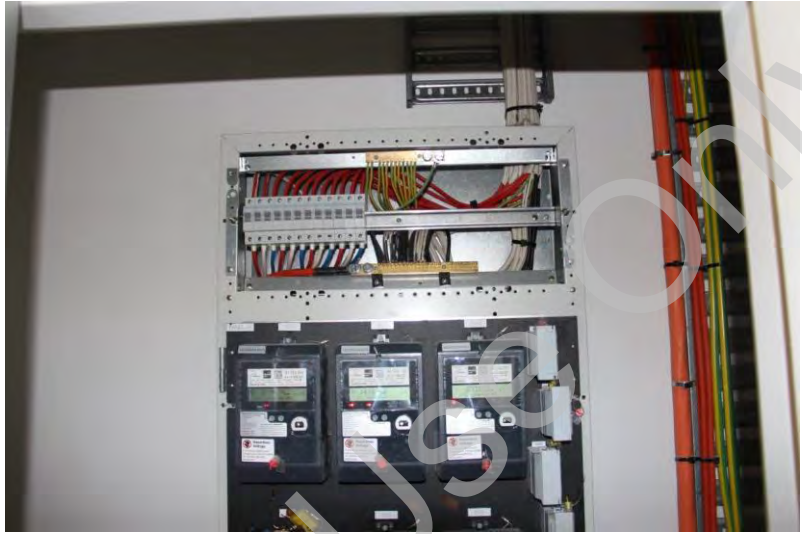
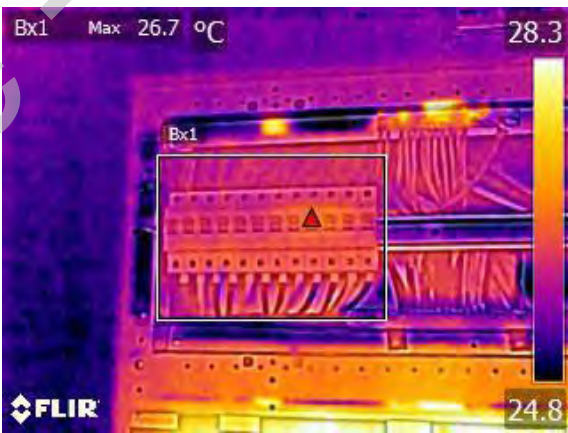
Details	Photographic Details
<p>Location: Tenancy Isolators – Level 33</p> <p>Finding: Isolating circuit breakers, and associated wiring and connections, were observed to be inoperative or operating within normal temperature conditions at the time of inspection.</p>

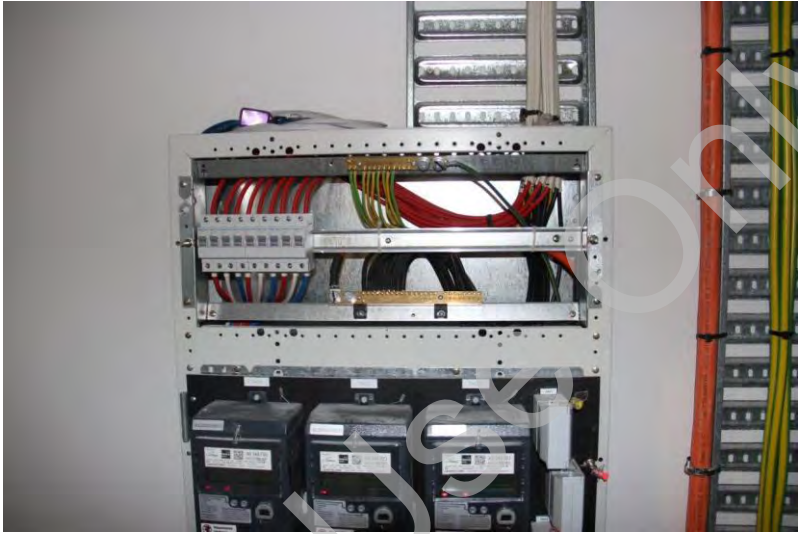
Details	Photographic Details
<p>Location: Tenancy Isolators – Level 34</p> <p>Finding: Isolating circuit breakers, and associated wiring and connections, were observed to be inoperative or operating within normal temperature conditions at the time of inspection.</p>

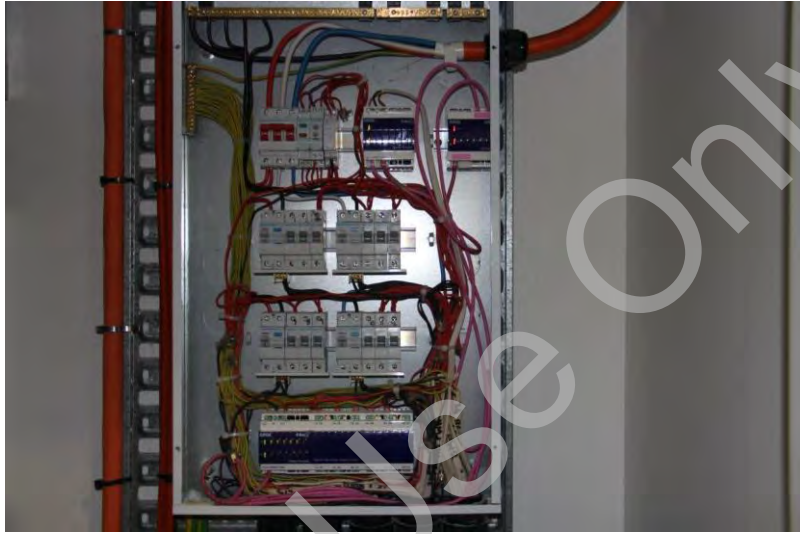
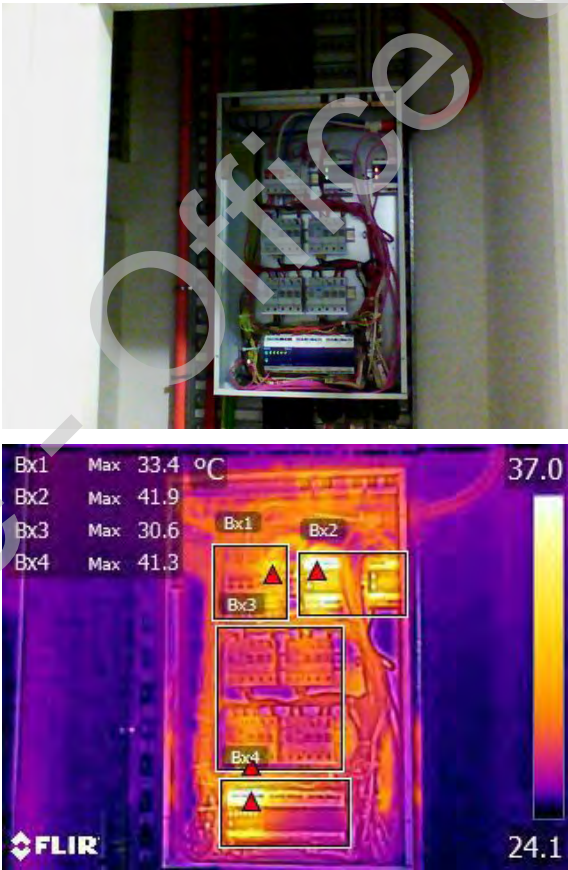
Details	Photographic Details										
<p>Location: Distribution Board – Level 35</p> <p>Finding: All isolators, circuit breakers, associated connections and wiring within the distribution board were observed to be operating within normal temperature conditions at the time of inspection.</p> <p>C-Bus2 relay unit was operational at the time of inspection and was operating within normal conditions.</p> <p>Note: Normal operating conditions are considered to be between ambient temperature and 70°C.</p>

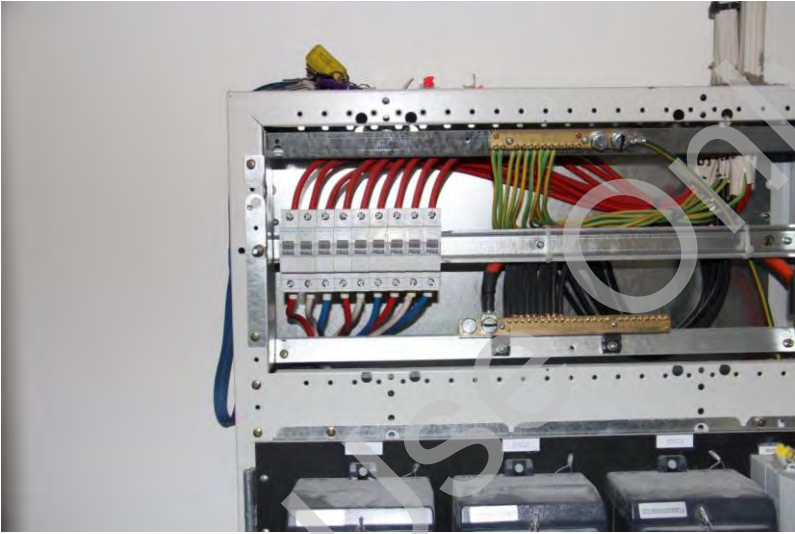
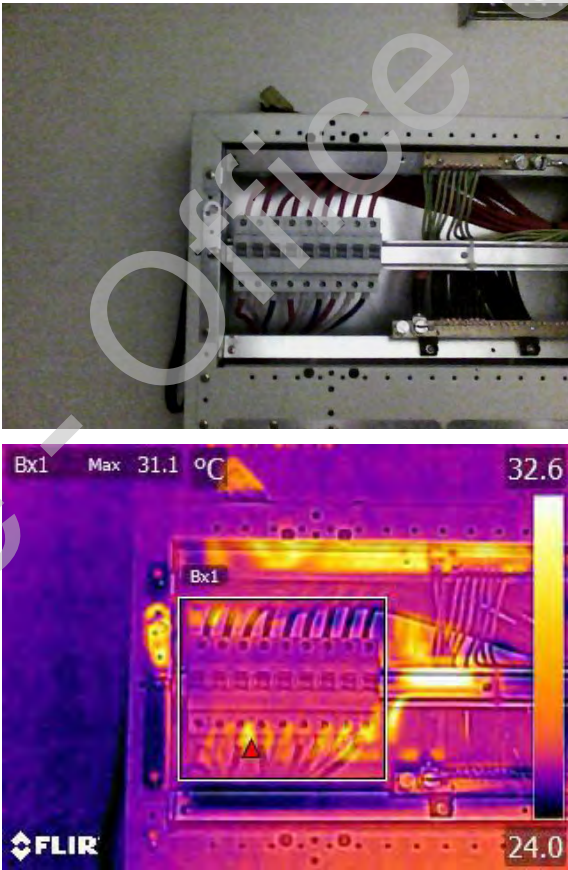
Details	Photographic Details
<p>Location: Tenancy Isolators – Level 35</p> <p>Finding: Isolating circuit breakers, and associated wiring and connections, were observed to be inoperative or operating within normal temperature conditions at the time of inspection.</p>

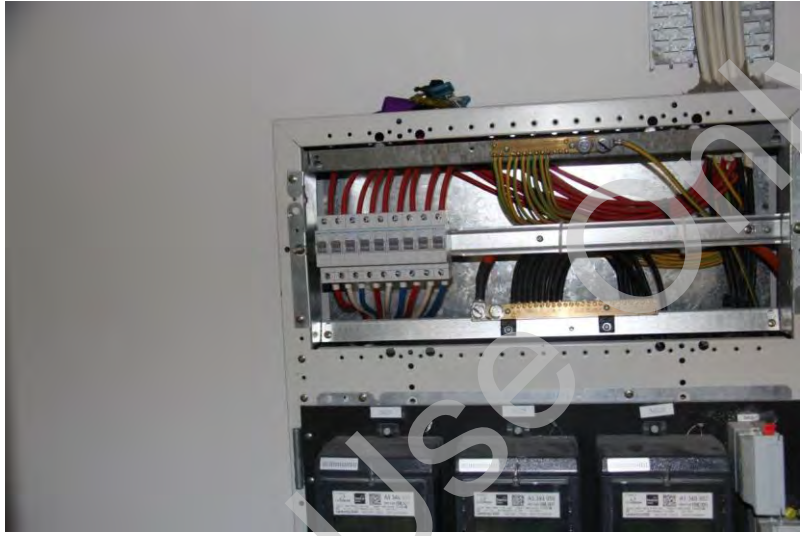
Details	Photographic Details
<p>Location: Tenancy Isolators – Level 36</p> <p>Finding: Isolating circuit breakers, and associated wiring and connections, were observed to be inoperative or operating within normal temperature conditions at the time of inspection.</p>

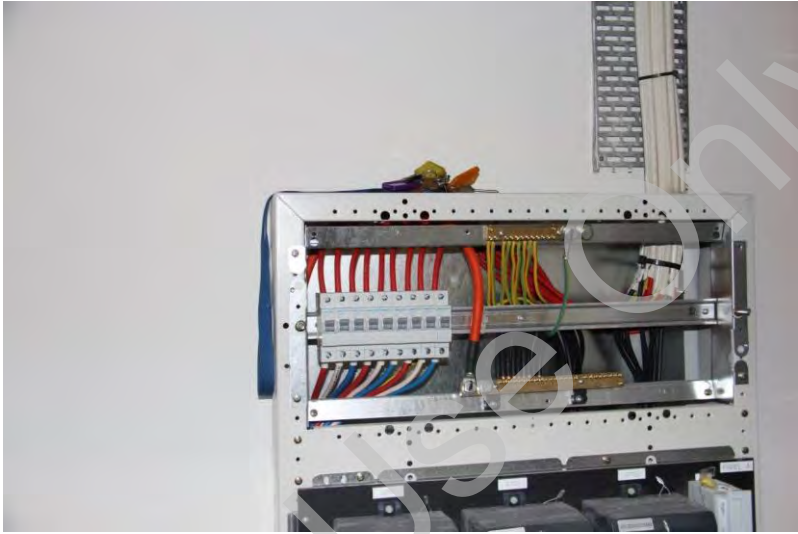
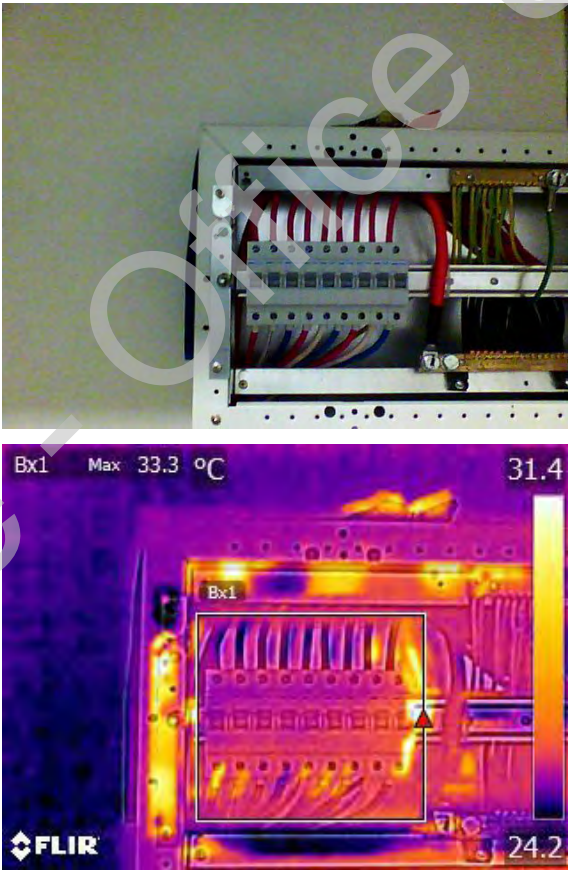
Details	Photographic Details
<p>Location: Tenancy Isolators – Level 37</p> <p>Finding: Isolating circuit breakers, and associated wiring and connections, were observed to be inoperative or operating within normal temperature conditions at the time of inspection.</p>

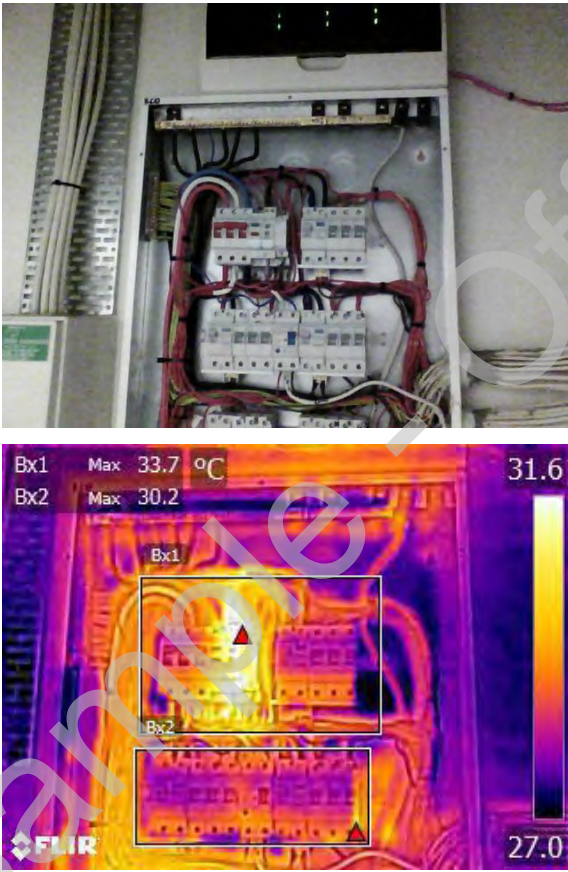
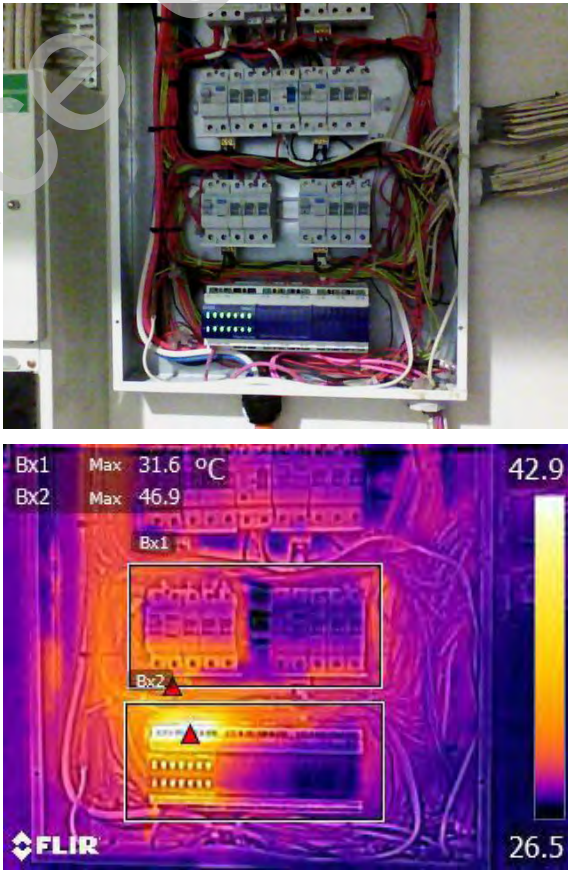
Details	Photographic Details
<p>Location: Distribution Board – Level 38</p> <p>Finding: All isolators, circuit breakers, associated connections and wiring within the distribution board were observed to be operating within normal temperature conditions at the time of inspection.</p> <p>C-Bus2 relay unit was operational at the time of inspection and was operating within normal conditions.</p> <p>Note: Normal operating conditions are considered to be between ambient temperature and 70°C.</p>

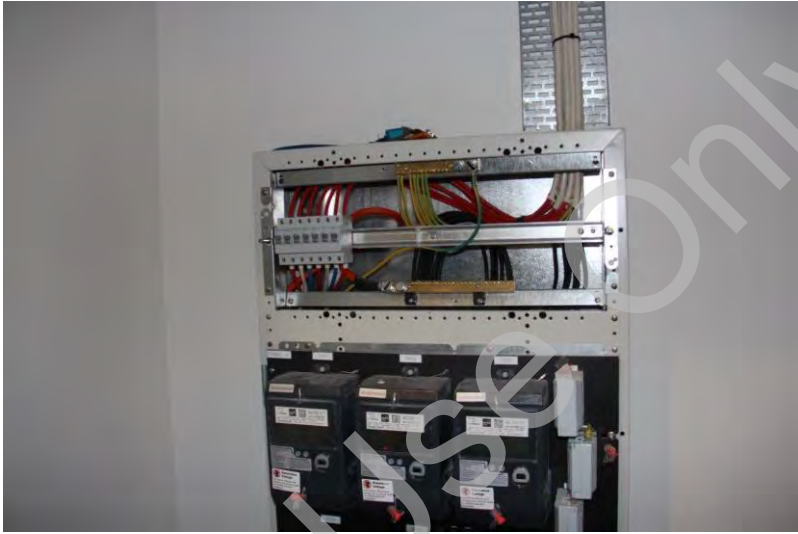
Details	Photographic Details
<p>Location: Tenancy Isolators – Level 39</p> <p>Finding: Isolating circuit breakers, and associated wiring and connections, were observed to be inoperative or operating within normal temperature conditions at the time of inspection.</p>
