Main Switchboard Thermal Imaging Inspection & Report

88 Sample St Suburb VIC 3000

5 October 2015

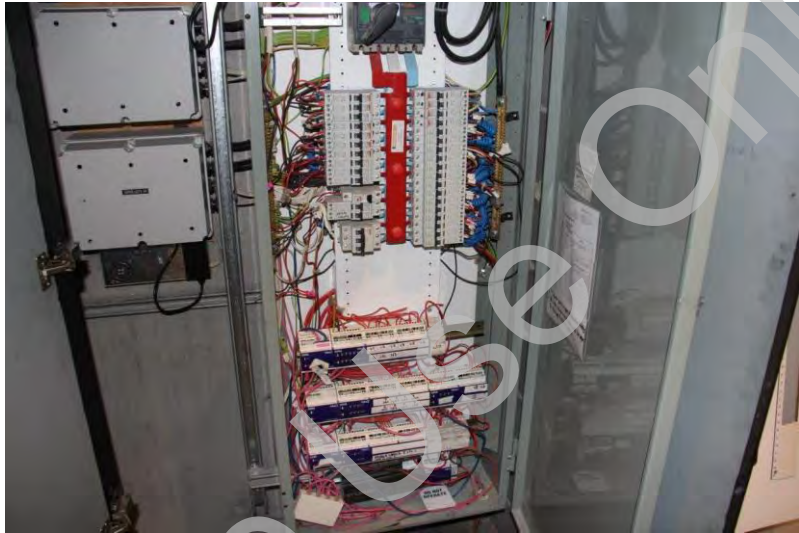
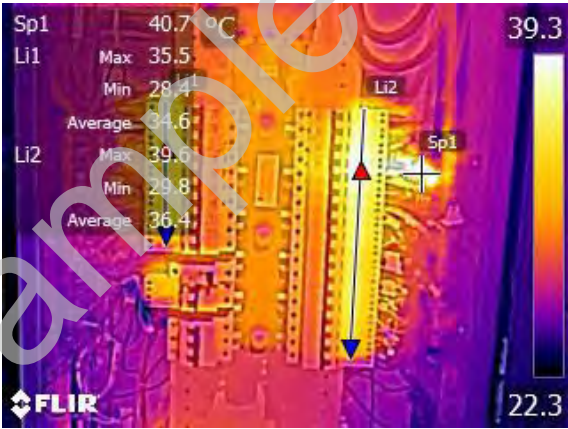
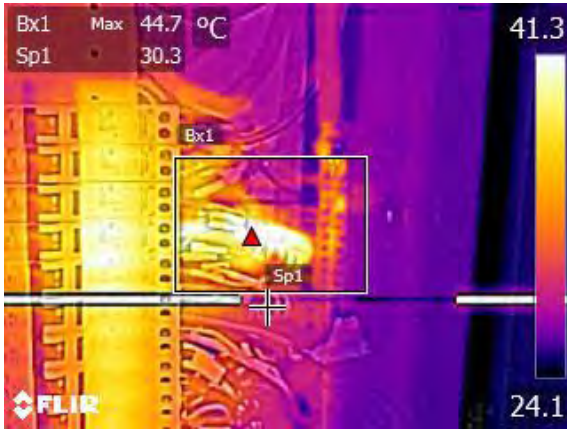
Details	Photographic Details
<p>Location: Distribution Board - Ground Level West</p> <p>Finding: Wiring connected to circuit breaker number 10 exhibits an elevated temperature when compared to other wiring. This circuit breaker services the "Foyer Lts, Main Entry, Main Room, Lobby L1". Wiring for circuit breaker number 10 exhibited an elevated temperature (~14°C differential) when compared to similar elements. All other elements were operating within normal temperature condition limits. This circuit breaker was investigated further, see details overleaf.</p>

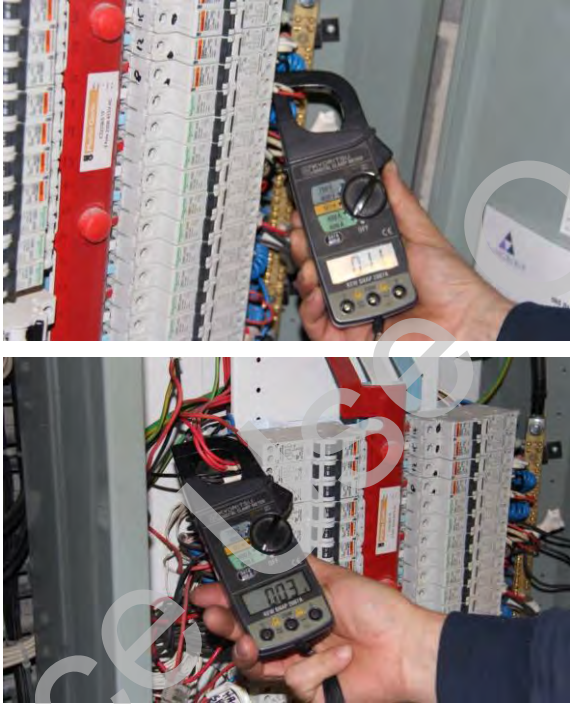
Details	Photographic Details								
<p>Location: Distribution Board - Ground Level West</p> <p>Finding: Current load on the wiring in question, adjacent to the connection to the circuit breaker, was found to be 11A. The circuit breaker is rated for a load of 16A. This has been compared to the 3A loading out of a capacity of 20A on circuit breaker number 1.</p> <p>Recommendation: During the next maintenance phase, it is recommended that the loading for circuit breaker number 10 be split, or the circuit breaker upgraded, in order to more evenly distribute the loadings across the panel.</p>

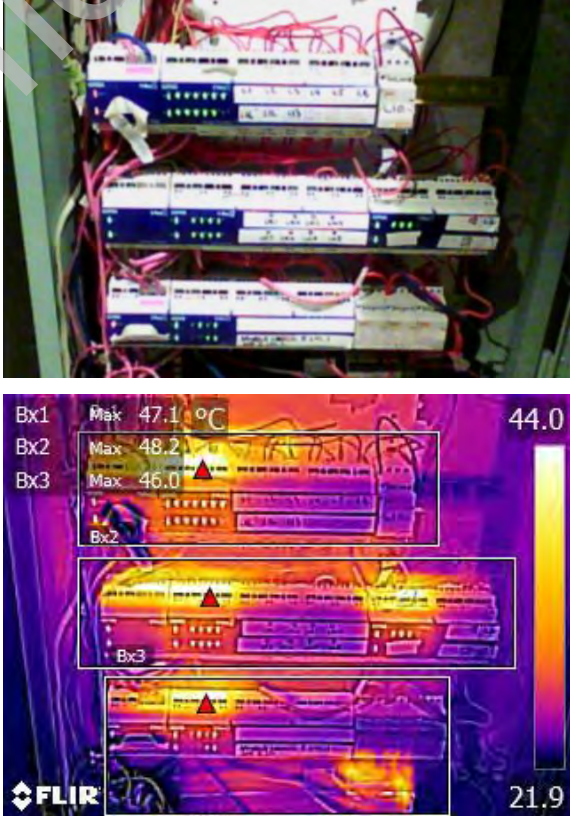
<p>Location: Distribution Board - Ground Level West</p> <p>Finding: All four C-Bus2 units were operational at the time of inspection and were operating within normal conditions. Note: Normal operating conditions for C-Bus units are considered to be between ambient temperature and 70°C, as this is generally the point that thermal overload protection is enabled.</p>

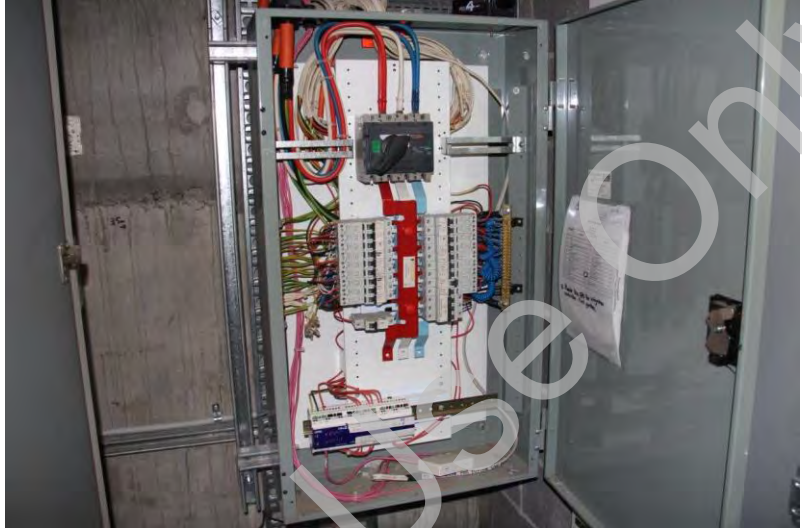
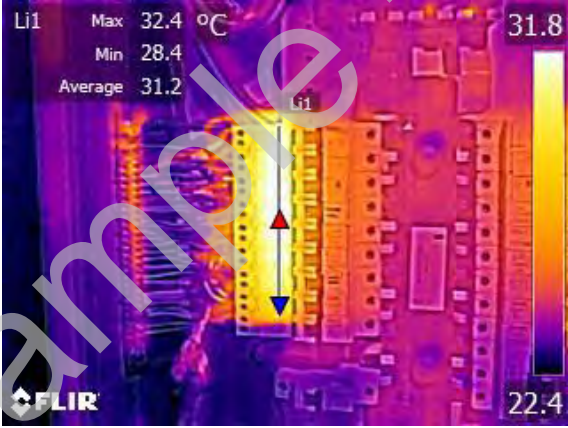
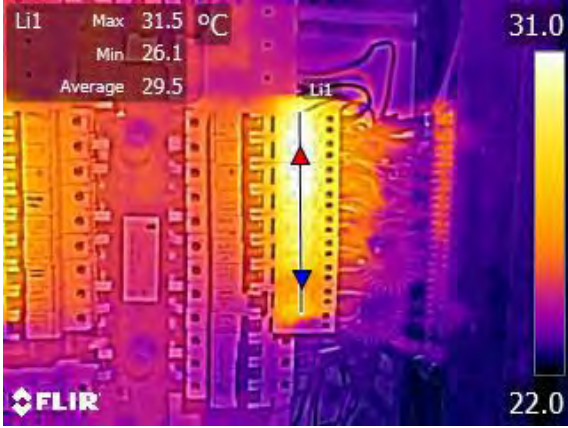
Details	Photographic Details
<p>Location: Distribution Board – Basement 1 West</p> <p>Finding: All circuit breakers, associated connections and wiring within the distribution board were operating within normal temperature conditions at the time of inspection.</p> <p>Note: Circuit breaker number 16, assigned to "Tank Room 2", was found manually isolated on the day of inspection.</p>

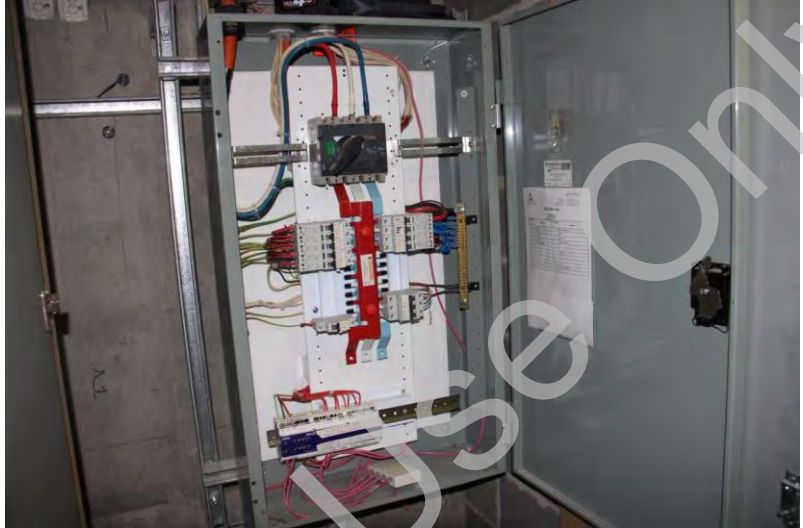
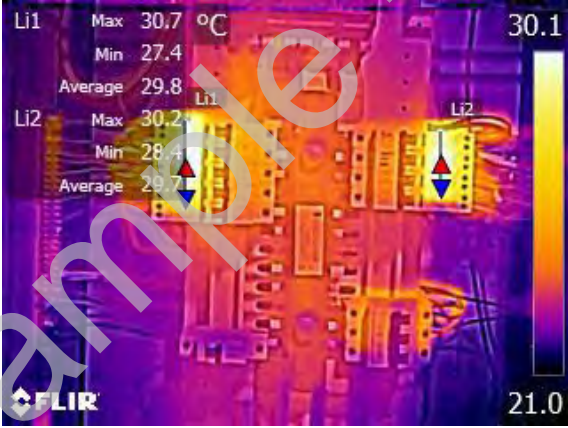
Details	Photographic Details
<p>Location: Distribution Board – Basement 1 West</p> <p>Finding: All circuit breakers, associated connections and wiring within the distribution board were operating within normal temperature conditions at the time of inspection.</p> <p>C-Bus2 relay unit was operational at the time of inspection and was operating within normal conditions.</p> <p>Note: Normal operating conditions for C-Bus units are considered to be between ambient temperature and 70°C.</p>

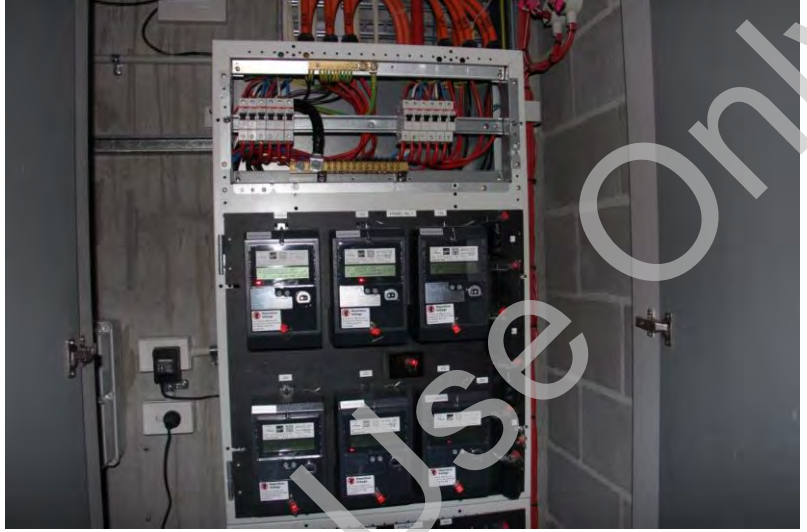
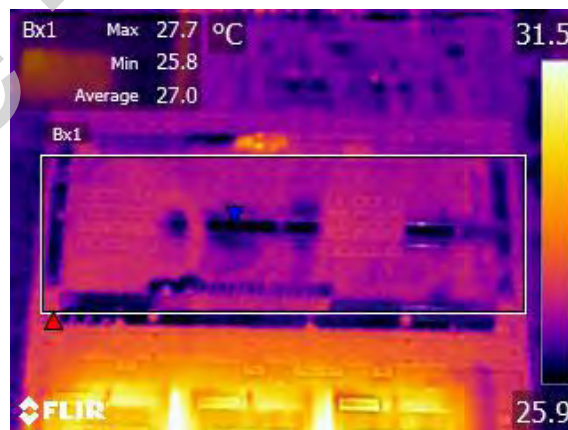
Details	Photographic Details
<p>Location: Switchboard & Tenancy Isolators – Level 2 West</p> <p>Finding: Circuit breakers were observed to be at an ambient temperature at the time of inspection.</p> <p>Note: Isolators for Levels 1-4 are contained within this panel.</p>

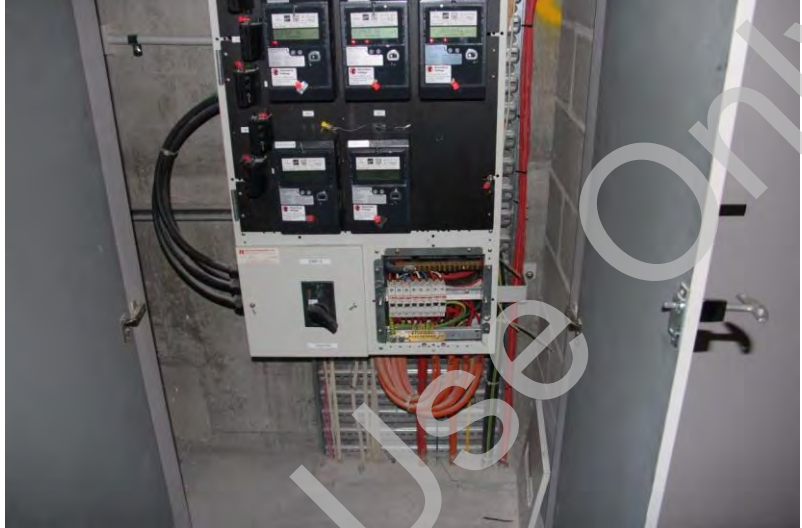
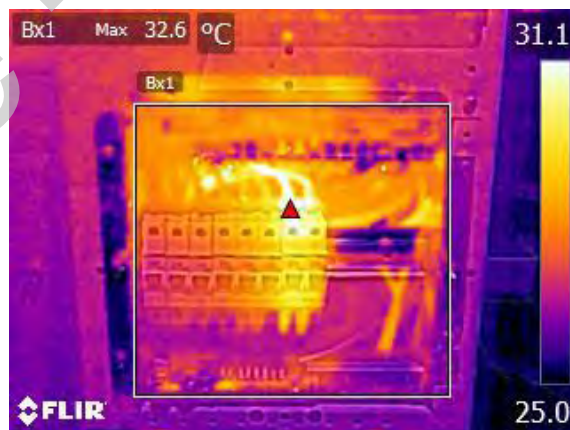
Details	Photographic Details
<p>Location: Switchboard & Tenancy Isolators – Level 5 West</p> <p>Finding: Circuit breakers were observed to be inoperative or operating within normal temperature conditions at the time of inspection.</p> <p>Note: Isolators for Levels 5-8 are contained within this panel.</p>

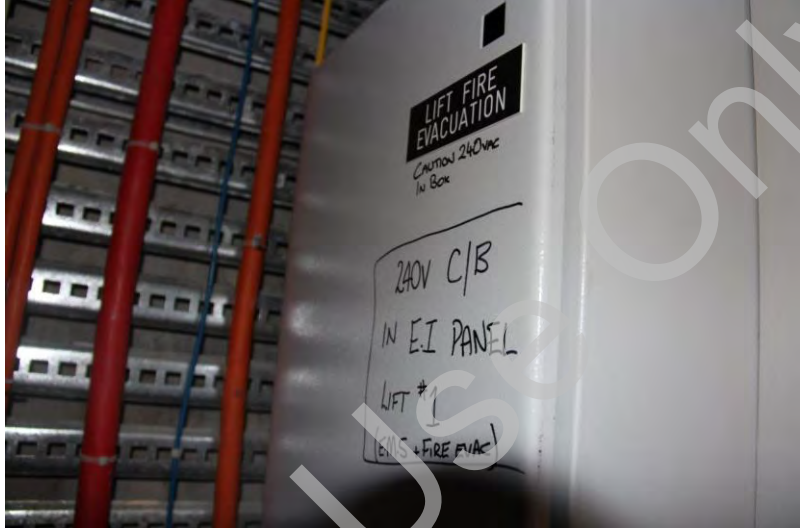
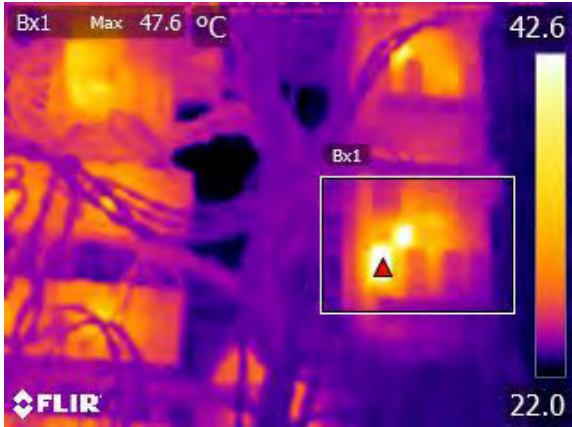
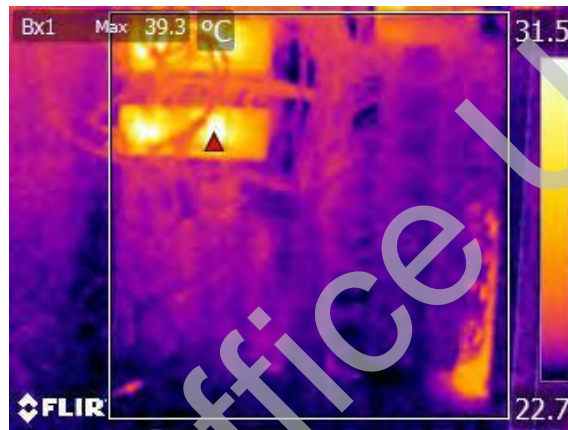
Details	Photographic Details
<p>Location: Lift & Fire Evacuation Panel – Level 8 West</p> <p>Finding: Circuit boards and associated wiring appear to be functioning within normal operating temperature conditions. One section showed a temperature differential of $\sim 10^{\circ}\text{C}$, which was not considered to be excessive.</p>

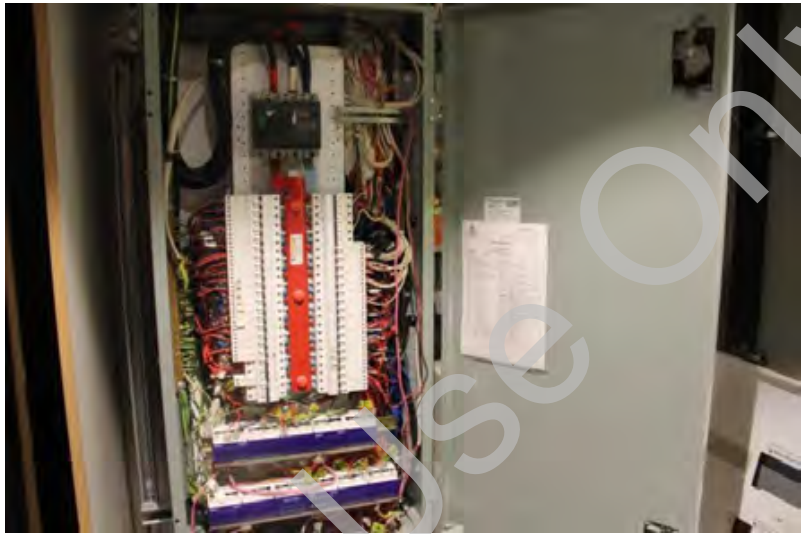
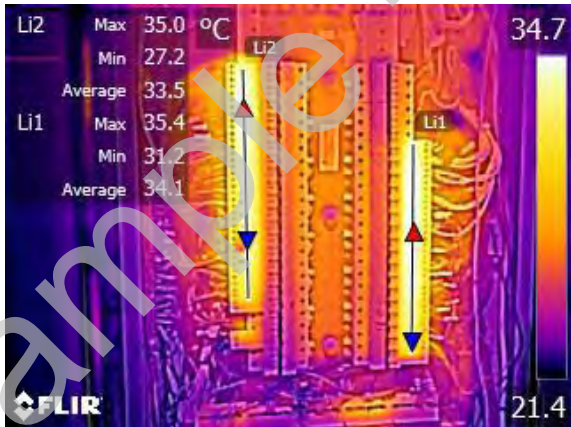
Details	Photographic Details																												
<p>Location: Distribution Board - Ground Level East</p> <p>Finding: All circuit breakers, associated connections and wiring within the distribution board were operating within normal temperature conditions at the time of inspection. One C-Bus2 dimmer unit did not appear to be operational, the other three C-Bus2 relay units were operating within normal temperature conditions at the time of inspection. Note: Normal operating conditions for C-Bus units are considered to be between ambient temperature and 70°C.</p>

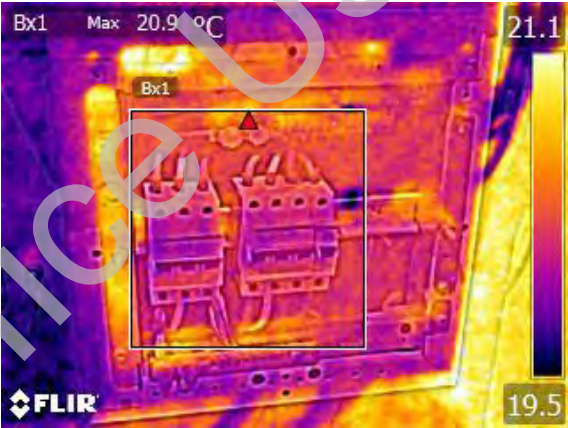
Details	Photographic Details
<p>Location: Isolators - Ground Level East</p> <p>Finding: Circuit breakers were observed to be inoperative or operating within normal temperature conditions at the time of inspection.</p>

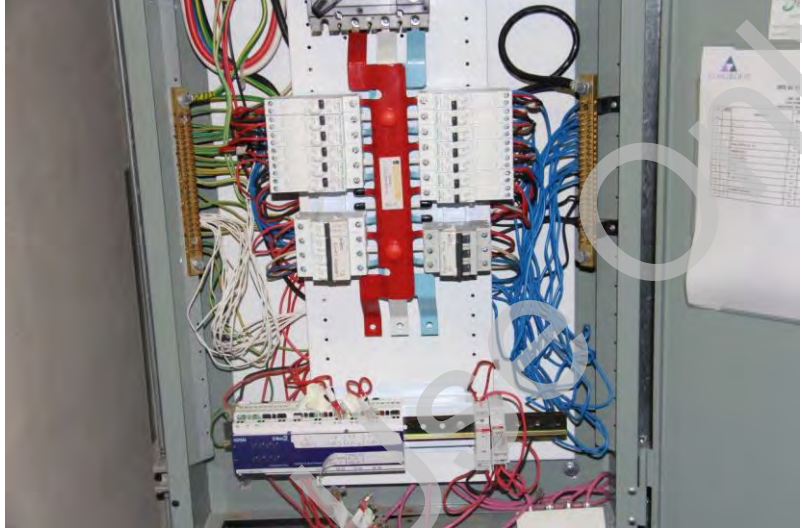
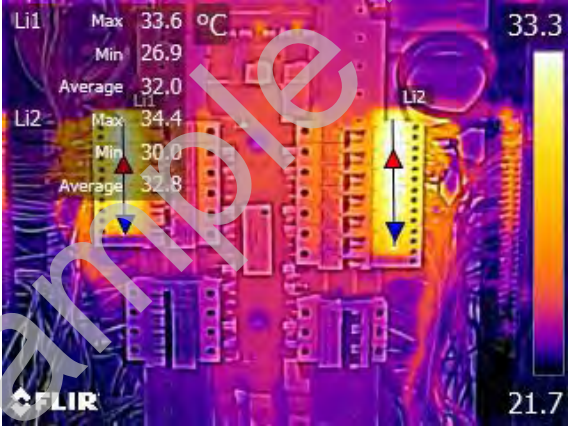
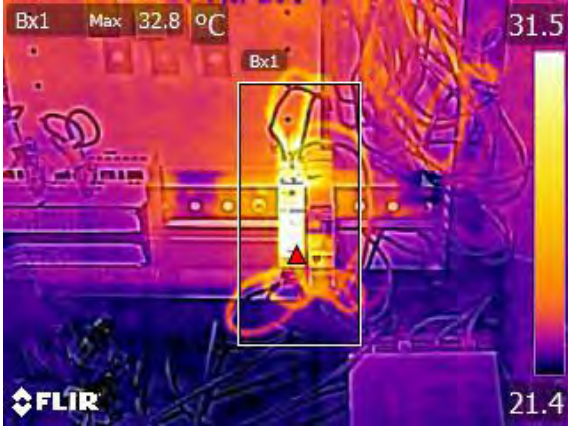
Details	Photographic Details
<p>Location: Distribution Board – Basement 1 – East</p> <p>Finding: All circuit breakers, associated connections and wiring within the distribution board were operating within normal temperature conditions at the time of inspection.</p> <p>Flood lights circuit breaker was present at the bottom of the board and was operating within normal temperature conditions.</p> <p>C-Bus2 relay unit was not operational at the time of inspection.</p>

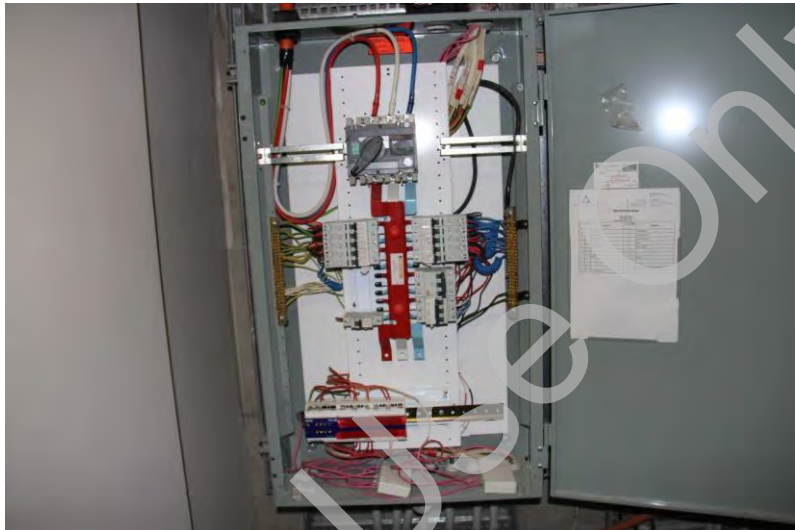
Details	Photographic Details																																
<p>Location: Distribution Board – Basement 2 – East</p> <p>Finding: All circuit breakers, associated connections and wiring within the distribution board were observed to be inoperative or operating within normal temperature conditions at the time of inspection.</p> <p>C-Bus2 relay unit was operational at the time of inspection and was operating within normal conditions.</p> <p>Note: Normal operating conditions for C-Bus units are considered to be between ambient temperature and 70°C.</p>

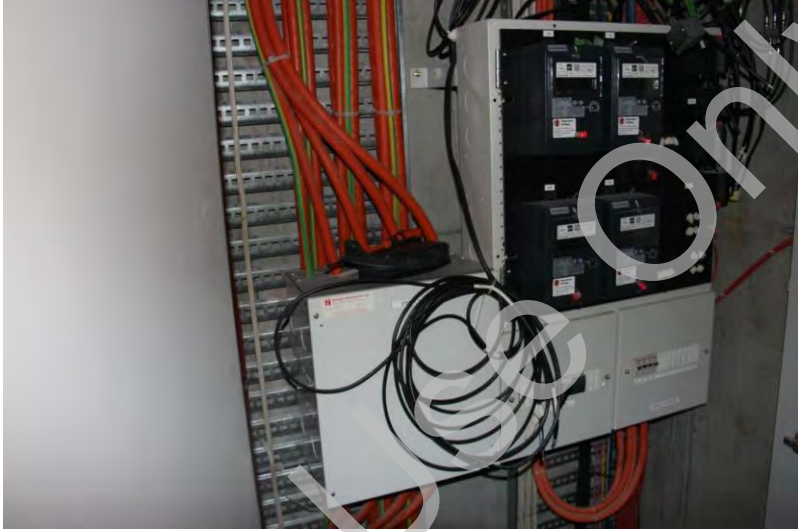
Details	Photographic Details
<p>Location: Switchboard & Tenancy Isolators – Level 1 East</p> <p>Finding: Circuit breakers were observed to be inoperative or operating within normal temperature conditions at the time of inspection.</p>

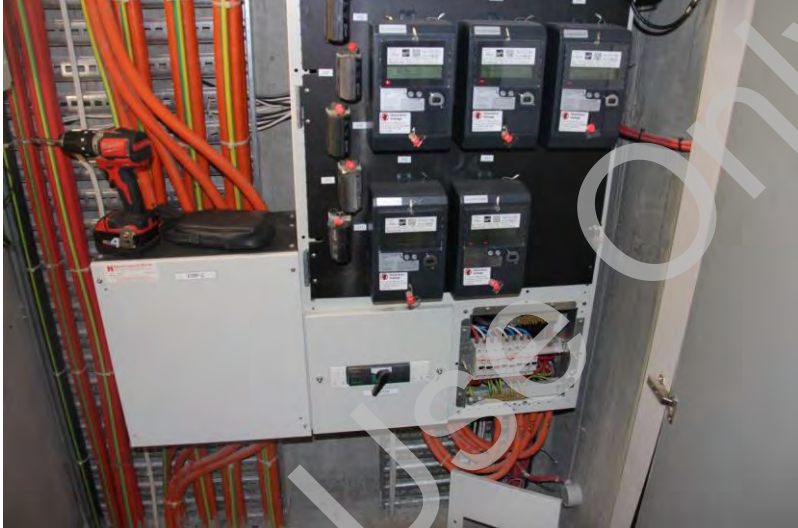
Details	Photographic Details
<p>Location: Switchboard & Tenancy Isolators – Level 2 East</p> <p>Finding: Circuit breakers were observed to be inoperative or operating within normal temperature conditions at the time of inspection.</p>

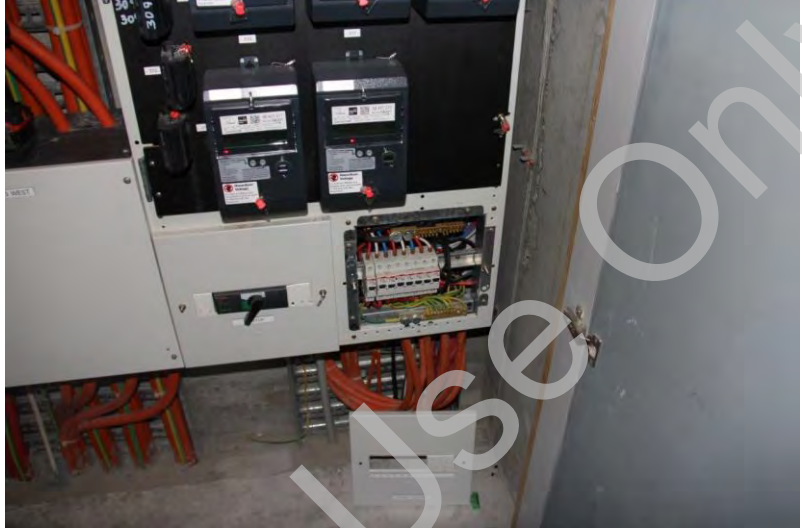
Details	Photographic Details
<p>Location: Switchboard & Tenancy Isolators – Level 3 East</p> <p>Finding: Circuit breakers were observed to be inoperative or operating within normal temperature conditions at the time of inspection.</p>

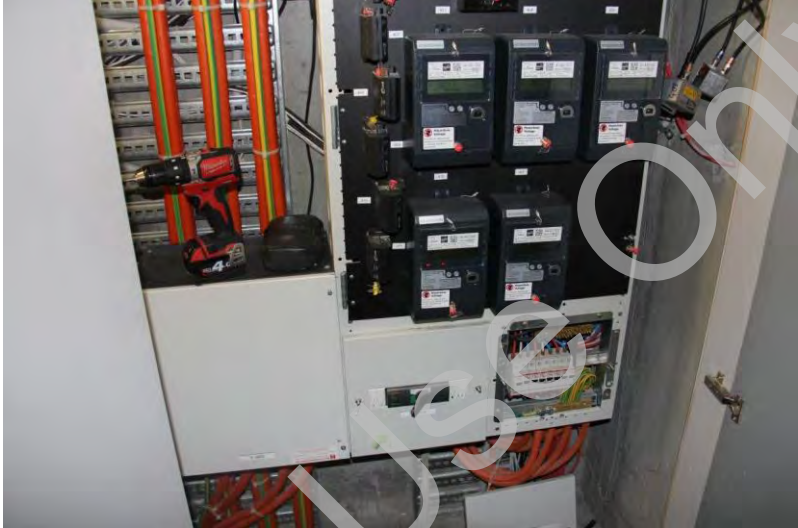
Details	Photographic Details
<p>Location: Switchboard & Tenancy Isolators – Level 4 East</p> <p>Finding: Circuit breakers were observed to be inoperative or operating within normal temperature conditions at the time of inspection.</p>

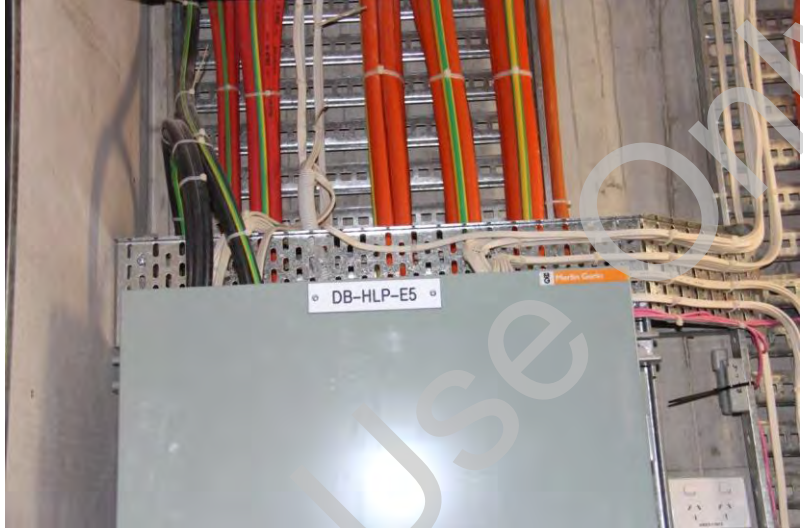
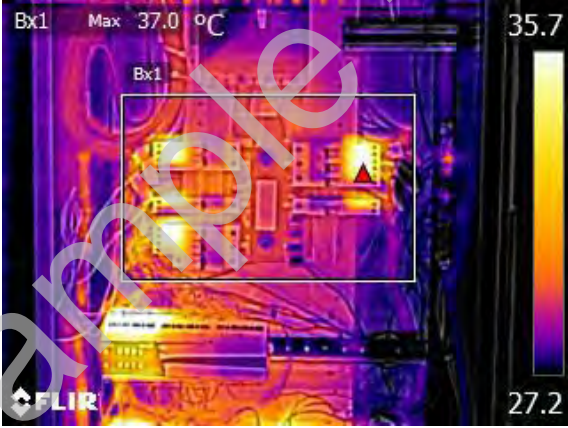
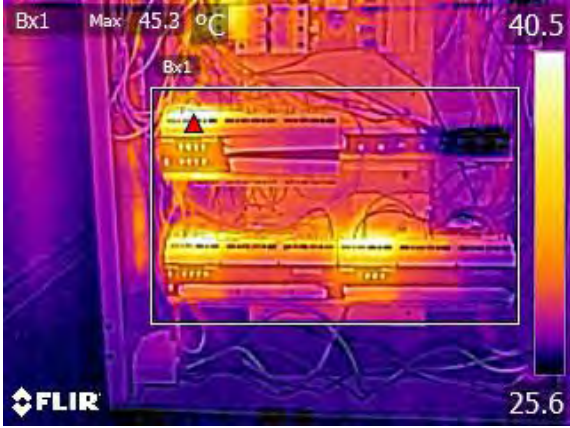
Details	Photographic Details
<p>Location: Distribution Board – Level 5 East</p> <p>Finding: All circuit breakers, associated connections and wiring within the distribution board were observed to be inoperative or operating within normal temperature conditions at the time of inspection.</p> <p>C-Bus2 relay units were operational at the time of inspection and were operating within normal conditions.</p> <p>Note: Normal operating conditions for C-Bus units are considered to be between ambient temperature and 70°C.</p>

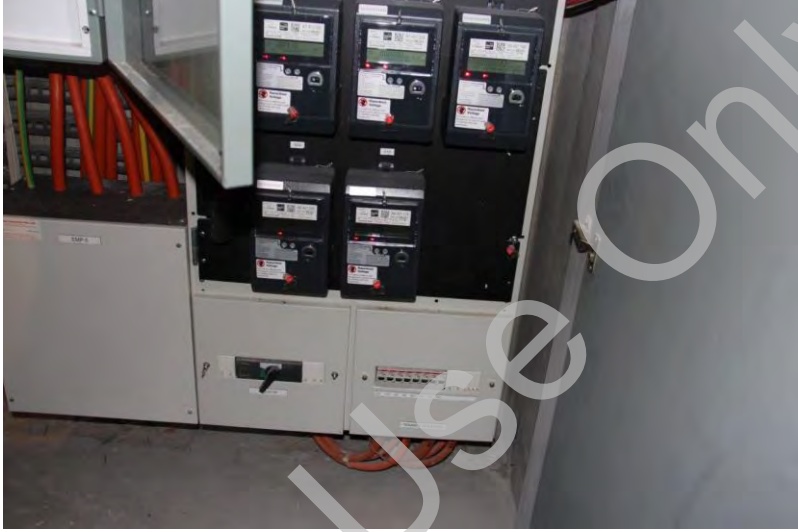
Details	Photographic Details
<p>Location: Switchboard & Tenancy Isolators – Level 5 East</p> <p>Finding: Circuit breakers were observed to be inoperative or operating within normal temperature conditions at the time of inspection.</p>

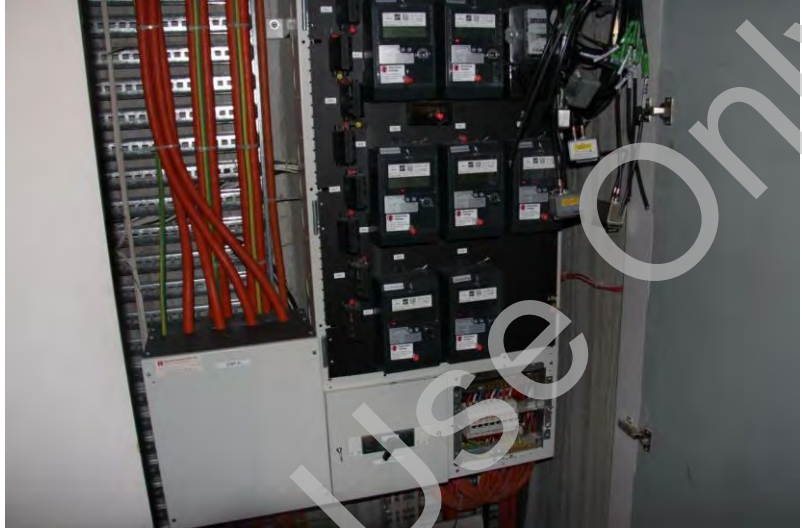
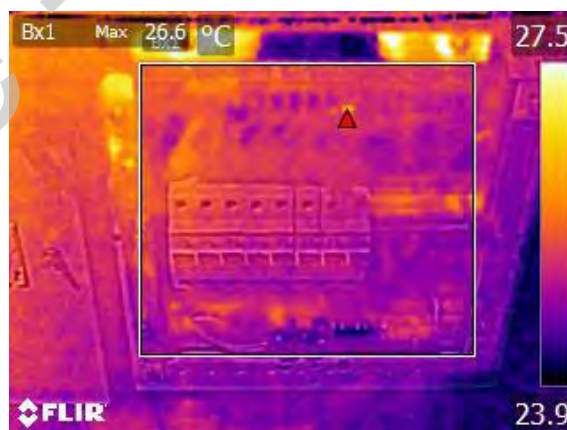
Details	Photographic Details
<p>Location: Switchboard & Tenancy Isolators – Level 6 East</p> <p>Finding: Circuit breakers were observed to be inoperative or operating within normal temperature conditions at the time of inspection.</p>

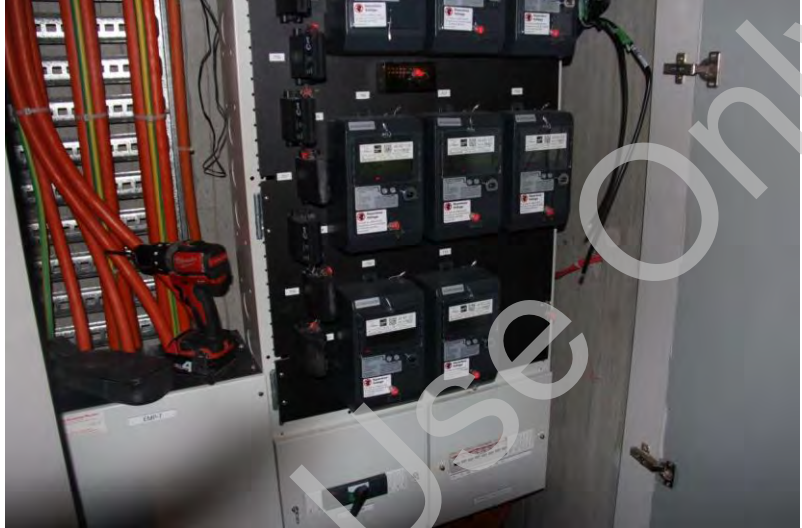
Details	Photographic Details
<p>Location: Switchboard & Tenancy Isolators – Level 7 East</p> <p>Finding: Circuit breakers were observed to be inoperative or operating within normal temperature conditions at the time of inspection.</p>

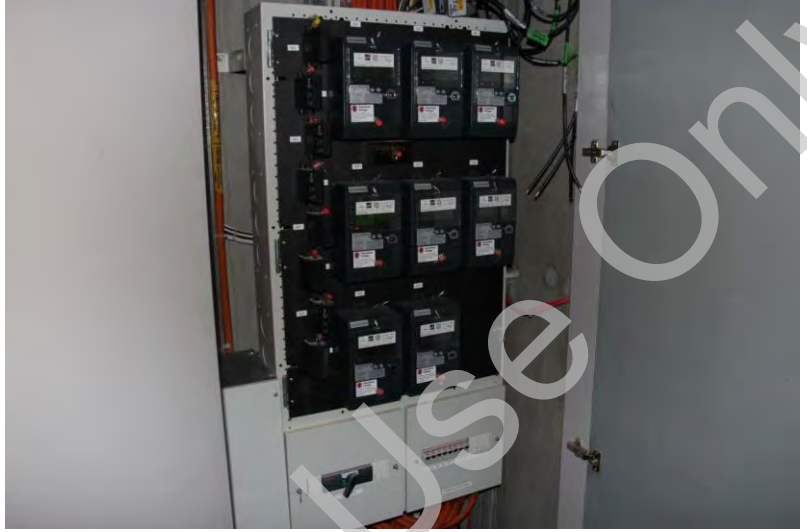
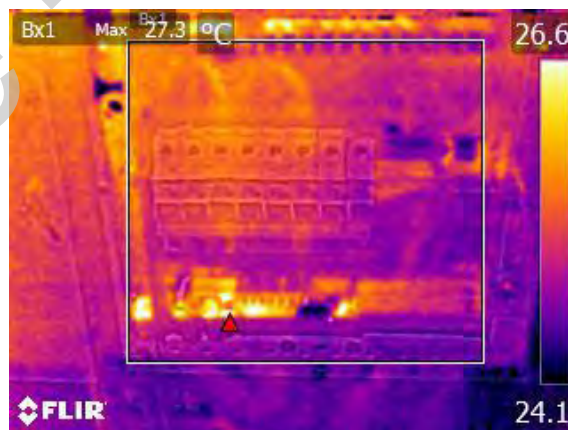
Details	Photographic Details
<p>Location: Switchboard & Tenancy Isolators – Level 8 East</p> <p>Finding: Circuit breakers were observed to be inoperative or operating within normal temperature conditions at the time of inspection.</p>

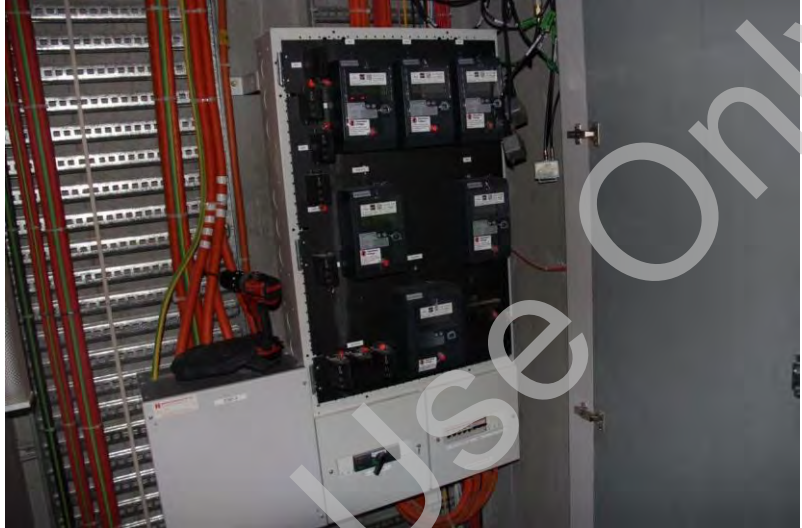
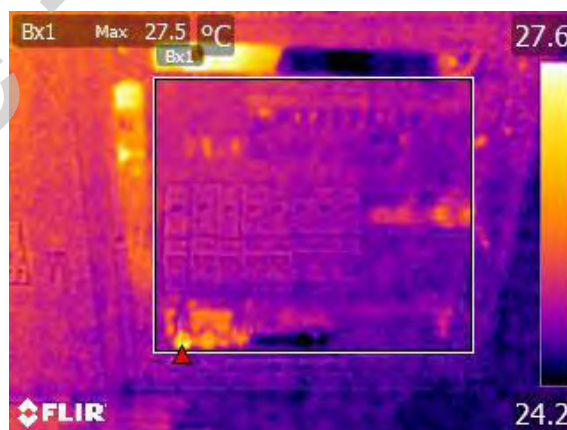
Details	Photographic Details
<p>Location: Switchboard & Tenancy Isolators – Level 9 East</p> <p>Finding: Circuit breakers were observed to be inoperative or operating within normal temperature conditions at the time of inspection.</p>

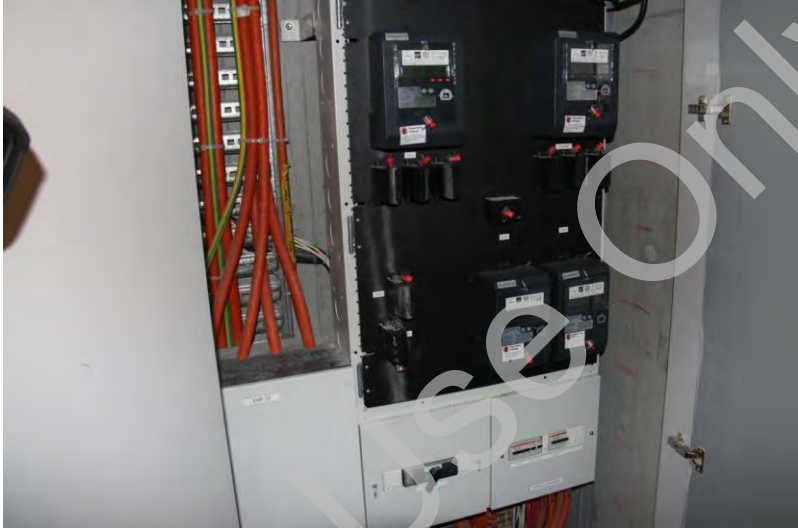
Details	Photographic Details
<p>Location: Switchboard & Tenancy Isolators – Level 12 East</p> <p>Finding: Circuit breakers were observed to be inoperative or operating within normal temperature conditions at the time of inspection.</p>

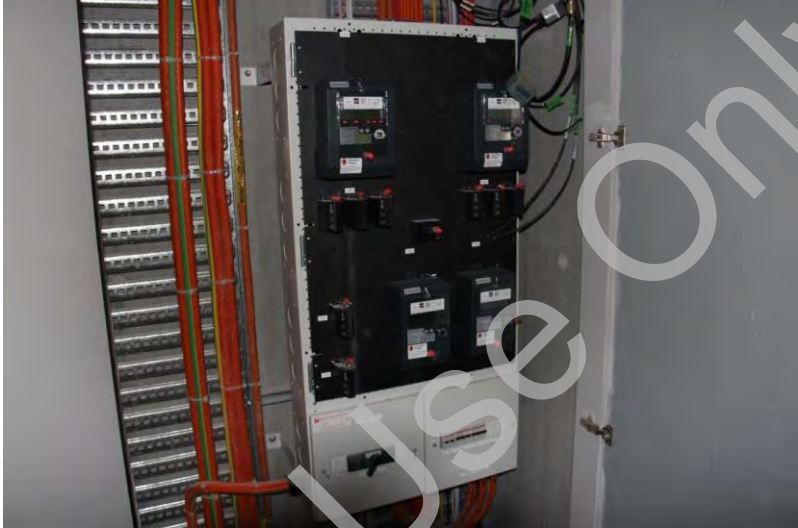
Details	Photographic Details
<p>Location: Switchboard & Tenancy Isolators – Level 13 East</p> <p>Finding: Circuit breakers were observed to be inoperative or operating within normal temperature conditions at the time of inspection.</p>

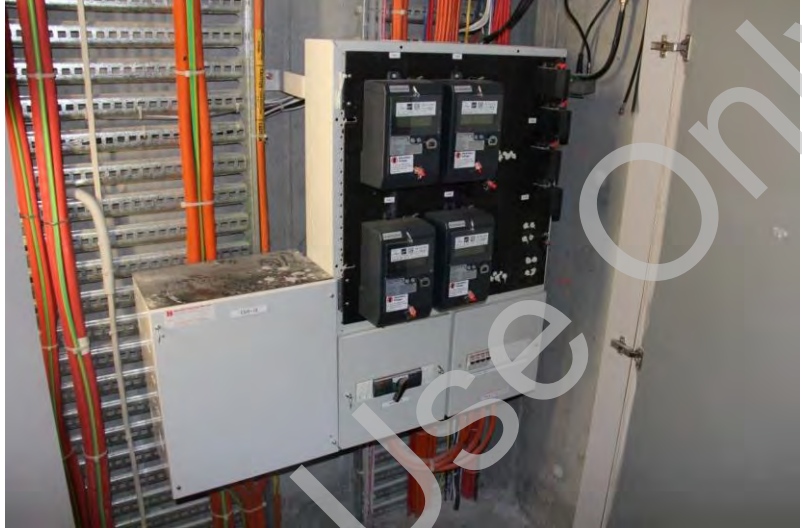
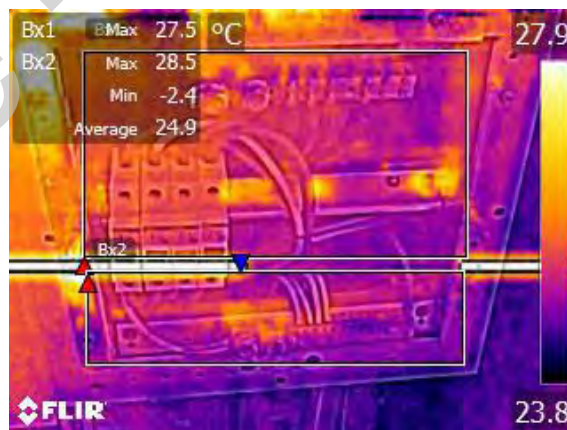
Details	Photographic Details
<p>Location: Switchboard & Tenancy Isolators – Level 14 East</p> <p>Finding: Circuit breakers were observed to be inoperative or operating within normal temperature conditions at the time of inspection.</p>

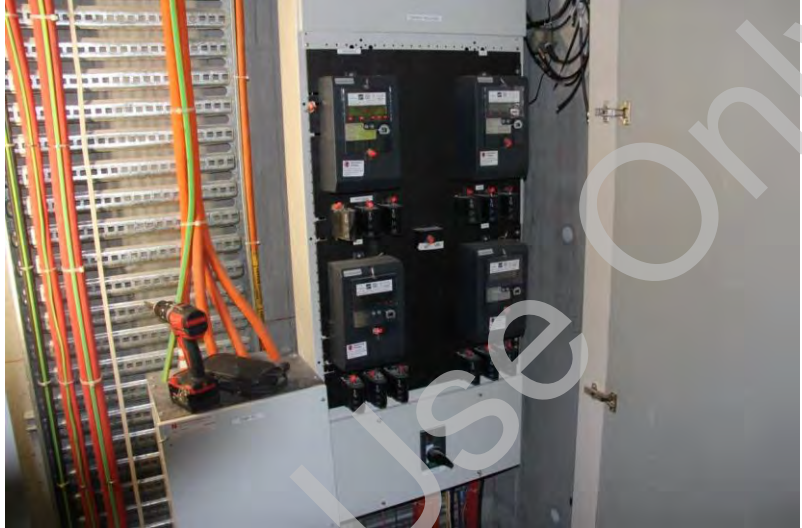
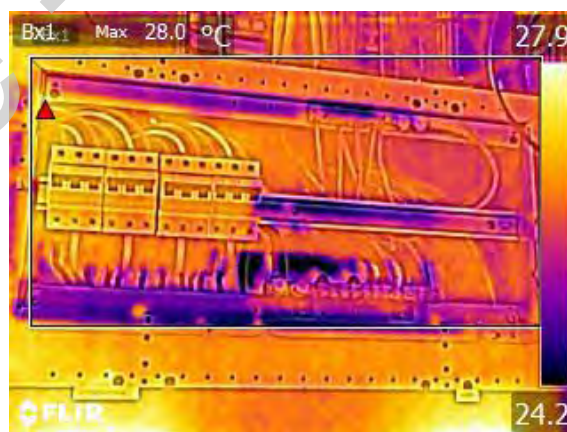
Details	Photographic Details
<p>Location: Switchboard & Tenancy Isolators – Level 15 East</p> <p>Finding: Circuit breakers were observed to be inoperative or operating within normal temperature conditions at the time of inspection.</p> <p>Note: Isolators for L17 are included within this panel.</p>

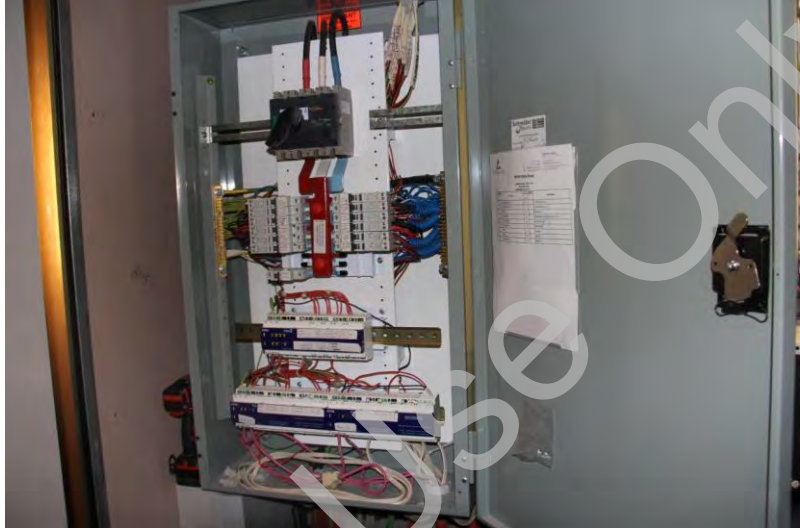
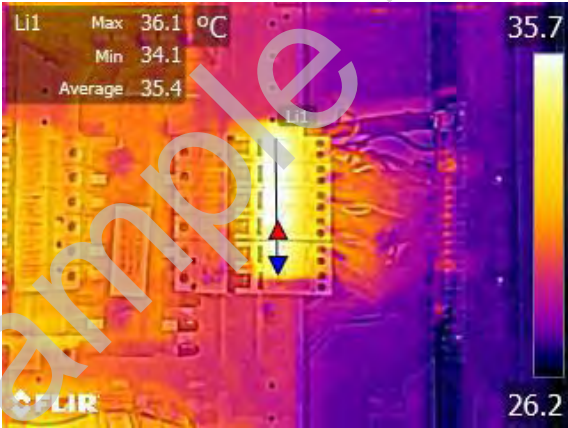
Details	Photographic Details
<p>Location: Distribution Board – Level 16 East</p> <p>Finding: All circuit breakers, associated connections and wiring within the distribution board were observed to be inoperative or operating within normal temperature conditions at the time of inspection.</p>

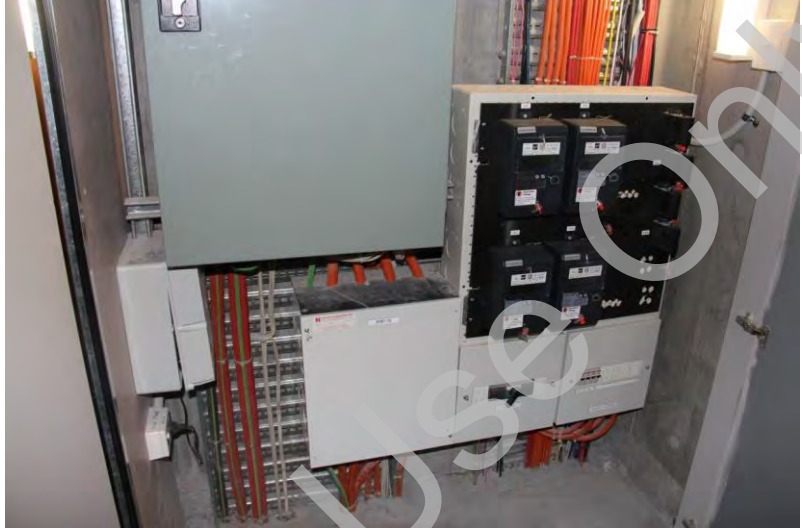
Details	Photographic Details
<p>Location: Switchboard & Tenancy Isolators – Level 16 East</p> <p>Finding: C-Bus2 relay units were operational at the time of inspection and were operating within normal conditions. Note: Normal operating conditions for C-Bus units are considered to be between ambient temperature and 70°C.</p> <p>Circuit breakers were observed to be inoperative or operating within normal temperature conditions at the time of inspection.</p>

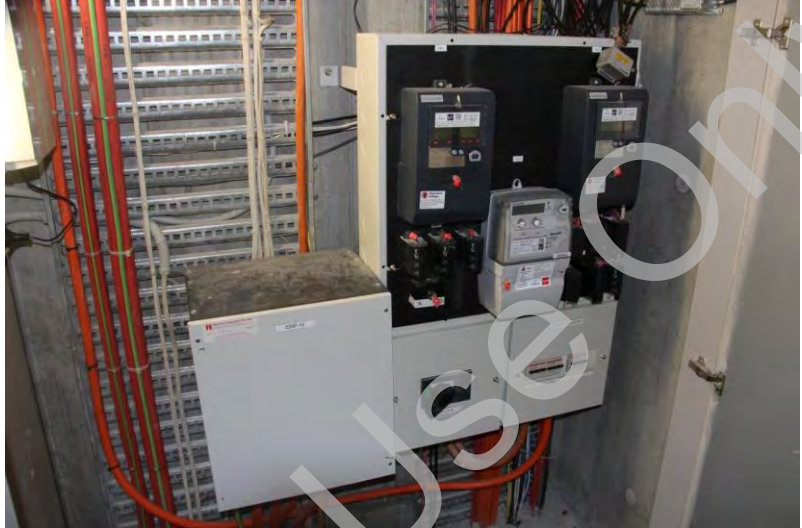
Details	Photographic Details
<p>Location: Switchboard & Tenancy Isolators – Level 18 East</p> <p>Finding: Circuit breakers were observed to be inoperative or operating within normal temperature conditions at the time of inspection.</p>

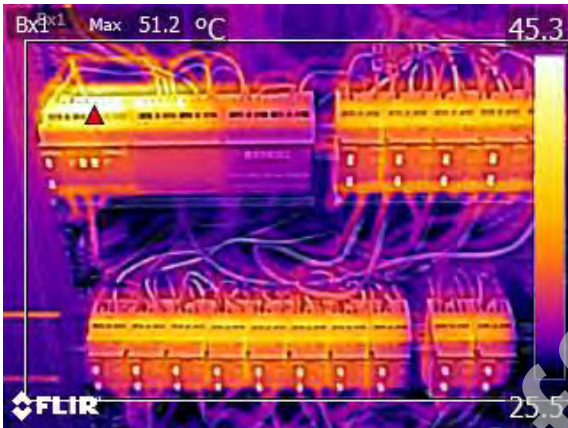
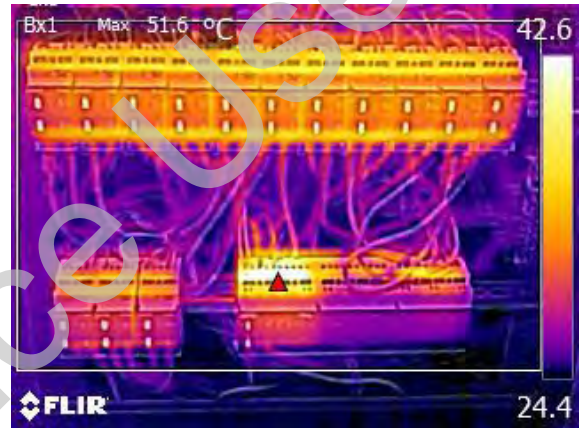
Details	Photographic Details
<p>Location: C-Bus2 Board – Level 19 East</p> <p>Finding: 39 C-Bus or C-Bus2 units were operational at the time of inspection and were operating within normal conditions. Note: Normal operating conditions for C-Bus units are considered to be between ambient temperature and 70°C.</p>

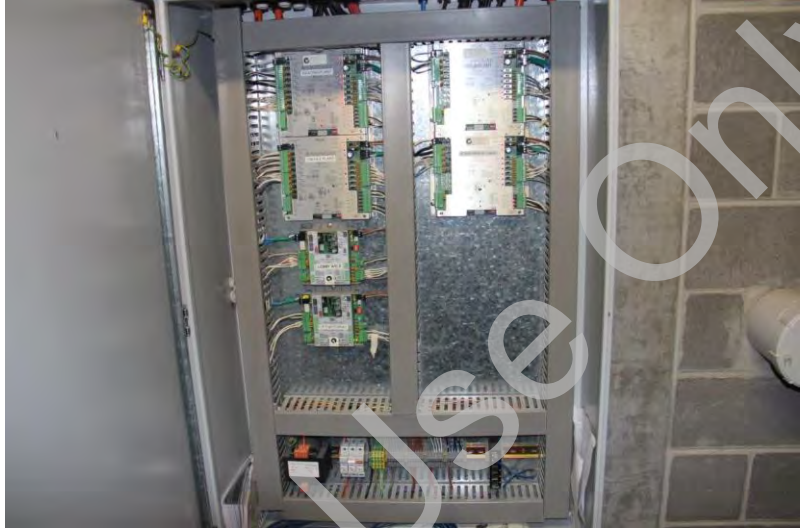
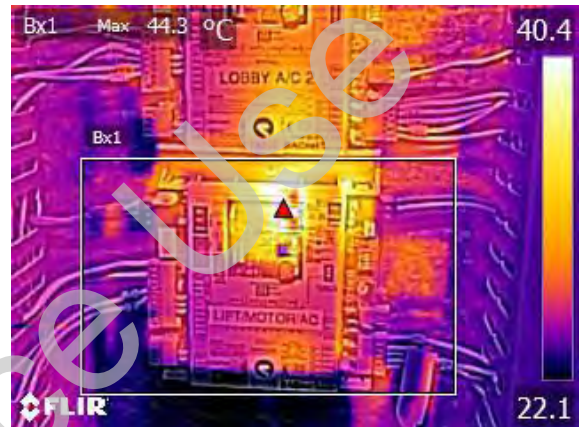
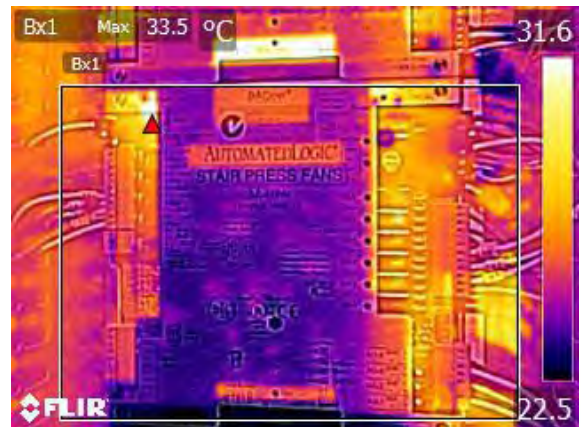
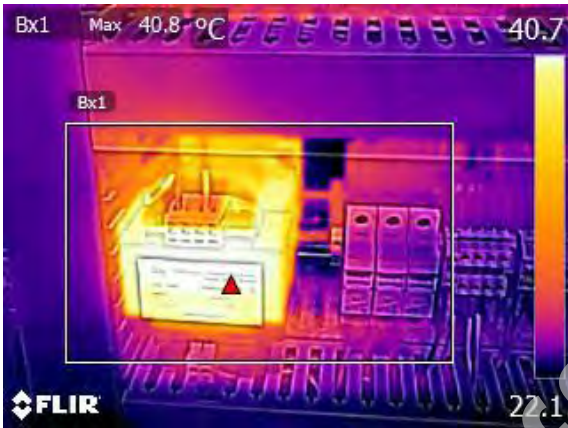
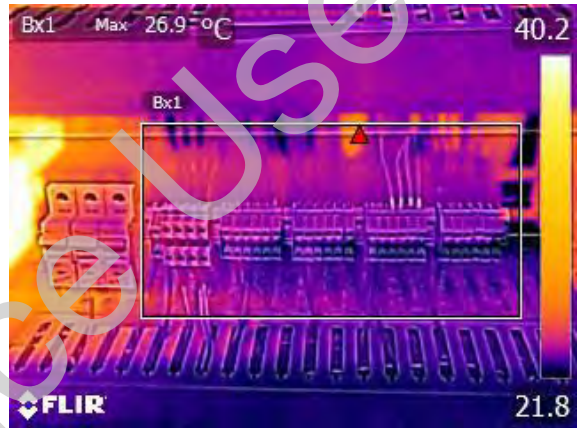
Details	Photographic Details
<p>Location: Automated Logic Control Board – Level 20 East</p> <p>Finding: Circuit boards, and associated connections, were observed to be operating within normal temperature conditions at the time of inspection.</p> <p>Altro control transformer is rated to have a temperature rise of 60°C, temperature of the transformer was found to be ~40°C, corresponding to a temperature rise from ambient of ~20°C. This transformer is operating within normal temperature conditions.</p>
