Main Switchboard Thermal Imaging Inspection & Report

88 Sample St Suburb VIC 3000

5 October 2015

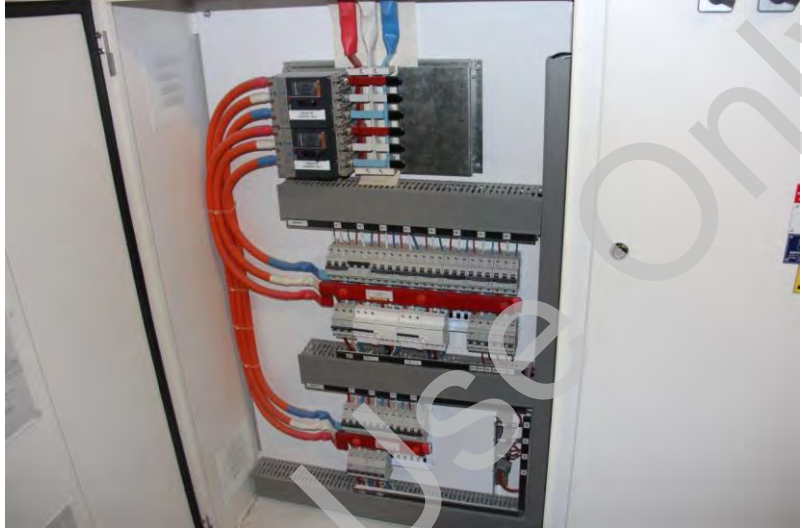
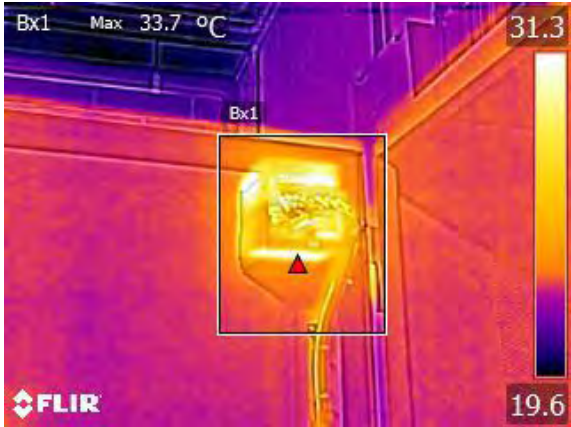
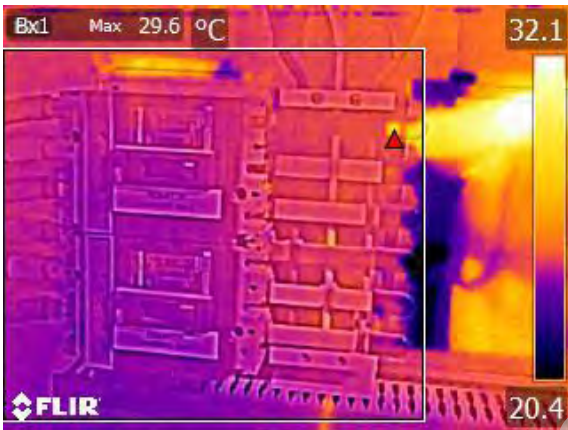
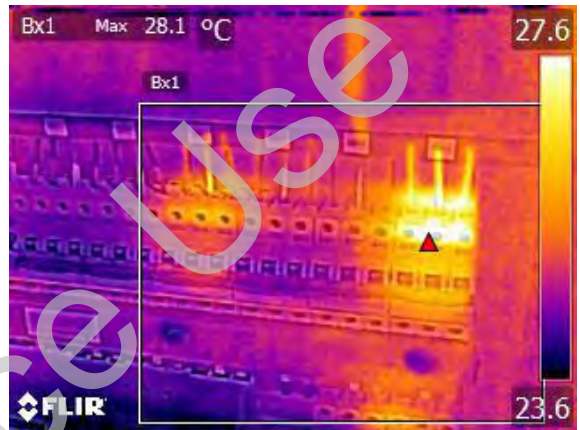
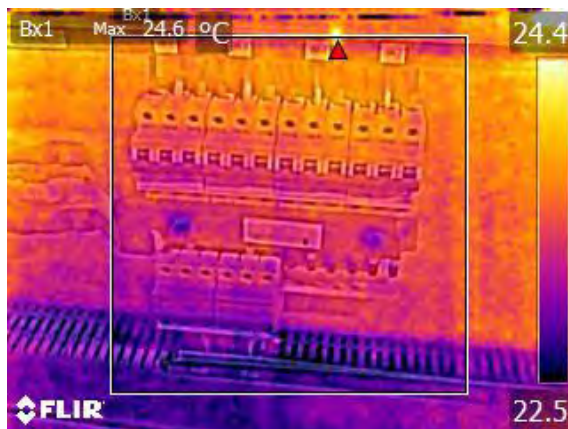
Details	Photographic Details
<p>Location: Circuit breaker cabinet – Level 20 East</p> <p>Finding: Phase connections were found to be operating within normal temperature conditions at the time of inspection.</p> <p>All circuit breakers, associated connections and wiring within the cabinet were observed to be inoperative or operating within normal temperature conditions at the time of inspection.</p>

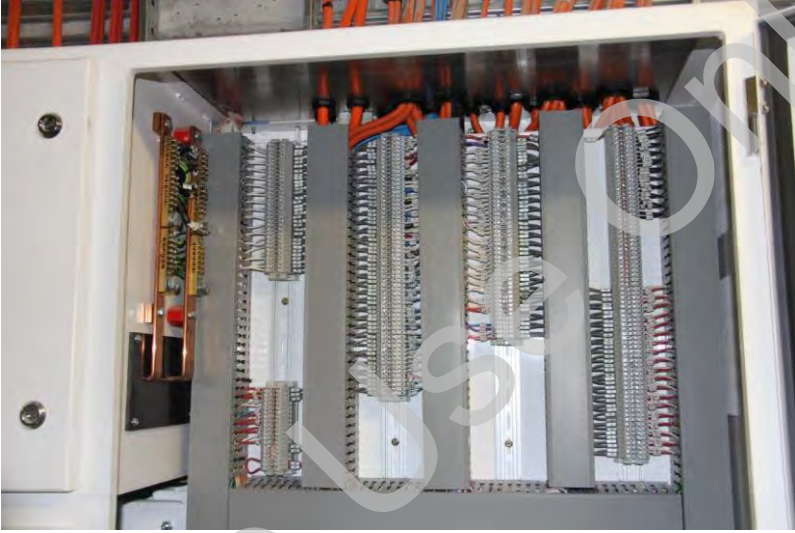
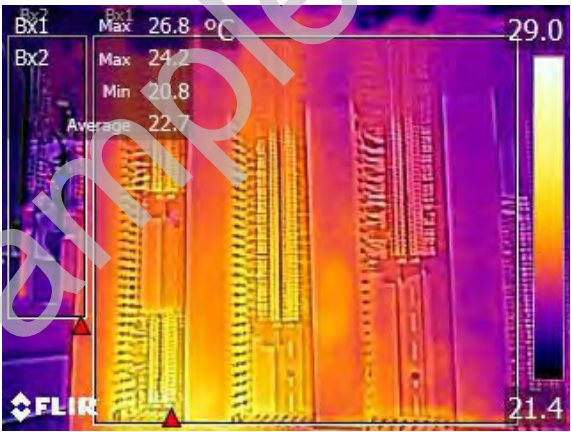
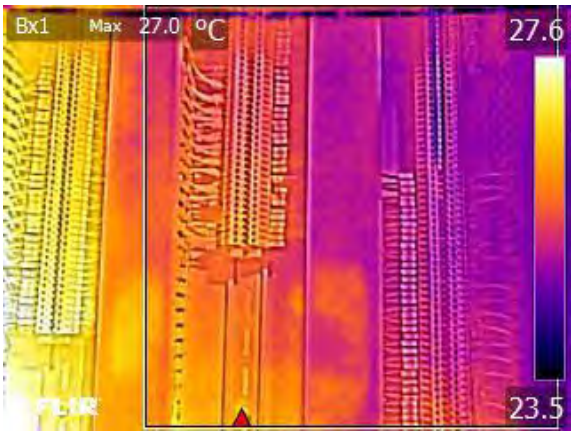
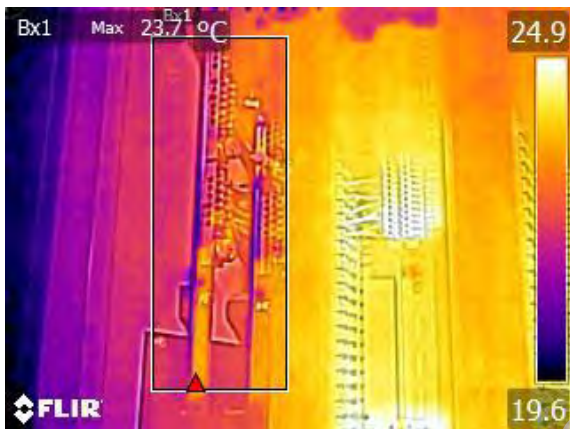
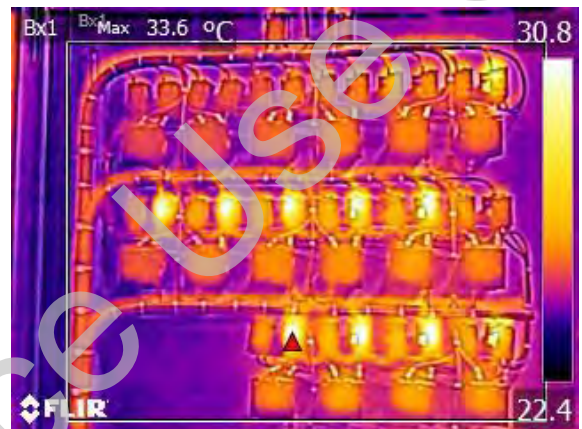
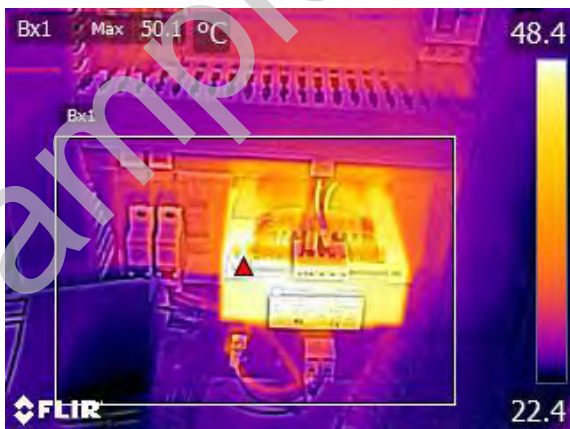
Details	Photographic Details
<p>Location: Switchboard & Tenancy Isolators – Level 20 East</p> <p>Finding: Control panel wiring and associated connections were found to be operating within normal temperature conditions.</p> <p>Class-B transformer is rated to have a temperature rise of 80°C, temperature of the transformer was found to be ~50°C, corresponding to a temperature rise from ambient of ~30°C. This transformer is operating within normal temperature conditions.</p> <p>IDEC power relays are rated to have a temperature rise of ~105°C from ambient when loaded. Maximum temperature rise from ambient observed on day of inspection was found to be ~80°C.</p>
