## Forensic Water Leak Investigation Report

1 Sample Street, Melbourne VIC 3000 (PS XXXXXXA)

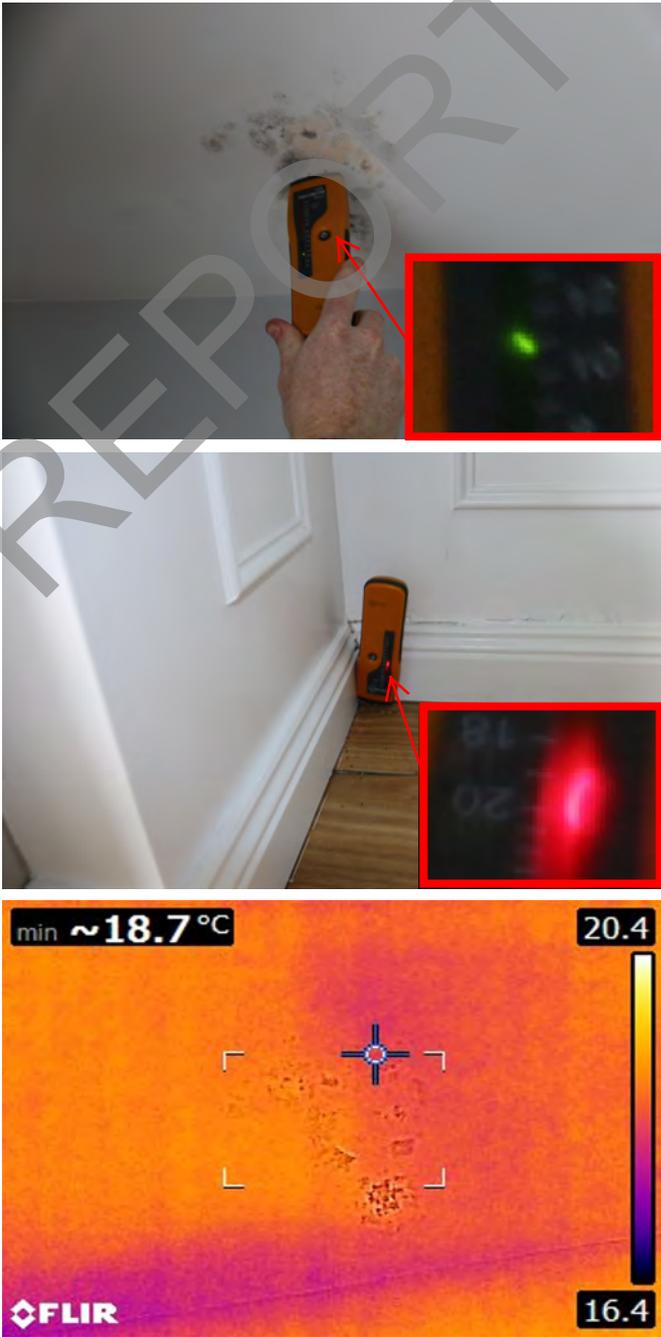
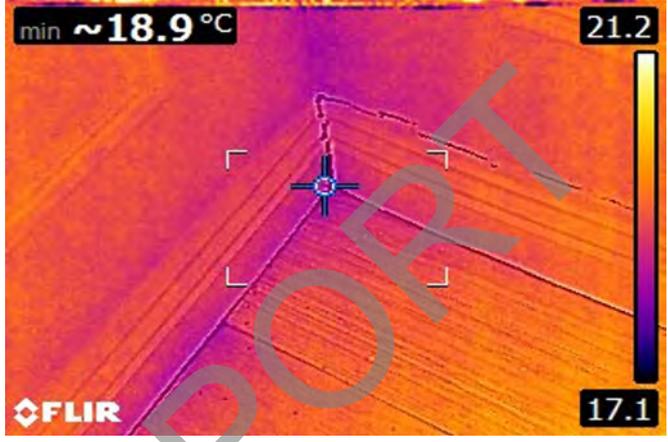
Item	Details	Photographic Details
1.	<p><b>Location:</b> Unit 18 - Living Area.</p> <p><b>Initial Conditions:</b> Internally, it can be seen that mold has formed on the ceiling and that the skirting boards appear to be swollen.</p> <p>Moisture readings were obtained in these 2 locations.</p> <ul style="list-style-type: none"> <li>• A moisture reading of 11% WME (Wood Moisture Equivalent) was obtained where the mold was growing, as shown in <b>Image 1</b>.</li> <li>• A moisture reading of 19-20% WME was obtained around the floorboards / skirtings, as shown in <b>Image 2</b>, indicating that the area was holding elevated levels of moisture.</li> </ul> <p>Upon viewing both areas with a thermal imaging camera, no indication of concerning levels of moisture were noted. Elevated moisture levels are typically indicated by dark purple regions on the camera which indicate lower temperatures. <b>Image 3</b> reinforces the results obtained in <b>Image 1</b>, whereas <b>Image 4</b> does not exhibit obvious signs of moisture presence, despite the WME reading of 19-20% obtained in this area.</p> <p>Given the result obtained by the moisture meter it appears the skirting boards were already wet prior to undertaking testing.</p>

<p>min ~18.9 °C</p> <p>21.2</p> <p>17.1</p> <p>FLIR</p>

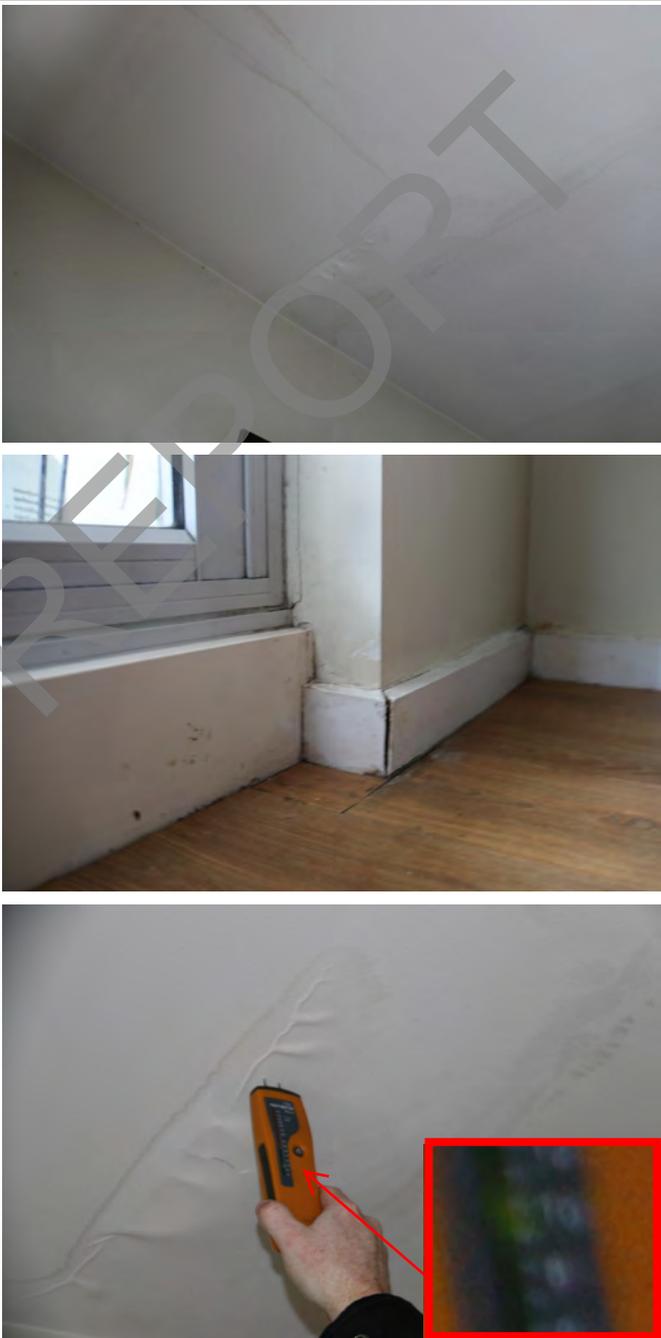
Item	Details	Photographic Details
2.	<p><b>Location:</b></p> <p>Unit 17 - Living Area.</p> <p><b>Initial Conditions:</b></p> <p>Internally, it can be seen that there is widespread staining on the ceiling and that the skirtings and floorboards appear to have deteriorated, as shown in <b>Images 1 &amp; 2</b>.</p> <p>Moisture readings were obtained in these 2 locations.</p> <ul style="list-style-type: none"> <li>• A moisture reading of 9-10% WME (Wood Moisture Equivalent) was obtained where the paint was blistering on the ceiling, as shown in <b>Image 3</b>.</li> <li>• A moisture reading of 15-17% WME was obtained around the floorboards / skirtings, as shown in <b>Image 4</b>, indicating that the area was holding slightly elevated levels of moisture.</li> </ul> <p>Upon viewing both areas with a thermal imaging camera, no indication of concerning levels of moisture was noted. Elevated moisture levels are typically indicated by dark purple regions on the camera which indicate lower temperatures. <b>Image 5</b> reinforces the results obtained in <b>Image 3</b>, whereas <b>Image 6</b> does not exhibit obvious signs of moisture presence, despite the WME reading of 15-17% obtained in this area.</p> <p>Given the result obtained by the moisture meter it appears the skirting boards were already wet prior to undertaking testing.</p>

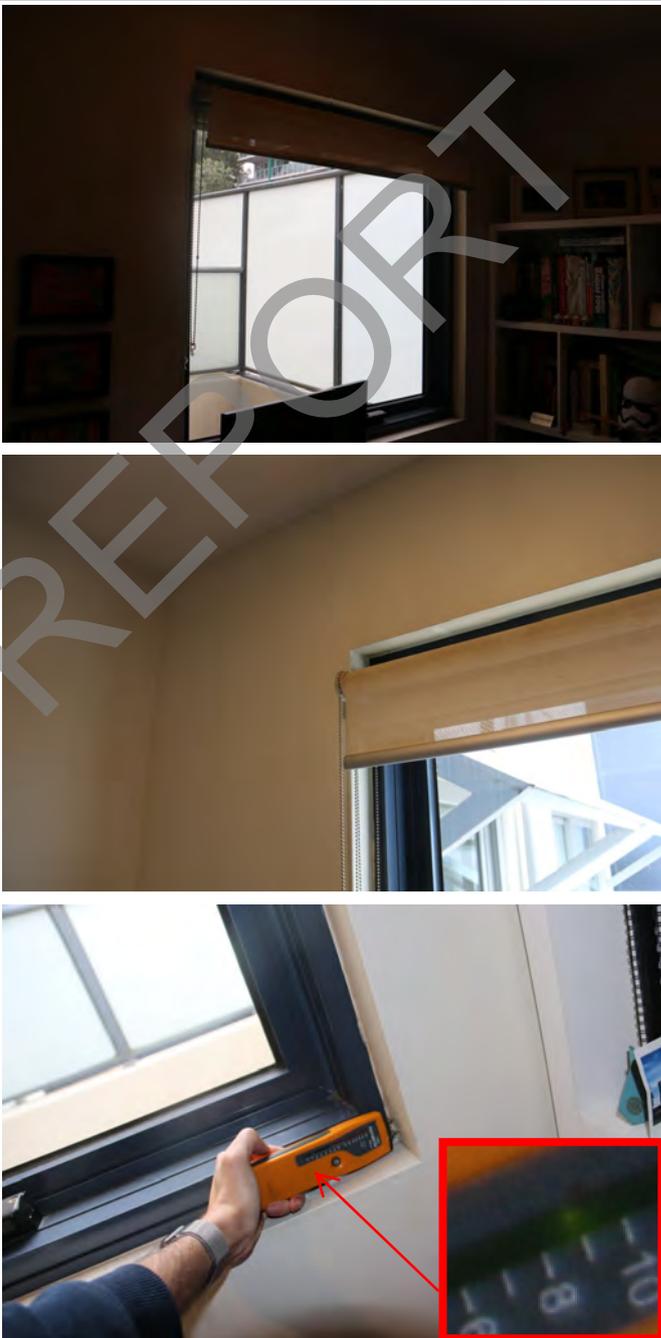
Item	Details	Photographic Details
3.	<p><b>Location:</b></p> <p>Unit 17 - Study.</p> <p><b>Initial Conditions:</b></p> <p>Internally, there does appear to be some discolouration in the paint along the window's head, as shown in <b>Images 1 &amp; 2</b>, however, it is unclear if this is the result of water damage or attempts to repair previously damaged sections of plaster.</p> <p>A moisture reading was obtained in this location.</p> <ul style="list-style-type: none"> <li>A moisture reading of 9% WME (Wood Moisture Equivalent) was obtained near the lower right-hand corner of the window, as shown in <b>Image 3</b>, indicating this area was dry.</li> </ul>

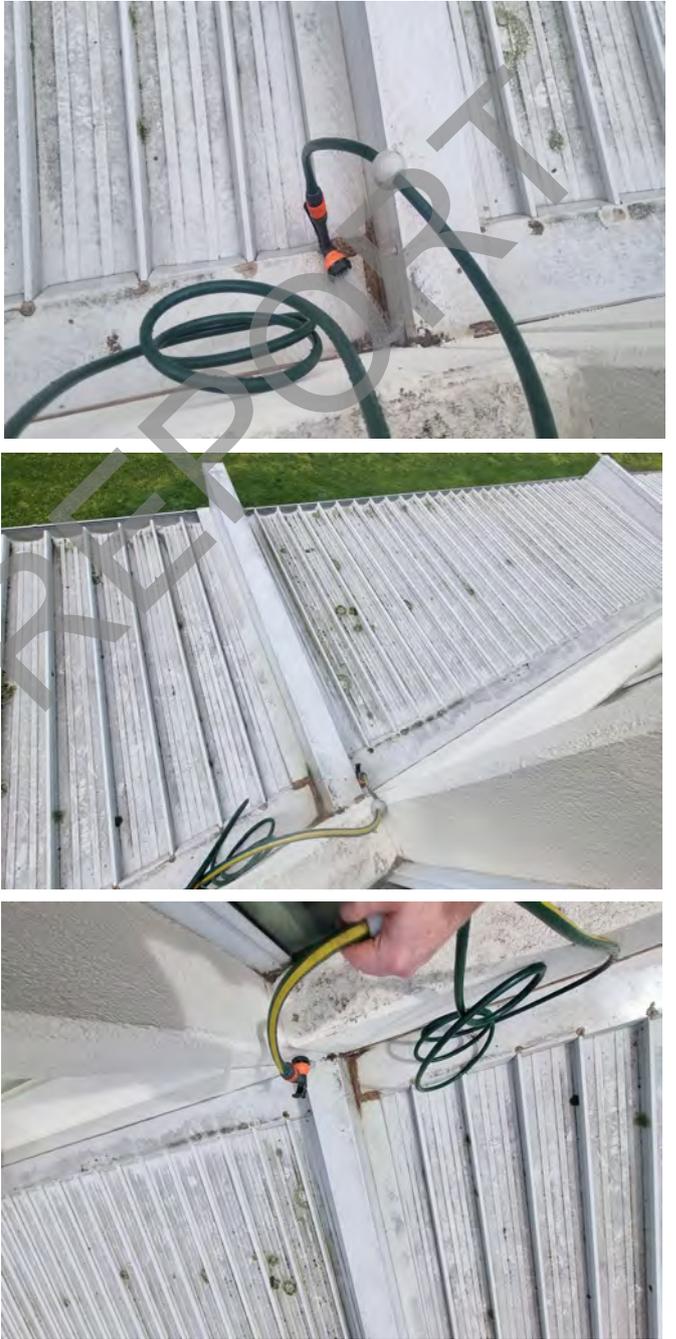
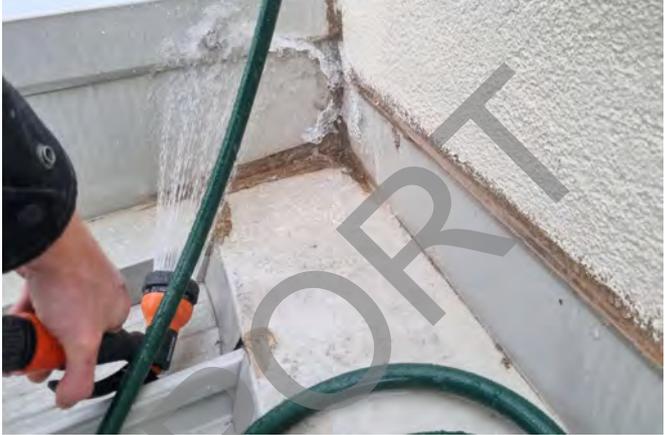
Item	Details	Photographic Details
4.	<p><b><u>Location:</u></b></p> <p>Level 2 - Roof sheeting.</p> <p><b><u>Finding:</u></b></p> <p>The following areas on the roof sheeting were tested, in order to identify if, and where, there was a point of vulnerability in the roof sheeting that was leading to the moisture ingress into the area below.</p> <p>In the order listed below, the following are some of the areas on the roof that were tested:</p> <ul style="list-style-type: none"> <li>• Unit 18 - directly onto the flashing (<b>Image 1</b>).</li> <li>• Unit 16 - directly onto the flashing (<b>Image 2</b>).</li> <li>• Unit 16/18 boundary - directly onto capping (<b>Image 3</b>).</li> <li>• Unit 16/18 boundary - underneath capping from Unit 18's side (<b>Image 4</b>).</li> </ul> <p>After emulating rainfall for just under 30 minutes, in these areas combined, no evidence of moisture ingress was noted.</p> <p>It is worth noting that during this stage of the inspection, it began to rain.</p> <p><b><u>Recommendations:</u></b></p> <p>See <b>Part#4</b> of this report.</p>

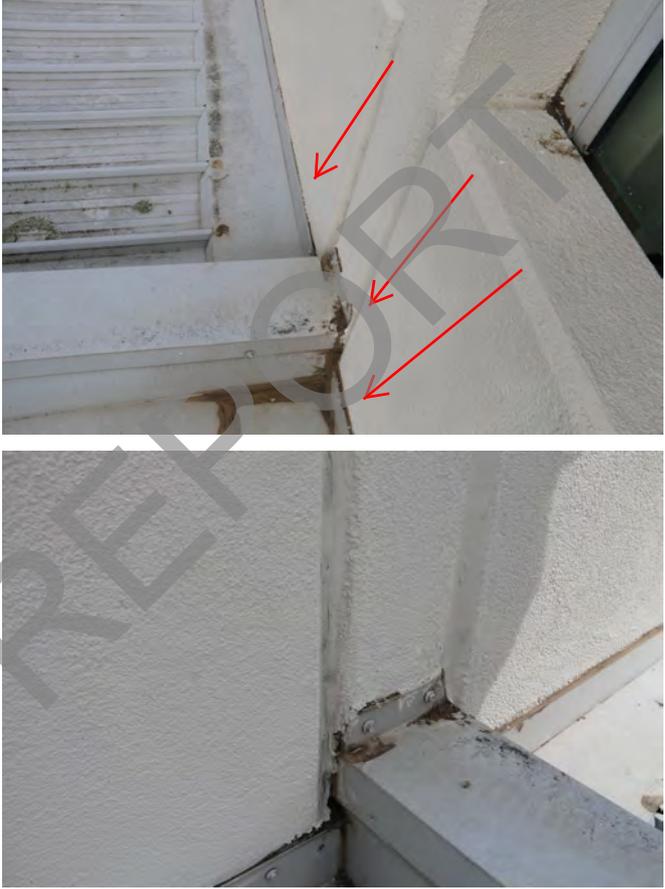
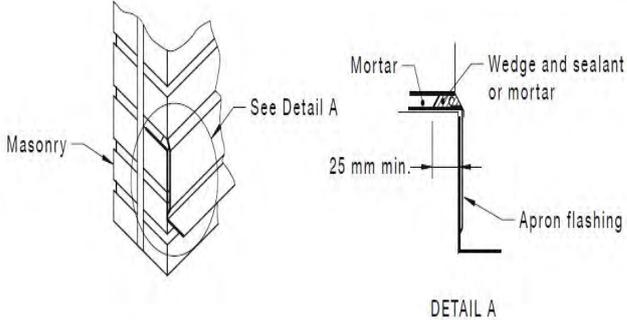
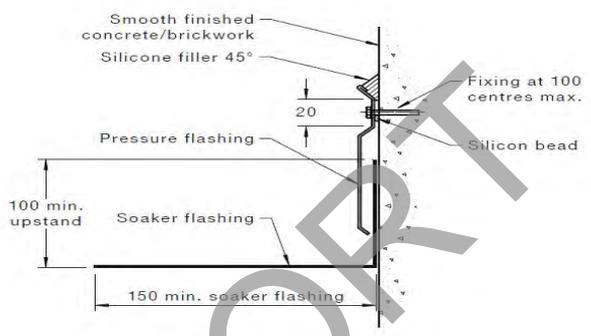
Item	Details	Photographic Details
5.	<p><b>Location:</b></p> <p>Level 2 - Roof sheeting.</p> <p><b>Finding:</b></p> <p>It was noted at the time of the inspection that the capping/flashings upturns were detailed poorly. They have been upturned on the external wall cladding with only flexible sealant protecting this junction from water penetration.</p> <p><b>Clause 8.4, Wall And Step Flashings, from HB39-2015, Installation Guide to Metal Roofing and Walling Cladding, states:</b></p> <p><i>"For material, thickness, expansion, sizes and covers, and wall and step flashings, see Clause 8.1. Additionally, the following points are to be observed [see Figure 8.4 (A)]:</i></p> <p>[...]</p> <p><i>(b) All wall and step flashings are to be fastened into masonry walls with galvanised aluminium/zinc alloy-coated or aluminium/zinc/magnesium-coated sheet metal wedges at each end of each length and other than pressure flashings at intermittent intervals not exceeding 500 mm [see Figure 8.4 (B)]. Alternatively, sloped wall flashings are to incorporate a weathering fold fixed into a 25 mm deep saw cut see Figure 8.4(A)(b).</i></p> <p><i>(c) Pressure flashings may be used in lieu of cutting grooves into walls provided they are used only with smooth surface finished walls, e.g. smooth finished concrete or smooth finished brickwork with flush pointed mortar courses, provided [see Figure 8.4(C)]-</i></p> <p>[...]</p>

Item	Details	Photographic Details
	<p><b>Images 3 &amp; 4, show Figures 8.4 (B &amp; C), Masonry Fixing Wedges &amp; Pressure Flashing, from HB39-2015</b></p> <p><b>Recommendations:</b></p> <p>The OC is to engage a suitably qualified contractor to install pressure flashings along this boundary.</p>

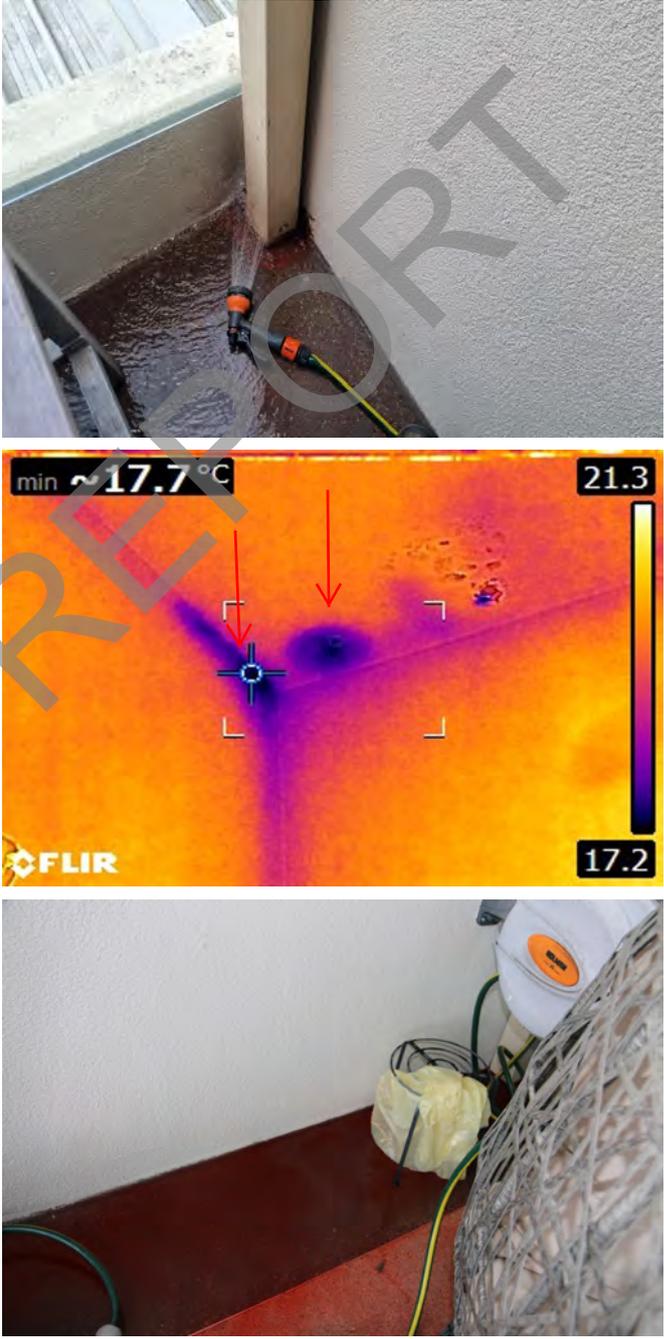
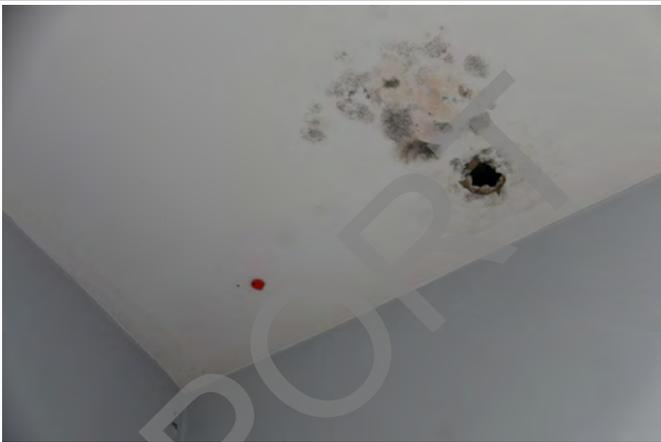
Item	Details	Photographic Details
6.	<p><b>Location:</b> Unit 18 - Level 2 Balcony.</p> <p><b>Finding:</b> Upon emulating rainfall on the level 2 balcony of Unit 18, as shown in <b>Image 1</b>, water ingress into the ceiling of the living area below was noted, as indicated by the cold spot (dark purple) present upon viewing the area with a thermal imaging camera, as shown <b>Image 2</b>.</p> <p>Following this, the Living Area's ceiling within Unit 17 was also inspected; however, no observable evidence of moisture ingress was noted.</p> <p>In light of the fact that it had been raining and the roof sheeting nearby had just been heavily tested, red food colouring was poured onto the balconies surface, as shown in <b>Image 3</b>, in order to confirm that it was surface moisture from the balcony inducing the leak.</p> <p>Shortly after doing so, the red water was seen seeping through the ceiling, as shown in <b>Image 4</b>.</p> <p>Based on these results, it is clear that surface moisture from the balcony is reaching the internal side of the ceiling underneath.</p> <p><b>Recommendations:</b> See <b>Part#4</b> of this report.</p>

A photograph showing a close-up of a white ceiling. There is a significant area of water damage, including a large, irregular brown stain and a smaller, dark circular hole. A small red dot is visible on the ceiling surface below the main stain.

After testing the Level 2 Roofs of Unit 16 & 18 and the Level 2 Balcony of Unit 18, given that water ingress was noted only during the latter, **it is clear that there is a point of failure within the weatherproofing system of the balcony.** This notion was bolstered by the fact that upon dye testing, the balcony surface, the coloring came through to the ceiling beneath.

### Unit 18 - Level 2 Balcony, Re-instatement.

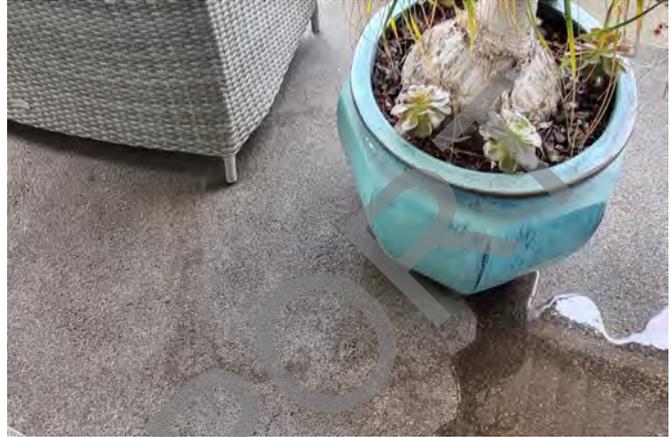
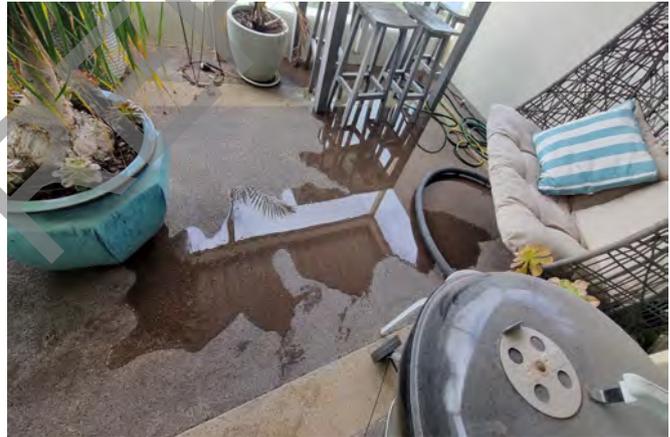
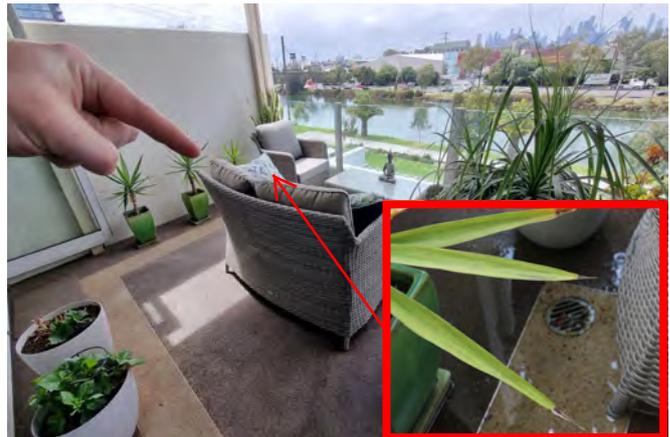
Item	Details	Photographic Details
7.	<p><b>Location:</b></p> <p>Unit 18 - Level 2 Balcony.</p> <p><b>Finding:</b></p> <p>It was noted at the time of the inspection that floor surface of Unit 18's level 2 balcony was not tiled. Based on discussion with one of the residents of the unit, it was established that new surface was applied in order to address issues relating to the balcony's surface falls. Despite this, water still accumulates in the center of the balcony, subsequently inducing staining, as shown in <b>Image 1</b>.</p> <p>Furthermore, while undertaking water testing on this balcony it was noted that surface moisture first fell to this suspected low point, before making its way to the balcony's outlet, as shown in <b>Images 2 &amp; 3</b>.</p> <p>In light of this, it appears as though the issues pertaining to the surface's falls were not resolved despite the previous works.</p> <p><b>Recommendations:</b></p> <p>When undertaking the works discussed in <b>Part#4</b> of this report, care should be taken to ensure that the balcony's floor surface is provided with consistent falls of no less than 10 mm/ m towards the designated outlet.</p>

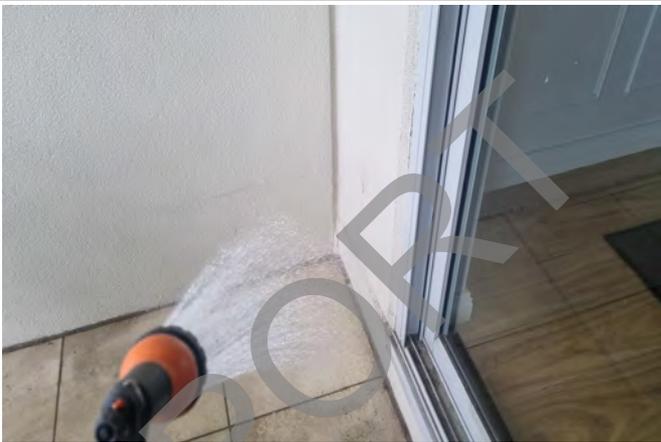
Item	Details	Photographic Details
8.	<p><b><u>Location:</u></b></p> <p>Unit 18 - Level 1 Balcony.</p> <p><b><u>Finding:</u></b></p> <p>After emulating rainfall for approximately 10 minutes on the level 1 balcony of Unit 18, as shown in <b>Image 1</b>, no evidence of moisture ingress into the living area ceiling of Unit 17 below was noted.</p> <p><b><u>Recommendations:</u></b></p> <p>See <b>Part#4</b> of this report.</p>

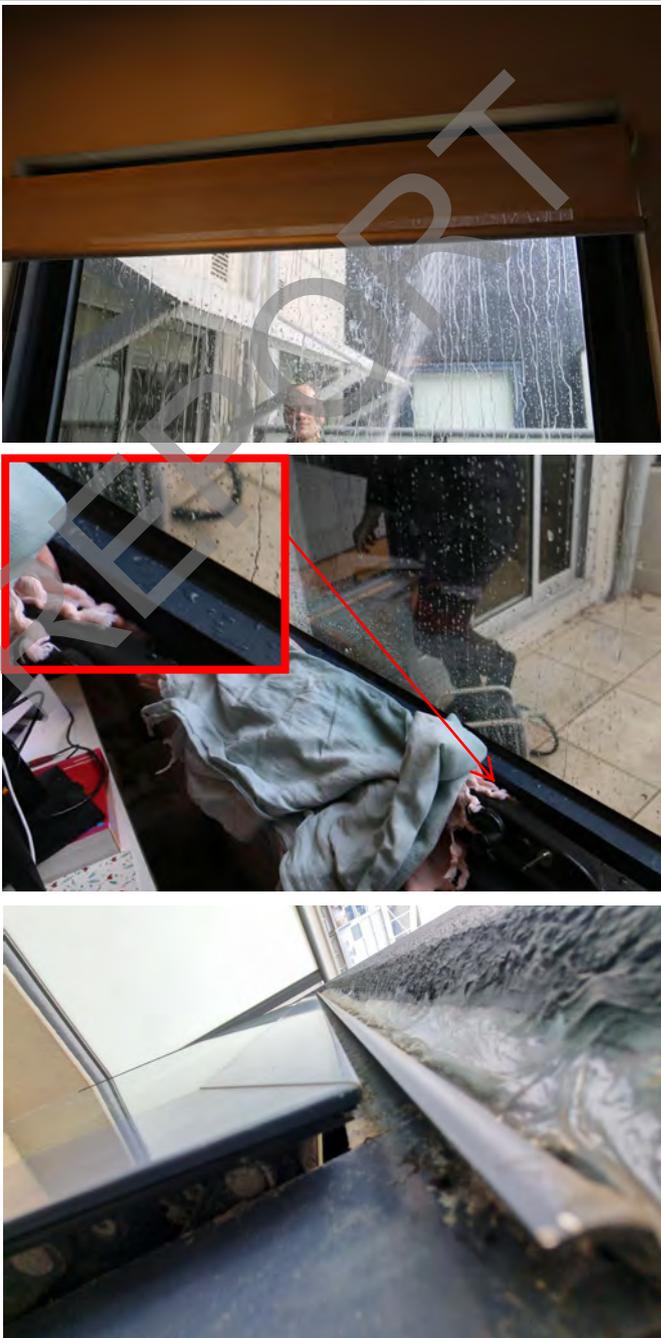
Item	Details	Photographic Details
9.	<p><b><u>Location:</u></b></p> <p>Unit 17 - Ground Courtyard.</p> <p><b><u>Finding:</u></b></p> <p>Upon emulating rainfall on the external facade above the study's window, as shown in <b>Image 1</b> , water began to bypass the window frame and enter and enter into the study, as shown in <b>Image 2</b>.</p> <p>Based on this test, it is clear that window frame is not weather-tight and is not an effective barrier against rain.</p> <p>It is worth mentioning that an excessive amount of silicone has been applied liberally to the head of the window, in an attempt to resolve the issue; however, this has proved to be ineffective.</p> <p><b><u>Recommendations:</u></b></p> <p>See <b>Part#4</b> of this report.</p>

The source of the water ingress at the window within the study, is simply from the external face of the window. This was confirmed upon emulating rainfall on the window and witnessing water ingress on the other side. It appears as though caulking has been applied liberally previously, in what was likely an attempt to prevent future water ingress; however, this is not long term, or effective (evidently), solution to the water ingress.

Engage a suitably qualified contractor to remove the window, adjust the opening size (if deemed necessary), and re-install the window ensuring flashings and provisions for movement are provided in accordance with the manufacturer's recommendations. Acceptance tests should be carried out upon the completion of these works.

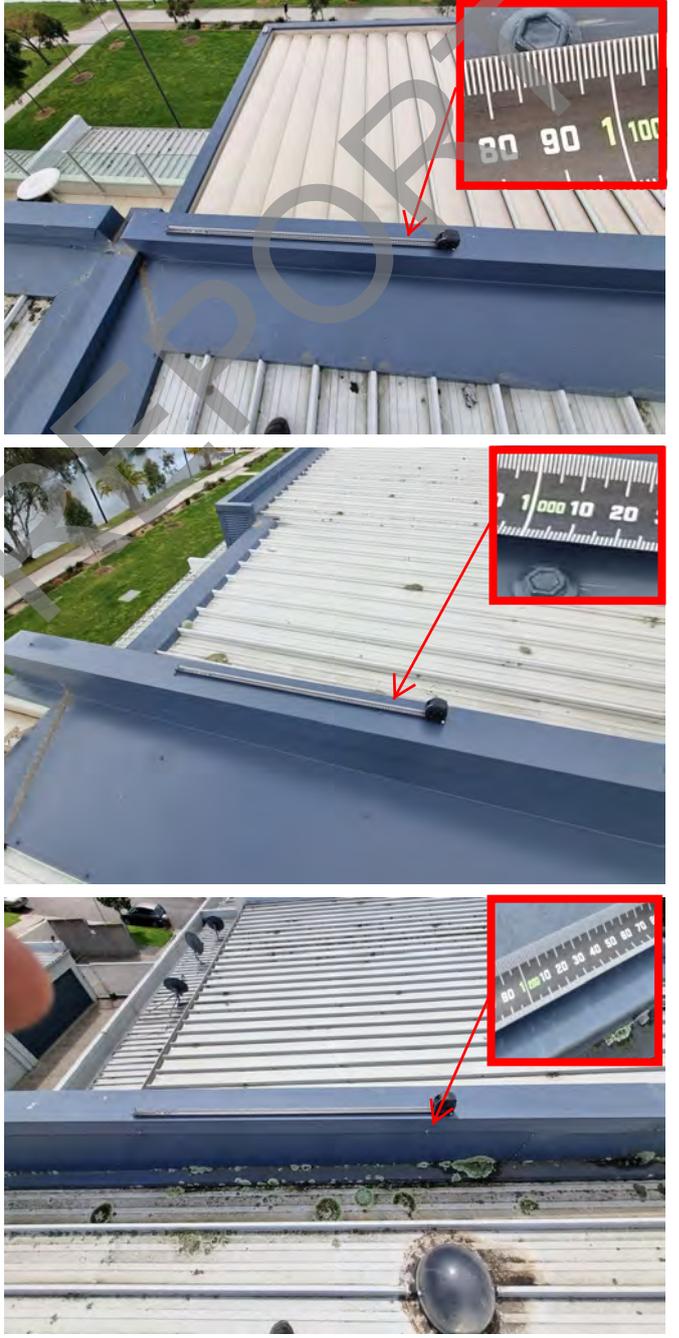
Item	Details	Photographic Details
10.	<p><b>Location:</b> Rooftop - Capping</p> <p><b>Finding:</b></p> <p>It was noted at the time of the inspection that the fixings in some of the capping were spaced too far apart. <b>Images 1 - 3</b>, show how the centers of some fixings approximately 1000 mm apart. This is despite the fact that the minimum requirement is to fix the capping every 500 mm.</p> <p>This is a safety issue as unsecured flashings have been known to come loose from buildings during strong wind events and there is the potential for someone to be seriously injured or killed if they are hit by one of these flying off from a rooftop.</p> <p><b>Clause 8.7, All Other Flashings And Cappings</b>, from <b>HB39-2015, Installation Code for Metal Roof and Wall Cladding</b>, states:</p> <p><i>"All other flashing and capping to be fastened to the metal roof covers at intervals not exceeding 500 mm with self-drilling roof screws into the roof supports it rivets into the roof cover. All self-drilling self-tapping roof screws are to be fastened on crests of roof covers. For particular situations, the following is to be taken into consideration:</i></p> <p>[...]</p> <p><i>(b) Parapet capping [...] to be fixed to parapet walls at intervals not exceeding 500 mm with masonry anchors and cleats that permit longitudinal expansion and contraction. A minimum fall of 3° to be provided across the width of the flashing to diver water back onto the roof coverings so as to prevent the water from dripping down the fascia causing unsightly staining [see Figure 8.7 (A)]</i></p>

Item	Details	Photographic Details
	<p><b><u>Recommendations:</u></b></p> <p>Additional fixings should be installed throughout the rooftop capping, ensuring that they are secured with fixings at least every 500 mm.</p>

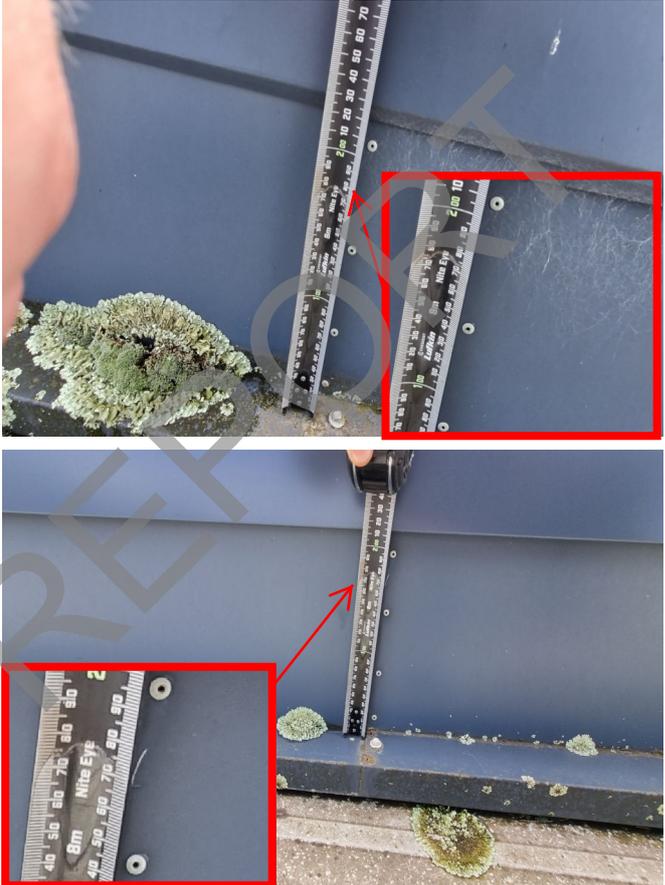
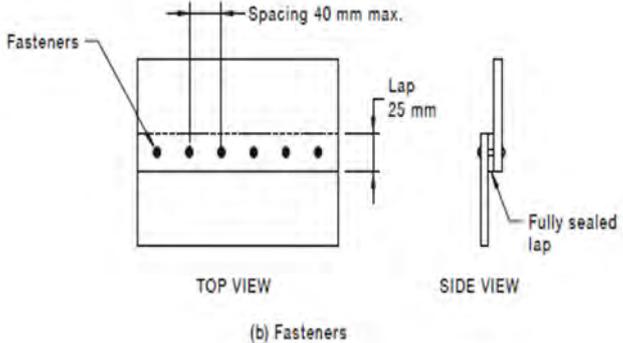
Item	Details	Photographic Details
11.	<p><b>Location:</b> Rooftop - joints.</p> <p><b>Finding:</b> It was noted at the time of the inspection, that some of the joints had been insufficiently fixed. <b>Images 1 &amp; 2</b>, demonstrate how the spacings between the fixings on the joints exceeds 40mm, despite this being the maximum allowable distance between fixings on lap joints in flashings, according to Australian Standards.</p> <p>Joints in roof capping can be considered points of vulnerability when it comes to moisture ingress, since it is where two points of discontinuity in the sheets meet. Sealing the joints, in conjunction with sufficiently fixing them, further mitigates the likelihood of moisture ingress from them.</p> <p><b>Clause 5.8.3, Fastening and Sealing with Sealants, from HB39-2015, Installation Code for Metal Roof and Wall Cladding, states:</b></p> <p><i>"Joints in aluminium/ zinc, aluminium/ zinc/ magnesium alloy- coated steel, prepainted steel flashings and capping are to be fastened at intervals not exceeding 40 mm and silicone sealed with neutral cure silicone sealants [...]"</i></p> <p><b>Image 3</b> shows <b>Figure 2.9, Sealant Joints from HB39-2015</b>, which illustrates the minimum requirements for a joint detail.</p> <p><b>Recommendations:</b> Additional fixings should be added to joints that have been insufficiently fixed. If it is noted that there is no silicone between said joints, then all the fixings will need to be removed and the joint sealed, prior to the installation of additional fixings.</p>

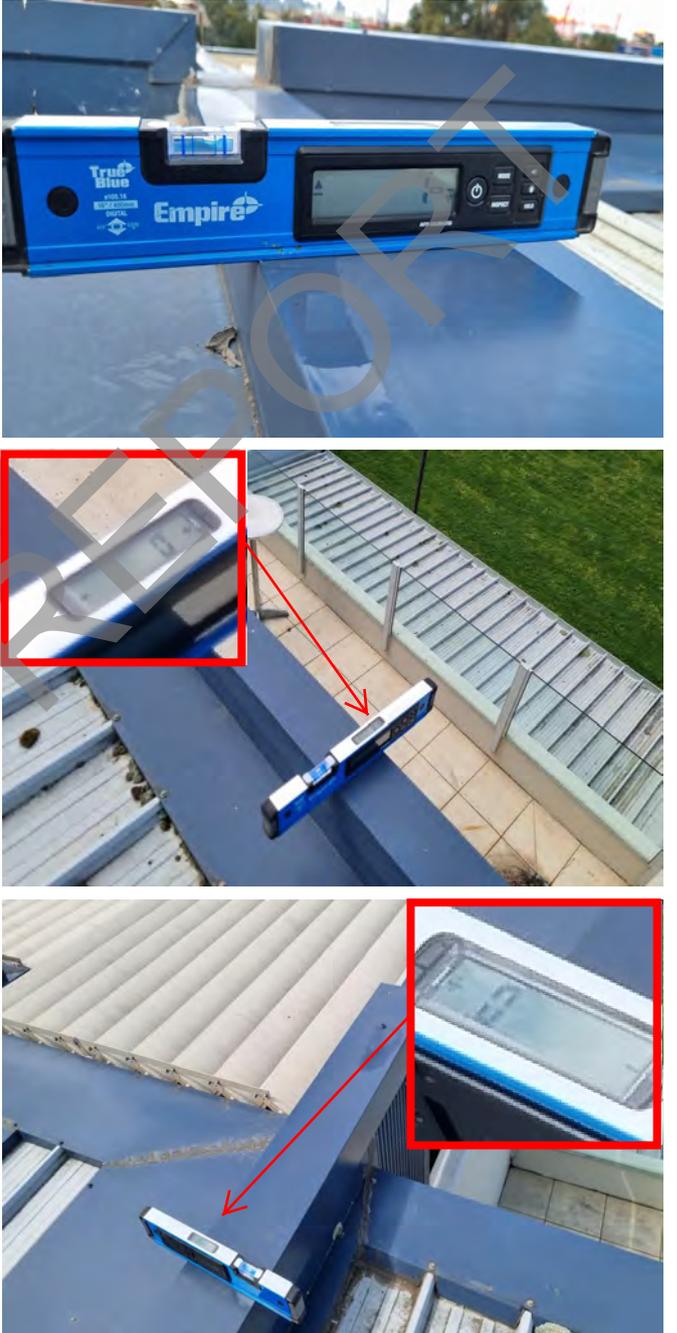
Item	Details	Photographic Details
12.	<p><b><u>Location:</u></b></p> <p>Rooftop - Cappings</p> <p><b><u>Findings:</u></b></p> <p>It was noted at the time of the inspection that the cappings on the had little to no fall on them (0 - 1 degrees), as shown in <b>Images 1 - 3</b>.</p> <p>It is worth noting that Australia Standards require parapet cappings to have a fall of 3 degrees in order to divert water away from the facade. When neither side falls to a facade it is still good practice to ensure that the horizontal surface has enough fall to facilitate the complete drainage of water.</p> <p><b>Clause 8.7, All Other Flashings And Cappings, from HB39-2015, Installation Code for Metal Roof and Wall Cladding, states:</b></p> <p><i>"All other flashings and cappings to be fastened to the metal roof cover at intervals not exceeding 500 mm with self- drilling roof screws into the roof supports or rivets into the roof cover. All self-drilling self- tapping roof screws are to be fastened on crests of roof covers. For particular situations, the following is to be taken into consideration:</i></p> <p>[...]</p> <p><i>(b) Parapet cappings [...] to be fixed to parapet walls at intervals not exceeding 500 mm with masonry anchors and cleats that permit longitudinal expansion and contraction. A minimum fall of 3° to be provided across the width of the flashing, to divert water back onto the roof coverings so as to prevent the water from dripping down the fascia causing unsightly staining [see Figure 8.7(A)]."</i></p> <p>[...]"</p> <p><b><u>Recommendations:</u></b></p> <p>The OC to engage a suitably qualified contractor too adjust the cappings to ensure that their falls are in accordance with Australian Standards and effectively facilitate the drainage of water from their surfaces.</p>

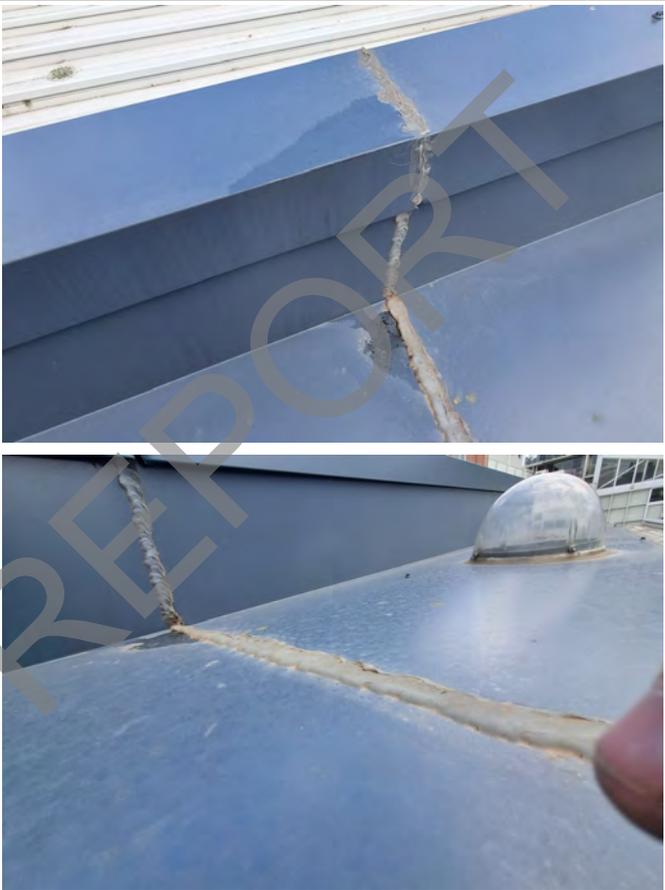
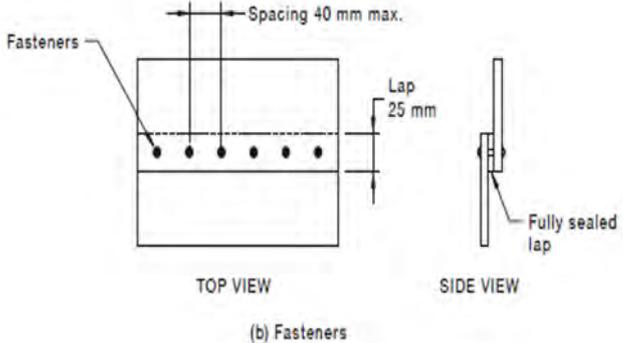
Item	Details	Photographic Details
13.	<p><b>Location:</b></p> <p>Rooftop - Flashing/Capping Joint.</p> <p><b>Finding:</b></p> <p>It was noted at the time of the inspection that the flashing/capping joint was had been liberally sealed and was preventing a small amount of water from drainage, as shown in <b>Images 1 &amp; 2</b></p> <p>Sealant should only need to be applied between lap joints, in order to mitigate these kind of obstructions.</p> <p><b>Clause 5.8.3, Fastening and Sealing with Sealants</b>, from <b>HB39-2015, Installation Code for Metal Roof and Wall Cladding</b>, states:</p> <p><i>"Joints in aluminium/ zinc, aluminium/ zinc/ magnesium alloy- coated steel, prepainted steel flashings and capping are to be fastened at intervals not exceeding 40 mm and silicone sealed with neutral cure silicone sealants</i></p> <p><i>Sealants are to be sandwiched between the lap of joints to provide a positive seal and to protect the silicone sealant from exposure to ultraviolet radiation (see Figure 2.9)"</i></p> <p><b>Image 3</b> shows <b>Figure 2.9, Sealant Joints from HB39-2015</b>, which illustrates the minimum requirements for a joint detail.</p> <p><b>Recommendations:</b></p> <p>The OC should engage a suitably qualified contractor to seal the detail the joints on the flashings so that they facilitate the complete drainage of water from the upstream side of the roof.</p>

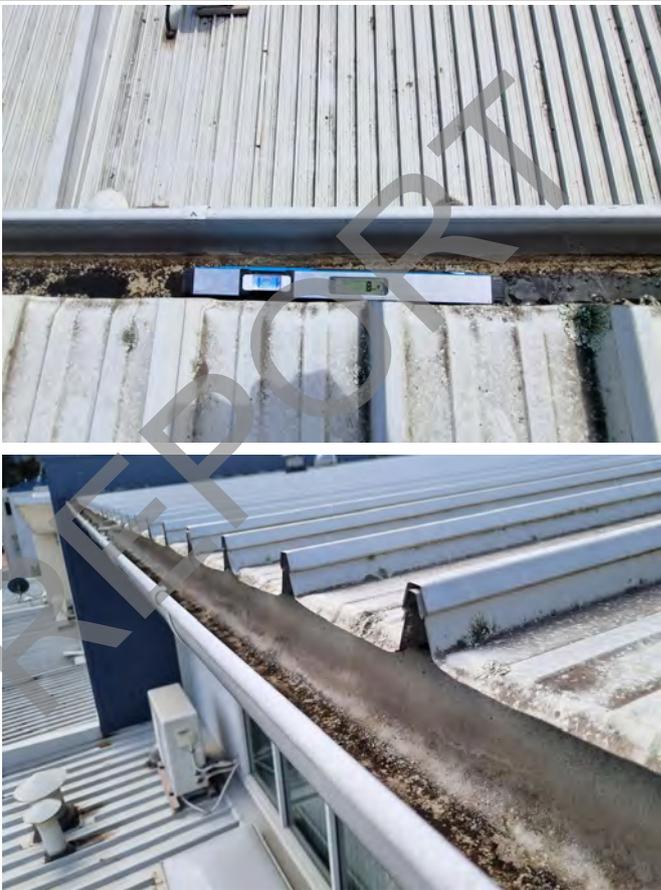
Item	Details	Photographic Details
14.	<p><b>Location:</b></p> <p>Roof.</p> <p><b>Finding:</b></p> <p>It was noted at the time of the inspection that at least one of the eaves gutters fell away from the outlet. <b>Images 1 &amp; 2</b>, illustrate the direction of fall with respect to the location of the outlet for that particular span of eaves gutter.</p> <p>The spirit level reading in <b>Image 1</b> demonstrates how the magnitude of this incorrect fall is at least 8 mm/m.</p> <p><b>Clause 5.6, Eaves Gutters</b>, from <b>HB39-2015, Installation Code for Metal Roof and Wall Cladding</b>, states:</p> <p><i>"In addition to the recommendations of Clause 5.2, the following apply to the eaves gutters, including any fascia mounted eaves gutters, deck-mounted eaves gutter and concealed eaves gutters [see Figure 5.6(A)]:</i></p> <p>[...]</p> <p><i>(f) Fall Eaves gutter brackets to be installed with a uniform fall towards the outlets to achieve an effective gradient with no permanent ponding. A minimum fall of 1:500 will ensure complete drainage.</i></p> <p>[...]"</p> <p><b>Recommendations:</b></p> <p>The falls in the eaves gutter should be adjusted to facilitate the complete drainage of water within them.</p>

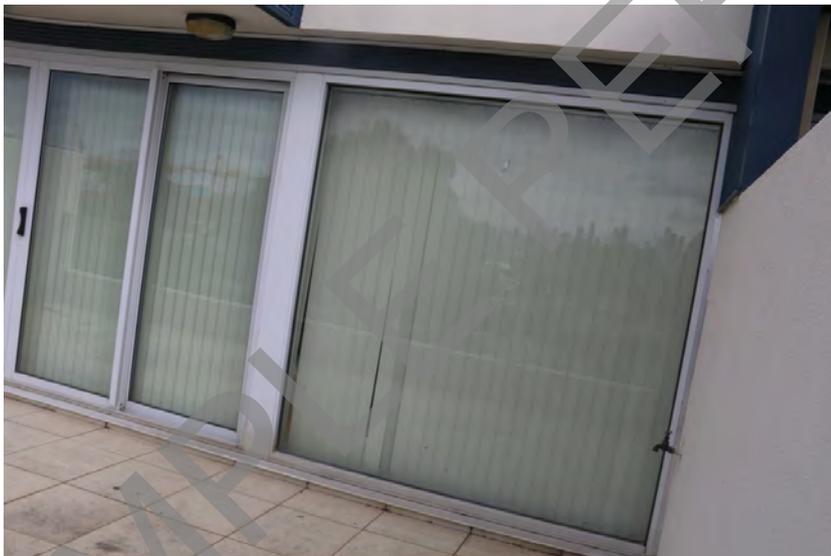
**Image 1: Unit 16's Balcony.**

Despite this, a previous investigation carried out by other contractors identified the point of failure to be on the Neighboring (Unit 16) unit's Level 2 - Balcony. Specifically, the points of vulnerability were noted as being the "*cracks and holes in external wall and window frame.*", seen in **Image 1**. **During the investigation no tests were carried out to confirm whether or not these were contributing factors to the leak. Prior to any internal repair works being carried out. This should be ruled out as an additional point of water ingress.**
