Forensic Water Leak Investigation Report

1 Sample Street, Melbourne VIC 3000 (PS XXXXXX)

Part 1: Inspection Notes

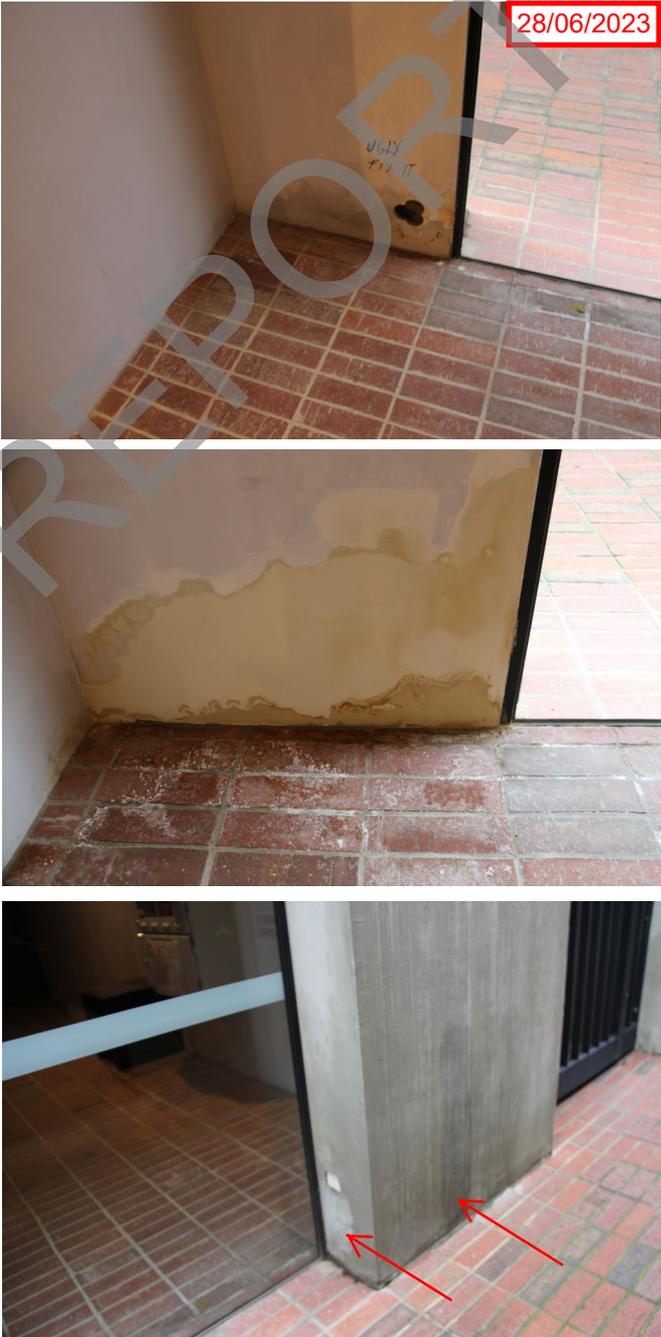
Item	Details	Photographic Details
1.	<p>Location:</p> <p>Ground Floor Lobby</p> <p>Initial Conditions:</p> <p>A water leak was originally noted into the ground floor entry lobby of the building at the time of Roscon's previous Forensic Building Defects Inspection Report in June 2023. The condition of the internal wall at this time can be seen in Image 1.</p> <p>Since this original inspection for the Forensic Building Defect report, the degree to which the wall had deteriorated since is difficult to ascertain as it had recently been patched, as shown in Image 2.</p> <p>Nevertheless, the new wall was already, visually, showing signs of deterioration as indicated by the darkened areas along the bottom. Furthermore, the amount of efflorescent staining on the brick appears to have increased as well.</p> <p>Externally, it can be seen that moisture is being wicked up the wall, as is indicated by the darkened render along the base of the wall. There is also a section of render that has come loose and delaminated from the wall substrate, likely as a result of this excess moisture, seen highlighted in Image 3.</p> <p>While undertaking the previous inspection, Roscon identified excessive moisture within the cavity of the wall, as shown in Image 4. The metal frame and surrounding building elements inside the cavity were heavily corroded and damaged when the cavity was originally inspected.</p> <p>The internal moisture readings were highest along the North-Western internal wall, where the visible moisture was highest, and extends in a radius outwards. Moisture was also noted in a close proximity to the along the entire length of the glass screen and swing door. The locations of moisture can be seen indicated in Image 5.</p>

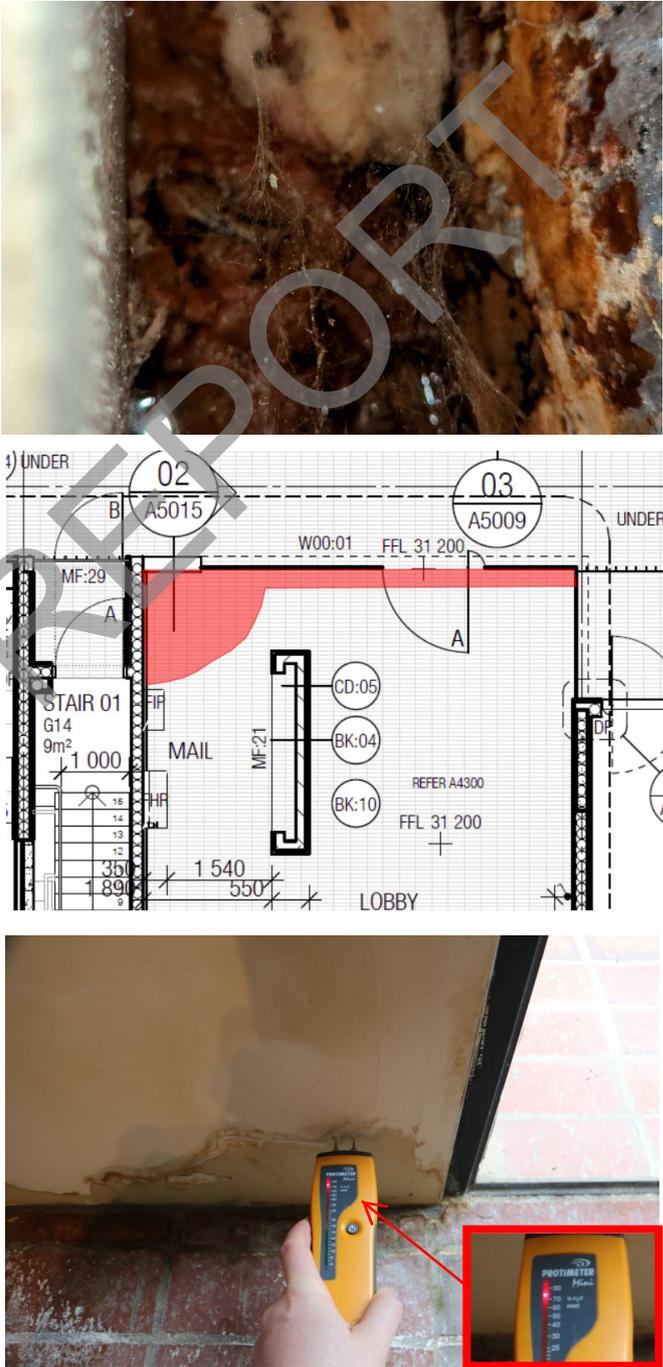
Item	Details	Photographic Details
	<p>Moisture readings were obtained throughout the ground floor lobby.</p> <ul style="list-style-type: none"> • A moisture reading of 75% WME (Wood Moisture Equivalent) was obtained at the internal wall, as seen in Image 6. • A moisture reading of 22% WME was obtained approximately 2 meters from the wall in the brick floor, as seen in Image 7. • A moisture reading of approximately 34% was obtained along the entire length of the glass windows and sliding door, as seen in Image 8. <p>The presence of moisture was again confirmed upon viewing the lobby areas with a thermal imaging camera, it was found that the wall and surrounding brick floor were already completely saturated, as indicated by the dark blue / purple regions, as shown in Image 9.</p> <p>The lower section of wall and surrounding brick floor were completely saturated at the time of inspection prior to any water testing occurring.</p>

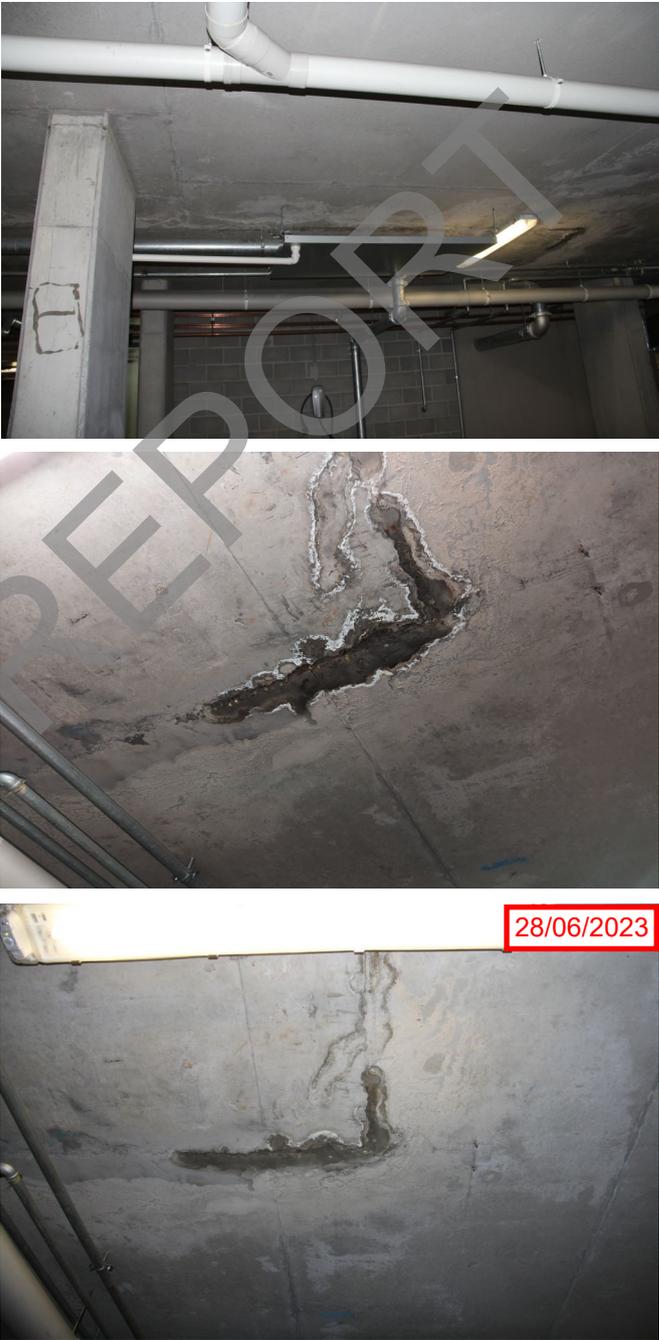
Item	Details	Photographic Details
2.	<p>Location:</p> <p>Basement - Car Parks G02 & G05.</p> <p>Initial Conditions:</p> <p>The leak is occurring above the car parking spaces G02 & G05, as shown in Images 1 & 2. A drip tray has been installed underneath part of the staining to the underside of the slab however this does not cover the full affected area.</p> <p>Since the original inspection for the Forensic Building Defect report, undertaken in June 2023, the overall condition of the underside of the concrete slab has deteriorated further. This was indicated by the increase of white efflorescent staining noted around a section of the leak, as seen in Images 2 & 3.</p> <p>Please note that Image 2, was not taken prior to the commencement of water testing.</p> <p>The leak is occurring below the wall and window/ opening threshold, mentioned in the previous item, as shown in Image 4.</p>

On the other hand, the water ingress into the basement above car spaces G02 & G05 and T07 are likely being caused by failures or deficiencies with the installation in the waterproofing membrane directly above the locations of the leaks.

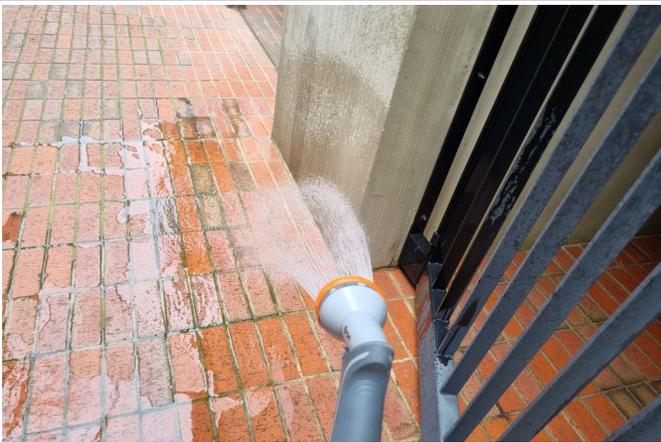
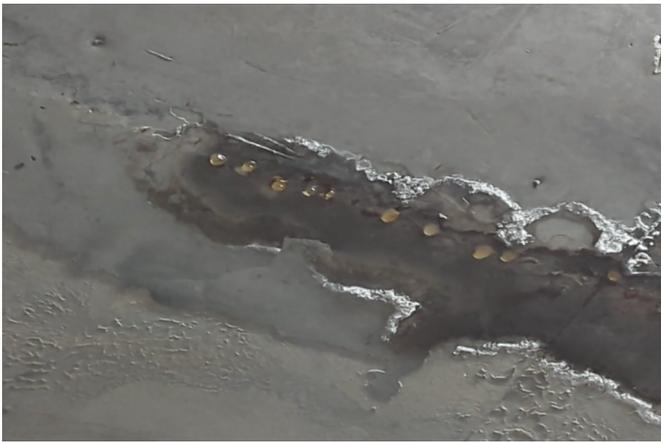
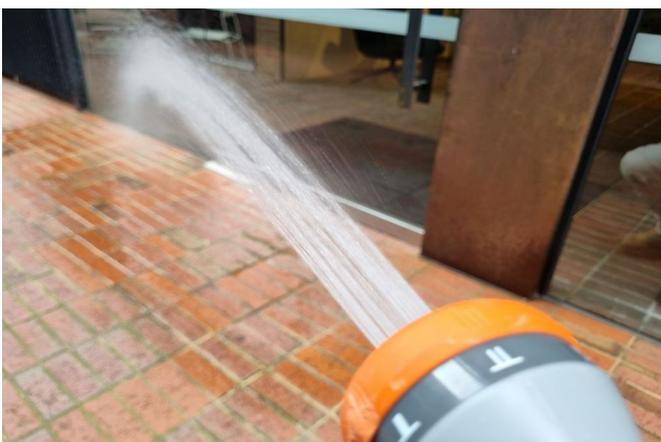
Item	Details	Photographic Details
3.	<p>Location: Ground Floor Lobby.</p> <p>Finding: After emulating rainfall along the brick floor of the central walkway and base of the external wall for 10-15 minutes, as shown in Image 1, water was witnessed actively dripping into the basement car park below, as seen in Image 2.</p> <p>Video of this water ingress can be seen in Video #1 in Part 7: Videos.</p> <p>This kind of ingress clearly demonstrates a point of failure in the waterproofing membrane system underneath the tiles or at the junction from the courtyard to the external wall of the property.</p> <p>On the other hand, there was no notable moisture increase to the surfaces inside the lobby, however, this is likely because the areas were already completely saturated before testing was conducted.</p> <p>After this area was tested, the rest of the external glazed wall was also water tested for approximately 10-15 minutes. The inside brick floor along the glazed wall was already wet before testing began and no notably difference in moisture content was recorded after testing concluded.</p> <p>Performance Requirement FP1.4 of the National Construction Code Volume One 2014 states:</p> <p><i>A roof and external wall (including openings around windows and doors) must prevent the penetration of water that could cause -</i></p> <ul style="list-style-type: none"> <i>(a) unhealthy or dangerous conditions, or loss of amenity for occupants, and</i> <i>(b) undue dampness or deterioration of building elements.</i> <p>A building defect has been noted.</p>

First and foremost, it is clear now that there are little-to-no effective waterproofing provisions in place to stop surface moisture from entering the entry lobby area. Not only is there no hob and/or strip drain to mitigate wind-driven rain from entering the lobby, the tiled system that spans the external courtyard and internal lobby appears to be homogeneous. This is allowing sub-paver moisture, via capillary action, to make its way deep into the lobby area. Furthermore, this is causing efflorescent staining to develop along the boundary of the internal area where high moisture readings are present.

1. Hydraulic Engineer to review the surface drainage provisions for the central walkway. Changes to how the stairways manage water may be necessary.
2. Remove soil and vegetation from planter boxes. Soil to be retained for reuse.

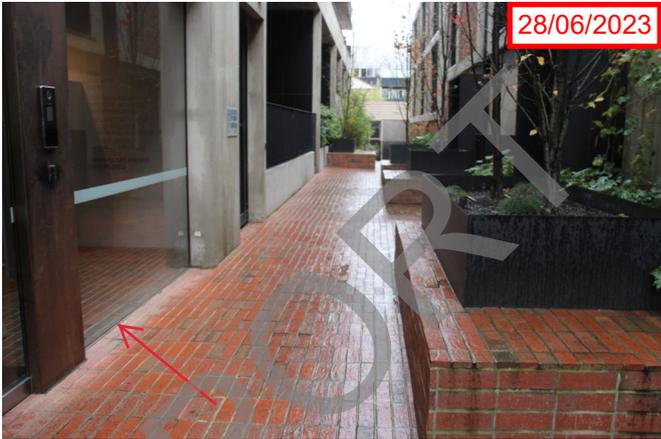
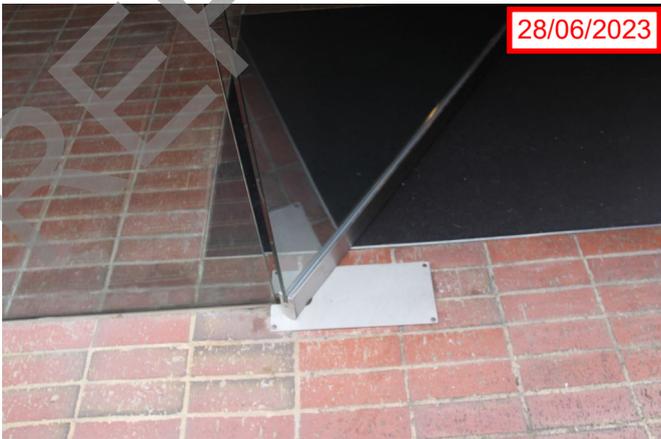
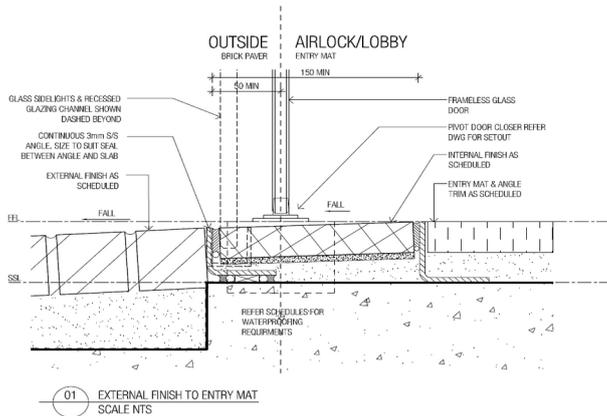
Item	Details	Photographic Details
4.	<p>Location: Ground Floor Lobby.</p> <p>Finding: It was noted at the time of the inspection that there was no visible provision for the upturn of the courtyard waterproofing membrane along the boundary of the lobby area and the external walkway, as shown in Image 1. The brick pavers installed throughout the courtyard appear to be continuous into the interior lobby of the building, as seen in Image 2. There is no separation or termination along the door threshold of the building to divide the external and internal areas.</p> <p>Upon review of the <i>CONSTRUCTION ISSUE</i> Architectural drawings, produced by XXXX drawing title "External Finish To Entry Mat" dated the XX/XX/2024 (Rev 02), (Image 3) it can be seen that the brick paving should be discontinuous between the internal and external areas at the entry door. This would allow the waterproofing membrane to be adequately terminated in order to prevent moisture from being able to spread beneath the surface level of the courtyard into the building. Unfortunately, none of these provisions have been installed and moisture is being transferred into the building beneath the brick pavers.</p> <p>The fixed glazing panels were noted to be installed in the floor in gaps between brick pavers, with no metal channel or angle being visible. It is not clear how the waterproofing membrane has been detailed at these junctions as there are no section drawings to indicate this transition and no membrane, channel or angle was noted on site.</p> <p>Due to the exterior and interior paved surface being one continuous system, sub-paver moisture is able to spread into the internal lobby area via capillary action, as shown in Image 4 and Image 5.</p>

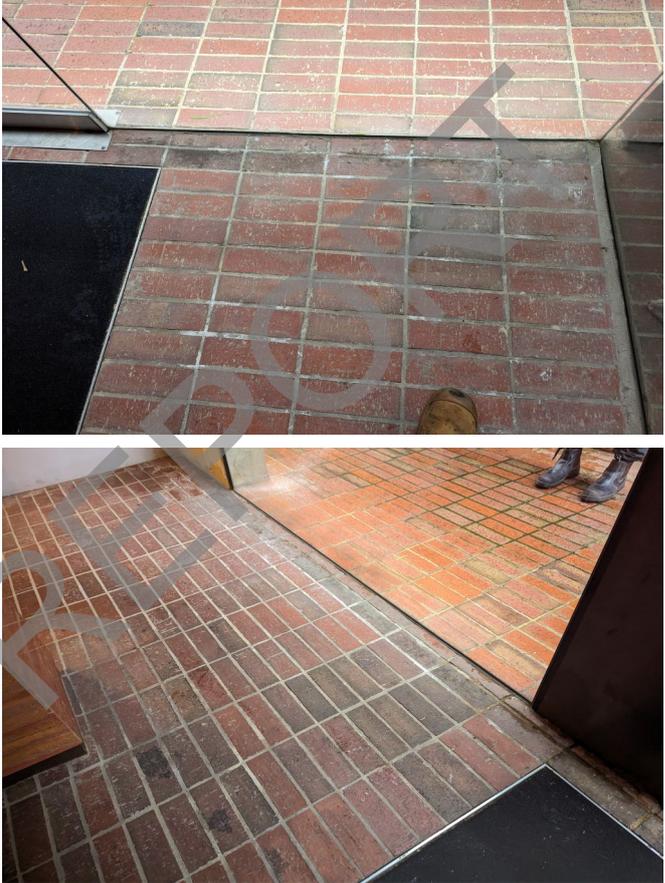
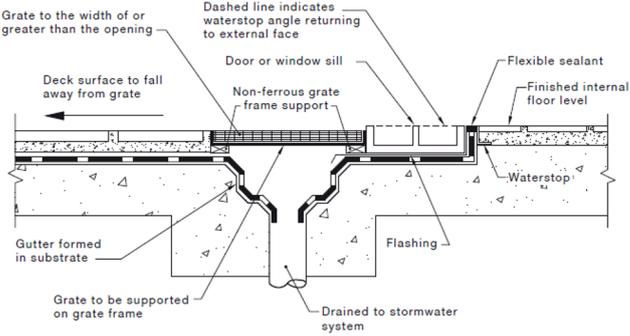
Item	Details	Photographic Details
	<p>Additionally, In the event of wind driven rain, surface water is easily able to bypass the building envelope and enter the lobby via the gap under the glazed door.</p> <p>Australian building regulations require there to be a physical barrier either via means of a hob, a strip drain or a metal angle between internal and external boundaries that are defined by windows / doors. This has not been achieved across the lobby opening and windows.</p> <p>Clause 2.8.3, Doors and Windows Onto External Waterproofed Areas, from AS4654.2-2012, Waterproofing Membranes for External Above-Ground Use, states:</p> <p><i>"For doors and windows onto external waterproofed areas, the following apply:</i></p> <p><i>(a) sub-sill flashing shall be included as part of the membrane system (see Note 1.)</i></p> <p><i>(b) where the internal and external finished floor levels do not allow an upturn, the membranes shall be fixed under the sill and terminate in the stormwater system (see Note 2)</i></p> <p>Image 6 shows Figure 2.9 from AS4654.2-2012 - Waterproofing membranes for external above ground use, which clearly illustrates the requirement for a strip drain to be installed at the opening junction of internal and external areas where the finished floor levels are the same.</p> <p>A building defect has been noted.</p> <p>Recommendations: See Part#6 of this report.</p>

7. Strip the walkway back to the bare concrete substrate. All tiles and screed to be disposed of.
8. Install strip drains at the base of openings / windows where there is no change of finish floor level between internal and external areas.

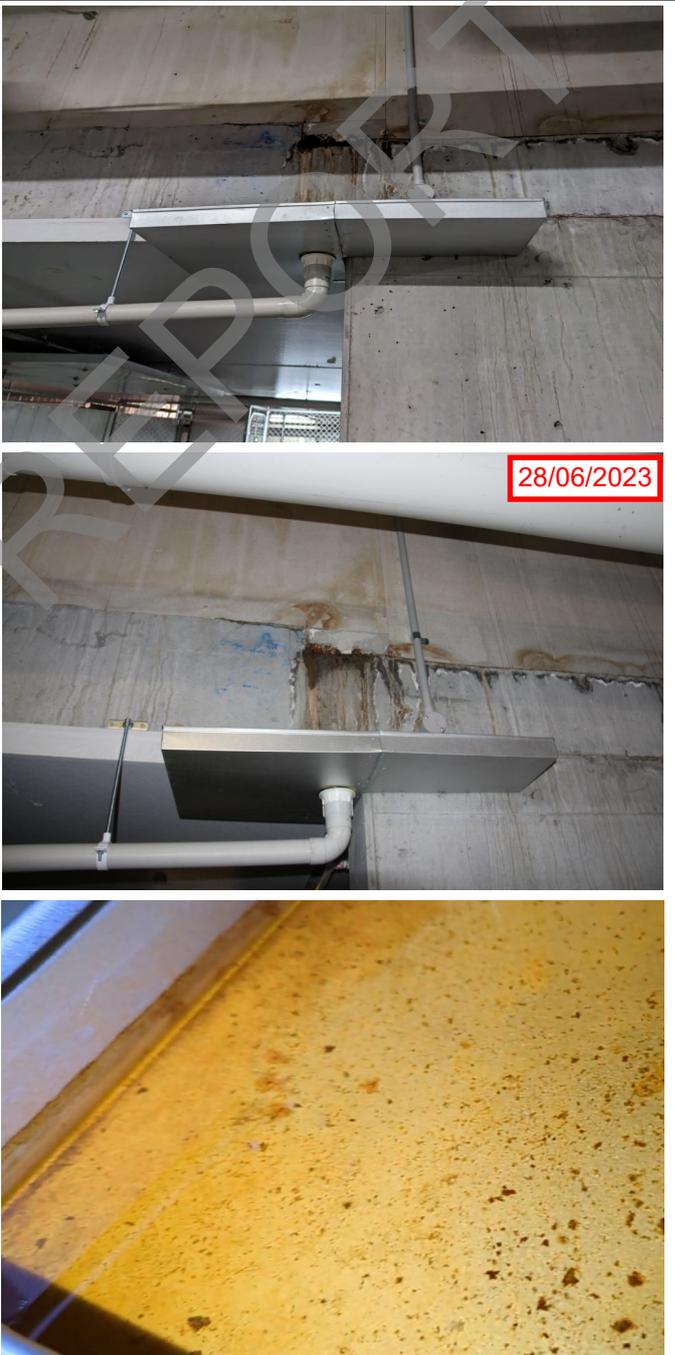
Item	Details	Photographic Details
5.	<p>Location:</p> <p>Basement - Car Park T07.</p> <p>Initial Conditions:</p> <p>The leak is occurring above Car Park T07, as shown in Image 1.</p> <p>Since the inspection for Roscon's original Forensic Building Defect Report in June 2023, the overall condition of the leak remained relatively similar, as shown in Image 2.</p> <p>The area where water was originating was visually wet prior to testing so no measurements were taken with the moisture meter or thermal imaging camera. Additionally the drip tray was found to actively be holding water, as shown in Image 3</p> <p>The leak is occurring underneath the area shown in Images 4 & 5 along the side of the central courtyards stairs.</p> <p>This water appears to be seeping from the cold joint between the two different sections of concrete. This makes sense as the area above is where the suspended slab changes level and stairs are used to access the lower central walkway. This matches with the drop in the ceiling height seen in the basement car park below.</p>

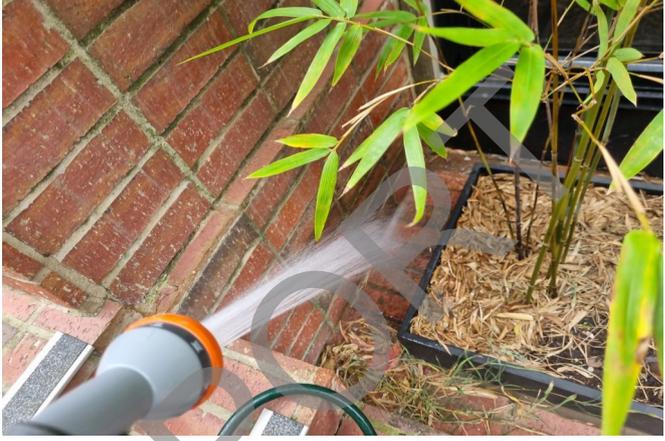
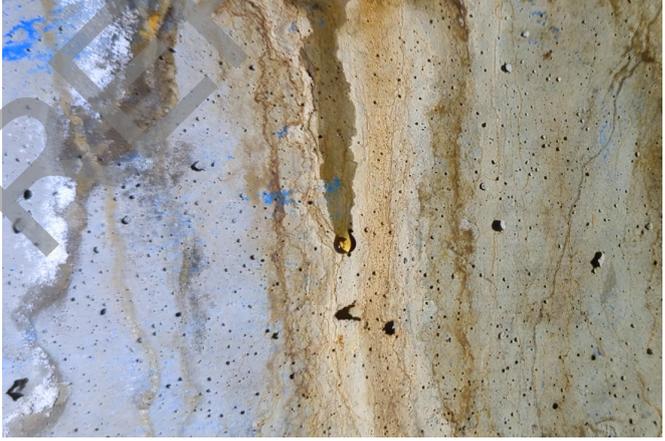
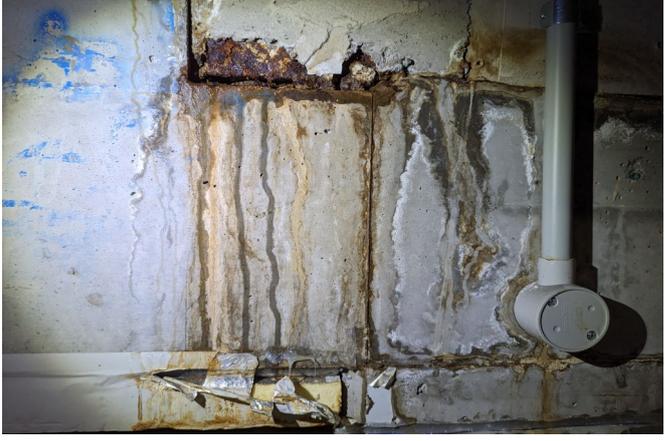
Item	Details	Photographic Details
6.	<p>Location: Basement - Car Park T07.</p> <p>Finding: After emulating rainfall on the raised planter area beside the central walkway for approximately 10-15 minutes, as shown in Image 1, water was witnessed actively dripping from this junction, as seen in Image 2. The rate of water discharge into the basement from this junction increased with water leaking from multiple points throughout this junction, as shown in Image 2.</p> <p>Video of this water ingress can be seen in Video #2 in Part 7: Videos.</p> <p>This kind of ingress clearly demonstrates a point of failure in the waterproofing membrane system underneath the pavers of the central courtyard. This entire area above ground should be waterproofed in order to prevent the penetration of water beneath the pavers and allowing it to seep from vulnerable points into the basement.</p> <p>Performance Requirement FP1.4 of the National Construction Code Volume One 2014 states: <i>"A roof and external wall (including openings around windows and doors) must prevent the penetration of water that could cause-</i> (a) <i>unhealthy or dangerous conditions, or loss of amenity for occupants; and</i> (b) <i>undue dampness or deterioration of building elements."</i></p> <p>A building defect has been noted.</p> <p>Recommendations: See Part#6 of this report.</p>

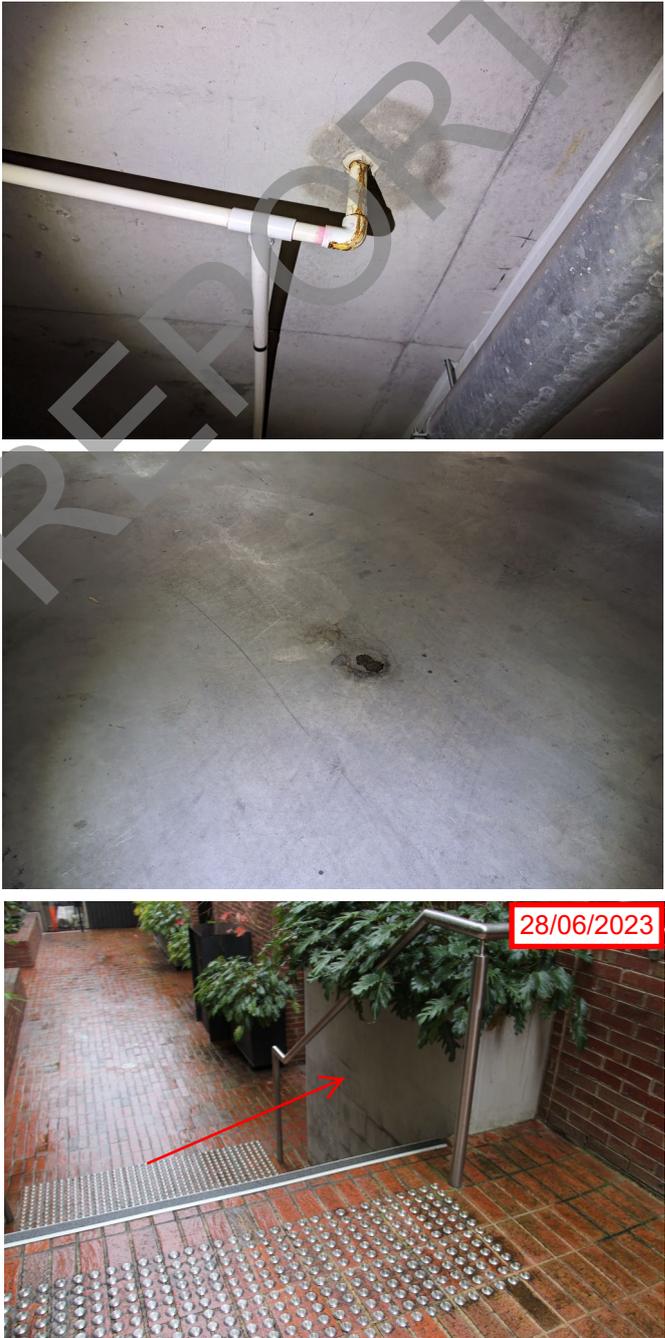
Item	Details	Photographic Details
7.	<p>Location:</p> <p>Basement - Adjacent to Car Park T06</p> <p>Initial Conditions:</p> <p>It was noted at the time of inspection that there are numerous smaller PVC pipes coming from the ground floor suspended slab that are leaking throughout the basement car park, as seen in Image 1 and Image 2. This particular pipe is adjacent to car parking space T06, as shown in Images 1 & 2.</p> <p>These pipes all appear to be irrigation provisions for the planter boxes installed throughout the central courtyard, as seen in Image 3. The planter shown here is the one directly above the pipe in Image 1 and 2.</p> <p>Prior to water testing, no measurements were taken with the moisture meter or thermal imaging camera. Dirt staining was noted around the neck of the pipe and directly underneath with the pipe itself being actively wet.</p>

Similarly, the staining emanating from the irrigation pipes penetrating the slab is being caused by an unobservable failure or deficient installation of the waterproofing system in the planter boxes themselves.

Likewise the attempts to reverse seal the irrigation pipe penetrations will not resolve the water ingress from the planter boxes long term. This is demonstrated by the fact that the penetration adjacent to car park T06 was made to leak despite the liberal application of a sealant around the underside of the penetration.

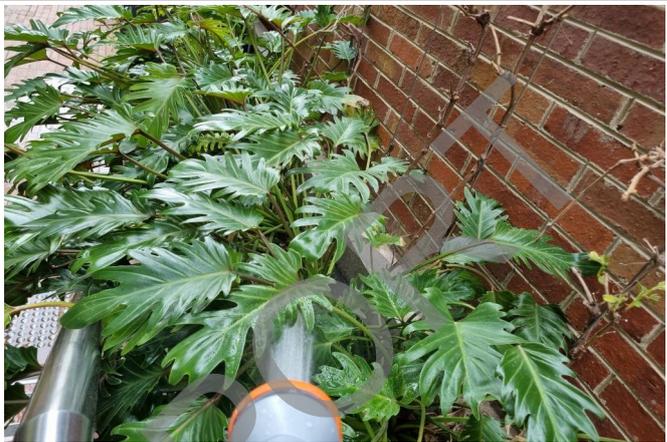
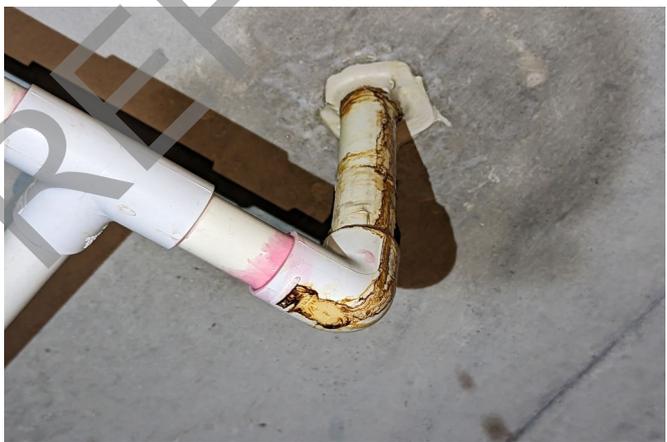
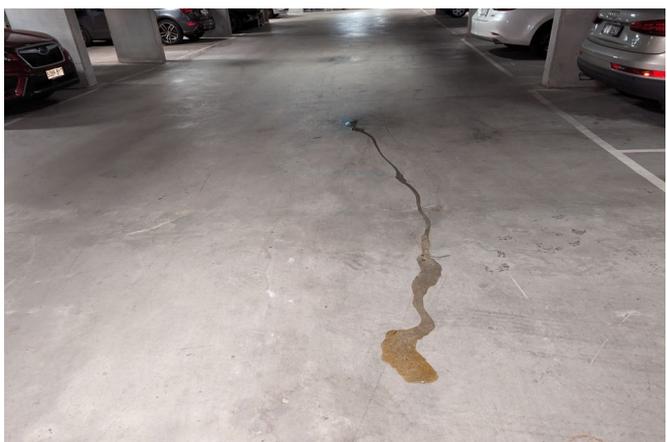
Item	Details	Photographic Details
8.	<p>Location: Basement - Adjacent To Car Park T06.</p> <p>Finding: After emulating rainfall for approximately 5 minutes in this planterbox, as shown in Image 1, water was witnessed actively dripping from what is believed to be the inlet for the irrigation system, as shown in Images 2 & 3.</p> <p>Video of this water ingress can be seen in Video #3 in Part 7: Videos.</p> <p>This kind of ingress clearly demonstrates a point of failure in the waterproofing system within the planter box itself. Furthermore, this failure was noted underneath most of the irrigation pipes. Image 4, shows another irrigation pipe which has been reverse sealed. This issue is systemic throughout the basement with many of these planter boxes showing signs of water leaking.</p> <p>Performance Requirement FP1.3 of the National Construction Code Volume One 2014 states:</p> <p><i>A drainage system for the disposal of surface water resulting from a storm having an average recurrence interval of—</i></p> <ul style="list-style-type: none"> (a) 20 years must— <ul style="list-style-type: none"> (i) convey surface water to an appropriate outfall; and (ii) avoid surface water damaging the building; and (b) 100 years must avoid the entry of surface water into a building. <p>A building defect has been noted.</p> <p>Recommendations: See Part#6 of this report.</p>
