## Occupational Health & Safety - Report

25 Bay Sample St Port Melbourne VIC 3207

## Part 1: Detailed Safety Report

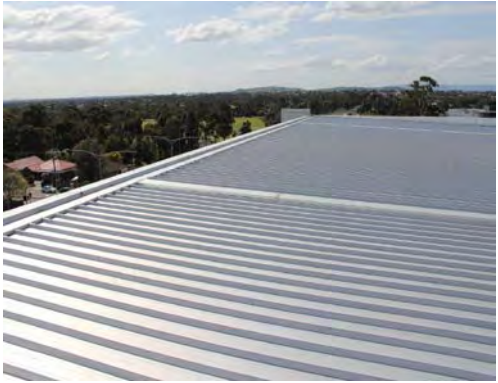
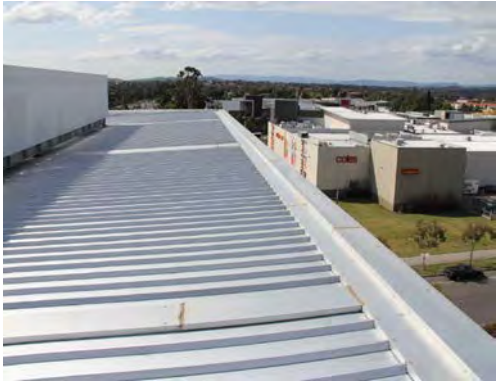
High Priority			
Item	Details		Photographic Details
1.	<p><b>Hazard:</b></p> <ul style="list-style-type: none"> <li>• Yes</li> <li>• No</li> <li>• NA</li> </ul> <p><b>Location:</b> Roof Level.</p> <p><b>Finding:</b> Extreme safety dangers for anyone accessing the roof area. Two anchor points on the north and south walls were observed, however the east and the west walls have no anchor points.</p> <p><b>Auditor's Recommendation:</b> To engage a suitable qualified contractor to install additional anchor points adjacent to the east and the west walls.</p> <p><b>Auditor's Risk Assessment:</b></p> <ul style="list-style-type: none"> <li>• Maintenance Required</li> <li>• Risk of Injury</li> <li>• Risk of Serious Injury</li> <li>• Risk Of Death</li> </ul>	<input checked="" type="checkbox"/> <input type="checkbox"/> <input type="checkbox"/>  <input type="checkbox"/> <input type="checkbox"/> <input type="checkbox"/> <input checked="" type="checkbox"/>

Quote: <input type="checkbox"/>			
Proceed: <input type="checkbox"/>			
No Action: <input type="checkbox"/>		<input type="checkbox"/> <input type="checkbox"/> <input type="checkbox"/> <input checked="" type="checkbox"/>	<p><b>Cost Estimate:</b></p> <ul style="list-style-type: none"> <li>• \$0 to \$500</li> <li>• \$501 to \$1000</li> <li>• \$1001 to \$1500</li> <li>• \$1501 to \$2000</li> <li>• &gt;\$2001</li> </ul> <input type="checkbox"/> <input type="checkbox"/> <input type="checkbox"/> <input type="checkbox"/> <input checked="" type="checkbox"/>

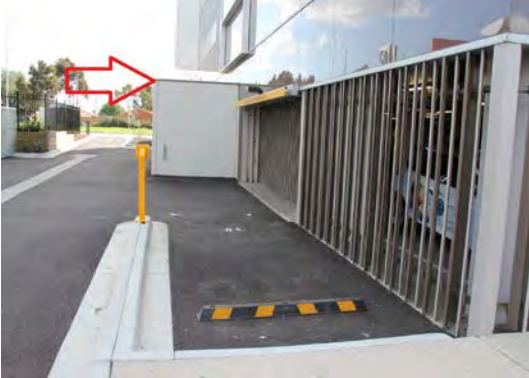
High Priority			
Item	Details		Photographic Details
2.	<p><b>Hazard:</b></p> <ul style="list-style-type: none"> <li>• Yes</li> <li>• No</li> <li>• NA</li> </ul> <p><b>Location:</b> Car park 30.</p> <p><b>Finding:</b> Owner/tenant that utilises the car park has no vision of cars coming in/out of the car park. This could result in an accident with the vehicles entering or exiting the car park.</p> <p><b>Auditor's Recommendation:</b> To engage a suitable qualified contractor to install convex parking mirror on the rear wall as indicated, so the owner/tenant utilising the car park can have a clear view on the vehicles entering or exiting from the car park.</p> <p><b>Auditor's Risk Assessment:</b></p> <ul style="list-style-type: none"> <li>• Maintenance Required</li> <li>• Risk of Injury</li> <li>• Risk of Serious Injury</li> <li>• Risk Of Death</li> </ul>	<input checked="" type="checkbox"/> <input type="checkbox"/> <input type="checkbox"/>  <input type="checkbox"/> <input type="checkbox"/> <input checked="" type="checkbox"/> <input type="checkbox"/>

<p><b>Cost Estimate:</b></p> <ul style="list-style-type: none"> <li>• \$0 to \$500</li> <li>• \$501 to \$1000</li> <li>• \$1001 to \$1500</li> <li>• \$1501 to \$2000</li> <li>• &gt;\$2001</li> </ul> <input checked="" type="checkbox"/> <input type="checkbox"/> <input type="checkbox"/> <input type="checkbox"/> <input type="checkbox"/>

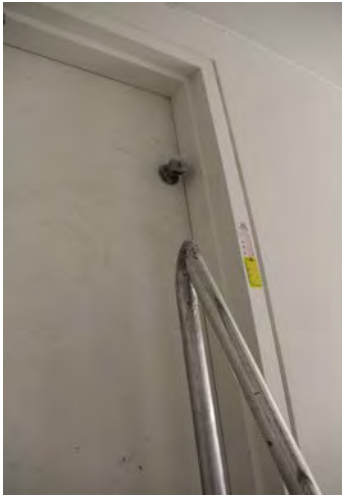
Quote: <input type="checkbox"/>			
Proceed: <input type="checkbox"/>			
No Action: <input type="checkbox"/>			
3.	<p><b>Hazard:</b></p> <ul style="list-style-type: none"> <li>• Yes</li> <li>• No</li> <li>• NA</li> </ul> <p><b>Location:</b> Roof level entrance.</p> <p><b>Finding:</b> The door is not self – locking, subsequently anyone can enter the roof area. Also, appropriate door signage missing.</p> <p><b>Auditor's Recommendation:</b> To engage a suitable qualified contractor to install a self locking mechanism on the door to avoid unauthorised people accessing to the roof level. Also, install appropriate signage 'Authorised Personnel Only'.</p> <p><b>Auditor's Risk Assessment:</b></p> <ul style="list-style-type: none"> <li>• Maintenance Required</li> <li>• Risk of Injury</li> <li>• Risk of Serious Injury</li> <li>• Risk Of Death</li> </ul>	<input checked="" type="checkbox"/> <input type="checkbox"/> <input type="checkbox"/>  <input type="checkbox"/> <input type="checkbox"/> <input checked="" type="checkbox"/> <input type="checkbox"/>

<p><b>Cost Estimate:</b></p> <ul style="list-style-type: none"> <li>• \$0 to \$500</li> <li>• \$501 to \$1000</li> <li>• \$1001 to \$1500</li> <li>• \$1501 to \$2000</li> <li>• &gt;\$2001</li> </ul> <input checked="" type="checkbox"/> <input type="checkbox"/> <input type="checkbox"/> <input type="checkbox"/> <input type="checkbox"/>

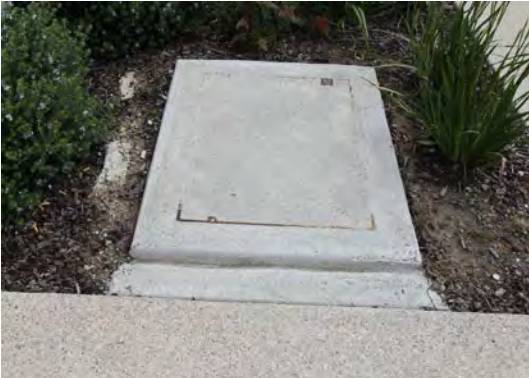
Medium Priority			
Item	Details		Photographic Details
4.	<p><b>Hazard:</b></p> <ul style="list-style-type: none"> <li>• Yes</li> <li>• No</li> <li>• NA</li> </ul> <p><b>Location:</b> Walkway adjacent to open car park entry.</p> <p>Quote: <input type="checkbox"/></p> <p><b>Finding:</b> Raised concrete pit, which is a tripping hazard.</p> <p>Proceed: <input type="checkbox"/></p> <p><b>Auditor's Recommendation:</b> To engage a suitable qualified contractor to build up the mulch to the finished floor level of the concrete pit, to eliminate the trip hazard.</p> <p><b>Auditor's Risk Assessment:</b></p> <ul style="list-style-type: none"> <li>• Maintenance Required</li> <li>• Risk of Injury</li> <li>• Risk of Serious Injury</li> <li>• Risk Of Death</li> </ul> <p>No Action: <input type="checkbox"/></p>	<input checked="" type="checkbox"/> <input type="checkbox"/> <input type="checkbox"/>  <input type="checkbox"/> <input checked="" type="checkbox"/> <input type="checkbox"/> <input type="checkbox"/>

<p><b>Cost Estimate:</b></p> <ul style="list-style-type: none"> <li>• \$0 to \$500</li> <li>• \$501 to \$1000</li> <li>• \$1001 to \$1500</li> <li>• \$1501 to \$2000</li> <li>• &gt;\$2001</li> </ul> <input checked="" type="checkbox"/> <input type="checkbox"/> <input type="checkbox"/> <input type="checkbox"/> <input type="checkbox"/>

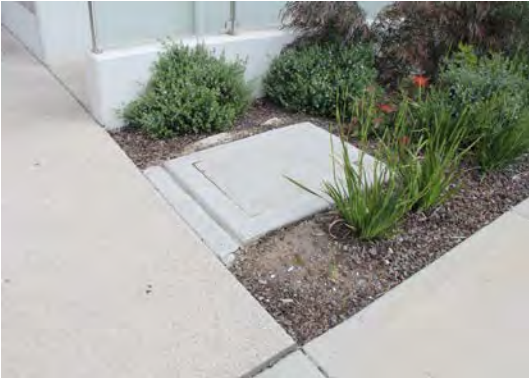
5.	<p><b>Hazard:</b></p> <ul style="list-style-type: none"> <li>• Yes</li> <li>• No</li> <li>• NA</li> </ul> <p><b>Location:</b> Garden bed adjacent to the cafe on Plenty Road.</p> <p>Quote: <input type="checkbox"/></p> <p><b>Finding:</b> Raised concrete pit, which is a tripping hazard.</p> <p>Proceed: <input type="checkbox"/></p> <p><b>Auditor's Recommendation:</b> To engage a suitable qualified contractor to build up the mulch to the finished floor level of the concrete pit, to eliminate the trip hazard.</p> <p><b>Auditor's Risk Assessment:</b></p> <ul style="list-style-type: none"> <li>• Maintenance Required</li> <li>• Risk of Injury</li> <li>• Risk of Serious Injury</li> <li>• Risk Of Death</li> </ul> <p>No Action: <input type="checkbox"/></p>	<input checked="" type="checkbox"/> <input type="checkbox"/> <input type="checkbox"/>  <input type="checkbox"/> <input checked="" type="checkbox"/> <input type="checkbox"/> <input type="checkbox"/>

<p><b>Cost Estimate:</b></p> <ul style="list-style-type: none"> <li>• \$0 to \$500</li> <li>• \$501 to \$1000</li> <li>• \$1001 to \$1500</li> <li>• \$1501 to \$2000</li> <li>• &gt;\$2001</li> </ul> <input checked="" type="checkbox"/> <input type="checkbox"/> <input type="checkbox"/> <input type="checkbox"/> <input type="checkbox"/>

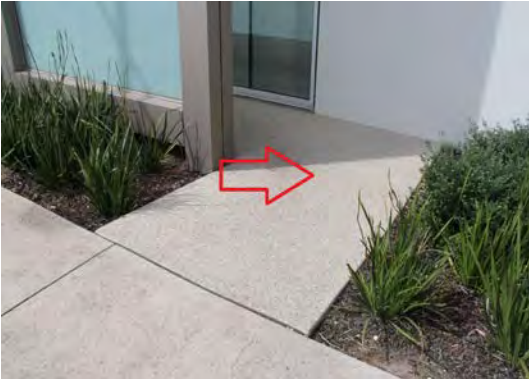
Medium Priority			
Item	Details		Photographic Details
6.	<p><b>Hazard:</b></p> <ul style="list-style-type: none"> <li>• Yes</li> <li>• No</li> <li>• NA</li> </ul> <p><b>Location:</b> Cafe entrance on Plenty Road.</p> <p><b>Finding:</b> Visible signs of water pooling as the concrete level is grated towards the bottom of the ramp, causing a slip hazard.</p> <p>Quote: <input type="checkbox"/></p> <p>Proceed: <input type="checkbox"/></p> <p>No Action: <input type="checkbox"/></p> <p><b>Auditor's Recommendation:</b> To engage a suitable qualified contractor to screed concrete to make the concrete fall towards the garden bed.</p> <p><b>Auditor's Risk Assessment:</b></p> <ul style="list-style-type: none"> <li>• Maintenance Required</li> <li>• Risk of Injury</li> <li>• Risk of Serious Injury</li> <li>• Risk Of Death</li> </ul>	<input checked="" type="checkbox"/> <input type="checkbox"/> <input type="checkbox"/>  <input type="checkbox"/> <input checked="" type="checkbox"/> <input type="checkbox"/> <input type="checkbox"/>

<p><b>Cost Estimate:</b></p> <ul style="list-style-type: none"> <li>• \$0 to \$500</li> <li>• \$501 to \$1000</li> <li>• \$1001 to \$1500</li> <li>• \$1501 to \$2000</li> <li>• &gt;\$2001</li> </ul> <input type="checkbox"/> <input checked="" type="checkbox"/> <input type="checkbox"/> <input type="checkbox"/> <input type="checkbox"/>

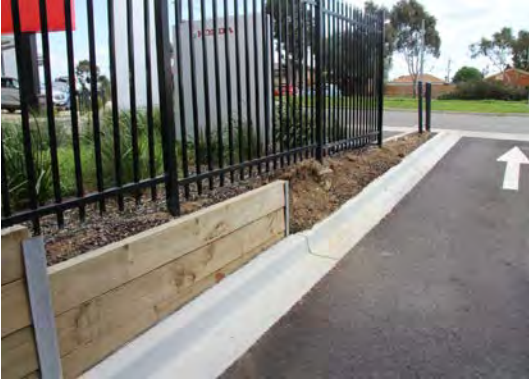
7.	<p><b>Hazard:</b></p> <ul style="list-style-type: none"> <li>• Yes</li> <li>• No</li> <li>• NA</li> </ul> <p><b>Location:</b> Driveway adjacent to the car park entrance.</p> <p><b>Finding:</b> Garden sleepers do not continue to the end of the ramp causing a trip hazard.</p> <p>Quote: <input type="checkbox"/></p> <p>Proceed: <input type="checkbox"/></p> <p>No Action: <input type="checkbox"/></p> <p><b>Auditor's Recommendation:</b> To engage a suitable qualified contractor to install additional garden sleepers until the end of the fence.</p> <p><b>Auditor's Risk Assessment:</b></p> <ul style="list-style-type: none"> <li>• Maintenance Required</li> <li>• Risk of Injury</li> <li>• Risk of Serious Injury</li> <li>• Risk Of Death</li> </ul>	<input checked="" type="checkbox"/> <input type="checkbox"/> <input type="checkbox"/> <input type="checkbox"/> <input checked="" type="checkbox"/> <input type="checkbox"/> <input type="checkbox"/>

<p><b>Cost Estimate:</b></p> <ul style="list-style-type: none"> <li>• \$0 to \$500</li> <li>• \$501 to \$1000</li> <li>• \$1001 to \$1500</li> <li>• \$1501 to \$2000</li> <li>• &gt;\$2001</li> </ul> <input type="checkbox"/> <input checked="" type="checkbox"/> <input type="checkbox"/> <input type="checkbox"/> <input type="checkbox"/>

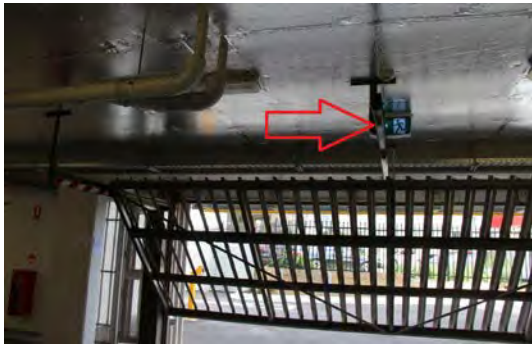
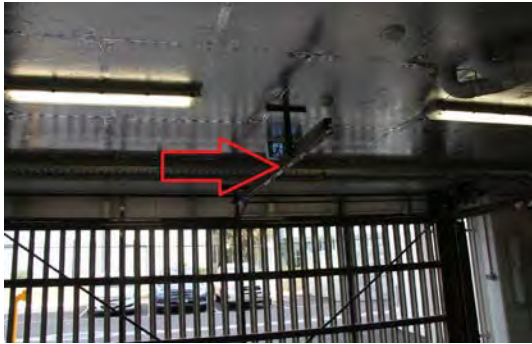
Medium Priority			
Item	Details		Photographic Details
8.	<p><b>Hazard:</b></p> <ul style="list-style-type: none"> <li>• Yes</li> <li>• No</li> <li>• NA</li> </ul> <p><b>Location:</b> Both the car park entrances.</p> <p><b>Finding:</b> Exit signs not clearly visible due to roller door frame/motor.</p>	<input checked="" type="checkbox"/> <input type="checkbox"/> <input type="checkbox"/>

Quote: <input type="checkbox"/>			
Proceed: <input type="checkbox"/>	<p><b>Auditor's Recommendation:</b> To engage a suitable qualified contractor to relocate the exit signs in front of the frame/motor, so they are clearly visible.</p>		
No Action: <input type="checkbox"/>	<p><b>Auditor's Risk Assessment:</b></p> <ul style="list-style-type: none"> <li>• Maintenance Required</li> <li>• Risk of Injury</li> <li>• Risk of Serious Injury</li> <li>• Risk Of Death</li> </ul>	<input type="checkbox"/> <input checked="" type="checkbox"/> <input type="checkbox"/> <input type="checkbox"/>	<p><b>Cost Estimate:</b></p> <ul style="list-style-type: none"> <li>• \$0 to \$500</li> <li>• \$501 to \$1000</li> <li>• \$1001 to \$1500</li> <li>• \$1501 to \$2000</li> <li>• &gt;\$2001</li> </ul> <input type="checkbox"/> <input checked="" type="checkbox"/> <input type="checkbox"/> <input type="checkbox"/> <input type="checkbox"/>

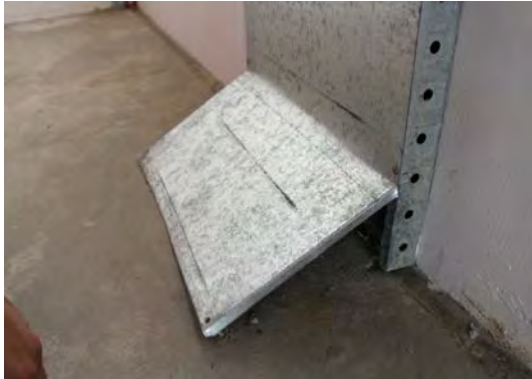
Medium Priority			
Item	Details		Photographic Details
9.	<p><b>Hazard:</b></p> <ul style="list-style-type: none"> <li>• Yes</li> <li>• No</li> <li>• NA</li> </ul> <p><b>Location:</b> Fibre optic cable tray adjacent to car park 29.</p> <p>Quote: <input type="checkbox"/></p> <p><b>Finding:</b> Metal sheeting causing a trip hazard.</p> <p>Proceed: <input type="checkbox"/></p> <p><b>Auditor's Recommendation:</b> To engage a suitable qualified contractor to install two bollards with reflective tapes around the bollards so that cars may not hit the cable tray, which may interrupt the internet services of the whole complex.</p> <p><b>Auditor's Risk Assessment:</b></p> <ul style="list-style-type: none"> <li>• Maintenance Required</li> <li>• Risk of Injury</li> <li>• Risk of Serious Injury</li> <li>• Risk Of Death</li> </ul>	<input checked="" type="checkbox"/> <input type="checkbox"/> <input type="checkbox"/>  <input type="checkbox"/> <input checked="" type="checkbox"/> <input type="checkbox"/> <input type="checkbox"/>

<p><b>Cost Estimate:</b></p> <ul style="list-style-type: none"> <li>• \$0 to \$500</li> <li>• \$501 to \$1000</li> <li>• \$1001 to \$1500</li> <li>• \$1501 to \$2000</li> <li>• &gt;\$2001</li> </ul> <input type="checkbox"/> <input checked="" type="checkbox"/> <input type="checkbox"/> <input type="checkbox"/> <input type="checkbox"/>

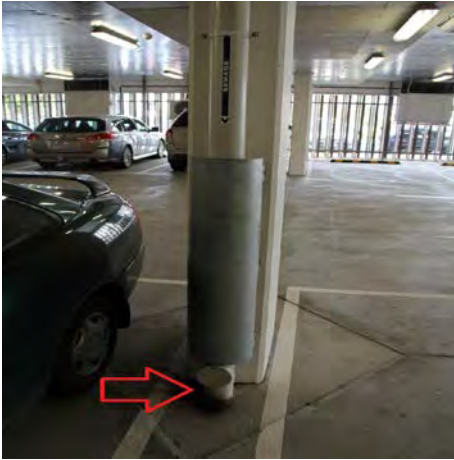
10.	<p><b>Hazard:</b></p> <ul style="list-style-type: none"> <li>• Yes</li> <li>• No</li> <li>• NA</li> </ul> <p><b>Location:</b> Sewage pipe adjacent to car park 13 &amp; 21.</p> <p>Quote: <input type="checkbox"/></p> <p><b>Finding:</b> Sewage leakage around the pipe, causing a slip hazard and unhygienic for people accessing the area.</p> <p>Proceed: <input type="checkbox"/></p> <p><b>Auditor's Recommendation:</b> To engage a suitable qualified contractor to rectify the sewage leak.</p> <p><b>Auditor's Risk Assessment:</b></p> <ul style="list-style-type: none"> <li>• Maintenance Required</li> <li>• Risk of Injury</li> <li>• Risk of Serious Injury</li> <li>• Risk Of Death</li> </ul>	<input checked="" type="checkbox"/> <input type="checkbox"/> <input type="checkbox"/>  <input type="checkbox"/> <input checked="" type="checkbox"/> <input type="checkbox"/> <input type="checkbox"/>

<p><b>Cost Estimate:</b></p> <ul style="list-style-type: none"> <li>• \$0 to \$500</li> <li>• \$501 to \$1000</li> <li>• \$1001 to \$1500</li> <li>• \$1501 to \$2000</li> <li>• &gt;\$2001</li> </ul> <input checked="" type="checkbox"/> <input type="checkbox"/> <input type="checkbox"/> <input type="checkbox"/> <input type="checkbox"/>

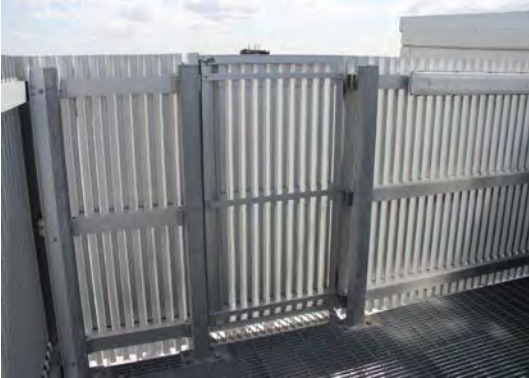
Medium Priority			
Item	Details		Photographic Details
11.	<p><b>Hazard:</b></p> <ul style="list-style-type: none"> <li>• Yes</li> <li>• No</li> <li>• NA</li> </ul> <p><b>Location:</b> Roof Entrance.</p> <p><b>Finding:</b> Missing appropriate signage on the door. Resulting in patrons/contractors accessing the area without realising the dangers.</p> <p>Quote: <input type="checkbox"/></p> <p>Proceed: <input type="checkbox"/></p> <p>No Action: <input type="checkbox"/></p> <p><b>Auditor's Recommendation:</b> To engage a suitable qualified contractor to install 'Authorised Personnel Only' signage.</p> <p><b>Auditor's Risk Assessment:</b></p> <ul style="list-style-type: none"> <li>• Maintenance Required</li> <li>• Risk of Injury</li> <li>• Risk of Serious Injury</li> <li>• Risk Of Death</li> </ul>	<input checked="" type="checkbox"/> <input type="checkbox"/> <input type="checkbox"/>  <input type="checkbox"/> <input checked="" type="checkbox"/> <input type="checkbox"/> <input type="checkbox"/>

<p><b>Cost Estimate:</b></p> <ul style="list-style-type: none"> <li>• \$0 to \$500</li> <li>• \$501 to \$1000</li> <li>• \$1001 to \$1500</li> <li>• \$1501 to \$2000</li> <li>• &gt;\$2001</li> </ul> <input checked="" type="checkbox"/> <input type="checkbox"/> <input type="checkbox"/> <input type="checkbox"/> <input type="checkbox"/>

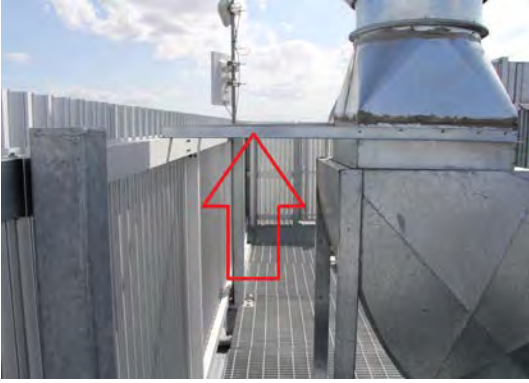
12.	<p><b>Hazard:</b></p> <ul style="list-style-type: none"> <li>• Yes</li> <li>• No</li> <li>• NA</li> </ul> <p><b>Location:</b> Roof level entrance catwalk.</p> <p><b>Finding:</b> The support rails of the mechanical air handling systems are very low and this is the only access to the roof area. Patrons/contractors may collide with the top rail.</p> <p>Quote: <input type="checkbox"/></p> <p>Proceed: <input type="checkbox"/></p> <p>No Action: <input type="checkbox"/></p> <p><b>Auditor's Recommendation:</b> To engage a suitable qualified contractor to install cushioning and reflective tape along the support rails.</p> <p><b>Auditor's Risk Assessment:</b></p> <ul style="list-style-type: none"> <li>• Maintenance Required</li> <li>• Risk of Injury</li> <li>• Risk of Serious Injury</li> <li>• Risk Of Death</li> </ul>	<input checked="" type="checkbox"/> <input type="checkbox"/> <input type="checkbox"/>  <input type="checkbox"/> <input checked="" type="checkbox"/> <input type="checkbox"/> <input type="checkbox"/>

<p><b>Cost Estimate:</b></p> <ul style="list-style-type: none"> <li>• \$0 to \$500</li> <li>• \$501 to \$1000</li> <li>• \$1001 to \$1500</li> <li>• \$1501 to \$2000</li> <li>• &gt;\$2001</li> </ul> <input checked="" type="checkbox"/> <input type="checkbox"/> <input type="checkbox"/> <input type="checkbox"/> <input type="checkbox"/>

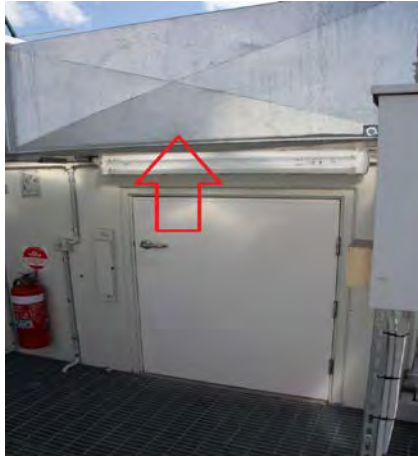
Medium Priority			
Item	Details		Photographic Details
13.	<p><b>Hazard:</b></p> <ul style="list-style-type: none"> <li>• Yes</li> <li>• No</li> <li>• NA</li> </ul> <p><b>Location:</b> Roof Entrance.</p> <p><b>Finding:</b> The mechanical air handling system is very low. Patrons/contractors may collide with the bottom of the system.</p> <p><b>Auditor's Recommendation:</b> To engage a suitable qualified contractor to install cushioning and reflective tape along the mechanical air handling system.</p> <p><b>Auditor's Risk Assessment:</b></p> <ul style="list-style-type: none"> <li>• Maintenance Required</li> <li>• Risk of Injury</li> <li>• Risk of Serious Injury</li> <li>• Risk Of Death</li> </ul>	<input checked="" type="checkbox"/> <input type="checkbox"/> <input type="checkbox"/>  <input type="checkbox"/> <input checked="" type="checkbox"/> <input type="checkbox"/> <input type="checkbox"/>

<p><b>Cost Estimate:</b></p> <ul style="list-style-type: none"> <li>• \$0 to \$500</li> <li>• \$501 to \$1000</li> <li>• \$1001 to \$1500</li> <li>• \$1501 to \$2000</li> <li>• &gt;\$2001</li> </ul> <input checked="" type="checkbox"/> <input type="checkbox"/> <input type="checkbox"/> <input type="checkbox"/> <input type="checkbox"/>

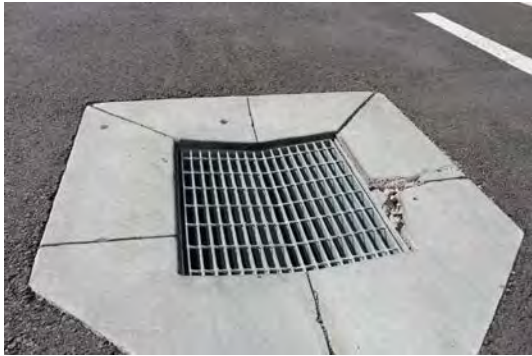
14.	<p><b>Hazard:</b></p> <ul style="list-style-type: none"> <li>• Yes</li> <li>• No</li> <li>• NA</li> </ul> <p><b>Location:</b> External car park entrance from Graduate Road.</p> <p><b>Finding:</b> Sunken grate lid, causing a trip hazard.</p> <p><b>Auditor's Recommendation:</b> To engage a suitable qualified contractor to raise the drain grate to match the finish floor level.</p> <p><b>Auditor's Risk Assessment:</b></p> <ul style="list-style-type: none"> <li>• Maintenance Required</li> <li>• Risk of Injury</li> <li>• Risk of Serious Injury</li> <li>• Risk Of Death</li> </ul>	<input checked="" type="checkbox"/> <input type="checkbox"/> <input type="checkbox"/>  <input type="checkbox"/> <input checked="" type="checkbox"/> <input type="checkbox"/> <input type="checkbox"/>

<p><b>Cost Estimate:</b></p> <ul style="list-style-type: none"> <li>• \$0 to \$500</li> <li>• \$501 to \$1000</li> <li>• \$1001 to \$1500</li> <li>• \$1501 to \$2000</li> <li>• &gt;\$2001</li> </ul> <input checked="" type="checkbox"/> <input type="checkbox"/> <input type="checkbox"/> <input type="checkbox"/> <input type="checkbox"/>

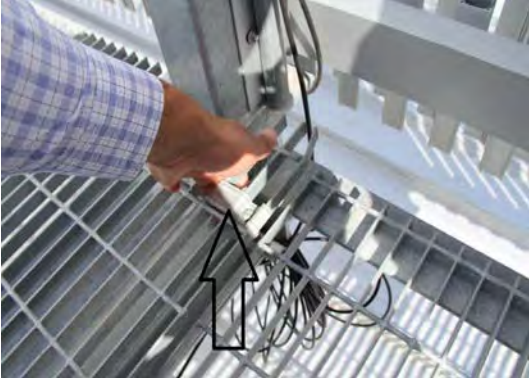
Medium Priority			
Item	Details		Photographic Details
15.	<p><b>Hazard:</b></p> <ul style="list-style-type: none"> <li>• Yes</li> <li>• No</li> <li>• NA</li> </ul> <p><b>Location:</b> Roof level.</p> <p><b>Finding:</b> The clips holding the flooring are loose, which presents as a fall hazard, if one of the flooring components was to dislodge.</p> <p>Quote: <input type="checkbox"/></p> <p>Proceed: <input type="checkbox"/></p> <p>No Action: <input type="checkbox"/></p>	<input checked="" type="checkbox"/> <input type="checkbox"/> <input type="checkbox"/>  <input type="checkbox"/> <input checked="" type="checkbox"/> <input type="checkbox"/> <input type="checkbox"/>

<p><b>Cost Estimate:</b></p> <ul style="list-style-type: none"> <li>• \$0 to \$500</li> <li>• \$501 to \$1000</li> <li>• \$1001 to \$1500</li> <li>• \$1501 to \$2000</li> <li>• &gt;\$2001</li> </ul> <input checked="" type="checkbox"/> <input type="checkbox"/> <input type="checkbox"/> <input type="checkbox"/> <input type="checkbox"/>

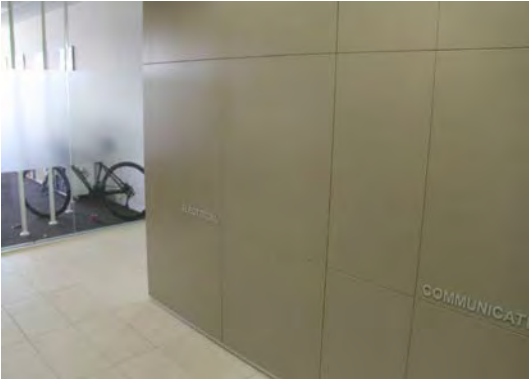
16.	<p><b>Hazard:</b></p> <ul style="list-style-type: none"> <li>• Yes</li> <li>• No</li> <li>• NA</li> </ul> <p><b>Location:</b> Electrical meter cabinets on each level.</p> <p><b>Finding:</b> The cabinets do not have locking mechanism, giving access to the general public to the electrical switchboard.</p> <p>Quote: <input type="checkbox"/></p> <p>Proceed: <input type="checkbox"/></p> <p>No Action: <input type="checkbox"/></p>	<input checked="" type="checkbox"/> <input type="checkbox"/> <input type="checkbox"/>  <input type="checkbox"/> <input checked="" type="checkbox"/> <input type="checkbox"/> <input type="checkbox"/>

<p><b>Cost Estimate:</b></p> <ul style="list-style-type: none"> <li>• \$0 to \$500</li> <li>• \$501 to \$1000</li> <li>• \$1001 to \$1500</li> <li>• \$1501 to \$2000</li> <li>• &gt;\$2001</li> </ul> <input type="checkbox"/> <input type="checkbox"/> <input checked="" type="checkbox"/> <input type="checkbox"/> <input type="checkbox"/>

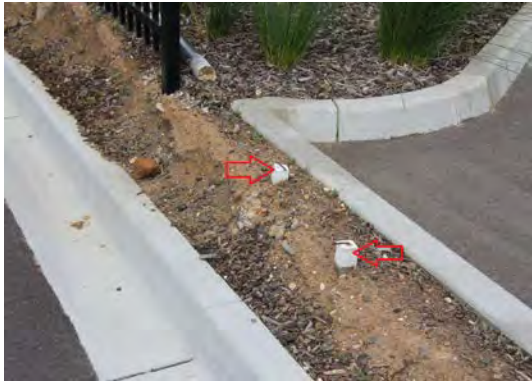
Low Priority/Maintenance			
Item	Details		Photographic Details
17.	<p><b>Hazard:</b></p> <ul style="list-style-type: none"> <li>• Yes</li> <li>• No</li> <li>• NA</li> </ul> <p><b>Location:</b> Garden bed along the driveway entrance for the car parks.</p> <p><b>Finding:</b> Exposed timber with protruding nails, causing a trip hazard.</p> <p><b>Auditor's Recommendation:</b> To engage a suitable qualified contractor to remove the two redundant timbers.</p> <p><b>Auditor's Risk Assessment:</b></p> <ul style="list-style-type: none"> <li>• Maintenance Required</li> <li>• Risk of Injury</li> <li>• Risk of Serious Injury</li> <li>• Risk Of Death</li> </ul>	<input checked="" type="checkbox"/> <input type="checkbox"/> <input type="checkbox"/>  <input type="checkbox"/> <input checked="" type="checkbox"/> <input type="checkbox"/> <input type="checkbox"/>

<p><b>Cost Estimate:</b></p> <ul style="list-style-type: none"> <li>• \$0 to \$500</li> <li>• \$501 to \$1000</li> <li>• \$1001 to \$1500</li> <li>• \$1501 to \$2000</li> <li>• &gt;\$2001</li> </ul> <input checked="" type="checkbox"/> <input type="checkbox"/> <input type="checkbox"/> <input type="checkbox"/> <input type="checkbox"/>

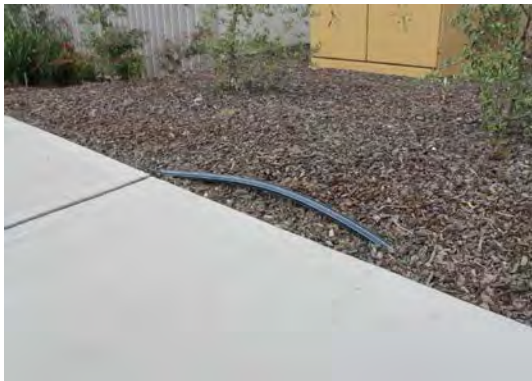
Quote: <input type="checkbox"/>			
Proceed: <input type="checkbox"/>			
No Action: <input type="checkbox"/>			
18.	<p><b>Hazard:</b></p> <ul style="list-style-type: none"> <li>• Yes</li> <li>• No</li> <li>• NA</li> </ul> <p><b>Location:</b> Garden bed along the walkway on Plenty Road.</p> <p><b>Finding:</b> Exposed irrigation pipe causing a trip hazard.</p> <p><b>Auditor's Recommendation:</b> To engage a suitable qualified contractor to rectify the irrigation pipe so it is not exposed.</p> <p><b>Auditor's Risk Assessment:</b></p> <ul style="list-style-type: none"> <li>• Maintenance Required</li> <li>• Risk of Injury</li> <li>• Risk of Serious Injury</li> <li>• Risk Of Death</li> </ul>	<input checked="" type="checkbox"/> <input type="checkbox"/> <input type="checkbox"/>  <input type="checkbox"/> <input checked="" type="checkbox"/> <input type="checkbox"/> <input type="checkbox"/>

<p><b>Cost Estimate:</b></p> <ul style="list-style-type: none"> <li>• \$0 to \$500</li> <li>• \$501 to \$1000</li> <li>• \$1001 to \$1500</li> <li>• \$1501 to \$2000</li> <li>• &gt;\$2001</li> </ul> <input checked="" type="checkbox"/> <input type="checkbox"/> <input type="checkbox"/> <input type="checkbox"/> <input type="checkbox"/>

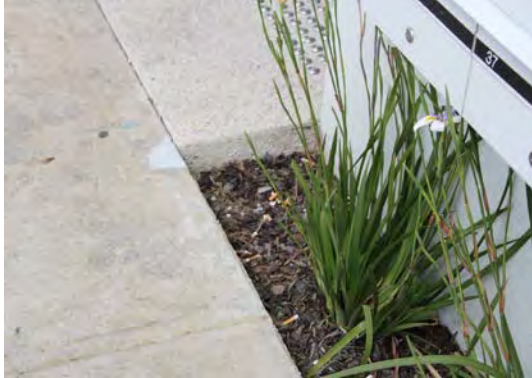
Low Priority/Maintenance			
Item	Details		Photographic Details
19.	<p><b>Hazard:</b></p> <ul style="list-style-type: none"> <li>• Yes</li> <li>• No</li> <li>• NA</li> </ul> <p><b>Location:</b> Garden bed adjacent to letter box.</p> <p><b>Finding:</b> Pit in the garden bed, which presents as a potential tripping hazard.</p> <p><b>Auditor's Recommendation:</b> To engage a suitable qualified contractor to build up the garden bed mulch to match the finish floor level.</p> <p><b>Auditor's Risk Assessment:</b></p> <ul style="list-style-type: none"> <li>• Maintenance Required</li> <li>• Risk of Injury</li> <li>• Risk of Serious Injury</li> <li>• Risk Of Death</li> </ul>	<input checked="" type="checkbox"/> <input type="checkbox"/> <input type="checkbox"/>  <input checked="" type="checkbox"/> <input type="checkbox"/> <input type="checkbox"/> <input type="checkbox"/>

<p><b>Cost Estimate:</b></p> <ul style="list-style-type: none"> <li>• \$0 to \$500</li> <li>• \$501 to \$1000</li> <li>• \$1001 to \$1500</li> <li>• \$1501 to \$2000</li> <li>• &gt;\$2001</li> </ul> <input checked="" type="checkbox"/> <input type="checkbox"/> <input type="checkbox"/> <input type="checkbox"/> <input type="checkbox"/>

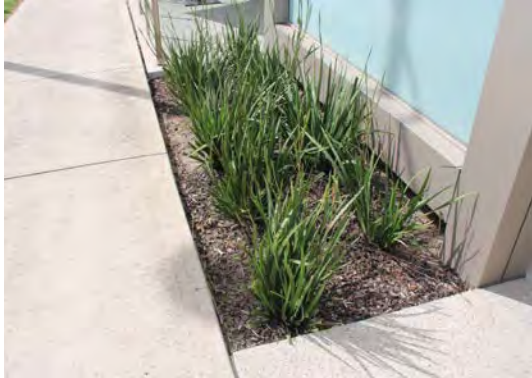
20.	<p><b>Hazard:</b></p> <ul style="list-style-type: none"> <li>• Yes</li> <li>• No</li> <li>• NA</li> </ul> <p><b>Location:</b> Garden bed adjacent to the cafe entrance on Plenty Road.</p> <p><b>Finding:</b> Pit in the garden bed, which presents as a potential tripping hazard.</p> <p><b>Auditor's Recommendation:</b> To engage a suitable qualified contractor to build up the garden bed mulch to match the finish floor level.</p> <p><b>Auditor's Risk Assessment:</b></p> <ul style="list-style-type: none"> <li>• Maintenance Required</li> <li>• Risk of Injury</li> <li>• Risk of Serious Injury</li> <li>• Risk Of Death</li> </ul>	<input checked="" type="checkbox"/> <input type="checkbox"/> <input type="checkbox"/>  <input checked="" type="checkbox"/> <input type="checkbox"/> <input type="checkbox"/> <input type="checkbox"/>

<p><b>Cost Estimate:</b></p> <ul style="list-style-type: none"> <li>• \$0 to \$500</li> <li>• \$501 to \$1000</li> <li>• \$1001 to \$1500</li> <li>• \$1501 to \$2000</li> <li>• &gt;\$2001</li> </ul> <input checked="" type="checkbox"/> <input type="checkbox"/> <input type="checkbox"/> <input type="checkbox"/> <input type="checkbox"/>

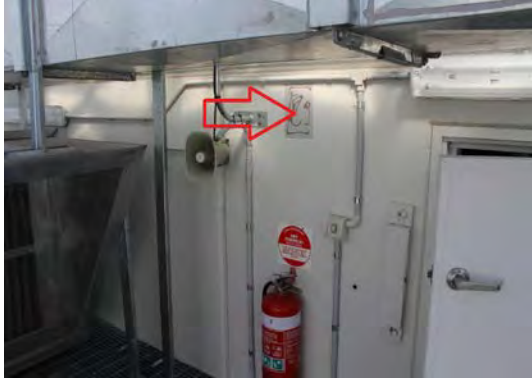
Low Priority/Maintenance			
Item	Details		Photographic Details
21.	<p><b>Hazard:</b></p> <ul style="list-style-type: none"> <li>• Yes</li> <li>• No</li> <li>• NA</li> </ul> <p><b>Location:</b> Roof Level.</p> <p>Quote: <input type="checkbox"/></p> <p><b>Finding:</b> Fire extinguisher signage missing.</p> <p>Proceed: <input type="checkbox"/></p> <p><b>Auditor's Recommendation:</b> To engage a suitable qualified contractor to install the required signage.</p> <p><b>Auditor's Risk Assessment:</b></p> <ul style="list-style-type: none"> <li>• Maintenance Required</li> <li>• Risk of Injury</li> <li>• Risk of Serious Injury</li> <li>• Risk Of Death</li> </ul>	<input checked="" type="checkbox"/> <input type="checkbox"/> <input type="checkbox"/>  <input checked="" type="checkbox"/> <input type="checkbox"/> <input type="checkbox"/> <input type="checkbox"/>

<p><b>Cost Estimate:</b></p> <ul style="list-style-type: none"> <li>• \$0 to \$500</li> <li>• \$501 to \$1000</li> <li>• \$1001 to \$1500</li> <li>• \$1501 to \$2000</li> <li>• &gt;\$2001</li> </ul> <input checked="" type="checkbox"/> <input type="checkbox"/> <input type="checkbox"/> <input type="checkbox"/> <input type="checkbox"/>

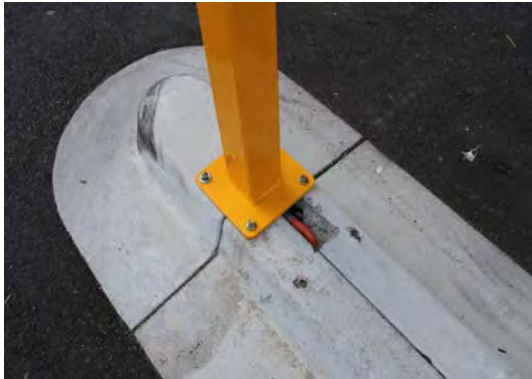
22.	<p><b>Hazard:</b></p> <ul style="list-style-type: none"> <li>• Yes</li> <li>• No</li> <li>• NA</li> </ul> <p><b>Location:</b> Access control pillar adjacent to the car park entrance.</p> <p>Quote: <input type="checkbox"/></p> <p><b>Finding:</b> Exposed electrical cabling.</p> <p>Proceed: <input type="checkbox"/></p> <p><b>Auditor's Recommendation:</b> To engage a suitable qualified contractor to rectify so the electrical cabling is not exposed.</p> <p><b>Auditor's Risk Assessment:</b></p> <ul style="list-style-type: none"> <li>• Maintenance Required</li> <li>• Risk of Injury</li> <li>• Risk of Serious Injury</li> <li>• Risk Of Death</li> </ul>	<input checked="" type="checkbox"/> <input type="checkbox"/> <input type="checkbox"/>  <input checked="" type="checkbox"/> <input type="checkbox"/> <input type="checkbox"/> <input type="checkbox"/>

<p><b>Cost Estimate:</b></p> <ul style="list-style-type: none"> <li>• \$0 to \$500</li> <li>• \$501 to \$1000</li> <li>• \$1001 to \$1500</li> <li>• \$1501 to \$2000</li> <li>• &gt;\$2001</li> </ul> <input checked="" type="checkbox"/> <input type="checkbox"/> <input type="checkbox"/> <input type="checkbox"/> <input type="checkbox"/>

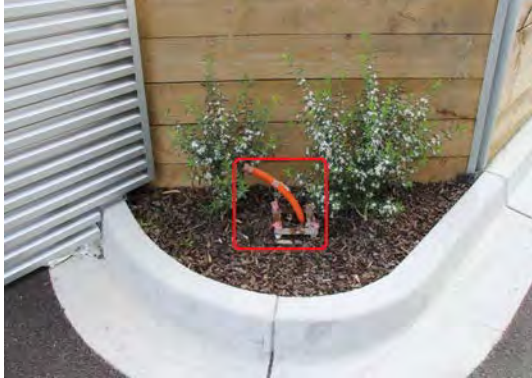
Low Priority/Maintenance			
Item	Details		Photographic Details
23.	<p><b>Hazard:</b></p> <ul style="list-style-type: none"> <li>• Yes</li> <li>• No</li> <li>• NA</li> </ul> <p><b>Location:</b> Garden bed adjacent to bin area.</p> <p><b>Finding:</b> Exposed redundant electrical conduit and bolts, which presents as a tripping hazard.</p> <p><b>Auditor's Recommendation:</b> To engage a suitable qualified contractor to remove the electrical conduit and concrete pad with bolts, if it is not going to be utilised.</p> <p><b>Auditor's Risk Assessment:</b></p> <ul style="list-style-type: none"> <li>• Maintenance Required</li> <li>• Risk of Injury</li> <li>• Risk of Serious Injury</li> <li>• Risk Of Death</li> </ul>	<input checked="" type="checkbox"/> <input type="checkbox"/> <input type="checkbox"/>

Quote: <input type="checkbox"/>			
Proceed: <input type="checkbox"/>			
No Action: <input type="checkbox"/>		<input checked="" type="checkbox"/> <input type="checkbox"/> <input type="checkbox"/> <input type="checkbox"/>	<p><b>Cost Estimate:</b></p> <ul style="list-style-type: none"> <li>• \$0 to \$500</li> <li>• \$501 to \$1000</li> <li>• \$1001 to \$1500</li> <li>• \$1501 to \$2000</li> <li>• &gt;\$2001</li> </ul> <input checked="" type="checkbox"/> <input type="checkbox"/> <input type="checkbox"/> <input type="checkbox"/> <input type="checkbox"/>

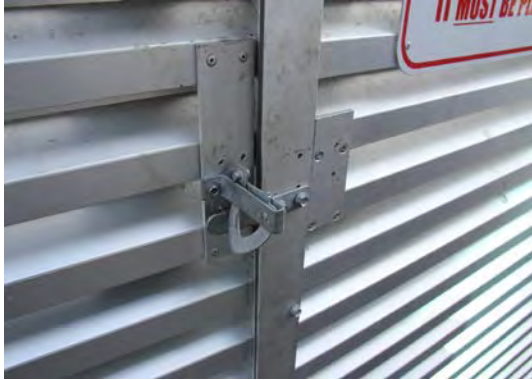
24.	<p><b>Hazard:</b></p> <ul style="list-style-type: none"> <li>• Yes</li> <li>• No</li> <li>• NA</li> </ul> <p><b>Location:</b> Bin area.</p> <p><b>Finding:</b> The bin area lock is not suitable for areas with high wind. It is evident by the holes on the door that this lock has been broken twice before.</p> <p><b>Auditor's Recommendation:</b> To engage a suitable qualified contractor to install a heavy duty locking mechanism onto the door.</p> <p><b>Auditor's Risk Assessment:</b></p> <ul style="list-style-type: none"> <li>• Maintenance Required</li> <li>• Risk of Injury</li> <li>• Risk of Serious Injury</li> <li>• Risk Of Death</li> </ul>	<input checked="" type="checkbox"/> <input type="checkbox"/> <input type="checkbox"/>

Quote: <input type="checkbox"/>			
Proceed: <input type="checkbox"/>			
No Action: <input type="checkbox"/>		<input checked="" type="checkbox"/> <input type="checkbox"/> <input type="checkbox"/> <input type="checkbox"/>	<p><b>Cost Estimate:</b></p> <ul style="list-style-type: none"> <li>• \$0 to \$500</li> <li>• \$501 to \$1000</li> <li>• \$1001 to \$1500</li> <li>• \$1501 to \$2000</li> <li>• &gt;\$2001</li> </ul> <input checked="" type="checkbox"/> <input type="checkbox"/> <input type="checkbox"/> <input type="checkbox"/> <input type="checkbox"/>

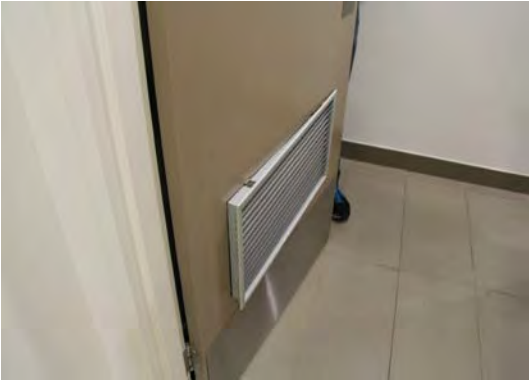
Low Priority/Maintenance			
Item	Details		Photographic Details
25.	<p><b>Hazard:</b></p> <ul style="list-style-type: none"> <li>• Yes</li> <li>• No</li> <li>• NA</li> </ul> <p><b>Location:</b> Male toilet door on level 1.</p> <p>Quote: <input type="checkbox"/></p> <p><b>Finding:</b> Loose air vent.</p> <p>Proceed: <input type="checkbox"/></p> <p><b>Auditor's Recommendation:</b> To engage a suitable qualified contractor to rectify the air vent on to the door.</p> <p><b>Auditor's Risk Assessment:</b></p> <ul style="list-style-type: none"> <li>• Maintenance Required</li> <li>• Risk of Injury</li> <li>• Risk of Serious Injury</li> <li>• Risk Of Death</li> </ul>	<input type="checkbox"/> <input checked="" type="checkbox"/> <input type="checkbox"/>  <input checked="" type="checkbox"/> <input type="checkbox"/> <input type="checkbox"/> <input type="checkbox"/>

<p><b>Cost Estimate:</b></p> <ul style="list-style-type: none"> <li>• \$0 to \$500</li> <li>• \$501 to \$1000</li> <li>• \$1001 to \$1500</li> <li>• \$1501 to \$2000</li> <li>• &gt;\$2001</li> </ul> <input checked="" type="checkbox"/> <input type="checkbox"/> <input type="checkbox"/> <input type="checkbox"/> <input type="checkbox"/>

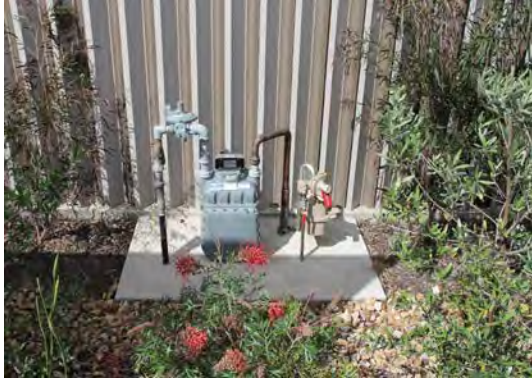
Recommendations			
Item	Details		Photographic Details
26.	<p><b>Hazard:</b></p> <ul style="list-style-type: none"> <li>• Yes</li> <li>• No</li> <li>• NA</li> </ul> <p><b>Location:</b> Gas meter adjacent to the cafe.</p> <p><b>Finding:</b> No locks installed, giving general public access to the gas meter.</p> <p><b>Auditor's Recommendation:</b> To engage a suitable qualified contractor to install a cage with lock around the gas meter.</p> <p><b>Auditor's Risk Assessment:</b></p> <ul style="list-style-type: none"> <li>• Maintenance Required</li> <li>• Risk of Injury</li> <li>• Risk of Serious Injury</li> <li>• Risk Of Death</li> </ul>	<input type="checkbox"/> <input checked="" type="checkbox"/> <input type="checkbox"/>  <input type="checkbox"/> <input type="checkbox"/> <input type="checkbox"/> <input type="checkbox"/>

<p><b>Cost Estimate:</b></p> <ul style="list-style-type: none"> <li>• \$0 to \$500</li> <li>• \$501 to \$1000</li> <li>• \$1001 to \$1500</li> <li>• \$1501 to \$2000</li> <li>• &gt;\$2001</li> </ul> <input type="checkbox"/> <input checked="" type="checkbox"/> <input type="checkbox"/> <input type="checkbox"/> <input type="checkbox"/>

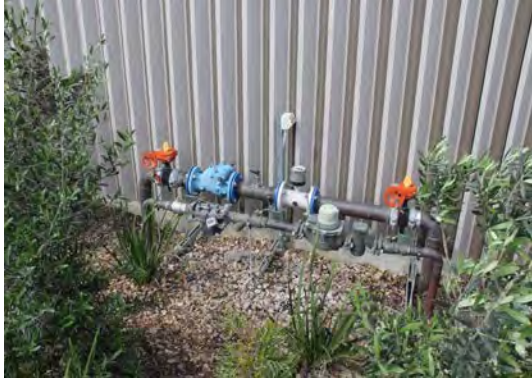
27.	<p><b>Hazard:</b></p> <ul style="list-style-type: none"> <li>• Yes</li> <li>• No</li> <li>• NA</li> </ul> <p><b>Location:</b> Water meter adjacent to the driveway entrance.</p> <p><b>Finding:</b> General public can easily access the water meter.</p> <p><b>Auditor's Recommendation:</b> To engage a suitable qualified contractor to install a cage with lock around the water meter.</p> <p><b>Auditor's Risk Assessment:</b></p> <ul style="list-style-type: none"> <li>• Maintenance Required</li> <li>• Risk of Injury</li> <li>• Risk of Serious Injury</li> <li>• Risk Of Death</li> </ul>	<input type="checkbox"/> <input checked="" type="checkbox"/> <input type="checkbox"/>  <input type="checkbox"/> <input type="checkbox"/> <input type="checkbox"/> <input type="checkbox"/>

<p><b>Cost Estimate:</b></p> <ul style="list-style-type: none"> <li>• \$0 to \$500</li> <li>• \$501 to \$1000</li> <li>• \$1001 to \$1500</li> <li>• \$1501 to \$2000</li> <li>• &gt;\$2001</li> </ul> <input type="checkbox"/> <input checked="" type="checkbox"/> <input type="checkbox"/> <input type="checkbox"/> <input type="checkbox"/>
