## Occupational Health & Safety - Report

25 Bay Sample St Port Melbourne VIC 3207

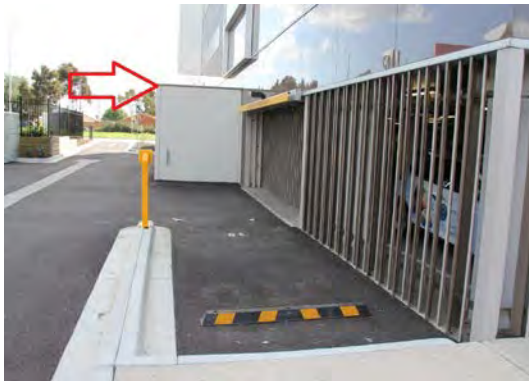
High Priority				
Item	Details		Photographic Details	
2.	<p><b>Hazard:</b></p> <ul style="list-style-type: none"> <li>• Yes</li> <li>• No</li> <li>• NA</li> </ul> <p><b>Location:</b> Car park 30.</p> <p><b>Finding:</b> Owner/tenant that utilises the car park has no vision of cars coming in/out of the car park. This could result in an accident with the vehicles entering or exiting the car park.</p> <p><b>Auditor's Recommendation:</b> To engage a suitable qualified contractor to install convex parking mirror on the rear wall as indicated, so the owner/tenant utilising the car park can have a clear view on the vehicles entering or exiting from the car park.</p> <p><b>Auditor's Risk Assessment:</b></p> <ul style="list-style-type: none"> <li>• Maintenance Required</li> <li>• Risk of Injury</li> <li>• Risk of Serious Injury</li> <li>• Risk Of Death</li> </ul>	<input checked="" type="checkbox"/> <input type="checkbox"/> <input type="checkbox"/>  <input type="checkbox"/> <input type="checkbox"/> <input checked="" type="checkbox"/> <input type="checkbox"/>

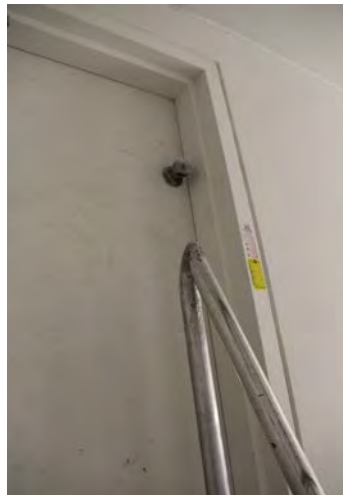
3.	<p><b>Hazard:</b></p> <ul style="list-style-type: none"> <li>• Yes</li> <li>• No</li> <li>• NA</li> </ul> <p><b>Location:</b> Roof level entrance.</p> <p><b>Finding:</b> The door is not self – locking, subsequently anyone can enter the roof area. Also, appropriate door signage missing.</p> <p><b>Auditor's Recommendation:</b> To engage a suitable qualified contractor to install a self locking mechanism on the door to avoid unauthorised people accessing to the roof level. Also, install appropriate signage 'Authorised Personnel Only'.</p> <p><b>Auditor's Risk Assessment:</b></p> <ul style="list-style-type: none"> <li>• Maintenance Required</li> <li>• Risk of Injury</li> <li>• Risk of Serious Injury</li> <li>• Risk Of Death</li> </ul>	<input checked="" type="checkbox"/> <input type="checkbox"/> <input type="checkbox"/>  <input type="checkbox"/> <input type="checkbox"/> <input checked="" type="checkbox"/> <input type="checkbox"/>

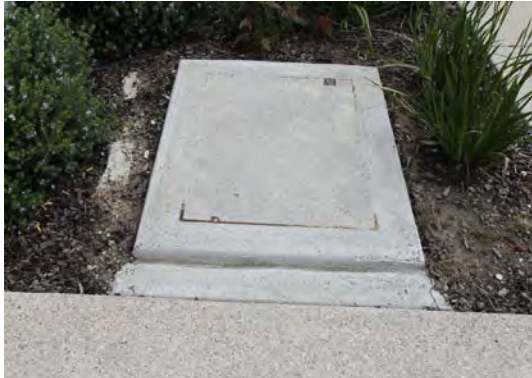
Medium Priority			
Item	Details		Photographic Details
4.	<p><b>Hazard:</b></p> <ul style="list-style-type: none"> <li>• Yes</li> <li>• No</li> <li>• NA</li> </ul> <p><b>Location:</b> Walkway adjacent to open car park entry.</p> <p>Quote: <input type="checkbox"/></p> <p><b>Finding:</b> Raised concrete pit, which is a tripping hazard.</p> <p>Proceed: <input type="checkbox"/></p> <p><b>Auditor's Recommendation:</b> To engage a suitable qualified contractor to build up the mulch to the finished floor level of the concrete pit, to eliminate the trip hazard.</p> <p><b>Auditor's Risk Assessment:</b></p> <ul style="list-style-type: none"> <li>• Maintenance Required</li> <li>• Risk of Injury</li> <li>• Risk of Serious Injury</li> <li>• Risk Of Death</li> </ul>	<input checked="" type="checkbox"/> <input type="checkbox"/> <input type="checkbox"/>  <input type="checkbox"/> <input checked="" type="checkbox"/> <input type="checkbox"/> <input type="checkbox"/>

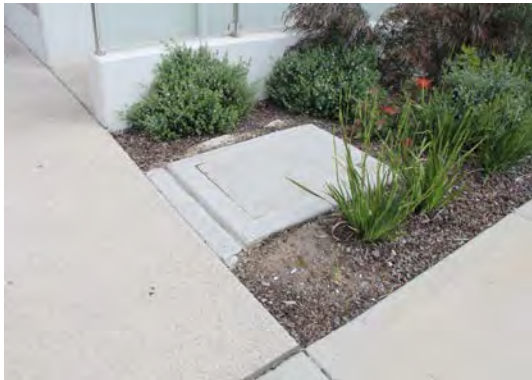
5.	<p><b>Hazard:</b></p> <ul style="list-style-type: none"> <li>• Yes</li> <li>• No</li> <li>• NA</li> </ul> <p><b>Location:</b> Garden bed adjacent to the cafe on Plenty Road.</p> <p>Quote: <input type="checkbox"/></p> <p><b>Finding:</b> Raised concrete pit, which is a tripping hazard.</p> <p>Proceed: <input type="checkbox"/></p> <p><b>Auditor's Recommendation:</b> To engage a suitable qualified contractor to build up the mulch to the finished floor level of the concrete pit, to eliminate the trip hazard.</p> <p><b>Auditor's Risk Assessment:</b></p> <ul style="list-style-type: none"> <li>• Maintenance Required</li> <li>• Risk of Injury</li> <li>• Risk of Serious Injury</li> <li>• Risk Of Death</li> </ul>	<input checked="" type="checkbox"/> <input type="checkbox"/> <input type="checkbox"/>  <input type="checkbox"/> <input checked="" type="checkbox"/> <input type="checkbox"/> <input type="checkbox"/>

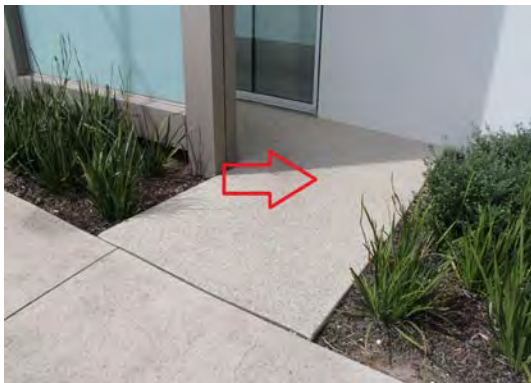
Medium Priority			
Item	Details		Photographic Details
6.	<p><b>Hazard:</b></p> <ul style="list-style-type: none"> <li>• Yes</li> <li>• No</li> <li>• NA</li> </ul> <p><b>Location:</b> Cafe entrance on Plenty Road.</p> <p><b>Finding:</b> Visible signs of water pooling as the concrete level is grated towards the bottom of the ramp, causing a slip hazard.</p> <p><b>Auditor's Recommendation:</b> To engage a suitable qualified contractor to screed concrete to make the concrete fall towards the garden bed.</p> <p><b>Auditor's Risk Assessment:</b></p> <ul style="list-style-type: none"> <li>• Maintenance Required</li> <li>• Risk of Injury</li> <li>• Risk of Serious Injury</li> <li>• Risk Of Death</li> </ul>	<input checked="" type="checkbox"/> <input type="checkbox"/> <input type="checkbox"/>  <input type="checkbox"/> <input checked="" type="checkbox"/> <input type="checkbox"/> <input type="checkbox"/>

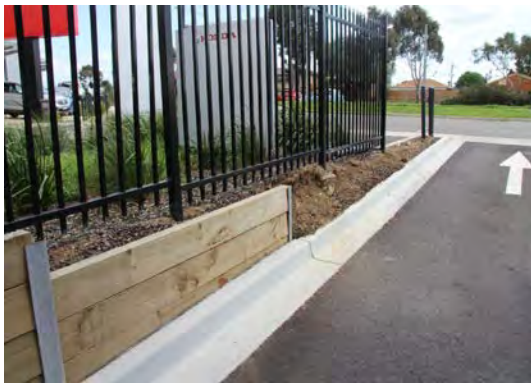
7.	<p><b>Hazard:</b></p> <ul style="list-style-type: none"> <li>• Yes</li> <li>• No</li> <li>• NA</li> </ul> <p><b>Location:</b> Driveway adjacent to the car park entrance.</p> <p><b>Finding:</b> Garden sleepers do not continue to the end of the ramp causing a trip hazard.</p> <p><b>Auditor's Recommendation:</b> To engage a suitable qualified contractor to install additional garden sleepers until the end of the fence.</p> <p><b>Auditor's Risk Assessment:</b></p> <ul style="list-style-type: none"> <li>• Maintenance Required</li> <li>• Risk of Injury</li> <li>• Risk of Serious Injury</li> <li>• Risk Of Death</li> </ul>	<input checked="" type="checkbox"/> <input type="checkbox"/> <input type="checkbox"/>  <input type="checkbox"/> <input checked="" type="checkbox"/> <input type="checkbox"/> <input type="checkbox"/>

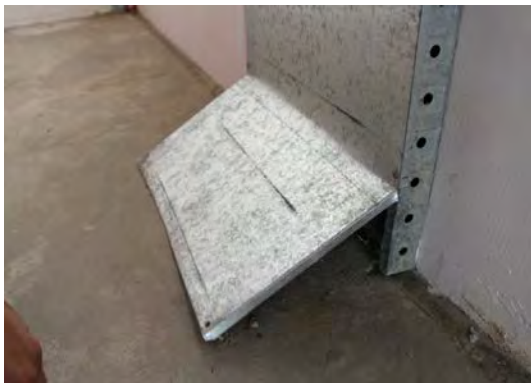
Medium Priority			
Item	Details		Photographic Details
9.	<p><b>Hazard:</b></p> <ul style="list-style-type: none"> <li>• Yes</li> <li>• No</li> <li>• NA</li> </ul> <p><b>Location:</b> Fibre optic cable tray adjacent to car park 29.</p> <p><b>Quote:</b> <input type="checkbox"/></p> <p><b>Finding:</b> Metal sheeting causing a trip hazard.</p> <p><b>Auditor's Recommendation:</b> To engage a suitable qualified contractor to install two bollards with reflective tapes around the bollards so that cars may not hit the cable tray, which may interrupt the internet services of the whole complex.</p> <p><b>Auditor's Risk Assessment:</b></p> <ul style="list-style-type: none"> <li>• Maintenance Required</li> <li>• Risk of Injury</li> <li>• Risk of Serious Injury</li> <li>• Risk Of Death</li> </ul>	<input checked="" type="checkbox"/> <input type="checkbox"/> <input type="checkbox"/>  <input type="checkbox"/> <input checked="" type="checkbox"/> <input type="checkbox"/> <input type="checkbox"/>

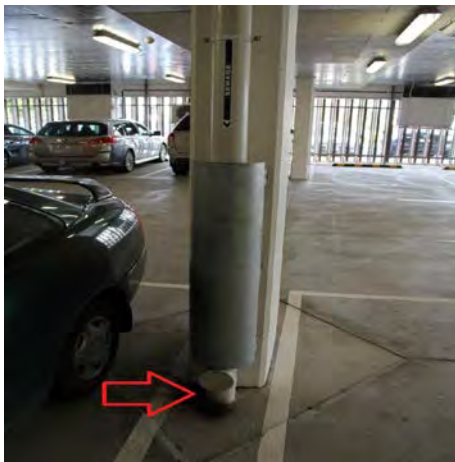
10.	<p><b>Hazard:</b></p> <ul style="list-style-type: none"> <li>• Yes</li> <li>• No</li> <li>• NA</li> </ul> <p><b>Location:</b> Sewage pipe adjacent to car park 13 &amp; 21.</p> <p><b>Quote:</b> <input type="checkbox"/></p> <p><b>Finding:</b> Sewage leakage around the pipe, causing a slip hazard and unhygienic for people accessing the area.</p> <p><b>Auditor's Recommendation:</b> To engage a suitable qualified contractor to rectify the sewage leak.</p> <p><b>Auditor's Risk Assessment:</b></p> <ul style="list-style-type: none"> <li>• Maintenance Required</li> <li>• Risk of Injury</li> <li>• Risk of Serious Injury</li> <li>• Risk Of Death</li> </ul>	<input checked="" type="checkbox"/> <input type="checkbox"/> <input type="checkbox"/>  <input type="checkbox"/> <input checked="" type="checkbox"/> <input type="checkbox"/> <input type="checkbox"/>

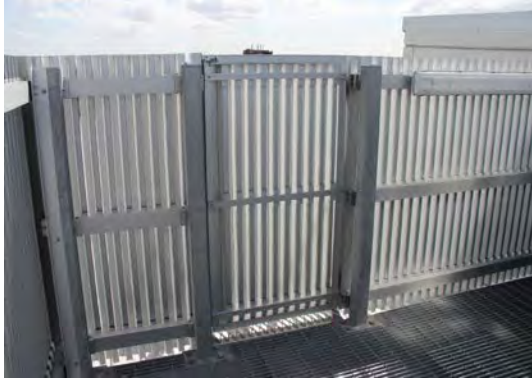
Medium Priority			
Item	Details		Photographic Details
11.	<p><b>Hazard:</b></p> <ul style="list-style-type: none"> <li>• Yes</li> <li>• No</li> <li>• NA</li> </ul> <p><b>Location:</b> Roof Entrance.</p> <p><b>Finding:</b> Missing appropriate signage on the door. Resulting in patrons/contractors accessing the area without realising the dangers.</p> <p>Quote: <input type="checkbox"/></p> <p>Proceed: <input type="checkbox"/></p> <p>No Action: <input type="checkbox"/></p> <p><b>Auditor's Recommendation:</b> To engage a suitable qualified contractor to install 'Authorised Personnel Only' signage.</p> <p><b>Auditor's Risk Assessment:</b></p> <ul style="list-style-type: none"> <li>• Maintenance Required</li> <li>• Risk of Injury</li> <li>• Risk of Serious Injury</li> <li>• Risk Of Death</li> </ul>	<input checked="" type="checkbox"/> <input type="checkbox"/> <input type="checkbox"/>  <input type="checkbox"/> <input checked="" type="checkbox"/> <input type="checkbox"/> <input type="checkbox"/>

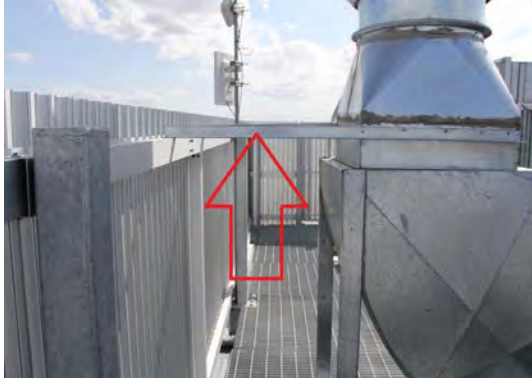
12.	<p><b>Hazard:</b></p> <ul style="list-style-type: none"> <li>• Yes</li> <li>• No</li> <li>• NA</li> </ul> <p><b>Location:</b> Roof level entrance catwalk.</p> <p><b>Finding:</b> The support rails of the mechanical air handling systems are very low and this is the only access to the roof area. Patrons/contractors may collide with the top rail.</p> <p>Quote: <input type="checkbox"/></p> <p>Proceed: <input type="checkbox"/></p> <p>No Action: <input type="checkbox"/></p> <p><b>Auditor's Recommendation:</b> To engage a suitable qualified contractor to install cushioning and reflective tape along the support rails.</p> <p><b>Auditor's Risk Assessment:</b></p> <ul style="list-style-type: none"> <li>• Maintenance Required</li> <li>• Risk of Injury</li> <li>• Risk of Serious Injury</li> <li>• Risk Of Death</li> </ul>	<input checked="" type="checkbox"/> <input type="checkbox"/> <input type="checkbox"/>  <input type="checkbox"/> <input checked="" type="checkbox"/> <input type="checkbox"/> <input type="checkbox"/>

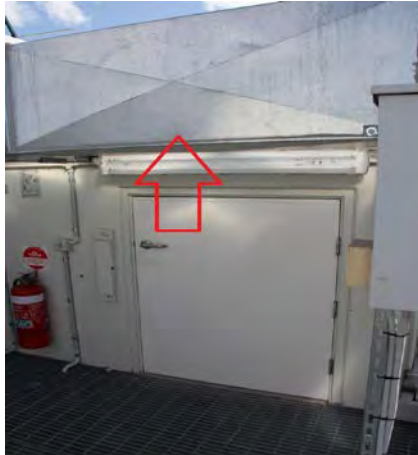
Medium Priority			
Item	Details		Photographic Details
13.	<p><b>Hazard:</b></p> <ul style="list-style-type: none"> <li>• Yes</li> <li>• No</li> <li>• NA</li> </ul> <p><b>Location:</b> Roof Entrance.</p> <p><b>Finding:</b> The mechanical air handling system is very low. Patrons/contractors may collide with the bottom of the system.</p> <p><b>Auditor's Recommendation:</b> To engage a suitable qualified contractor to install cushioning and reflective tape along the mechanical air handling system.</p> <p><b>Auditor's Risk Assessment:</b></p> <ul style="list-style-type: none"> <li>• Maintenance Required</li> <li>• Risk of Injury</li> <li>• Risk of Serious Injury</li> <li>• Risk Of Death</li> </ul>	<input checked="" type="checkbox"/> <input type="checkbox"/> <input type="checkbox"/>  <input type="checkbox"/> <input checked="" type="checkbox"/> <input type="checkbox"/> <input type="checkbox"/>

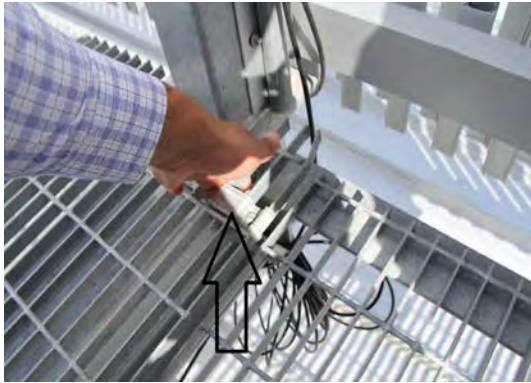
Medium Priority			
Item	Details		Photographic Details
15.	<p><b>Hazard:</b></p> <ul style="list-style-type: none"> <li>• Yes</li> <li>• No</li> <li>• NA</li> </ul> <p><b>Location:</b> Roof level.</p> <p><b>Finding:</b> The clips holding the flooring are loose, which presents as a fall hazard, if one of the flooring components was to dislodge.</p> <p>Quote: <input type="checkbox"/></p> <p>Proceed: <input type="checkbox"/></p> <p>No Action: <input type="checkbox"/></p> <p><b>Auditor's Recommendation:</b> To engage a suitable qualified contractor to secure all the loose clips.</p> <p><b>Auditor's Risk Assessment:</b></p> <ul style="list-style-type: none"> <li>• Maintenance Required</li> <li>• Risk of Injury</li> <li>• Risk of Serious Injury</li> <li>• Risk Of Death</li> </ul>	<input checked="" type="checkbox"/> <input type="checkbox"/> <input type="checkbox"/>  <input type="checkbox"/> <input checked="" type="checkbox"/> <input type="checkbox"/> <input type="checkbox"/>

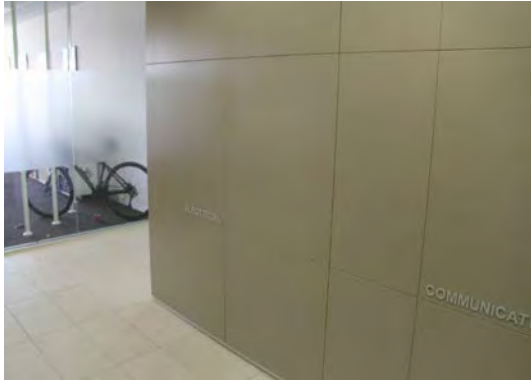
16.	<p><b>Hazard:</b></p> <ul style="list-style-type: none"> <li>• Yes</li> <li>• No</li> <li>• NA</li> </ul> <p><b>Location:</b> Electrical meter cabinets on each level.</p> <p><b>Finding:</b> The cabinets do not have locking mechanism, giving access to the general public to the electrical switchboard.</p> <p>Quote: <input type="checkbox"/></p> <p>Proceed: <input type="checkbox"/></p> <p>No Action: <input type="checkbox"/></p> <p><b>Auditor's Recommendation:</b> To engage a suitable qualified contractor to install locks on all the electrical meter cabinets to eliminate unauthorised people being able to access the area.</p> <p><b>Auditor's Risk Assessment:</b></p> <ul style="list-style-type: none"> <li>• Maintenance Required</li> <li>• Risk of Injury</li> <li>• Risk of Serious Injury</li> <li>• Risk Of Death</li> </ul>	<input checked="" type="checkbox"/> <input type="checkbox"/> <input type="checkbox"/>  <input type="checkbox"/> <input checked="" type="checkbox"/> <input type="checkbox"/> <input type="checkbox"/>

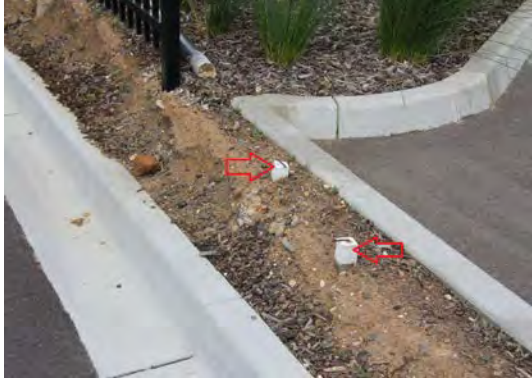
Low Priority/Maintenance			
Item	Details		Photographic Details
17.	<p><b>Hazard:</b></p> <ul style="list-style-type: none"> <li>• Yes</li> <li>• No</li> <li>• NA</li> </ul> <p><b>Location:</b> Garden bed along the driveway entrance for the car parks.</p> <p><b>Finding:</b> Exposed timber with protruding nails, causing a trip hazard.</p> <p><b>Auditor's Recommendation:</b> To engage a suitable qualified contractor to remove the two redundant timbers.</p> <p><b>Auditor's Risk Assessment:</b></p> <ul style="list-style-type: none"> <li>• Maintenance Required</li> <li>• Risk of Injury</li> <li>• Risk of Serious Injury</li> <li>• Risk Of Death</li> </ul>	<input checked="" type="checkbox"/> <input type="checkbox"/> <input type="checkbox"/>  <input type="checkbox"/> <input checked="" type="checkbox"/> <input type="checkbox"/> <input type="checkbox"/>

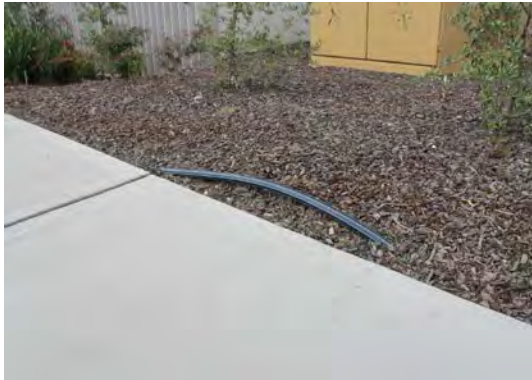
Quote: <input type="checkbox"/>			
Proceed: <input type="checkbox"/>			
No Action: <input type="checkbox"/>			
18.	<p><b>Hazard:</b></p> <ul style="list-style-type: none"> <li>• Yes</li> <li>• No</li> <li>• NA</li> </ul> <p><b>Location:</b> Garden bed along the walkway on Plenty Road.</p> <p><b>Finding:</b> Exposed irrigation pipe causing a trip hazard.</p> <p><b>Auditor's Recommendation:</b> To engage a suitable qualified contractor to rectify the irrigation pipe so it is not exposed.</p> <p><b>Auditor's Risk Assessment:</b></p> <ul style="list-style-type: none"> <li>• Maintenance Required</li> <li>• Risk of Injury</li> <li>• Risk of Serious Injury</li> <li>• Risk Of Death</li> </ul>	<input checked="" type="checkbox"/> <input type="checkbox"/> <input type="checkbox"/>  <input type="checkbox"/> <input checked="" type="checkbox"/> <input type="checkbox"/> <input type="checkbox"/>

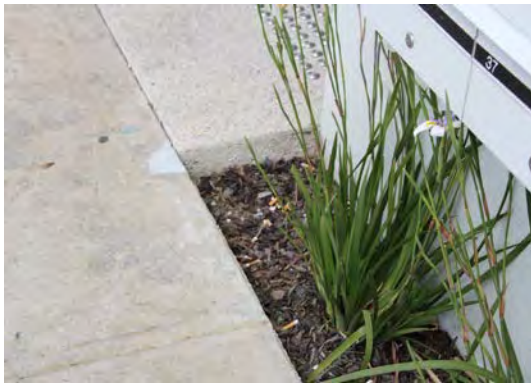
Low Priority/Maintenance			
Item	Details		Photographic Details
19.	<p><b>Hazard:</b></p> <ul style="list-style-type: none"> <li>• Yes</li> <li>• No</li> <li>• NA</li> </ul> <p><b>Location:</b> Garden bed adjacent to letter box.</p> <p><b>Finding:</b> Pit in the garden bed, which presents as a potential tripping hazard.</p> <p><b>Auditor's Recommendation:</b> To engage a suitable qualified contractor to build up the garden bed mulch to match the finish floor level.</p> <p><b>Auditor's Risk Assessment:</b></p> <ul style="list-style-type: none"> <li>• Maintenance Required</li> <li>• Risk of Injury</li> <li>• Risk of Serious Injury</li> <li>• Risk Of Death</li> </ul>	<input checked="" type="checkbox"/> <input type="checkbox"/> <input type="checkbox"/>  <input checked="" type="checkbox"/> <input type="checkbox"/> <input type="checkbox"/> <input type="checkbox"/>

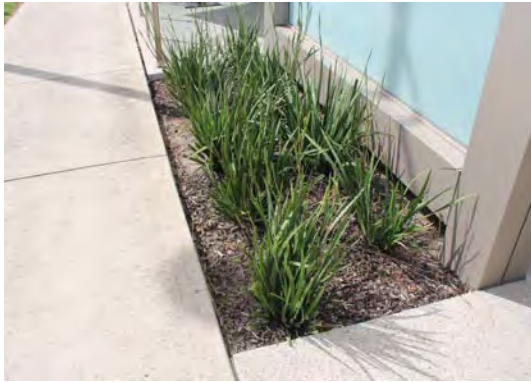
20.	<p><b>Hazard:</b></p> <ul style="list-style-type: none"> <li>• Yes</li> <li>• No</li> <li>• NA</li> </ul> <p><b>Location:</b> Garden bed adjacent to the cafe entrance on Plenty Road.</p> <p><b>Finding:</b> Pit in the garden bed, which presents as a potential tripping hazard.</p> <p><b>Auditor's Recommendation:</b> To engage a suitable qualified contractor to build up the garden bed mulch to match the finish floor level.</p> <p><b>Auditor's Risk Assessment:</b></p> <ul style="list-style-type: none"> <li>• Maintenance Required</li> <li>• Risk of Injury</li> <li>• Risk of Serious Injury</li> <li>• Risk Of Death</li> </ul>	<input checked="" type="checkbox"/> <input type="checkbox"/> <input type="checkbox"/>  <input checked="" type="checkbox"/> <input type="checkbox"/> <input type="checkbox"/> <input type="checkbox"/>

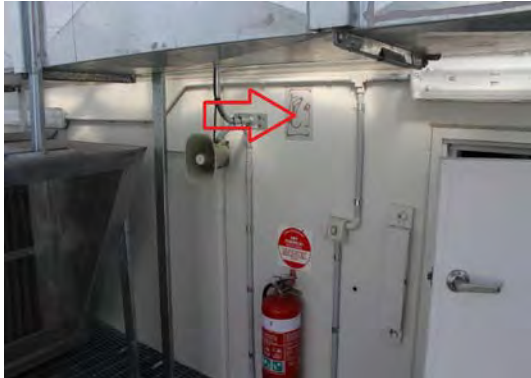
Low Priority/Maintenance			
Item	Details		Photographic Details
21.	<p><b>Hazard:</b></p> <ul style="list-style-type: none"> <li>• Yes</li> <li>• No</li> <li>• NA</li> </ul> <p><b>Location:</b> Roof Level.</p> <p><b>Finding:</b> Fire extinguisher signage missing.</p> <p><b>Auditor's Recommendation:</b> To engage a suitable qualified contractor to install the required signage.</p> <p><b>Auditor's Risk Assessment:</b></p> <ul style="list-style-type: none"> <li>• Maintenance Required</li> <li>• Risk of Injury</li> <li>• Risk of Serious Injury</li> <li>• Risk Of Death</li> </ul>	<input checked="" type="checkbox"/> <input type="checkbox"/> <input type="checkbox"/>  <input checked="" type="checkbox"/> <input type="checkbox"/> <input type="checkbox"/> <input type="checkbox"/>

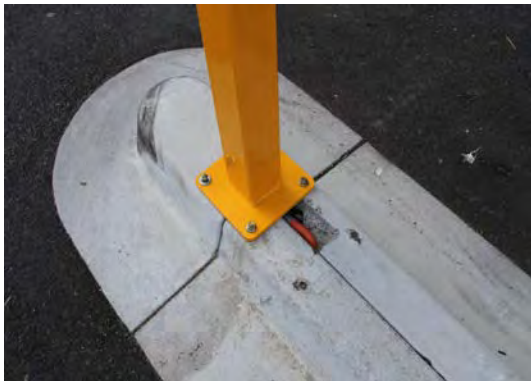
Quote: <input type="checkbox"/>			
Proceed: <input type="checkbox"/>			
No Action: <input type="checkbox"/>			
22.	<p><b>Hazard:</b></p> <ul style="list-style-type: none"> <li>• Yes</li> <li>• No</li> <li>• NA</li> </ul> <p><b>Location:</b> Access control pillar adjacent to the car park entrance.</p> <p><b>Finding:</b> Exposed electrical cabling.</p> <p><b>Auditor's Recommendation:</b> To engage a suitable qualified contractor to rectify so the electrical cabling is not exposed.</p> <p><b>Auditor's Risk Assessment:</b></p> <ul style="list-style-type: none"> <li>• Maintenance Required</li> <li>• Risk of Injury</li> <li>• Risk of Serious Injury</li> <li>• Risk Of Death</li> </ul>	<input checked="" type="checkbox"/> <input type="checkbox"/> <input type="checkbox"/>  <input checked="" type="checkbox"/> <input type="checkbox"/> <input type="checkbox"/> <input type="checkbox"/>

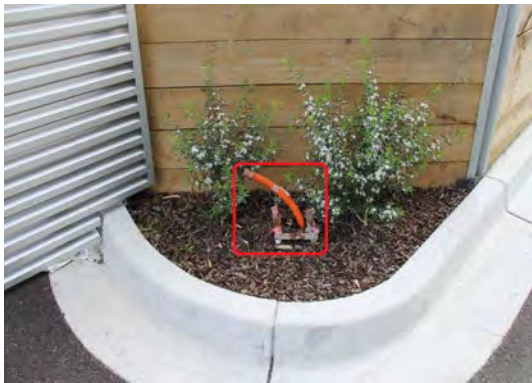
Low Priority/Maintenance			
Item	Details		Photographic Details
23.	<p><b>Hazard:</b></p> <ul style="list-style-type: none"> <li>• Yes</li> <li>• No</li> <li>• NA</li> </ul> <p><b>Location:</b> Garden bed adjacent to bin area.</p> <p><b>Finding:</b> Exposed redundant electrical conduit and bolts, which presents as a tripping hazard.</p> <p><b>Auditor's Recommendation:</b> To engage a suitable qualified contractor to remove the electrical conduit and concrete pad with bolts, if it is not going to be utilised.</p> <p><b>Auditor's Risk Assessment:</b></p> <ul style="list-style-type: none"> <li>• Maintenance Required</li> <li>• Risk of Injury</li> <li>• Risk of Serious Injury</li> <li>• Risk Of Death</li> </ul>	<input checked="" type="checkbox"/> <input type="checkbox"/> <input type="checkbox"/>  <input checked="" type="checkbox"/> <input type="checkbox"/> <input type="checkbox"/> <input type="checkbox"/>

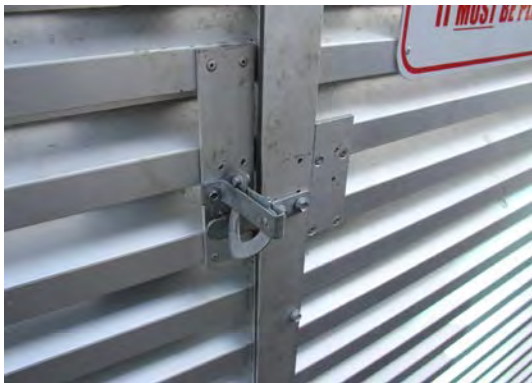
24.	<p><b>Hazard:</b></p> <ul style="list-style-type: none"> <li>• Yes</li> <li>• No</li> <li>• NA</li> </ul> <p><b>Location:</b> Bin area.</p> <p><b>Finding:</b> The bin area lock is not suitable for areas with high wind. It is evident by the holes on the door that this lock has been broken twice before.</p> <p><b>Auditor's Recommendation:</b> To engage a suitable qualified contractor to install a heavy duty locking mechanism onto the door.</p> <p><b>Auditor's Risk Assessment:</b></p> <ul style="list-style-type: none"> <li>• Maintenance Required</li> <li>• Risk of Injury</li> <li>• Risk of Serious Injury</li> <li>• Risk Of Death</li> </ul>	<input checked="" type="checkbox"/> <input type="checkbox"/> <input type="checkbox"/>  <input checked="" type="checkbox"/> <input type="checkbox"/> <input type="checkbox"/> <input type="checkbox"/>

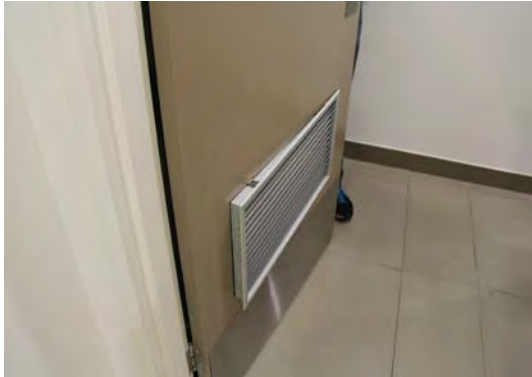
Low Priority/Maintenance				
Item	Details		Photographic Details	
25.	<p><b>Hazard:</b></p> <ul style="list-style-type: none"> <li>• Yes</li> <li>• No</li> <li>• NA</li> </ul> <p><b>Location:</b> Male toilet door on level 1.</p>	<input type="checkbox"/> <input checked="" type="checkbox"/> <input type="checkbox"/>

<p>Quote: <input type="checkbox"/></p> <p>Proceed: <input type="checkbox"/></p> <p>No Action: <input type="checkbox"/></p>	<p><b>Finding:</b> Loose air vent.</p> <p><b>Auditor's Recommendation:</b> To engage a suitable qualified contractor to rectify the air vent on to the door.</p> <p><b>Auditor's Risk Assessment:</b></p> <ul style="list-style-type: none"> <li>• Maintenance Required</li> <li>• Risk of Injury</li> <li>• Risk of Serious Injury</li> <li>• Risk Of Death</li> </ul>	<input checked="" type="checkbox"/> <input type="checkbox"/> <input type="checkbox"/> <input type="checkbox"/>

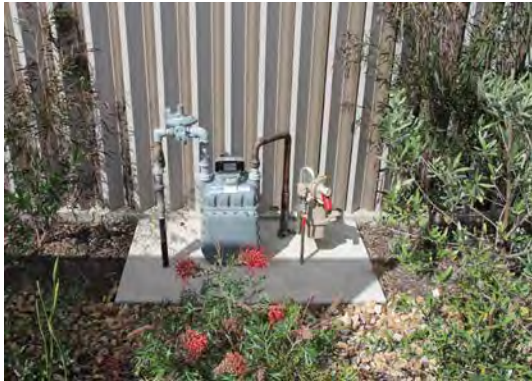
Recommendations			
Item	Details		Photographic Details
26.	<p><b>Hazard:</b></p> <ul style="list-style-type: none"> <li>• Yes</li> <li>• No</li> <li>• NA</li> </ul> <p><b>Location:</b> Gas meter adjacent to the cafe.</p> <p><b>Finding:</b> No locks installed, giving general public access to the gas meter.</p> <p><b>Auditor's Recommendation:</b> To engage a suitable qualified contractor to install a cage with lock around the gas meter.</p> <p><b>Auditor's Risk Assessment:</b></p> <ul style="list-style-type: none"> <li>• Maintenance Required</li> <li>• Risk of Injury</li> <li>• Risk of Serious Injury</li> <li>• Risk Of Death</li> </ul>	<input type="checkbox"/> <input checked="" type="checkbox"/> <input type="checkbox"/>

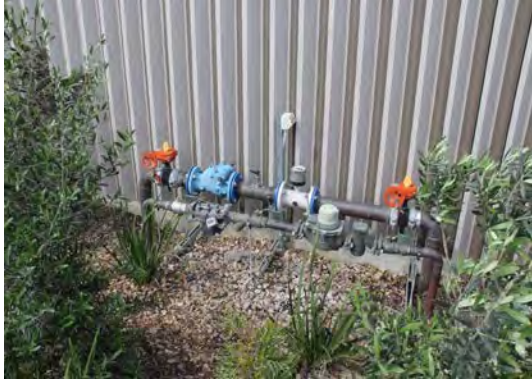
27.	<p><b>Hazard:</b></p> <ul style="list-style-type: none"> <li>• Yes</li> <li>• No</li> <li>• NA</li> </ul> <p><b>Location:</b> Water meter adjacent to the driveway entrance.</p> <p><b>Finding:</b> General public can easily access the water meter.</p> <p><b>Auditor's Recommendation:</b> To engage a suitable qualified contractor to install a cage with lock around the water meter.</p> <p><b>Auditor's Risk Assessment:</b></p> <ul style="list-style-type: none"> <li>• Maintenance Required</li> <li>• Risk of Injury</li> <li>• Risk of Serious Injury</li> <li>• Risk Of Death</li> </ul>	<input type="checkbox"/> <input checked="" type="checkbox"/> <input type="checkbox"/>
