Occupational Health & Safety Report

Part 1: Detailed Safety Report

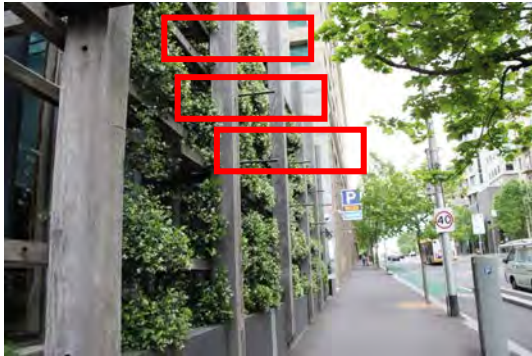
External Area Sample Street

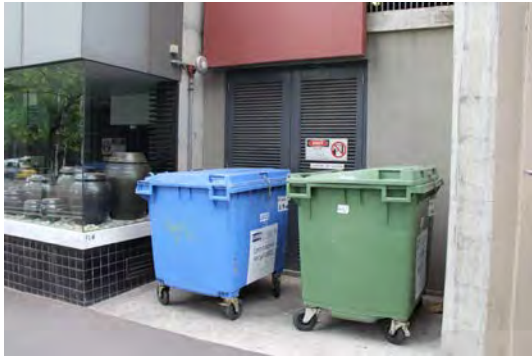
<p>Cost Estimate:</p> <ul style="list-style-type: none"> \$0 to \$500 \$501 to \$1000 \$1001 to \$1500 \$1501 to \$2000 >\$2001

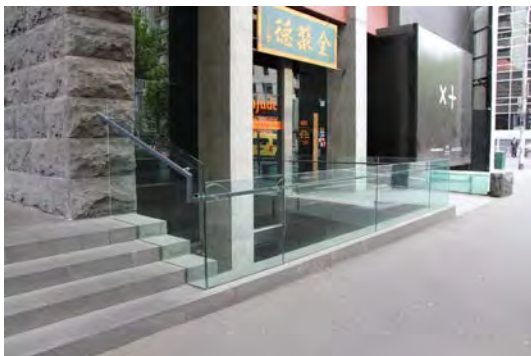
<p>Cost Estimate:</p> <ul style="list-style-type: none"> • \$0 to \$500 • \$501 to \$1000 • \$1001 to \$1500 • \$1501 to \$2000 • >\$2001 <input checked="" type="checkbox"/> <input type="checkbox"/> <input type="checkbox"/> <input type="checkbox"/> <input type="checkbox"/>

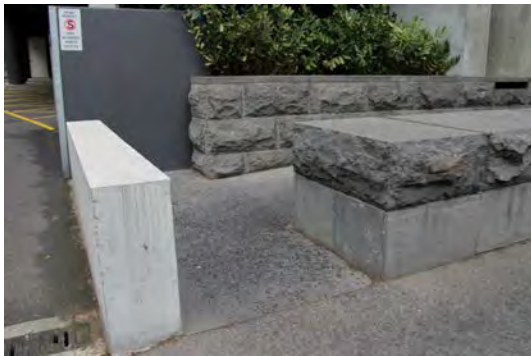
<p>Cost Estimate:</p> <ul style="list-style-type: none"> • \$0 to \$500 • \$501 to \$1000 • \$1001 to \$1500 • \$1501 to \$2000 • >\$2001 <input checked="" type="checkbox"/> <input type="checkbox"/> <input type="checkbox"/> <input type="checkbox"/> <input type="checkbox"/>

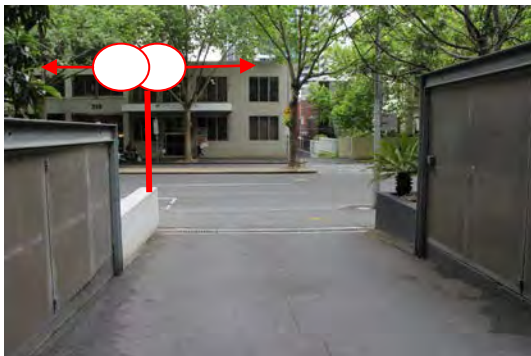
<p>Cost Estimate:</p> <ul style="list-style-type: none"> • \$0 to \$500 • \$501 to \$1000 • \$1001 to \$1500 • \$1501 to \$2000 • >\$2001 <input type="checkbox"/> <input type="checkbox"/> <input checked="" type="checkbox"/> <input type="checkbox"/> <input type="checkbox"/>

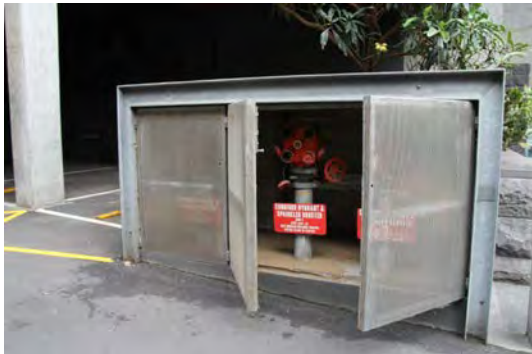
<p>Cost Estimate:</p> <ul style="list-style-type: none"> • \$0 to \$500 • \$501 to \$1000 • \$1001 to \$1500 • \$1501 to \$2000 • >\$2001 <input type="checkbox"/> <input type="checkbox"/> <input type="checkbox"/> <input checked="" type="checkbox"/> <input type="checkbox"/>

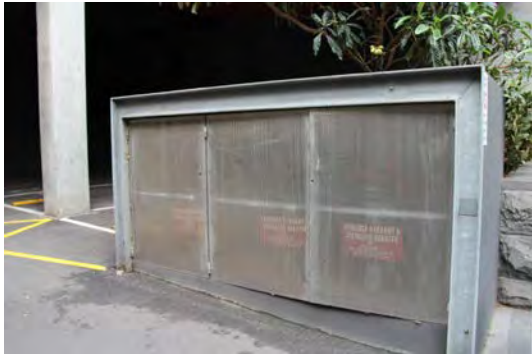
<p>Cost Estimate:</p> <ul style="list-style-type: none"> • \$0 to \$500 • \$501 to \$1000 • \$1001 to \$1500 • \$1501 to \$2000 • >\$2001 <input checked="" type="checkbox"/> <input type="checkbox"/> <input type="checkbox"/> <input type="checkbox"/> <input type="checkbox"/>

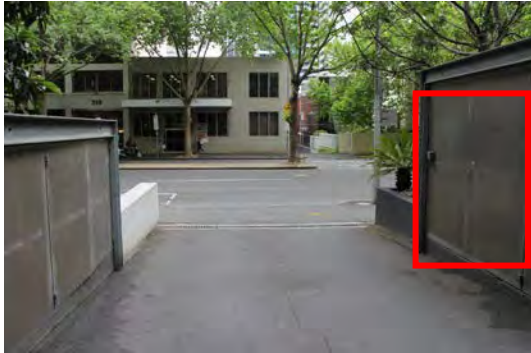
Item	Details		Photographic Details
11.	<p>Hazard:</p> <ul style="list-style-type: none"> • Yes • No • NA <p>Location: External area.</p> <p>Quote: <input type="checkbox"/></p> <p>Finding: Cabinets to gas meter do not have any signage which could cause confusion.</p> <p>Proceed: <input type="checkbox"/></p> <p>Auditor's Recommendation: Install appropriate and compliant signage denoting the area as the gas meter room.</p> <p>No Action: <input type="checkbox"/></p> <p>Auditor's Risk Assessment:</p> <ul style="list-style-type: none"> • Maintenance Required • Risk of Injury • Risk of Serious Injury • Risk Of Death 	<input type="checkbox"/> <input type="checkbox"/> <input checked="" type="checkbox"/> <input checked="" type="checkbox"/> <input type="checkbox"/> <input type="checkbox"/> <input type="checkbox"/>

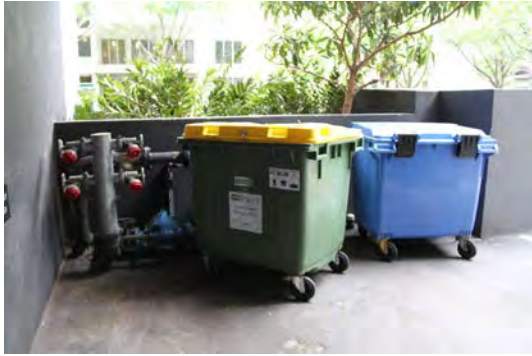
Car Park Entrance and Car Park All Levels

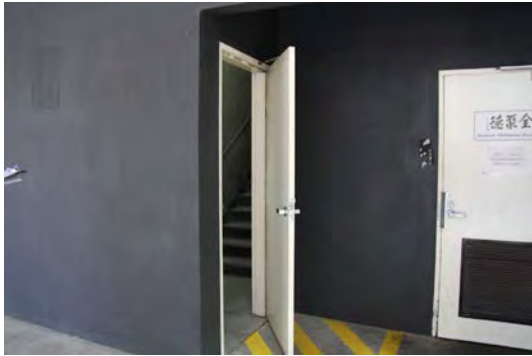
<p>Cost Estimate:</p> <ul style="list-style-type: none"> • \$0 to \$500 • \$501 to \$1000 • \$1001 to \$1500 • \$1501 to \$2000 • >\$2001 	<input checked="" type="checkbox"/> <input type="checkbox"/> <input type="checkbox"/> <input type="checkbox"/> <input type="checkbox"/>

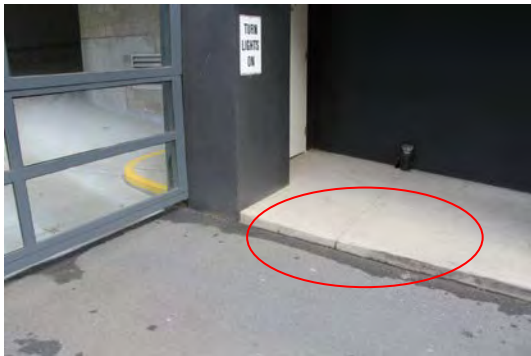
<p>Cost Estimate:</p> <ul style="list-style-type: none"> • \$0 to \$500 • \$501 to \$1000 • \$1001 to \$1500 • \$1501 to \$2000 • >\$2001 	<input checked="" type="checkbox"/> <input type="checkbox"/> <input type="checkbox"/> <input type="checkbox"/> <input type="checkbox"/>

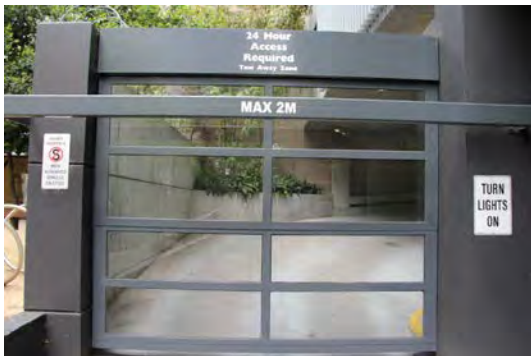
<p>Cost Estimate:</p> <ul style="list-style-type: none"> • \$0 to \$500 • \$501 to \$1000 • \$1001 to \$1500 • \$1501 to \$2000 • >\$2001 <input checked="" type="checkbox"/> <input type="checkbox"/> <input type="checkbox"/> <input type="checkbox"/> <input type="checkbox"/>

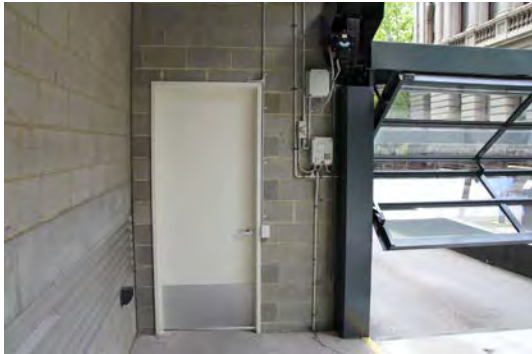
<p>Cost Estimate:</p> <ul style="list-style-type: none"> • \$0 to \$500 • \$501 to \$1000 • \$1001 to \$1500 • \$1501 to \$2000 • >\$2001 <input checked="" type="checkbox"/> <input type="checkbox"/> <input type="checkbox"/> <input type="checkbox"/> <input type="checkbox"/>

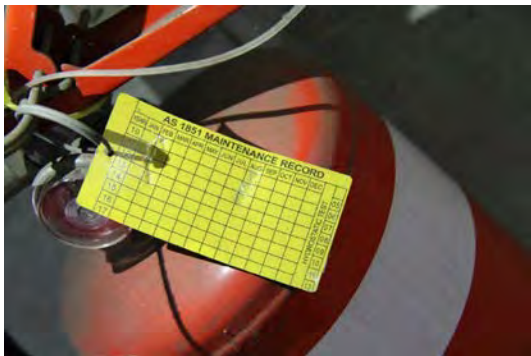
<p>Cost Estimate:</p> <ul style="list-style-type: none"> • \$0 to \$500 • \$501 to \$1000 • \$1001 to \$1500 • \$1501 to \$2000 • >\$2001

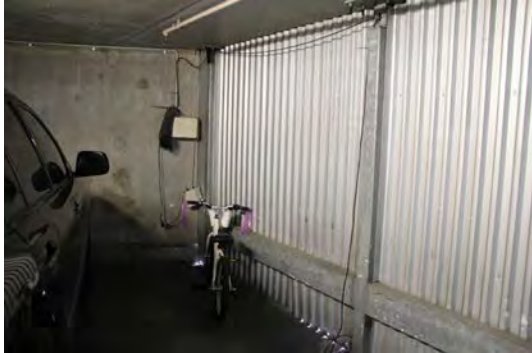
Item	Details		Photographic Details
21.	<p>Hazard:</p> <ul style="list-style-type: none"> • Yes • No • NA <p>Location: Car park.</p> <p>Quote: <input type="checkbox"/></p> <p>Finding: Electrical wiring has been tampered to provide external electricity.</p> <p>Proceed: <input type="checkbox"/></p> <p>Auditor's Recommendation: Terminate the connection and install an outdoor weather proof GPO.</p> <p>No Action: <input type="checkbox"/></p> <p>Auditor's Risk Assessment:</p> <ul style="list-style-type: none"> • Maintenance Required • Risk of Injury • Risk of Serious Injury • Risk Of Death 	<input checked="" type="checkbox"/> <input type="checkbox"/> <input type="checkbox"/> <input type="checkbox"/> <input type="checkbox"/> <input type="checkbox"/> <input checked="" type="checkbox"/>

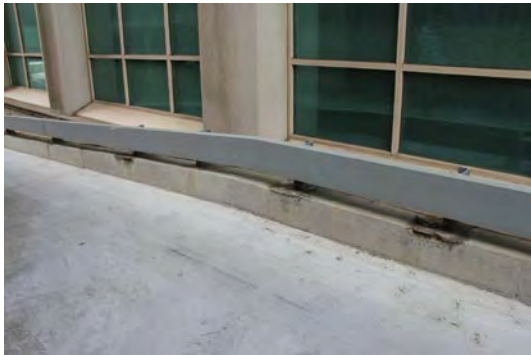
<p>Cost Estimate:</p> <ul style="list-style-type: none"> • \$0 to \$500 • \$501 to \$1000 • \$1001 to \$1500 • \$1501 to \$2000 • >\$2001 <input type="checkbox"/> <input checked="" type="checkbox"/> <input type="checkbox"/> <input type="checkbox"/> <input type="checkbox"/>

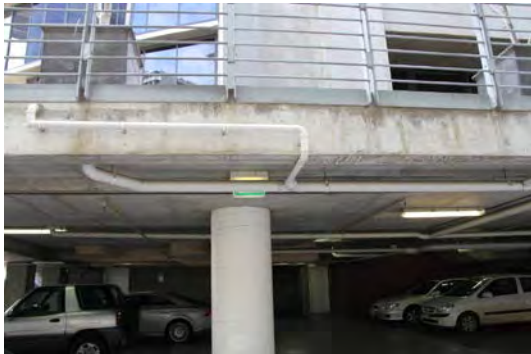
<p>Cost Estimate:</p> <ul style="list-style-type: none"> • \$0 to \$500 • \$501 to \$1000 • \$1001 to \$1500 • \$1501 to \$2000 • >\$2001 <input type="checkbox"/> <input type="checkbox"/> <input checked="" type="checkbox"/> <input type="checkbox"/> <input type="checkbox"/>

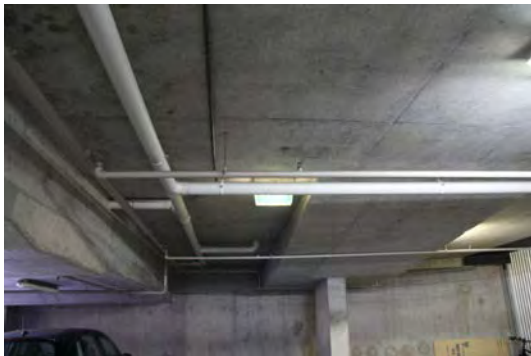
<p>Cost Estimate:</p> <ul style="list-style-type: none"> • \$0 to \$500 • \$501 to \$1000 • \$1001 to \$1500 • \$1501 to \$2000 • >\$2001 	<input checked="" type="checkbox"/> <input type="checkbox"/> <input type="checkbox"/> <input type="checkbox"/> <input type="checkbox"/>

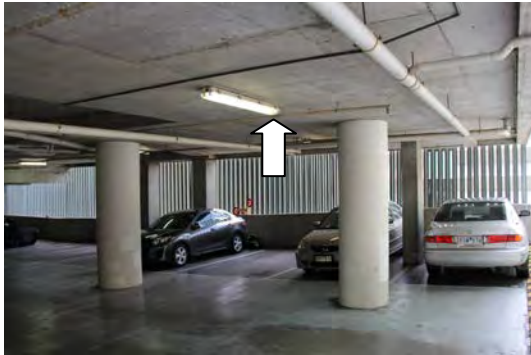
<p>Cost Estimate:</p> <ul style="list-style-type: none"> • \$0 to \$500 • \$501 to \$1000 • \$1001 to \$1500 • \$1501 to \$2000 • >\$2001 	<input checked="" type="checkbox"/> <input type="checkbox"/> <input type="checkbox"/> <input type="checkbox"/> <input type="checkbox"/>

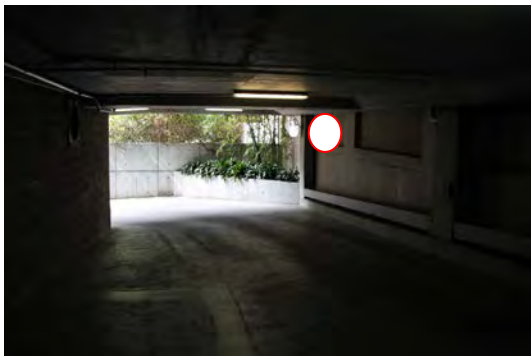
<p>Cost Estimate:</p> <ul style="list-style-type: none"> • \$0 to \$500 • \$501 to \$1000 • \$1001 to \$1500 • \$1501 to \$2000 • >\$2001 <input checked="" type="checkbox"/> <input type="checkbox"/> <input type="checkbox"/> <input type="checkbox"/> <input type="checkbox"/>

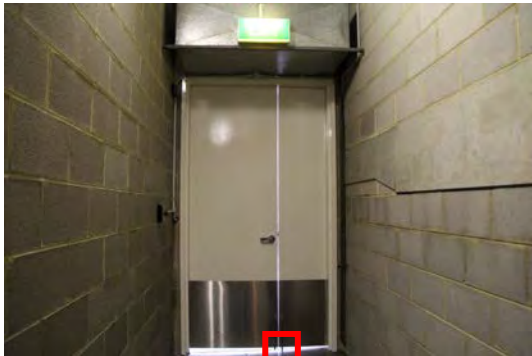
Item	Details		Photographic Details		
31.	<p>Hazard:</p> <ul style="list-style-type: none"> • Yes • No • NA <p>Location: Ground level.</p> <p>Quote: <input type="checkbox"/></p> <p>Finding: Emergency exit door has door hardware enabling it to be in a locked position, compromising emergency exit. The hardware is not compliant. The door has no exit signage.</p> <p>Proceed: <input type="checkbox"/></p> <p>Auditor's Recommendation: Remove the non compliant door hardware and install appropriate/recommended signage.</p> <p>No Action: <input type="checkbox"/></p> <p>Auditor's Risk Assessment:</p> <ul style="list-style-type: none"> • Maintenance Required • Risk of Injury • Risk of Serious Injury • Risk Of Death 	<input checked="" type="checkbox"/> <input type="checkbox"/> <input type="checkbox"/>

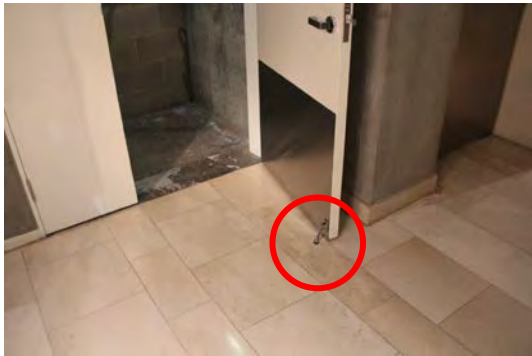
Item	Details		Photographic Details
33.	<p>Hazard:</p> <ul style="list-style-type: none"> • Yes • No • NA <p>Location: Ground level.</p> <p>Quote: <input type="checkbox"/></p> <p>Finding: Emergency exit door has non compliant door hardware, compromising emergency exit.</p> <p>Proceed: <input type="checkbox"/></p> <p>Auditor's Recommendation: Remove the non compliant door hardware.</p> <p>No Action: <input type="checkbox"/></p> <p>Auditor's Risk Assessment:</p> <ul style="list-style-type: none"> • Maintenance Required • Risk of Injury • Risk of Serious Injury • Risk Of Death 	<input checked="" type="checkbox"/> <input type="checkbox"/> <input type="checkbox"/> <input checked="" type="checkbox"/> <input type="checkbox"/> <input checked="" type="checkbox"/> <input type="checkbox"/>

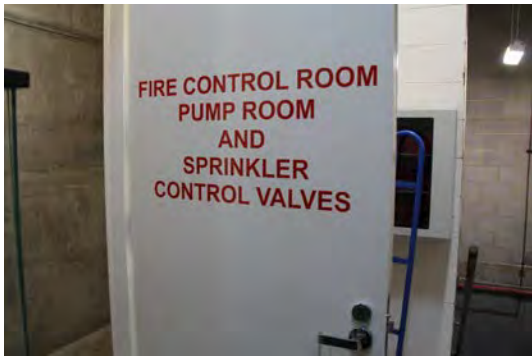
34.	<p>Hazard:</p> <ul style="list-style-type: none"> • Yes • No • NA <p>Location: Ground level plant rooms.</p> <p>Quote: <input type="checkbox"/></p> <p>Finding: Fire control and pump room is currently on a master key system limiting access to emergency services.</p> <p>Proceed: <input type="checkbox"/></p> <p>Auditor's Recommendation: Alter the barrel to a 003 key this is predominantly used in the industry by MFB and other emergency services.</p> <p>No Action: <input type="checkbox"/></p> <p>Auditor's Risk Assessment:</p> <ul style="list-style-type: none"> • Maintenance Required • Risk of Injury • Risk of Serious Injury • Risk Of Death 	<input checked="" type="checkbox"/> <input type="checkbox"/> <input type="checkbox"/> <input checked="" type="checkbox"/> <input type="checkbox"/> <input type="checkbox"/> <input checked="" type="checkbox"/>

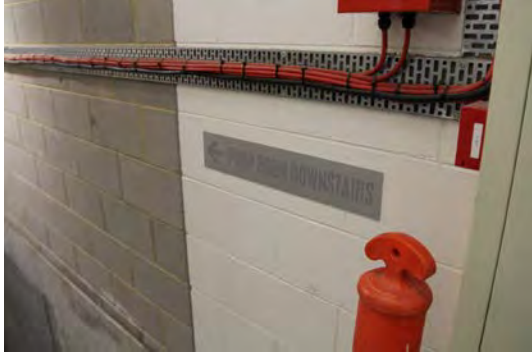
Item	Details		Photographic Details
35.	<p>Hazard:</p> <ul style="list-style-type: none"> • Yes • No • NA <p>Location: Ground level plant rooms.</p> <p>Quote: <input type="checkbox"/></p> <p>Finding: Pump room signage visibility and location is poor.</p> <p>Proceed: <input type="checkbox"/></p> <p>Auditor's Recommendation: Install a new signage that has high visibility.</p> <p>No Action: <input type="checkbox"/></p> <p>Auditor's Risk Assessment:</p> <ul style="list-style-type: none"> • Maintenance Required • Risk of Injury • Risk of Serious Injury • Risk Of Death 	<input type="checkbox"/> <input type="checkbox"/> <input checked="" type="checkbox"/> <input checked="" type="checkbox"/> <input type="checkbox"/> <input type="checkbox"/> <input type="checkbox"/>

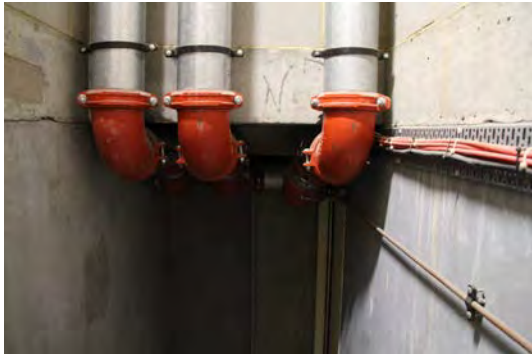
36.	<p>Hazard:</p> <ul style="list-style-type: none"> • Yes • No • NA <p>Location: Ground level plant rooms.</p> <p>Quote: <input type="checkbox"/></p> <p>Finding: Fire booster mains can result in head collision when walking down the stairs.</p> <p>Proceed: <input type="checkbox"/></p> <p>Auditor's Recommendation: To install padded high visibility foam to the underside of the pipes.</p> <p>No Action: <input type="checkbox"/></p> <p>Auditor's Risk Assessment:</p> <ul style="list-style-type: none"> • Maintenance Required • Risk of Injury • Risk of Serious Injury • Risk Of Death 	<input checked="" type="checkbox"/> <input type="checkbox"/> <input type="checkbox"/> <input checked="" type="checkbox"/> <input checked="" type="checkbox"/> <input type="checkbox"/> <input type="checkbox"/>

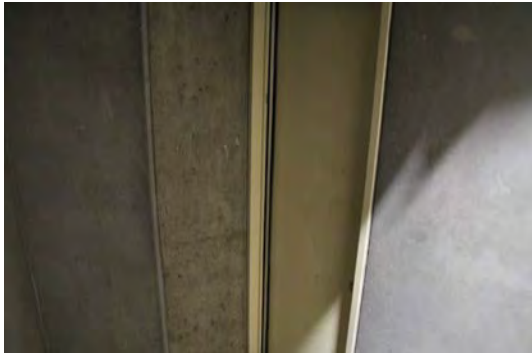
Item	Details		Photographic Details	
37.	<p>Hazard:</p> <ul style="list-style-type: none"> • Yes • No • NA <p>Location: Ground level plant rooms.</p> <p>Quote: <input type="checkbox"/></p> <p>Finding: Fire pump room is not labelled.</p> <p>Proceed: <input type="checkbox"/></p> <p>Auditor's Recommendation: Install appropriate/recommended signage.</p> <p>No Action: <input type="checkbox"/></p> <p>Auditor's Risk Assessment:</p> <ul style="list-style-type: none"> • Maintenance Required • Risk of Injury • Risk of Serious Injury • Risk Of Death 	<input checked="" type="checkbox"/> <input type="checkbox"/> <input type="checkbox"/> <input checked="" type="checkbox"/> <input type="checkbox"/> <input type="checkbox"/> <input type="checkbox"/>

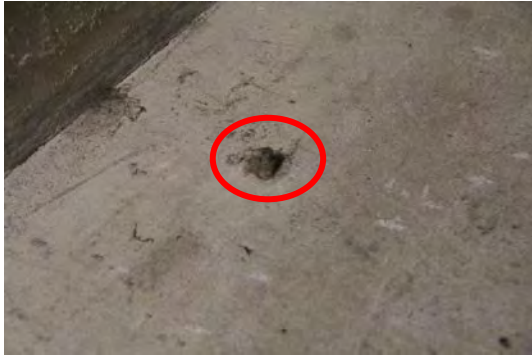
Item	Details		Photographic Details	
39.	<p>Hazard:</p> <ul style="list-style-type: none"> • Yes • No • NA <p>Location: Ground level plant rooms.</p> <p>Quote: <input type="checkbox"/></p> <p>Finding: Exposed bolt on floor which is tripping hazard outside the commercial tenant plant room.</p> <p>Proceed: <input type="checkbox"/></p> <p>Auditor's Recommendation: Grind bolt back to the finished floor level.</p> <p>No Action: <input type="checkbox"/></p> <p>Auditor's Risk Assessment:</p> <ul style="list-style-type: none"> • Maintenance Required • Risk of Injury • Risk of Serious Injury • Risk Of Death 	<input checked="" type="checkbox"/> <input type="checkbox"/> <input type="checkbox"/> <input type="checkbox"/> <input checked="" type="checkbox"/> <input type="checkbox"/> <input type="checkbox"/>

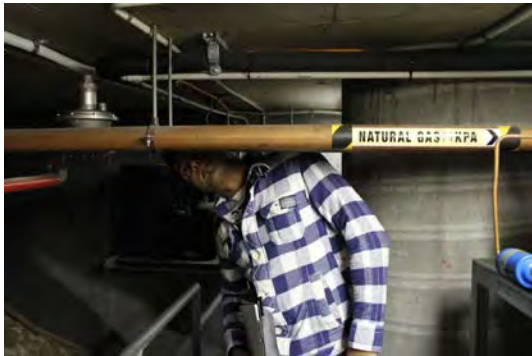
40.	<p>Hazard:</p> <ul style="list-style-type: none"> • Yes • No • NA <p>Location: Ground level plant rooms.</p> <p>Quote: <input type="checkbox"/></p> <p>Finding: Plant infrastructure at head height on ramp which could lead to injuries.</p> <p>Proceed: <input type="checkbox"/></p> <p>Auditor's Recommendation: Install high visibility padding around the pipe and appropriate signage.</p> <p>No Action: <input type="checkbox"/></p> <p>Auditor's Risk Assessment:</p> <ul style="list-style-type: none"> • Maintenance Required • Risk of Injury • Risk of Serious Injury • Risk Of Death 	<input checked="" type="checkbox"/> <input type="checkbox"/> <input type="checkbox"/> <input checked="" type="checkbox"/> <input checked="" type="checkbox"/> <input type="checkbox"/> <input type="checkbox"/>

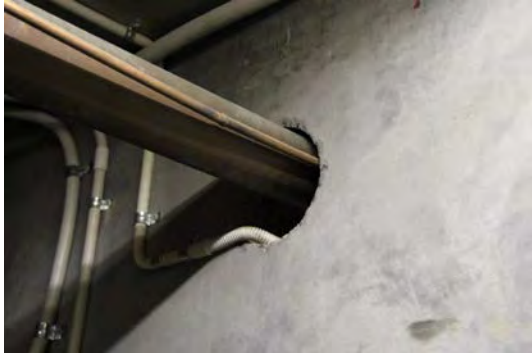
42.	<p>Hazard:</p> <ul style="list-style-type: none"> • Yes • No • NA <p>Location: Ground level plant rooms.</p> <p>Quote: <input type="checkbox"/></p> <p>Finding: Unsealed penetration impacting the fire integrity of the building.</p> <p>Proceed: <input type="checkbox"/></p> <p>Auditor's Recommendation: Seal all unsealed penetrations.</p> <p>No Action: <input type="checkbox"/></p> <p>Auditor's Risk Assessment:</p> <ul style="list-style-type: none"> • Maintenance Required • Risk of Injury • Risk of Serious Injury • Risk Of Death 	<input checked="" type="checkbox"/> <input type="checkbox"/> <input type="checkbox"/> <input checked="" type="checkbox"/> <input type="checkbox"/> <input checked="" type="checkbox"/> <input type="checkbox"/>

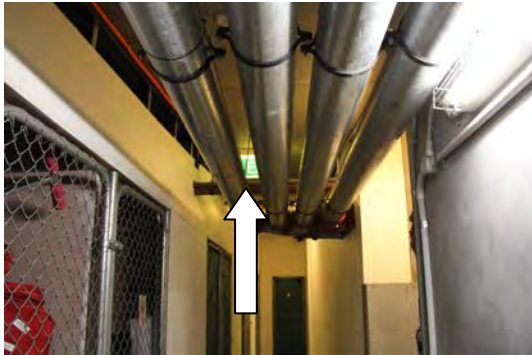
Item	Details		Photographic Details
43.	<p>Hazard:</p> <ul style="list-style-type: none"> • Yes • No • NA <p>Location: Ground level plant rooms.</p> <p>Quote: <input type="checkbox"/></p> <p>Finding: Emergency exit light installed behind storm water pipes, which is not clearly visible.</p> <p>Proceed: <input type="checkbox"/></p> <p>Auditor's Recommendation: Relocate emergency exit lights under the storm water pipes.</p> <p>No Action: <input type="checkbox"/></p> <p>Auditor's Risk Assessment:</p> <ul style="list-style-type: none"> • Maintenance Required • Risk of Injury • Risk of Serious Injury • Risk Of Death 	<input checked="" type="checkbox"/> <input type="checkbox"/> <input type="checkbox"/> <input checked="" type="checkbox"/> <input checked="" type="checkbox"/> <input type="checkbox"/> <input type="checkbox"/>

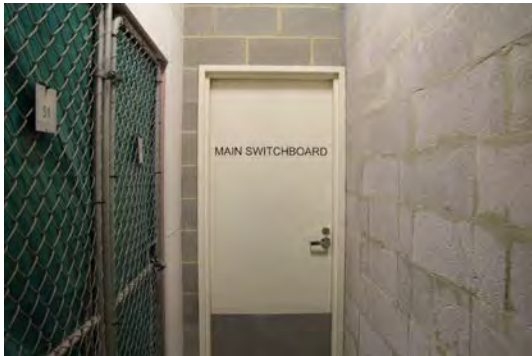
44.	<p>Hazard:</p> <ul style="list-style-type: none"> • Yes • No • NA <p>Location: Ground level switchboard.</p> <p>Quote: <input type="checkbox"/></p> <p>Finding: Main switchboard missing appropriate signage. 'Authorised personnel only'</p> <p>Proceed: <input type="checkbox"/></p> <p>Auditor's Recommendation: Install 'Authorised personnel only' signage.</p> <p>No Action: <input type="checkbox"/></p> <p>Auditor's Risk Assessment:</p> <ul style="list-style-type: none"> • Maintenance Required • Risk of Injury • Risk of Serious Injury • Risk Of Death 	<input checked="" type="checkbox"/> <input type="checkbox"/> <input type="checkbox"/> <input checked="" type="checkbox"/> <input type="checkbox"/> <input type="checkbox"/> <input type="checkbox"/>

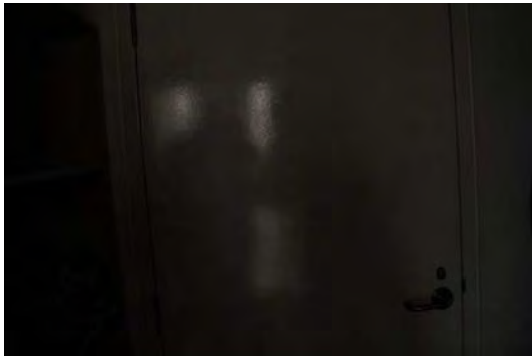
Item	Details		Photographic Details
45.	<p>Hazard:</p> <ul style="list-style-type: none"> • Yes • No • NA <p>Location: Ground level switchboard.</p> <p>Quote: <input type="checkbox"/></p> <p>Finding: Main switchboard room missing signage.</p> <p>Proceed: <input type="checkbox"/></p> <p>Auditor's Recommendation: Install appropriate/recommended signage.</p> <p>No Action: <input type="checkbox"/></p> <p>Auditor's Risk Assessment:</p> <ul style="list-style-type: none"> • Maintenance Required • Risk of Injury • Risk of Serious Injury • Risk Of Death 	<input type="checkbox"/> <input checked="" type="checkbox"/> <input type="checkbox"/> <input checked="" type="checkbox"/> <input type="checkbox"/> <input type="checkbox"/> <input type="checkbox"/>

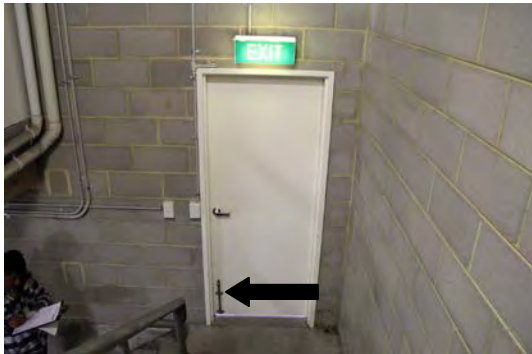
Item	Details		Photographic Details
47.	<p>Hazard:</p> <ul style="list-style-type: none"> • Yes • No • NA <p>Location: Ground level.</p> <p>Quote: <input type="checkbox"/></p> <p>Finding: Emergency exit door to car park is not labelled and has non compliant door hardware.</p> <p>Proceed: <input type="checkbox"/></p> <p>Auditor's Recommendation: Install appropriate/recommended signage and remove non compliant door hardware.</p> <p>No Action: <input type="checkbox"/></p> <p>Auditor's Risk Assessment:</p> <ul style="list-style-type: none"> • Maintenance Required • Risk of Injury • Risk of Serious Injury • Risk Of Death 	<input checked="" type="checkbox"/> <input type="checkbox"/> <input type="checkbox"/> <input checked="" type="checkbox"/> <input checked="" type="checkbox"/> <input type="checkbox"/> <input type="checkbox"/>

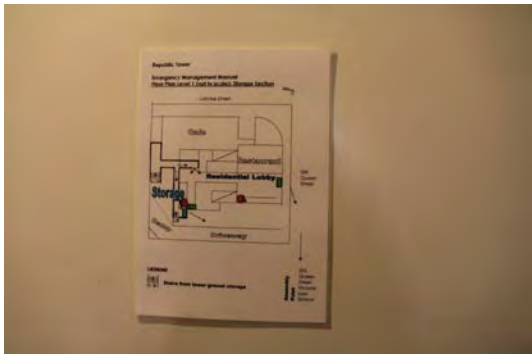
48.	<p>Hazard:</p> <ul style="list-style-type: none"> • Yes • No • NA <p>Location: Ground level and throughout the building.</p> <p>Quote: <input type="checkbox"/></p> <p>Finding: The Evacuation Plans & Procedures do not comply with current Australian Standards (AS 3745-2010).</p> <p>Proceed: <input type="checkbox"/></p> <p>Auditor's Recommendation: To engage a qualified contractor to develop new Evacuation Plans & Procedures.</p> <p>No Action: <input type="checkbox"/></p> <p>Auditor's Risk Assessment:</p> <ul style="list-style-type: none"> • Maintenance Required • Risk of Injury • Risk of Serious Injury • Risk Of Death 	<input checked="" type="checkbox"/> <input type="checkbox"/> <input type="checkbox"/> <input checked="" type="checkbox"/> <input type="checkbox"/> <input type="checkbox"/> <input checked="" type="checkbox"/>

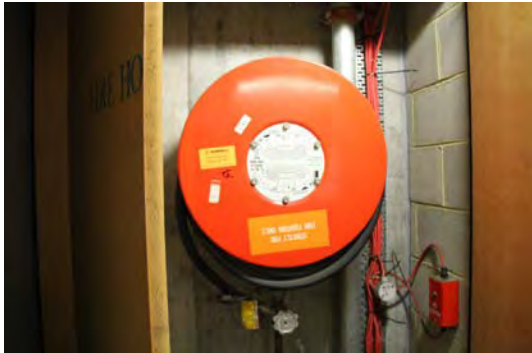
Item	Details		Photographic Details
49.	<p>Hazard:</p> <ul style="list-style-type: none"> • Yes • No • NA <p>Location: Apartment levels throughout the building.</p> <p>Quote: <input type="checkbox"/></p> <p>Finding: Hose reels in the entire building have not been serviced within the last 6 months.</p> <p>Proceed: <input type="checkbox"/></p> <p>Auditor's Recommendation: Engage a suitably qualified contractor.</p> <p>No Action: <input type="checkbox"/></p> <p>Auditor's Risk Assessment:</p> <ul style="list-style-type: none"> • Maintenance Required • Risk of Injury • Risk of Serious Injury • Risk Of Death 	<input checked="" type="checkbox"/> <input type="checkbox"/> <input type="checkbox"/> <input checked="" type="checkbox"/> <input type="checkbox"/> <input type="checkbox"/> <input type="checkbox"/>

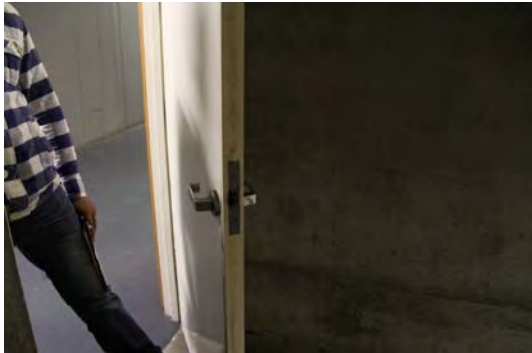
50.	<p>Hazard:</p> <ul style="list-style-type: none"> • Yes • No • NA <p>Location: Apartment levels throughout the building.</p> <p>Quote: <input type="checkbox"/></p> <p>Finding: Currently some emergency exit door allows residents/patrons to enter back into the building after they have existed into the emergency stairwell, which is not complaint.</p> <p>Proceed: <input type="checkbox"/></p> <p>Auditor's Recommendation: Lock all emergency exit doors so if any residents/patrons enter the emergency stairwell; they cannot enter back into the buildings common areas.</p> <p>No Action: <input type="checkbox"/></p> <p>Auditor's Risk Assessment:</p> <ul style="list-style-type: none"> • Maintenance Required • Risk of Injury • Risk of Serious Injury • Risk Of Death 	<input checked="" type="checkbox"/> <input type="checkbox"/> <input type="checkbox"/> <input type="checkbox"/> <input type="checkbox"/> <input checked="" type="checkbox"/> <input type="checkbox"/> <input type="checkbox"/>

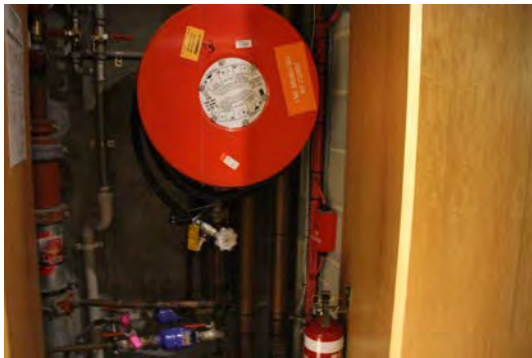
Item	Details		Photographic Details	
51.	<p>Hazard:</p> <ul style="list-style-type: none"> • Yes • No • NA <p>Location: Apartment levels throughout the building.</p> <p>Quote: <input type="checkbox"/></p> <p>Finding: Fire hose reel cupboard signage does not indicate there is a portable fire extinguisher located behind the door in every level.</p> <p>Proceed: <input type="checkbox"/></p> <p>Auditor's Recommendation: Install the appropriate/recommended signage as per Australian Standards so occupants and visitors are aware and can find one during an emergency.</p> <p>No Action: <input type="checkbox"/></p> <p>Auditor's Risk Assessment:</p> <ul style="list-style-type: none"> • Maintenance Required • Risk of Injury • Risk of Serious Injury • Risk Of Death 	<input checked="" type="checkbox"/> <input type="checkbox"/> <input type="checkbox"/> <input type="checkbox"/> <input type="checkbox"/> <input type="checkbox"/> <input checked="" type="checkbox"/>

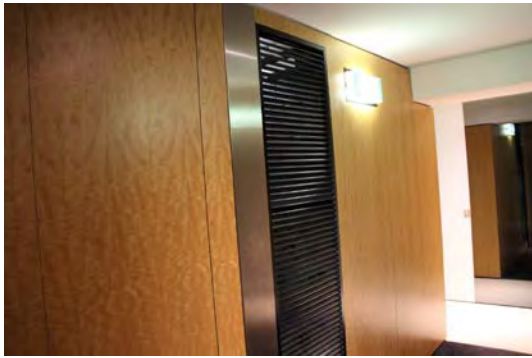
52.	<p>Hazard:</p> <ul style="list-style-type: none"> • Yes • No • NA <p>Location: Apartment levels throughout the building.</p> <p>Quote: <input type="checkbox"/></p> <p>Finding: All apartment levels have an emergency exit door leading to the emergency stairwell. However they are not clearly labelled and is disguised as air grills that could potentially mislead occupants.</p> <p>Proceed: <input type="checkbox"/></p> <p>Auditor's Recommendation: To update emergency light exit housing with directional arrows and install appropriate/recommended signs on the door.</p> <p>No Action: <input type="checkbox"/></p> <p>Auditor's Risk Assessment:</p> <ul style="list-style-type: none"> • Maintenance Required • Risk of Injury • Risk of Serious Injury • Risk Of Death 	<input checked="" type="checkbox"/> <input type="checkbox"/> <input type="checkbox"/> <input type="checkbox"/> <input type="checkbox"/> <input type="checkbox"/> <input checked="" type="checkbox"/>

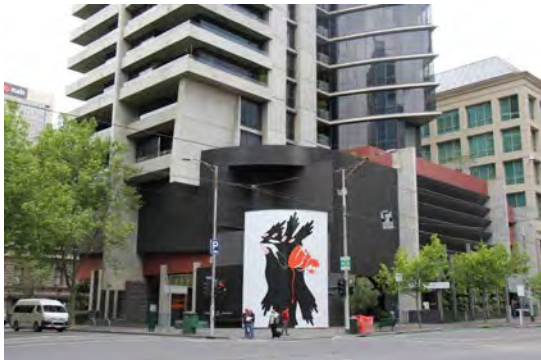
56.	<p>Hazard:</p> <ul style="list-style-type: none"> • Yes • No • NA <p>Location: Private apartment levels throughout the building.</p> <p>Quote: <input type="checkbox"/></p> <p>Finding: Auditors could access the private apartments (25, 26 and 28) when using a general access key to the elevators. This highly compromises the security of private lot owners.</p> <p>Proceed: <input type="checkbox"/></p> <p>Auditor's Recommendation: Review access control system and program keys to access to specified floors and restrict access to everyone.</p> <p>No Action: <input type="checkbox"/></p> <p>Auditor's Risk Assessment:</p> <ul style="list-style-type: none"> • Maintenance Required • Risk of Injury • Risk of Serious Injury • Risk Of Death 	<input checked="" type="checkbox"/> <input type="checkbox"/> <input type="checkbox"/> <input checked="" type="checkbox"/> <input type="checkbox"/> <input type="checkbox"/> <input type="checkbox"/>

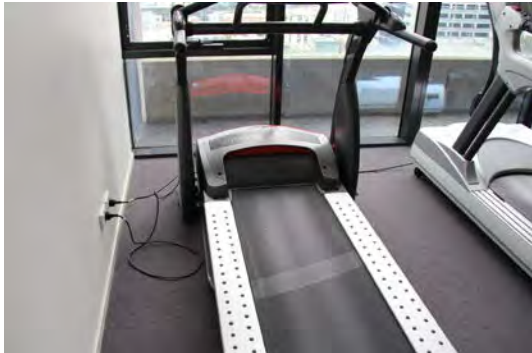
Item	Details		Photographic Details	
57.	<p>Hazard:</p> <ul style="list-style-type: none"> • Yes • No • NA <p>Location: Recreational area gym.</p> <p>Quote: <input type="checkbox"/></p> <p>Finding: Exposed electrical caballing to power treadmills causing a trip hazard.</p> <p>Proceed: <input type="checkbox"/></p> <p>Auditor's Recommendation: Tape down the cables to the carpet to eliminate hazard.</p> <p>No Action: <input type="checkbox"/></p> <p>Auditor's Risk Assessment:</p> <ul style="list-style-type: none"> • Maintenance Required • Risk of Injury • Risk of Serious Injury • Risk Of Death 	<input checked="" type="checkbox"/> <input type="checkbox"/> <input type="checkbox"/>

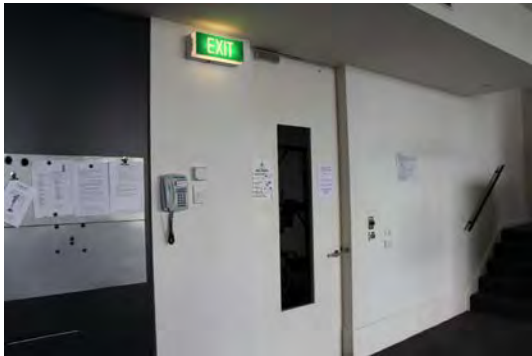
Item	Details		Photographic Details
59.	<p>Hazard:</p> <ul style="list-style-type: none"> • Yes • No • NA <p>Location: Recreational area gym.</p> <p>Quote: <input type="checkbox"/></p> <p>Finding: Emergency exit door is not labelled.</p> <p>Proceed: <input type="checkbox"/></p> <p>Auditor's Recommendation: Install appropriate/recommended signage.</p> <p>No Action: <input type="checkbox"/></p> <p>Auditor's Risk Assessment:</p> <ul style="list-style-type: none"> • Maintenance Required • Risk of Injury • Risk of Serious Injury • Risk Of Death 	<input checked="" type="checkbox"/> <input type="checkbox"/> <input type="checkbox"/> <input checked="" type="checkbox"/> <input type="checkbox"/> <input type="checkbox"/> <input type="checkbox"/>

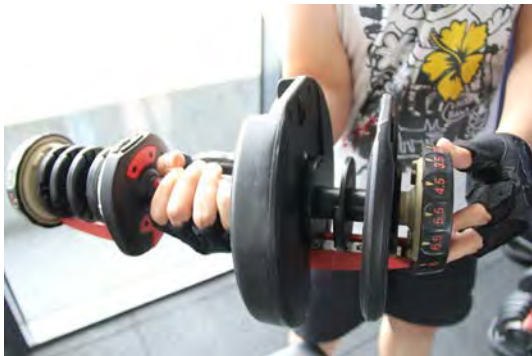
60.	<p>Hazard:</p> <ul style="list-style-type: none"> • Yes • No • NA <p>Location: Recreational area gym.</p> <p>Quote: <input type="checkbox"/></p> <p>Finding: 3 bar bells are not operating as designed; they are not rotating and unable to change weights.</p> <p>Proceed: <input type="checkbox"/></p> <p>Auditor's Recommendation: Replace and remove the broken equipment so it doesn't impact any patrons.</p> <p>No Action: <input type="checkbox"/></p> <p>Auditor's Risk Assessment:</p> <ul style="list-style-type: none"> • Maintenance Required • Risk of Injury • Risk of Serious Injury • Risk Of Death 	<input checked="" type="checkbox"/> <input type="checkbox"/> <input type="checkbox"/> <input type="checkbox"/> <input checked="" type="checkbox"/> <input type="checkbox"/> <input type="checkbox"/>

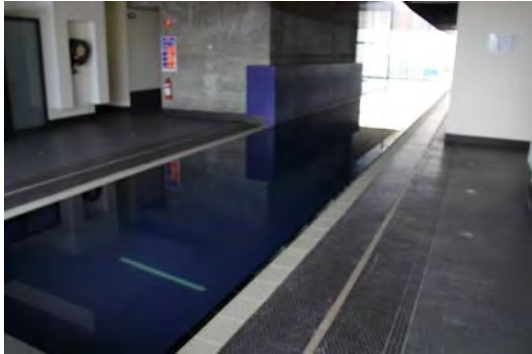
Item	Details		Photographic Details	
61.	<p>Hazard:</p> <ul style="list-style-type: none"> • Yes • No • NA <p>Location: Recreational area pool.</p> <p>Quote: <input type="checkbox"/></p> <p>Finding: No pool depth marker and no diving signage on pool concourse as per guidelines for safe pool operation by Royal Life Saving Victoria.</p> <p>Proceed: <input type="checkbox"/></p> <p>Auditor's Recommendation: Install appropriate/recommended signage.</p> <p>No Action: <input type="checkbox"/></p> <p>Auditor's Risk Assessment:</p> <ul style="list-style-type: none"> • Maintenance Required • Risk of Injury • Risk of Serious Injury • Risk Of Death 	<input checked="" type="checkbox"/> <input type="checkbox"/> <input type="checkbox"/> <input type="checkbox"/> <input checked="" type="checkbox"/> <input type="checkbox"/> <input type="checkbox"/>

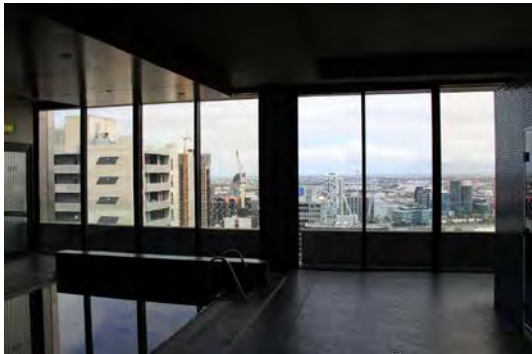
62.	<p>Hazard:</p> <ul style="list-style-type: none"> • Yes • No • NA <p>Location: Recreational area pool.</p> <p>Quote: <input type="checkbox"/></p> <p>Finding: No decal on glass doors which could result in patrons walking directly into the glass.</p> <p>Proceed: <input type="checkbox"/></p> <p>Auditor's Recommendation: Install decal or similar safety stickers as present on the front glass entry door on the ground level.</p> <p>No Action: <input type="checkbox"/></p> <p>Auditor's Risk Assessment:</p> <ul style="list-style-type: none"> • Maintenance Required • Risk of Injury • Risk of Serious Injury • Risk Of Death 	<input checked="" type="checkbox"/> <input type="checkbox"/> <input type="checkbox"/> <input type="checkbox"/> <input checked="" type="checkbox"/> <input type="checkbox"/> <input type="checkbox"/>

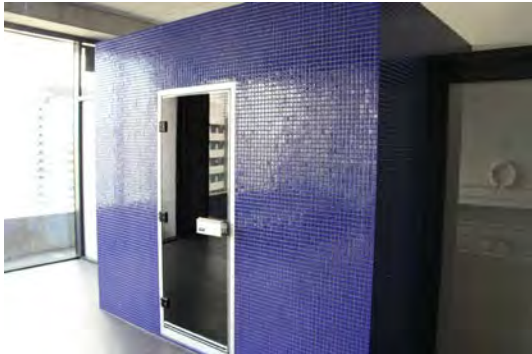
Item	Details		Photographic Details
63.	<p>Hazard:</p> <ul style="list-style-type: none"> • Yes • No • NA <p>Location: Recreational area pool.</p> <p>Quote: <input type="checkbox"/></p> <p>Finding: Appropriate signage to sauna and indicating the temperature and etiquette not present.</p> <p>Proceed: <input type="checkbox"/></p> <p>Auditor's Recommendation: Install appropriate/recommended signage.</p> <p>No Action: <input type="checkbox"/></p> <p>Auditor's Risk Assessment:</p> <ul style="list-style-type: none"> • Maintenance Required • Risk of Injury • Risk of Serious Injury • Risk Of Death 	<input checked="" type="checkbox"/> <input type="checkbox"/> <input type="checkbox"/> <input type="checkbox"/> <input checked="" type="checkbox"/> <input type="checkbox"/> <input type="checkbox"/>

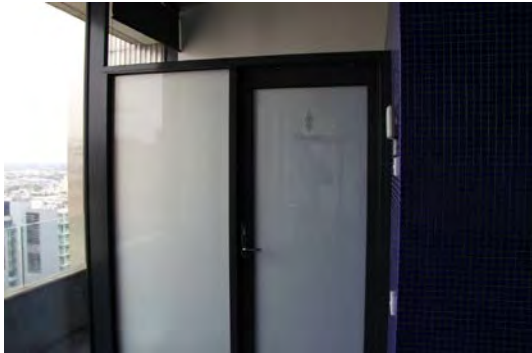
64.	<p>Hazard:</p> <ul style="list-style-type: none"> • Yes • No • NA <p>Location: Recreational area pool.</p> <p>Quote: <input type="checkbox"/></p> <p>Finding: Male and Female change room signage is not clear due to frosting, which could result in opposite sex walking into the wrong change room.</p> <p>Proceed: <input type="checkbox"/></p> <p>Auditor's Recommendation: Install appropriate/recommended signage that is clearly visible.</p> <p>No Action: <input type="checkbox"/></p> <p>Auditor's Risk Assessment:</p> <ul style="list-style-type: none"> • Maintenance Required • Risk of Injury • Risk of Serious Injury • Risk Of Death 	<input type="checkbox"/> <input type="checkbox"/> <input checked="" type="checkbox"/> <input type="checkbox"/> <input checked="" type="checkbox"/> <input type="checkbox"/> <input type="checkbox"/>

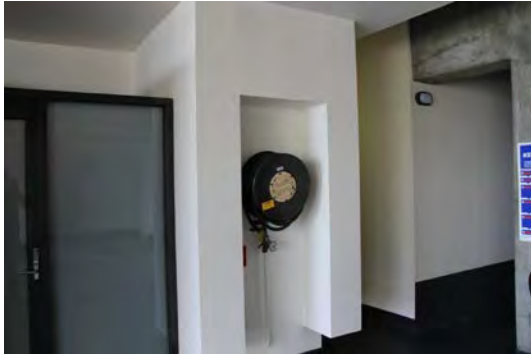
Item	Details		Photographic Details
65.	<p>Hazard:</p> <ul style="list-style-type: none"> • Yes • No • NA <p>Location: Recreational area pool.</p> <p>Quote: <input type="checkbox"/></p> <p>Finding: Fire hose reel not labelled which makes it very difficult to find in an emergency when looking side on from any end of the pool.</p> <p>Proceed: <input type="checkbox"/></p> <p>Auditor's Recommendation: Install appropriate/recommended signage.</p> <p>No Action: <input type="checkbox"/></p> <p>Auditor's Risk Assessment:</p> <ul style="list-style-type: none"> • Maintenance Required • Risk of Injury • Risk of Serious Injury • Risk Of Death 	<input checked="" type="checkbox"/> <input type="checkbox"/> <input type="checkbox"/> <input type="checkbox"/> <input checked="" type="checkbox"/> <input type="checkbox"/> <input type="checkbox"/>

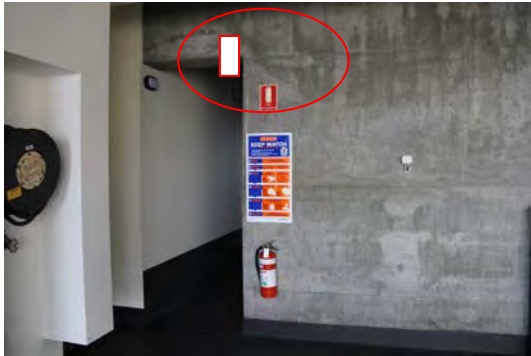
66.	<p>Hazard:</p> <ul style="list-style-type: none"> • Yes • No • NA <p>Location: Recreational area pool.</p> <p>Quote: <input type="checkbox"/></p> <p>Finding: Patrons on the other side of the pool plant room will not be able to see the portable extinguisher signage as it is currently displayed only on one side.</p> <p>Proceed: <input type="checkbox"/></p> <p>Auditor's Recommendation: Relocate signage as per diagram and install on the corner of the wall so that it can be clearly visible from the other side of the plant room.</p> <p>No Action: <input type="checkbox"/></p> <p>Auditor's Risk Assessment:</p> <ul style="list-style-type: none"> • Maintenance Required • Risk of Injury • Risk of Serious Injury • Risk Of Death 	<input checked="" type="checkbox"/> <input type="checkbox"/> <input type="checkbox"/> <input type="checkbox"/> <input checked="" type="checkbox"/> <input type="checkbox"/> <input type="checkbox"/>

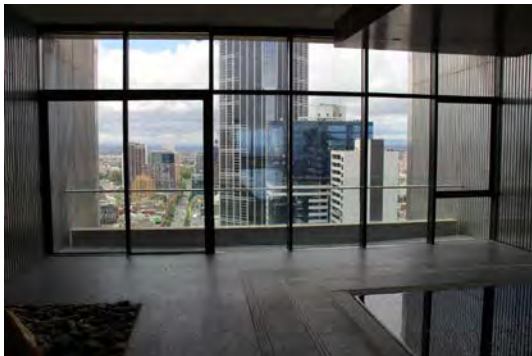
68.	<p>Hazard:</p> <ul style="list-style-type: none"> • Yes • No • NA <p>Location: Recreational area pool.</p> <p>Quote: <input type="checkbox"/></p> <p>Finding: No decal on glass doors which could result in patrons walking directly into the glass.</p> <p>Proceed: <input type="checkbox"/></p> <p>Auditor's Recommendation: Install decal or similar safety stickers as present on the front glass entry door.</p> <p>No Action: <input type="checkbox"/></p> <p>Auditor's Risk Assessment:</p> <ul style="list-style-type: none"> • Maintenance Required • Risk of Injury • Risk of Serious Injury • Risk Of Death 	<input checked="" type="checkbox"/> <input type="checkbox"/> <input type="checkbox"/> <input type="checkbox"/> <input checked="" type="checkbox"/> <input type="checkbox"/> <input type="checkbox"/>

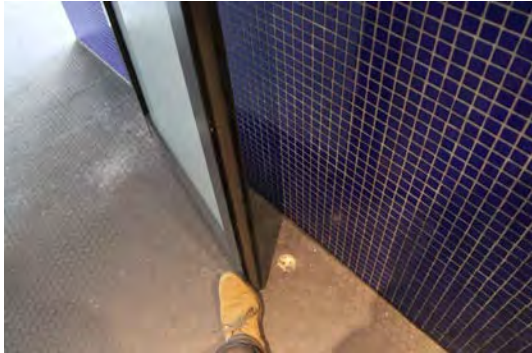
Item	Details		Photographic Details	
69.	<p>Hazard:</p> <ul style="list-style-type: none"> • Yes • No • NA <p>Location: Recreational area pool.</p> <p>Quote: <input type="checkbox"/></p> <p>Finding: Male change room door stopper is broken resulting in sharp edges. Additionally if the door is push hard enough, the handle will crack the tiles.</p> <p>Proceed: <input type="checkbox"/></p> <p>Auditor's Recommendation: Install a new door stopper.</p> <p>No Action: <input type="checkbox"/></p> <p>Auditor's Risk Assessment:</p> <ul style="list-style-type: none"> • Maintenance Required • Risk of Injury • Risk of Serious Injury • Risk Of Death 	<input checked="" type="checkbox"/> <input type="checkbox"/> <input type="checkbox"/> <input type="checkbox"/> <input checked="" type="checkbox"/> <input type="checkbox"/> <input type="checkbox"/>

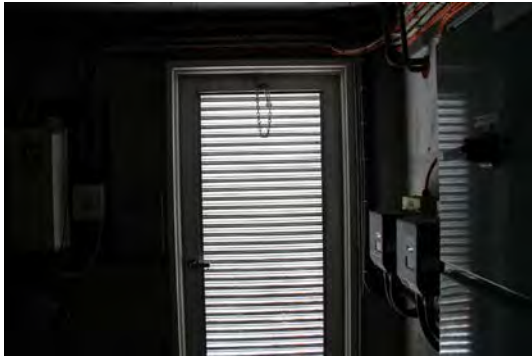
Item	Details		Photographic Details
73.	<p>Hazard:</p> <ul style="list-style-type: none"> • Yes • No • NA <p>Location: Roof.</p> <p>Quote: <input type="checkbox"/></p> <p>Finding: Signage to roof and roof plant room missing.</p> <p>Proceed: <input type="checkbox"/></p> <p>Auditor's Recommendation: Install appropriate 'authorised personnel only' signage.</p> <p>No Action: <input type="checkbox"/></p> <p>Auditor's Risk Assessment:</p> <ul style="list-style-type: none"> • Maintenance Required • Risk of Injury • Risk of Serious Injury • Risk Of Death 	<input checked="" type="checkbox"/> <input type="checkbox"/> <input type="checkbox"/> <input type="checkbox"/> <input checked="" type="checkbox"/> <input type="checkbox"/> <input type="checkbox"/>

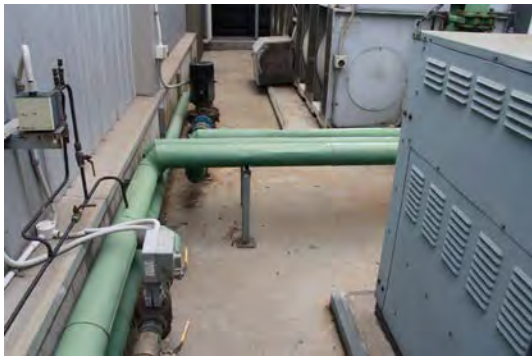
74.	<p>Hazard:</p> <ul style="list-style-type: none"> • Yes • No • NA <p>Location: Roof.</p> <p>Quote: <input type="checkbox"/></p> <p>Finding: Catwalk ramp not installed over water pipes resulting in trade's men crushing the pipe due to walking over them.</p> <p>Proceed: <input type="checkbox"/></p> <p>Auditor's Recommendation: To install a similar catwalk ramp as currently installed over the condenser water pipes.</p> <p>No Action: <input type="checkbox"/></p> <p>Auditor's Risk Assessment:</p> <ul style="list-style-type: none"> • Maintenance Required • Risk of Injury • Risk of Serious Injury • Risk Of Death 	<input checked="" type="checkbox"/> <input type="checkbox"/> <input type="checkbox"/> <input type="checkbox"/> <input type="checkbox"/> <input checked="" type="checkbox"/> <input type="checkbox"/> <input type="checkbox"/>

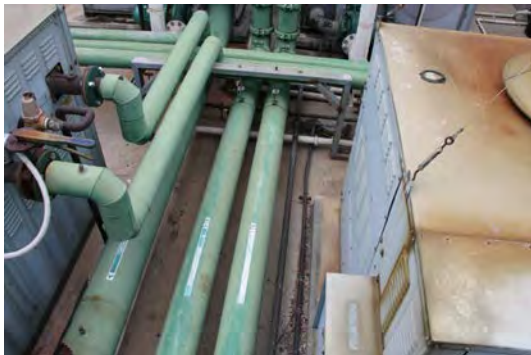
Item	Details		Photographic Details
75.	<p>Hazard:</p> <ul style="list-style-type: none"> • Yes • No • NA <p>Location: Roof.</p> <p>Finding: Catwalk ramp not installed over water pipes resulting in trade's men crushing the pipe due to walking over them.</p> <p>Auditor's Recommendation: To install a similar catwalk ramp as currently installed over the condenser water pipes.</p> <p>Auditor's Risk Assessment:</p> <ul style="list-style-type: none"> • Maintenance Required • Risk of Injury • Risk of Serious Injury • Risk Of Death 	<input checked="" type="checkbox"/> <input type="checkbox"/> <input type="checkbox"/> <input type="checkbox"/> <input checked="" type="checkbox"/> <input type="checkbox"/> <input type="checkbox"/>

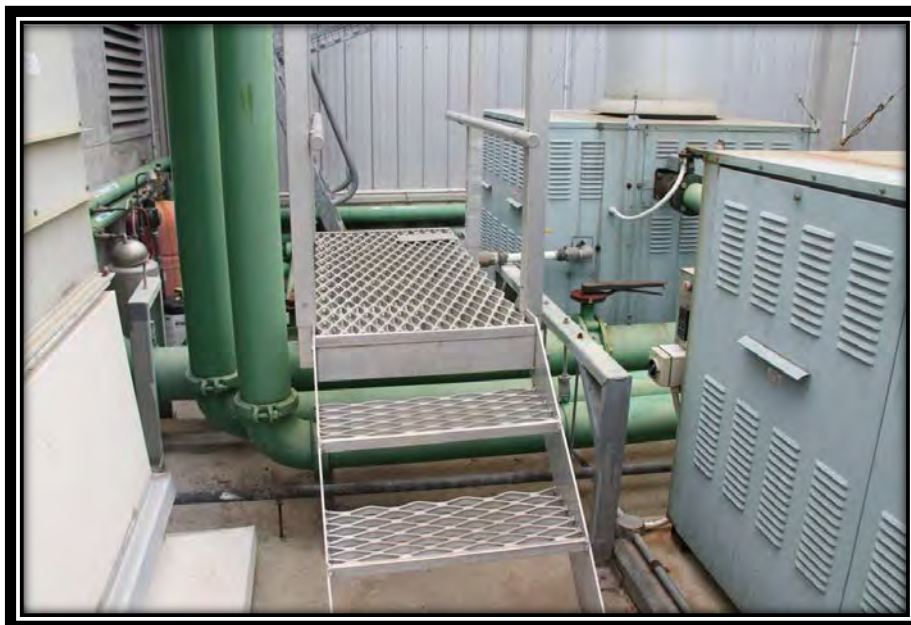
Condenser water pipes cat way example.

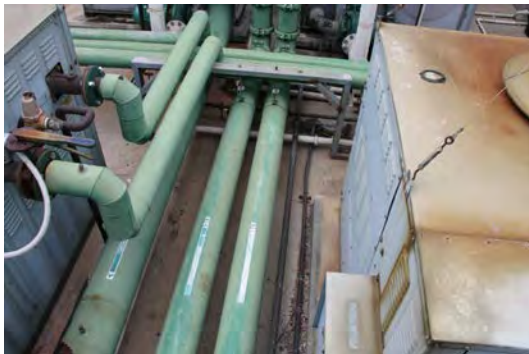
Item	Details		Photographic Details
76.	<p>Hazard:</p> <ul style="list-style-type: none"> • Yes • No • NA <p>Location: Roof.</p> <p>Quote: <input type="checkbox"/></p> <p>Finding: Due to the age of the building, some of the pipe markings have deteriorated to the level where it is not possible to read.</p> <p>Proceed: <input type="checkbox"/></p> <p>Auditor's Recommendation: Install new appropriate/recommended signage.</p> <p>No Action: <input type="checkbox"/></p> <p>Auditor's Risk Assessment:</p> <ul style="list-style-type: none"> • Maintenance Required • Risk of Injury • Risk of Serious Injury • Risk Of Death 	<input type="checkbox"/> <input type="checkbox"/> <input checked="" type="checkbox"/> <input checked="" type="checkbox"/> <input type="checkbox"/> <input type="checkbox"/> <input type="checkbox"/>

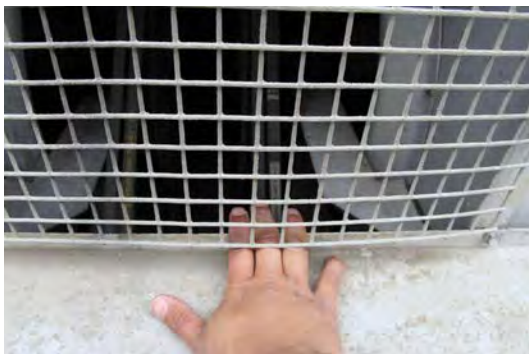
77.	<p>Hazard:</p> <ul style="list-style-type: none"> • Yes • No • NA <p>Location: Roof.</p> <p>Quote: <input type="checkbox"/></p> <p>Finding: The guards on side of the water tanks are allowing fingers to get caught in the belt drive.</p> <p>Proceed: <input type="checkbox"/></p> <p>Auditor's Recommendation: Install additional brackets and tighten existing brackets to ensure fingers cannot access the area.</p> <p>No Action: <input type="checkbox"/></p> <p>Auditor's Risk Assessment:</p> <ul style="list-style-type: none"> • Maintenance Required • Risk of Injury • Risk of Serious Injury • Risk Of Death 	<input checked="" type="checkbox"/> <input type="checkbox"/> <input type="checkbox"/> <input type="checkbox"/> <input type="checkbox"/> <input type="checkbox"/> <input checked="" type="checkbox"/> <input type="checkbox"/>

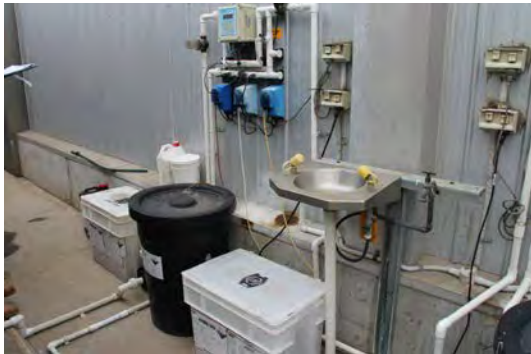
Item	Details		Photographic Details
78.	<p>Hazard:</p> <ul style="list-style-type: none"> • Yes • No • NA <p>Location: Roof and pool plant area (behind pool).</p> <p>Quote: <input type="checkbox"/></p> <p>Finding: Material Safety Data Sheet missing for all pool chemicals.</p> <p>Proceed: <input type="checkbox"/></p> <p>Auditor's Recommendation: Affix Material Safety Data Sheet where chemicals are stored.</p> <p>No Action: <input type="checkbox"/></p> <p>Auditor's Risk Assessment:</p> <ul style="list-style-type: none"> • Maintenance Required • Risk of Injury • Risk of Serious Injury • Risk Of Death 	<input checked="" type="checkbox"/> <input type="checkbox"/> <input type="checkbox"/> <input checked="" type="checkbox"/> <input checked="" type="checkbox"/> <input type="checkbox"/> <input type="checkbox"/>

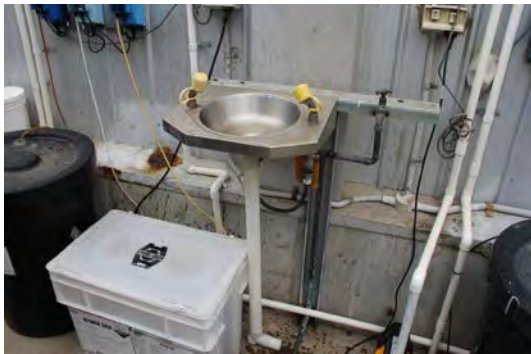
79.	<p>Hazard:</p> <ul style="list-style-type: none"> • Yes • No • NA <p>Location: Roof.</p> <p>Quote: <input type="checkbox"/></p> <p>Finding: Eye wash station missing signage. Further it is very hard to access the wash with one isolated button located under the sink.</p> <p>Proceed: <input type="checkbox"/></p> <p>Auditor's Recommendation: Install a foot operated eye wash to allow easy use of eye wash when required.</p> <p>No Action: <input type="checkbox"/></p> <p>Auditor's Risk Assessment:</p> <ul style="list-style-type: none"> • Maintenance Required • Risk of Injury • Risk of Serious Injury • Risk Of Death 	<input checked="" type="checkbox"/> <input type="checkbox"/> <input type="checkbox"/> <input type="checkbox"/> <input type="checkbox"/> <input checked="" type="checkbox"/> <input type="checkbox"/>

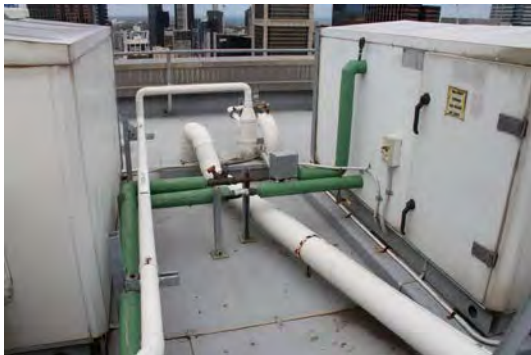
Item	Details		Photographic Details	
80.	<p>Hazard:</p> <ul style="list-style-type: none"> • Yes • No • NA <p>Location: Roof.</p> <p>Quote: <input type="checkbox"/></p> <p>Finding: Catwalk ramp not installed over water pipes resulting in trade's men crushing the pipe due to walking over it.</p> <p>Proceed: <input type="checkbox"/></p> <p>Auditor's Recommendation: To install a similar catwalk ramp as currently installed over the condenser water pipe.</p> <p>No Action: <input type="checkbox"/></p> <p>Auditor's Risk Assessment:</p> <ul style="list-style-type: none"> • Maintenance Required • Risk of Injury • Risk of Serious Injury • Risk Of Death 	<input checked="" type="checkbox"/> <input type="checkbox"/> <input type="checkbox"/> <input checked="" type="checkbox"/> <input checked="" type="checkbox"/> <input type="checkbox"/> <input type="checkbox"/>
