Occupational Health & Safety Report

Part 1: Detailed Safety Report

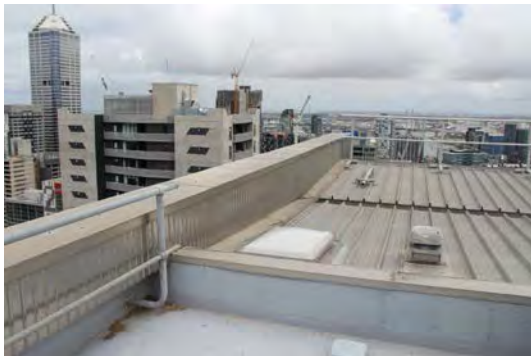
81.	<p>Hazard:</p> <ul style="list-style-type: none"> • Yes • No • NA <p>Location: Roof.</p> <p>Quote: <input type="checkbox"/></p> <p>Finding: Hand rail missing along both facade walls (north & south) which could lead to anyone falling over the edge. Hand rails are required when the parapet is less than 1.2m in height.</p> <p>Proceed: <input type="checkbox"/></p> <p>Auditor's Recommendation: Continue the current hand rails system all the way to the end to comply OH&S requirements.</p> <p>No Action: <input type="checkbox"/></p> <p>Auditor's Risk Assessment:</p> <ul style="list-style-type: none"> • Maintenance Required • Risk of Injury • Risk of Serious Injury • Risk Of Death 	<input checked="" type="checkbox"/> <input type="checkbox"/> <input type="checkbox"/> <input type="checkbox"/> <input type="checkbox"/> <input type="checkbox"/> <input checked="" type="checkbox"/>

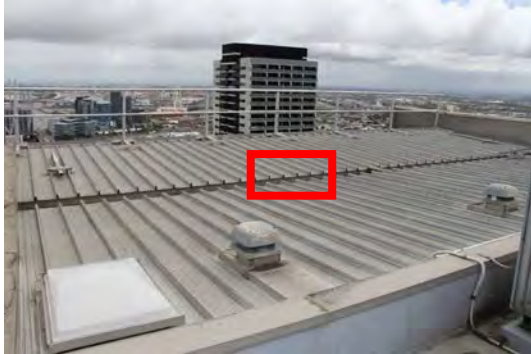
Item	Details		Photographic Details	
82.	<p><u>Hazard:</u></p> <ul style="list-style-type: none"> • Yes • No • NA <p><u>Location:</u> Roof.</p> <p>Quote: <input type="checkbox"/></p> <p><u>Finding:</u> Currently there are 2 anchor points on the north & south side of the roof. The anchor system is archaic potentially allowing tradesmen to fall over the roof with 10 meters of slack rope.</p> <p>Proceed: <input type="checkbox"/></p> <p><u>Auditor's Recommendation:</u> To install a third anchor point in the middle of the roof as shown in the picture. This will act as a failsafe system which will not permit excess slack rope.</p> <p>No Action: <input type="checkbox"/></p> <p><u>Auditor's Risk Assessment:</u></p> <ul style="list-style-type: none"> • Maintenance Required • Risk of Injury • Risk of Serious Injury • Risk Of Death 	<input checked="" type="checkbox"/> <input type="checkbox"/> <input type="checkbox"/>

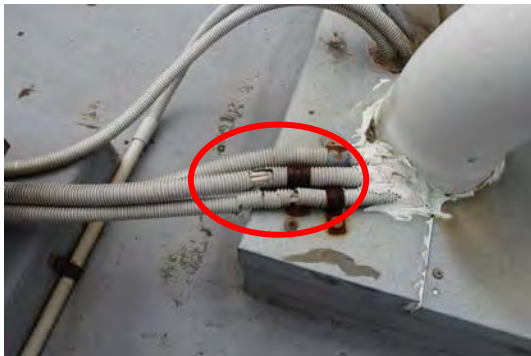
83.	<p><u>Hazard:</u></p> <ul style="list-style-type: none"> • Yes • No • NA <p><u>Location:</u> Roof.</p> <p>Quote: <input type="checkbox"/></p> <p><u>Finding:</u> Electrical conduits overtime has become brittle and is breaking away leaving exposed live cables.</p> <p>Proceed: <input type="checkbox"/></p> <p><u>Auditor's Recommendation:</u> To engage a suitably qualified contractor to replace the conduit.</p> <p>No Action: <input type="checkbox"/></p> <p><u>Auditor's Risk Assessment:</u></p> <ul style="list-style-type: none"> • Maintenance Required • Risk of Injury • Risk of Serious Injury • Risk Of Death 	<input checked="" type="checkbox"/> <input type="checkbox"/> <input type="checkbox"/>

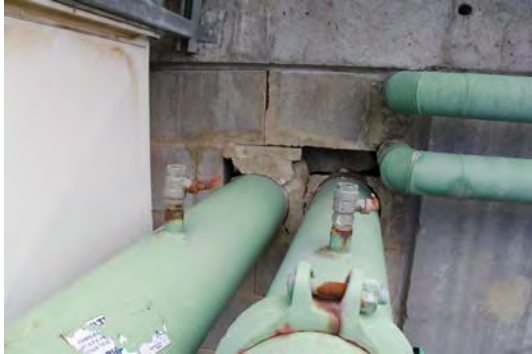
Item	Details		Photographic Details
84.	<p>Hazard:</p> <ul style="list-style-type: none"> • Yes • No • NA <p>Location: Roof.</p> <p>Quote: <input type="checkbox"/></p> <p>Finding: Due to the movement and vibration of the condensed water pipes over time, the block work wall has deteriorated and collapsed in the area.</p> <p>Proceed: <input type="checkbox"/></p> <p>Auditor's Recommendation: To engage a suitably qualified contractor to repair and prevent a complete collapse.</p> <p>No Action: <input type="checkbox"/></p> <p>Auditor's Risk Assessment:</p> <ul style="list-style-type: none"> • Maintenance Required • Risk of Injury • Risk of Serious Injury • Risk Of Death 	<input checked="" type="checkbox"/> <input type="checkbox"/> <input type="checkbox"/> <input type="checkbox"/> <input type="checkbox"/> <input type="checkbox"/> <input checked="" type="checkbox"/>
