## Detailed Windows Inspection

49 Sample Road Melbourne VIC 3122

## Part 1: Inspection Notes

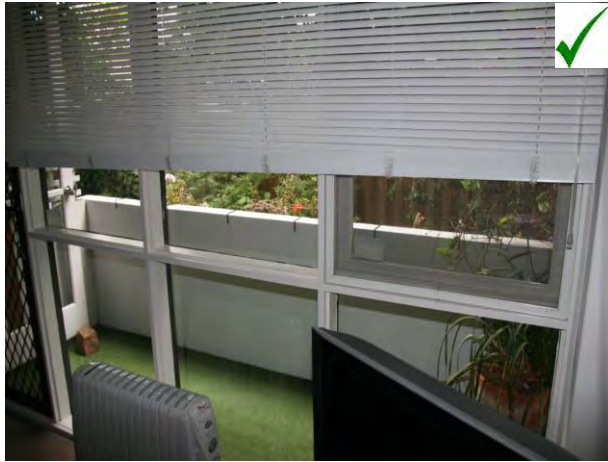
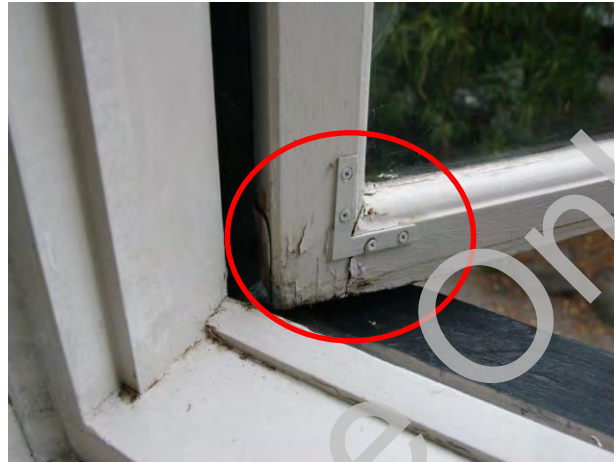
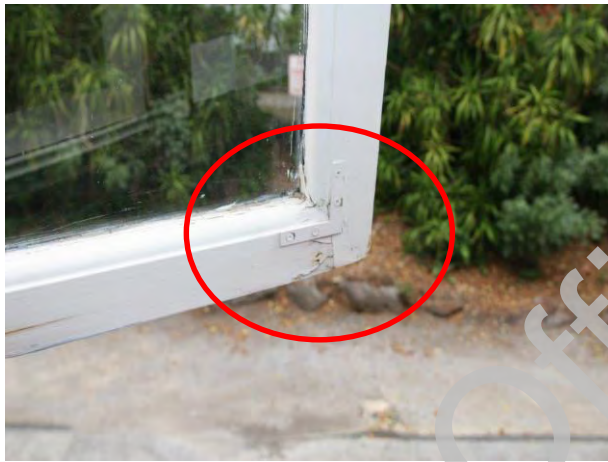
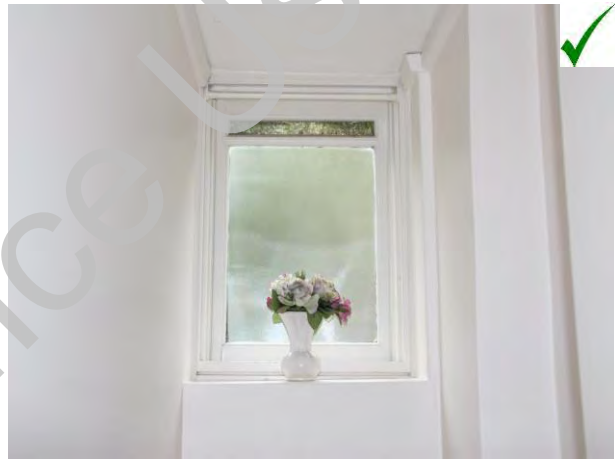
Location	Inspection Notes
Kitchen	Replace window sash. Patch and paint window frame.
Dining	Prepare and paint entire window frame, sash and sill.
Living	Good condition. No action required.
Bedroom 1	Replace entire sash as it is falling apart, 'L' brackets have been used to hold the sash in place. Prepare and paint window frame.
Toilet	Good condition. No action required.
Bathroom	Replace glazing as it has cracked above the exhaust fan.
Bedroom 2	Replace window stays as it is not opening/closing properly.

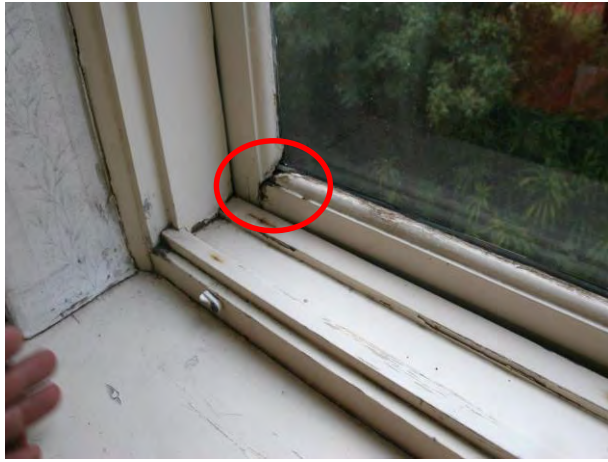
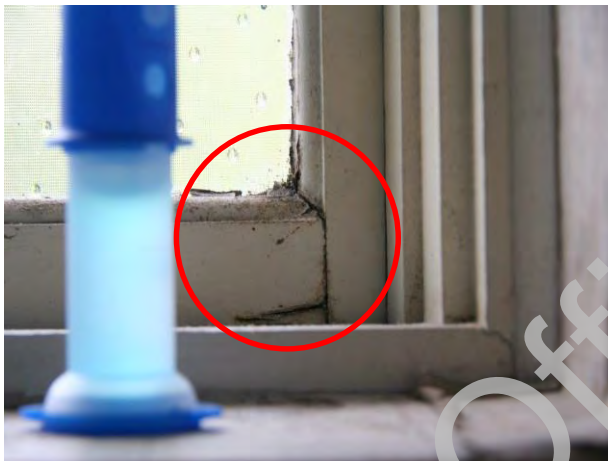
## Unit 9

Location	Inspection Notes
Kitchen	Replace window sash as the seal around the glazing has deteriorated and the sash is cracked. Prepare and paint window frame.
Dining	Replace entire window sash, frame & glazing as they have deteriorated beyond repair.
Living	Replace door hardware.
Bedroom 1	Replace entire window sash, frame & glazing as they have deteriorated beyond repair.
Toilet	Replace window sash. Prepare and paint frame.
Bathroom	Replace window sash. Prepare and paint frame.
Bedroom 2	Replace entire window sash, frame & glazing as they have deteriorated beyond repair.

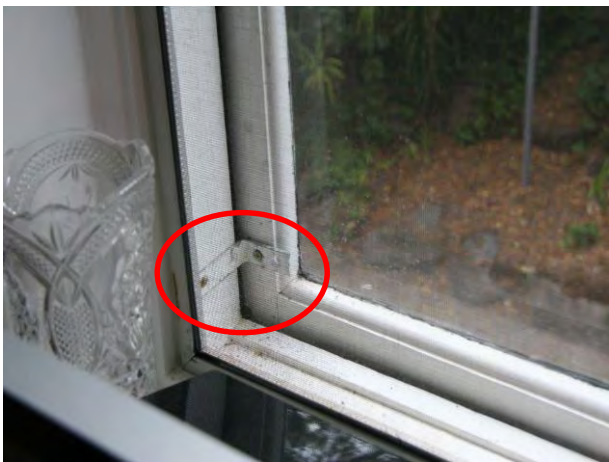
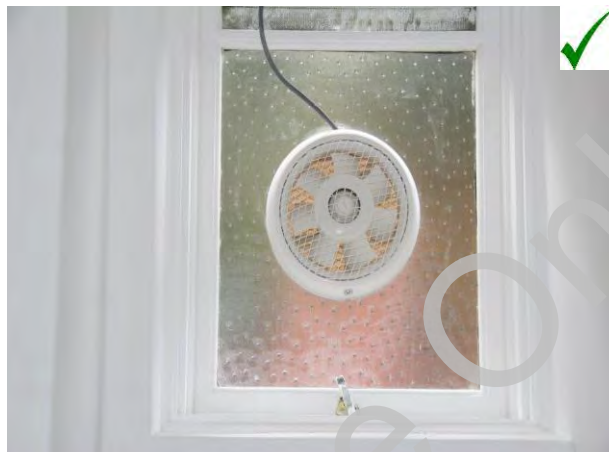
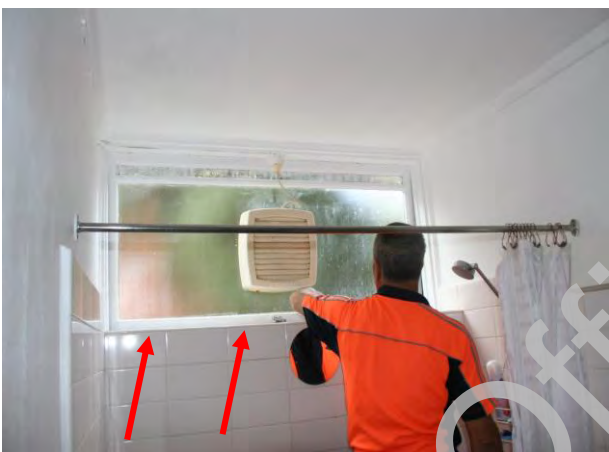
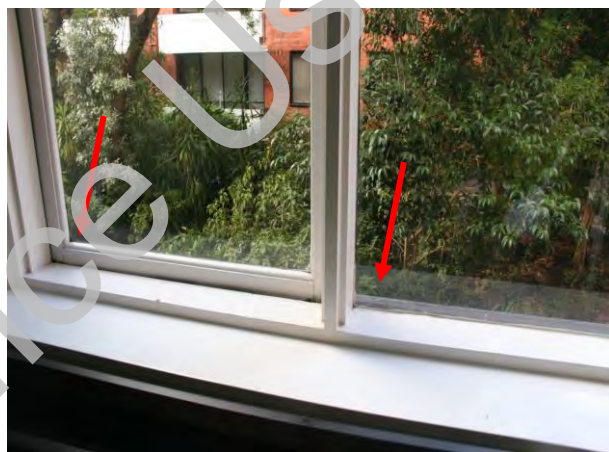
## Unit 2

Location	Inspection Notes
<b>Kitchen</b>	Replace window stays as the window does not open and has been screwed shut. A make safe was undertaken to screw the window shut as it was not secured properly. Patch and paint affected areas after replacement.
<b>Bedroom 1</b>	Replace external window sill.
<b>Living</b>	Good condition. No action required.
<b>Bedroom 2</b>	Replace window stays as the window does not open and has been screwed shut. A make safe was undertaken to screw the window shut as it was not secured properly. Patch and paint affected areas after replacement.
<b>Toilet</b>	Good condition. No action required.
<b>Bathroom</b>	Requires the window sash to be planed down as the window doesn't close properly. Patch and paint affected areas after replacement.
<b>Bedroom 3</b>	Replace window sash. Prepare and paint window frame and external sill.

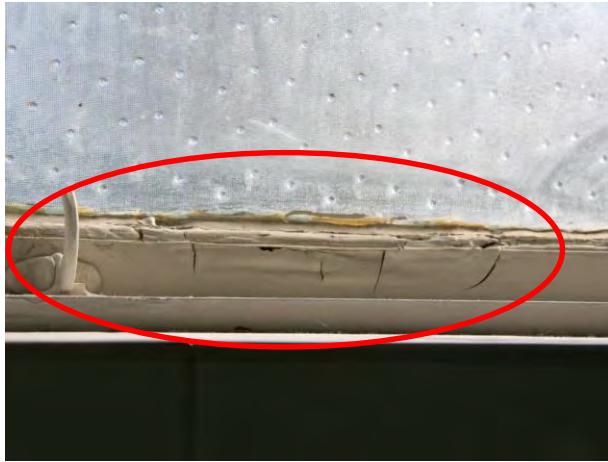
## Unit 3

Location	Inspection Notes
Bedroom 1	Replace the window sash and glazing for both windows as the seals have deteriorated.
Toilet	Good condition. No action required.
Bathroom	Replace the entire window sash, frame and glazing as they have deteriorated beyond repair.
Kitchen	Replace the window sash and external sill.
Living	Prepare and paint external frame.
Dining	Replace window sash as it has deteriorated and is allowing internal airflow. The tenants have placed aluminium foil to reduce the airflow however this is a temporary fix and a more permanent solution should be arranged.
Bedroom 2	Replace window hardware as it is not operational

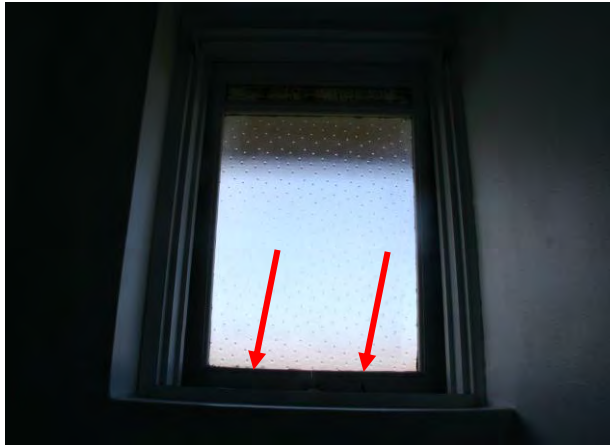
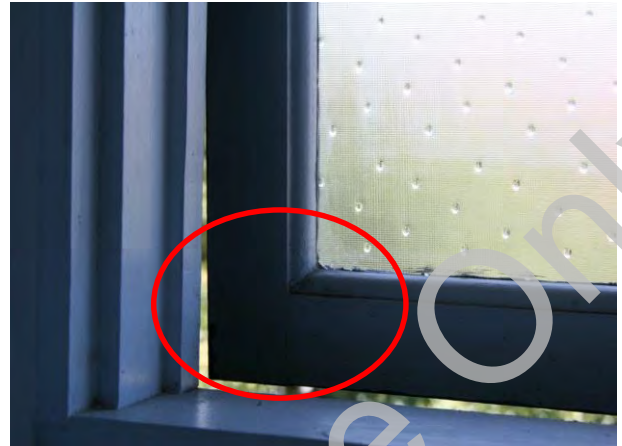
## Unit 6

Location	Inspection Notes
Kitchen	Good condition. No action required.
Dining	Prepare and paint window sash.
Living	Good condition. No action required.
Bedroom 1	Prepare and paint window frame.
Toilet	Prepare and paint window sash.
Bathroom	Replace window glazing to include an exhaust fan.
Bedroom 2	Prepare and paint window sash.

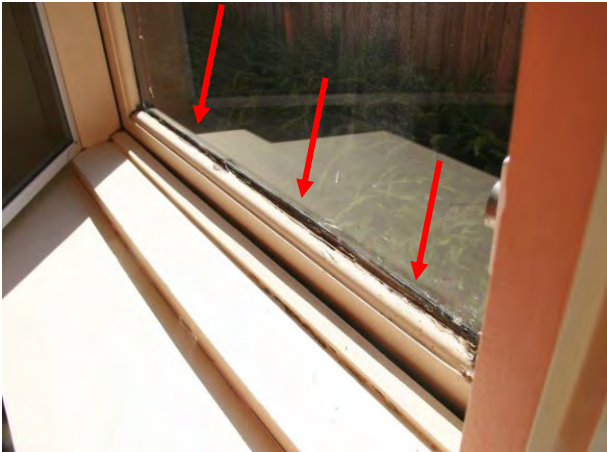
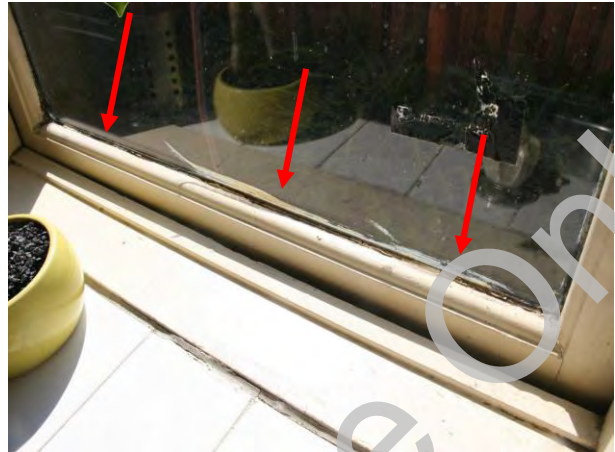
## Unit 13

Location	Inspection Notes
Bedroom 1	Replace window sash as it has completely deteriorated. Prepare and paint window frame.
Living	Good condition. No action required.
Dining	Prepare and paint window frame.
Kitchen	Replace window seal. Prepare and paint window sash.
Bedroom 2	Replace window sash. Prepare and paint external sill.
Toilet	Good condition. No action required.
Bathroom	Replace window chain. When the window is closed it does not open again. Prepare and paint window sash and frame.

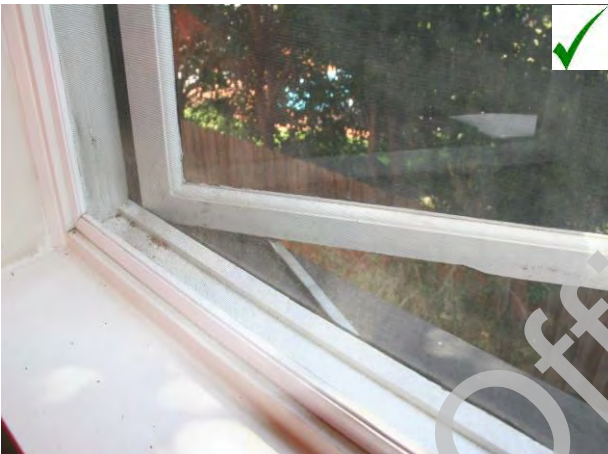
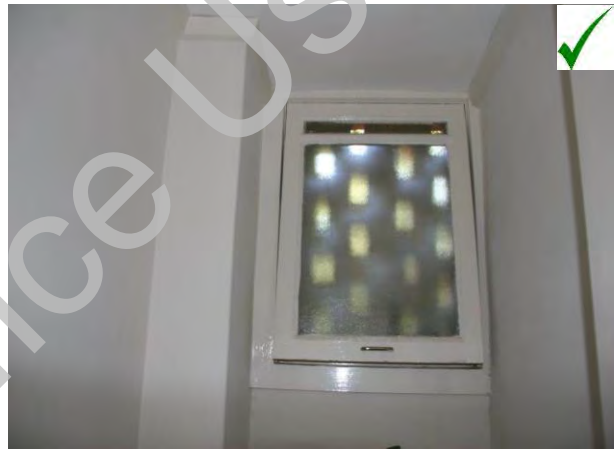
## Unit 14

Location	Inspection Notes
Bedroom 1	Replace window sash as is has completely deteriorated.
Living	Good condition. No action required.
Dining	Prepare and paint window sash.
Kitchen	Replace window sash and ventilation mesh at the top of the window. Prepare and paint external sill.
Bedroom 2	Good condition. No action required.
Toilet	Good condition. No action required.
Bathroom	Replace window sash as it has completely deteriorated. Prepare and paint window frame.

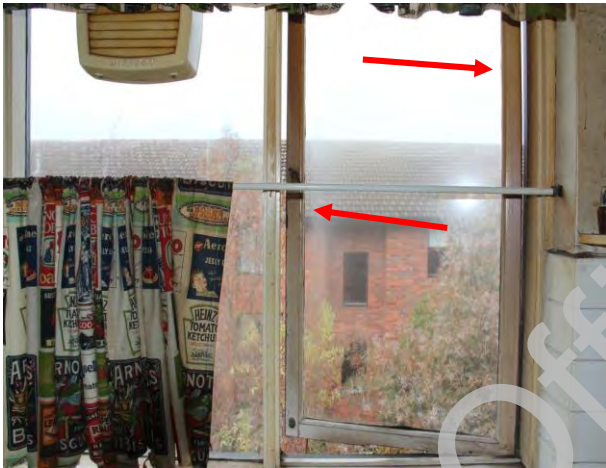
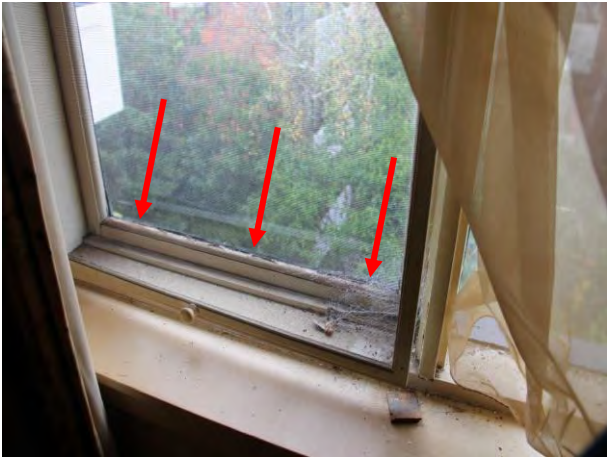
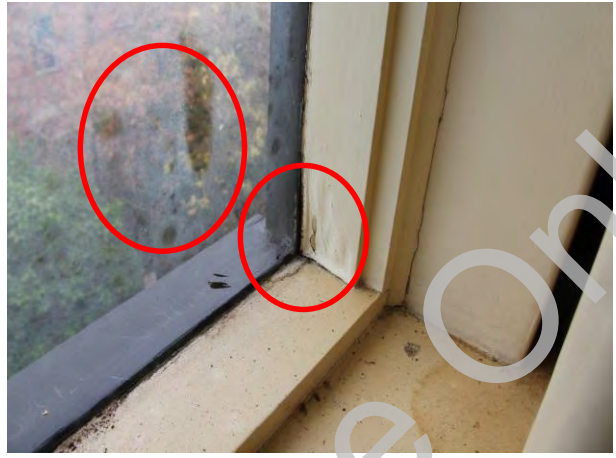
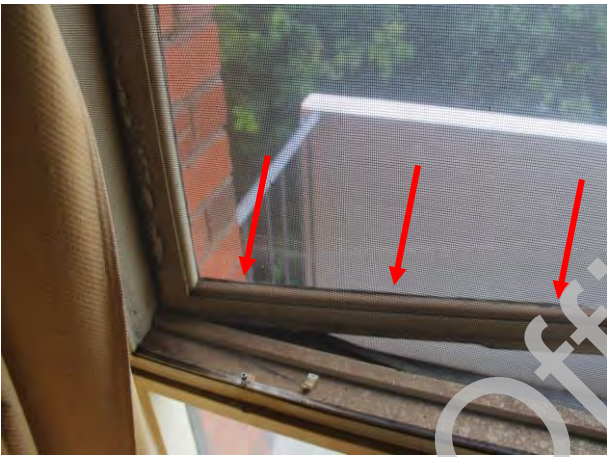
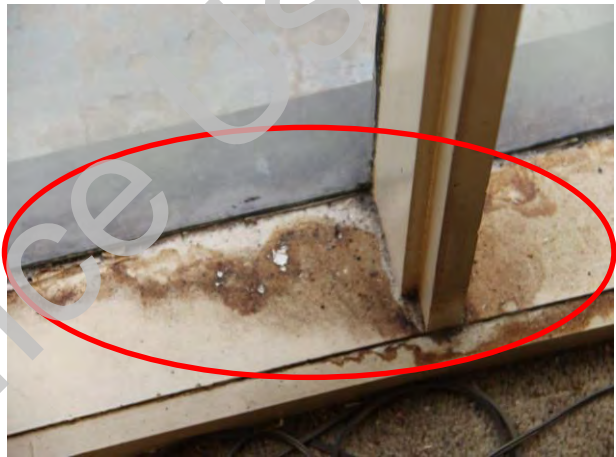
## Unit 12

Location	Inspection Notes
Kitchen	Replace entire window frame, sash and glazing as they have completely deteriorated.
Bathroom	Replace window sash. Prepare and paint window frame.
Toilet	Prepare & paint window frame and sash.
Bedroom 1	Replace entire window frame, sash and glazing as they have completely deteriorated.
Living	Replace window sash. Prepare and paint entire window frame. Replace seals around glazing as they have deteriorated.
Bedroom 2	Replace window sash. Prepare and paint window frame.

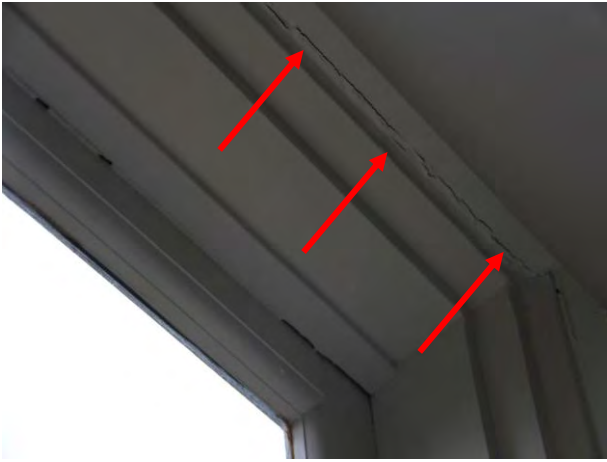
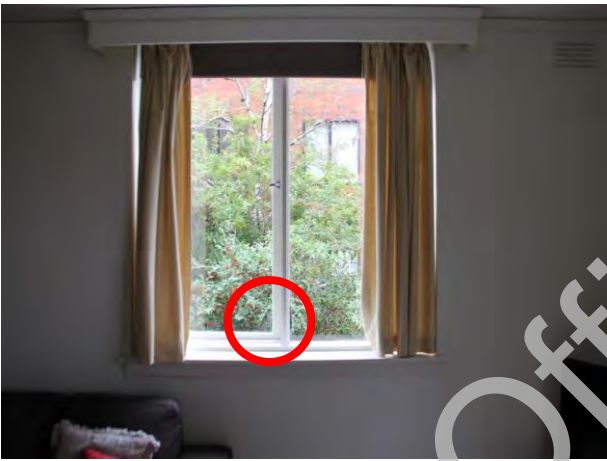
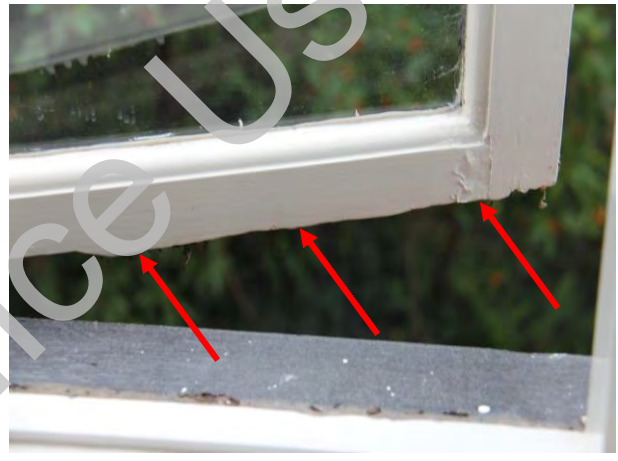
## Unit 1

Location	Inspection Notes
Bathroom	Replace seal around glazing.
Toilet	Replace ventilation mesh above the glazing.
Bedroom 1	Two windows: Replace window sash and hardware on north-facing window. Prepare and paint all other window frames and sash.
Kitchen	Re-seal crack between window frame and kitchen tiles. Prepare and paint after repairs are completed.
Living	Two windows: Replace door hardware and door sash on right hand side of west facing windows. Replace window sash on south face.
Bedroom 2	Replace and re-seal glazing as the glazing has dropped approx. 25mm out of the sash.

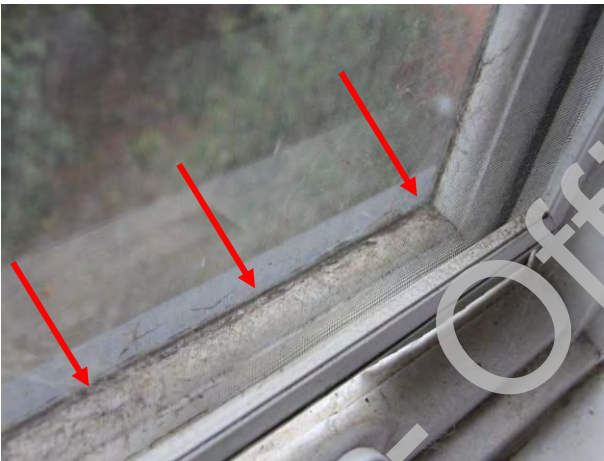
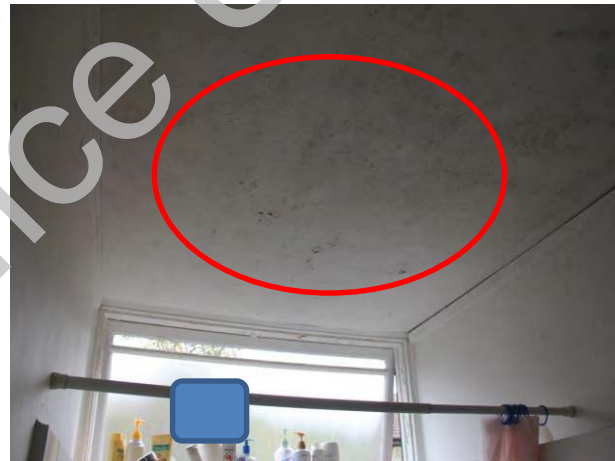
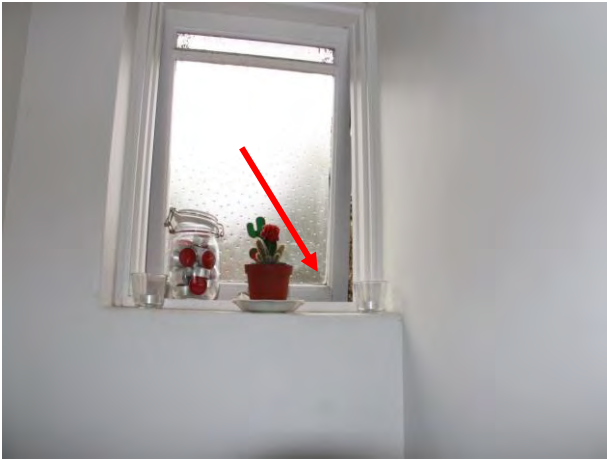
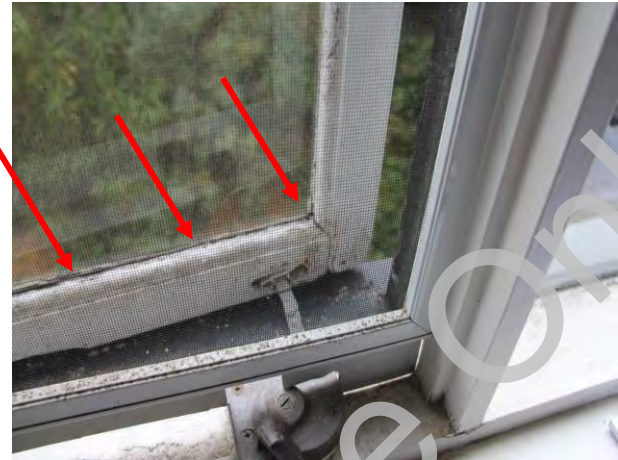
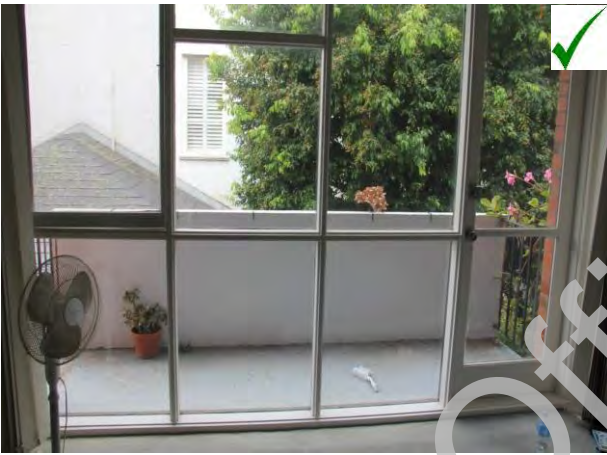
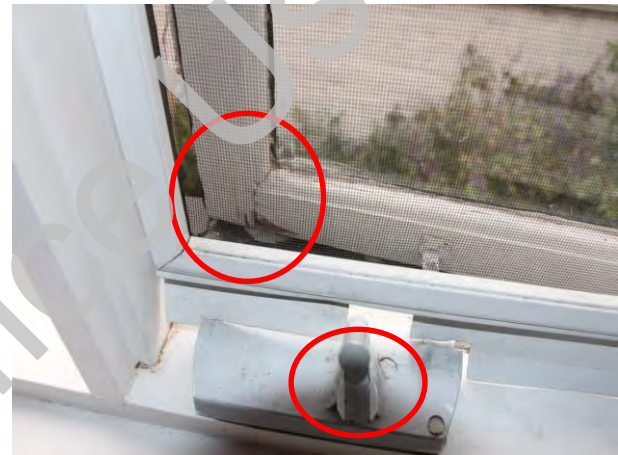
## Unit 4

Location	Inspection Notes
Bedroom 1	Prepare and paint window frame and sash.
Bathroom	Replace window frame and sash. Replace glazing to include an exhaust fan as the ceiling has been damaged by condensation.
Toilet	Replace window sash. Prepare and paint window frame.
Bedroom 2	Replace window sash. Prepare and paint window frame.
Living/Bedroom 3	Good condition. No action required.
Lounge	Replace window sash, external sill and window chain.
Kitchen	Replace window sash and external sill. Replace exhaust fan as it is not working and will eventually cause damage to the ceiling (similar to the bathroom)

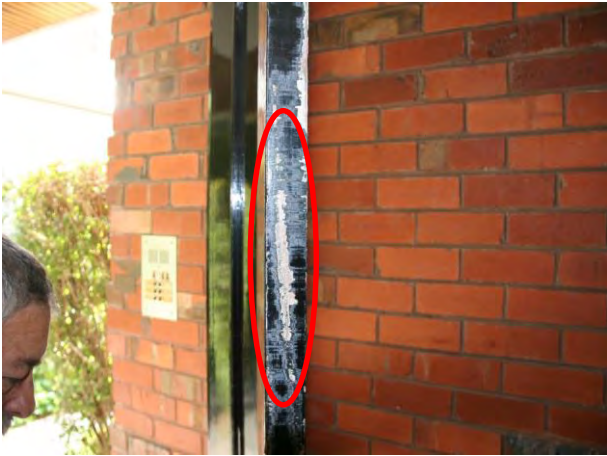
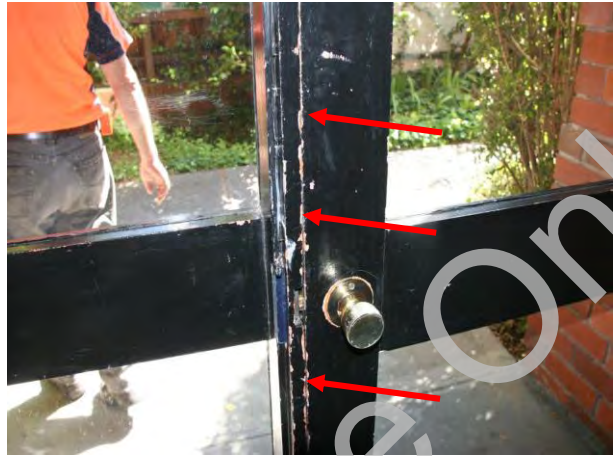
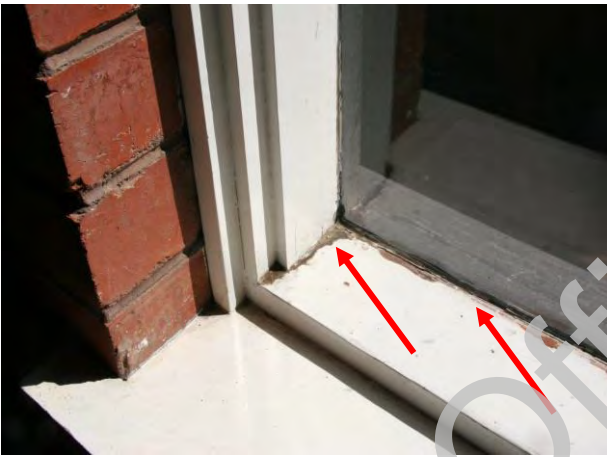
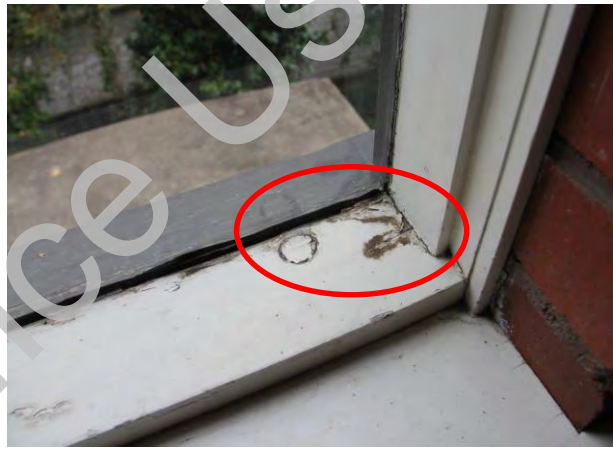
Location	Inspection Notes:
<p><b>NB: These are general findings about the common areas in the building and are not specific to any location.</b></p>	
<b>Window Frame</b>	The majority of the window frames in the common areas require replacement as they have deteriorated. A minority have paint damage and require preparing and painting.
<b>Window Glazing</b>	A majority of the windows glazing have dropped by up to 50mm, this can be attributed to a poor window seal and need to be replaced as water ingress will cause further damage to the window frames.
<b>Glazing Seal</b>	As mentioned above, the glazing seal has deteriorated on all windows and will require replacement to mitigate further damages.
<b>Common Doors</b>	All common doors require preparation and painting to maintain the aesthetics of the building. Roscon recommends to plane the latch edge of the doors prior to painting as it was found that the doors fit too tightly in the frame and has been scratched on the latch edge.
