Forensic Building Defects Report

1 Sample St Suburb VIC 3000 (PS 123456X)

Roscon Property Services were engaged by OC manager to conduct a Forensic Building Defects Report for the property at 1 Sample St Suburb VIC 3000. The investigation was undertaken on Thursday 15 August 2018 at approximately 9:00am.

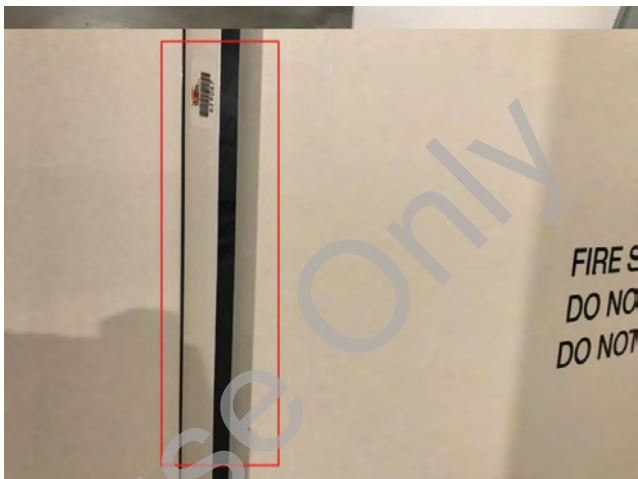
Level 1

Item	Details	Photographic Details
24.	<p>Location:</p> <p>Level 1 - Western door to car park</p> <p>Finding:</p> <p>The western door to the carpark is a fire safety door that does not contain the metal fire rating labels on the door frames and leafs. Proper signage indicating that the door is a fire safety door has been displayed.</p> <p>AS 1905.1-2005 clause 6.1.2 states:</p> <p>"(a) When the installation is complete, the manufacturer or the certifier shall inspect each installed fire-resistant doorset and shall affix the prescribed metal tag to the edge of the door leaf and to the doorframe, only if it can be confirmed that-</p> <ul style="list-style-type: none"> (i) hardware has been installed in accordance with the specified instructions of the relevant manufacturer; (ii) hinges are correctly aligned; (iii) the doorset latches satisfactorily from the fully open position and from any intermediate position; (iv) the closer, if any, demonstrates satisfactory action as specified in Clause 2.2.5; (v) on the basis of evidence of test or the opinion of a registered testing authority, or both, and evidence of manufacture to the specifications of the tested specimen, the doorset complies with all other requirements of this Standard; <p>and</p> <p>(vi) the clearances specified in Clause 5.5.2 have been met."</p> <p>A defect has been noted.</p> <p>Recommendations:</p> <p>The builder is to install appropriate metal tags on door frame and leaf in accordance to the manufacturer's specifications.</p>

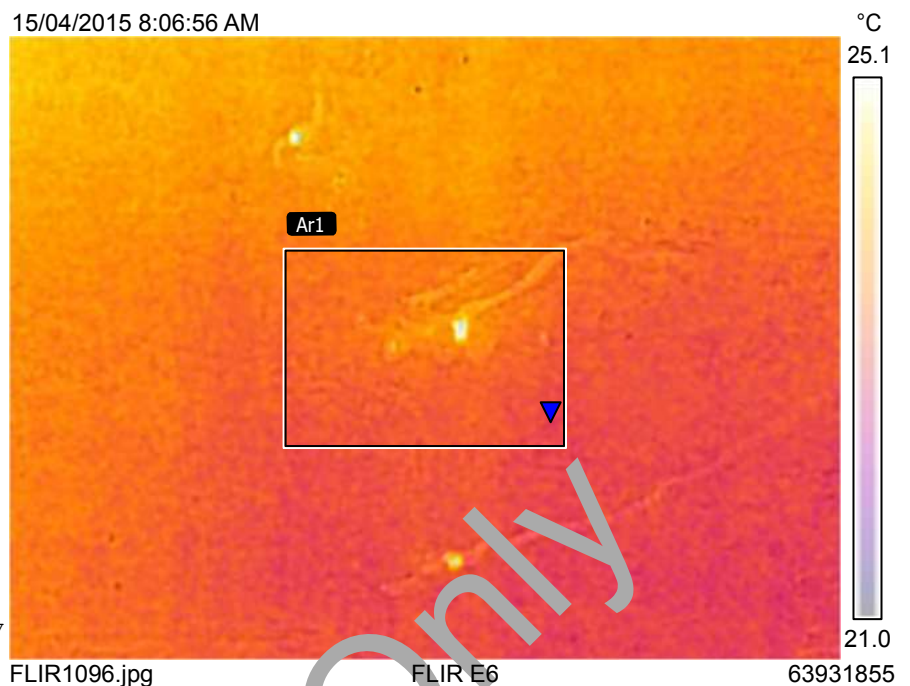
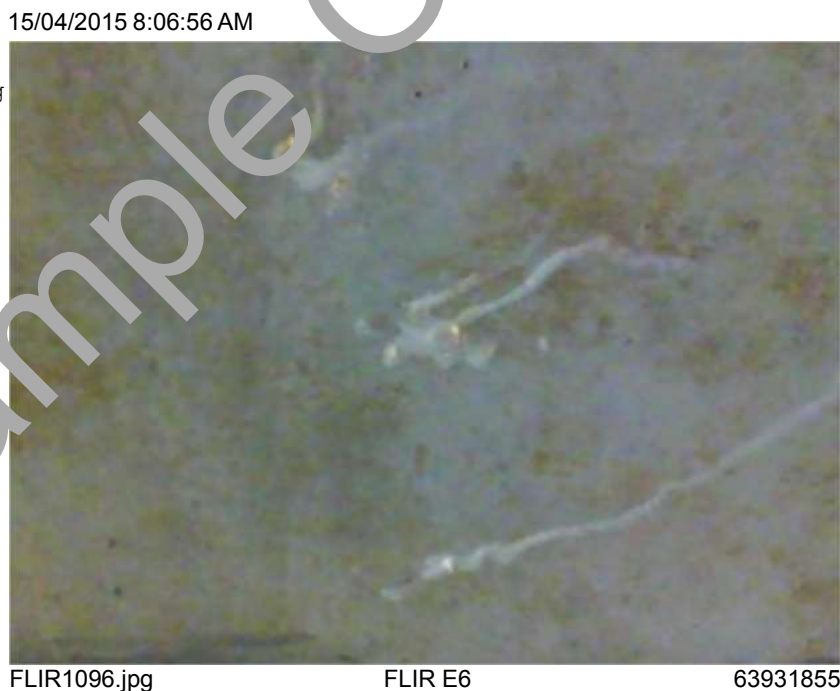
This is evident in photos: 1096, 1097 & 1098

Prolonged exposure to water can result in the slab losing its structural integrity over a long period of time.

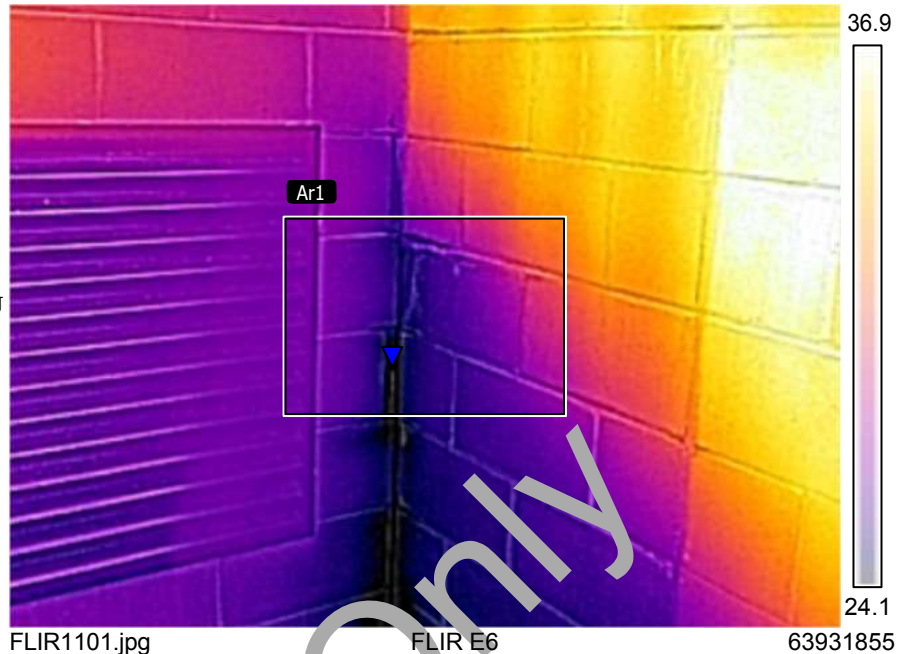
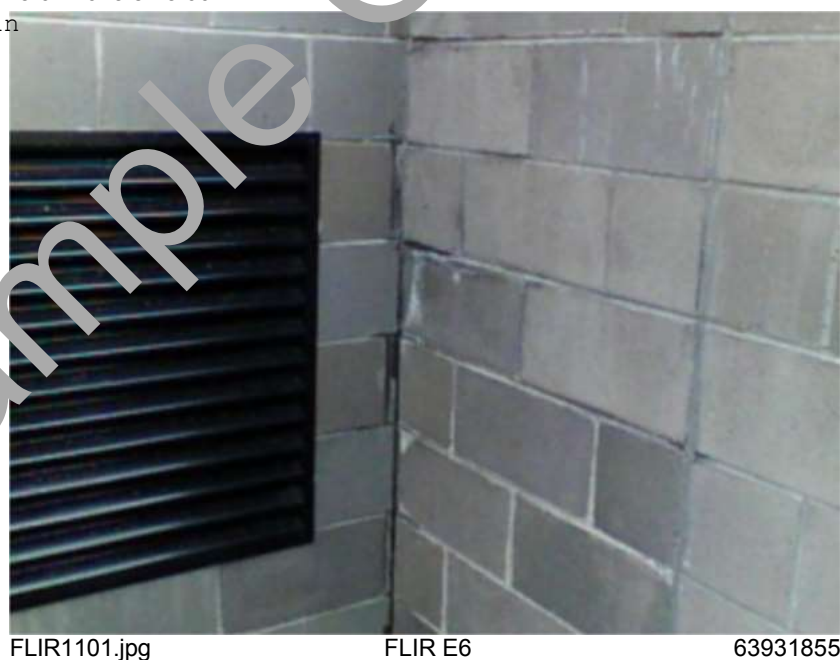
This is evident in photos: 1101, 1102 & 1103.

Water can be seen penetrating through the blockwork wall and running down the entire corner. On the other side of this wall there is a garden bed which is the main contributor to the water ingress. Efflorescence should be pressure washed off the wall, and rectification works include the digging up of the garden, installation of an aggie drain and crushed rock along the wall at 600mm deep, and the application of a waterproof membrane to prevent further water damage to the blockwork wall.
