Dilapidation Survey Report

28 Sample Street Suburb VIC 3008

Plan of Subdivision: PS 123456

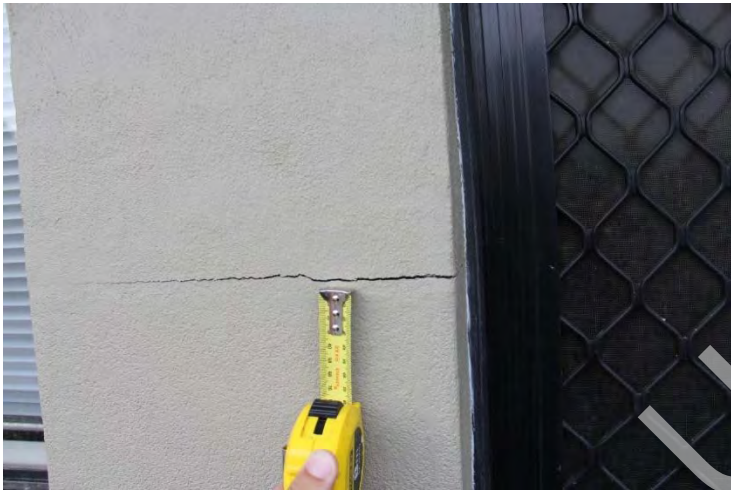
Item	Photographic Evidence	Assessments	
1.

Assessment Type: Good <input type="checkbox"/> Fair <input checked="" type="checkbox"/> Poor <input type="checkbox"/>	Impact Category: 1 <input type="checkbox"/> 2 <input checked="" type="checkbox"/> 3 <input type="checkbox"/> 4 <input type="checkbox"/> 5 <input type="checkbox"/>
Location: Unit 1 - Left of front door	Auditors Comments: <ul style="list-style-type: none"> Crack due to building movement on façade wall. Approx. 2-3mm.

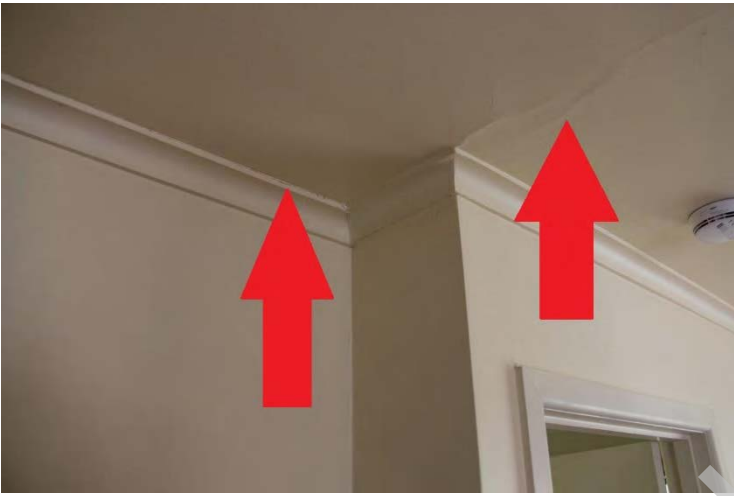
Item	Photographic Evidence	Assessments	
3.

Assessment Type: Good Fair Poor	<input type="checkbox"/> <input checked="" type="checkbox"/> <input type="checkbox"/>
		Impact Category: 1 2 3 4 5	<input checked="" type="checkbox"/> <input type="checkbox"/> <input type="checkbox"/> <input type="checkbox"/> <input type="checkbox"/>
Location: Unit 1 – Southern wall/ceiling of kitchen	Auditors Comments: <ul style="list-style-type: none"> Buckling of plater ceiling is present and fine cracks in skirting. Approx. 1mm.

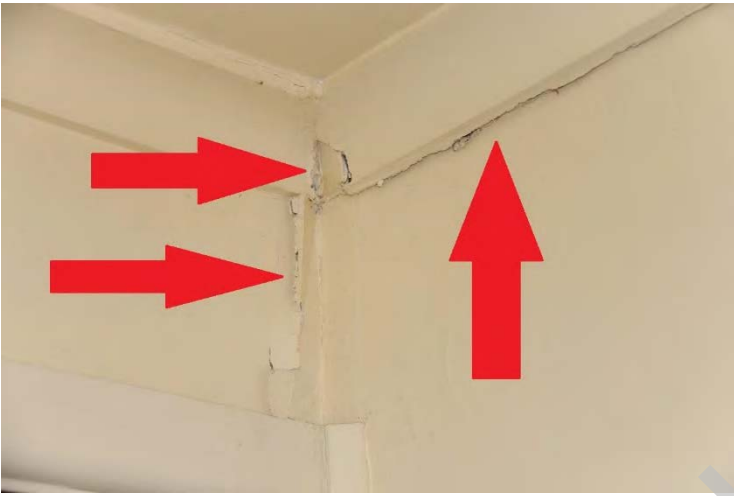
Item	Photographic Evidence	Assessments	
5.

Assessment Type: Good Fair Poor	<input type="checkbox"/> <input checked="" type="checkbox"/> <input type="checkbox"/>
		Impact Category: 1 2 3 4 5	<input type="checkbox"/> <input type="checkbox"/> <input checked="" type="checkbox"/> <input type="checkbox"/> <input type="checkbox"/>
Location: Unit 1 – Southern wall/ceiling of kitchen	Auditors Comments: <ul style="list-style-type: none"> Skirting has broken away towards the corner and rendering is coming away from the wall.

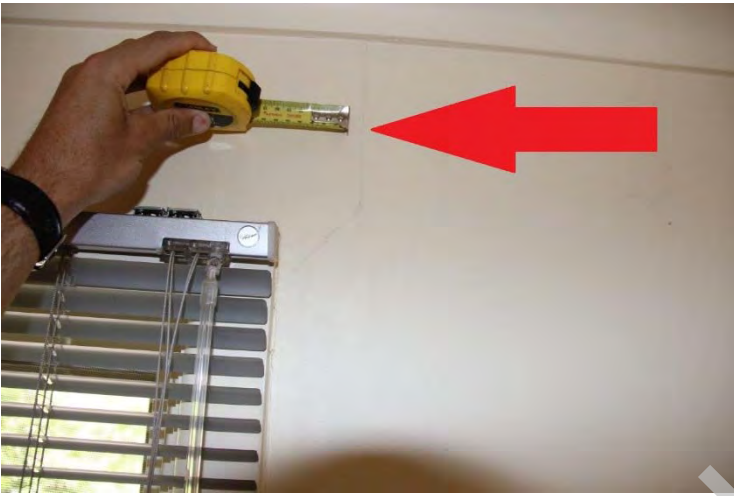
Item	Photographic Evidence	Assessments	
7.

Assessment Type: Good Fair Poor	<input type="checkbox"/> <input checked="" type="checkbox"/> <input type="checkbox"/>
		Impact Category: 1 2 3 4 5	<input checked="" type="checkbox"/> <input type="checkbox"/> <input type="checkbox"/> <input type="checkbox"/> <input type="checkbox"/>
Location: Unit 1 – Western wall of lounge	Auditors Comments: <ul style="list-style-type: none"> Fine crack to the right of venetian blind frame (approx. 1mm)

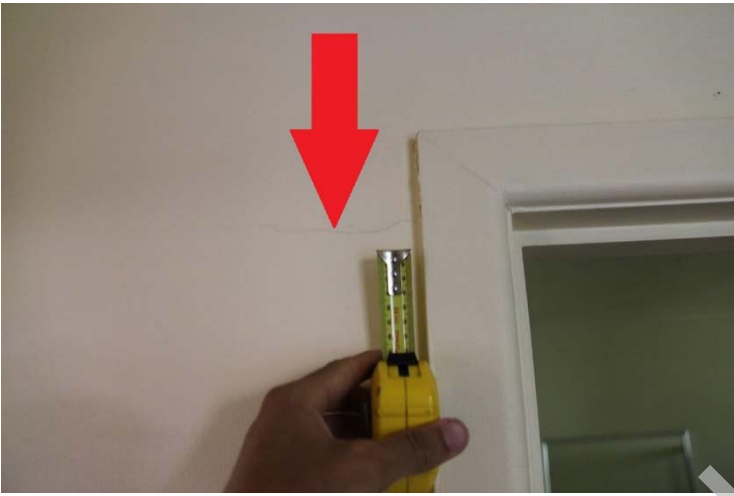
Item	Photographic Evidence	Assessments	
9.

Assessment Type: Good Fair Poor	<input type="checkbox"/> <input checked="" type="checkbox"/> <input type="checkbox"/>
		Impact Category: 1 2 3 4 5	<input checked="" type="checkbox"/> <input type="checkbox"/> <input type="checkbox"/> <input type="checkbox"/> <input type="checkbox"/>
Location: Unit 1 – entrance to bathroom	Auditors Comments: <ul style="list-style-type: none"> Fine crack to left of doorway entrance to bathroom. Approx. 1mm.

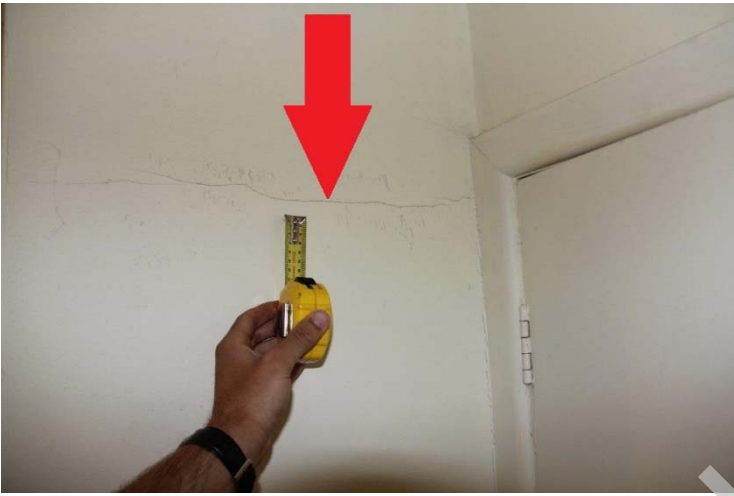
Item	Photographic Evidence	Assessments	
11.

Assessment Type: Good Fair Poor	<input type="checkbox"/> <input checked="" type="checkbox"/> <input type="checkbox"/>
		Impact Category: 1 2 3 4 5	<input checked="" type="checkbox"/> <input type="checkbox"/> <input type="checkbox"/> <input type="checkbox"/> <input type="checkbox"/>
Location: Unit 1 – bathroom	Auditors Comments: <ul style="list-style-type: none"> Long fine crack to left of doorway in bathroom. Approx. 1mm.

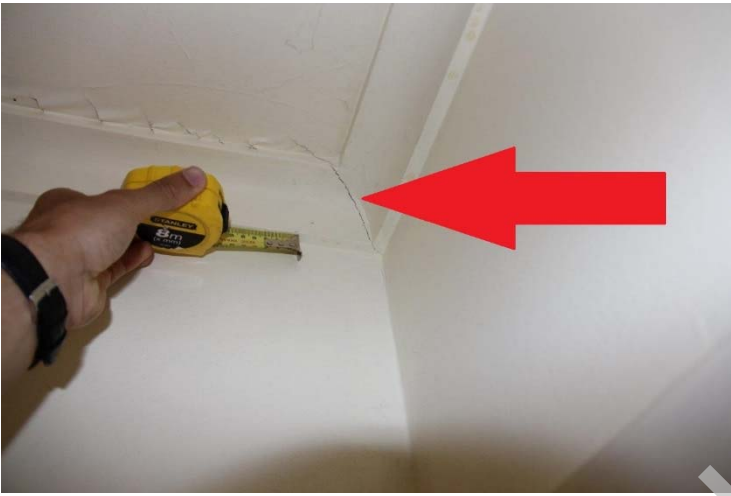
Item	Photographic Evidence	Assessments	
13.

Assessment Type: Good Fair Poor	<input type="checkbox"/> <input checked="" type="checkbox"/> <input type="checkbox"/>
		Impact Category: 1 2 3 4 5	<input checked="" type="checkbox"/> <input type="checkbox"/> <input type="checkbox"/> <input type="checkbox"/> <input type="checkbox"/>
Location: Unit 1 – bathroom	Auditors Comments: <ul style="list-style-type: none"> Fine crack to in skirting. Approx. 1mm.

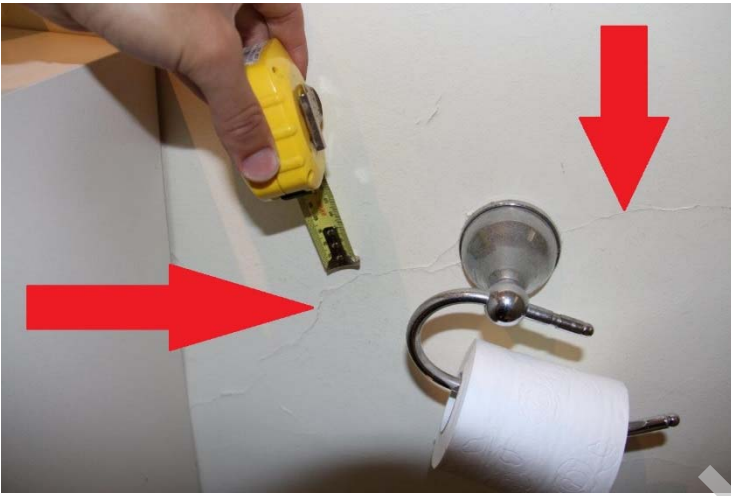
Item	Photographic Evidence	Assessments	
15.

Assessment Type: Good Fair Poor	<input type="checkbox"/> <input checked="" type="checkbox"/> <input type="checkbox"/>
		Impact Category: 1 2 3 4 5	<input checked="" type="checkbox"/> <input type="checkbox"/> <input type="checkbox"/> <input type="checkbox"/> <input type="checkbox"/>
Location: Unit 1 – bathroom	Auditors Comments: <ul style="list-style-type: none"> Multiple fine cracks throughout wall near toilet (eastern wall). Approx. 1mm.

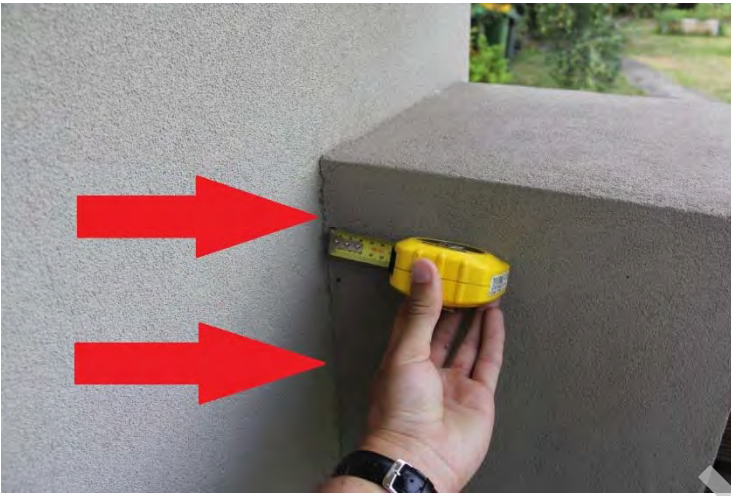
Item	Photographic Evidence	Assessments	
17.

Assessment Type: Good Fair Poor	<input type="checkbox"/> <input checked="" type="checkbox"/> <input type="checkbox"/>
		Impact Category: 1 2 3 4 5	<input type="checkbox"/> <input checked="" type="checkbox"/> <input type="checkbox"/> <input type="checkbox"/> <input type="checkbox"/>
Location: Unit 1 – Exterior	Auditors Comments: <ul style="list-style-type: none"> Fine crack running between concrete fence pillar and western building façade (southern fence). Approx. 2mm.

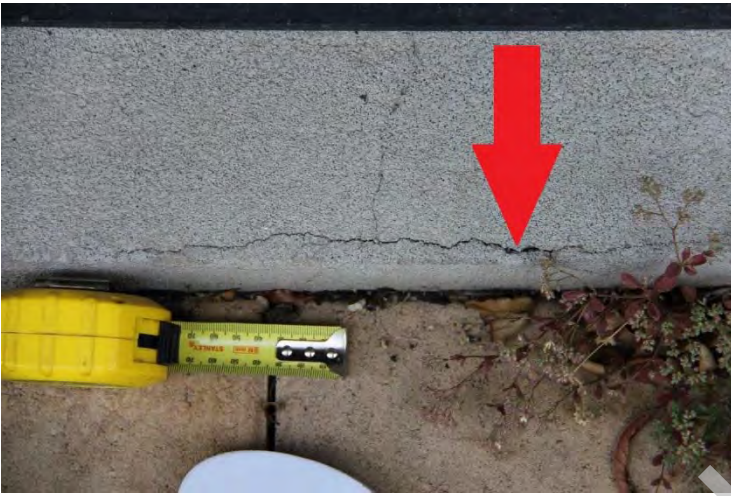
Item	Photographic Evidence	Assessments	
19.

Assessment Type: Good Fair Poor	<input type="checkbox"/> <input checked="" type="checkbox"/> <input type="checkbox"/>
		Impact Category: 1 2 3 4 5	<input type="checkbox"/> <input checked="" type="checkbox"/> <input type="checkbox"/> <input type="checkbox"/> <input type="checkbox"/>
Location: Unit 1 – Exterior	Auditors Comments: <ul style="list-style-type: none"> Crack in slab at base of courtyard entry/exit doorway. Approx. 2mm.

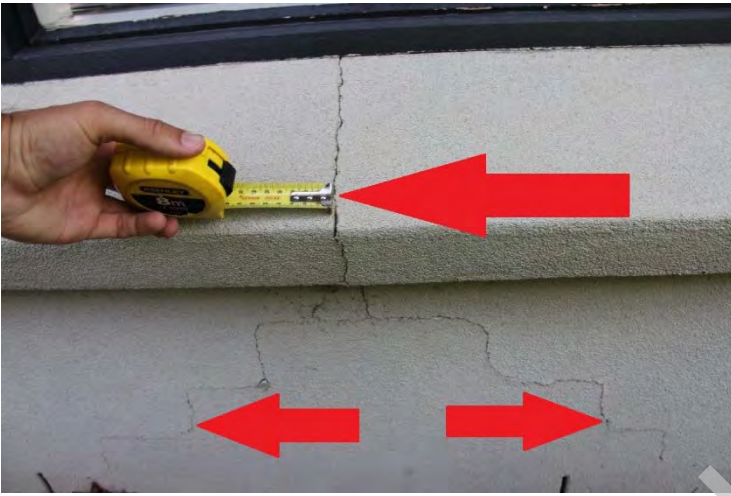
Item	Photographic Evidence	Assessments	
21.

Assessment Type: Good Fair Poor	<input type="checkbox"/> <input checked="" type="checkbox"/> <input type="checkbox"/>
		Impact Category: 1 2 3 4 5	<input type="checkbox"/> <input checked="" type="checkbox"/> <input type="checkbox"/> <input type="checkbox"/> <input type="checkbox"/>
Location: Unit 1 – Exterior	Auditors Comments: <ul style="list-style-type: none"> Crack in façade render under western window. Approx. 2mm.

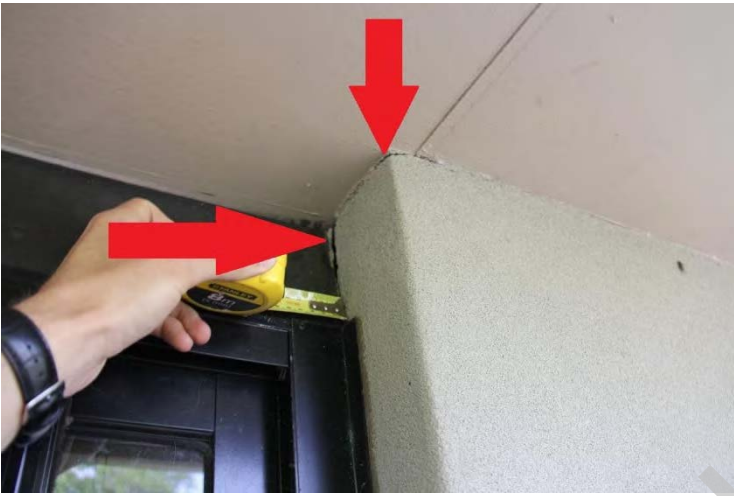
Item	Photographic Evidence	Assessments	
23.

Assessment Type: Good Fair Poor	<input type="checkbox"/> <input checked="" type="checkbox"/> <input type="checkbox"/>
		Impact Category: 1 2 3 4 5	<input type="checkbox"/> <input checked="" type="checkbox"/> <input type="checkbox"/> <input type="checkbox"/> <input type="checkbox"/>
Location: Unit 1 – Exterior	Auditors Comments: <ul style="list-style-type: none"> Crack between western façade and eaves. Crack also present between façade and door frame. Approx. 1-2mm.

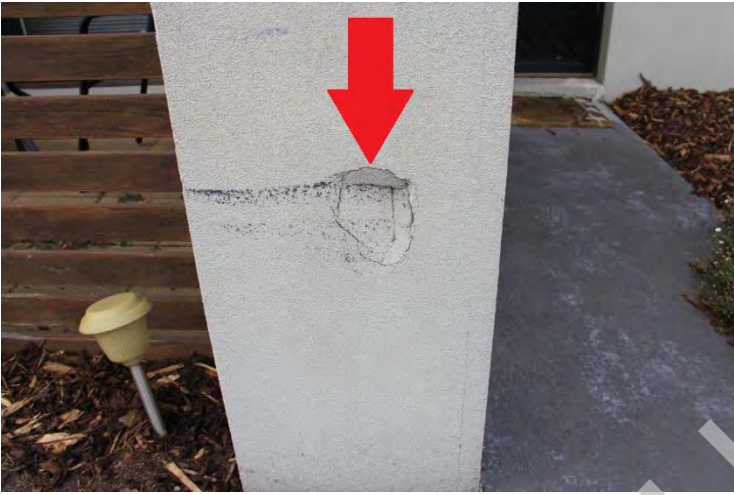
Item	Photographic Evidence	Assessments	
25.

Assessment Type: Good <input type="checkbox"/> Fair <input type="checkbox"/> Poor <input checked="" type="checkbox"/>	<input checked="" type="checkbox"/> <input type="checkbox"/> <input type="checkbox"/> <input type="checkbox"/> <input type="checkbox"/>
Location: Unit 2 – Exterior	Auditors Comments: <ul style="list-style-type: none"> Façade of fencing pillar is broken – most likely due to a vehicle collision. Cracking and indent of approximately 15-20mm.

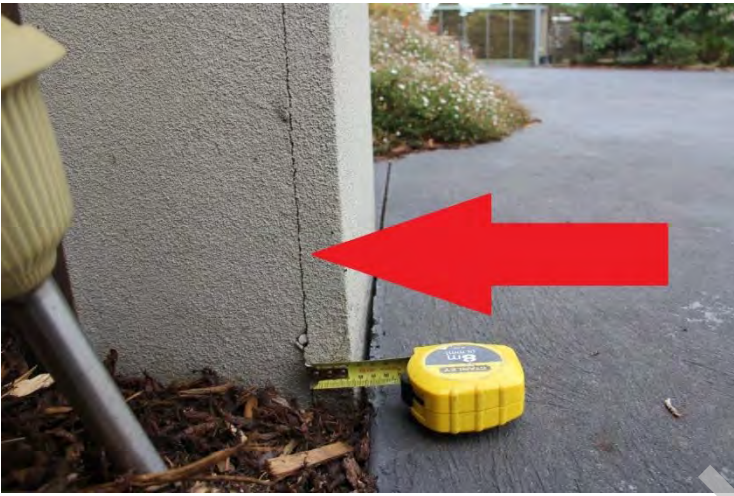
Item	Photographic Evidence	Assessments	
27.

Assessment Type: Good Fair Poor	<input type="checkbox"/> <input checked="" type="checkbox"/> <input type="checkbox"/>
		Impact Category: 1 2 3 4 5	<input checked="" type="checkbox"/> <input type="checkbox"/> <input type="checkbox"/> <input type="checkbox"/> <input type="checkbox"/>
Location: Unit 2 – Exterior	Auditors Comments: <ul style="list-style-type: none"> Fine crack running up corner of fence pillar (same pillar as noted in Item 25 & 26). Approx. 1-2mm.

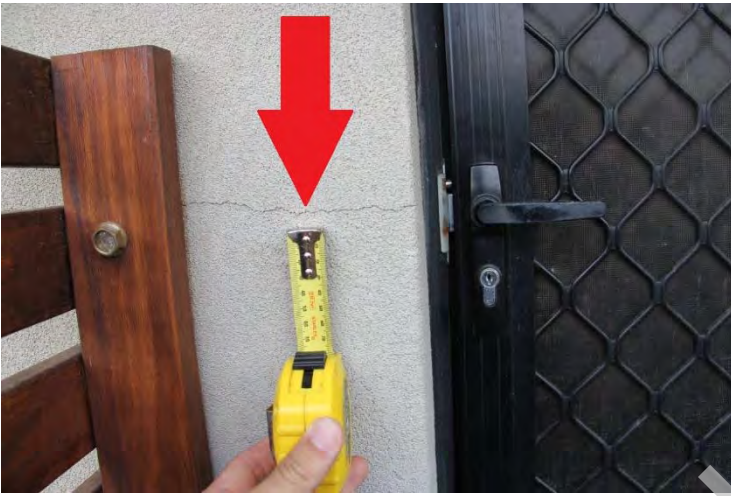
Item	Photographic Evidence	Assessments	
29.

Assessment Type: Good Fair Poor	<input type="checkbox"/> <input checked="" type="checkbox"/> <input type="checkbox"/>
		Impact Category: 1 2 3 4 5	<input checked="" type="checkbox"/> <input type="checkbox"/> <input type="checkbox"/> <input type="checkbox"/> <input type="checkbox"/>
Location: Unit 2 – Exterior	Auditors Comments: <ul style="list-style-type: none"> Fine crack running across external facade of Unit 2 near left side of door entrance. Approx. 1mm.

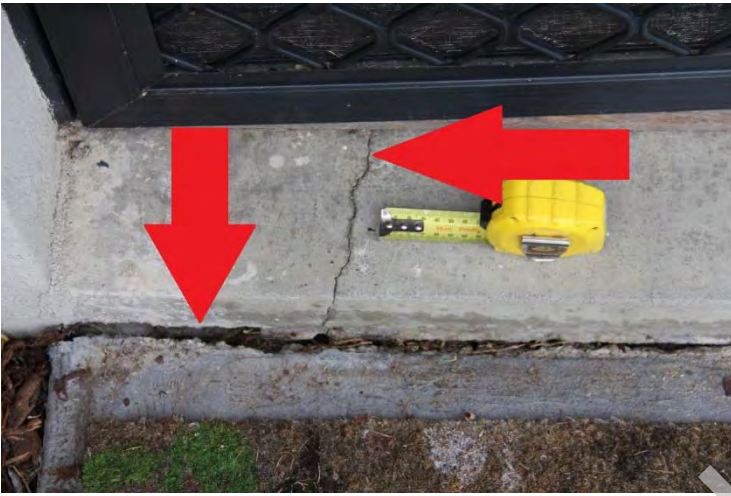
Item	Photographic Evidence	Assessments	
31.

Assessment Type: Good Fair Poor	<input type="checkbox"/> <input checked="" type="checkbox"/> <input type="checkbox"/>
		Impact Category: 1 2 3 4 5	<input checked="" type="checkbox"/> <input type="checkbox"/> <input checked="" type="checkbox"/> <input type="checkbox"/> <input type="checkbox"/>
Location: Unit 2 – Exterior	Auditors Comments: <ul style="list-style-type: none"> Fine crack (Approx. 1-2mm) in slab and large gap (approx. 20-30mm) between slab and concrete walkway.

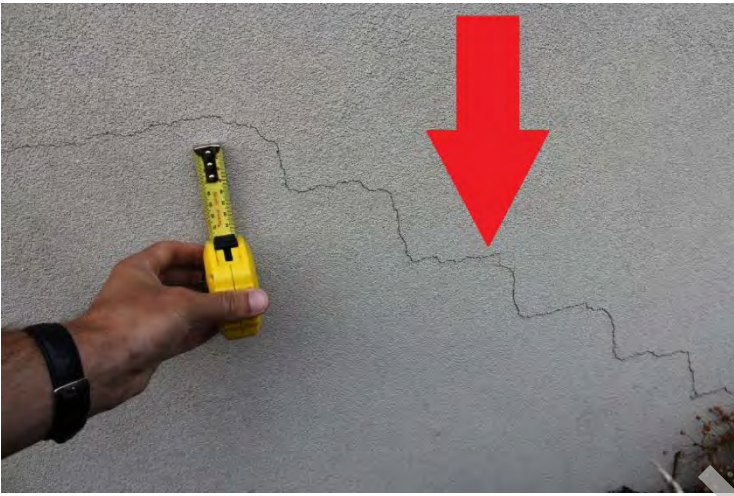
Item	Photographic Evidence	Assessments	
33.

Assessment Type: Good Fair Poor	<input type="checkbox"/> <input checked="" type="checkbox"/> <input type="checkbox"/>
		Impact Category: 1 2 3 4 5	<input type="checkbox"/> <input checked="" type="checkbox"/> <input type="checkbox"/> <input type="checkbox"/> <input type="checkbox"/>
Location: Unit 2 – Exterior	Auditors Comments: <ul style="list-style-type: none"> Long crack running along northern façade between Units 1 & 2. Approx. 2mm.

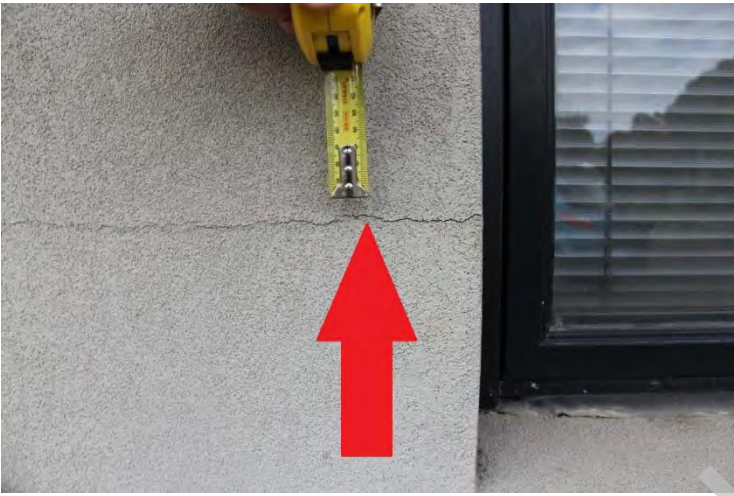
Item	Photographic Evidence	Assessments	
35.

Assessment Type: Good Fair Poor	<input type="checkbox"/> <input checked="" type="checkbox"/> <input type="checkbox"/>
		Impact Category: 1 2 3 4 5	<input checked="" type="checkbox"/> <input type="checkbox"/> <input type="checkbox"/> <input type="checkbox"/> <input type="checkbox"/>
Location: Unit 2 – Exterior	Auditors Comments: <ul style="list-style-type: none"> Fine crack to left of window on exterior of northern façade. Approx. 1mm.

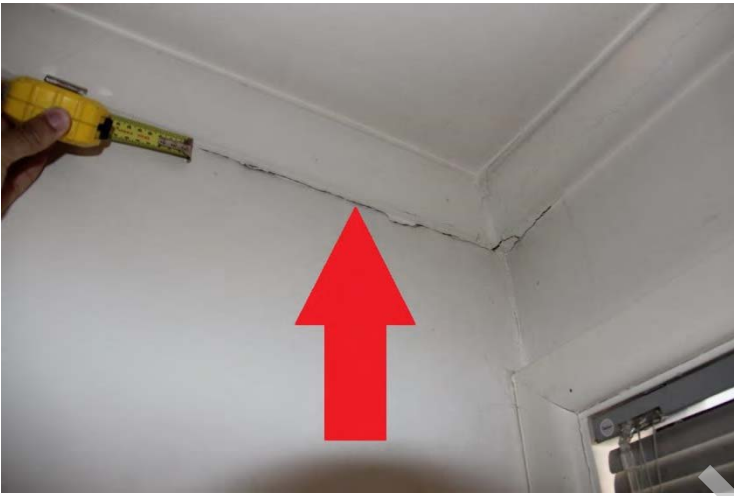
Item	Photographic Evidence	Assessments	
39.

Assessment Type: Good Fair Poor	<input type="checkbox"/> <input checked="" type="checkbox"/> <input type="checkbox"/>
		Impact Category: 1 2 3 4 5	<input type="checkbox"/> <input checked="" type="checkbox"/> <input type="checkbox"/> <input type="checkbox"/> <input type="checkbox"/>
Location: Unit 2 – Interior, lounge	Auditors Comments: <ul style="list-style-type: none"> Crack between wall and skirting board near window with venetian blinds. Approx. 2mm.

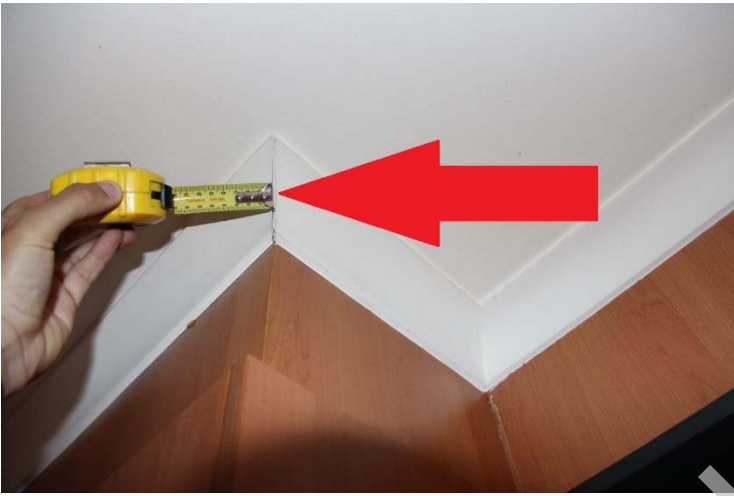
Item	Photographic Evidence	Assessments	
41.

Assessment Type: Good Fair Poor	<input type="checkbox"/> <input checked="" type="checkbox"/> <input type="checkbox"/>
		Impact Category: 1 2 3 4 5	<input checked="" type="checkbox"/> <input type="checkbox"/> <input type="checkbox"/> <input type="checkbox"/> <input type="checkbox"/>
Location: Unit 2 – Interior, kitchen	Auditors Comments: <ul style="list-style-type: none"> Crack between skirting board sections. Approx. 1mm.

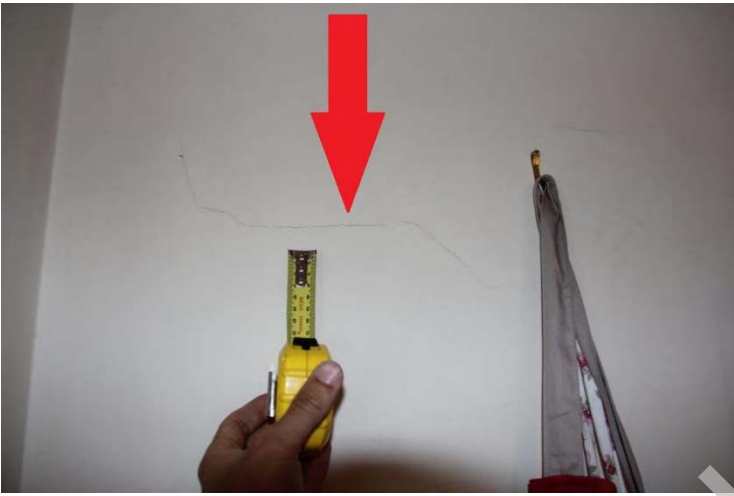
Item	Photographic Evidence	Assessments	
43.

Assessment Type: Good Fair Poor	<input type="checkbox"/> <input checked="" type="checkbox"/> <input type="checkbox"/>
		Impact Category: 1 2 3 4 5	<input checked="" type="checkbox"/> <input type="checkbox"/> <input type="checkbox"/> <input type="checkbox"/> <input type="checkbox"/>
Location: Unit 2 – Interior	Auditors Comments: <ul style="list-style-type: none"> Crack in rendering. Approx. 1mm.

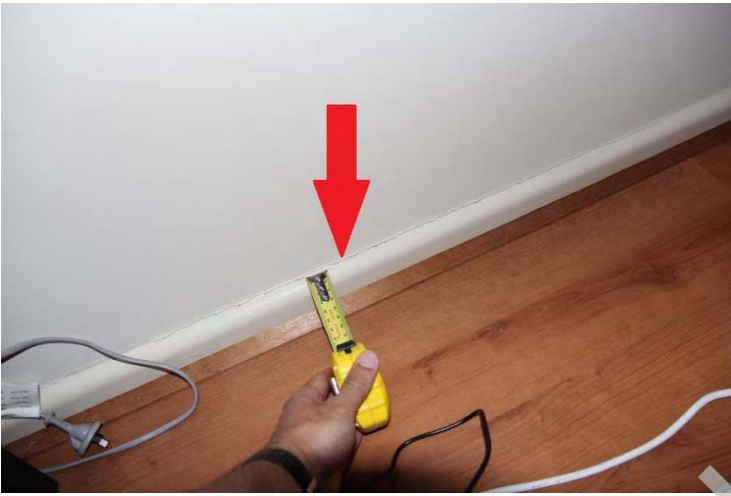
Item	Photographic Evidence	Assessments	
45.

Assessment Type: Good Fair Poor	<input type="checkbox"/> <input checked="" type="checkbox"/> <input type="checkbox"/>
		Impact Category: 1 2 3 4 5	<input checked="" type="checkbox"/> <input type="checkbox"/> <input type="checkbox"/> <input type="checkbox"/> <input type="checkbox"/>
Location: Unit 2 – Interior, lounge & kitchen	Auditors Comments: <ul style="list-style-type: none"> Crack in skirting. Approx. 1mm.

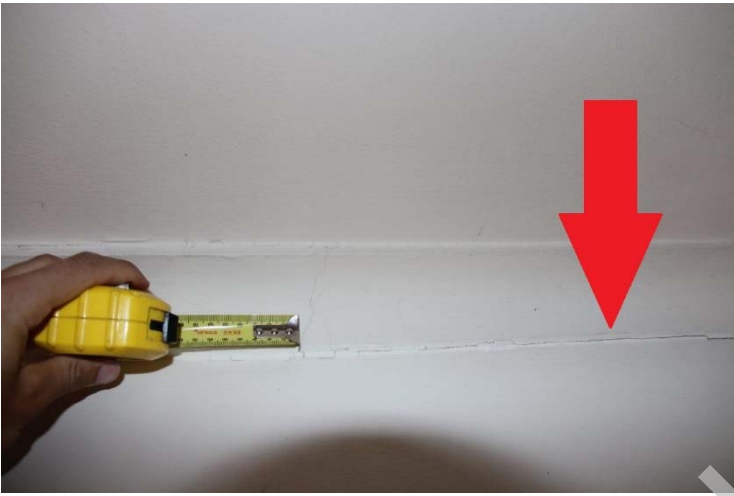
Item	Photographic Evidence	Assessments	
47.

Assessment Type: Good Fair Poor	<input type="checkbox"/> <input checked="" type="checkbox"/> <input type="checkbox"/>
		Impact Category: 1 2 3 4 5	<input checked="" type="checkbox"/> <input type="checkbox"/> <input type="checkbox"/> <input type="checkbox"/> <input type="checkbox"/>
Location: Unit 2 – Interior, lounge & kitchen	Auditors Comments: <ul style="list-style-type: none"> Crack between skirting and plaster wall. Approx. 1mm.

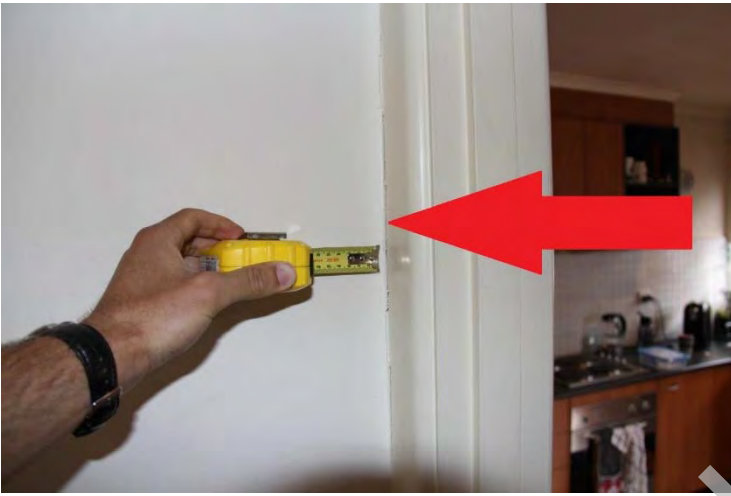
Item	Photographic Evidence	Assessments	
49.

Assessment Type: Good Fair Poor	<input type="checkbox"/> <input checked="" type="checkbox"/> <input type="checkbox"/>
		Impact Category: 1 2 3 4 5	<input type="checkbox"/> <input checked="" type="checkbox"/> <input type="checkbox"/> <input type="checkbox"/> <input type="checkbox"/>
Location: Unit 2 – Bedroom	Auditors Comments: <ul style="list-style-type: none"> Gap between skirting and wall. Approx. 2mm. 		
50.

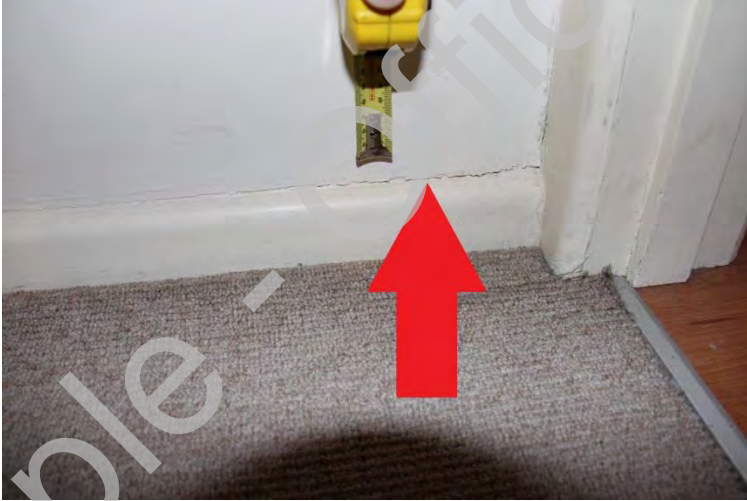
Assessment Type: Good Fair Poor	<input type="checkbox"/> <input checked="" type="checkbox"/> <input type="checkbox"/>
		Impact Category: 1 2 3 4 5	<input type="checkbox"/> <input checked="" type="checkbox"/> <input type="checkbox"/> <input type="checkbox"/> <input type="checkbox"/>
Location: Unit 2 – Bedroom	Auditors Comments: <ul style="list-style-type: none"> Gap between skirting and wall. Approx. 2mm.

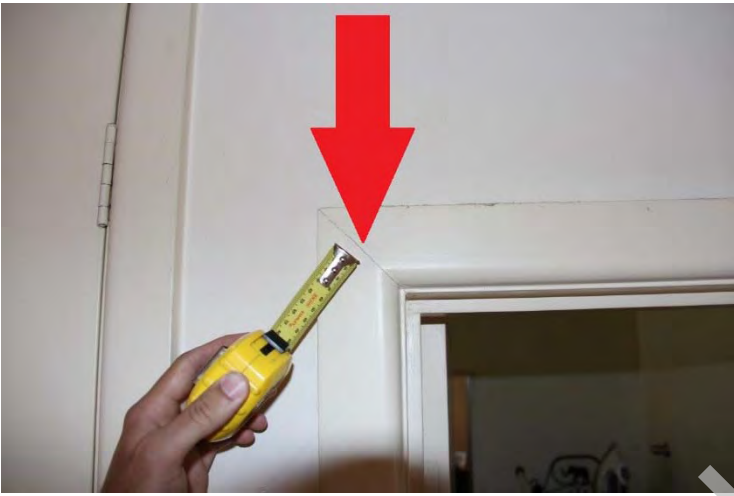
Item	Photographic Evidence	Assessments	
51.

Assessment Type: Good Fair Poor	<input type="checkbox"/> <input checked="" type="checkbox"/> <input type="checkbox"/>
		Impact Category: 1 2 3 4 5	<input checked="" type="checkbox"/> <input type="checkbox"/> <input type="checkbox"/> <input type="checkbox"/> <input type="checkbox"/>
Location: Unit 2 – Bedroom	Auditors Comments: <ul style="list-style-type: none"> Gap in door frame skirting. Approx. 1mm.

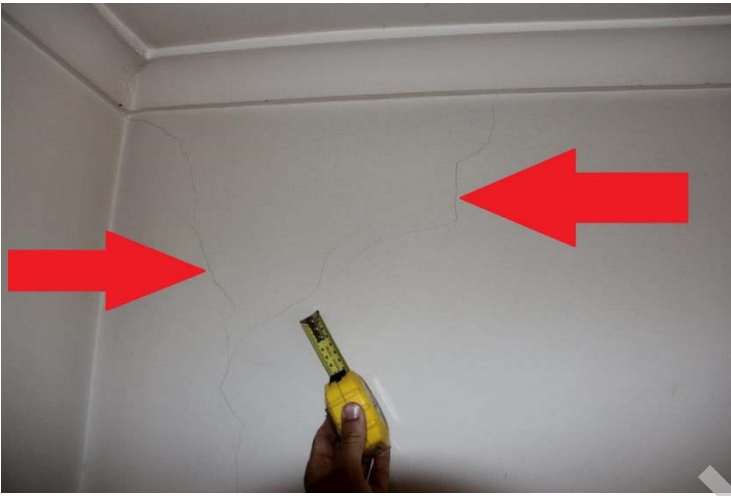
Item	Photographic Evidence	Assessments	
53.

Assessment Type: Good Fair Poor	<input type="checkbox"/> <input checked="" type="checkbox"/> <input type="checkbox"/>
		Impact Category: 1 2 3 4 5	<input checked="" type="checkbox"/> <input type="checkbox"/> <input type="checkbox"/> <input type="checkbox"/> <input type="checkbox"/>
Location: Unit 2 – Bedroom	Auditors Comments: <ul style="list-style-type: none"> Long cracks running vertically along wall finishing at skirting. Approx. 1mm.

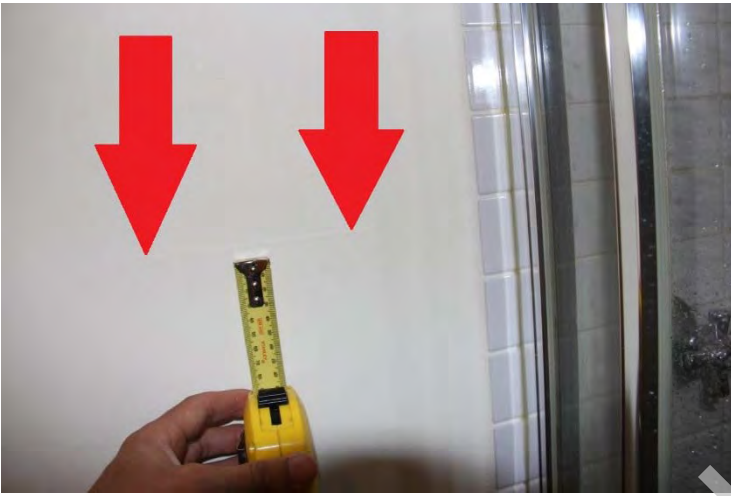
Item	Photographic Evidence	Assessments	
55.

Assessment Type: Good Fair Poor	<input type="checkbox"/> <input checked="" type="checkbox"/> <input type="checkbox"/>
		Impact Category: 1 2 3 4 5	<input type="checkbox"/> <input type="checkbox"/> <input type="checkbox"/> <input type="checkbox"/> <input type="checkbox"/>
Location: Unit 2 – Bathroom	Auditors Comments: <ul style="list-style-type: none"> Paint/render finish is flawed with a line present left of shower cubical.

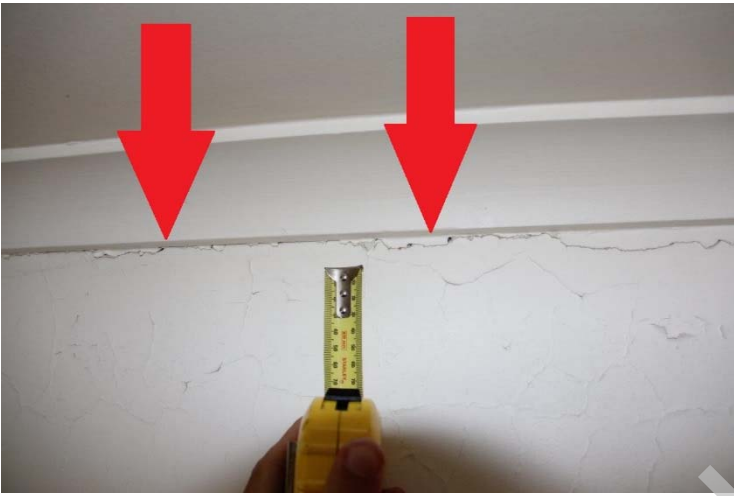
Item	Photographic Evidence	Assessments	
57.

Assessment Type: Good Fair Poor	<input type="checkbox"/> <input checked="" type="checkbox"/> <input type="checkbox"/>
		Impact Category: 1 2 3 4 5	<input checked="" type="checkbox"/> <input type="checkbox"/> <input type="checkbox"/> <input type="checkbox"/> <input type="checkbox"/>
Location: Unit 2 – Bathroom	Auditors Comments: <ul style="list-style-type: none"> Multiple cracks close to skirting. Approx. 1mm.

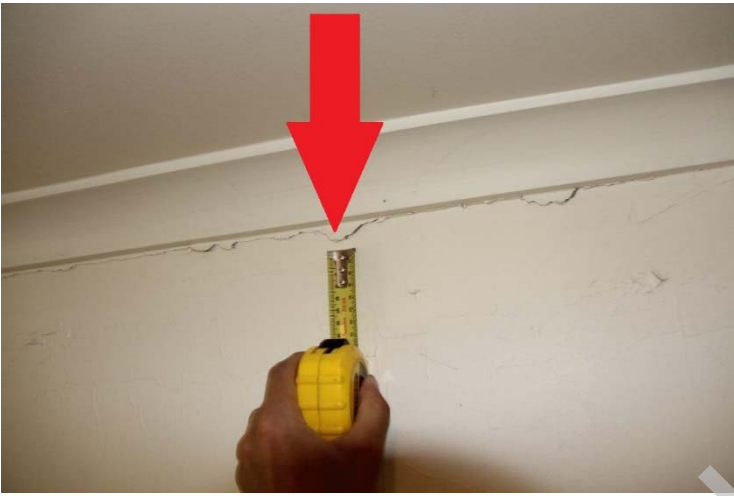
Item	Photographic Evidence	Assessments	
59.

Assessment Type: Good Fair Poor	<input type="checkbox"/> <input checked="" type="checkbox"/> <input type="checkbox"/>
		Impact Category: 1 2 3 4 5	<input type="checkbox"/> <input checked="" type="checkbox"/> <input type="checkbox"/> <input type="checkbox"/> <input type="checkbox"/>
Location: Unit 2 – Bathroom	Auditors Comments: <ul style="list-style-type: none"> Cracking and paint flaking between skirting and wall. Approx. 2mm.

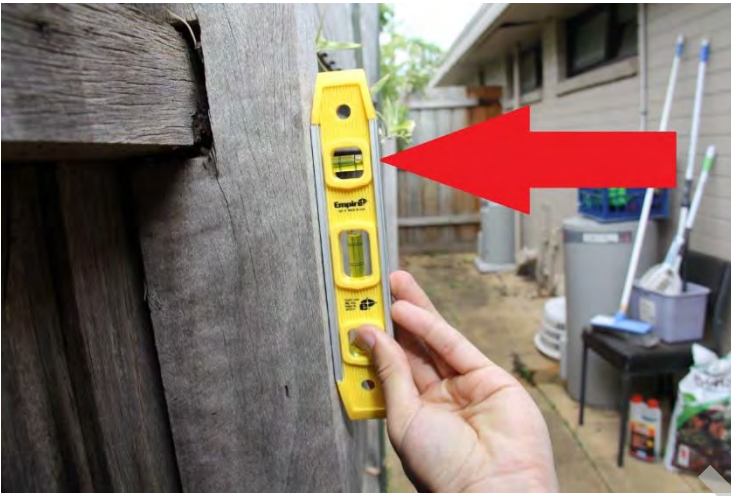
Item	Photographic Evidence	Assessments	
61.

Assessment Type: Good Fair Poor	<input type="checkbox"/> <input checked="" type="checkbox"/> <input type="checkbox"/>
		Impact Category: 1 2 3 4 5	<input type="checkbox"/> <input checked="" type="checkbox"/> <input type="checkbox"/> <input type="checkbox"/> <input type="checkbox"/>
Location: Unit 2 – Courtyard	Auditors Comments: <ul style="list-style-type: none"> Furthest east fence post is leaning toward neighbouring property while the other two posts are more or less vertically straight. An exact measurement of angle was not taken and these photos are simply for general evidence of condition (see "Property Photos" for more general photos including fence railing dislodgement).

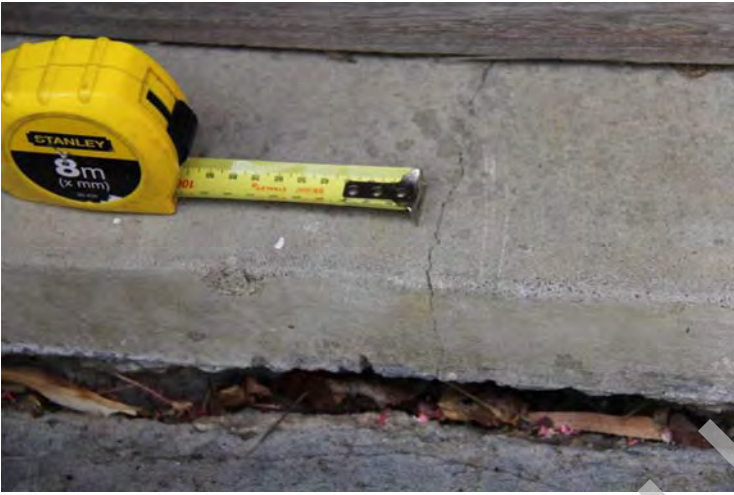
Item	Photographic Evidence	Assessments	
62.

Assessment Type: Good Fair Poor	<input type="checkbox"/> <input checked="" type="checkbox"/> <input type="checkbox"/>
		Impact Category: 1 2 3 4 5	<input checked="" type="checkbox"/> <input type="checkbox"/> <input checked="" type="checkbox"/> <input type="checkbox"/> <input type="checkbox"/>
Location: Unit 3 – Doorway entrance	Auditors Comments: <ul style="list-style-type: none"> Fine crack (Approx. 1mm) in slab and large gap (approx. 20-30mm) between slab and concrete walkway.

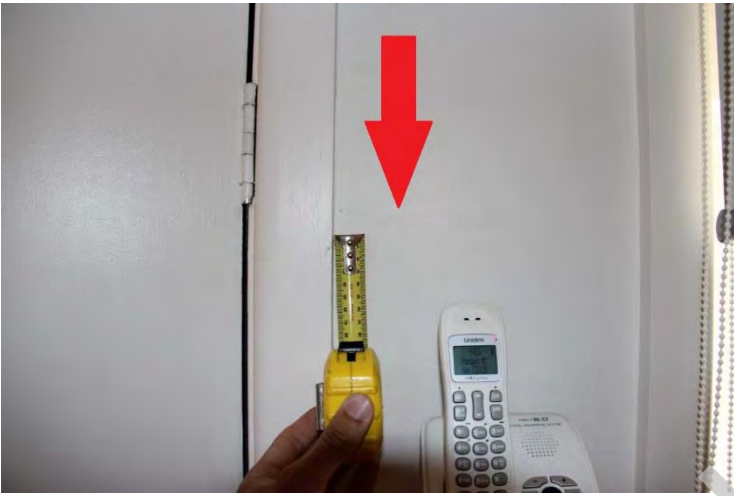
Item	Photographic Evidence	Assessments	
64.

Assessment Type: Good Fair Poor	<input type="checkbox"/> <input checked="" type="checkbox"/> <input type="checkbox"/>
		Impact Category: 1 2 3 4 5	<input checked="" type="checkbox"/> <input type="checkbox"/> <input type="checkbox"/> <input type="checkbox"/> <input type="checkbox"/>
Location: Unit 3 – Interior	Auditors Comments: <ul style="list-style-type: none"> Fine crack to right of entrance doorway. Approx. 0.5mm.

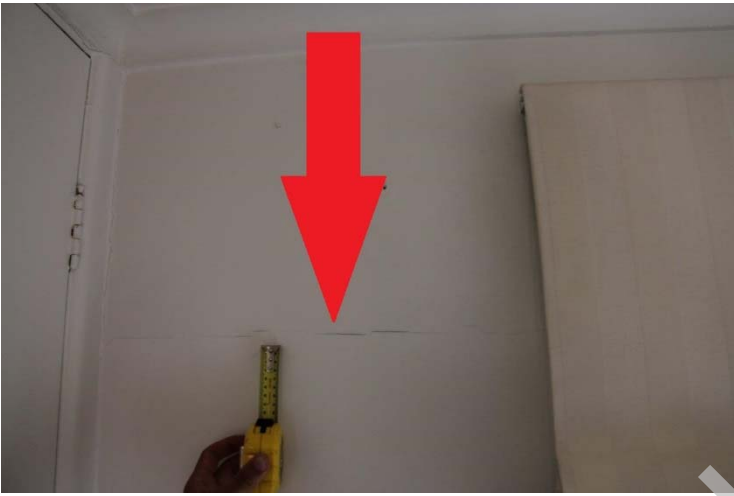
Item	Photographic Evidence	Assessments	
66.

Assessment Type: Good Fair Poor	<input type="checkbox"/> <input checked="" type="checkbox"/> <input type="checkbox"/>
		Impact Category: 1 2 3 4 5	<input type="checkbox"/> <input checked="" type="checkbox"/> <input type="checkbox"/> <input type="checkbox"/> <input type="checkbox"/>
Location: Unit 3 – Bedroom	Auditors Comments: <ul style="list-style-type: none"> Cracking to right of wardrobe. Approx. 1-2mm.

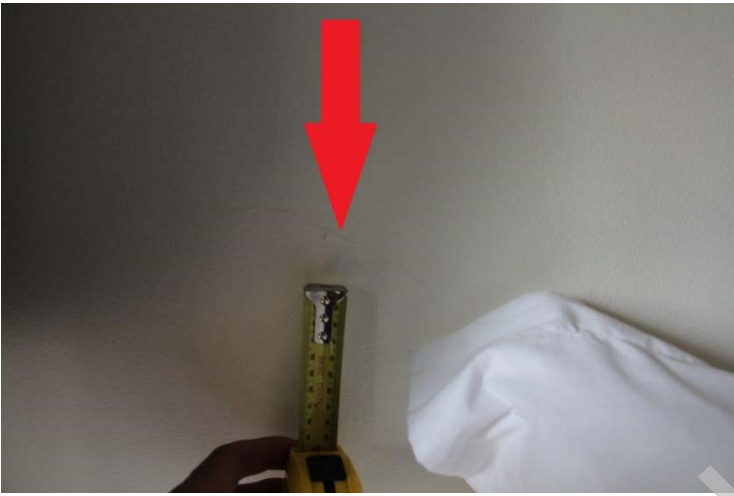
Item	Photographic Evidence	Assessments	
68.

Assessment Type: Good <input type="checkbox"/> Fair <input checked="" type="checkbox"/> Poor <input type="checkbox"/>	<input type="checkbox"/> <input checked="" type="checkbox"/> <input type="checkbox"/>
		Impact Category: 1 <input type="checkbox"/> 2 <input type="checkbox"/> 3 <input type="checkbox"/> 4 <input type="checkbox"/> 5 <input type="checkbox"/>	<input checked="" type="checkbox"/> <input type="checkbox"/> <input type="checkbox"/> <input type="checkbox"/> <input type="checkbox"/>
Location: Unit 3 – Bedroom	Auditors Comments: <ul style="list-style-type: none"> Fine crack to left of master bed (western wall). Approx. 0.5mm.

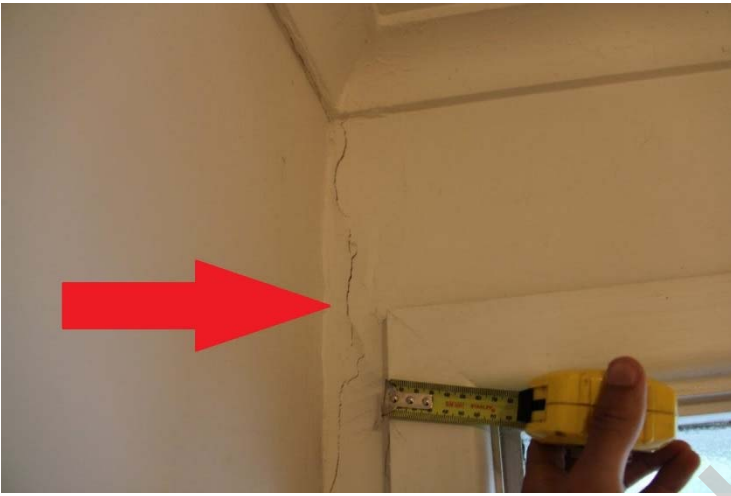
Item	Photographic Evidence	Assessments	
70.

Assessment Type: Good Fair Poor	<input type="checkbox"/> <input checked="" type="checkbox"/> <input type="checkbox"/>
		Impact Category: 1 2 3 4 5	<input checked="" type="checkbox"/> <input type="checkbox"/> <input type="checkbox"/> <input type="checkbox"/> <input type="checkbox"/>
Location: Unit 3 – Bathroom	Auditors Comments: <ul style="list-style-type: none"> Crack to upper left-hand side of bathroom window frame. Approx. 1mm.

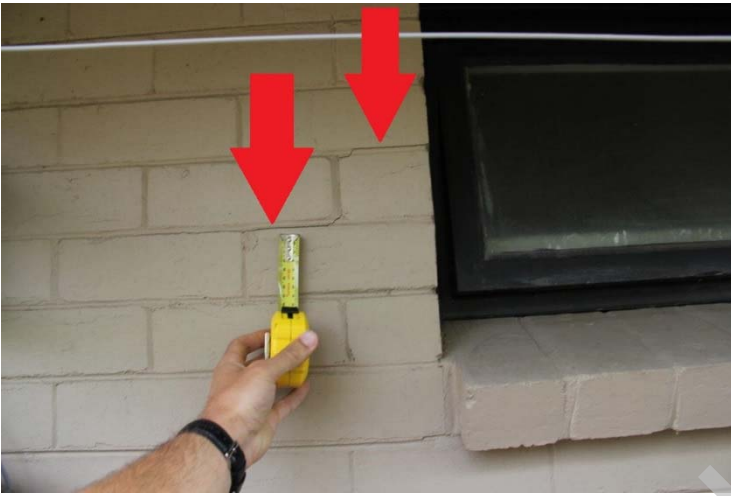
Item	Photographic Evidence	Assessments	
72.

Assessment Type: Good Fair Poor	<input type="checkbox"/> <input checked="" type="checkbox"/> <input type="checkbox"/>
		Impact Category: 1 2 3 4 5	<input checked="" type="checkbox"/> <input type="checkbox"/> <input type="checkbox"/> <input type="checkbox"/> <input type="checkbox"/>
Location: Unit 3 – Courtyard	Auditors Comments: <ul style="list-style-type: none"> Crack to left of window frame. Approx. 1mm.

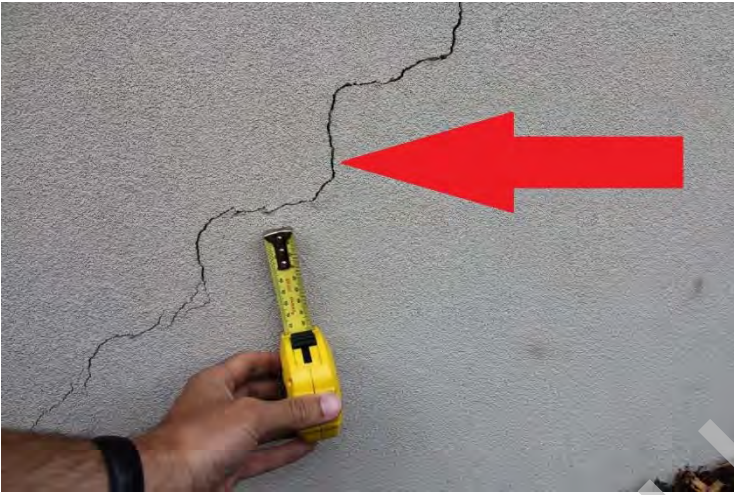
Item	Photographic Evidence	Assessments	
74.

Assessment Type: Good Fair Poor	<input type="checkbox"/> <input checked="" type="checkbox"/> <input type="checkbox"/>
		Impact Category: 1 2 3 4 5	<input type="checkbox"/> <input checked="" type="checkbox"/> <input type="checkbox"/> <input type="checkbox"/> <input type="checkbox"/>
Location: Unit 4 – Northern exterior	Auditors Comments: <ul style="list-style-type: none"> Long running cracking between Unit 4 and 3. Approx. 2mm width.

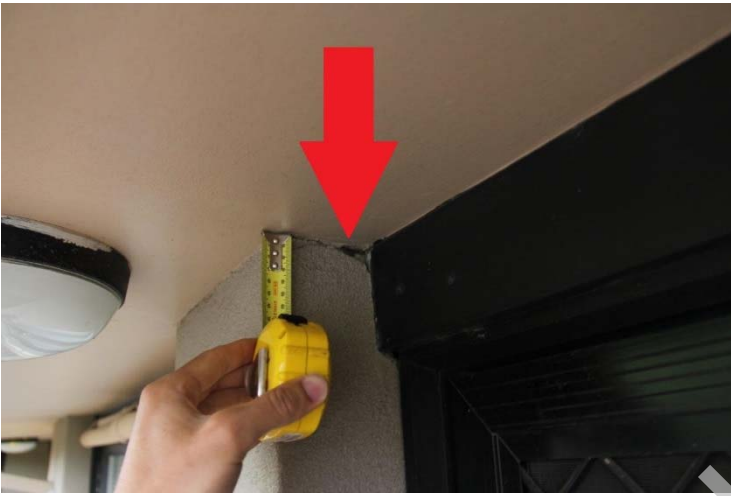
Item	Photographic Evidence	Assessments	
76.

Assessment Type: Good Fair Poor	<input type="checkbox"/> <input checked="" type="checkbox"/> <input type="checkbox"/>
		Impact Category: 1 2 3 4 5	<input type="checkbox"/> <input checked="" type="checkbox"/> <input type="checkbox"/> <input type="checkbox"/> <input type="checkbox"/>
Location: Unit 4 – Northern exterior	Auditors Comments: <ul style="list-style-type: none"> Missing render near door frame has created a gap. Approx. 3-5mm.

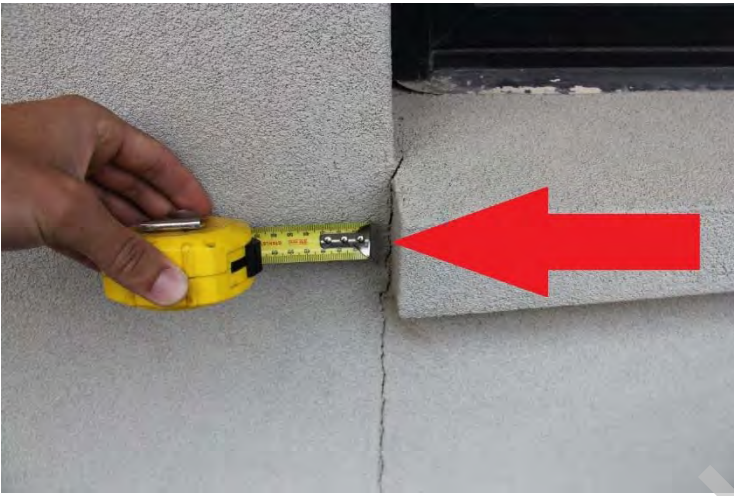
Item	Photographic Evidence	Assessments	
78.

Assessment Type: Good Fair Poor	<input type="checkbox"/> <input checked="" type="checkbox"/> <input type="checkbox"/>
		Impact Category: 1 2 3 4 5	<input type="checkbox"/> <input checked="" type="checkbox"/> <input type="checkbox"/> <input type="checkbox"/> <input type="checkbox"/>
Location: Unit 4 – Northern exterior	Auditors Comments: <ul style="list-style-type: none"> Crack present near window sill. Approx. 1-2mm. 		
79.

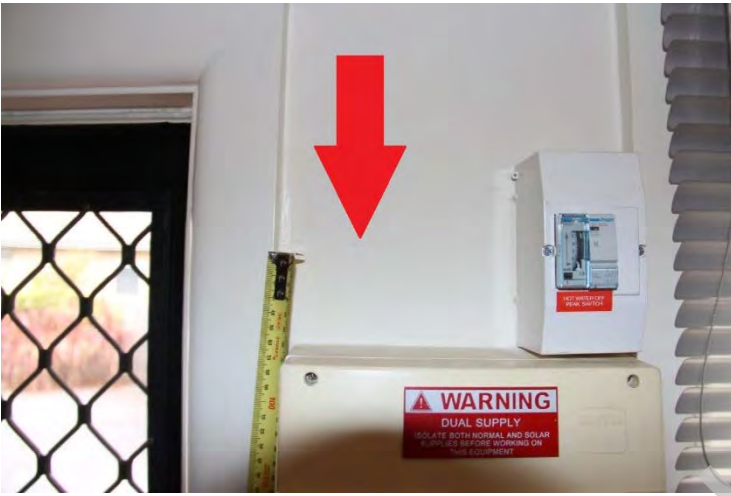
Item	Photographic Evidence	Assessments	
80.

Assessment Type: Good Fair Poor	<input type="checkbox"/> <input checked="" type="checkbox"/> <input type="checkbox"/>
		Impact Category: 1 2 3 4 5	<input checked="" type="checkbox"/> <input type="checkbox"/> <input type="checkbox"/> <input type="checkbox"/> <input type="checkbox"/>
Location: Unit 4 – Kitchen	Auditors Comments: <ul style="list-style-type: none"> Fine crack near right-hand side of door frame. Approx. 0.2-0.5mm.

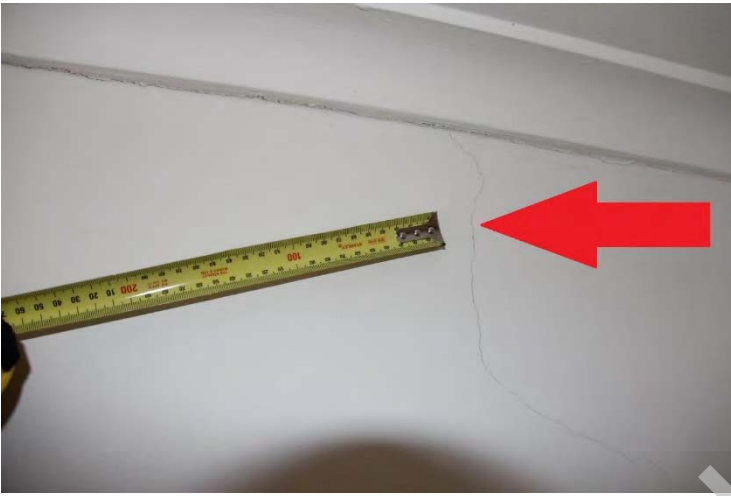
Item	Photographic Evidence	Assessments	
82.

Assessment Type: Good Fair Poor	<input type="checkbox"/> <input checked="" type="checkbox"/> <input type="checkbox"/>
		Impact Category: 1 2 3 4 5	<input checked="" type="checkbox"/> <input type="checkbox"/> <input type="checkbox"/> <input type="checkbox"/> <input type="checkbox"/>
Location: Unit 4 – Kitchen & lounge	Auditors Comments: <ul style="list-style-type: none"> Medium length, fine crack running along wall. Approx. 0.5mm.

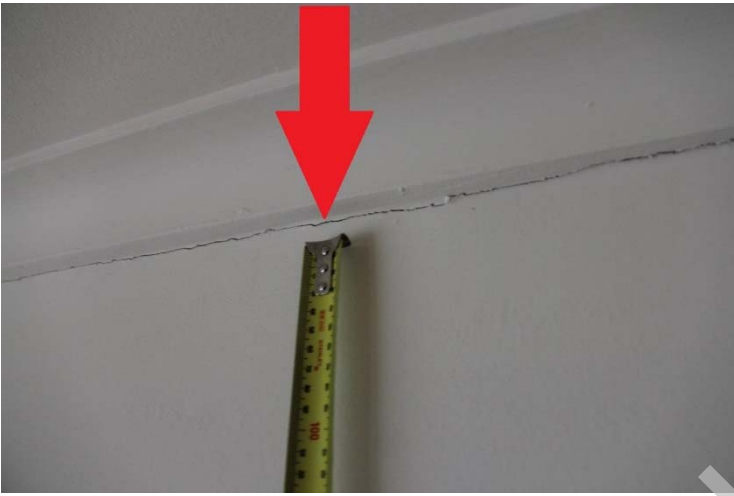
Item	Photographic Evidence	Assessments	
84.

Assessment Type: Good Fair Poor	<input type="checkbox"/> <input checked="" type="checkbox"/> <input type="checkbox"/>
		Impact Category: 1 2 3 4 5	<input checked="" type="checkbox"/> <input type="checkbox"/> <input type="checkbox"/> <input type="checkbox"/> <input type="checkbox"/>
Location: Unit 4 – Kitchen & lounge	Auditors Comments: <ul style="list-style-type: none"> Crack underneath skirting board. Approx. 1mm.

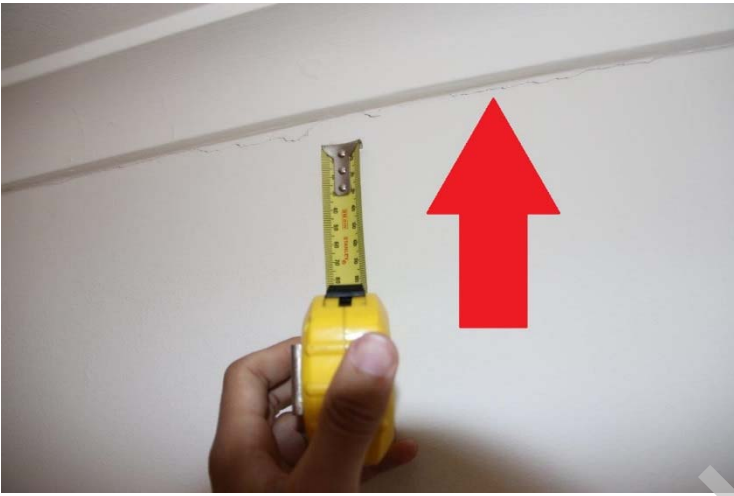
Item	Photographic Evidence	Assessments	
86.

Assessment Type: Good Fair Poor	<input type="checkbox"/> <input checked="" type="checkbox"/> <input type="checkbox"/>
		Impact Category: 1 2 3 4 5	<input checked="" type="checkbox"/> <input type="checkbox"/> <input type="checkbox"/> <input type="checkbox"/> <input type="checkbox"/>
Location: Unit 4 – Bedroom	Auditors Comments: <ul style="list-style-type: none"> Crack underneath skirting board. Approx. 0.5mm.

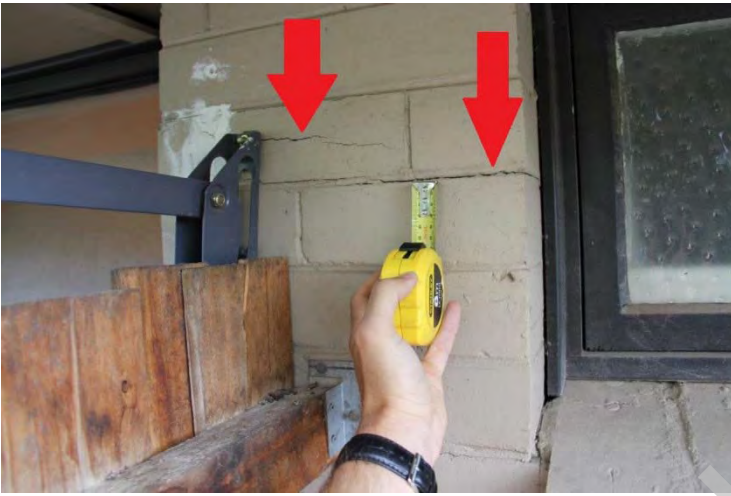
Item	Photographic Evidence	Assessments	
88.

Assessment Type: Good Fair Poor	<input type="checkbox"/> <input checked="" type="checkbox"/> <input type="checkbox"/>
		Impact Category: 1 2 3 4 5	<input type="checkbox"/> <input checked="" type="checkbox"/> <input type="checkbox"/> <input type="checkbox"/> <input type="checkbox"/>
Location: Unit 4 – Courtyard	Auditors Comments: <ul style="list-style-type: none"> Cracking present in brickwork left of window. Approx. 1-2mm.
