Dilapidation Survey Report

28 Sample Street Suburb VIC 3008

Plan of Subdivision: PS 123456

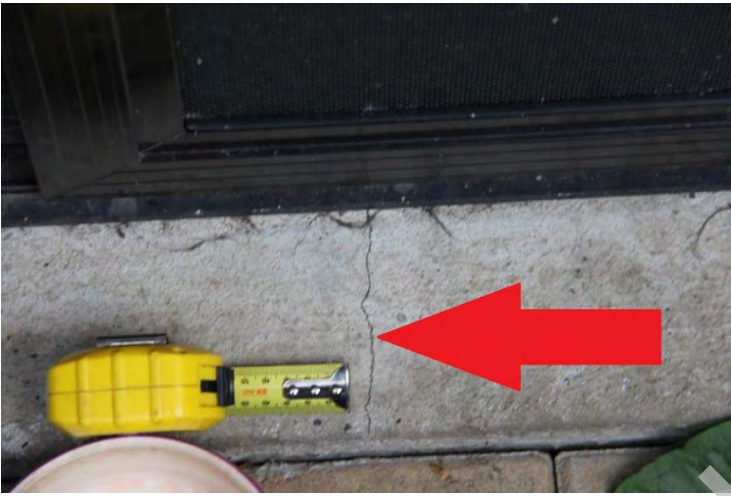
Item	Photographic Evidence	Assessments	
90.

Assessment Type: Good Fair Poor	<input type="checkbox"/> <input checked="" type="checkbox"/> <input type="checkbox"/>
		Impact Category: 1 2 3 4 5	<input checked="" type="checkbox"/> <input type="checkbox"/> <input type="checkbox"/> <input type="checkbox"/> <input type="checkbox"/>
Location: Unit 4 – Courtyard	Auditors Comments: <ul style="list-style-type: none"> Cracking present in floor slab near base of doorframe. Approx. 1mm.

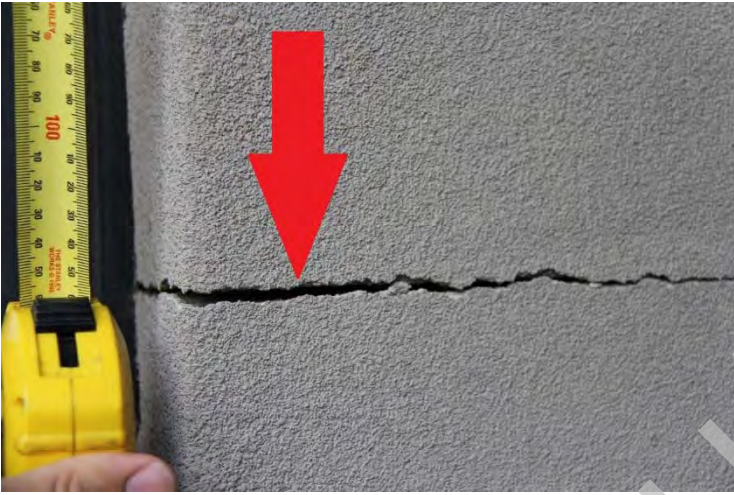
Item	Photographic Evidence	Assessments	
92.

<u>Assessment Type:</u> Good Fair Poor	<input type="checkbox"/> <input type="checkbox"/> <input checked="" type="checkbox"/>
		<u>Impact Category:</u> 1 2 3 4 5	<input type="checkbox"/> <input checked="" type="checkbox"/> <input type="checkbox"/> <input type="checkbox"/> <input type="checkbox"/>
<u>Location:</u> Unit 5 – Exterior	<u>Auditors Comments:</u> <ul style="list-style-type: none"> Crack present below Unit 5 house number and next to window frame of Unit 6. Approx. 5mm.

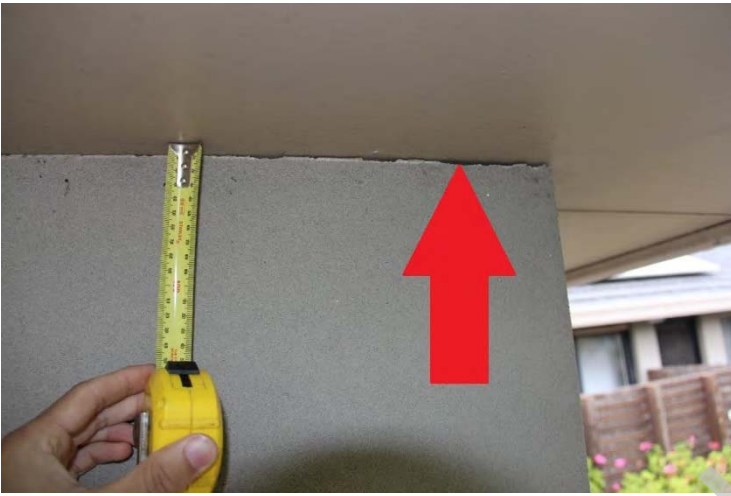
Item	Photographic Evidence	Assessments	
94.

Assessment Type: Good Fair Poor	<input type="checkbox"/> <input checked="" type="checkbox"/> <input type="checkbox"/>
		Impact Category: 1 2 3 4 5	<input type="checkbox"/> <input checked="" type="checkbox"/> <input type="checkbox"/> <input type="checkbox"/> <input type="checkbox"/>
Location: Unit 5 – Exterior	Auditors Comments: <ul style="list-style-type: none"> Gap present between eave and rendered wall. Approx. 2mm.

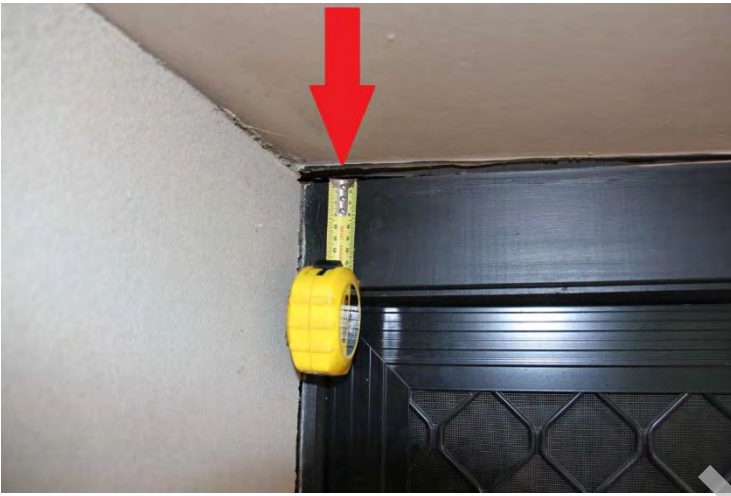
Item	Photographic Evidence	Assessments	
96.

Assessment Type: Good Fair Poor	<input type="checkbox"/> <input checked="" type="checkbox"/> <input type="checkbox"/>
		Impact Category: 1 2 3 4 5	<input type="checkbox"/> <input checked="" type="checkbox"/> <input type="checkbox"/> <input type="checkbox"/> <input type="checkbox"/>
Location: Unit 5 – Exterior	Auditors Comments: <ul style="list-style-type: none"> Gap present between eave and door frame. Approx. 5mm.

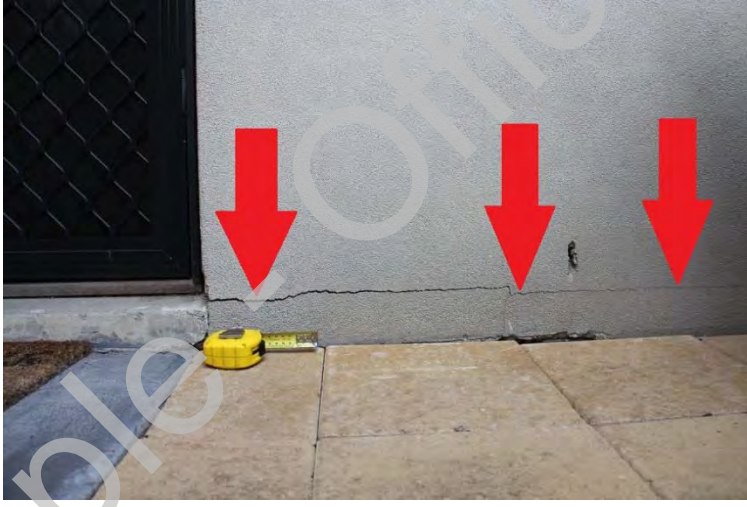
97.

Assessment Type: Good Fair Poor	<input type="checkbox"/> <input checked="" type="checkbox"/> <input type="checkbox"/>
		Impact Category: 1 2 3 4 5	<input type="checkbox"/> <input checked="" type="checkbox"/> <input type="checkbox"/> <input type="checkbox"/> <input type="checkbox"/>
Location: Unit 5 – Exterior	Auditors Comments: <ul style="list-style-type: none"> Crack running at base of rendered wall to right of Unit 5 doorway entrance. Approx. 2-3mm.

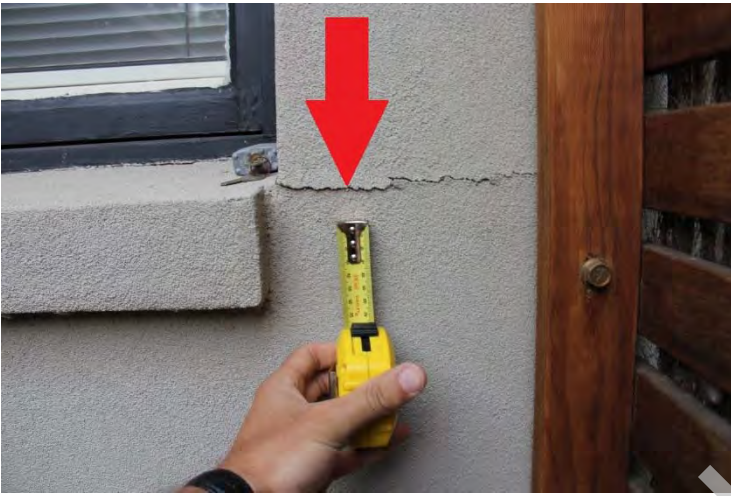
Item	Photographic Evidence	Assessments	
98.

Assessment Type: Good Fair Poor	<input type="checkbox"/> <input checked="" type="checkbox"/> <input type="checkbox"/>
		Impact Category: 1 2 3 4 5	<input type="checkbox"/> <input checked="" type="checkbox"/> <input type="checkbox"/> <input type="checkbox"/> <input type="checkbox"/>
Location: Unit 5 – Exterior	Auditors Comments: <ul style="list-style-type: none"> Crack to right of window frame on external of rendered wall. Approx. 2mm.

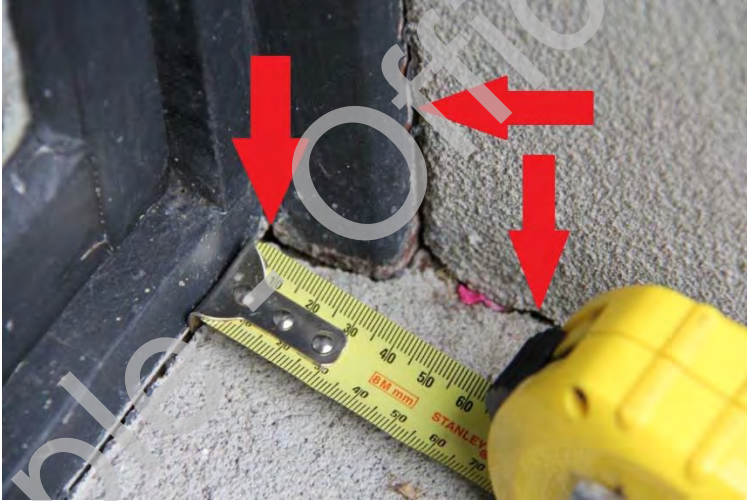
99.

Assessment Type: Good Fair Poor	<input type="checkbox"/> <input checked="" type="checkbox"/> <input type="checkbox"/>
		Impact Category: 1 2 3 4 5	<input type="checkbox"/> <input checked="" type="checkbox"/> <input type="checkbox"/> <input type="checkbox"/> <input type="checkbox"/>
Location: Unit 5 – Exterior	Auditors Comments: <ul style="list-style-type: none"> Gaps and cracks between window frame and external façade. Approx. 2mm.

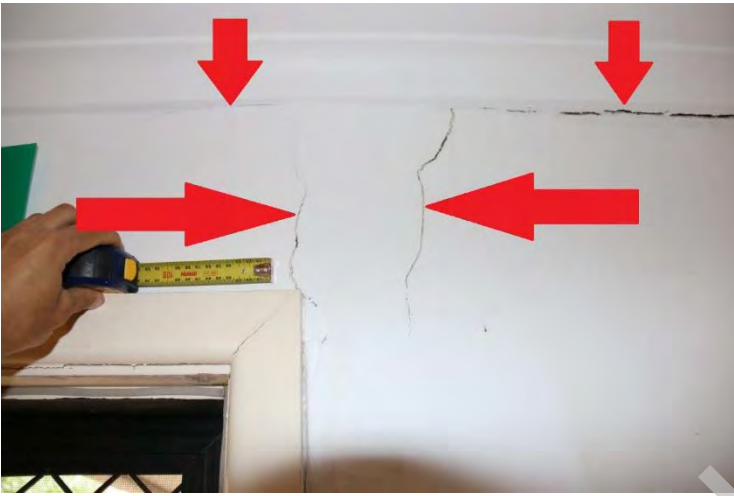
Item	Photographic Evidence	Assessments	
100.

Assessment Type: Good Fair Poor	<input type="checkbox"/> <input checked="" type="checkbox"/> <input type="checkbox"/>
		Impact Category: 1 2 3 4 5	<input type="checkbox"/> <input checked="" type="checkbox"/> <input type="checkbox"/> <input type="checkbox"/> <input type="checkbox"/>
Location: Unit 5 – Internal	Auditors Comments: <ul style="list-style-type: none"> Crack to right of door frame running to ceiling and extending along the skirting board. Ranging from approx. 1-5mm.

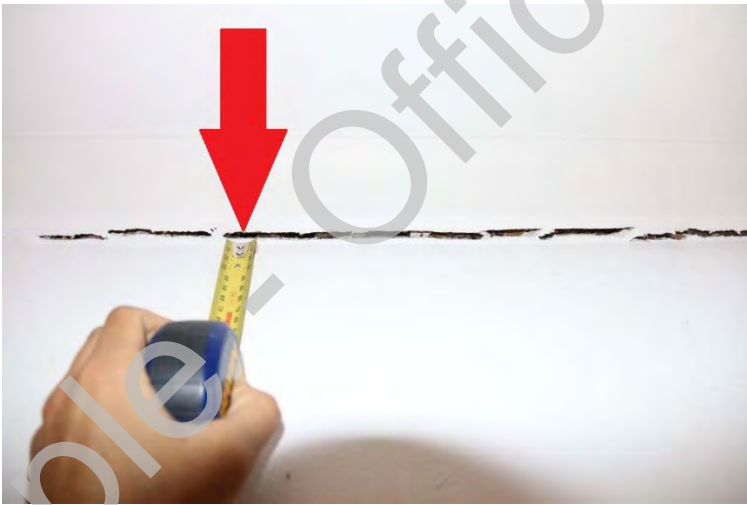
101.

Assessment Type: Good Fair Poor	<input type="checkbox"/> <input type="checkbox"/> <input checked="" type="checkbox"/>
		Impact Category: 1 2 3 4 5	<input type="checkbox"/> <input type="checkbox"/> <input checked="" type="checkbox"/> <input type="checkbox"/> <input type="checkbox"/>
Location: Unit 5 – Interior	Auditors Comments: <ul style="list-style-type: none"> Continuation of crack from Item 100 (see above) under skirting board. Approx. 5-7mm.

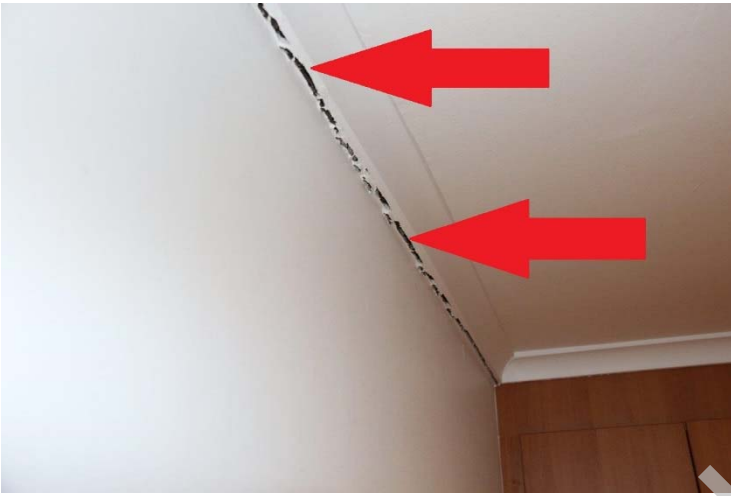
Item	Photographic Evidence	Assessments	
102.

Assessment Type: Good Fair Poor	<input type="checkbox"/> <input type="checkbox"/> <input checked="" type="checkbox"/>
		Impact Category: 1 2 3 4 5	<input type="checkbox"/> <input type="checkbox"/> <input checked="" type="checkbox"/> <input type="checkbox"/> <input type="checkbox"/>
Location: Unit 5 – Internal	Auditors Comments: <ul style="list-style-type: none"> Continuation of crack from Item 101 (see above) under skirting board. Approx. 5-7mm.

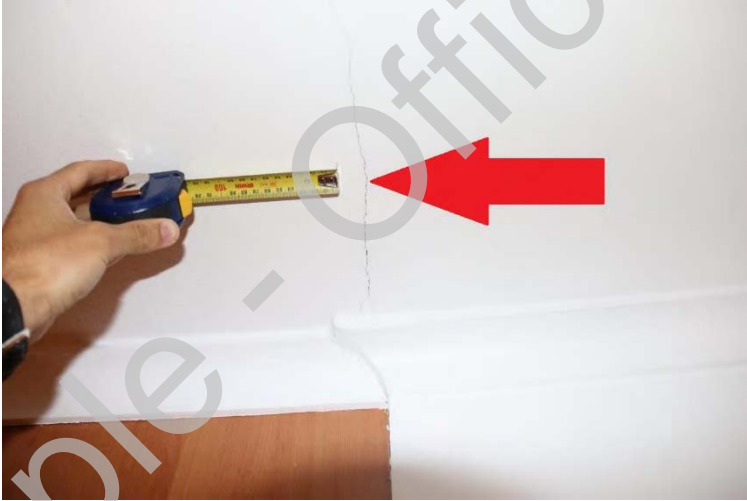
103.

Assessment Type: Good Fair Poor	<input type="checkbox"/> <input checked="" type="checkbox"/> <input type="checkbox"/>
		Impact Category: 1 2 3 4 5	<input checked="" type="checkbox"/> <input type="checkbox"/> <input type="checkbox"/> <input type="checkbox"/> <input type="checkbox"/>
Location: Unit 5 – Interior	Auditors Comments: <ul style="list-style-type: none"> Crack running outwards from skirting board in kitchen. Approx. 1mm.

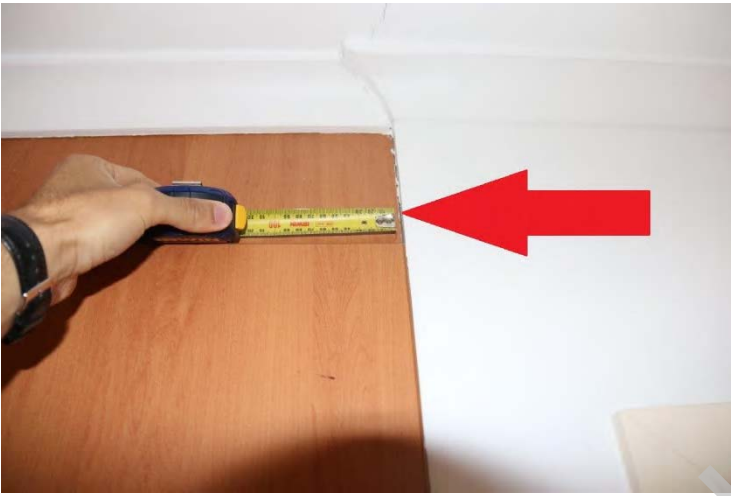
Item	Photographic Evidence	Assessments	
104.

Assessment Type: Good Fair Poor	<input type="checkbox"/> <input checked="" type="checkbox"/> <input type="checkbox"/>
		Impact Category: 1 2 3 4 5	<input type="checkbox"/> <input checked="" type="checkbox"/> <input type="checkbox"/> <input type="checkbox"/> <input type="checkbox"/>
Location: Unit 5 – Internal	Auditors Comments: <ul style="list-style-type: none"> Gap between mezzanine cupboard and wall. Approx. 3mm.

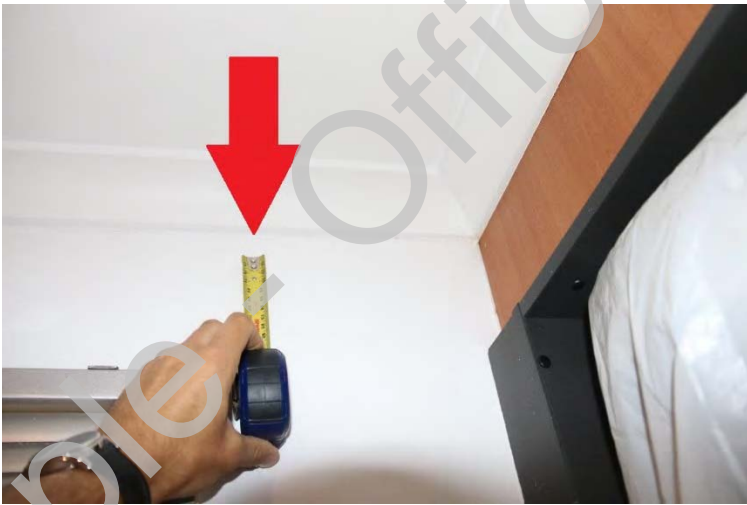
105.

Assessment Type: Good Fair Poor	<input type="checkbox"/> <input checked="" type="checkbox"/> <input type="checkbox"/>
		Impact Category: 1 2 3 4 5	<input checked="" type="checkbox"/> <input type="checkbox"/> <input type="checkbox"/> <input type="checkbox"/> <input type="checkbox"/>
Location: Unit 5 – Interior	Auditors Comments: <ul style="list-style-type: none"> Fine crack under skirting board to right of window frame. Approx. 1mm.

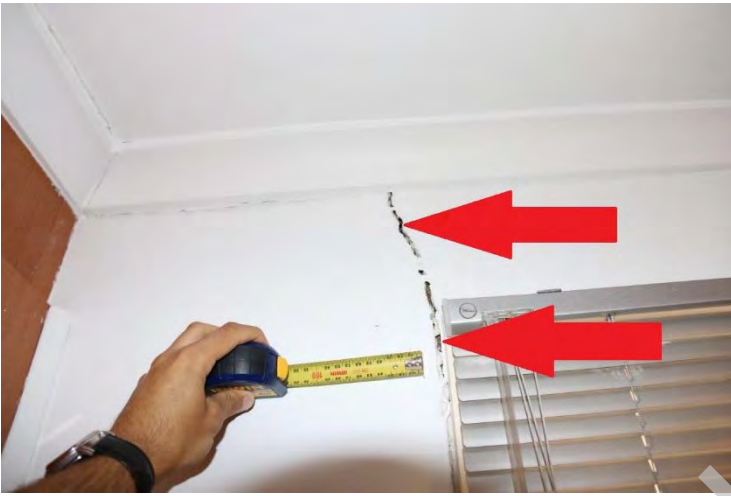
Item	Photographic Evidence	Assessments	
106.

Assessment Type: Good Fair Poor	<input type="checkbox"/> <input type="checkbox"/> <input checked="" type="checkbox"/>
		Impact Category: 1 2 3 4 5	<input type="checkbox"/> <input type="checkbox"/> <input checked="" type="checkbox"/> <input type="checkbox"/> <input type="checkbox"/>
Location: Unit 5 – Internal	Auditors Comments: <ul style="list-style-type: none"> Crack to left of window frame. Approx. 5-7mm. 		
107.

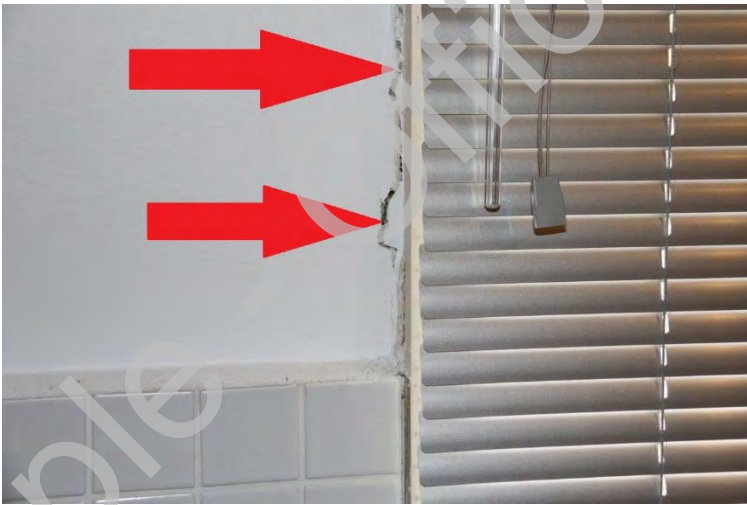
Assessment Type: Good Fair Poor	<input type="checkbox"/> <input type="checkbox"/> <input checked="" type="checkbox"/>
		Impact Category: 1 2 3 4 5	<input type="checkbox"/> <input type="checkbox"/> <input checked="" type="checkbox"/> <input type="checkbox"/> <input type="checkbox"/>
Location: Unit 5 – Interior	Auditors Comments: <ul style="list-style-type: none"> Crack to left of window frame. Approx. 5-7mm.

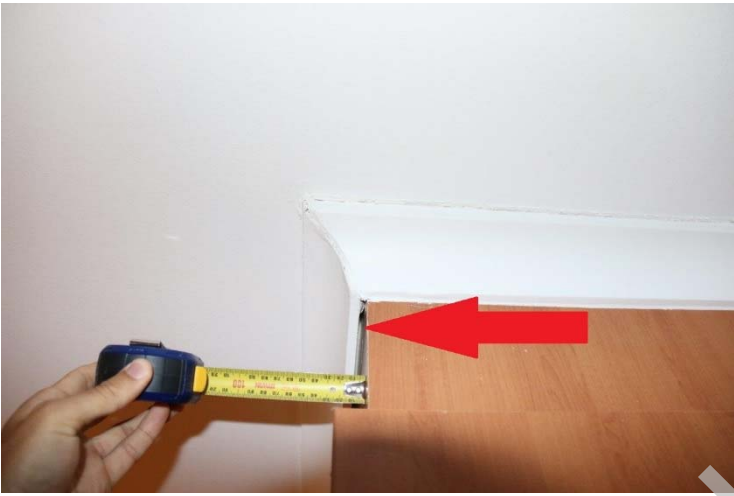
Item	Photographic Evidence	Assessments	
108.

Assessment Type: Good Fair Poor	<input type="checkbox"/> <input checked="" type="checkbox"/> <input type="checkbox"/>
		Impact Category: 1 2 3 4 5	<input type="checkbox"/> <input checked="" type="checkbox"/> <input type="checkbox"/> <input type="checkbox"/> <input type="checkbox"/>
Location: Unit 5 – Internal	Auditors Comments: <ul style="list-style-type: none"> Gap between skirting board and cupboard. Approx. 5mm. 		
109.

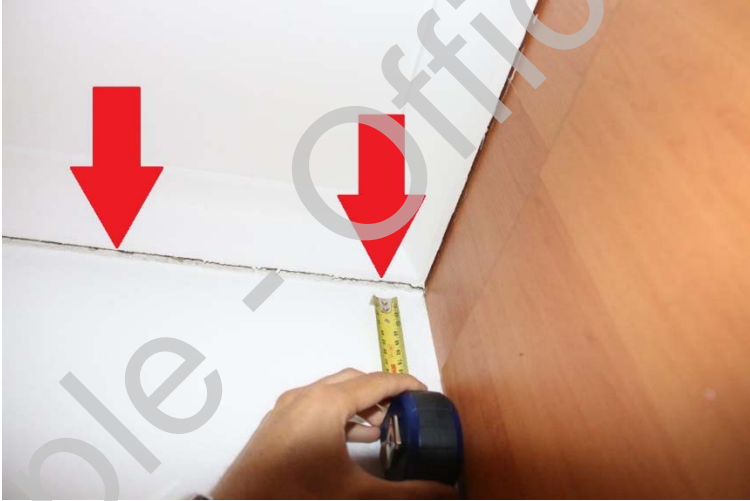
Assessment Type: Good Fair Poor	<input type="checkbox"/> <input checked="" type="checkbox"/> <input type="checkbox"/>
		Impact Category: 1 2 3 4 5	<input type="checkbox"/> <input checked="" type="checkbox"/> <input type="checkbox"/> <input type="checkbox"/> <input type="checkbox"/>
Location: Unit 5 – Interior	Auditors Comments: <ul style="list-style-type: none"> Crack under skirting board. Approx. 3mm.

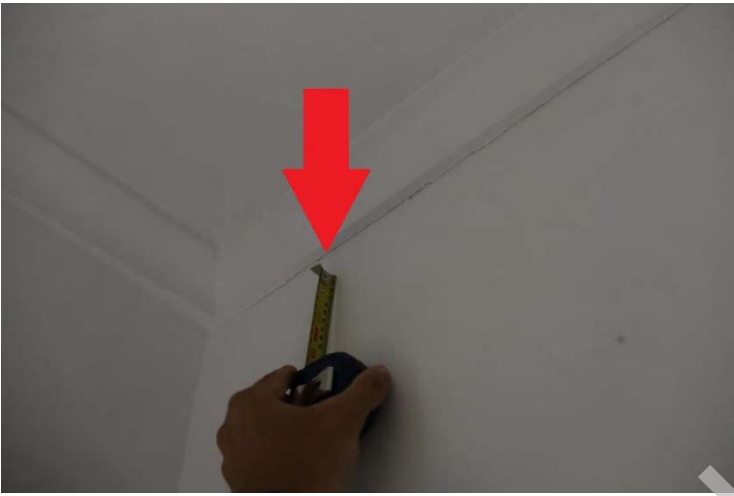
Item	Photographic Evidence	Assessments	
110.

Assessment Type: Good Fair Poor	<input type="checkbox"/> <input checked="" type="checkbox"/> <input type="checkbox"/>
		Impact Category: 1 2 3 4 5	<input checked="" type="checkbox"/> <input type="checkbox"/> <input type="checkbox"/> <input type="checkbox"/> <input type="checkbox"/>
Location: Unit 5 – Internal lounge/ kitchen	Auditors Comments: <ul style="list-style-type: none"> Crack below skirting board. Approx. 1mm. 		
111.

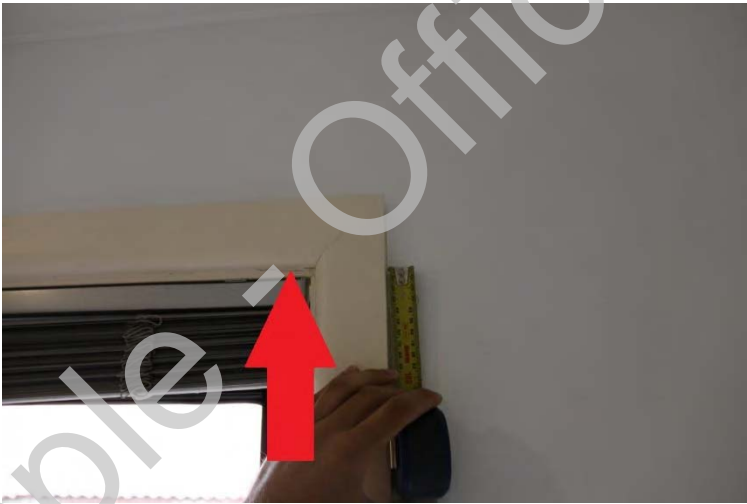
Assessment Type: Good Fair Poor	<input type="checkbox"/> <input checked="" type="checkbox"/> <input type="checkbox"/>
		Impact Category: 1 2 3 4 5	<input type="checkbox"/> <input checked="" type="checkbox"/> <input type="checkbox"/> <input type="checkbox"/> <input type="checkbox"/>
Location: Unit 5 – Exterior	Auditors Comments: <ul style="list-style-type: none"> Crack under skirting board of window frame.

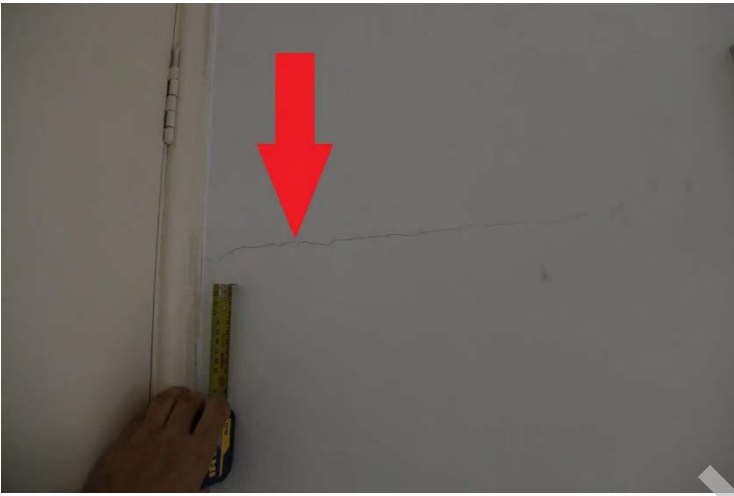
Item	Photographic Evidence	Assessments	
112.

Assessment Type: Good Fair Poor	<input type="checkbox"/> <input checked="" type="checkbox"/> <input type="checkbox"/>
		Impact Category: 1 2 3 4 5	<input checked="" type="checkbox"/> <input type="checkbox"/> <input type="checkbox"/> <input type="checkbox"/> <input type="checkbox"/>
Location: Unit 5 – Internal lounge/ kitchen	Auditors Comments: <ul style="list-style-type: none"> Crack to right of door frame. Approx. 1mm. 		
113.

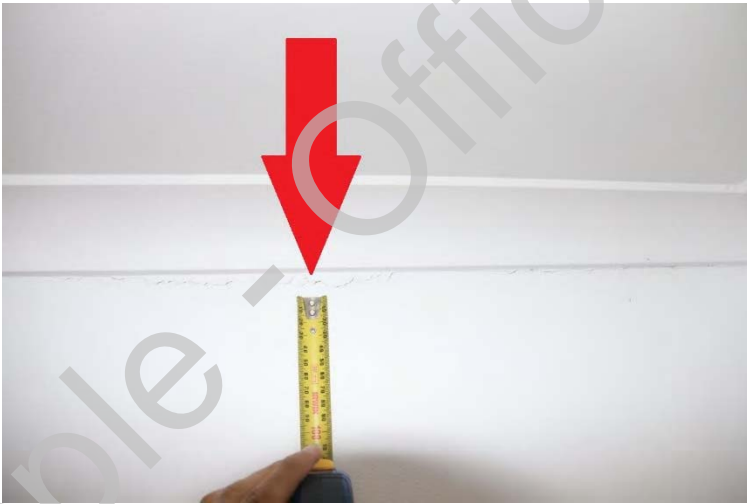
Assessment Type: Good Fair Poor	<input type="checkbox"/> <input checked="" type="checkbox"/> <input type="checkbox"/>
		Impact Category: 1 2 3 4 5	<input checked="" type="checkbox"/> <input type="checkbox"/> <input type="checkbox"/> <input type="checkbox"/> <input type="checkbox"/>
Location: Unit 5 – Exterior	Auditors Comments: <ul style="list-style-type: none"> Crack under skirting board. Approx. 1mm.

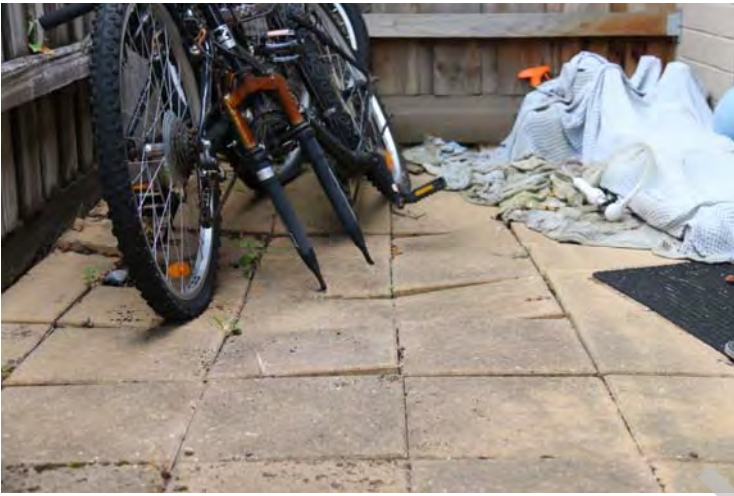
Item	Photographic Evidence	Assessments	
114.

Assessment Type: Good Fair Poor	<input type="checkbox"/> <input checked="" type="checkbox"/> <input type="checkbox"/>
		Impact Category: 1 2 3 4 5	<input checked="" type="checkbox"/> <input type="checkbox"/> <input type="checkbox"/> <input type="checkbox"/> <input type="checkbox"/>
Location: Unit 5 – External	Auditors Comments: <ul style="list-style-type: none"> Sunken tiled area approx. 30mm below architecturally designed FFL (finished floor level).

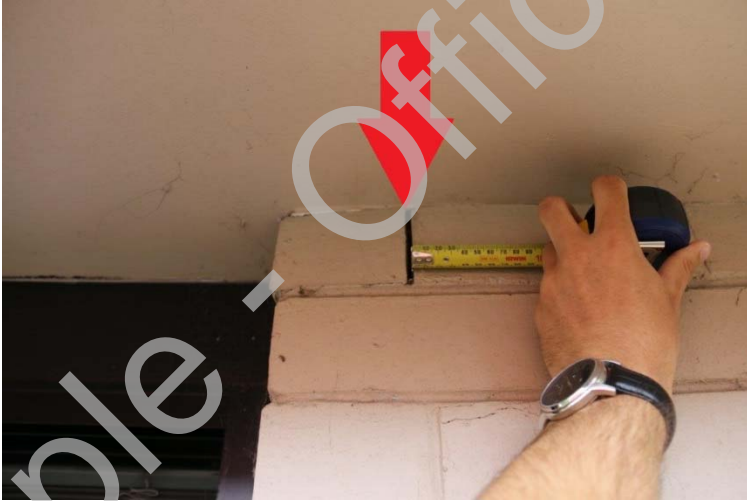
115.

Assessment Type: Good Fair Poor	<input type="checkbox"/> <input checked="" type="checkbox"/> <input type="checkbox"/>
		Impact Category: 1 2 3 4 5	<input type="checkbox"/> <input checked="" type="checkbox"/> <input type="checkbox"/> <input type="checkbox"/> <input type="checkbox"/>
Location: Unit 5 – Exterior	Auditors Comments: <ul style="list-style-type: none"> Gap between bricks to top right of door frame. Approx. 5mm.

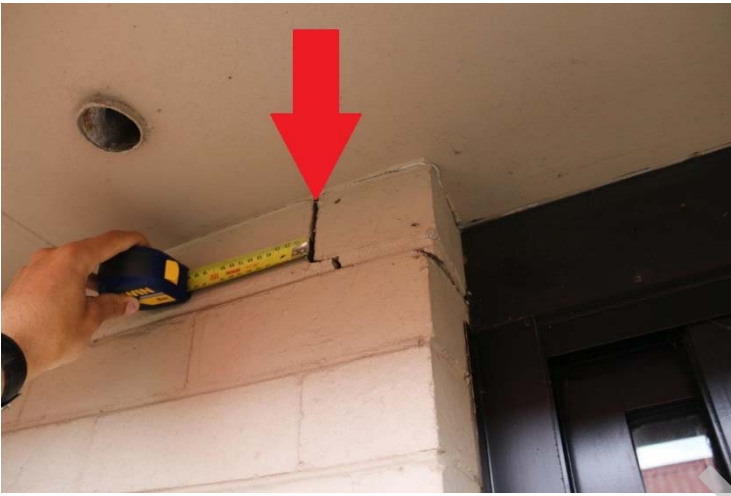
Item	Photographic Evidence	Assessments	
116.

Assessment Type: Good Fair Poor	<input type="checkbox"/> <input checked="" type="checkbox"/> <input type="checkbox"/>
		Impact Category: 1 2 3 4 5	<input type="checkbox"/> <input checked="" type="checkbox"/> <input type="checkbox"/> <input type="checkbox"/> <input type="checkbox"/>
Location: Unit 5 – External	Auditors Comments: <ul style="list-style-type: none"> Gap between bricks to top left of door frame. Approx. 5mm.

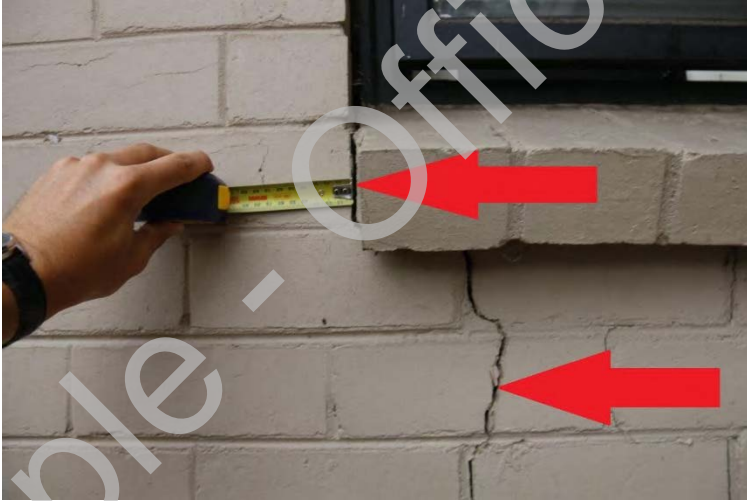
117.

Assessment Type: Good Fair Poor	<input type="checkbox"/> <input checked="" type="checkbox"/> <input type="checkbox"/>
		Impact Category: 1 2 3 4 5	<input type="checkbox"/> <input checked="" type="checkbox"/> <input type="checkbox"/> <input type="checkbox"/> <input type="checkbox"/>
Location: Unit 5 – Exterior	Auditors Comments: <ul style="list-style-type: none"> Cracking below window frame on external façade. Approx. 3mm.

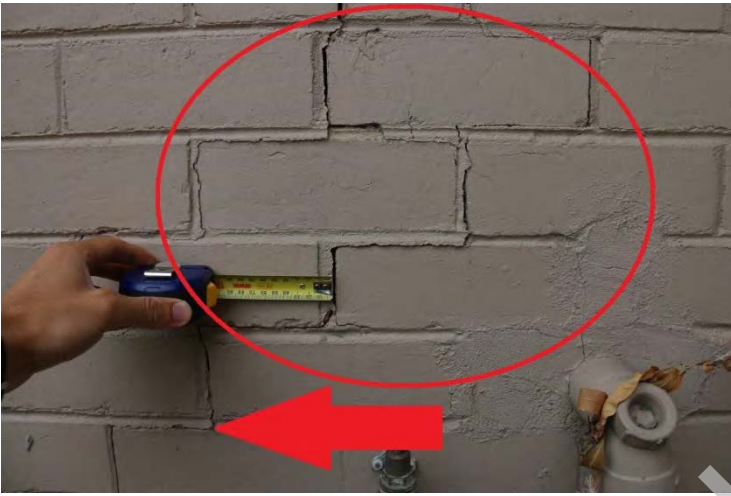
Item	Photographic Evidence	Assessments	
118.

Assessment Type: Good Fair Poor	<input type="checkbox"/> <input checked="" type="checkbox"/> <input type="checkbox"/>
		Impact Category: 1 2 3 4 5	<input type="checkbox"/> <input checked="" type="checkbox"/> <input type="checkbox"/> <input type="checkbox"/> <input type="checkbox"/>
Location: Unit 5 – External	Auditors Comments: <ul style="list-style-type: none"> Continued cracking (from Item 117) below window frame on external façade. Approx. 3mm.

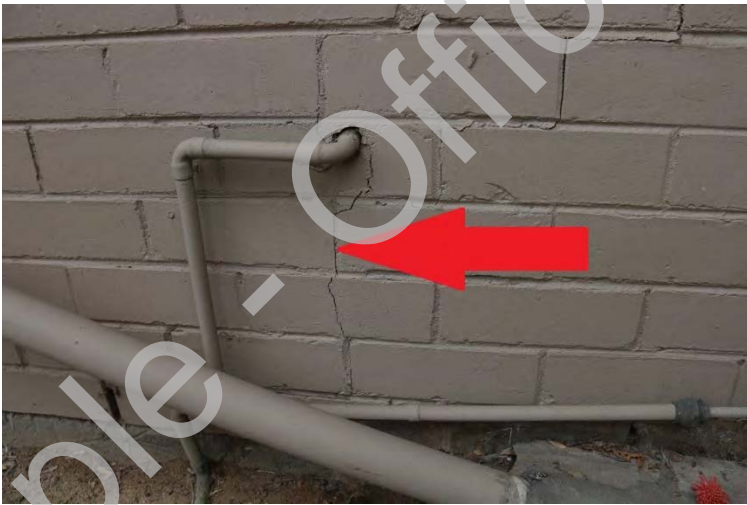
119.

Assessment Type: Good Fair Poor	<input type="checkbox"/> <input checked="" type="checkbox"/> <input type="checkbox"/>
		Impact Category: 1 2 3 4 5	<input type="checkbox"/> <input checked="" type="checkbox"/> <input type="checkbox"/> <input type="checkbox"/> <input type="checkbox"/>
Location: Unit 5 – Exterior	Auditors Comments: <ul style="list-style-type: none"> Cracking on external façade. Approx. 2mm.

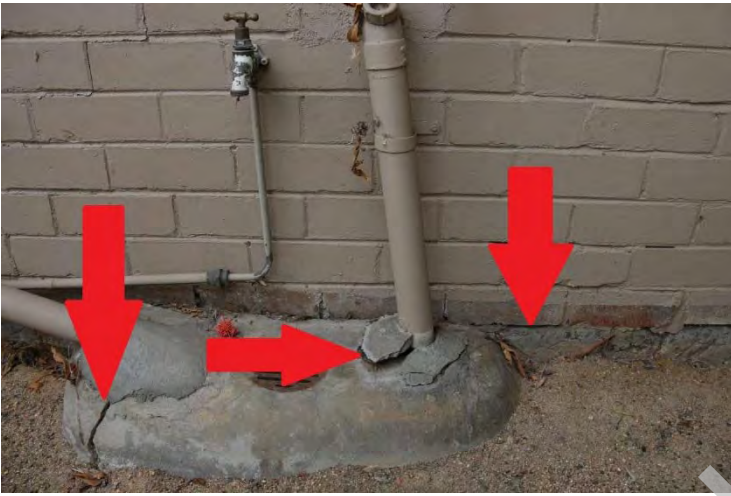
Item	Photographic Evidence	Assessments	
120.

Assessment Type: Good <input type="checkbox"/> Fair <input type="checkbox"/> Poor <input checked="" type="checkbox"/>	<input type="checkbox"/> <input type="checkbox"/> <input checked="" type="checkbox"/>
		Impact Category: 1 <input type="checkbox"/> 2 <input type="checkbox"/> 3 <input checked="" type="checkbox"/> 4 <input type="checkbox"/> 5 <input type="checkbox"/>	<input type="checkbox"/> <input type="checkbox"/> <input checked="" type="checkbox"/> <input type="checkbox"/> <input type="checkbox"/>
Location: Unit 5 – External	Auditors Comments: <ul style="list-style-type: none"> Cracking of greywater housing and at base of façade. Approx. 5-10mm.

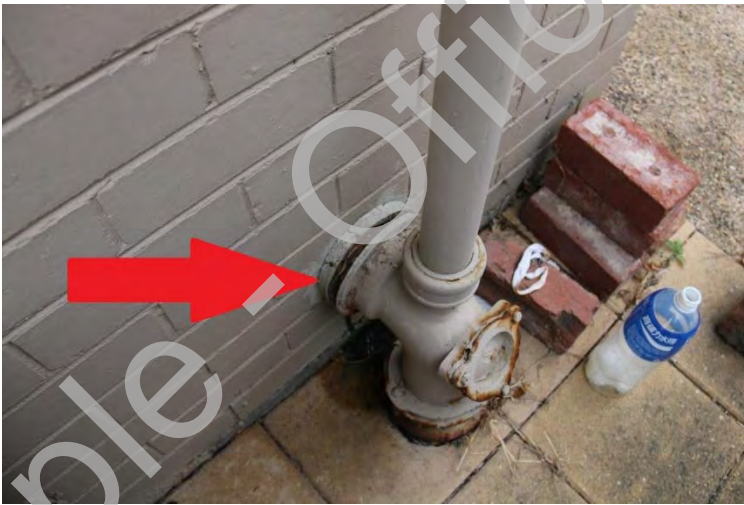
121.

Assessment Type: Good <input type="checkbox"/> Fair <input type="checkbox"/> Poor <input checked="" type="checkbox"/>	<input type="checkbox"/> <input type="checkbox"/> <input checked="" type="checkbox"/>
		Impact Category: 1 <input type="checkbox"/> 2 <input type="checkbox"/> 3 <input type="checkbox"/> 4 <input checked="" type="checkbox"/> 5 <input type="checkbox"/>	<input type="checkbox"/> <input type="checkbox"/> <input type="checkbox"/> <input checked="" type="checkbox"/> <input type="checkbox"/>
Location: Unit 5 – Exterior	Auditors Comments: <ul style="list-style-type: none"> Gap present between wastewater piping and façade. Approx. 15mm.

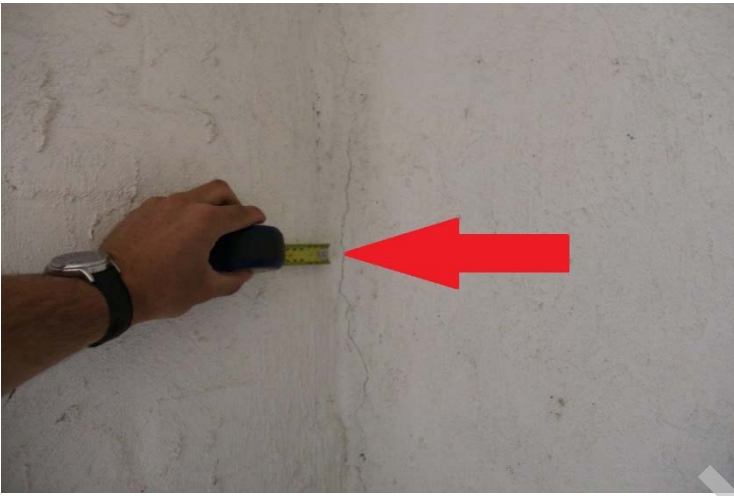
Item	Photographic Evidence	Assessments	
122.

Assessment Type: Good Fair Poor	<input type="checkbox"/> <input checked="" type="checkbox"/> <input type="checkbox"/>
		Impact Category: 1 2 3 4 5	<input checked="" type="checkbox"/> <input type="checkbox"/> <input type="checkbox"/> <input type="checkbox"/> <input type="checkbox"/>
Location: Storeroom	Auditors Comments: <ul style="list-style-type: none"> Cracking in storeroom. Approx. 1mm. 		
123.

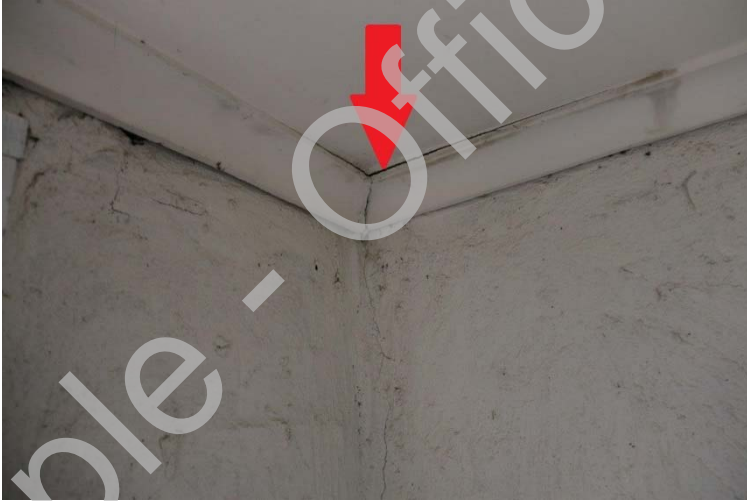
Assessment Type: Good Fair Poor	<input type="checkbox"/> <input checked="" type="checkbox"/> <input type="checkbox"/>
		Impact Category: 1 2 3 4 5	<input type="checkbox"/> <input checked="" type="checkbox"/> <input type="checkbox"/> <input type="checkbox"/> <input type="checkbox"/>
Location: Storeroom	Auditors Comments: <ul style="list-style-type: none"> Gap between skirting board and ceiling. Approx. 2mm.

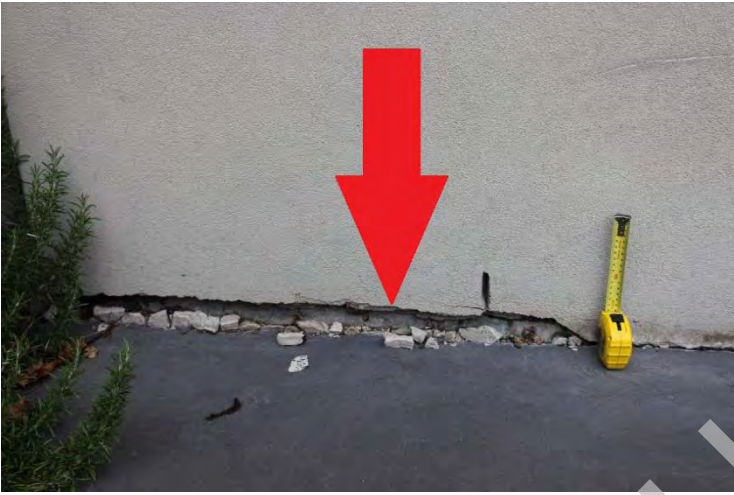
Item	Photographic Evidence	Assessments	
124.

Assessment Type: Good <input type="checkbox"/> Fair <input checked="" type="checkbox"/> Poor <input type="checkbox"/>	Impact Category: 1 <input type="checkbox"/> 2 <input type="checkbox"/> 3 <input checked="" type="checkbox"/> 4 <input type="checkbox"/> 5 <input type="checkbox"/>
Location: Unit 6 – Exterior	Auditors Comments: <ul style="list-style-type: none"> Gap present between veneered wall and founding slab. Approx. 25mm.

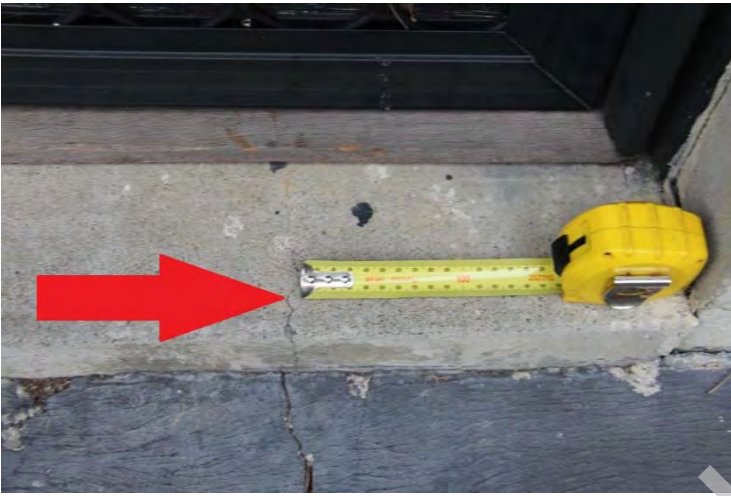
Item	Photographic Evidence	Assessments	
126.

Assessment Type: Good <input type="checkbox"/> Fair <input checked="" type="checkbox"/> Poor <input type="checkbox"/>	Impact Category: 1 <input type="checkbox"/> 2 <input checked="" type="checkbox"/> 3 <input type="checkbox"/> 4 <input type="checkbox"/> 5 <input type="checkbox"/>
Location: Unit 6 – Exterior	Auditors Comments: <ul style="list-style-type: none"> Crack between wall and fence pillar. Approx. 3-5mm.

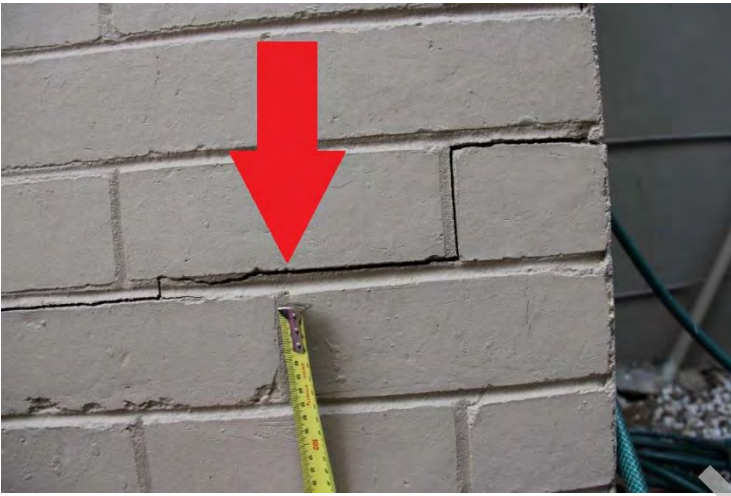
Item	Photographic Evidence	Assessments	
130.

Assessment Type: Good Fair Poor	<input type="checkbox"/> <input checked="" type="checkbox"/> <input type="checkbox"/>
		Impact Category: 1 2 3 4 5	<input type="checkbox"/> <input checked="" type="checkbox"/> <input type="checkbox"/> <input type="checkbox"/> <input type="checkbox"/>
Location: Unit 6 – Exterior	Auditors Comments: <ul style="list-style-type: none"> Long crack present near water tap. Approx. 1-2mm.

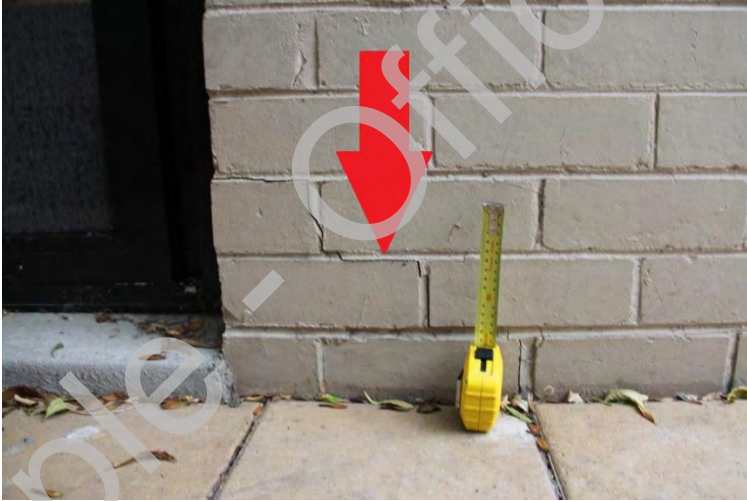
131.

Assessment Type: Good Fair Poor	<input type="checkbox"/> <input checked="" type="checkbox"/> <input type="checkbox"/>
		Impact Category: 1 2 3 4 5	<input type="checkbox"/> <input checked="" type="checkbox"/> <input type="checkbox"/> <input type="checkbox"/> <input type="checkbox"/>
Location: Unit 6 – Exterior	Auditors Comments: <ul style="list-style-type: none"> Cracking continuing mentioned in previous Item.

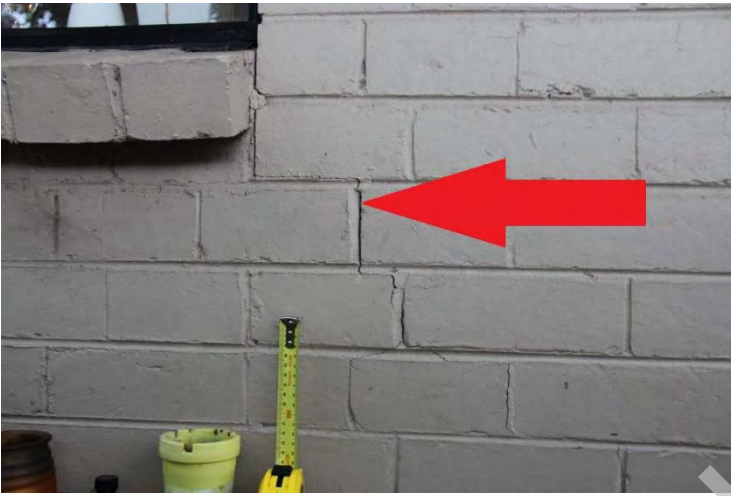
Item	Photographic Evidence	Assessments	
132.

Assessment Type: Good Fair Poor	<input type="checkbox"/> <input checked="" type="checkbox"/> <input type="checkbox"/>
		Impact Category: 1 2 3 4 5	<input type="checkbox"/> <input checked="" type="checkbox"/> <input type="checkbox"/> <input type="checkbox"/> <input type="checkbox"/>
Location: Unit 6 – Exterior	Auditors Comments: <ul style="list-style-type: none"> Cracking near bottom right-hand side of door frame. Approx. 1mm.

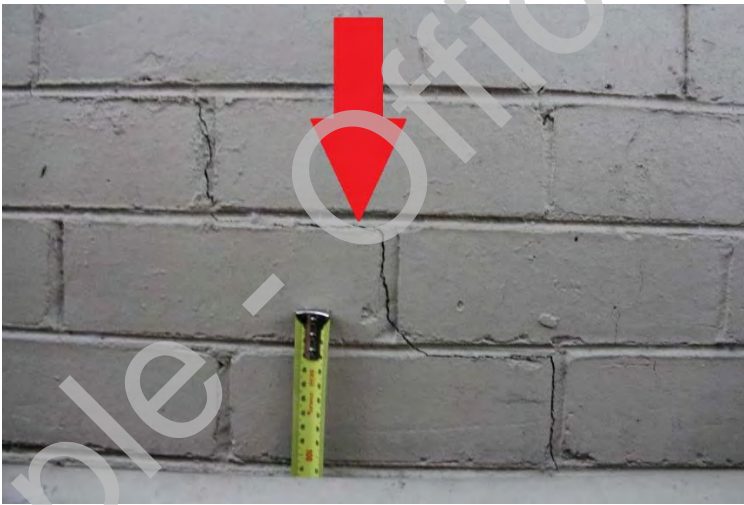
133.

Assessment Type: Good Fair Poor	<input type="checkbox"/> <input checked="" type="checkbox"/> <input type="checkbox"/>
		Impact Category: 1 2 3 4 5	<input type="checkbox"/> <input checked="" type="checkbox"/> <input type="checkbox"/> <input type="checkbox"/> <input type="checkbox"/>
Location: Unit 6 – Exterior	Auditors Comments: <ul style="list-style-type: none"> Cracking to bottom right-hand side of window frame. Approx. 1mm.

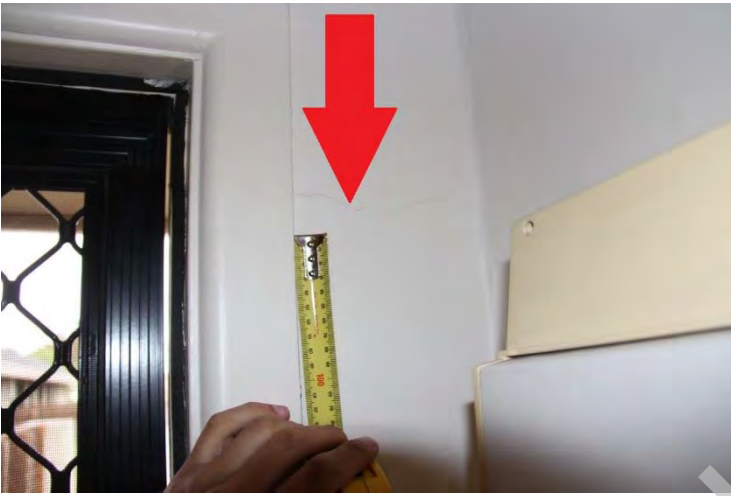
Item	Photographic Evidence	Assessments	
134.

Assessment Type: Good Fair Poor	<input type="checkbox"/> <input checked="" type="checkbox"/> <input type="checkbox"/>
		Impact Category: 1 2 3 4 5	<input type="checkbox"/> <input checked="" type="checkbox"/> <input type="checkbox"/> <input type="checkbox"/> <input type="checkbox"/>
Location: Unit 6 – Exterior	Auditors Comments: <ul style="list-style-type: none"> Cracking near small water utility pipe. Approx. 1mm.

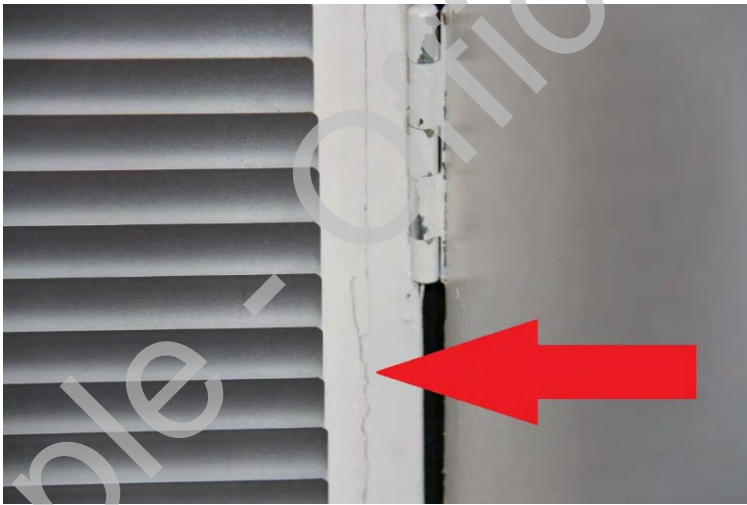
135.

Assessment Type: Good Fair Poor	<input type="checkbox"/> <input checked="" type="checkbox"/> <input type="checkbox"/>
		Impact Category: 1 2 3 4 5	<input checked="" type="checkbox"/> <input type="checkbox"/> <input type="checkbox"/> <input type="checkbox"/> <input type="checkbox"/>
Location: Unit 6 – Interior	Auditors Comments: <ul style="list-style-type: none"> Fine crack to right of entrance doorframe. Approx. 0.5mm.

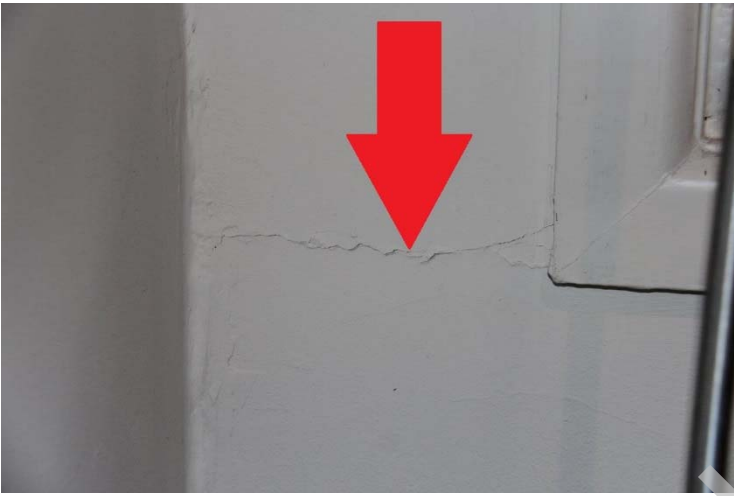
Item	Photographic Evidence	Assessments	
136.

Assessment Type: Good Fair Poor	<input type="checkbox"/> <input checked="" type="checkbox"/> <input type="checkbox"/>
		Impact Category: 1 2 3 4 5	<input checked="" type="checkbox"/> <input type="checkbox"/> <input type="checkbox"/> <input type="checkbox"/> <input type="checkbox"/>
Location: Unit 6 – Interior	Auditors Comments: <ul style="list-style-type: none"> Fine crack to left of entrance doorframe. Approx. 0.5mm.

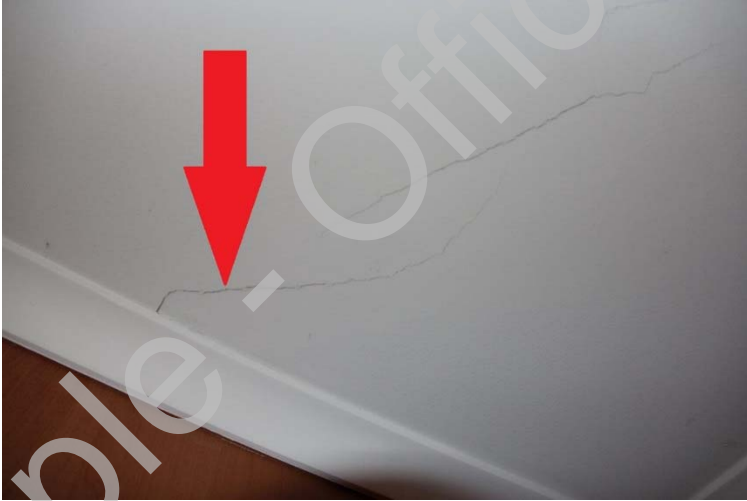
137.

Assessment Type: Good Fair Poor	<input type="checkbox"/> <input checked="" type="checkbox"/> <input type="checkbox"/>
		Impact Category: 1 2 3 4 5	<input checked="" type="checkbox"/> <input type="checkbox"/> <input type="checkbox"/> <input type="checkbox"/> <input type="checkbox"/>
Location: Unit 6 – Interior, lounge	Auditors Comments: <ul style="list-style-type: none"> Fine crack to left of western window frame. Approx. 0.5mm.

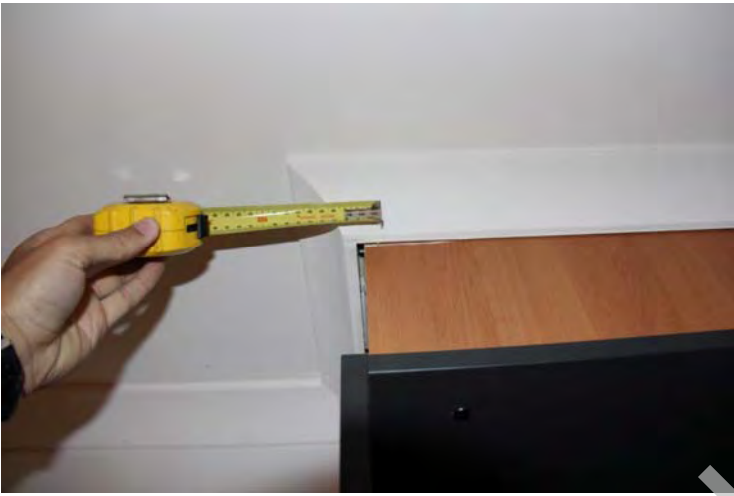
Item	Photographic Evidence	Assessments	
138.

Assessment Type: Good Fair Poor	<input type="checkbox"/> <input checked="" type="checkbox"/> <input type="checkbox"/>
		Impact Category: 1 2 3 4 5	<input type="checkbox"/> <input checked="" type="checkbox"/> <input type="checkbox"/> <input type="checkbox"/> <input type="checkbox"/>
Location: Unit 6 – Kitchen	Auditors Comments: <ul style="list-style-type: none"> Cracking of ceiling to eastern corner of kitchen. Approx. 1mm.

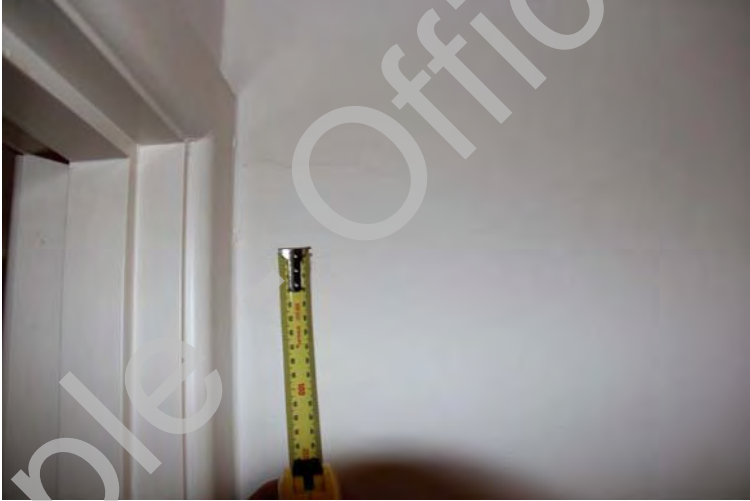
Assessment Type: Good Fair Poor	<input type="checkbox"/> <input checked="" type="checkbox"/> <input type="checkbox"/>
		Impact Category: 1 2 3 4 5	<input type="checkbox"/> <input checked="" type="checkbox"/> <input type="checkbox"/> <input type="checkbox"/> <input type="checkbox"/>
Location: Unit 6 – Interior, kitchen	Auditors Comments: <ul style="list-style-type: none"> Gap is skirting. Approx. 3-5mm. 		
139.

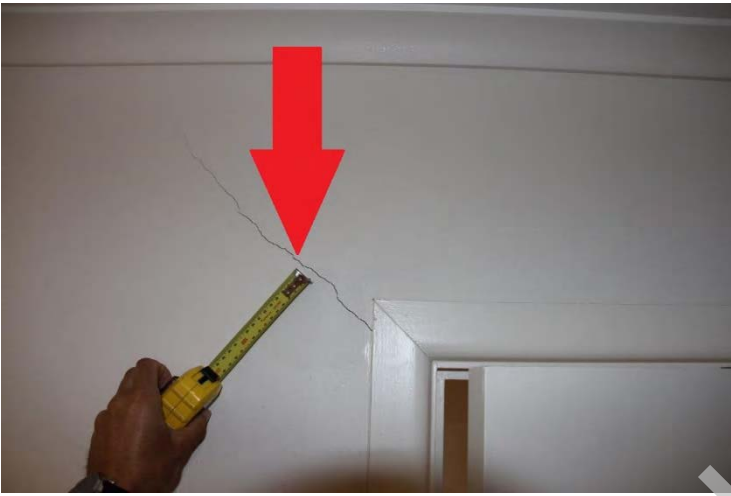
Item	Photographic Evidence	Assessments	
140.

Assessment Type: Good Fair Poor	<input type="checkbox"/> <input checked="" type="checkbox"/> <input type="checkbox"/>
		Impact Category: 1 2 3 4 5	<input checked="" type="checkbox"/> <input type="checkbox"/> <input type="checkbox"/> <input type="checkbox"/> <input type="checkbox"/>
Location: Unit 6 – Bedroom	Auditors Comments: <ul style="list-style-type: none"> Fine crack to right of bedroom doorway. Approx. 0.2-0.5mm.

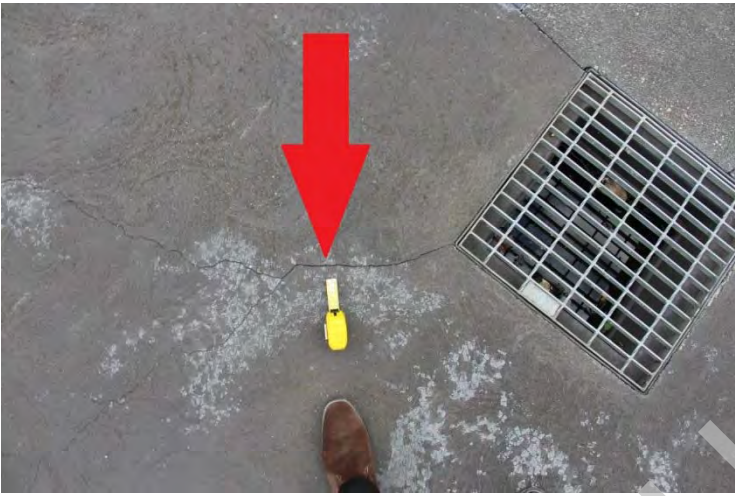
Item	Photographic Evidence	Assessments	
143.

Assessment Type: Good <input type="checkbox"/> Fair <input checked="" type="checkbox"/> Poor <input type="checkbox"/>	<input type="checkbox"/> <input checked="" type="checkbox"/> <input type="checkbox"/>
		Impact Category: 1 <input type="checkbox"/> 2 <input checked="" type="checkbox"/> 3 <input type="checkbox"/> 4 <input type="checkbox"/> 5 <input type="checkbox"/>	<input type="checkbox"/> <input checked="" type="checkbox"/> <input type="checkbox"/> <input type="checkbox"/> <input type="checkbox"/>
Location: Driveway	Auditors Comments: <ul style="list-style-type: none"> Extensive cracking of the common driveway is present with long cracks ranging in width from <1mm up to 2mm. Please refer to "Property Photos" document for further evidence of current condition and other minor gaps and cracks between pillars, walls and the driveway.
