# Dilapidation Survey Report

1 Sample Street, Melbourne VIC 3022

9 March 2017

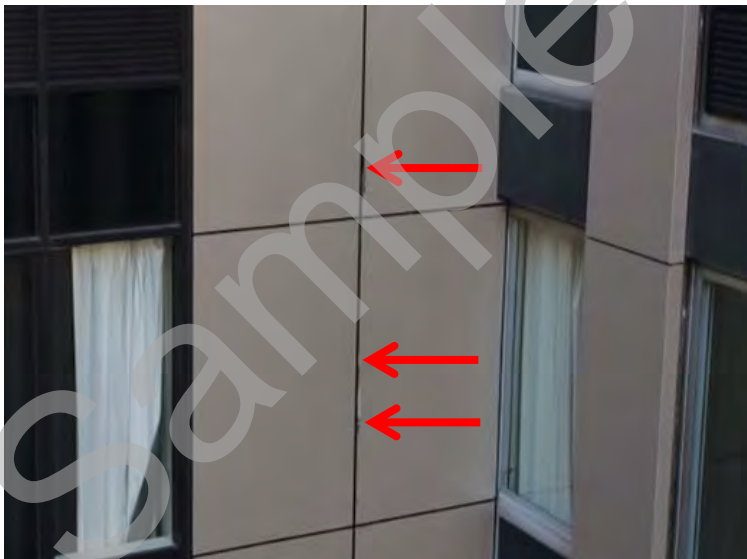
57.

<div> <b>Assessment Type:</b>             Good <input type="checkbox"/>            Fair <input checked="" type="checkbox"/>            Poor <input type="checkbox"/> </div> <div> <b>Impact Category:</b>             1 <input checked="" type="checkbox"/>            2 <input type="checkbox"/>            3 <input type="checkbox"/>            4 <input type="checkbox"/>            5 <input type="checkbox"/> </div>
<b>Location:</b> West Façade – Levels 5 & 6	<b>Auditors Comments:</b> <ul style="list-style-type: none"> <li>Aluminium panels that are situated at the corner of both level 5 and 6 had dents and was slightly damaged.</li> </ul>
