## Detailed Windows Inspection

49 Sample Road Melbourne VIC 3122

## Part 2: Detailed Windows Inspection

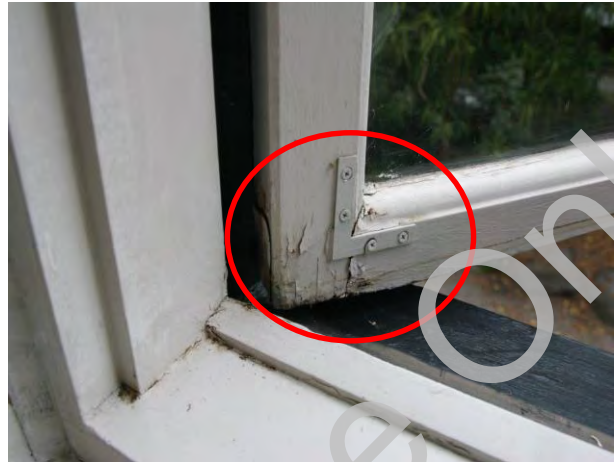
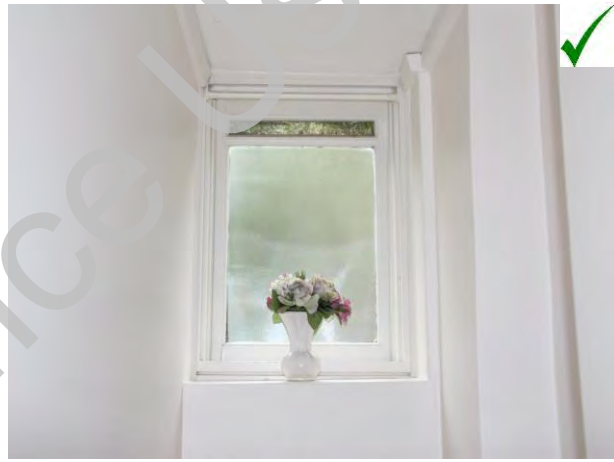
Location	Inspection Notes
Kitchen	Replace window sash. Patch and paint window frame.
Dining	Prepare and paint entire window frame, sash and sill.
Living	Good condition. No action required.
Bedroom 1	Replace entire sash as it is falling apart, 'L' brackets have been used to hold the sash in place. Prepare and paint window frame.
Toilet	Good condition. No action required.
Bathroom	Replace glazing as it has cracked above the exhaust fan.
Bedroom 2	Replace window stays as it is not opening/closing properly.

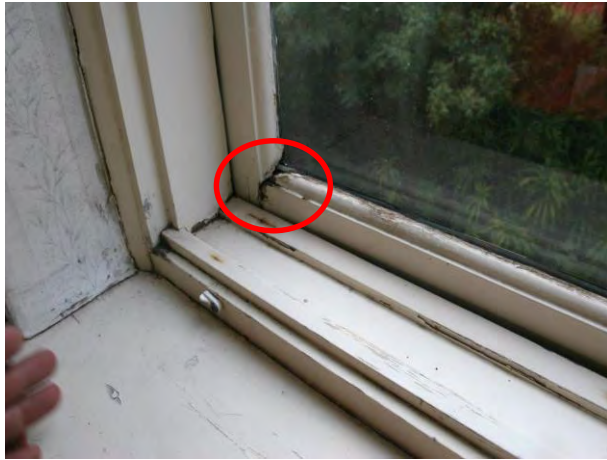
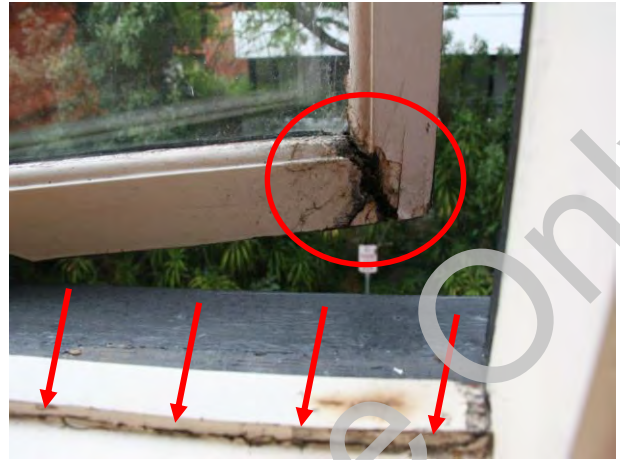
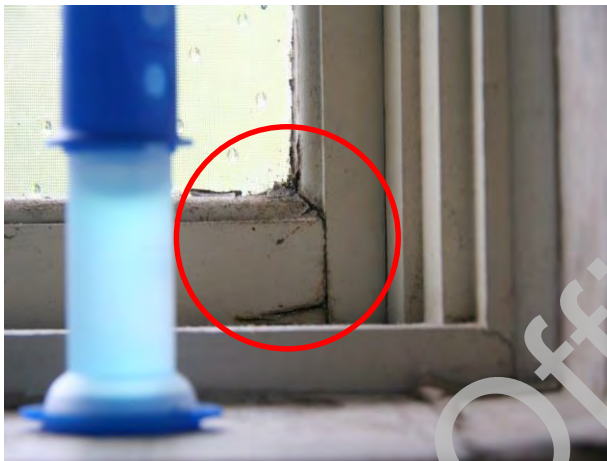
## Unit 9

Location	Inspection Notes
Kitchen	Replace window sash as the seal around the glazing has deteriorated and the sash is cracked. Prepare and paint window frame.
Dining	Replace entire window sash, frame & glazing as they have deteriorated beyond repair.
Living	Replace door hardware.
Bedroom 1	Replace entire window sash, frame & glazing as they have deteriorated beyond repair.
Toilet	Replace window sash. Prepare and paint frame.
Bathroom	Replace window sash. Prepare and paint frame.
Bedroom 2	Replace entire window sash, frame & glazing as they have deteriorated beyond repair.

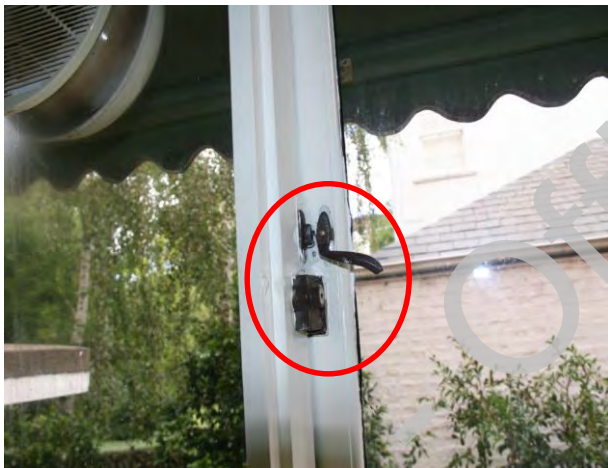
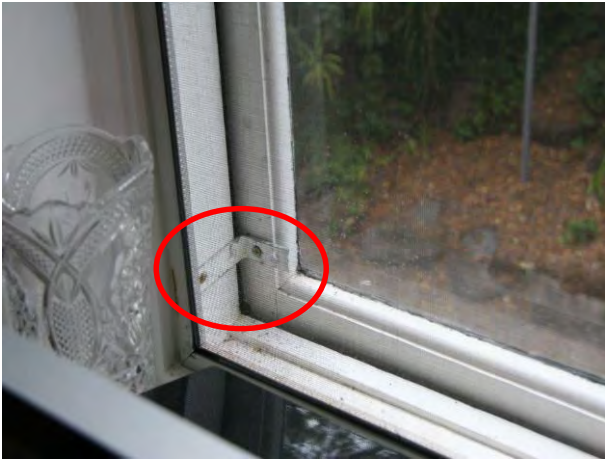
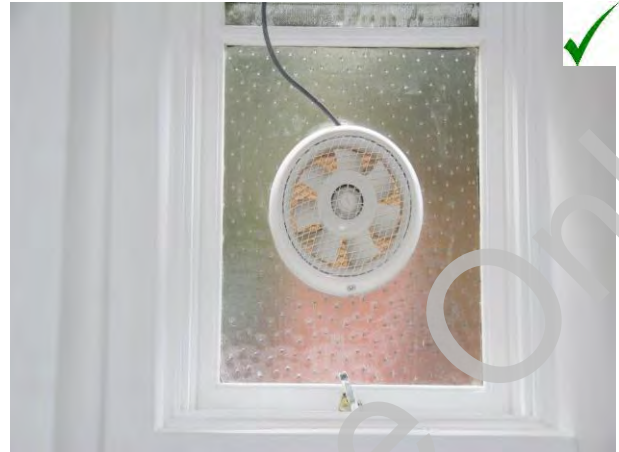
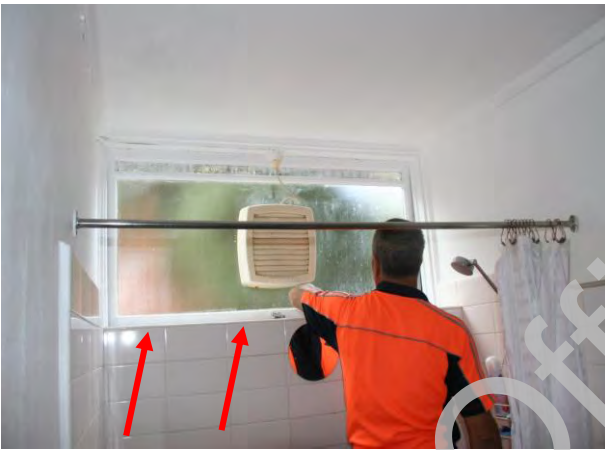
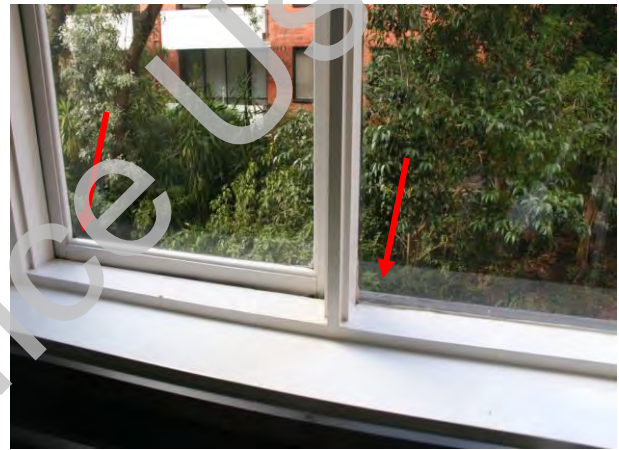
## Unit 2

Location	Inspection Notes
Kitchen	Replace window stays as the window does not open and has been screwed shut. A make safe was undertaken to screw the window shut as it was not secured properly. Patch and paint affected areas after replacement.
Bedroom 1	Replace external window sill.
Living	Good condition. No action required.
Bedroom 2	Replace window stays as the window does not open and has been screwed shut. A make safe was undertaken to screw the window shut as it was not secured properly. Patch and paint affected areas after replacement.
Toilet	Good condition. No action required.
Bathroom	Requires the window sash to be planed down as the window doesn't close properly. Patch and paint affected areas after replacement.
Bedroom 3	Replace window sash. Prepare and paint window frame and external sill.

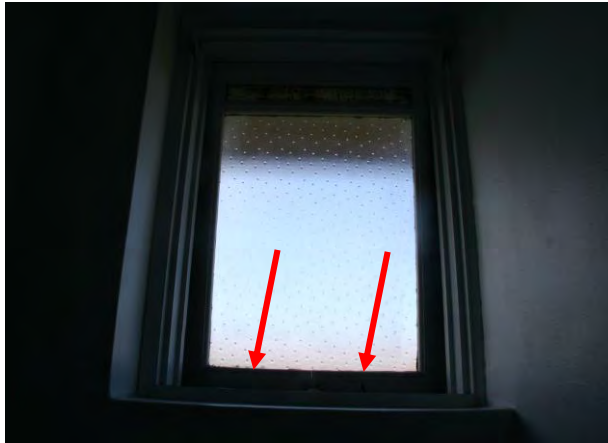
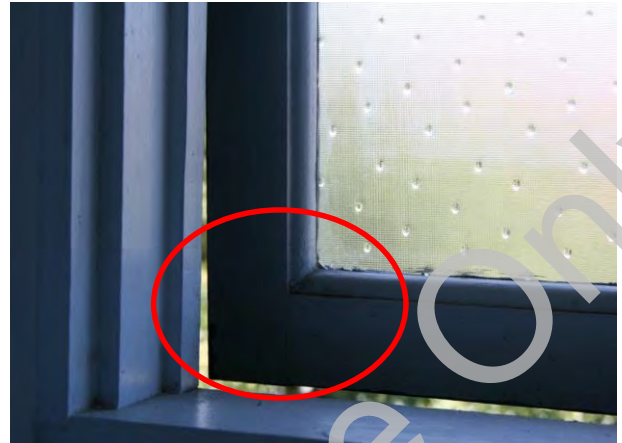
## Unit 6

Location	Inspection Notes
Kitchen	Good condition. No action required.
Dining	Prepare and paint window sash.
Living	Good condition. No action required.
Bedroom 1	Prepare and paint window frame.
Toilet	Prepare and paint window sash.
Bathroom	Replace window glazing to include an exhaust fan.
Bedroom 2	Prepare and paint window sash.

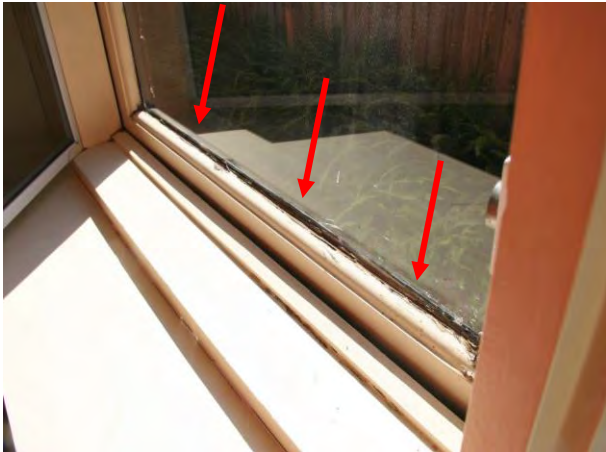
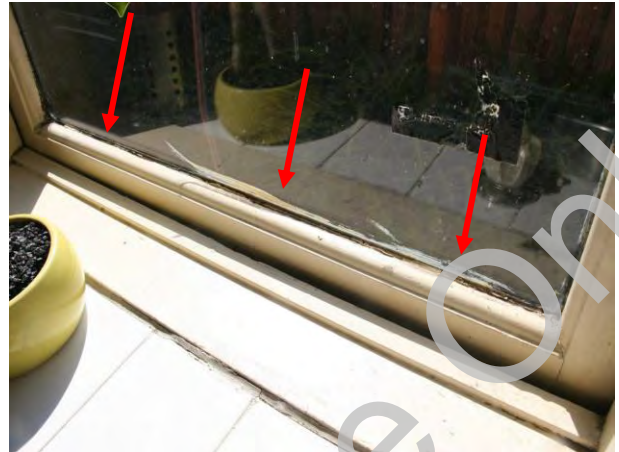
## Unit 13

Location	Inspection Notes
Bedroom 1	Replace window sash as it has completely deteriorated. Prepare and paint window frame.
Living	Good condition. No action required.
Dining	Prepare and paint window frame.
Kitchen	Replace window seal. Prepare and paint window sash.
Bedroom 2	Replace window sash. Prepare and paint external sill.
Toilet	Good condition. No action required.
Bathroom	Replace window chain. When the window is closed it does not open again. Prepare and paint window sash and frame.

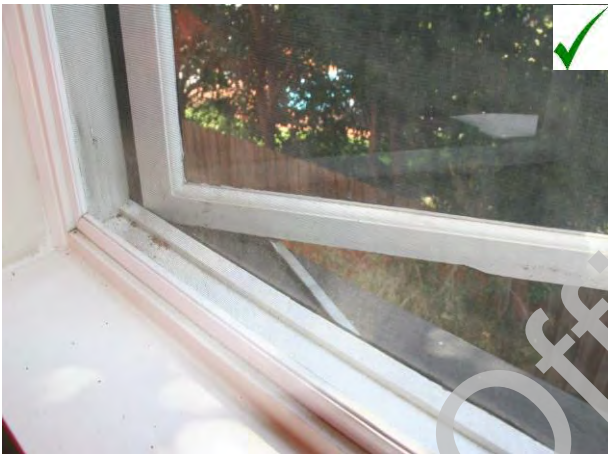
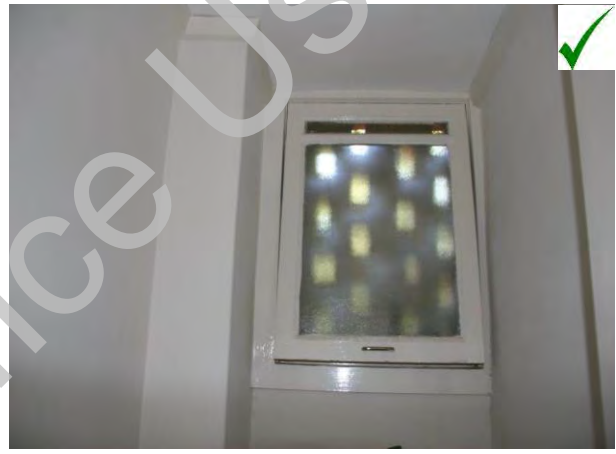
## Unit 14

Location	Inspection Notes
Bedroom 1	Replace window sash as is has completely deteriorated.
Living	Good condition. No action required.
Dining	Prepare and paint window sash.
Kitchen	Replace window sash and ventilation mesh at the top of the window. Prepare and paint external sill.
Bedroom 2	Good condition. No action required.
Toilet	Good condition. No action required.
Bathroom	Replace window sash as it has completely deteriorated. Prepare and paint window frame.

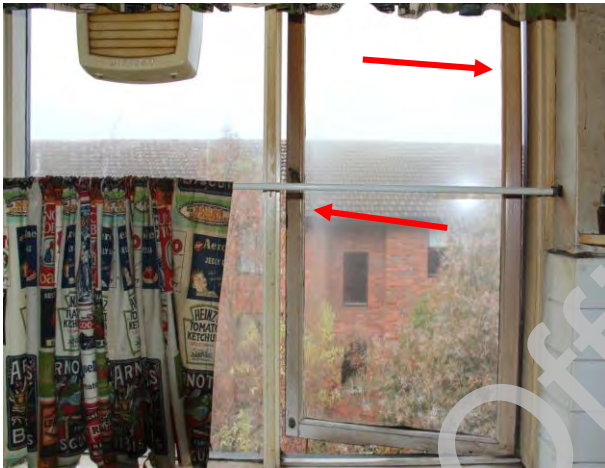
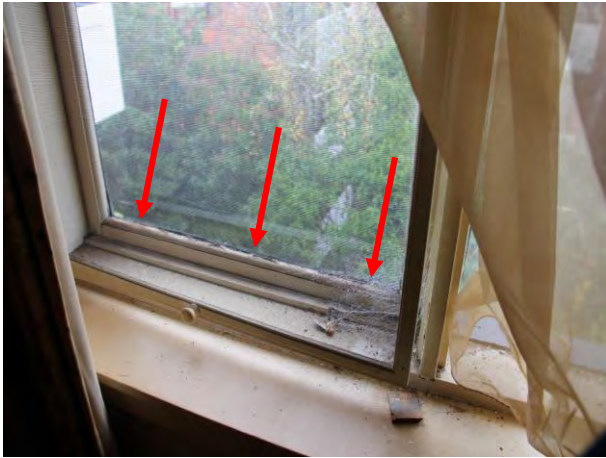
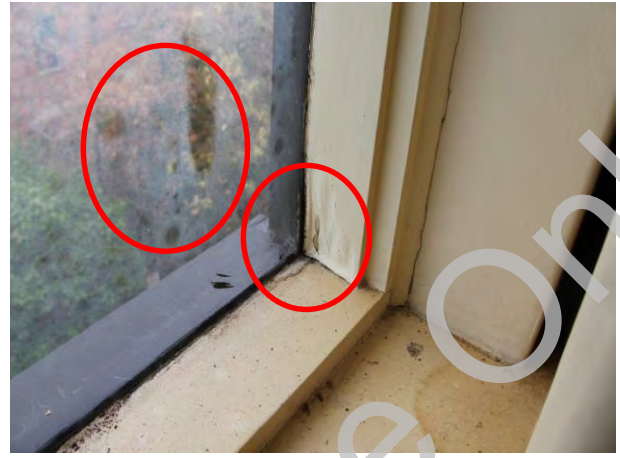
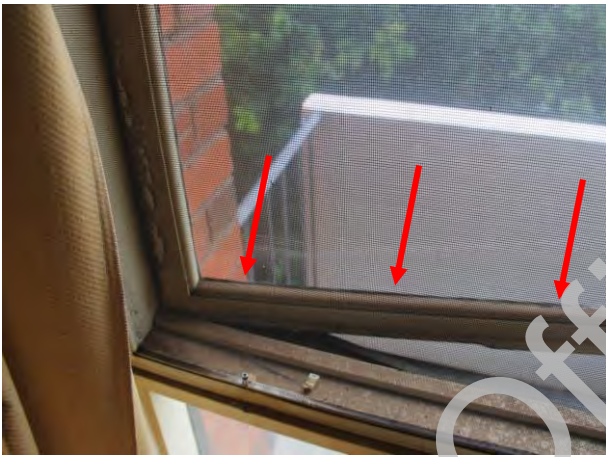
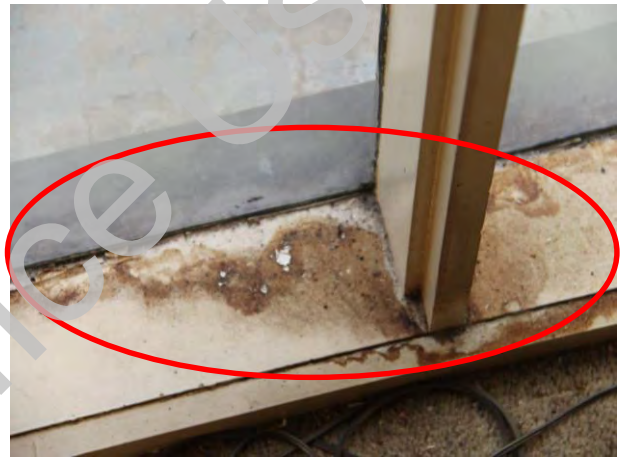
## Unit 12

Location	Inspection Notes
Kitchen	Replace entire window frame, sash and glazing as they have completely deteriorated.
Bathroom	Replace window sash. Prepare and paint window frame.
Toilet	Prepare & paint window frame and sash.
Bedroom 1	Replace entire window frame, sash and glazing as they have completely deteriorated.
Living	Replace window sash. Prepare and paint entire window frame. Replace seals around glazing as they have deteriorated.
Bedroom 2	Replace window sash. Prepare and paint window frame.

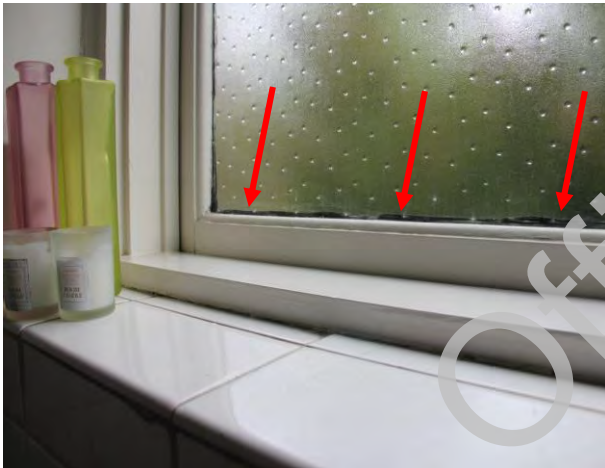
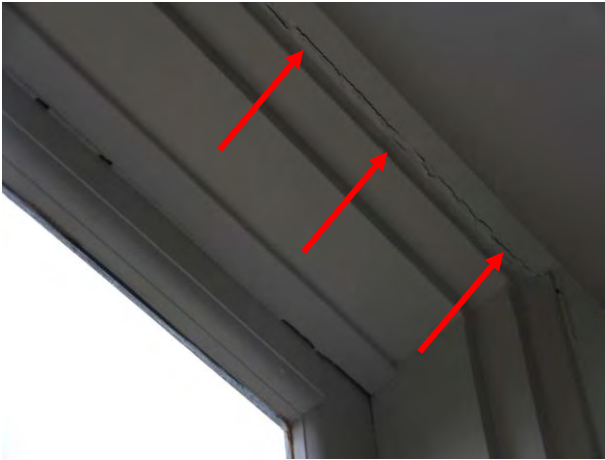
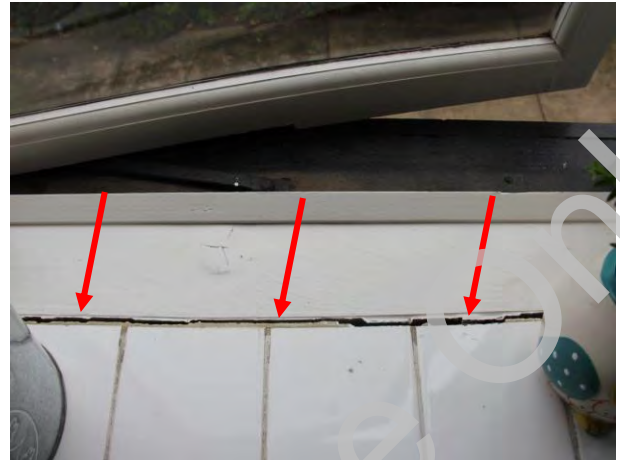
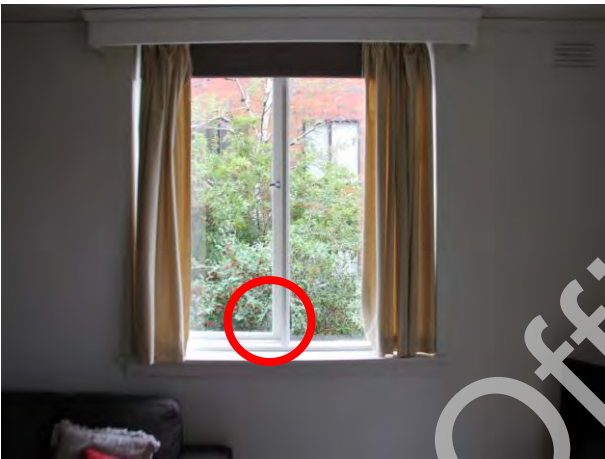
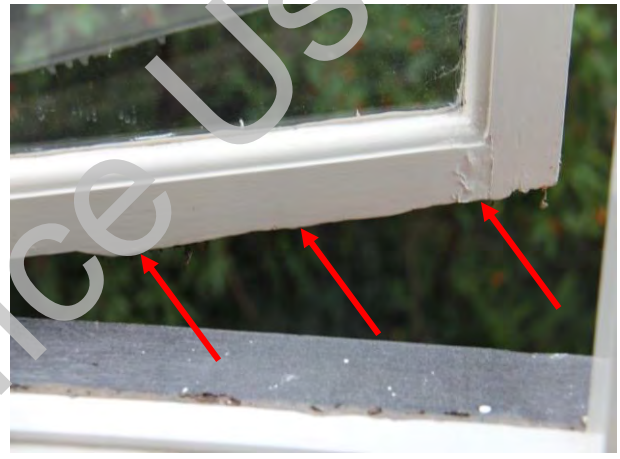
## Unit 1

Location	Inspection Notes
Bathroom	Replace seal around glazing.
Toilet	Replace ventilation mesh above the glazing.
Bedroom 1	Two windows: Replace window sash and hardware on north-facing window. Prepare and paint all other window frames and sash.
Kitchen	Re-seal crack between window frame and kitchen tiles. Prepare and paint after repairs are completed.
Living	Two windows: Replace door hardware and door sash on right hand side of west facing windows. Replace window sash on south face.
Bedroom 2	Replace and re-seal glazing as the glazing has dropped approx. 25mm out of the sash.

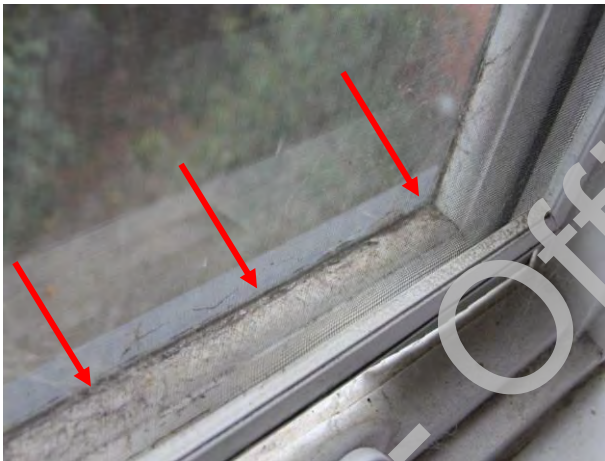
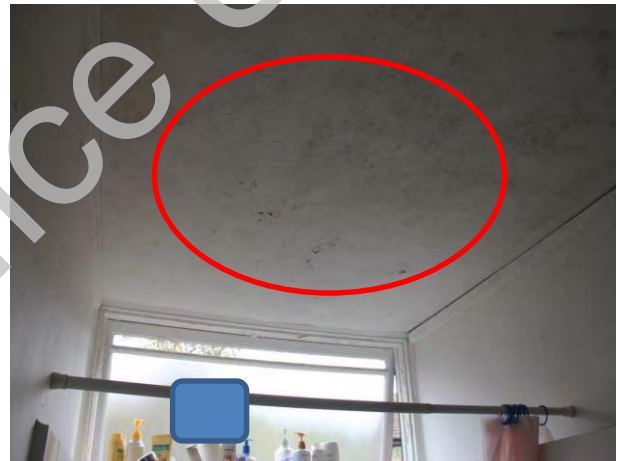
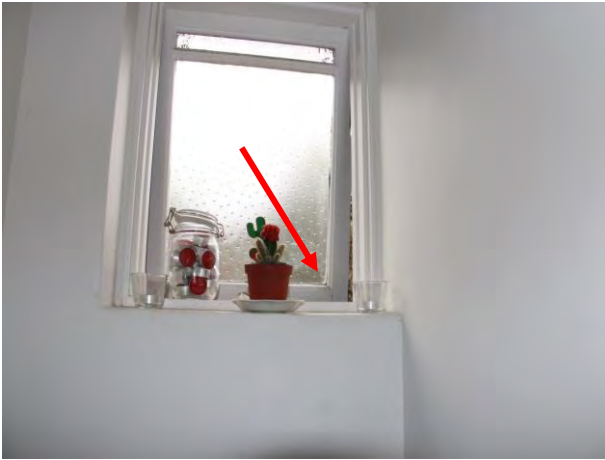
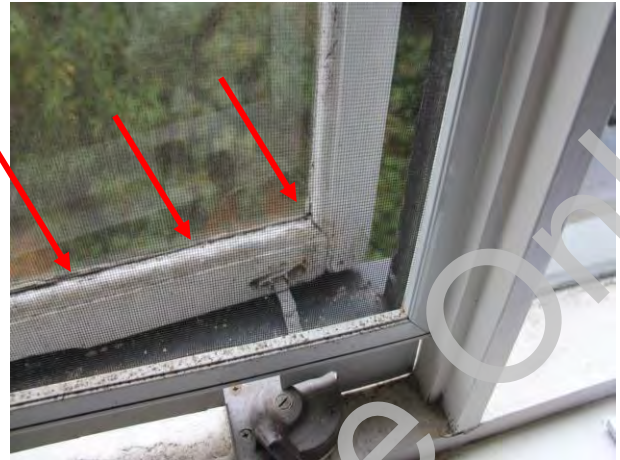
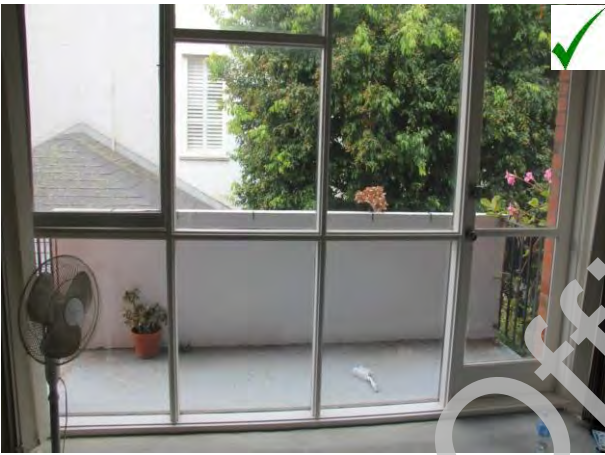
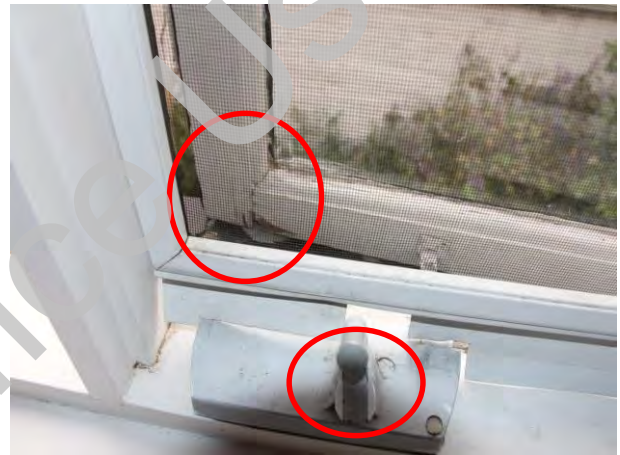
## Unit 4

Location	Inspection Notes
Bedroom 1	Prepare and paint window frame and sash.
Bathroom	Replace window frame and sash. Replace glazing to include an exhaust fan as the ceiling has been damaged by condensation.
Toilet	Replace window sash. Prepare and paint window frame.
Bedroom 2	Replace window sash. Prepare and paint window frame.
Living/Bedroom 3	Good condition. No action required.
Lounge	Replace window sash, external sill and window chain.
Kitchen	Replace window sash and external sill. Replace exhaust fan as it is not working and will eventually cause damage to the ceiling (similar to the bathroom)

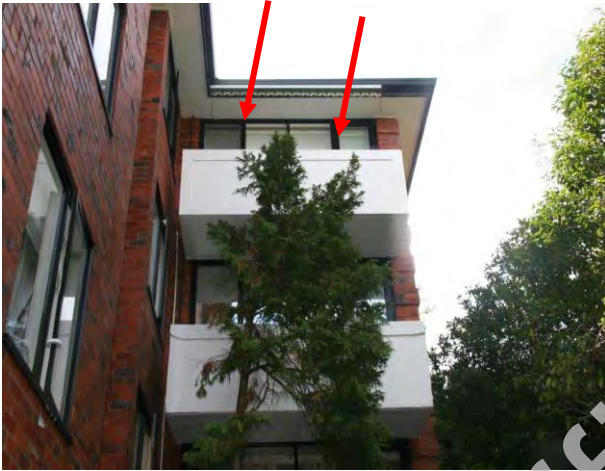
## Unit 15

Location	Inspection Notes
Living	Replace the window frame with a new PVC window frame as the existing frame has deteriorated due to water damage.
Bedroom 1	Good condition. No action required.
Kitchen	Good condition. No action required.

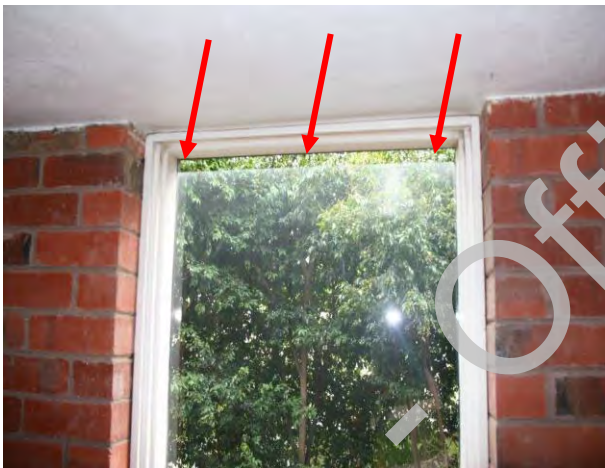
## Common Areas

Location	Inspection Notes:
	NB: These are general findings about the common areas in the building and are not specific to any location.
Window Frame	The majority of the window frames in the common areas require replacement as they have deteriorated. A minority have paint damage and require preparing and painting.
Window Glazing	A majority of the windows glazing have dropped by up to 50mm, this can be attributed to a poor window seal and need to be replaced as water ingress will cause further damage to the window frames.
Glazing Seal	As mentioned above, the glazing seal has deteriorated on all windows and will require replacement to mitigate further damages.
Common Doors	All common doors require preparation and painting to maintain the aesthetics of the building. Roscon recommends to plane the latch edge of the doors prior to painting as it was found that the doors fit too tightly in the frame and has been scratched on the latch edge.
