## Occupational Health & Safety Report

1 Sample Street, Melbourne VIC 3022 Sample Only (PS 123456 - OC1 only)

13 December 2016

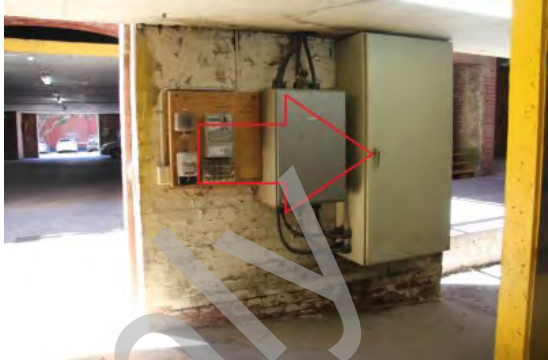
Item	Details	Photo
<p>#17</p> <p>Quote <input type="checkbox"/></p> <p>Proceed <input type="checkbox"/></p> <p>No Action <input type="checkbox"/></p>	<p><b>Risk Assessment:</b></p> <ul style="list-style-type: none"> <li><input type="checkbox"/> Maintenance Required</li> <li><input checked="" type="checkbox"/> Risk Of Injury</li> <li><input type="checkbox"/> Risk Of Serious Injury</li> <li><input type="checkbox"/> Risk Of Death</li> </ul> <p><b>Location:</b> Main Switchboard - northern boundary.</p> <p><b>Auditor's Finding:</b> 'MAIN SWITCHBOARD' is prone for tampering</p> <p><b>Auditor's Recommendation:</b> It is recommended that a standard power industry lock be installed for the cabinet to prevent unauthorised access.</p>

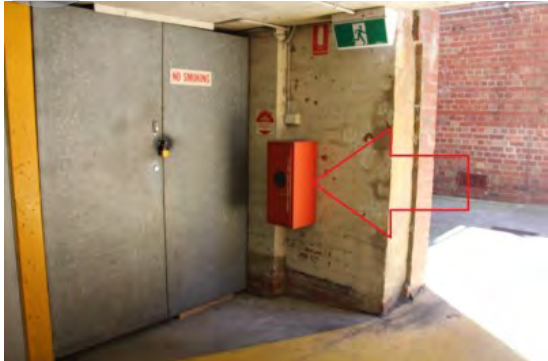
<p>#18</p> <p>Quote <input type="checkbox"/></p> <p>Proceed <input type="checkbox"/></p> <p>No Action <input type="checkbox"/></p>	<p><b>Risk Assessment:</b></p> <ul style="list-style-type: none"> <li><input type="checkbox"/> Maintenance Required</li> <li><input type="checkbox"/> Risk Of Injury</li> <li><input checked="" type="checkbox"/> Risk Of Serious Injury</li> <li><input type="checkbox"/> Risk Of Death</li> </ul> <p><b>Location:</b> Main Switchboard - northern boundary.</p> <p><b>Auditor's Finding:</b> No 003 keys provided for occupants to access the fire extinguisher in times of emergency.</p> <p><b>Auditor's Recommendation:</b> It is recommended that a 003 key be kept on site in a safe break glass case to be used to access the fire extinguisher in times of emergency.</p>

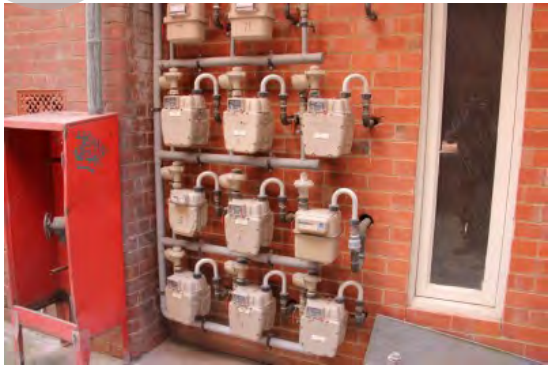
<p>#22</p> <p>Quote <input type="checkbox"/></p> <p>Proceed <input type="checkbox"/></p> <p>No Action <input type="checkbox"/></p>	<p><b>Risk Assessment:</b></p> <ul style="list-style-type: none"> <li><input checked="" type="checkbox"/> Maintenance Required</li> <li><input type="checkbox"/> Risk Of Injury</li> <li><input type="checkbox"/> Risk Of Serious Injury</li> <li><input type="checkbox"/> Risk Of Death</li> </ul> <p><b>Location:</b> Central Walkway</p> <p><b>Auditor's Finding:</b> Gas meters have no existing lock and are prone to tampering by unauthorised personnel.</p> <p><b>Auditor's Recommendation:</b> Engage a suitably qualified contractor to secure the area by installing a cage and standard industry pad locks as a measure to prevent unauthorised tampering.</p>

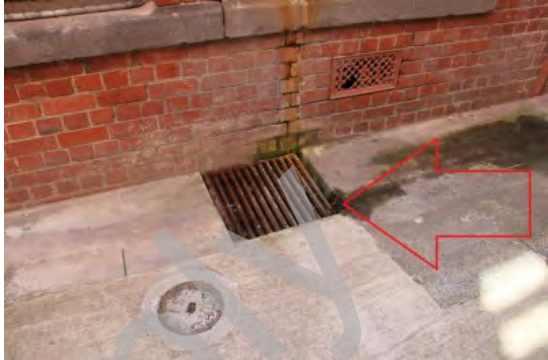
Item	Details	Photo
<p>#23</p> <p>Quote <input type="checkbox"/></p> <p>Proceed <input type="checkbox"/></p> <p>No Action <input type="checkbox"/></p>	<p><b>Risk Assessment:</b></p> <ul style="list-style-type: none"> <li><input type="checkbox"/> Maintenance Required</li> <li><input checked="" type="checkbox"/> Risk Of Injury</li> <li><input type="checkbox"/> Risk Of Serious Injury</li> <li><input type="checkbox"/> Risk Of Death</li> </ul> <p><b>Location:</b> Central Walkway - storm water grate adjacent Lot PT16A.</p> <p><b>Auditor's Finding:</b> Storm water grate is not flush with the finished floor level and is a trip hazard.</p> <p><b>Auditor's Recommendation:</b> Engage a suitably qualified concreter to reinstall the grate to finish flush with floor level to minimise risk of injury.</p>

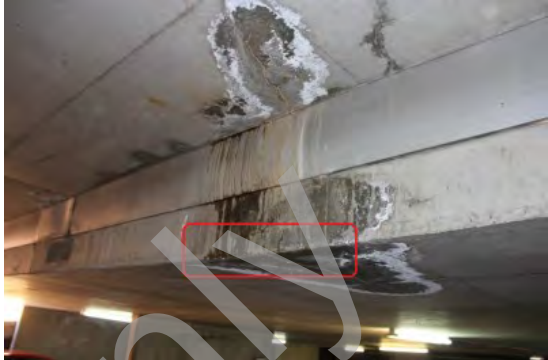
Item	Details	Photo
<p>#27</p> <p>Quote <input type="checkbox"/></p> <p>Proceed <input type="checkbox"/></p> <p>No Action <input type="checkbox"/></p>	<p><b>Risk Assessment:</b></p> <ul style="list-style-type: none"> <li><input type="checkbox"/> Maintenance Required</li> <li><input checked="" type="checkbox"/> Risk Of Injury</li> <li><input type="checkbox"/> Risk Of Serious Injury</li> <li><input type="checkbox"/> Risk Of Death</li> </ul> <p><b>Location:</b> 1st level carpark adjacent car space 72.</p> <p><b>Auditor's Finding:</b> Current water ingress through slab causing water pooling and slip hazards in the carpark levels not to mention concrete cancer issues in the future.</p> <p><b>Auditor's Recommendation:</b> Address water ingress issues by a suitably qualified contractor.</p>

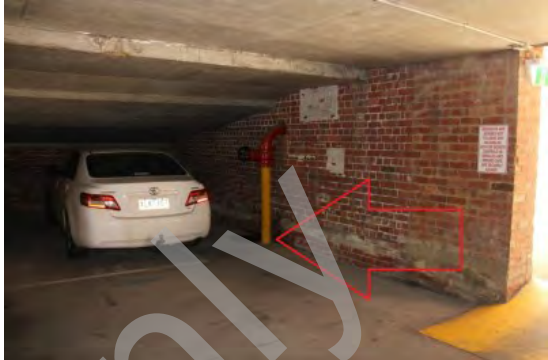
Item	Details	Photo
<p>#37</p> <p>Quote <input type="checkbox"/></p> <p>Proceed <input type="checkbox"/></p> <p>No Action <input type="checkbox"/></p>	<p><b>Risk Assessment:</b></p> <ul style="list-style-type: none"> <li><input type="checkbox"/> Maintenance Required</li> <li><input checked="" type="checkbox"/> Risk Of Injury</li> <li><input type="checkbox"/> Risk Of Serious Injury</li> <li><input type="checkbox"/> Risk Of Death</li> </ul> <p><b>Location:</b> Car space 23 on ground level.</p> <p><b>Auditor's Finding:</b> Fire services pipe is in risk of collision with vehicles.</p> <p><b>Auditor's Recommendation:</b> Engage contractor to install bollards to protect the service pipe.</p>

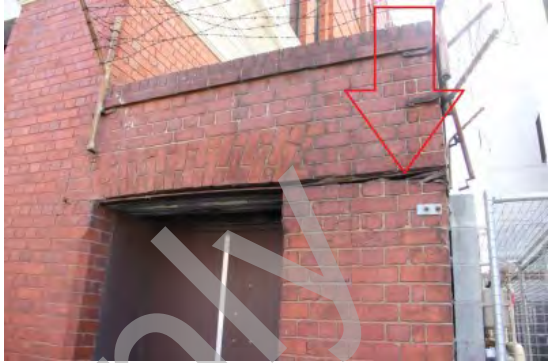
Item	Details	Photo
<p>#40</p> <p>Quote <input type="checkbox"/></p> <p>Proceed <input type="checkbox"/></p> <p>No Action <input type="checkbox"/></p>	<p><b>Risk Assessment:</b></p> <p><input checked="" type="checkbox"/> Maintenance Required  <input type="checkbox"/> Risk Of Injury  <input type="checkbox"/> Risk Of Serious Injury  <input type="checkbox"/> Risk Of Death</p> <p><b>Location:</b>            South-Western Boundary adjacent 22 Peel St Collingwood development.</p> <p><b>Auditor's Finding:</b>            In our opinion the structural integrity of the masonry is questionable with separation between masonry bricks and metal lintel over the doorway has occurred.</p> <p><b>Auditor's Recommendation:</b>            Engage a suitably qualified Structural Engineer to address the issue and take remedial action as required.</p>
