Occupational Health & Safety Report

1 Sample Street, Melbourne VIC 3022 (PS 123456 - OC1 only)

13 December 2016

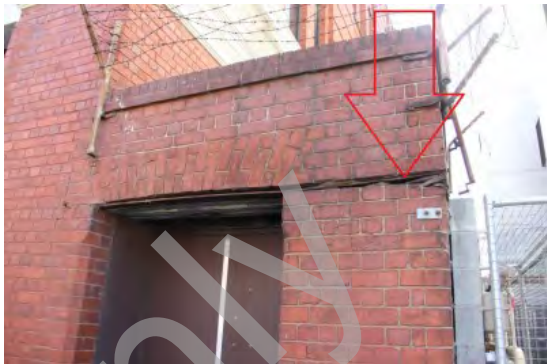
Item	Details	Photo
#40 Quote <input type="checkbox"/> Proceed <input type="checkbox"/> No Action <input type="checkbox"/>	<p>Risk Assessment:</p> <p><input checked="" type="checkbox"/> Maintenance Required</p> <p><input type="checkbox"/> Risk Of Injury</p> <p><input type="checkbox"/> Risk Of Serious Injury</p> <p><input type="checkbox"/> Risk Of Death</p> <p>Location: South-Western Boundary adjacent 22 Peel St Collingwood development.</p> <p>Auditor's Finding: In our opinion the structural integrity of the masonry is questionable with separation between masonry bricks and metal lintel over the doorway has occurred.</p> <p>Auditor's Recommendation: Engage a suitably qualified Structural Engineer to address the issue and take remedial action as required.</p>

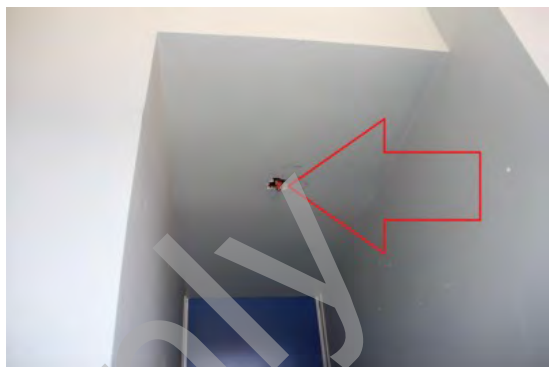
Item	Details	Photo
#42 Quote <input type="checkbox"/> Proceed <input type="checkbox"/> No Action <input type="checkbox"/>	<p>Risk Assessment:</p> <p><input type="checkbox"/> Maintenance Required</p> <p><input type="checkbox"/> Risk Of Injury</p> <p><input checked="" type="checkbox"/> Risk Of Serious Injury</p> <p><input type="checkbox"/> Risk Of Death</p> <p>Location: First Floor Common Area Walkway adjacent Northern boundary.</p> <p>Auditor's Finding: Sprinkler head servicing the area has been found to be made redundant.</p> <p>Auditor's Recommendation: Engage a suitably qualified fire sprinkler contractor to re-install the fire sprinkler servicing the area.</p>

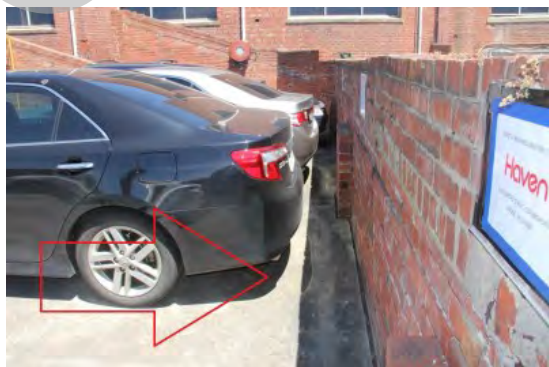
#43 Quote <input type="checkbox"/> Proceed <input type="checkbox"/> No Action <input type="checkbox"/>	<p>Risk Assessment:</p> <p><input type="checkbox"/> Maintenance Required</p> <p><input checked="" type="checkbox"/> Risk Of Injury</p> <p><input type="checkbox"/> Risk Of Serious Injury</p> <p><input type="checkbox"/> Risk Of Death</p> <p>Location: Car Park - topmost level</p> <p>Auditor's Finding: No wheel stops or bollards provided to prevent cars from impacting with masonry wall.</p> <p>Auditor's Recommendation: It is recommended that rubber wheel stops be installed to improve overall safety.</p>

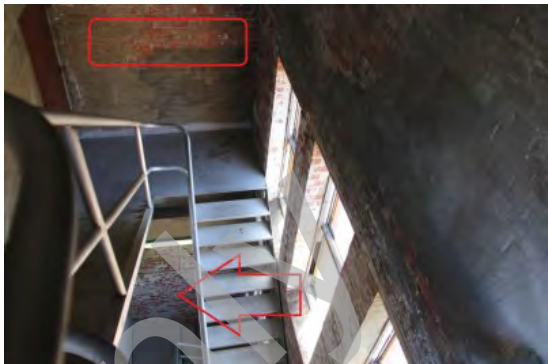
Item	Details	Photo
#44 Quote <input type="checkbox"/> Proceed <input type="checkbox"/> No Action <input type="checkbox"/>	<p>Risk Assessment:</p> <p><input type="checkbox"/> Maintenance Required</p> <p><input checked="" type="checkbox"/> Risk Of Injury</p> <p><input type="checkbox"/> Risk Of Serious Injury</p> <p><input type="checkbox"/> Risk Of Death</p> <p>Location: Fire exit stairwell</p> <p>Auditor's Finding: Once occupants enter the stairwell there are no more exit direction signage provided.</p> <p>Auditor's Recommendation: It is recommended to install a few exit signage in the stairwell to facilitate ease of egress during emergencies.</p>

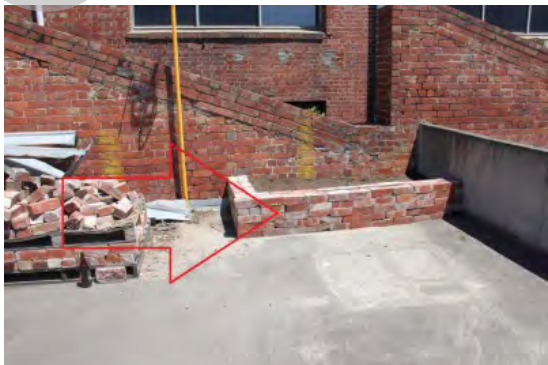
#45 Quote <input type="checkbox"/> Proceed <input type="checkbox"/> No Action <input type="checkbox"/>	<p>Risk Assessment:</p> <p><input checked="" type="checkbox"/> Maintenance Required</p> <p><input type="checkbox"/> Risk Of Injury</p> <p><input type="checkbox"/> Risk Of Serious Injury</p> <p><input type="checkbox"/> Risk Of Death</p> <p>Location: Planter box area on top most carpark level.</p> <p>Auditor's Finding: make shift planter box did not appear to be a solid structure and was not water proofed appropriately. This can cause water ingress issues and lead to deterioration of the slab.</p> <p>Auditor's Recommendation: Engage a suitably qualified contractor to remove the planter box from the area.</p>
