Main Switchboard Thermal Imaging Inspection & Report

183 Sample Road Suburb VIC 3004

12 October 2015

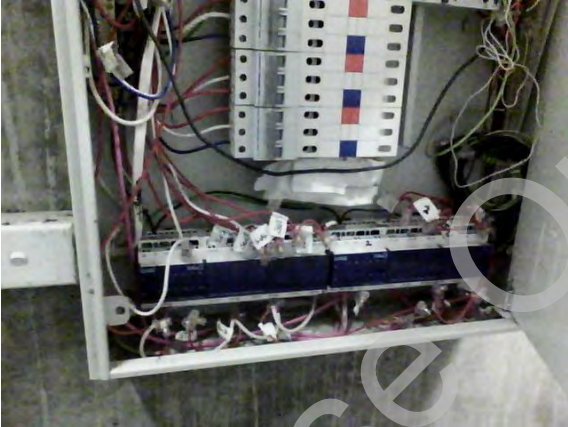
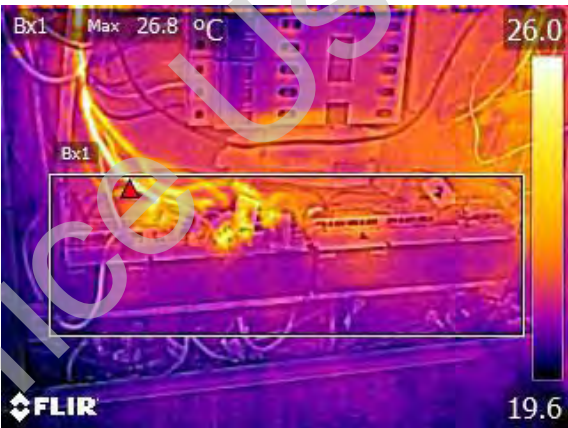
Details	Photographic Details
<p>Location: Distribution Board - Ground Level</p> <p>Finding: C-Bus2 relay units were not operational at the time of inspection.</p>

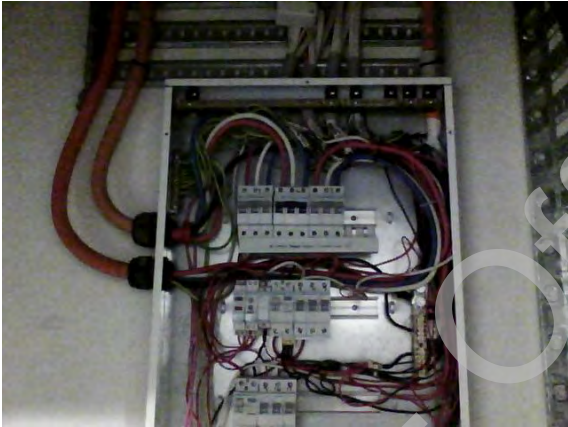
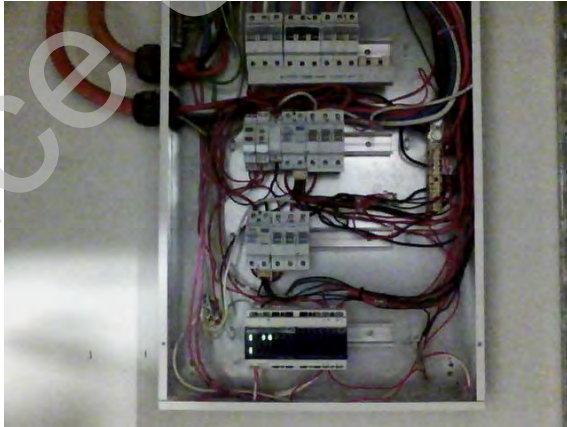
Details	Photographic Details
<p>Location: Distribution Board: Common Area – Level 8</p> <p>Finding: All isolators, circuit breakers, associated connections and wiring within the distribution board were observed to be operating within normal temperature conditions at the time of inspection.</p> <p>C-Bus2 relay unit was operational at the time of inspection and was operating within normal conditions.</p> <p>Note: Normal operating conditions are considered to be between ambient temperature and 70°C.</p>

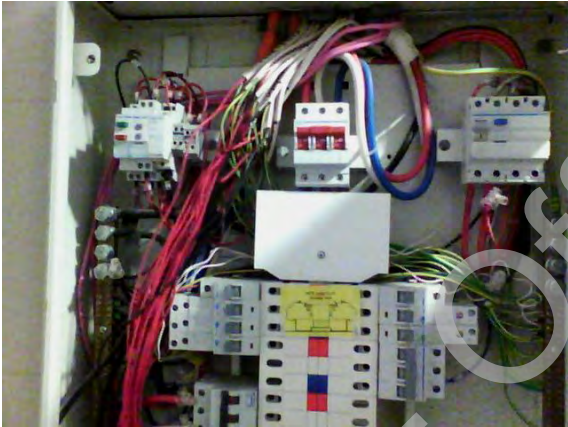
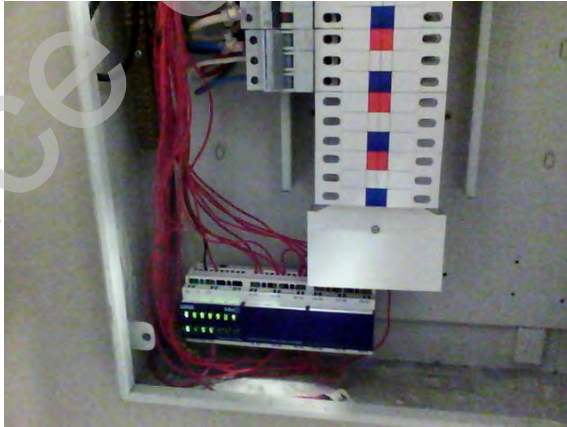
Details	Photographic Details
<p>Location: Distribution Board: Gym/Pool – Level 8</p> <p>Finding: All isolators, circuit breakers, associated connections and wiring within the distribution board were observed to be operating within normal temperature conditions at the time of inspection.</p> <p>C-Bus2 relay unit was operational at the time of inspection and was operating within normal conditions.</p> <p>Note: Normal operating conditions are considered to be between ambient temperature and 70°C.</p>

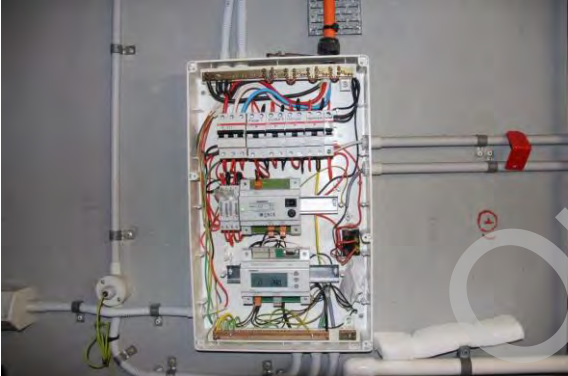
Details	Photographic Details
<p>Location: Distribution Board: Pool Plant Area– Level 8</p> <p>Finding: All isolating circuit breakers, associated connections and wiring within the distribution board were observed to be operating within normal temperature conditions at the time of inspection.</p> <p>Transformers are generally rated, as a minimum, to withstand a ~40°C temperature rise from ambient. This transformer was found to be operating at ~30°C above ambient temperature on the day of inspection, which is considered to be within a normal operating range.</p> <p>Controller, and associated wiring and connections, was found to be operating within a normal temperature range.</p>

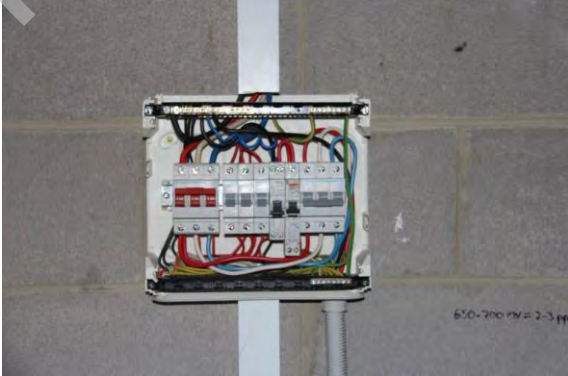
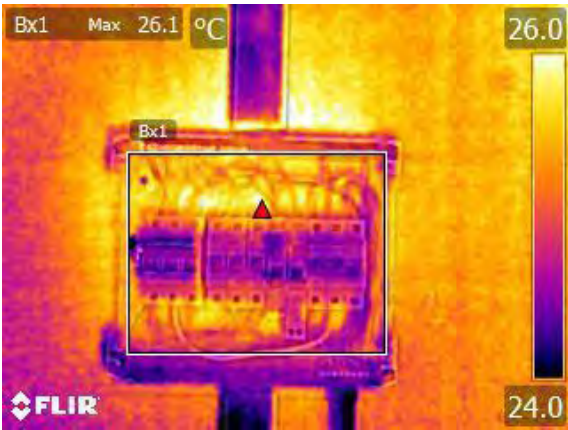
<p>Location: Isolation Panel: Pool Plant Area – Level 8</p> <p>Finding: All isolating circuit breakers, associated connections and wiring were observed to be operating within normal temperature conditions at the time of inspection.</p>

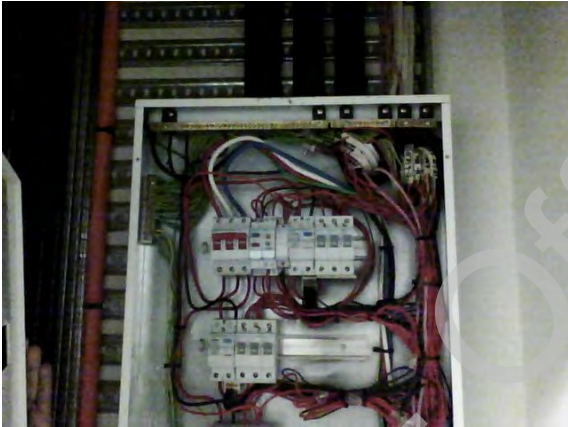
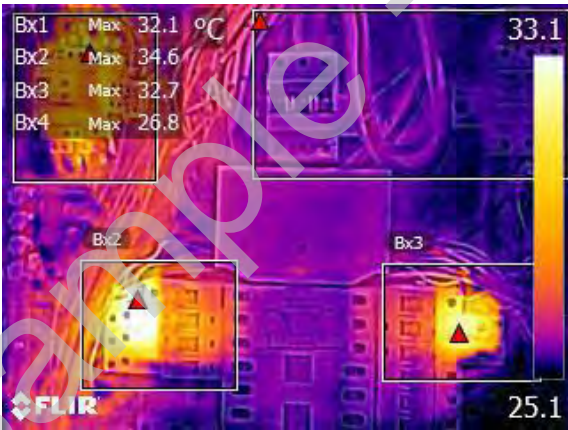
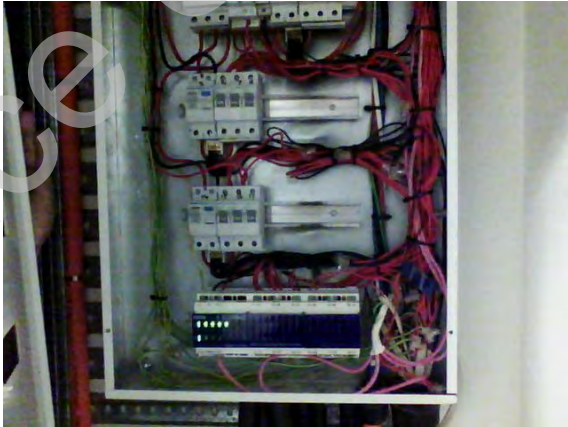
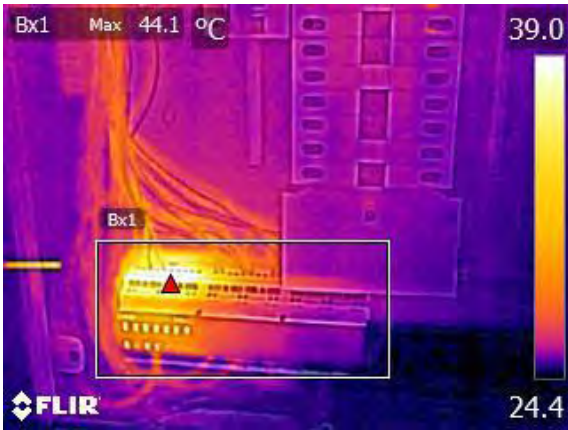
Details	Photographic Details
<p>Location: Distribution Board – Level 10</p> <p>Finding: All isolators, circuit breakers, associated connections and wiring within the distribution board were observed to be operating within normal temperature conditions at the time of inspection.</p> <p>C-Bus2 relay unit was operational at the time of inspection and was operating within normal conditions.</p> <p>Note: Normal operating conditions are considered to be between ambient temperature and 70°C.</p>

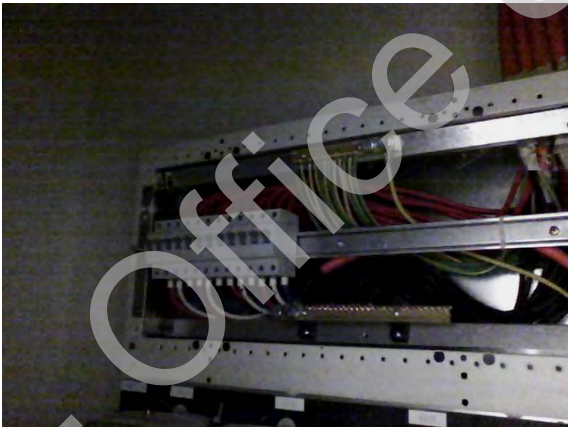
Details	Photographic Details
<p>Location: Tenancy Isolators – Level 10</p> <p>Finding: Isolating circuit breakers, and associated wiring and connections, were observed to be inoperative or operating within normal temperature conditions at the time of inspection.</p>

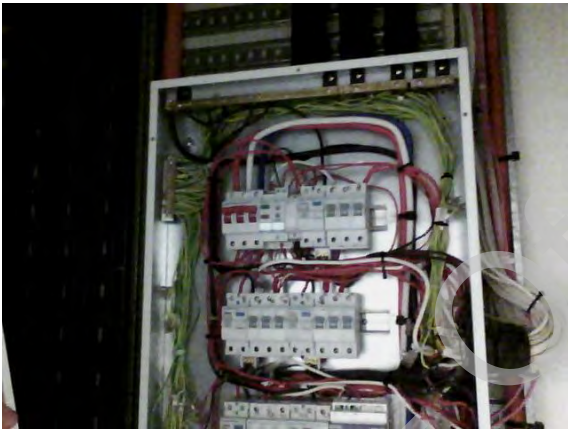
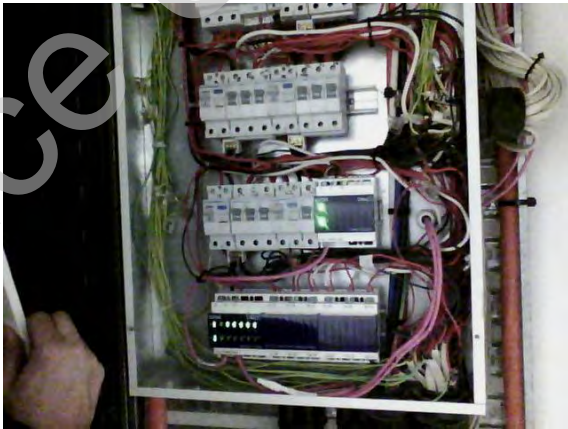
Details	Photographic Details
<p>Location: Distribution Board – Level 15</p> <p>Finding: All isolators, circuit breakers, associated connections and wiring within the distribution board were observed to be operating within normal temperature conditions at the time of inspection.</p> <p>C-Bus2 relay units were operational at the time of inspection and were operating within normal conditions.</p> <p>Note: Normal operating conditions are considered to be between ambient temperature and 70°C.</p>

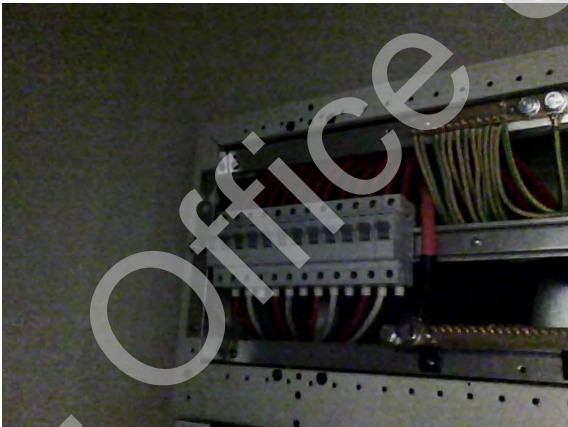
Details	Photographic Details
<p>Location: Tenancy Isolators – Level 19</p> <p>Finding: Isolating circuit breakers, and associated wiring and connections, were observed to be inoperative or operating within normal temperature conditions at the time of inspection.</p>

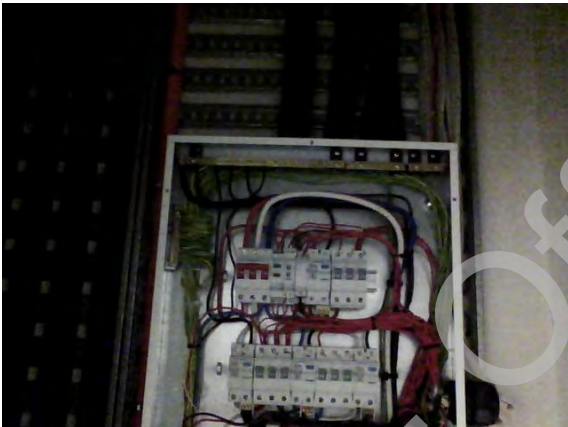
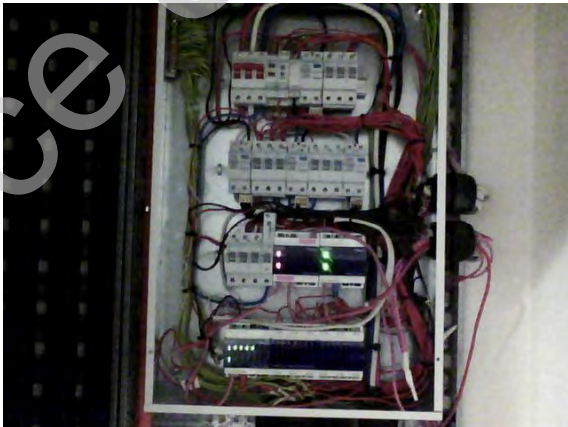
Details	Photographic Details
<p>Location: Distribution Board – Level 20</p> <p>Finding: All isolators, circuit breakers, associated connections and wiring within the distribution board were observed to be operating within normal temperature conditions at the time of inspection.</p> <p>C-Bus2 relay units were operational at the time of inspection and were operating within normal conditions.</p> <p>Note: Normal operating conditions are considered to be between ambient temperature and 70°C.</p>

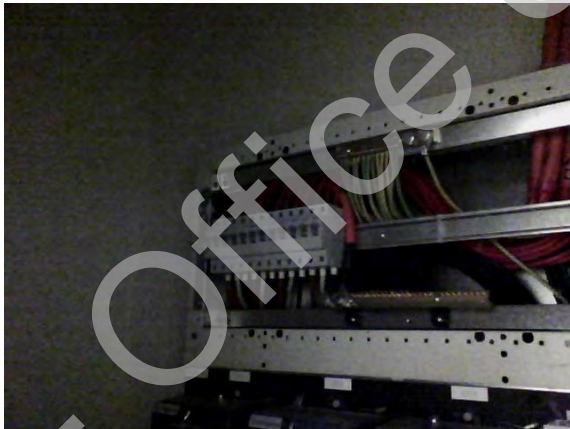
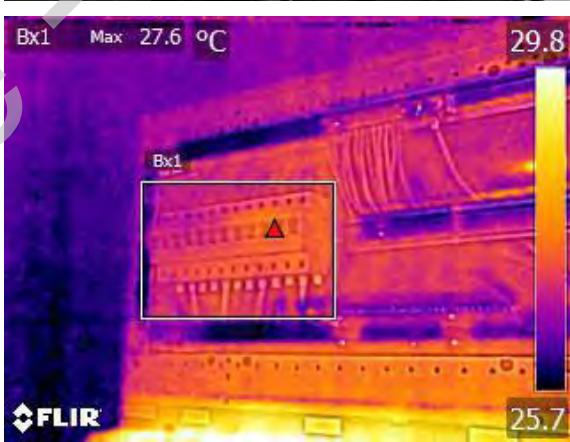
Details	Photographic Details
<p>Location: Tenancy Isolators – Level 21</p> <p>Finding: Isolating circuit breakers, and associated wiring and connections, were observed to be inoperative or operating within normal temperature conditions at the time of inspection.</p>

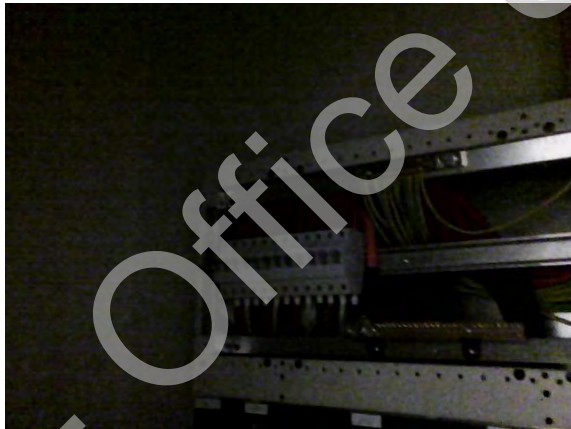
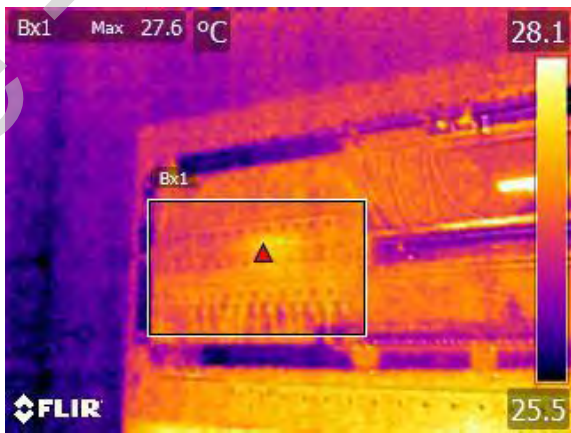
Details	Photographic Details
<p>Location: Tenancy Isolators – Level 22</p> <p>Finding: Isolating circuit breakers, and associated wiring and connections, were observed to be inoperative or operating within normal temperature conditions at the time of inspection.</p>

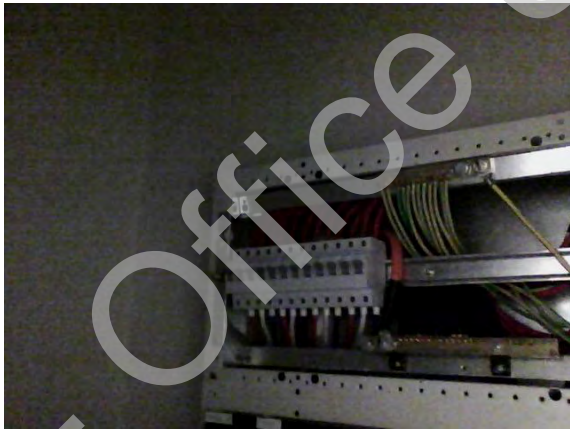
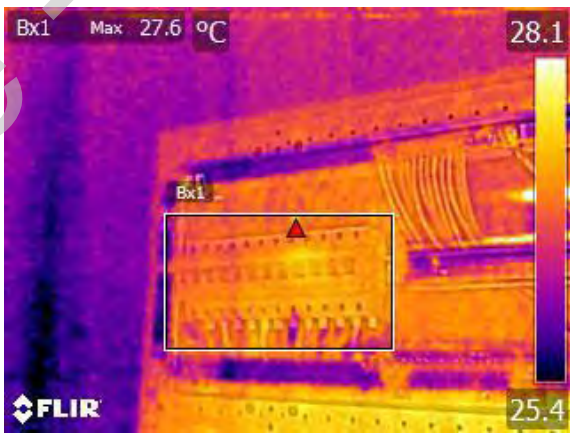
Details	Photographic Details
<p>Location: Tenancy Isolators – Level 23</p> <p>Finding: Isolating circuit breakers, and associated wiring and connections, were observed to be inoperative or operating within normal temperature conditions at the time of inspection.</p>

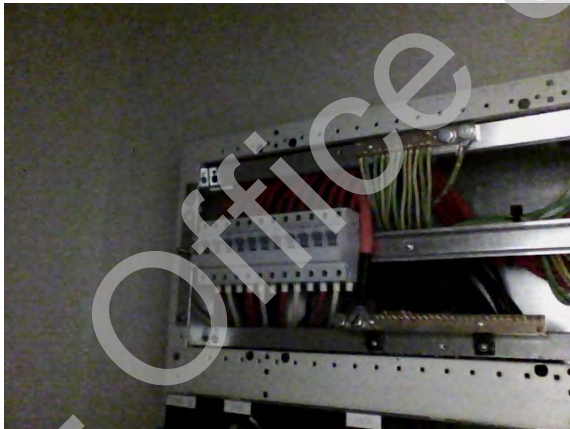
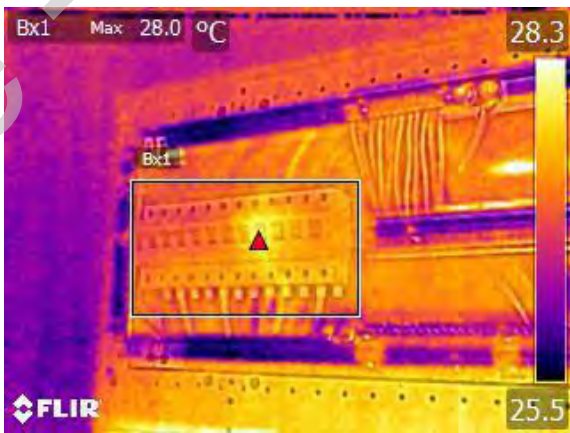
Details	Photographic Details
<p>Location: Tenancy Isolators – Level 24</p> <p>Finding: Isolating circuit breakers, and associated wiring and connections, were observed to be inoperative or operating within normal temperature conditions at the time of inspection.</p>

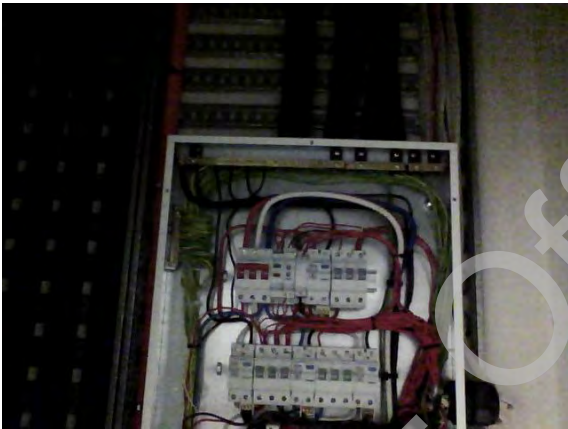
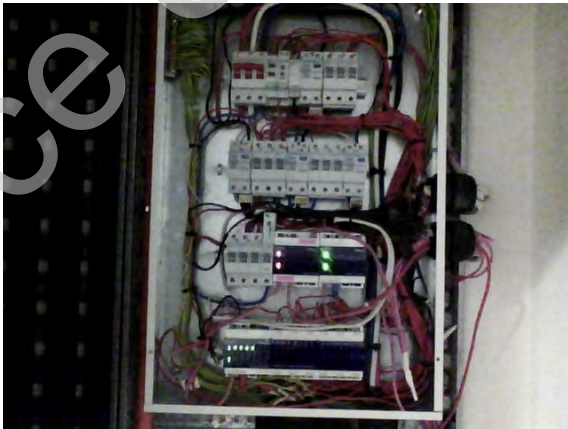
Details	Photographic Details
<p>Location: Distribution Board – Level 30</p> <p>Finding: All isolators, circuit breakers, associated connections and wiring within the distribution board were observed to be operating within normal temperature conditions at the time of inspection.</p> <p>C-Bus2 relay units were operational at the time of inspection and were operating within normal conditions.</p> <p>Note: Normal operating conditions are considered to be between ambient temperature and 70°C.</p>

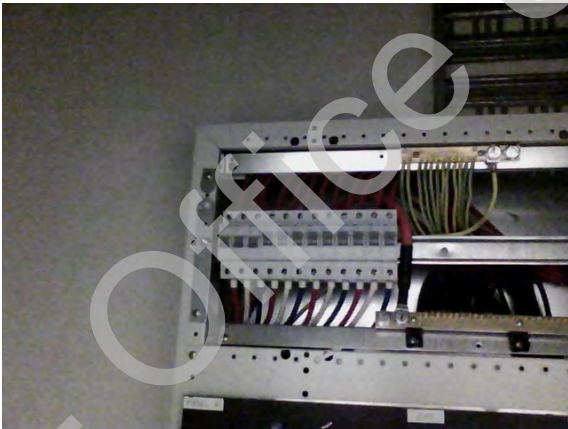
Details	Photographic Details
<p>Location: Tenancy Isolators – Level 30</p> <p>Finding: Isolating circuit breakers, and associated wiring and connections, were observed to be inoperative or operating within normal temperature conditions at the time of inspection.</p>

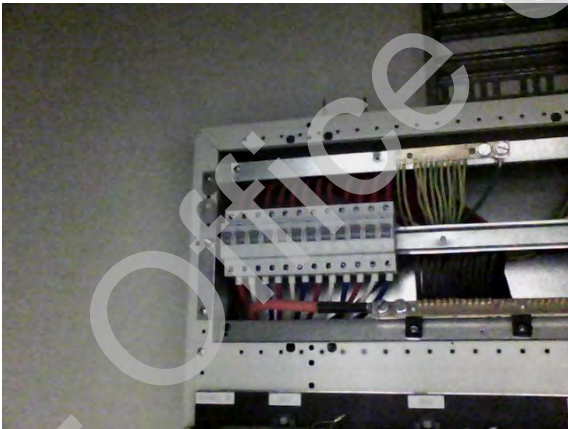
Details	Photographic Details
<p>Location: Tenancy Isolators – Level 31</p> <p>Finding: Isolating circuit breakers, and associated wiring and connections, were observed to be inoperative or operating within normal temperature conditions at the time of inspection.</p>

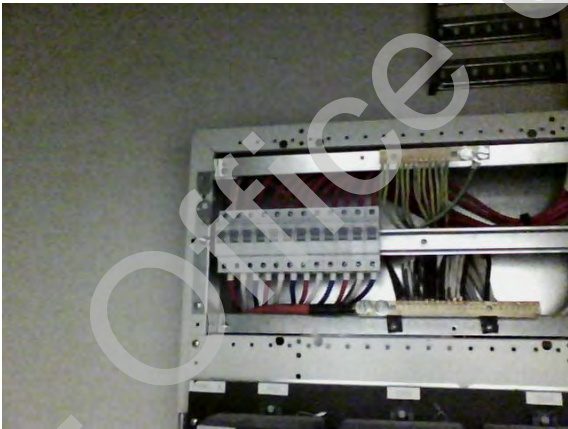
Details	Photographic Details
<p>Location: Tenancy Isolators – Level 33</p> <p>Finding: Isolating circuit breakers, and associated wiring and connections, were observed to be inoperative or operating within normal temperature conditions at the time of inspection.</p>

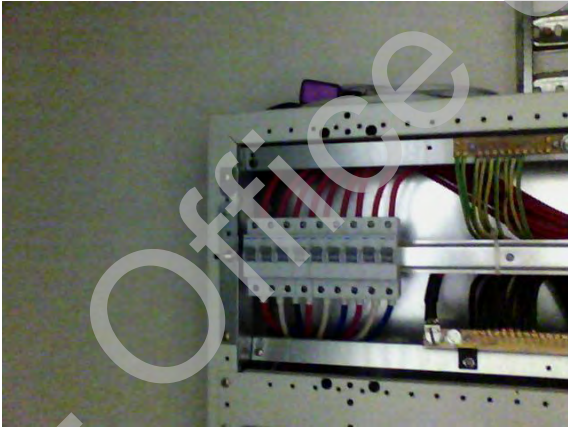
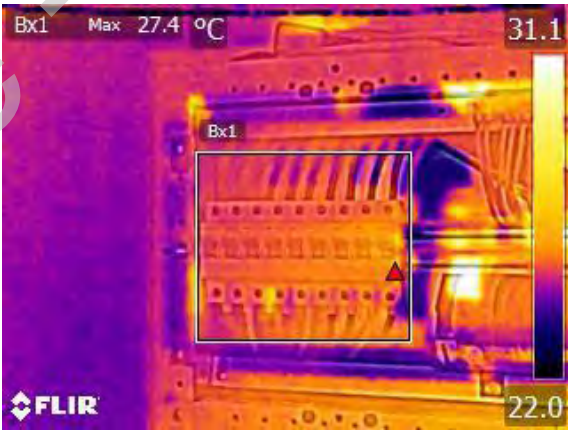
Details	Photographic Details
<p>Location: Tenancy Isolators – Level 34</p> <p>Finding: Isolating circuit breakers, and associated wiring and connections, were observed to be inoperative or operating within normal temperature conditions at the time of inspection.</p>

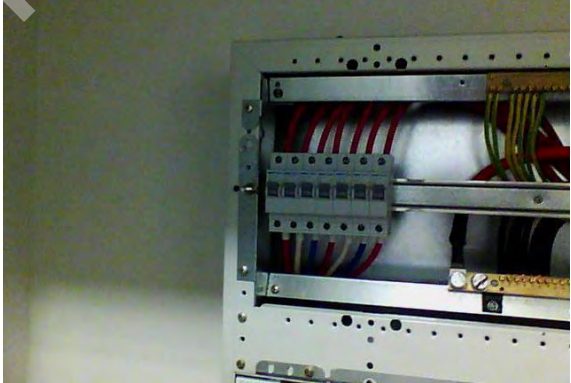
Details	Photographic Details
<p>Location: C-Bus2 Relay Board – Level 38</p> <p>Finding: C-Bus2 relay units were operational at the time of inspection and were operating within normal conditions. Note: Normal operating conditions are considered to be between ambient temperature and 70°C.</p>	   
<p>Location: Tenancy Isolators – Level 38</p> <p>Finding: Isolating circuit breakers, and associated wiring and connections, were observed to be inoperative or operating within normal temperature conditions at the time of inspection.</p>

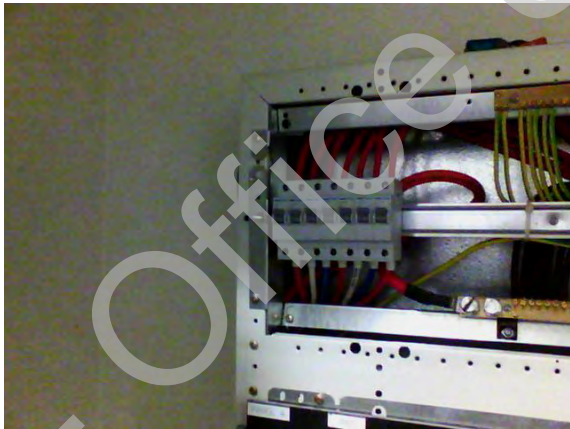
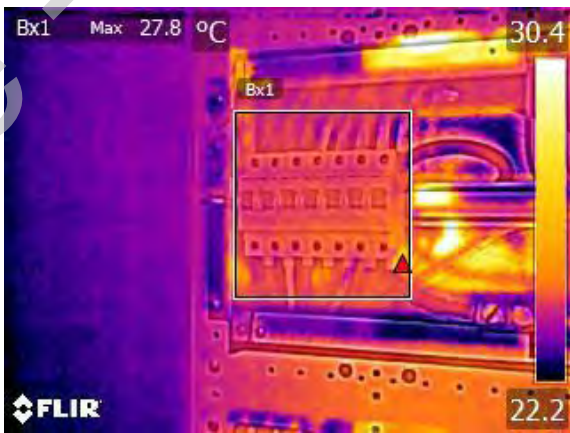
Level 40

Details	Photographic Details
<p>Location: Tenancy Isolators – Level 40</p> <p>Finding: Isolating circuit breakers, and associated wiring and connections, were observed to be inoperative or operating within normal temperature conditions at the time of inspection.</p>	  <p>A photograph showing a rack of electrical equipment. The top section contains several rows of terminal blocks with numerous colored wires (red, yellow, green, blue) connected. Below the terminal blocks are three large, dark-colored isolating circuit breakers with labels and handles.</p>
<div data-bbox="510 925 1082 1352">   <p>A close-up photograph of the terminal blocks, showing the intricate wiring and connections.</p> </div> <div data-bbox="510 1361 1082 1792">   <p>A thermal image of the same terminal block area. The image shows temperature variations, with a color scale on the right ranging from 24.3 (purple) to 32.4 (yellow). A specific point is labeled 'Bx1' with a temperature of 28.4 °C. The FLIR logo is visible in the bottom left corner.</p> </div>
