Main Switchboard Thermal Imaging Inspection & Report

88 Sample St Suburb VIC 3000

5 October 2015

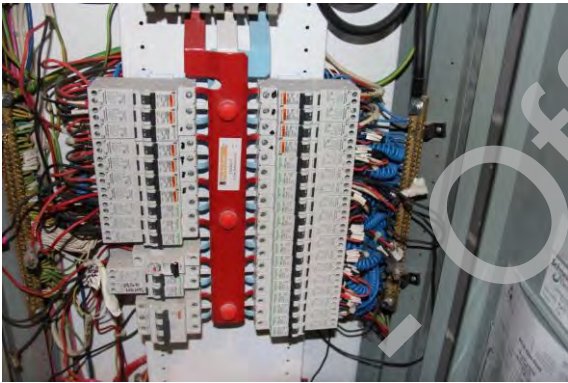
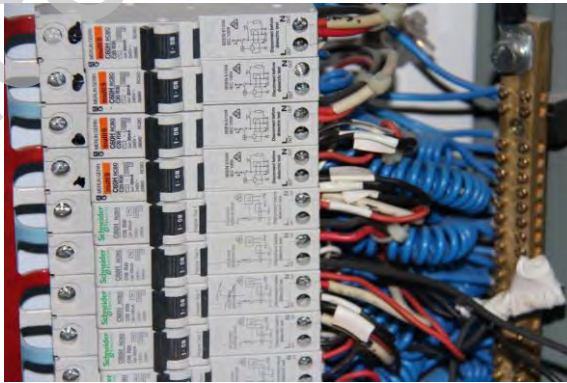
- The thermal imaging inspection throughout the building presented few anomalies, with only significant elevated temperatures found in the Ground Level West distribution board wiring & circuit breaker. The uncovered nature of the top panel box on L10 of the eastern tower was also noted as a concern.

Details	Photographic Details
<p>Location: Distribution Board - Ground Level West</p> <p>Finding: Wiring connected to circuit breaker number 10 exhibits an elevated temperature when compared to other wiring. This circuit breaker services the "Foyer Lts, Main Entry, Main Room, Lobby L1". Wiring for circuit breaker number 10 exhibited an elevated temperature (~14°C differential) when compared to similar elements. All other elements were operating within normal temperature condition limits. This circuit breaker was investigated further, see details overleaf.</p>

Details	Photographic Details								
<p>Location: Distribution Board - Ground Level West</p> <p>Finding: Current load on the wiring in question, adjacent to the connection to the circuit breaker, was found to be 11A. The circuit breaker is rated for a load of 16A. This has been compared to the 3A loading out of a capacity of 20A on circuit breaker number 1.</p> <p>Recommendation: During the next maintenance phase, it is recommended that the loading for circuit breaker number 10 be split, or the circuit breaker upgraded, in order to more evenly distribute the loadings across the panel.</p>

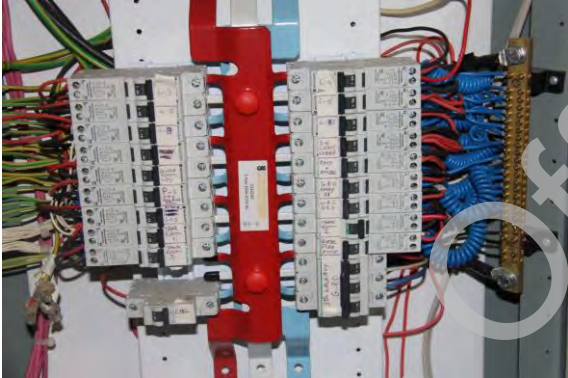
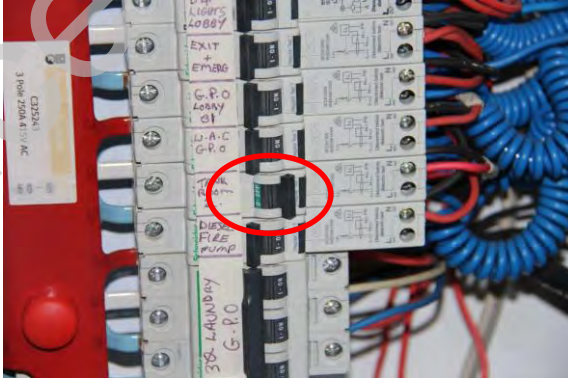
Details	Photographic Details
<p>Location: Distribution Board – Basement 1 West</p> <p>Finding: All circuit breakers, associated connections and wiring within the distribution board were operating within normal temperature conditions at the time of inspection.</p> <p>Note: Circuit breaker number 16, assigned to "Tank Room 2", was found manually isolated on the day of inspection.</p>

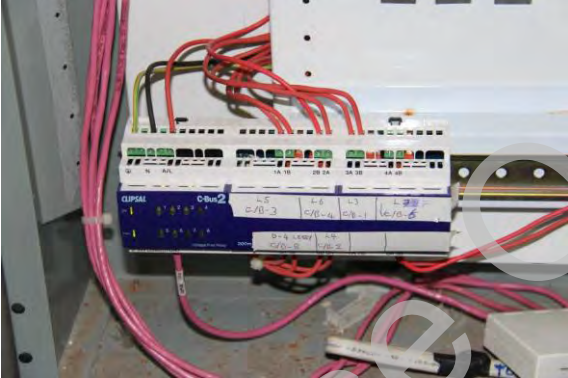
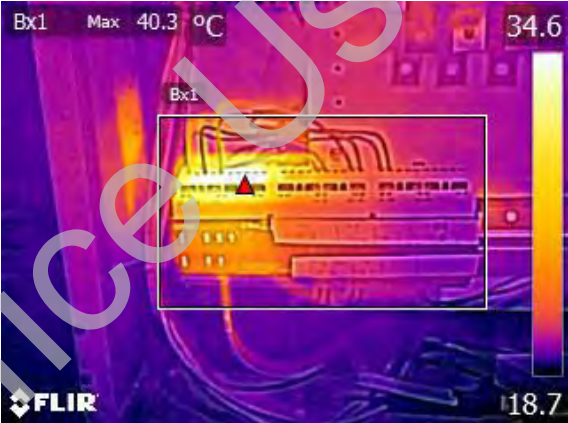
Details	Photographic Details
<p>Location: Distribution Board – Basement 1 West</p> <p>Finding: C-Bus2 relay unit was operational at the time of inspection and was operating within normal conditions. Note: Normal operating conditions for C-Bus units are considered to be between ambient temperature and 70°C.</p>

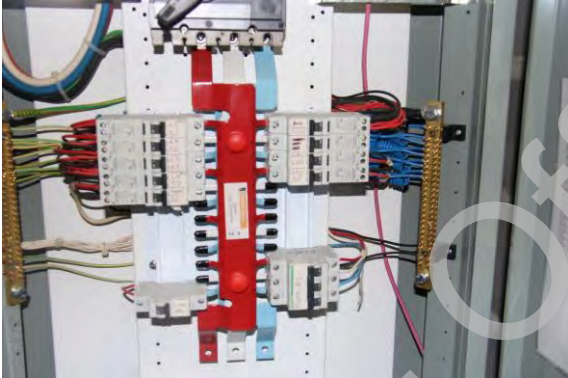
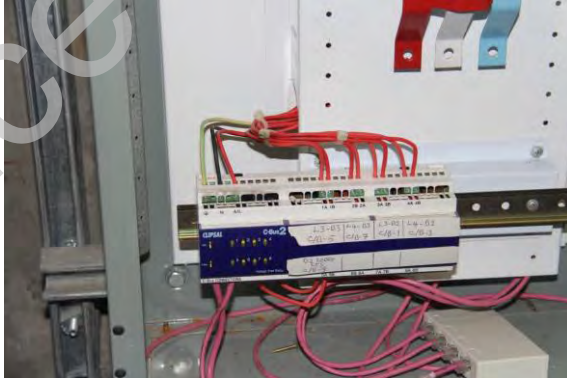
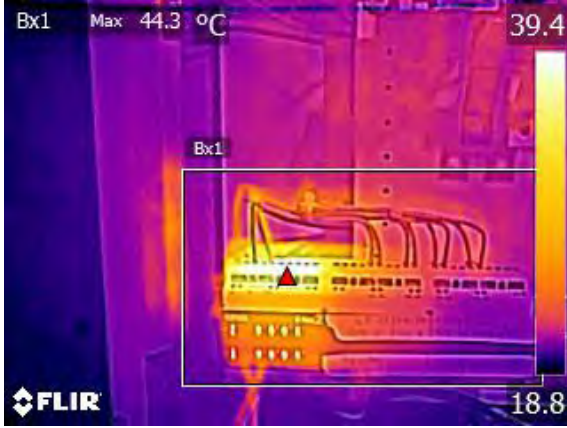
Details	Photographic Details
<p>Location: Distribution Board – Basement 1 West</p> <p>Finding: All circuit breakers, associated connections and wiring within the distribution board were operating within normal temperature conditions at the time of inspection.</p> <p>C-Bus2 relay unit was operational at the time of inspection and was operating within normal conditions.</p> <p>Note: Normal operating conditions for C-Bus units are considered to be between ambient temperature and 70°C.</p>

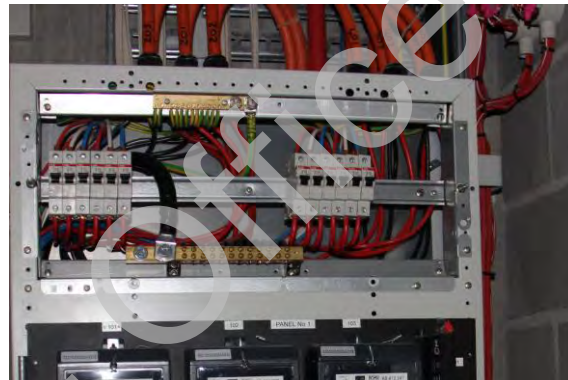
Details	Photographic Details
<p>Location: Switchboard & Tenancy Isolators – Level 2 West</p> <p>Finding: Circuit breakers were observed to be at an ambient temperature at the time of inspection.</p> <p>Note: Isolators for Levels 1-4 are contained within this panel.</p>

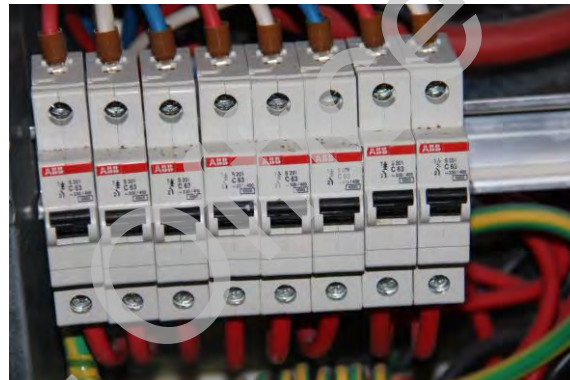
Details	Photographic Details
<p>Location: Switchboard & Tenancy Isolators – Level 5 West</p> <p>Finding: Circuit breakers were observed to be inoperative or operating within normal temperature conditions at the time of inspection.</p> <p>Note: Isolators for Levels 5-8 are contained within this panel.</p>

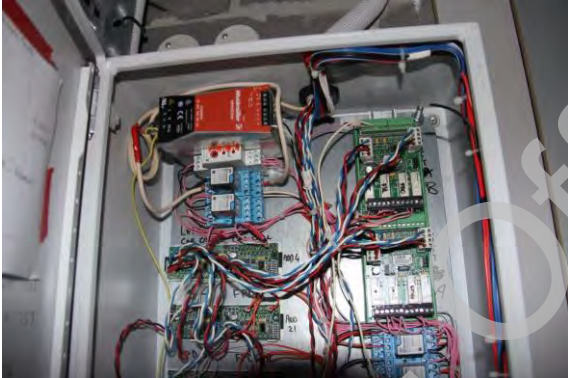
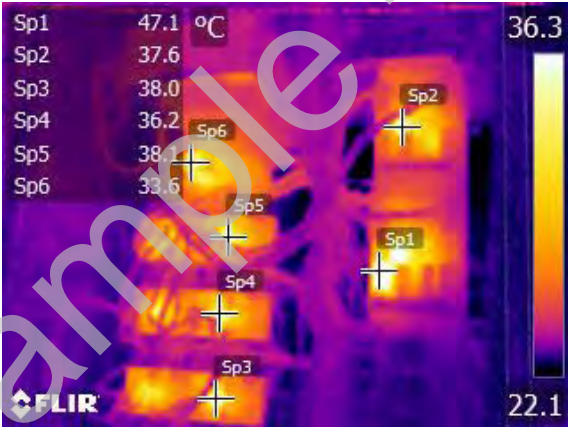
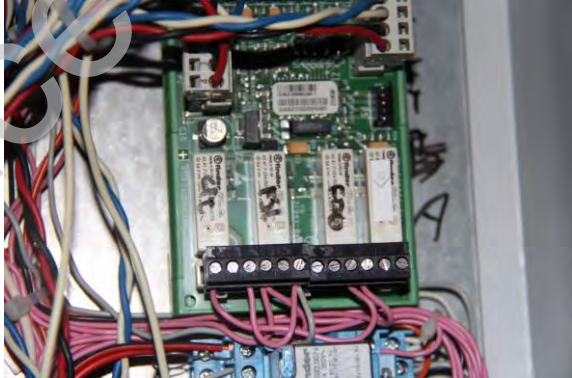
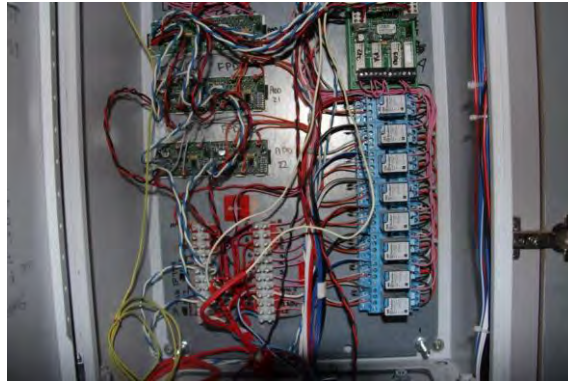
Details	Photographic Details
<p>Location: Lift & Fire Evacuation Panel – Level 8 West</p> <p>Finding: Circuit boards and associated wiring appear to be functioning within normal operating temperature conditions. One section showed a temperature differential of $\sim 10^{\circ}\text{C}$, which was not considered to be excessive.</p>

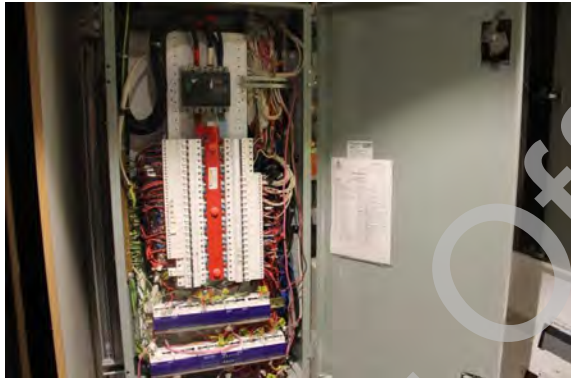
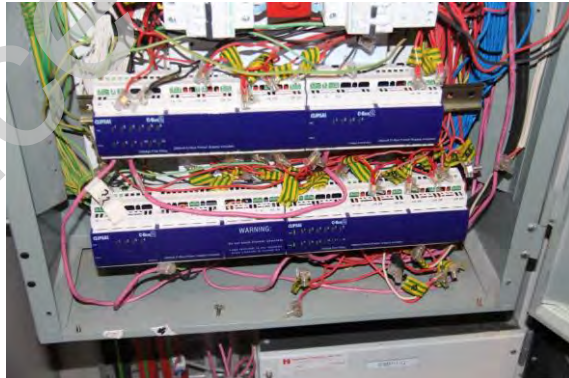
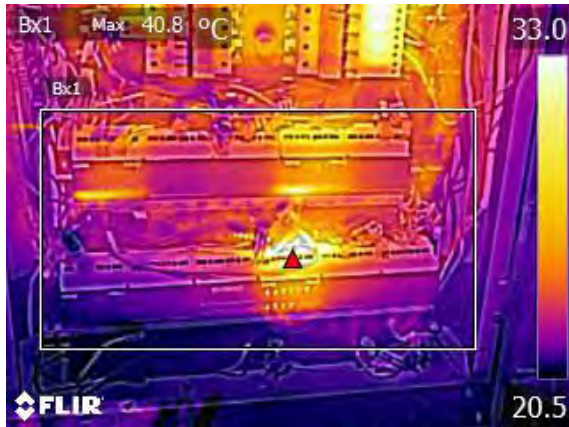
Details	Photographic Details																												
<p>Location: Distribution Board - Ground Level East</p> <p>Finding: All circuit breakers, associated connections and wiring within the distribution board were operating within normal temperature conditions at the time of inspection. One C-Bus2 dimmer unit did not appear to be operational, the other three C-Bus2 relay units were operating within normal temperature conditions at the time of inspection. Note: Normal operating conditions for C-Bus units are considered to be between ambient temperature and 70°C.</p>

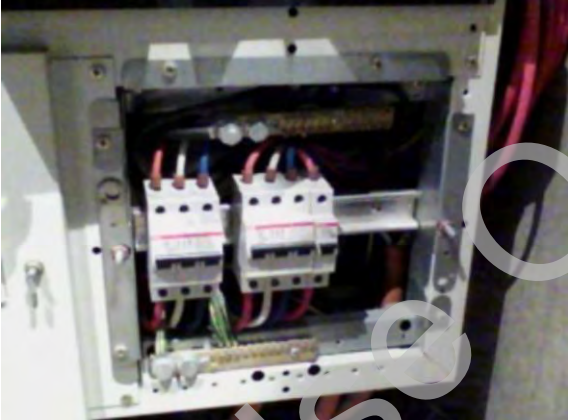
Details	Photographic Details
<p>Location: Isolators - Ground Level East</p> <p>Finding: Circuit breakers were observed to be inoperative or operating within normal temperature conditions at the time of inspection.</p>

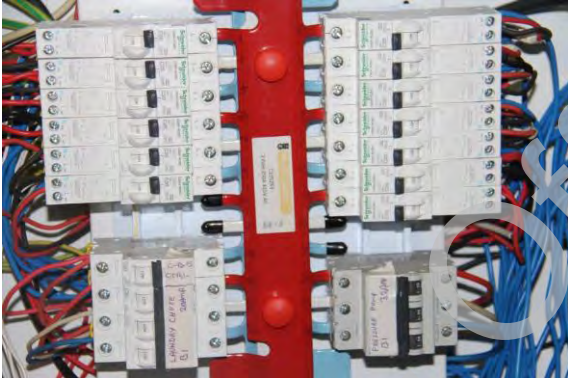
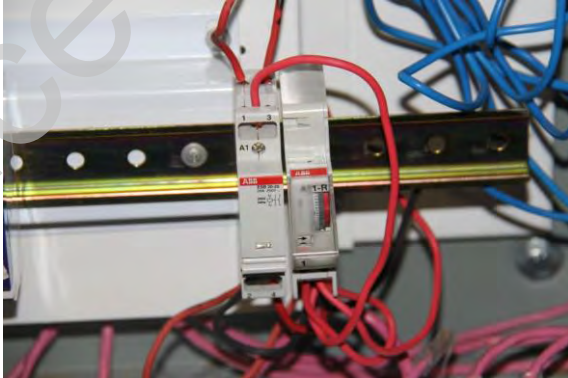
Details	Photographic Details
<p>Location: Distribution Board – Basement 1 – East</p> <p>Finding: All circuit breakers, associated connections and wiring within the distribution board were operating within normal temperature conditions at the time of inspection.</p> <p>Flood lights circuit breaker was present at the bottom of the board and was operating within normal temperature conditions.</p> <p>C-Bus2 relay unit was not operational at the time of inspection.</p>

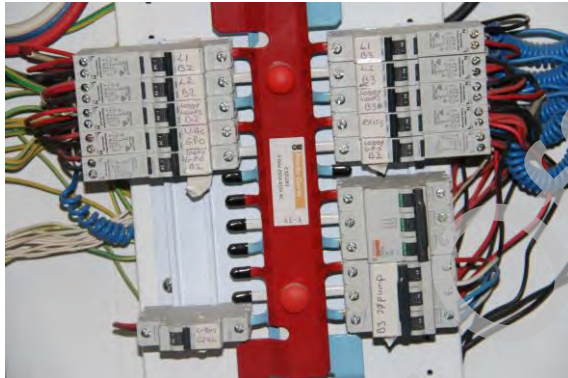
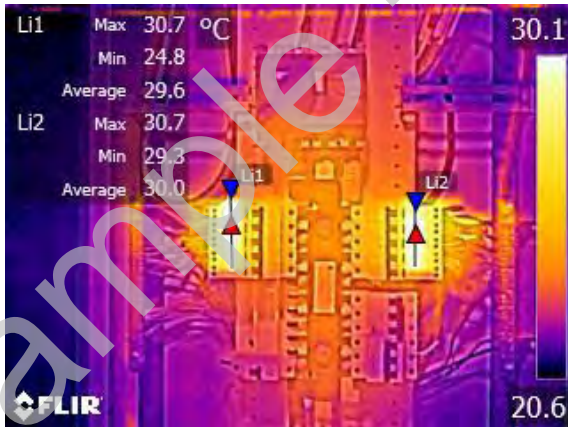
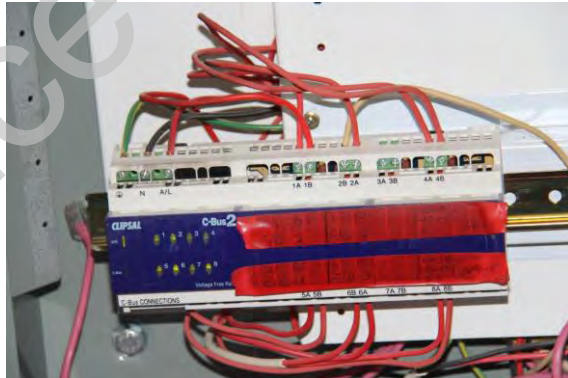
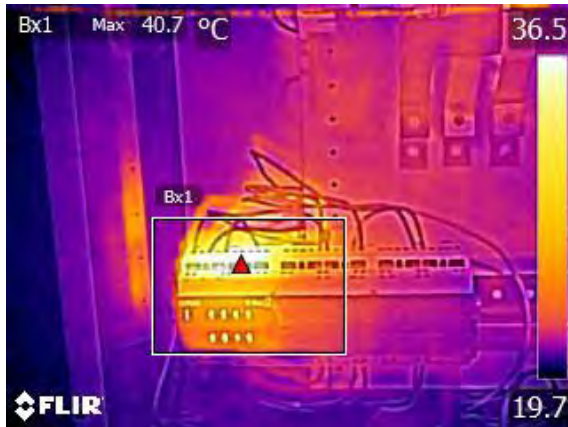
Details	Photographic Details																																
<p>Location: Distribution Board – Basement 2 – East</p> <p>Finding: All circuit breakers, associated connections and wiring within the distribution board were observed to be inoperative or operating within normal temperature conditions at the time of inspection.</p> <p>C-Bus2 relay unit was operational at the time of inspection and was operating within normal conditions.</p> <p>Note: Normal operating conditions for C-Bus units are considered to be between ambient temperature and 70°C.</p>

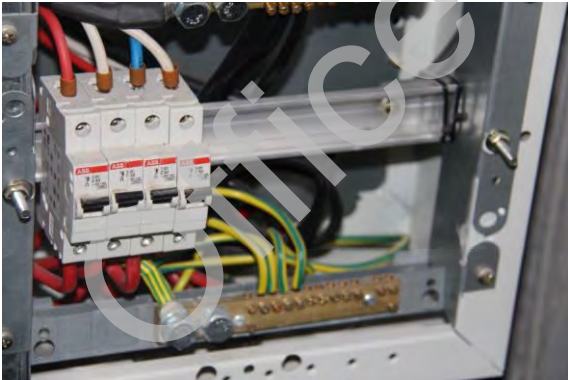
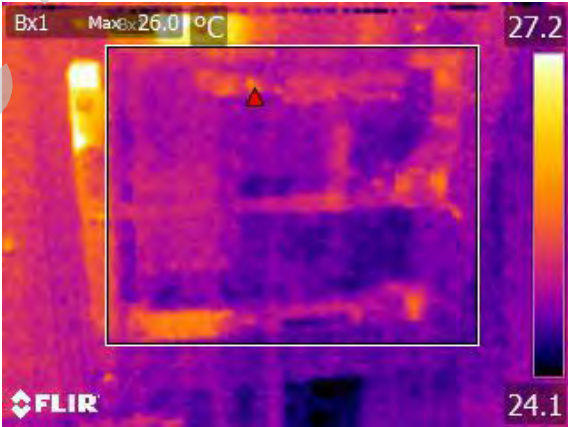
Details	Photographic Details
<p>Location: Switchboard & Tenancy Isolators – Level 1 East</p> <p>Finding: Circuit breakers were observed to be inoperative or operating within normal temperature conditions at the time of inspection.</p>

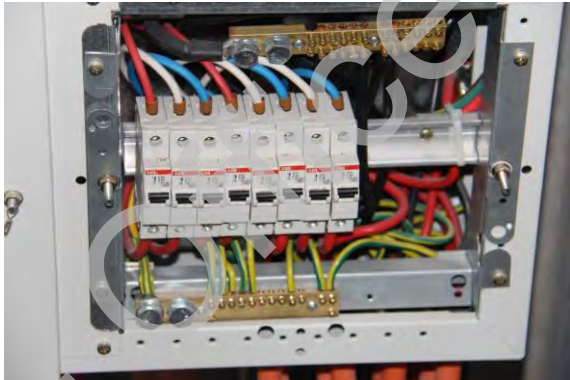
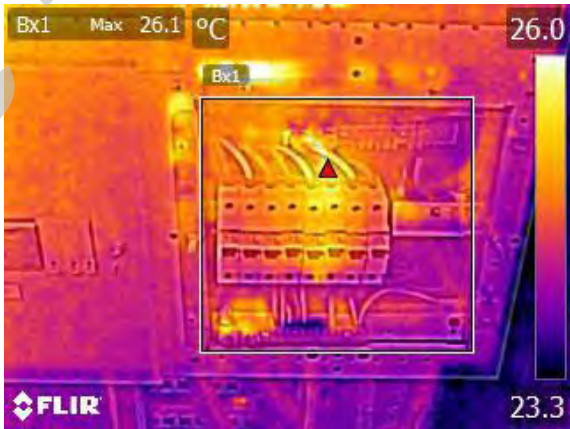
Details	Photographic Details
<p>Location: Switchboard & Tenancy Isolators – Level 2 East</p> <p>Finding: Circuit breakers were observed to be inoperative or operating within normal temperature conditions at the time of inspection.</p>

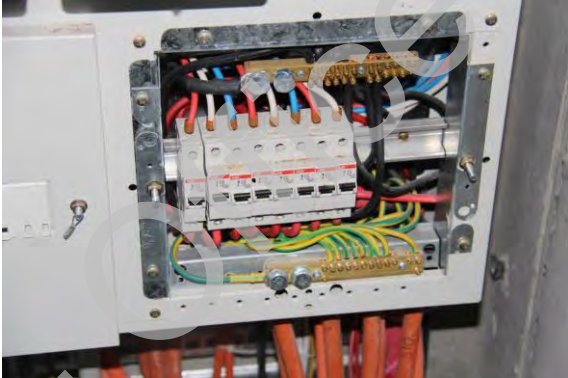
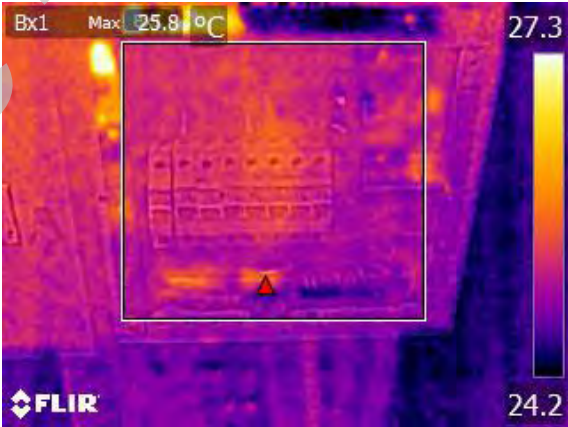
Details	Photographic Details
<p>Location: Switchboard & Tenancy Isolators – Level 3 East</p> <p>Finding: Circuit breakers were observed to be inoperative or operating within normal temperature conditions at the time of inspection.</p>

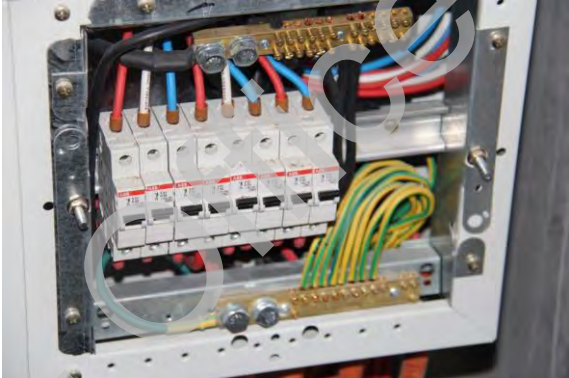
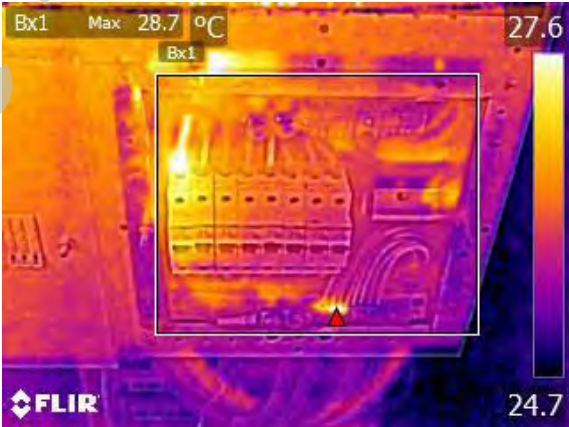
Details	Photographic Details
<p>Location: Switchboard & Tenancy Isolators – Level 4 East</p> <p>Finding: Circuit breakers were observed to be inoperative or operating within normal temperature conditions at the time of inspection.</p>

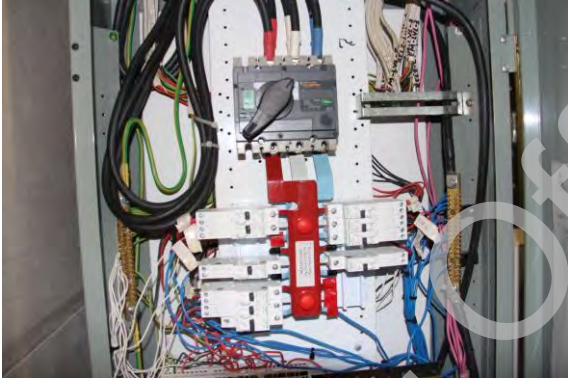
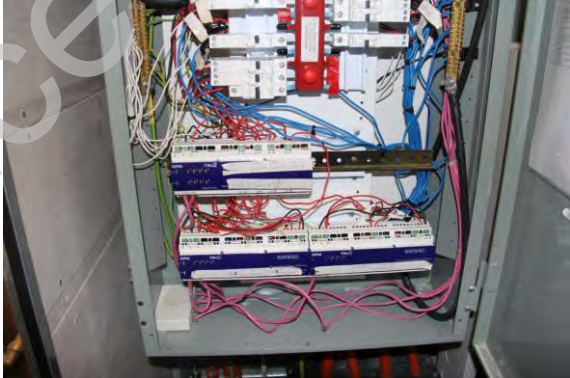
Details	Photographic Details
<p>Location: Distribution Board – Level 5 East</p> <p>Finding: All circuit breakers, associated connections and wiring within the distribution board were observed to be inoperative or operating within normal temperature conditions at the time of inspection.</p> <p>C-Bus2 relay units were operational at the time of inspection and were operating within normal conditions.</p> <p>Note: Normal operating conditions for C-Bus units are considered to be between ambient temperature and 70°C.</p>

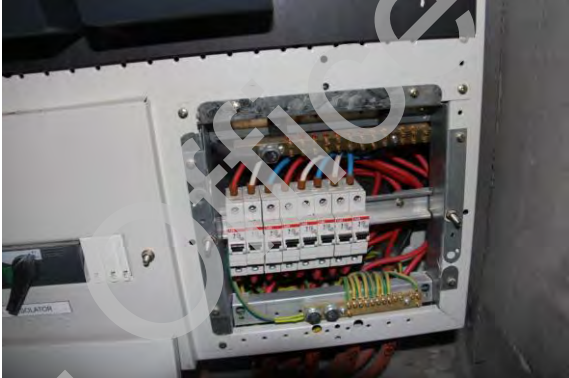
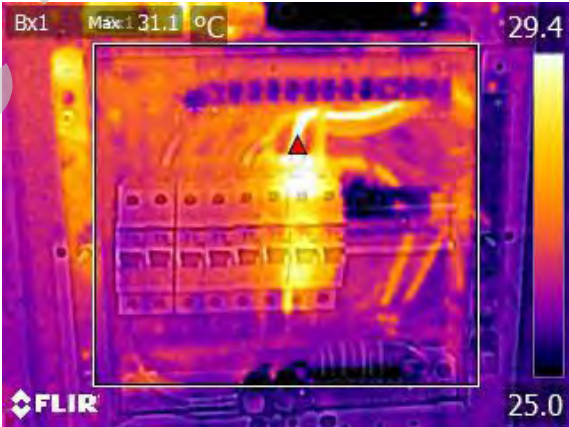
Details	Photographic Details
<p>Location: Switchboard & Tenancy Isolators – Level 5 East</p> <p>Finding: Circuit breakers were observed to be inoperative or operating within normal temperature conditions at the time of inspection.</p>

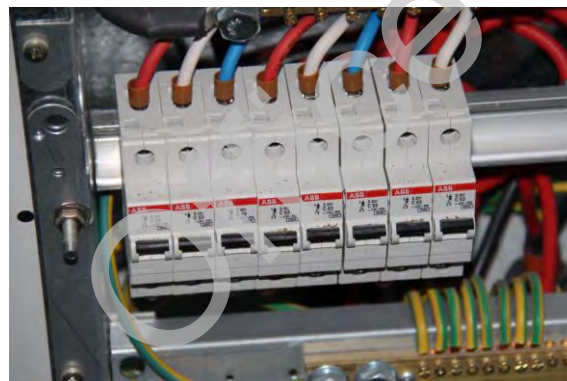
Details	Photographic Details
<p>Location: Switchboard & Tenancy Isolators – Level 6 East</p> <p>Finding: Circuit breakers were observed to be inoperative or operating within normal temperature conditions at the time of inspection.</p>

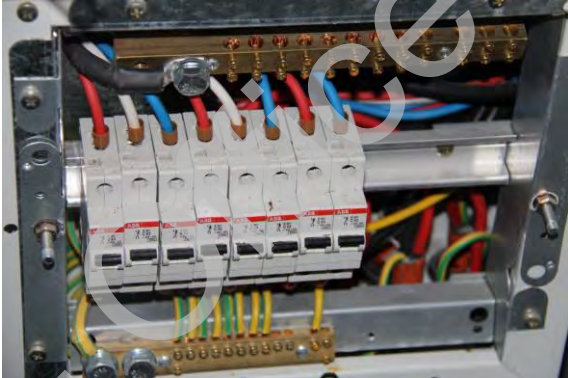
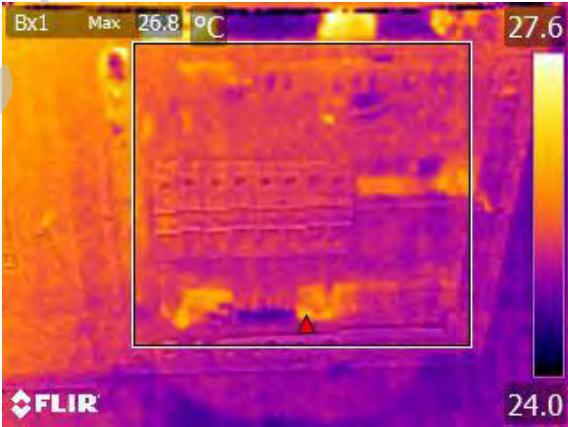
Level 7 - East

Details	Photographic Details
<p>Location: Switchboard & Tenancy Isolators – Level 7 East</p> <p>Finding: Circuit breakers were observed to be inoperative or operating within normal temperature conditions at the time of inspection.</p>

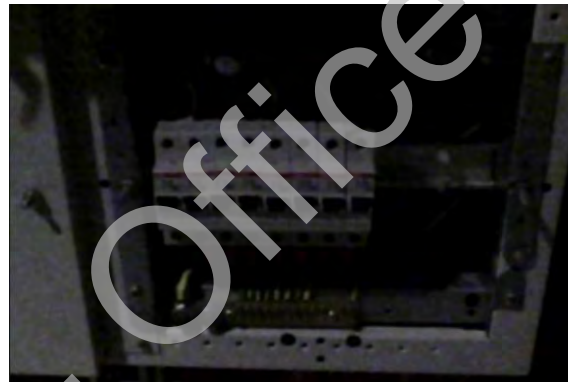
Level 8 - East

Details	Photographic Details
<p>Location: Switchboard & Tenancy Isolators – Level 8 East</p> <p>Finding: Circuit breakers were observed to be inoperative or operating within normal temperature conditions at the time of inspection.</p>

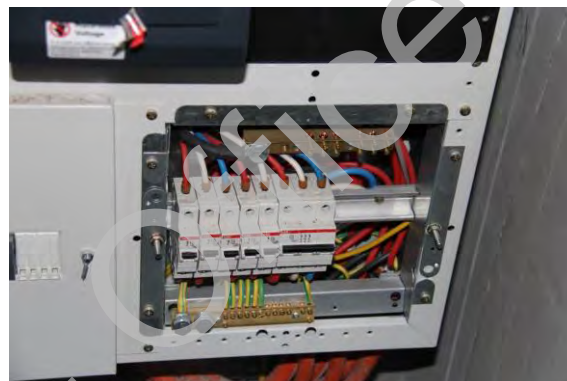
Level 9 - East

Details	Photographic Details
<p>Location: Switchboard & Tenancy Isolators – Level 9 East</p> <p>Finding: Circuit breakers were observed to be inoperative or operating within normal temperature conditions at the time of inspection.</p>

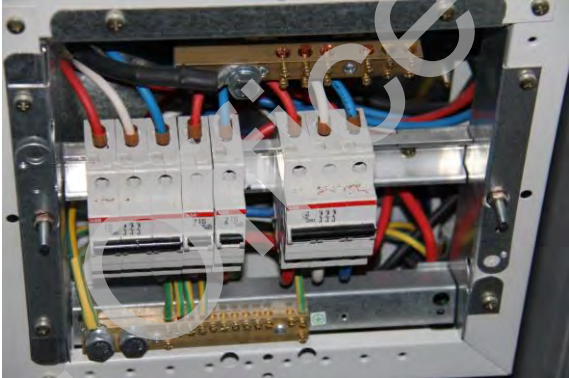
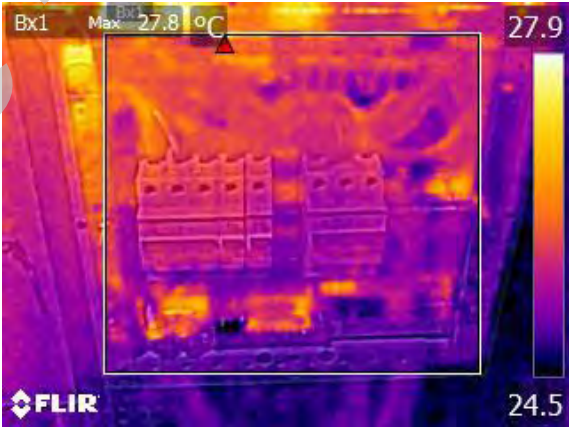
Level 12 - East

Details	Photographic Details
<p>Location: Switchboard & Tenancy Isolators – Level 12 East</p> <p>Finding: Circuit breakers were observed to be inoperative or operating within normal temperature conditions at the time of inspection.</p>

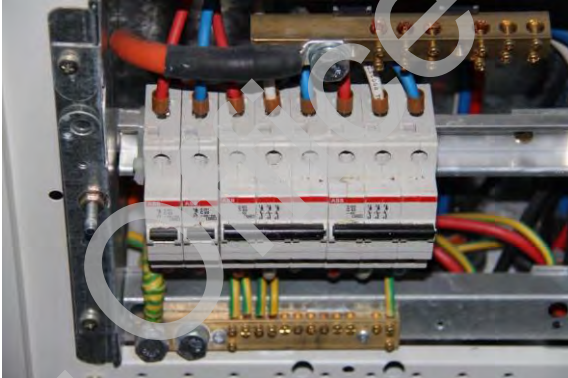
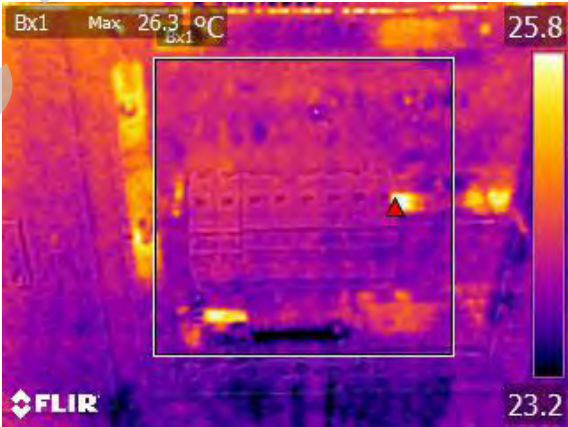
Level 13 - East

Details	Photographic Details
<p>Location: Switchboard & Tenancy Isolators – Level 13 East</p> <p>Finding: Circuit breakers were observed to be inoperative or operating within normal temperature conditions at the time of inspection.</p>

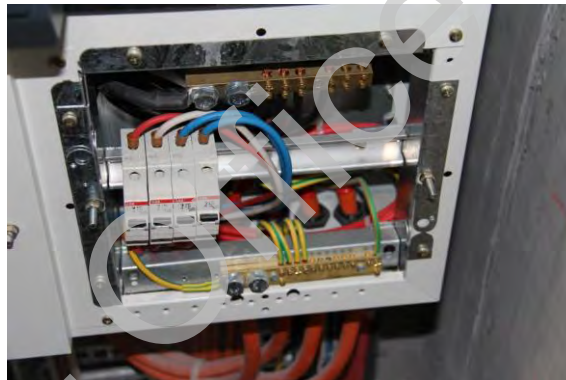
Level 14 - East

Details	Photographic Details
<p>Location: Switchboard & Tenancy Isolators – Level 14 East</p> <p>Finding: Circuit breakers were observed to be inoperative or operating within normal temperature conditions at the time of inspection.</p>

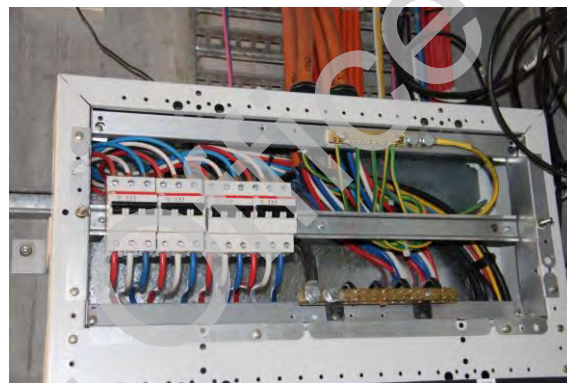
Level 15 - East

Details	Photographic Details
<p>Location: Switchboard & Tenancy Isolators – Level 15 East</p> <p>Finding: Circuit breakers were observed to be inoperative or operating within normal temperature conditions at the time of inspection.</p> <p>Note: Isolators for L17 are included within this panel.</p>

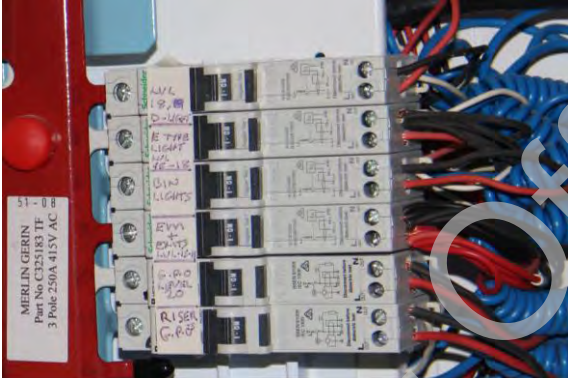
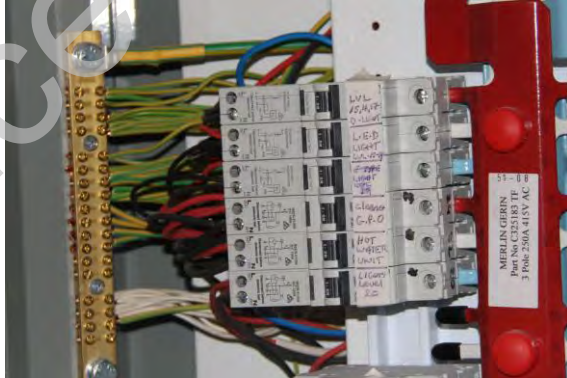
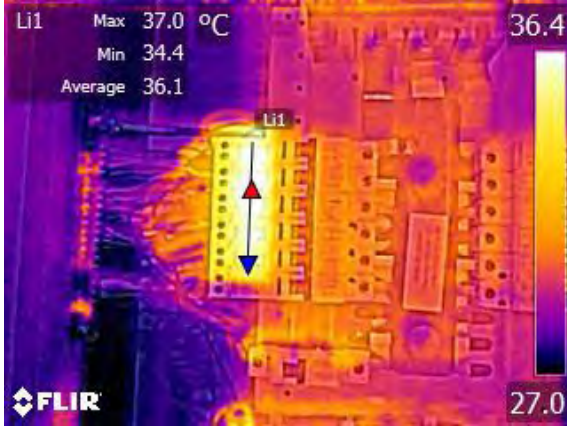
Level 16 – East

Details	Photographic Details
<p>Location: Distribution Board – Level 16 East</p> <p>Finding: All circuit breakers, associated connections and wiring within the distribution board were observed to be inoperative or operating within normal temperature conditions at the time of inspection.</p>

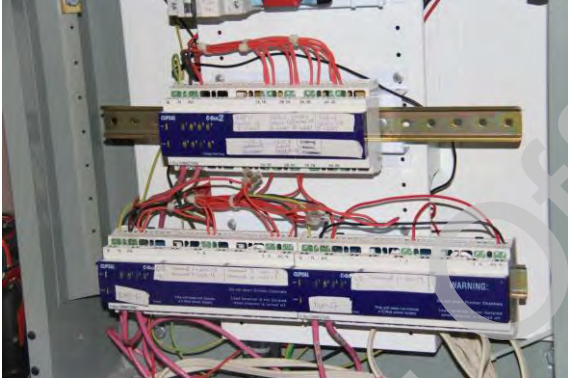
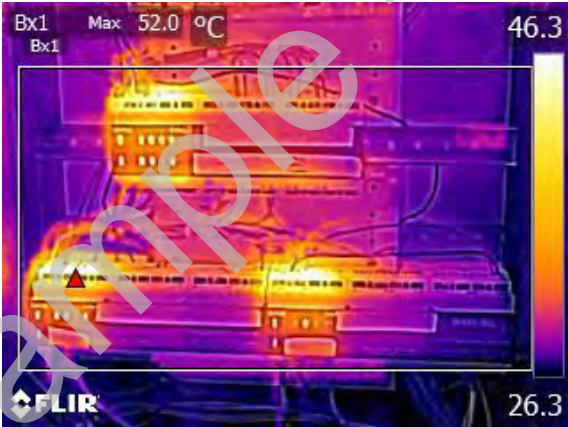
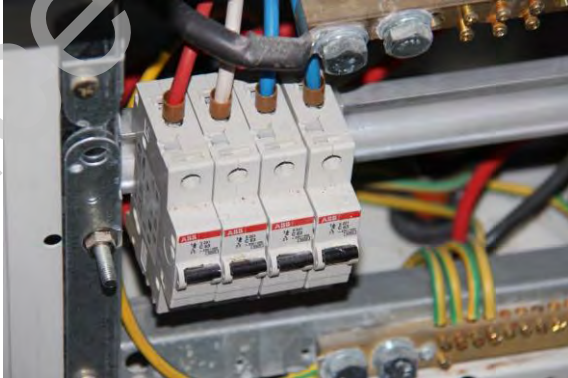
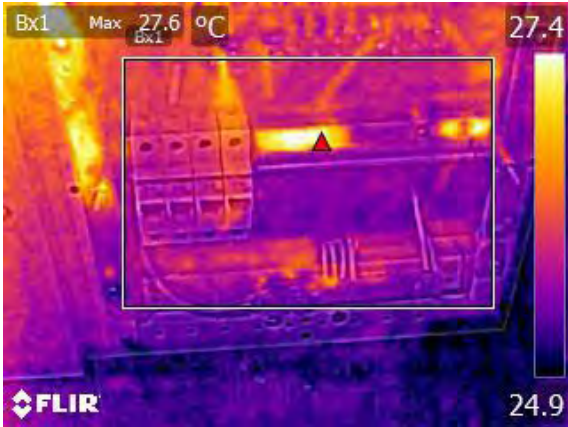
Details	Photographic Details
<p>Location: Switchboard & Tenancy Isolators – Level 16 East</p> <p>Finding: C-Bus2 relay units were operational at the time of inspection and were operating within normal conditions. Note: Normal operating conditions for C-Bus units are considered to be between ambient temperature and 70°C.</p> <p>Circuit breakers were observed to be inoperative or operating within normal temperature conditions at the time of inspection.</p>

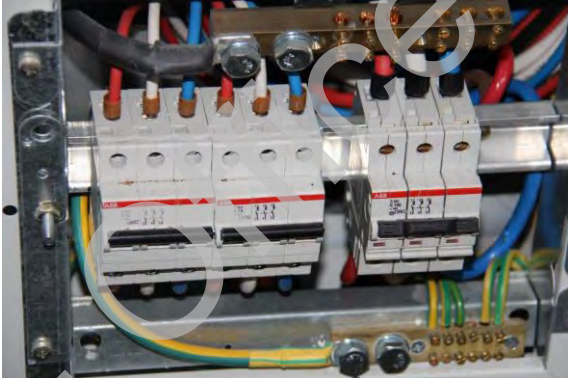
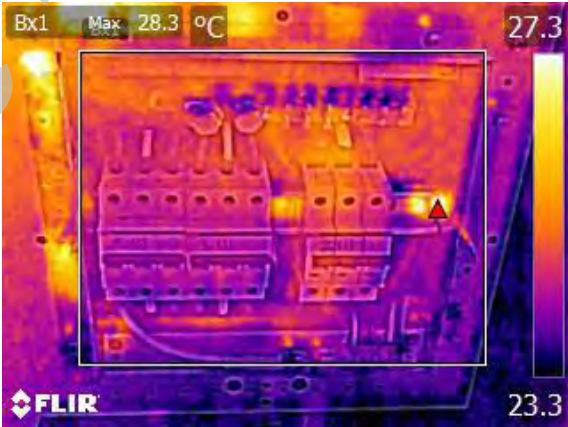
Level 18 - East

Details	Photographic Details
<p>Location: Switchboard & Tenancy Isolators – Level 18 East</p> <p>Finding: Circuit breakers were observed to be inoperative or operating within normal temperature conditions at the time of inspection.</p>

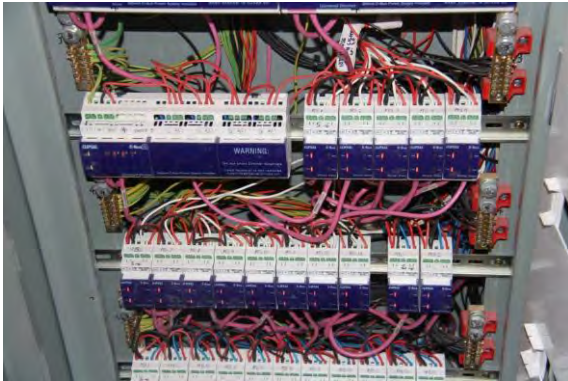
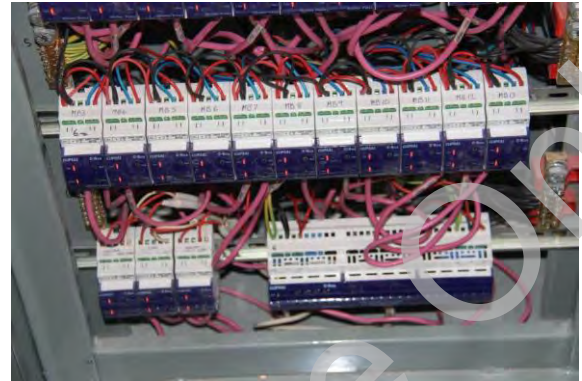
Level 19 - East

Details	Photographic Details
<p>Location: C-Bus2 Board – Level 19 East</p> <p>Finding: 39 C-Bus or C-Bus2 units were operational at the time of inspection and were operating within normal conditions. Note: Normal operating conditions for C-Bus units are considered to be between ambient temperature and 70°C.</p>

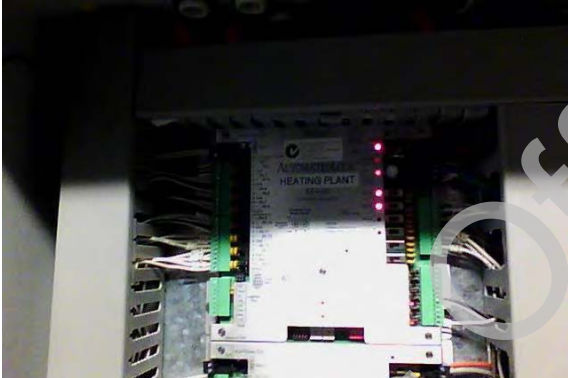
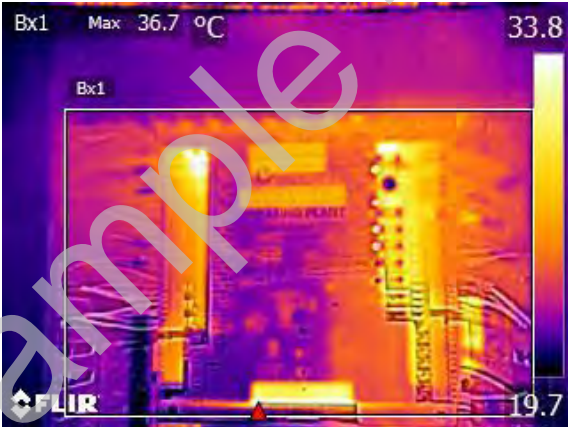
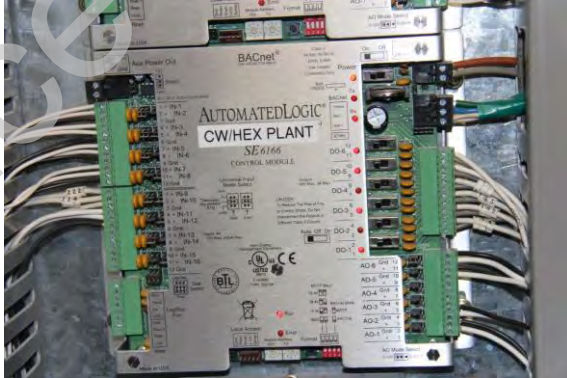
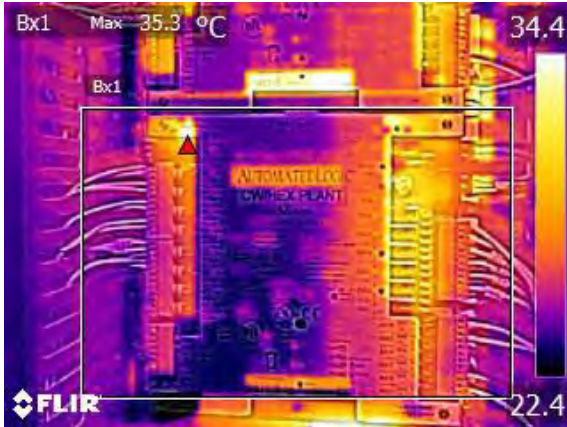
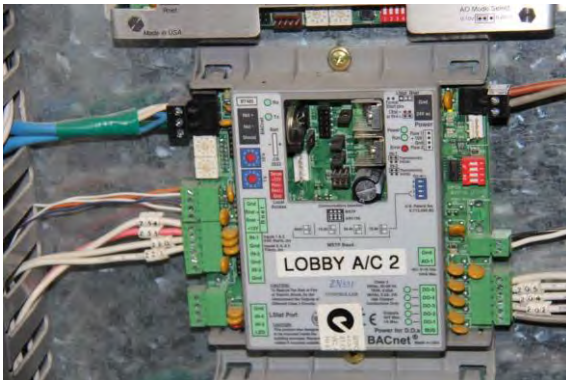
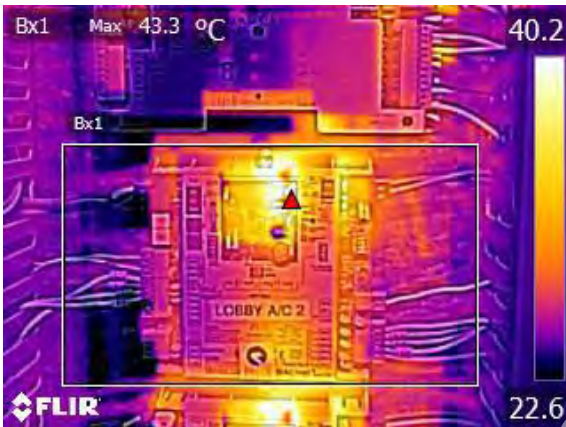
Level 20 - East

Details	Photographic Details
<p>Location: Automated Logic Control Board – Level 20 East</p> <p>Finding: Circuit boards, and associated connections, were observed to be operating within normal temperature conditions at the time of inspection.</p> <p>Altro control transformer is rated to have a temperature rise of 60°C, temperature of the transformer was found to be ~40°C, corresponding to a temperature rise from ambient of ~20°C. This transformer is operating within normal temperature conditions.</p>

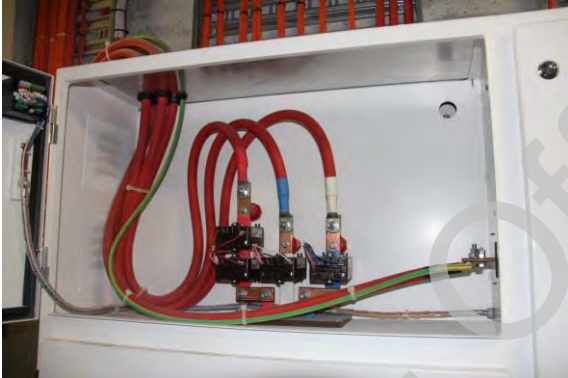
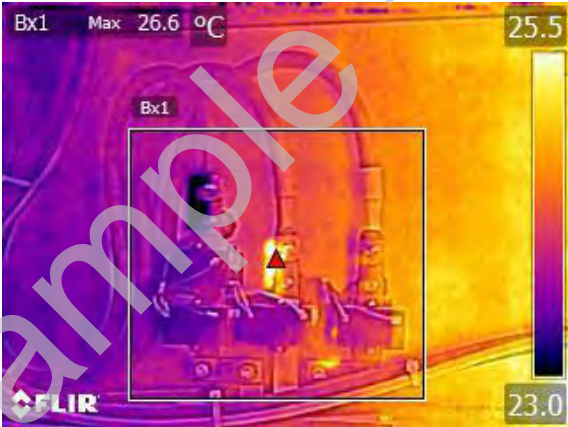
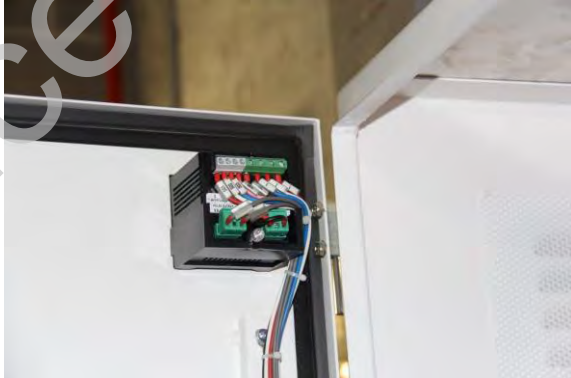
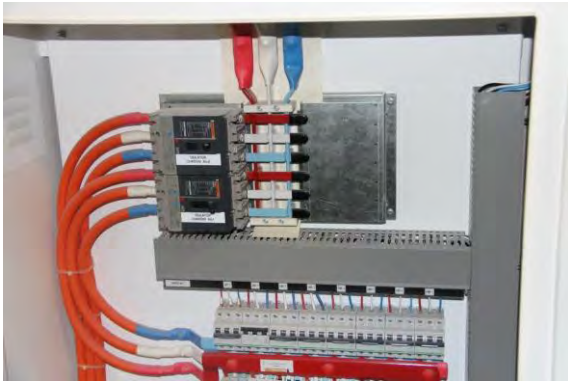
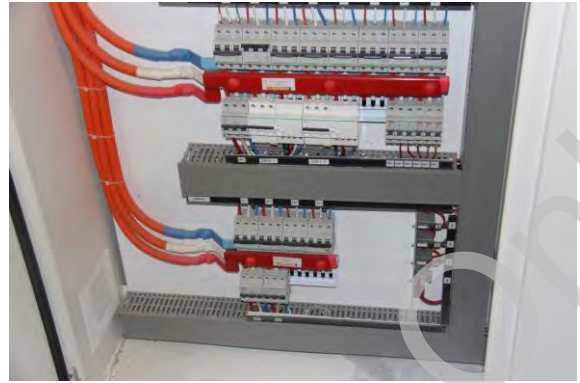
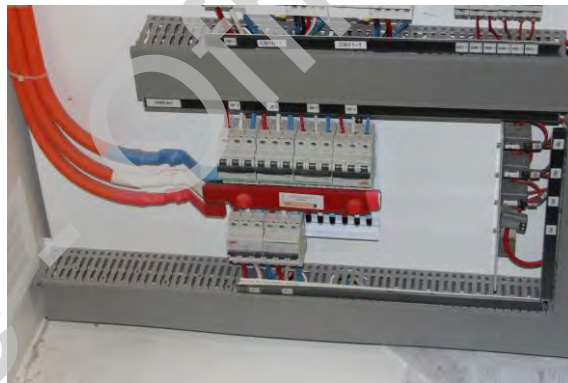
Details	Photographic Details
<p>Location: Circuit breaker cabinet – Level 20 East</p> <p>Finding: Phase connections were found to be operating within normal temperature conditions at the time of inspection.</p> <p>All circuit breakers, associated connections and wiring within the cabinet were observed to be inoperative or operating within normal temperature conditions at the time of inspection.</p>

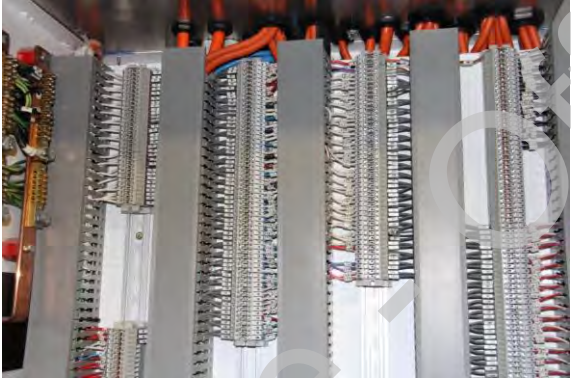
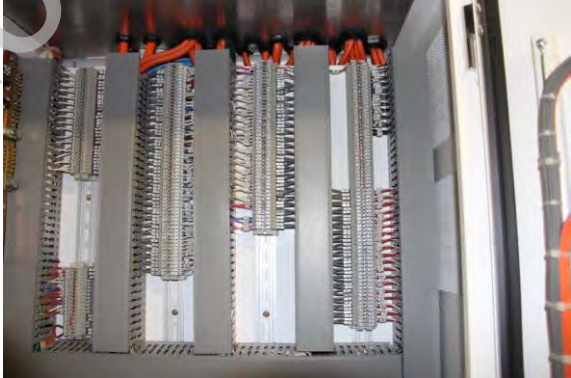
Details	Photographic Details
<p>Location: Switchboard & Tenancy Isolators – Level 20 East</p> <p>Finding: Control panel wiring and associated connections were found to be operating within normal temperature conditions.</p> <p>Class-B transformer is rated to have a temperature rise of 80°C, temperature of the transformer was found to be ~50°C, corresponding to a temperature rise from ambient of ~30°C. This transformer is operating within normal temperature conditions.</p> <p>IDEC power relays are rated to have a temperature rise of ~105°C from ambient when loaded. Maximum temperature rise from ambient observed on day of inspection was found to be ~80°C.</p>
