## Forensic Water Leak Investigation Report

1 Sample Street, Melbourne VIC 3000 (PS XXXXXXA)

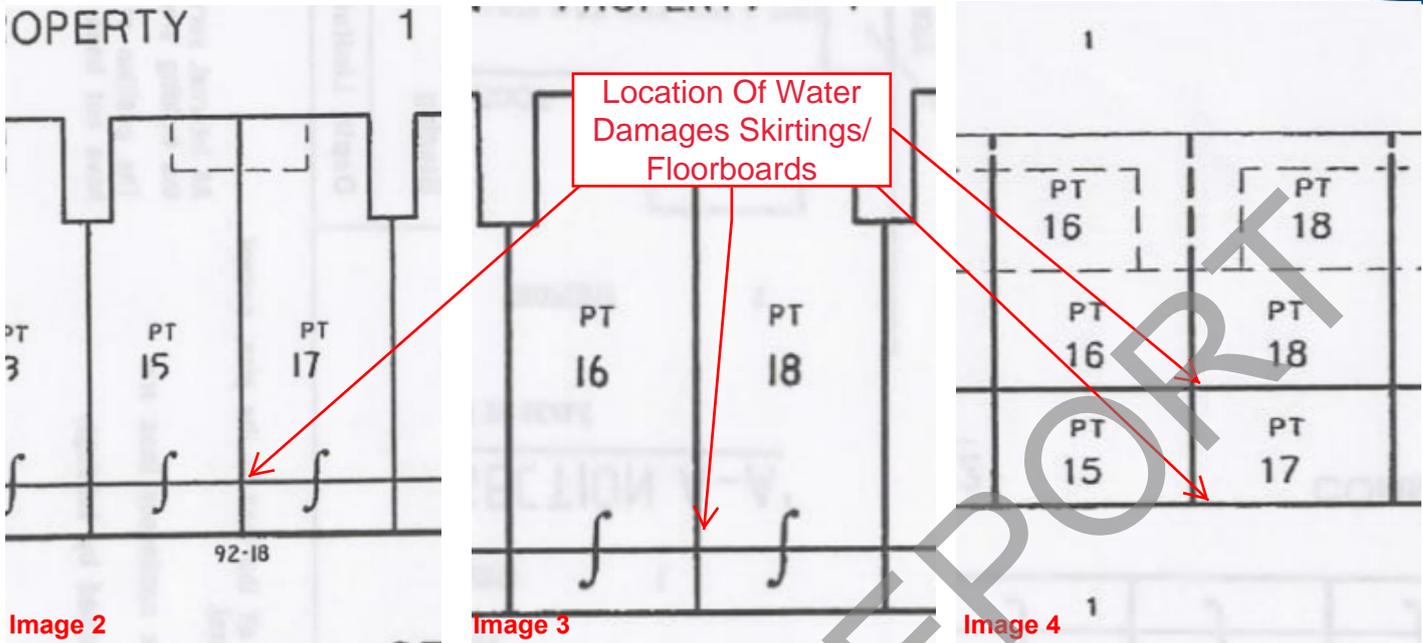
**Images 2 - 4: Snips from Sheets 2, 3 & 4 of the Plan of Subdivision (PS430798A)**

The adjacent/above balconies on Ground and Level 1 of Units 17 & 18 were inspected and were noted to be mostly covered from rain, the balconies of Units 15 & 16 are believed to be of similar construction. In light of this, it is doubtful that the balconies are the source of the moisture in the skirtings/floorboards seen in Units 17 & 18, as the roof works have almost entirely resolved the water ingress into the ceiling of Unit 17, according to the resident, and may be an ongoing symptom of that leak, and the affected skirtings/floorboards in Unit 18 are directly beneath an active leak. Nevertheless to rule out the possibility of the balconies of Units 15,16 ,17 & 18, being the cause/s of the water damage, they should be water tested; however, again this is unlikely to produce any results.
