Forensic Water Leak Investigation Report

1 Sample Street, Melbourne VIC 3000 (PS XXXXXX)

Part 1: Inspection Notes

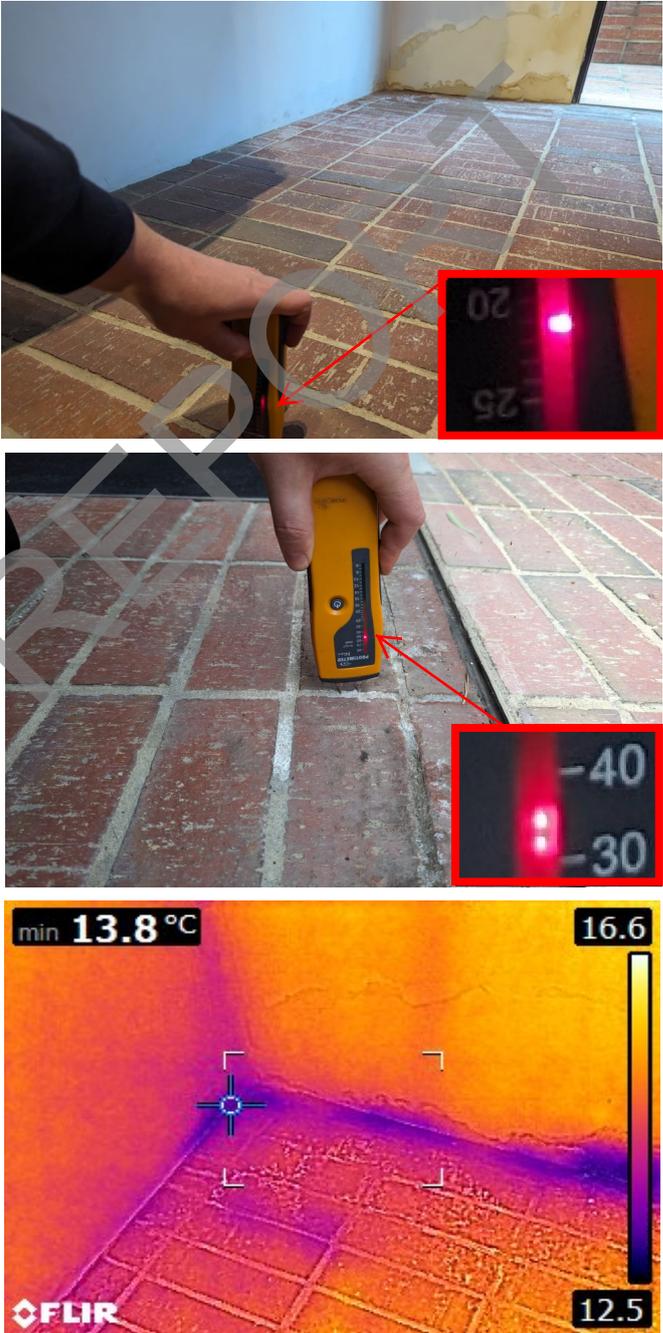
Item	Details	Photographic Details
	<p>Moisture readings were obtained throughout the ground floor lobby.</p> <ul style="list-style-type: none"> • A moisture reading of 75% WME (Wood Moisture Equivalent) was obtained at the internal wall, as seen in Image 6. • A moisture reading of 22% WME was obtained approximately 2 meters from the wall in the brick floor, as seen in Image 7. • A moisture reading of approximately 34% was obtained along the entire length of the glass windows and sliding door, as seen in Image 8. <p>The presence of moisture was again confirmed upon viewing the lobby areas with a thermal imaging camera, it was found that the wall and surrounding brick floor were already completely saturated, as indicated by the dark blue / purple regions, as shown in Image 9.</p> <p>The lower section of wall and surrounding brick floor were completely saturated at the time of inspection prior to any water testing occurring.</p>

<p>The 'Photographic Details' column contains three images illustrating thermal imaging on a brick floor. The top image shows a hand holding a yellow thermal imager, with a red laser line and a red-bordered inset showing a temperature scale with '20' and '-25'. The middle image shows a similar view with a red-bordered inset showing a scale with '-40' and '-30'. The bottom image is a full thermal image with a color scale from 13.8°C (min) to 16.6°C (max) and 12.5°C (bottom right). A crosshair is visible in the center of the thermal image.</p>

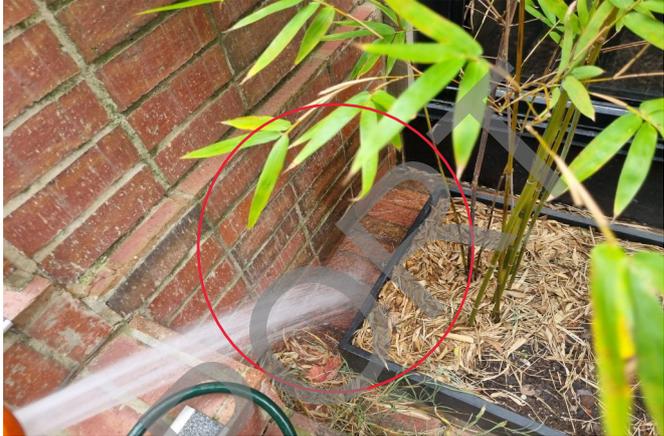
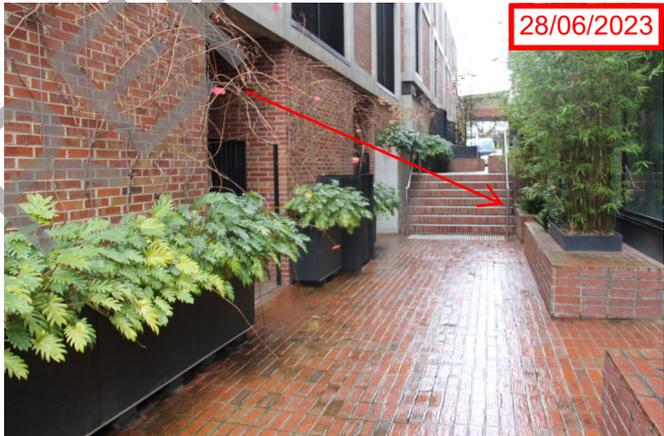
Item	Details	Photographic Details
5.	<p>Location:</p> <p>Basement - Car Park T07.</p> <p>Initial Conditions:</p> <p>The leak is occurring above Car Park T07, as shown in Image 1.</p> <p>Since the inspection for Roscon's original Forensic Building Defect Report in June 2023, the overall condition of the leak remained relatively similar, as shown in Image 2.</p> <p>The area where water was originating was visually wet prior to testing so no measurements were taken with the moisture meter or thermal imaging camera. Additionally the drip tray was found to actively be holding water, as shown in Image 3</p> <p>The leak is occurring underneath the area shown in Images 4 & 5 along the side of the central courtyards stairs.</p> <p>This water appears to be seeping from the cold joint between the two different sections of concrete. This makes sense as the area above is where the suspended slab changes level and stairs are used to access the lower central walkway. This matches with the drop in the ceiling height seen in the basement car park below.</p>

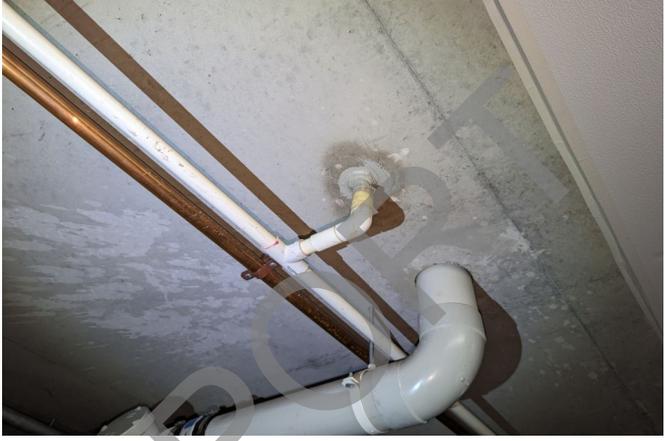
Item	Details	Photographic Details
8.	<p>Location: Basement - Adjacent To Car Park T06.</p> <p>Finding: After emulating rainfall for approximately 5 minutes in this planterbox, as shown in Image 1, water was witnessed actively dripping from what is believed to be the inlet for the irrigation system, as shown in Images 2 & 3.</p> <p>Video of this water ingress can be seen in Video #3 in Part 7: Videos.</p> <p>This kind of ingress clearly demonstrates a point of failure in the waterproofing system within the planter box itself. Furthermore, this failure was noted underneath most of the irrigation pipes. Image 4, shows another irrigation pipe which has been reverse sealed. This issue is systemic throughout the basement with many of these planter boxes showing signs of water leaking.</p> <p>Performance Requirement FP1.3 of the National Construction Code Volume One 2014 states:</p> <p><i>A drainage system for the disposal of surface water resulting from a storm having an average recurrence interval of—</i></p> <ul style="list-style-type: none"> (a) 20 years must— <ul style="list-style-type: none"> (i) convey surface water to an appropriate outfall; and (ii) avoid surface water damaging the building; and (b) 100 years must avoid the entry of surface water into a building. <p>A building defect has been noted.</p> <p>Recommendations: See Part#6 of this report.</p>
