## Detailed Building Curtain Wall Inspection

42 Sample Street Melbourne VIC 3000

Roscon Property Services have been engaged by the Owner's Corporation to inspect the condition of the curtain walls (glass panels) of 42 Sample Street Melbourne VIC 3000. The property was inspected on Thursday July 14 2014.

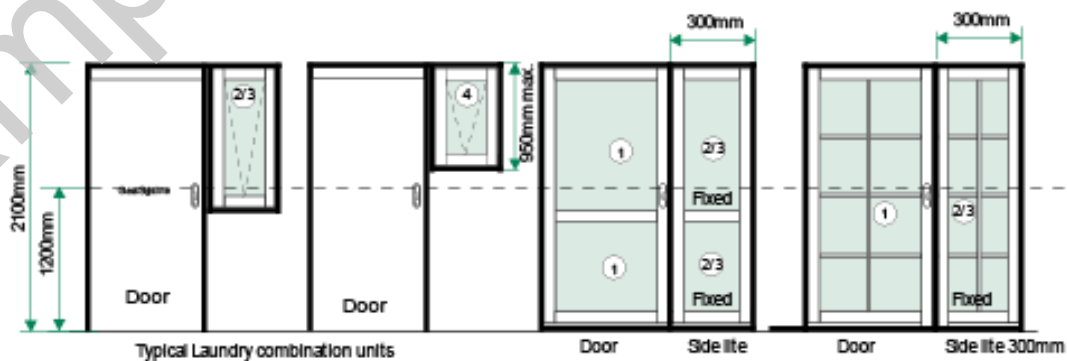
## 4. Glass - 300mm of the opening sash of the door

- 1) Grade A Safety Glass only used in doors
- 2) Grade A Safety Glass Area over  $0.3\text{m}^2$
- 3) 5mm annealed Area less than  $0.3\text{m}^2$
- 4) Ordinary annealed glass to withstand design wind load – use Australian Standard Aspect Ratio chart

All panels within the nearest vertical sight lines less than 300mm from the nearest edge of the doorway opening shall be glazed as follows:

- a) Fully framed wholly or partially within 1200mm from floor or ground level
- b) Grade A Safety glass with these exceptions:
  - A minimum of 5mm ordinary annealed may be used up to a maximum area of 0.3m<sup>2</sup> (500mm x 600mm example size)

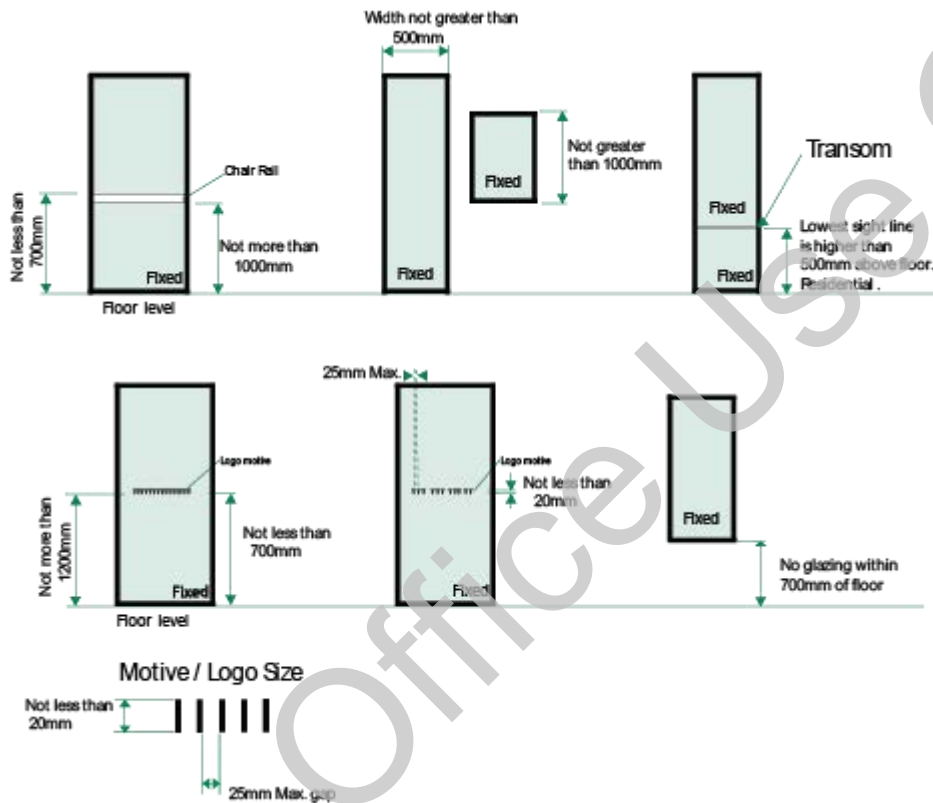
- a) The sight size width is less than or equal to 500mm
- b) The sight size height is less than or equal to 1000mm
- c) The lowest sightline is higher than 500mm above the floor level in residential buildings
- d) Where a crash/chair rail, handrail or transom is provided and located with its upper edges not less than 700mm or its bottom edge not more than 1000mm above the floor level
- e) The glazing is marked for visibility

DH Door Height	MHLE Motif Height Lower edge	M Motif
2400	1187	20
2100	1037	20
2065	1019	20

Outside these following parameters glass panel will need to be fitted with a motif permanently etched into the glass OR

Self-adhesive label that cannot be removed in single action
